# Building and Timber Pest Inspection Report

Inspection Date: Mon, 16 Mar 2026

Property Address: 37 Kerwin Cir, Hebersham NSW 2770,  
Australia

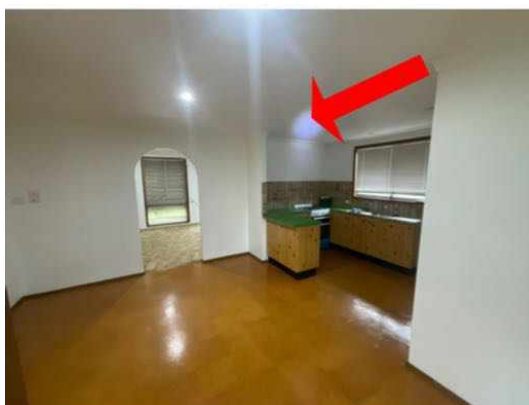
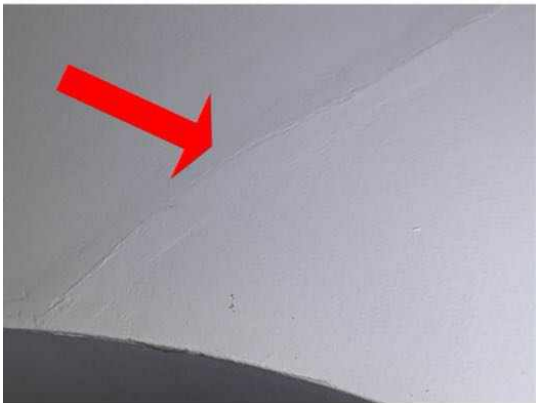
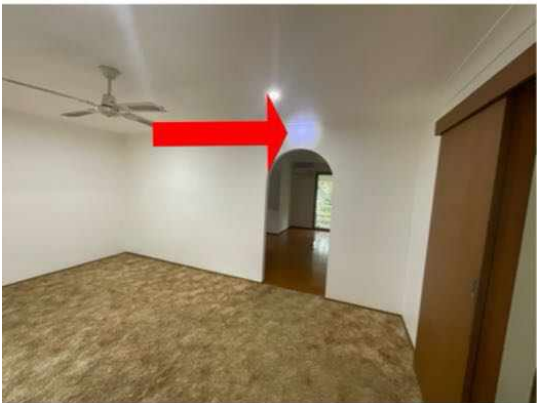
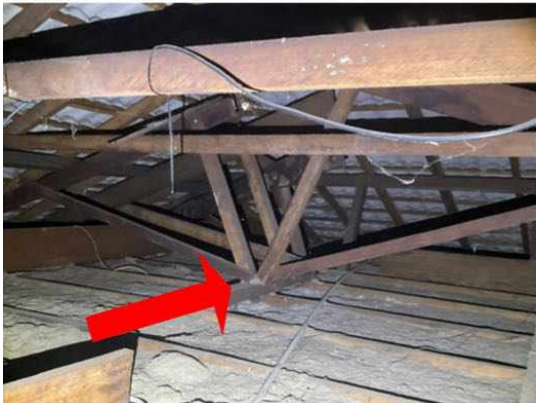
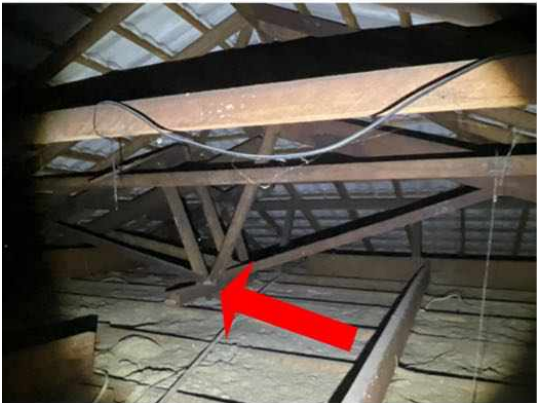
Building: Main Building  
Location: All Internal Areas  
Finding: Cracking to Ceiling and Wall – Possible Structural Load Influence  
Information: Cracking was observed to the internal ceiling lining and adjacent wall surfaces. The cracking appears to follow the line where the roof structure strutting transfers dead loads down to the supporting wall framing.

Such cracking may occur due to:

- Load concentration from roof framing members
- Minor movement or settlement of the supporting wall framing
- Shrinkage or movement in plasterboard joints

While the cracking currently appears to be relatively minor and typical of stress movement in plasterboard linings, monitoring is recommended. If the cracking continues to widen or propagate, further assessment by a qualified structural engineer or licensed builder is recommended.

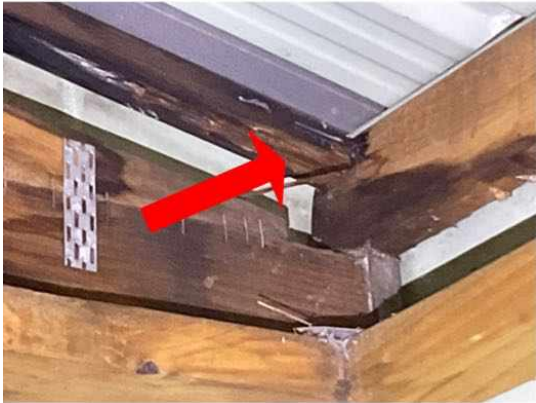
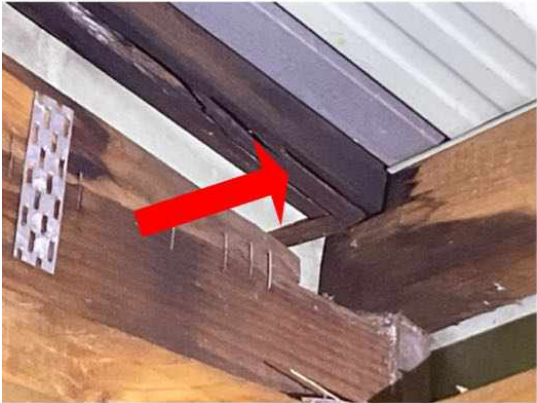
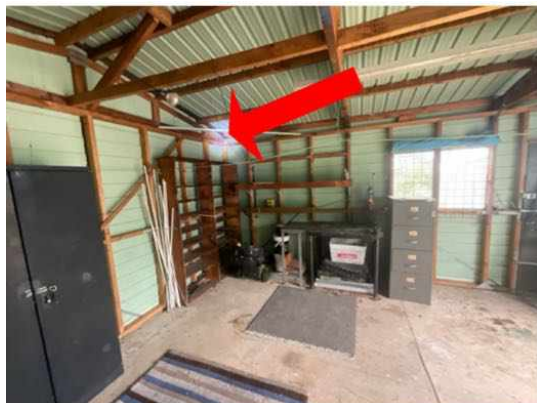
**Finding 2.02**

Building: Main Building  
Location: Garage  
Finding: Timber Damage Noted – garage  
Information: Signs of timber splitting and insect-related damage were observed in the roof void. Black ants were present within the timber, suggesting possible historical pest activity. While no live termites were found during the inspection, further invasive investigation by a licensed pest technician is strongly recommended to rule out active infestation or structural compromise.

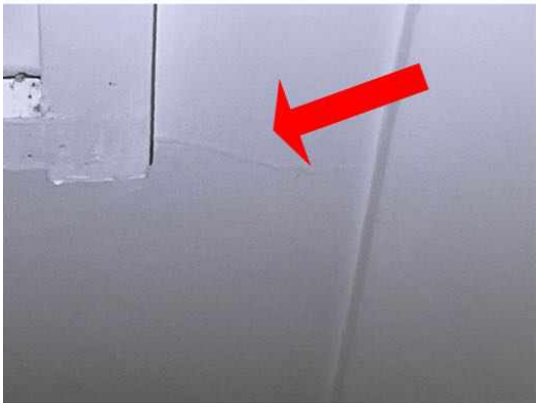
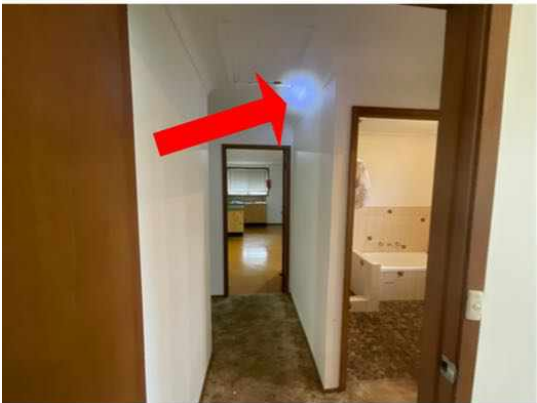
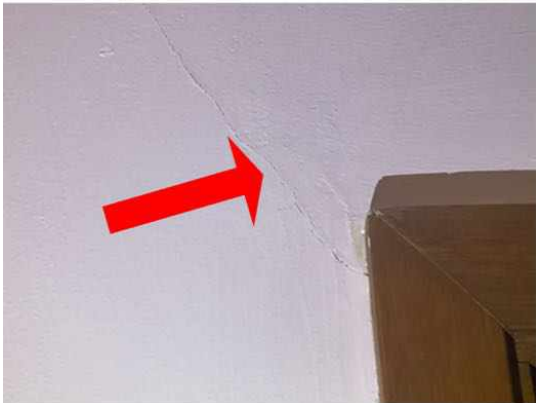
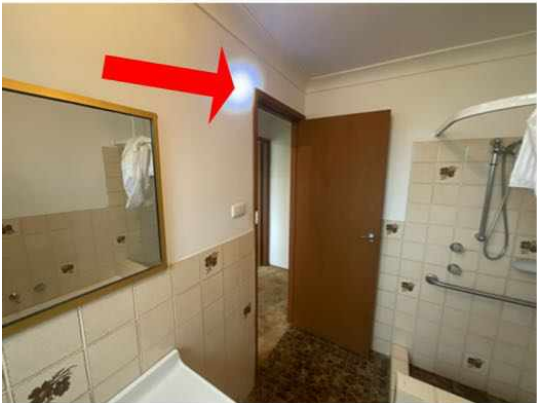
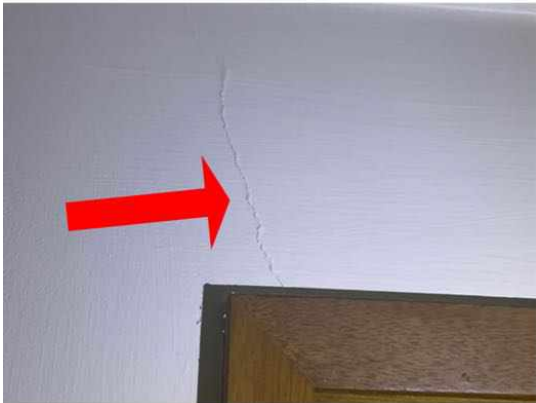
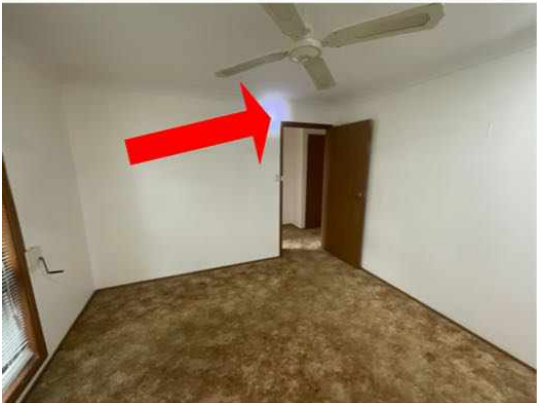
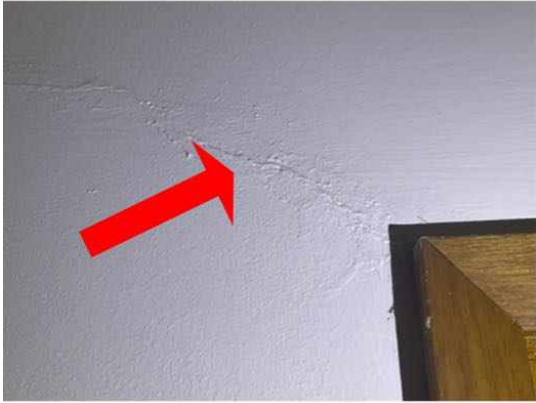
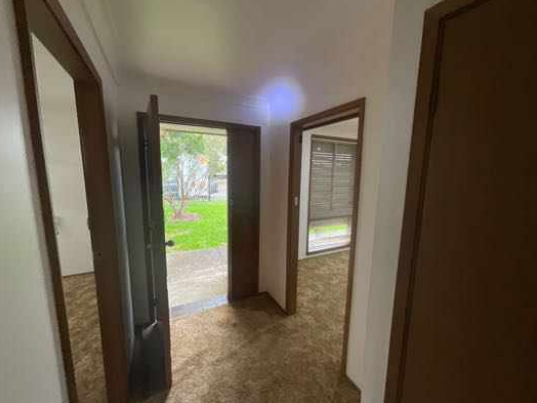
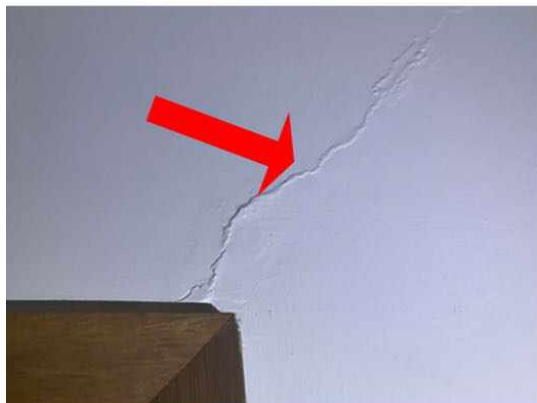
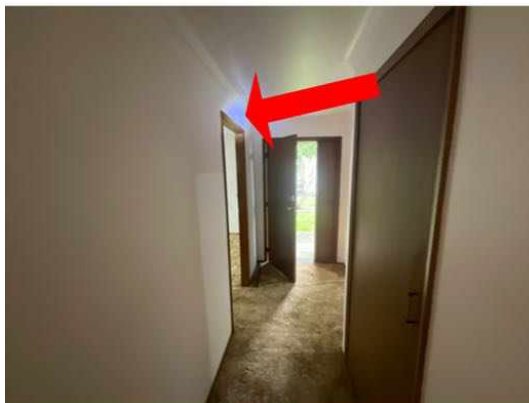
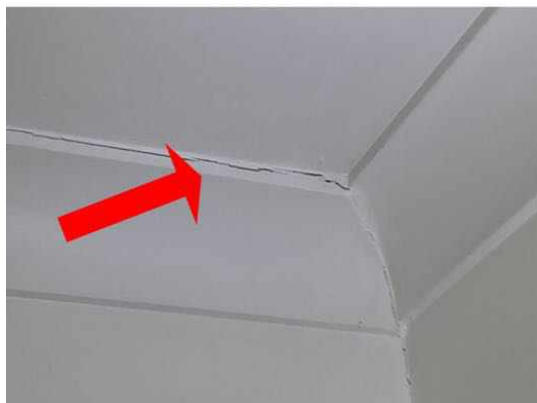
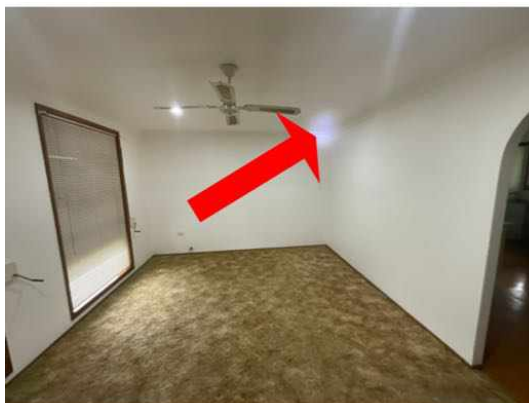
### Finding 3.01

| Finding: | Cracking to Internal Walls and Ceilings |
| Information: | Cracking was observed to several internal wall and ceiling linings throughout the dwelling. The cracking appears to be associated with stress and load transfer from the roof framing above, particularly where roof truss strutting bears onto the supporting wall structure. |

Based on observations within the roof space, roof framing members and strutting elements are located above this area which may contribute to load concentration and minor movement in the ceiling and wall linings. As a result, plasterboard cracking has developed along joints and wall/ceiling intersections.

At the time of inspection, no obvious failure of the roof framing members was observed; however, the extent of cracking suggests that movement has occurred within the structure or supporting framing.

It is recommended that the affected areas be monitored. If the cracking continues to widen or additional cracking develops, further assessment by a qualified structural engineer or licensed builder is recommended.

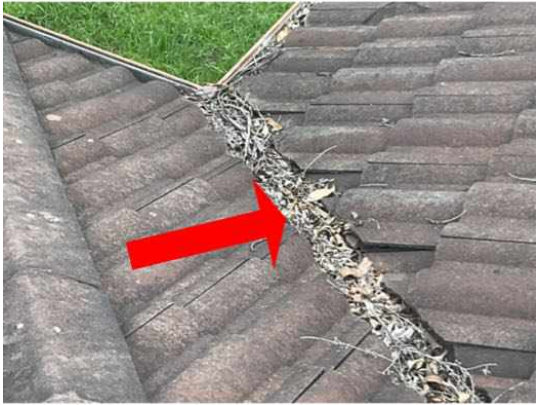
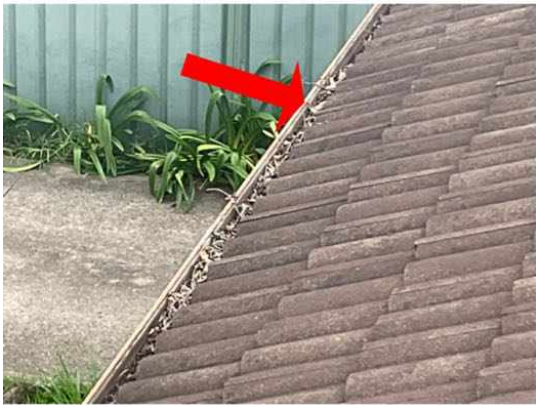
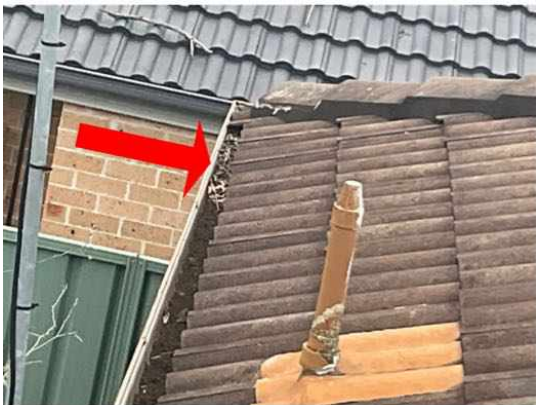
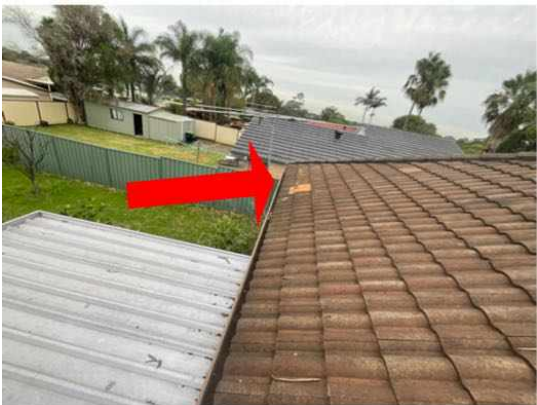
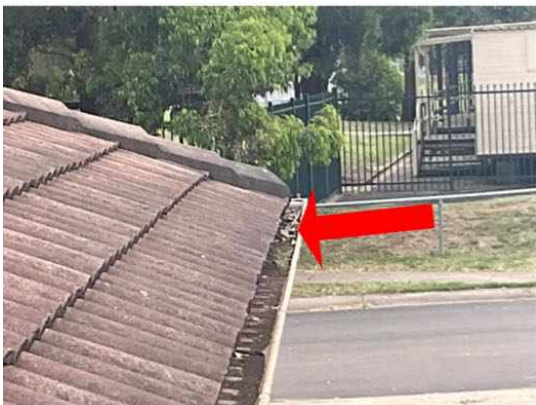
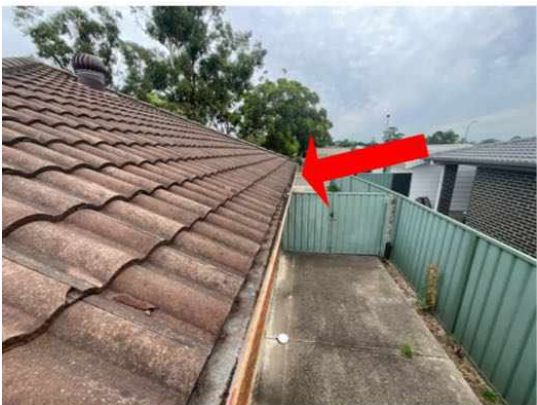
### Finding 3.03

Blocked gutters are likely to lead to high levels of moisture in the affected areas. Such moisture will not only cause rust and decay of the associated building materials, but can also provide conditions that are conducive to termite and timber pest activity. Blockages in gutters should therefore be removed immediately to ensure dry conditions are maintained.

Consult a Licensed Plumber for further specific advice on remedial works that may be required. In the interim, it is highly advised that blocked gutters be removed by the homeowner or a general handyperson as a matter of urgency.

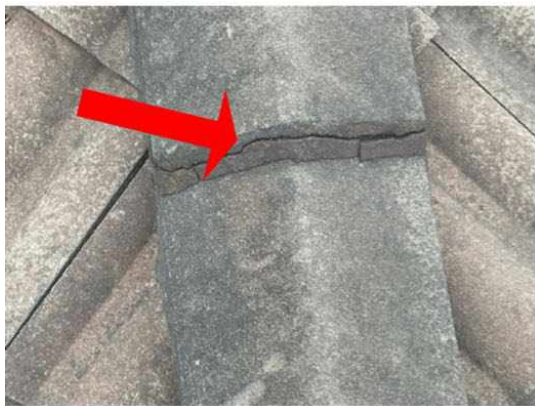
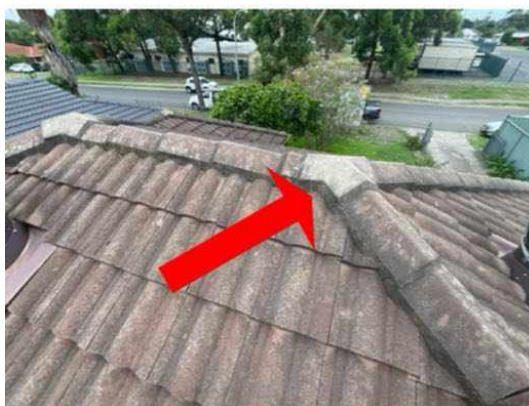
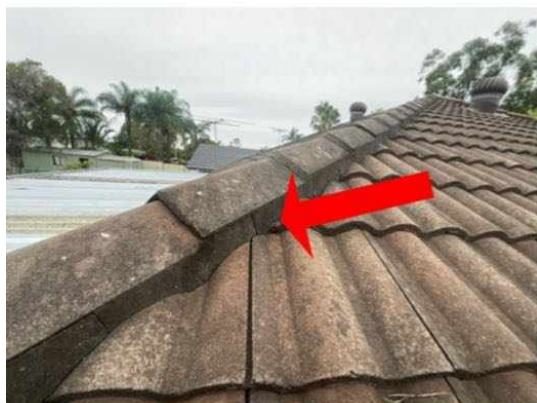
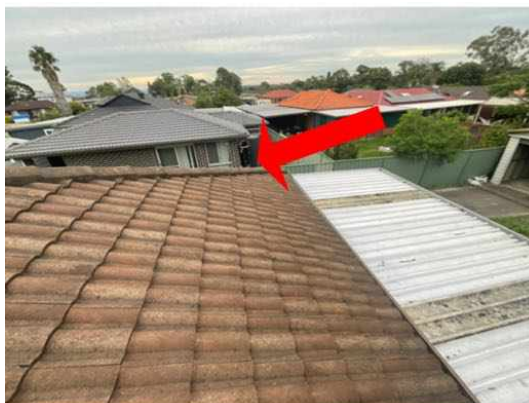
Finding 3.04

Building: Main Building  
Location: Roof Exterior  
Finding: Mortar - Deterioration  
Information: Mortar, or 'bedding', is the material which fills joins and intersections between tiles and other building elements on the exterior roof covering, such as gable ends, hip capping and valleys. Upon inspection of the exterior roof, it was noted that sections of the mortar show varying levels of deterioration.

Mortar generally deteriorates as a result of frequent exposure to weather conditions over a prolonged period of time. Mortar that is deteriorating may allow water ingress into the roof void, putting associated building elements and roofing structures at risk of water damage. Deteriorated mortar also detracts from the functionality of roof tiles and other roofing elements, potentially decreasing weather tightness and roof drainage.

Mortar deterioration can be attended to by a handyperson where areas of deterioration are localised and easily accessible. Otherwise, consultation with a roofing contractor is advised where greater works are required.

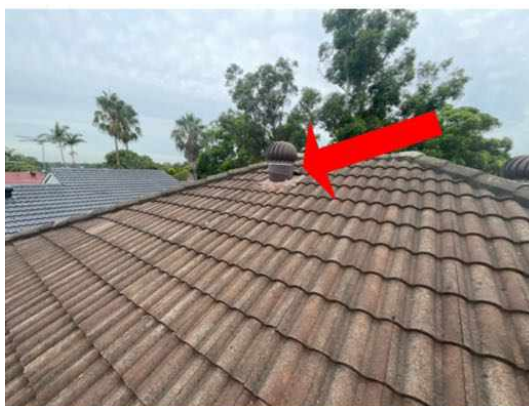
### Finding 3.05

| Finding: | Roof plumbing - Flashing inadequate |
| Information: | Some sections of the roof are missing or have inadequate roof flashings. Flashings are metal and other materials which are applied to seals and intersections between roof coverings and building elements. They are designed to aid in weatherproofing of roof joins. |

Flashings that are not installed adequately or are missing are likely to result in water penetration to the interior of the property, as well as creating excessively damp conditions against the exterior surfaces and around the base perimeter of the building.

Premature ageing and secondary building defects are imminent where roof plumbing is missing or inadequately installed. Additionally, water pooling also creates an environment that is susceptible to termite and pest infestation.

A roofing plumber should be appointed as soon as possible to install relevant roof plumbing materials, ensuring that no further damage is sustained.

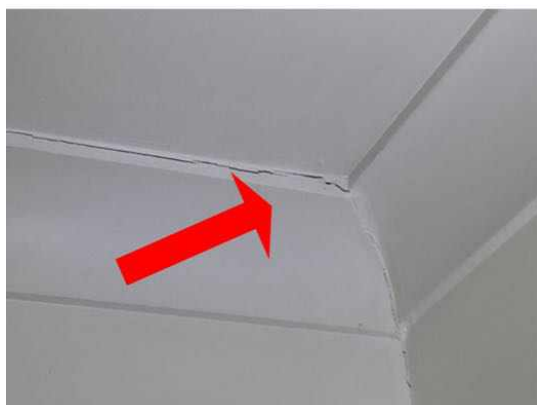
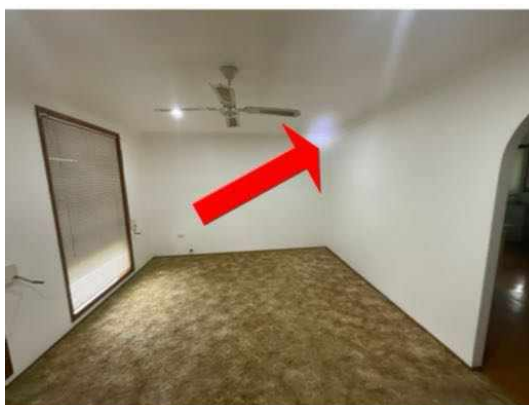
### Finding 3.06

| Information: | Sagging and uneven cornices generally indicate that the building materials have swollen, due to contact with water, or the movement of the ceiling joints or that fixings (e.g. nails or glue) have become loose and require reattachment. In some cases, sagging and uneven surfaces may also indicate that there are structural issues causing surfaces to warp, twist, or sag. |

Where sagging appears to be major, appointment of a structural engineer is advised to further inspect the property. Otherwise, minor works such as re-gluing of wall/ceiling sheets may be required and should be performed by an aptly qualified plasterer or carpenter.

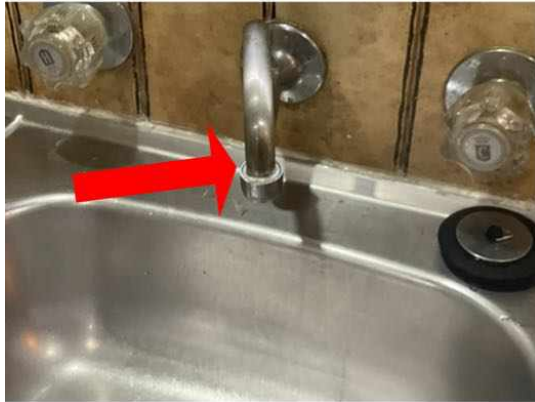
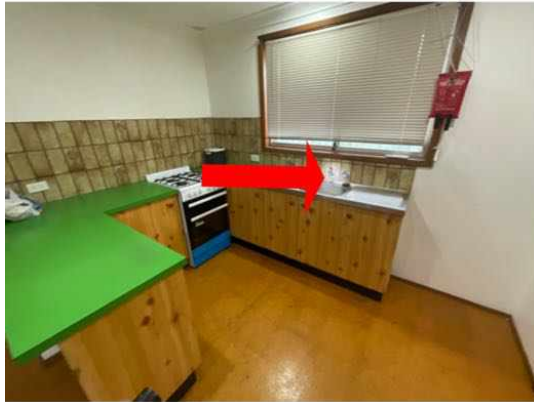
### Finding 3.07

| Finding: | Vanity Tap - leaking |

plumbing fitting is not properly sealed or installed.

Licensed plumber to inspect and rectify the leaking connection to ensure watertight installation and compliance with AS/NZS 3500 Plumbing and Drainage Standards.

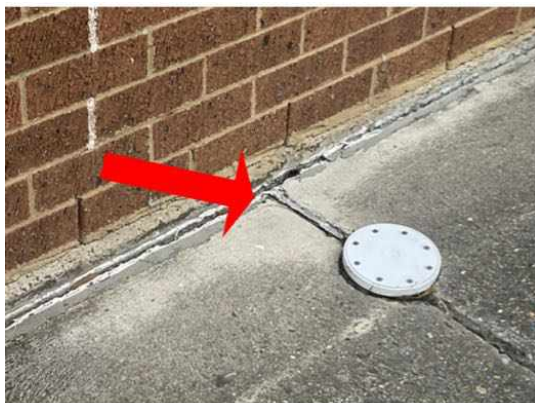
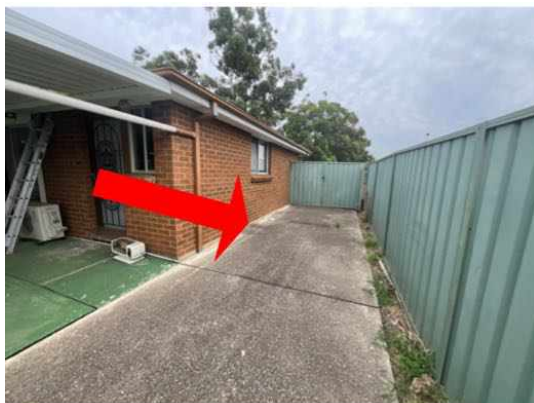
### Finding 3.08

Building: Main Building  
 Location: All External Areas  
 Finding: Concrete paving - Erosion  
 Information: Erosion under concrete paving was identified at the time of inspection. For all the concrete paving without the right support, concrete will crack, sink and cease to be the sturdy. It's imperative to fix erosion under concrete immediately as well as improve rainwater drainage away from the building foundations.

Suggestion of the inspection from the structure engineer and A qualified tradesmen to be nominated to fix the defect as soon as possible.

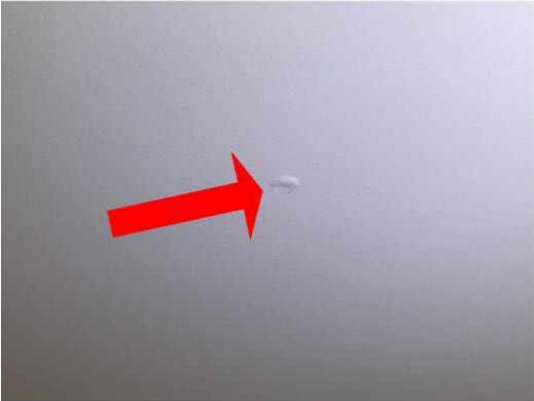
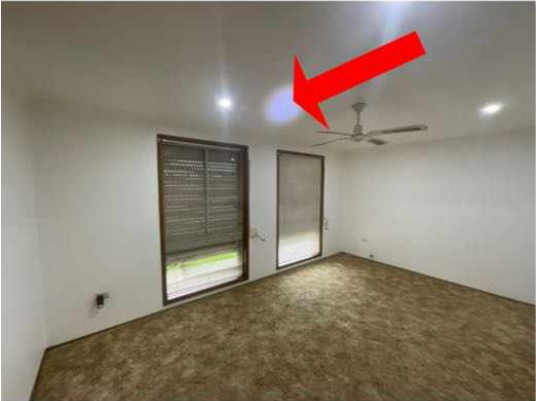
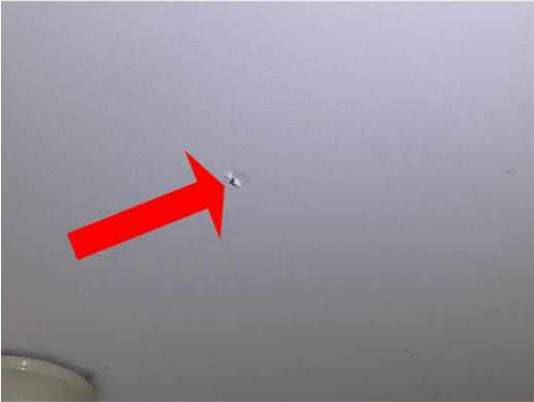
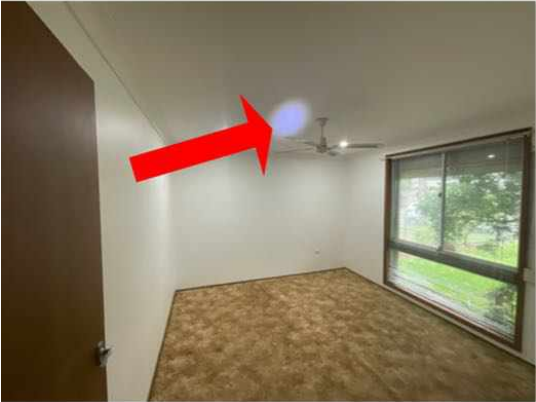
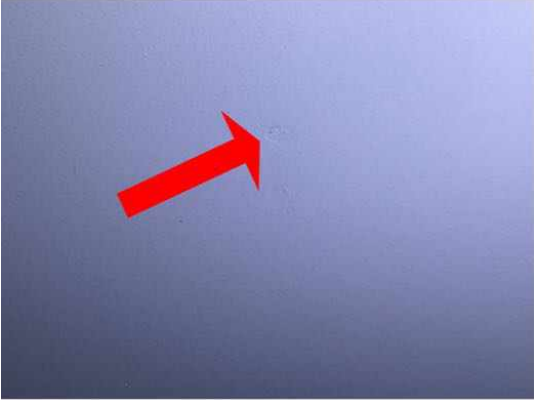
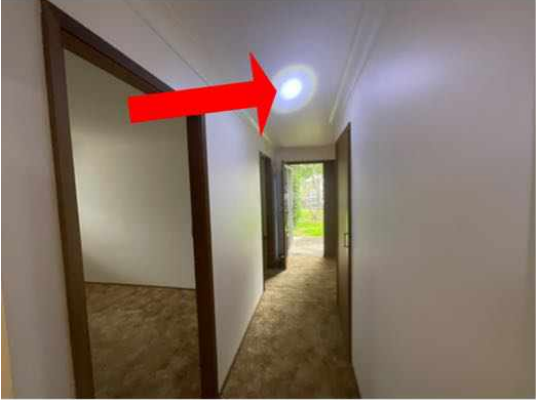
Nail/screw popping was observed to the ceiling lining. This is indicated by visible protrusions and minor cracking around the fixing points of the plasterboard. This condition is typically caused by inadequate fixing, movement of framing members, or poor installation workmanship.

Installation of plasterboard should comply with AS/NZS 2589:2017 – Gypsum Linings – Application and Finishing and NCC 2022 – Housing Provisions H2D2 (Construction in accordance with good building practice).

It is recommended that the builder rectify the affected areas by re-fixing the plasterboard where necessary and making good the ceiling finish.

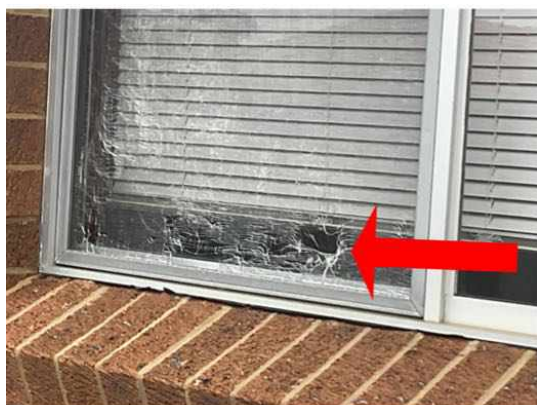
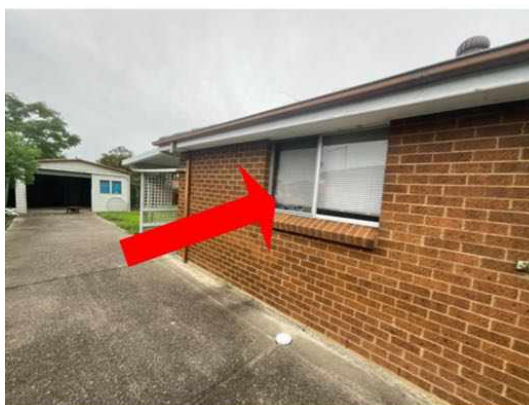
### Finding 3.10

| Finding: | Flyscreens - Damaged |
| Information: | Flyscreens were found to be damaged to the windows in this area at the time of inspection. This damaged building element detracts from the operational state of the window. Where not replaced, damaged flyscreens allow pest and insect ingress into the adjoining room/s. It is advised that all damaged building elements be replaced in order to ensure the full function of all building structures. A general handyperson may be appointed to replace flyscreens at the discretion of the client. |

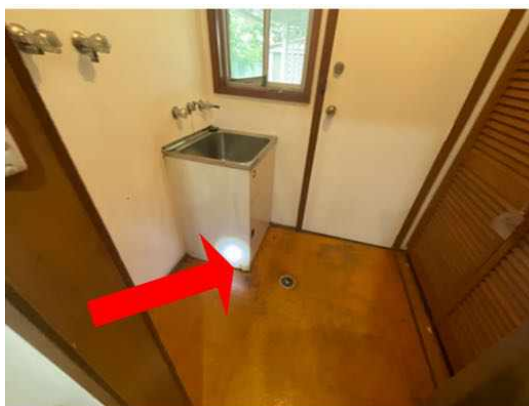
### Finding 3.11

| Finding: | Evidence of excessive moisture was present at the time of inspection - laundry |
| Information: | Moisture was identified in the laundry involving moisture accumulation on the wall. Upon inspection, there's noticeable dampness spreading across the surface, suggesting potential water ingress or inadequate waterproofing. This issue warrants immediate attention to prevent further damage, such as mold growth or structural deterioration. This moisture poses a risk of structural damage and mold development if left unattended. |

It is highly recommended that all plumbing and drainage fixtures and fittings be maintained regularly in order to prevent excessive moisture being present in the external / internal property.

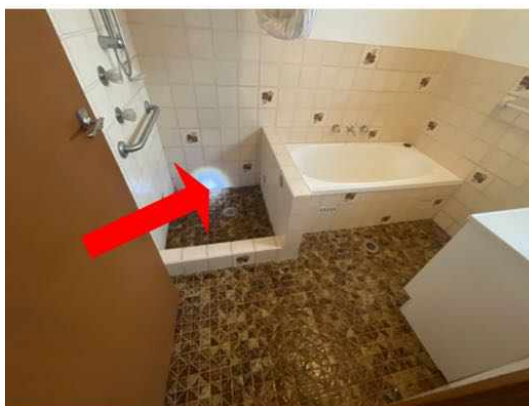
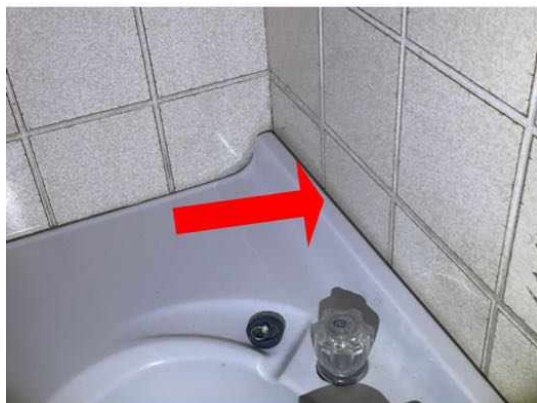
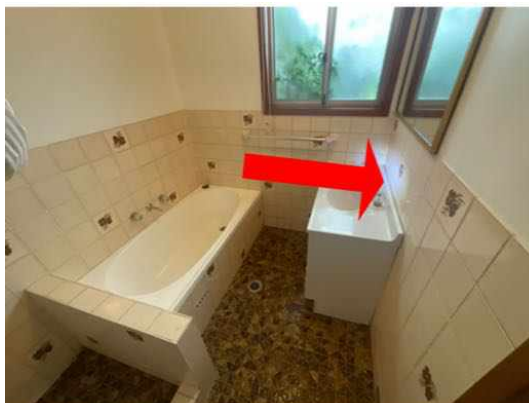
### Finding 3.12

| Finding: | Sealant and grouting - Missing or damaged |
| Information: | It was noted on inspection that sealant or grout is degraded to the tiled shower alcove and or other areas of the bathroom. |

Different materials and floor areas move at different rates, generally causing cracking to grout or sealant at this point. A flexible sealant is required to allow for expected expansion and contraction, while keeping the joint water tight and protective of all associated building materials.

There appears to be excessive mould to the sealant and grout which will likely require scraping out and replacement.

Flexible and mould resistant materials should be applied to affected areas to prevent any subsequent water damage that is likely to occur. Regular maintenance and replacement of damage or missing or damaged sealant and grout is highly recommended to the wet areas, as this is a regular wear and tear defect. Sealant and grouting in areas that come into regular contact with water should be maintained for the long term care of your property.

A sealant specialist or tiling contractor should be appointed to complete these works as soon as possible

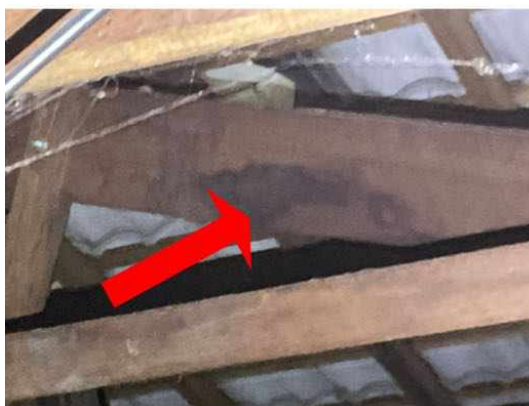
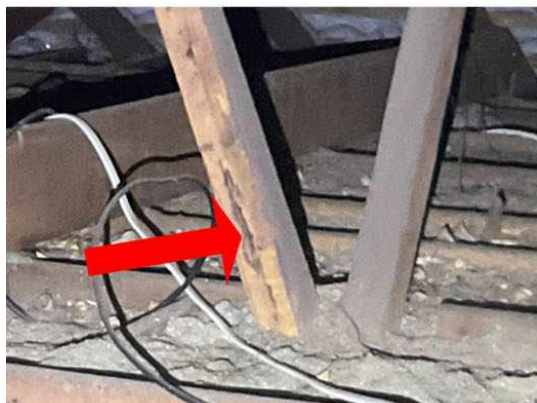
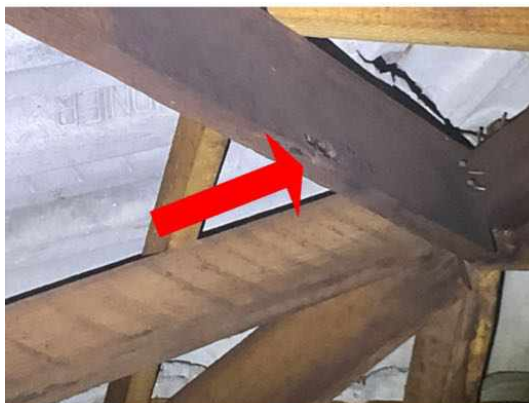
### Finding 3.13

| Information: | Chemical delignification also known as wood defibration refers to the chemical breakdown of timber building elements. This breakdown of the Lignin deteriorates the wood impacting on the structural integrity and tensile strength of the affected building element. |

Chemical delignification is most common near marine environments due to the high levels of salt in the air however this deterioration may also occur in other areas where timber elements are frequently exposed to damaging gases chemicals etc.

Where timber building elements have deteriorated repair and / or replacement is required immediately to ensure the safety of the associated structures. The likely cause of the defibration should also be investigated and dealt with accordingly.

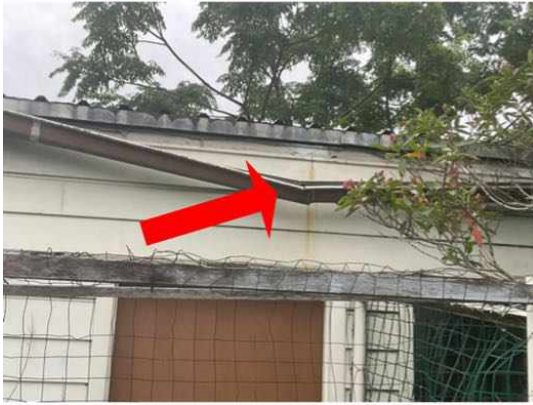
### Finding 3.14

| Finding: | Building Element (Gutter) - Damaged |
| Information: | Damaged gutter were found to be present to roof plumbing work. The damage of gutter creates damp conditions in the affected area , causing potential for water pooling and subsequent water damage if left unattended. These conditions may also attract termite attack, particularly if the area is subject to minimal levels of sun throughout daylight hours. |

It is highly advised that a licensed roof plumber or proper tradesperson be appointed to rectify any water leaks that may be present. Areas of repair and replacement of plumbing fittings and fixtures may be required and, as such, a quotation should be sought.

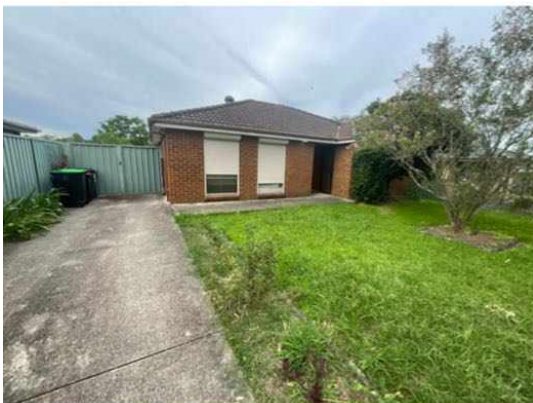
### Finding 6.01

Building: Main Building  
Location: All Areas  
Finding: Garden Beds - Conditions Conducive to Termites  
Information: Garden beds were found to be evident in the garden area. These garden beds can include untreated timber, and with a combination of moisture from watering hosing can make conditions conducive to termite activity and termite ingress.

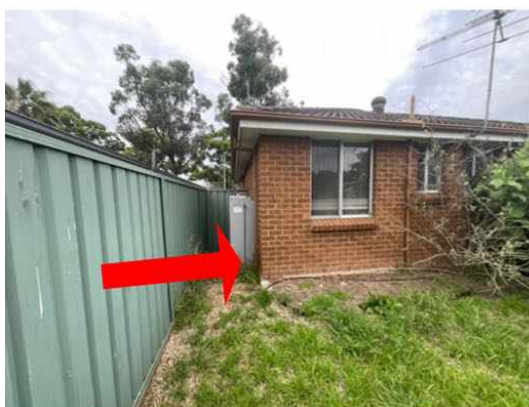
### Finding 6.02

| Information: | The Hot Water System (HWS) overflow was found to be disconnected from storm water drainage and is creating excessive moisture in the surrounding area. |

These damp conditions can lead to secondary defects such as rot, rust or corrosion of associated building elements, the formation of fungal decay, or even the creation of potential slip hazards. When coupled with poor site drainage, pooling of water may also attract termite activity to this area.

It is highly recommended that a licensed plumber be appointed to connect the HWS overflow in order to prevent such an environment from being created. These minor works should be carried out as soon as possible.

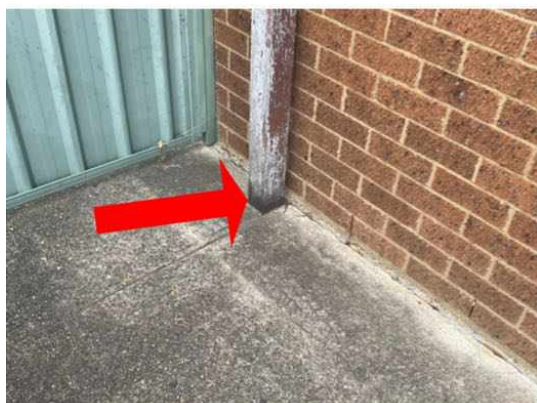
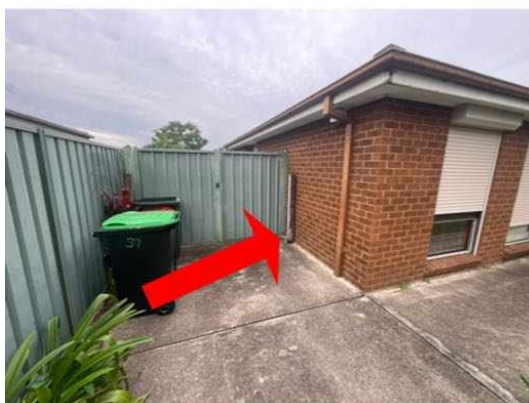
| Information: | Any timbers in direct ground contact provide opportunity for concealed termite entry and are likely to be subject to premature rot and decay as the soil retains moisture or damp conditions against the timbers. |

Remove untreated timber that is in direct contact with external grounds. Consider replacement with more durable materials i.e. treated timber or non timber elements. Frequent pest inspections are advised to readily identify any termite activity in these areas.

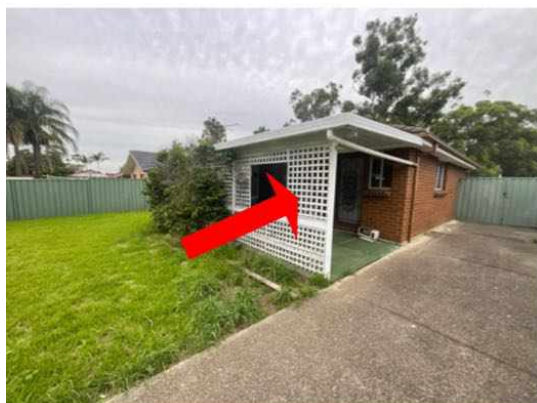
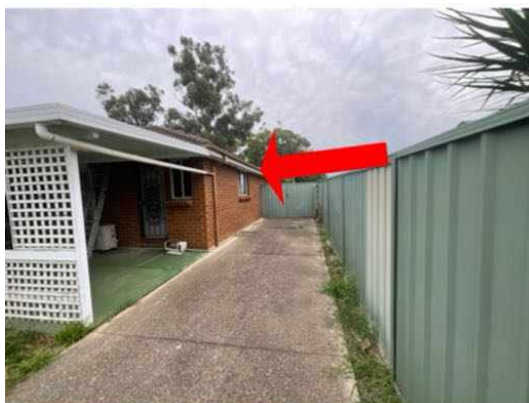
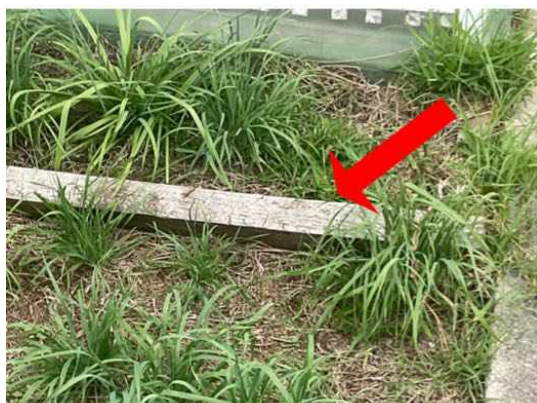
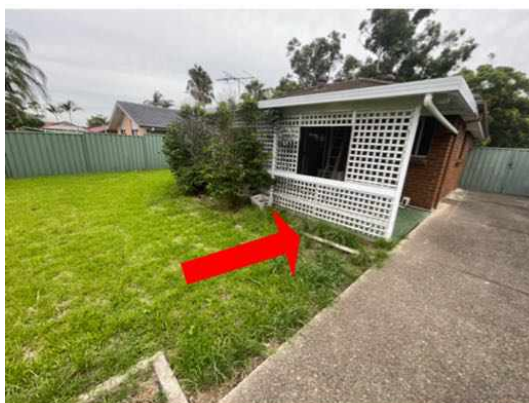
### Finding 6.05

Information: External timbers that are frequently exposed to harsh weather conditions require adequate protection in order to maintain their condition. Where timbers have not been painted or treated adequately, general deterioration is likely to occur at an accelerated rate.

If left unattended, replacement of these timbers is likely to be necessary in the short-term future. Adequate treatment of these timbers is required as soon as possible by a painting contractor or general handyman.

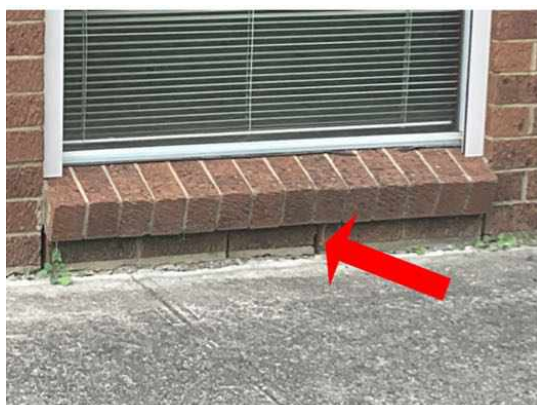
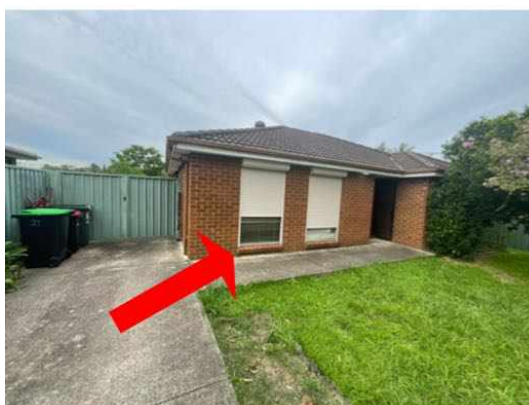
### Finding 6.06

Building: Main Building  
 Location: All Areas  
 Finding: Bridging or breaching of termite barriers - weep holes  
 Information: Bridging is the spanning of a termite barrier or inspection zone so that subterranean termites are provided with passage over or around that barrier.

Weep holes in the exterior brickwork of the property are designed to allow condensation that may build up between the brickwork and subsequent timber framework to drain from within the wall hence preventing any deterioration of the

Additionally build-up of moisture is likely to occur if weep holes are covered further attracting termite activity to these areas.

It is highly recommended that weep holes are left exposed in all areas throughout the external property. Therefore if any termite activity leading into weep holes becomes easily detectable during frequent pest inspections.

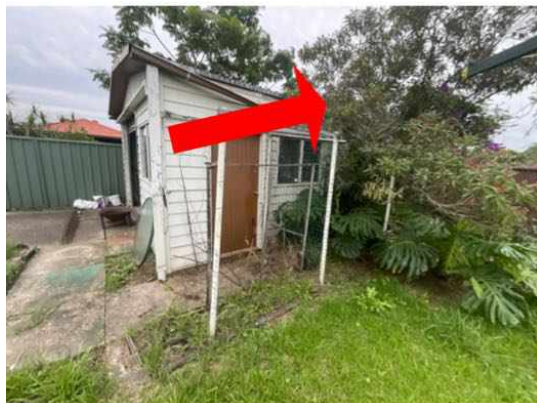
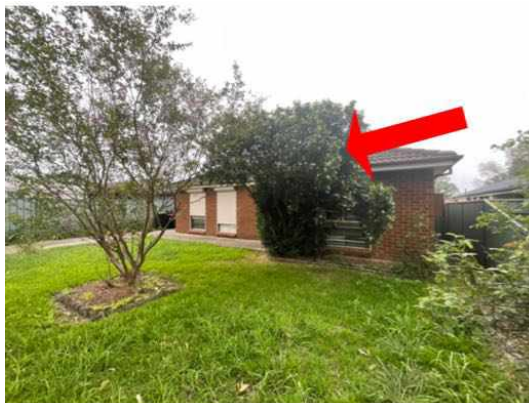
### Finding 6.07

Gutters are a critical part of the building's management of storm water and rain. It is therefore important that they be kept clear to prevent secondary damage to associated building elements, including exterior and interior walls, ceiling linings and any adjoining building elements. Where gutters are blocked, pooling of rainwater is likely to occur, fast-tracking rust and corrosion of the roof plumbing elements.

It is highly advised that all overhanging tree branches be removed as soon as possible to prevent any further damage. Repair and/or replacement of sections of damaged guttering may also be required where the extent of the damage necessitates.

Such works should be performed by the homeowner; however, appointment of a landscape contractor or an arborist may be required. Consultation with a licensed roof plumber is required where guttering has been damaged.

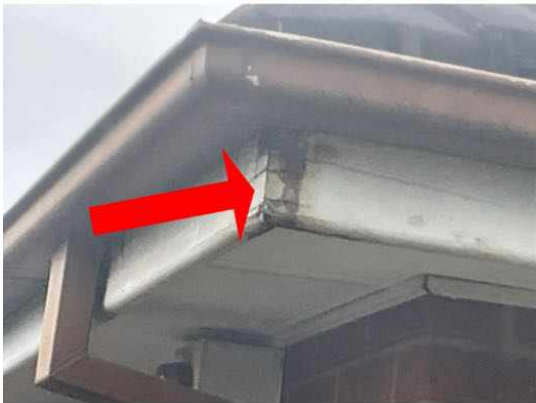
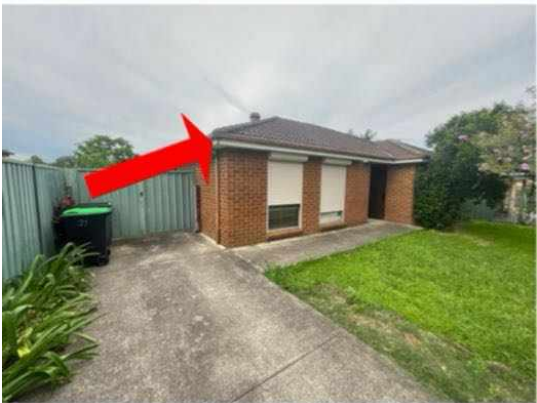
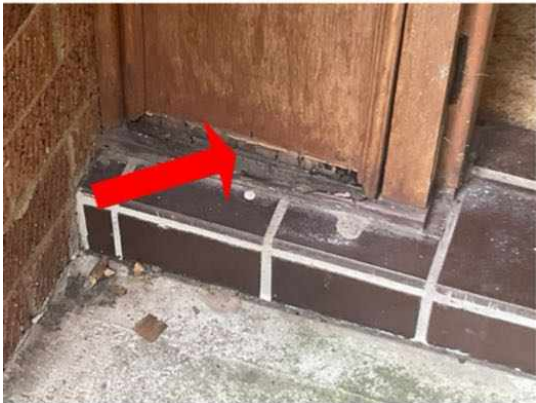
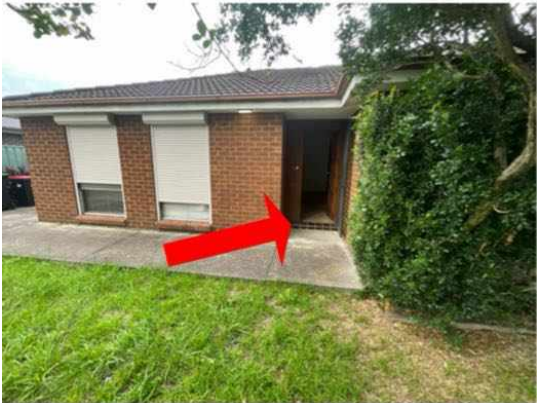
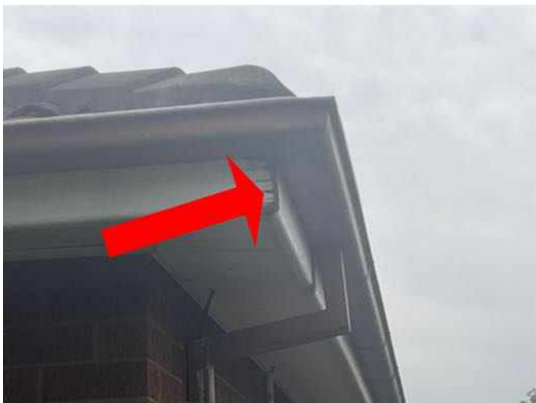
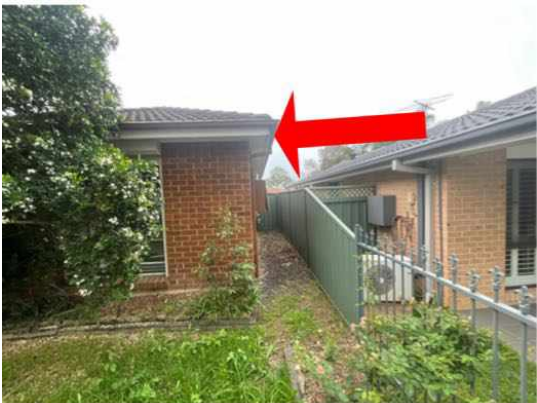
### Finding 7.01

Finding: Wood rot

Information: This building element shows evidence of wood rot. Wood rot, also known as Fungal Decay, occurs when timbers and other cellulose building materials are exposed to damp conditions on an ongoing basis. This could be the result of exposure to weathering over a prolonged period of time, or the attraction of excessive moisture from other abutting building materials. Contributing factors also include poor air ventilation in the area.

Wood rot is often associated with general damp problems and is evidenced by a 'musty' smell or mould and mildew occurring on surfaces. If left unmanaged, damp conditions can lead to further health problems and the decay of timbers will continue.

Early intervention and regular maintenance, particularly of exterior timbers, will prolong the useful life of these building elements. Prior to any works being performed, the cause of the moisture that has created the visible wood rot should be identified and addressed in a suitable manner. Replacement of affected timbers may then be a necessary step in protecting surrounding building elements from such deterioration.

A qualified plumber may be appointed to assess the cause of excessive moisture and to provide advice on any remedial works as required. A qualified carpenter or registered builder may also be required to replace affected building materials.

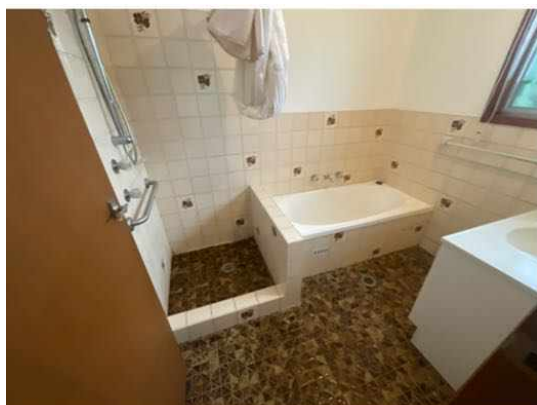
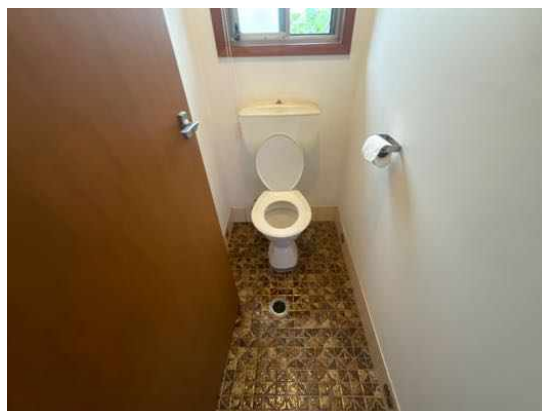
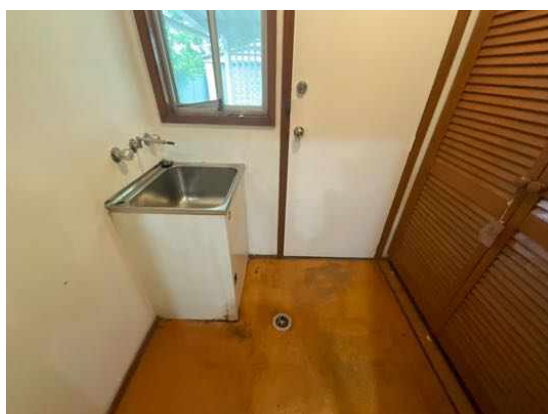
| Finding: | Water Proofing Membranes - Information Only |
| Information: | Internal Water Proofing Membranes, are crucial in preventing water ingress into the property is important to know that the Membrane System used is to Australian Standards and has been installed correctly. Please refer to the original Building Documents or Maintenance Schedule for the relevant information including; - Membrane used and Manufacturers Specifications. - The Installer and Installation Certification. Especially with older property's where this information is unavailable, all wet areas should be monitored. Generally new waterproofing with a certificate may only have a guarantee of 8yrs. If any leaks, water staining, peeling or bubbling of the paint become evident to any adjacent walls or ceilings below a licensed builder or waterproofing specialist is recommended to investigate further. |

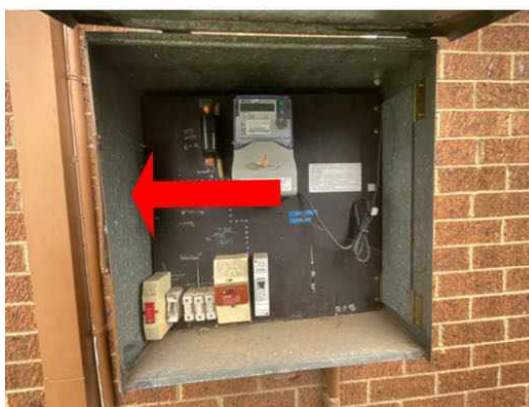
Location: All Areas  
 Finding: Termite Management System - no evidence of a chemical installation  
 Information: The application of a post-construction chemical termite barrier is highly recommended for all properties, particularly if live termite activity has been found on the site previously. Such barriers are highly effective in preventing termite attack on any timber building elements throughout the property.

A durable notice should be placed in the switchboard unit to indicate current termite barriers. At the time of inspection, it appeared as though no termite management system has been installed, with no evidence to suggest preventative works taking place.

The client may consider gaining further advice from a pest controller as to the costs and procedures involved with this application. It is recommended that obtaining such advice be a short-term priority.

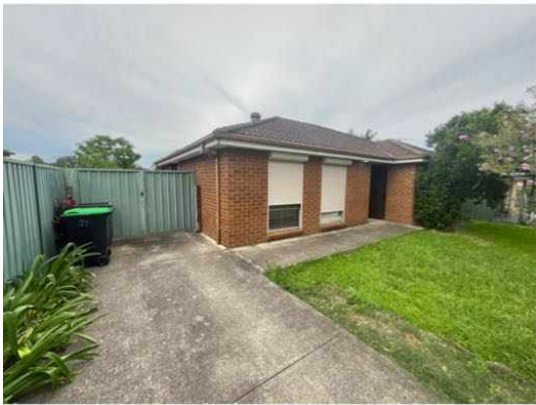
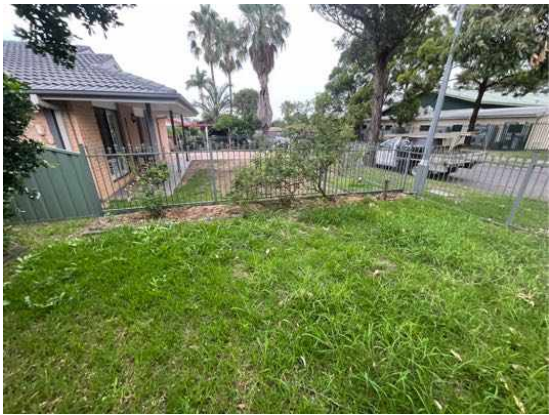
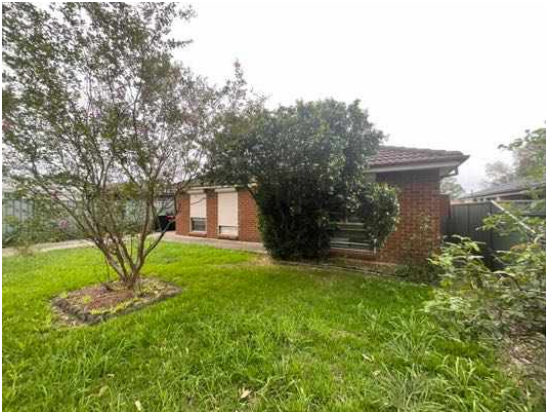
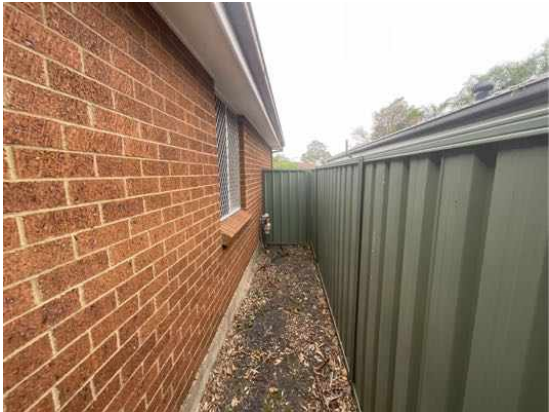
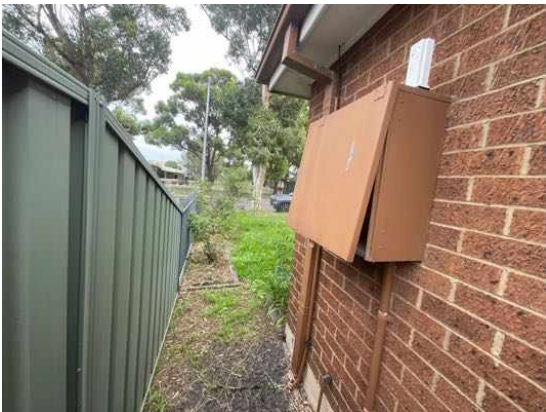
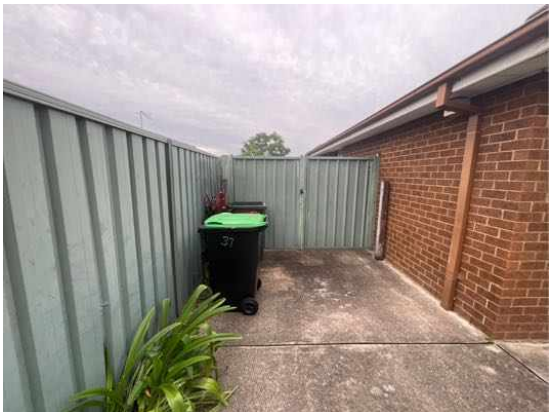
Building: Main Building  
 Location: All Areas  
 Finding: Additional Photos - Obstructions and Limitations  
 Information: These photographs are an indication of the obstructions and limitations which impeded full inspection of the property at the time of inspection. These obstructions can hide an array of defects and should be removed to allow full inspection to be carried out. A re-inspection is recommended once the areas are made accessible.
