# Building and Timber Pest Inspection Report

Inspection Date: Mon, 16 Mar 2026

Property Address: 37 Kerwin Cir, Hebersham NSW 2770,  
Australia

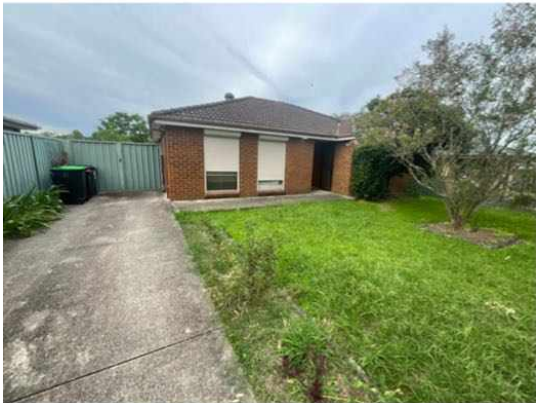
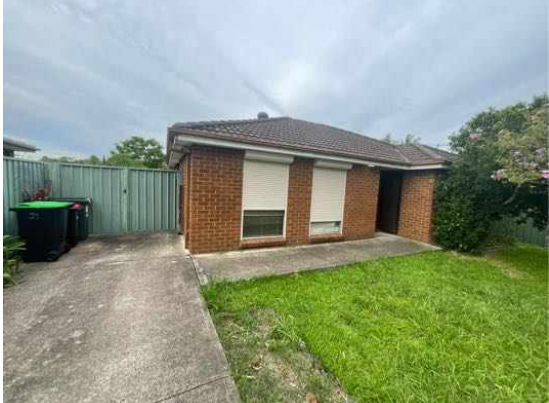
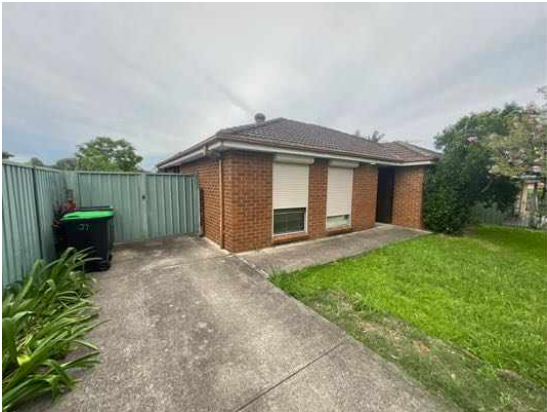
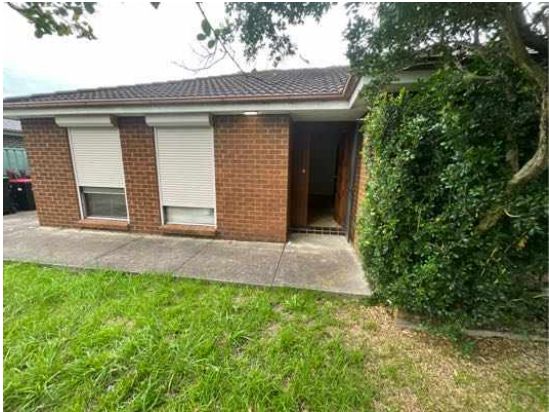
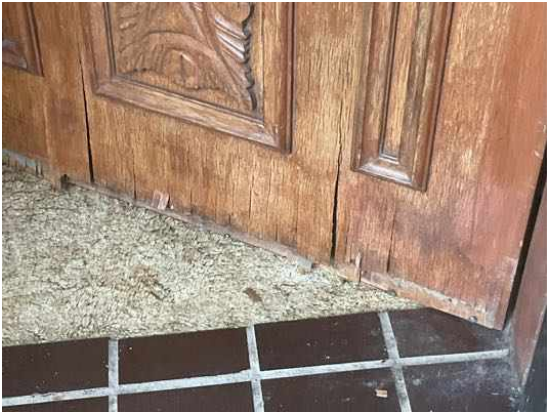
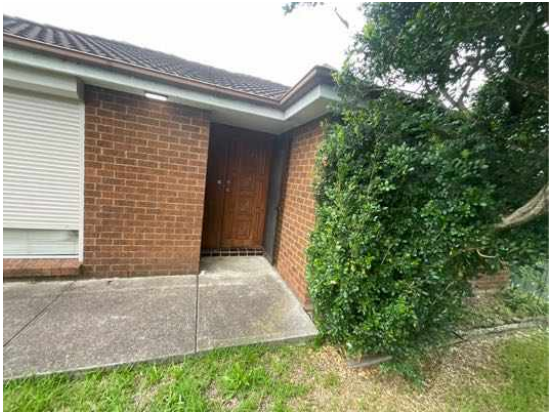
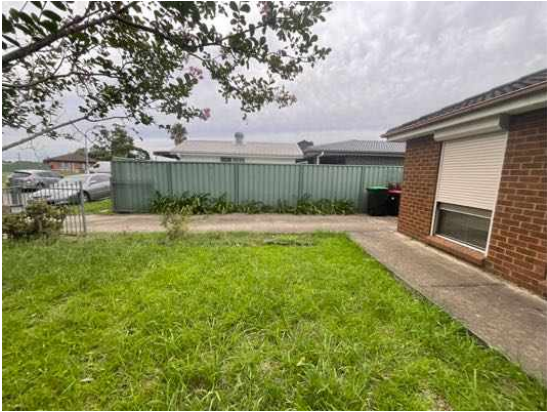
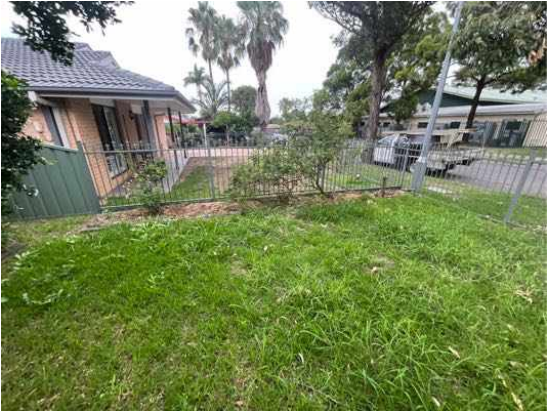
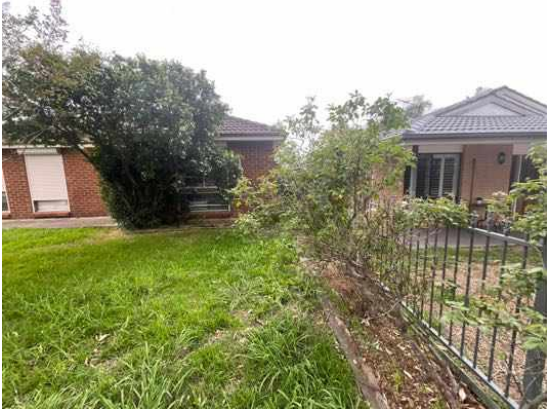
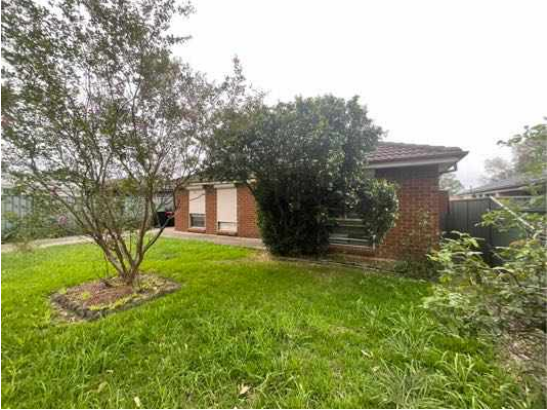
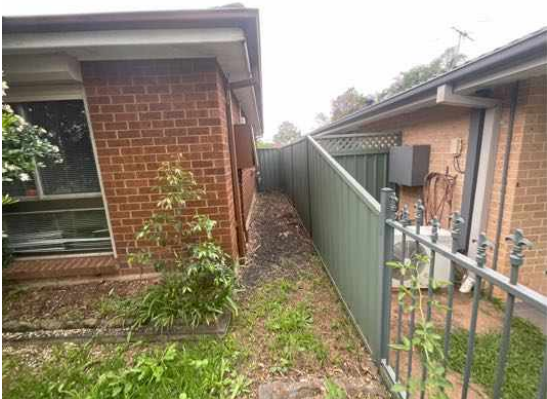
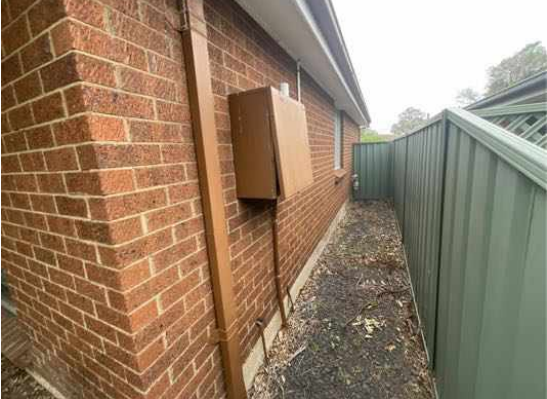
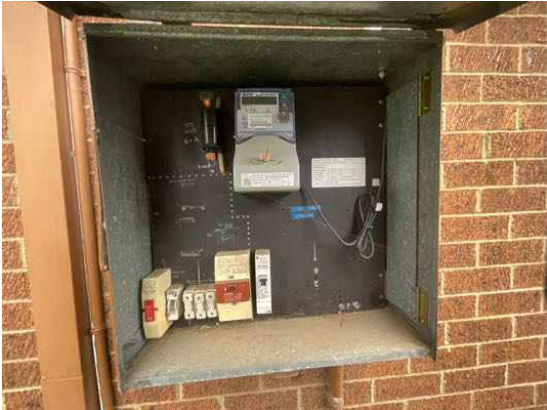
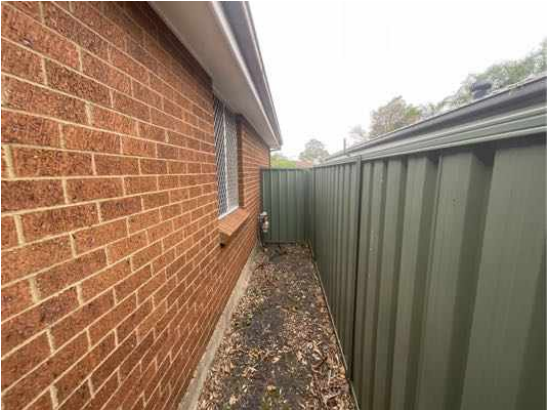
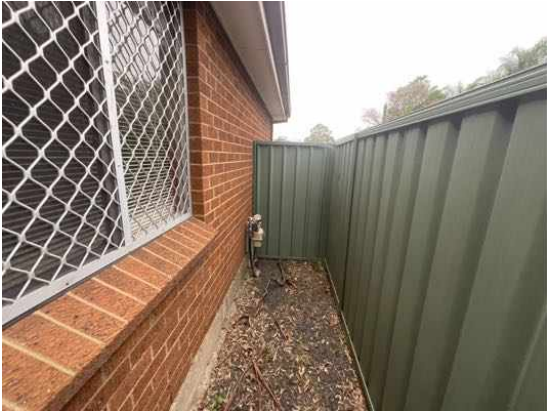
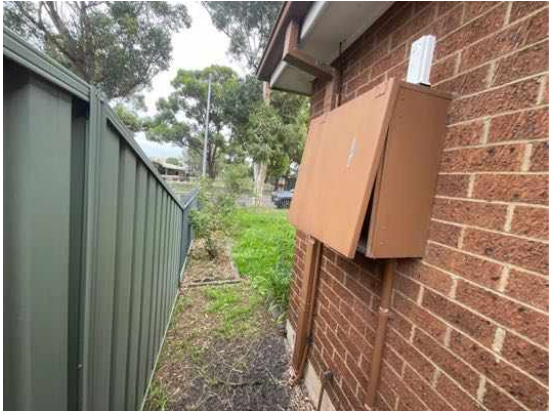
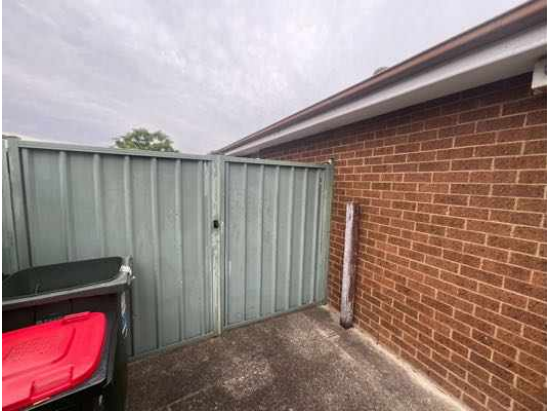
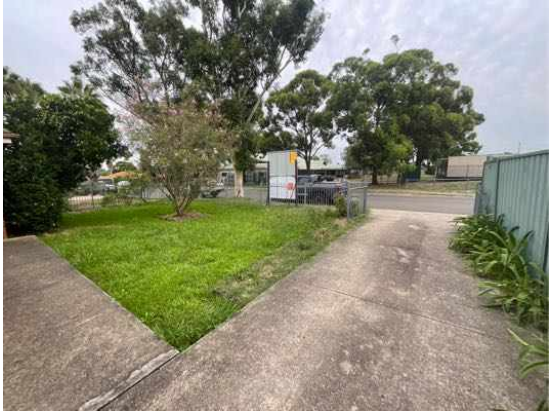
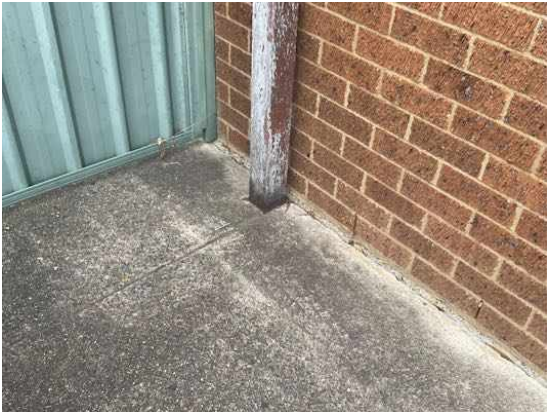
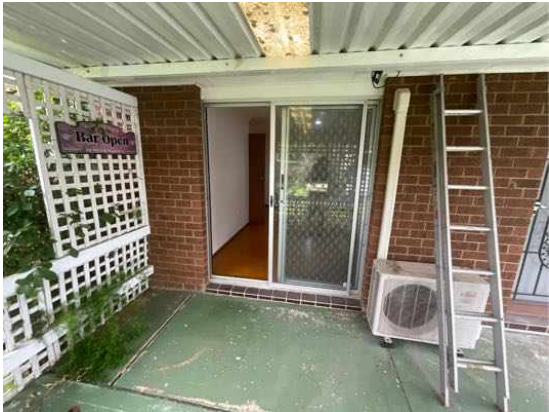
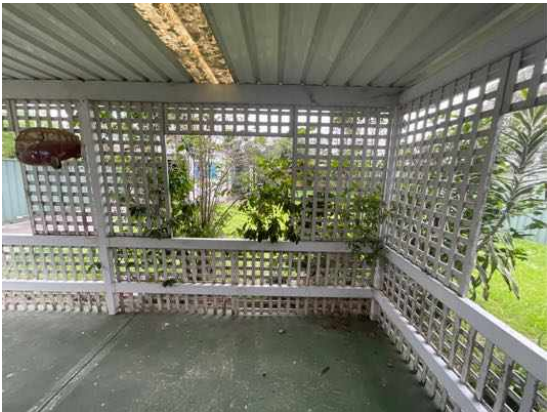
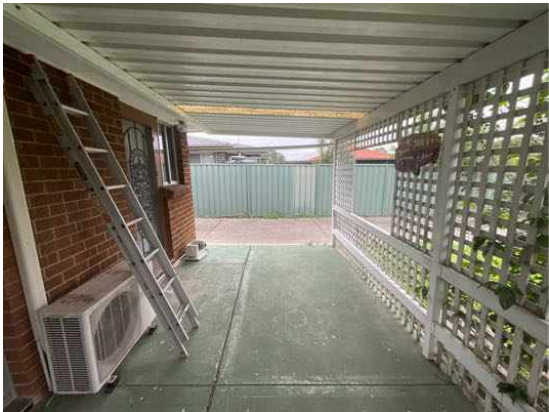
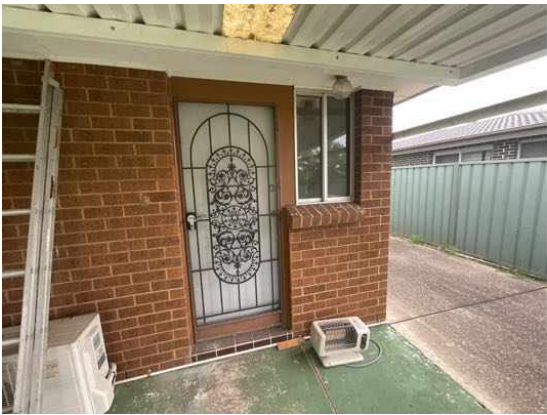
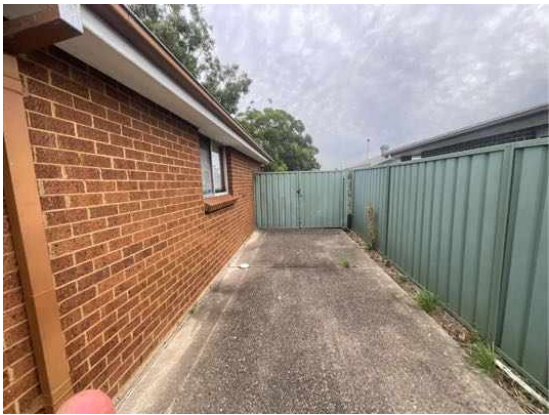
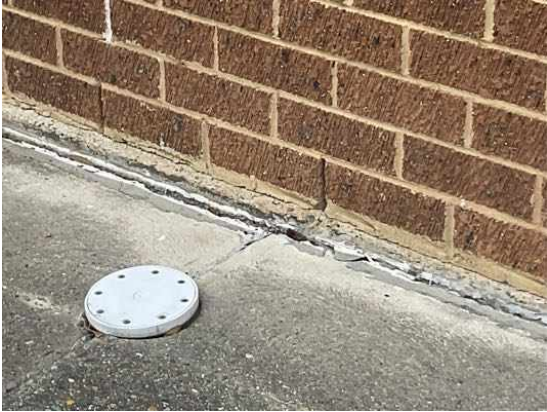
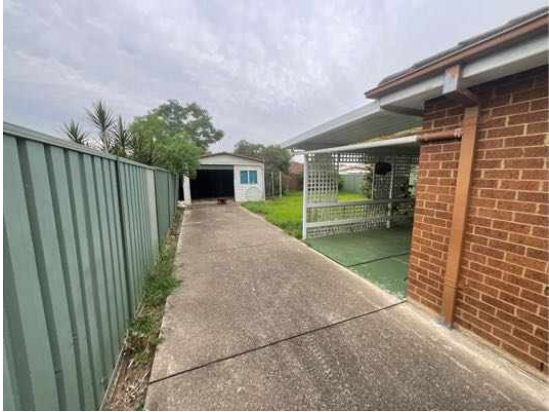
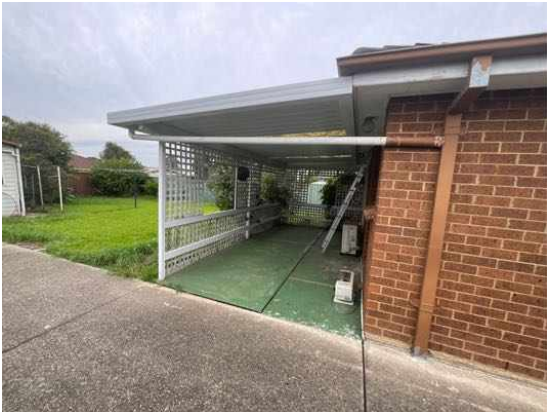
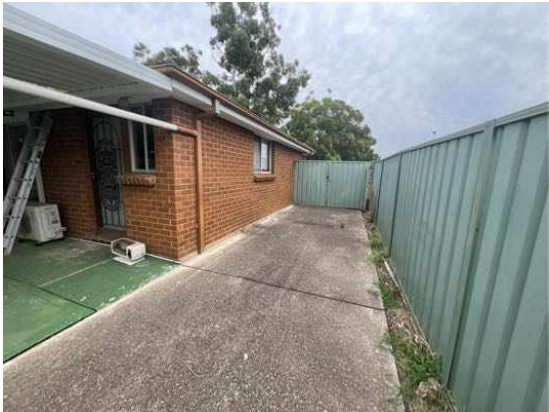
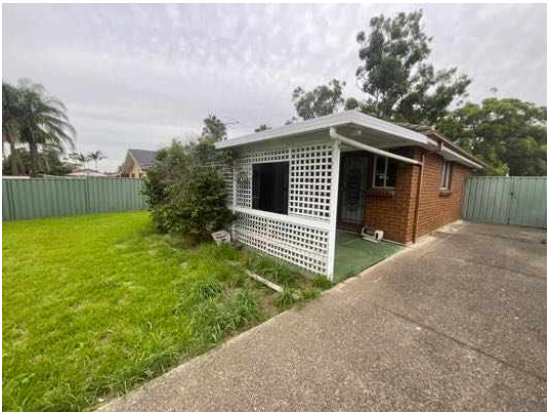
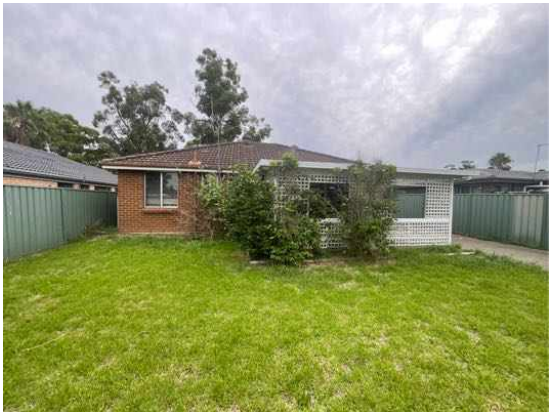
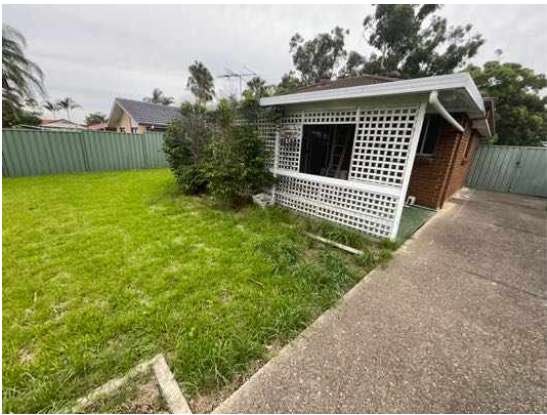
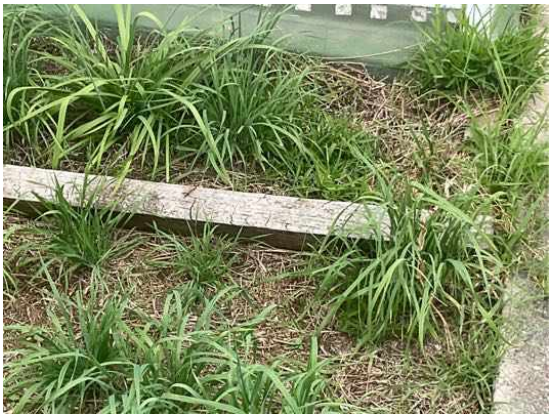
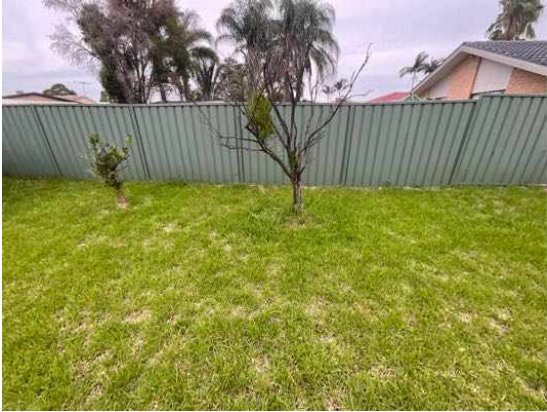
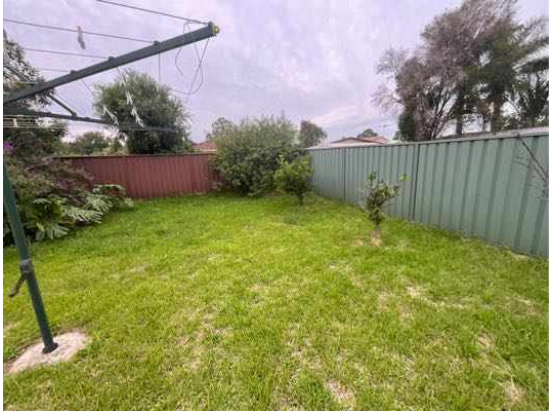
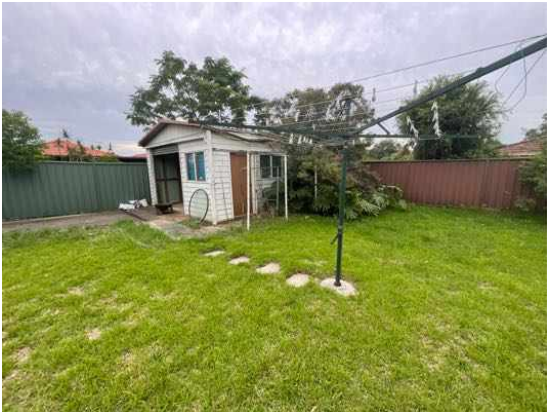
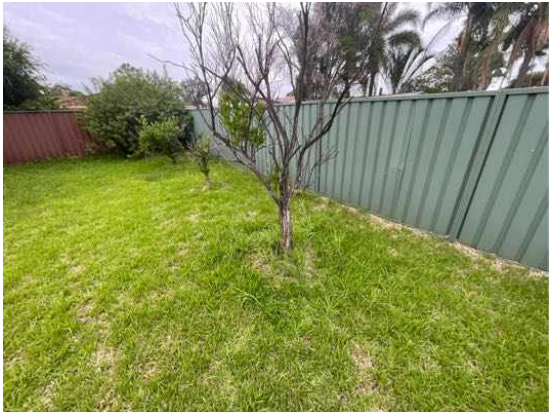
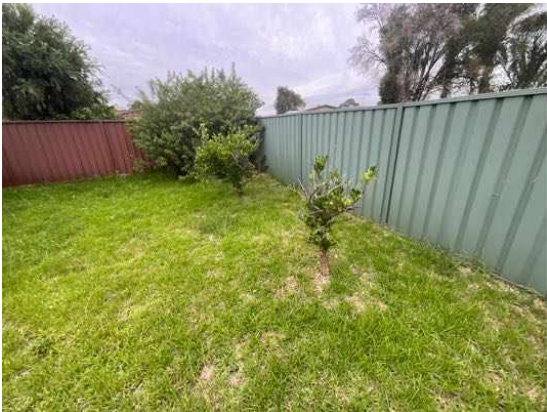
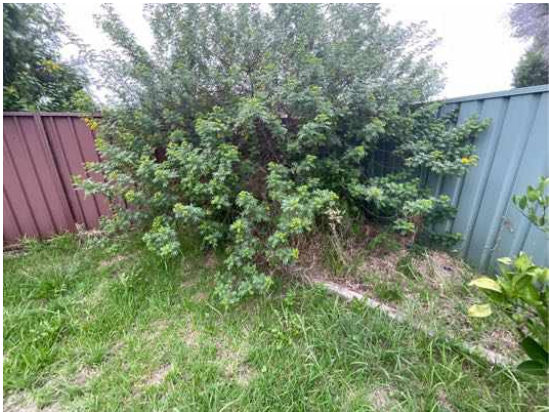
Building: Main Building  
Location: All Areas  
Finding: Additional Photos  
Information: Additional photos are provided for your general reference
