Building and Timber Pest Inspection Report

Inspection Date: Thu, 26 Mar 2026

Property Address: 5 Yanco Ave, Jamisontown NSW 2750,
Australia

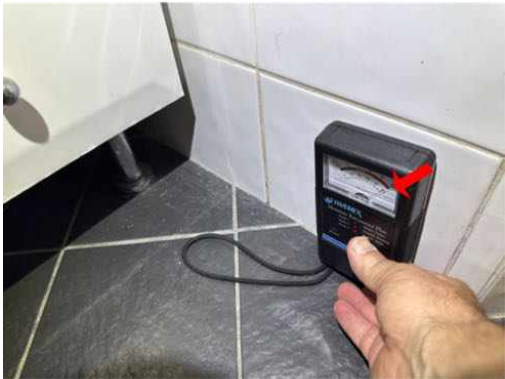
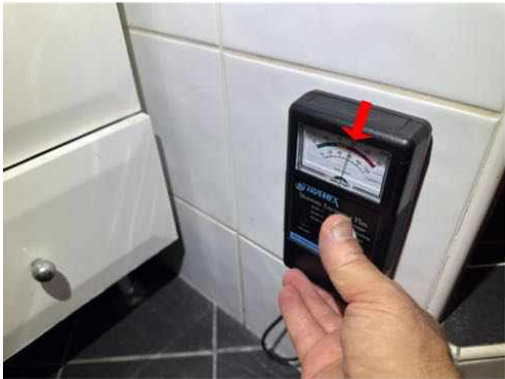
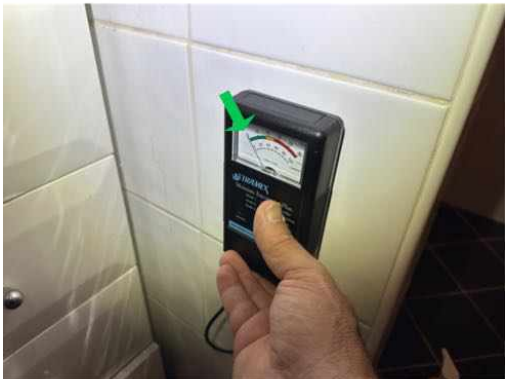
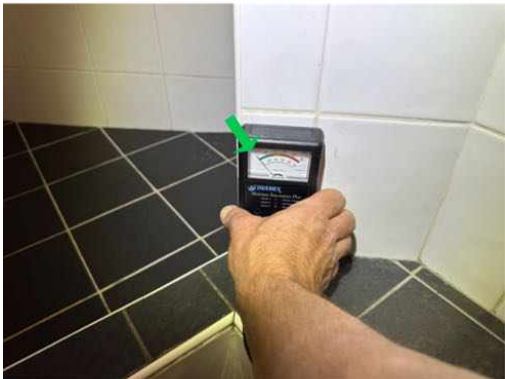
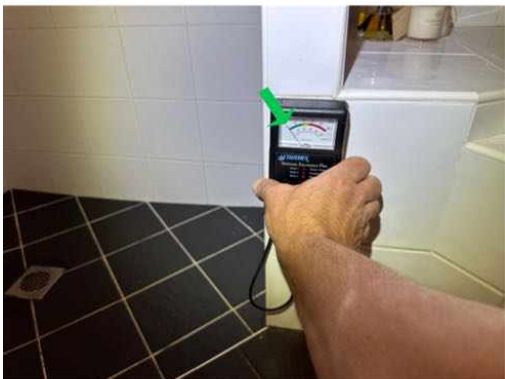
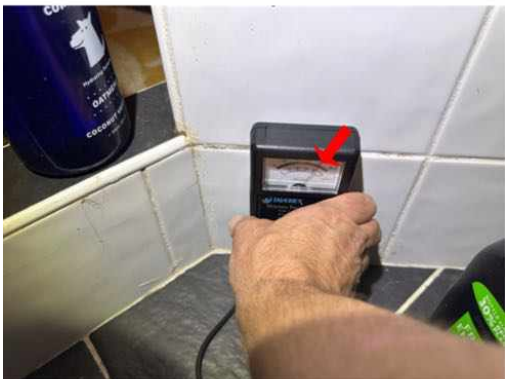
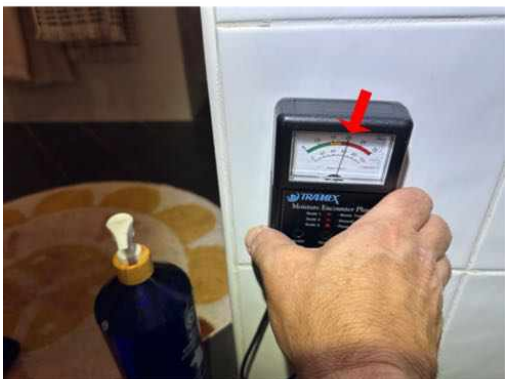
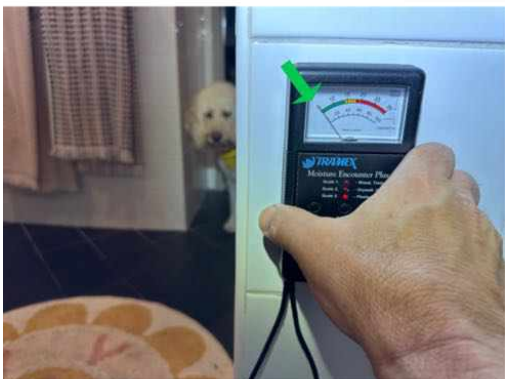
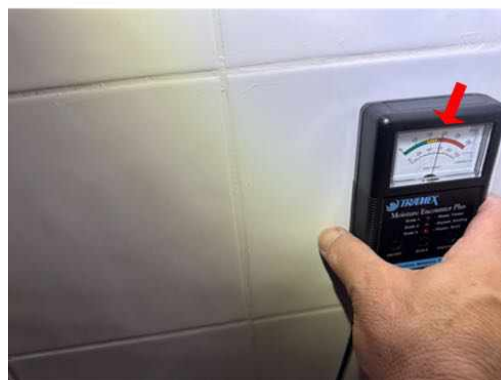
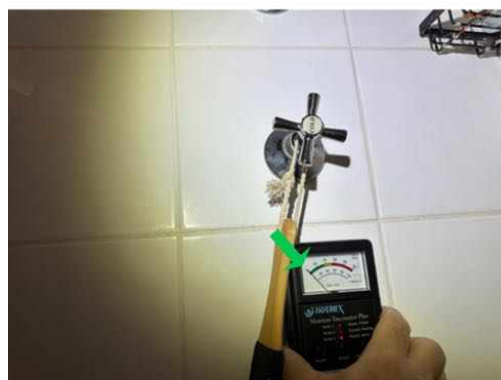
Building: Main Building
Location: Bathroom > Centre Left
Finding: Moisture meter: used in Shower area.
Information: A moisture meter was used during the inspection and isolated spots of excessive moisture was detected to accessible walls inside the property at the time of inspection.

It was noted on inspection that sealant or grout is in fair condition to most of the tiled shower alcove, with some areas requiring maintenance.

Different materials and floor areas move at different rates, generally causing cracking to grout or sealant at this point. A flexible sealant is required to allow for expected expansion and contraction, while keeping the joint water tight and protective of all associated building materials.

Flexible and mould resistant materials should be applied to affected areas to prevent any subsequent water damage that is likely to occur. Regular maintenance and replacement of damage or missing or damaged sealant and grout is highly recommended to the wet areas, as this is a regular wear and tear defect. Sealant and grouting in areas that come into regular contact with water should be maintained for the long term care of your property.

Monitoring the area is advised and if any visual signs of excessive moisture appear (peeling paint, mould) then consultation with a qualified plumber or bathroom specialist would be advised to identify the cause of damp and to perform remedial works as required.

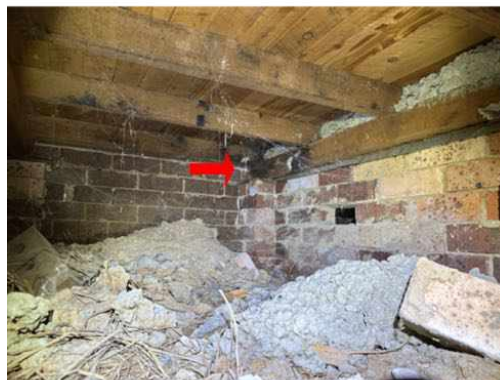
Finding 2.02

Building:	Main Building
Location:	Subfloor/Bathroom > Centre Left
Finding:	Water leak - subfloor.
Information:	A water leak was found in this area at the time of inspection. Subfloor water leaks can be detrimental to surrounding building elements; their potential causes include damage to plumbing fittings and fixtures, through to water damage and deterioration of associated building elements.

Rust, corrosion, decay and water damage are potential outcomes where a minor water leak is left unattended. More serious defects may also result, such as water damage to structural building elements.

In extreme cases, structural damage may develop due to a prolonged water leak. It is highly advised that subfloor water leaks be addressed by a licensed plumber as a matter of relative urgency.

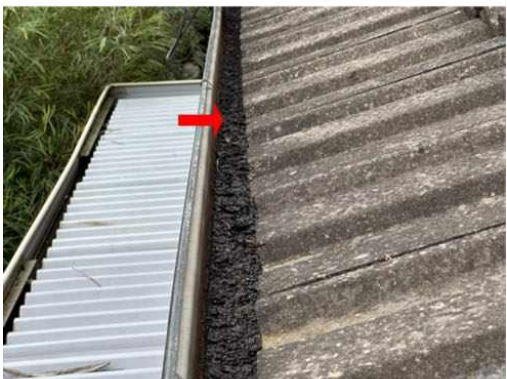
Blocked gutters are likely to lead to high levels of moisture in the affected areas. Such moisture will not only cause rust and decay of the associated building materials, but can also provide conditions that are conducive to termite and timber pest activity. Blockages in gutters should therefore be removed immediately to ensure dry conditions are maintained.

Consult a Licensed Plumber for further specific advice on remedial works that may be required. In the interim, it is highly advised that blocked gutters be removed by the homeowner or a general handyperson as a matter of urgency.

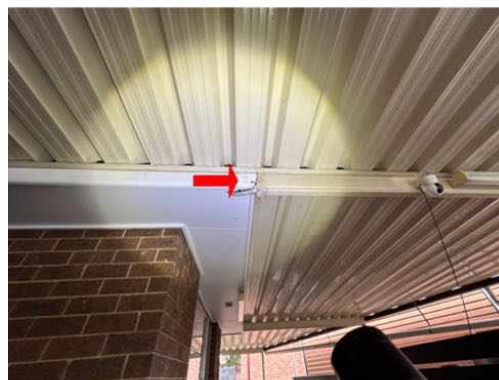
Finding 3.02

Building: Main Building
 Location: Roof Exterior > Front Left
 Finding: Roof plumbing - leaking.
 Information: Some sections of the roof are not adequately drained via gutters and downpipes. Gutters and downpipes that are not installed adequately are likely to result in excessively damp conditions against the exterior surfaces and around the base perimeter of the building.

Excessive moisture creates an environment which accelerates the deterioration of building elements in the area, as well as being conducive to termite and pest infestation. Such an environment is likely to necessitate repair and/or replacement of building elements, which are prone to sustaining wood rot, rust or corrosion.

A roofing plumber should be appointed as soon as possible to install relevant roof plumbing materials. Depending on the extent of the damage, repair and/or replacement of damaged building elements may be required.

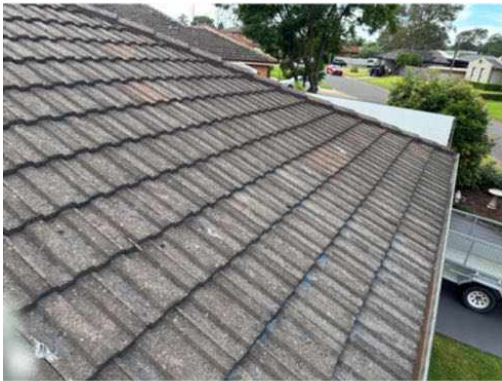
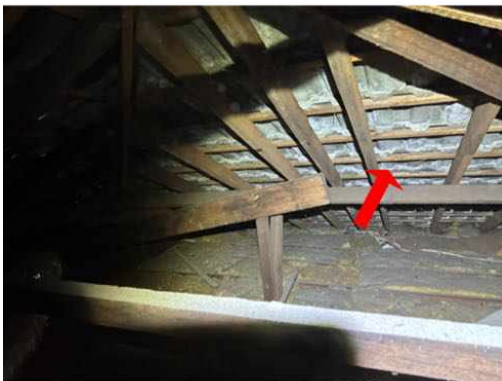
Building:	Main Building
Location:	Roof Exterior > All Areas
Finding:	Roof tiles - Weathered
Information:	Upon inspection of the exterior roofing, the majority of roof tiles were considered to be in a fair condition. While weathering of the tiles is consistent with the age of the property, maintenance works are required.

Isolated areas of mortar have come loose in the valleys and minor cracking is also present. Re-pointing and re-sealing the may be considered as an interim solution by the client to help preserve and extend the life span of the tiles.

Where left unmanaged, deteriorating roof tiles are likely to lead to a number of secondary defects, including minor water leaks and weather exposure to internal roofing structures.

Consultation with a roofing contractor is highly advised to gain advice on cost of remedial works that may be required in the short to medium term. Remedial works are likely to increase the longevity of the exterior roofing structure.

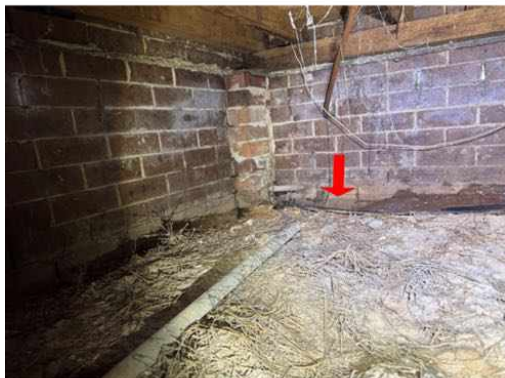
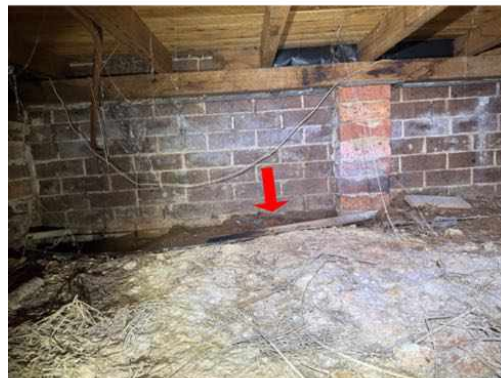
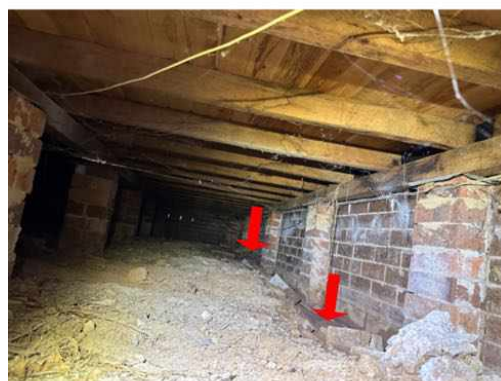
Finding 3.05

Building: Main Building
 Location: Subfloor > Front
 Finding: Water pooling - subfloor area.
 Information: Water appears to be pooling against the sub floor walls. It is suspected that this is a result of poor site drainage but may also be due to excessive moisture from disconnected awning downpipes drains.

Where water is pooling under the house, water damage to the sub structure may occur.

fungal decay in the area.

Consult a Licensed Plumber regarding the cost of potential site drainage rectification works.

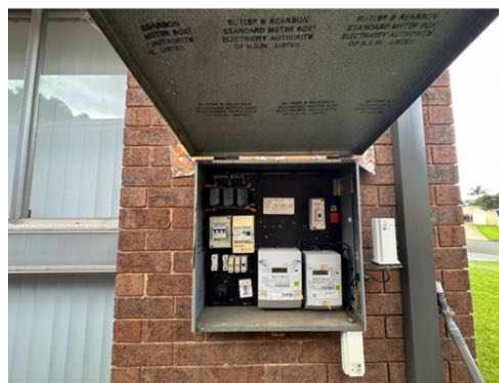
Building:	Main Building
Location:	Electrical circuit box > Front Left
Finding:	Termite Management System - no evidence of a chemical installation
Information:	The application of a post-construction chemical termite barrier is highly recommended for all properties, particularly if live termite activity has been found on the site

A durable notice should be placed in the switchboard unit to indicate current termite barriers. At the time of inspection, it appeared as though no termite management system has been installed, with no evidence to suggest preventative works taking place.

The client may consider gaining further advice from a pest controller as to the costs and procedures involved with this application. It is recommended that obtaining such advice be a short-term priority.

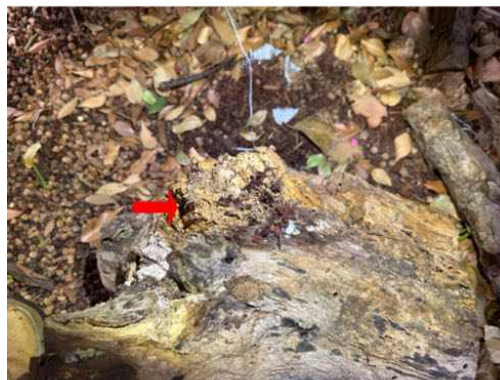
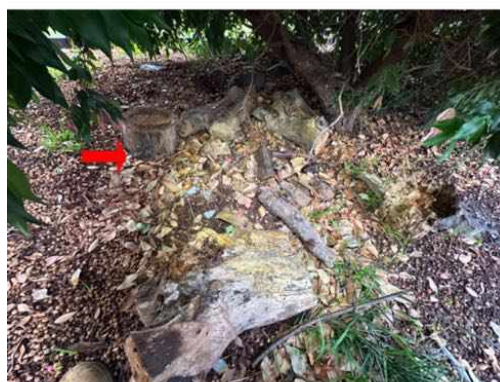
Finding 6.02

Building:	Main Building
Location:	Front Elevation > Front Right
Finding:	In ground contact
Information:	Any timbers in direct ground contact, including tree stumps provide opportunity for concealed termite entry and are likely to be subject to premature rot and decay as the soil retains moisture or damp conditions against the timbers.

Remove untreated timber and all tree stumps that is in direct contact with external grounds. Consider replacement with more durable materials i.e. treated timber or non timber elements. Frequent pest inspections are advised to readily identify any termite activity in these areas.

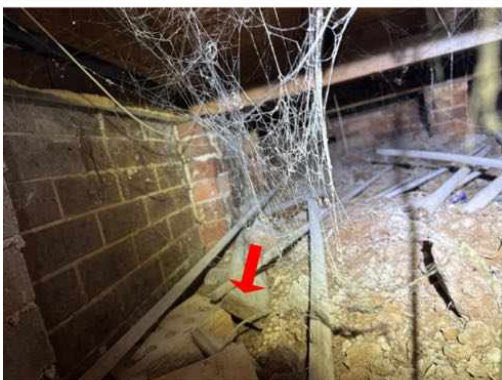
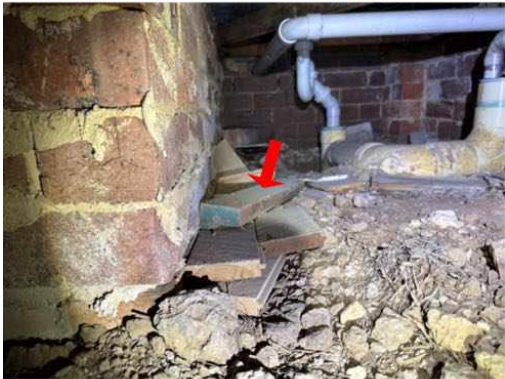
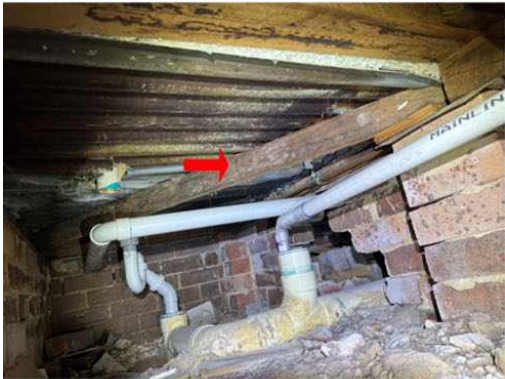
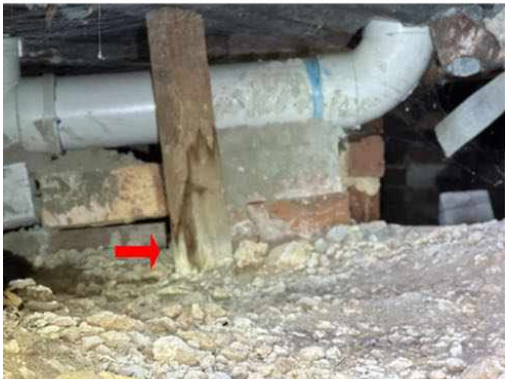
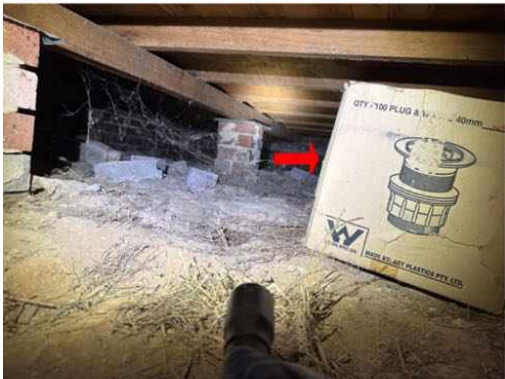
Finding 6.05

Information: An array of debris was found in the subfloor area at the time of inspection. Debris in this area restricts subfloor ventilation and creates potential for concealed pest entry. Stored timbers and other materials may also make the area susceptible to termite activity and wood rot.

A clear and empty subfloor will be better ventilated and easier to maintain in a dry condition. The removal of any timber debris is vital in minimising the risk of termite or wood borer activity.

Debris in the subfloor should be removed as soon as possible. Depending on the location and amount of debris and stored items, the homeowner may elect to undertake this task. Alternatively there are a large number of rubbish removal subcontractors that could undertake these works.

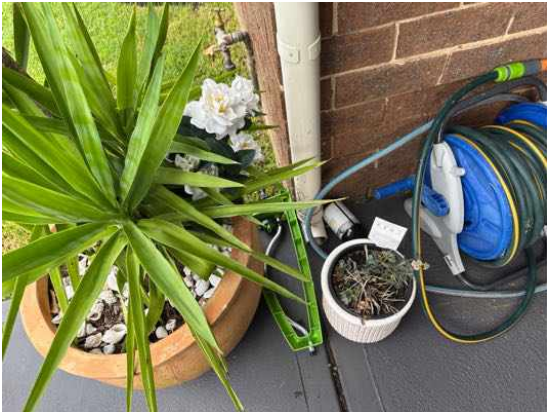
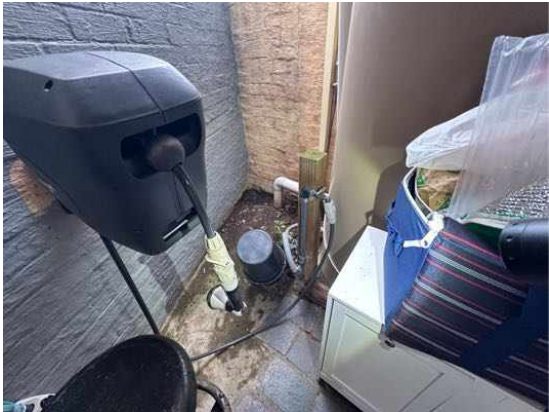
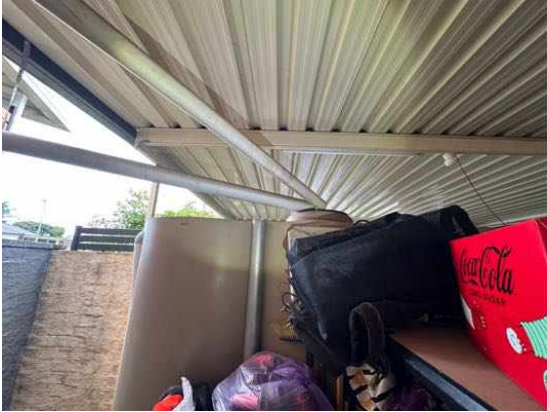
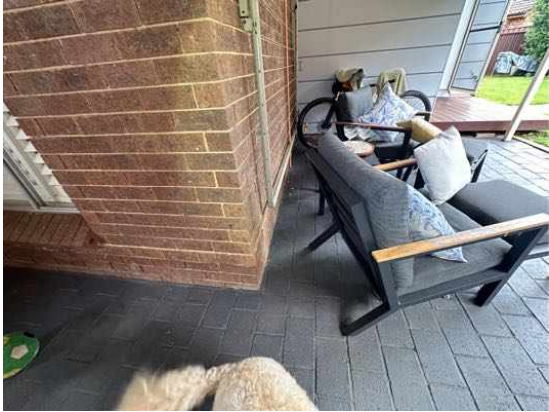
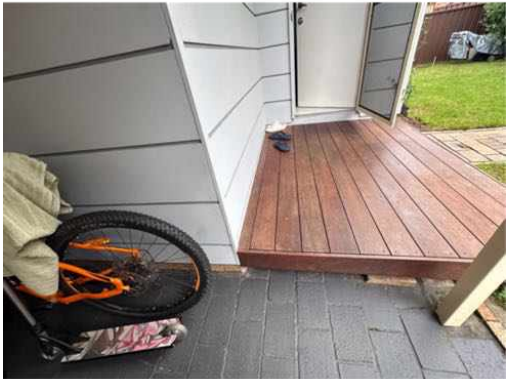
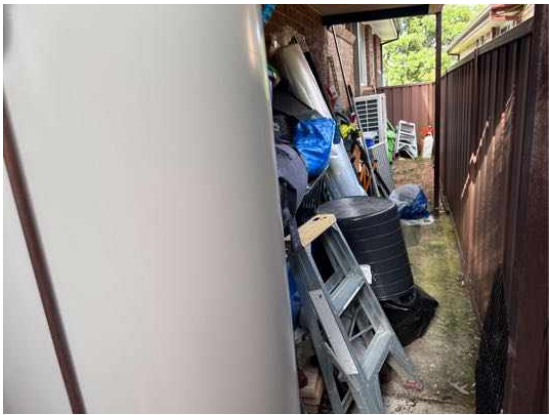
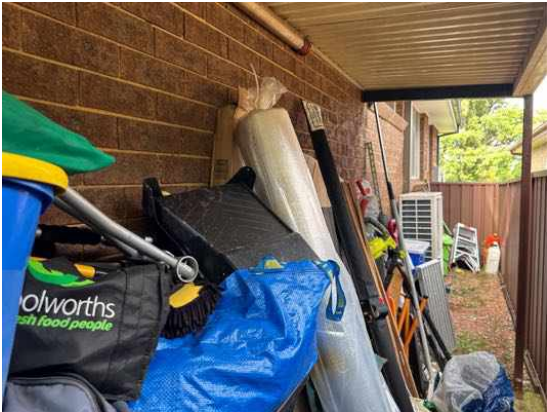
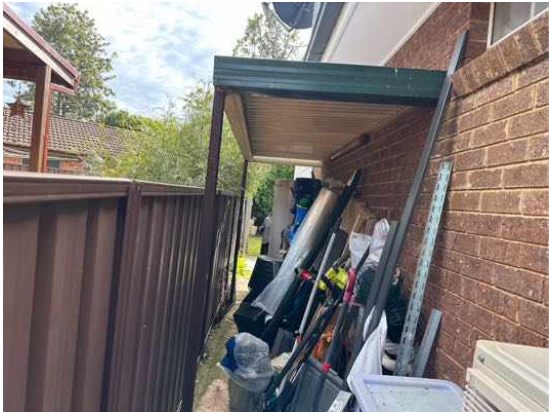
Noted Item

Building: Main Building
Location: All Areas > All Areas
Finding: Additional Photos - Obstructions and Limitations
Information: These photographs are an indication of the obstructions and limitations which impeded full inspection of the property at the time of inspection. These obstructions can hide an array of defects and should be removed to allow full inspection to be carried out. A re-inspection is recommended once the areas are made accessible.

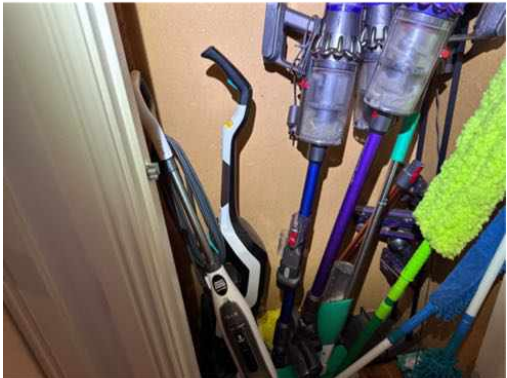
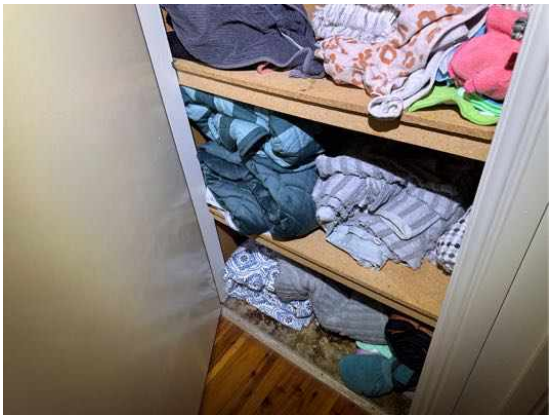
Noted Item

Building: Main Building
 Location: All Areas > All Areas
 Finding: Additional Photos - Obstructions and Limitations
 Information: These photographs are an indication of the obstructions and limitations which impeded full inspection of the property at the time of inspection. These obstructions can hide an array of defects and should be removed to allow full inspection to be carried out. A re-inspection is recommended once the areas are made accessible.

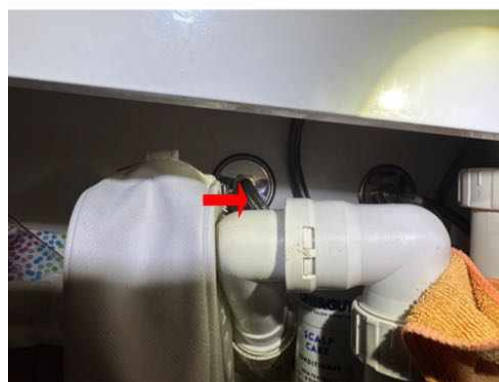
Building: Main Building
 Location: All Areas > All Areas
 Finding: Pipe: Flexible Braided pipes.
 Information: Braided Stainless Steel Flexi connector hose are popular in modern home fit outs because they can be bent into shape. They started to be installed in the early two thousands and their use is now extremely widespread in contemporary construction and renovations.

Flexible braided hoses accounted for more than one in five water damage claims lodged by Australian households according to research released by general insurer IAG.

It is recommended that the Flexi pipes to be replaced at the owners discretion to avoid an “escape water incident” which may lead to water damage to other building elements in the home.

This work can be undertaken by a licensed plumber, general handy person at the owners discretion.

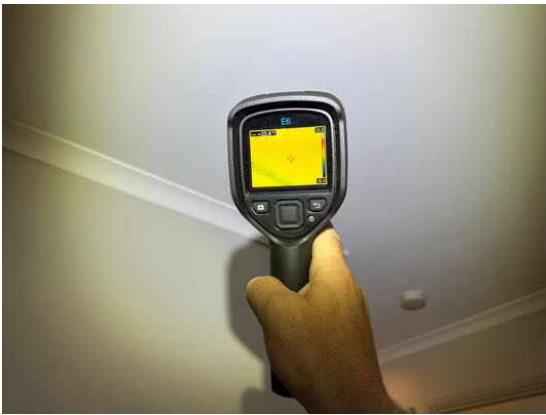
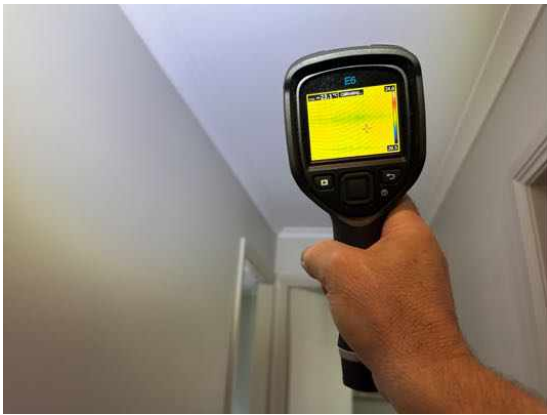
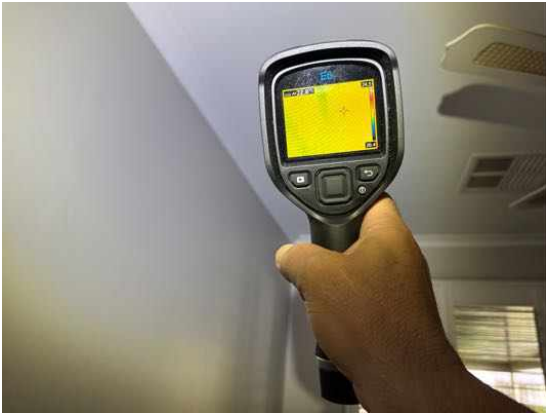
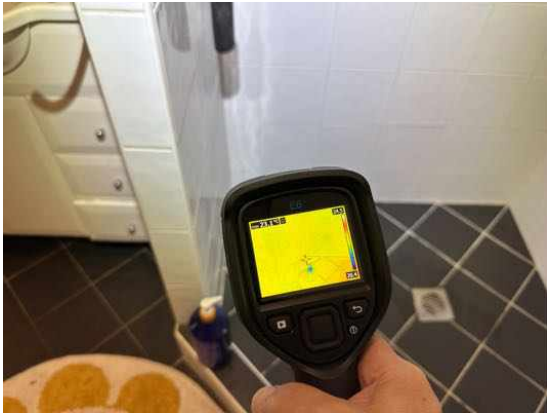
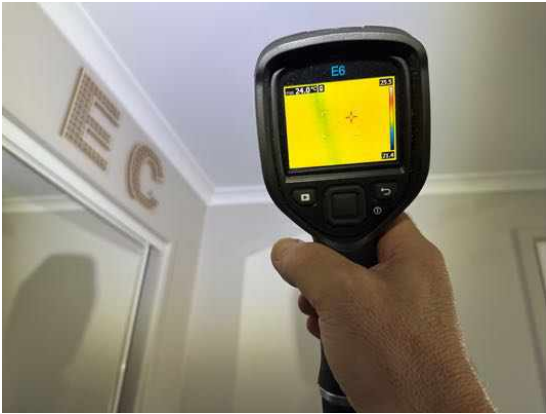
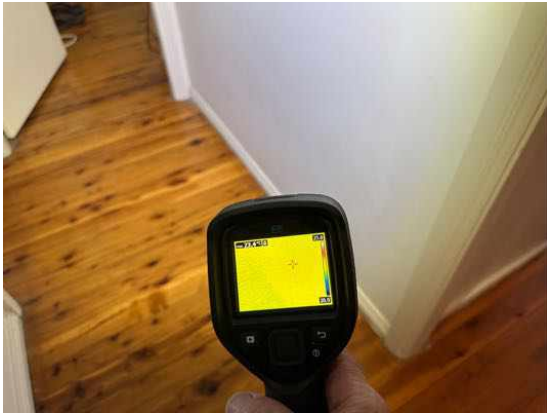
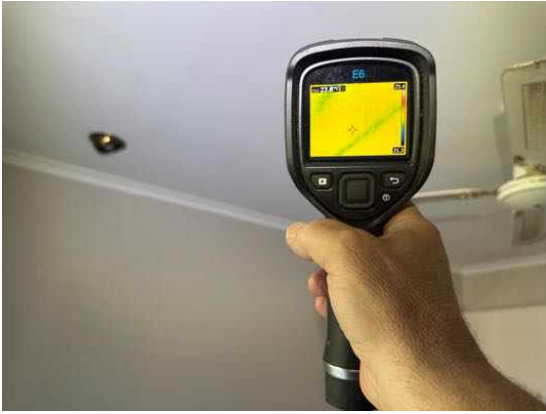
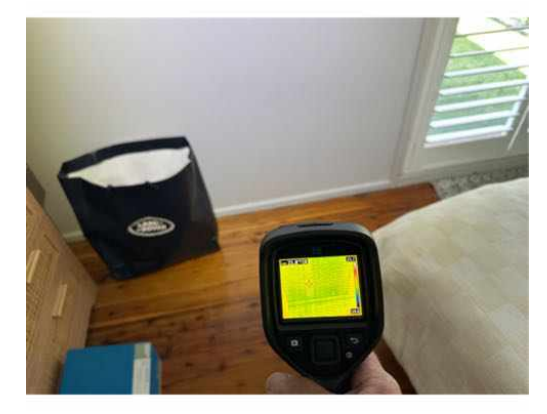
Building:	Main Building
Location:	All Areas > All Areas
Finding:	Thermal imaging: No excessive moisture presentation.
Information:	At the time of inspection there appeared to be no excessive moisture presentation in this area.

NOTE: If the Property has been vacant for a period of time or wet areas not used, moisture levels or leaks may not be detectable at the time of the inspection because often only frequent use of water pipes (showers, taps etc) result in a leak being identifiable. We advise further testing on pipes and water susceptible areas (such as the bathroom and laundry) after more frequent use has occurred.

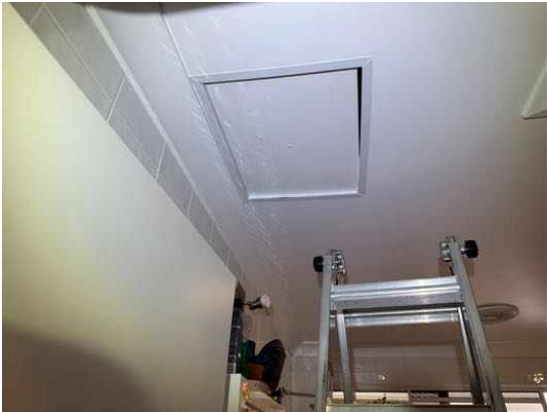
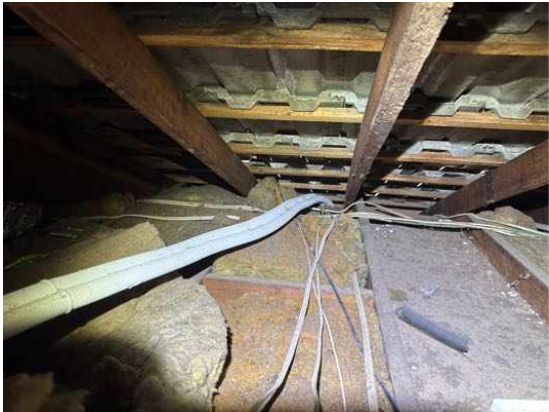
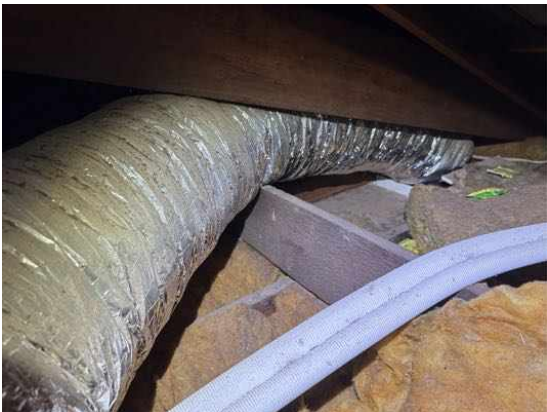
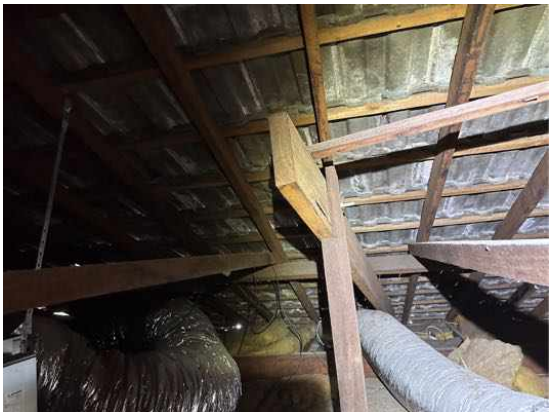
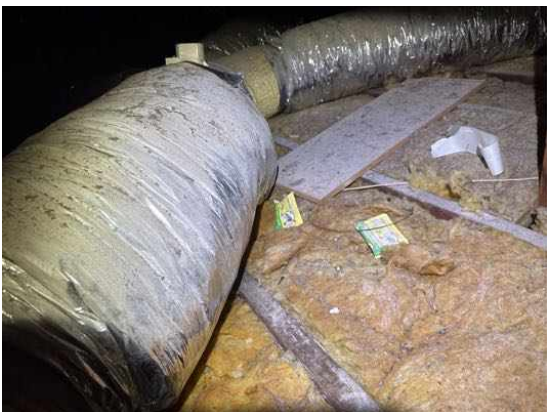
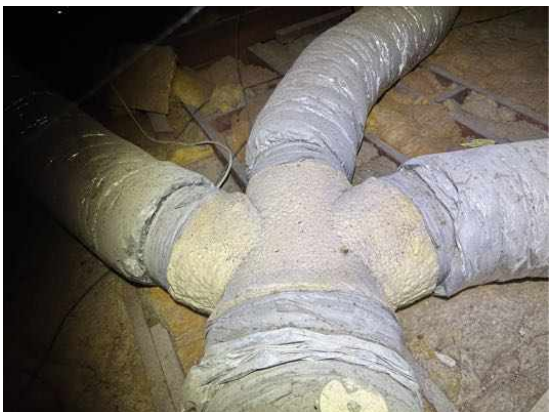
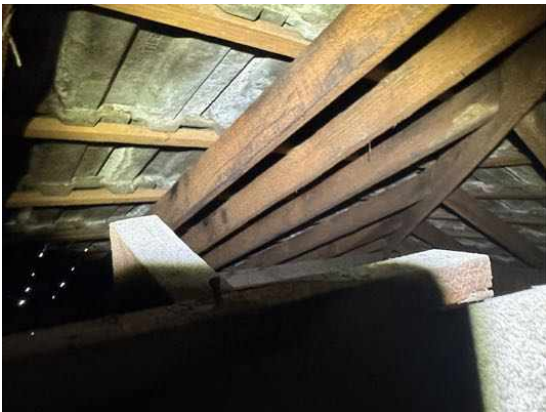
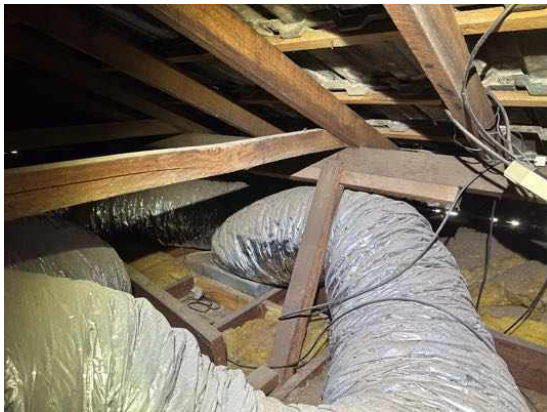
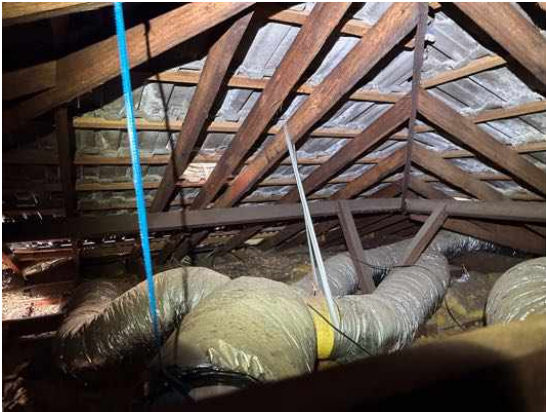
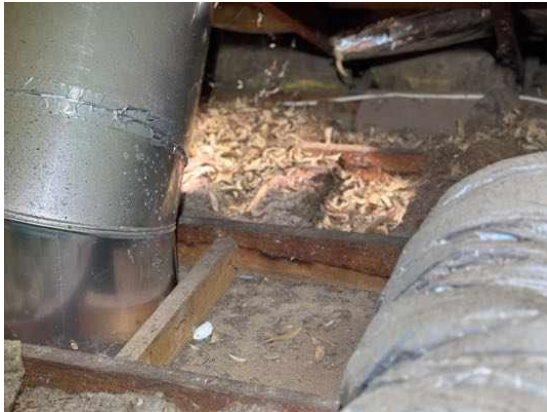
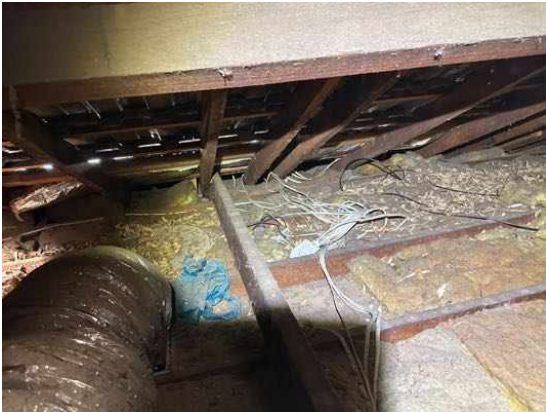
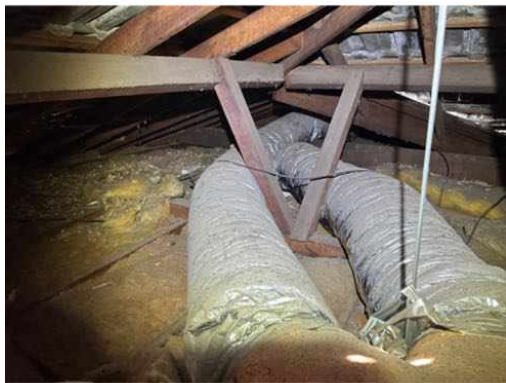
Building: Main Building
Location: All Areas > All Areas
Finding: Roof void: limited access.
Information: Limited access to the roof void was present due to facts including but not limited to access hatch size or placement, insulation, air conditioning ductwork, for this reason inspection to the roof void was minimal and a range of defect's from minor to major may not be visible at the time of inspection.
