# Building and Timber Pest Inspection Report

Inspection Date: Wed, 18 Feb 2026

Property Address: 7A Foote St, Templestowe Lower VIC 3107,  
Australia

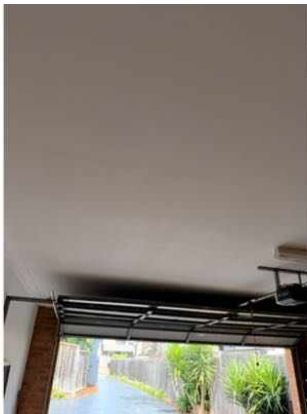
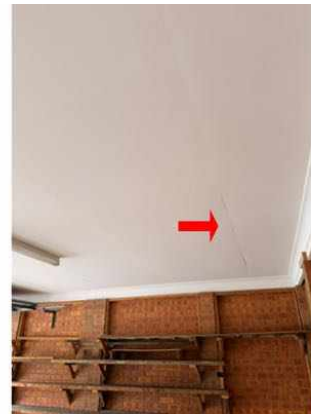
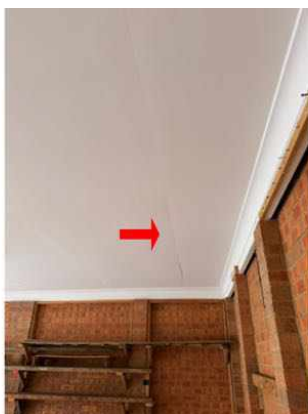
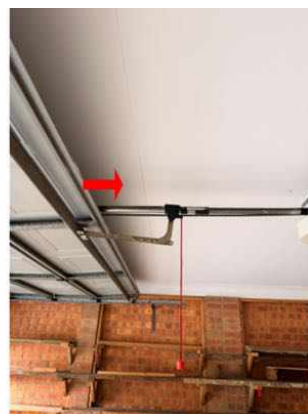
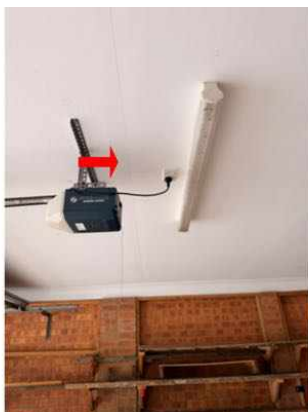
This may indicate prior movement or past repair work, and the finish may continue to crack or deteriorate over time.

This may indicate inadequate joint support/backing and/or poor joint setting, and cracking may continue to worsen with normal movement and vibration.

Engage a qualified plasterer/builder to investigate the joint support (e.g., backing/nogging and fixing at sheet joints) and complete appropriate repairs (re-fix/re-sheet as required, then re-set and repaint).
