# Building and Timber Pest Inspection Report

Inspection Date: Thu, 12 Mar 2026

Property Address: 9 William Ln, Redfern NSW 2016, Australia

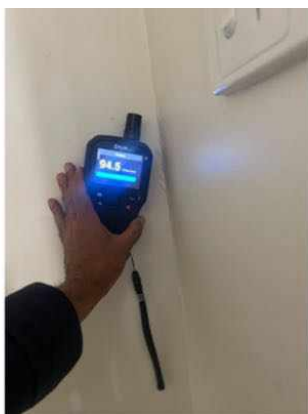
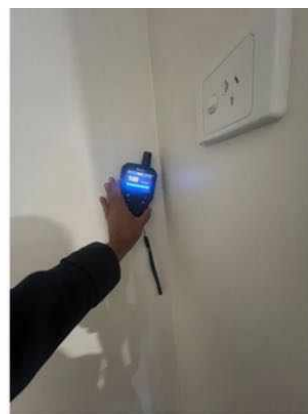
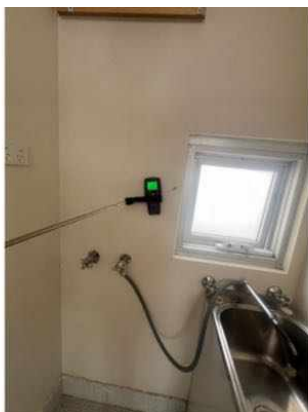
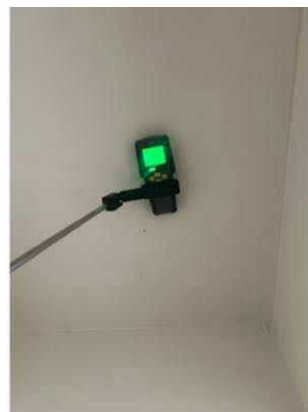
#### Finding 3.01

Building: Main Building  
Location: All Internal Areas  
Finding: Elevated Moisture – Further Investigation Recommended - rear cupboard , laundry , ceiling below laundry/bathroom  
Information: Elevated moisture readings were detected in several locations, dampness can contribute to deterioration if left unaddressed. Inspector was not able to inspect the external wall due to space constraints. A further investigation by a licensed plumber or waterproofing specialist is recommended to confirm the source and ensure no concealed issues are developing.

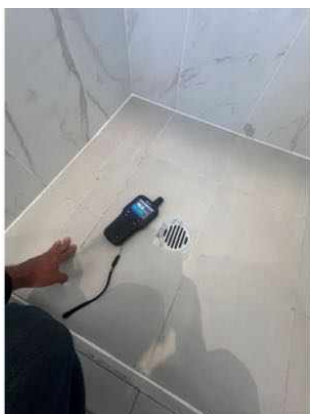
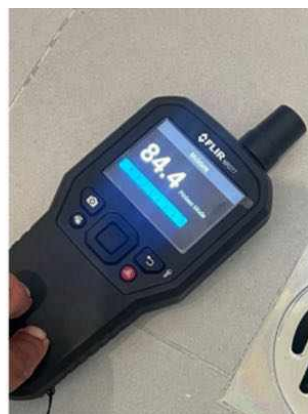
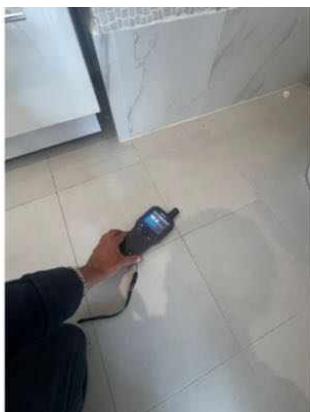
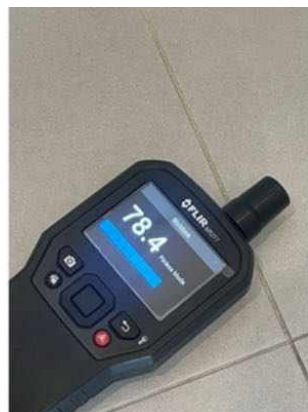
### Finding 3.02

Building:	Main Building
Location:	Bathroom, Laundry
Finding:	Elevated Moisture Bathroom (No visible deterioration noted) - Further investigation recommended
Information:	Elevated moisture levels were detected to tiled surfaces in bathroom/shower areas. Persistent moisture ingress can lead to concealed damage, including timber rot and mould growth.

Elevated moisture readings in tiled wet areas can occur from normal shower use, age/deterioration of waterproofing membranes, plumbing leaks or moisture absorption through grout lines. While no damage was visible, elevated readings may indicate moisture retention behind tiles, which can be a conducive condition for future deterioration if not monitored.

A further inspection by a licensed waterproofing specialist is recommended.

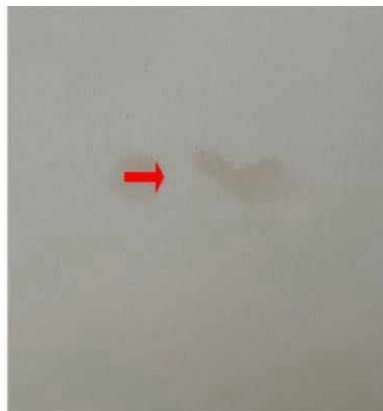
### Finding 3.03

Building:	Main Building
Location:	Kitchen
Finding:	Ceiling - Water stained
Information:	Water staining to ceiling linings in this area was evident at the time of inspection. Water staining indicates that surfaces have been exposed to excessive moisture over time. The minerals and other elements in the water lead to staining, which may graduate to corrosion and deterioration if left unmanaged.

While mostly an appearance defect, water staining can be indicative of more serious defects, which may be currently concealed by interior ceilings.

Where water staining is active, a licensed plumber must be consulted to identify the cause of the staining and to provide advice on any reparation works that may be required. Replacement of any damaged structures is advised.

Conversely, where water staining is old and inactive, affected building materials may be repaired or replaced at client discretion.

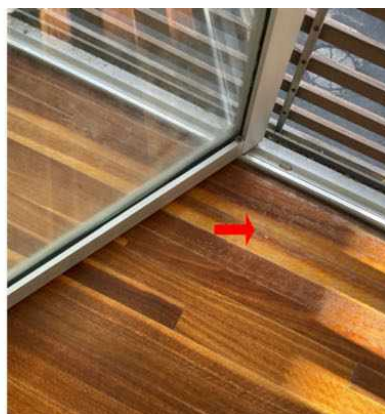
Building: Main Building  
Location: All External Areas - Balcony & Lounge  
Finding: Water staining - lounge facade  
Information: Water staining was evident in this area at the time of inspection. Water staining indicates that surfaces have been exposed to excessive moisture over time. The minerals and other elements in the water lead to staining, which may graduate to corrosion and deterioration if left unmanaged.

While mostly an appearance defect, water staining can be indicative of more serious defects, which may be currently concealed by other building elements.

Where water staining is active, a licensed plumber must be consulted to identify the cause of the staining and to provide advice on any reparation works that may be required. Replacement of any broken or damaged structures is advised.

Conversely, where water staining is old and inactive, affected building materials may be repaired or replaced at client discretion. A qualified carpenter or registered builder may be appointed to perform these works.

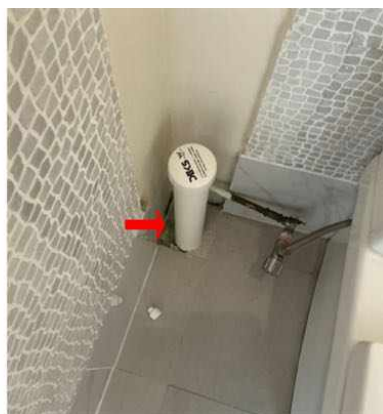
### Finding 3.06

Information: The installation of this building element appears to have been completed to a substandard level of workmanship or is incomplete. Generally substandard repairs or installation are related to poor workmanship, the use of inappropriate materials, or a failure to complete installation to a suitable standard.

Where installation is substandard and/or incomplete, the client should contact the responsible trade to undertake rectification. Unfinished and substandard building works are likely to degrade more quickly and may create potential for secondary defects to associated building elements.

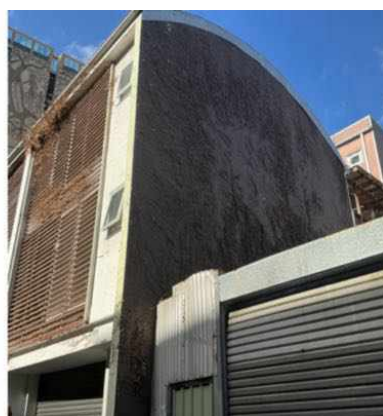
### Finding 3.07

Building:	Main Building
Location:	All Internal Areas
Finding:	Vegetation
Information:	Climbing vegetation was observed growing across sections of the external wall, façade and screening elements of the building. Vegetation in direct contact with building surfaces can trap moisture, contribute to deterioration of finishes over time, and obscure areas of the wall that would otherwise be visible for inspection. The dense growth also limited full visual assessment of some wall surfaces during the inspection. It is recommended that vegetation be trimmed back and removed from direct contact with the building to allow proper inspection and reduce the risk of moisture retention and concealed defects.

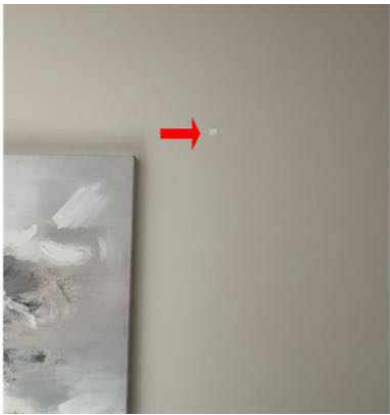
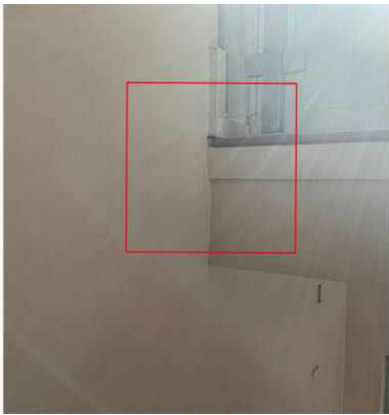
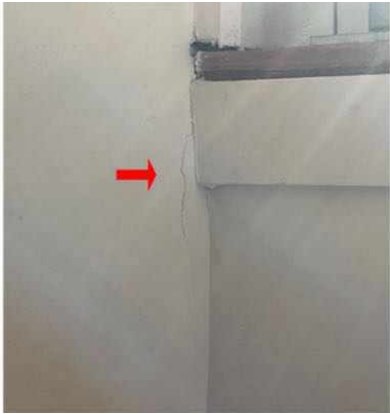
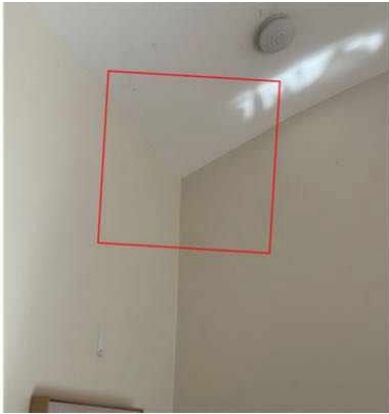
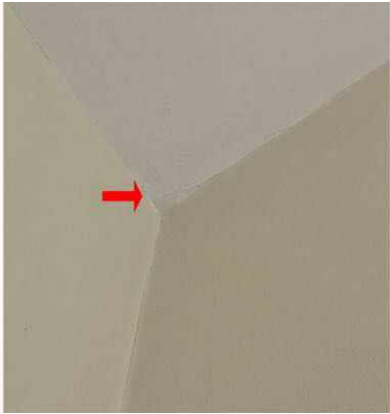
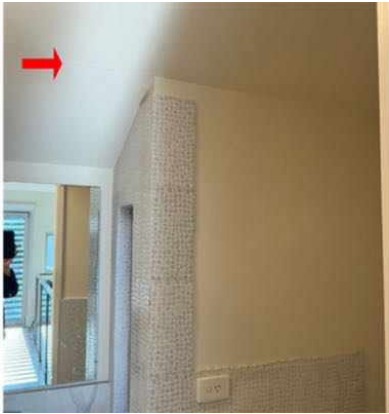
Building:	Main Building
Location:	All Internal Areas
Finding:	Paint finish and hairline cracking

Information: The paint finish in this area was identified as being incomplete at the time of inspection including some hairline minor cracking.

Whilst incomplete or missing paint finish is generally an appearance defect, it can also lead to the development of secondary building defects over time. Incomplete areas of paint finish expose the area to moisture, potentially accelerating the deterioration of underlying building materials.

Incomplete paint finishes should be sanded back, filled, leveled and painted, as applicable. Where inadequate or missing paint protection has led to the deterioration of the associated building element, repair and/or replacement of this building element may be required.

A painting contractor should be appointed as soon as possible to perform necessary works to aid the appearance of the affected area and to ensure the area is protected against further deterioration. Alternatively, the homeowner following manufacturer instructions may perform these works.

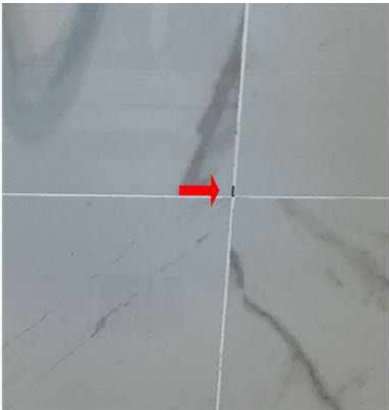
### Finding 3.11

Building:	Main Building
Location:	All Internal Areas
Finding:	Sealant and grouting - Missing or degraded
Information:	It was noted on inspection that sealant or grout is degraded. There is also evidence of poor workmanship and excessive use of sealant. Silicone should never be used as a first line of defence against waterproofing. Further inspection by a licensed waterproofing contractor is highly recommended.

Different materials and floor areas move at different rates, generally causing cracking to grout or sealant at this point. A flexible sealant is required to allow for expected expansion and contraction, while keeping the joint water tight and protective of all associated building materials.

There appears to be excessive mould to the sealant and grout which will likely require scraping out and replacement.

Flexible and mould resistant materials should be applied to affected areas to prevent any subsequent water damage that is likely to occur. Regular maintenance and replacement of damage or missing or damaged sealant and grout is highly recommended to the wet areas, as this is a regular wear and tear defect. Sealant and grouting in areas that come into regular contact with water should be maintained for the long term care of your property.

A sealant specialist or tiling contractor should be appointed to complete these works as soon as possible

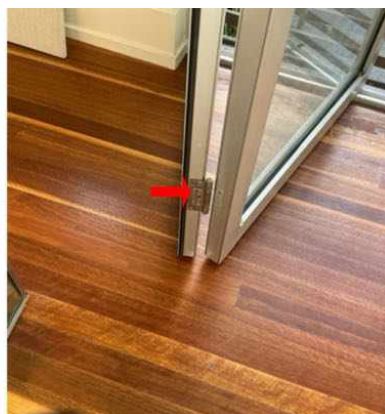
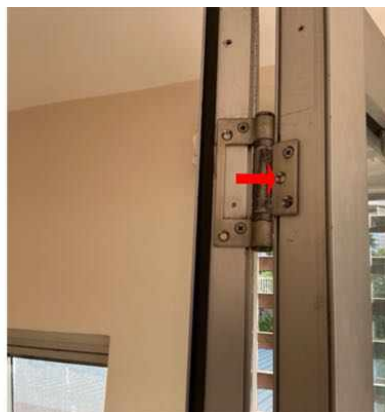
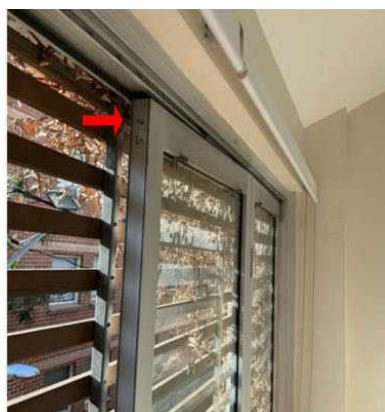
### Finding 3.12

Building:	Main Building
Location:	All Internal Areas
Finding:	Building element - Damaged - doors missing fixings and second story not opening
Information:	Breakage occurs generally when the building materials have either aged and decayed, or as a result of damage (accidental or deliberate).

Repair and/or replacement of broken elements is advised to ensure that additional secondary defects do not arise as a consequence. Such works are necessary, as all building elements play a key role in the operation and function of the overall structure and its performance.

A relevant tradesperson should be appointed to repair or replace the affected building element prior to any subsequent damage being caused.

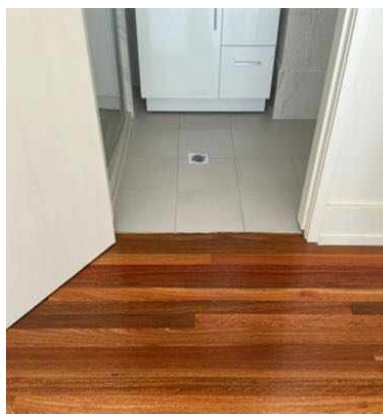
Building:	Main Building
Location:	Bathroom
Finding:	Bathroom & external floor threshold
Information:	The bathroom floor is at the same level as the adjoining timber flooring. This configuration is typical in modern apartments and is permitted where compliant waterproofing and floor falls are provided. No evidence of moisture damage was observed at the time of inspection; however, waterproofing performance cannot be confirmed without invasive inspection.

Care should be taken to avoid excessive water migration beyond the bathroom during use.

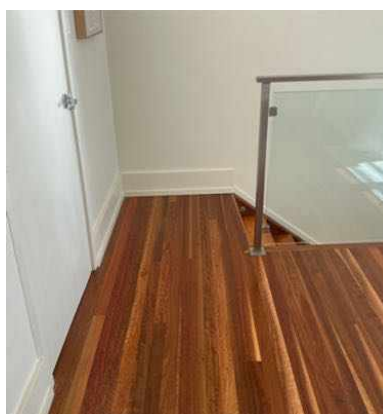
### Finding 3.16

Building:	Main Building
Location:	Bedroom
Finding:	Floors - bouncy or creaking
Information:	The internal flooring in this area was identified as being bouncy at the time of inspection. A bouncy floor surface generally presents as a discernible change in level as they are walked across, in noisy or creaking flooring, or in consequent movement of surrounding furniture and fixtures.

Bouncy floors generally indicate that the floorboards or the subfloor structures are coming loose from the joists that they are installed on. Bouncy flooring may also be the result of gaps between flooring and stumps or joist structures, which require packing.

The client is advised to seek quotations for required repairs from a Registered Builder specialising in re-stumping. The potential resolution may range from packing gaps in subfloor structures through to replacement of subfloors stumps and refixing of flooring.

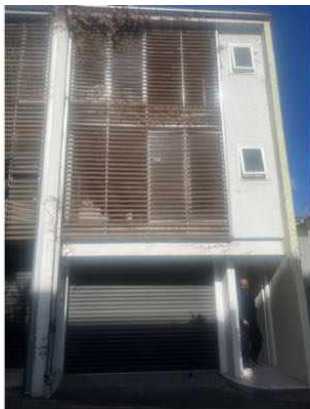
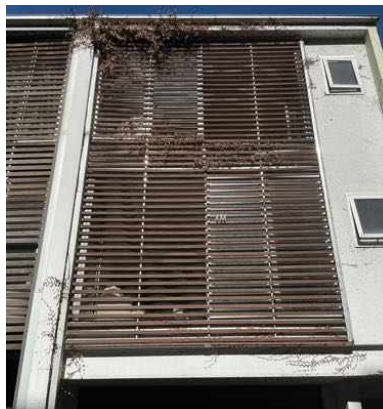
existing vegetation will assist greatly in preventing Bridging from occurring.

The removal of any such materials that may be conducive to termite activity should be carried out as soon as possible and arrange re inspection to minimize the risk of termite attack.

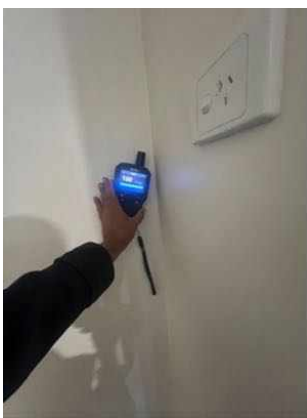
### Finding 6.02

Building:	Main Building
Location:	All Internal Areas - Laundry and cupboard
Finding:	Elevated moisture - identified
Information:	Elevated moisture can attract termites and produce conditions that promote fungal growth and wood decay.

Prior to any remedial works being performed a qualified plumber should be appointed to further inspect the property and to identify the cause of the excessive moisture.

Works to remove affected building elements may then be necessary and should be performed by an appropriate tradesperson.

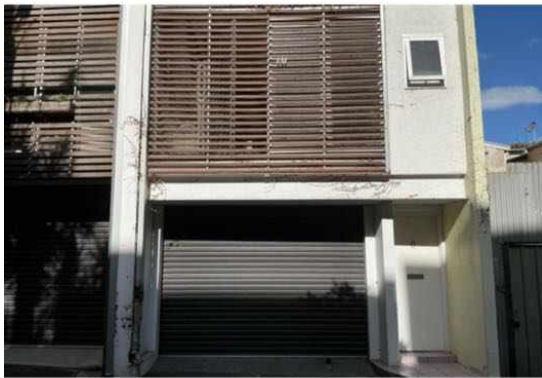
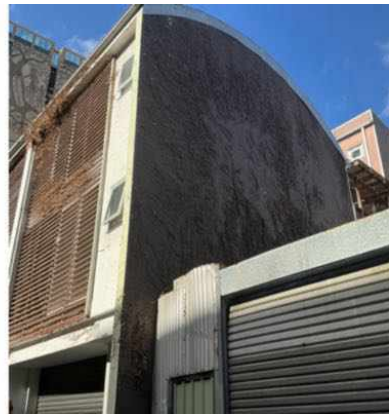
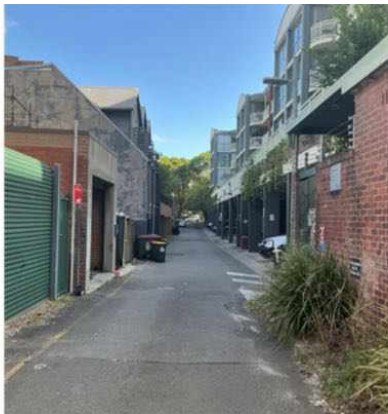
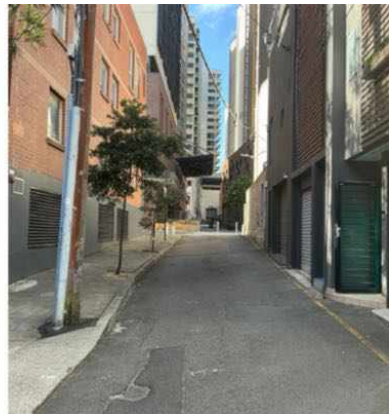
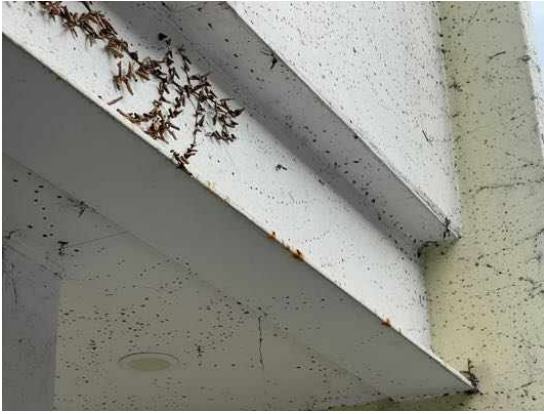
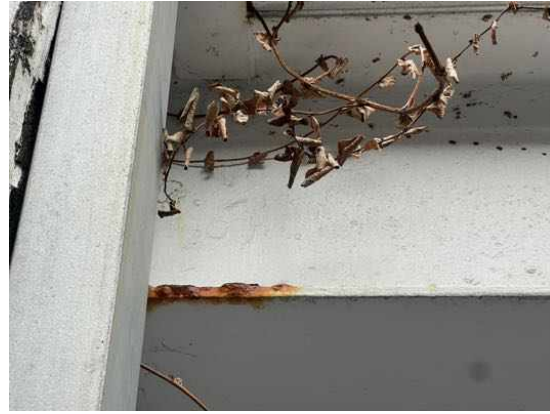
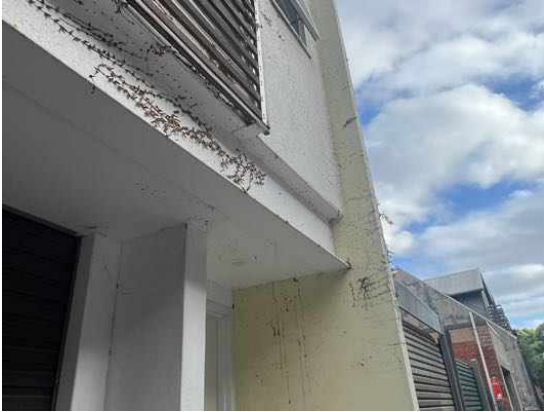
Building: Main Building  
Location: All External Areas  
Finding: Additional Photos - Obstructions and Limitations  
Information: These photographs are an indication of the obstructions and limitations which impeded full inspection of the property at the time of inspection. These obstructions can hide an array of defects and should be removed to allow full inspection to be carried out. A re-inspection is recommended once the areas are made accessible.

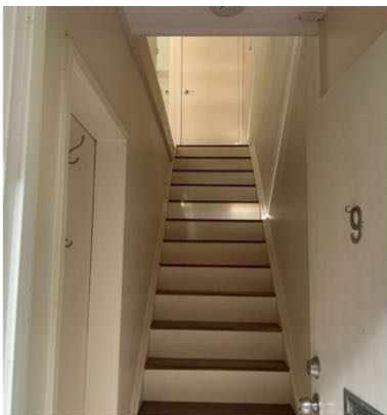
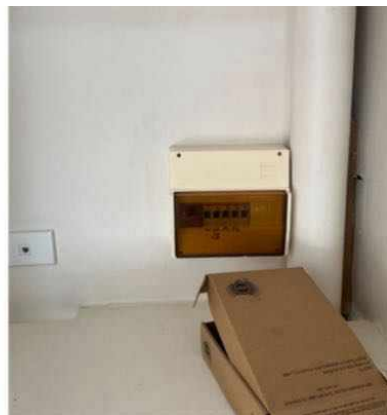
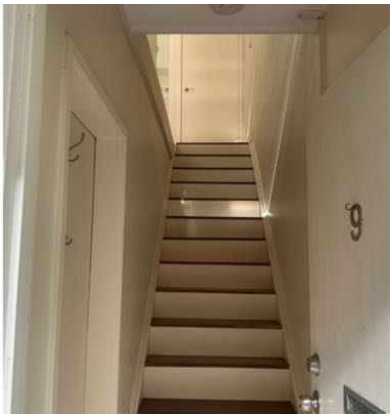
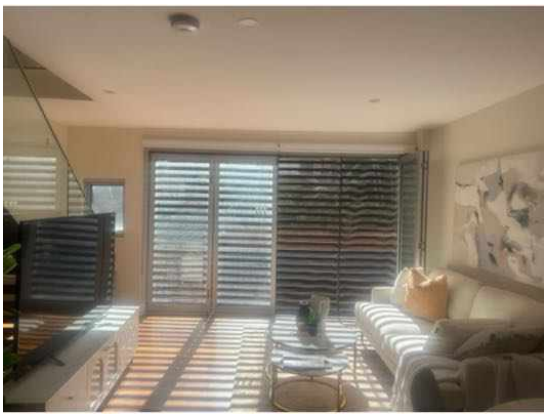
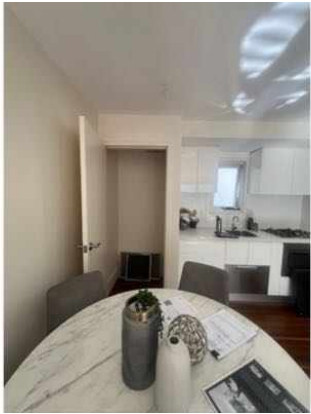
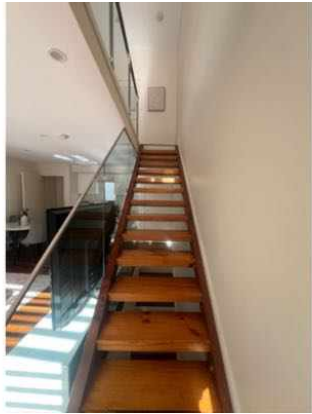
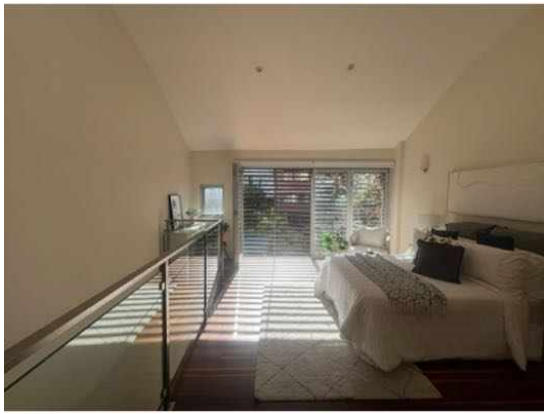
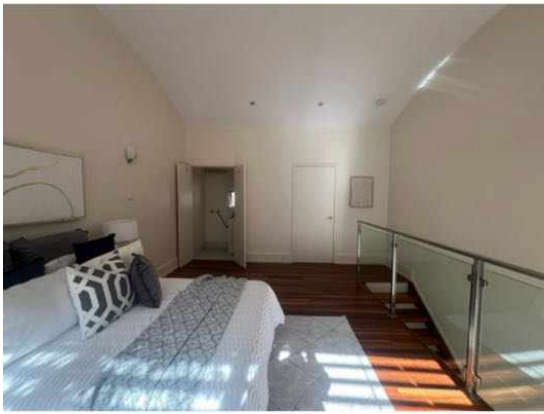
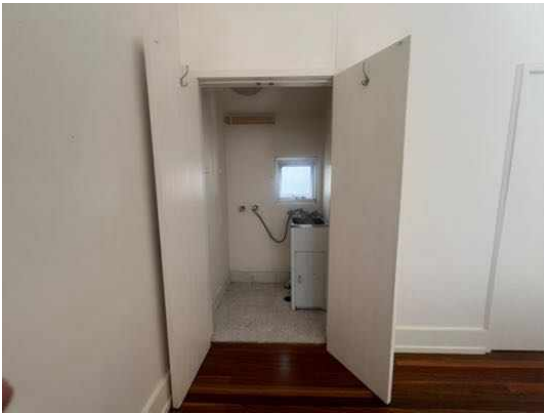
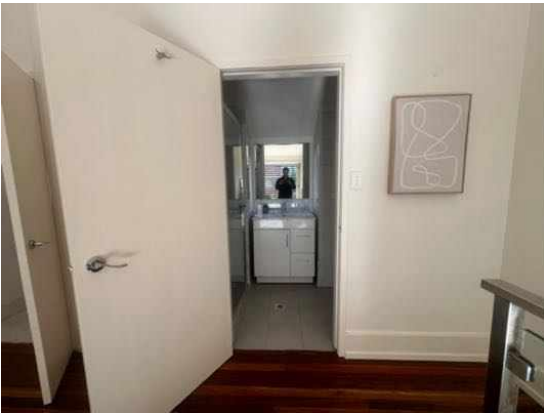
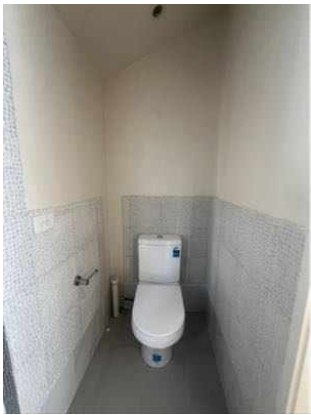
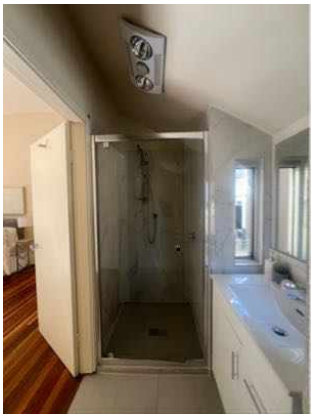
Building: Main Building  
 Location: All Internal Areas  
 Finding: Additional Photos - Obstructions and Limitations  
 Information: These photographs are an indication of the obstructions and limitations which impeded full inspection of the property at the time of inspection. These obstructions can hide an array of defects and should be removed to allow full inspection to be carried out. A re-inspection is recommended once the areas are made accessible.
