# Building and Timber Pest Inspection Report

Inspection Date: Tue, 10 Feb 2026

Property Address: 15 Oak St, Beaumaris VIC 3193, Australia

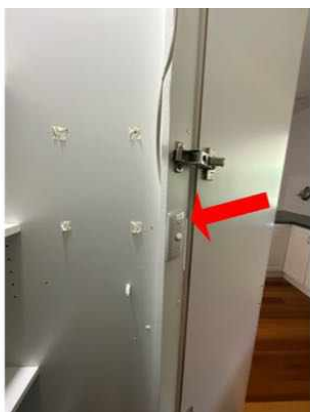
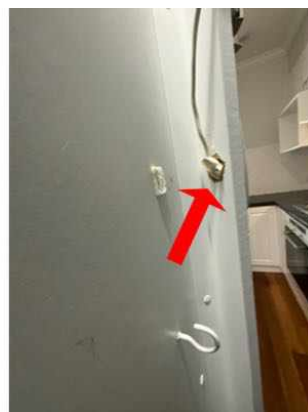
Building:  
 Location: Kitchen  
 Finding: Electrical wires exposed within the kitchen pantry  
 Information: At the time of inspection, it was noted that the electrical wires at the back of the light switch in the kitchen pantry were exposed.

This exposed wiring represents a potential safety hazard due to personal contact.

A licensed electrician should be contacted immediately to inspect the area and ensure the area complies with current standards and is safe.

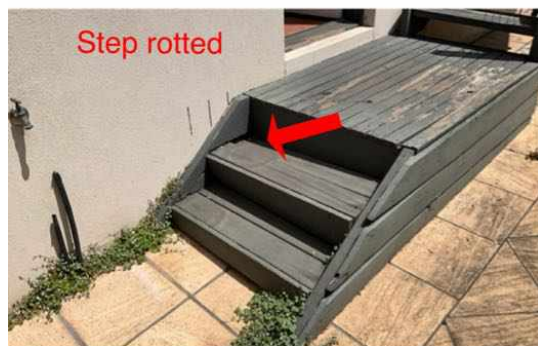
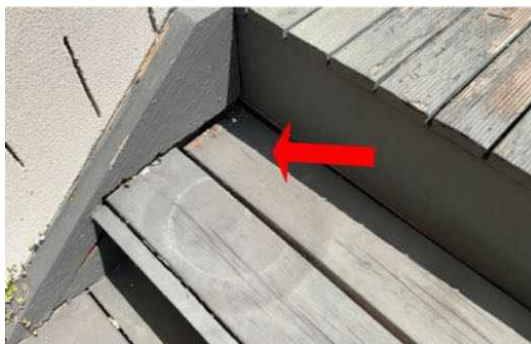
#### Finding 1.02

Building:  
 Location: All External Areas  
 Finding: Steps and handrails deteriorated/ missing - urgent safety hazard  
 Information: The timber step outside the laundry shows evidence of wood rot and has collapsed. It is suspected that a lack of maintenance over the years may have caused deterioration in the area resulting in rotting and collapse of the step. This poses a tripping falling hazard.

It was also noted that the handrail to the stairs from the upstairs balcony was not connected which also poses a falling hazard.

A qualified carpenter or registered builder should be engaged to replace affected building materials as a matter of urgency.

Failure to act on this defect may result in further deterioration and significant safety hazards.

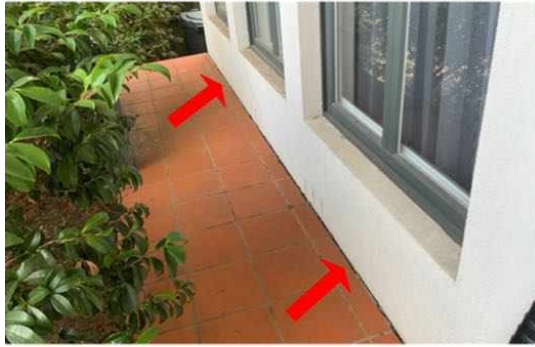
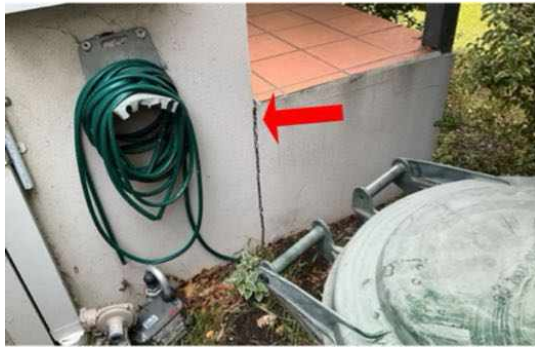
Finding: Distinct Cracking - External Concrete Paving

Information: Distinct cracks were identified between the front porch paving and the wall. It is suspected that the cracking may have occurred due to subsidence and movement in the front porch - away from the house.

Expansion and contraction of the concrete may also have occurred due to environmental factors. Such factors include variable moisture and weather conditions, the presence of trees and their roots having a settling or lifting affect on the soil over a sustained period of time

Cracking to this degree may also be due to poor original installation of the concrete. Factors such as poor compaction of the sub surface and/or inadequate reinforcing of the slab may create cracking and other secondary defects.

Repairs are likely to be required to prevent further cracking and to reduce hazards associated with cracking, such as tripping. Monitoring of all cracking should be conducted frequently. Always contact a building inspector should cracks widen, lengthen, or become more numerous.

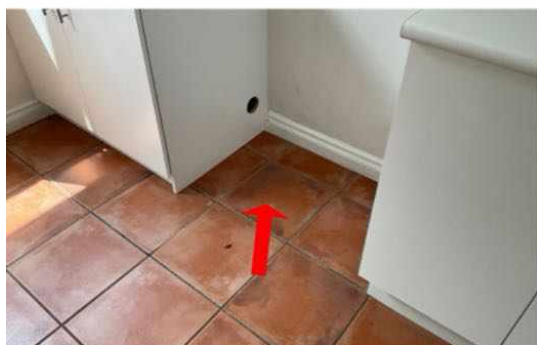
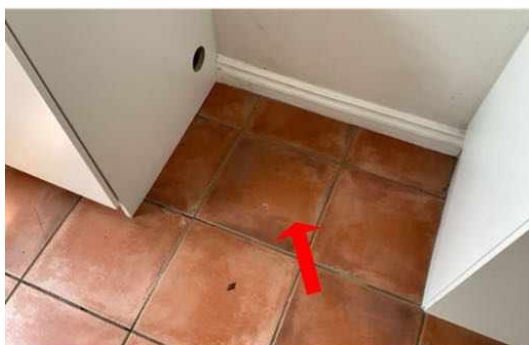
## Finding 2.02

Finding: Distinct Cracking and subsidence to the tiled floor in the laundry

Information: Distinct cracking and subsidence was identified to the tiled area in the laundry. It is suspected the floor underneath the tiles is damaged and is not giving enough support for the tiles. This is classified as a major defect. It is suspected the floor tiles will need to be ripped up and the floor inspected underneath these tiles. It is highly likely new flooring will need to be laid before new tiles are put down.

The extent of the repairs may only be obvious once the tiles and flooring has been removed and the extent of the damage noted. The purchase should be aware that significant works may be required.

Please note: The flooring in this area should not be walked on as there is a possibility of the floor collapsing.

A registered builder should be engaged to perform these works as a matter of urgency.

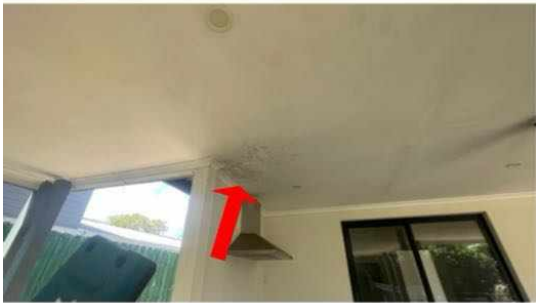
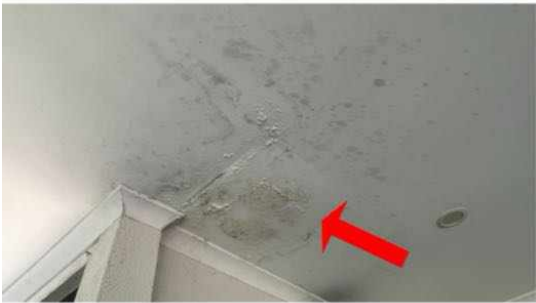
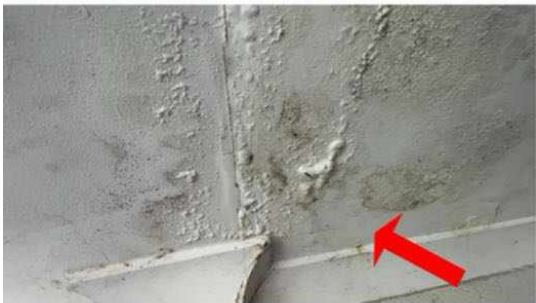
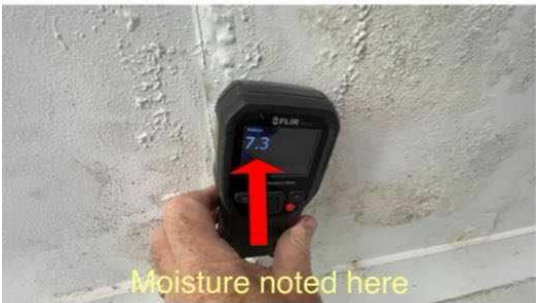
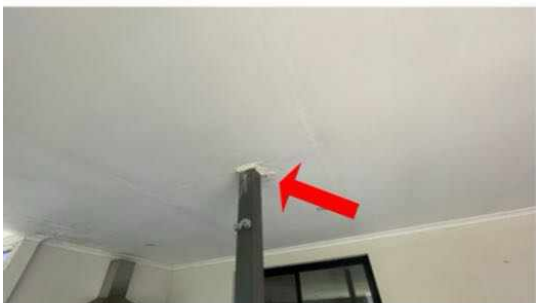
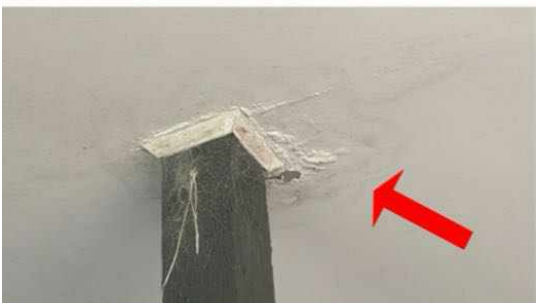
### Finding 2.03

Finding: Ceiling linings - Water stained with moisture noted in some areas

Information: At the time of inspection, there appeared to be some staining to various areas of the ceiling linings at the rear of the property ( underneath the balcony). When the area was tested with a moisture meter, moisture was noted in one of the areas. This is classified as a major defect.

Staining indicates that surfaces have been exposed to excessive moisture over time. The minerals and other elements in the water lead to staining, which may graduate to corrosion and deterioration if left unmanaged.

Once the water leaks have been addressed, all affected building materials may be repaired or replaced at client discretion. A registered builder may be engaged to perform this task.

This defect must be acted on and should not be left unattended.

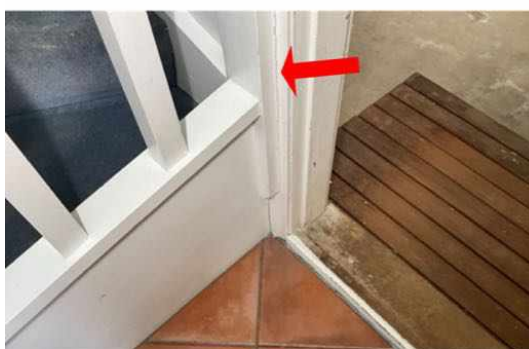
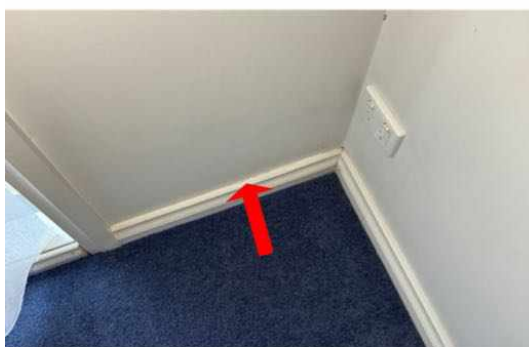
## Finding 2.05

Note: photos included are indicative of fine cracking noted at the the time of inspection. Other fine cracks may be present but not recorded here.

Where excessive moisture has caused the roofing structure to swell and sag, the source of the water leak should primarily be identified prior to any remedial works being performed.

Monitoring of all cracking should be conducted frequently. Always contact a building inspector should cracks widen, lengthen, or become more numerous.

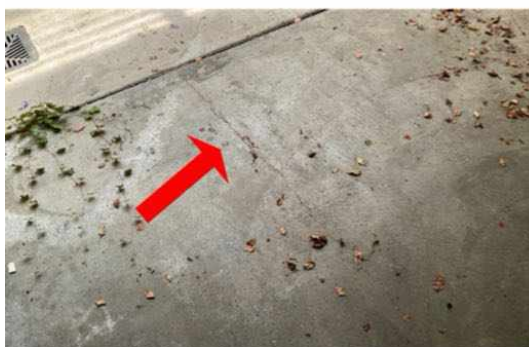
Finding 3.02

Building:  
 Location: Garage  
 Finding: Cracking - Concrete flooring within garage - Fine  
 Information: Fine cracks were identified in the concrete flooring of the garage . Although fine cracks are quite noticeable, they are often only considered to be an appearance defect, and usually do not indicate any structural damage.

Fine cracks may also be due to poor original installation of the concrete. Factors such as poor compaction of the sub surface and/or inadequate reinforcing of the slab may create cracking and other secondary defects.

Monitoring of all cracking should be conducted frequently. Always contact a building inspector should cracks widen, lengthen, or become more numerous.

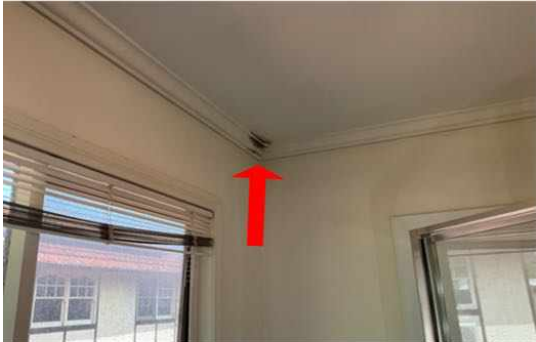
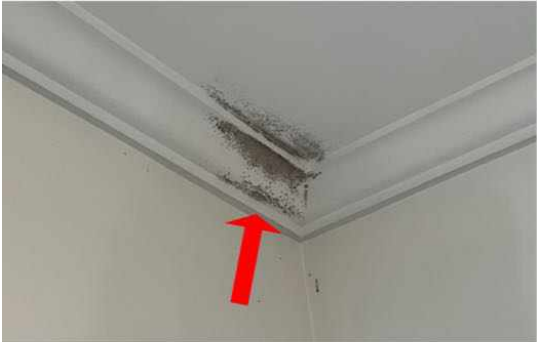
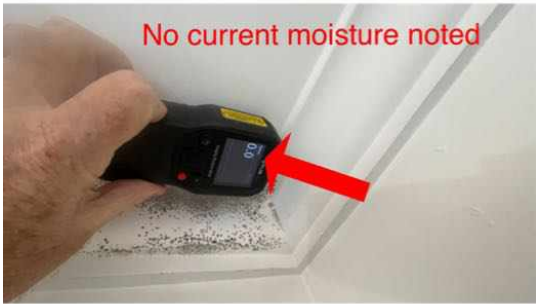
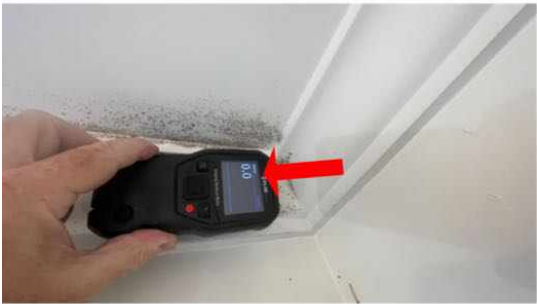
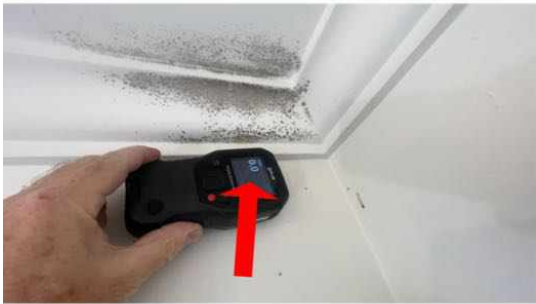
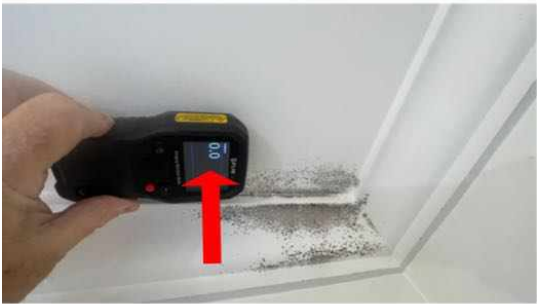
Building:  
 Location: Ensuite > Upstairs  
 Finding: Ceiling - Water stained and mouldy  
 Information: Water staining and mould was noted to ceiling linings in this area at the time of inspection. Water staining indicates that surfaces have been exposed to excessive moisture over time. It is suspected that the bathroom immediately above this area may have leaked previously, resulting in the ceiling becoming stained. No current moisture was noted within the area when tested with a moisture meter.

While mostly an appearance defect, water staining can be indicative of more serious defects, which may be currently concealed by interior ceilings.

Where water staining is active ( not suspected in this instance), a licensed plumber must be consulted to identify the cause of the staining and to provide advice on any

reparation works that may be required. Replacement of any damaged structures is advised.

Conversely, where water staining is old and inactive, affected building materials may be repaired or replaced at client discretion. The mould on the ceiling should also be cleaned by a mould specialist.

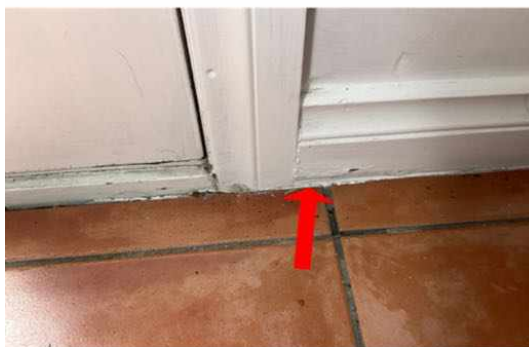
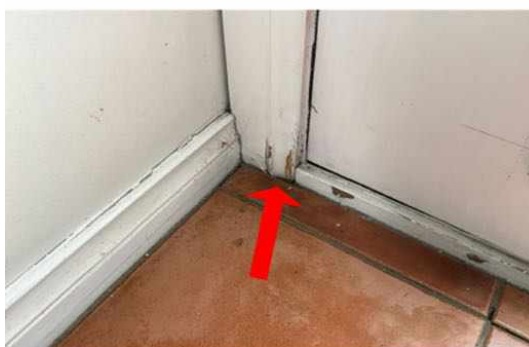
**Finding 3.04**

Building:  
Location: Laundry  
Finding: Moisture damage to architraves and door frame in the laundry area

Information: Evidence of moisture damage was identified to the architraves and door frame in the laundry area.

It is suspected that this has occurred as a result of excess moisture from either internal spills or external sources.

At the time of inspection no current moisture was noted when checked with a moisture meter. As a result , no further damage is likely in this area.

A licenced carpenter or competent handyman should be engaged to inspect the moisture damaged areas and repair or replace any items where necessary.

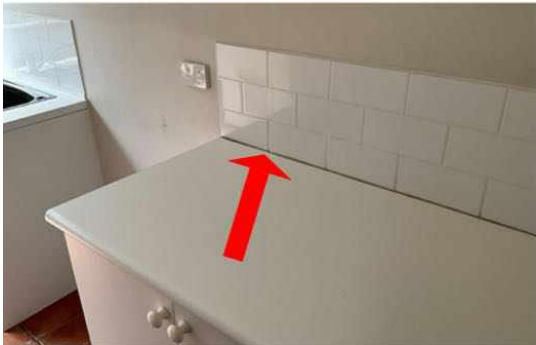
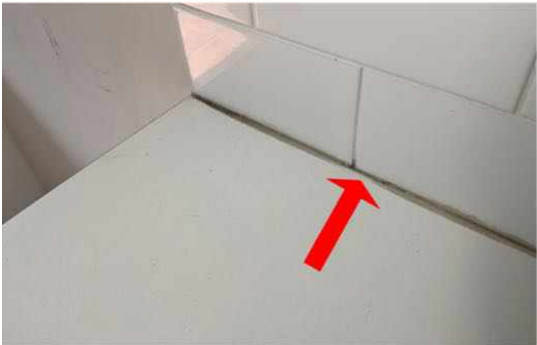
### Finding 3.05

Building:  
 Location: Laundry  
 Finding: Sealant - Degraded in this area  
 Information: Sealant is deteriorated in this area.

Failure to do so is likely to lead to water damage to the surrounding area.

Where Sealant is damaged or missing , a tiling contractor should be appointed immediately to re-apply any silicone where necessary.

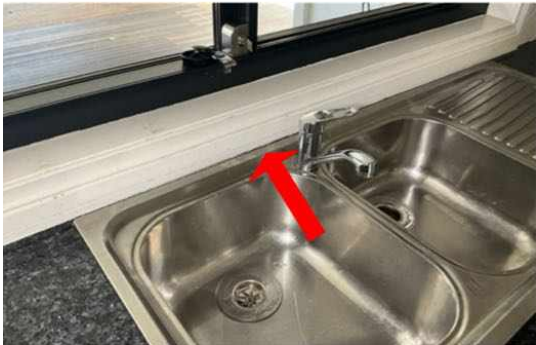
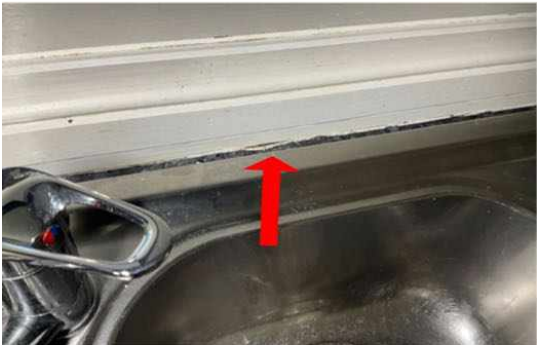
**Finding 3.06**

Building: Kitchen  
Location: Kitchen  
Finding: Sealant - Damaged or Missing  
Information: Sealant is damaged or missing in this area. Sealant is used to protect gaps and crevices in building materials to ensure that they are water-tight and prevent water penetration to the associated structures.

Failure to do so may lead to water damage to the surrounding area.

Where sealant is missing or damaged , a general handyman may be appointed to re-apply any silicone where necessary.

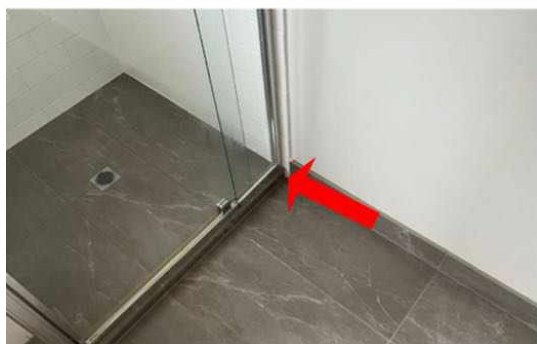
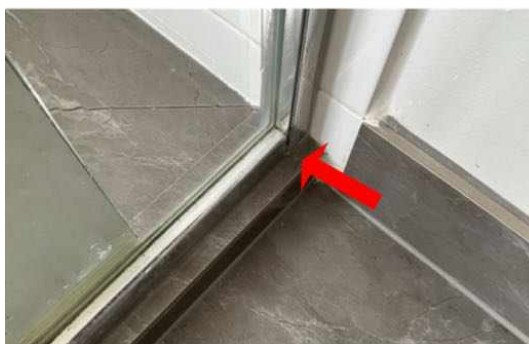
### Finding 3.09

Finding: Shower screen seal - Leaking

Information: Leaking was evident to the shower screen where it meets the wall at the time of inspection. It is suspected that the leaking has occurred as a result of the screen not being sealed correctly in this area.

Leaking from the shower, where left unattended, can lead to water damage and necessitate extensive remedial works being required. Active water leaks may also create an environment that is susceptible to the formation and development of mould.

Appointment of a tiling contractor or competent handyman is required to repair / replace the sealant. Such works should be performed immediately to ensure that no further damage occurs.

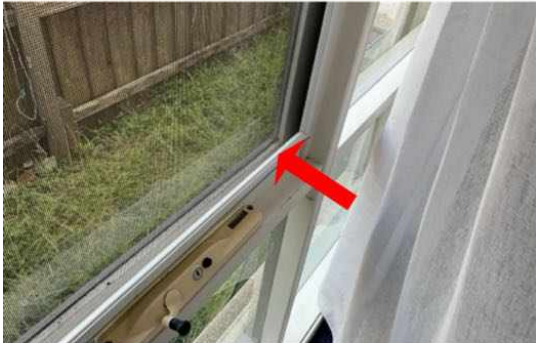
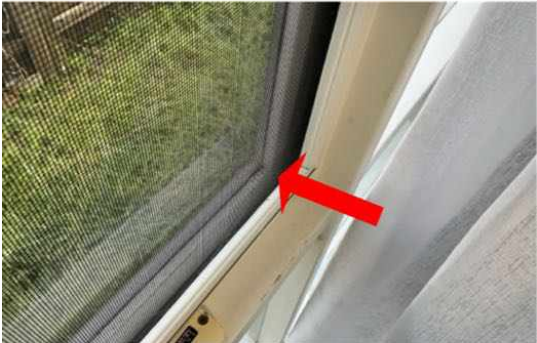
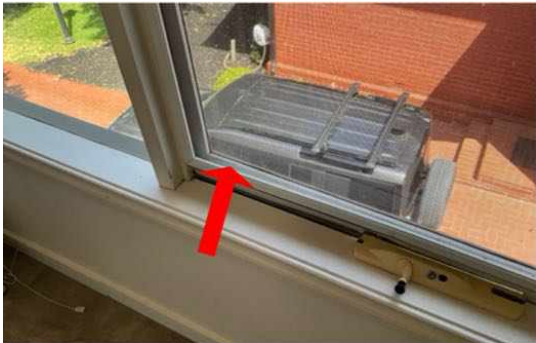
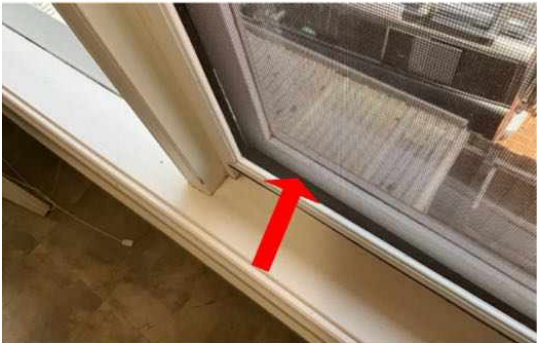
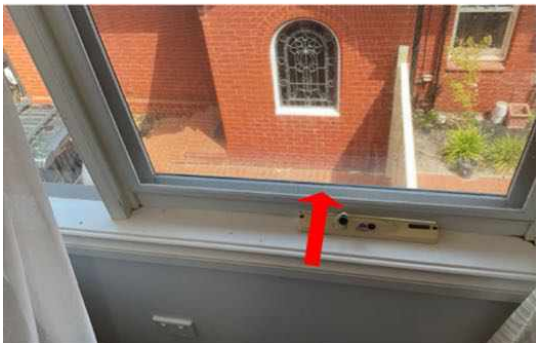
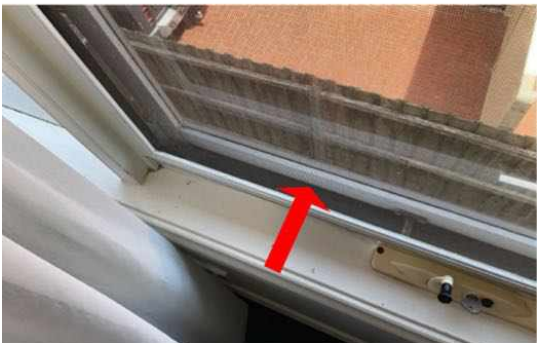
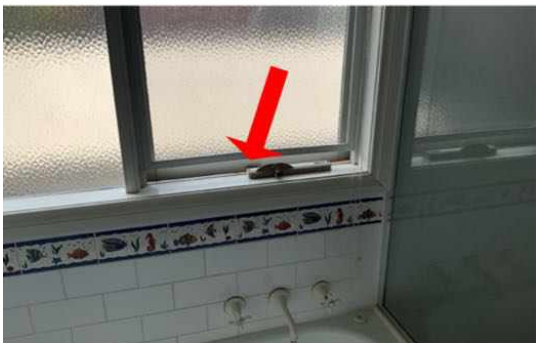
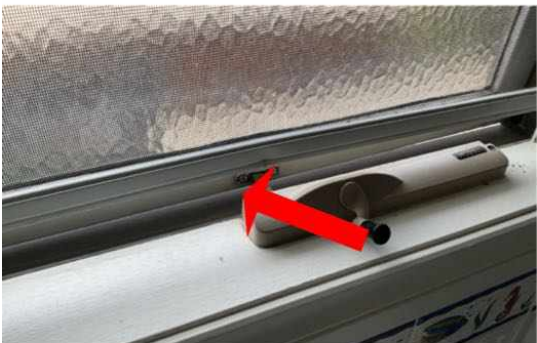
### Finding 3.10

Restricted function of the window may also create potential for secondary defects to the associated building elements, such as damage to the window frames as well as a potential safety hazard if required for emergency egress from the building.

The most usual causes are swelling of timbers due to moisture, bulging or bowing of frames, or general material degeneration. Lack of maintenance can also contribute to the windows sticking.

Easement may be required, which may involve some sanding and repainting. It will almost always include ensuring the areas are cleaned and free of any debris that may be detrimental to their operational state

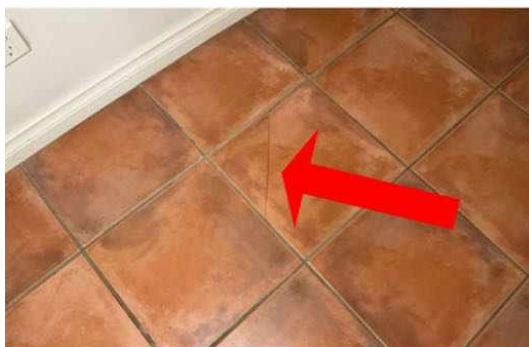
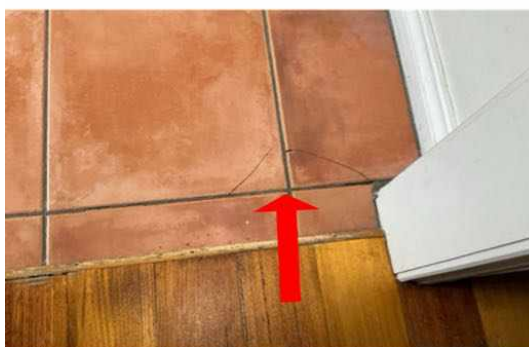
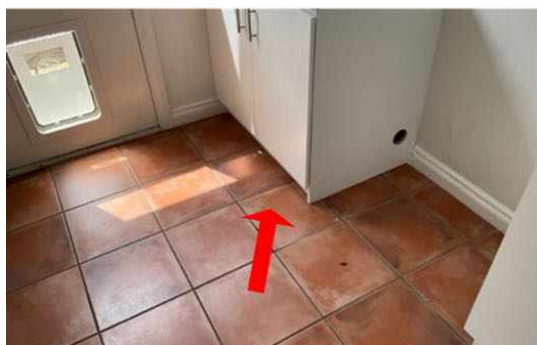
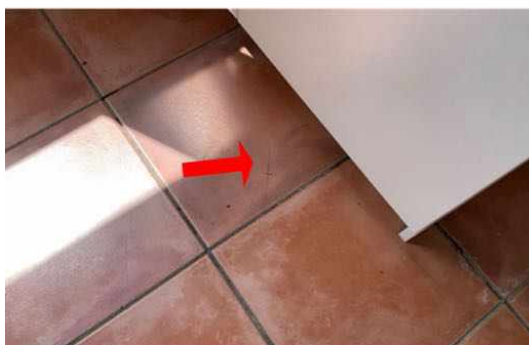
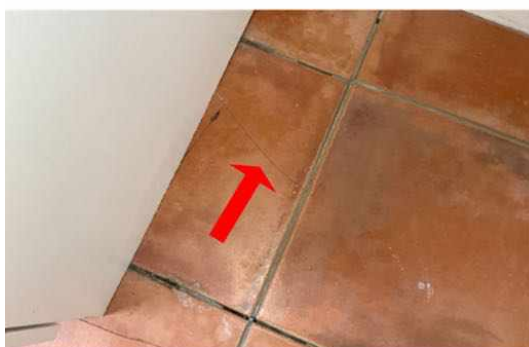
Finding 3.11

Finding: Floor tiles - Cracked

Information: Cracking in the floor tiles was evident in this area at the time of inspection. It is suspected that this cracking has occurred as a result of the floor being uneven and lacking a solid or suitable foundation for the tiles to be laid on. Settlement in the floor foundations may also have caused movement and resulted in the cracking of tiles in this area. Impact damage to the area may also be a cause.

Cracked tiles throughout the household detract from the overall appearance of the affected areas, as well as creating potential for water penetration to adjoining building elements. If left unmanaged, water damage may occur as a result of constant water penetration over a prolonged period of time.

While not considered a matter of urgency, replacement of cracked floor tiles is advised as a solution. A tiling contractor or general handyperson may be appointed to perform these works at client discretion. Where cracks become more numerous, consultation with a registered builder specialising in re-stumping may be required.

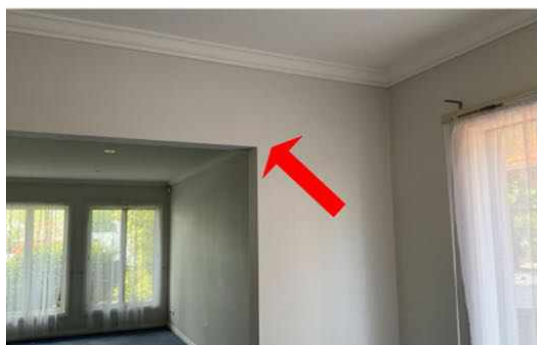
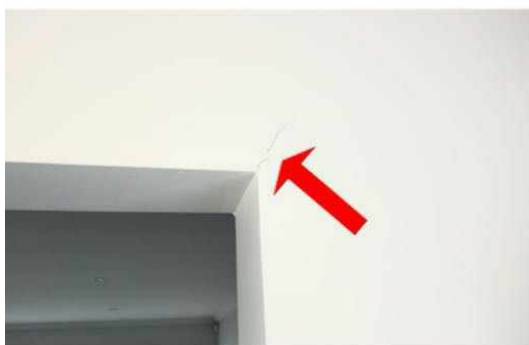
### Finding 3.12

Finding: Cracking - Noticeable

Information: Cracking was noted within the plasterboard wall in the upstairs living area.

Noticeable cracks are a common occurrence as a result of many primary defects. Such causes may include age, general wear and tear, expected building movement, general expansion/contraction of building materials in different weather conditions, and/or minor failings in the installation or application of building materials.

Noticeable cracks may result in minor sticking or jamming of associated doors and windows, which require easement. However, noticeable cracks are easily filled and repaired.

Monitoring of all cracking should be conducted frequently. Always contact a building inspector should cracks widen, lengthen, or become more numerous. Additionally, your building inspector should also be contacted if associated building elements such as doors and windows become more difficult to operate over time.

Relevant tradespeople, such as carpenters, painters and plasterers, should be appointed to perform remedial works, as deemed necessary.

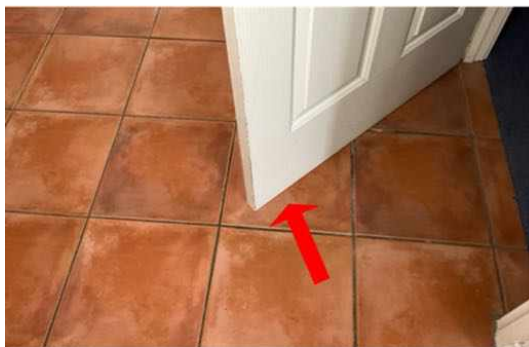
Finding: Door - Binding/jamming  
 Information: Binding and/or jamming of this door is evident during standard operation. This defect inhibits the functionality of the affected door as well as creating potential for secondary defects to associated building elements, such as damage to the floor covering.

A door that binds to flooring or to the associated door frame may have several causes, ranging from minor defects, such as poor installation of the door or deteriorated hinges, through to major structural issues, such as damage to subfloor structures.

Where door binding/jamming appears to indicate major structural issues ( not suspected in this instance) , a registered builder specialising in re-stumping should be appointed to provide an estimate on the cost of rectification.

For minor causes, a qualified carpenter or general handyperson should be appointed to perform minor rectification works at client discretion.

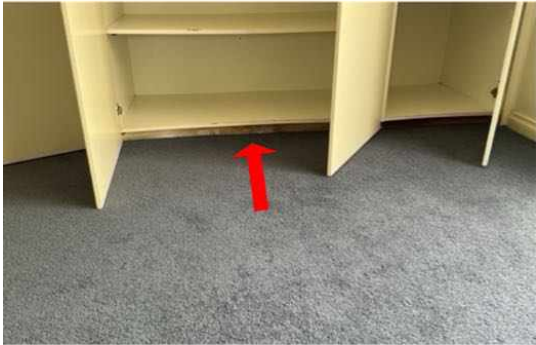
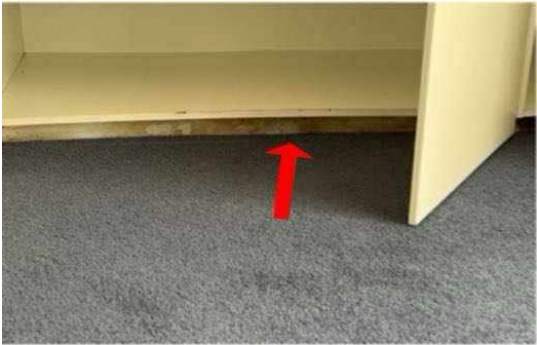
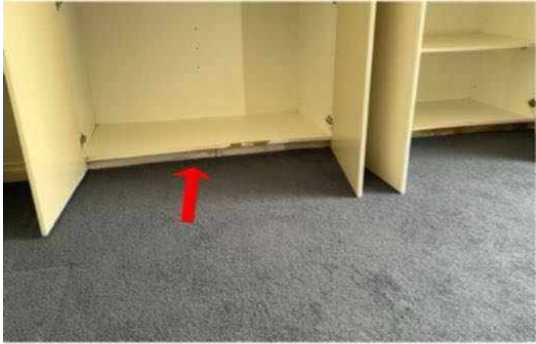
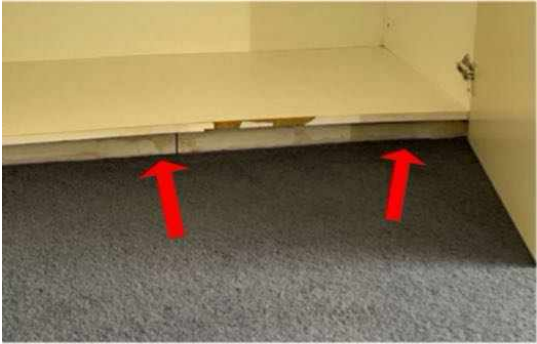
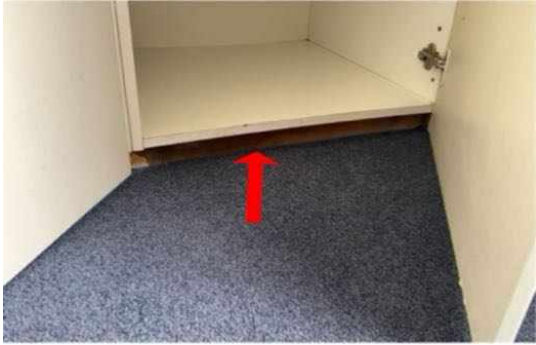
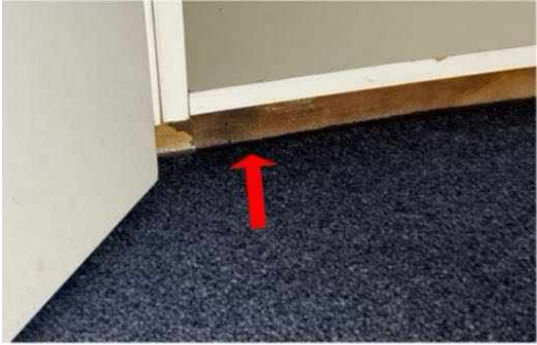
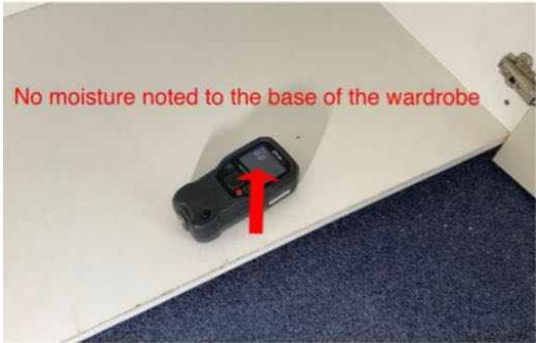
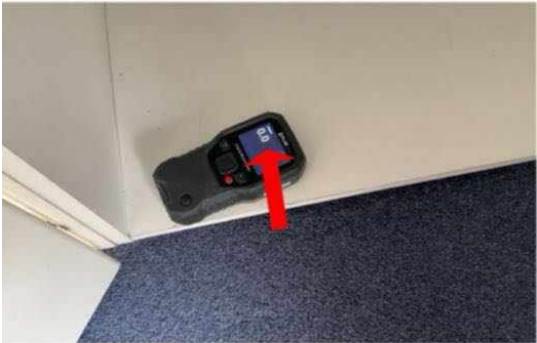
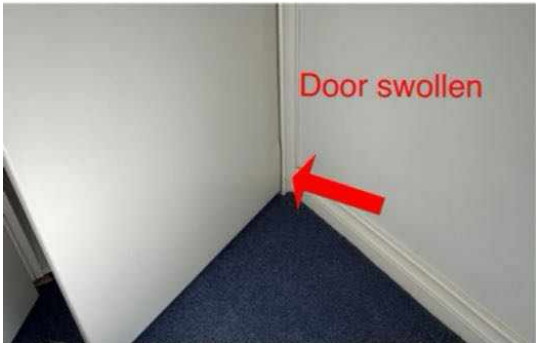
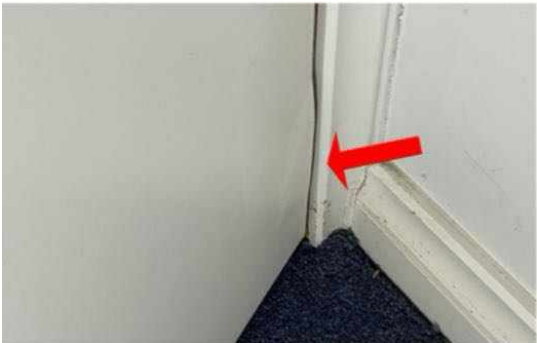
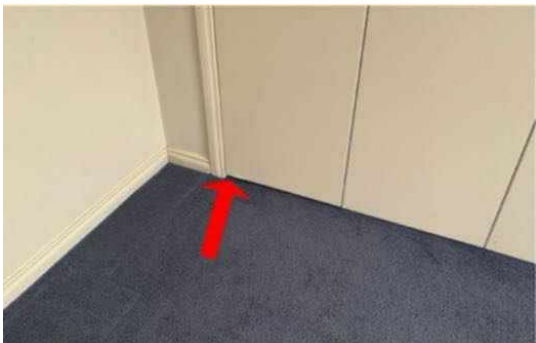
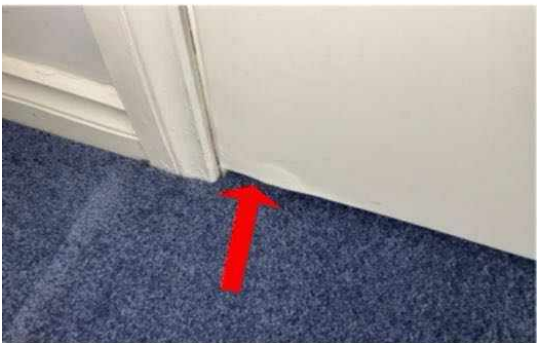
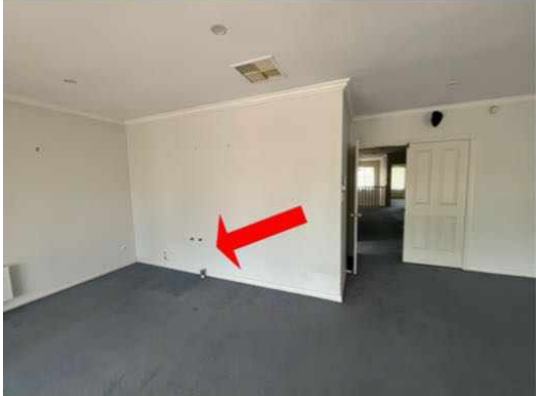
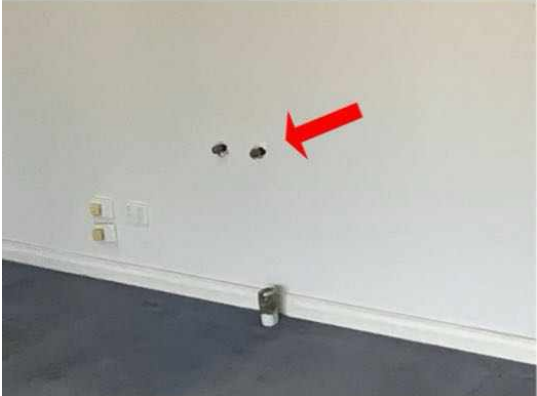
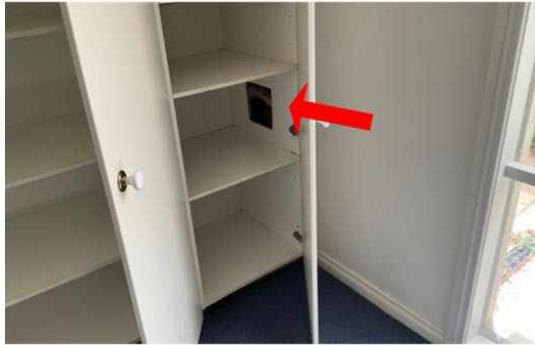
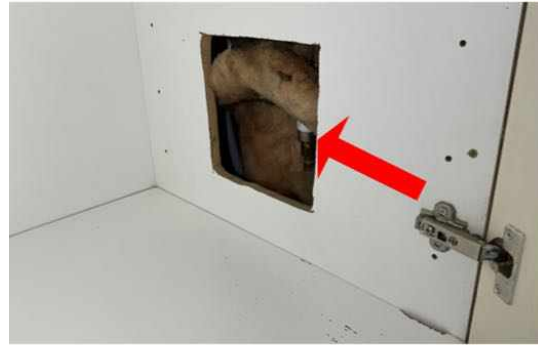
### Finding 3.15

Building:  
 Location: Bedroom  
 Finding: Moisture staining to the wardrobe bedroom  
 Information: Evidence of moisture staining was identified to the base of the wardrobe in the second bedroom upstairs at the time of inspection. Evidence of moisture damage was also noted to the base of the wardrobe doors. No current moisture was noted within the area when tested with a moisture meter.

It is unclear as to the cause of the staining. It may have potentially been from a leak in the pipework within the wall immediately behind the wardrobe or the piping inside the wardrobe .

Please note there was a damp smell within the bedroom at the time of inspection

The area should be monitored for any further signs of staining . Should this occur, consultation with a damp specialist should be sorted to determine the cause of the dampness. This may involve an invasive inspection of the wardrobe and possibly the flooring.

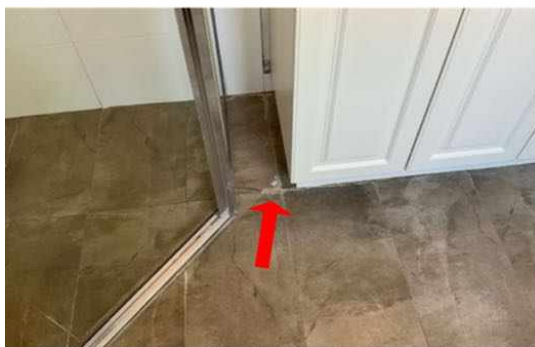
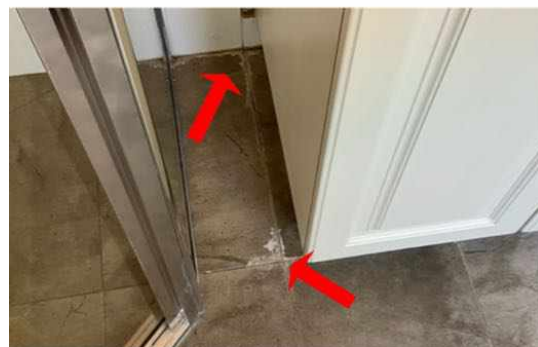
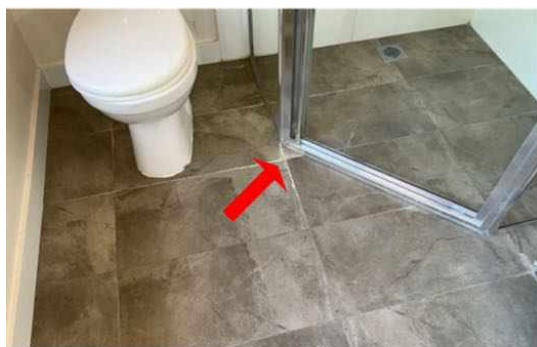
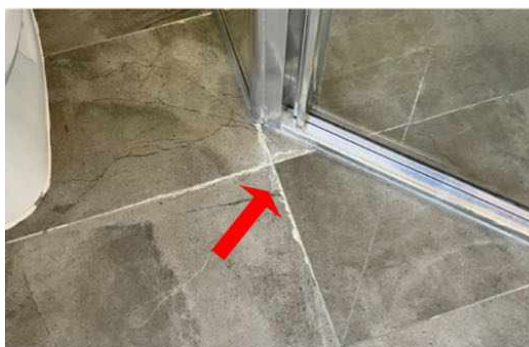
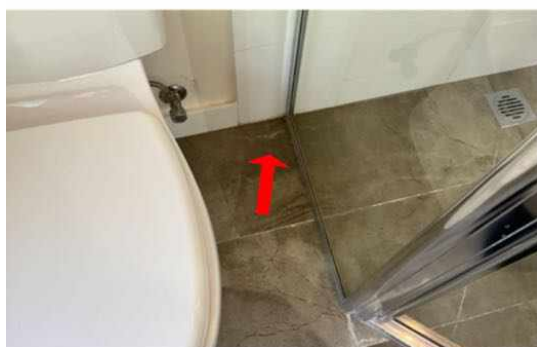
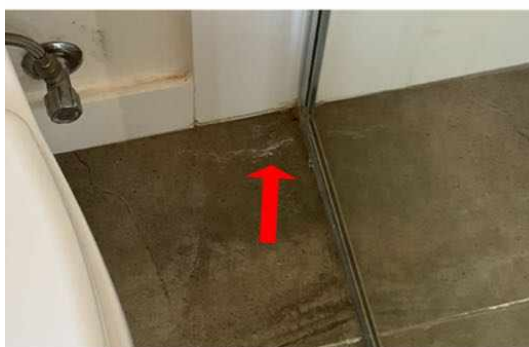
It is typically seen as white salt deposits between the tiles. While detracting from the overall appearance of the affected area, efflorescence is not likely to develop into secondary damage if left unmanaged.

Generally, soluble salt deposits can be removed by dry brushing with a stiff-bristled brush. Repeated dry brushing is an ideal treatment for eliminating this forming of efflorescence.

A cleaning contractor or general handyperson may be appointed to perform these works at the discretion of the client.

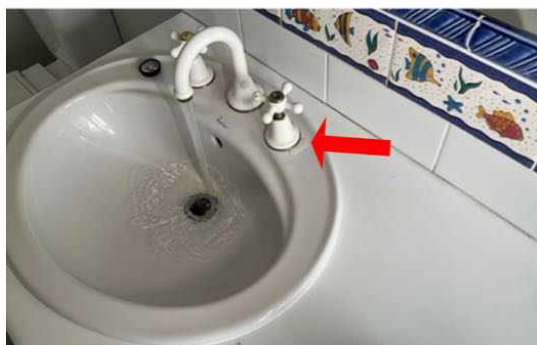
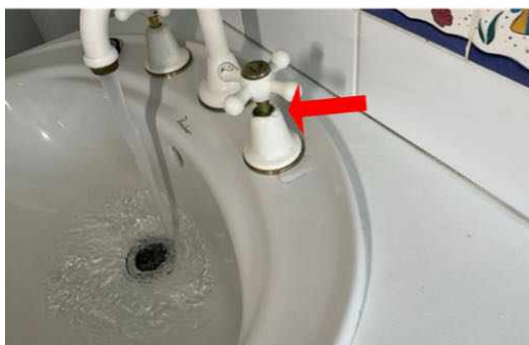
### Finding 3.17

Finding: Tap - Leaking

Information: The tap in the kitchen was found to be leaking at the time of inspection. This is a common defect that is consistent with general ageing of the tapwear.

While this defect only seems minor, if left unmanaged, it is likely to result in the development of rust, water damage and/or extensive water usage.

It is advised that a licensed plumber be appointed to perform remedial works on the affected tap. Such works should be performed prior to the development of secondary defects to ensure adequate functionality of all associated building elements.

Please note this defect should not be left unattended. Failure to repair this leaking tap may result in further deterioration of the property.

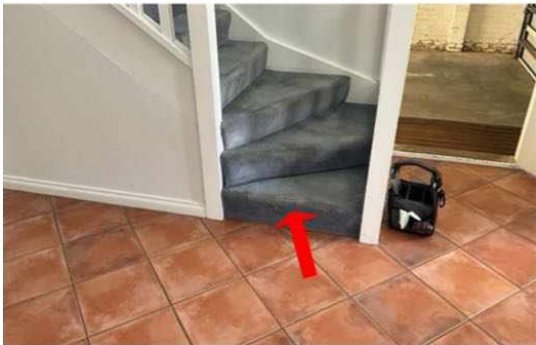
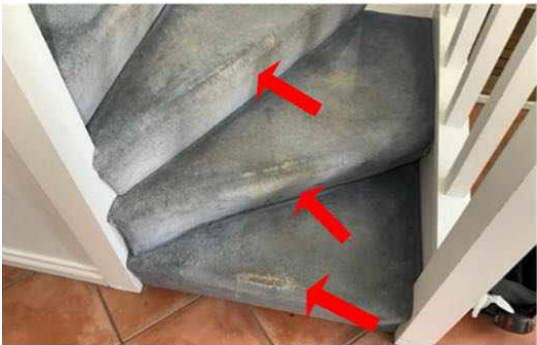
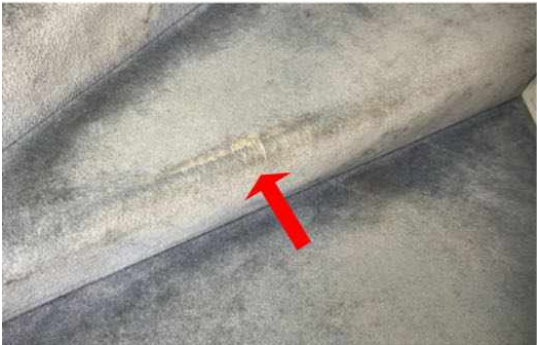
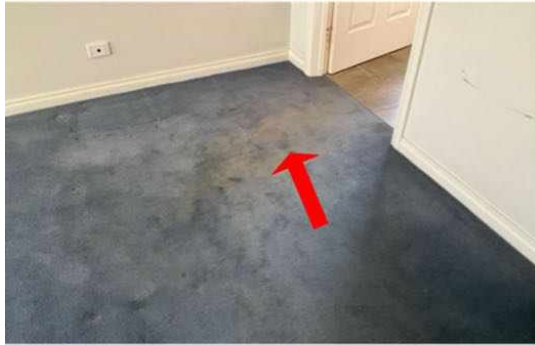
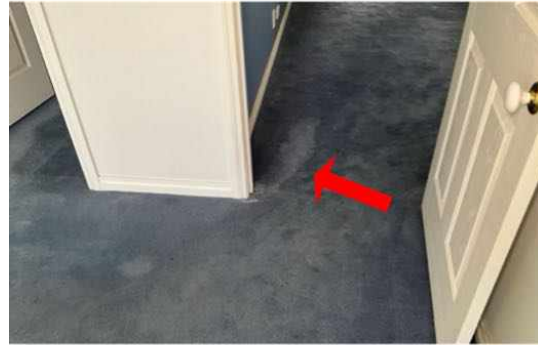
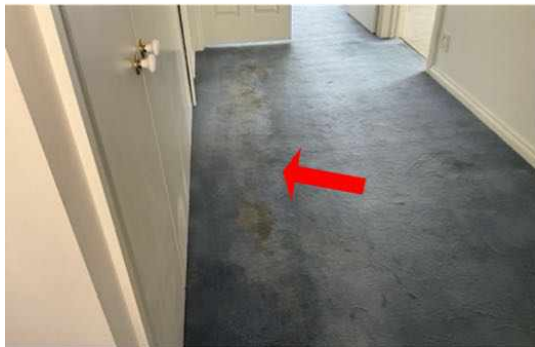
**Finding 3.21**

Finding: Carpet deteriorated in some areas

Information: At the time of inspection, some areas of the carpet throughout the property showed signs of wear . This is consistent with properties of this age, in particular where the property hasn't been looked after.

The carpet may be replaced at the discretion of the homeowner.

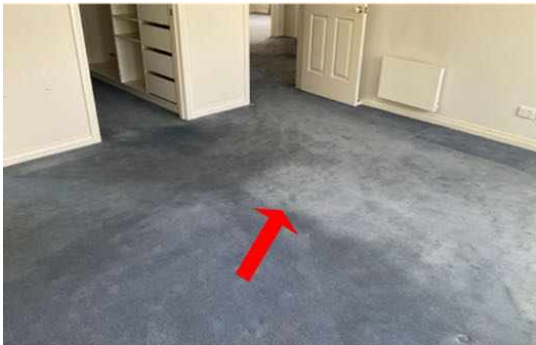
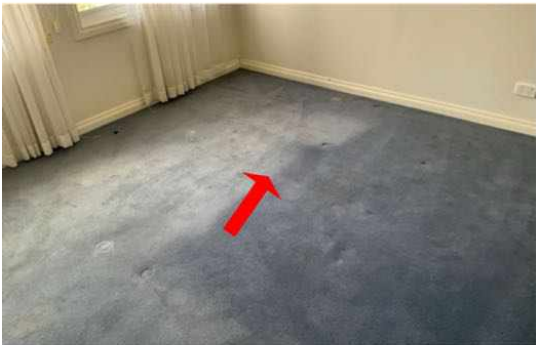
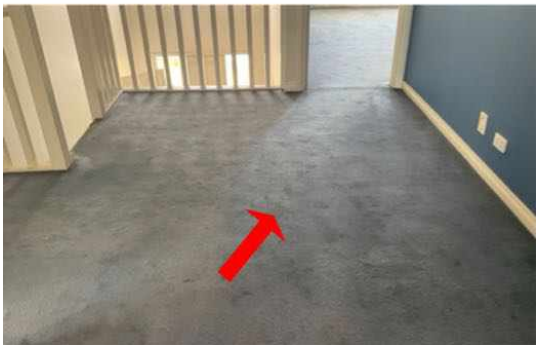
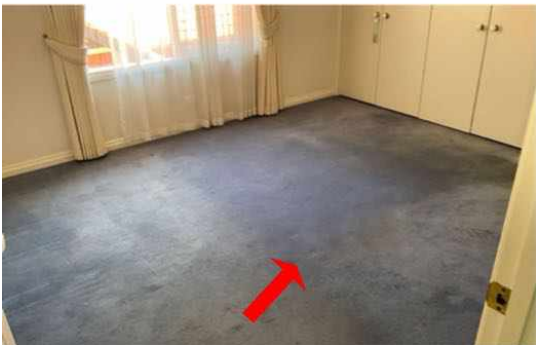
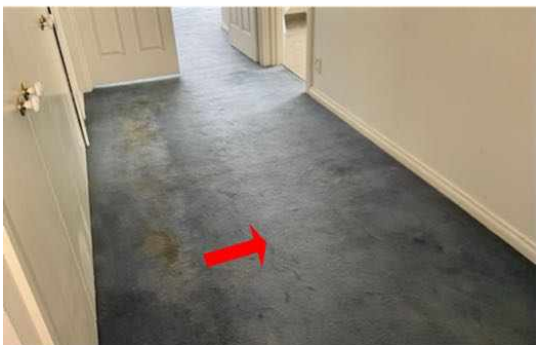
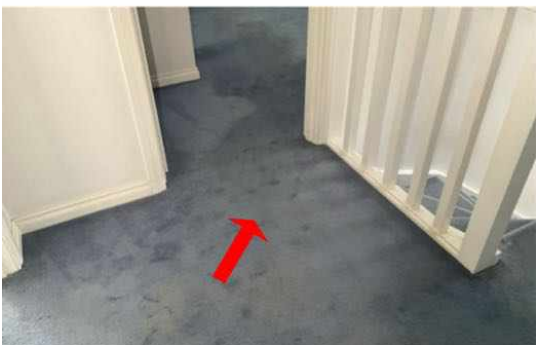
### Finding 3.22

Creaking floors generally indicate that the fixings for the flooring may be coming loose slightly.

The area should be monitored for any changes or unevenness. Should this occur, consultation with a registered builder should be undertaken to determine the cause. The potential resolution may involve regluing and screwing the floor down through to replacement of subfloor support structures.

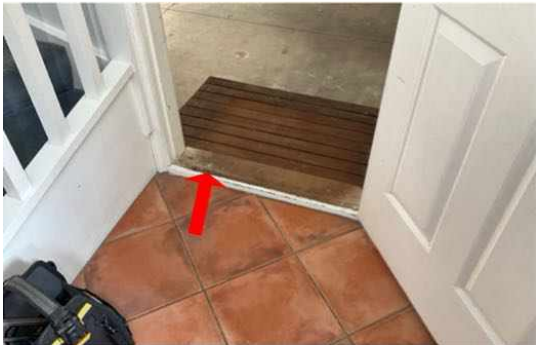
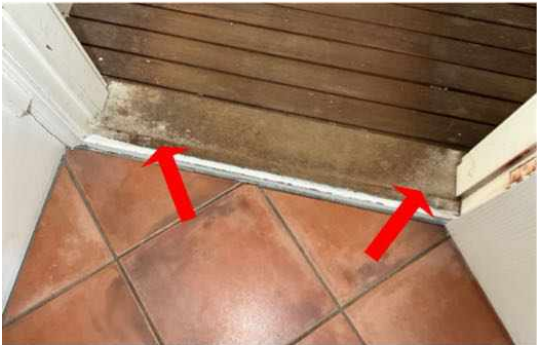
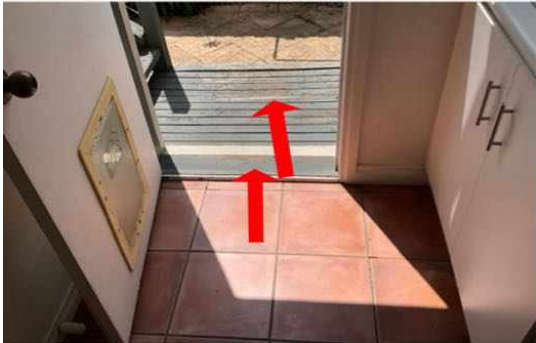
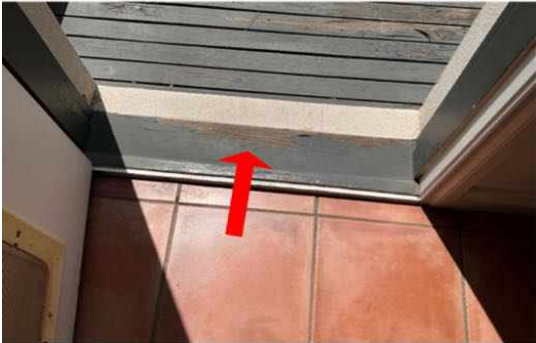
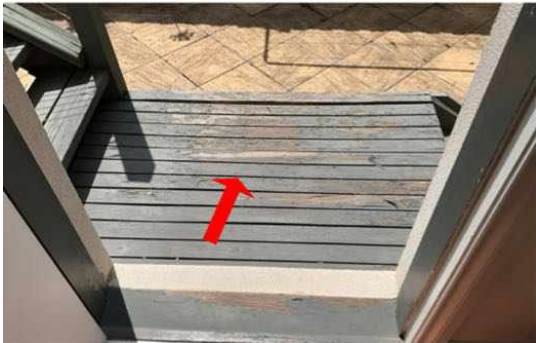
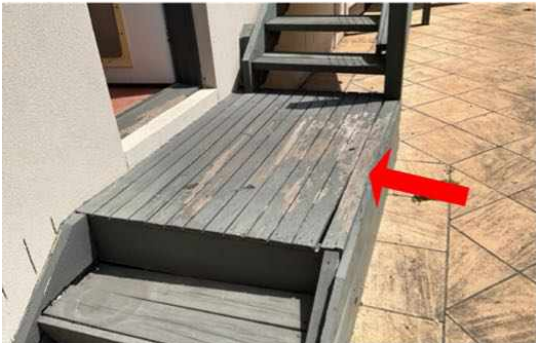
**Finding 3.23**

Building:  
Location: All External Areas  
Finding: Timber - exposed to weather  
Information: External timbers that are frequently exposed to harsh weather conditions require adequate protection in order to maintain their condition. Where timbers have not been painted or treated adequately, general deterioration is likely to occur at an accelerated rate.

If left unattended, replacement of these timbers is likely to be necessary in the short-term future.

Adequate treatment of these timbers is required as soon as possible by a painting contractor or general handyman.
