# Building and Timber Pest Inspection Report

Inspection Date: Tue, 10 Feb 2026

Property Address: 15 Oak St, Beaumaris VIC 3193, Australia

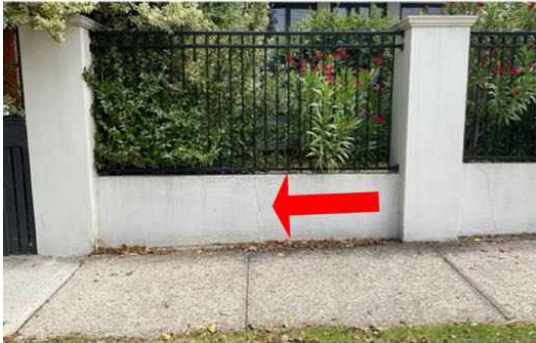
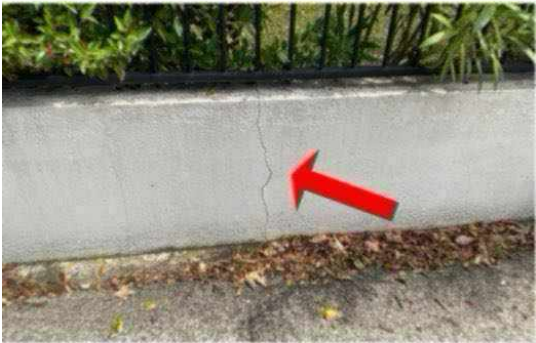
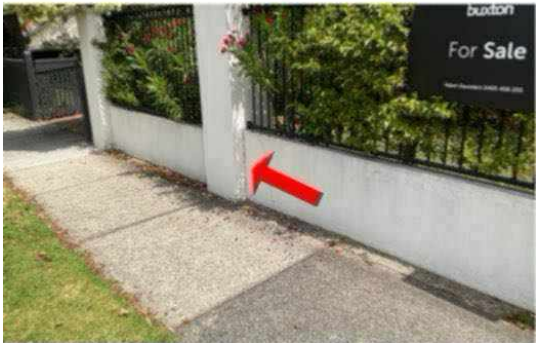
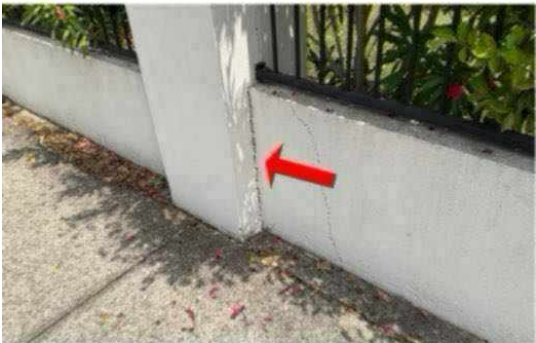
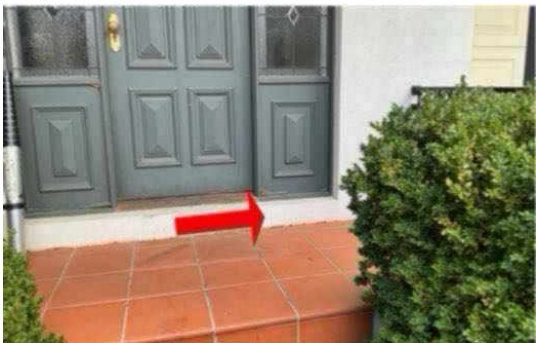
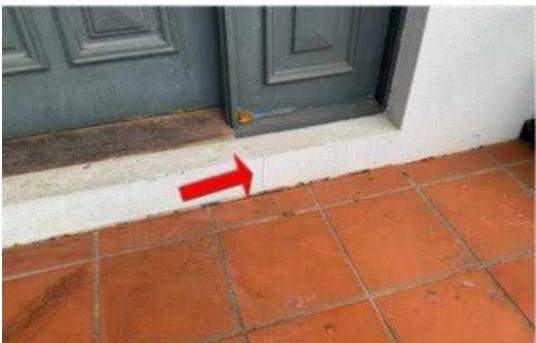
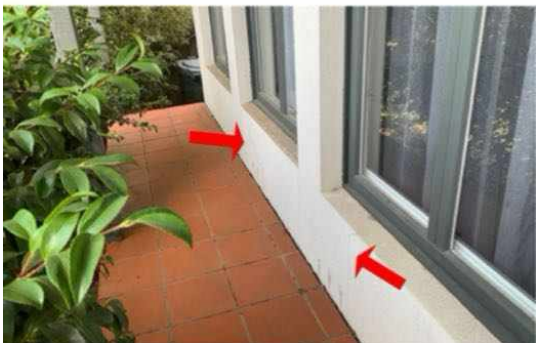
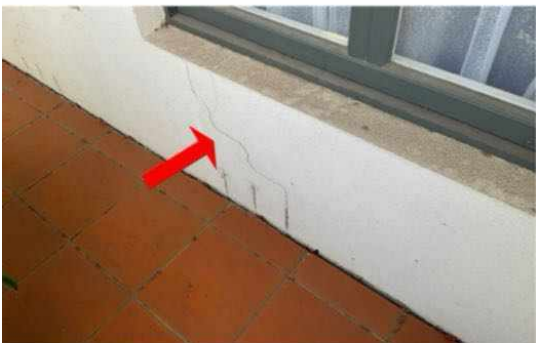
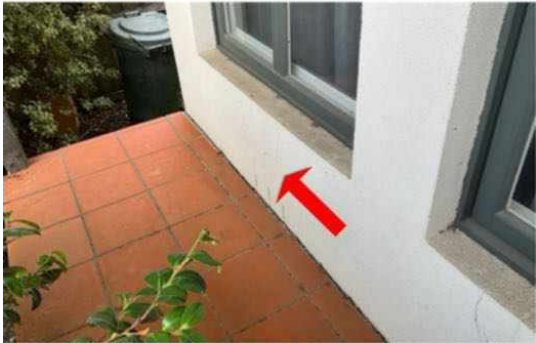
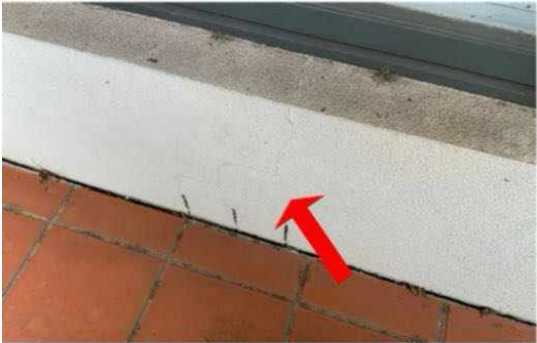
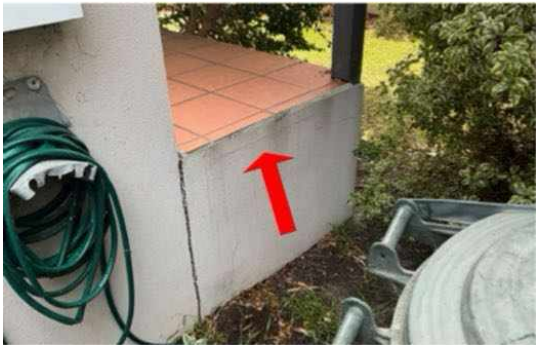
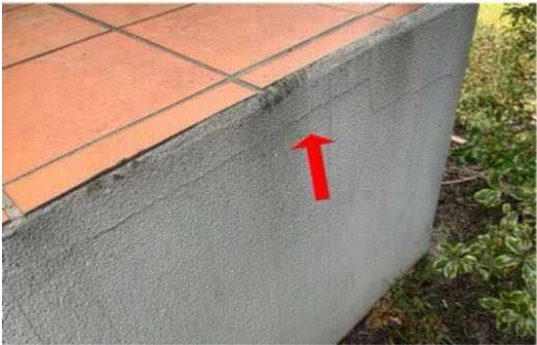
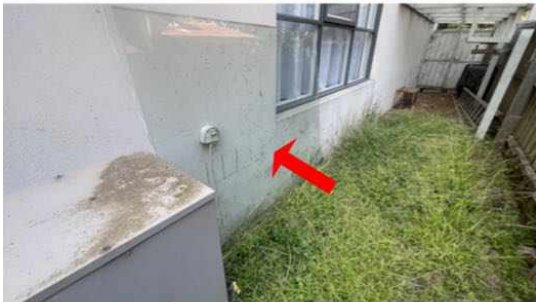
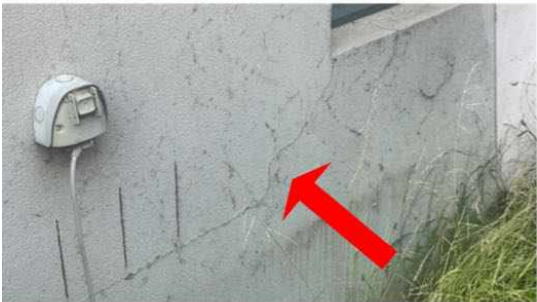
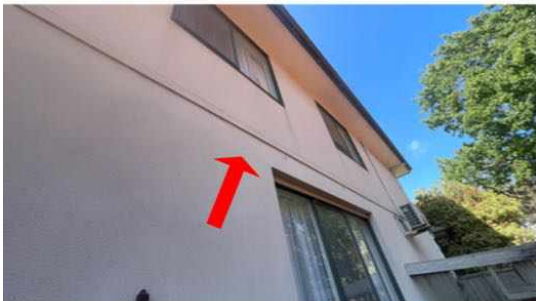
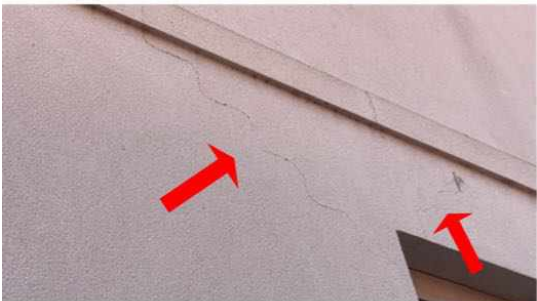
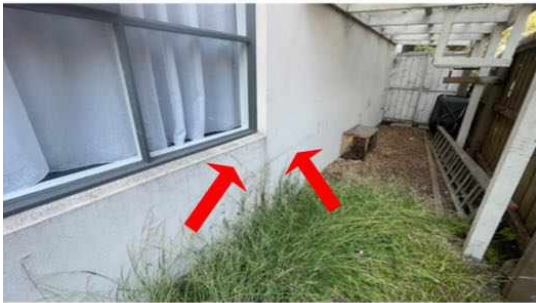
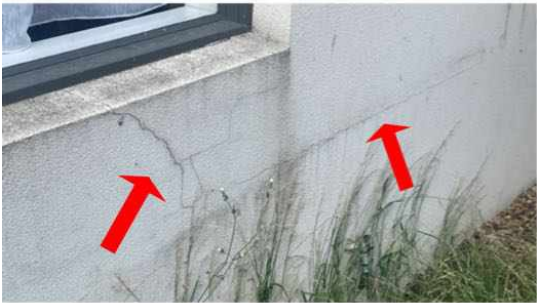
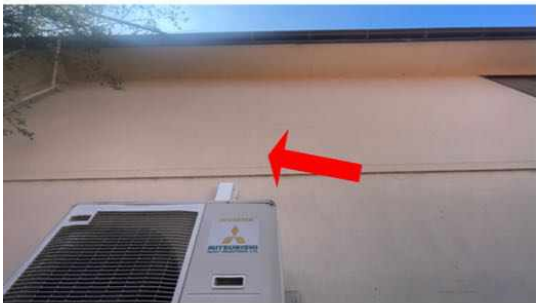
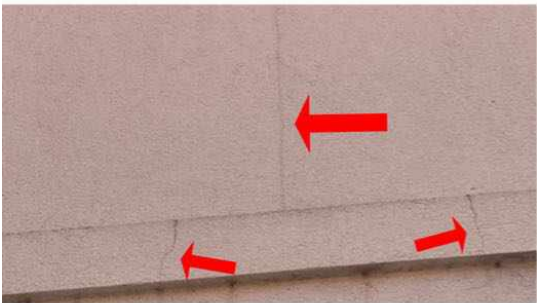
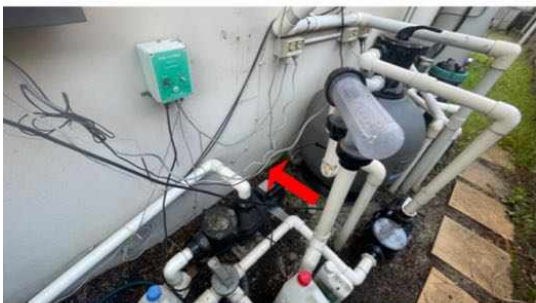
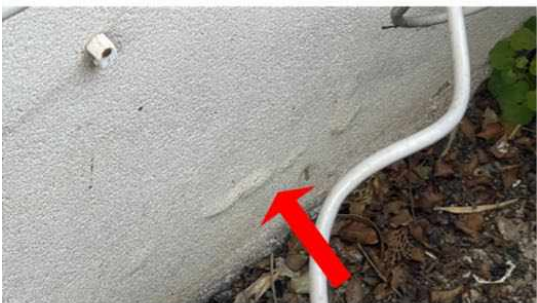
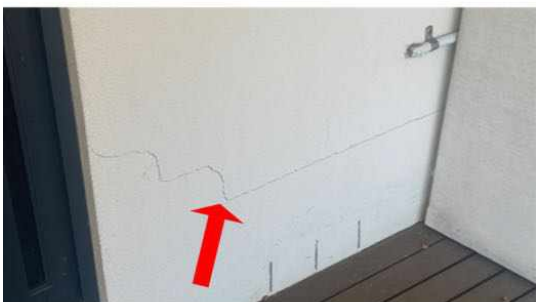
### Finding 3.24

Finding: Rendered wall - minor cracking

Information: Minor cracking to the rendered wall was identified at the time of inspection. It is suspected the cracking has occurred in the joints between various cement sheets on the wall.

This type of cracking is often consistent with general movement of the foundations of the property and is not considered a major structural defect.

Whilst it is more of an appearance issue, repairs may be required as failure to act may allow moisture to enter the crack and cause secondary damage to other building elements.

Consultation with a suitably qualified renderer should be sought to determine costs involved with any repairs necessary.

Should cracks increase in size or number, speak with your building inspector for further advice.

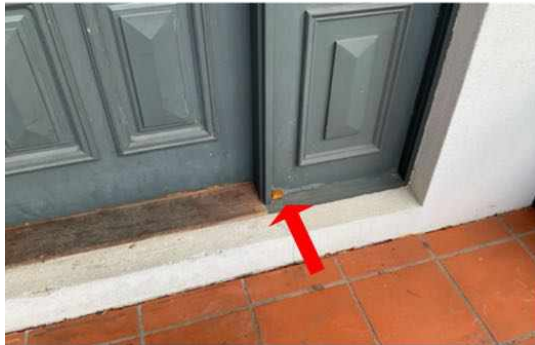
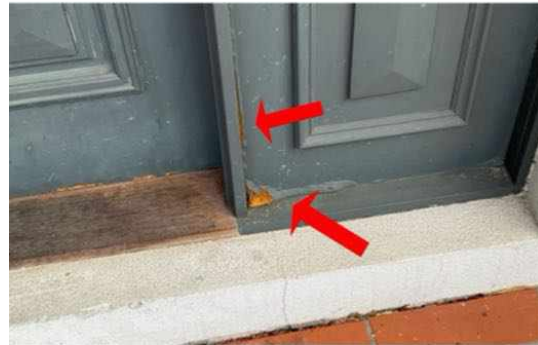
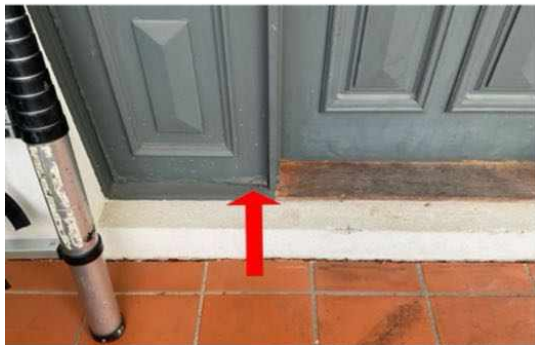
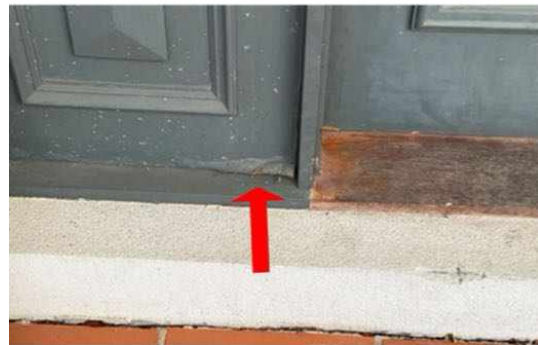
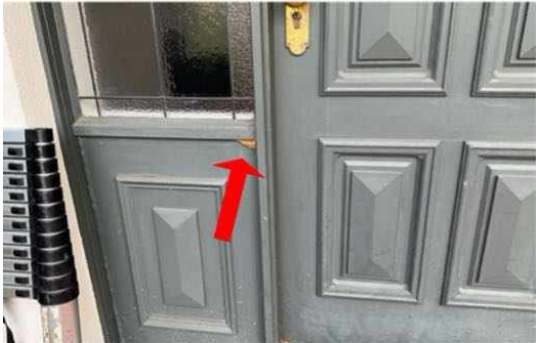
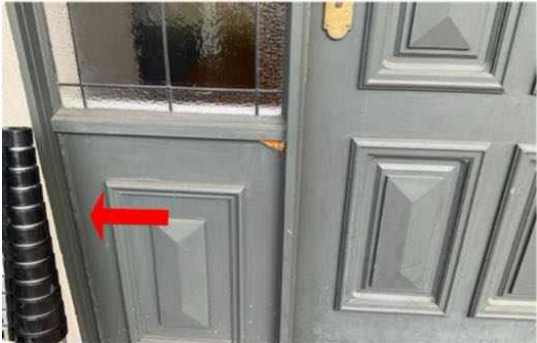
Finding 3.25

Building:  
Location: Entry  
Finding: Materials - Damaged and possibly unsuitable  
Information: At the time of inspection, the panels on either side of the door were deteriorated and showing evidence of moisture damage.

The materials used may be unsuitable for their intended purpose. Generally, this occurs in older homes or homes where people have undertaken ad-hoc repairs, extensions and/or renovations.

The workmanship is consequently substandard and the use of building materials not specifically suited to the purpose is likely to result in the development of minor and major defects over time. It is highly likely that the panels will need replacement.

A registered builder should be appointed to replace unsuitable materials to ensure the longevity of the entrance panels.

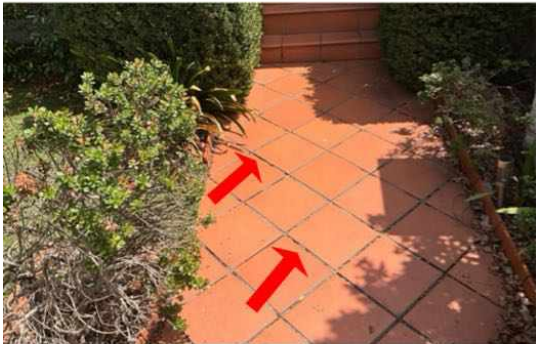
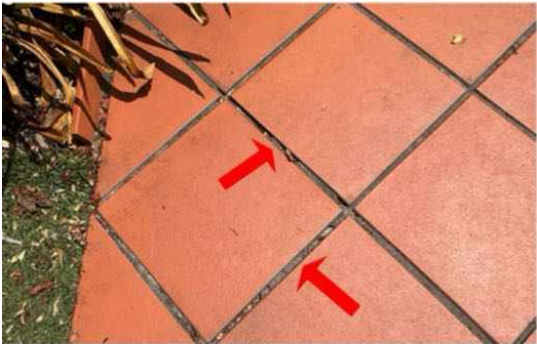
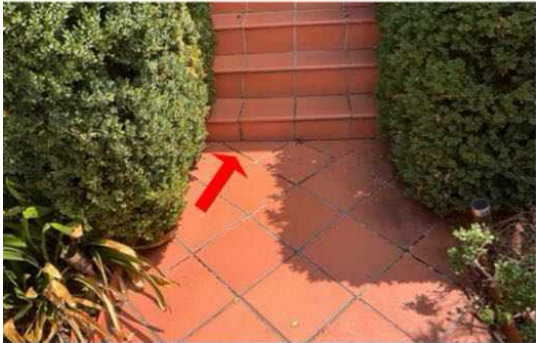
**Finding 3.26**

Building:  
Location: Yard - Front  
Finding: Exterior Grouting - Missing or damaged  
Information: It was noted on inspection that grout is degraded to the joints within the pathway tiles at the time of inspection.

The tiles and slab can move at different rates, generally causing cracking to grout at this point.

The grout should be scraped out and fresh grout applied where necessary.

A competent handyman may be appointed to complete these works.

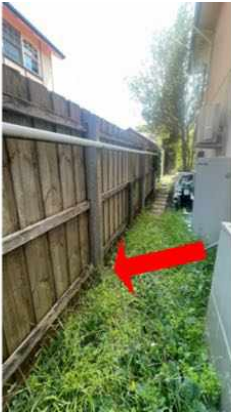
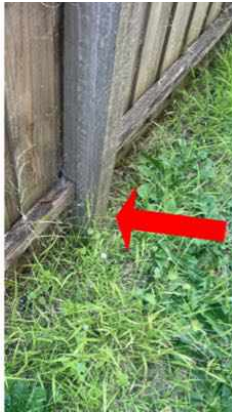
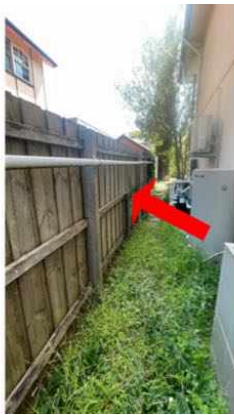
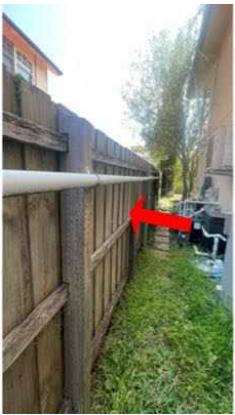
**Finding 3.27**

Finding: Fencing - slightly wobbly and deteriorated

Information: It was noted at the time of inspection that a section of the fencing at the side of the property was slightly wobbly. Other sections of the fence were also deteriorated.

Typically fencing deteriorates due to age and or wear, rot and or rust which is generally expected for a structure of this age, due to prolonged exposure to weather conditions. Sometimes inadequate installation or maintenance can be to blame.

Repair of several elements of the fencing will be required.

A licensed fencing contractor should be appointed to provide further advice and perform rectification works as necessary.

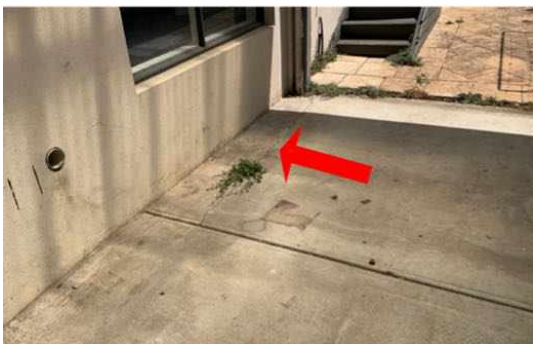
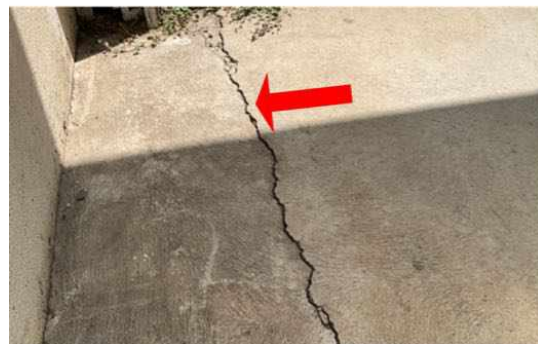
### Finding 3.29

Finding: Distinct Cracking - Garage Concrete floor

Information: Distinct cracks were identified in concrete paving of the garage . Distinct cracks are generally found in older concrete paving, and may also present as a trip hazard as consequence of an uneven or curved surface.

General age and expected deterioration of the paved areas is a common cause of this type of cracking. However, expansion and contraction of the slab may also have occurred due to environmental factors. Such factors include variable moisture and weather conditions, the presence of trees and their roots having a settling or lifting affect on the soil, or the effect of load bearing over a sustained period of time

Cracking to this degree may also be due to poor original installation of the concrete. Factors such as poor compaction of the sub surface and/or inadequate reinforcing of the slab may create cracking and other secondary defects.

Repairs are likely to be required to prevent further cracking and to reduce hazards associated with cracking, such as tripping. Monitoring of all cracking should be conducted frequently. Always contact a building inspector should cracks widen, lengthen, or become more numerous.

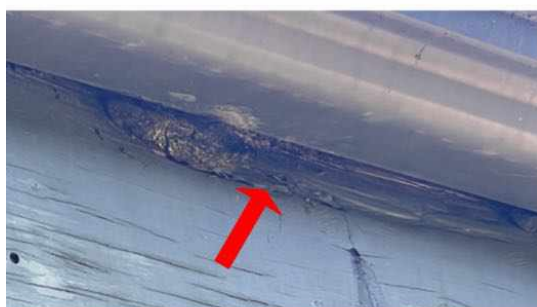
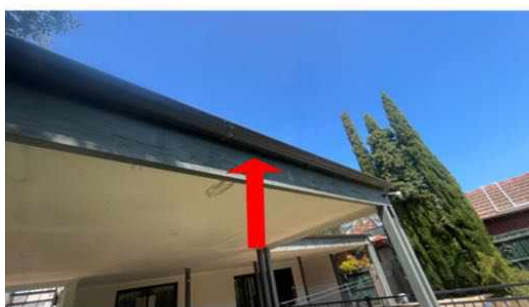
### Finding 3.30

Building:	
Location:	Roof Exterior
Finding:	Fascia - Wood rot noted
Information:	Wood rot was found to be affecting the fascia in this area. Wood rot, also known as Fungal Decay, occurs when timbers and other cellulose building materials are exposed to damp conditions on an ongoing basis.

It is likely that this wood rot has developed as a result of faults in the roof cover or plumbing, creating excessive moisture in this areas. Frequent exposure to rain and other weather conditions also make fascias and barges susceptible to accelerated deterioration.

Early intervention and regular maintenance will prolong the useful life of these building elements. Prior to any works being performed, the cause of the moisture that has created the visible wood rot should be identified and addressed in a suitable manner.

It is advised that a roof plumber be appointed to inspect all roof plumbing and subsequently identify the cause of the wood rot. Replacement of affected fascias and barges may then be a necessary step in protecting surrounding building elements from such deterioration.

A qualified plumber may be appointed to assess the cause of excessive moisture and to provide advice on any remedial works as required. A qualified carpenter or registered builder may also be required to replace affected building materials.

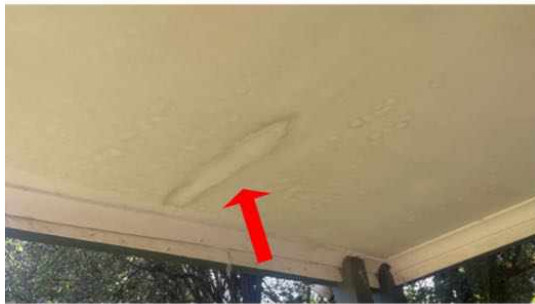
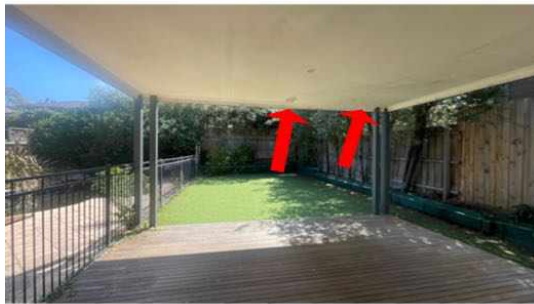
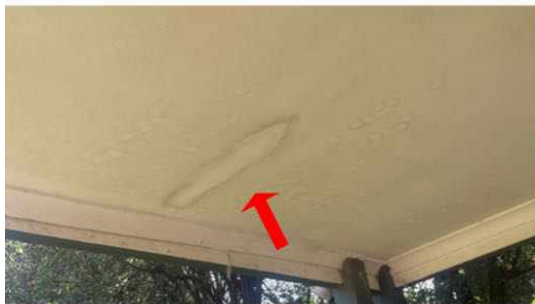
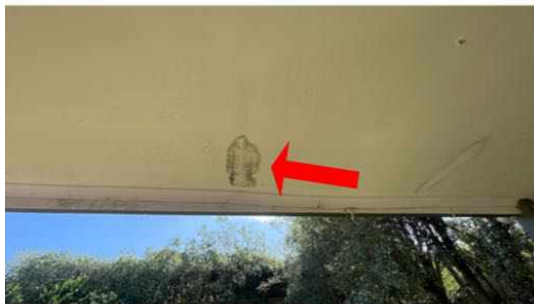
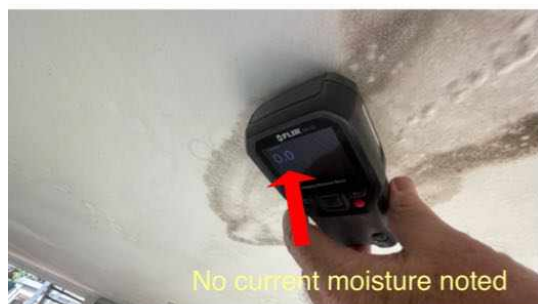
### Finding 3.31

Building:	
Location:	All External Areas
Finding:	Ceiling - Water stained
Information:	Water staining to ceiling linings in this area was evident at the time of inspection. Water staining indicates that surfaces have been exposed to excessive moisture over time.

The minerals and other elements in the water lead to staining, which may graduate to corrosion and deterioration if left unmanaged.

While mostly an appearance defect, water staining can be indicative of more serious defects, which may be currently concealed by interior ceilings.

Please note: no moisture was evident to the stained areas when tested with a moisture meter.

Where water staining is active ( not suspected in this instance), a licensed plumber must be consulted to identify the cause of the staining and to provide advice on any reparation works that may be required. Replacement of any damaged structures is advised.

Conversely, where water staining is old and inactive, affected building materials may be repaired or replaced at client discretion.

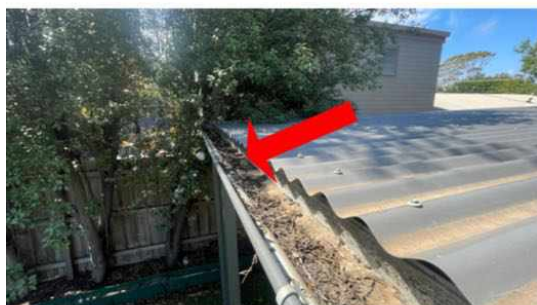
### Finding 3.32

Building:	
Location:	Roof Exterior
Finding:	Gutters - Blocked
Information:	Roof plumbing structures, such as guttering and downpipes, should be free of all debris to prevent blockages. Blockages of the guttering and downpipes will lead to pooling and accumulated water overflows, which is likely to subsequently flood eaves and exterior walls.

Blocked gutters are likely to lead to high levels of moisture in the affected areas. Such moisture will not only cause rust and decay of the associated building materials, but can also provide conditions that are conducive to termite and timber pest activity. Blockages in gutters should therefore be removed immediately to ensure dry conditions are maintained.

Consult a Licensed Plumber for further specific advice on remedial works that may be required. In the interim, it is highly advised that blocked gutters be removed by the homeowner or a general handyperson as a matter of urgency.

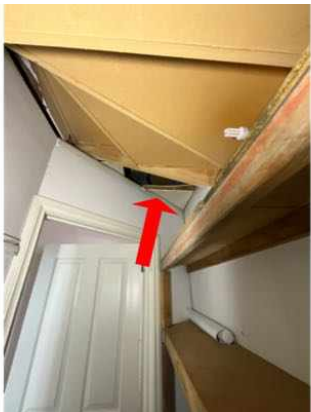
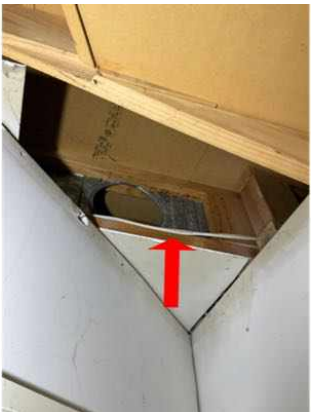
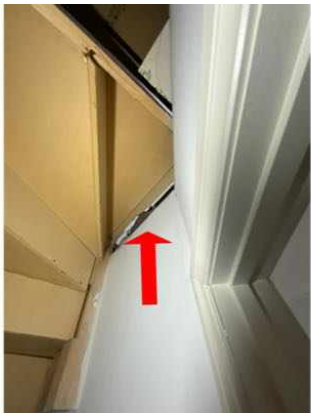
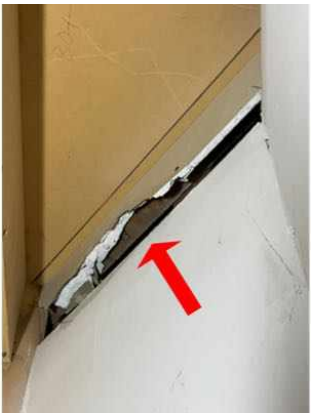
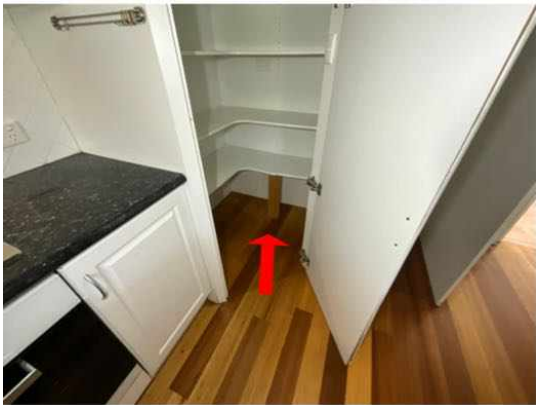
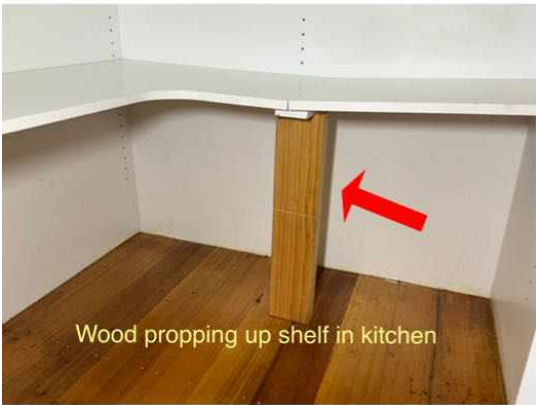
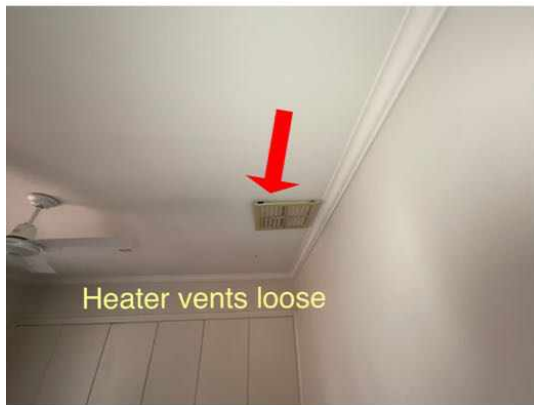
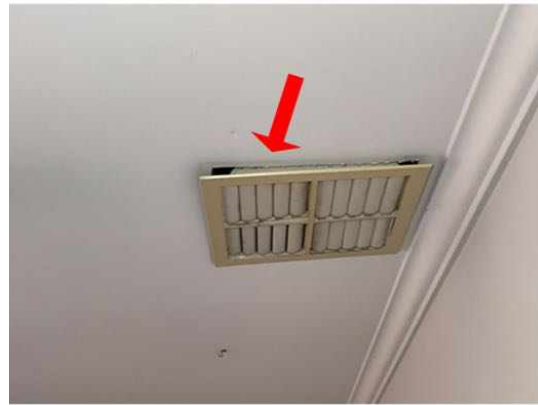
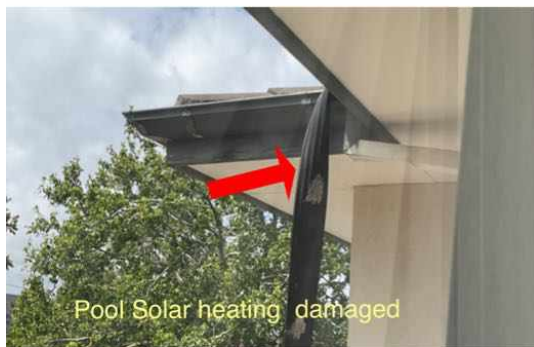
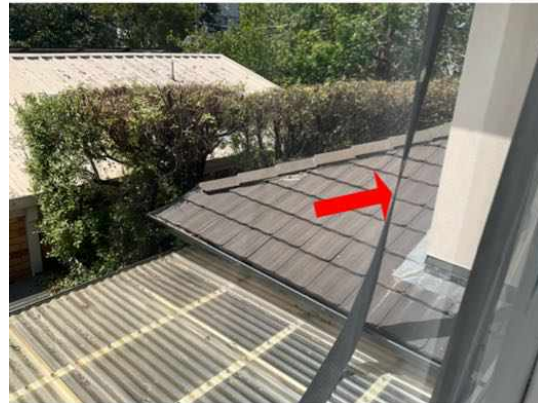
Finding: Additional Photos - minor defects

Information: Additional photos are provided for your general reference. Arrows have been included where necessary to highlight areas of importance.

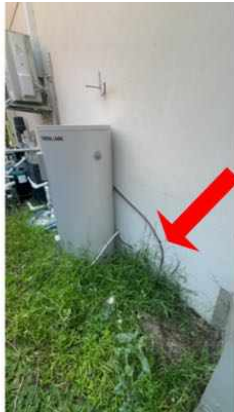
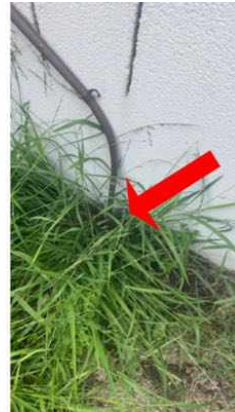
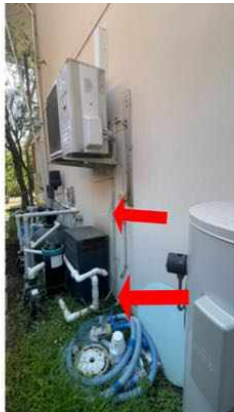
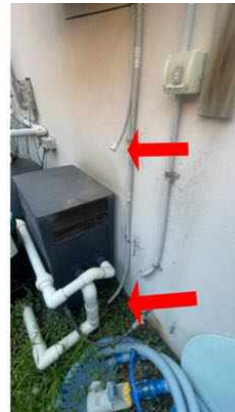
These damp conditions can lead to secondary defects such as rot, rust or corrosion of associated building elements, the formation of fungal decay, or even the creation of potential slip hazards. When coupled with poor site drainage, pooling of water may also attract termite activity to this area.

It is highly recommended that a qualified plumber be appointed to install adequate drainage to the overflow or at least redirect it away from the edge of the house. These works will ensure that the area remains dry and free of any secondary defects.

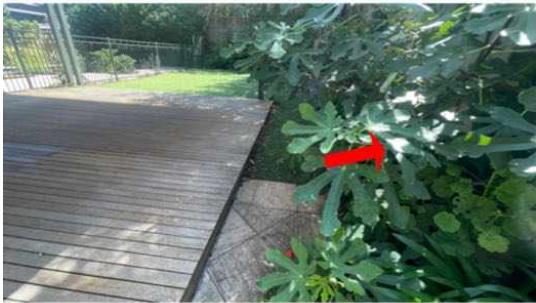
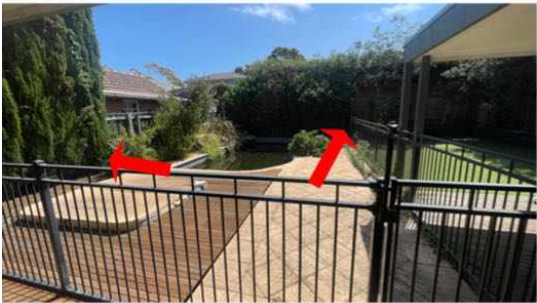
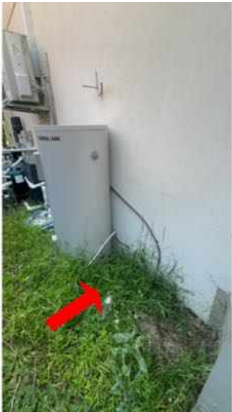
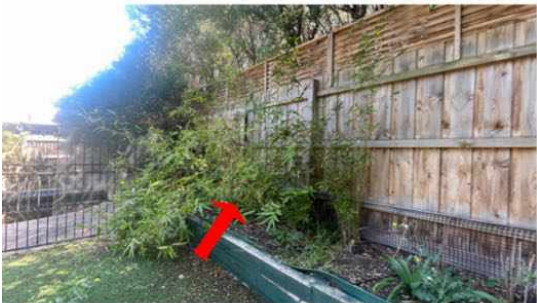
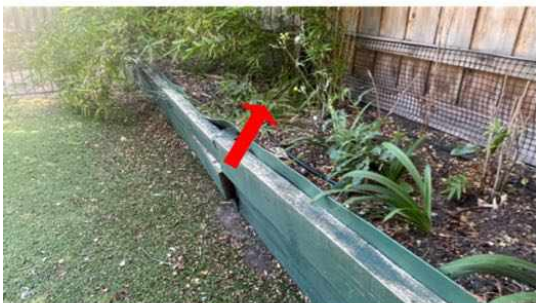
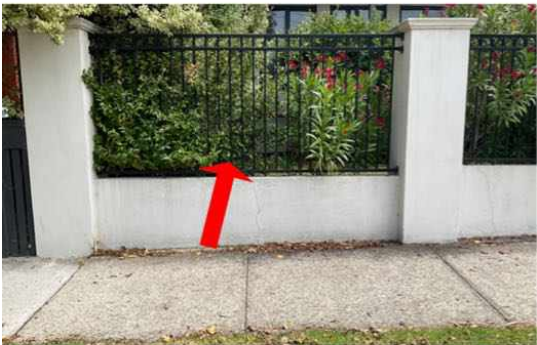
## Finding 6.02

Finding: Trees and Garden Beds - Conditions Conducive to Termites

Information: Trees and Garden beds were found to be evident around and against the property. These areas can include untreated timber, and with a combination of moisture from rainfall and hosing, can make conditions conducive to termite activity and termite ingress.

The removal and replanting of species that do not provide "cover" or cutting back of existing vegetation will assist greatly in preventing this from occurring.

The removal of any such materials that may be conducive to termite activity should be carried out as soon as possible to minimize the risk of potential termite attack.

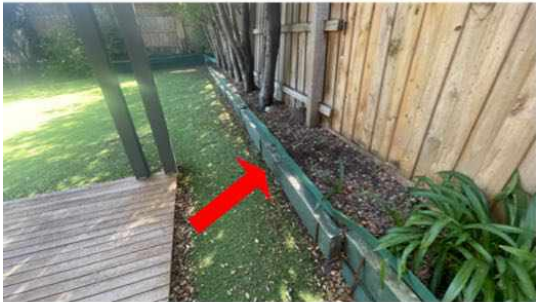
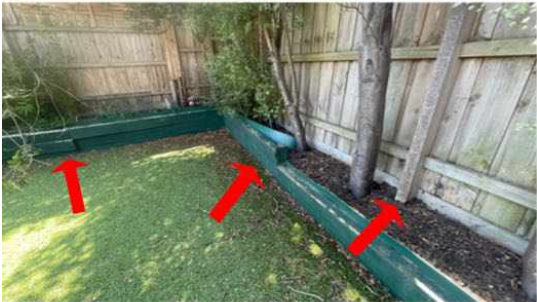
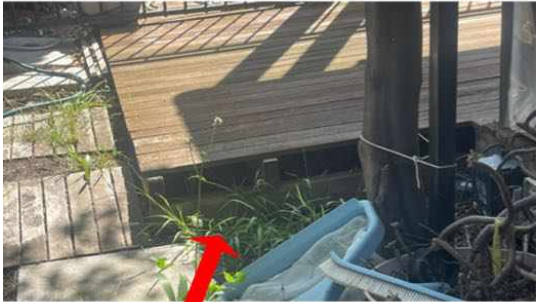
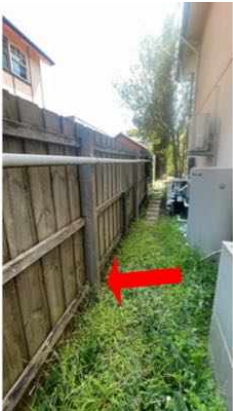
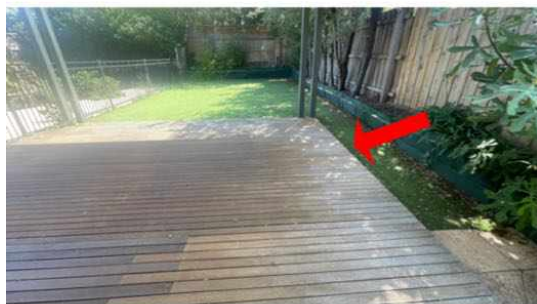
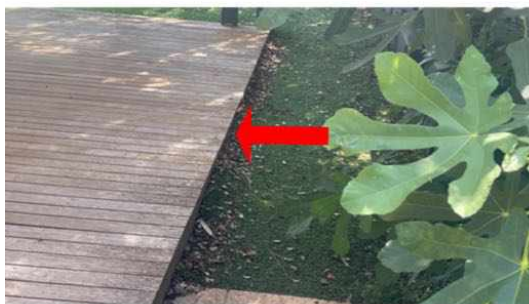
Finding 6.03

Building:  
Location: All External Areas  
Finding: Building materials in direct ground contact - conducive to termites  
Information: Where timber elements are in direct contact with the ground and consequently moisture or dampness, they become conducive to termite activity. Whether timber is used as a building element, part of a fencing structure or stored as an unused item, they can provide an environment that is attractive to termite infestation.

When met with excessive moisture, timber begins to decay and develop wood rot. Any timbers that are in direct contact with external grounds especially if left untreated or non-durable also provide ingress for subterranean termites into that particular element.

Where possible, the removal of any such materials that may be conducive to termite activity should be carried out as soon as possible to minimise the risk of termite attack. Where not possible or practical, regular monitoring of timber elements is recommended. Replacement of any damaged materials should be carried out where necessary.

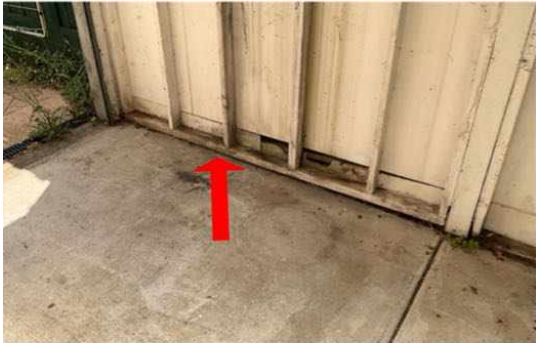
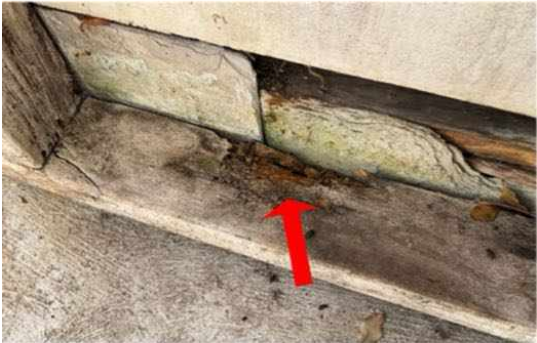
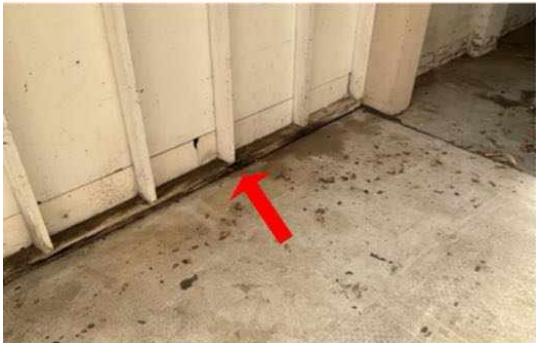
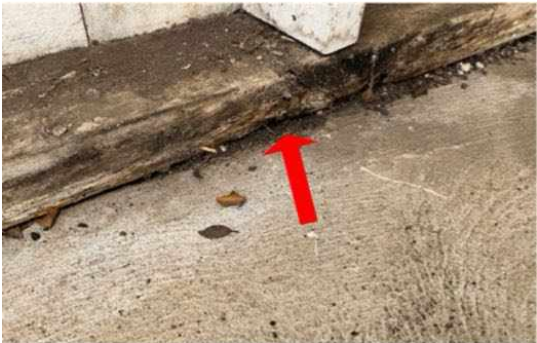
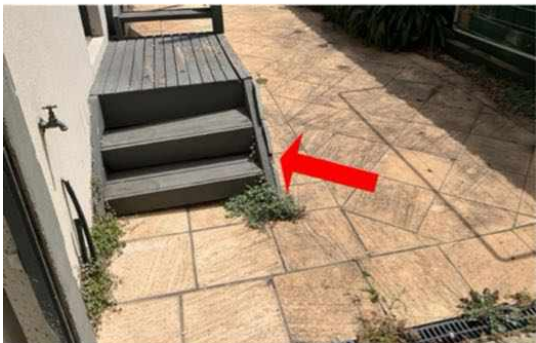
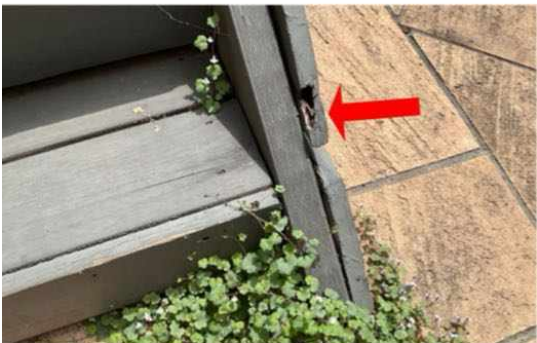
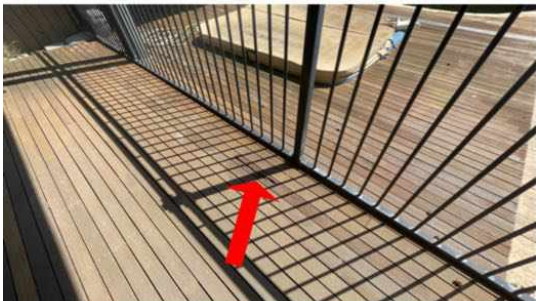
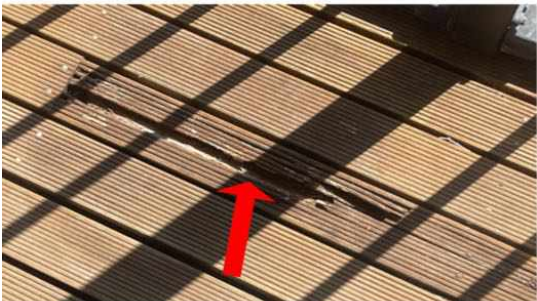
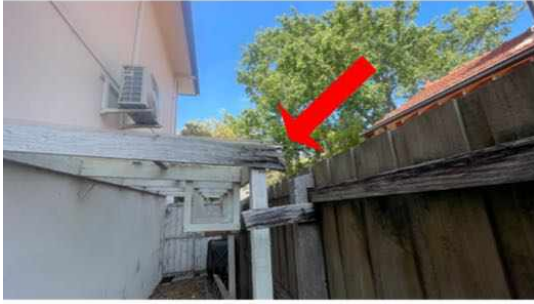
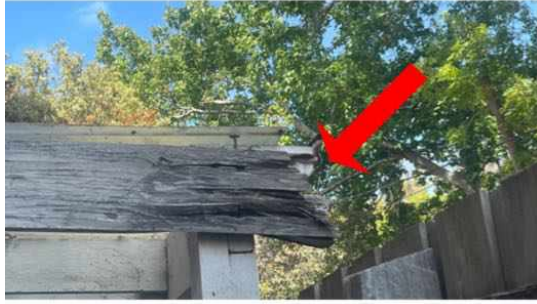
## Evidence of fungal decay activity and/or damage

Finding: Wood rot

Early intervention and regular maintenance, particularly of exterior timbers, will prolong the useful life of these building elements. Prior to any works being performed, the cause of the moisture that has created the visible wood rot should be identified and addressed in a suitable manner. Repair or replacement of affected timbers may then be a necessary step in protecting surrounding building elements from such deterioration.

A qualified plumber may be appointed to assess the cause of excessive moisture and to provide advice on any remedial works as required. A qualified carpenter or registered builder may be engaged to replace affected building materials where necessary.

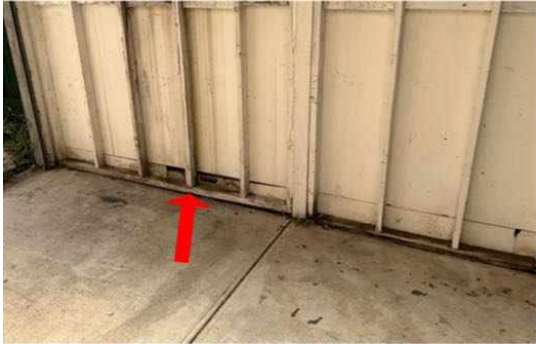
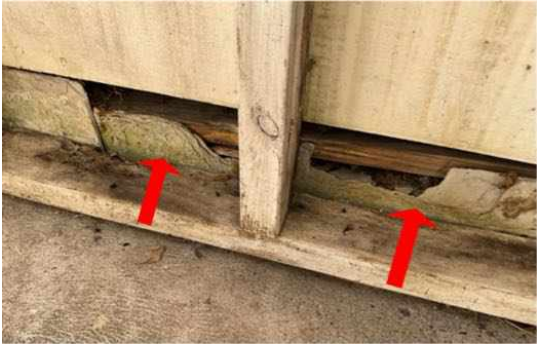
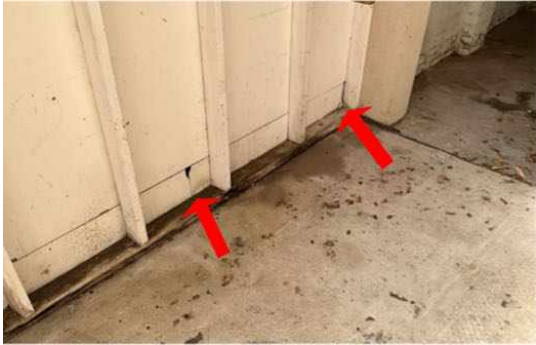
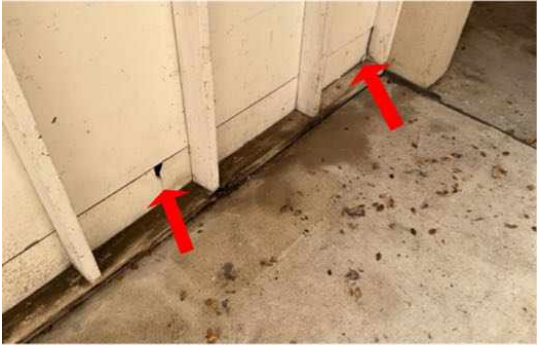
Building: Garage  
Location: Garage  
Finding: Asbestos - Suspected ACM Identified on Site  
Information: The Cement sheet on the side wall of the garage may potentially be an Asbestos Containing Material (ACM). The observable areas of cement sheet were found to be damaged / deteriorated at the base. Damaged and deteriorated ACMs have a higher probability of releasing airborne asbestos fibres, creating a significant health safety risk.

As Asbestos Reporting is outside the scope of this report, we advise that you consider a separate Asbestos Inspection and Condition Audit, which can include the taking of samples for definitive confirmation of the presence of Asbestos.

In the interim, the client is advised to act with caution, especially when considering any damage to building materials general wear and tear renovations extensions demolition and general maintenance activities due to the suspected presence of Asbestos.

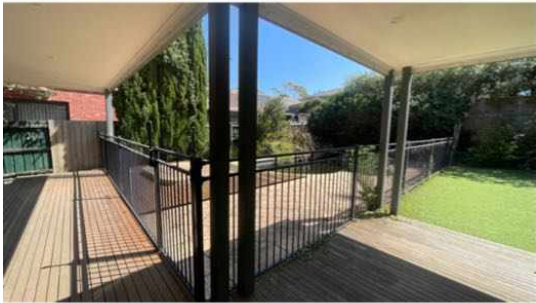
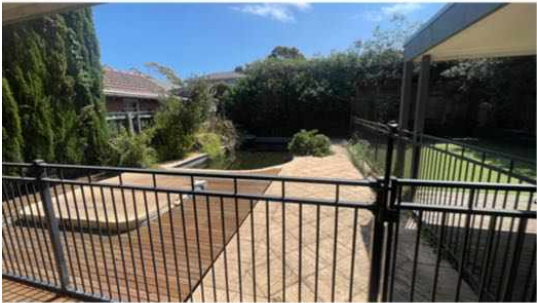
Building:  
Location: Pool Area  
Finding: Pool , equipment and fencing  
Information: Please note that this inspection does not cover pool, spa, any equipment or fencing.

It is highly advised that a pool specialist be appointed to inspect the pool and associated equipment and provide advice on compliance and any rectification works that may be required.

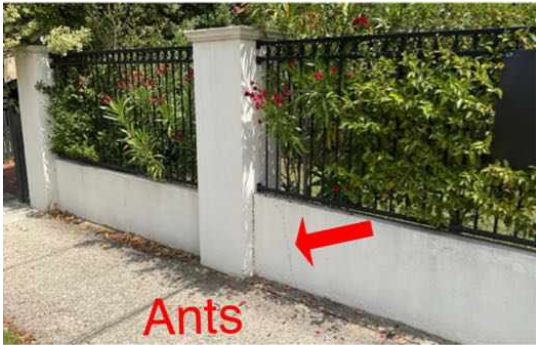
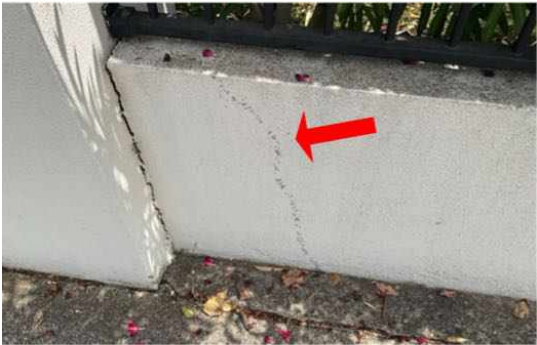
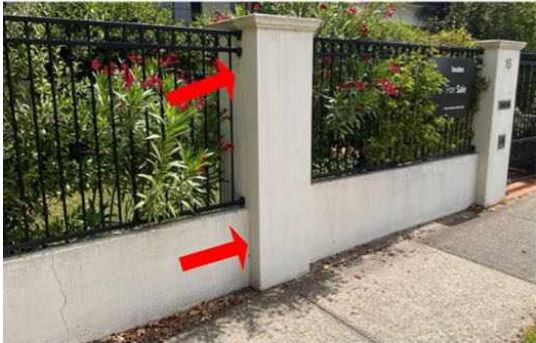
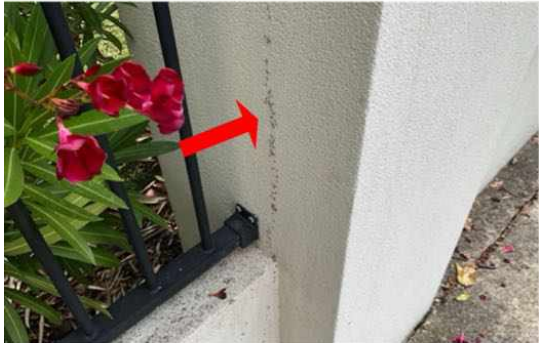
Building:  
Location: Exterior walls - front  
Finding: Additional Photos for your information - trails of ants  
Information: Additional photos are provided for your general reference.

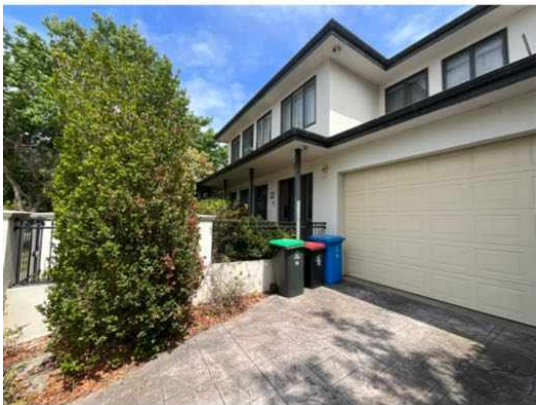
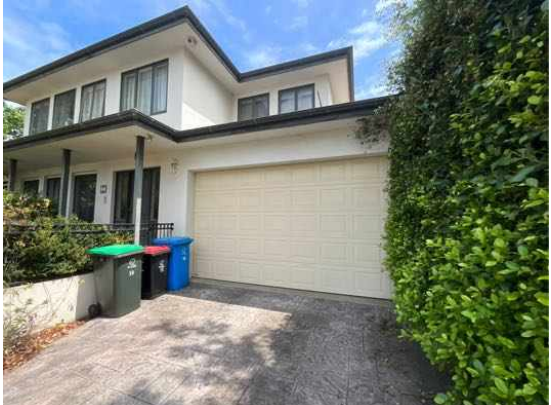
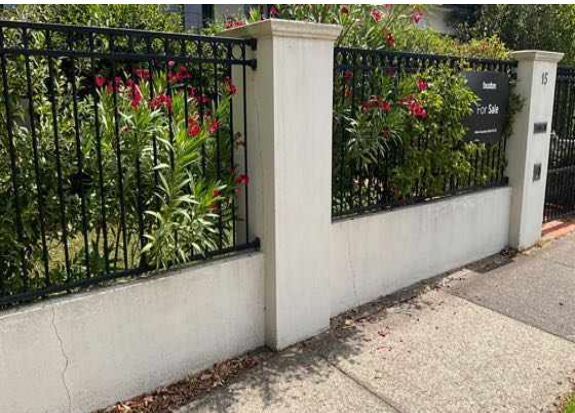
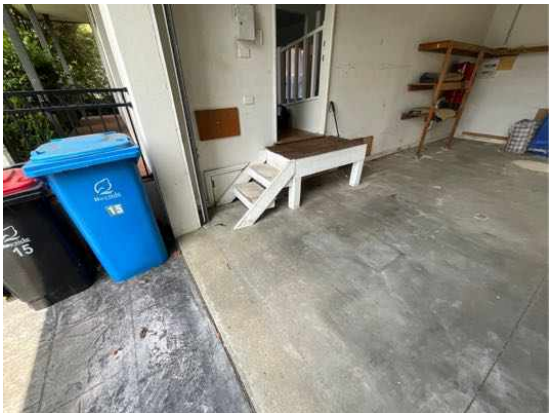
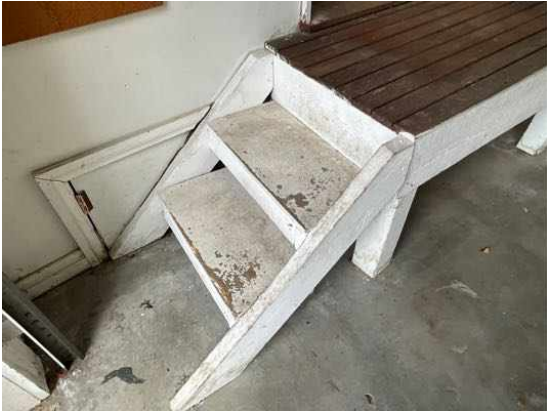
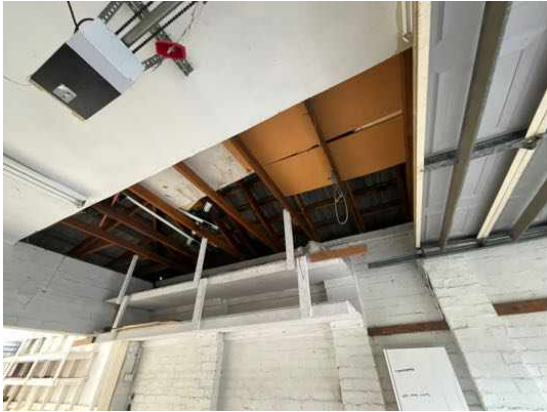
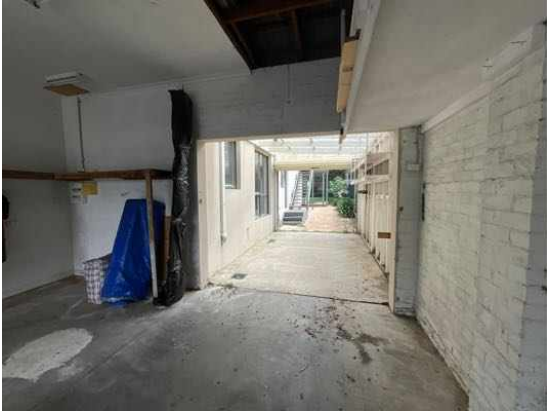
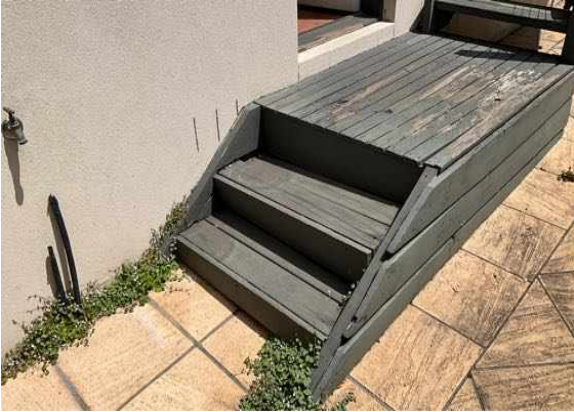
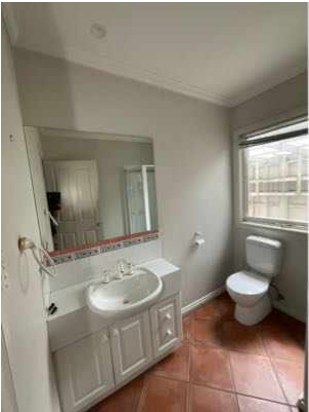
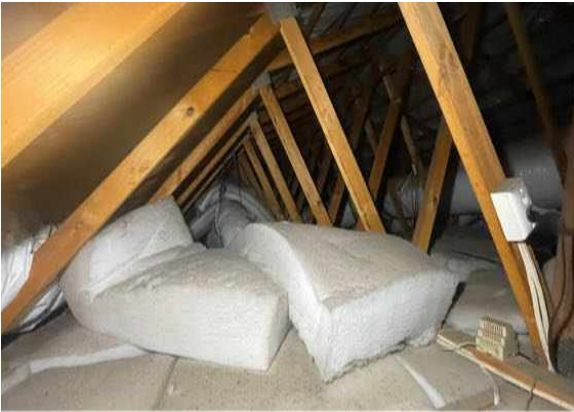
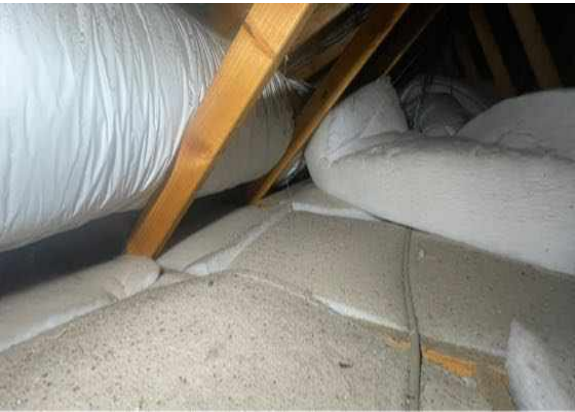
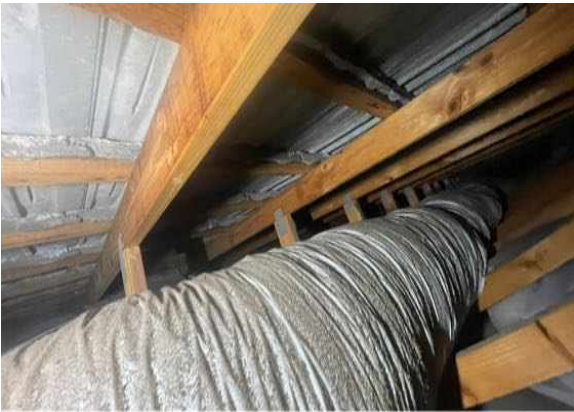
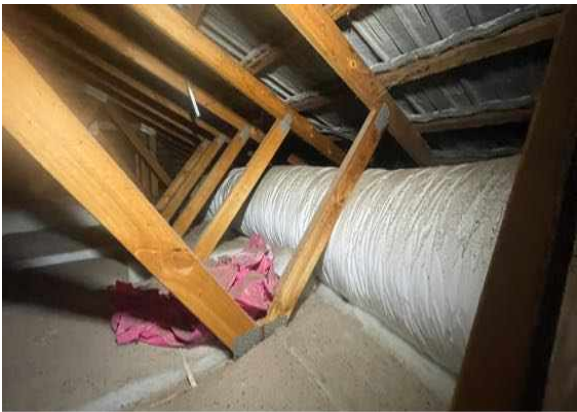
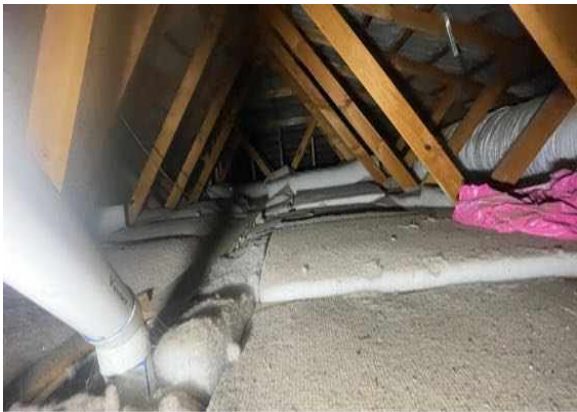
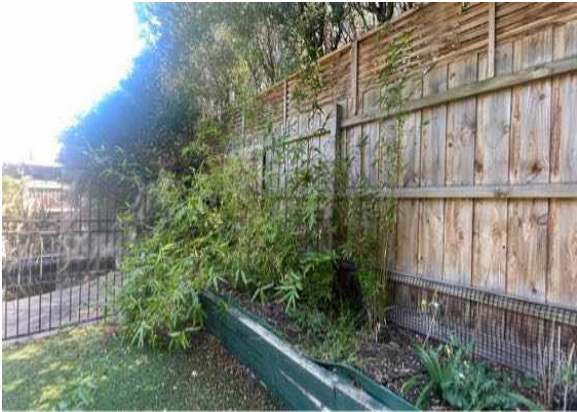
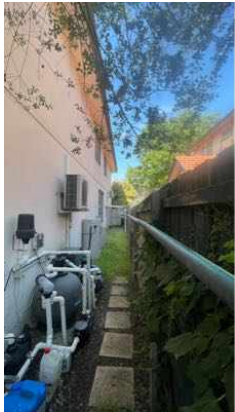
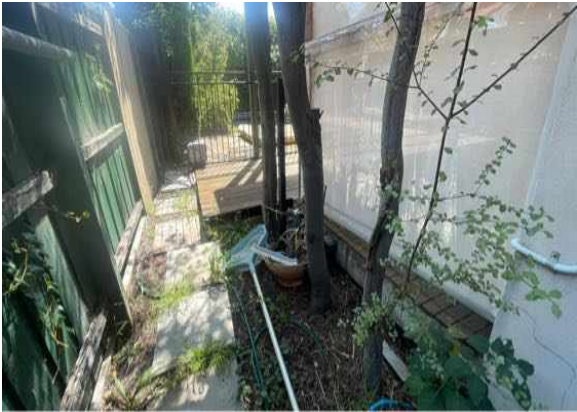
Building:  
Location: All Areas  
Finding: Additional Photos - Obstructions and Limitations  
Information: These photographs are an indication of the obstructions and limitations which impeded full inspection of the property at the time of inspection. These obstructions can hide an array of defects and should be removed to allow full inspection to be carried out. A re-inspection is recommended once the areas are made accessible.
