Building and Timber Pest Inspection Report

Inspection Date: Mon, 16 Feb 2026

Property Address: 93 Village way Maribyrnong

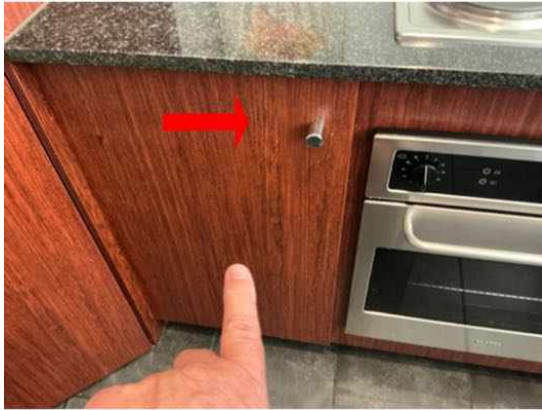
Finding 3.11

Building:	Main Building
Location:	Kitchen
Finding:	Cabinet edge tape and minor chips to laminate
Information:	It was observed that the tape to the kitchen cabinets have sustained some previous damage

Edge tape is required to prevent the ingress of moisture to the substrate of the cabinet carcass preventing swelling and premature deterioration of the cabinet structure . There were also chips in the laminate observed.

A qualified cabinet maker should be engaged to review at the clients discretion

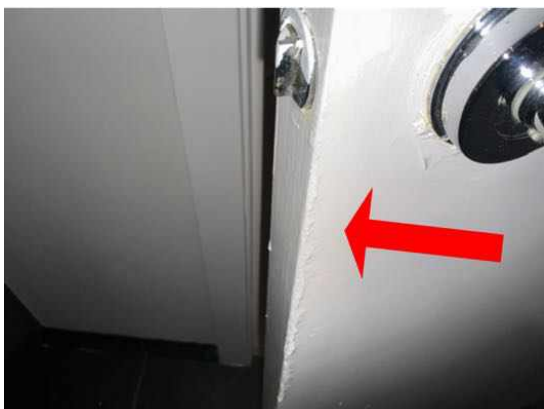
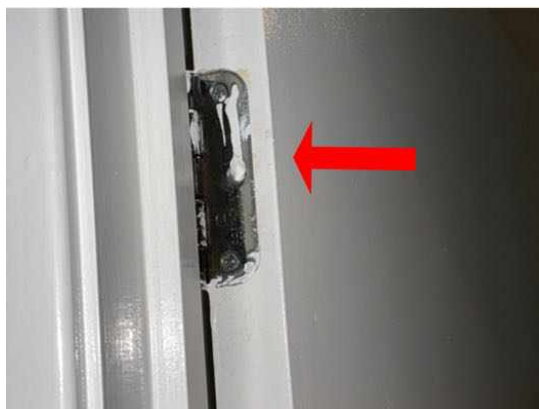
Finding 3.15

Building: Main Building
 Location: Linen Cupboard
 Finding: Door - Binding/jamming
 Information: Binding and/or jamming of the linen cupboard door is evident during standard operation. This defect inhibits the functionality of the affected door as well as creating potential for secondary defects to associated building elements, such as damage to the floor covering.

A door that binds to flooring or to the associated door frame may have several causes, ranging from minor defects, such as poor installation of the door or deteriorated hinges.

For minor causes, a qualified carpenter or general handyperson should be appointed to perform minor rectification works at client discretion.

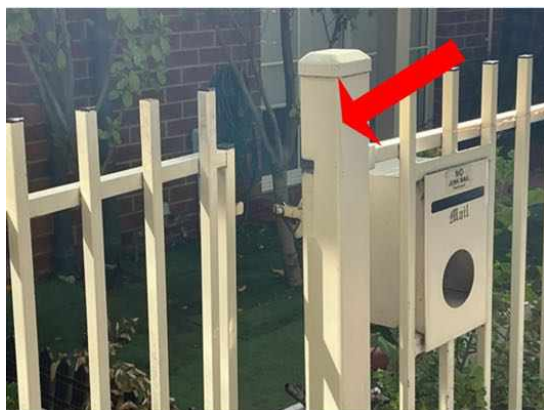
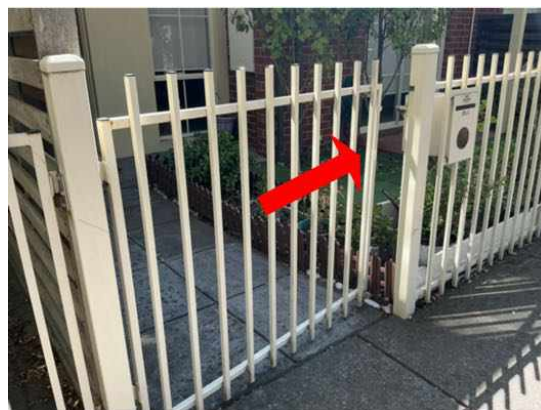
Building: Main Building
 Location: Yard - Front
 Finding: Metal gate binding
 Information: It was observed at the time of the inspection that the metal gate to the front yard was binding on the post and causing some damage to the powder coating finish. Unattended to the finish or gate could prematurely deteriorate.

A general handyman should be engaged to review at the owners discretion

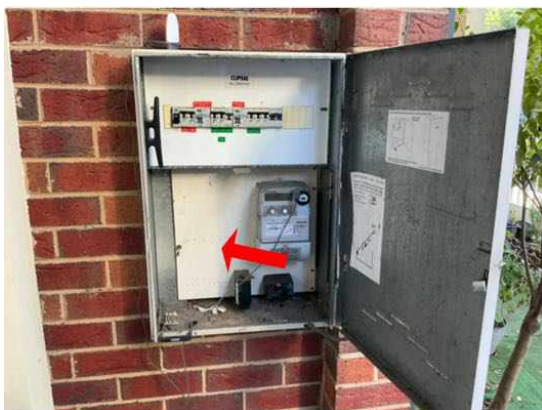
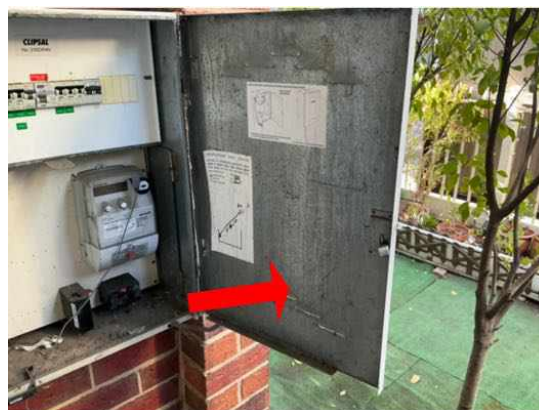
Building:	Main Building
Location:	Meter Box
Finding:	Termite Management System - no evidence of a chemical installation
Information:	The application of a post-construction chemical termite barrier is highly recommended for all properties, particularly if live termite activity has been found on the site previously. Such barriers are highly effective in preventing termite attack on any timber building elements throughout the property.

A durable notice should be placed in the switchboard unit to indicate current termite barriers. At the time of inspection, it appeared as though no termite management system has been installed, with no evidence to suggest preventative works taking place.

The client may consider gaining further advice from a pest controller as to the costs and procedures involved with this application. It is recommended that obtaining such advice be a short-term priority.

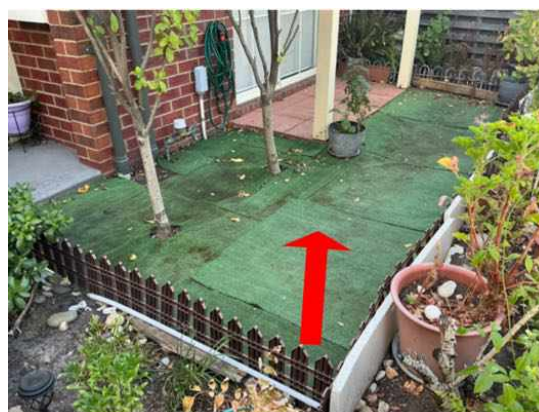
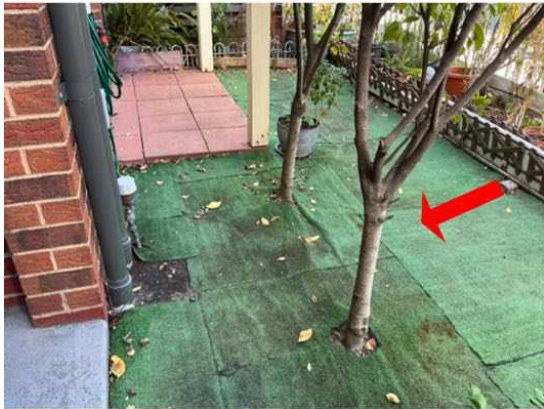
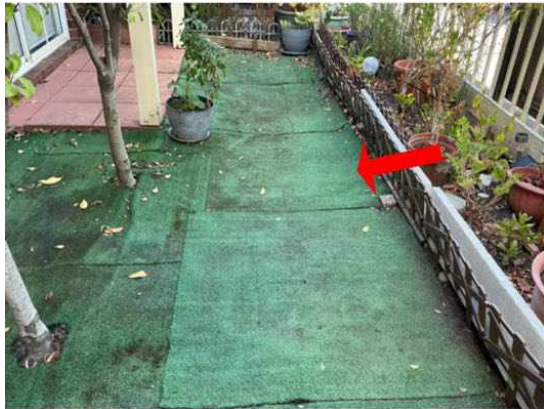
Finding 6.02

Building:	Main Building
Location:	Yard - Front
Finding:	Site drainage - Inadequate
Information:	The site drainage in the front yard area was found to be inadequate at the time of inspection, creating potential for subsequent water damage to associated building elements.

Excessive ground moisture is conducive to termite infestation

Where site drainage is inadequate, installation of an Agricultural (Aggie) Drain may be required. A qualified plumber should be appointed to further inspect the property and perform any remedial works as necessary. Water damage and secondary defects are likely to occur if left unmanaged.

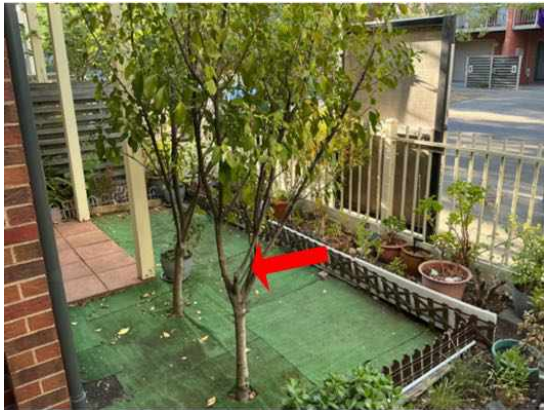
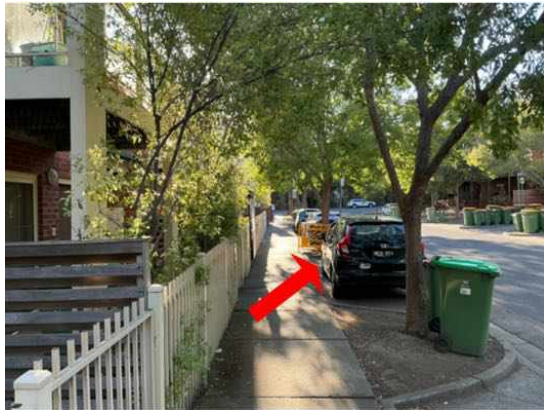
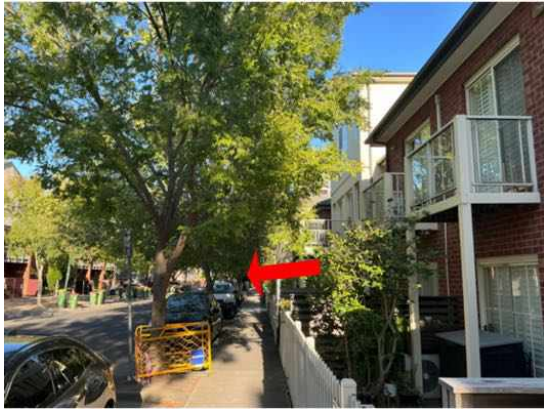
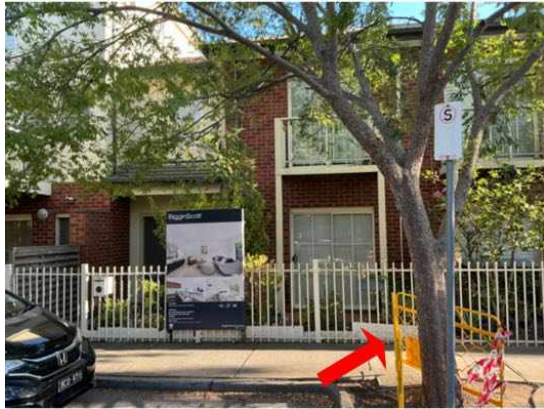
Finding 6.03

Building: Main Building
 Location: All External Areas
 Finding: Trees/large/termite
 Information: It was observed that there were several large trees next to or nearby the building.

The trees have the potential to provide conducive conditions for termite infestation

It is recommended that periodic 12 monthly inspections by a registered pest control contractor be undertaken and further reinstatement of outdated termite barriers as soon as possible.

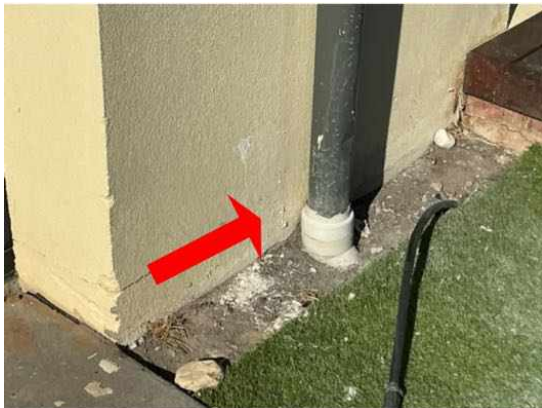
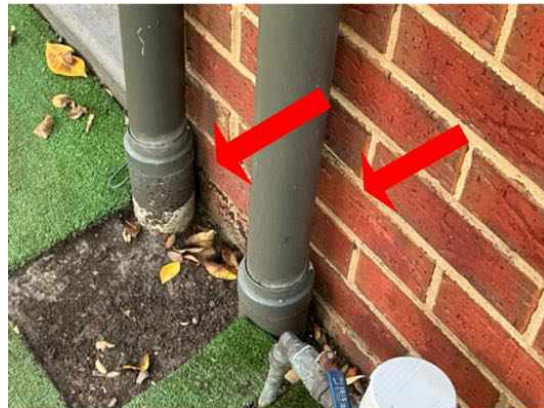
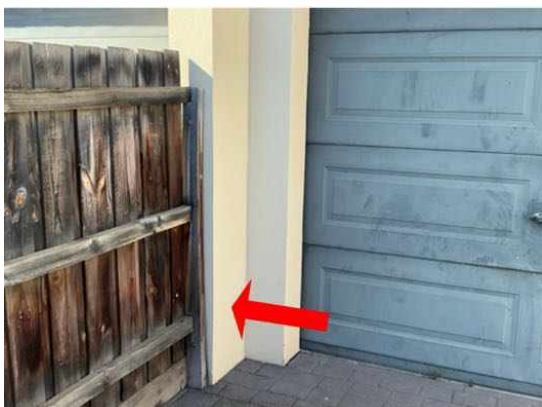
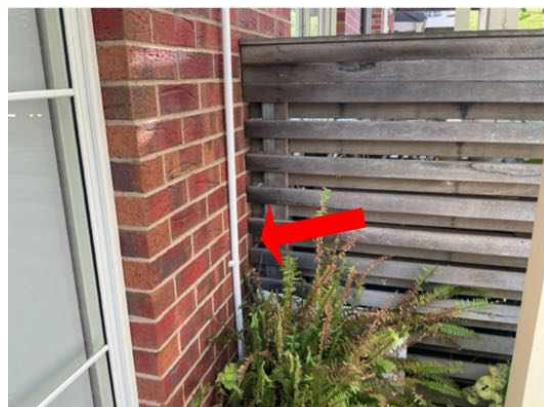
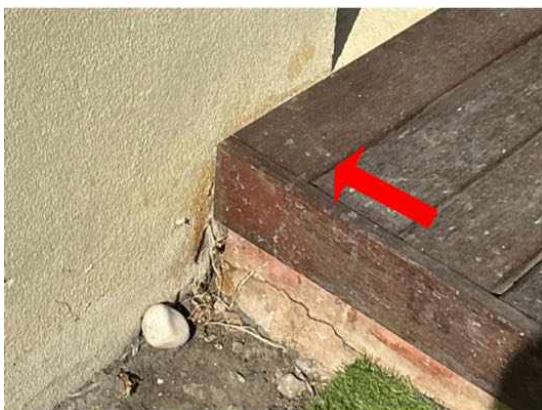
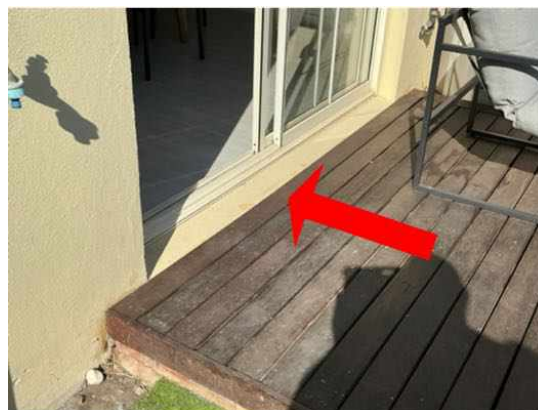
Finding 6.04

Building:	Main Building
Location:	All External Areas
Finding:	Bridging or breaching of termite barriers - adjacent internal flooring
Information:	Bridging is the spanning of a termite barrier or inspection zone so that subterranean termites are provided with passage over or around that barrier.

It is important for internal flooring to be raised above adjacent external ground levels. Where external ground levels are above internal flooring water pooling and subsequent internal flooding is likely to occur which may attract termite activity to the internal area.

It is highly advised that a landscaper or paver be appointed to lower external grounds that are raised above adjacent internal flooring. Alternatively if external grounds and internal flooring is level installation of a raised door sill may be appropriate in preventing any water pooling in the area.

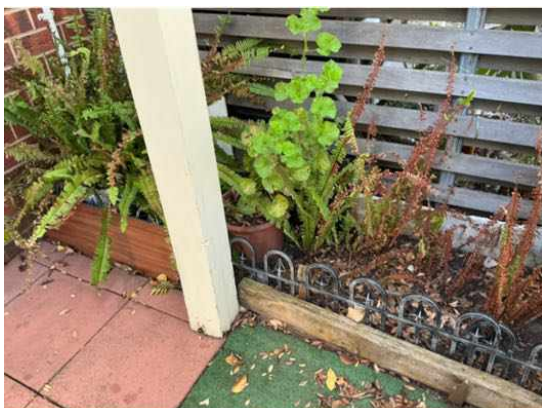
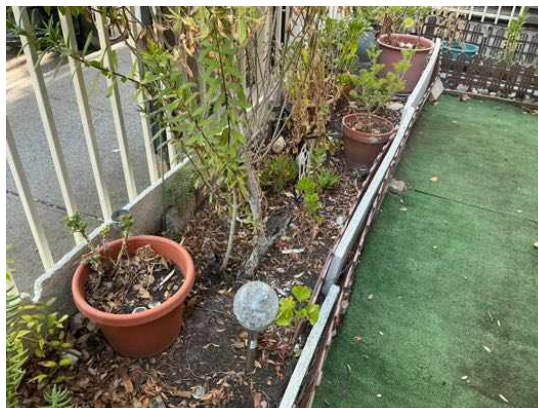
Finding 6.05

Building:	Main Building
Location:	All External Areas
Finding:	Garden Beds - Conditions Conducive to Termites
Information:	Garden beds were found to be evident in the garden area. These garden beds can include untreated timber, and with a combination of moisture from watering hosing can make conditions conducive to termite activity and termite ingress.

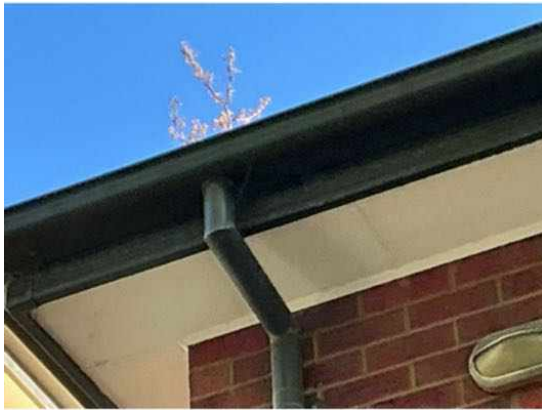
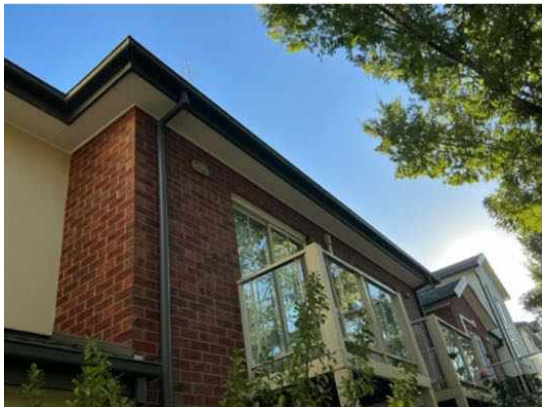
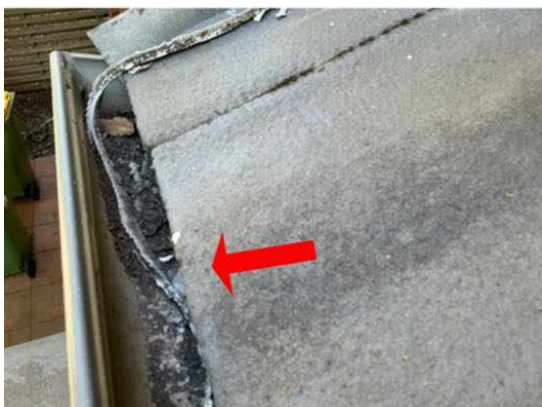
Finding 6.06

Building:	Main Building
Location:	All External Areas
Finding:	Gutters - Blocked
Information:	Roof plumbing structures, such as guttering and downpipes, should be free of all debris to prevent blockages. Blockages of the guttering and downpipes will lead to pooling and accumulated water overflows, which is likely to subsequently flood eaves and exterior walls.

Blocked gutters are likely to lead to high levels of moisture in the affected areas. Such

moisture will not only cause rust and decay of the associated building materials, but can also provide conditions that are conducive to termite and timber pest activity. Blockages in gutters should therefore be removed immediately to ensure dry conditions are maintained.

Consult a Licensed Plumber for further specific advice on remedial works that may be required. In the interim, it is highly advised that blocked gutters be removed by the homeowner or a general handyperson as a matter of urgency.

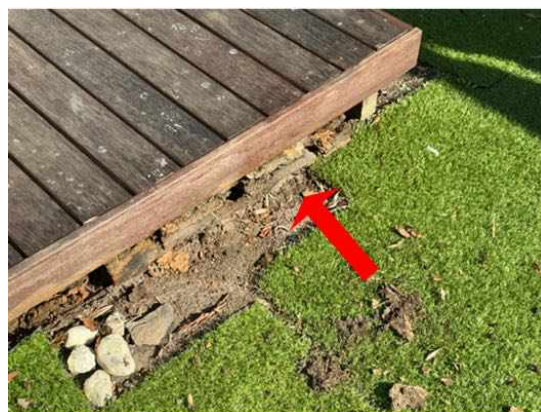
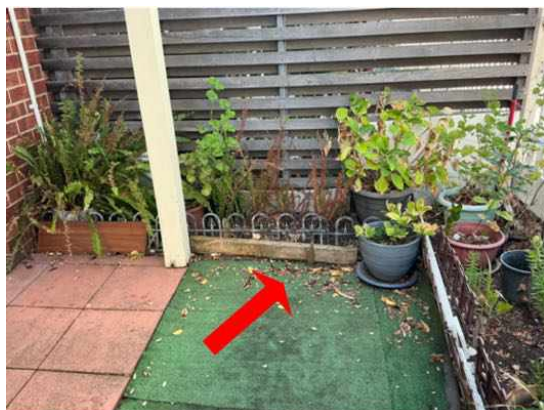
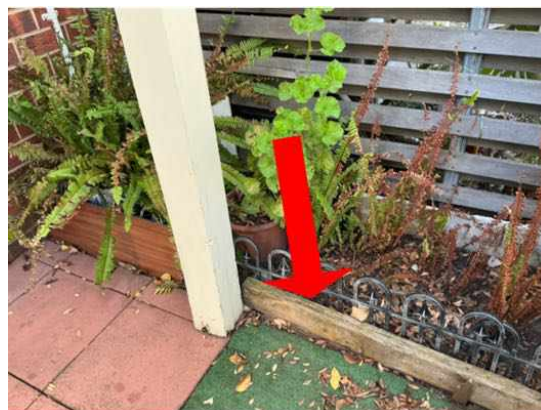
Finding 6.07

Location:	All External Areas
Finding:	Untreated or non-durable timbers in a hazardous environment
Information:	To reduce the risk of timber pest attack it is essential that timber used in a hazardous environment (e.g. in direct contact with the ground or frequently exposed to damp conditions) is of sufficient durability and/or is adequately preservative treated.

Untreated timbers in direct contact with the ground are likely to develop severe wood rot and/or fungal decay if left unattended creating attraction for subterranean termites to infest the timbers from surrounding areas.

If untreated or non-durable timbers are found to be in a hazardous environment it is highly advised that replacement of these building elements be performed as soon as possible to aid the protection of the property against termite / timber pest attack.

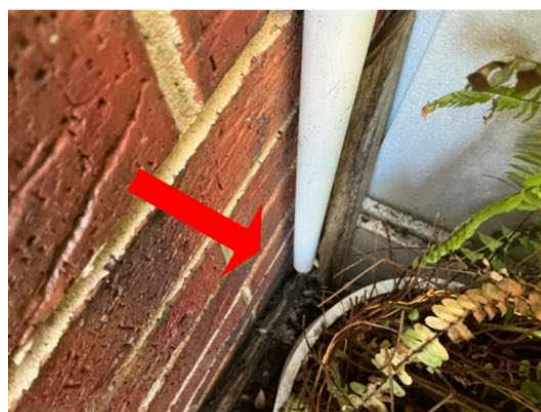
Finding 6.08

Building:	Main Building
Location:	Front Elevation
Finding:	Air conditioner condenser pipe not connected
Information:	The A/C Condenser overflows were found to be disconnected from the stormwater system and is creating excessive moisture to the surrounding area.

Such leaking creates an environment which is conducive to an array of defects including water damage to associated building materials and the attraction of termites or timber pest infestation.

A Licensed plumber should be engaged to review as soon as possible

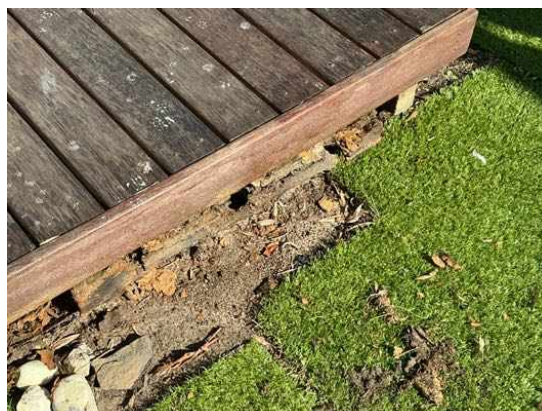
Finding 7.01

Building:	Main Building
Location:	Deck
Finding:	Wood rot
Information:	This building element shows evidence of wood rot. Wood rot, also known as Fungal

Decay, occurs when timbers and other cellulose building materials are exposed to damp conditions on an ongoing basis. This could be the result of exposure to weathering over a prolonged period of time, or the attraction of excessive moisture from other abutting building materials. Contributing factors also include poor air ventilation in the area.

Wood rot is often associated with general damp problems and is evidenced by a 'musty' smell or mould and mildew occurring on surfaces. If left unmanaged, damp conditions can lead to further health problems and the decay of timbers will continue.

Early intervention and regular maintenance, particularly of exterior timbers, will prolong the useful life of these building elements. Prior to any works being performed, the cause of the moisture that has created the visible wood rot should be identified and addressed in a suitable manner. Replacement of affected timbers may then be a necessary step in protecting surrounding building elements from such deterioration.

A qualified plumber may be appointed to assess the cause of excessive moisture and to provide advice on any remedial works as required. A qualified carpenter or registered builder may also be required to replace affected building materials.

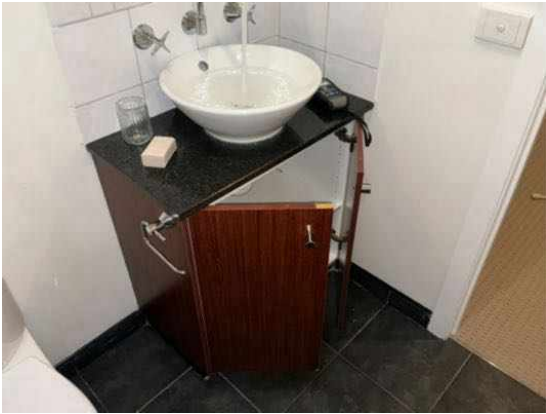
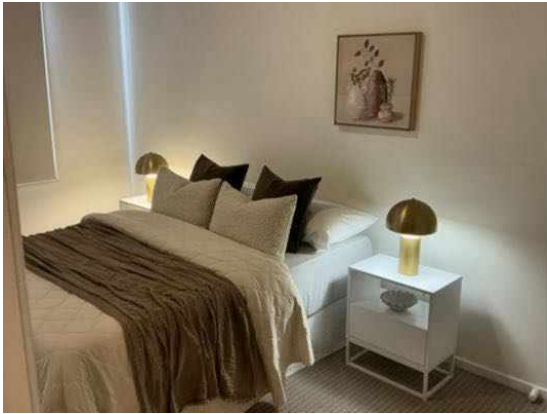
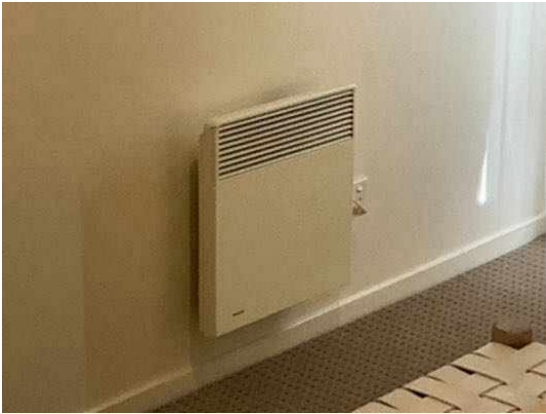
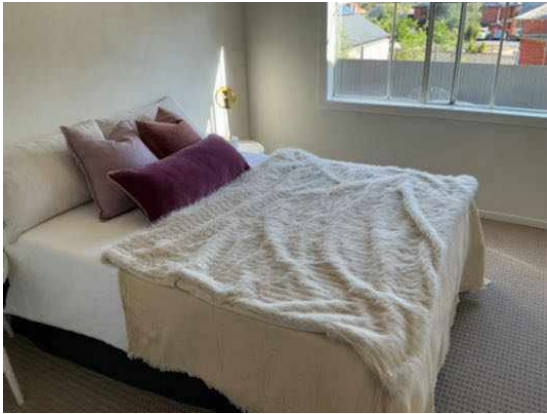
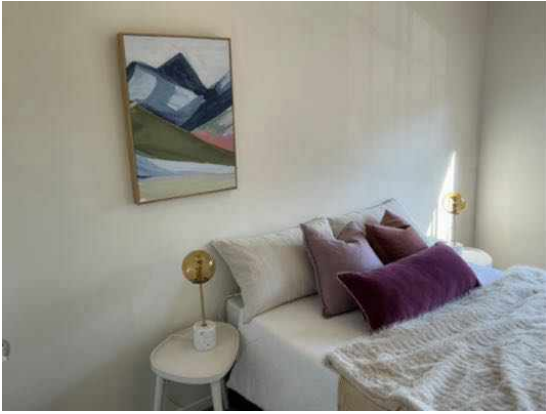
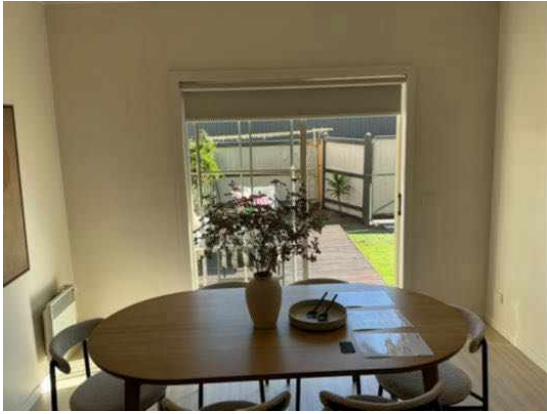
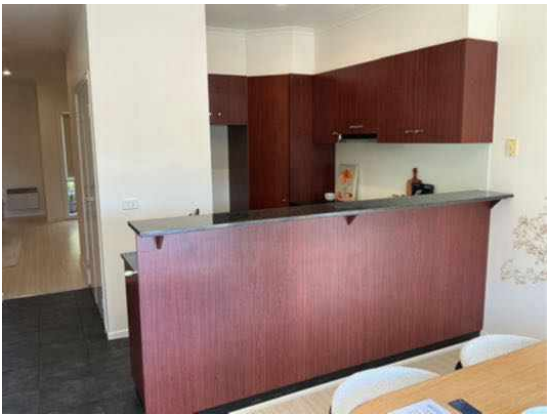
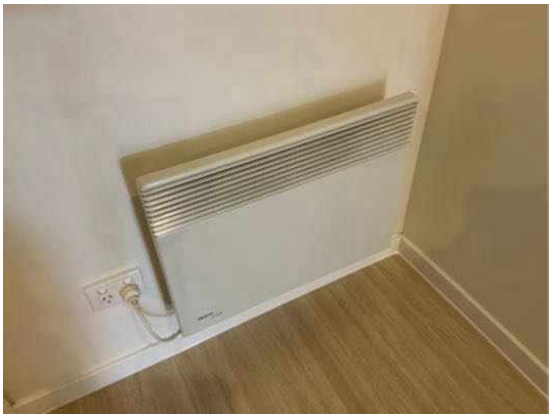
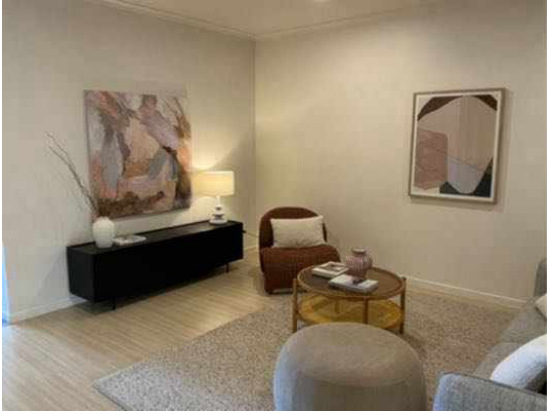
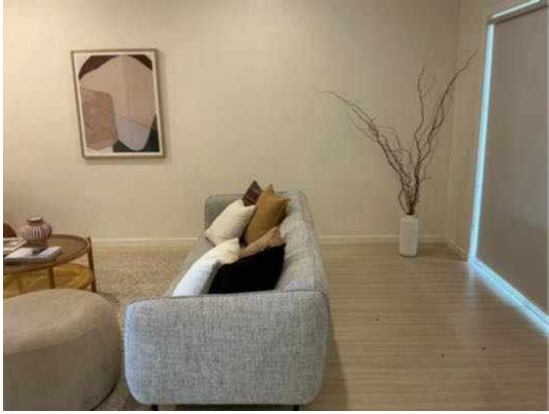
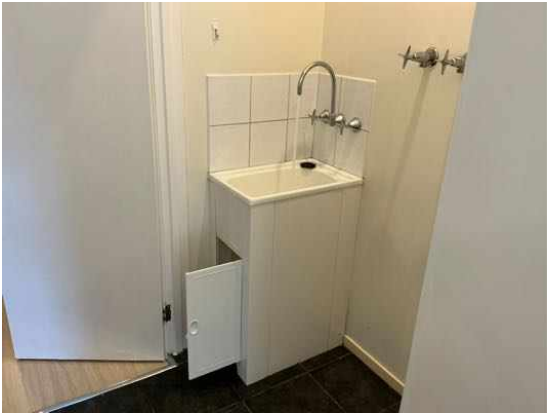
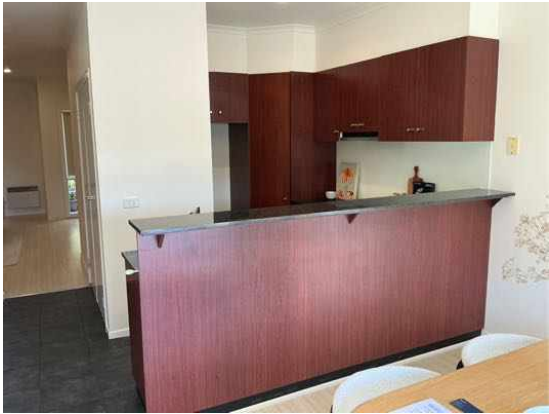
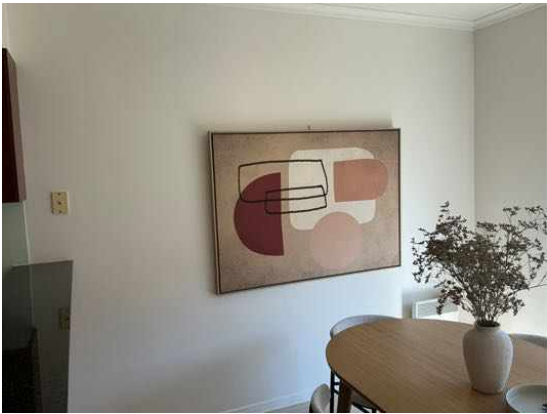
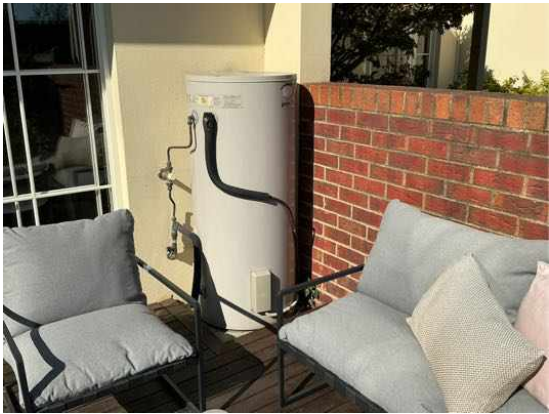
Information: These photographs are an indication of the obstructions and limitations which impeded full inspection of the property at the time of inspection. These obstructions can hide an array of defects and should be removed to allow full inspection to be carried out. A re-inspection is recommended once the areas are made accessible.

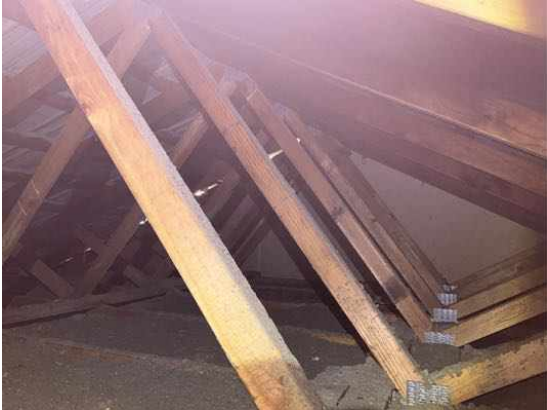
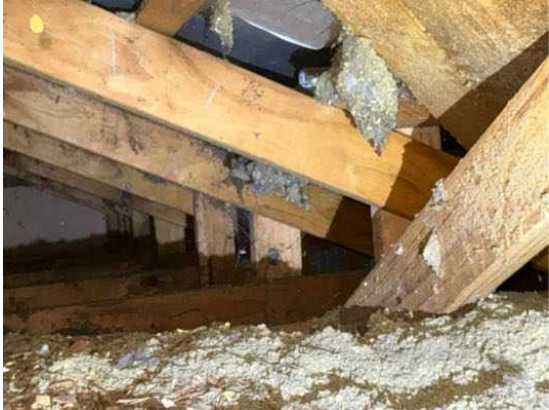
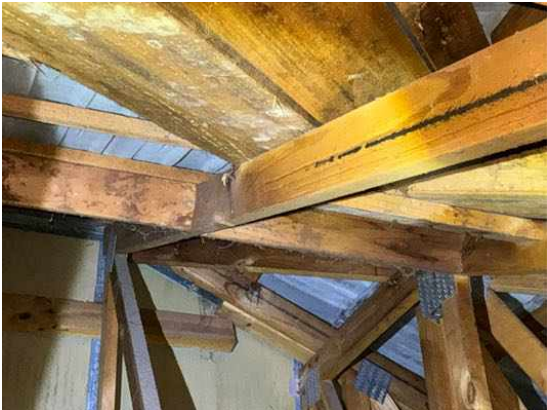
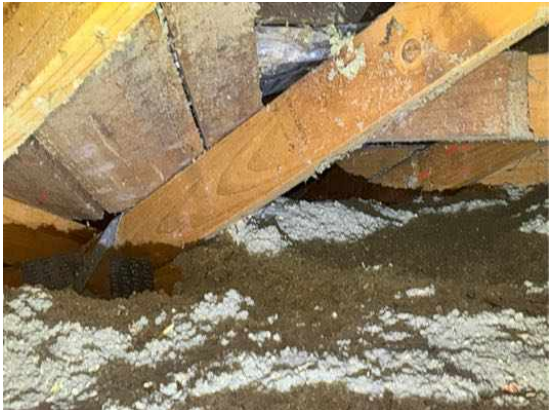
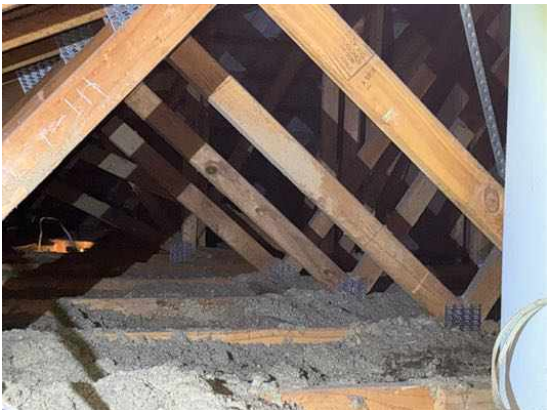
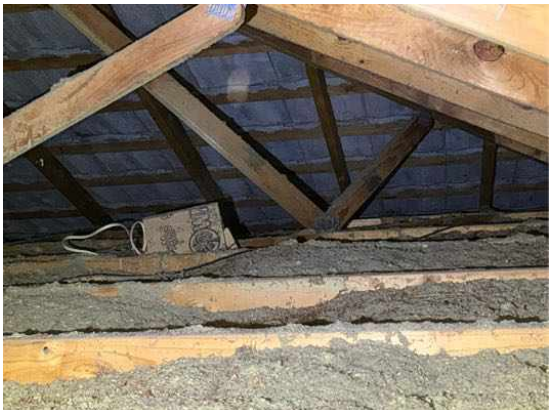
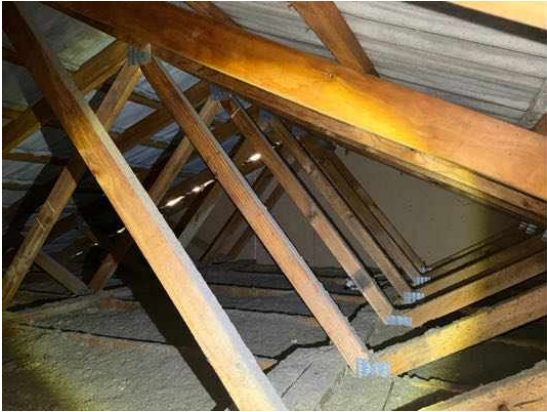
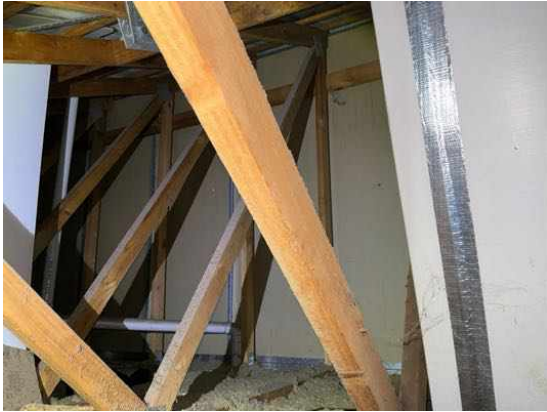
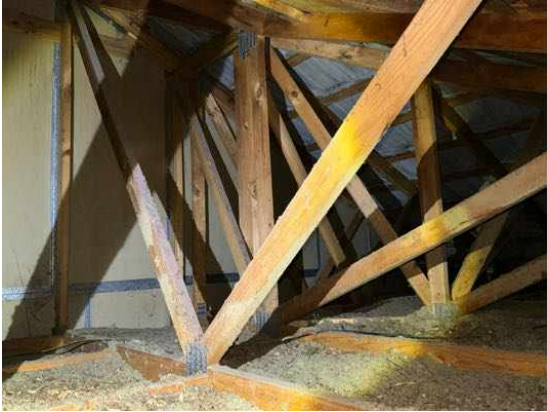
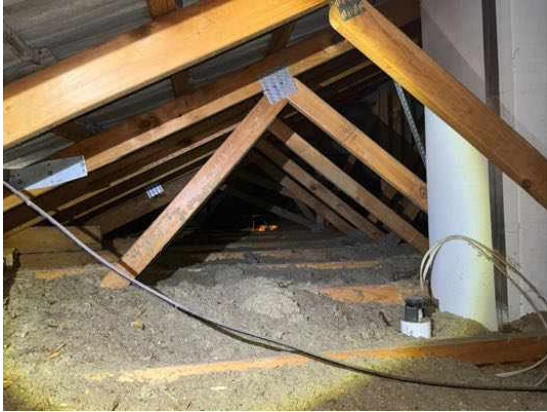
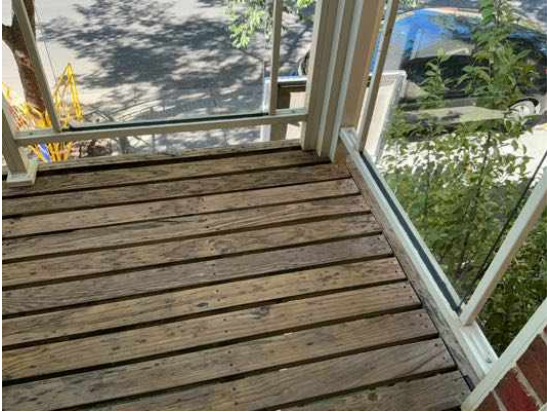
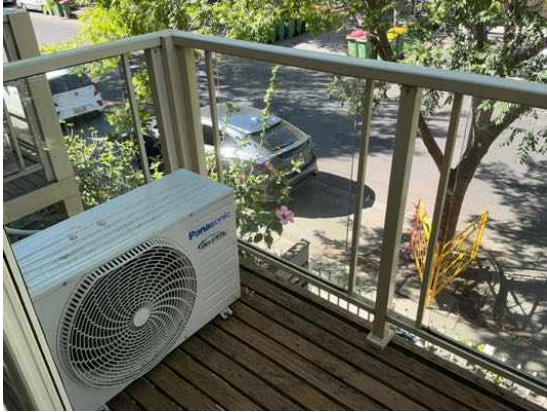
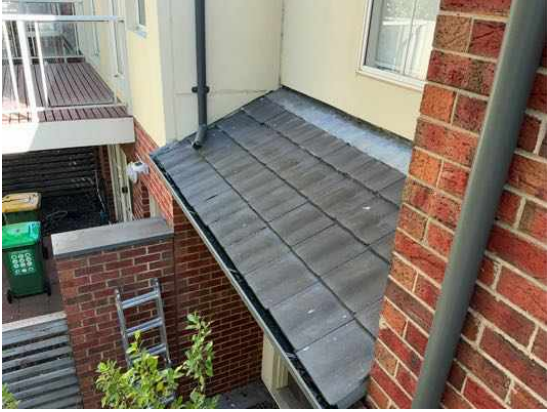
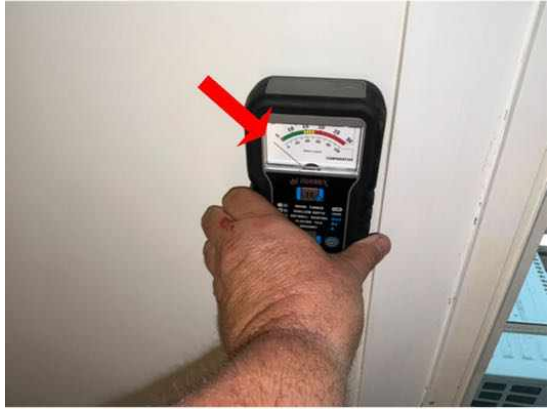
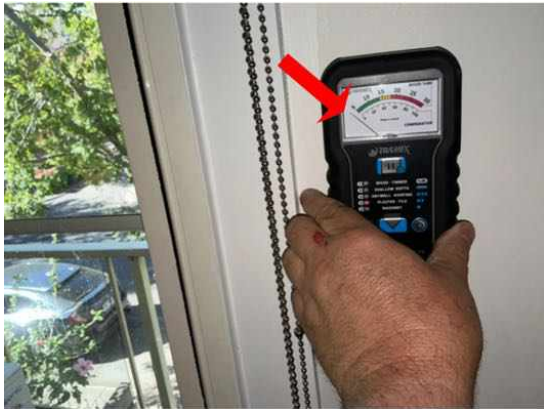
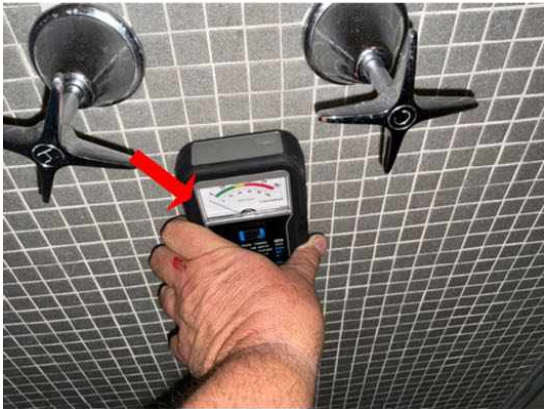
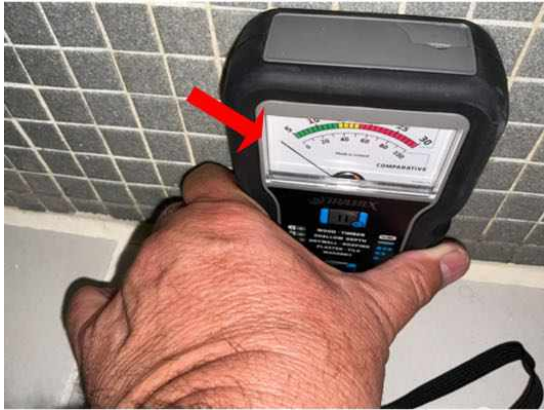
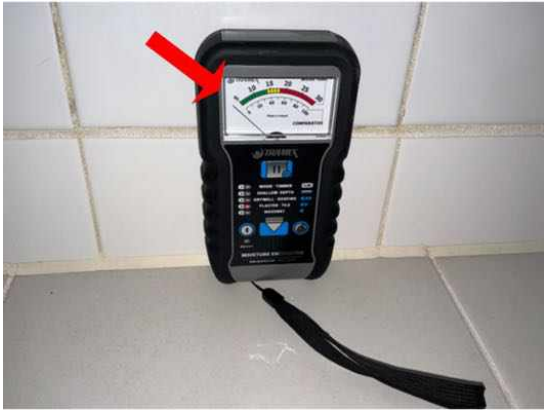
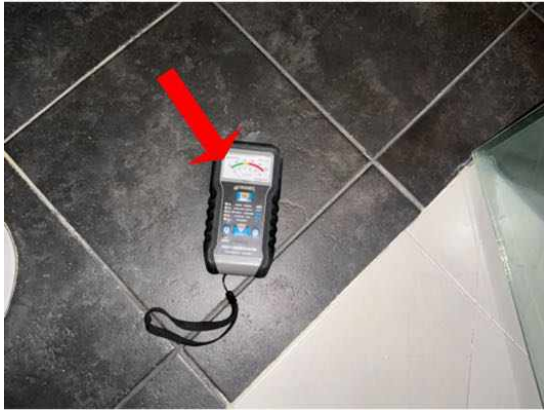
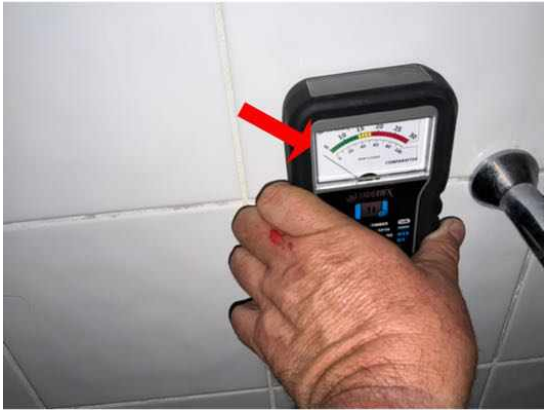
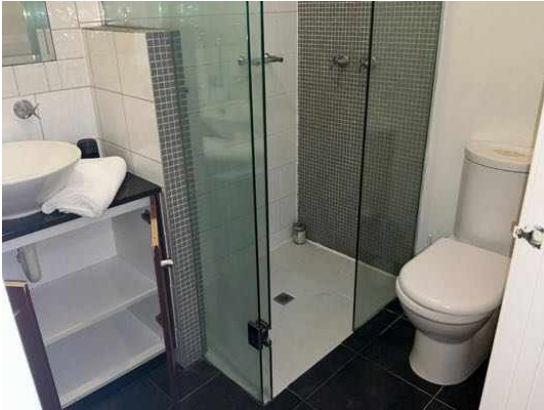
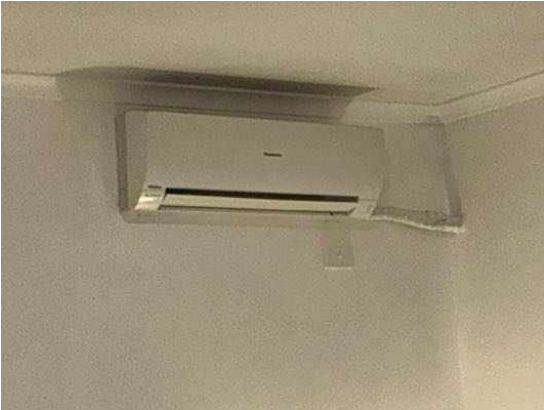
Building: Main Building
Location: All Areas
Finding: Additional Photos
Information: Additional photos are provided for your general reference
