Building and Timber Pest Inspection Report

Inspection Date: Thu, 22 Jan 2026

Property Address: 119B MacKays Rd, Upper Kangaroo River
NSW 2577, Australia

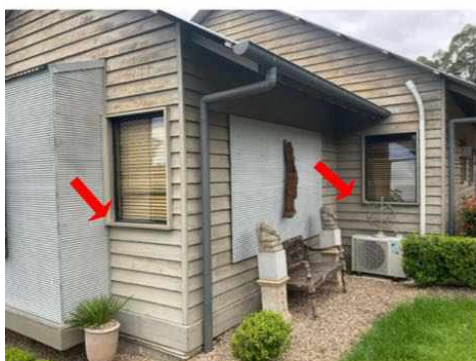
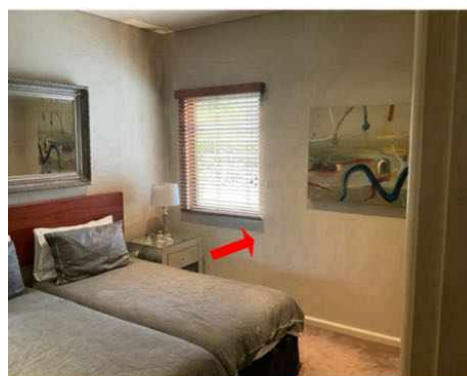
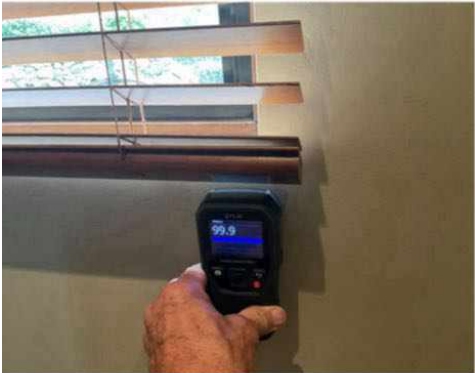
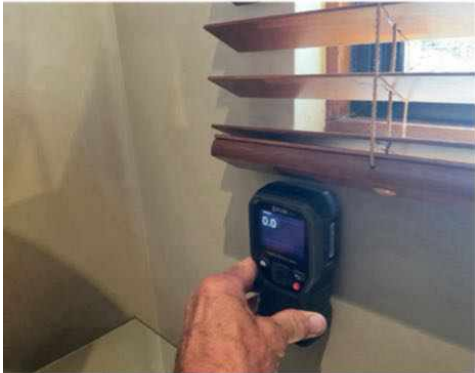
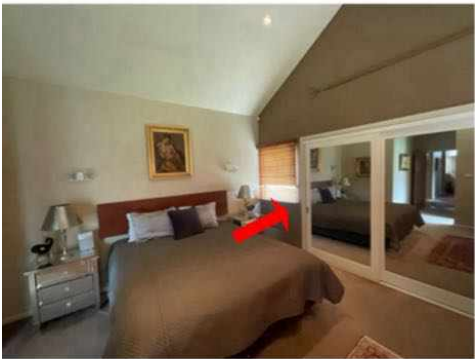
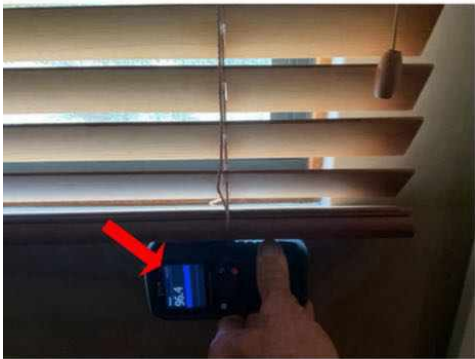
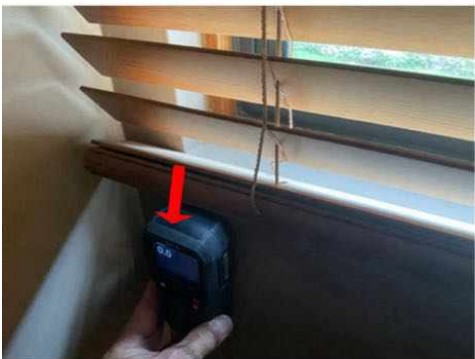
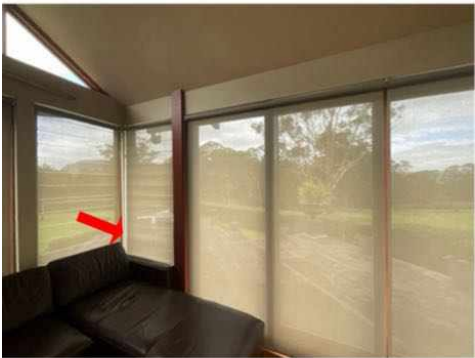
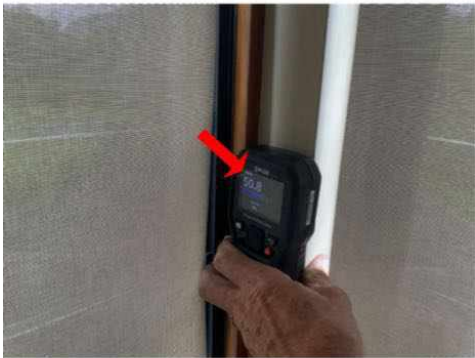
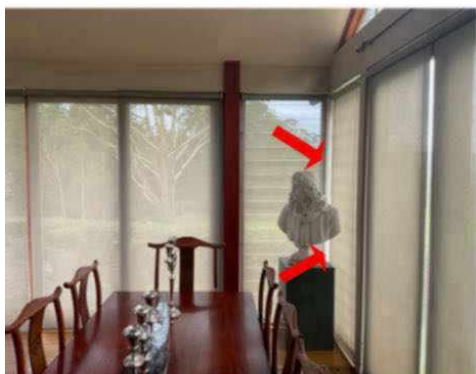
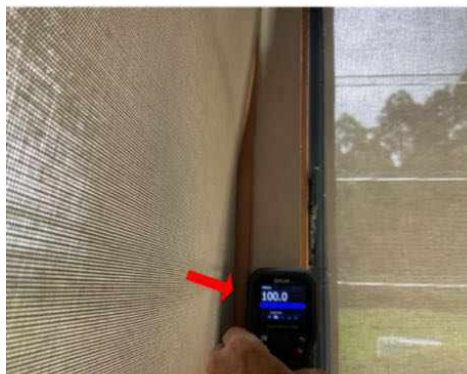
Building: Building 1
Location: Two bedrooms, loungeroom, hall
Finding: Evidence of excessive moisture was present at the time of inspection
Information: Excessive moisture was found in many window and wall areas at the time of the inspection. Moisture readings of between 50.8 and 100 were found in these pictured areas.

Nil readings were found next to most of these areas for reference.

Excessive moisture can attract termites and produce conditions that promote termite attack, fungal growth and wood decay. Excessive moisture is generally caused by deteriorated, inadequate or missing roof drainage, damaged external sealant, cladding or flashings and poor site drainage.

It is highly recommended that all window and cladding areas be checked, sealed and maintained regularly in order to prevent excessive moisture being present in the internal property.

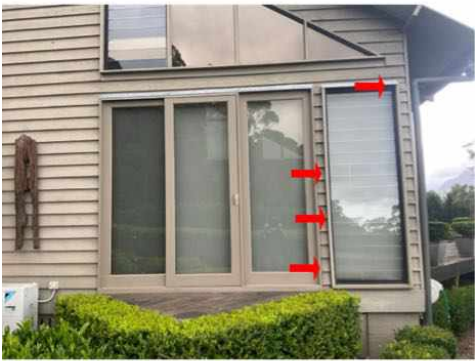
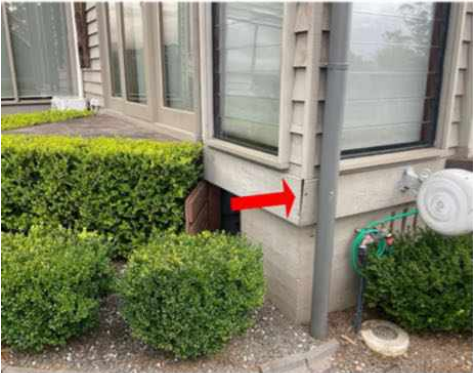
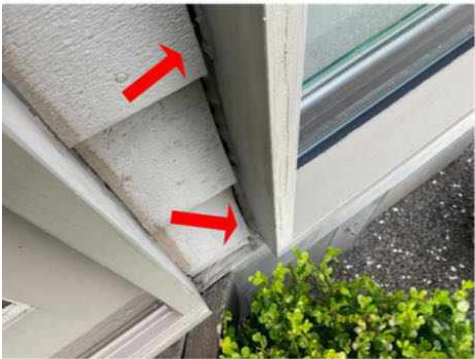
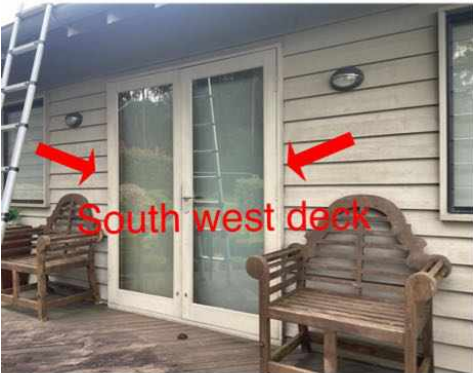
Finding 3.02

Building:	Building 1
Location:	Exterior walls
Finding:	Sealant (external) - missing
Information:	It was noted on inspection that areas of external sealant was missing to small areas of many external walls.

It is thought this is the reason for the excessive moisture found in some internal walls areas.

Flexible sealants should be applied to these affected areas to prevent any subsequent water damage that is likely to occur.

A sealant specialist or skilled handy person should be appointed to complete these works as soon as possible to stop any internal moisture damage.

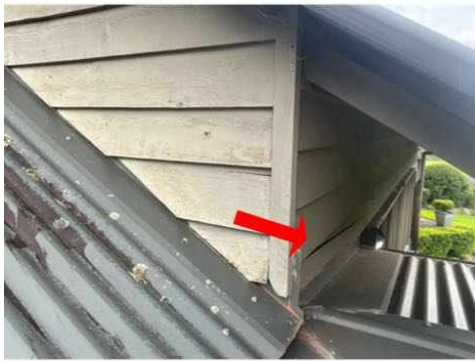
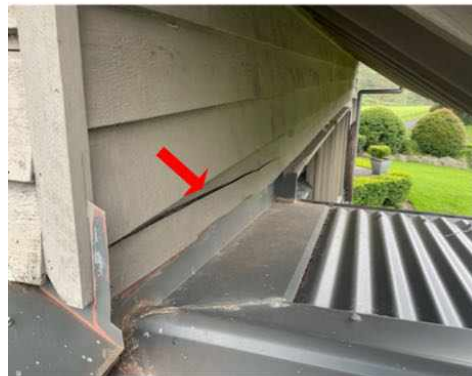
Finding 3.03

Building: Building 1
Location: Pictured left rear wall area
Finding: Cladding and timber damage (minor)
Information: Evidence of damage was identified to the left side wall where the cladding is damaged. A carpenter would be the trade responsible for replacement of this wall cladding.

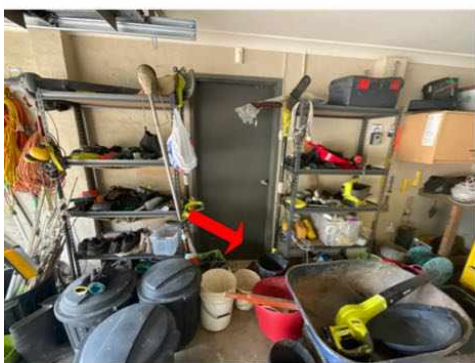
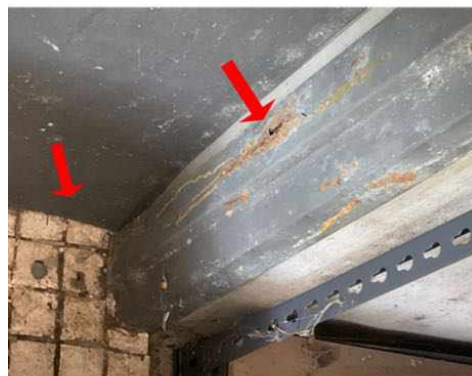
Finding 3.04

Building:	Building 1
Location:	Garage
Finding:	Door - Binding/jamming and delaminating with severe frame rust
Information:	Binding and delaminating of this door was evident during standard operation. This defect inhibits the functionality of the affected door. This door was only opened 20cm as it appeared severely damaged it may not close if opened fully. The metal door frame is also severely rusted.

A door that binds to flooring or to the associated door frame may have several causes, ranging from minor defects, such as poor installation of the door or deteriorated hinges, through to major structural issues, such as damage to subfloor structures.

A qualified carpenter or general handyperson should be appointed to perform replacement works to the door and frame at client discretion.

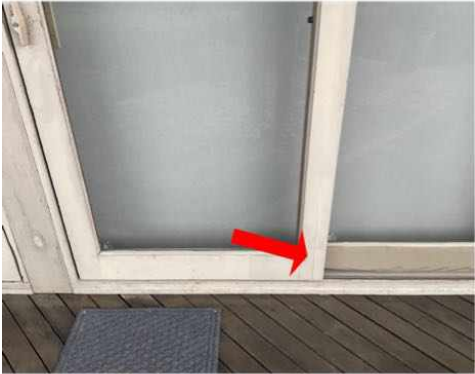
Finding 3.05

Building:	Building 1
Location:	Pictured areas
Finding:	Doors damaged (minor)

Information: These pictured rear doors and door track were found to be damaged at the time of the inspection. Some joints are coming apart and have minor splitting.

Repairs to these broken doors is advised to improve the operational state of the associated doors.

A qualified carpenter should be appointed to repair these doors in ten next few months.

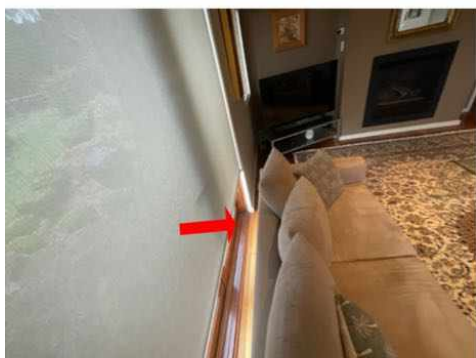
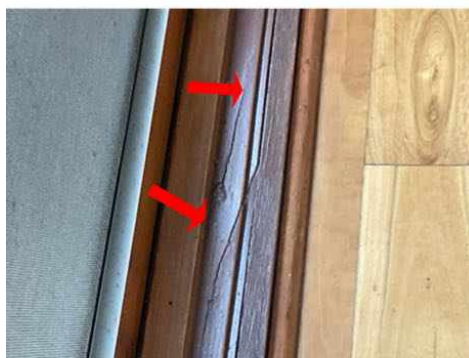
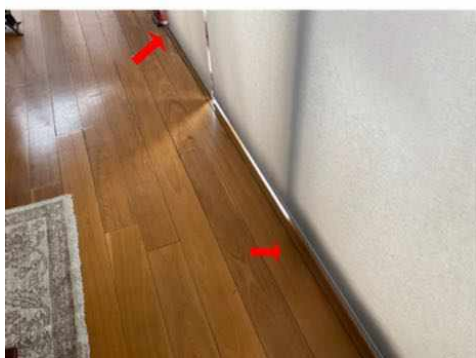
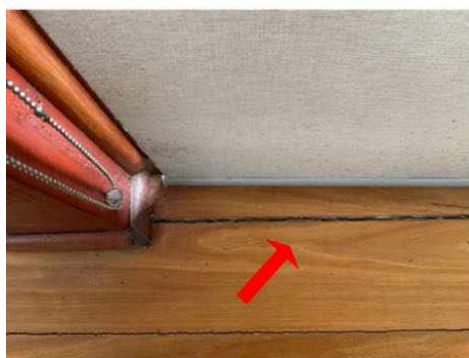
Finding 3.06

Building: Building 1

Location:	Lounge Rooms and small areas
Finding:	Timber flooring - splitting on small areas
Information:	At the time of inspection, visible signs of stress and splitting were noted in some flooring. These two areas should be monitored annually to ensure further damage does not occur.

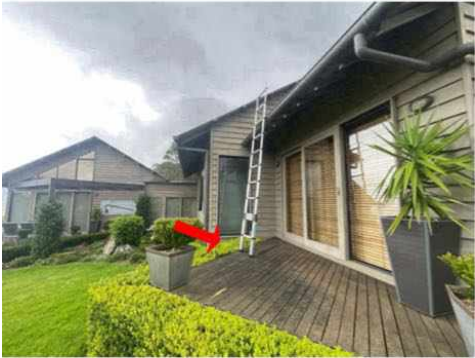
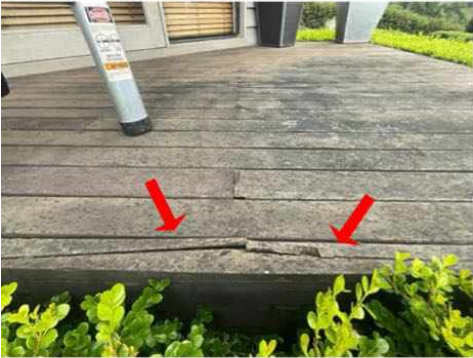
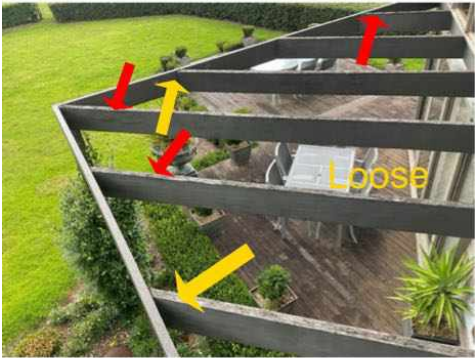
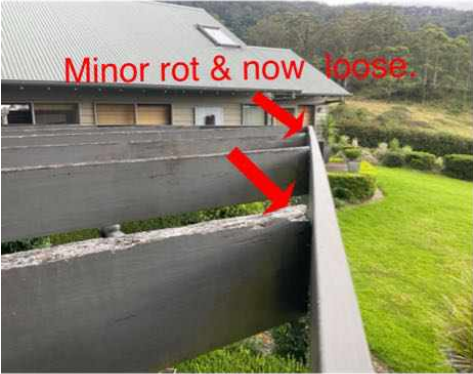
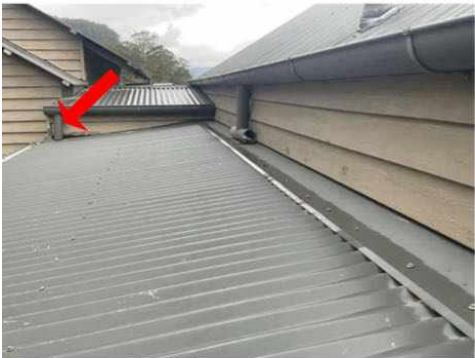
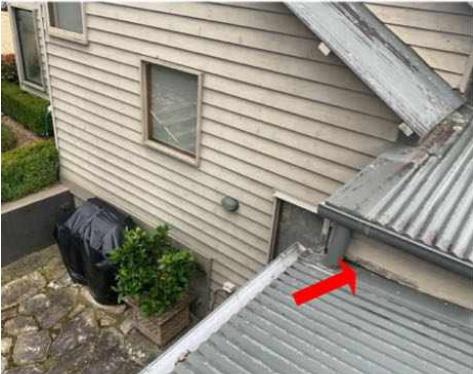
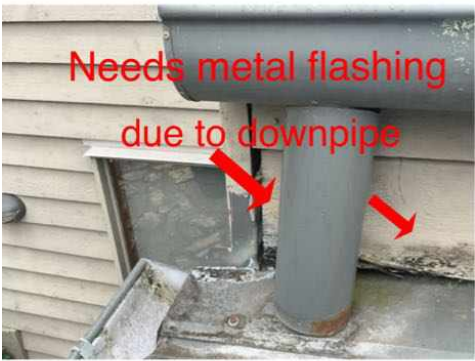
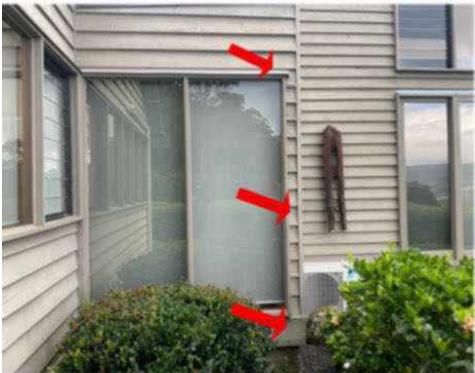
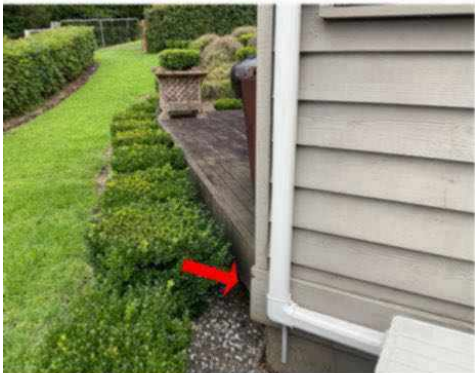
Finding 3.07

Building:	Building 1
Location:	Pictured areas
Finding:	Wood rot and loose timber
Information:	The building shows evidence of wood rot to some decks, cladding and pergola areas. Wood rot, also known as Fungal Decay, occurs when timbers and other cellulose building materials are exposed to damp conditions on an ongoing basis. This could be the result of exposure to weathering over a prolonged period of time, or the attraction of excessive moisture from other abutting building materials.

Early intervention and regular maintenance, particularly of exterior timbers, will prolong the useful life of these building elements. Replacement of these affected timbers may then be a necessary step in protecting surrounding building elements from such deterioration.

A qualified carpenter or registered builder may also be required to replace affected building materials.

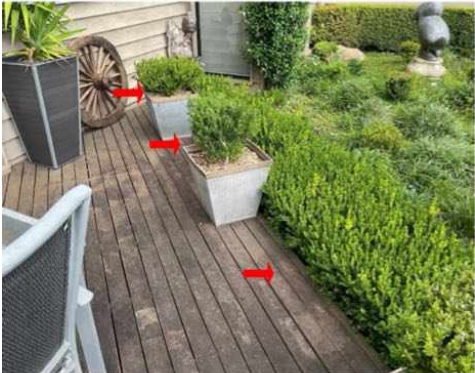
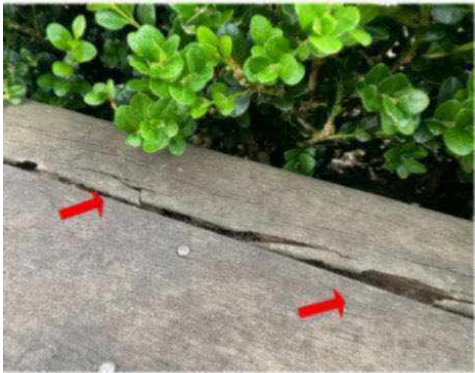
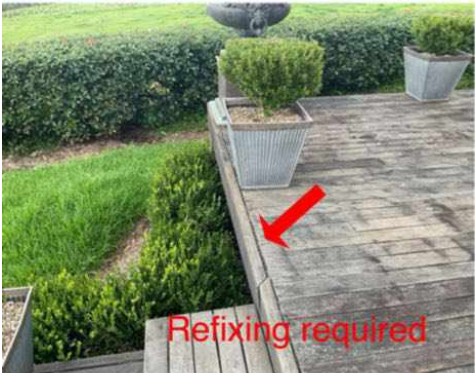
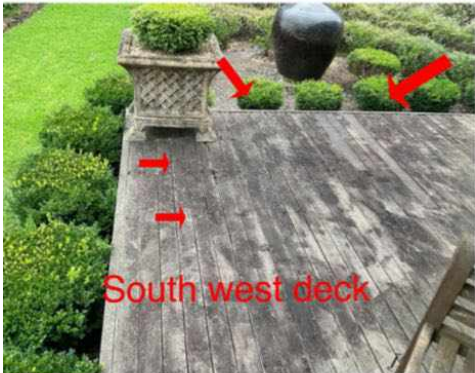
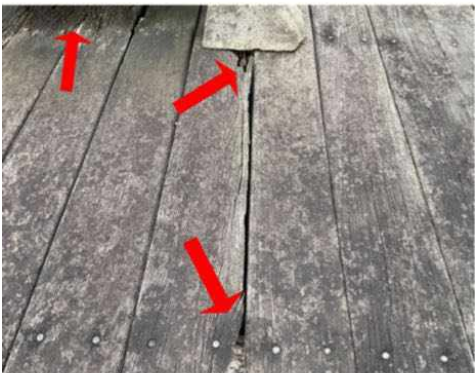
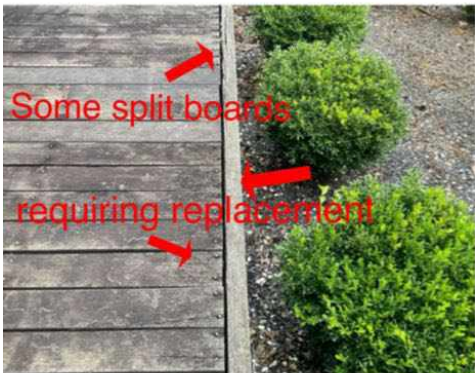
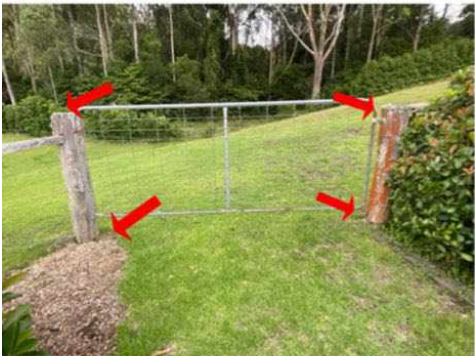
Finding 3.08

Building: Building 1
Location: Pictured areas
Finding: Wood rot and loose timber (continued)
Information:

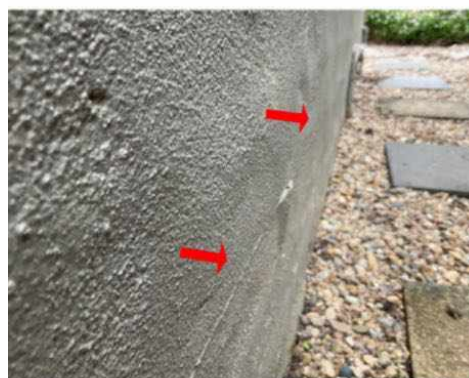
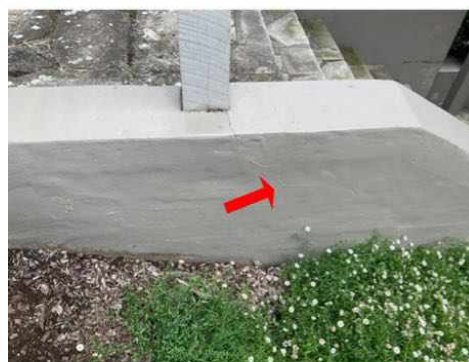
Building:	Building 4
Location:	Exterior walls
Finding:	Render (external) cracking.
Information:	It has been observed that cracking to some external rendered surfaces mostly small garage wall areas. The degree of damage is described as “slight” noticeable cracks which are easily filled. Cracking of this size are generally less than 5mm in width.

Always contact your building inspector should cracks widen, lengthen, or become more numerous.

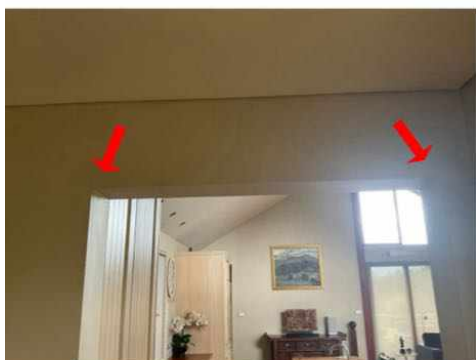
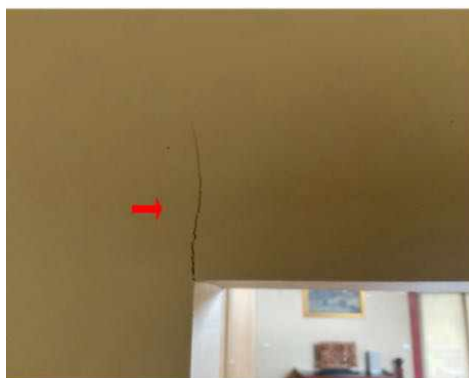
Finding 3.11

Building:	Building 1
Location:	Hall areas
Finding:	Cracking - Damage Category 1 - Fine (up to 1mm)
Information:	Although fine cracks are quite noticeable, they are often only considered to be an appearance defect, and usually do not indicate any structural damage. Generally, the cause of a fine crack is indicative of a separation between building materials and finishes (e.g. paint, plaster, etc.) along joints.

Cracking of this nature can generally be repaired with minor sanding, filling and/or repainting. Such works should be performed by a qualified painter or a general handyman.

Monitoring of all cracking should be conducted frequently. Always contact a building inspector should cracks widen, lengthen, or become more numerous.

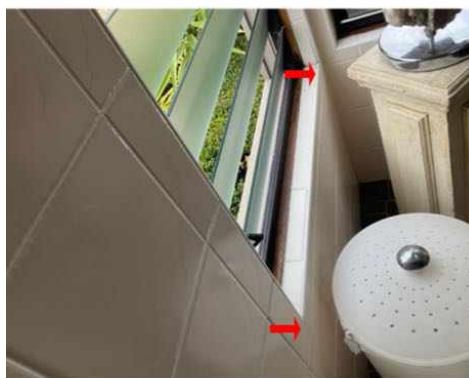
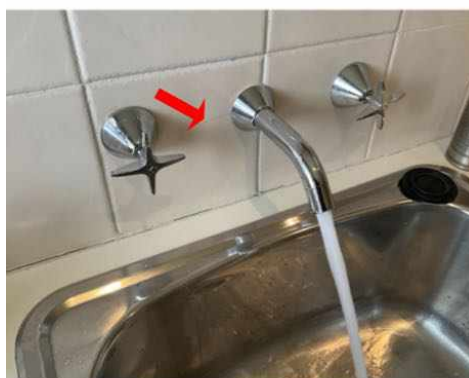
Finding 3.12

Building:	Building 1
Location:	Bathroom & laundry
Finding:	Tiles cracked
Information:	Cracked tiles were evident in these two pictured areas at the time of inspection. It is suspected that this cracking has occurred as a result of minor settlement.

Cracked tiles throughout the household detract from the overall appearance of the affected areas. In wet areas of kitchens and bathrooms, it can lead to water damage of adjoining walls and floors.

Replacement of cracked tiles is recommended as soon as possible. A tiling contractor may be appointed to perform these works. Where cracks become more numerous, contact a licensed building inspector for further investigation.

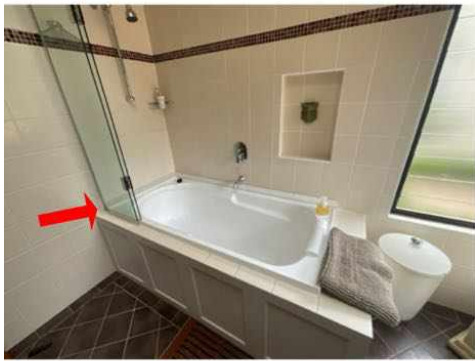
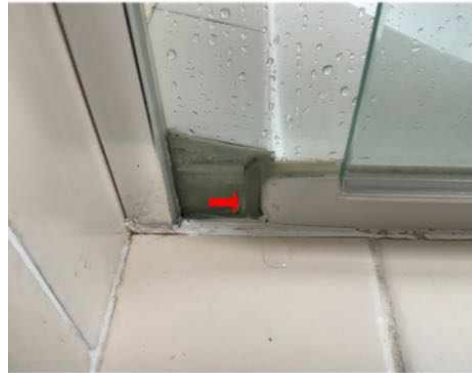
Finding 3.13

Building:	Building 1
Location:	Bathroom
Finding:	Shower screen - Leaking
Information:	Leaking was evident to the shower screening at the time of inspection. It is suspected that the leaking has occurred as a result missing sealant. Leaking from the shower , where left unattended, is likely to lead to water damage to adjoining flooring and walls. Such damage can lead to water damage and necessitate extensive remedial works being required. Active water leaks may also create an environment that is susceptible to the formation and development of mould.

Appointment of a sealant expert is required to repair or replace this missing sealant. Such works should be performed as soon as possible to ensure that no further damage occurs.

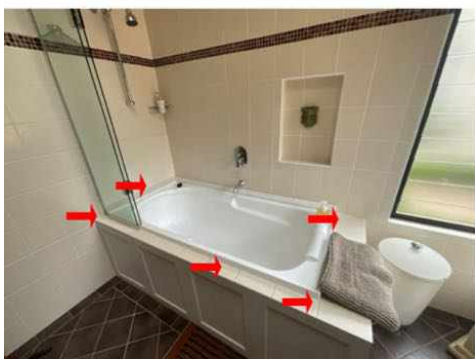
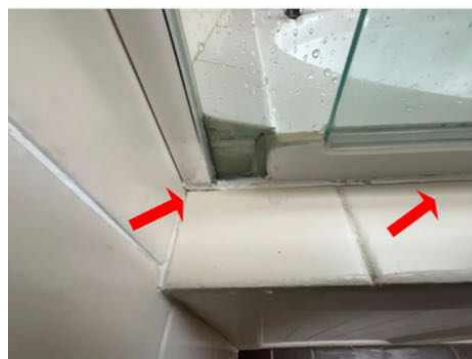
Finding 3.14

Building:	Building 1
Location:	Laundry and bathroom
Finding:	Sealant and grouting - Missing or damaged
Information:	It was noted on inspection that sealant or grout is degraded to these pictured areas.

Different materials and floor areas move at different rates, generally causing cracking to grout or sealant at this point. A flexible sealant is required to allow for expected expansion and contraction, while keeping the joint water tight and protective of all associated building materials.

Flexible and mould resistant materials should be applied to affected areas to prevent any subsequent water damage that is likely to occur. Regular maintenance and replacement of damage or missing or damaged sealant and grout is highly recommended to the wet areas, as this is a regular wear and tear defect. Sealant and grouting in areas that come into regular contact with water should be maintained for the long term care of your property.

A sealant specialist or tiling contractor should be appointed to complete these works as soon as possible

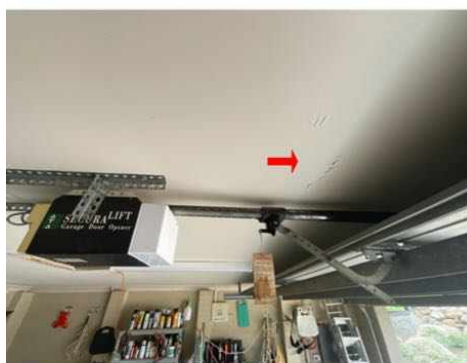
Finding 3.15

Building:	Building 2
Location:	Pictured areas
Finding:	External painting deteriorated
Information:	Much of the external paintwork on the pergola and small areas of the garage ceiling have been neglected and require attention to prepare and re-paint.

Whilst incomplete or missing paint finish is generally an appearance defect, it can also lead to the development of secondary building defects over time. Incomplete areas of paint finish expose the area to moisture, potentially accelerating the deterioration of underlying building materials.

Degraded paint finishes should be sanded back, filled, leveled and painted, as applicable. Where inadequate or missing paint protection has led to the deterioration of the associated building element, repair and/or replacement of this building element may be required.

A painting contractor should be appointed as soon as possible to perform necessary works to aid the appearance of the affected area and to ensure the area is protected against further deterioration. Alternatively, the homeowner following manufacturer instructions may perform these works.

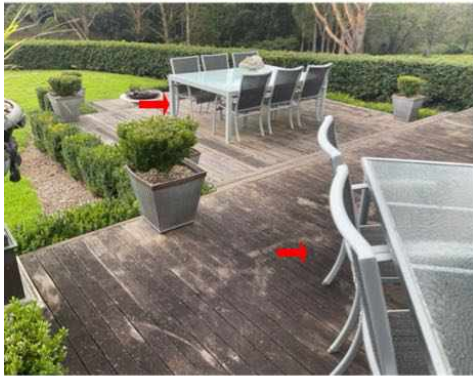
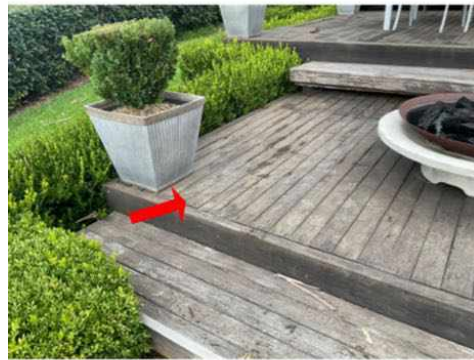
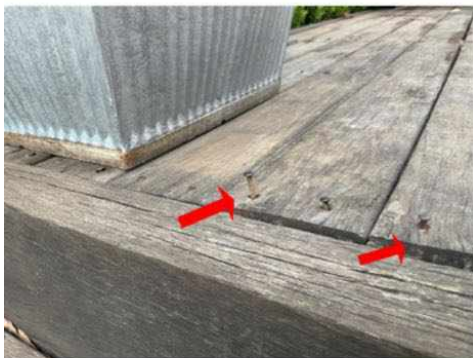
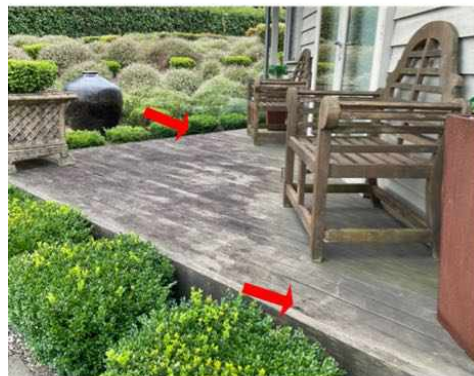
Finding 3.16

Building: Building 1
Location: Pictured areas
Finding: Nails - Popping
Information: Numerous popped nails were identified at the time of inspection. Nails and screws are held by the friction between them and the surface that they are applied to. Over time, the nails and screws can back out, which is often a result of general ageing and deterioration of the building structure.

If left unmanaged, internal wall and ceiling sheeting may become loose and unstable, increasing the rate of deterioration of these building elements and creating potential for the development of secondary defects.

Re-fastening of popped nails will help to maintain the stability of these, and associated, building elements. Such minor works will also help to improve the appearance of the affected area and secure the linings. These works should be performed by a qualified carpenter or plasterer at client discretion.

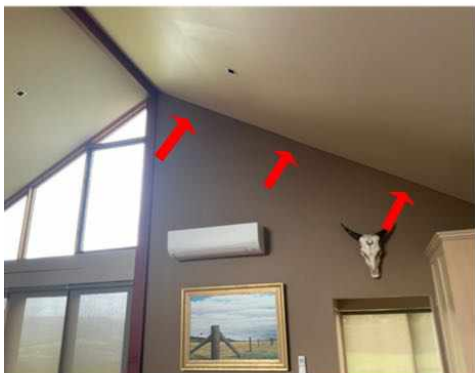
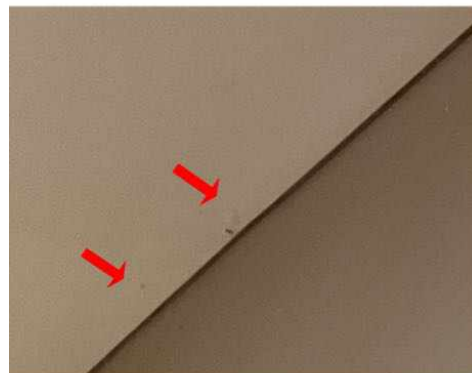
Finding 3.17

Building:	Building 1
Location:	Lounge Room
Finding:	Ceiling nails - Popping
Information:	Some perimeter ceiling popped nails were identified in the internal loungeroom ceiling at the time of inspection. Nails and screws hold simply by the friction between them and the surface they are applied to. Over time, the nails and screws can back out, which is often a result of general ageing and deterioration of the building structure.

If left unmanaged, the ceiling sheets may become loose and unstable, increasing the rate of deterioration of the internal ceiling and creating potential for the development of secondary defects.

Re-fastening of popped nails will help to maintain the stability of the internal ceiling and associated building elements. Such minor works will also help to improve the appearance of the affected area and secure the ceiling sheets, so as to prevent the onset of ceiling sagging. These works should be performed by a qualified carpenter or plasterer at client discretion.

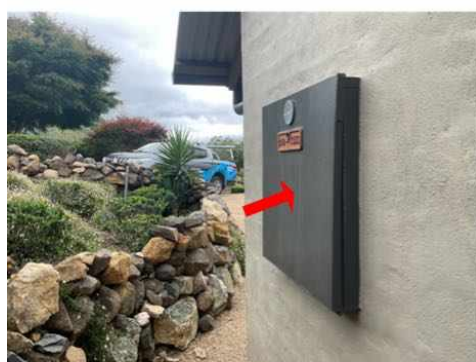
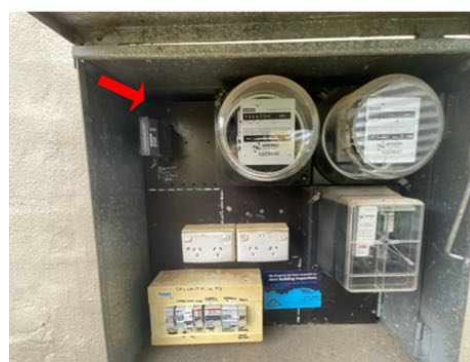
Building:	Building 1
Location:	Meter Box
Finding:	Termite Management System - no evidence of a chemical installation
Information:	The application of a post-construction chemical termite barrier is highly recommended for all properties. Such barriers are highly effective in preventing termite attack on any timber building elements throughout the property.

A durable notice should be placed in the switchboard unit to indicate current termite barriers. At the time of inspection, no durable notice was evident and it appeared as though no chemical termite management system has been installed, with no evidence to suggest preventative works taking place since the property was built.

The client may consider gaining further advice from a pest controller as to the costs and procedures involved with a 'chemical' application. It is recommended that obtaining such advice be a short-term priority.

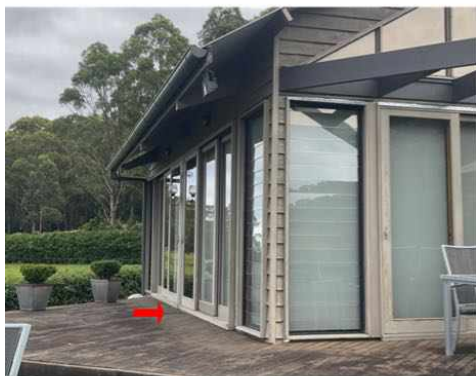
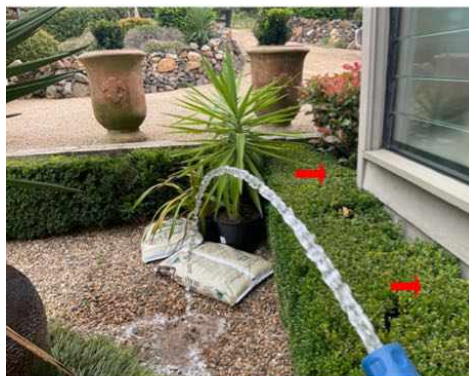
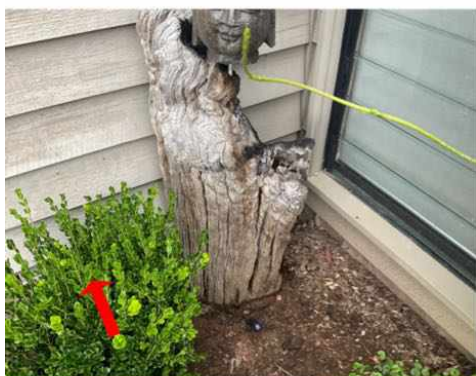
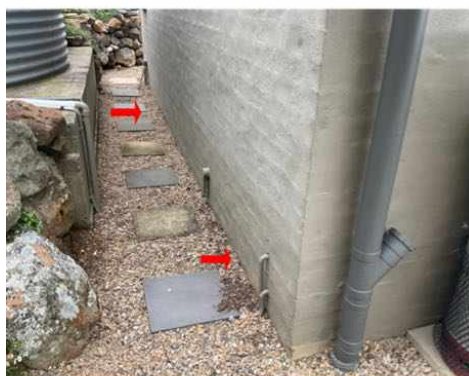
Finding 6.02

Building:	Building 1
Location:	Yard - front
Finding:	Bridging - Vegetation and decking
Information:	Where vegetation and decking obstructs inspection of building elements, also known as bridging as it provides a bridging point for the access of termites, full inspection can not be achieved. Consequently moisture or dampness may be present and the areas becomes conducive to termite activity. Plants and decks against or very close to buildings provide cover, shade and can provide an environment that is attractive to

The removal and replanting of plant species that do not provide "cover" or cutting back of existing vegetation and leaving a small gap between decking and the building walls will assist greatly in preventing Bridging from occurring.

The removal of any plant materials that may be conducive to termite activity should be carried out as soon as possible and arrange re inspection to minimize the risk of termite attack.

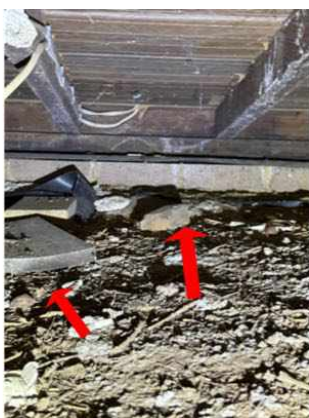
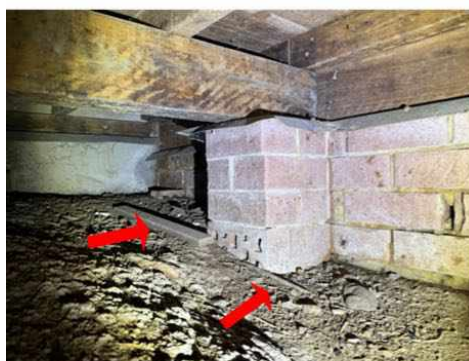
Building:	Building 1
Location:	Subfloor
Finding:	Timber in contact with the ground
Information:	Any timbers in direct ground contact provide opportunity for concealed termite entry and are likely to be subject to premature rot and decay as the soil retains moisture or damp conditions against the timbers.

Removal of all waste timber that is in direct contact with ground is highly advised. This timber is promoting mould and wood rot and is very attractive to termites.

Frequent pest inspections are advised to readily identify any termite activity in these areas.

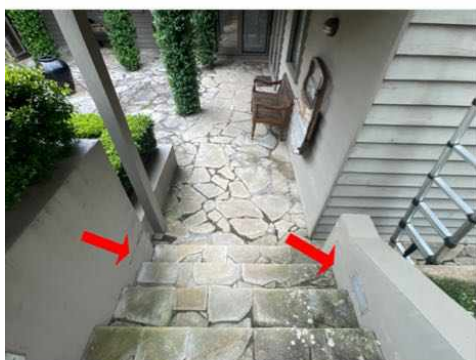
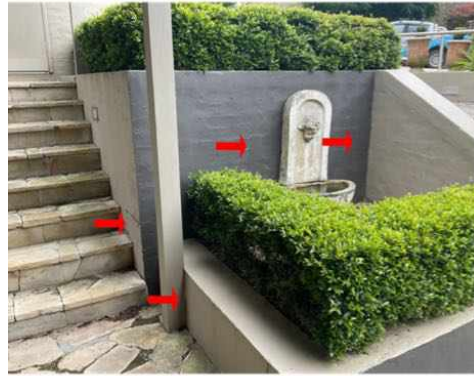
Finding 6.05

Building:	Building 1
Location:	Central stairs and some subfloor areas
Finding:	Damp rising and paint damage from moisture
Information:	Rising damp describes the upward movement of water in low sections of building elements (e.g. walls) by capillary action - the movement of water through porous materials such as bricks, sandstone or mortar.

Rising damp is generally managed by the installation of a damp proof course during construction. A Damp Proof Course (DPC) is an impermeable barrier at the base of the wall above ground level. However, many 19th Century buildings have no damp course installed, or the materials have failed. The DPC may have been omitted as a consequence of poor workmanship, or it may have been bridged where materials built up against the side of the house allow moisture ingress above the DPC level.

The first step in addressing rising damp is to diagnose the cause. The identified cause should be addressed first before addressing the appearance and other defects which have resulted from the rising damp. If the original cause is not resolved, further cases of damp are likely to ensue, resulting in secondary defects.

Consultation with a qualified plumber is advised immediately to identify the cause of the damp and perform remedial works as required.

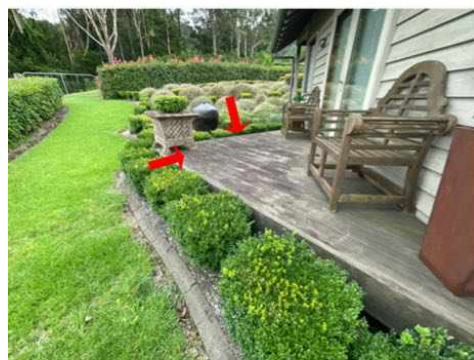
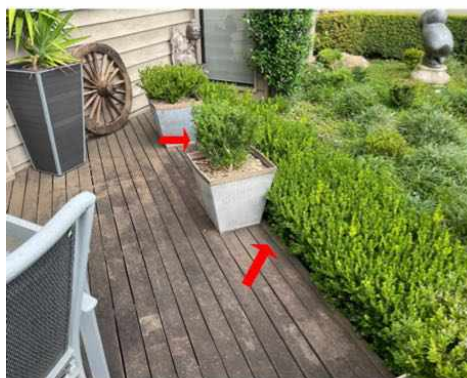
Finding 7.01

Building:	Building 1
Location:	Small reads of decks, cladding and rear left pergola
Finding:	Fungal decay - present (localised)
Information:	Fungal decay also known as wood decay or wood rot generally refers to the deterioration of timber elements when in contact with excessive levels of moisture for a prolonged period of time.

The development of fungal decay is accelerated by temperatures from 5degreeC to 40degreeC as well as the presence of oxygen. Generally fungal decay develops on timber elements that are in use in an external environment which are exposed to rain penetration.

In this case, the affected timber element is in a decaying state and will need replacement by a carpenter or licensed builder.

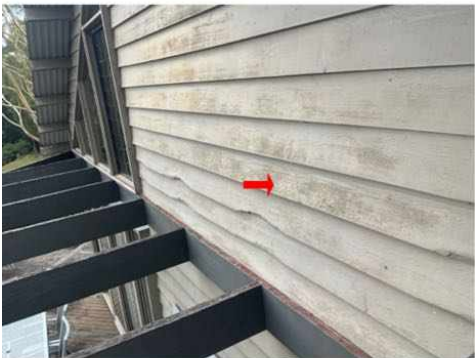
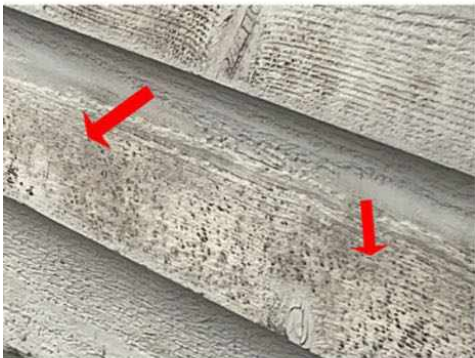
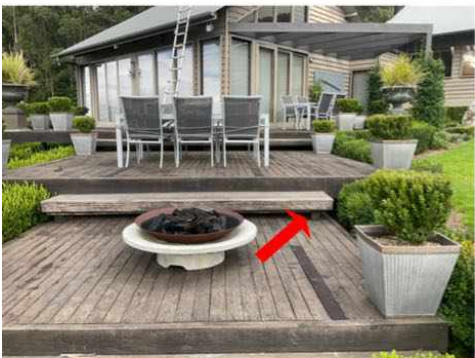
Finding 8.01

Building:	Building 2
Location:	Pictured areas
Finding:	Evidence of wood borer activity identified
Information:	Wood borers small beetles that colonise in exposed timber elements are a common timber pest that are regularly mistaken for termites. Although wood borer activity is generally not detrimental to the affected timber they may lead to serious damage and necessitate replacement of certain building elements if left unattended.

The other commonly known borer the Anobium borer is more likely to attack floorboards and may cause severe structural damage to flooring areas.

As no live wood borer activity was identified treatment is not required at this time. Replacement of affected timbers may be considered by the client for superficial reasons.

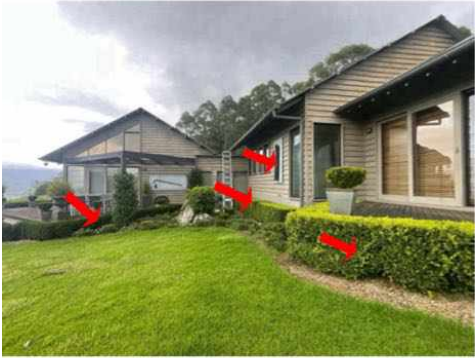
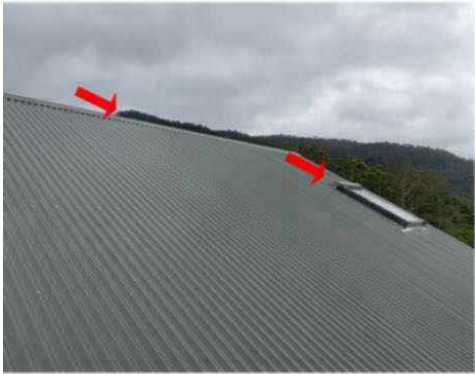
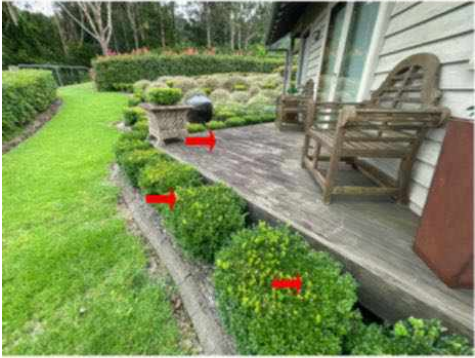
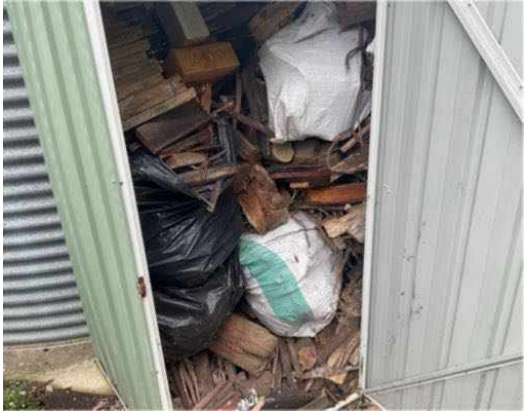
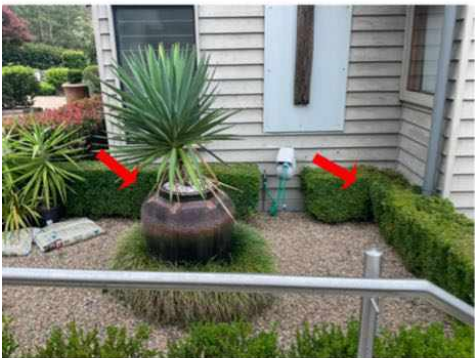
Building: Building 1
Location: All External Areas
Finding: Additional Photos - Obstructions and Limitations of EXTERNAL AREAS
Information: These photographs are an indication of the obstructions and limitations which impeded full inspection of external areas at the time of inspection. These obstructions can hide an array of defects and should be removed to allow full inspection to be carried out. A re-inspection is recommended once the areas are made accessible.

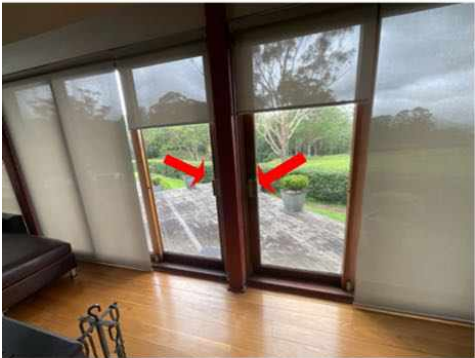
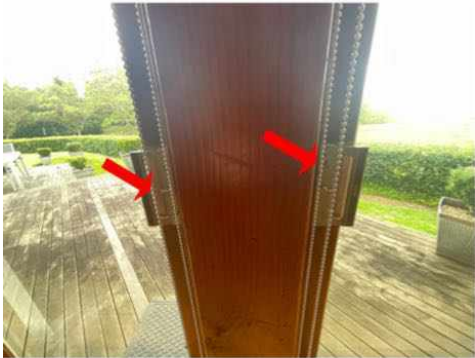
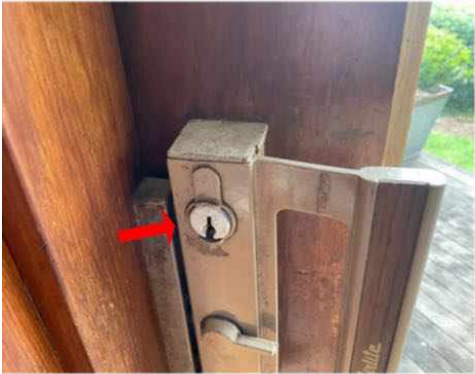
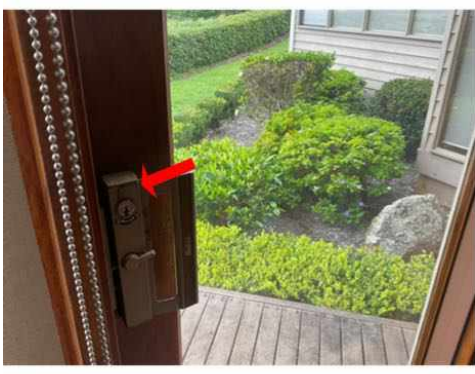
Building: Building 1
Location: All Internal Areas
Finding: Additional Photos - Obstructions and Limitations of INTERNAL AREAS
Information: These photographs are an indication of the obstructions and limitations which impeded full inspection of Internal areas at the time of inspection. These obstructions can hide an array of defects and should be removed to allow full inspection to be carried out. A re-inspection is recommended once the areas are made accessible.

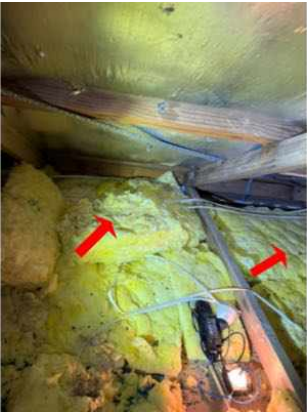
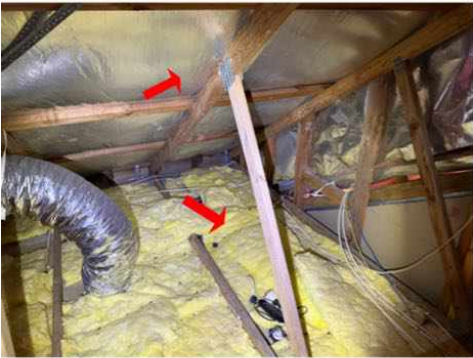
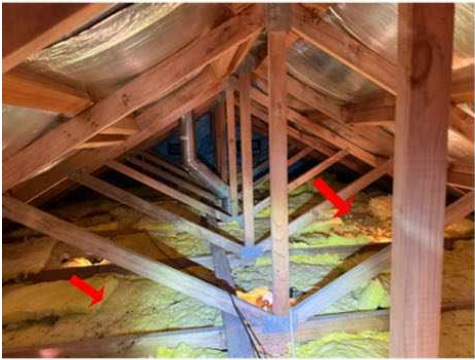
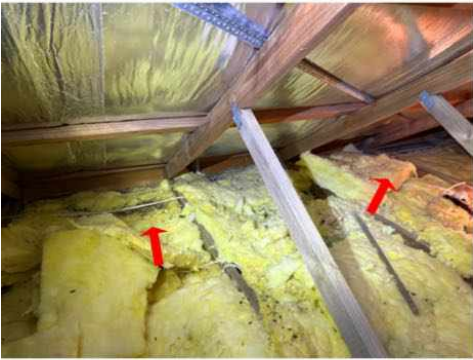
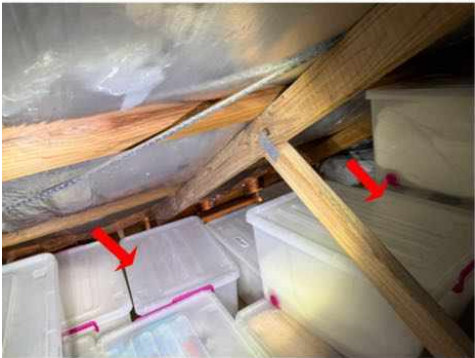
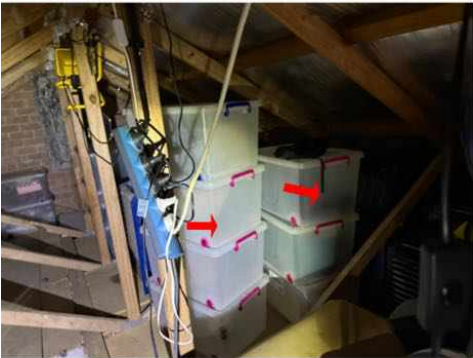
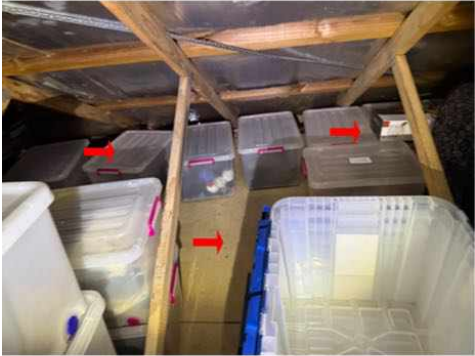
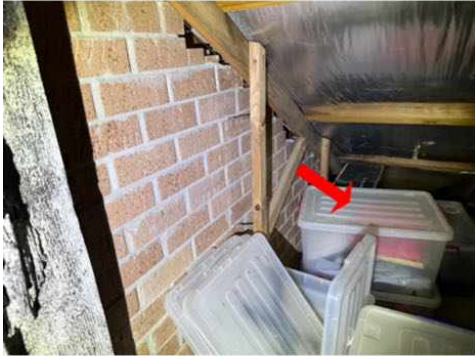
Building: Building 1
Location: All Roof cavity areas
Finding: Additional Photos - Obstructions and Limitations of the ROOF CAVITY
Information: These photographs are an indication of the obstructions and limitations which impeded full inspection of roof cavity areas at the time of inspection. These obstructions can hide an array of defects and should be removed to allow full inspection to be carried out if applicable. A re-inspection is recommended once the areas are made accessible.

The inspection was also limited to areas with an allowable crawl space of 600mm x 600mm, in particular towards the external walls where the roof line diminishes, these areas were not accessible.

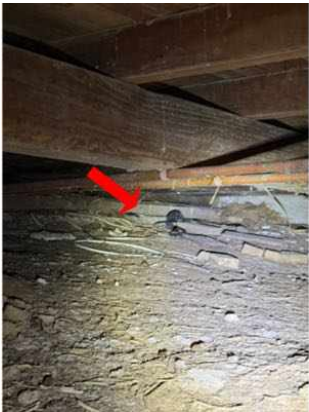
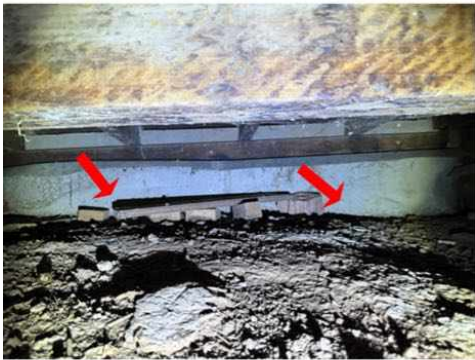
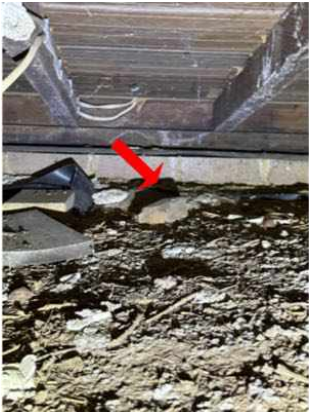
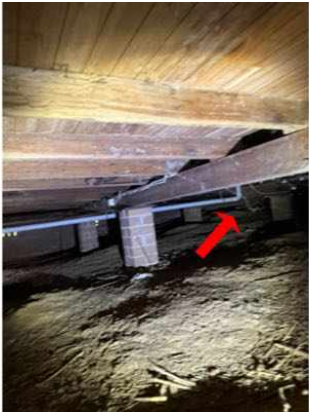
Building: Building 1
 Location: All Subfloor Areas
 Finding: Additional Photos - Obstructions and Limitations of SUBFLOOR AREAS
 Information: These photographs are an indication of the obstructions and limitations which impeded full inspection of subfloor areas at the time of inspection. These obstructions can hide an array of defects and should be removed to allow full inspection to be carried out. A re-inspection is recommended once the areas are made accessible.

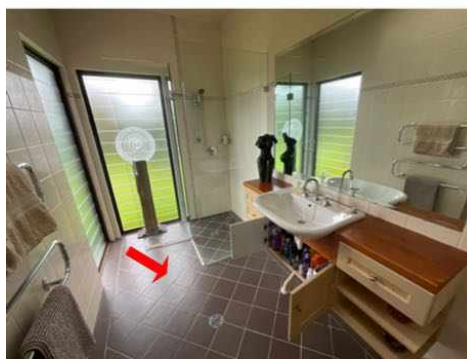
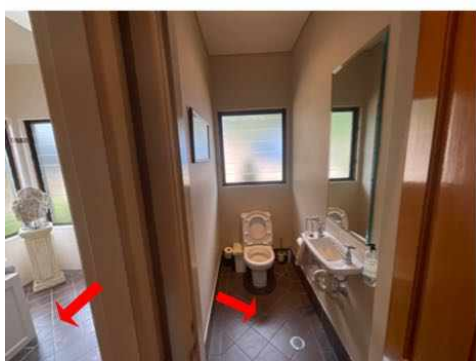
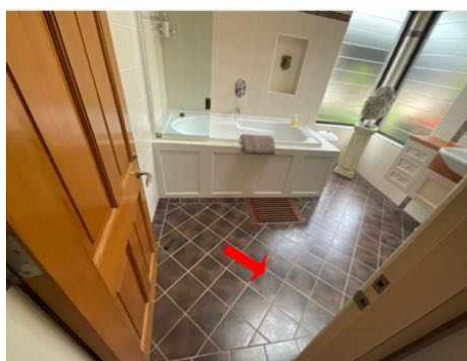
Building: Building 1
 Location: Bathrooms and laundry
 Finding: Waterproofing membranes - Information Only
 Information: Internal Water Proofing Membranes, are crucial in preventing water ingress into the property is important to know that the Membrane System used is to Australian Standards and has been installed correctly.

With older property's where this information is unavailable all wet areas should be monitored. If any leaks, water staining, peeling or bubbling of the paint become evident to any adjacent walls or ceilings below a licensed builder or waterproofing specialist is recommended to investigate further.

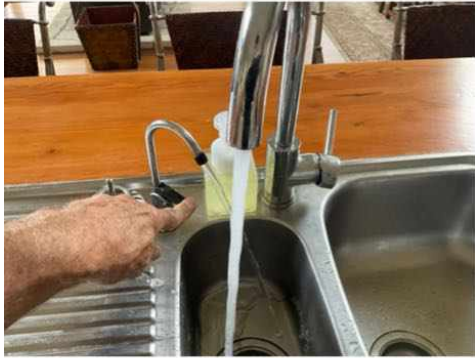
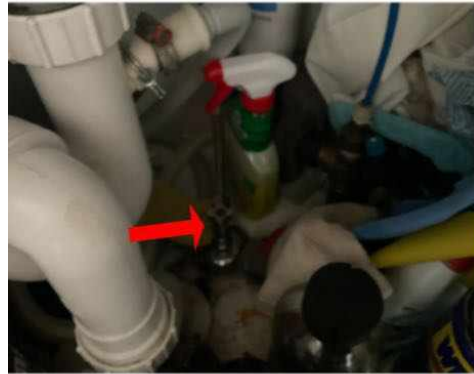
Building: Building 1
 Location: Kitchen
 Finding: Hot water not working

Information: While most of the hot water appears to be gas, the kitchen hot appears to be from an electric tank under the rear subfloor.

The kitchen hot water tank was turned off at the time of the inspection and should be checked after it has time to heat.
