# Building and Timber Pest Inspection Report

Inspection Date: Fri, 13 Mar 2026

Property Address: 61 Waruda St, Yagoona NSW 2199,  
Australia

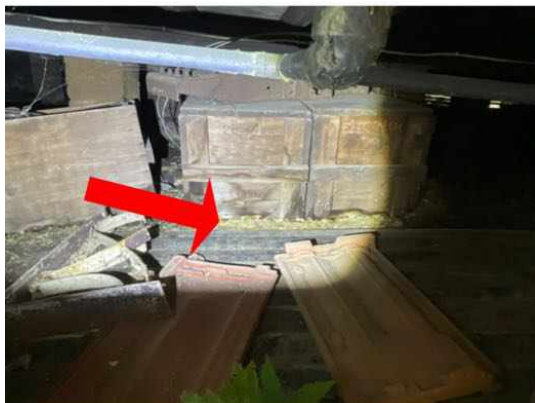
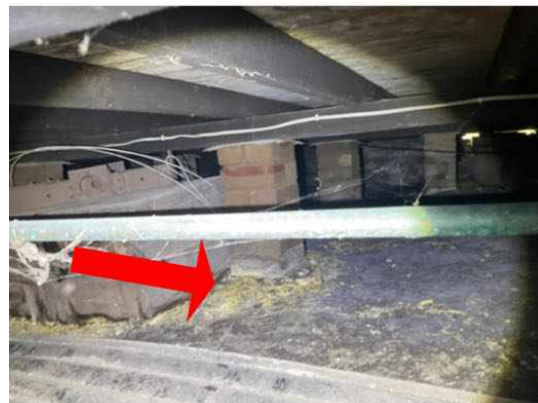
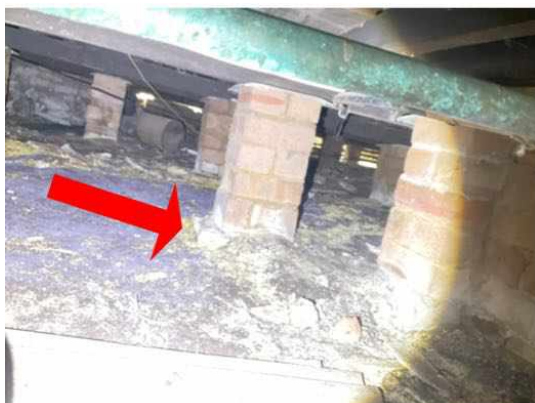
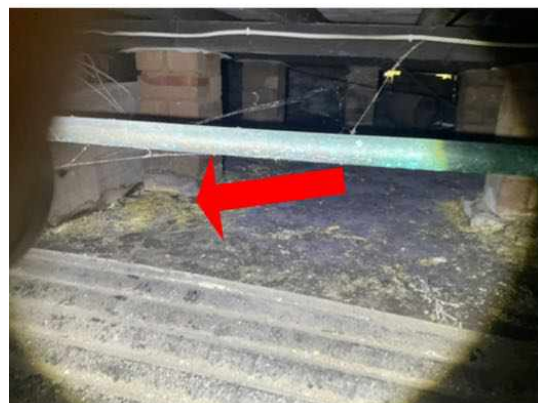
#### Finding 1.01

Building: Main Building  
 Location: Subfloor  
 Finding: Subfloor Ventilation - Inadequate (mouldy subfloor soil to some areas)  
 Information: Adequate subfloor ventilation aids in preventing excessive moisture wood rot and termite activity by ensuring a dry subfloor environment. Where ventilation is substandard it is usually caused by factors such as failure to install adequate vents during construction subsequent building works or earth and vegetation covering over vents low subfloor clearance and items or debris in the subfloor restricting airflow. Subfloor ventilation can be improved in most cases by addressing the causes such as exposing subfloor vents installing additional new vents installing mechanical (forced airflow) ventilation and removing debris from the subfloor. A registered builder should be appointed as soon as possible to perform these works as necessary.

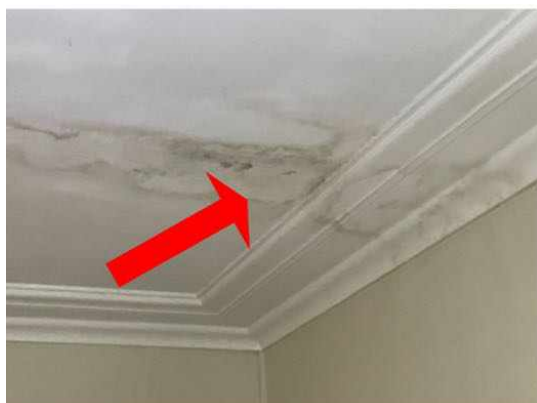
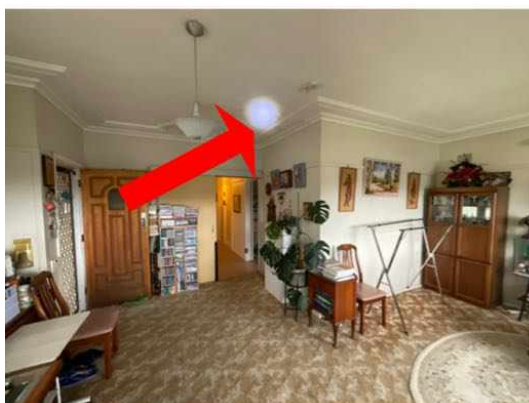
## Finding 2.01

Building:	Main Building
Location:	Living Room
Finding:	Ceiling - Water damaged
Information:	Water damage to the ceiling lining is generally an indication of excessive moisture being present in the roof void, usually via a leak to the roof covering.

Where water damage is evident to the ceiling, the primary requirement is to identify and rectify the source of the leak. A roofing plumber should be appointed as soon as possible to identify the leak and perform rectification works as necessary, ensuring the water damage is restricted.

Once the leak is repaired, consultation with relevant tradespeople, including plasterers and painters, is advised. Rectification works may include replacement of ceiling lining or minor repainting, depending on the extent of the damage.

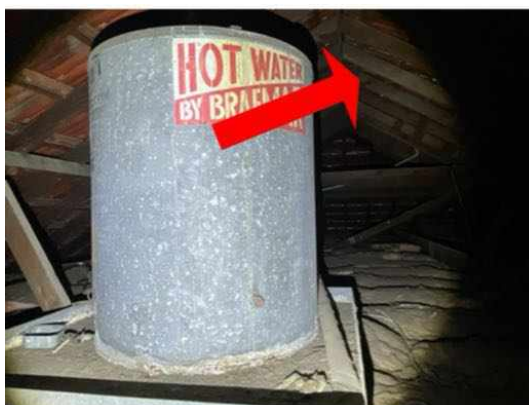
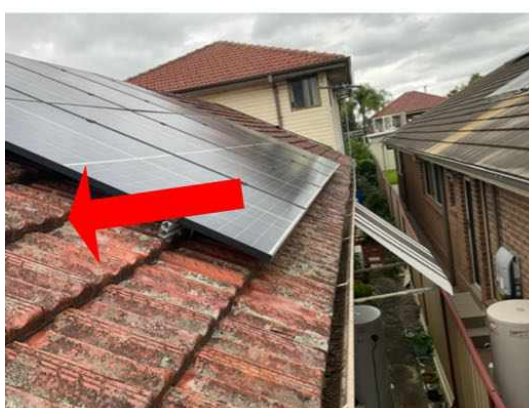
## Finding 2.02

Building:	Main Building
Location:	Roof Void / Roof Exterior
Finding:	Exterior roof - Leaking
Information:	Active roof leaks were evident at the time of inspection. Roof leaks can have a number of causes, including damage to roof coverings, deterioration of roof fixtures and fittings, or loosely associated materials (fascias etc.).

Where water leaks are active, rain penetration is likely to cause water damage to associated structures and building elements in this area, which can have a range of implications. If left unmanaged, the development of major structural damage to the roofing and associated structures may occur.

A roof plumber should be appointed as soon as possible to primarily identify the cause of the leak, and to provide subsequent repair works as necessary. Depending on the extent of the damage, replacement of sections of the roof covering and/or

roofing structures may be required, and may be performed by a registered builder or qualified carpenter.

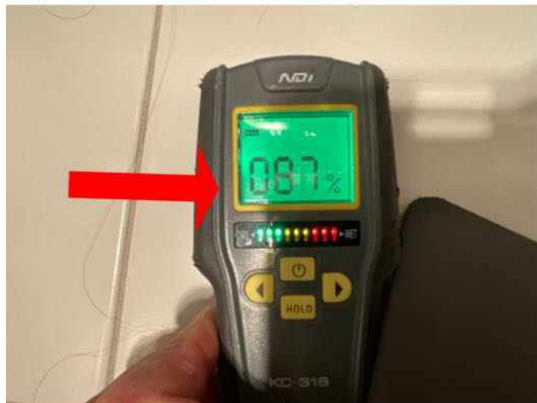
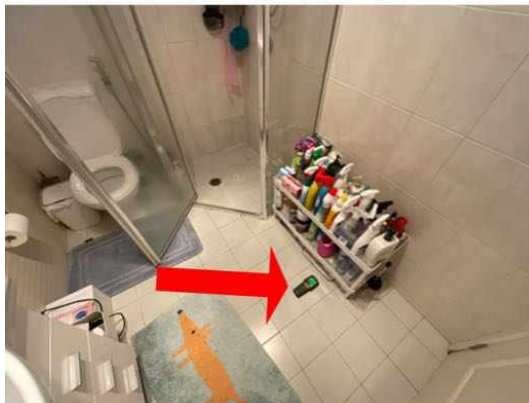
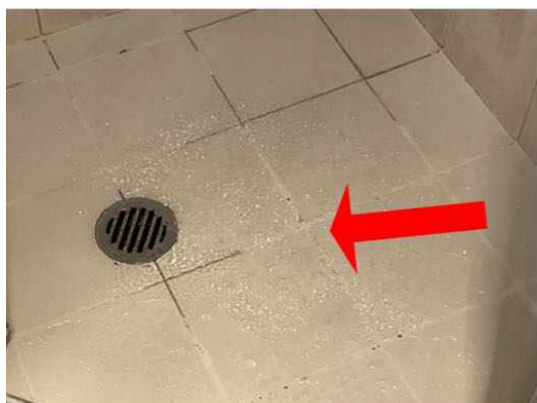
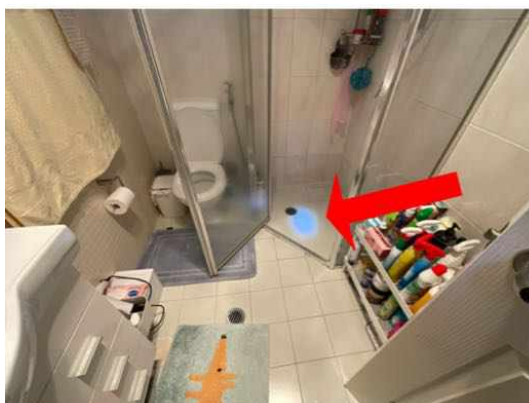
### Finding 2.03

Building:	Main Building
Location:	Bathroom > Upstairs
Finding:	Bathroom - Damp
Information:	Damp is evident to the lower 300mm of wall to the bathroom alcove. This defect is quite common, and is suspected to have been caused by moisture permeating through the grouting in this area, which shows evidence of deterioration. Leaking pipes within the adjoining wall is also a possible cause. Damp (or structural damp) refers to the presence of unwanted moisture in the structure of a building, either as the result of intrusion from outside, or condensation from within the structure. In the bathroom area, internal water leaks or other sources of excessive moisture are generally the cause of damp. Unmanaged damp in the bathroom recess is likely to facilitate the formation and development of mould and fungi growth, decaying associated building materials and compromising their structural integrity. It is important to address damp conditions, as the World Health Organisation notes that excess moisture leads - on almost all indoor materials - to growth of microbes such as moulds, fungi and bacteria, which subsequently emit spores and other matter into the indoor air. Exposure to these contaminants is associated with a wide range of respiratory and other health-related problems. Consultation with a qualified plumber

or bathroom specialist is advised immediately to identify the cause of damp and to perform remedial works as required. Where excessive mould growth is present, further inspection by a specialist environmental health inspector should also be considered. Always ensure that sealant and grout is in good condition to prevent any moisture issues occurring in the future.

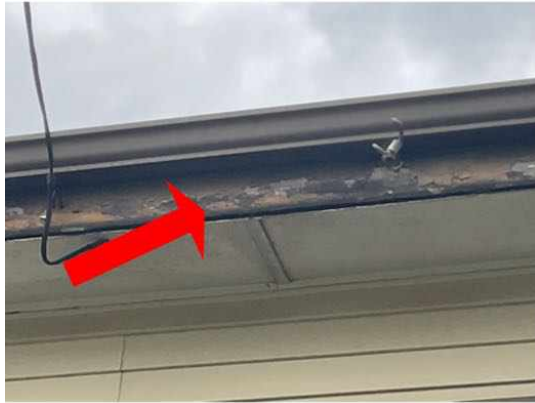
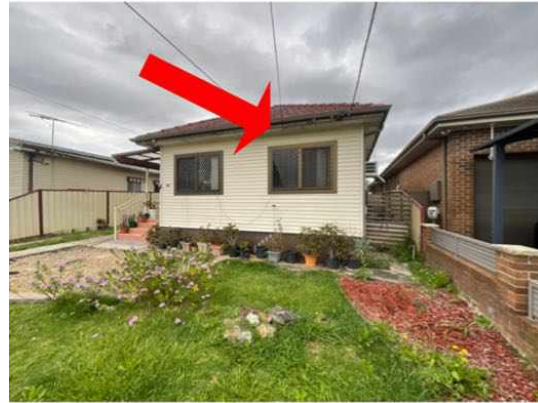
### Finding 3.01

Building:	Main Building
Location:	All External Areas
Finding:	External painting deteriorated
Information:	Much of the external paintwork including but not limited to windows, fascias, guttering, veranda and other external fitments have been neglected and require attention to prepare and re-paint.

Whilst incomplete or missing paint finish is generally an appearance defect, it can also lead to the development of secondary building defects over time. Incomplete areas of paint finish expose the area to moisture, potentially accelerating the deterioration of underlying building materials.

Degraded paint finishes should be sanded back, filled, leveled and painted, as applicable. Where inadequate or missing paint protection has led to the deterioration of the associated building element, repair and/or replacement of this building element may be required.

A painting contractor should be appointed as soon as possible to perform necessary works to aid the appearance of the affected area and to ensure the area is protected against further deterioration. Alternatively, the homeowner following manufacturer instructions may perform these works.

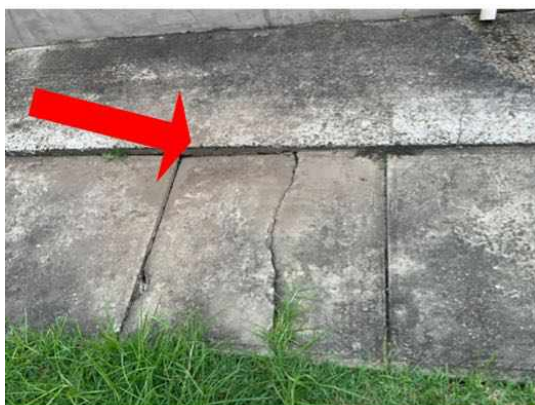
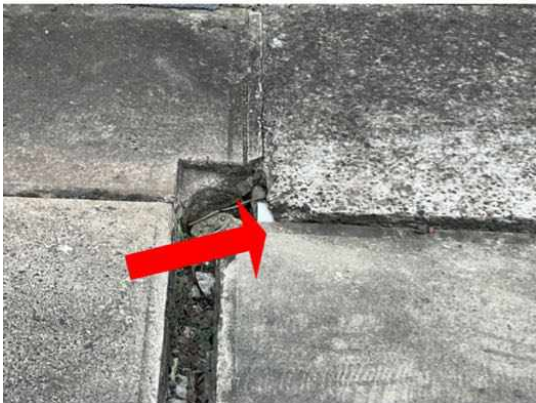
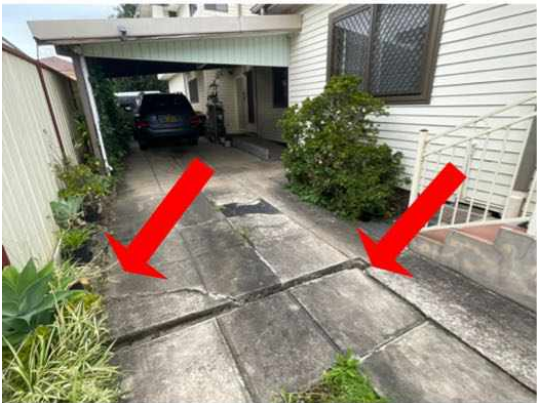
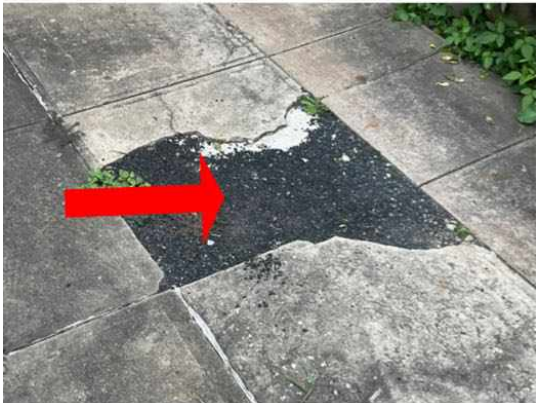
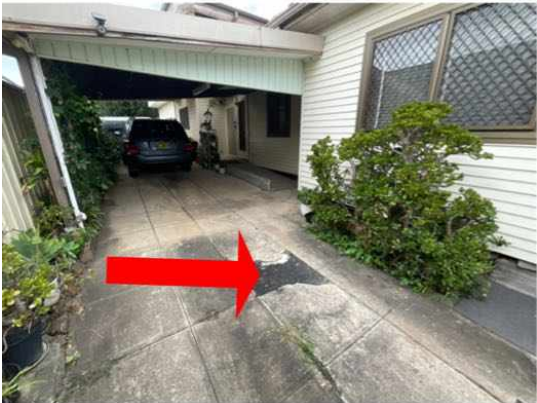
### Finding 3.02

Building:	Main Building
Location:	All External Areas
Finding:	Concrete paving - Erosion
Information:	Erosion under concrete paving was identified at the time of inspection. For all the concrete paving without the right support, concrete will crack, sink and cease to be the sturdy. It's imperative to fix erosion under concrete immediately as well as improve rainwater drainage away from the building foundations.

Suggestion of the inspection from the structure engineer and A qualified tradesmen to be nominated to fix the defect as soon as possible.

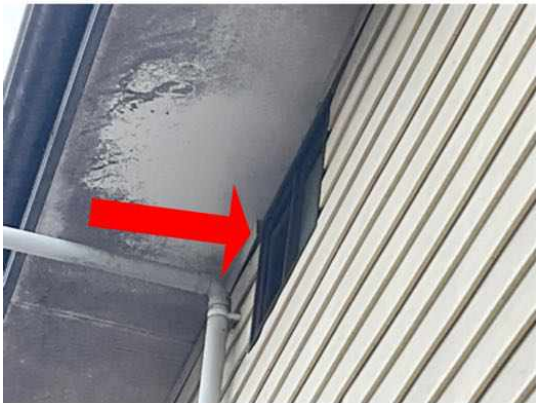
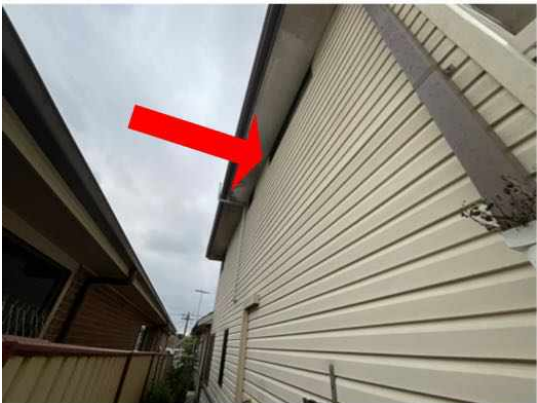
**Finding 3.03**

Building: Main Building  
Location: All External Areas  
Finding: External Cladding - Damaged  
Information: At the time of inspection, the external cladding at the front elevation was found to be damaged. Further inspection by Licensed Building or Qualified Carpenter is highly recommended to ensure its safety and structural integrity of the area. If left unmanaged, the area is likely to deteriorate further, potentially creating not weather tight.

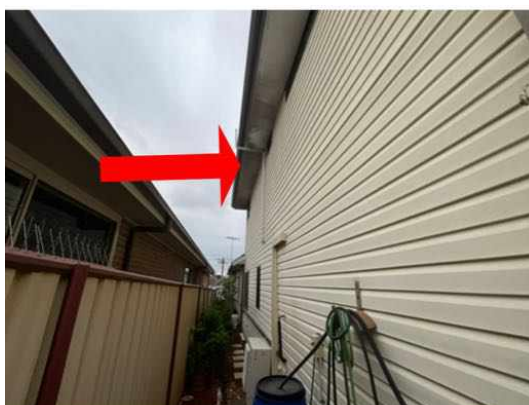
**Finding 3.04**

Building:	Main Building
Location:	All External Areas
Finding:	Eaves lining - Mould
Information:	Mould to eave linings in this area was evident at the time of inspection. Mould indicates that surfaces have been exposed to excessive moisture over time. The minerals and other elements in the water lead to staining, which may graduate to corrosion and deterioration if left unmanaged.

While mostly an appearance defect, mould can be indicative of more serious defects, which may be currently concealed by lining.

Where water staining is active, a licensed plumber must be consulted to identify the cause of the staining and to provide advice on any reparation works that may be required. Replacement of any damaged structures is advised.

Conversely, where water staining is old and inactive, affected building materials may be repaired or replaced at client

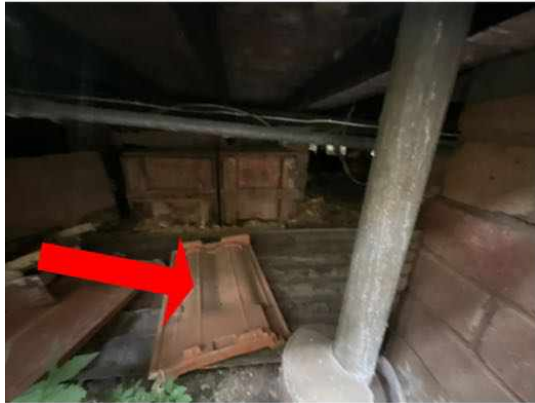
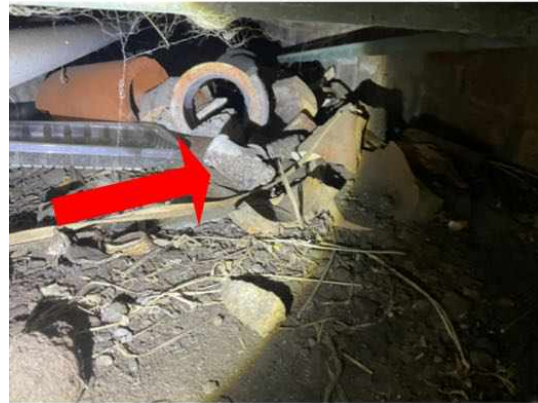
### Finding 3.05

Building:	Main Building
Location:	Subfloor
Finding:	Subfloor - Debris
Information:	An array of debris was found in the subfloor area at the time of inspection. Debris in this area restricts subfloor ventilation and creates potential for concealed pest entry. Stored timbers and other materials may also make the area susceptible to termite activity and wood rot.

A clear and empty subfloor will be better ventilated and easier to maintain in a dry condition. The removal of any timber debris is vital in minimising the risk of termite or wood borer activity.

Debris in the subfloor should be removed as soon as possible. Depending on the location and amount of debris and stored items, the homeowner may elect to

undertake this task. Alternatively there are a large number of rubbish removal subcontractors that could undertake these works.

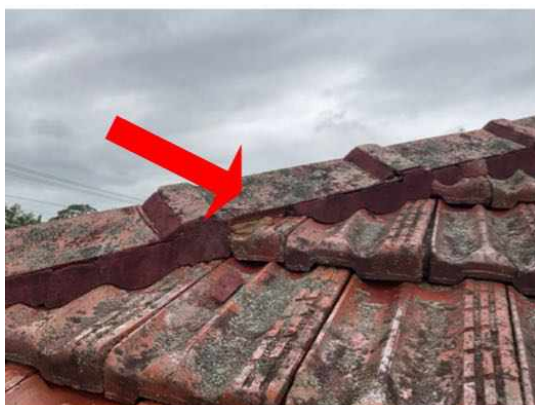
### Finding 3.06

Building:	Main Building
Location:	Roof Exterior
Finding:	Mortar - Deterioration
Information:	Mortar, or 'bedding', is the material which fills joins and intersections between tiles and other building elements on the exterior roof covering, such as gable ends, hip capping and valleys. Upon inspection of the exterior roof, it was noted that sections of the mortar show varying levels of deterioration.

Mortar generally deteriorates as a result of frequent exposure to weather conditions over a prolonged period of time. Mortar that is deteriorating may allow water ingress into the roof void, putting associated building elements and roofing structures at risk of water damage. Deteriorated mortar also detracts from the functionality of roof tiles and other roofing elements, potentially decreasing weather tightness and roof drainage.

Mortar deterioration can be attended to by a handyperson where areas of deterioration are localised and easily accessible. Otherwise, consultation with a roofing contractor is advised where greater works are required.

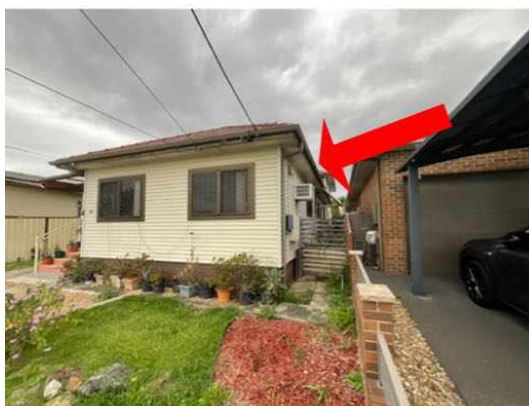
### Finding 3.07

Building:	Main Building
Location:	Roof Exterior
Finding:	Gutters - Blocked
Information:	Roof plumbing structures, such as guttering and downpipes, should be free of all debris to prevent blockages. Blockages of the guttering and downpipes will lead to pooling and accumulated water overflows, which is likely to subsequently flood eaves and exterior walls.

Blocked gutters are likely to lead to high levels of moisture in the affected areas. Such moisture will not only cause rust and decay of the associated building materials, but can also provide conditions that are conducive to termite and timber pest activity. Blockages in gutters should therefore be removed immediately to ensure dry conditions are maintained.

Consult a Licensed Plumber for further specific advice on remedial works that may be required. In the interim, it is highly advised that blocked gutters be removed by the homeowner or a general handyperson as a matter of urgency.

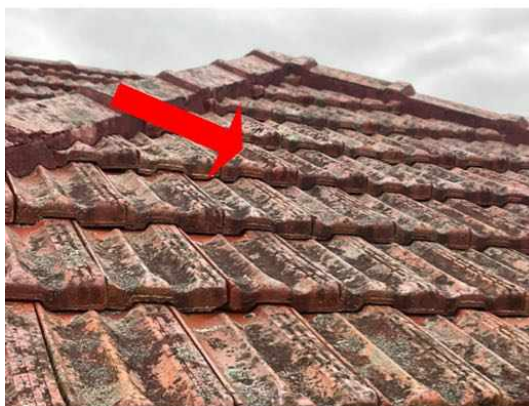
### Finding 3.08

Building:	Main Building
Location:	Roof Exterior
Finding:	Mould Growth on Roof Tiles
Information:	Green mould and organic growth are visible along the edges of the roof tiles. This indicates prolonged moisture retention on the tile surfaces, likely due to limited sunlight exposure, humidity, or debris build-up.

If left untreated, mould and moss growth can retain moisture, leading to deterioration of the roof tile surface coating, increased water absorption, and potential long-term

damage. It can also contribute to blocked roof drainage systems and cause leaks.

It is recommended that the roof be professionally cleaned to remove mould and moss build-up. Preventative maintenance such as installing zinc or copper strips, ensuring adequate roof drainage, and applying an appropriate roof sealant/coating should be considered. Regular inspection and cleaning are advised to maintain the durability of the roof system.

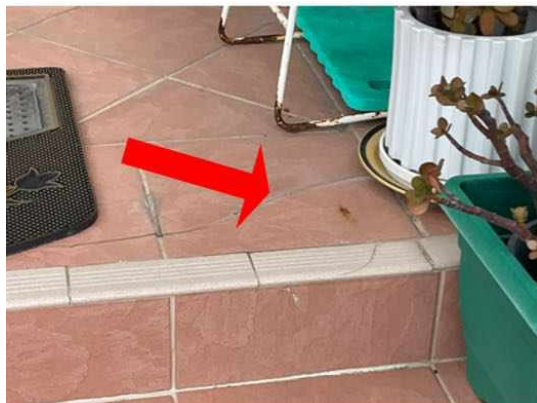
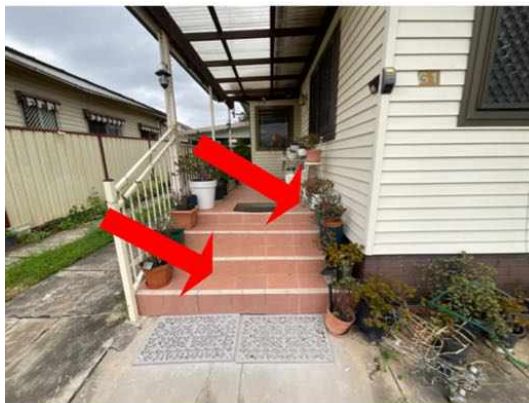
### Finding 3.09

Building:	Main Building
Location:	Porch
Finding:	Cracked floor tiles
Information:	Cracking in the floor tiles was evident in this area at the time of inspection. It is suspected that this cracking has occurred as a result of minor settlement or shrinkage of the slab.

Cracked tiles throughout the household detract from the overall appearance of the affected areas however it is unlikely to create or lead to any secondary defects.

While not considered a matter of urgency, replacement of cracked floor tiles is recommended at the clients discretion. A tiling contractor may be appointed to perform these works. Where cracks become more numerous, contact a licensed building inspector for further investigation.

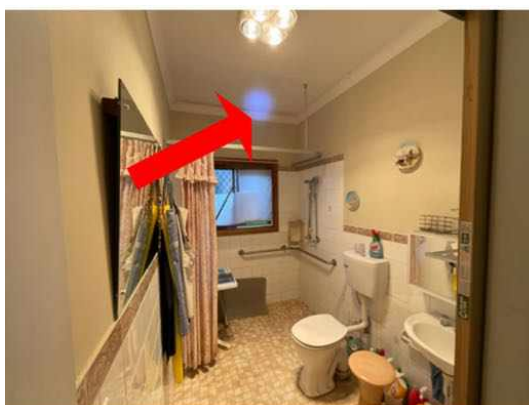
### Finding 3.10

Building:	Main Building
Location:	Bathroom
Finding:	Cornices - Sagging
Information:	Sagging and uneven cornices generally indicate that the building materials have swollen, due to contact with water, or the movement of the ceiling joints or that fixings (e.g. nails or glue) have become loose and require reattachment. In some cases, sagging and uneven surfaces may also indicate that there are structural issues causing surfaces to warp, twist, or sag.

Where sagging appears to be major, appointment of a structural engineer is advised to further inspect the property. Otherwise, minor works such as re-gluing of wall/ceiling sheets may be required and should be performed by an aptly qualified plasterer or carpenter.

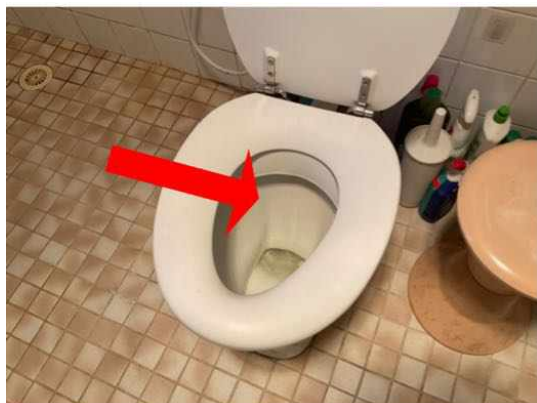
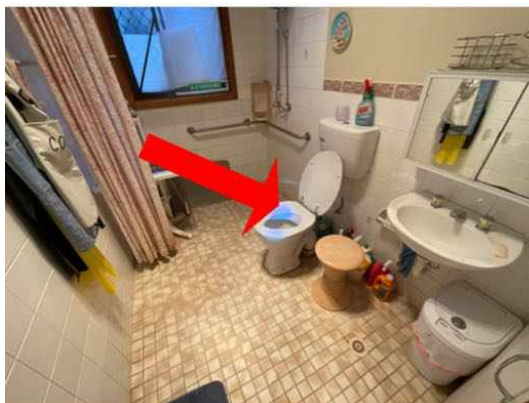
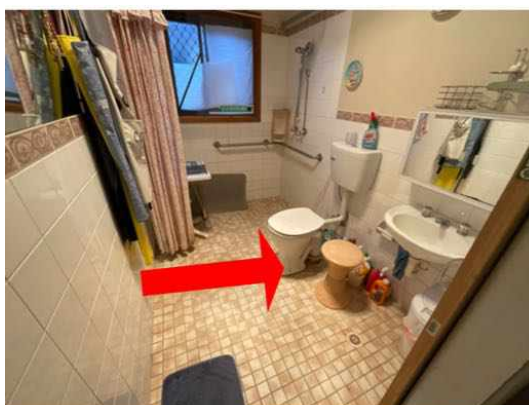
### Finding 3.11

Building:	Main Building
Location:	Bathroom
Finding:	Toilet - Not functional
Information:	The toilet did not functional properly at the time of inspection.

Non-operational building elements such as this are vital to the function of the household and must be fixed.

A qualified plumber should be appointed immediately to repair the toilet and return it to an operational state.

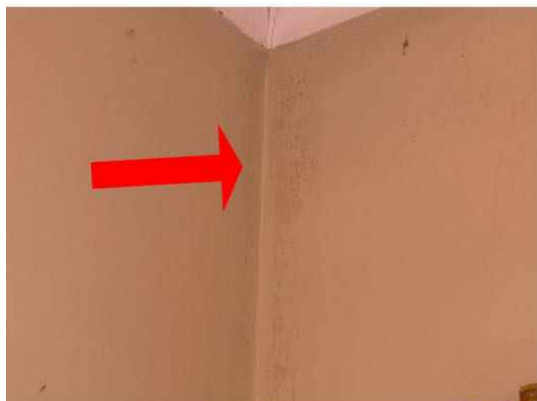
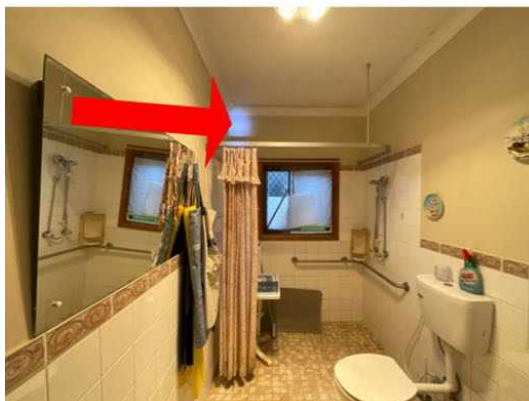
### Finding 3.12

Building:	Main Building
Location:	Bathroom
Finding:	Bathroom Wall / Ceiling - Mould Growth
Information:	Minor mould growth was observed to the bathroom ceiling along the joint line. This is likely due to condensation and elevated moisture levels within the bathroom environment.

While the mould appears localised and minor at the time of inspection, prolonged moisture exposure may lead to further deterioration of paint finishes and potential substrate damage.

- Clean and treat affected areas with an appropriate mould removal solution.

- Repaint with mould-resistant paint if required.
- Improve ventilation (ensure exhaust fan is operational and ducted externally).
- Monitor for recurrence.

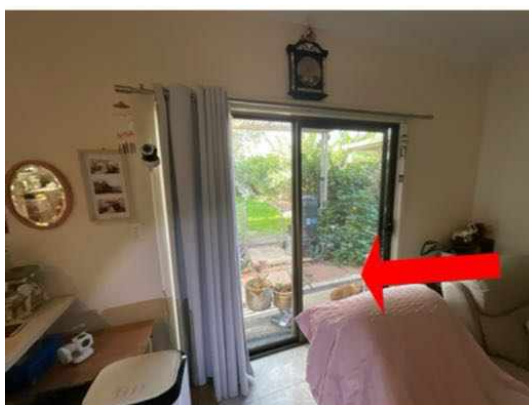
### Finding 3.13

Building: Main Building  
 Location: Living Room  
 Finding: Sliding Door - Stiff to slide  
 Information: The door in this area was jammed and difficult to slide along the associated tracks at the time of the inspection. Restricted function of the affected door may pose as a potential safety hazard if required for emergency egress from the building.

Generally, factors such as general age of the building element and a lack of maintenance are the usual causes for this type of defect.

Replacement of door hardware or tracks may be required, as well as minor repairs and cleaning. A registered builder or general handy person will be required to repair the affected doors.

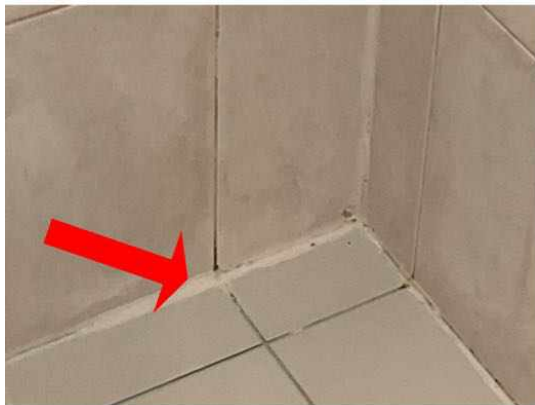
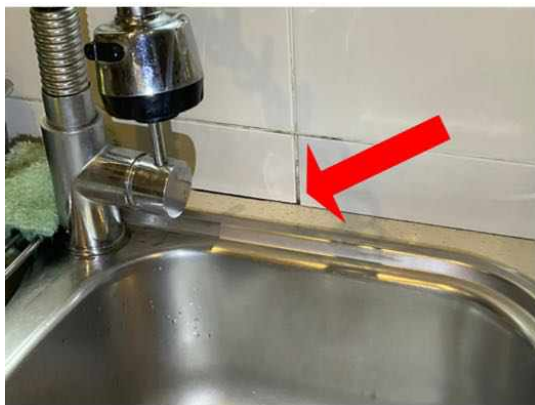
### Finding 3.14

Building: Main Building  
Location: Bathroom / Kitchen  
Finding: Sealant and grouting - Missing or damaged  
Information: It was noted on inspection that sealant or grout is degraded to the tiled shower alcove and or other areas of the bathroom.

Different materials and floor areas move at different rates, generally causing cracking to grout or sealant at this point. A flexible sealant is required to allow for expected expansion and contraction, while keeping the joint water tight and protective of all associated building materials.

There appears to be excessive mould to the sealant and grout which will likely require scraping out and replacement.

Flexible and mould resistant materials should be applied to affected areas to prevent any subsequent water damage that is likely to occur. Regular maintenance and replacement of damage or missing or damaged sealant and grout is highly recommended to the wet areas, as this is a regular wear and tear defect. Sealant and grouting in areas that come into regular contact with water should be maintained for the long term care of your property.

A sealant specialist or tiling contractor should be appointed to complete these works as soon as possible

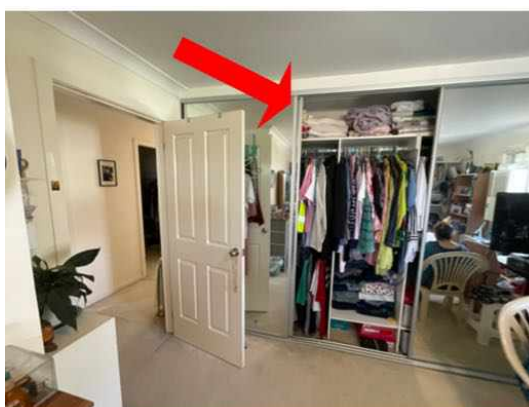
Building:	Main Building
Location:	Bedroom > Upstairs
Finding:	Misaligned Sliding Door – Wardrobe
Information:	The sliding door to the wardrobe was found to be misaligned. The door panels are not sitting level within the tracks and do not close flush, resulting in poor operation and uneven appearance.

The builder/tradesperson is to realign the sliding door panels by adjusting the rollers and track guides to ensure smooth operation and flush closure in accordance with manufacturer's installation requirements.

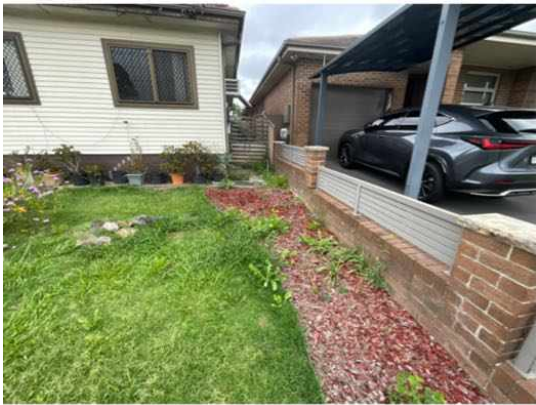
#### Finding 6.01

Building:	Main Building
Location:	All Areas
Finding:	Garden Beds - Conditions Conducive to Termites
Information:	Garden beds were found to be evident in the garden area. These garden beds can include untreated timber, and with a combination of moisture from watering hosing can make conditions conducive to termite activity and termite ingress.

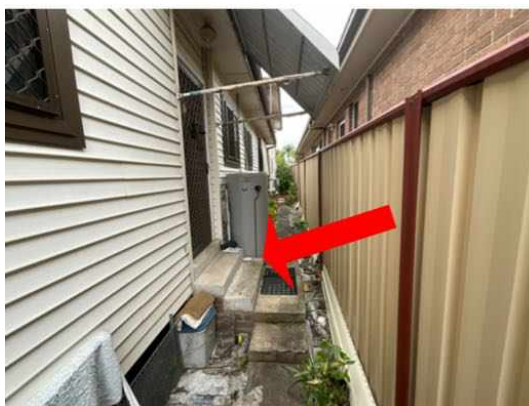
### Finding 6.04

Building:	Main Building
Location:	All Areas
Finding:	Overflow - Not plumbed for drainage
Information:	The overflow is not plumbed or connected to suitable drainage, which has resulted in the surrounding area becoming excessively damp. These damp conditions can lead to secondary defects such as rot, rust or corrosion of associated building elements, the formation of fungal decay, or even the creation of potential slip hazards. When coupled with poor site drainage, pooling of water may also attract termite activity to this area. It is highly recommended that a qualified plumber be appointed to install adequate drainage to the overflow. These works will ensure that the area remains dry and free of any secondary defects.

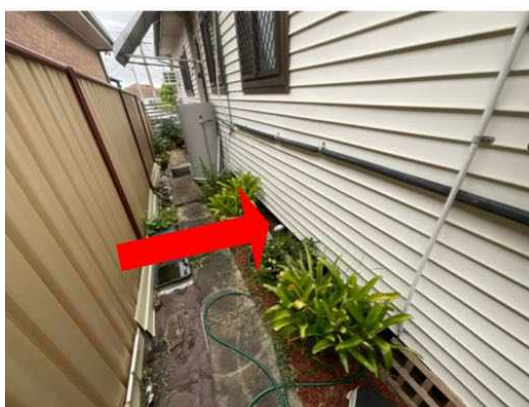
### Finding 6.05

Building:	Main Building
Location:	All Areas
Finding:	Bridging of termite barrier/inspection zones
Information:	Bridging is the spanning of a termite barrier or inspection zone so that subterranean termites are provided with passage over or around that barrier.

It is recommended that minimum 75mm clearance below the bottom of weep or ventilation holes be maintained where possible, otherwise annual inspections should be conducted by a licensed pest control company. Vegetation should also be kept clear of walls to allow regular inspection of all areas.

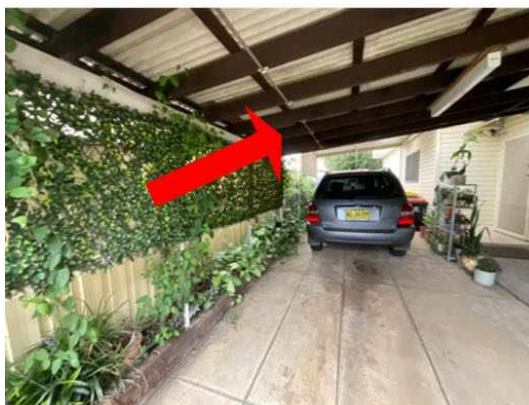
Building:	Main Building
Location:	All Areas
Finding:	Timber - exposed to weather
Information:	External timbers that are frequently exposed to harsh weather conditions require adequate protection in order to maintain their condition. Where timbers have not been painted or treated adequately, general deterioration is likely to occur at an accelerated rate.

If left unattended, replacement of these timbers is likely to be necessary in the short-term future. Adequate treatment of these timbers is required as soon as possible by a painting contractor or general handyman.

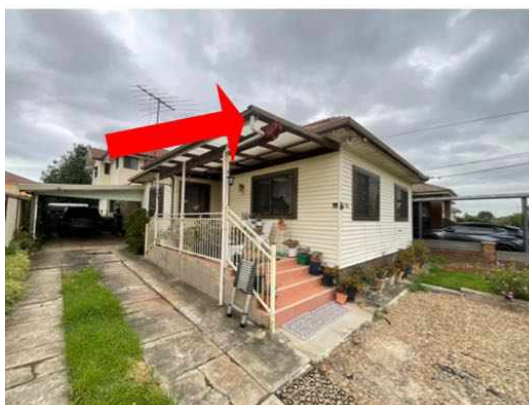
### Finding 7.01

Building:	Main Building
Location:	All Areas
Finding:	Wood rot

Information: This building element shows evidence of wood rot. Wood rot, also known as Fungal Decay, occurs when timbers and other cellulose building materials are exposed to damp conditions on an ongoing basis. This could be the result of exposure to weathering over a prolonged period of time, or the attraction of excessive moisture from other abutting building materials. Contributing factors also include poor air ventilation in the area.

Wood rot is often associated with general damp problems and is evidenced by a 'musty' smell or mould and mildew occurring on surfaces. If left unmanaged, damp conditions can lead to further health problems and the decay of timbers will continue.

Early intervention and regular maintenance, particularly of exterior timbers, will prolong the useful life of these building elements. Prior to any works being performed, the cause of the moisture that has created the visible wood rot should be identified and addressed in a suitable manner. Replacement of affected timbers may then be a necessary step in protecting surrounding building elements from such deterioration.

A qualified plumber may be appointed to assess the cause of excessive moisture and to provide advice on any remedial works as required. A qualified carpenter or registered builder may also be required to replace affected building materials.

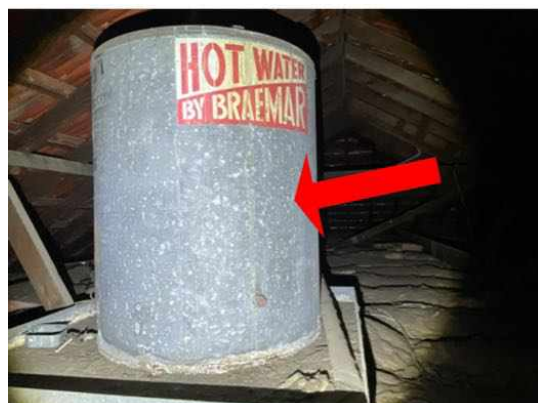
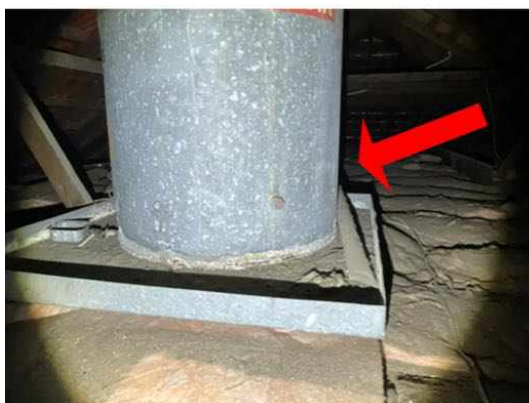
Building:	Main Building
Location:	Roof Void
Finding:	Gravity-Fed HWS - Disconnected
Information:	It was noted at the time of inspection that a disconnected gravity-fed hot water system (HWS) remains in this area.

Despite this plumbing structure being unused, it is likely to be storing residual water, and is therefore susceptible to rust and corrosion. If allowed to continue, rust and corrosion is likely to lead to damage to adjoining building elements, and may also make the area susceptible to termite or timber pest activity.

While it is a costly exercise to remove the disused gravity-fed HWS, it is advisable in the short-term future to prevent any further damage to the area. Further consultation with a licensed plumber is required to gain further advice on removal of the structure.

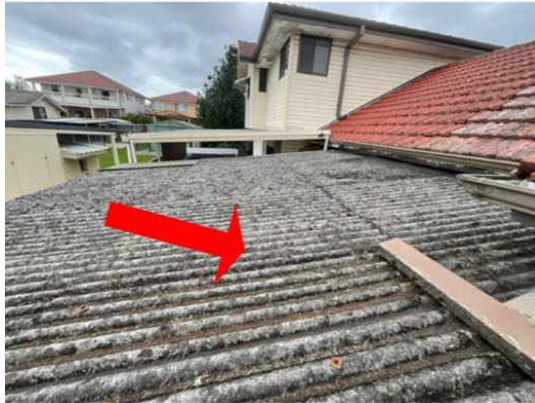
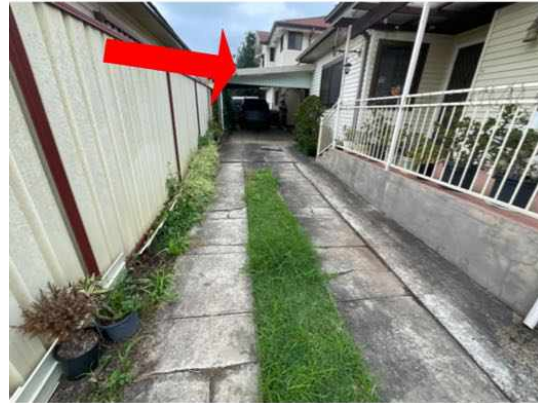
Building:	Main Building
Location:	All Areas
Finding:	Asbestos - Suspected ACM Identified on Site
Information:	Reporting on Asbestos is outside the Scope of this Report. This suspected defect is highlighted as a caution only. We suspect, based on our experience in the building industry, that there is a higher risk of the identified building element containing asbestos.

As Asbestos Reporting is outside the scope of this report, we advise that you consider a separate Asbestos Inspection and Condition Audit, which can include the taking of samples for definitive confirmation of the presence of Asbestos.

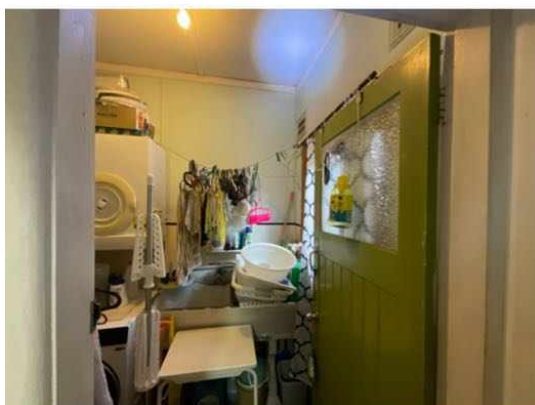
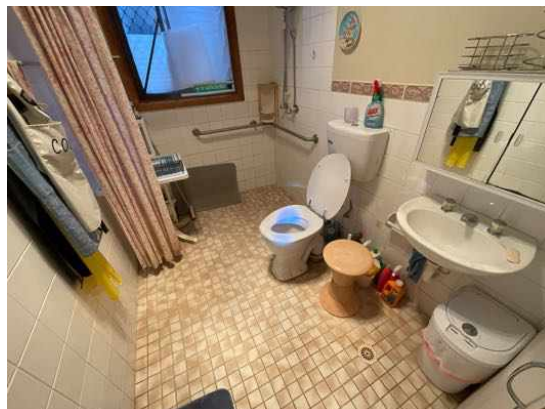
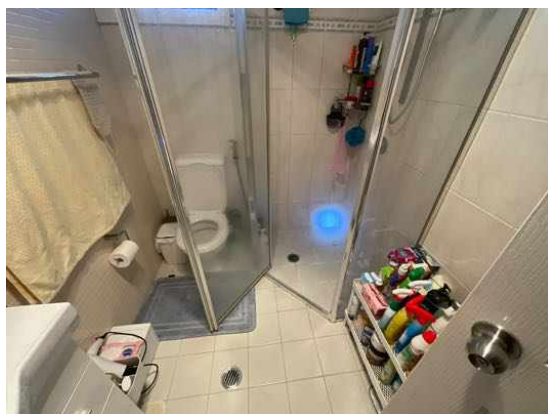
Building:	Main Building
Location:	All Areas
Finding:	Water Proofing Membranes - Information Only
Information:	Internal Water Proofing Membranes, are crucial in preventing water ingress into the property is important to know that the Membrane System used is to Australian Standards and has been installed correctly. Please refer to the original Building Documents or Maintenance Schedule for the relevant information including; - Membrane used and Manufacturers Specifications. - The Installer and Installation Certification. Especially with older property's where this information is unavailable, all wet areas should be monitored. Generally new waterproofing with a certificate may only have a guarantee of 8yrs. If any leaks, water staining, peeling or bubbling of the paint become evident to any adjacent walls or ceilings below a licensed builder or waterproofing specialist is recommended to investigate further.

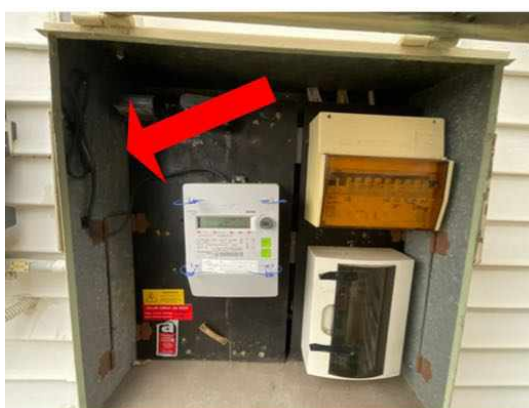
Building: Main Building  
 Location: All Areas  
 Finding: Termite Management System - no evidence of a chemical installation  
 Information: The application of a post-construction chemical termite barrier is highly recommended for all properties, particularly if live termite activity has been found on the site previously. Such barriers are highly effective in preventing termite attack on any timber building elements throughout the property.

A durable notice should be placed in the switchboard unit to indicate current termite barriers. At the time of inspection, it appeared as though no termite management system has been installed, with no evidence to suggest preventative works taking place.

The client may consider gaining further advice from a pest controller as to the costs and procedures involved with this application. It is recommended that obtaining such advice be a short-term priority.
