# Building and Timber Pest Inspection Report

Inspection Date: Fri, 13 Mar 2026

Property Address: 61 Waruda St, Yagoona NSW 2199,  
Australia

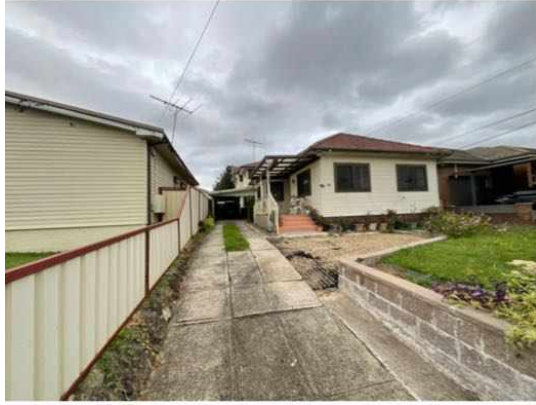
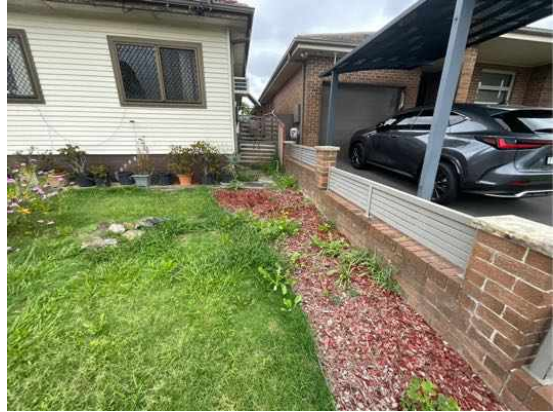
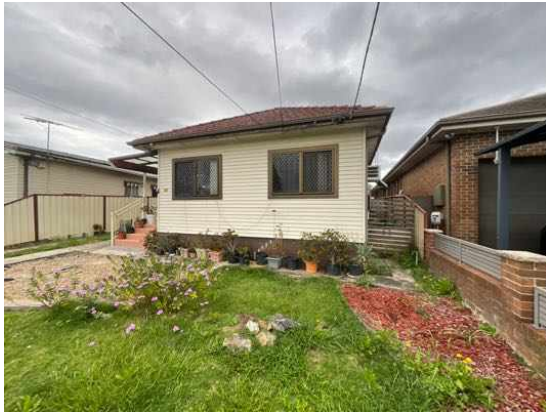
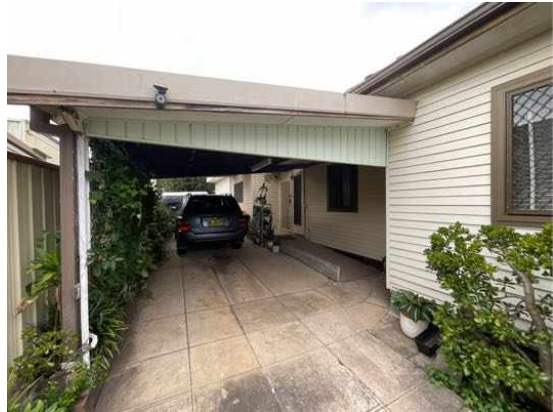
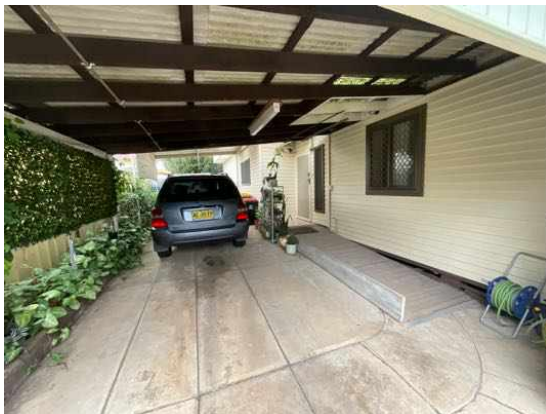
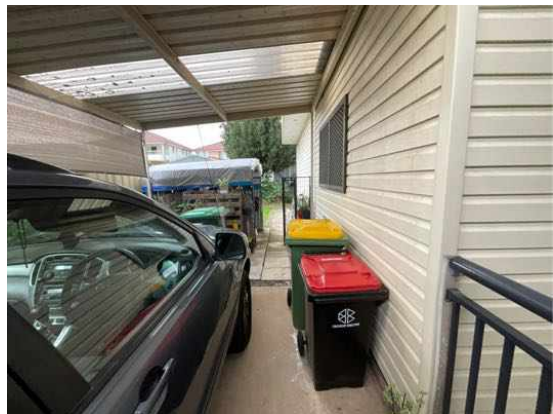
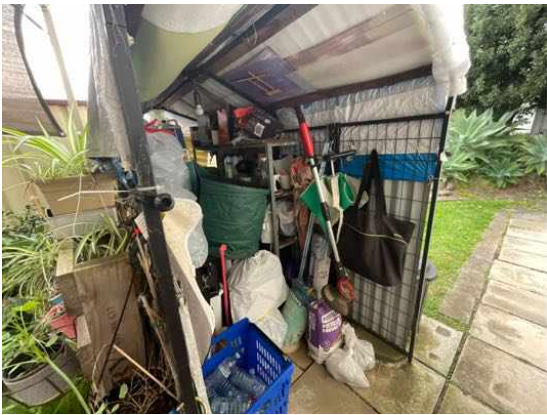
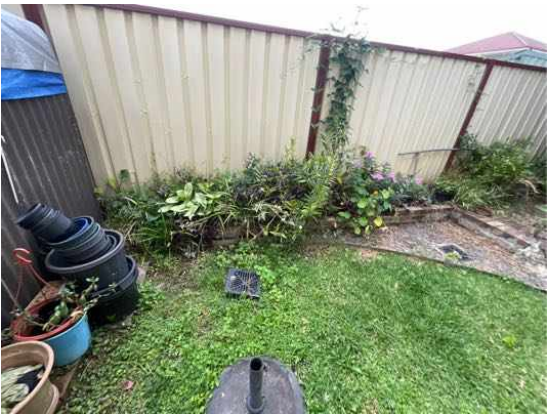
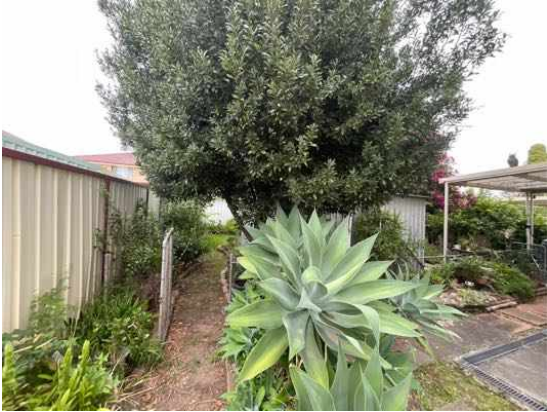
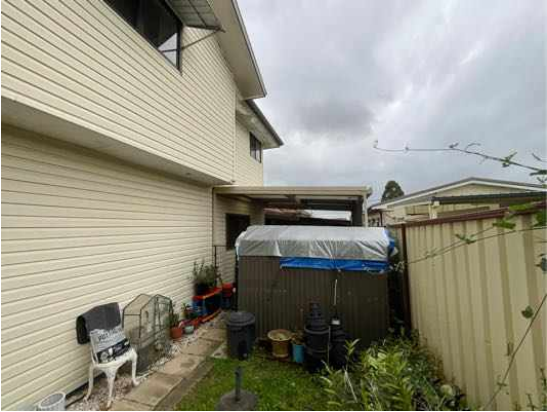
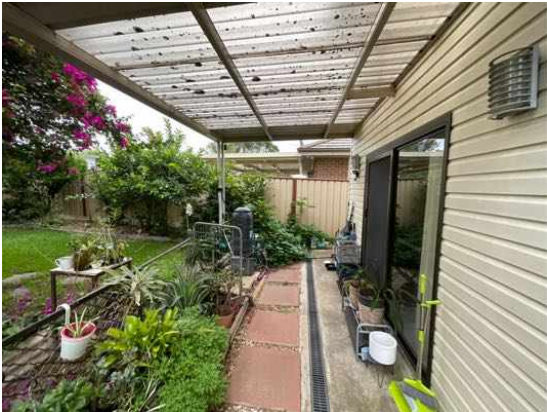
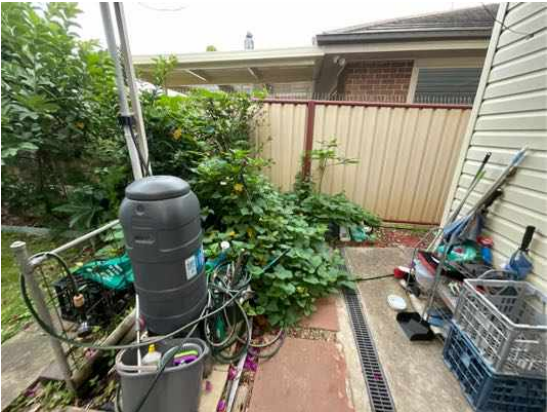
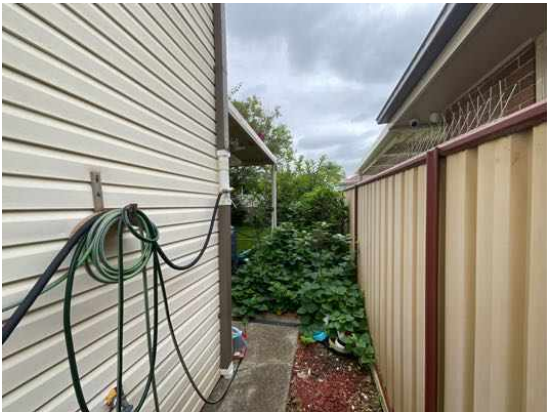
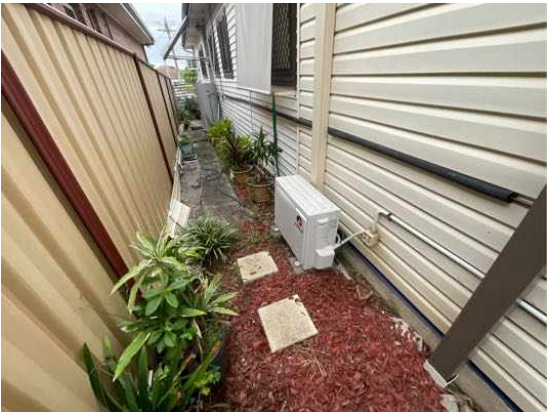
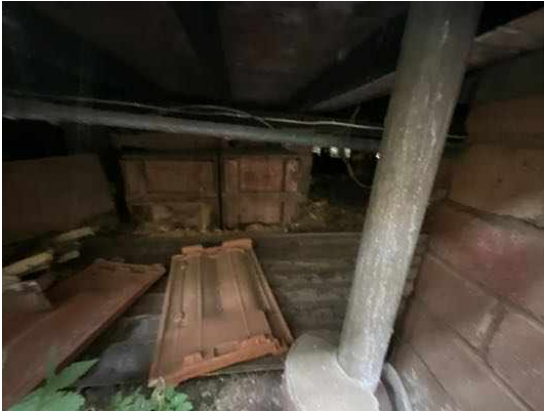
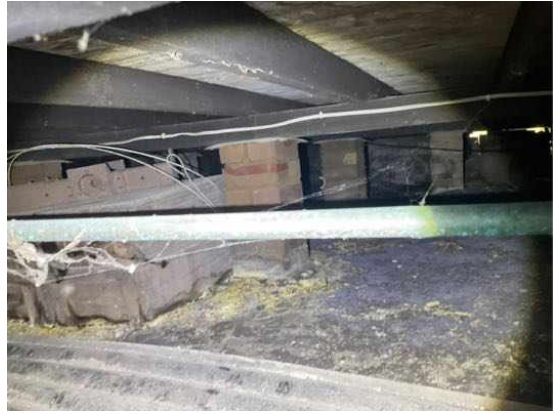
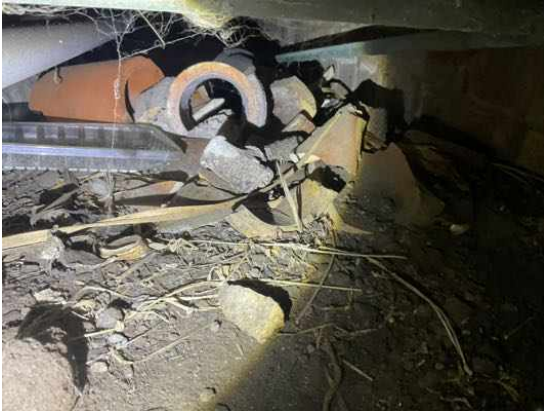
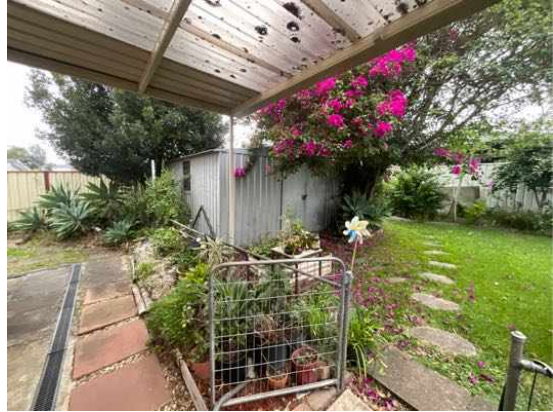
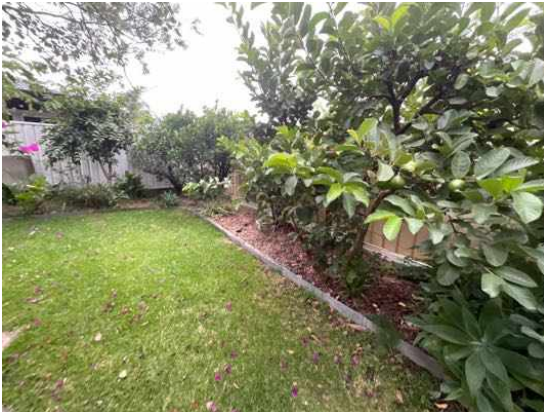
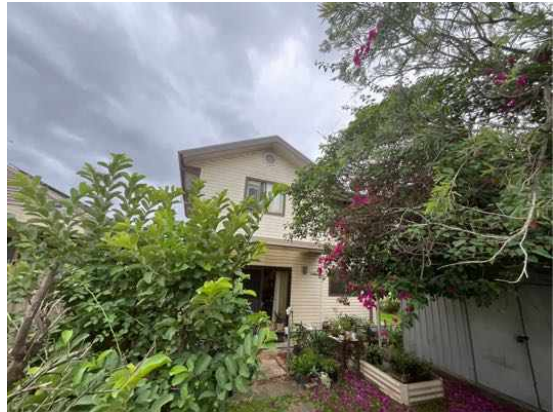
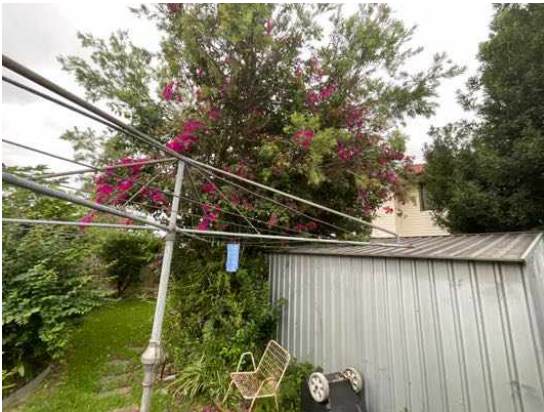
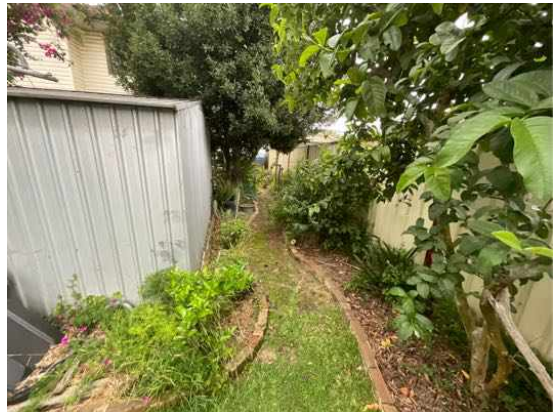
Finding: Additional Photos - Obstructions and Limitations

Information: These photographs are an indication of the obstructions and limitations which impeded full inspection of the property at the time of inspection. These obstructions can hide an array of defects and should be removed to allow full inspection to be carried out. A re-inspection is recommended once the areas are made accessible.
