Building Inspection Report

Inspection Date: Mon, 23 Feb 2026

Property Address: 8 McFarlane Ct, Highett VIC 3190, Australia

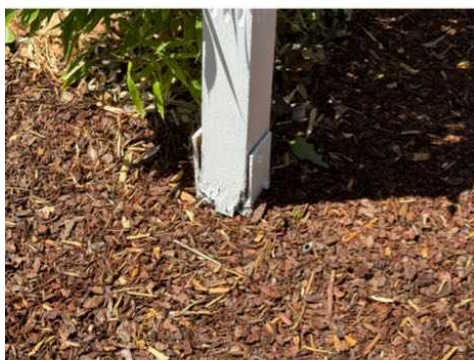
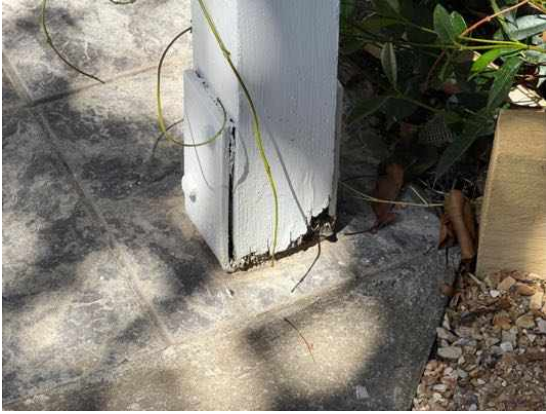
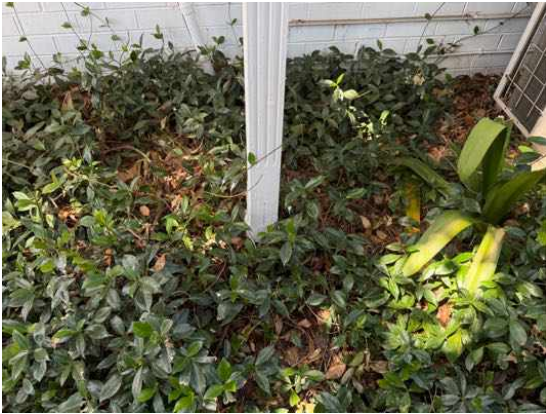
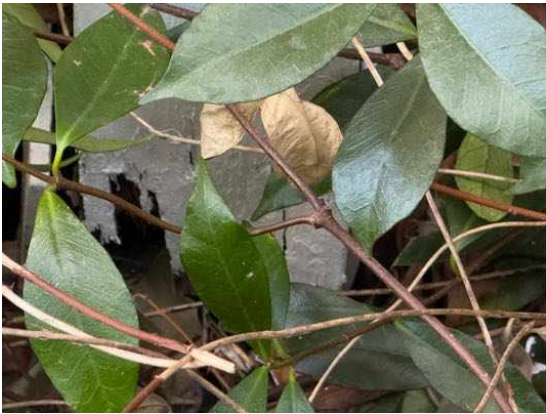
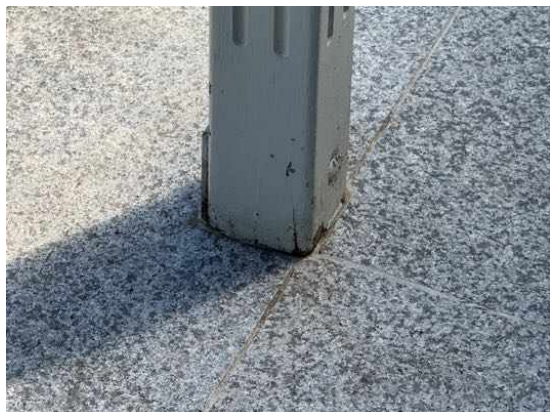
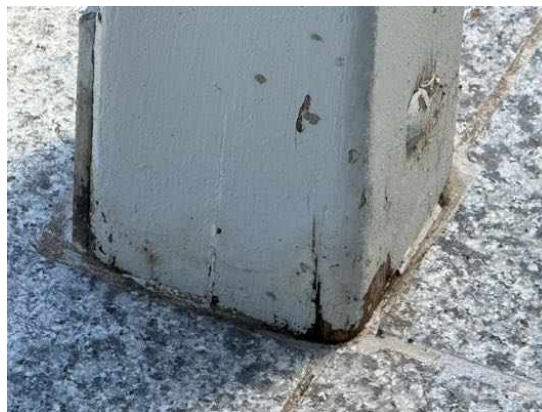
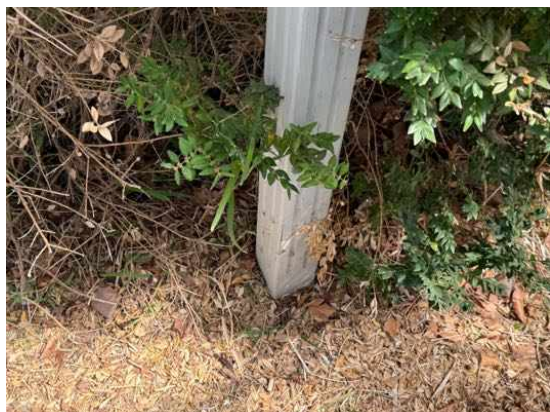
Defects 3.01

Building: Building 1
Location: All Areas > All Areas
Finding: Timber in the ground and exposed to excessive weather conditions
Information: External timbers in the ground and are frequently exposed to harsh and extreme weather conditions, will require adequate protection and maintenance in order to maintain their condition. Other timbers are exposed to moisture from ground contact which exposes these areas to accelerated wood rot and decay, damage and deterioration. Where timbers have not been painted properly or treated adequately, general deterioration is likely to occur at an accelerated rate.

If left unattended, replacement of these timbers is likely to be necessary in the future. Adequate treatment of these timbers is required to ensure excessive weathering does not occur, painting of these areas may be carried out by the client or by a painting contractor or general handyman.

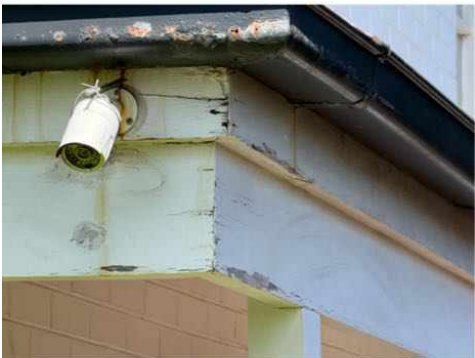
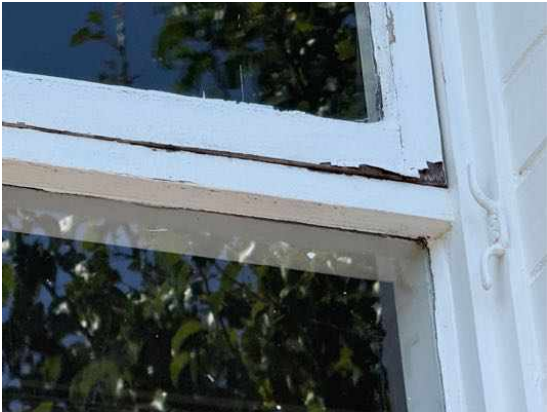
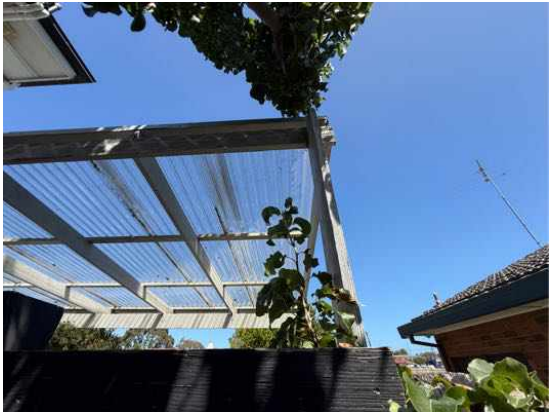
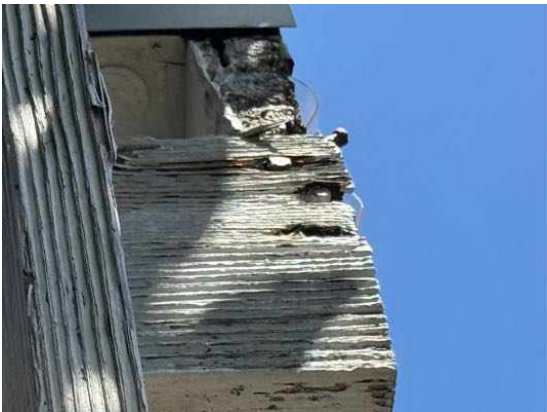
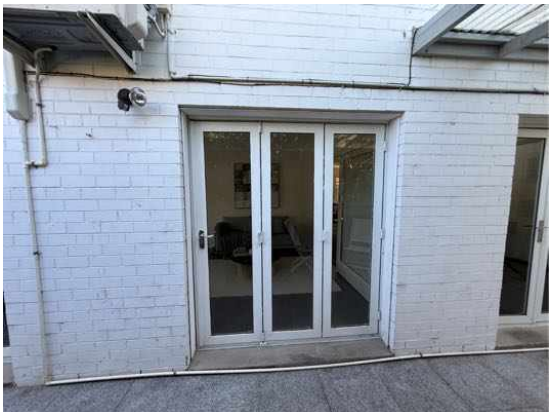
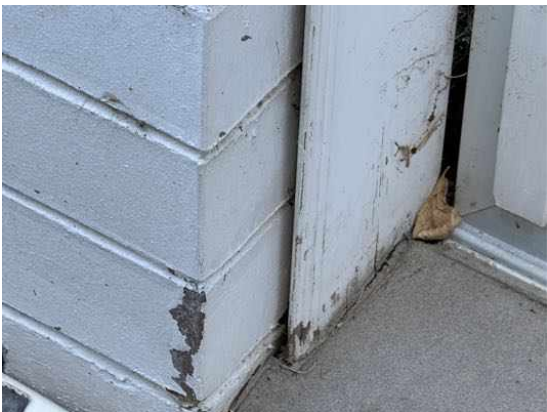
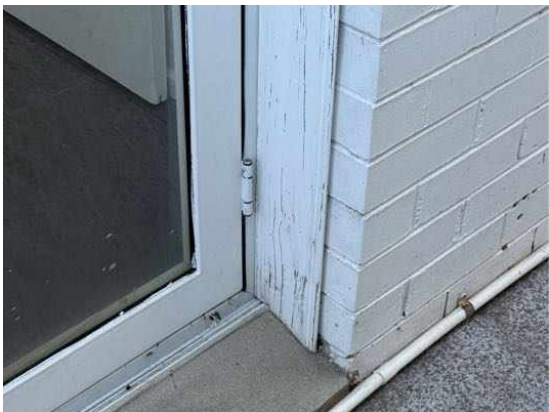
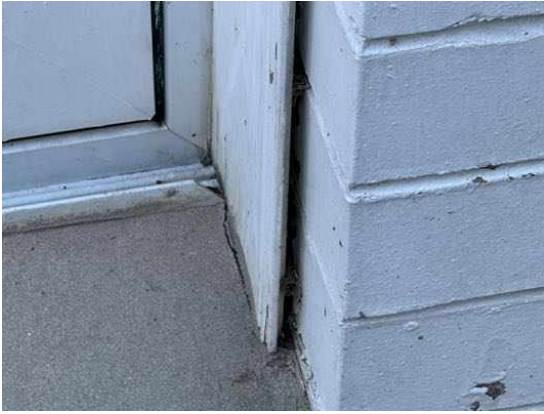
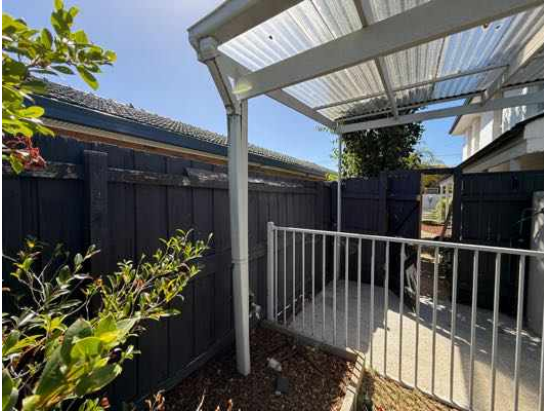
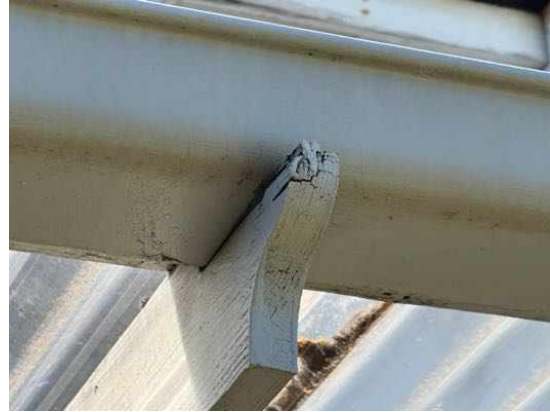
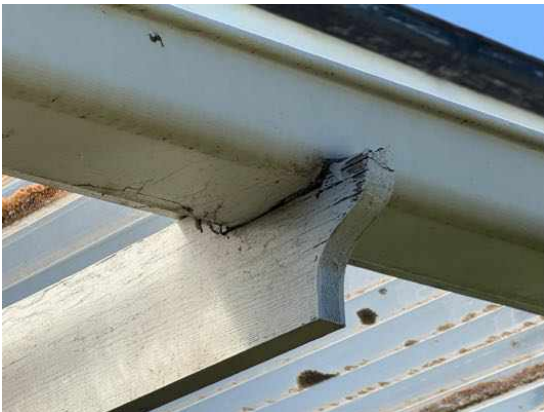
Defects 3.02

Building:	Building 1
Location:	All Areas > All Areas
Finding:	Timber - exposed to excessive weather conditions
Information:	External timbers that are frequently exposed to harsh and extreme weather conditions and will require adequate protection and maintenance in order to maintain their condition. Other timbers are exposed to moisture from ground contact which exposes these areas to accelerated damage and deterioration. Where timbers have not been painted properly or treated adequately, general deterioration is likely to occur at an accelerated rate.

If left unattended, replacement of these timbers is likely to be necessary in the short-term future. Adequate treatment of these timbers is required as soon as possible by a painting contractor, home owner or general handyman.

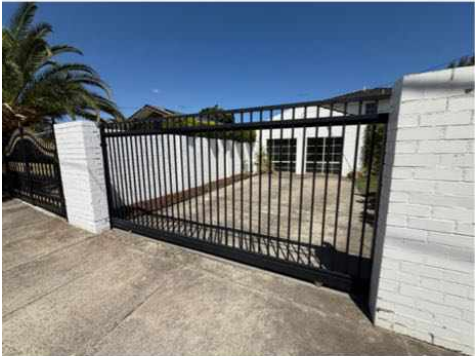
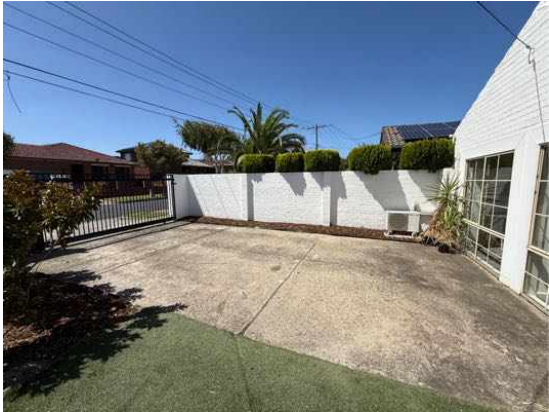
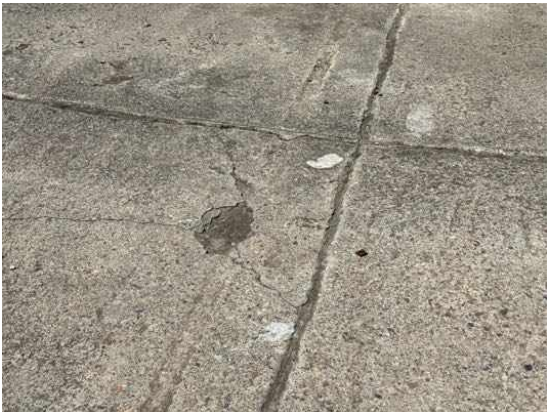
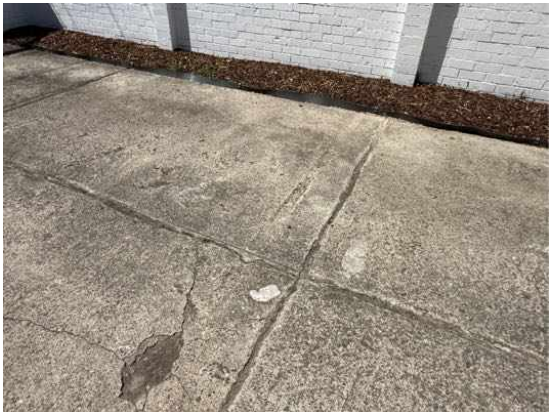
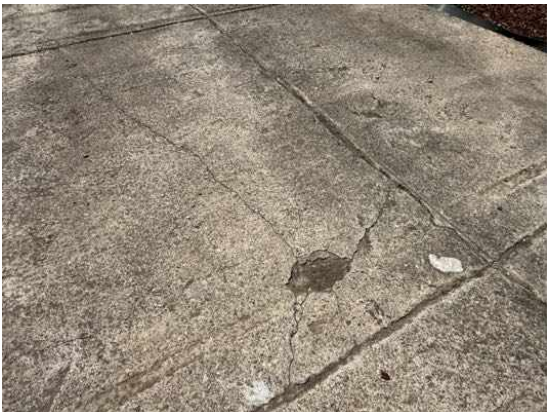
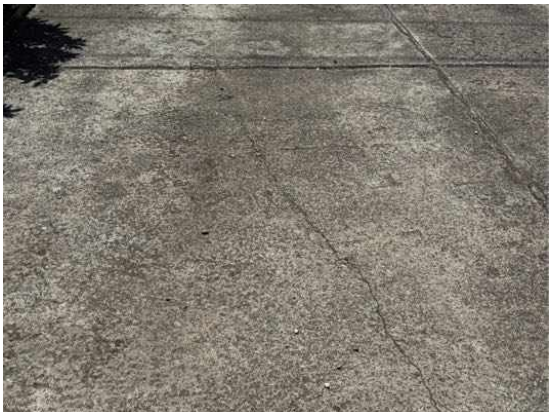
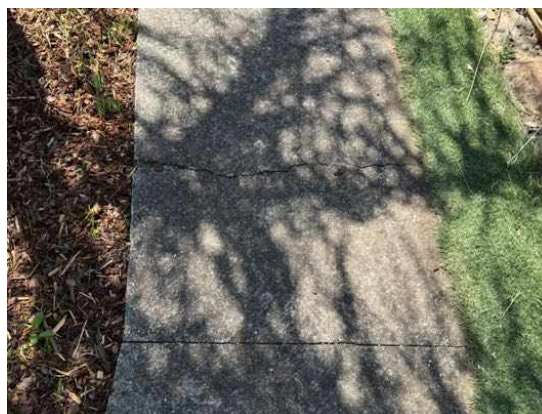
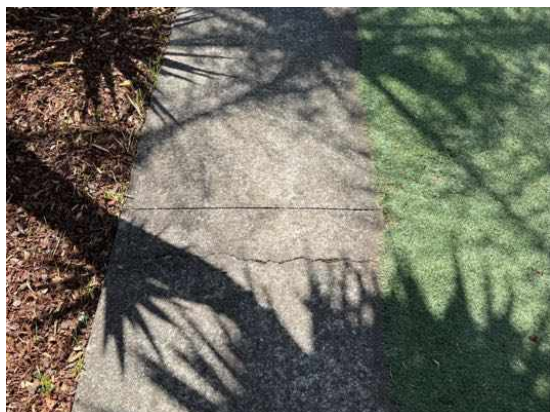
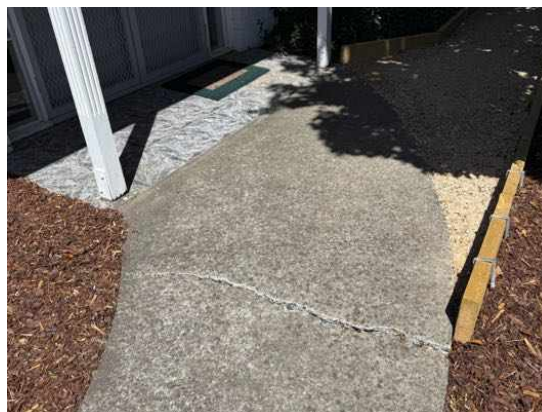
Defects 3.03

Building:	Building 1
Location:	All Areas > All Areas
Finding:	Concrete driveway cracks
Information:	Numerous cracks on the driveway were observed at the time of the inspection. Also the rear pergola concrete showed concrete cracked and lifted, this area is considered to be a tripping hazard for occupants, especially young children and elderly. This area should be removed and re-instated to improve the overall appearance and aesthetics of the area.

Concrete cracks are a common occurrence as a result of many primary defects. Such causes may include age, general wear and tear, expected building movement, general

expansion/contraction of building materials in different weather conditions, and/or minor failings in the installation or application of building materials. Monitoring of all cracking should be conducted periodically. Contact a relevant tradespersons, especially where cracks have become trip hazards for occupants.

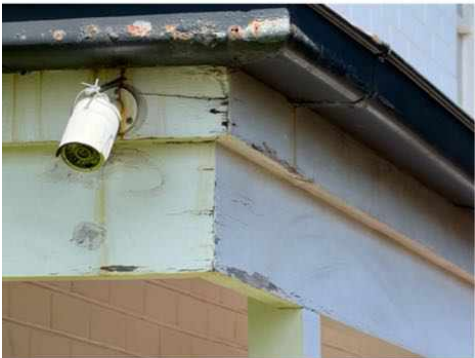
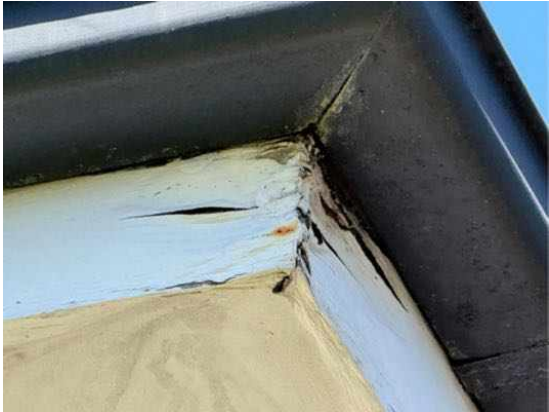
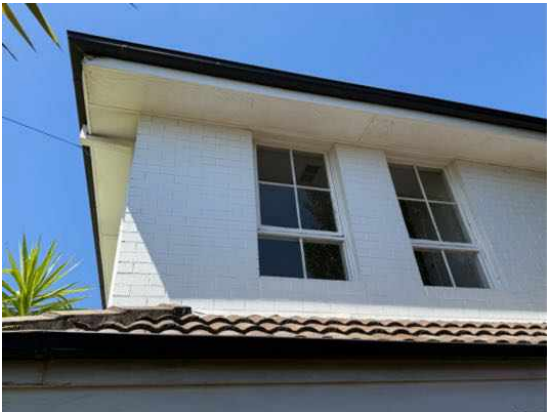
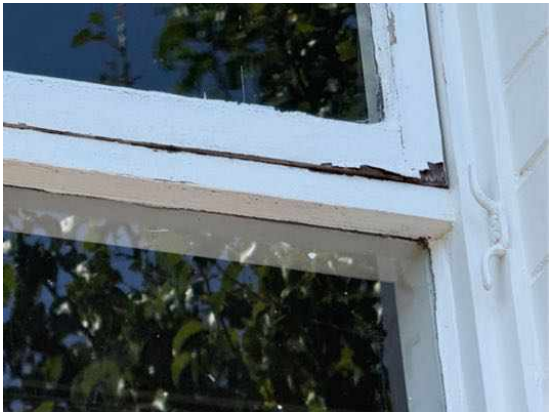
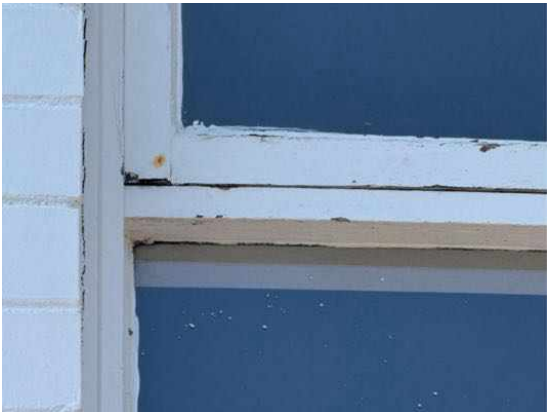
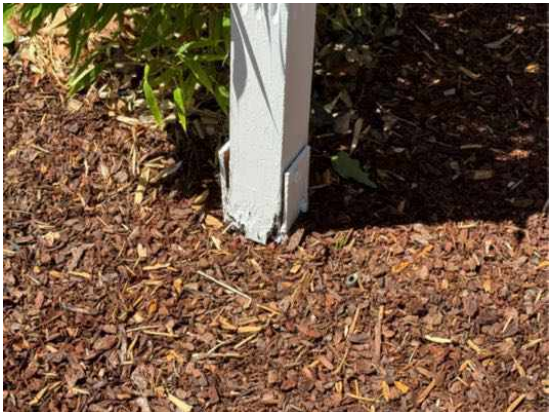
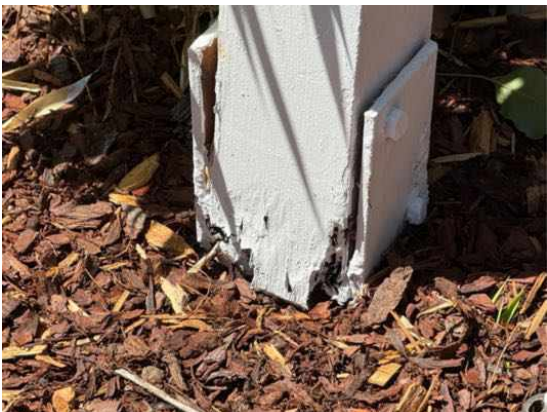
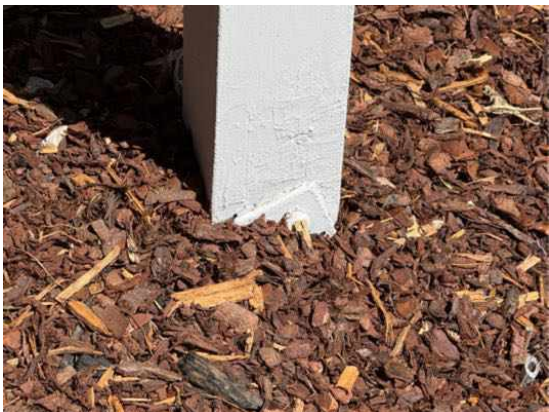
Defects 3.04

Building:	Building 1
Location:	All Areas > All Areas
Finding:	Wood rot
Information:	Wood rot was found to be affecting some fascias and numerous other building elements and materials around the exterior and interior areas of the home. Wood rot, also known as Fungal Decay, occurs when timbers and other cellulose building materials are exposed to damp conditions on an ongoing basis.

The roof plumbing in these areas may be creating excessive moisture in this areas and or it may be due to frequent exposure to rain and other weather conditions also make fascias and other numerous building elements susceptible to accelerated deterioration. Early intervention and regular maintenance such as painting will prolong the useful life of these building elements. Prior to any works being performed, the cause of the moisture that has created the visible wood rot should be identified and addressed in a suitable manner.

It is advised that the relevant tradespersons be appointed to inspect and subsequently identify the cause of the numerous areas of wood rot. Replacement of affected building elements and materials may then be a necessary step in protecting surrounding areas from secondary damage and deterioration. A qualified plumber and other specialists may be appointed to assess the cause of excessive moisture and to provide advice on any remedial works as required. A qualified carpenter or registered

builder may also be required to replace affected building materials.

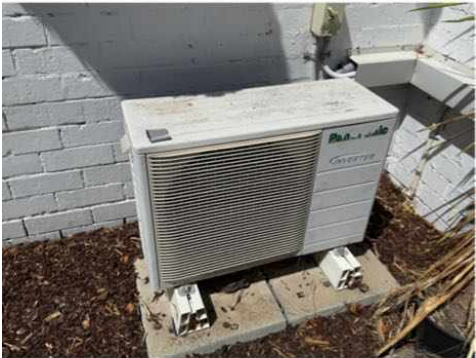
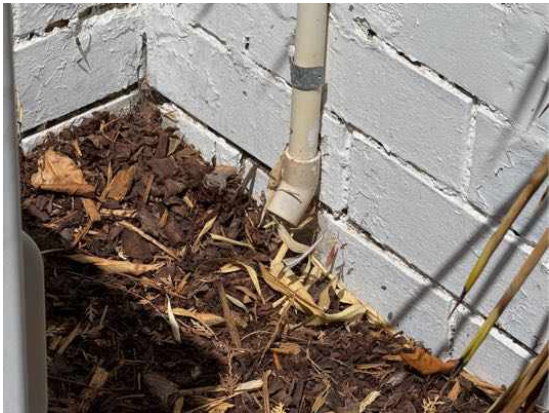
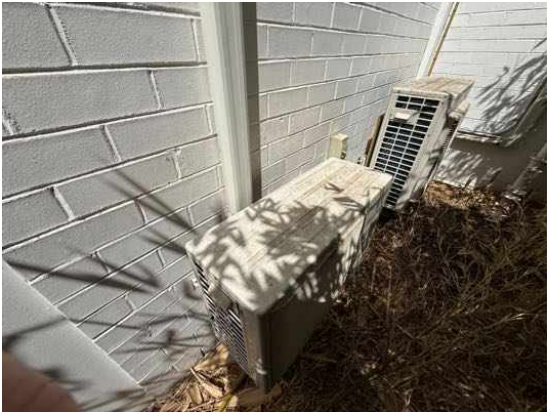
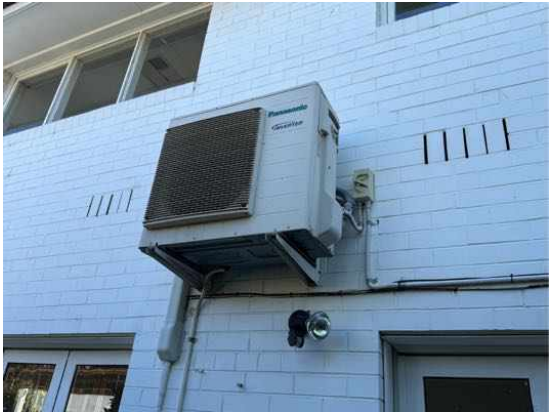
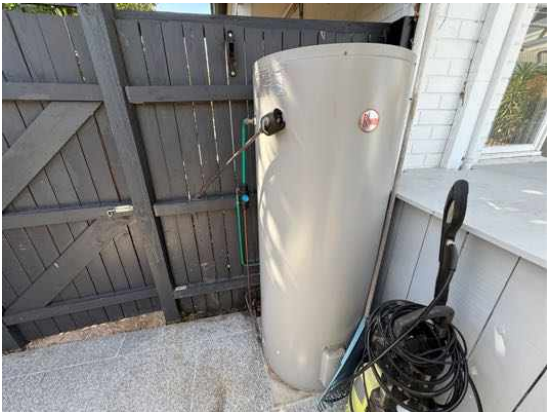
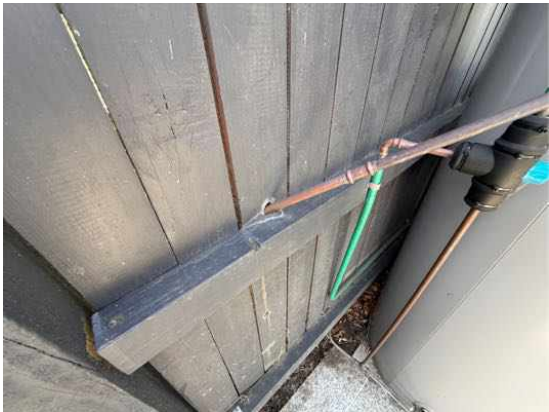
Defects 3.05

Building: Building 1
Location: All Areas > All Areas
Finding: HWS and air-conditioning overflows not connected
Information: The Hot Water System (HWS) and external air-conditioning units showed that the overflow pipes not to be connected to any form of storm water drainage system and may in the future create excessive moisture in the surrounding area, as these units as they get aged, deteriorated and particularly during their use. These damp conditions can lead to secondary defects such as rot, rust or corrosion of associated and adjoining building elements, as well as the formation of fungal decay and even the creation of potential slip hazards for occupants. When coupled with poor site

drainage, pooling of water may also attract termite activity to these areas. It is highly recommended that a licensed plumber be appointed to connect the HWS and air-conditioning overflows in order to prevent such an environment from being created. These remedial works should be carried out as soon as possible.

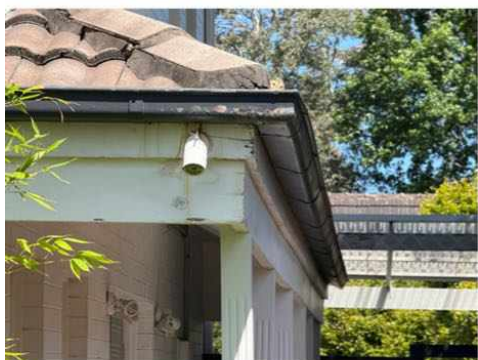
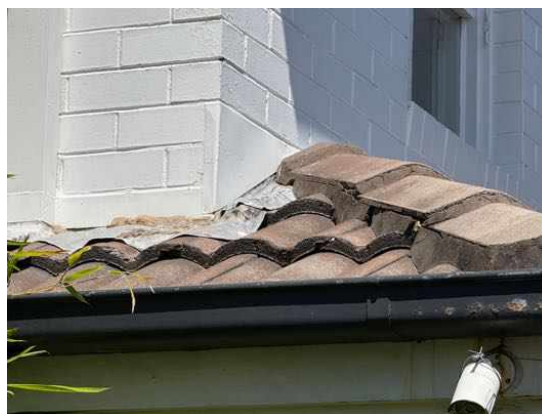
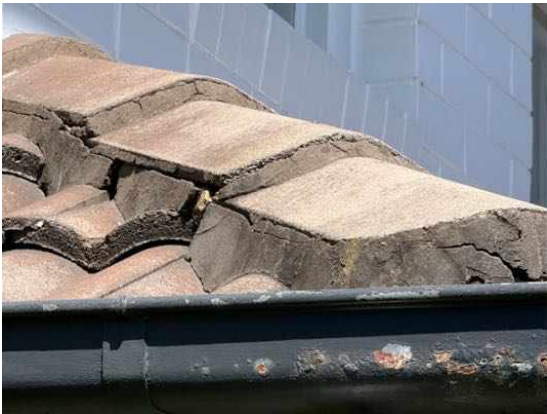
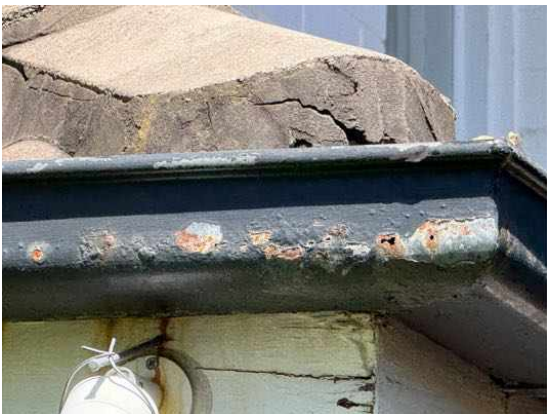
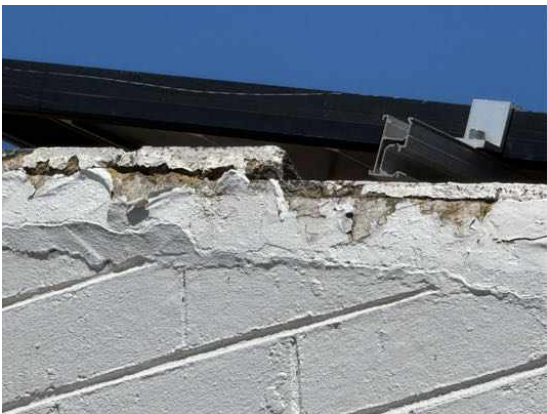
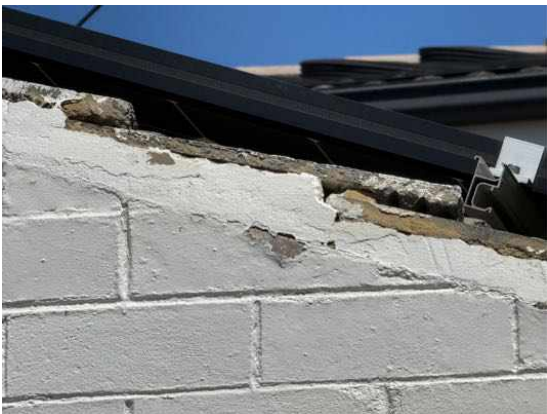
Defects 3.06

Building:	Building 1
Location:	All Areas > All Areas
Finding:	Roof tiles - Weathered
Information:	Upon inspection of the exterior roofing, the majority of roof tiles were considered to be aged and in a weathered and deteriorated condition. Also some roof tiles were observed to be chipped or dislodged and not in their original positions. The roof tiles due to the weathering are suspected to becoming porous and becoming wet and moist on the underside of the roof tiles during outside wet conditions and therefore the possibility of secondary defects in the future. While weathering of the tiles is consistent with the age of the property, maintenance works are and will be required in the future to maintain a weather and waterproof roof.

Isolated areas of mortar are coming loose on the ridge and hip areas, minor chipping to numerous tiles is also present. Re-pointing and re-sealing the may be considered as an interim solution by the client to help preserve and extend the life span of the tiles. Where left unmanaged, deteriorating roof tiles are likely to lead to a number of secondary defects, including minor water leaks and weather exposure to internal roofing structures. Consultation with a roofing contractor is highly recommended to gain advice on cost of remedial works that may be required in the short to medium term. Remedial works are likely to increase the longevity of the exterior roofing structure.

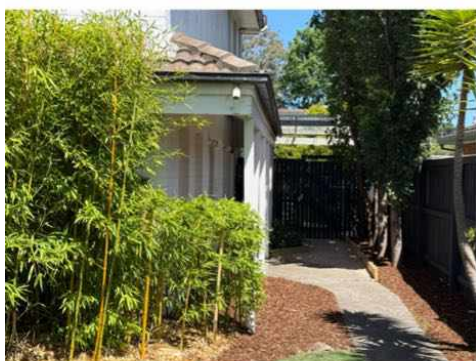
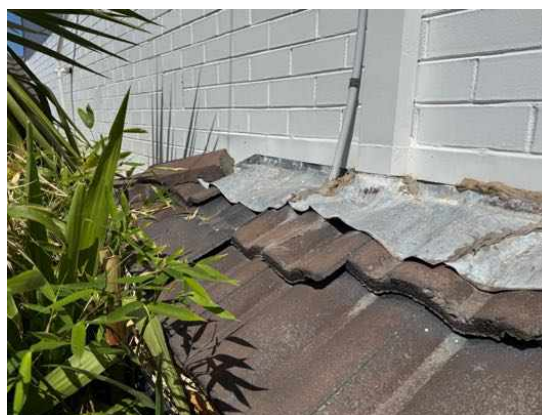
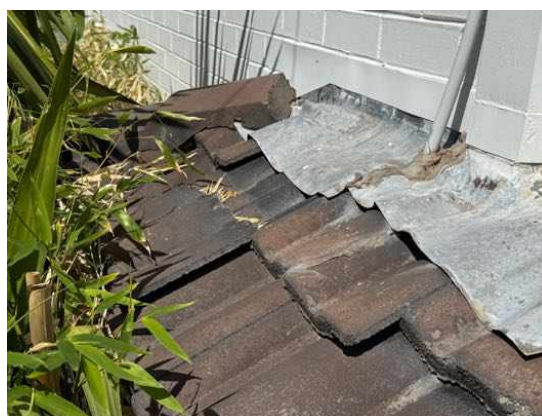
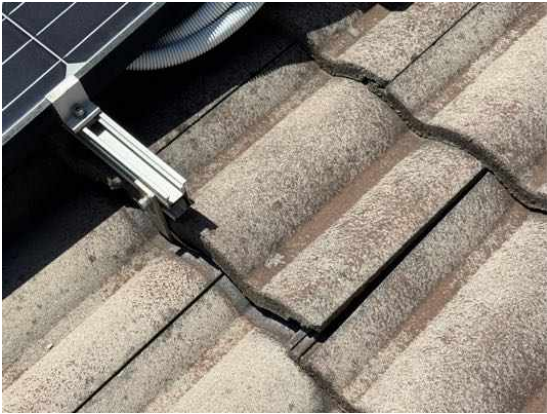
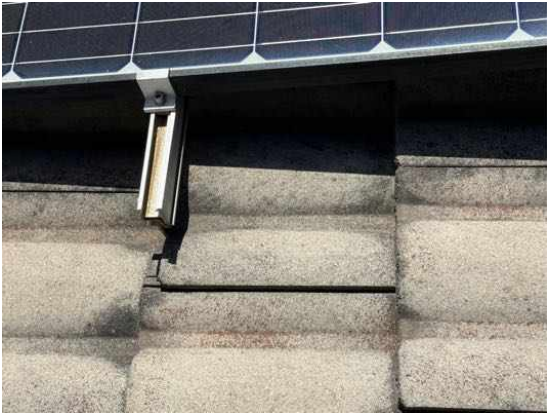
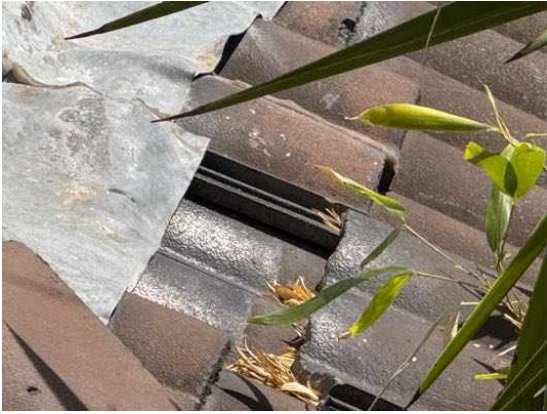
Defects 3.07

Building: Building 1
Location: All Areas > All Areas
Finding: Roof tiles - Dislodge or slippage
Information: Upon inspection of the roof tiles, it was observed that a couple of roof tiles have either slipped or have been dislodged from their original positions. Roof tiles may slip over time due to a number of minor causes, including not placed correctly upon installation, not stuck down on the top of valley irons, flashings, roof tile chips and breakages, failings in the adjoining battens, or fixings that may have failed.

In this case I suspect that tiles have slipped or dislodged from they original positions, these roof tiles will require replacement and some form of fixing down or a good quality silicon sealant, client may consider to add silicon to the bottom side of the tiles to stick them down to the top of the metal flashings. Roof tiles that have moved from their original position may allow water penetration into the roof void, exposing roofing structures to excessive moisture. This creates an environment that is conducive to water damage and accelerated deterioration of all associated building elements below. Replacement of broken, loose or missing roofing tiles is recommended immediately or in the short term future to prevent the development of any secondary defects. A roofing plumber or roof tiler should be appointed to complete such works immediately or in the short term future.

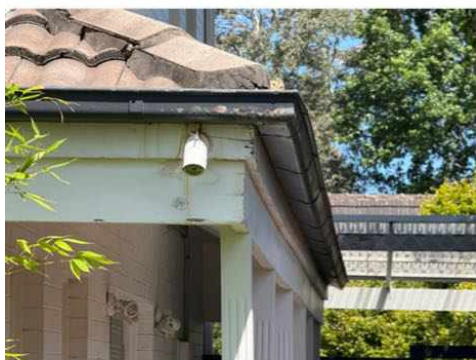
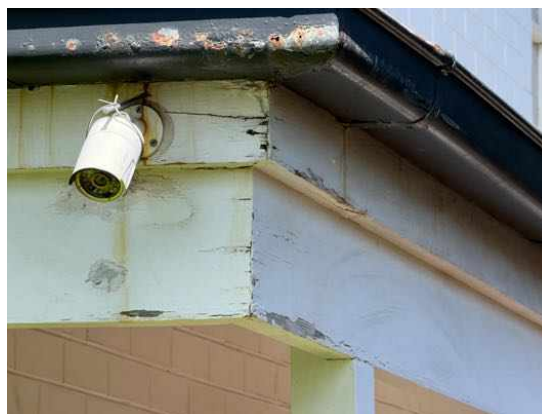
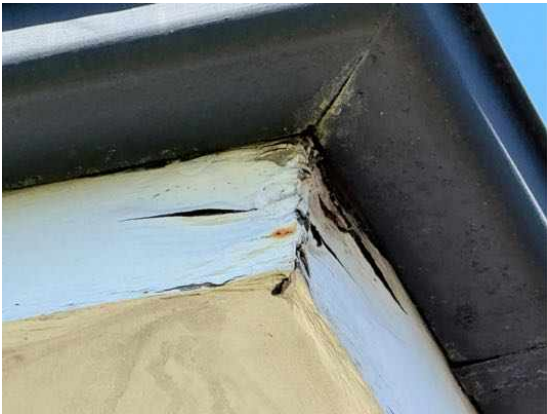
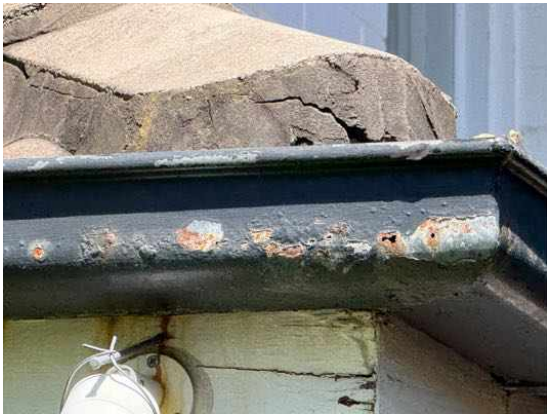
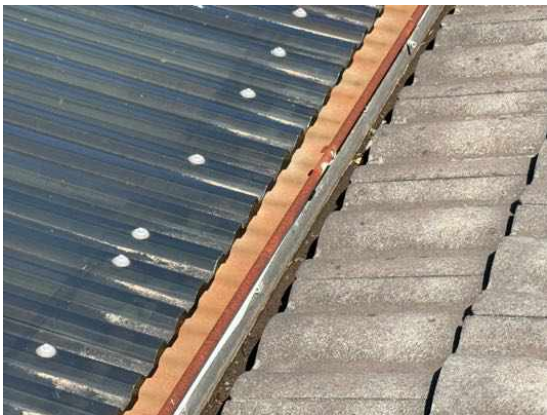
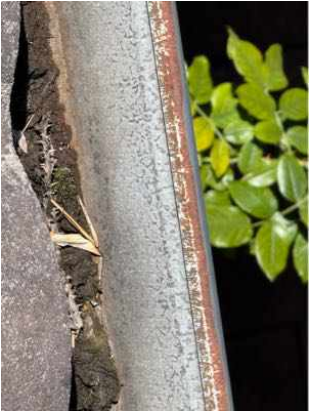
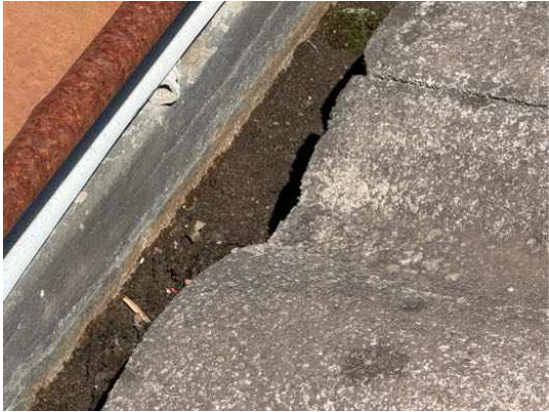
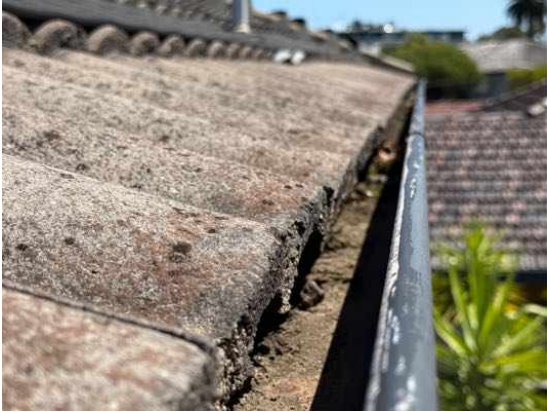
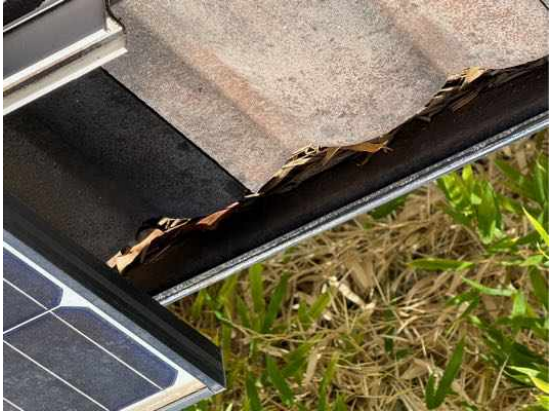
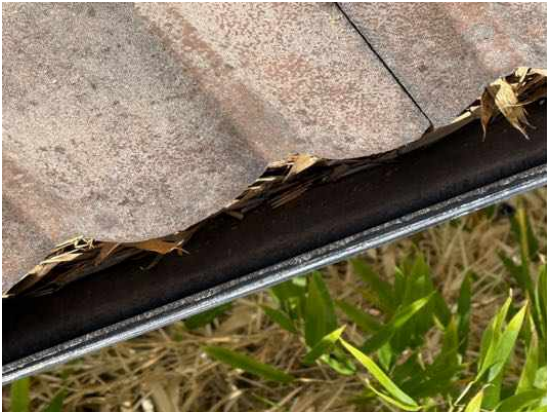
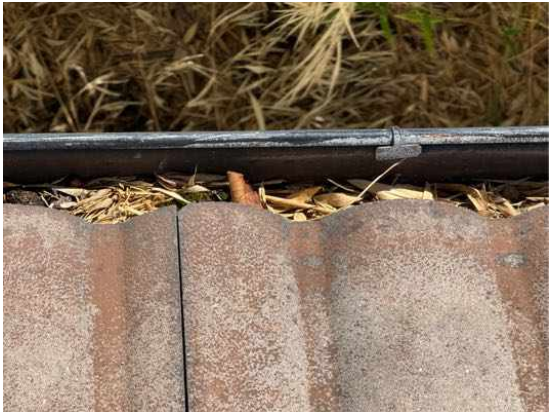
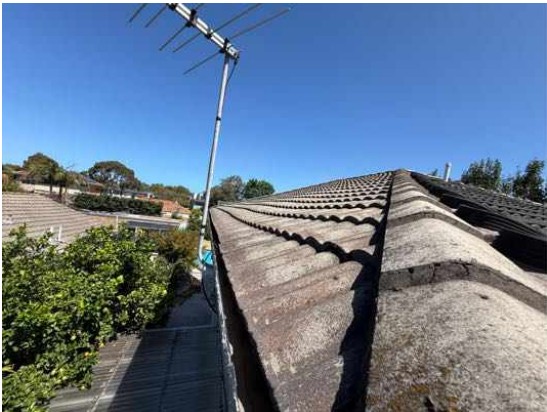
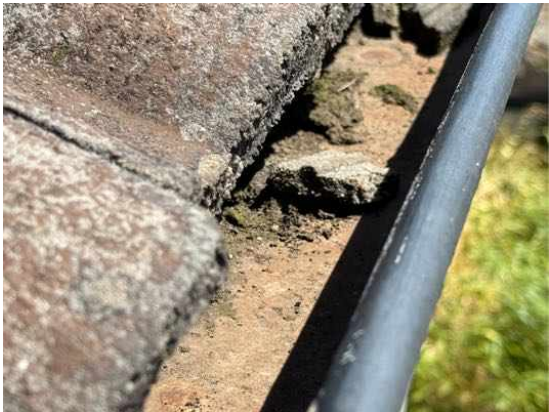
Defects 3.08

Building:	Building 1
Location:	All Areas > All Areas
Finding:	Roof gutters and down-pipes
Information:	Guttering and down-pipe are showing signs of rust and corrosion. It has likely developed as a result of debris and leaf matter sitting in the guttering. A surface that is found to be rusted provides no protection to the underlying iron, the deteriorating condition is likely to worsen if not addressed and left unmanaged, it is therefore recommended that the relevant tradespersons remove and replace any building elements observed to be rusted or as much rust as possible, clean and re-paint these areas.

Upon inspection of the roof gutters, numerous were observed to have excessive leaf matter and debris. Roof plumbing structures, such as guttering and downpipes, should be free of all debris to prevent blockages. Blockages of the guttering and downpipes will lead to pooling and accumulated water overflows, which is likely to subsequently flood eaves and exterior walls.

Where possible, the use of galvanized (treated) metals or colour-bond metals aid in rust prevention, as does regular general maintenance of the gutters. Rust formation can be controlled with coatings, such as paint, that isolate the iron from the environment. Rusting and corrosion should be managed by ideally removing or limiting the affected surface from exposure to moisture and harsh weather conditions. A licensed roof plumber or other relevant tradespersons may be appointed to rectify the affected areas and a qualified carpenter to replace any building elements that have been severely affected by wood rot and water damage.

Blocked gutters are likely to lead to high levels of moisture in the affected areas. Such moisture will not only cause rust and decay of the associated building materials, but can also provide conditions that are conducive to termite and timber pest activity. Blockages in gutters should therefore be removed immediately to ensure dry conditions are maintained. Consultation with a Licensed Plumber for further specific advice on remedial works is required. In the interim, it is highly advised that blocked gutters be removed by a gutter cleaning company or a relevant tradespersons in the short term future.

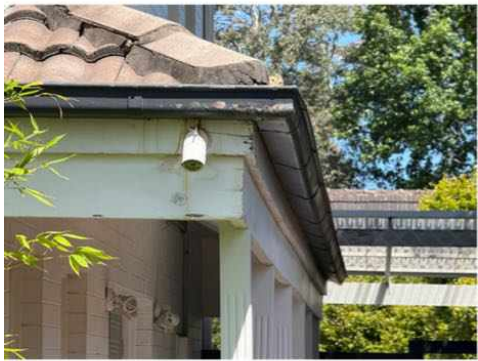
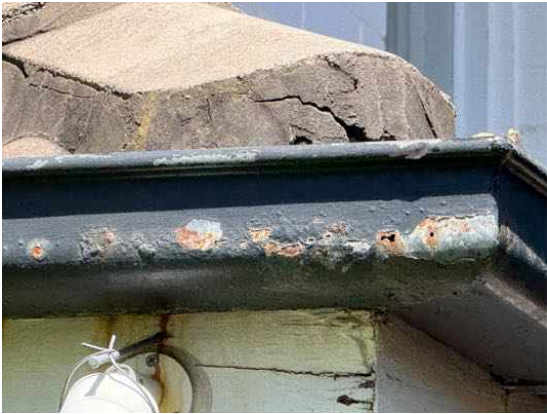
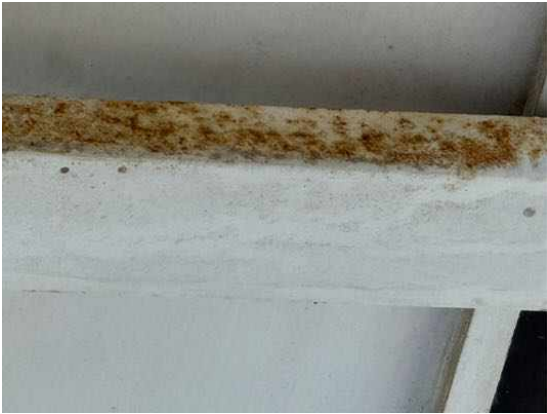
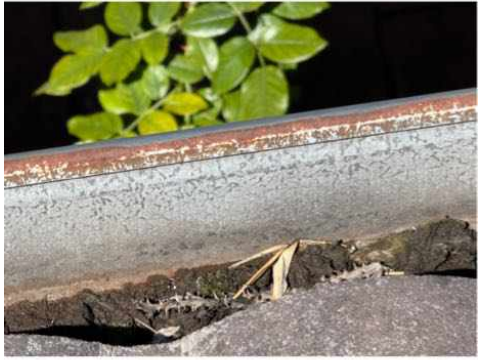
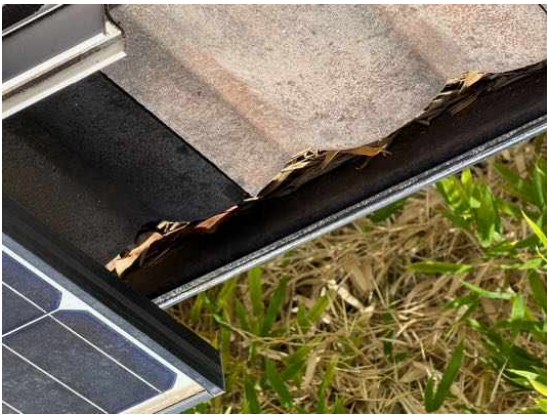
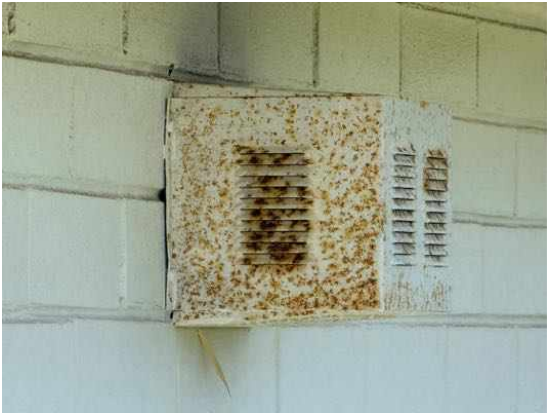
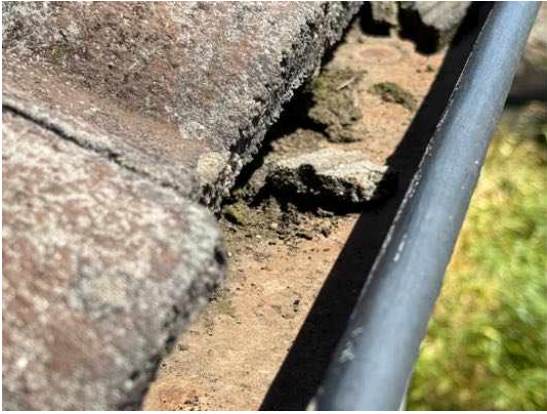
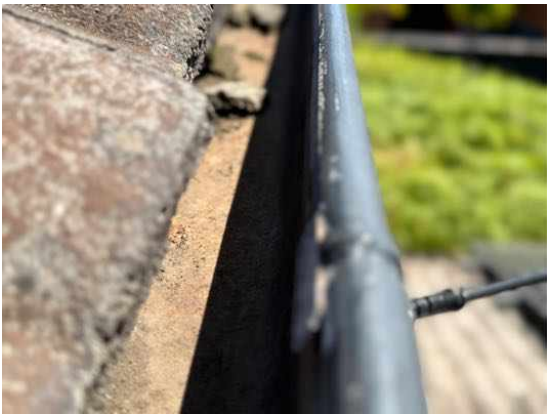
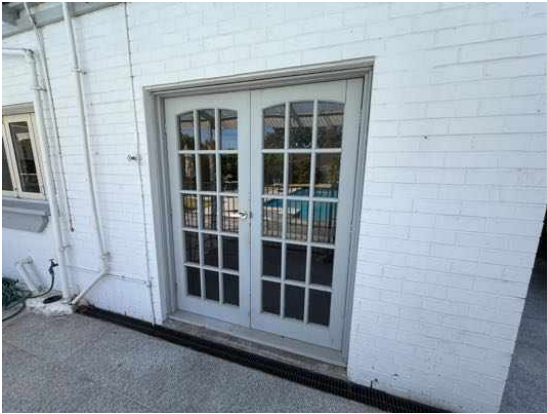
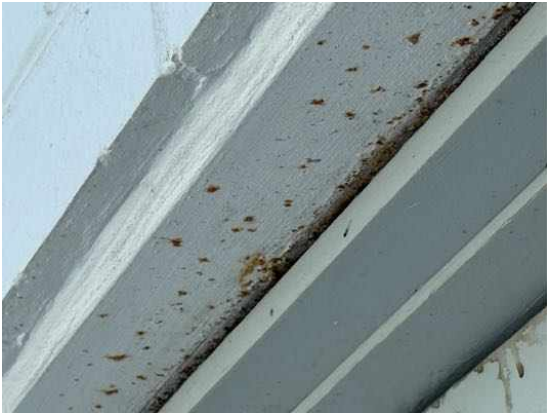
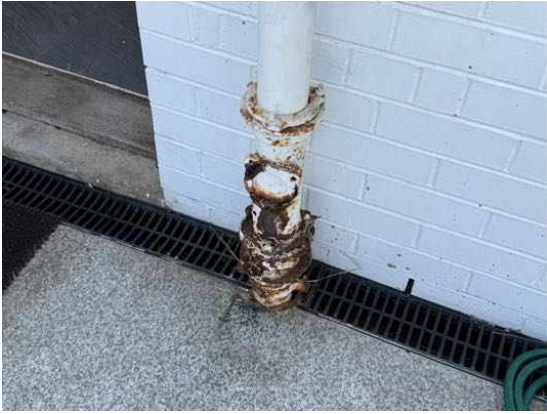
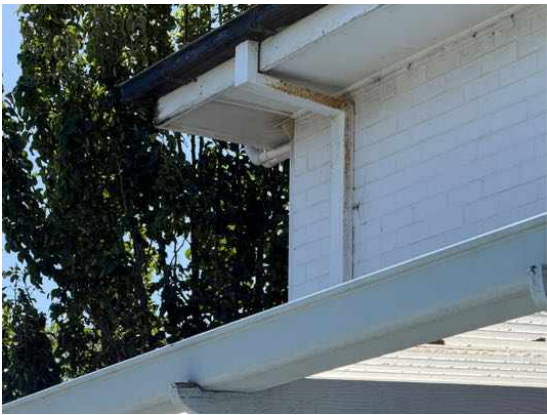
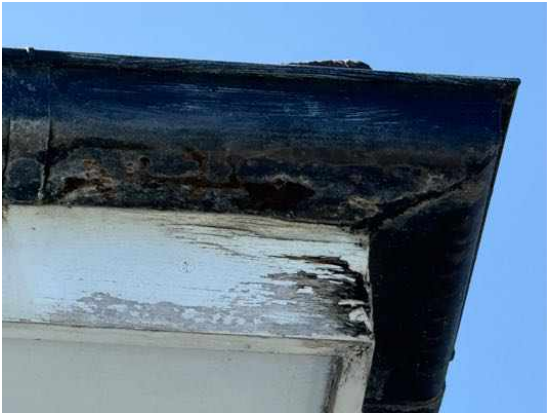
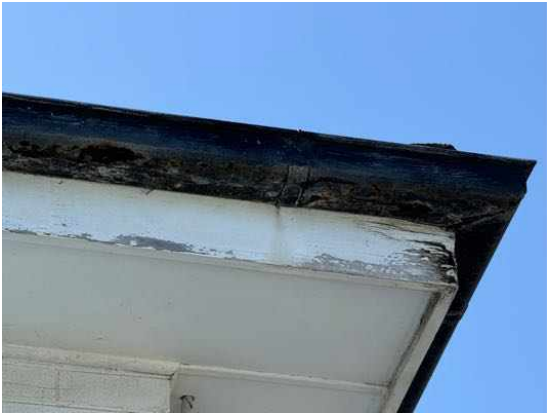
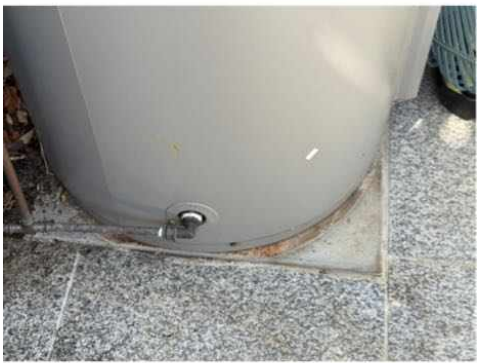
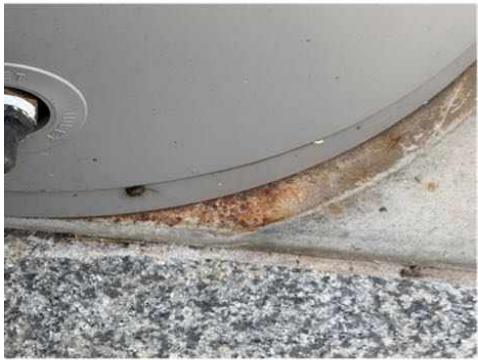
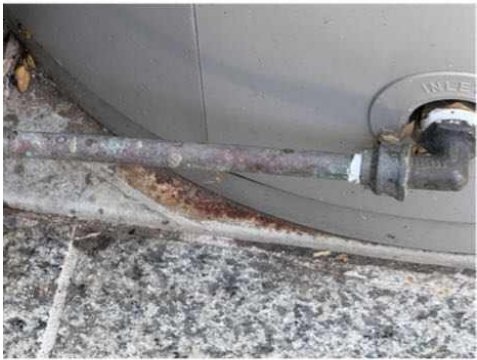
Defects 3.09

Building:	Building 1
Location:	All Areas > All Areas
Finding:	Building elements show excessive rust and deterioration
Information:	Numerous building elements, gutters and down-pipes were observed to be rusted and deteriorated at the time of the inspection. Roof plumbing, such as guttering and downpipes, should be free of all debris to prevent rust, blockages and accelerated deterioration. Rust and decay in roof plumbing will lead to secondary defects that may affect building roof structure and interior areas if left unmanaged. Blockages of the guttering is suspected to have already caused eaves damage, water pooling and suspected gutter water overflows.

Blocked, rusted and deteriorated gutters are likely to lead to high levels of moisture to the adjoining perimeter building structures in affected areas. Such moisture will not only cause wood rot, rust and decay of the associated building materials, but can also provide conditions that are conducive to termite and timber pest activity. Rusted and decayed gutters, valleys, flashings and downpipes should be rectified immediately or in the short term future to ensure dry conditions are maintained. Consultation with a licensed plumber for further specific advice on remedial works is recommended and required.

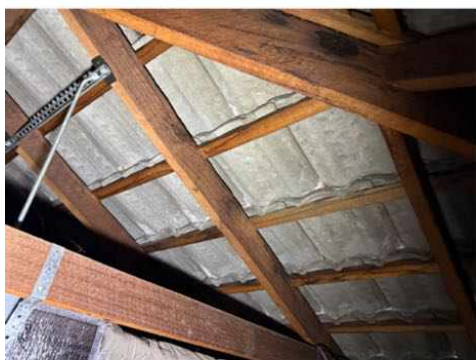
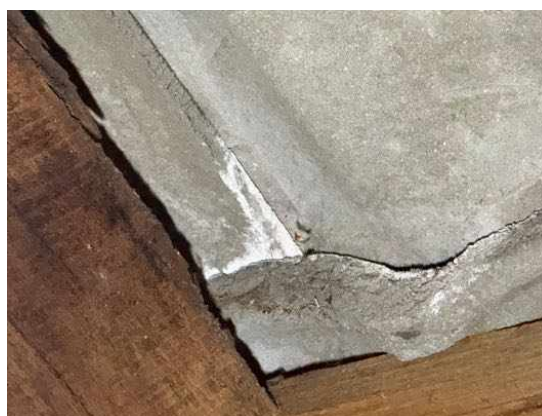
Defects 3.10

Building: Building 1
Location: All Areas > All Areas
Finding: Roof tiles show moisture to the underside of tiles
Information: During our inspection of the roof space it was observed that the roof tiles were suspected to be showing signs of some moisture to the underside of the roof tiles. Due to the top protective coating worn off over time, they are not sealed enough to prevent moisture build-up and suspected to becoming porous during outside wet conditions and therefore the possibility of secondary defects is highly possible in the short term future. While weathering of the tiles is consistent with the age of the property, replacement or remedial work and maintenance works will be required immediately or in the short term future to maintain a weather and waterproof roof.

Where left unmanaged, deteriorating roof tiles are highly likely to lead to a number of secondary defects, including high moisture and or water leaks into the roof space and onto the internal roof structures. Consultation with a roofing company or contractor is highly recommended to gain advice on cost of remedial works that may be required in the short to medium term. This should not be left unmanaged. Remedial works are likely to increase the longevity of the exterior roofing structure.

Re-pointing will also be required on the ridge and hip areas. Client should either appoint a re-sealing company to re-seal the roof tiles for a good and proper seal or the more expensive option, new roof tiles. Sealing the roof tiles is an interim solution to help preserve and extend the life span of the tiles or the client may consider new roof tiles on the entire roof in the future.
