Building Inspection Report

Inspection Date: Mon, 23 Feb 2026

Property Address: 8 McFarlane Ct, Highett VIC 3190, Australia

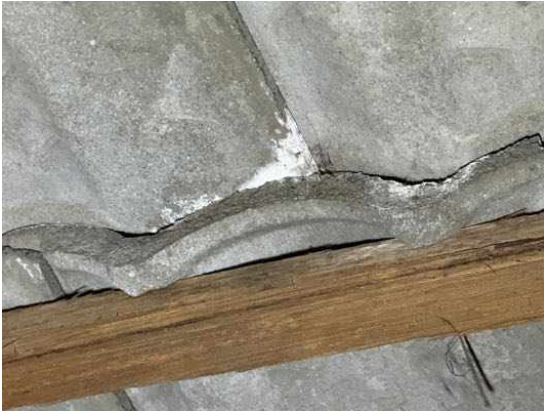
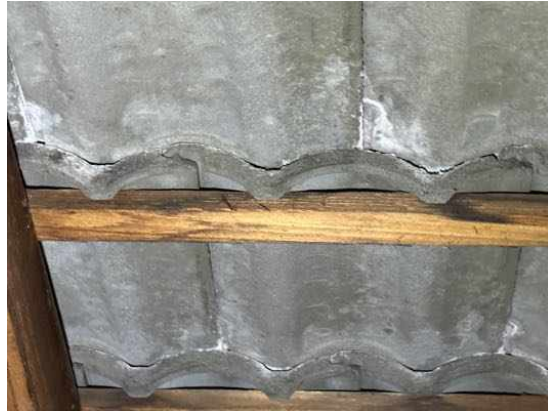
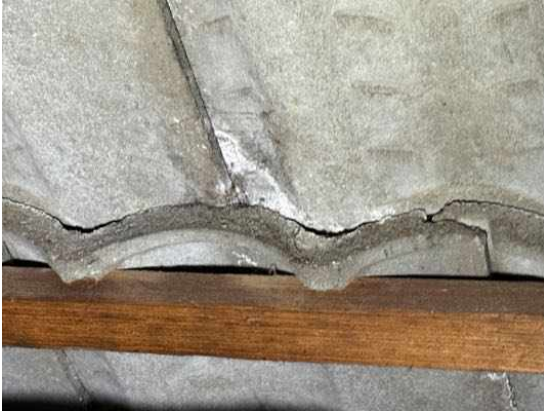
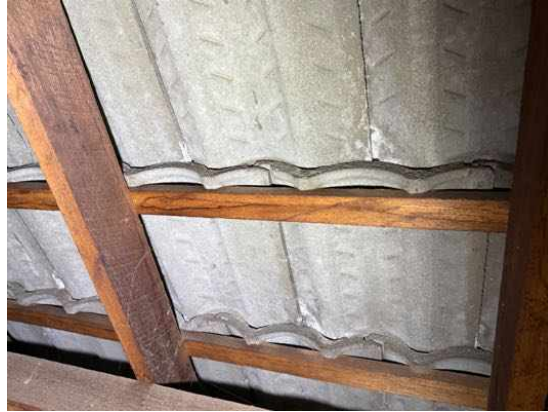
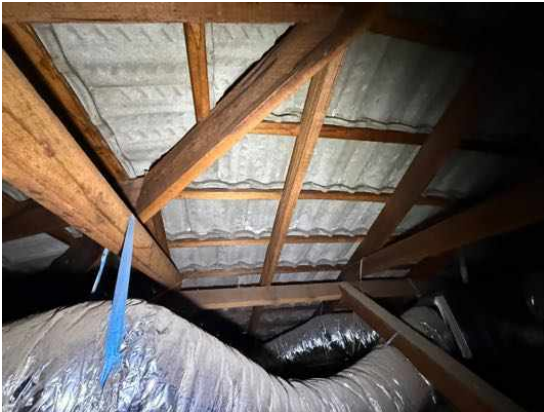
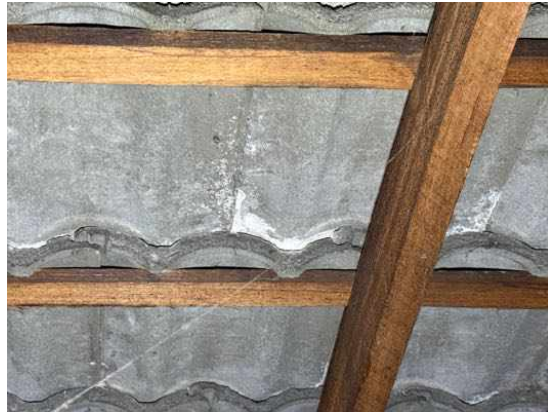
Defects 3.10

Building: Building 1
Location: All Areas > All Areas
Finding: Roof tiles show moisture to the underside of tiles
Information: During our inspection of the roof space it was observed that the roof tiles were suspected to be showing signs of some moisture to the underside of the roof tiles. Due to the top protective coating worn off over time, they are not sealed enough to prevent moisture build-up and suspected to becoming porous during outside wet conditions and therefore the possibility of secondary defects is highly possible in the short term future. While weathering of the tiles is consistent with the age of the property, replacement or remedial work and maintenance works will be required immediately or in the short term future to maintain a weather and waterproof roof.

Where left unmanaged, deteriorating roof tiles are highly likely to lead to a number of secondary defects, including high moisture and or water leaks into the roof space and onto the internal roof structures. Consultation with a roofing company or contractor is highly recommended to gain advice on cost of remedial works that may be required in the short to medium term. This should not be left unmanaged. Remedial works are likely to increase the longevity of the exterior roofing structure.

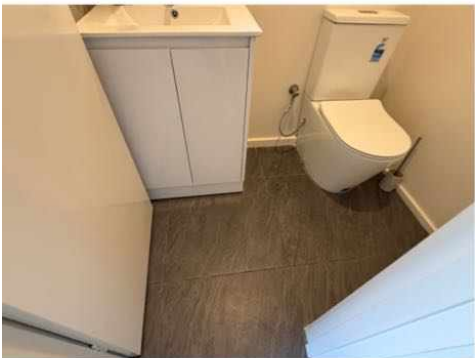
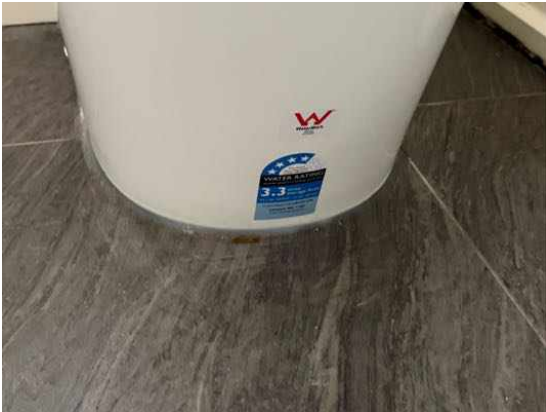
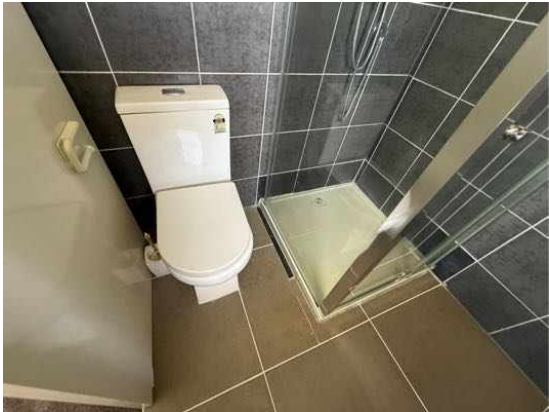
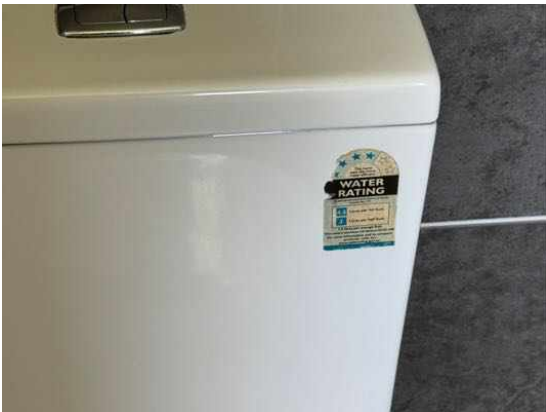
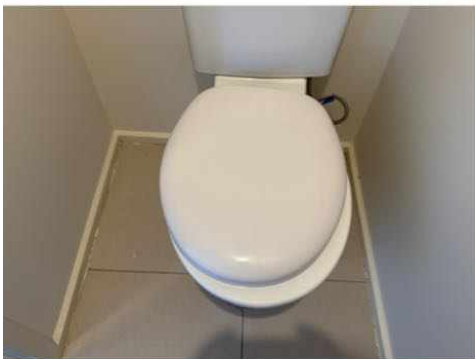
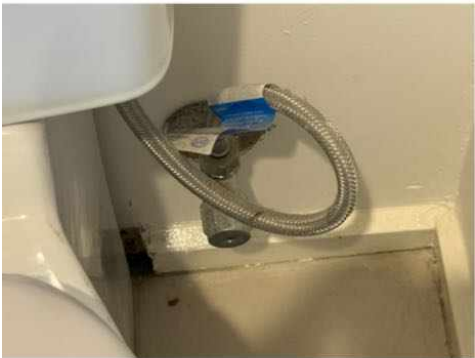
Defects 3.11

Building:	Building 1
Location:	Bathroom > All Areas
Finding:	Toilet manufacturers stickers
Information:	At the time of the inspection it was observed that the toilets have manufactures stickers still on them, this is considered to detract from the overall quality and appearance of the home. These should be removed and cleaned off all bathroom and toilets, fittings and fixtures. This should be performed as part of the handover cleaning.

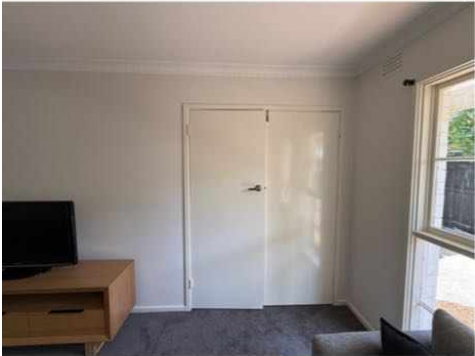
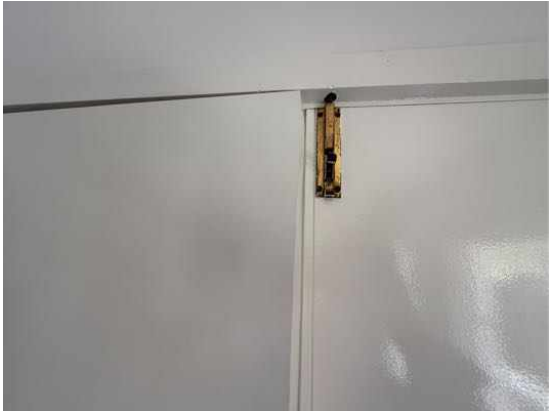
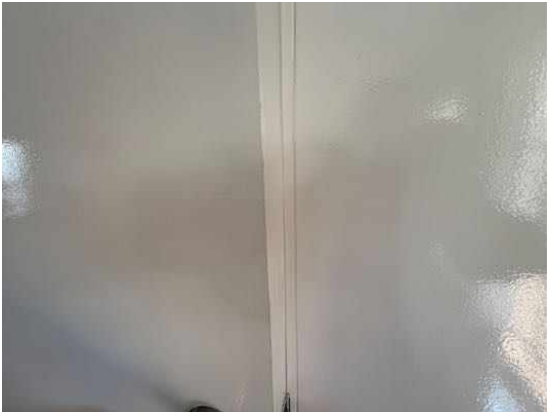
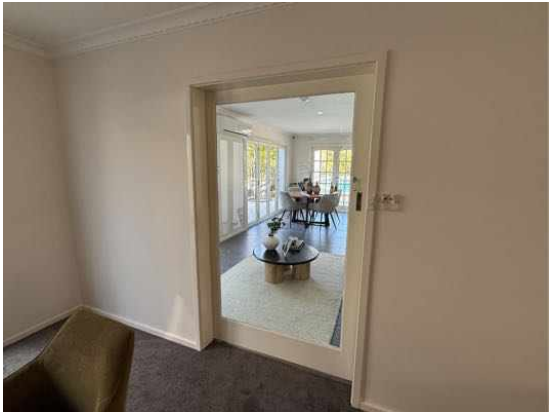
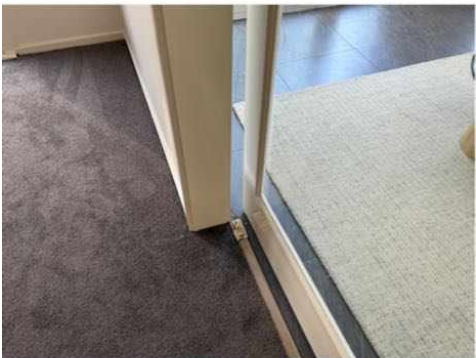
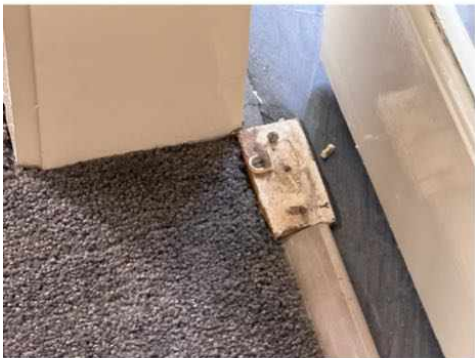
Defects 3.12

Building: Building 1
Location: All Areas > All Areas
Finding: Doors adjustments and maintenance
Information: Some doors throughout the home were observed to require only minor maintenance and adjustments to make good during standard operation. Doors should get some adjustment and maintenance to ensure doors operate correctly during standard operation. These types of defects can inhibit the functionality of the affected doors as well as creating potential for secondary defects to associated building elements, such as the door jamb and floor. Generally, factors such as a lack of maintenance or general deterioration are the usual causes for these types of defects.

It is suspected that back garage door is damaged and deteriorated beyond repair. Replacement of some door hardware may be required where deemed to be necessary, as well as minor repairs and cleaning. A qualified carpenter should be appointed to perform minor rectification works in the future.

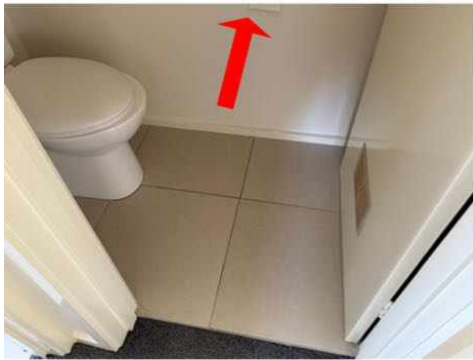
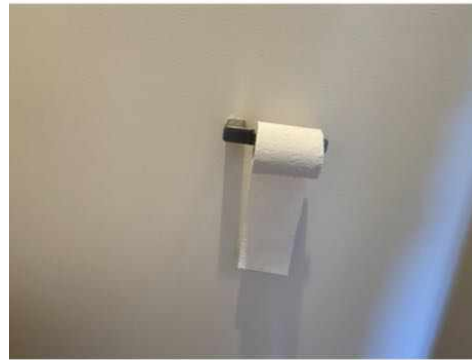
Defects 3.13

Building:	Building 1
Location:	Toilet (WC) > All Areas
Finding:	Toilet roll holders - Loose
Information:	The toilet roll holders and towel rail were found to be loose at the time of inspection. While not a major operational defect, function can deteriorate if the problem is left unmanaged. It is recommended that some remedial works to rectify the loose toilet roll holders and towel rails to its original fixing. If these cannot be rectified to function as intended, client is recommended to renew. A qualified carpenter may be required to perform these works.

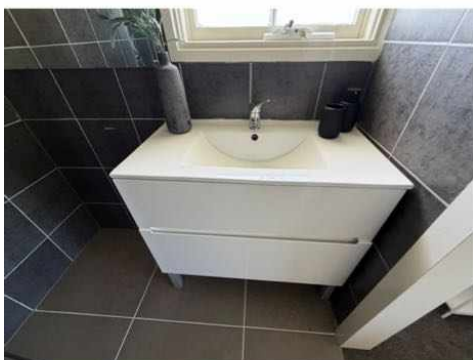
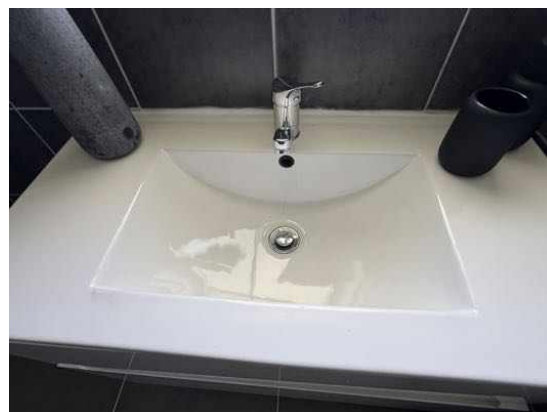
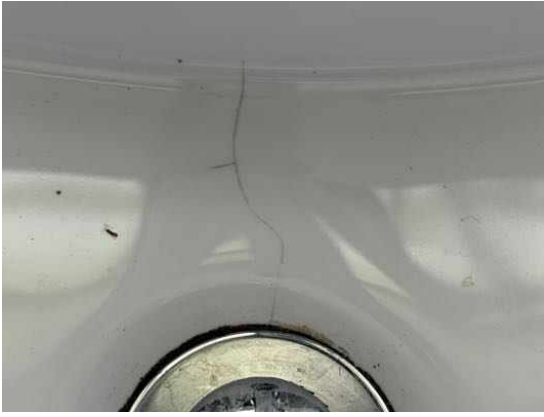
Defects 3.14

Building:	Building 1
Location:	Ensuite - Master > All Areas
Finding:	Bathroom basin cracked
Information:	Bathroom basin crack was observed to the bathroom basin at the time of inspection, it is suspected to have been caused by an impact damage. While the cracking appears to be minor, any further impact damage sustained by the basin may lead to additional cracking or breakage. The cracking may provide a potential for water and moisture leaks and water damage may occur to associated cabinetry, walls or flooring, if the cracking is left unmanaged. Consultation with a plumber regarding basin replacement may be required, this is at the clients discretion.

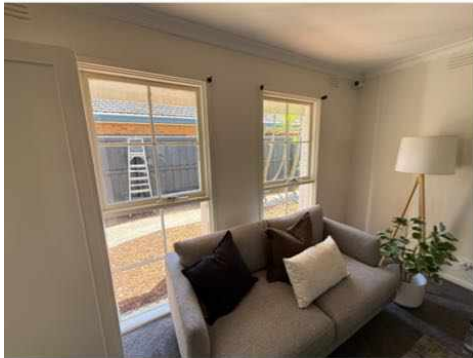
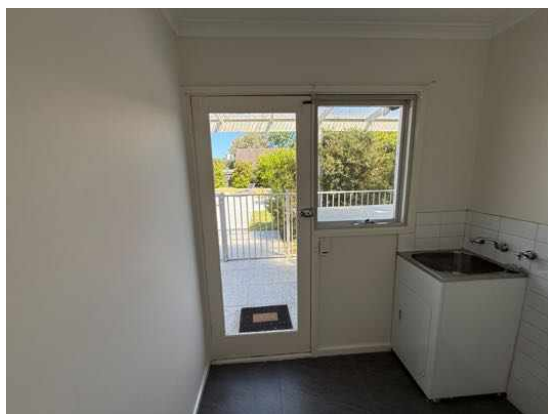
Defects 3.15

Building:	Building 1
Location:	All Areas > All Areas
Finding:	Flyscreens
Information:	Flyscreens were found to be missing to the windows and exterior doors throughout the home at the time of inspection. Whether the flyscreens have not been installed or have been removed for maintenance and or painting purposes, this missing building element detracts from the operational state of the window. Where not replaced, missing flyscreens allow pest and insect ingress into the adjoining room/s. It is advised that all missing building elements be installed or replaced in order to ensure the full function of all building structures. A flyscreen company or a qualified carpenter may be appointed to replace flyscreens at the discretion of the client.

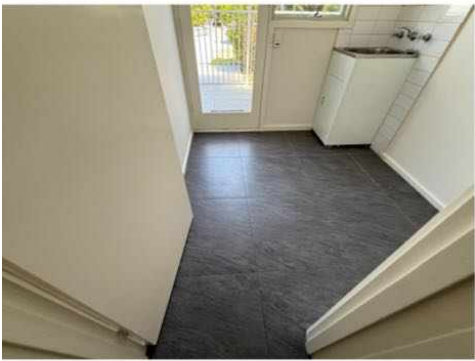
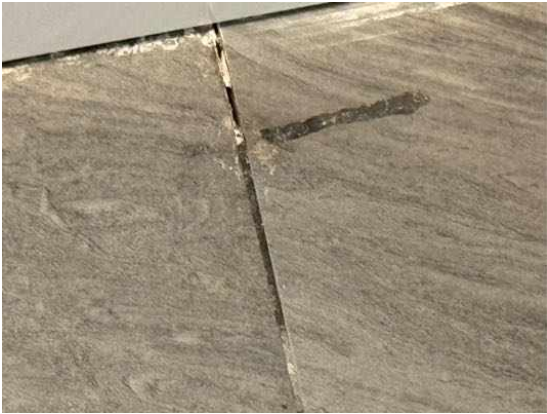
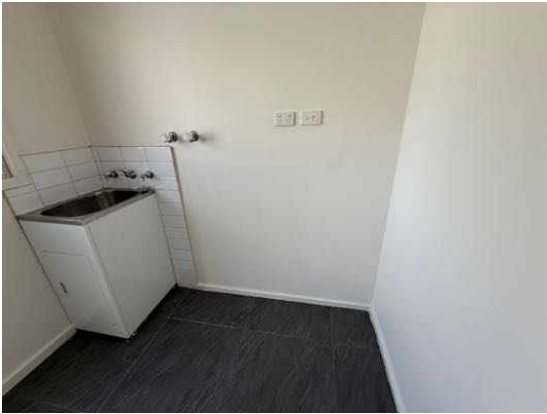
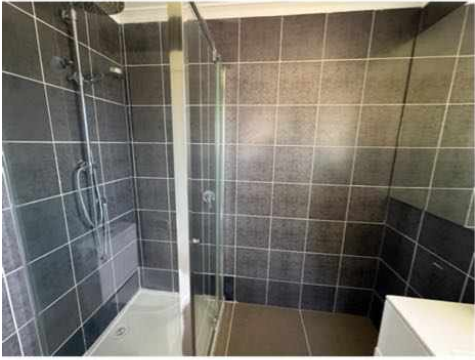
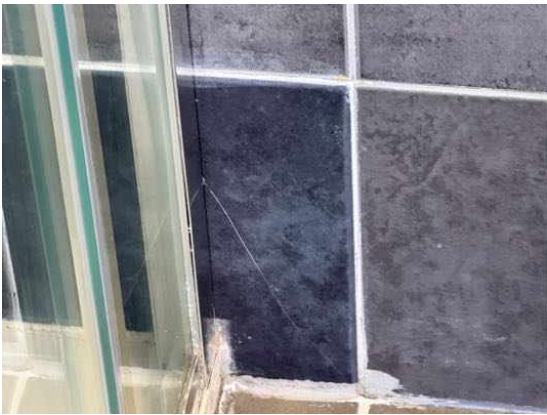
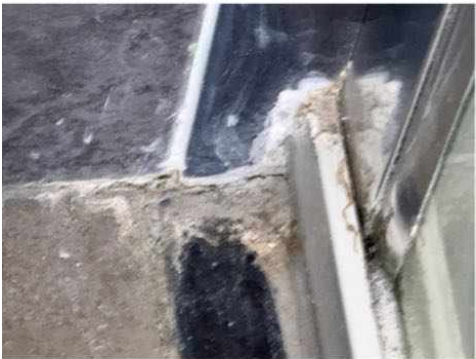
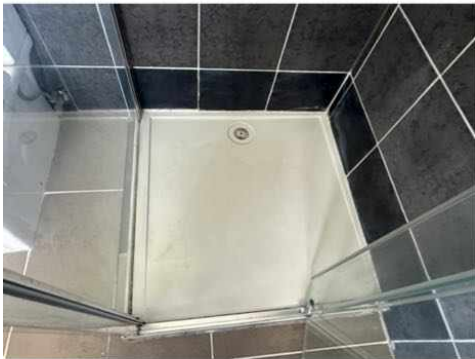
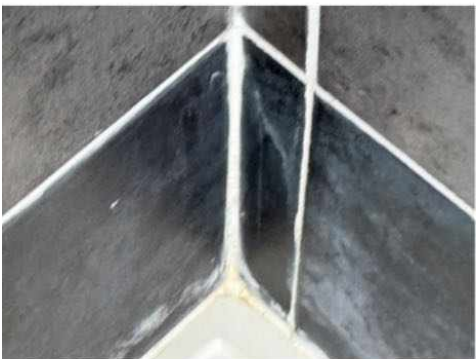
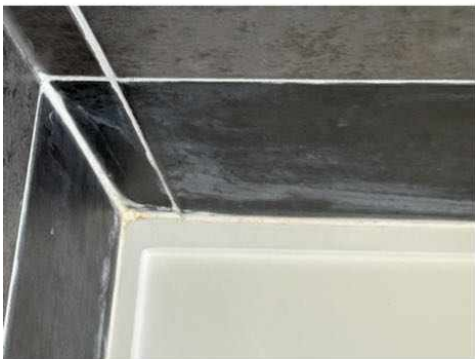
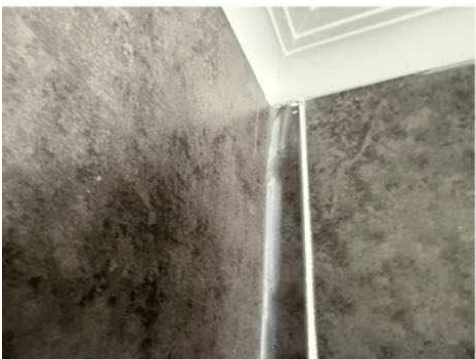
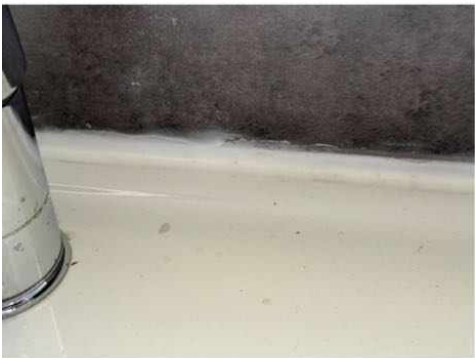
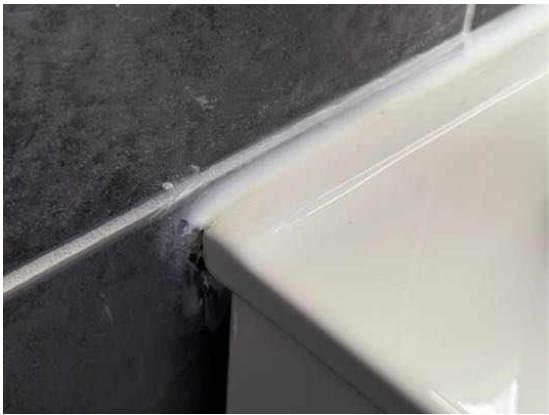
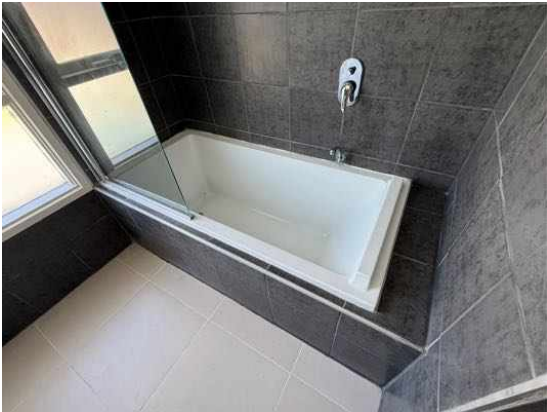
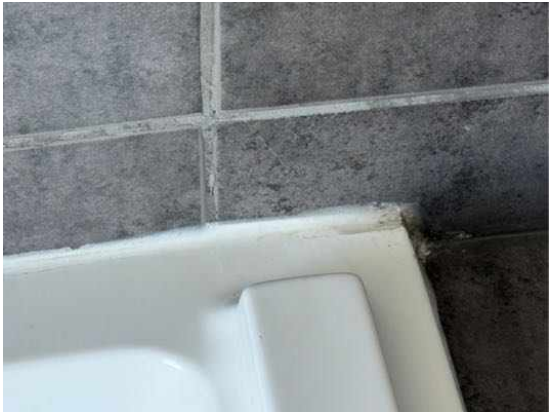
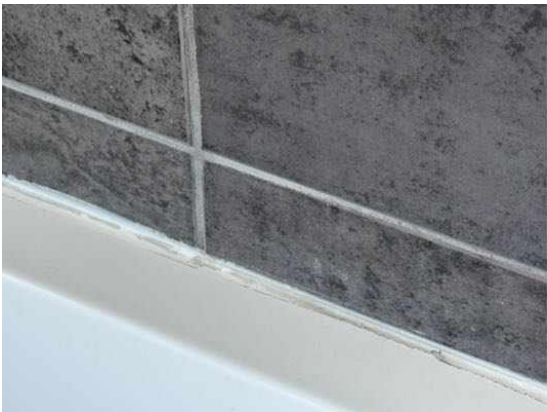
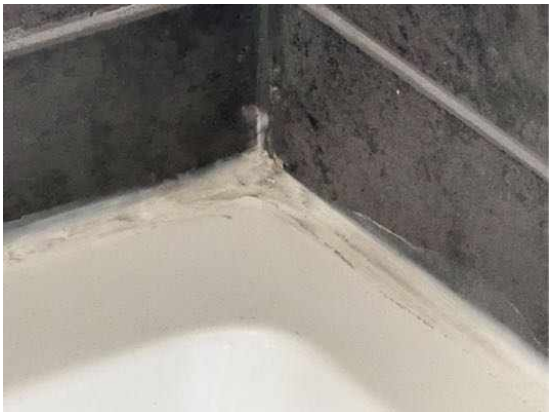
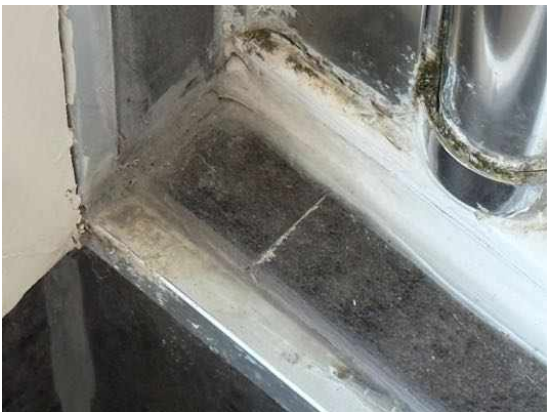
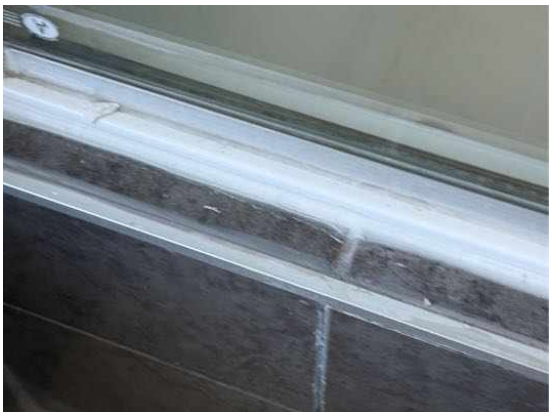
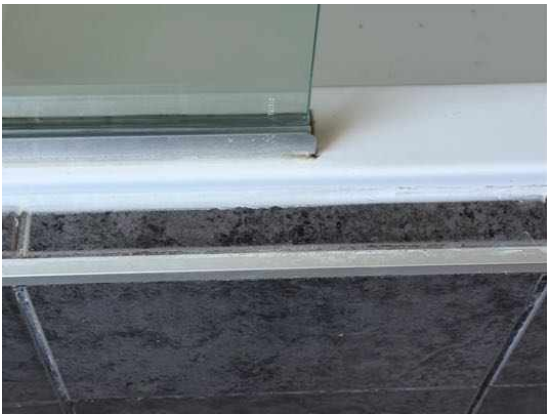
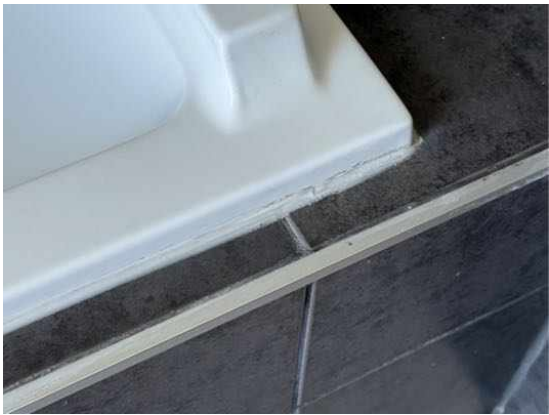
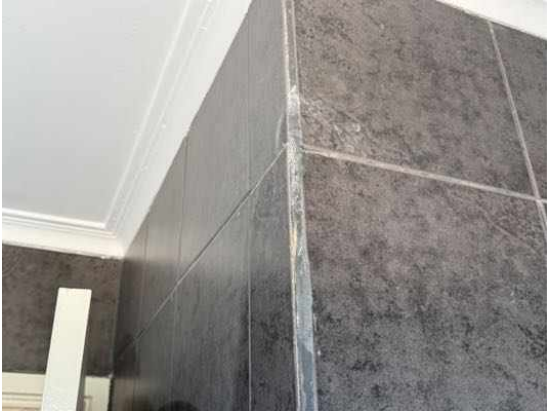
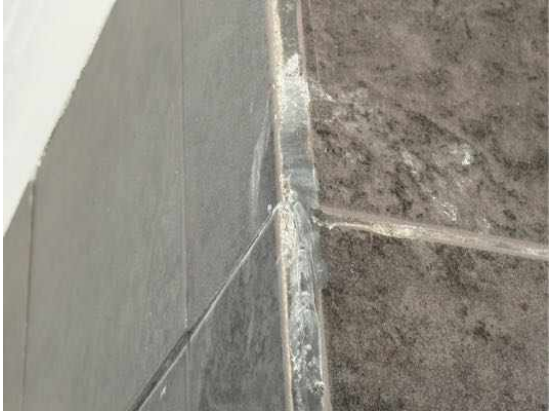
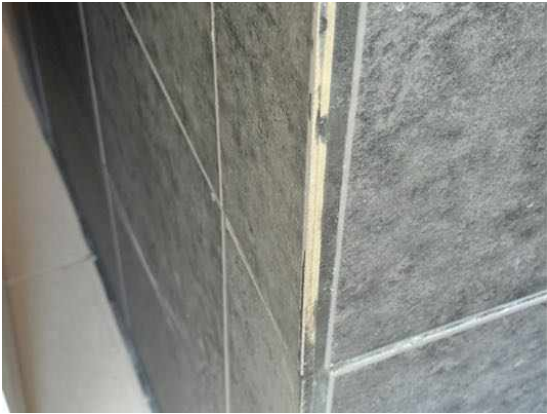
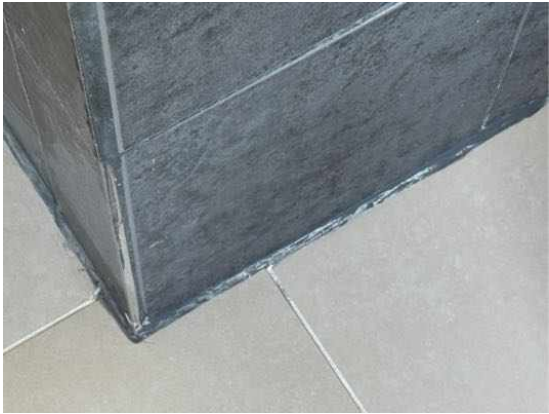
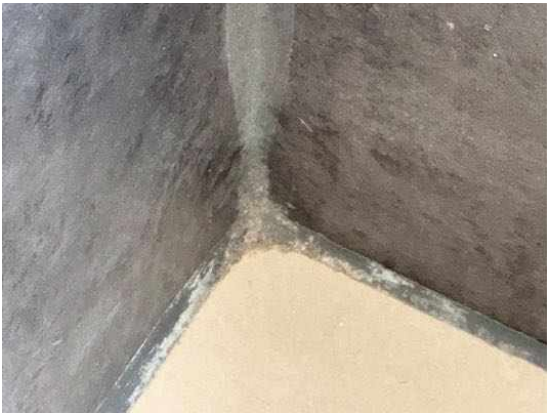
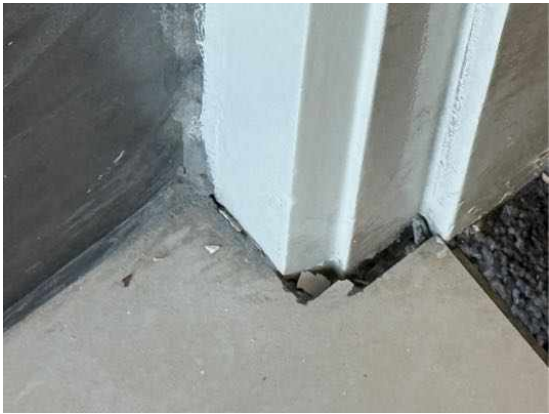
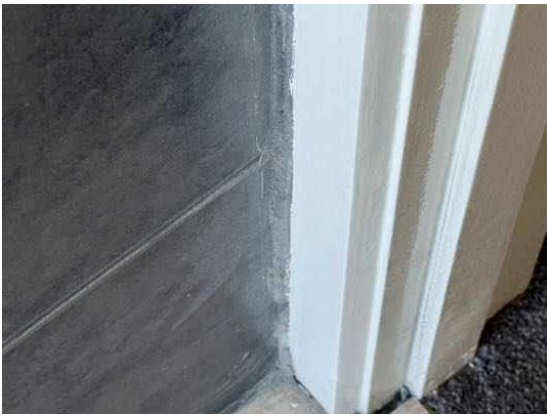
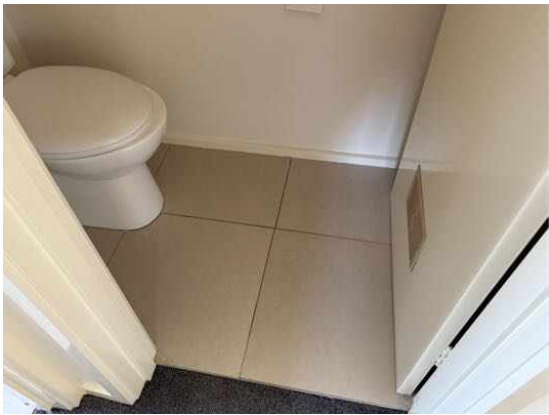
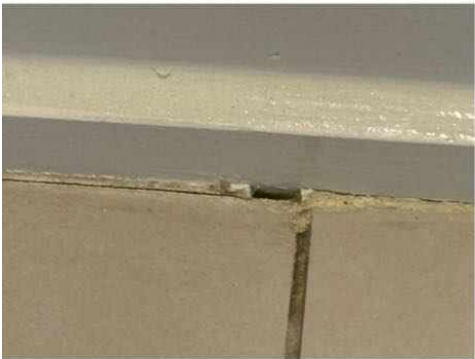
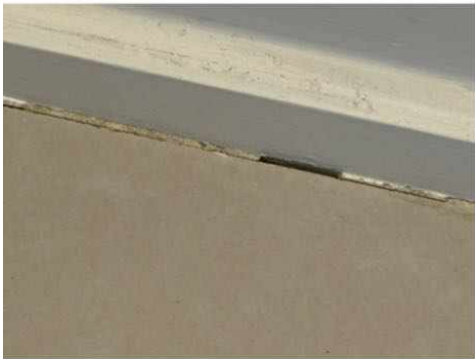
Defects 3.16

Building:	Building 1
Location:	Bathroom > All Areas
Finding:	Grout and sealant maintenance
Information:	It was observed that grout and sealant in the tiled shower alcove and in the bathrooms, laundry and kitchen areas require maintenance to ensure these areas remain watertight at all times. It is highly recommended that the client appoint a professional wall and floor tiler to provide remedial work to rectify the shower floor grout and sealant before any further use, water damage to the adjoining areas is likely to occur if left unmanaged.

Grout and sealant were observed to have been either deteriorated, dislodged or missing, in these types of wet areas if not rectified and maintained adequately it is highly likely that these areas will have accelerated damage and deterioration to the substrate as well as more serious secondary defects to the adjoining floor and wall structures. Regular maintenance and replacement of grout to any holes or damaged sealant is highly recommended to the wet areas, as this is a regular wear and tear defect. Sealant and grouting in areas that come into regular contact with water should be maintained for the long term care of your property.

Different materials on the walls and floor areas move at different rates, generally causing cracking to grout or sealant at these points. A flexible sealant is required to allow for expected expansion and contraction, while keeping the joint water tight and protective of all associated building structures and materials. Flexible and mould resistant materials should be applied to affected areas to prevent any subsequent water damage that is likely to occur if left unmanaged. A sealant specialist or tiling contractor should be appointed to complete these works immediately or as soon as possible.

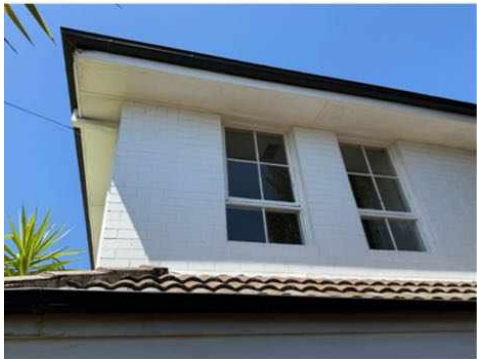
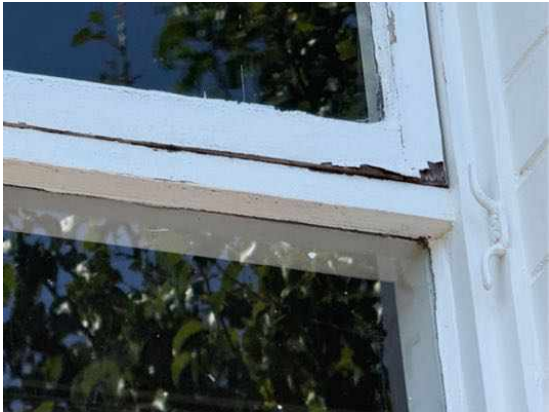
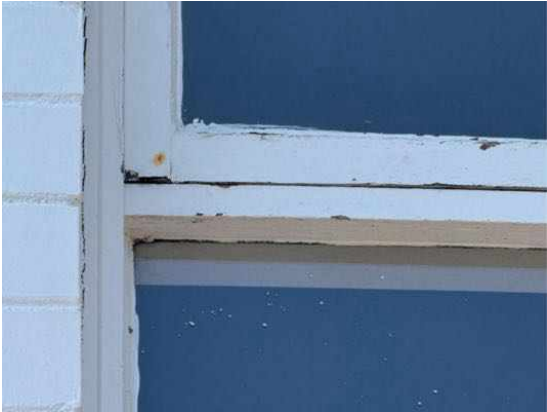
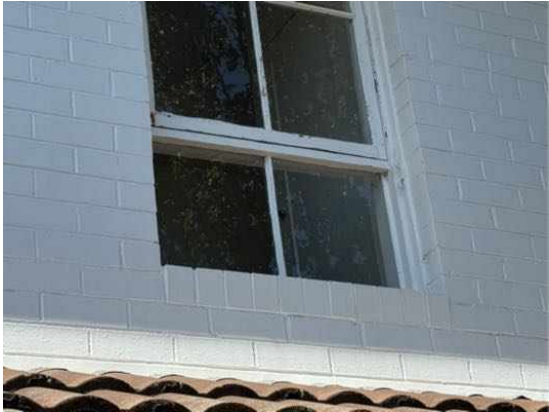
Noted Item

Building: Building 1
Location: All Areas > All Areas
Finding: Additional Photos
Information: Additional photos are provided for either future maintenance items for clients attention and or general reference. Arrows may have been included to highlight areas of importance. Please discuss these photos with your building consultant for clarification.

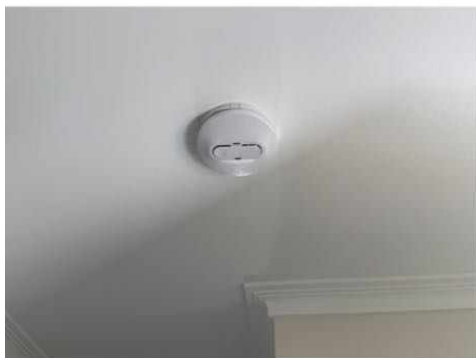
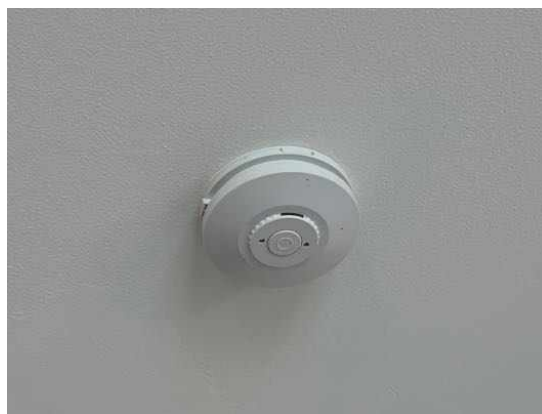
Noted Item

Building:	Building 1
Location:	All Areas > All Areas
Finding:	Smoke detectors and alarms
Information:	Reporting on Smoke Detectors or Alarms, including hard wired smoke detection systems and their legislative requirements, is outside the Scope of this Report. Please note that this defect is highlighted as a caution only. We suspect, based on our experience in the building industry, that smoke detectors are sometimes get overlooked, or they may be in a poor condition, so we recommend that they always should be addressed prior to occupation to improve occupant safety.

Always ensure sufficient working and suitable smoke detectors are installed prior and during to occupying any building. Additionally, it is advised that all smoke detectors be tested by the homeowner on a monthly basis.

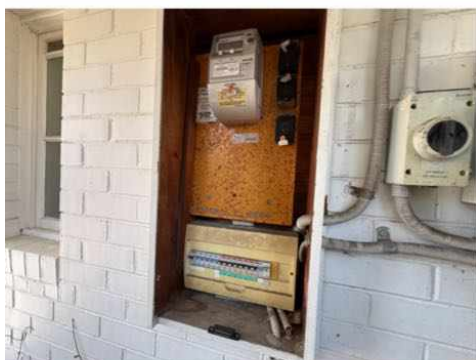
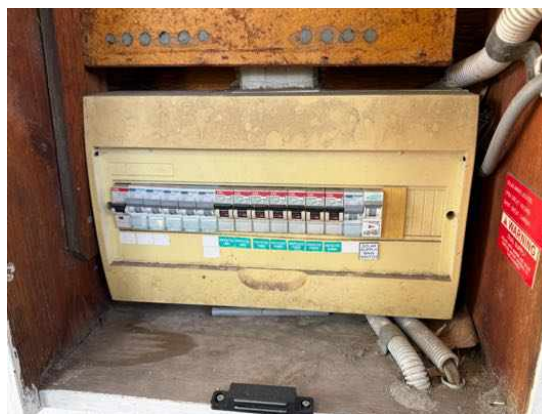
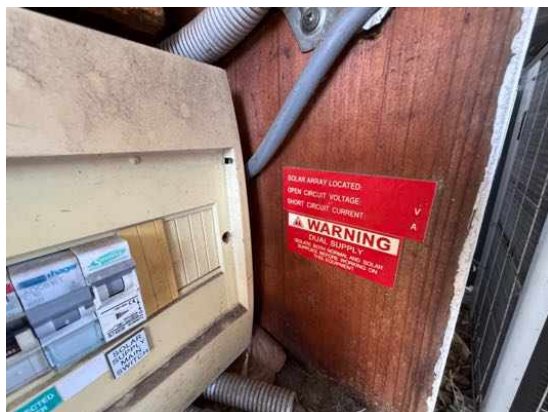
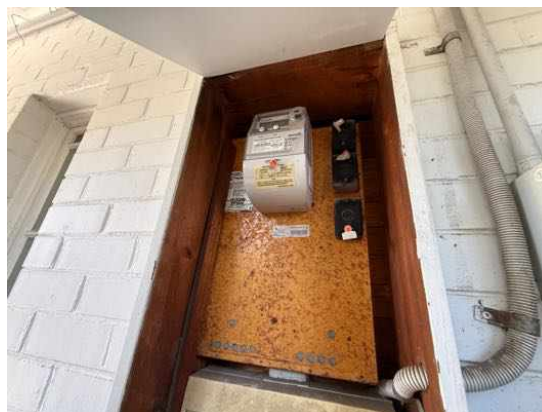
Noted Item

Building:	Building 1
Location:	All Areas > All Areas
Finding:	Termite Management System - no evidence of a chemical installation or durable notice
Information:	At the time of the inspection no application of a chemical termite barrier or durable notice was observed. Such barriers are highly effective and highly recommended for all properties in preventing termite attack on any timber building elements throughout the property.

A durable notice should be placed in the switchboard unit or in the another accessible area to indicate current termite barriers. At the time of inspection, no evidence to suggest preventative works taking place. The client may consider gaining further advice from builders or a pest controller and as to the costs and procedures involved with this application. It is recommended that obtaining such advice be a short-term priority.

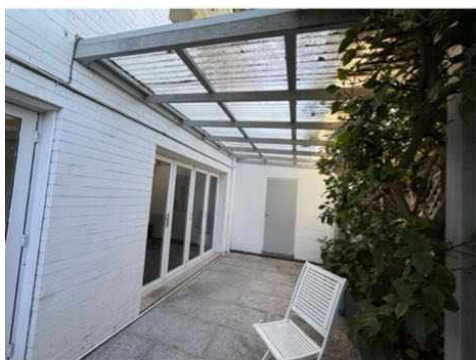
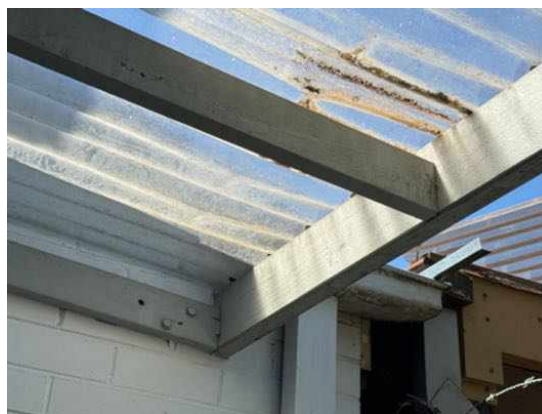
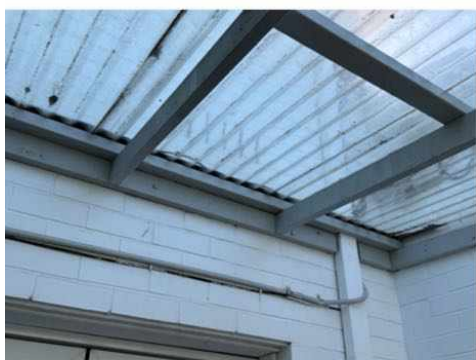
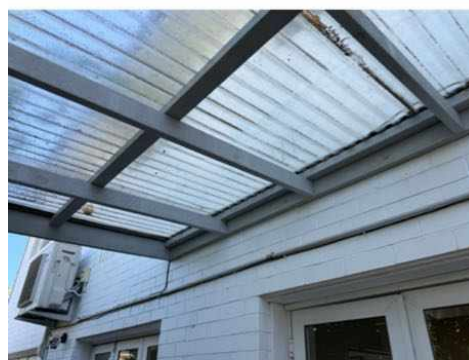
Noted Item

Building:	Building 1
Location:	All Areas > All Areas
Finding:	Building elements missing - roof brackets and bolts
Information:	Bolts that connect the perimeter beams and posts and rafter brackets on the front verandah were observed to have been omitted or missing at the time of the inspection. The front porch and carport areas have no bolts and or rafter brackets installed from posts to perimeter beams and rafters, these types of building elements are an essential part of the building structure and will improve the longevity of the building structure as it becomes aged and deteriorated. Although some building elements may seem irrelevant or unnecessary, all building elements play a key role in the operation and function of the overall structure and its performance.

All maintenance or replacement of any missing and broken building elements should be replaced or installed to ensure that no secondary damage or functional issues occur to associated building elements or materials not being installed. A qualified carpenter, builder or another appropriate tradesperson should be appointed to clean, maintain or replace the missing building elements or materials deemed necessary.
