Building and Timber Pest Inspection Report

Inspection Date: Mon, 16 Mar 2026

Property Address: 103/6 River Rd W, Parramatta NSW 2150,
Australia

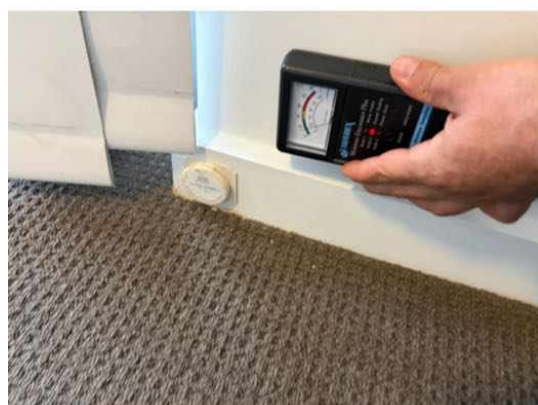
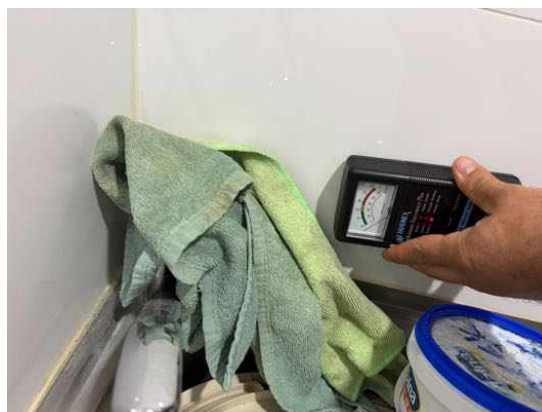
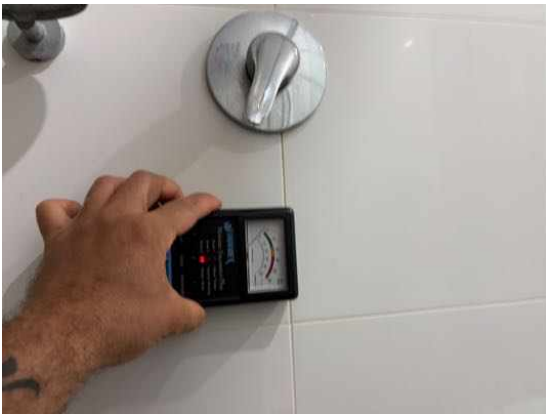
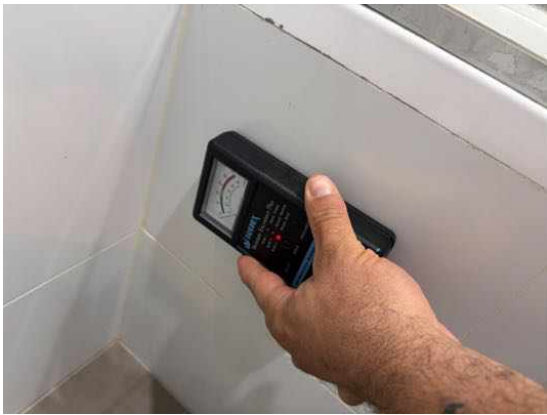
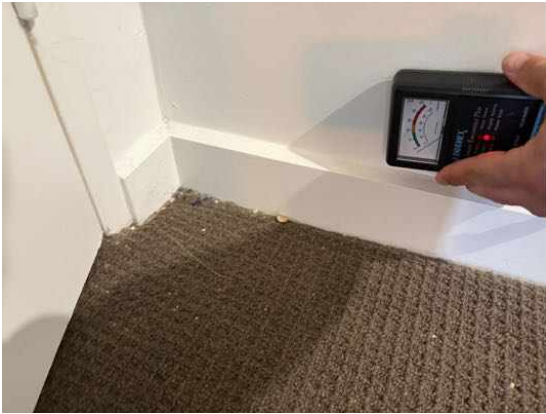
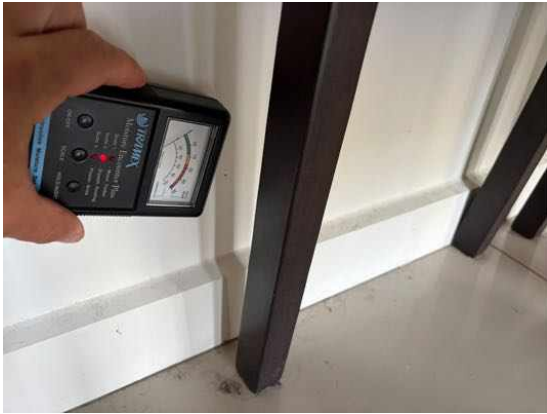
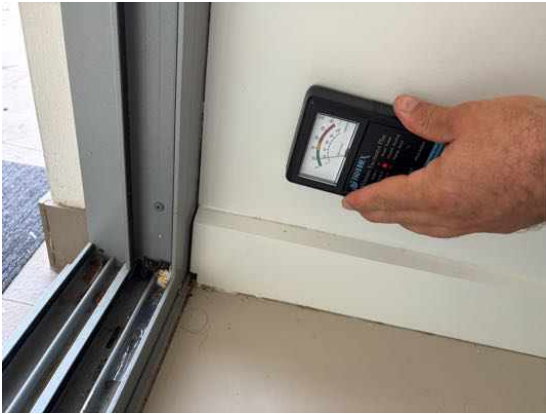
Building: Main Building
 Location: All Areas
 Finding: Moisture metre
 Information: During the inspection the property was checked for moisture using a moisture metre.

This is for information only.

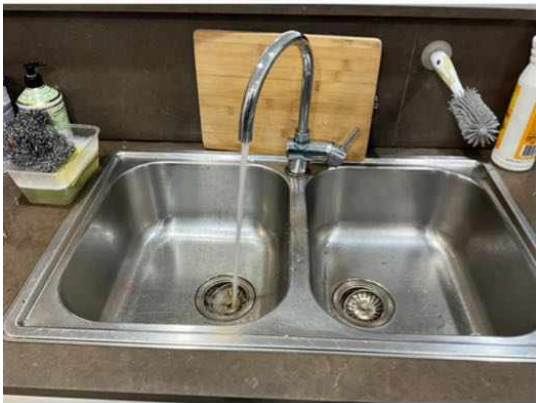
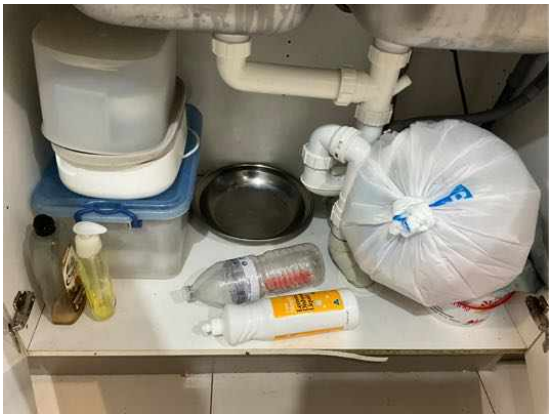
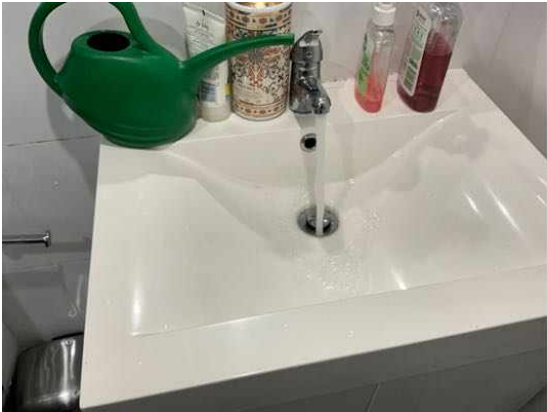
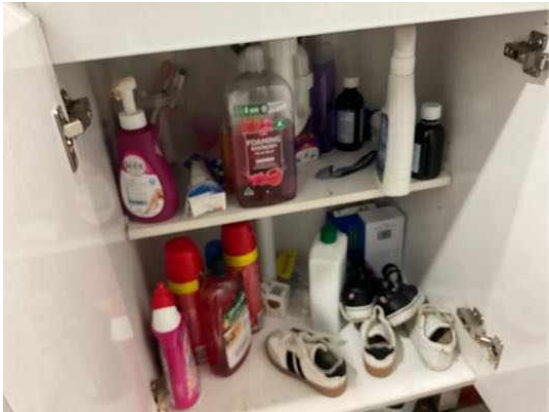
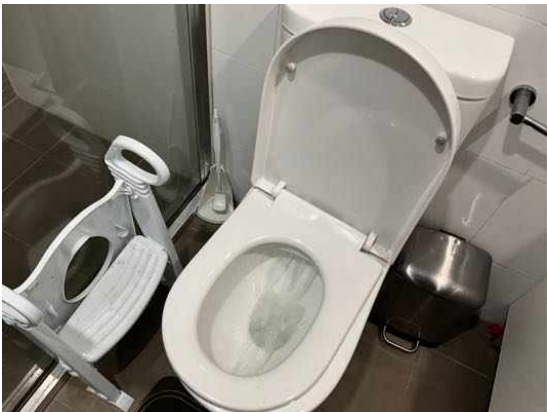
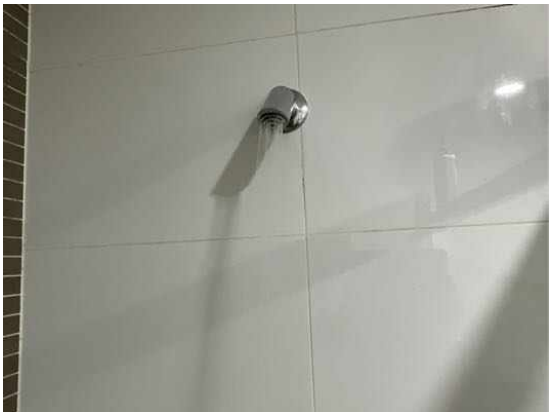
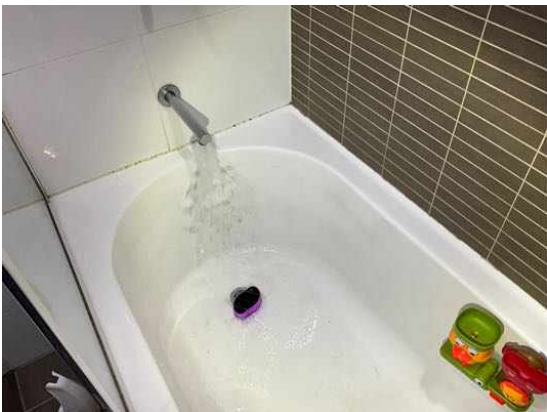
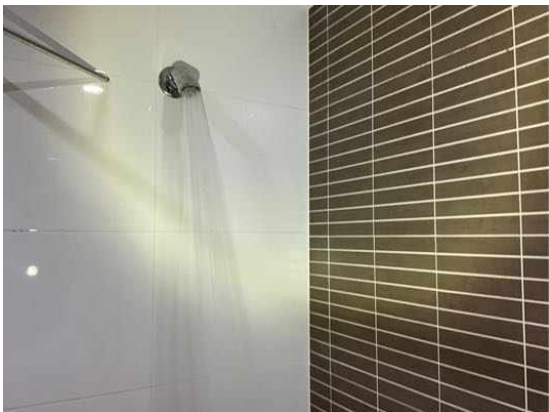
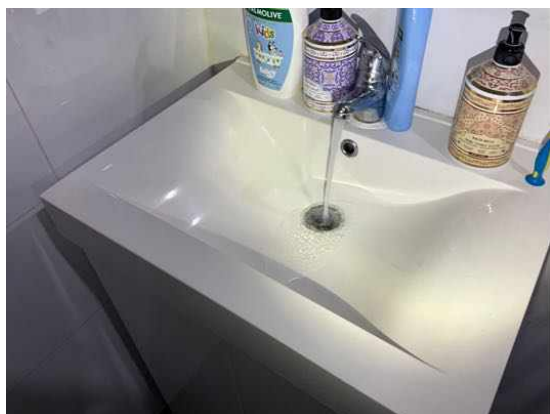
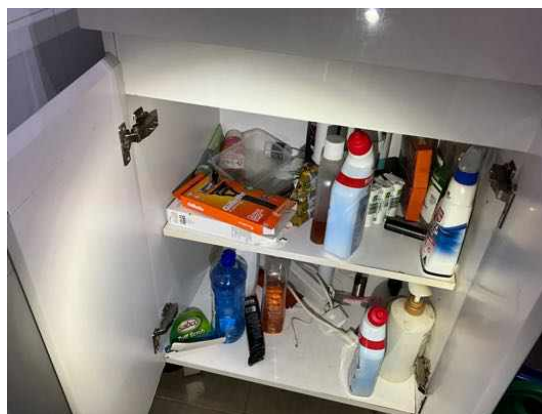
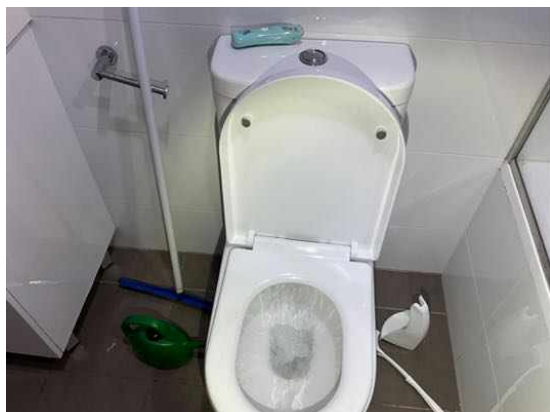
Building: Main Building
Location: All Wet Areas
Finding: Additional Photos
Information:

Additional photos are provided for your general reference.

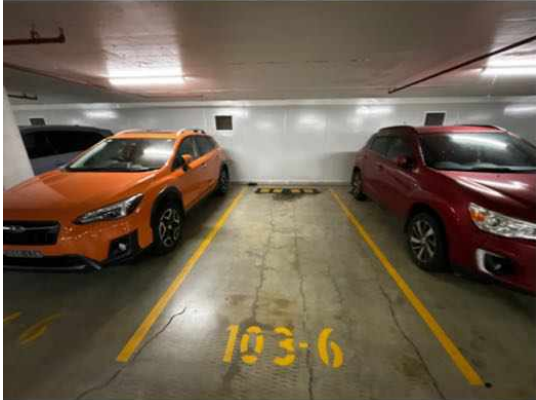
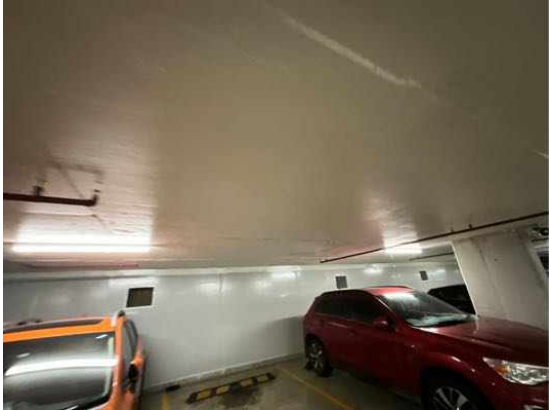
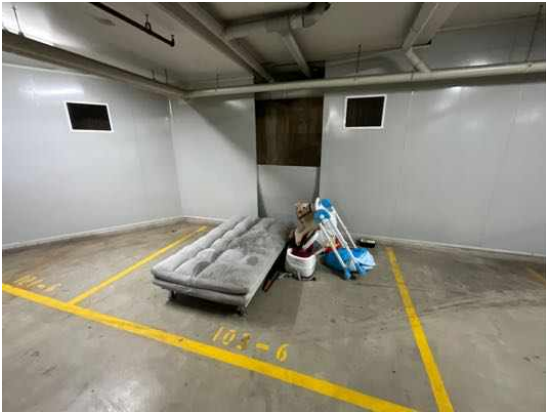
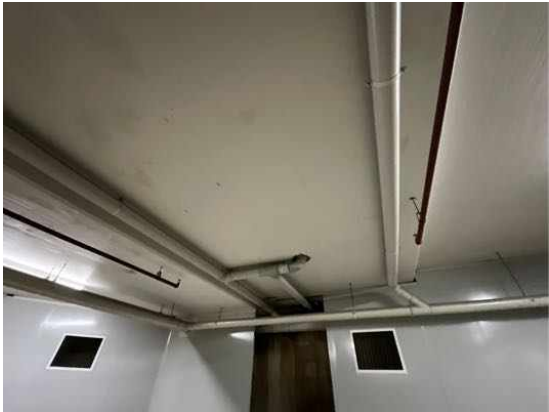
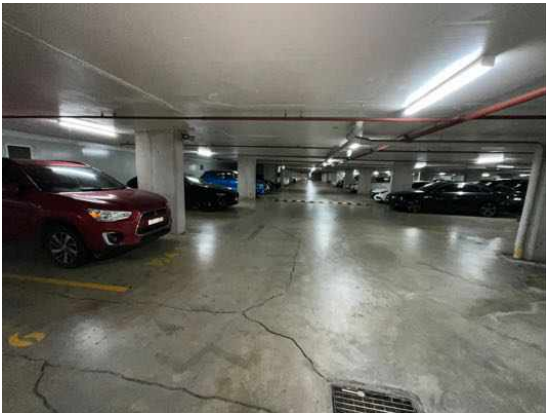
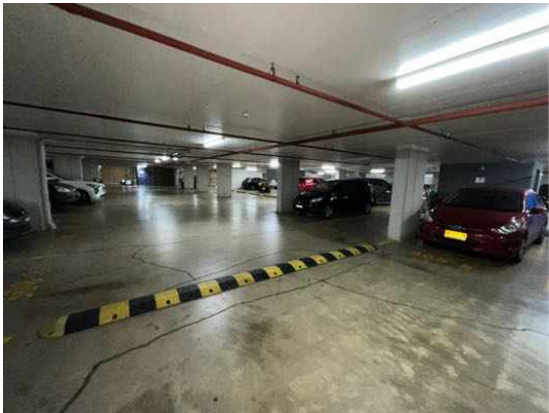
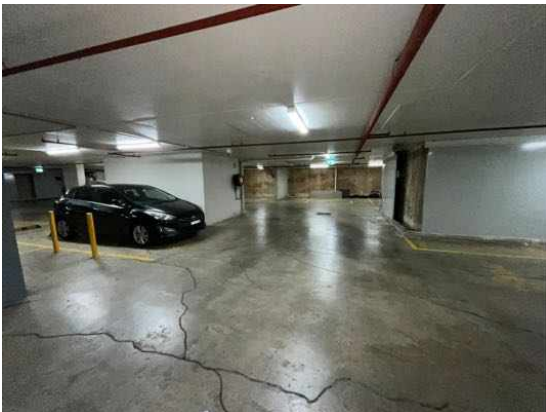
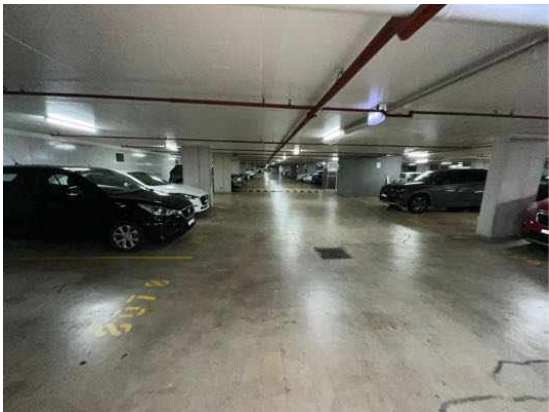
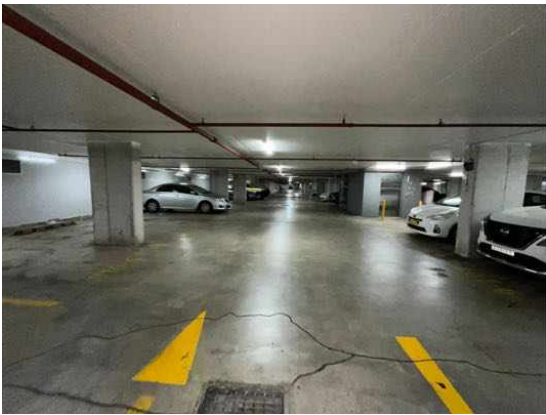
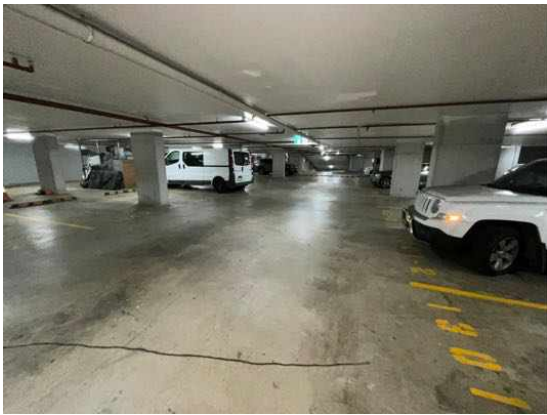
Building:	Main Building
Location:	Garage
Finding:	Additional Photos- Garage
Information:	Additional photos are provided for your general reference. Arrows may have been included to highlight areas of importance. Please discuss these photos with your building consultant for clarification.

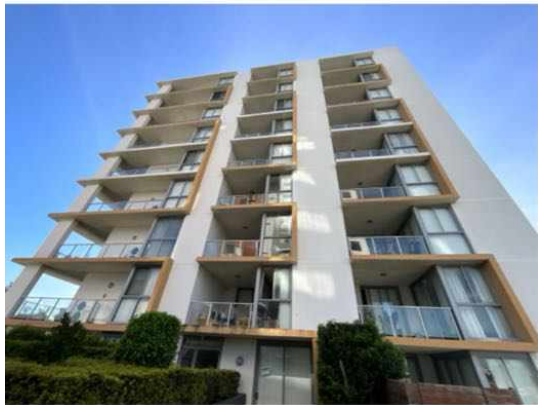
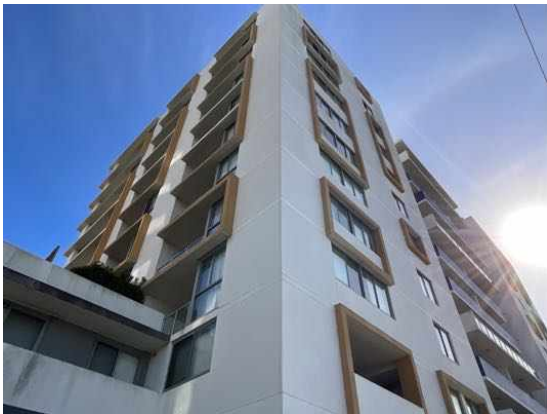
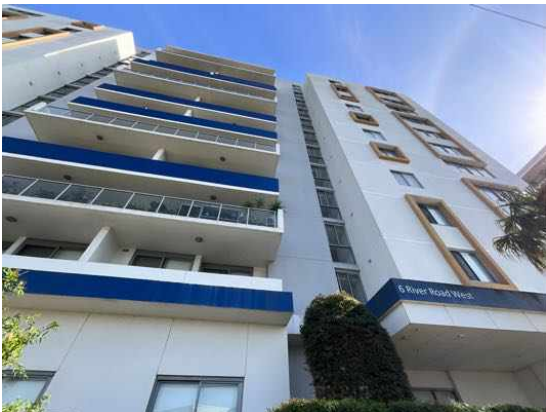
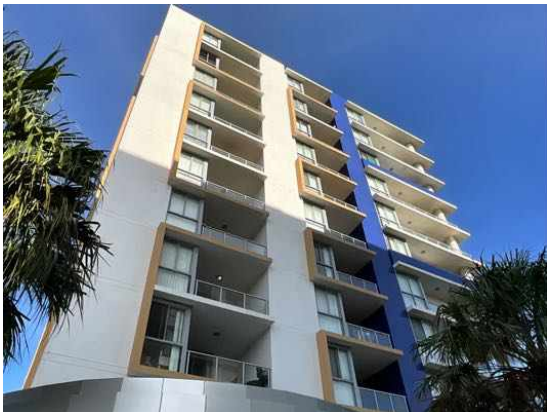
Finding: Additional Photos

Information: Additional photos are provided for your general reference.
