Building and Timber Pest Inspection Report

Inspection Date: Wed, 1 Apr 2026

Property Address: 70 Edgeware Rd, Enmore NSW 2042,
Australia

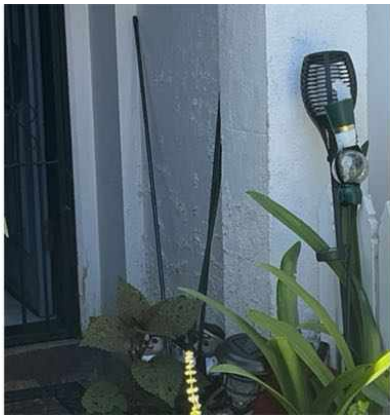
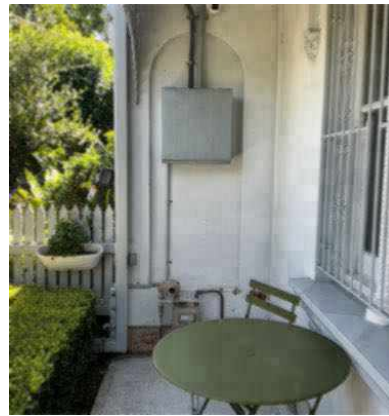
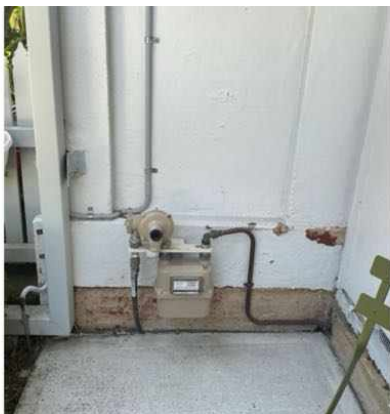
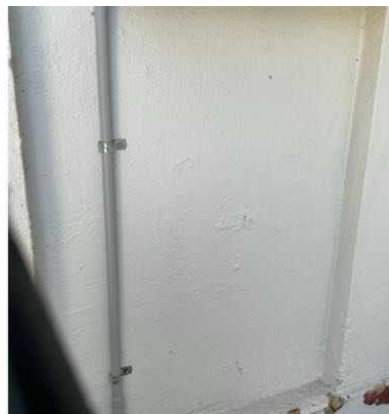
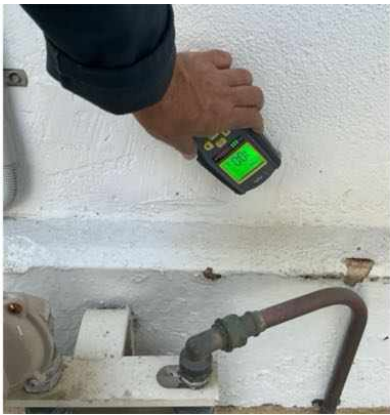
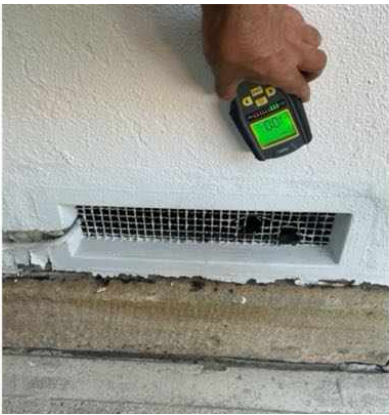
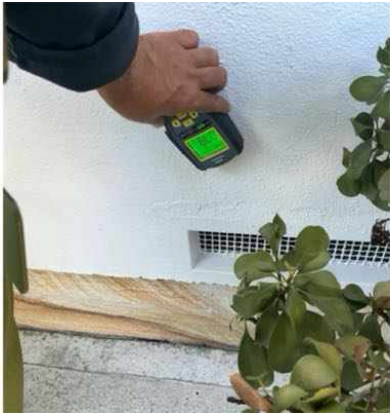
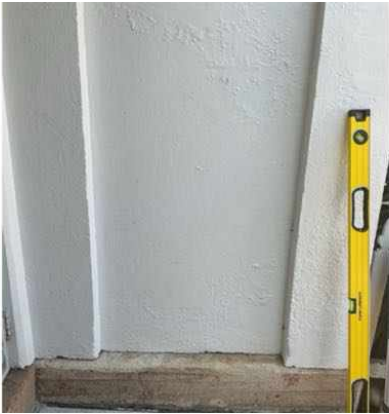
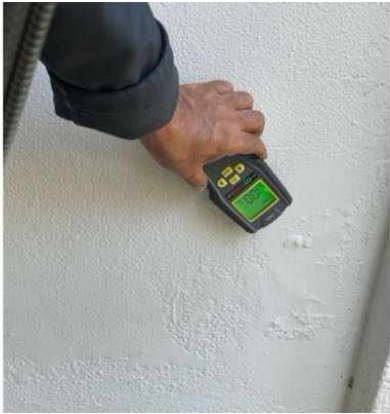
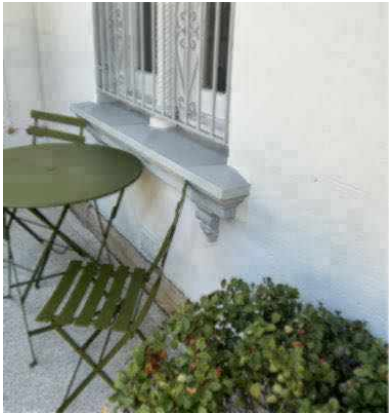
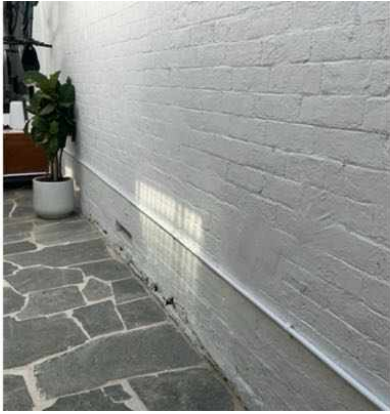
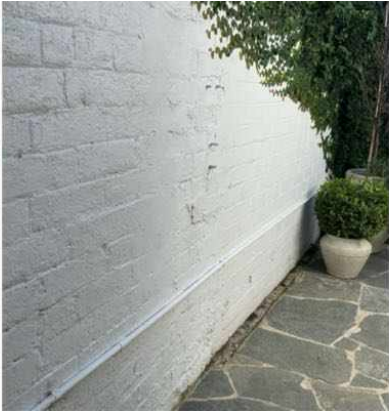
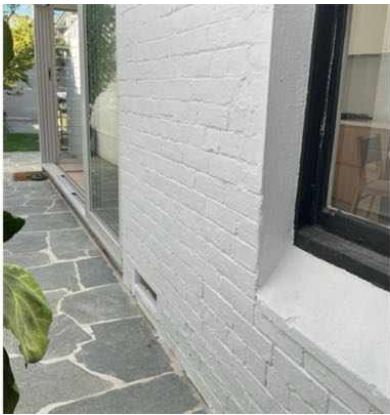
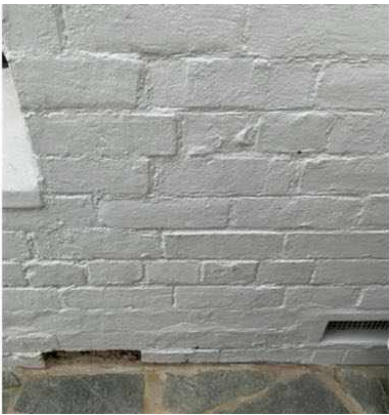
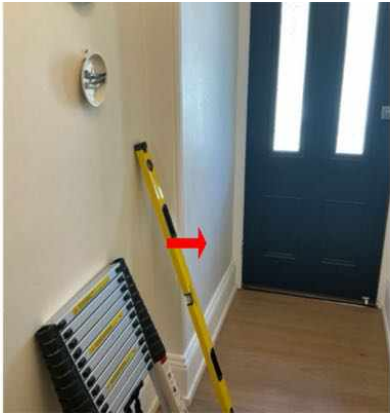
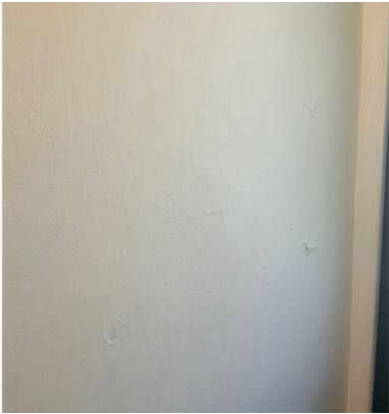
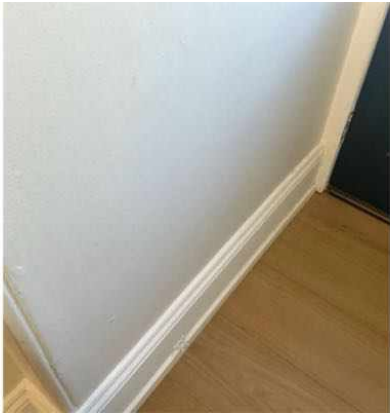
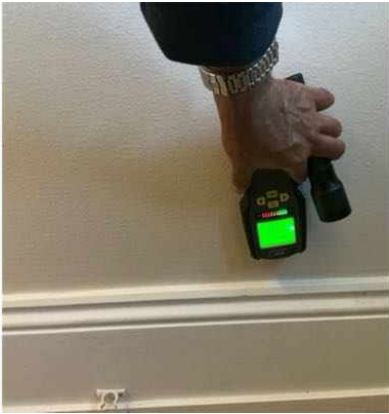
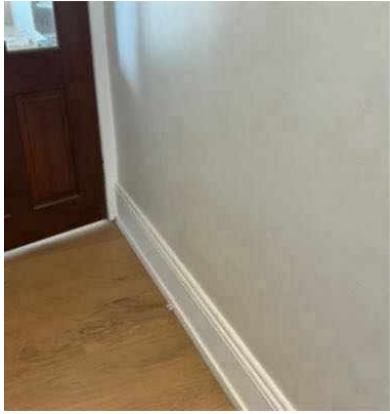
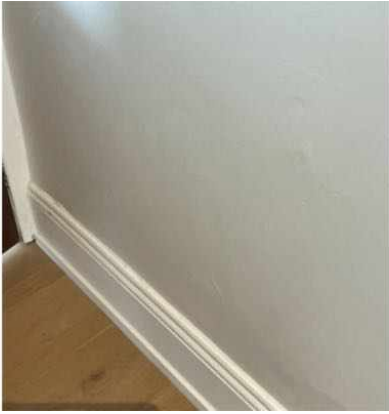
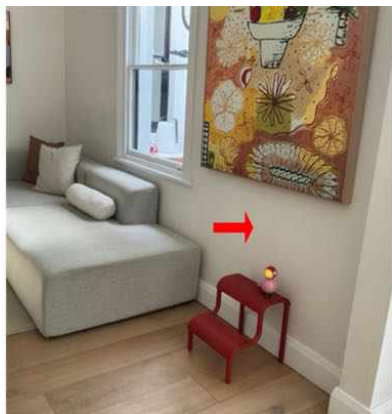
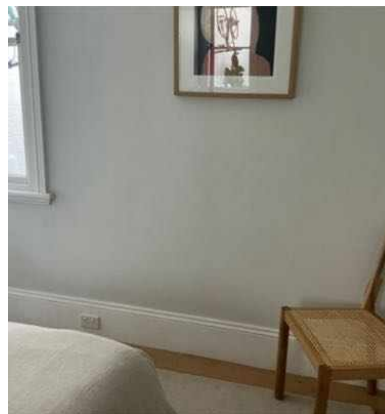
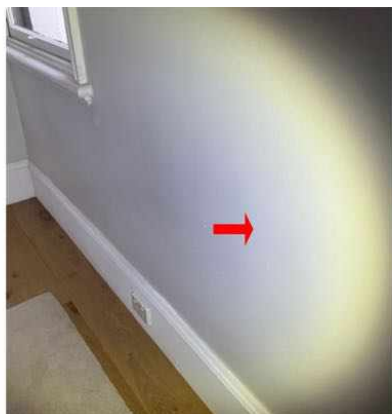
The first step in addressing damp is to diagnose the cause. The identified cause should be addressed first prior to repairing the appearance and other defects which have resulted from the rising damp. If the original cause is not resolved, further cases of damp are likely to ensue, resulting in secondary defects.

Consultation with a qualified plumber is advised immediately to identify the cause of damp and perform remedial works as required. Where excessive mould growth is present, further inspection by a specialist environmental health inspector should also be considered.

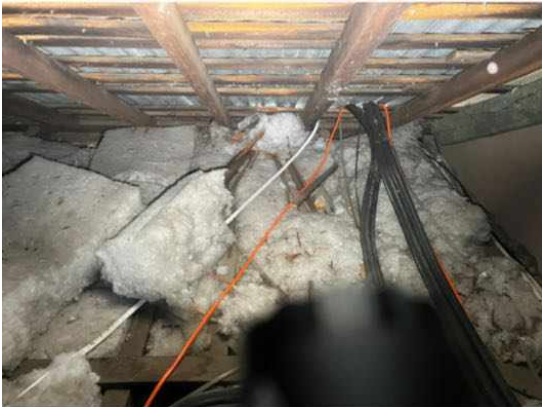
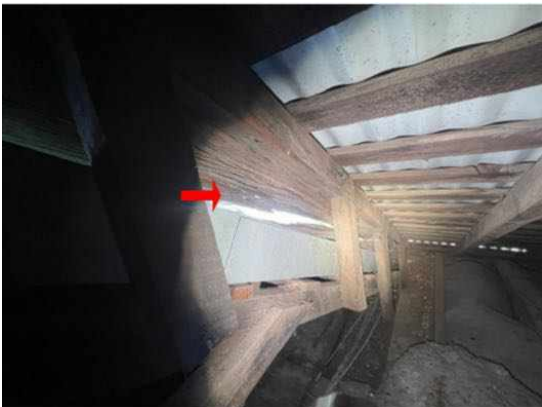
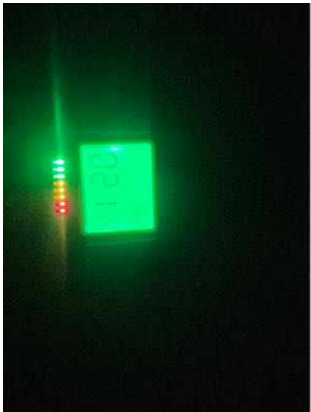
Finding 2.02

Building:	Main Building
Location:	Roof Void
Finding:	Roof Void condition (Timber splitting , Decay , elevated moisture and delignification)
Information:	Significant deterioration was observed to multiple roof framing members, including splitting, decay, and early-stage delignification consistent with prolonged moisture exposure. Localised areas of advanced deterioration were noted, including a substantial void within a fascia element, which may allow water ingress and indicates material failure. Elevated moisture readings at the time of inspection suggest an active or ongoing moisture source.

Urgent investigation to identify the source of moisture, along with rectification by a licensed carpenter and/or roofing contractor, is recommended.

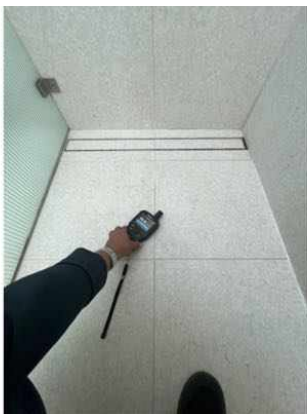
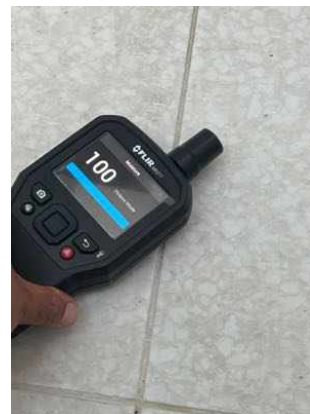
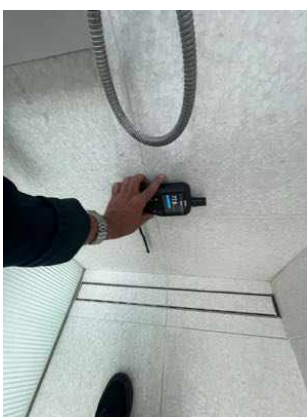
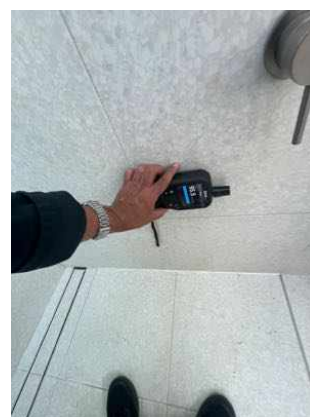
Finding 3.01

Elevated moisture readings in tiled wet areas can occur from normal shower use, age/deterioration of waterproofing membranes, plumbing leaks or moisture absorption through grout lines. While no damage was visible, elevated readings may indicate moisture retention behind tiles, which can be a conducive condition for future deterioration if not monitored.

Monitor the area over time for signs of drumming, efflorescence, tile movement, or grout deterioration. Further inspection by a licensed waterproofing is recommended (e.g., pressure testing, membrane assessment).

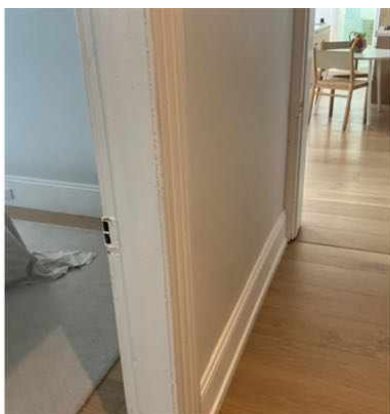
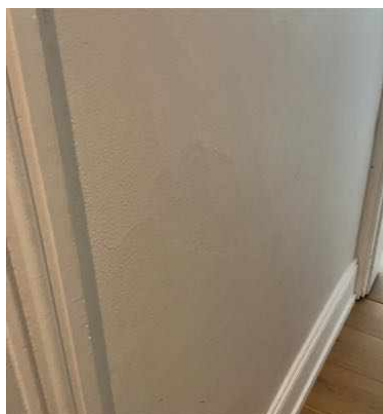
Finding 3.02

Building: Main Building
 Location: All Internal Areas

Render may swell and shrink with changes in air humidity if the area has sustained moisture damage. Any exposure to moisture is capable of causing rendered areas to become drummy and/or cracked over a prolonged period of time. Drummy render generally requires chipping off and re-rendering or painting.

Specialist trades are available for these types of services. A registered builder may be required to undertake works if damage is extensive, or if secondary building defects have resulted. Immediate action is recommended to ensure that no further damage is sustained in the affected area.

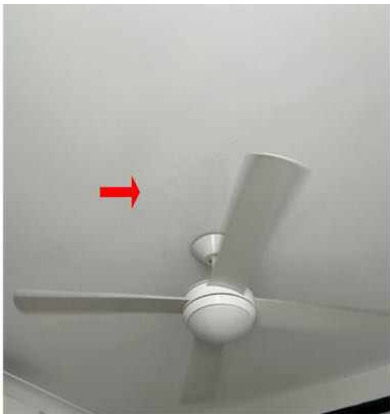
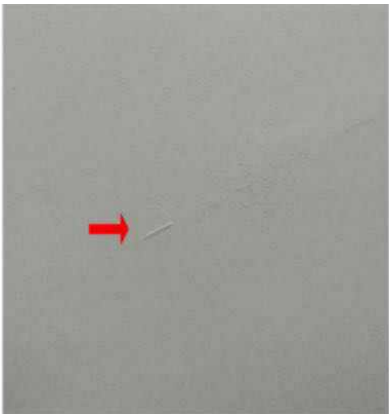
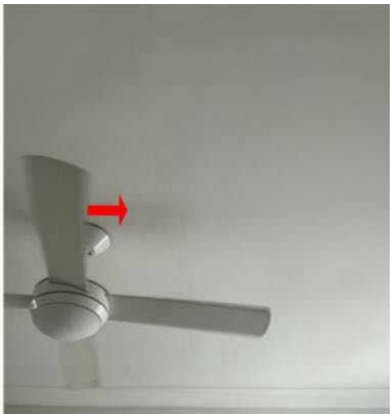
Finding 3.03

Building: Main Building
 Location: All Internal Areas - Bedrooms

It is highly advised that the affected paint be cleaned to allow a further, more invasive

inspection by a licensed plumber. Failure to act on this defect may necessitate major works in the future.

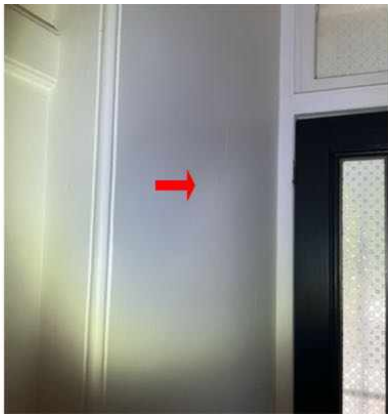
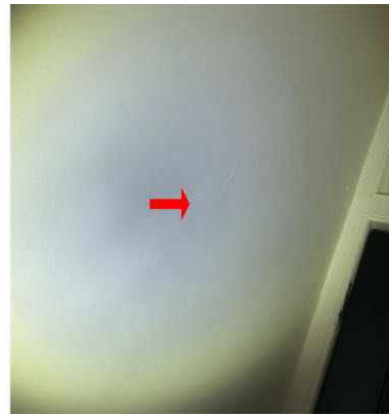
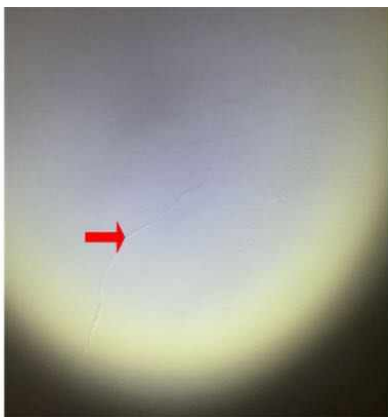
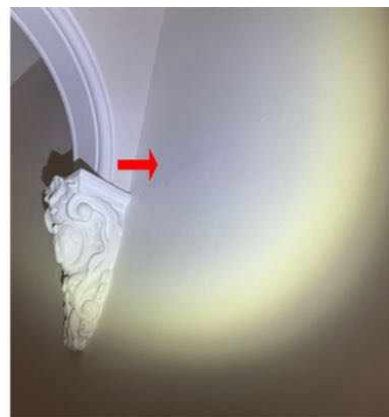
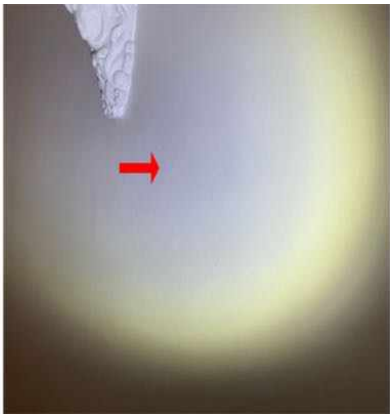
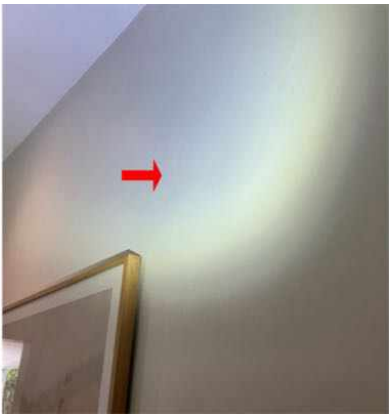
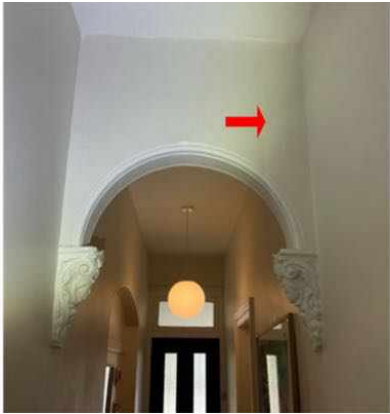
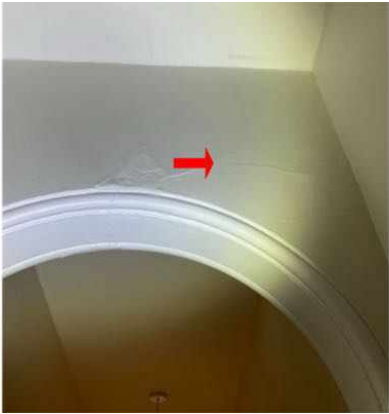
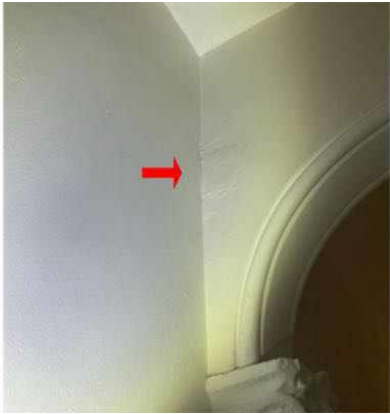
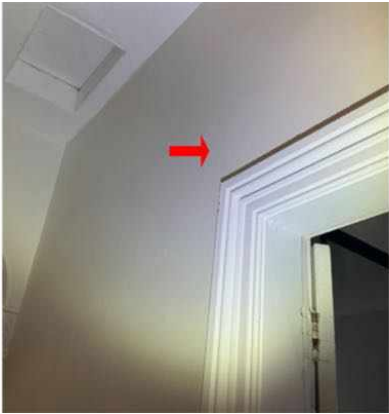
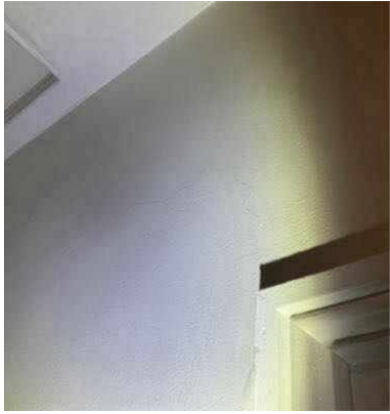
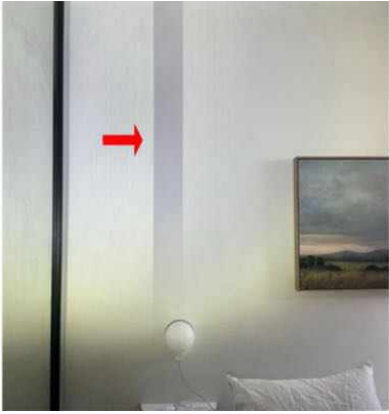
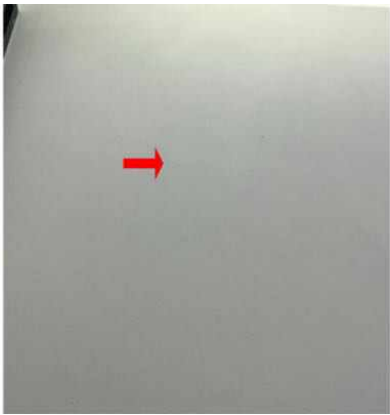
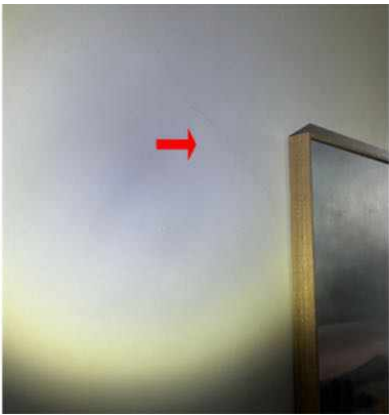
Building: Main Building
Location: All Internal Areas
Finding: Cracks to internal render - Category 2
Information: It has been observed that cracking to internal rendered surfaces has occurred. The degree of damage falls within Category 2, described as noticeable cracks which are easily filled. Cracking of this size are generally less than 5mm in width. There was also evidence of previous repairs extent of which can't be determined during a visual non invasive inspection.

Category 2 damage is required to be monitored for a period of 12 months. After the monitoring period, a crack rated at Category 2 or above is considered a defect requiring rectification.

Always contact your building inspector should cracks widen, lengthen, or become more numerous.

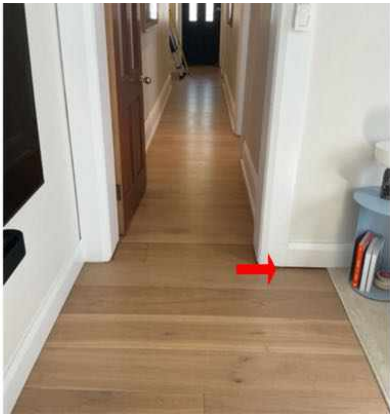
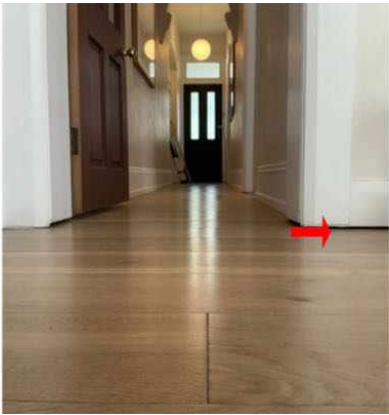
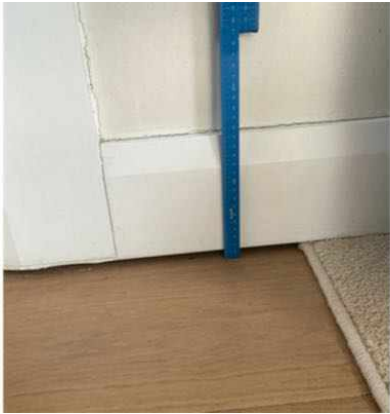
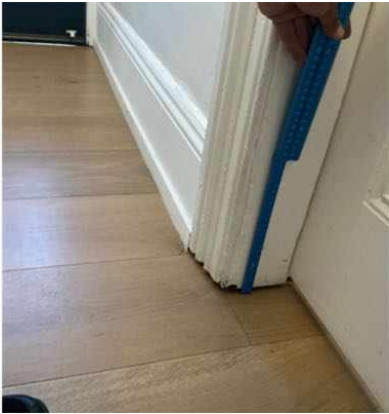
Finding 3.07

Building: Main Building
Location: All Internal Areas
Finding: Gap between skirting and Floor
Information: gap is visible between the skirting board and the laminate/timber floor finish, indicating minor floor level variation or movement of the floating floor system. This condition is most consistent with minor slab/floor unevenness, floor finish movement or shrinkage. While primarily cosmetic/serviceability in nature, monitoring is recommended and further assessment may be warranted by a licensed builder if additional signs of structural movement become apparent.

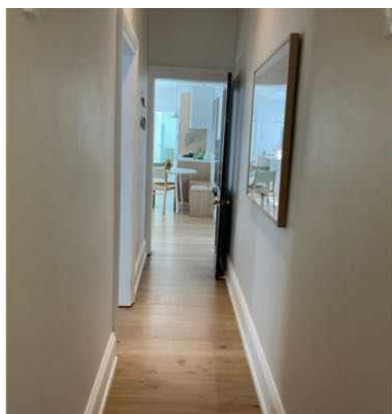
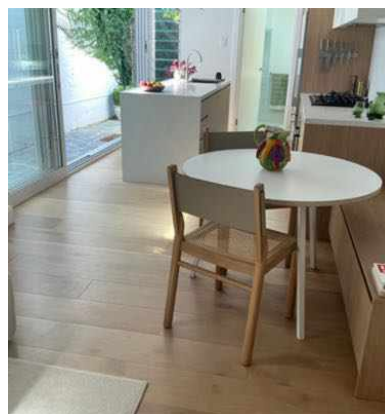
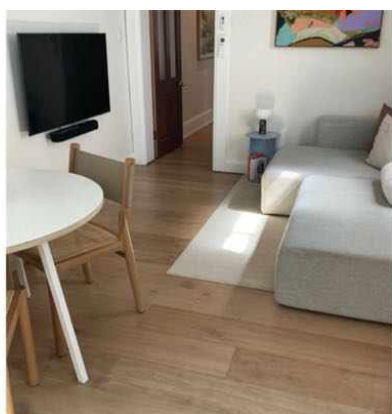
Finding 3.08

Building: Main Building
 Location: All Internal Areas
 Finding: Floors - bouncy to some areas
 Information: The internal flooring in this area was identified as being bouncy at the time of inspection. A bouncy floor surface generally presents as a discernible change in level as they are walked across, in noisy or creaking flooring, or in consequent movement of surrounding furniture and fixtures.

Bouncy floors generally indicate that the floorboards or the subfloor structures are coming loose from the joists that they are installed on. Bouncy flooring may also be the result of gaps between flooring and stumps or joist structures, which require packing.

The client is advised to seek quotations for required repairs from a Registered Builder specialising in re-stumping. The potential resolution may range from packing gaps in subfloor structures through to replacement of subfloors stumps and refixing of flooring.

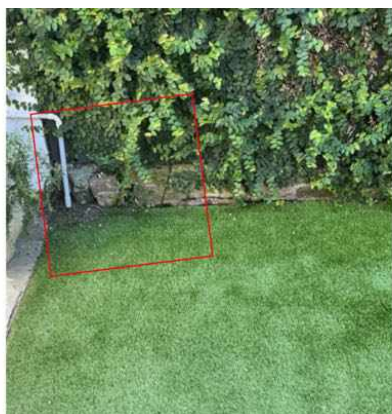
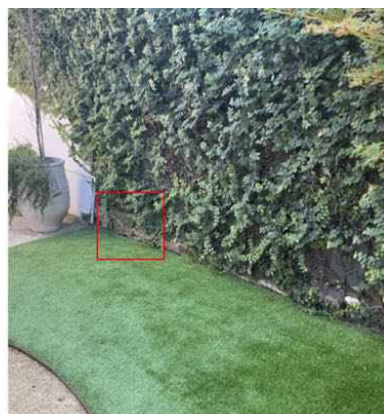
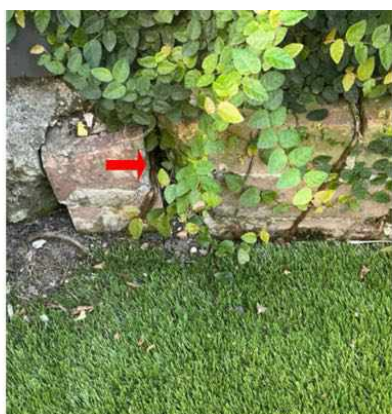
Finding 3.09

Building: Main Building
 Location: All External Areas
 Finding: Building element - Damaged - Brickwork cracking (Sleeper wall under fence)

Information: Breakage occurs generally when the building materials have either aged and decayed, or as a result of damage (accidental or deliberate).

Repair and/or replacement of broken elements is advised to ensure that additional secondary defects do not arise as a consequence. Such works are necessary, as all building elements play a key role in the operation and function of the overall structure and its performance.

A relevant tradesperson should be appointed to repair or replace the affected building element prior to any subsequent damage being caused.

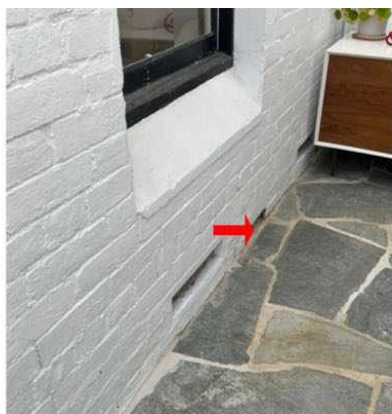
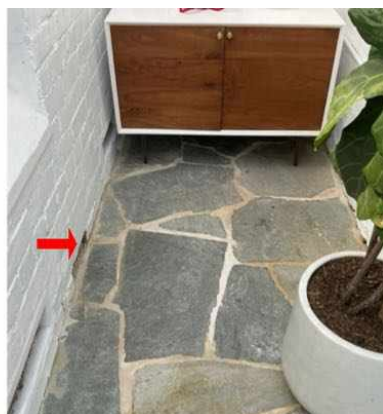
Building:	Main Building
Location:	All External Areas - Side
Finding:	Building element - Damaged - Brick face missing or damaged
Information:	Breakage occurs generally when the building materials have either aged and decayed, or as a result of damage (accidental or deliberate).

Repair and/or replacement of broken elements is advised to ensure that additional secondary defects do not arise as a consequence. Such works are necessary, as all building elements play a key role in the operation and function of the overall structure and its performance.

A relevant tradesperson should be appointed to repair or replace the affected building element prior to any subsequent damage being caused.

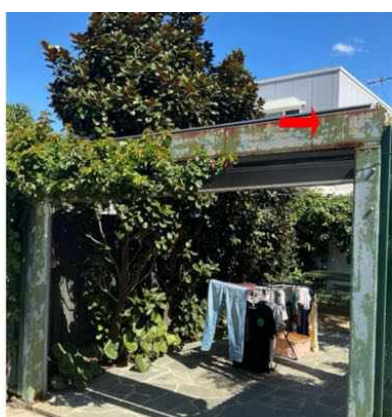
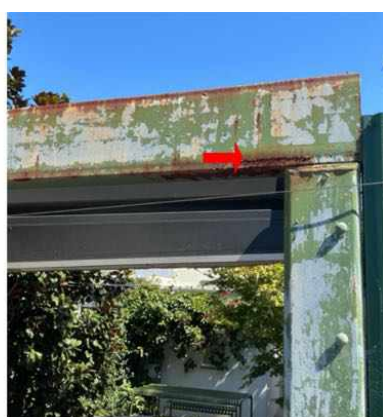
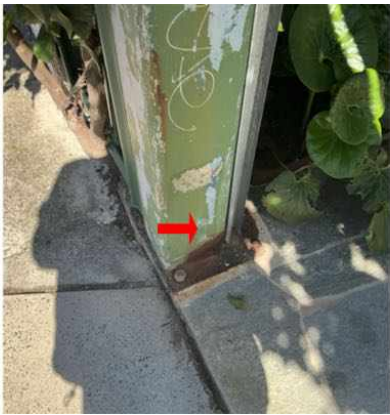
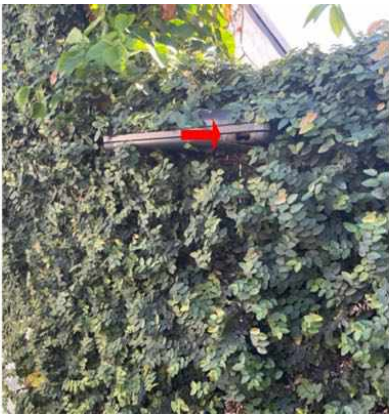
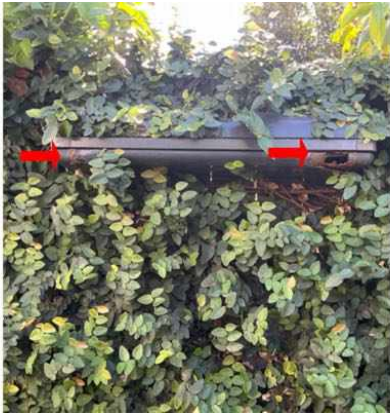
Finding 3.12

Building:	Main Building
Location:	All External Areas - Rear
Finding:	Building element - Rusted or corroded
Information:	This building element shows evidence of rusting and corrosion, which is likely to have developed as a result of excessive exposure to moisture and or inadequate coatings.

As surface rust provides no protection to the underlying iron, the deteriorating condition is likely to worsen if not addressed in the short-term future.

Where possible, the use of galvanized (treated) metals or aluminium coated metals aid in rust prevention, as does regular general maintenance. Rust formation can be controlled with coatings, such as paint, that isolate the iron from the environment.

Rusting and corrosion should be managed by ideally removing or limiting the affected surface from exposure to moisture. A registered builder may be appointed to replace any building elements that have been severely affected by rust or water damage.

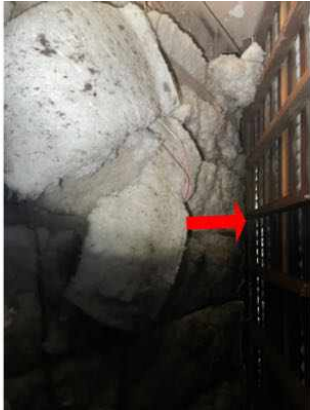
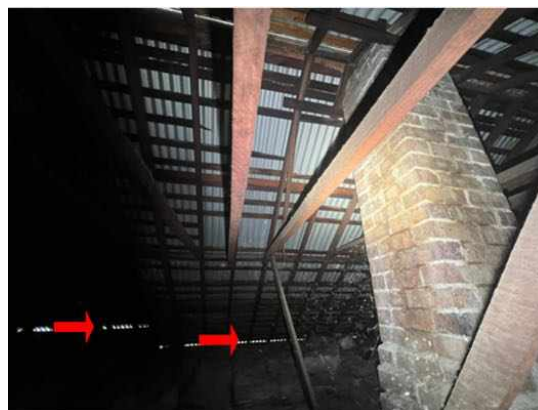
Finding 3.13

Building: Main Building
 Location: Roof Void
 Finding: Roof Void – No Sarking & Light Ingress
 Information: Light ingress is visible through multiple roof tile laps, which is typical of older tile roofs without sarking and may allow minor wind-driven moisture or dust into the space, though no active leaks were observed.

Consider retrofitting sarking or roof wrap in the future to improve thermal and moisture performance.

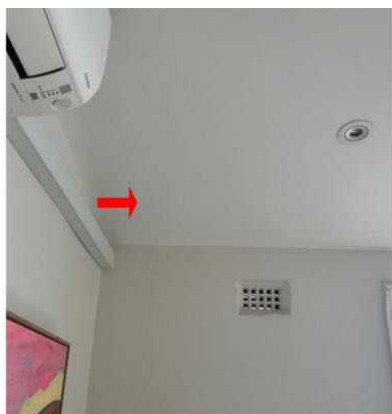
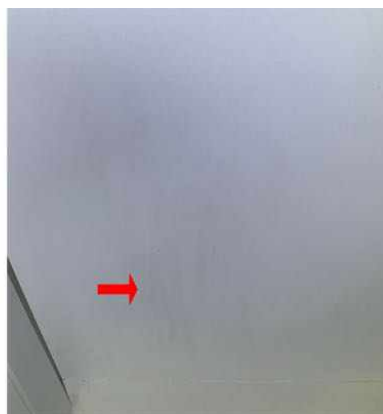
Finding 3.15

Building:	Main Building
Location:	All Internal Areas - Lounge
Finding:	Water staining
Information:	The pattern is consistent with possible historic moisture staining; however, no active water ingress or deterioration was evident at the time of inspection. Monitoring is recommended, and further investigation by a suitably qualified tradesperson should be undertaken if the condition worsens or moisture is detected.

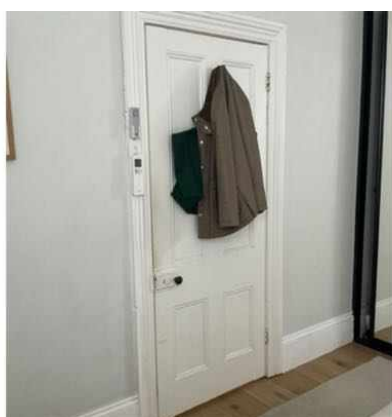
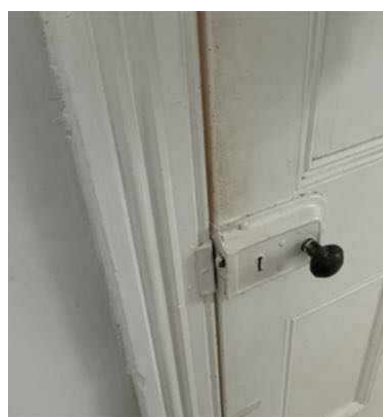
Finding 3.16

Building:	Main Building
Location:	Bedroom 2
Finding:	Doors - Binding/Jamming
Information:	Binding and/or jamming of several doors throughout the property were evident during standard operation. This defect inhibits the functionality of affected doors as well as creating potential for secondary defects to associated building elements, such as damage to the floor covering.

A door that binds to flooring or to the associated door frame may have several causes, ranging from minor defects, such as poor installation of the door or deteriorated hinges, through to major structural issues, such as damage to subfloor structures.

Where door binding/jamming appears to indicate major structural issues, a registered builder specialising in re-stumping should be appointed to provide an estimate on the cost of rectification.

For minor causes, a qualified carpenter or general handyman should be appointed to perform minor rectification works at client discretion.

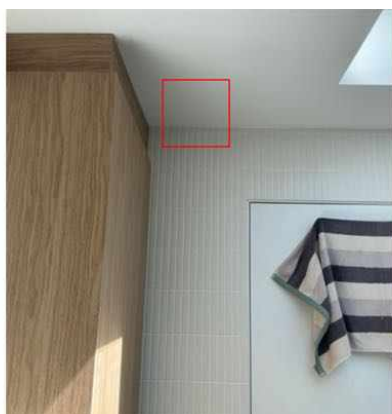
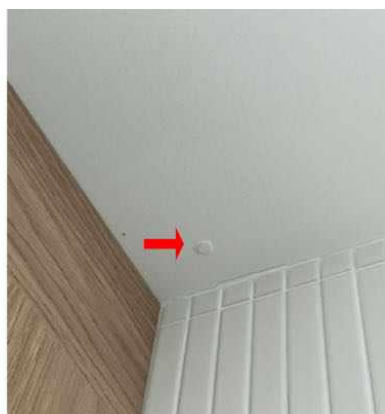
Finding 3.17

Building:	Main Building
Location:	All Internal Areas
Finding:	Ceiling nails - Popping To some areas
Information:	Numerous popped nails were identified in the internal ceiling at the time of inspection. Nails and screws hold simply by the friction between them and the surface they are applied to. Over time, the nails and screws can back out, which is often a result of general ageing and deterioration of the building structure.

If left unmanaged, the ceiling sheets may become loose and unstable, increasing the rate of deterioration of the internal ceiling and creating potential for the development of secondary defects.

Re-fastening of popped nails will help to maintain the stability of the internal ceiling and associated building elements. Such minor works will also help to improve the appearance of the affected area and secure the ceiling sheets, so as to prevent the onset of ceiling sagging. These works should be performed by a qualified carpenter or plasterer at client discretion.

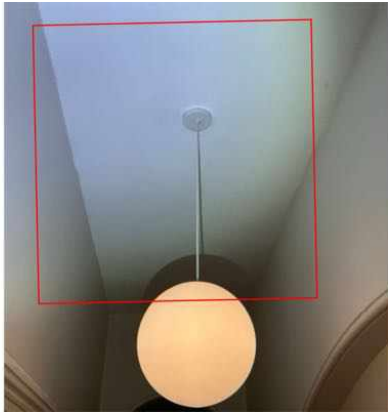
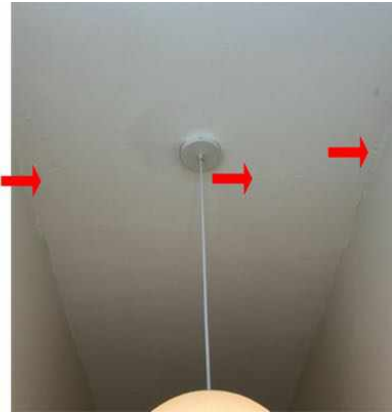
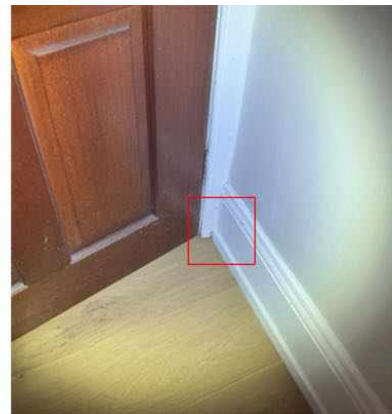
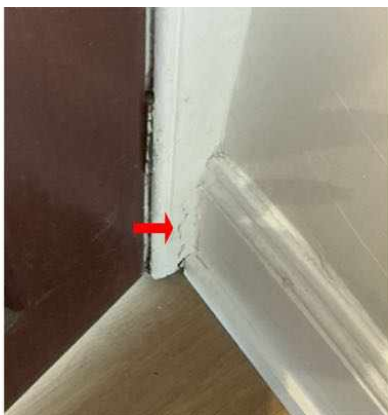
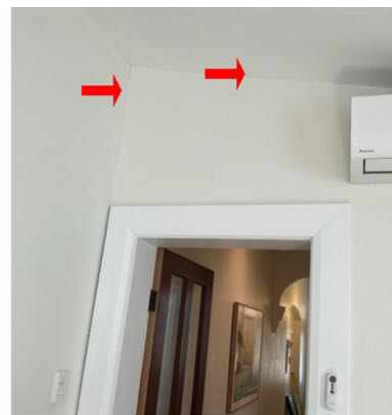
Finding 3.19

Building:	Main Building
Location:	All Internal Areas
Finding:	Paint Finish & Hairline Cracking - To some areas
Information:	The paint finish in this area was identified as being incomplete at the time of inspection including some hairline minor cracking.

Whilst incomplete or missing paint and minor cracking and imperfections in finish is generally an appearance defect, it can also lead to the development of secondary building defects over time. Incomplete areas of paint finish expose the area to moisture, potentially accelerating the deterioration of underlying building materials.

Incomplete paint finishes should be sanded back, filled, leveled and painted, as applicable. Where inadequate or missing paint protection has led to the deterioration of the associated building element, repair and/or replacement of this building element may be required.

A painting contractor should be appointed as soon as possible to perform necessary works to aid the appearance of the affected area and to ensure the area is protected against further deterioration. Alternatively, the homeowner following manufacturer instructions may perform these works.

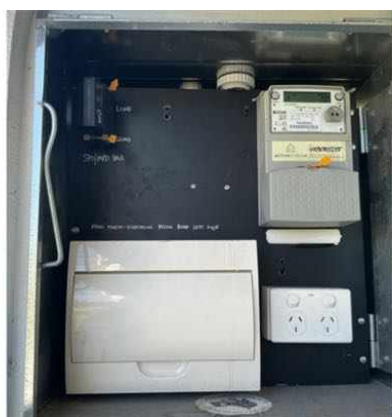
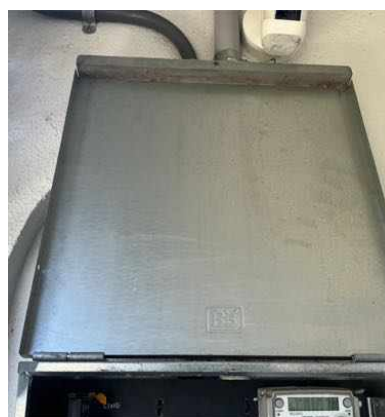
Building:	Main Building
Location:	All External Areas
Finding:	Termite Management System - no evidence of a chemical installation
Information:	The application of a post-construction chemical termite barrier is highly recommended for all properties, particularly if live termite activity has been found on the site previously. Such barriers are highly effective in preventing termite attack on any timber building elements throughout the property.

A durable notice should be placed in the switchboard unit to indicate current termite barriers. At the time of inspection, it appeared as though no termite management system has been installed, with no evidence to suggest preventative works taking place.

The client may consider gaining further advice from a pest controller as to the costs and procedures involved with this application. It is recommended that obtaining such advice be a short-term priority.

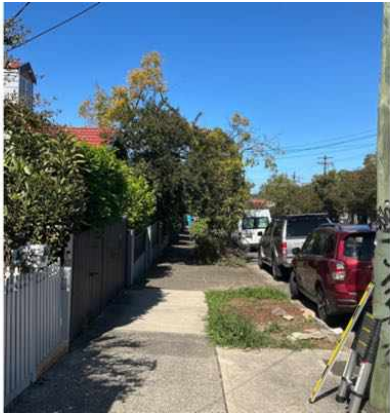
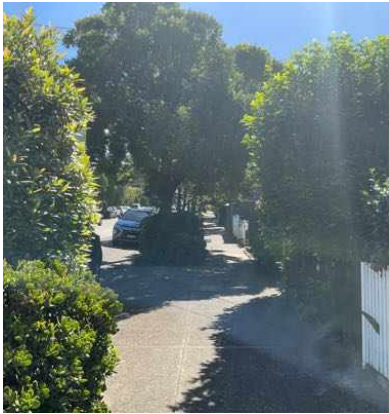
Finding 6.02

Building:	Main Building
Location:	All External Areas
Finding:	Trees within 50m
Information:	Trees within 50m of the property can be conducive to termite activity. It is recommended an invasive inspection of all trees with 50m to the property be carried out by a qualified pest control expert.

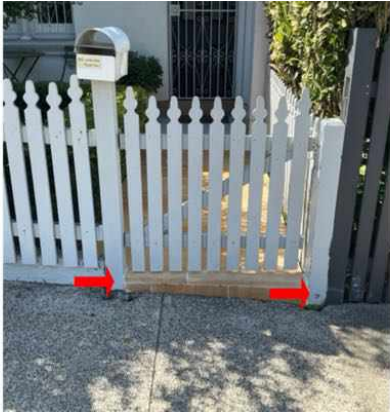
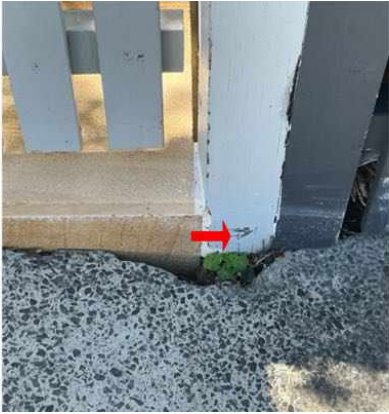
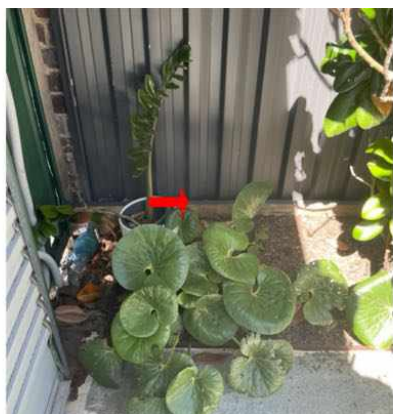
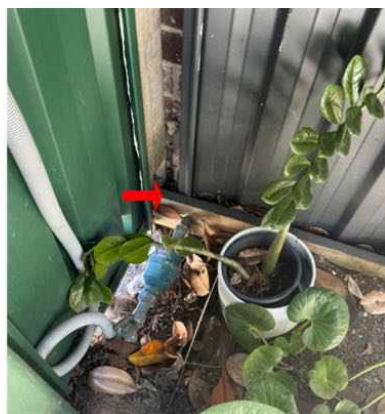
Finding 6.03

Building: Main Building
Location: All External Areas
Finding: In ground contact - Timber to some areas
Information: Any timbers in direct ground contact provide opportunity for concealed termite entry and are likely to be subject to premature rot and decay as the soil retains moisture or damp conditions against the timbers.

Remove untreated timber that is in direct contact with external grounds. Consider replacement with more durable materials i.e. treated timber or non timber elements. Frequent pest inspections are advised to readily identify any termite activity in these areas.

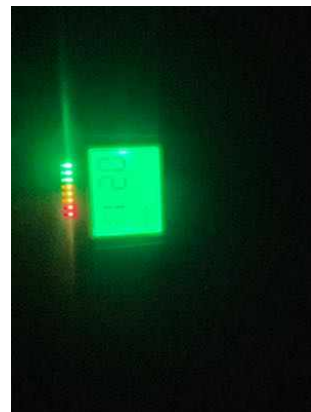
Building:	Main Building
Location:	All Internal Areas - Roof void
Finding:	Elevated moisture - identified
Information:	Elevated moisture can attract termites and produce conditions that promote fungal growth and wood decay.

Elevated moisture is generally caused by deteriorated, inadequate or missing roof drainage, leaking plumbing pipes or fixtures, poorly plumbed HWS overflows or condenser units and poor site drainage.

If mould growth has been found there may be environmental biological or health issues involved. In these cases an appropriately qualified inspector should also be contacted.

Prior to any remedial works being performed a qualified plumber should be appointed to further inspect the property and to identify the cause of the excessive moisture. Works to remove affected building elements may then be necessary and should be performed by an appropriate tradesperson.

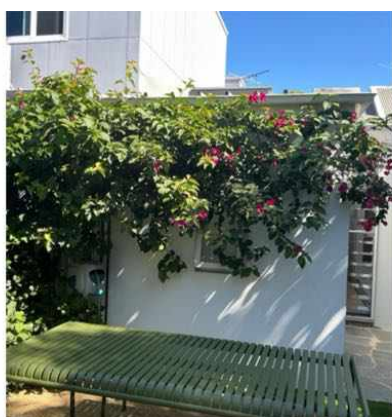
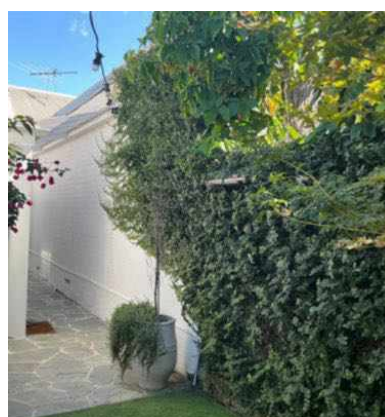
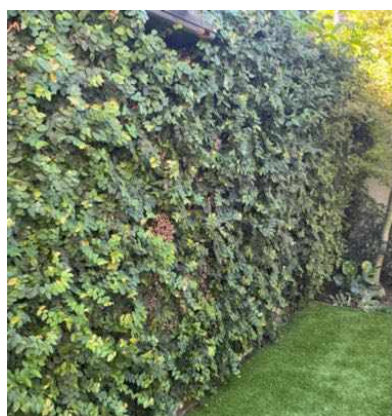
Finding 6.06

Location: All External Areas
 Finding: Bridging - Vegetation
 Information: Where vegetation obstructs inspection of building elements, also known as bridging as it provides a bridging point for the access of termites, full inspection can not be achieved. Consequently moisture or dampness may be present and the areas becomes conducive to termite activity. Plants against or very close to buildings provide cover, shade and can provide an environment that is attractive to termite infestation.

The removal and replanting of species that do not provide "cover" or cutting back of existing vegetation will assist greatly in preventing Bridging from occurring.

The removal of any such materials that may be conducive to termite activity should be carried out as soon as possible and arrange re inspection to minimize the risk of termite attack.

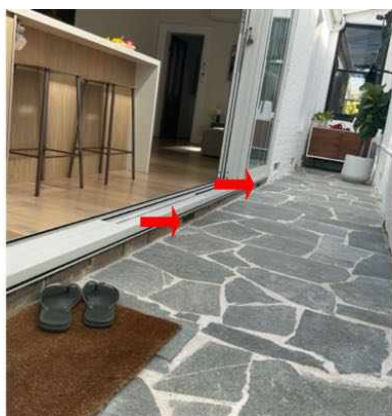
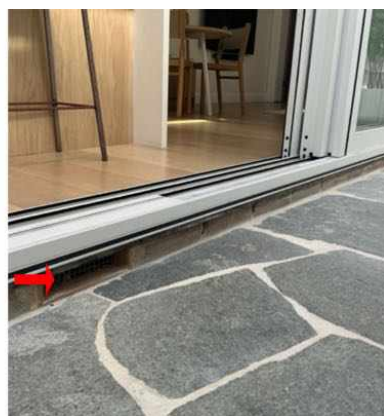
Finding 6.07

Building: Main Building
 Location: Subfloor
 Finding: Subfloor ventilation - Inadequate
 Information: Adequate subfloor ventilation aids in preventing excessive moisture wood rot and termite activity by ensuring a dry subfloor environment.

Where ventilation is substandard it is usually caused by factors such as failure to install adequate vents during construction subsequent building works or earth and vegetation covering over vents low subfloor clearance and items or debris in the subfloor restricting airflow.

Subfloor ventilation can be improved in most cases by addressing the causes such as exposing subfloor vents installing additional new vents installing mechanical (forced airflow) ventilation and removing debris from the subfloor.

A registered builder should be appointed as soon as possible to perform these works as necessary.

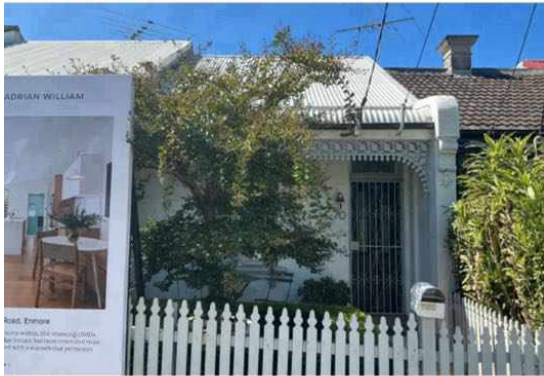
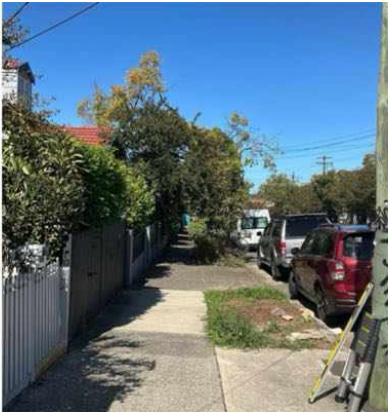
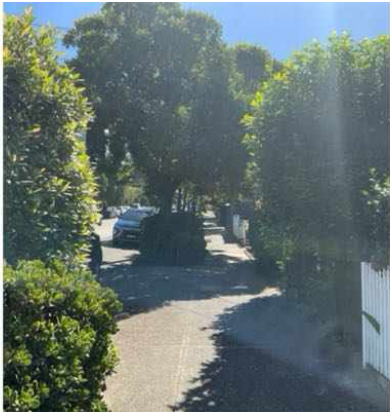
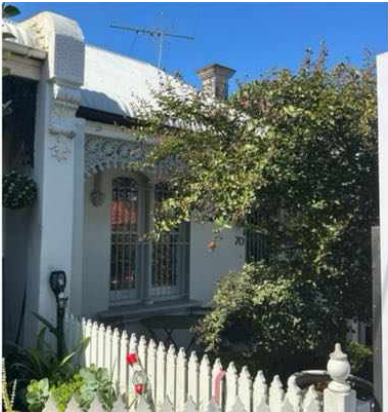
Noted Item

Building: Main Building
Location: All External Areas
Finding: Additional Photos - Obstructions and Limitations
Information: These photographs are an indication of the obstructions and limitations which impeded full inspection of the property at the time of inspection. These obstructions can hide an array of defects and should be removed to allow full inspection to be carried out. A re-inspection is recommended once the areas are made accessible.
