Building and Timber Pest Inspection Report

Inspection Date: Wed, 1 Apr 2026

Property Address: 70 Edgeware Rd, Enmore NSW 2042,
Australia

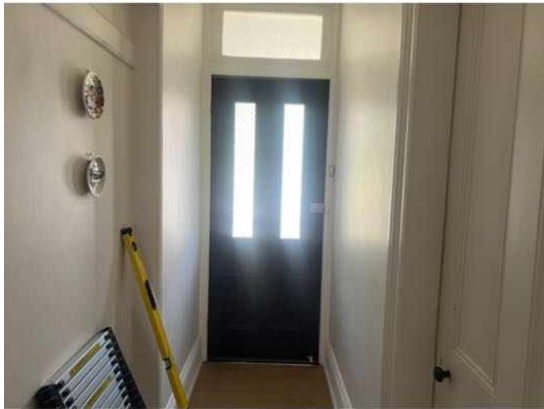
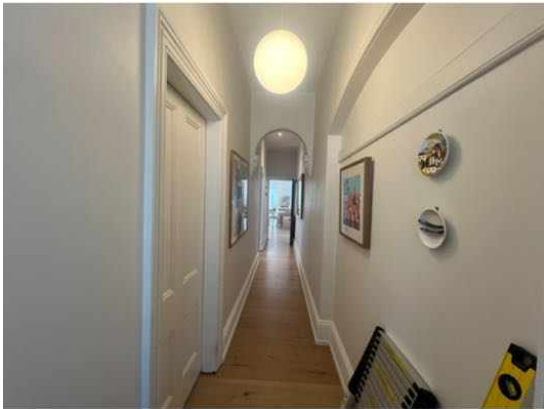
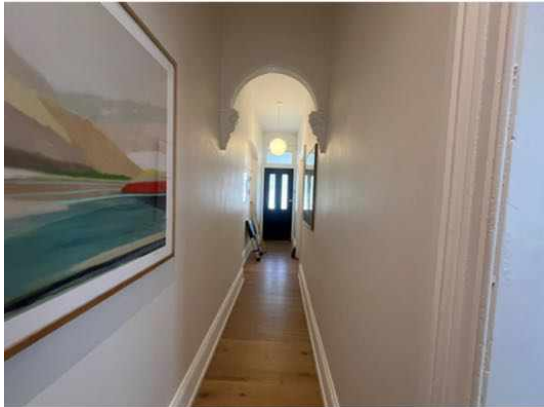
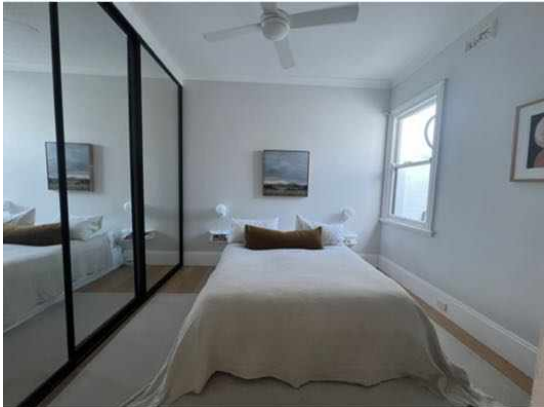
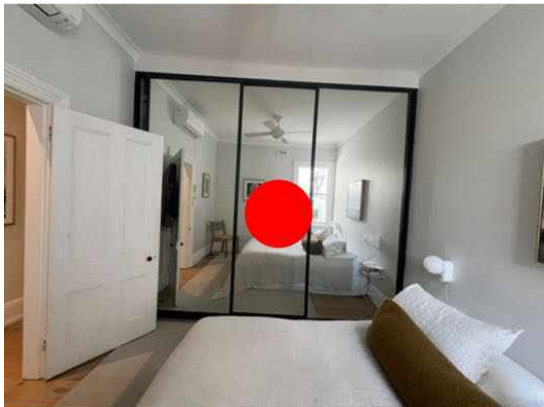
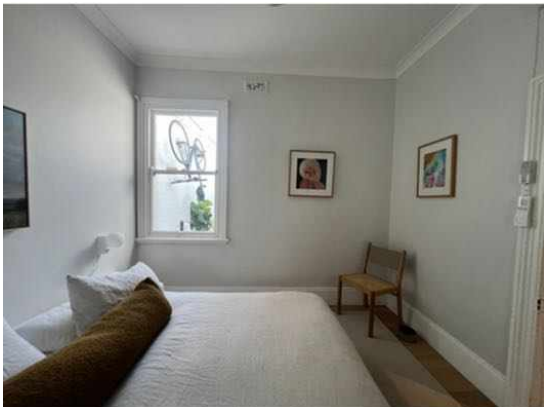
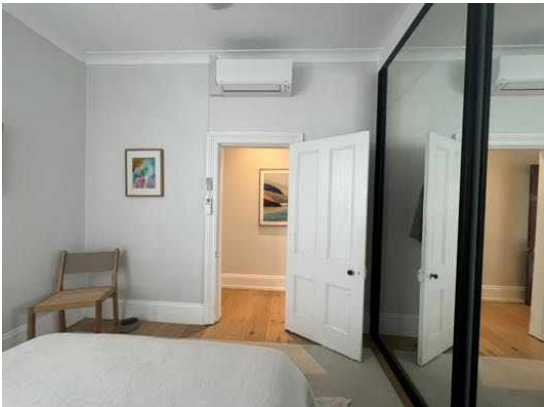
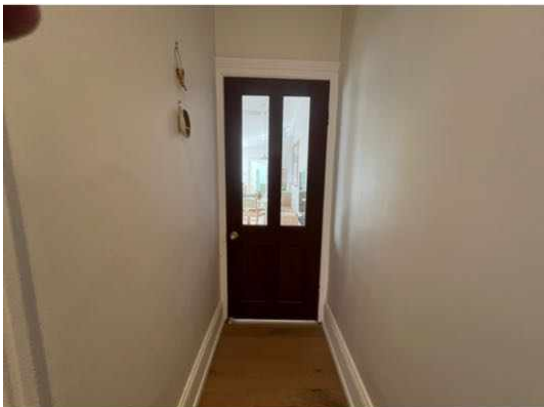
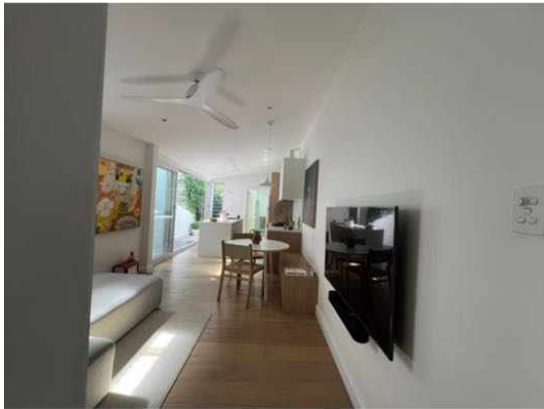
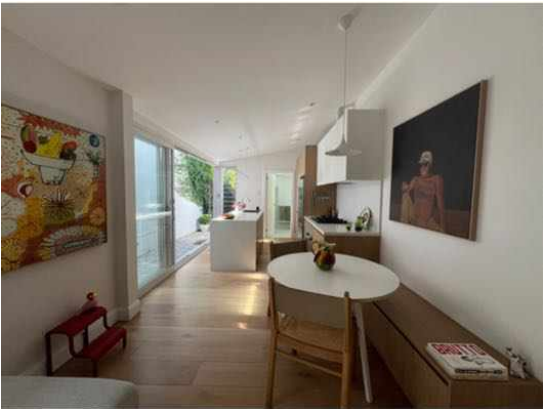
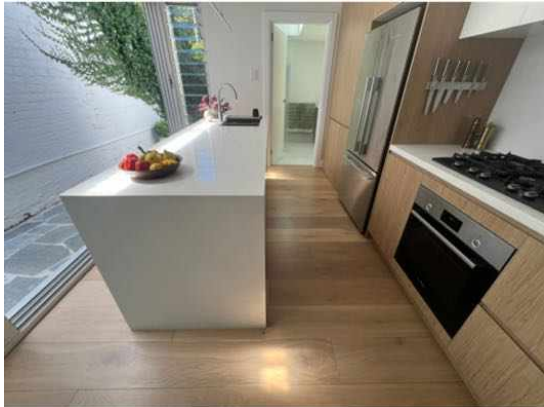
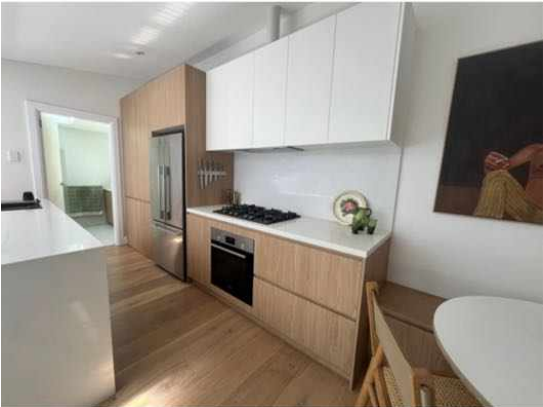
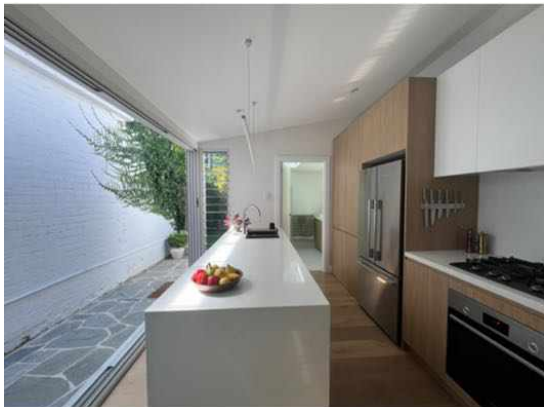
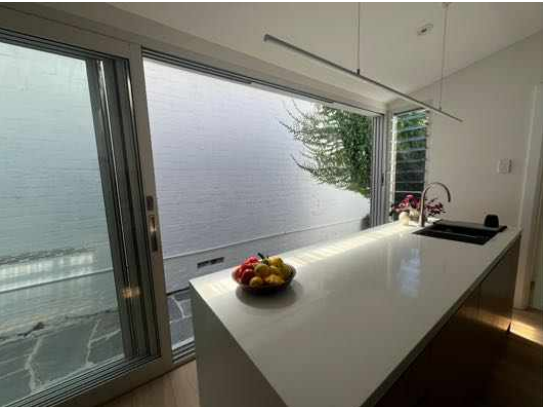
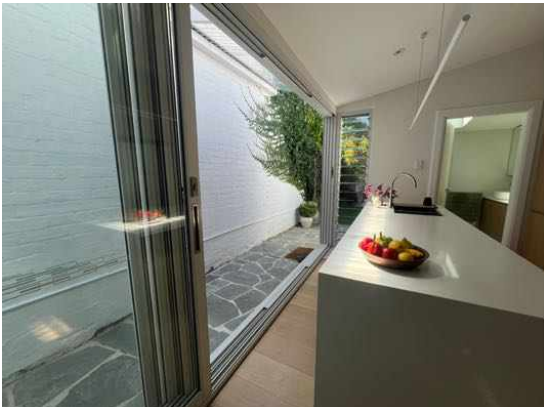
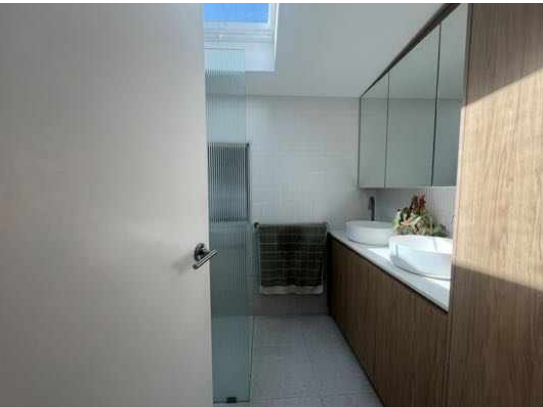
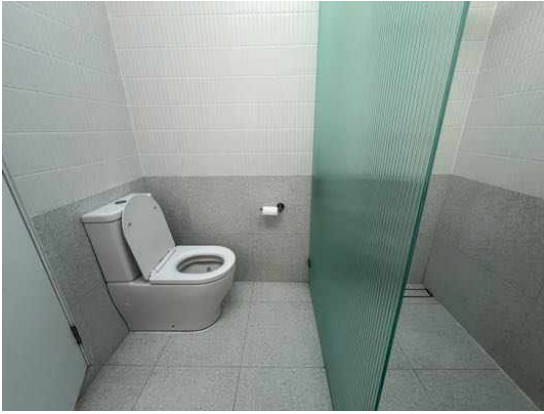
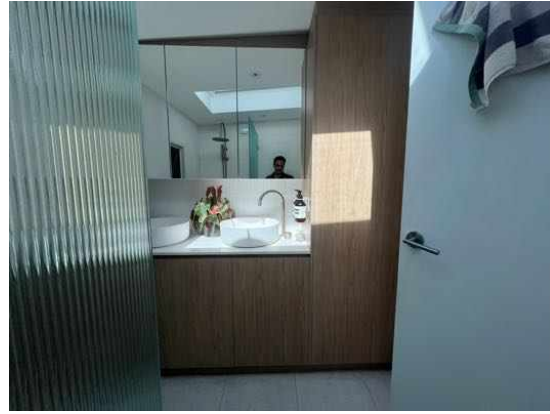
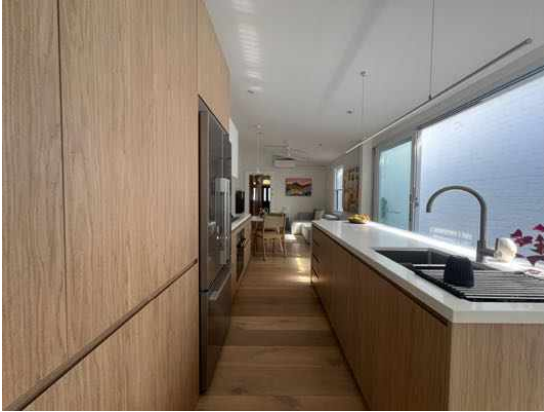
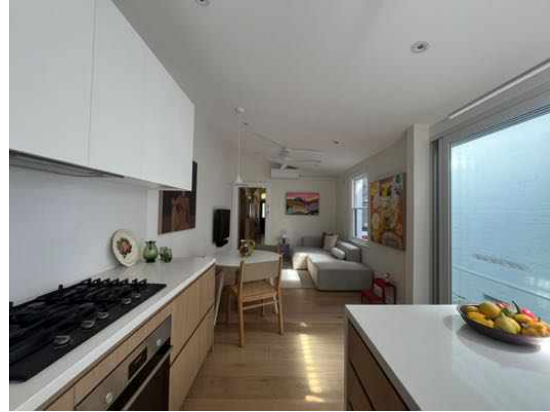
Building:	Main Building
Location:	All Internal Areas
Finding:	Additional Photos - Obstructions and Limitations
Information:	These photographs are an indication of the obstructions and limitations which impeded full inspection of the property at the time of inspection. These obstructions can hide an array of defects and should be removed to allow full inspection to be carried out. A re-inspection is recommended once the areas are made accessible.

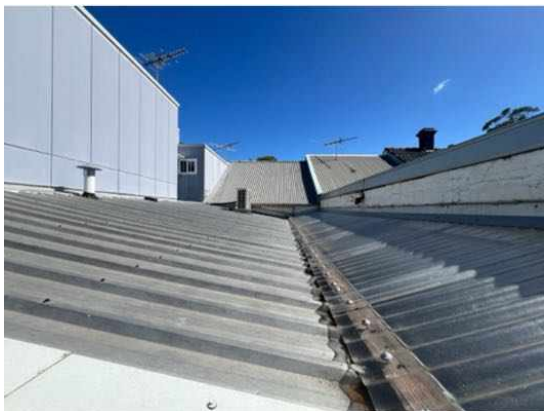
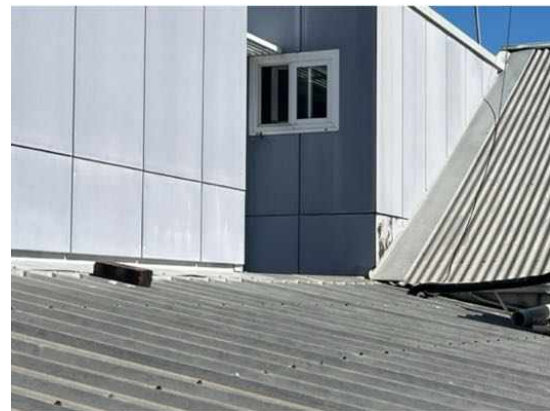
Building: Main Building
 Location: Roof Exterior
 Finding: Additional Photos - Obstructions and Limitations
 Information: These photographs are an indication of the obstructions and limitations which impeded full inspection of the property at the time of inspection. These obstructions can hide an array of defects and should be removed to allow full inspection to be carried out. A re-inspection is recommended once the areas are made accessible.

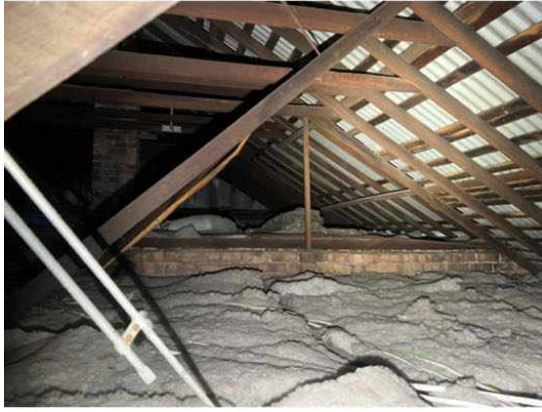
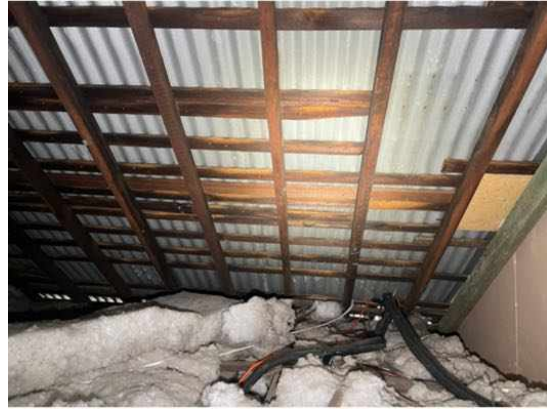
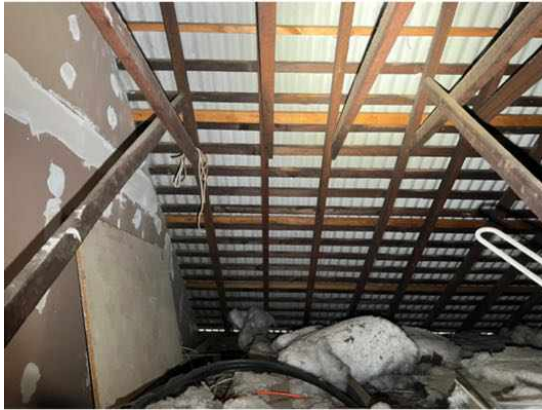
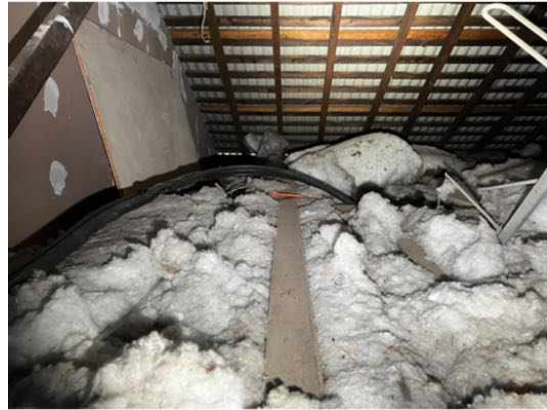
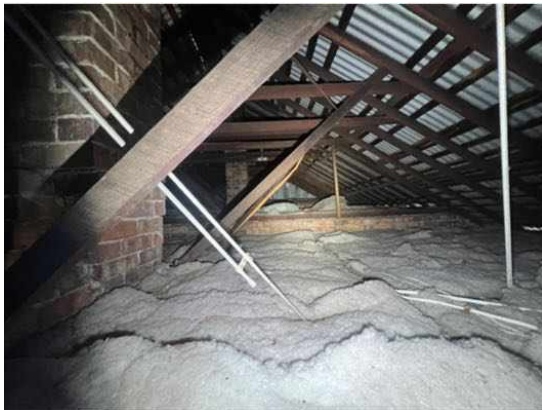
Building:	Main Building
Location:	Roof Void
Finding:	Additional Photos - Obstructions and Limitations
Information:	These photographs are an indication of the obstructions and limitations which impeded full inspection of the property at the time of inspection. These obstructions can hide an array of defects and should be removed to allow full inspection to be carried out. A re-inspection is recommended once the areas are made accessible.

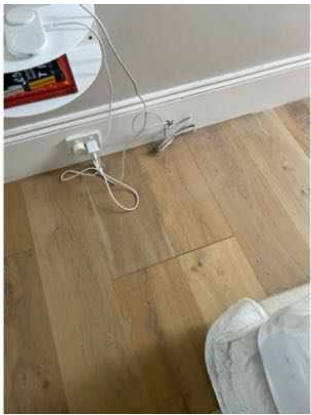
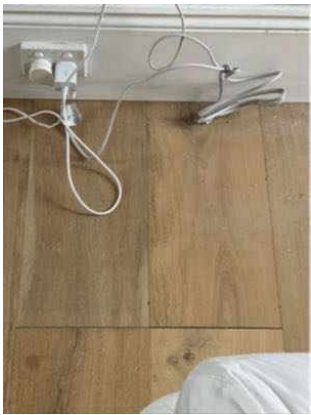
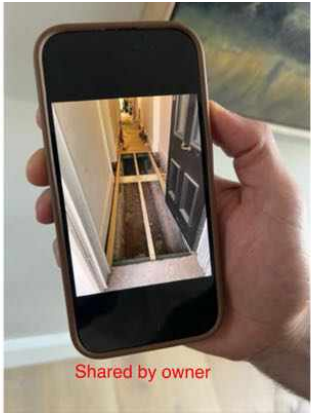
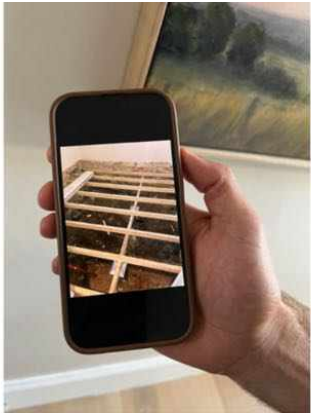
Building:	Main Building
Location:	Subfloor
Finding:	Additional Photos - Obstructions and Limitations
Information:	These photographs are an indication of the obstructions and limitations which impeded full inspection of the property at the time of inspection. These obstructions can hide an array of defects and should be removed to allow full inspection to be carried out. A re-inspection is recommended once the areas are made accessible. includes pictures shared by the owner as we were unable to open the access point to subfloor.
