Building and Timber Pest Inspection Report

Inspection Date: Mon, 16 Mar 2026

Property Address: 3 Annesley Ave, Bowral NSW 2576,
Australia

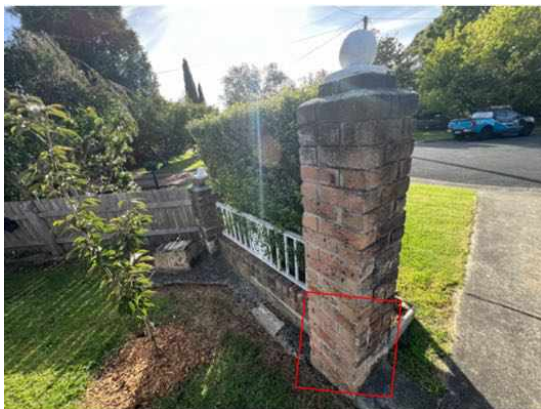
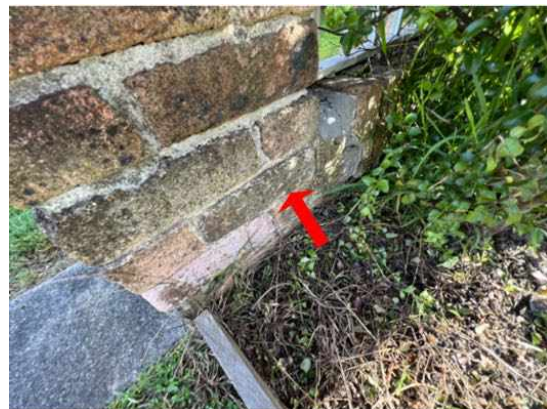
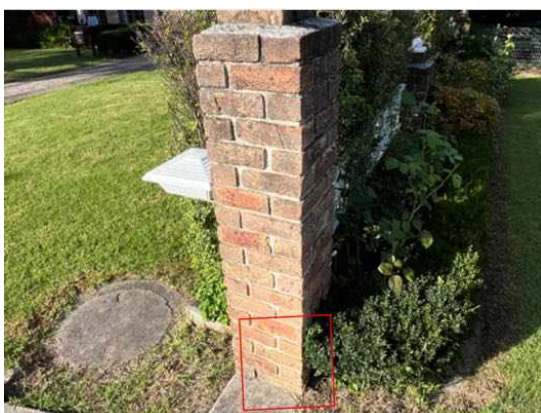
Building: Yard
Location: Yard - Front
Finding: Brick Pier - Unstable
Information: Upon inspection of the brick pier to the front wall, it was noted that the brick pier appears unstable. The pier may not have been adequately reinforced, as it appears the core of the pier may not have been properly filled with mortar or concrete to provide sufficient internal strength.

Where masonry piers are not adequately filled or reinforced, they may lack the structural rigidity required to resist movement, which can result in instability at the base and potential deterioration over time.

Remedial works are recommended. A registered builder or bricklayer should be appointed to inspect the pier and undertake repairs as required in the short term.

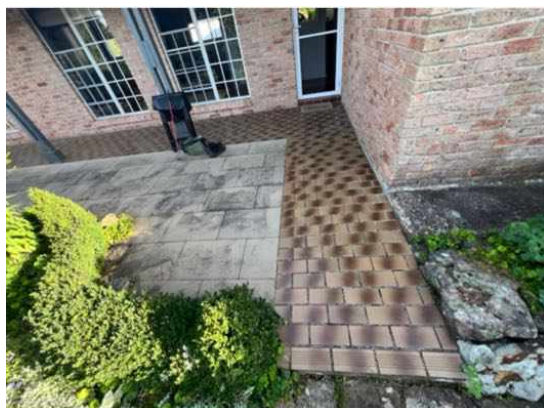
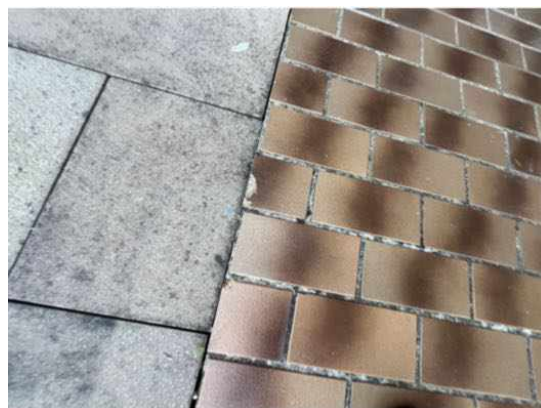
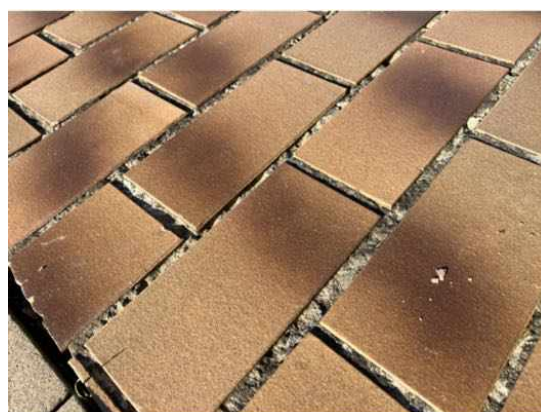
Building: Main Building
Location: Front path
Finding: Grout - degraded
Information: Grout is degraded in this area. Grout is used to protect gaps and crevices in building materials to ensure that they are water-tight and prevent water penetration to the associated structures.

Where grout is missing, a tiling contractor should be appointed immediately to apply grout and re-apply any silicone where necessary. Failure to do so is likely to lead to water damage to the surrounding area.

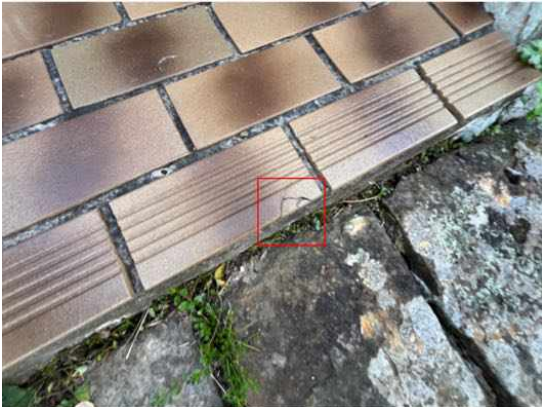
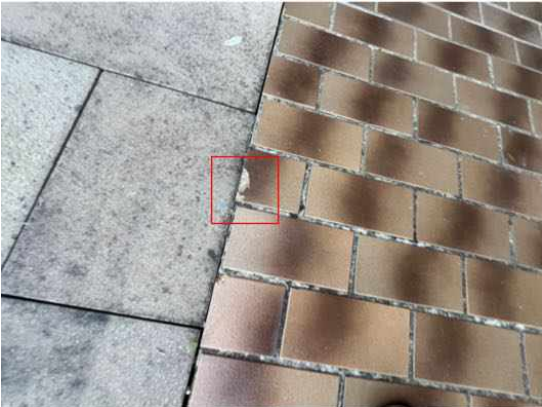
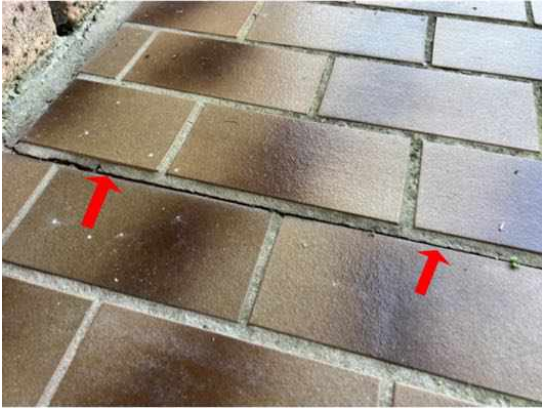
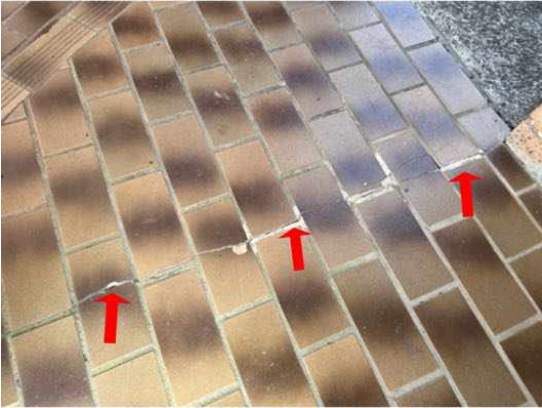
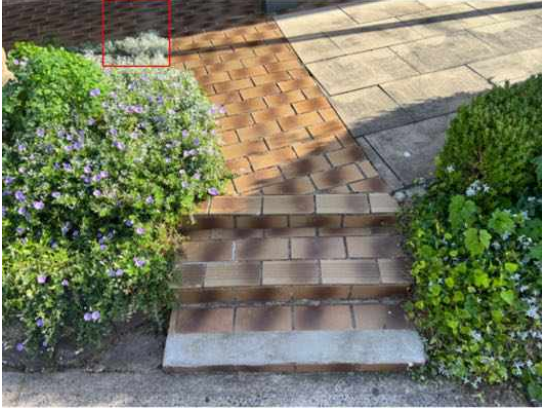
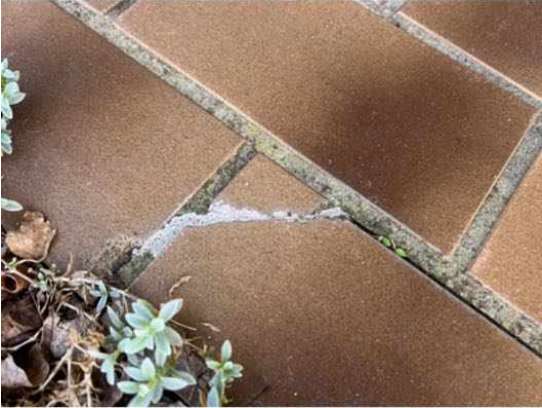
Finding 3.02

Building: Main Building
Location: Verandah
Finding: Tiles - Cracked or damaged
Information: Cracking was evident to the tiling in this area at the time of inspection. While the

cracking appears to be minor, this area is frequently exposed to water, allowing potential for water penetration into adjoining sections of walls or flooring.

If left unmanaged, water penetration to these areas may lead to subsequent water damage, which is likely necessitate repair work to affected building elements.

A tiling contractor should be appointed to ensure that no further water damage occurs. The re-application of silicone and grouting throughout remaining tile work is also advised, to further protect the area against water penetration.

Where water penetration has led to water damage, appointment of a relevant tradesperson may be required to repair damaged building elements.

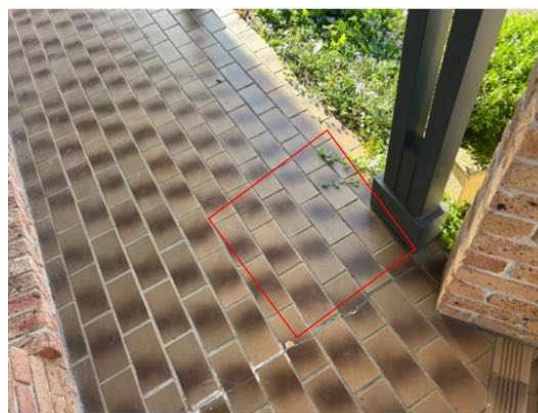
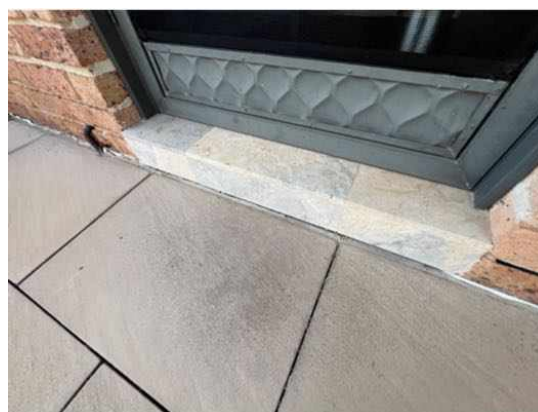
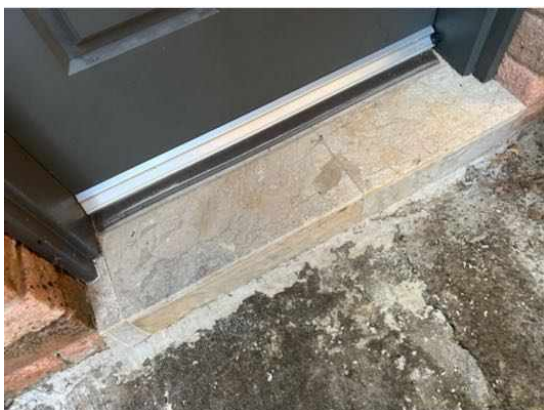
Finding 3.03

Information: Drummy tiled areas were identified at the time of inspection. The term 'drummy' refers to tiles that have become detached from their fixing, despite otherwise being in relatively good condition. Such defects are generally caused by physical or moisture damage to the area. Drummy tiled areas may also be a direct result of poor workmanship during the construction process.

Tiled areas may swell and shrink with changes in air humidity if the area has sustained moisture damage. Any exposure to moisture is capable of causing tiled areas to become drummy and/or cracked over a prolonged period of time. Drummy tiled areas generally require removal and replacement of affected tiles, with adequate sealant and grouting.

Specialist trades are available for these types of services. A registered builder may be required to undertake works if damage is extensive or if secondary building defects have resulted. Otherwise, it is advised that a tiling contractor be appointed to perform works as necessary. Immediate action is recommended to ensure that no further damage is sustained in the affected area.

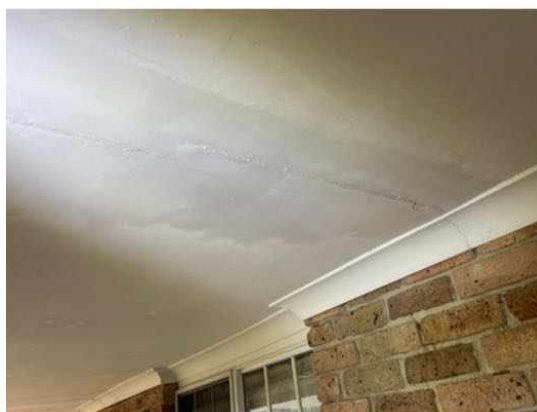
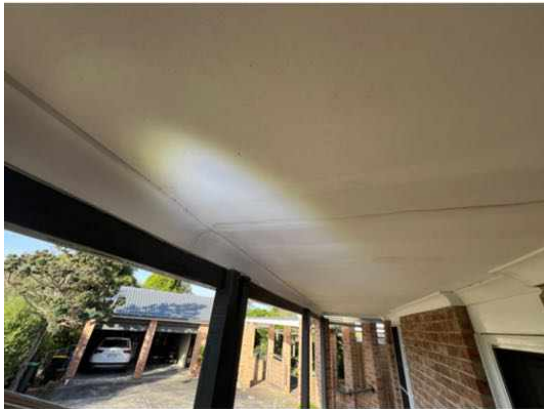
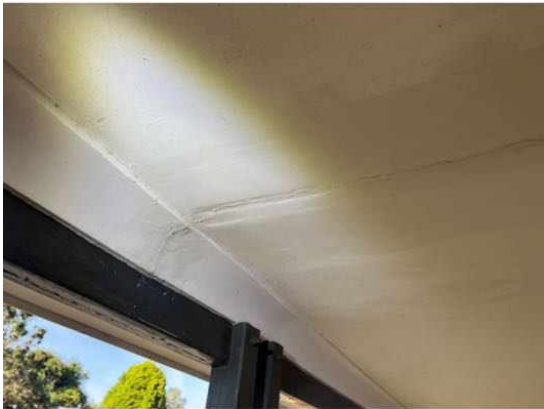
Finding 3.04

Building:	Main Building
Location:	Verandah
Finding:	Ceiling - Incomplete or substandard works
Information:	The ceiling patches to this area appear to be incomplete or have been completed to a substandard level.

Works that have not been completed to a satisfactory level create potential for the development of building defects and may impede on the safety and integrity of the overall structure.

It is highly recommended that a licensed plasterboard contractor should be appointed to repair the ceiling. To ensure the safety of the area and the longevity of all associated building elements.

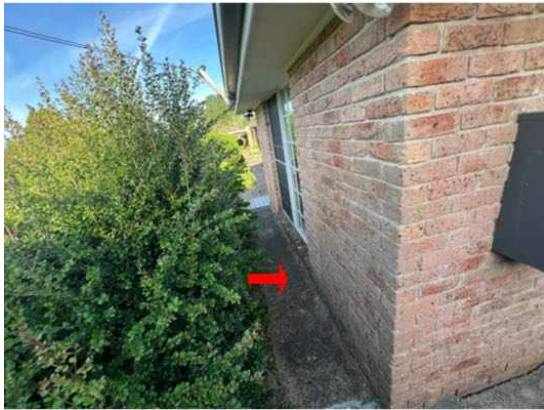
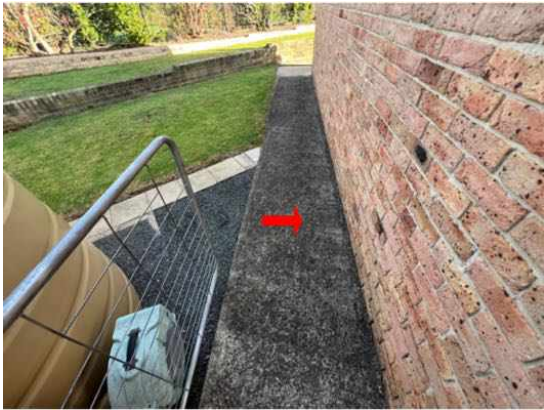
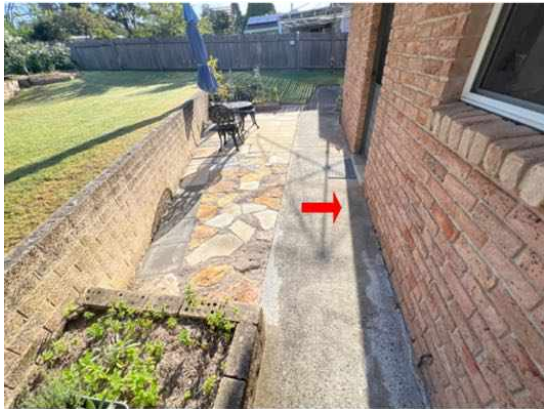
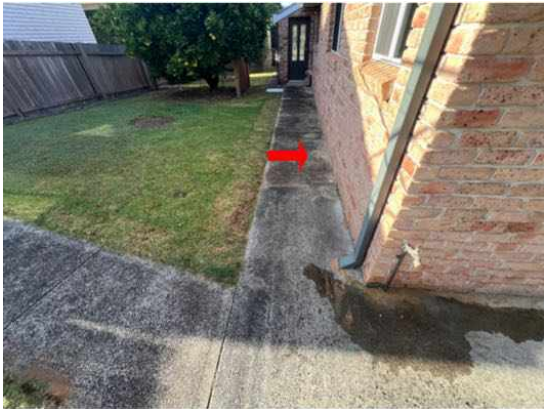
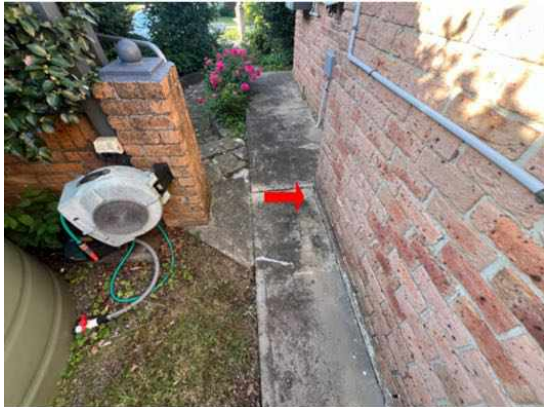
Finding 3.05

Building: Main Building
Location: All External Areas
Finding: Perimeter Paving - Insufficient Fall
Information: The perimeter paving or ground levels were found to have an inadequate slope away from the adjoining building structure, creating potential for water pooling in this area.

Perimeter paving is required to fall from the building by a minimum of 25mm in the first metre and bare ground should fall away from the house by 50mm in the first meter. This standard ensures that excessive moisture does not pool around the base of building structures, which creates potential for water and structural damage, as well as making the area susceptible to termite and timber pest activity.

Where paving or ground levels do not have adequate fall, a licensed paving contractor should be appointed to install or remove and re-level pavement.

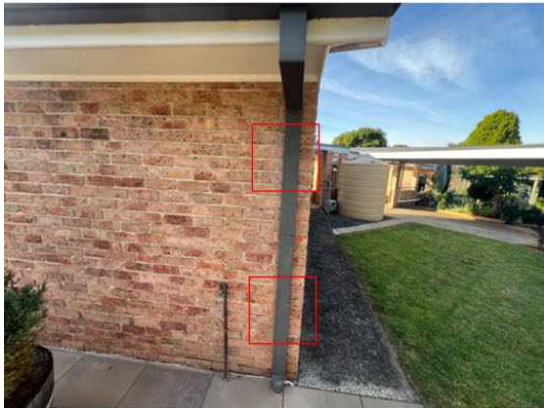
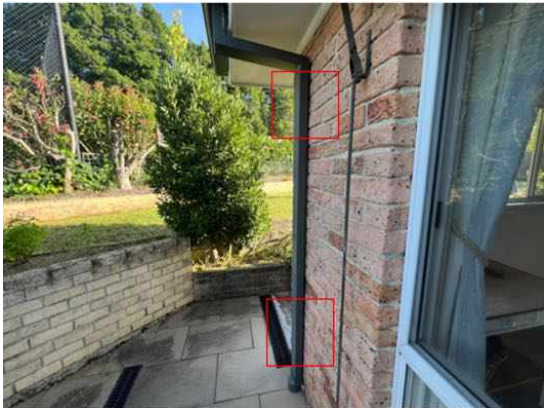
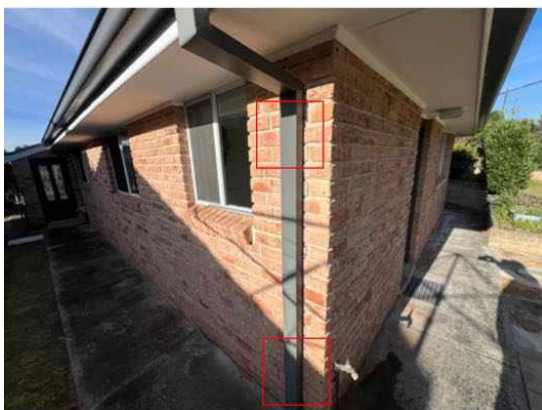
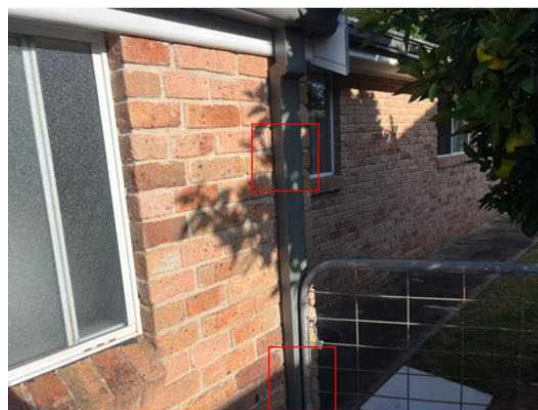
Finding 3.06

Building: Main Building
Location: All External Areas
Finding: Downpipe – Not Securely Clipped
Information: Sections of downpipe were observed to be unsecured or poorly fastened to the structure. This may result in movement, misalignment, or detachment during weather events, increasing the risk of water overflow and damage to surrounding elements.

A licensed plumber or general tradesperson should be engaged to properly secure the pipework and ensure ongoing effective drainage.

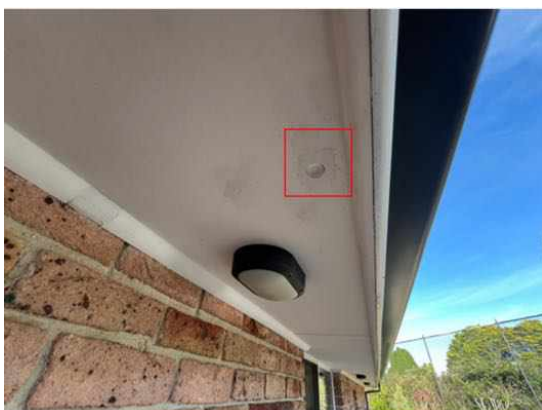
Finding 3.07

Building:	Main Building
Location:	Exterior walls - rear
Finding:	Eave Lining - Damaged
Information:	Breakage occurs generally when the building materials have either aged and decayed, or as a result of damage (accidental or deliberate).

Repair and/or replacement of broken elements is advised to ensure that additional secondary defects do not arise as a consequence. Such works are necessary, as all building elements play a key role in the operation and function of the overall structure and its performance.

A carpenter should be appointed to repair or replace the damaged eave lining prior to any subsequent damage being caused.

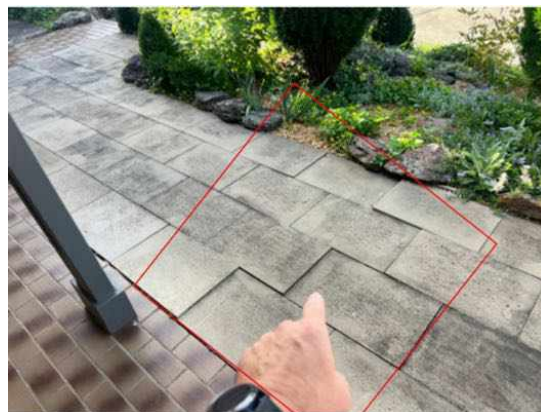
Finding 3.08

Building:	Main Building
Location:	Yard - Front, Back
Finding:	Paving - Uneven
Information:	Sections of the external paved area are uneven, creating a potential trip hazard. It appears as though the area has been subject to rough installation, or that paving

sections have lifted due to movements in the foundation of the property.

Where paving creates a trip hazard, personal injury may ensue if due caution is not taken by all persons within this area.

Re-paving of the area is required as soon as possible to remedy this situation. Further consultation with a specialist concreter is advised.

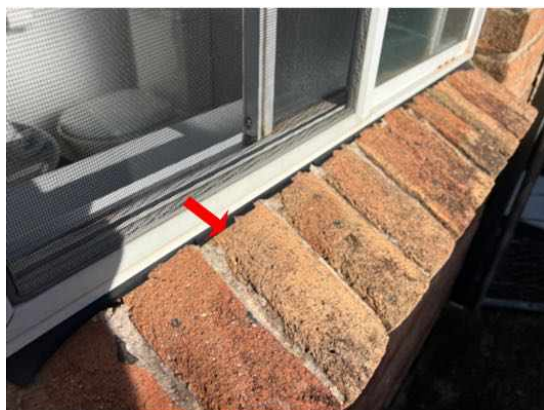
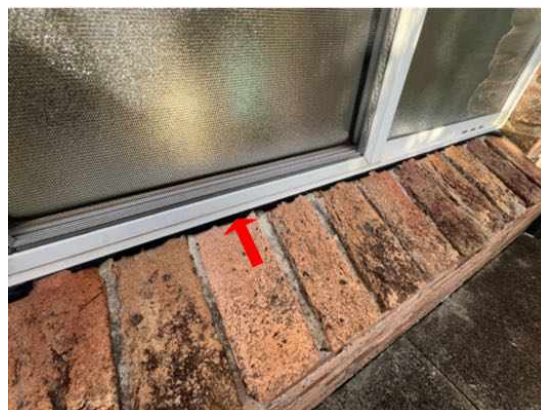
Finding 3.09

Building:	Main Building
Location:	Exterior walls - right side
Finding:	Window Sill Seals - damaged/compromised
Information:	The window seals have been damaged/compromised at the time of installation and subsequent failure to provide adequate protection and coverage. Due to frequent exposure to weather conditions and subsequent moisture, will lead to water ingress, energy loss and even pest entry.

Where window seals have not fully covered the gap between the brickwork and window, the window is no longer weather-tight; rain penetration and subsequent water damage is therefore likely to ensue. Insulation of the area against external weather conditions will also be compromised.

It is recommended that all window sill seals be replaced by a general handyman or

sealant expert to prevent any further damage and to restore the window to a fully functional level.

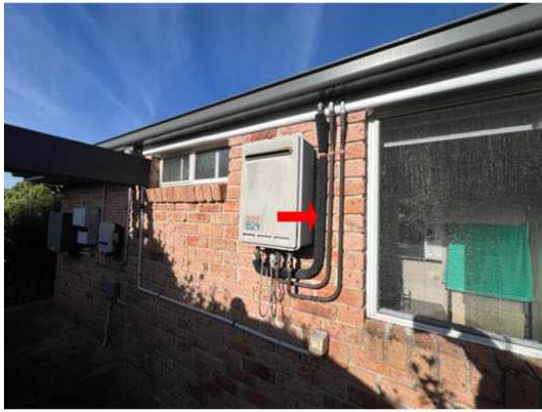
Finding 3.10

Building:	Main Building
Location:	Exterior walls - right side
Finding:	Pipework - Insulation deteriorated
Information:	Sections of the pipe insulation show evidence of damage and deterioration. It is suspected that this deterioration has developed as a result of excessive exposure to weather, including UV exposure in daylight. Deteriorated insulation reduces the effectiveness of the material in helping to maintain the desired temperature and work most efficiently.

If left in an exposed position, it is likely that the deterioration will continue and worsen over time, potentially resulting in secondary building defects as well as a further loss in insulating properties.

Some areas of replacement of pipe insulation is likely to be required. Further preventative measures to remove or protect the material from future exposure are also advisable. Consultation with a licensed plumber is advised to gain quotes for the repair and/or replacement of deteriorated insulation.

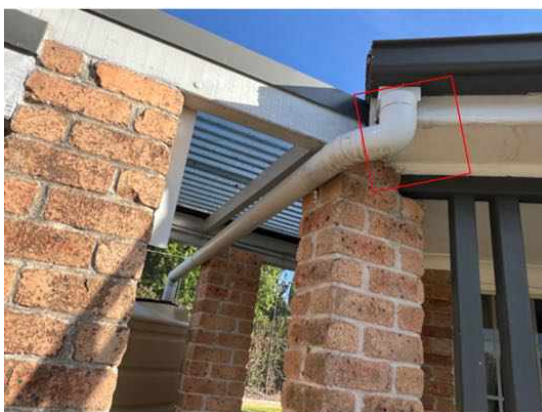
Finding 3.11

Finding: Eaves - Water Staining

Information: Water staining was observed to sections of the eave lining at the time of inspection. This staining is typically the result of moisture ingress from roof drainage issues, such as blocked or overflowing gutters, damaged flashing, or roof leaks above the affected area.

While no active leak was confirmed, the presence of water staining suggests a history of water exposure that may lead to material deterioration over time if left unaddressed. The appearance of staining also detracts from the overall condition of the eaves and associated roofing structures.

It is recommended that a licensed roof plumber be engaged to assess the area, identify the source of the staining, and carry out any required repairs to prevent further water ingress and deterioration.

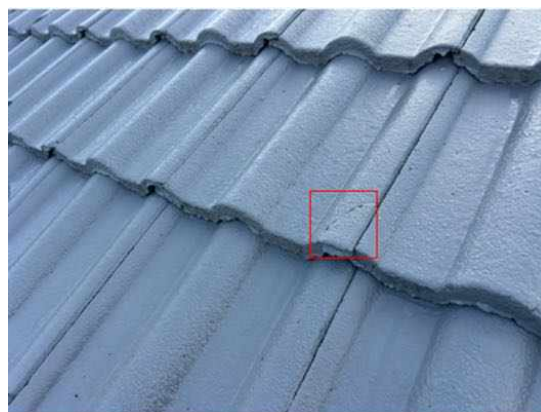
Finding 3.12

Finding: Roof tiles - Broken

Information: Upon inspection of the exterior roof covering, broken roofing tiles were identified. Broken and friable roof tiles are generally the result of ageing and weathering of what is essentially a porous material.

If left to further deteriorate, broken and brittle roof tiles are likely to lead to water penetration via the roof into the ceiling space, causing secondary damage to ceiling linings, insulation and roof structures. Broken roof tiles are also likely to detract from the effectiveness of the roof drainage system, creating potential for secondary damage to the exterior roof covering and roof plumbing.

Replacement of broken tiles is required and should be performed by a roofing contractor as soon as possible.

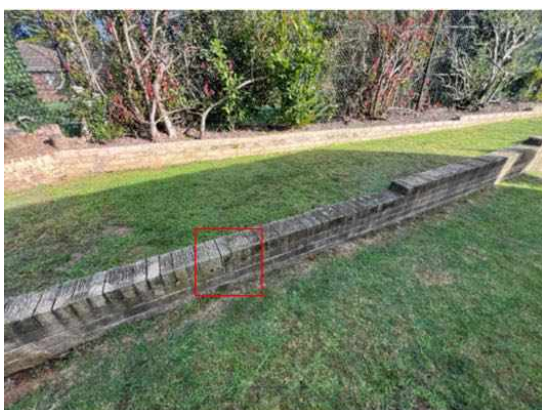
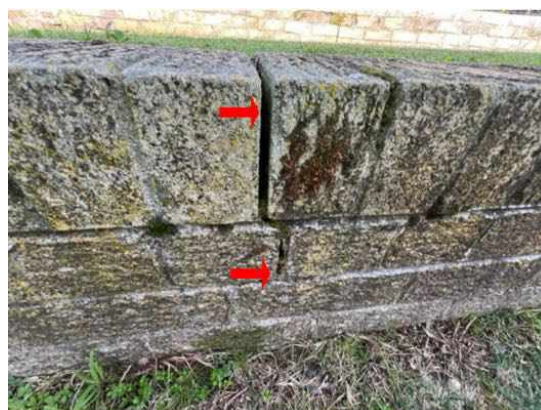
Finding 3.18

Building:	Yard
Location:	Yard - Back

Information: The brick retaining wall in this area was observed to be leaning and out of plumb. Retaining walls that display noticeable movement are commonly affected by poor original design, inadequate footing support, insufficient drainage provisions behind the wall, or gradual ground movement and soil pressure acting against the structure.

Movement of brick retaining walls may also occur where backfill drainage has not been effectively managed, allowing hydrostatic pressure to build behind the wall. Over time, continued movement may result in further displacement, cracking of the masonry, or localised structural instability.

While the retaining wall is relatively low in height, ongoing movement may lead to progressive deterioration if left unaddressed. Monitoring alone may not prevent further displacement where the underlying cause remains present.

It is recommended that a qualified Bricklayer or registered Builder be engaged to assess the retaining wall and determine whether corrective works are required to address the movement and restore structural stability.

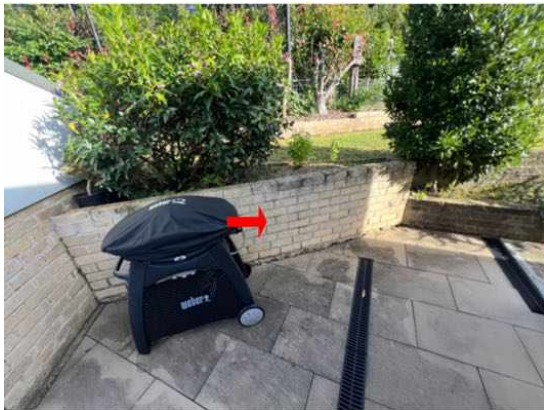
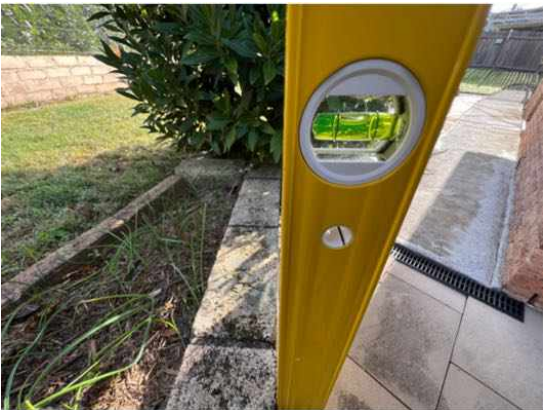
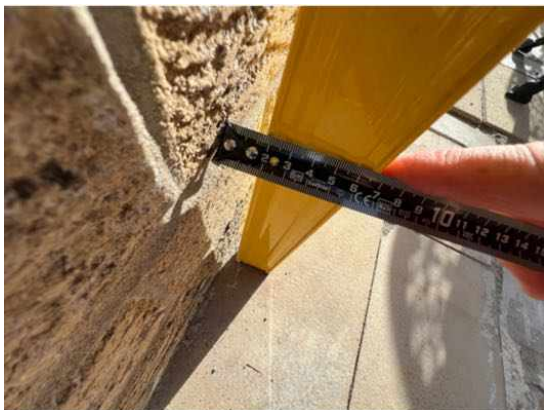
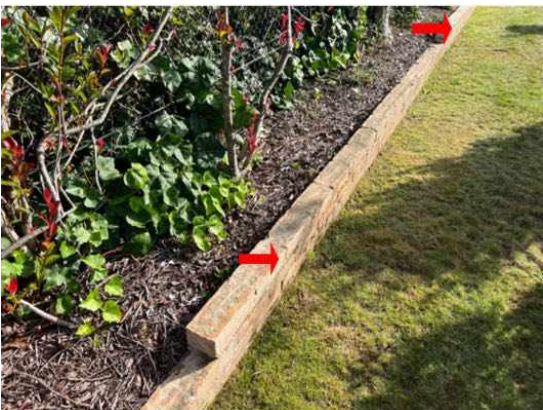
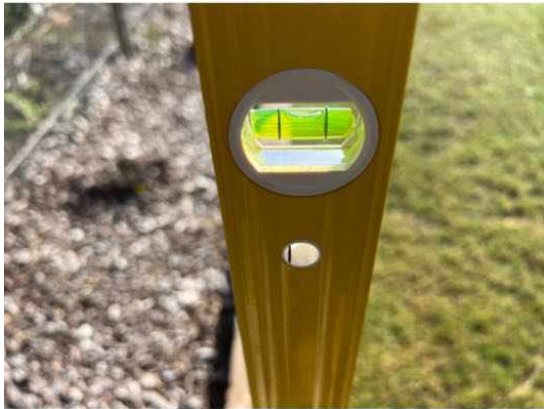
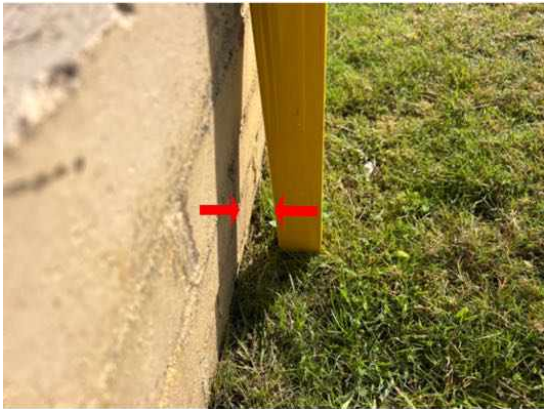
Finding 3.19

Building: Yard
 Location: Yard - Back
 Finding: Retaining wall - Defective
 Information:

The retaining wall in this area was found to be defective at the time of inspection. Generally, defective retaining walls are caused by poor original design or material use. However, deteriorated retaining walls may also be a result of substandard construction, poor site drainage or unmanaged stormwater flows.

If left unmanaged, the retaining wall may become a safety hazard if it continues to destabilise. Where retaining walls further rot and decay, an environment is created that is conducive to termite and pest infestation.

Significant repair and replacement should be expected. Where retaining walls are considered structural walls, a structural engineer / surveyor should be consulted regarding required remedial works. Otherwise, a landscaper or retaining wall installer may be appointed to repair or replace the wall, at the discretion of the client.

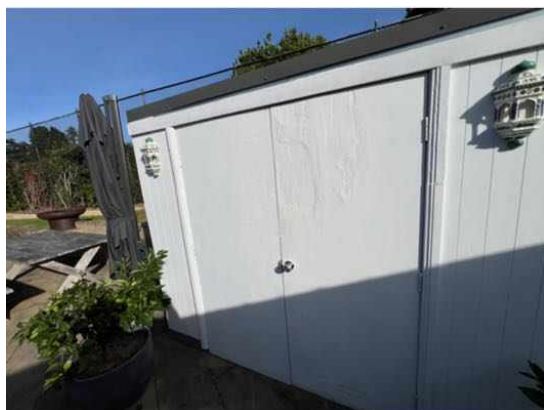
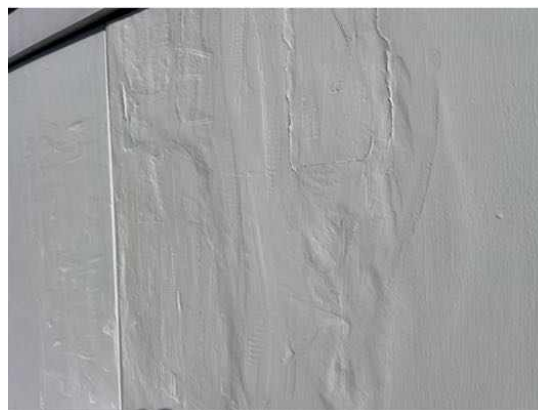
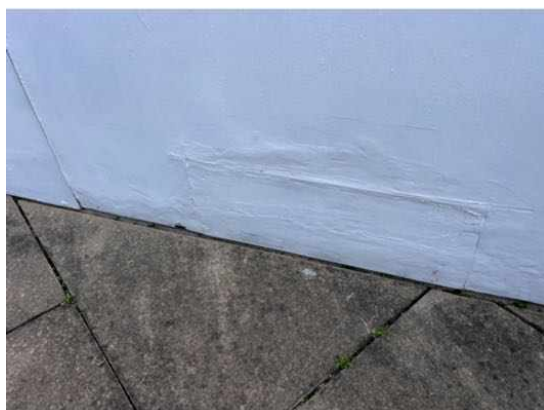
Finding 3.21

Building:	Shed
Location:	Shed
Finding:	Door - Damaged
Information:	Breakage occurs generally when the building materials have either aged and decayed, or as a result of damage (accidental or deliberate).

Repair and/or replacement of broken elements is advised to ensure that additional secondary defects do not arise as a consequence. Such works are necessary, as all building elements play a key role in the operation and function of the overall structure and its performance.

A licensed carpenter should be appointed to repair or replace the affected timber element prior to any subsequent damage being caused.

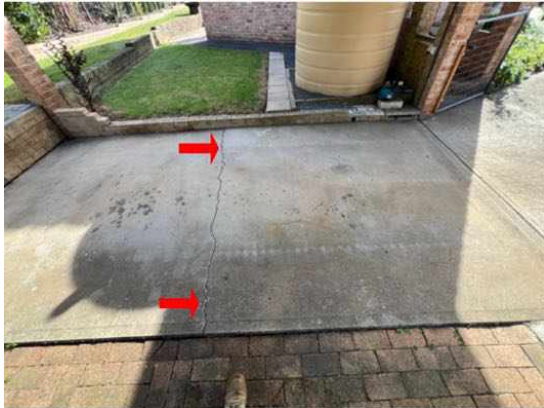
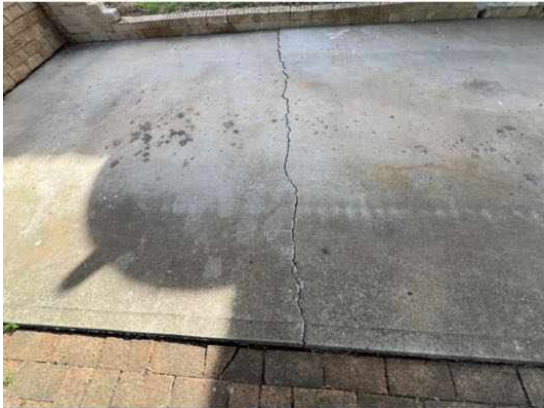
Finding 3.22

Building:	Carport
Location:	Carport
Finding:	Cracking - External Concrete Paving Damage Category 2 - Distinct (less than 3mm)
Information:	Distinct cracks were identified in external concrete paving. Distinct cracks are generally found in older concrete paving, and may also present as a trip hazard as consequence of an uneven or curved surface.

General age and expected deterioration of the paved areas is a common cause of this type of cracking. However, expansion and contraction of the slab may also have occurred due to environmental factors. Such factors include variable moisture and weather conditions, the presence of trees and their roots having a settling or lifting affect on the soil, or the effect of load bearing, e.g. heavy vehicles over a sustained period of time.

Cracking to this degree may also be due to poor original installation of the concrete. Factors such as poor compaction of the sub surface and/or inadequate reinforcing of the slab may create cracking and other secondary defects.

Repairs are likely to be required to prevent further cracking and to reduce hazards associated with cracking, such as tripping. Monitoring of all cracking should be conducted frequently. Always contact a building inspector should cracks widen, lengthen, or become more numerous.

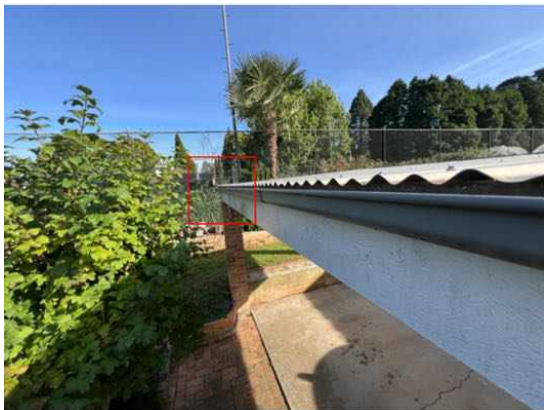
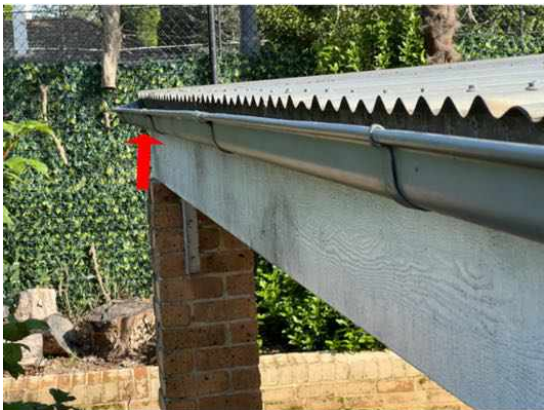
Finding 3.23

Building: Carport
Location: Roof Exterior - Carport
Finding: Gutter - Sagging
Information: The guttering in this area was observed to be sagging at the time of inspection. This is often caused by inadequate fixing, blocked gutters, or excessive water weight from poor drainage.

Sagging gutters can impede proper water flow, potentially leading to water overflow, damage to fascia boards, and moisture ingress into associated structures.

It is recommended that a roofing plumber or general handyman be engaged to assess and secure the guttering to restore proper alignment and functionality.

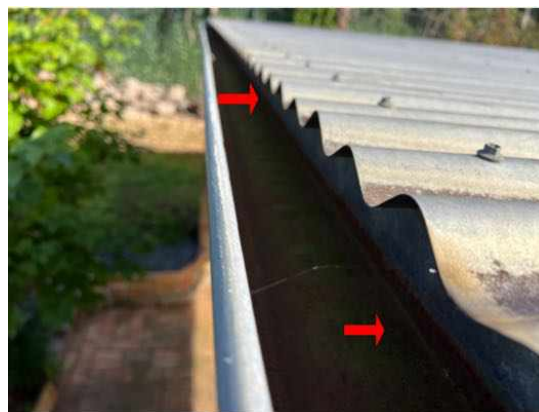
Finding 3.24

Building: Carport
Location: Roof Exterior - Carport
Finding: Roof plumbing - Rusted or corroded
Information: The roof plumbing has areas of rust and corrosion. It is suspected that this has been caused by blockages, resulting in pooling or standing water, that have prematurely

rusted elements of the roof plumbing.

Rusted roof plumbing will generally develop holes and leaks that can affect other building elements with poor drainage of storm water. Poorly drained roof areas will also lead to damp conditions surrounding the base perimeter of the building which, if left unmanaged, can lead to a range of secondary building defects.

Repair and/or replacement of rusted roof plumbing is highly required in order to reinstate the roof drainage system to a fully operational level. To further maintain these areas, gutters should be cleaned frequently, allowing the avoidance of any partial blockages.

A licensed plumber or specialist roof restoration company should be appointed to undertake these works. It is advised that such works be completed as soon as possible to prevent any further damage and deterioration.

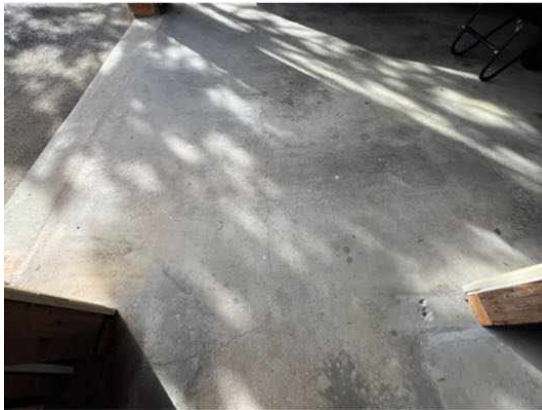
Finding 3.25

Building:	Garage
Location:	Garage
Finding:	Cracking - External Concrete Paving Damage Category 0 - Hairline (less than 1mm)
Information:	Hairline cracks were identified in external concrete paving. Hairline cracks are very minor in nature and generally are only ever an appearance defect. To be classified as a Category 0 or hairline crack, the crack width would be less than 0.3mm. While such cracking may be noticeable in some cases, it is common and does not indicate any structural damage.

Generally the cause of a hairline crack in existing concrete paving such as driveways and pathways is indicative of the expansion and contraction of the concrete. Such causes are generally due to environmental factors, such as moisture levels, weather conditions, root systems of nearby trees or the soil types on which they are laid.

Hairline cracks may also be due to poor original installation of the concrete. Factors such as poor compaction of the sub surface and/or inadequate reinforcing of the slab may create cracking and other secondary defects.

Monitoring of all cracking should be conducted frequently. Always contact a building inspector should cracks widen, lengthen, or become more numerous.

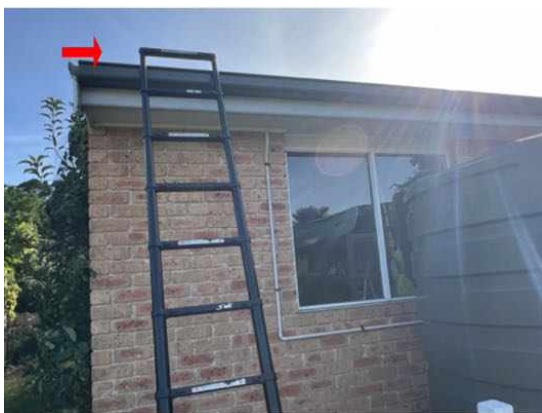
Finding 3.26

Building:	Garage
Location:	Roof Exterior - Garage
Finding:	Roof tiles - Broken
Information:	Upon inspection of the exterior roof covering, broken roofing tiles were identified. Broken and friable roof tiles are generally the result of ageing and weathering of what is essentially a porous material.

If left to further deteriorate, broken and brittle roof tiles are likely to lead to water penetration via the roof into the ceiling space, causing secondary damage to ceiling linings, insulation and roof structures. Broken roof tiles are also likely to detract from the effectiveness of the roof drainage system, creating potential for secondary damage to the exterior roof covering and roof plumbing.

Replacement of broken tiles is required and should be performed by a roofing contractor as soon as possible.

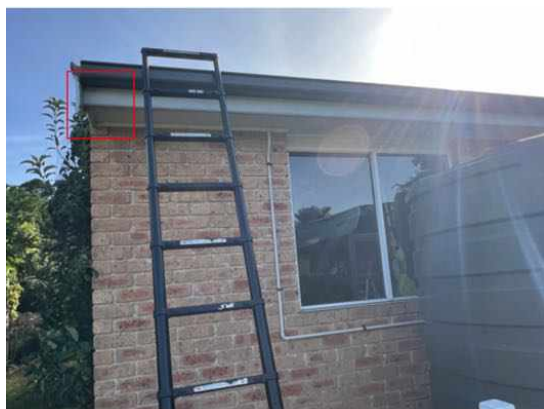
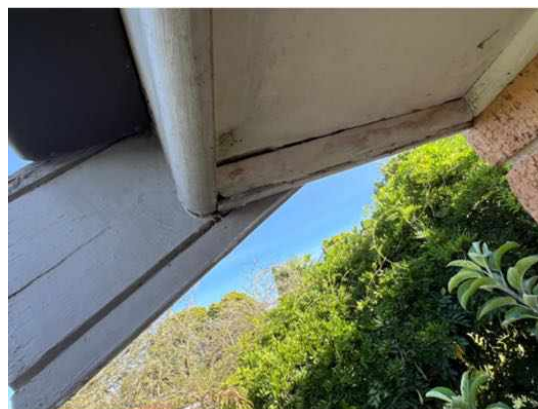
Finding 3.27

Building: Garage
 Location: Roof Exterior - Garage
 Finding: Eaves - Water Staining
 Information: Water staining was observed to sections of the eave lining at the time of inspection. This staining is typically the result of moisture ingress from roof drainage issues, such as blocked or overflowing gutters, damaged flashing, or roof leaks above the affected area.

While no active leak was confirmed, the presence of water staining suggests a history of water exposure that may lead to material deterioration over time if left unaddressed. The appearance of staining also detracts from the overall condition of the eaves and associated roofing structures.

It is recommended that a licensed roof plumber be engaged to assess the area, identify the source of the staining, and carry out any required repairs to prevent further water ingress and deterioration.

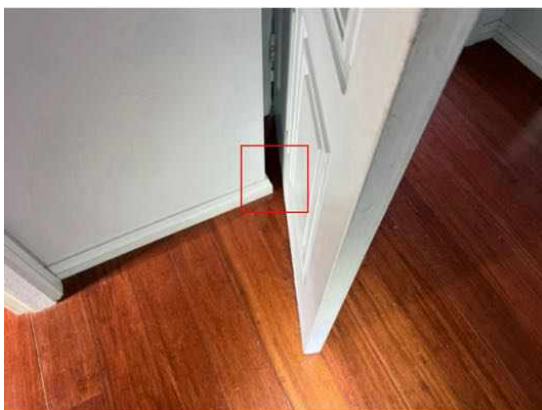
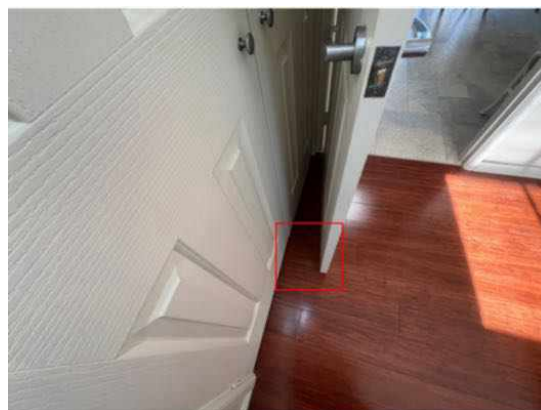
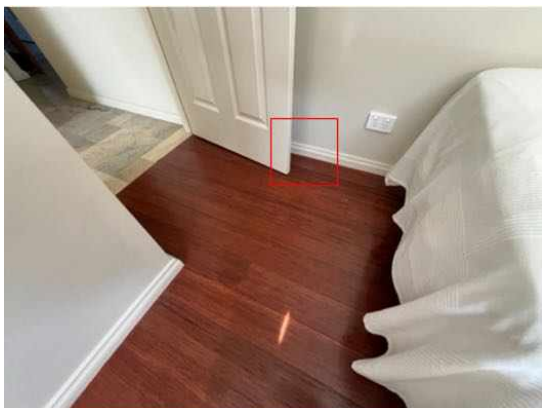
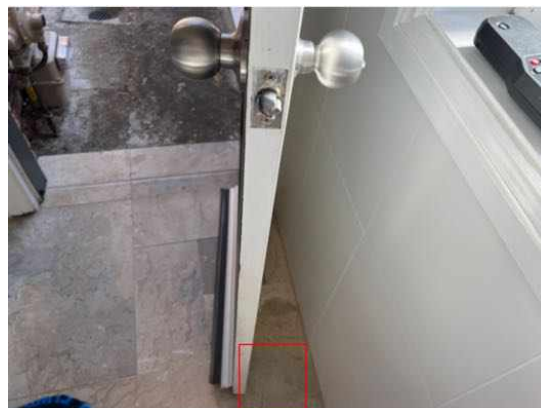
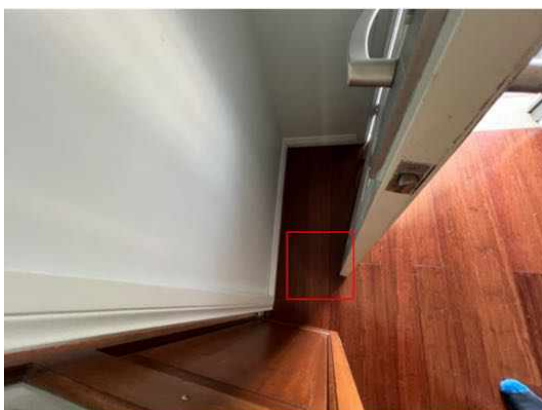
Finding 3.28

Building: Main Building
 Location: Entry, Bedroom 3, Bedroom 2, Toilet (WC), Bedroom 4
 Finding: Door stop - Missing
 Information: The door stop is missing or is inadequate to stop the door handle from damaging the wall. Although some building elements may seem irrelevant or unnecessary, all building elements play a key role in the operation and function of the overall structure and its performance.

Re-installation or replacement of the door stop is advised as soon as possible to prevent any subsequent damage to the door or associated structures. A general handyman may be appointed to perform these works at client discretion.

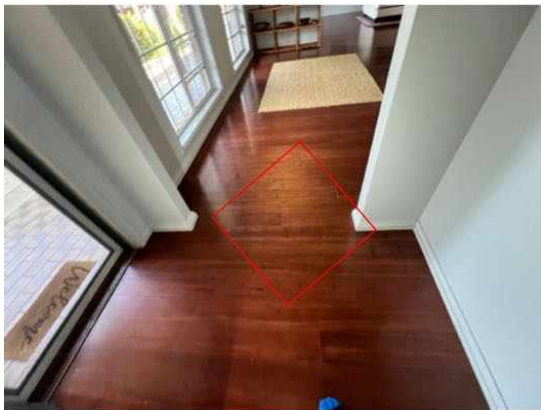
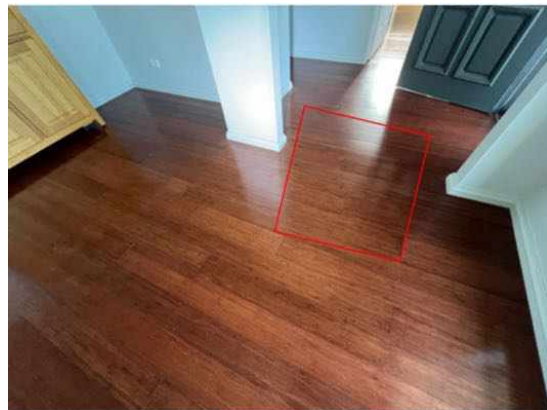
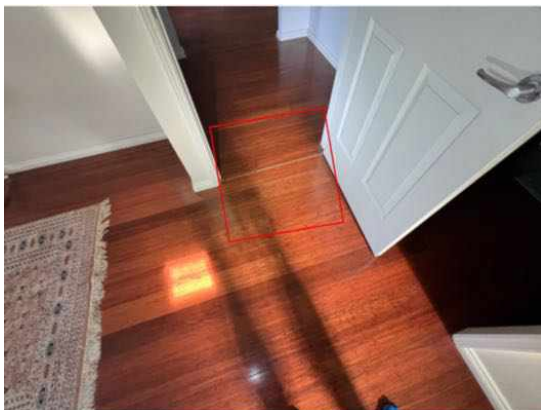
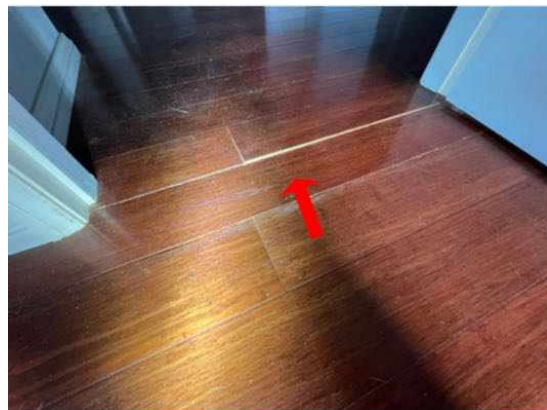
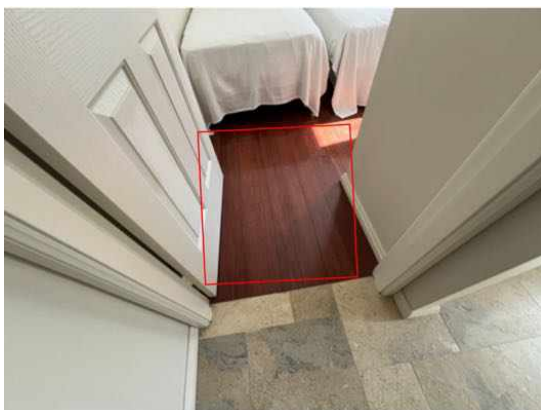
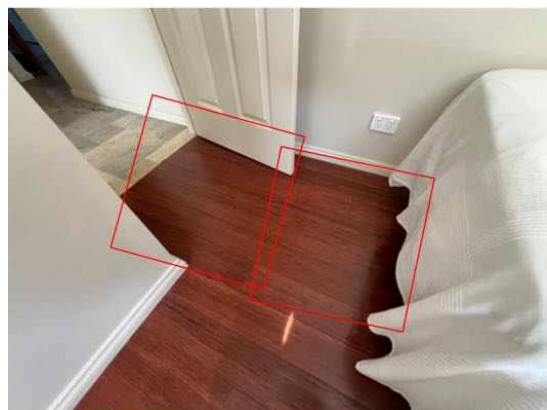
Finding 3.29

Building: Main Building
 Location: Formal Lounge, Bedroom 1, Bedroom 2
 Finding: Laminate Flooring - Uneven (slab)
 Information: The internal laminated flooring in this area is out of level and uneven. Uneven flooring is likely to indicate the flooring installed over the concrete slab is not level, showing noticeable irregularities across the finished surface.

An unlevel floor can create aesthetic issues, such as visible gaps between boards and uneven transitions at doorways, which detracts from the overall appearance. Functional problems may arise, including difficulty in closing doors, improper furniture placement, and increased wear on floor finishes. Significant unevenness may also indicate underlying issues with the concrete slab, such as settlement, moisture related movement, or inadequate surface preparation prior to installation, which could compromise the performance of the flooring system.

Consult a flooring specialist or a registered builder to assess the extent of the unevenness and determine the underlying causes.

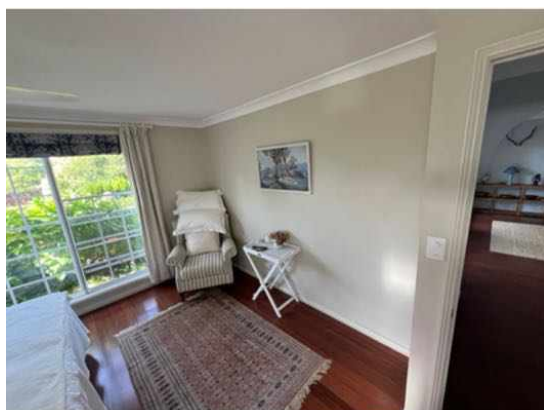
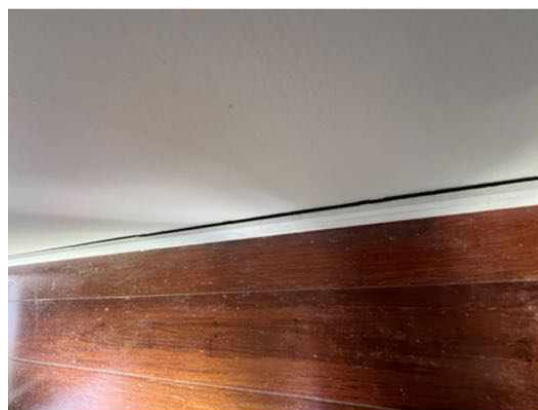
Finding 3.30

Building:	Main Building
Location:	Bedroom 1
Finding:	Skirting Boards - Gaps / Slight Detachment
Information:	Timber skirting boards in this area were observed to have visible gaps between the skirting and the adjacent wall surface, with sections showing slight detachment from the wall. This condition commonly occurs where skirting boards have not been securely fixed, where fixings have loosened over time, or where minor movement has occurred between the wall lining and the floor structure.

While generally considered a maintenance-related issue, continued movement or inadequate fixing may result in further detachment if left unattended.

Consult a carpenter to inspect the affected skirting boards and undertake any necessary repairs to restore proper fixing and alignment.

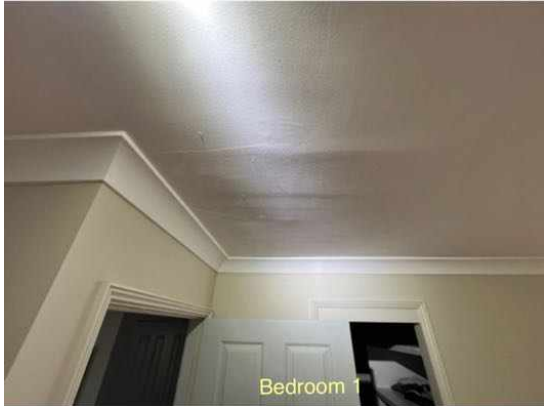
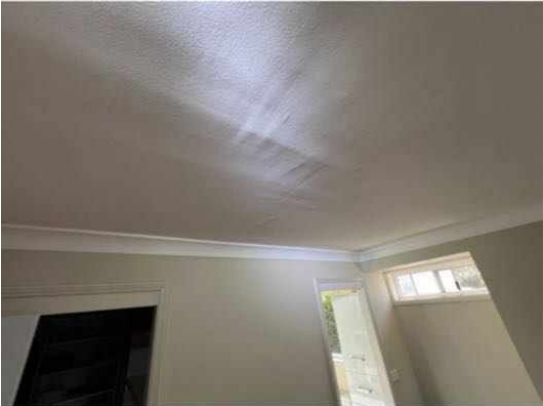
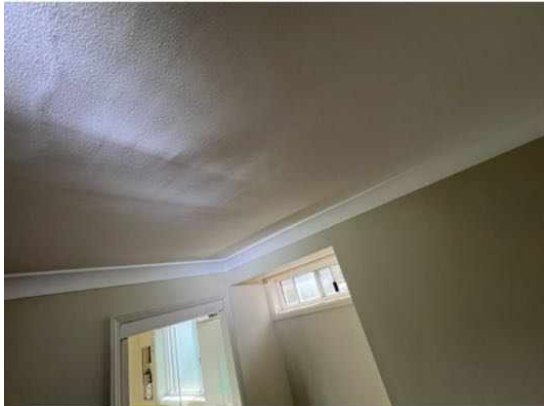
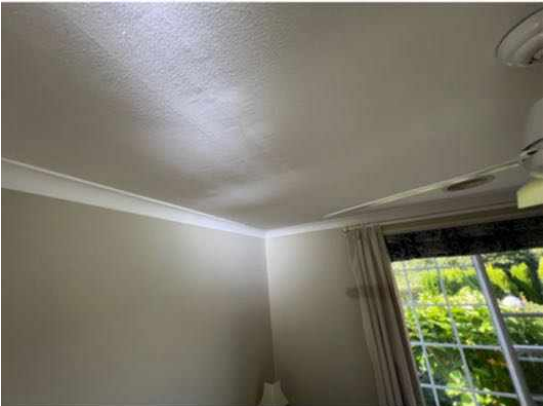
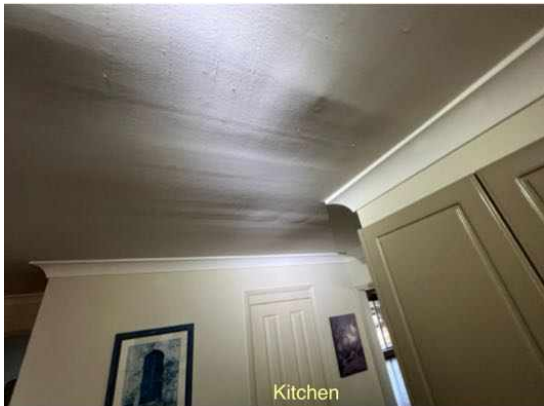
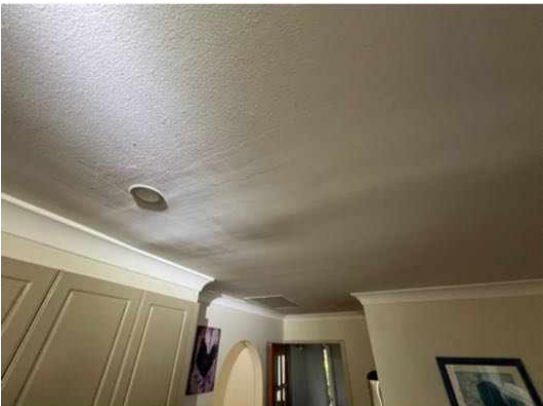
Finding 3.31

Building:	Main Building
Location:	Bedroom 1, Kitchen, Living Room,
Finding:	Ceiling - localised sagging, hairline cracks, substandard works
Information:	The internal ceiling lining in this area exhibits localised sagging between framing members, accompanied by hairline cracking and substandard flushing to joints and screw fixings. Sagging of this nature generally occurs where ceiling sheets are inadequately fixed, where fixings have loosened over time, or where the ceiling lining has not been properly supported during installation. Hairline cracking to joints and screw heads is commonly associated with minor movement within the framing or insufficient joint finishing.

If left unmanaged, continued movement or loosening of fixings may result in further joint separation, visible deflection, and deterioration of the ceiling finish.

It is recommended that a qualified plasterer assess the affected ceiling area and undertake rectification works as required to restore alignment and finish.
