Building and Timber Pest Inspection Report

Inspection Date: Mon, 16 Mar 2026

Property Address: 3 Annesley Ave, Bowral NSW 2576,
Australia

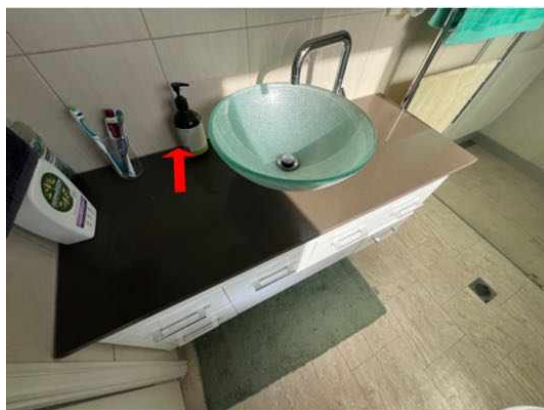
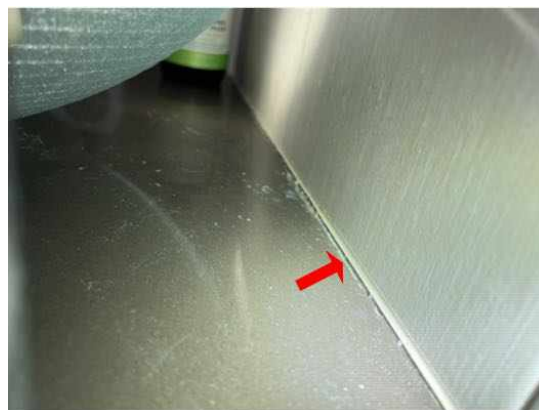
Finding 3.34

Building:	Main Building
Location:	Ensuite, Bathroom
Finding:	Sealant and grouting - Missing or damaged
Information:	It was noted on inspection that sealant or grout is degraded to the tiled shower alcove and or other areas of the bathroom.

Different materials and floor areas move at different rates, generally causing cracking to grout or sealant at this point. A flexible sealant is required to allow for expected expansion and contraction, while keeping the joint water tight and protective of all associated building materials.

There appears to be excessive mould to the sealant and grout which will likely require scraping out and replacement.

Flexible and mould resistant materials should be applied to affected areas to prevent any subsequent water damage that is likely to occur. Regular maintenance and replacement of damage or missing or damaged sealant and grout is highly recommended to the wet areas, as this is a regular wear and tear defect. Sealant and grouting in areas that come into regular contact with water should be maintained for the long term care of your property.

A sealant specialist or tiling contractor should be appointed to complete these works as soon as possible

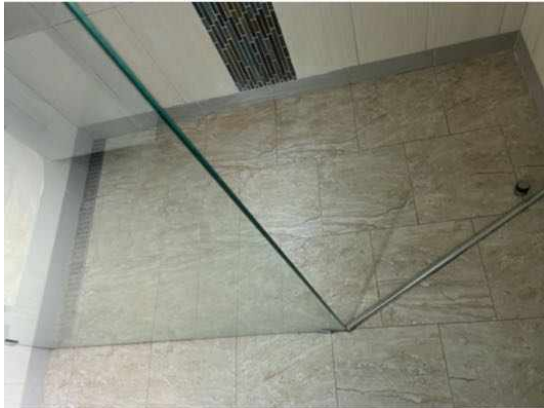
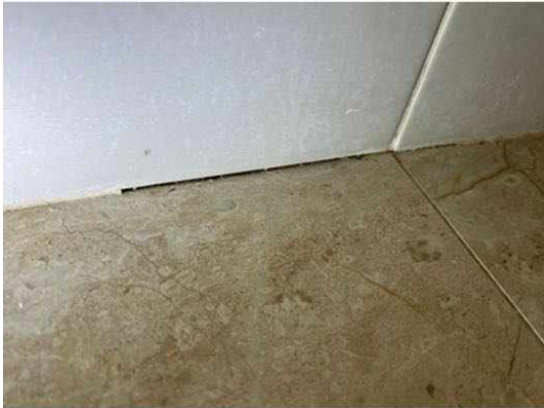
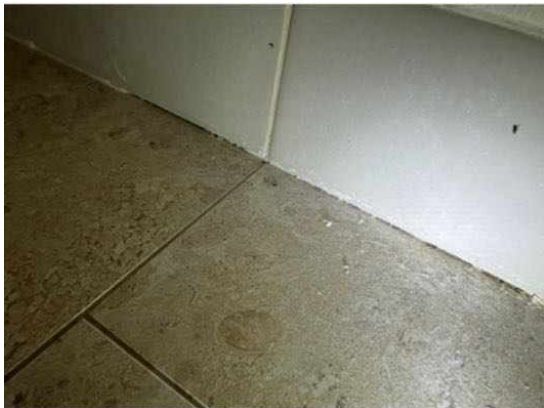
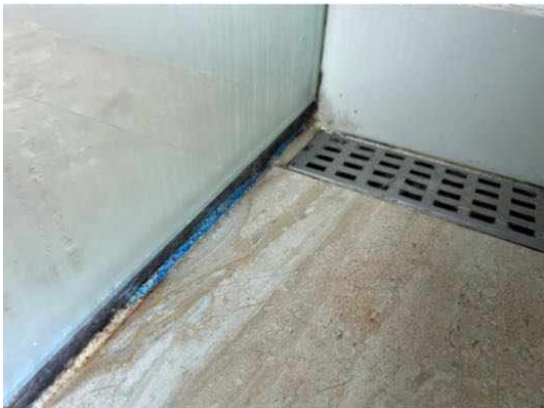
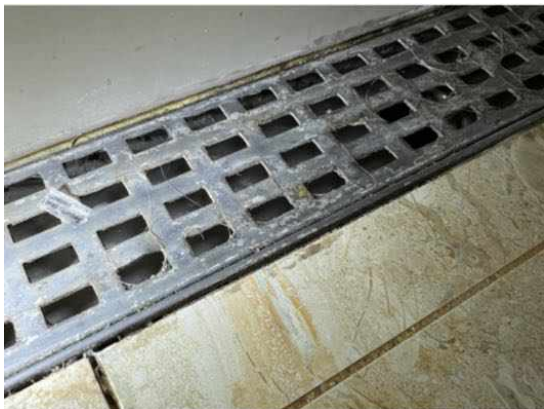
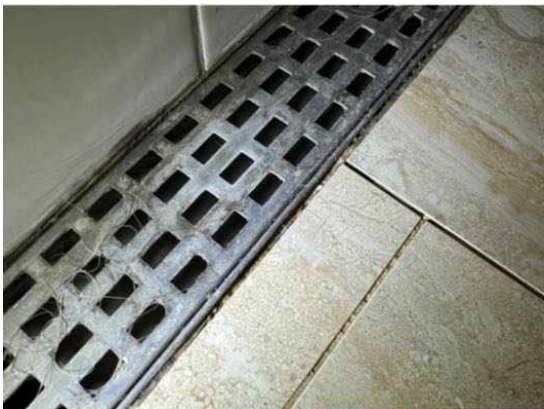
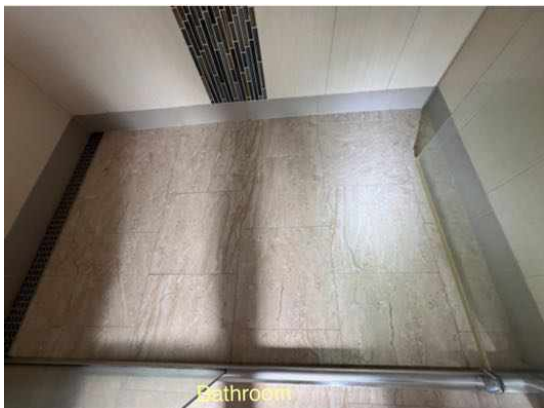
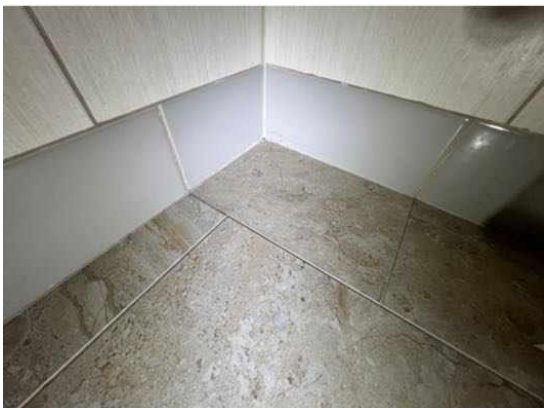
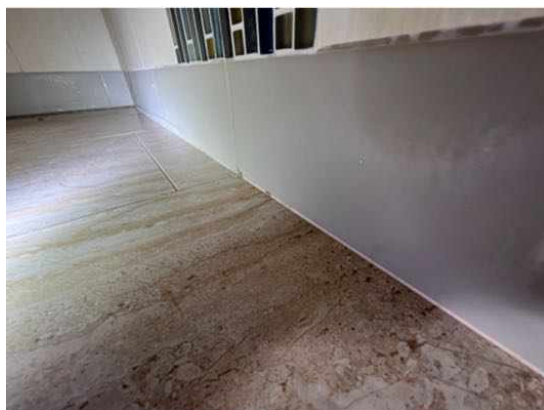
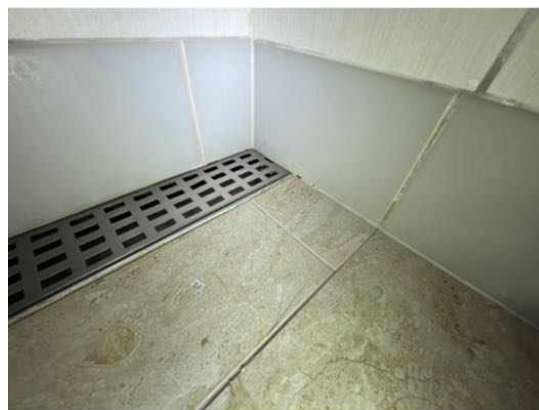
Finding 3.35

Building:	Main Building
Location:	Ensuite, Bathroom
Finding:	Moisture in Shower
Information:	Moisture is evident behind the tiles to the shower alcove. This defect is quite common, and is suspected to have been caused by moisture permeating through the grouting in this area. Leaking pipes within the adjoining wall is also a possible cause.

Damp (or structural damp) refers to the presence of unwanted moisture in the structure of a building, either as the result of intrusion from outside, or condensation from within the structure. In the shower area, internal water leaks or other sources of excessive moisture are generally the cause of damp. Always ensure that sealant and grout is in good condition to prevent any moisture issues occurring in the future.

Consultation with a qualified plumber or bathroom specialist is advised to identify the cause of damp and to perform remedial works as required.

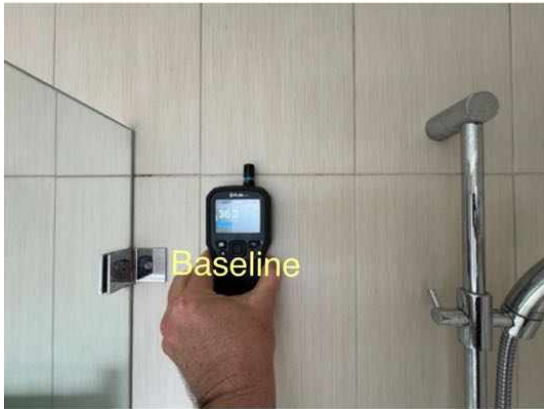
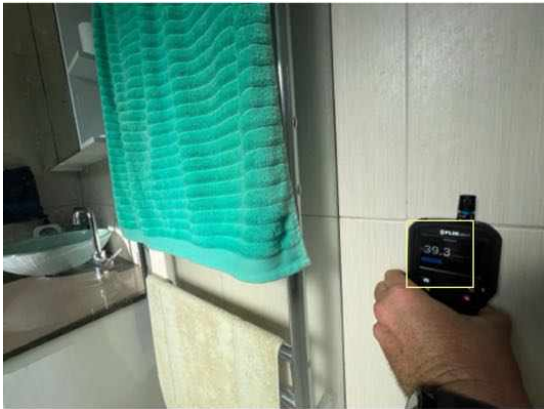
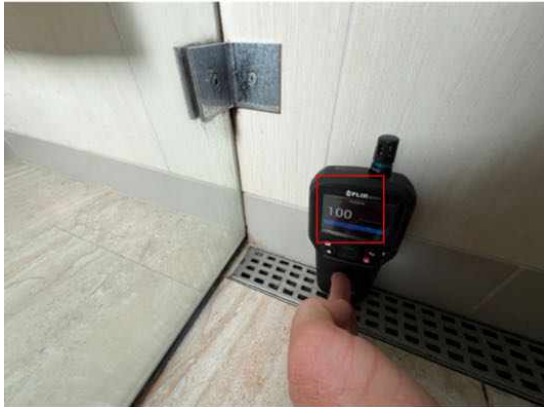
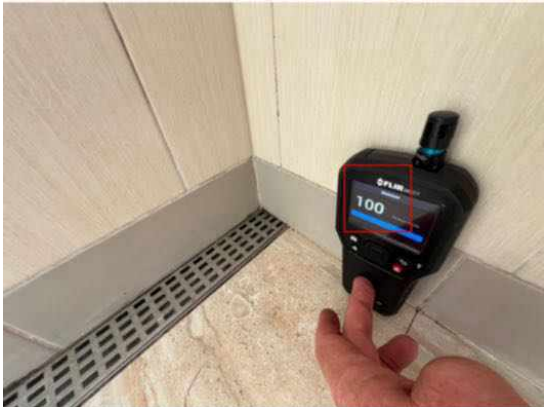
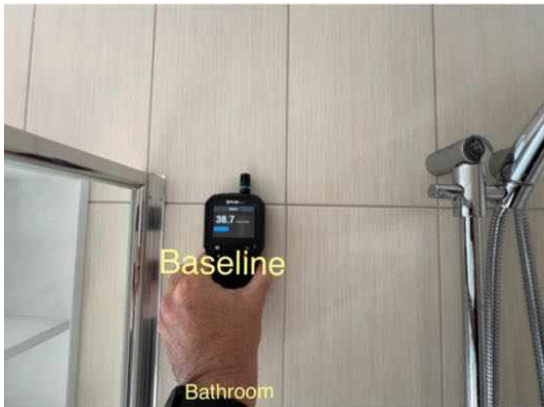
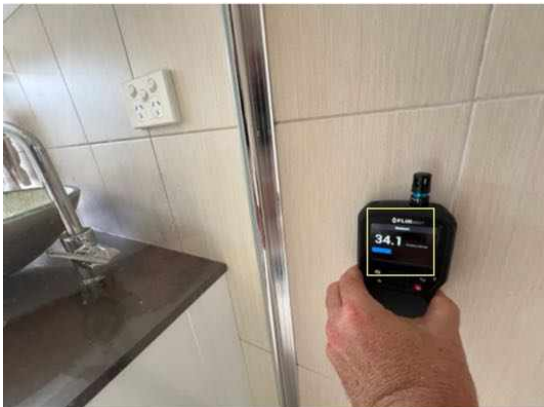
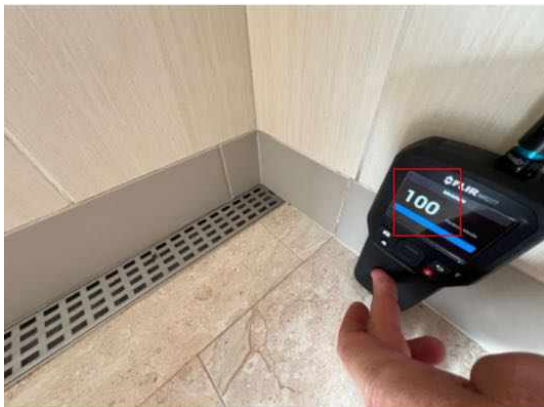
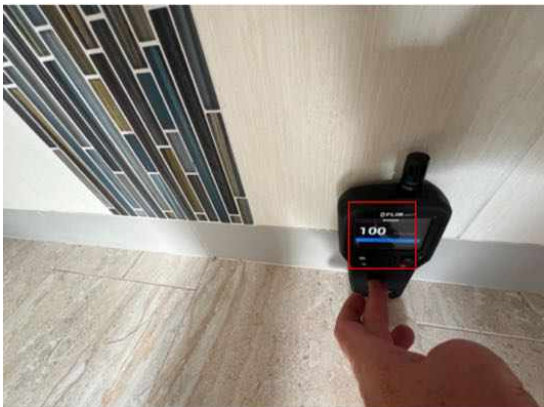
Please note, the moisture meter used operates on the principle of electrical impedance, generating a low-frequency alternating electric field between its electrodes. The instrument measures moisture content within the material at a maximum depth of 19mm below the surface, rather than on the surface itself.

As a result, surface moisture such as residual water on shower tiles does not influence the reading, ensuring that the measurement reflects subsurface moisture levels within the building material, not superficial wetness.

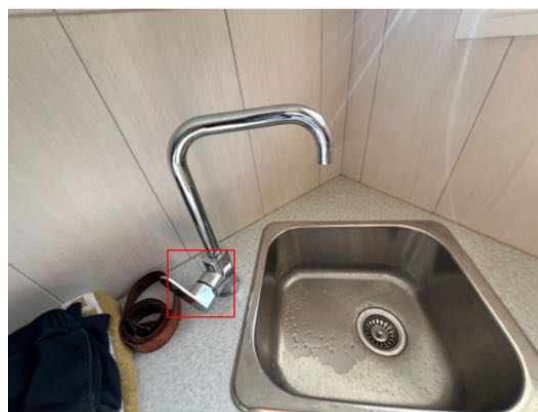
Finding 3.36

Building: Main Building
 Location: Ensuite, Laundry
 Finding: Tap - Water hammer
 Information: This tap shows evidence of water hammer being present. Water hammer, a pressure surge resulting when a fluid is forced to suddenly change direction, is a common defect in plumbing fittings, particularly those that are aged and not frequently maintained. Water hammer is generally caused by factors that create high water pressure in the affected plumbing fixture, usually evidenced by a faint banging noise during operation of the affected tap.

Although water hammer is generally considered to be a minor defect, subsequent damage such as erosion of tap hardware and/or water damage to associated building elements is likely to occur if left unmanaged.

A licensed plumber should be appointed as soon as possible to replace any affected tap hardware and perform any remedial works as necessary. Please be advised that the appointment of a cabinet maker or qualified carpenter may be necessary if water damage to associated building elements has occurred.

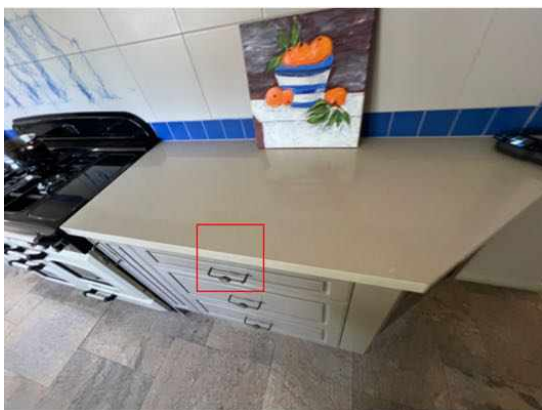
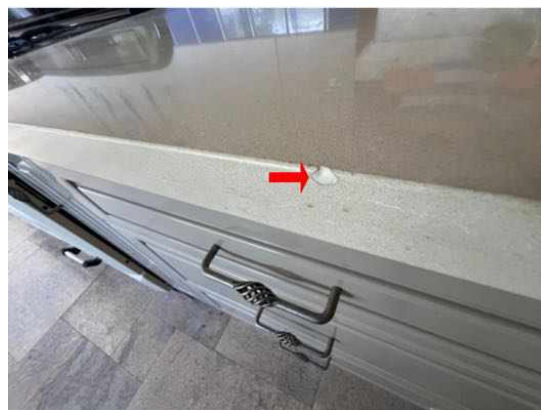
Finding 3.37

Building: Main Building
 Location: Kitchen
 Finding: Stone Benchtop – Chip to Surface
 Information: A visible chip was identified to the surface of the stone benchtop. This type of damage is typically the result of excessive impact, point loading, or internal stress within the material.

Chipping may compromise both the appearance and integrity of the benchtop and could worsen over time with ongoing use or exposure to temperature fluctuations.

Assessment by a qualified stone or cabinetry specialist is recommended to determine whether repair or replacement is necessary.

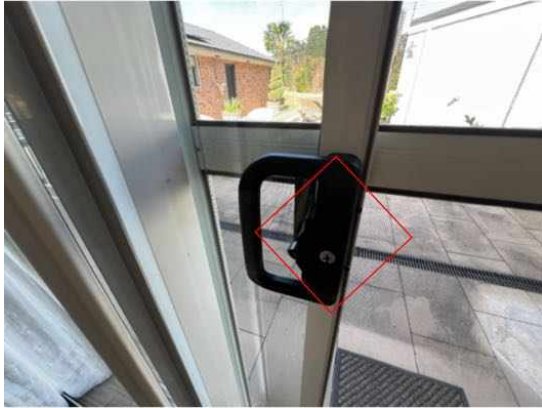
Finding 3.39

Finding: Door Handle - Loose

Information: The door handle in this area was identified as loose at the time of inspection. A loose door handle can impede the proper operation of the door and, if left unattended, may lead to further deterioration or damage to the associated door structure.

This defect is typically caused by wear and tear, insufficient fixing, or deterioration of the handle's components.

It is recommended that a qualified carpenter or general handyperson be appointed to secure or replace the handle to restore its functionality and ensure proper operation.

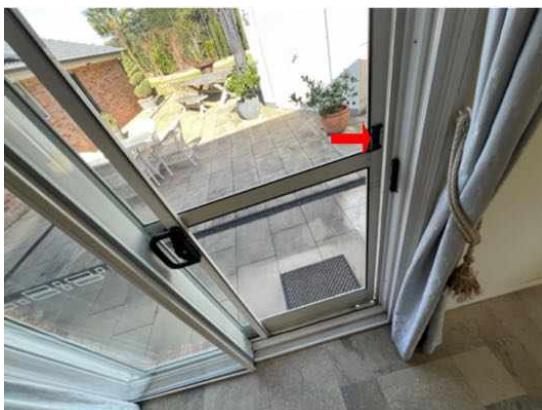
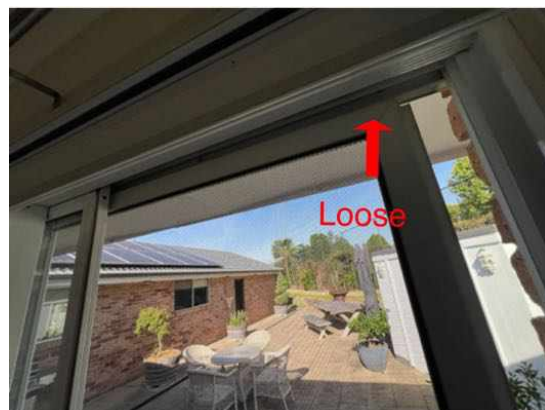
Finding 3.40

Information: The sliding door was noted to be misaligned or not running correctly within its track. This condition is typically caused by loose fixings, missing or damaged rollers, or lack of proper adjustment.

If left unadjusted, the door may scrape, jam, or fail to close properly over time.

A carpenter should be engaged to realign and adjust the sliding door to ensure smooth and correct operation.

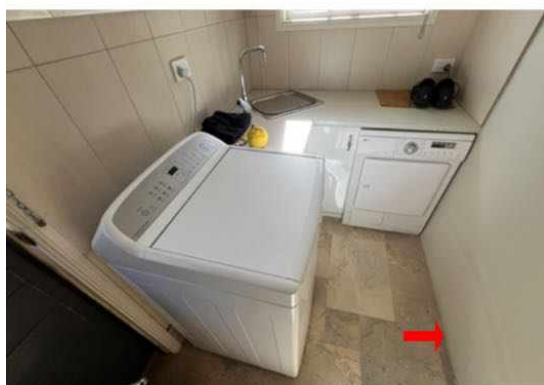
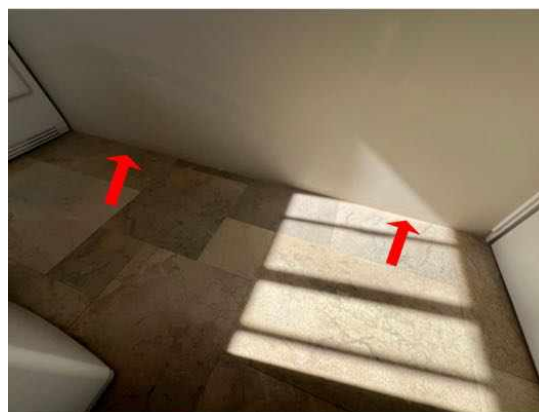
Finding 3.41

Location: Laundry
 Finding: Skirting tiles - Missing
 Information: Skirting tiles were missing in this area at the time of inspection. Complete tiled skirting is important in preventing water ingress into the adjoining walls and flooring, protecting the areas against potential water damage. The incomplete skirting also detracts from the overall appearance of the area.

If left unmanaged, water ingress into adjoining areas may have major implications, and may potentially necessitate works to other building elements in the long-term future.

It is highly recommended that a tiling contractor be appointed to complete these minor works as soon as possible to prevent such damage from occurring.

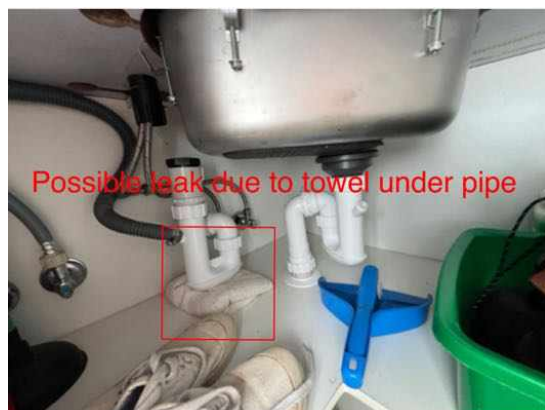
Finding 3.42

Building: Main Building
 Location: Laundry
 Finding: Possible leak - Additional Photos
 Information: Additional photos are provided for your general reference

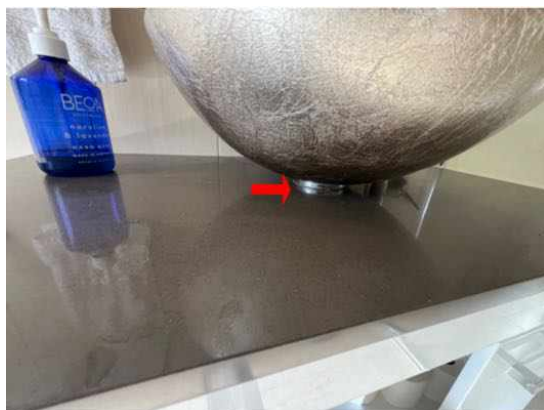
Building: Main Building
 Location: Bathroom
 Finding: Basin - loose
 Information: The basin was found to be inadequately secured to the benchtop at the time of inspection. This may have resulted from poor installation, deterioration of the adhesive or fixings, or movement of the surrounding materials over time.

An unsecured sink can lead to water ingress around the benchtop, potential damage to cabinetry, and increased risk of loosening further with regular use.

It is recommended that a plumber be engaged to properly secure the sink to prevent further movement and ensure long-term functionality.

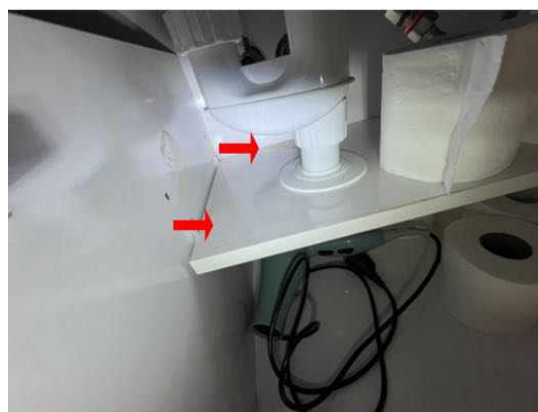
Finding 3.45

Building:	Main Building
Location:	Bathroom
Finding:	Water staining - sink cabinetry
Information:	A water staining was observed to the cabinetry beneath the sink at the time of inspection. Water staining in this area is generally indicative of a previous or active leak from plumbing fixtures, waste connections, or sealant deterioration around the sink junction.

If left unmanaged, persistent moisture can lead to material deterioration, mould growth, and potential damage to adjacent cabinetry or flooring. It is advised that a licensed plumber be engaged to inspect the area, determine if an active leak is present, and undertake any necessary rectification works.

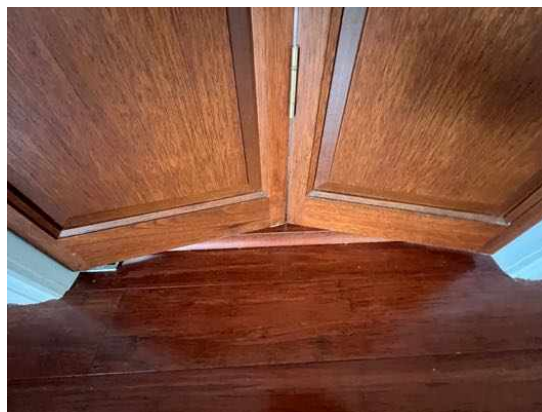
Finding 3.46

Building:	Main Building
Location:	Rumpus Room
Finding:	Door - Binding/jamming
Information:	Binding and/or jamming of this door is evident during standard operation. This defect inhibits the functionality of the affected door as well as creating potential for secondary defects to associated building elements, such as damage to the floor covering.

A door that binds to flooring or to the associated door frame may have several causes, ranging from minor defects, such as poor installation of the door or deteriorated hinges, through to major structural issues, such as damage to subfloor structures.

Where door binding/jamming appears to indicate major structural issues, a registered builder specialising in re-stumping should be appointed to provide an estimate on the cost of rectification.

For minor causes, a qualified carpenter or general handyperson should be appointed to perform minor rectification works at client discretion.

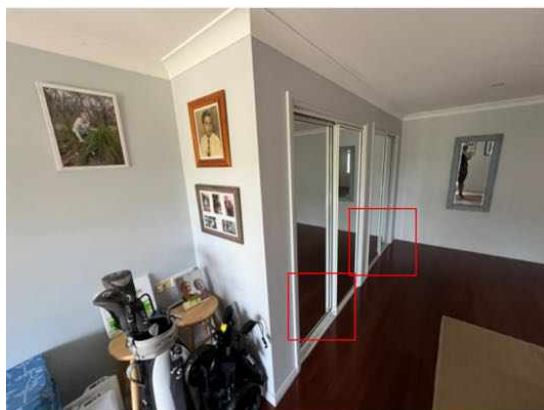
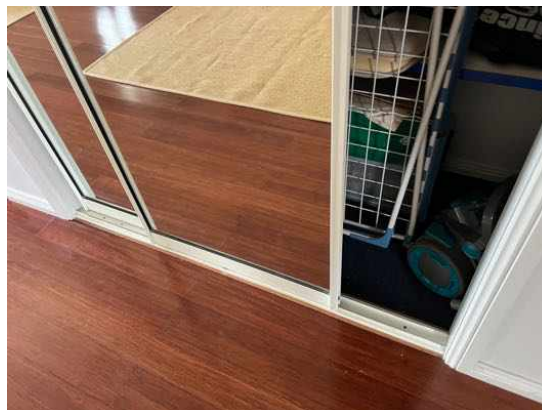
Finding 3.47

Building:	Main Building
Location:	Bedroom 4
Finding:	Doors - Stiff to slide
Information:	Several doors throughout the property were jammed and difficult to slide along the associated tracks at the time of the inspection. Restricted function of the affected doors may pose as a potential safety hazard if required for emergency egress from the building.

Generally, factors such as general age of the building element and a lack of maintenance are the usual causes for this type of defect.

Replacement of door hardware or tracks may be required, as well as minor repairs and cleaning. A registered builder or general handy person will be required to repair the affected doors.

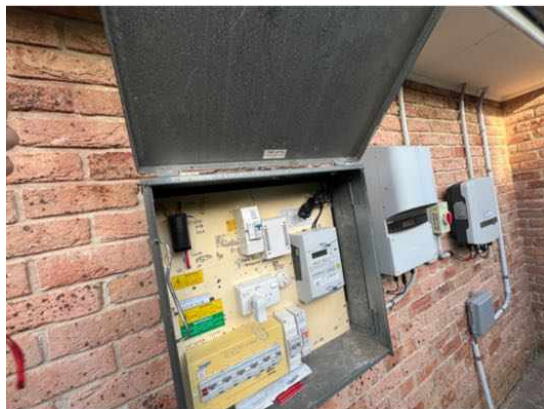
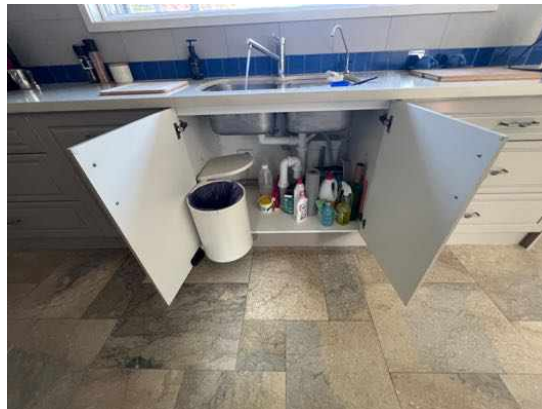
At the time of inspection, no Durable Notice was identified, and there was no evidence to suggest that a termite management system had been installed or that preventative treatments had taken place. In the absence of a recorded termite barrier, the property remains susceptible to potential termite attack on timber building elements.

It is recommended that the purchaser make further inquiries with the vendor regarding any past termite treatments or history of termite activity at the property, including any treatments applied to trees on-site. Additionally, consultation with a licensed pest controller is advised to assess the feasibility and cost of installing a post-construction chemical termite barrier. If a termite management system is installed, a Durable Notice should be placed in the switchboard unit or another accessible location to indicate the type of barrier in place and its maintenance requirements.

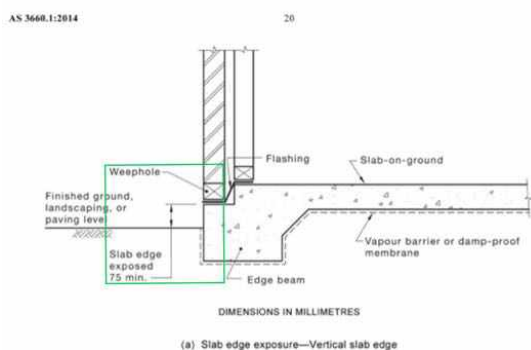
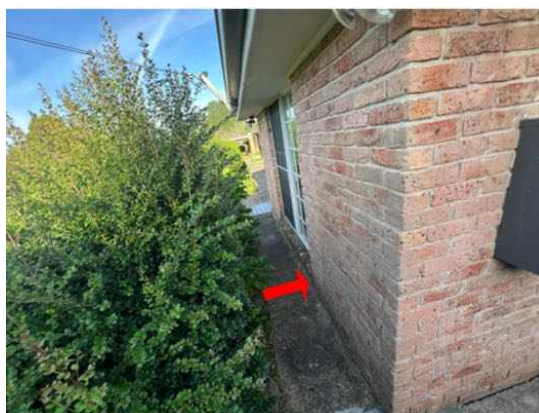
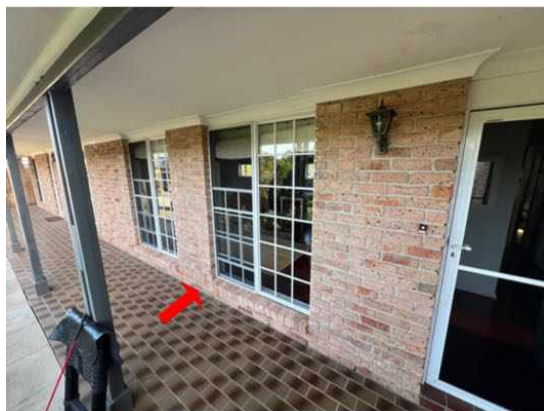
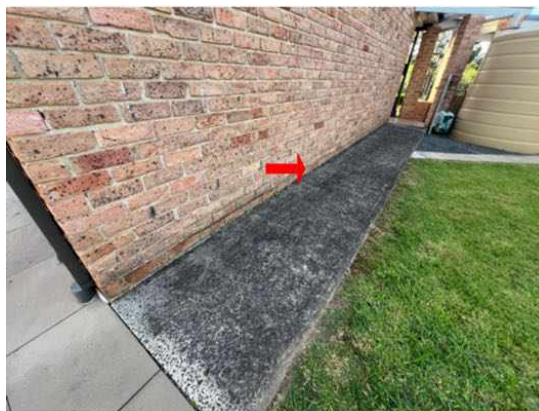
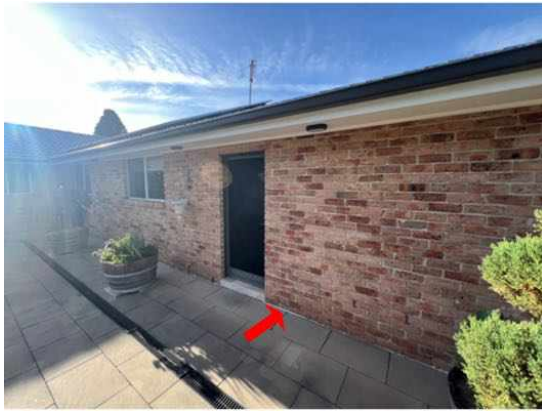
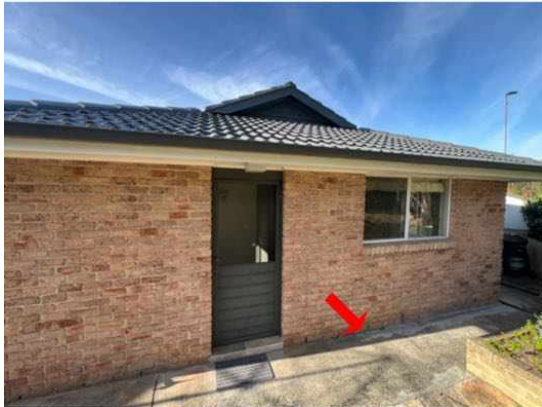
If the slab edge is not properly exposed there is a high risk of termite attack. Sometimes, in order to determine the type of slab, a suitably qualified person such as an architect or builder may be required to consult the construction plans.

Where the slab edge cannot be properly inspected, it is highly recommended that termite or timber pest inspections be carried out every 6-12 months to aid protection of the property against infestation.

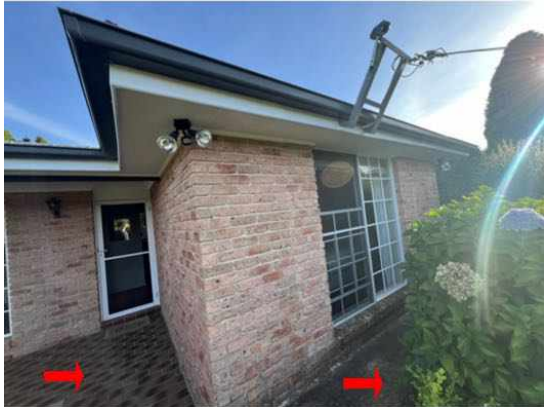
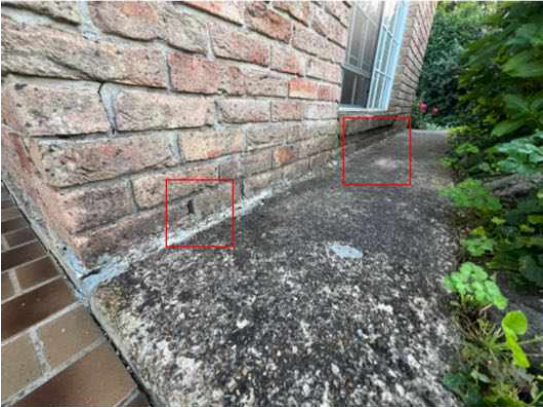
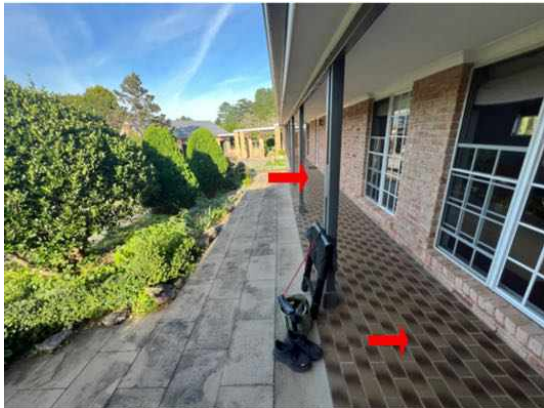
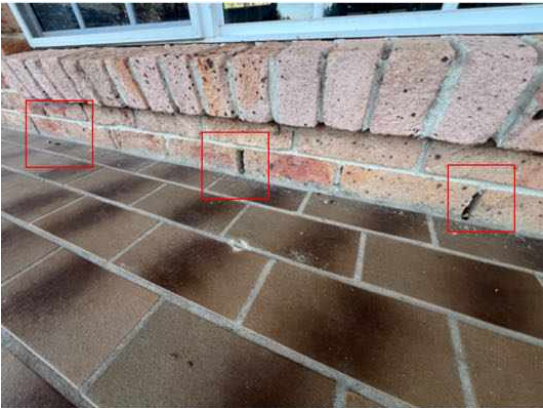
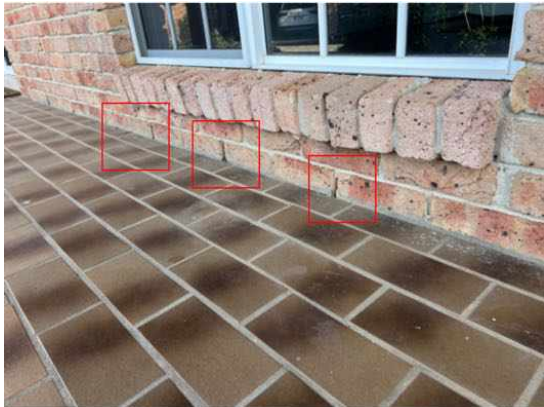
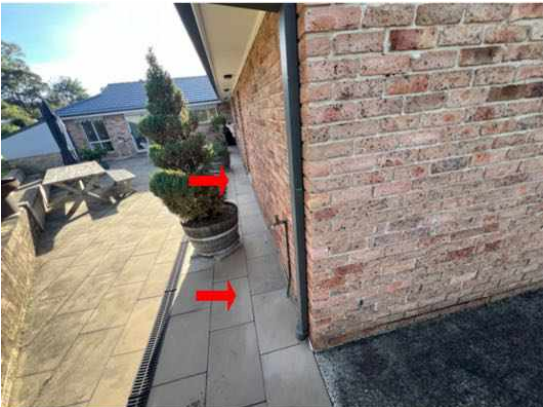
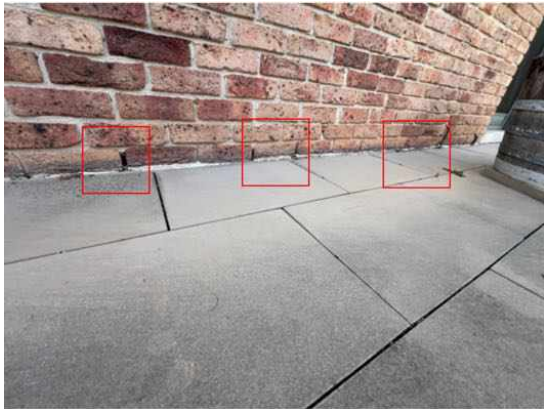
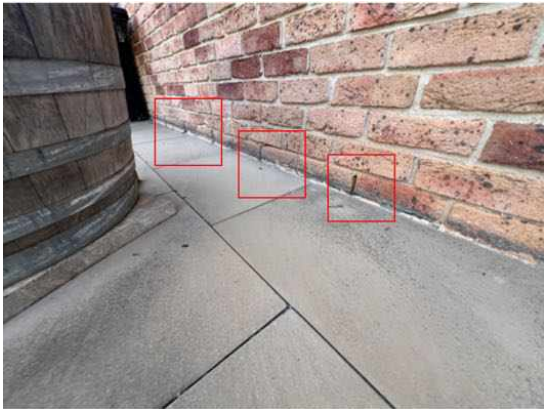
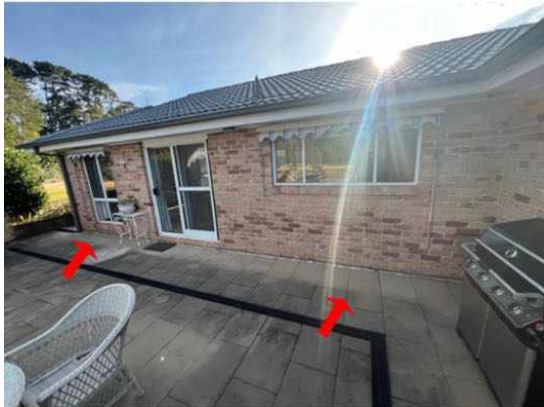
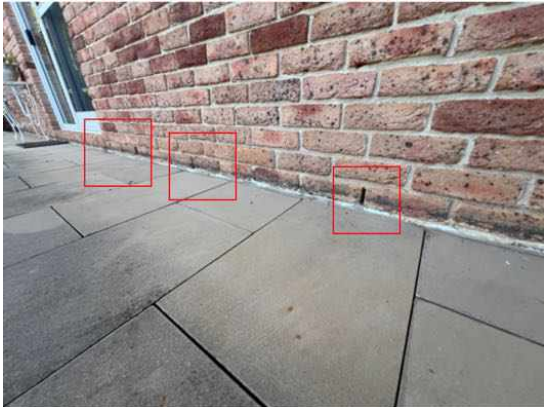
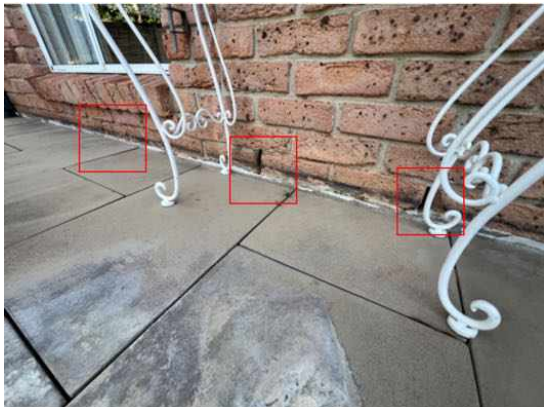
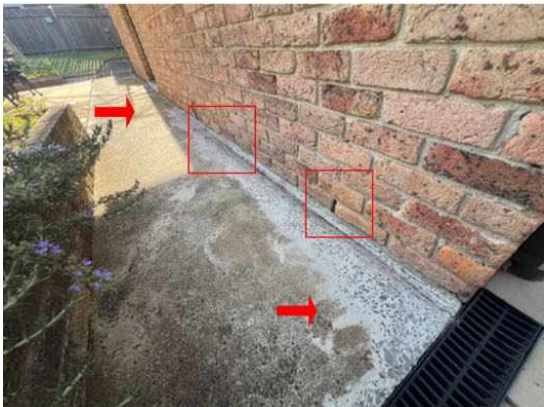
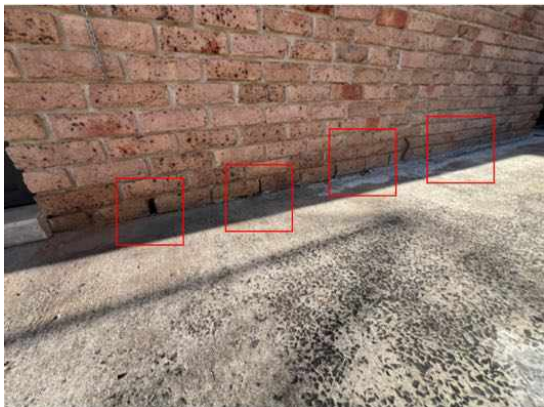
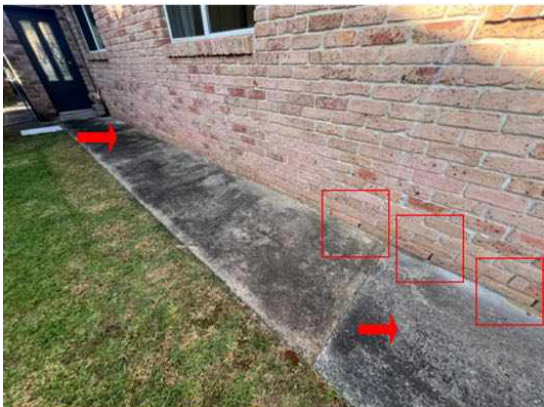
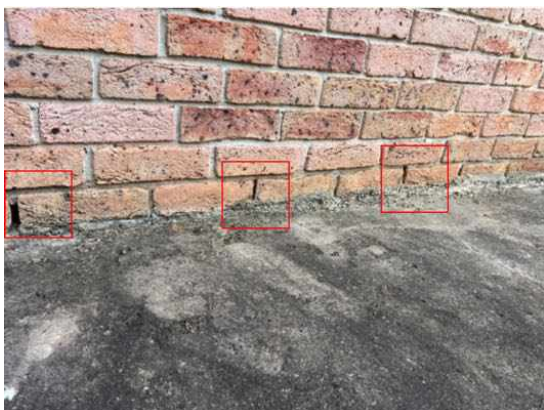
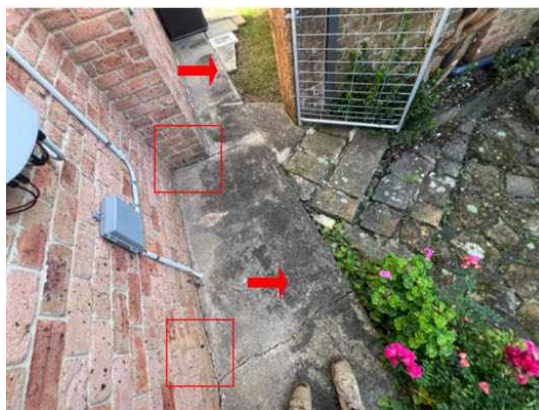
Generally this takes the form of finished ground levels external paving or concrete being retrospectively installed above the damp course level the adjacent internal floor level or weep and ventilation holes.

Where bridging has occurred full inspection is prevented and termites may enter a property in a concealed or undetectable manner.

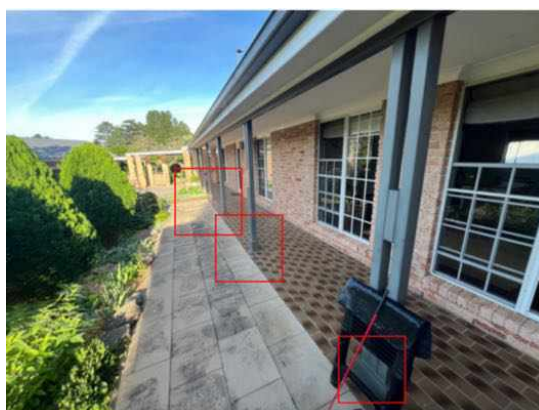
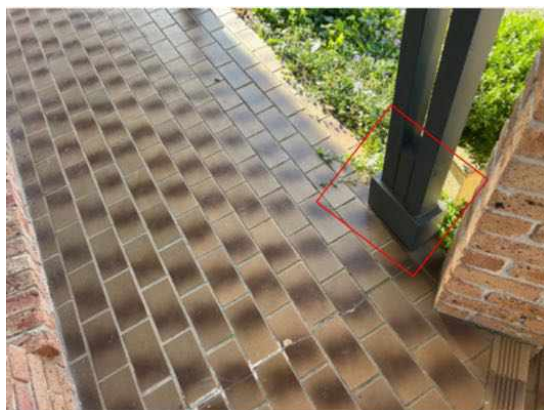
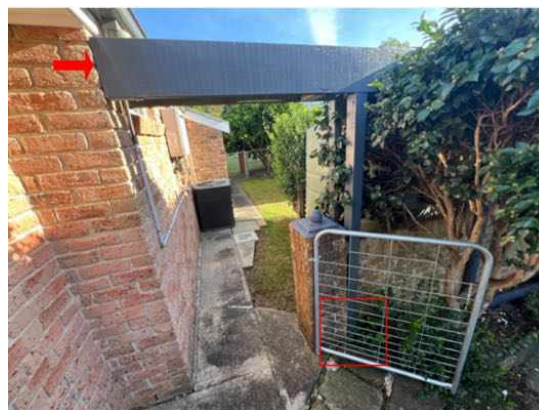
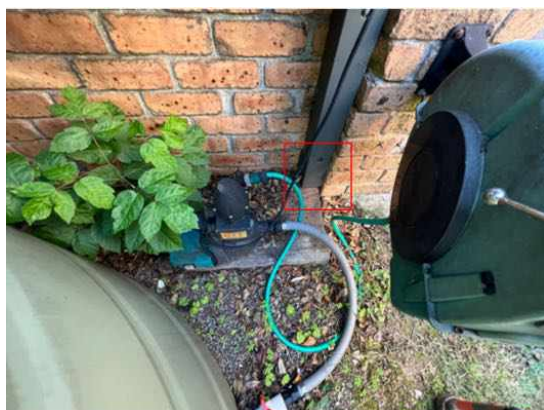
Finding 6.05

Building: Main Building
 Location: Verandah, Exterior walls - right side
 Finding: Bridging of termite barrier - Posts.
 Information: Posts that are attached to home from ground to structure without a 75mm inspection zone (metal stirrup) causes a bridging point. Bridging of termite barriers occurs when termites bridge (usually by building a mud tunnel) a termite barrier or inspection zone or where termites have a passage allowing them to bridge the barrier.

Generally this takes the form of finished ground levels external paving or concrete being retrospectively installed above the damp course level the adjacent internal floor level or weep and ventilation holes.

Where bridging has occurred full inspection is prevented and termites may enter a property in a concealed or undetectable manner.

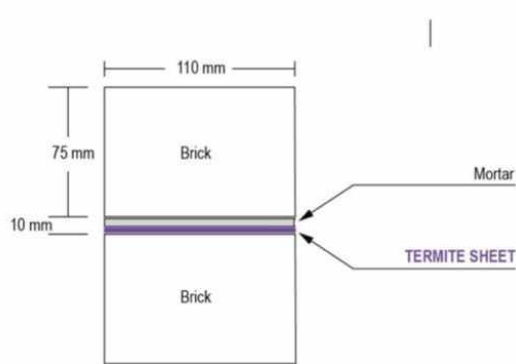
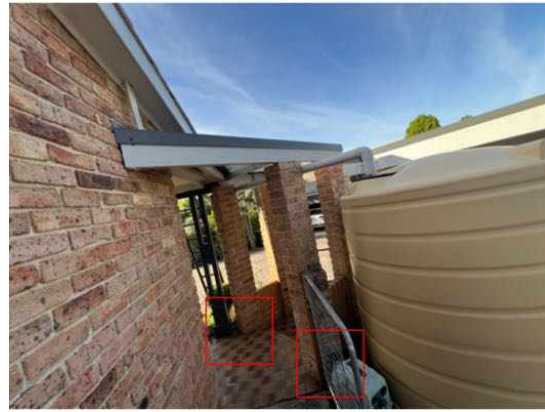
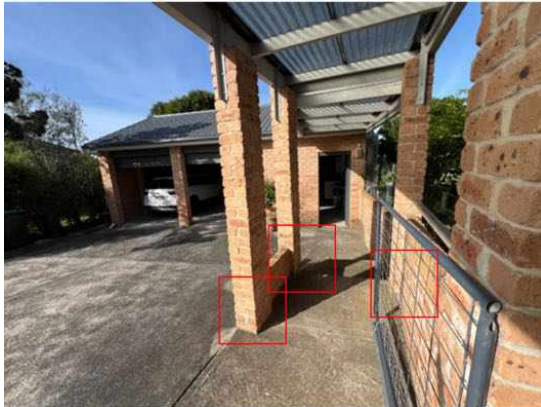
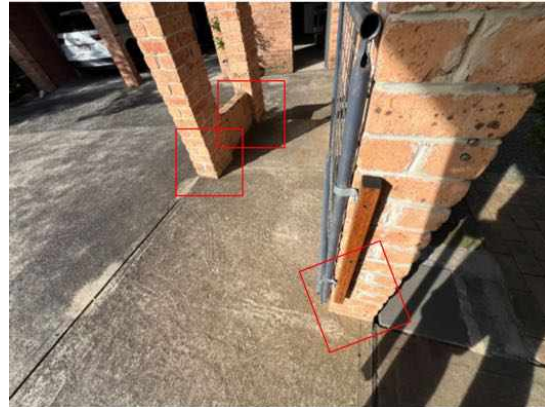
Finding 6.06

Building:	Main Building
Location:	Breezeway
Finding:	Bridging of termite barrier - brick piers.
Information:	Brick pier that are attached from ground to structure without a visible inspection zone (barrier 75mm AFL) causes a bridging point. Bridging of termite barriers occurs when termites bridge (usually by building a mud tunnel) a termite barrier or inspection zone or where termites have a passage allowing them to bridge the barrier.

Generally this takes the form of finished ground levels external paving or concrete being retrospectively installed above the damp course level the adjacent internal floor level or weep and ventilation holes.

Where bridging has occurred full inspection is prevented and termites may enter a property in a concealed or undetectable manner.

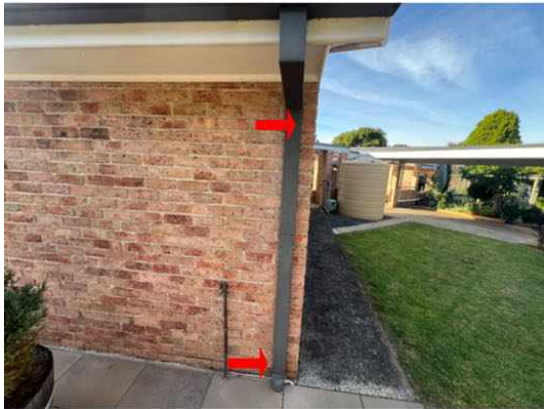
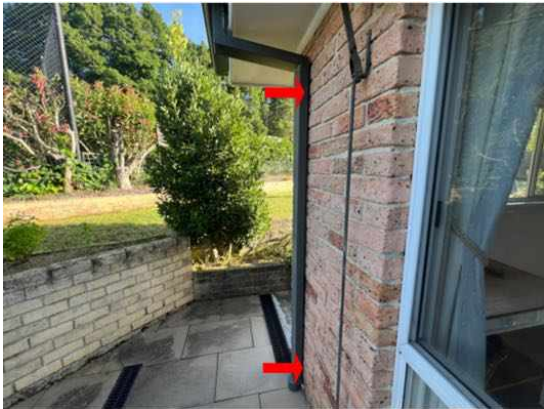
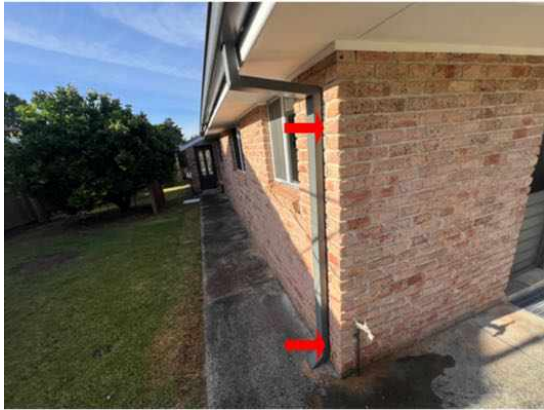
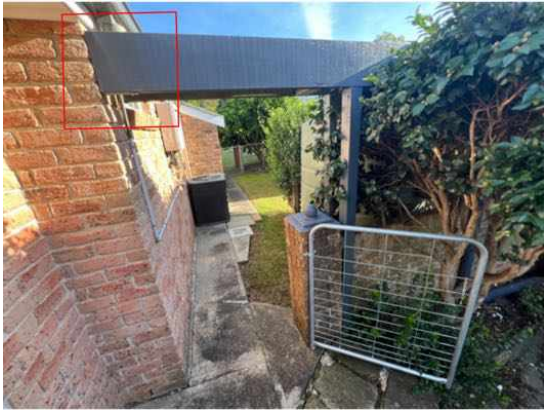
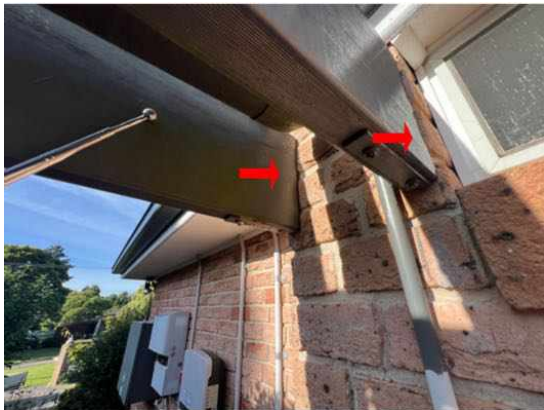
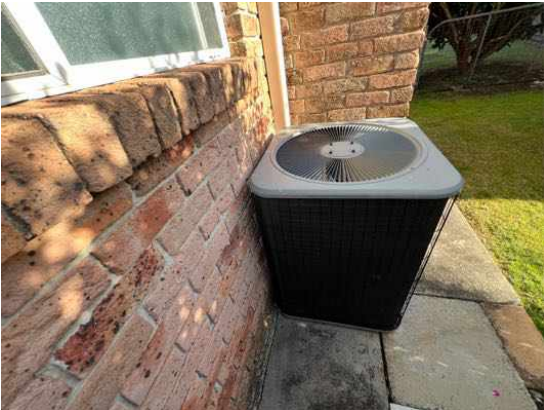
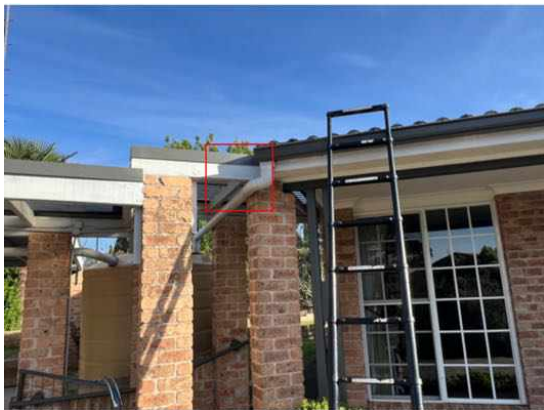
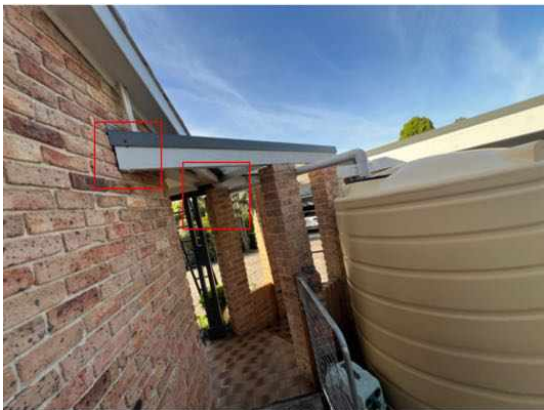
Finding 6.07

Building:	Main Building
Location:	All External Areas
Finding:	Bridging - Attachments to Buildings.
Information:	Bridging occurs when items against a building provide a concealed entry point for termites into the building or by passing around a termite management system.

Where any part of an attachment to a building is not isolated and is not provided with a clear gap of not less than 25mm from the building, bridging occurs. Attachments to buildings such as hot water services, downpipes, verandahs, decks, steps, fences, service conduits and the like provide the opportunity for concealed entry.

Building attachments of this nature need to be frequently inspected for termite activity by a qualified inspector

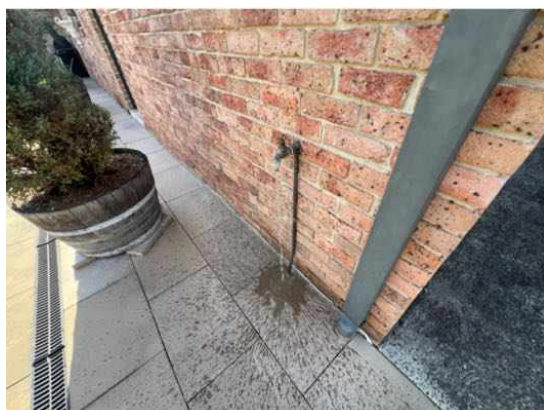
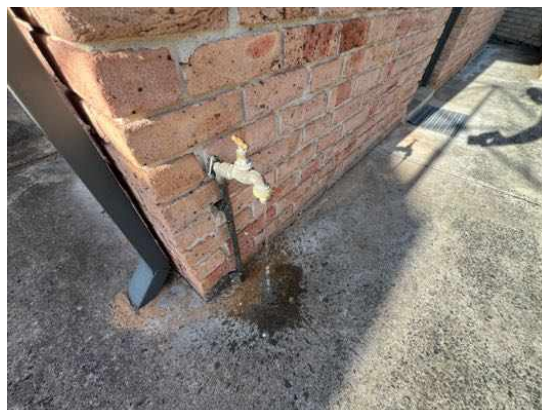
Finding 6.08

Building:	Main Building
Location:	All External Areas
Finding:	External taps - Not plumbed for drainage
Information:	The External taps is not plumbed or connected to suitable drainage, which has resulted in the surrounding area becoming excessively damp. These damp conditions can lead to secondary defects such as rot, rust or corrosion of associated building elements, the formation of fungal decay, or even the creation of potential slip hazards. When coupled with poor site drainage, pooling of water may also attract termite activity to this area. It is highly recommended that a qualified plumber be appointed to install adequate drainage to the overflow. These works will ensure that the area remains dry and free of any secondary defects.

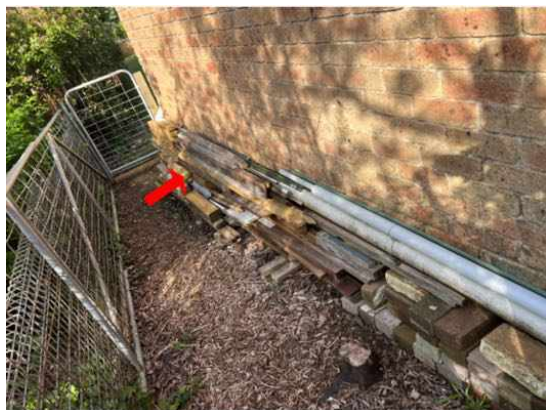
weather conditions or excessive moisture wood rot is likely to develop on timbers that are not treated.

It is highly recommended that any stored timbers be immediately removed from areas in which they may attract any termite / timber pest attack. Minimisation of risk / prevention of termite attack is far more adequate than dealing with the presence of termite activity.

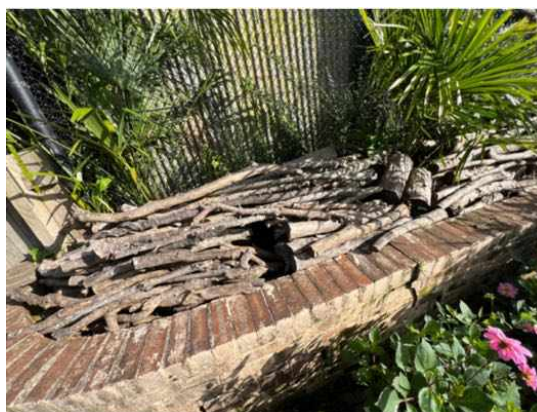
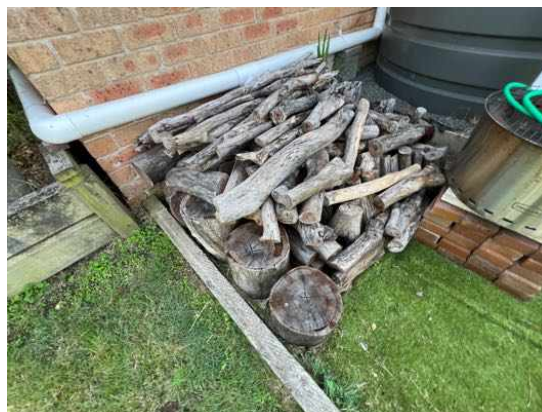
Finding 6.11

Building:	Yard
Location:	Yard
Finding:	Firewood Stored Directly on Ground – Conducive to Timber Pest Activity
Information:	Firewood was observed to be stored directly on the ground within the property. Timber stored in direct contact with soil creates conditions highly conducive to termite activity and timber decay, as the ground retains moisture and provides shelter for timber pests.

It is recommended that firewood be stored off the ground on a raised platform or in a dedicated storage rack to minimise the risk of timber pest attack. Regular inspections of the stored timber and the surrounding ground area are also advised. The client should consult a licensed pest controller for further advice on timber pest management and preventative measures.

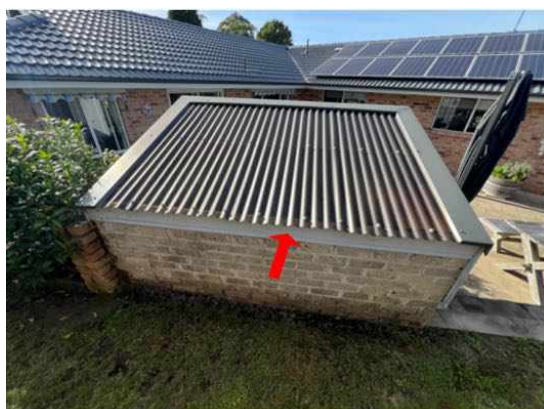
Finding 6.12

Building:	Shed
Location:	Shed
Finding:	Guttering - Not Installed (Photos shown in previous defect section)
Information:	The absence of guttering at this property increases the risk of water pooling around the foundation, which creates conditions highly conducive to termite activity. Without adequate guttering, rainwater is not effectively directed away from the building, potentially causing prolonged moisture retention, soil erosion, or water ingress into lower areas. These conditions can attract termites and facilitate their movement into the structure.

It is recommended that a licensed roof plumber install guttering to ensure proper water drainage and minimise the risk of moisture-related issues and termite infestations. This work should be prioritised to protect the building's structural integrity.
