Building and Timber Pest Inspection Report

Inspection Date: Mon, 16 Mar 2026

Property Address: 3 Annesley Ave, Bowral NSW 2576,
Australia

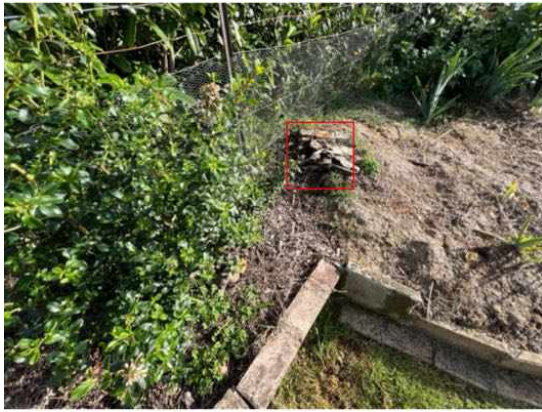
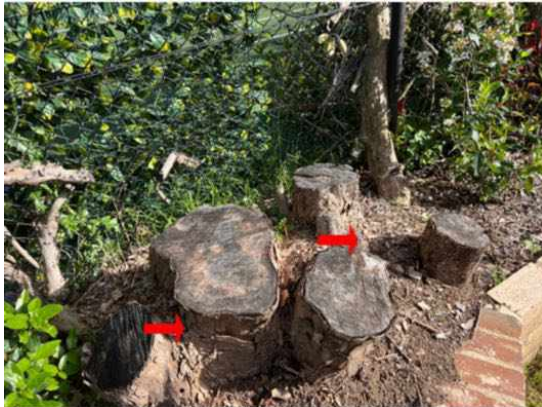
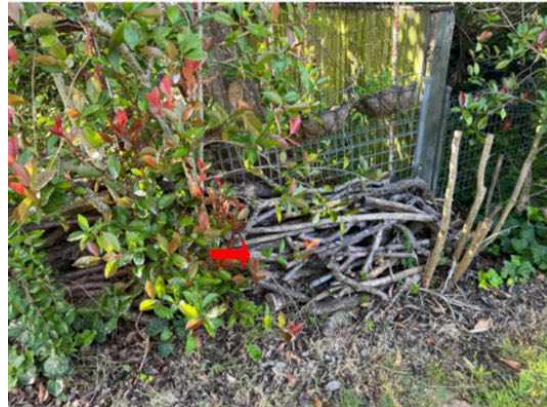
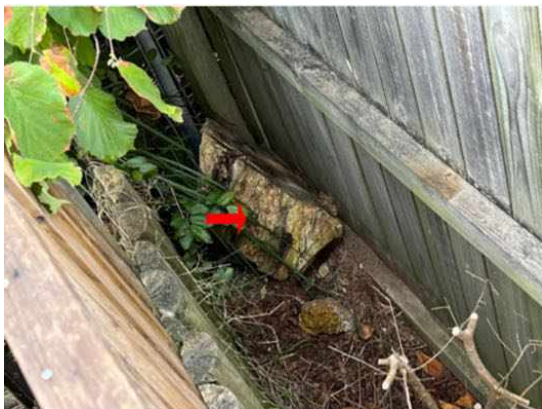
Even in the absence of visible termite workings at the time of inspection, decayed timber material can support undetected subterranean termite harbourage, particularly when located in close proximity to the dwelling. The risk of concealed termite ingress into structural timbers is increased when such materials are not removed or managed appropriately.

The client is advised to consult a licensed pest management professional to assess the site and determine whether treatment or removal of the stumps or trees is required. Ongoing timber pest inspections should be maintained at regular intervals to monitor for any future activity.

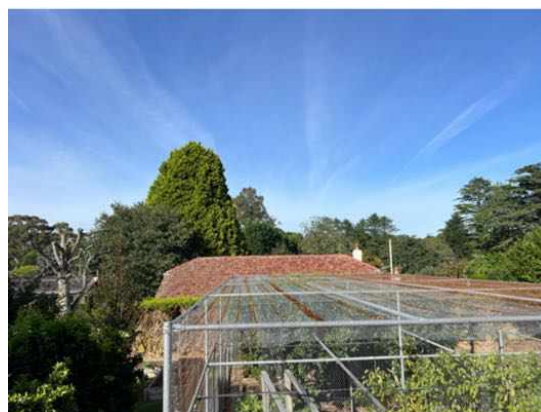
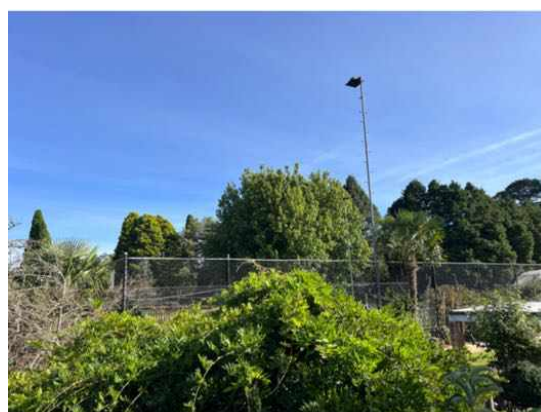
Finding 6.15

Building:	Yard
Location:	The Site
Finding:	Timber Pest Risk – Trees Within 50m of Dwelling
Information:	Mature trees were identified within 50 metres of the dwelling. The presence of trees in close proximity to the structure increases the risk of termite activity, as trees provide a natural food source and nesting environment for termites. Tree roots can also contribute to excessive moisture retention in the soil, creating conducive conditions for timber pest activity.

Regular monitoring for signs of termite activity is advised. A licensed pest inspector should be engaged to assess the area and provide further recommendations on risk

mitigation and management.

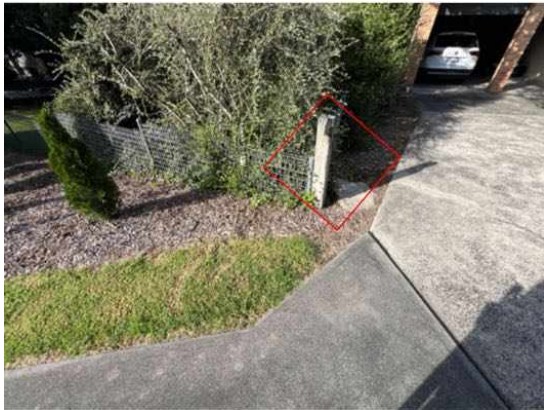
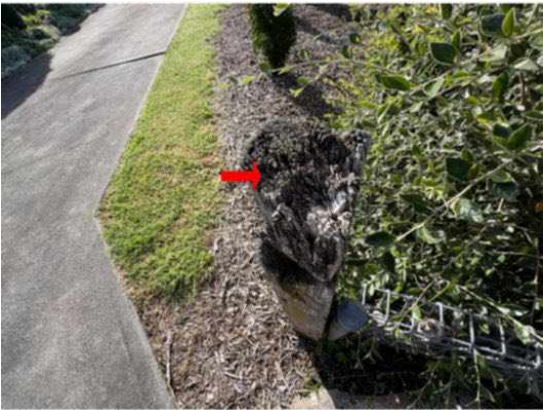
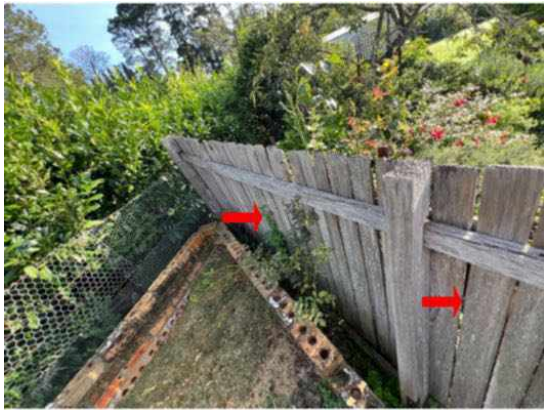
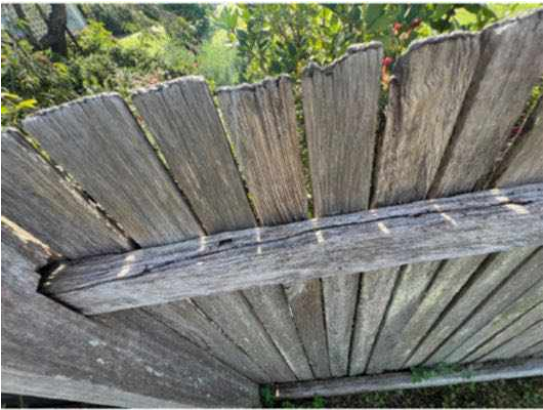
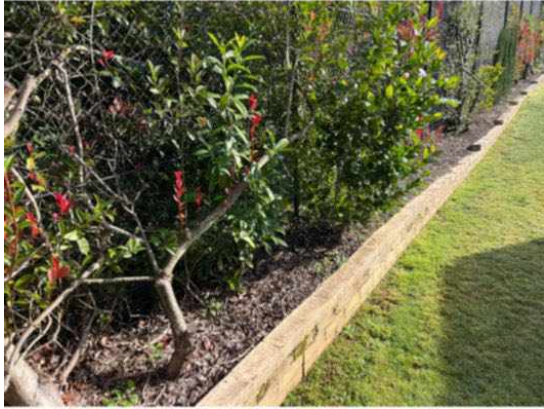
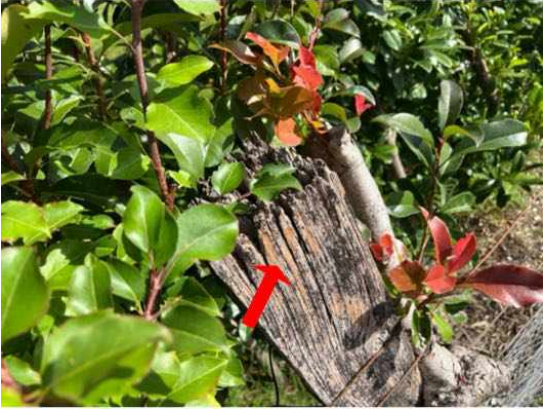
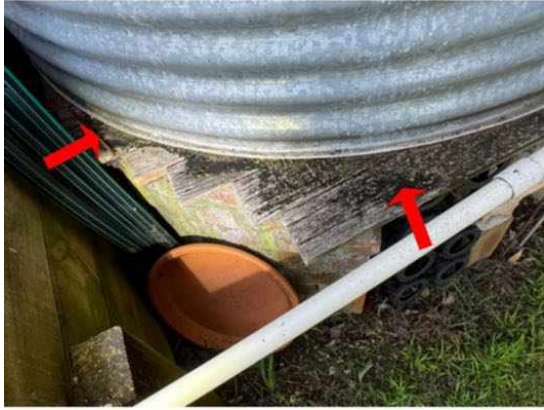
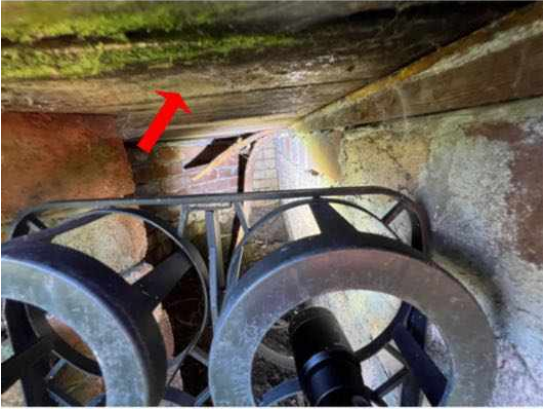
Finding 7.01

Building:	Yard
Location:	The Site
Finding:	Fungal decay - present (localised)
Information:	Fungal decay also known as wood decay or wood rot generally refers to the deterioration of timber elements when in contact with excessive levels of moisture for a prolonged period of time.

The development of fungal decay is accelerated by temperatures in the range of 5degreeC to 40degreeC as well as the presence of oxygen. Generally fungal decay develops on timber elements that are in use in an external environment which are exposed to rain penetration.

In this case although the affected timber element is in a decaying state the extent of any visible damage appears to be localised to a specific area and is yet to spread to other parts of the building element or affect adjoining structures. The fungal decay is therefore likely to be of a relatively superficial nature with minimal impact on the

structural integrity or tensile strength of the timber element.

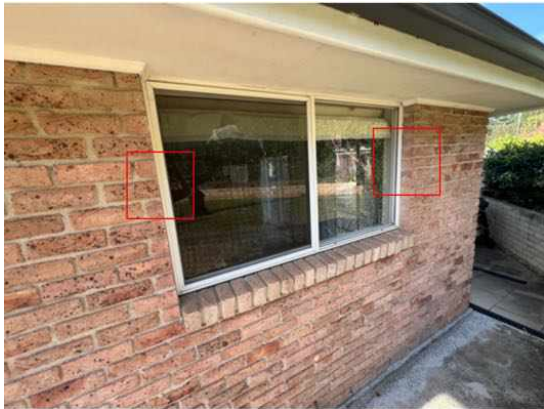
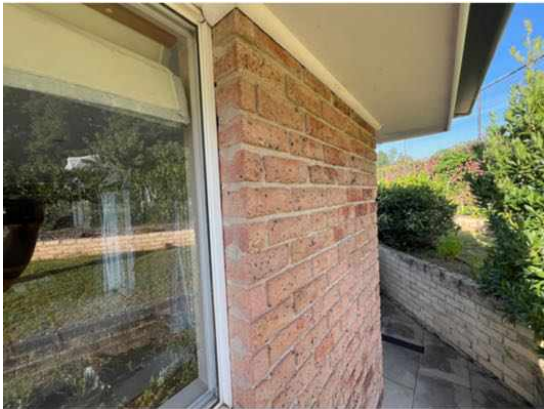
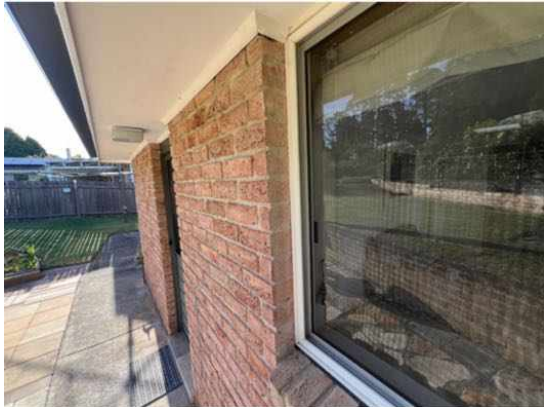
This condition appears to be primarily cosmetic and does not appear to affect the structural performance of the brickwork.

This item is noted for your information.

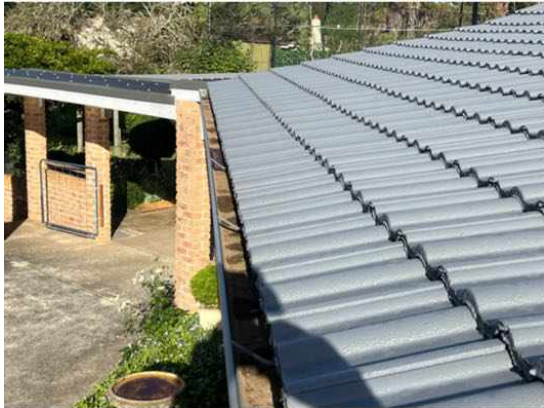
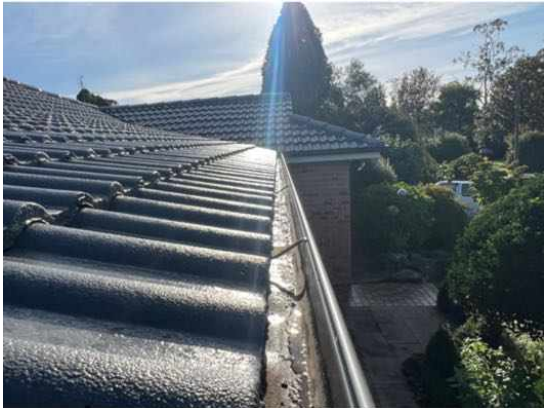
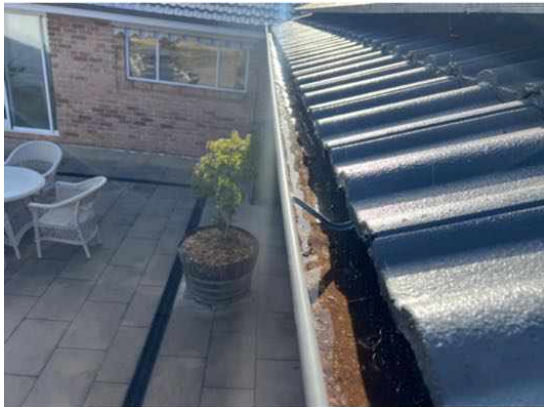
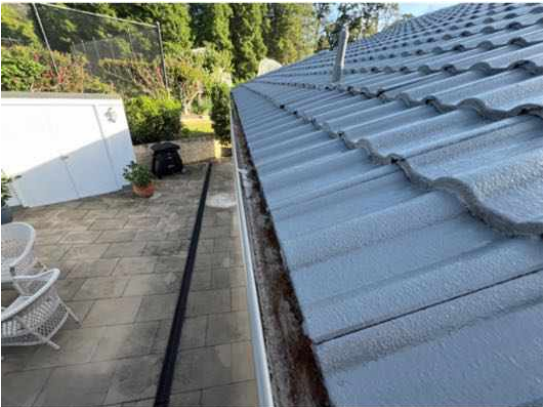
Noted Item

Building: Main Building
Location: Roof Exterior
Finding: Gutter - Clear and clean
Information: At the time of inspection, the gutters were found to be clear of debris and in a clean condition. Blocked gutters are a common cause of water ingress and associated damage to eaves, walls, and internal ceilings. While no concerns were noted at present, it is essential that gutters are routinely maintained and kept free of debris to ensure proper stormwater flow and to avoid potential overflow issues during periods of heavy rainfall.

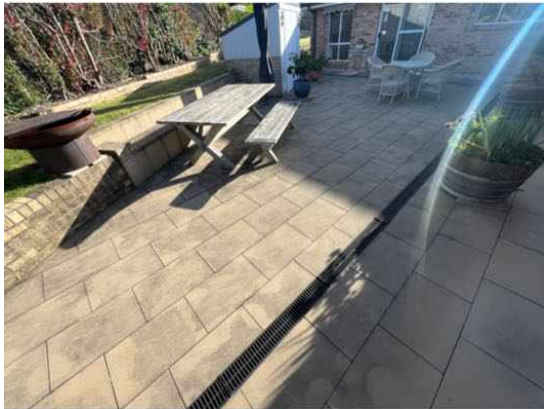
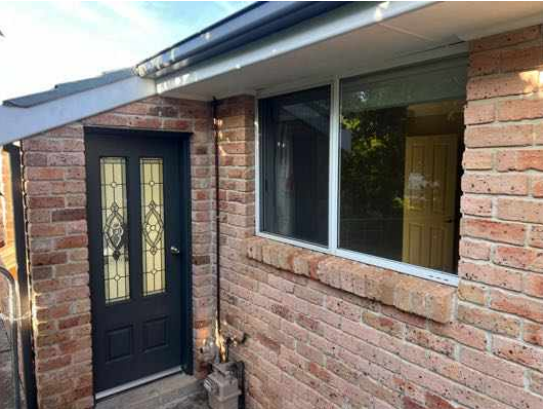
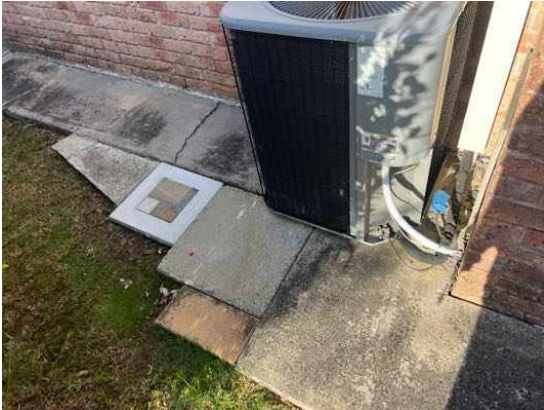
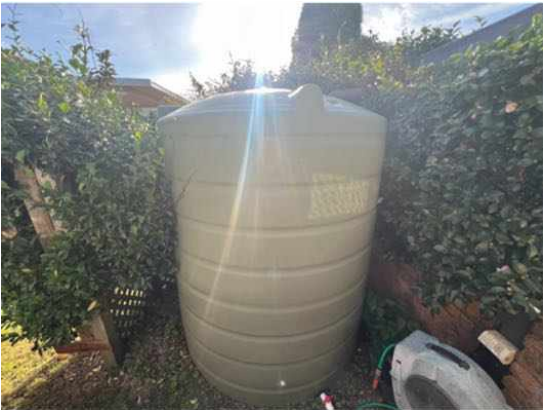
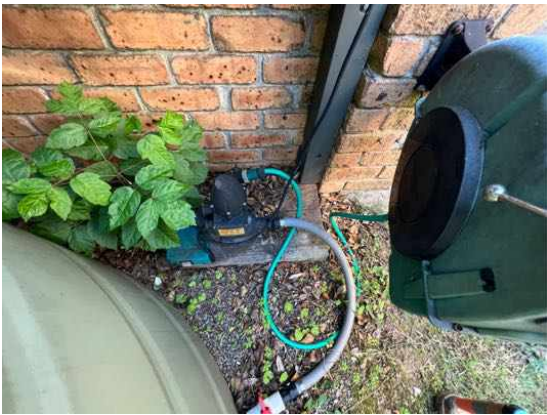
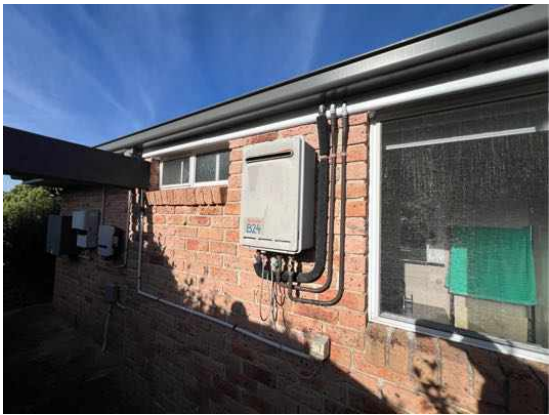
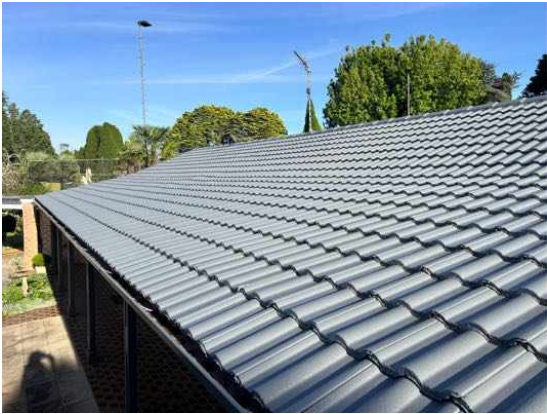
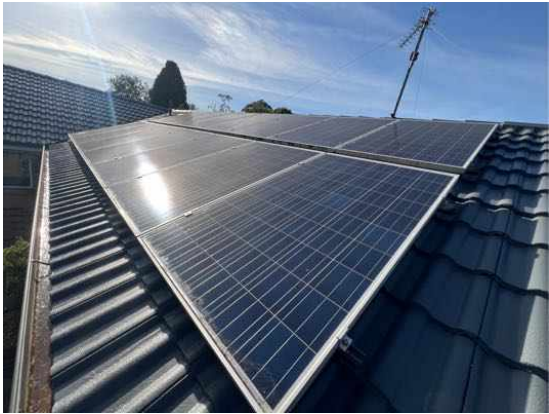
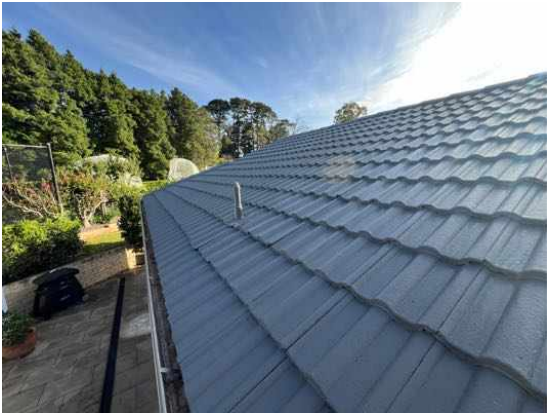
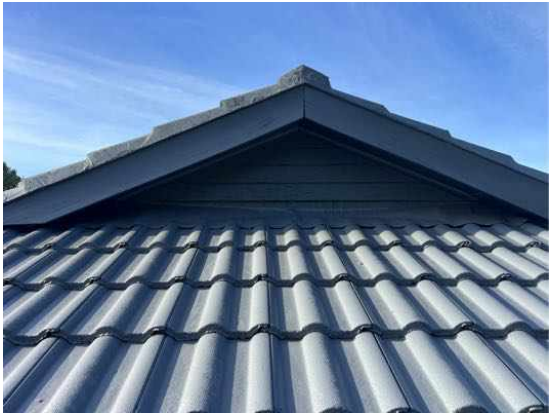
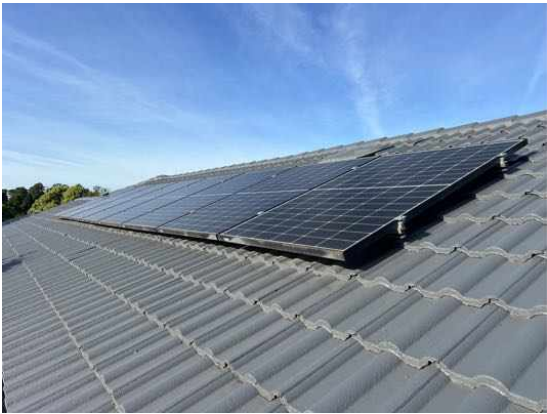
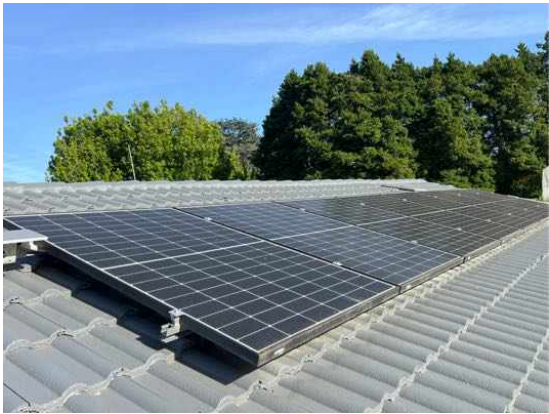
Noted Item

Building: Main Building
Location:
Finding: FYI - Additional Photos
Information: Additional photos are provided for your general reference and may include obstructions, testing of water & windows, moisture readings or minor maintenance items.

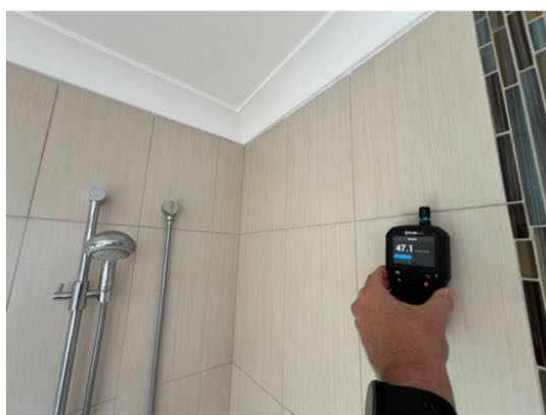
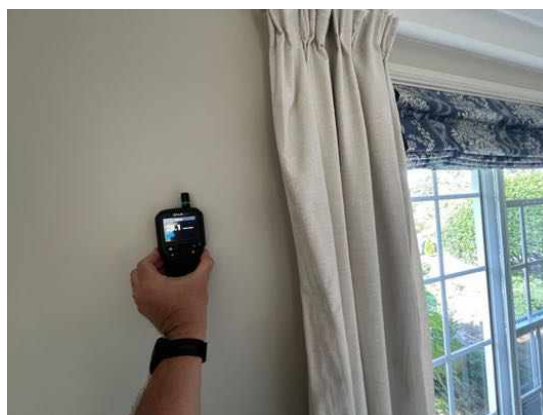
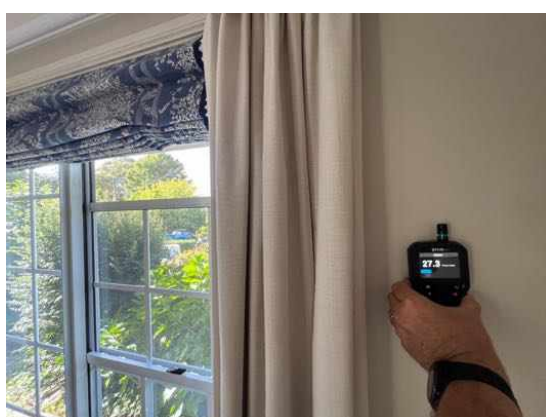
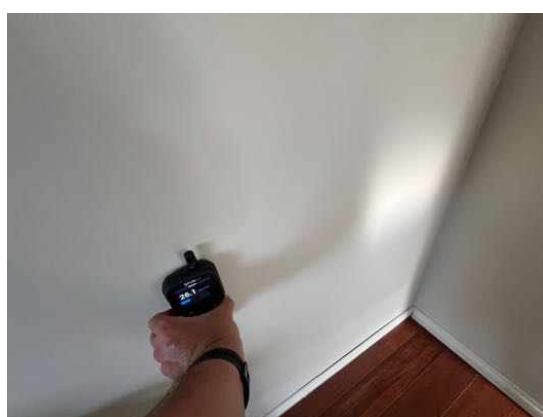
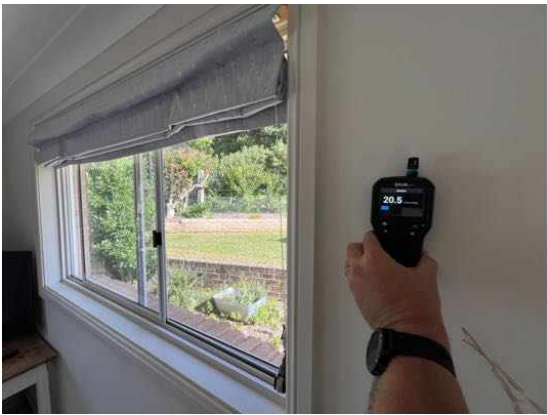
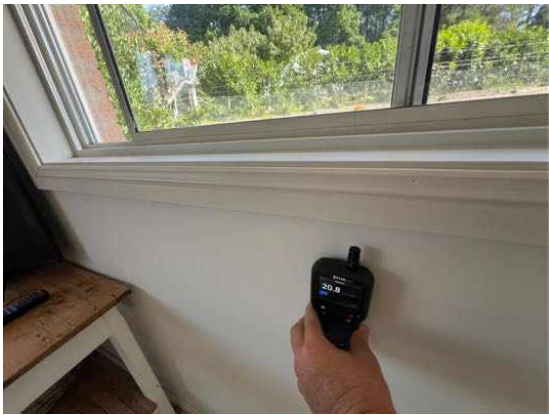
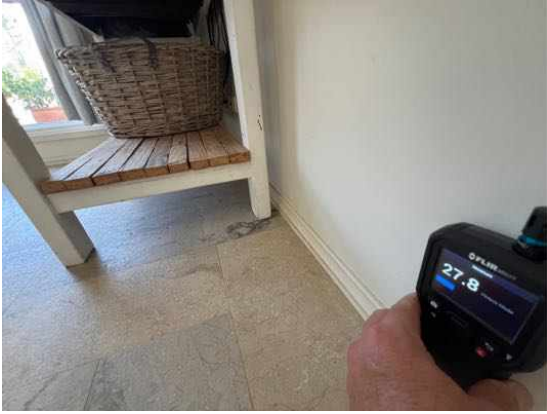
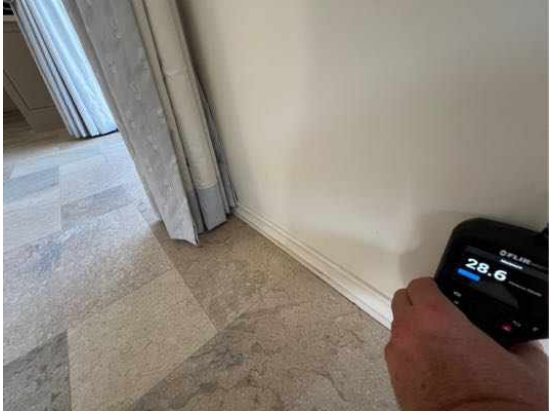
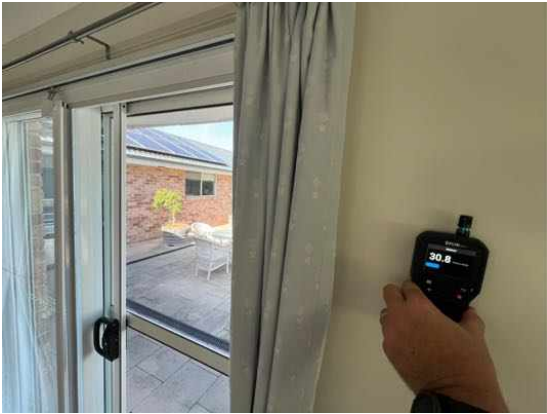
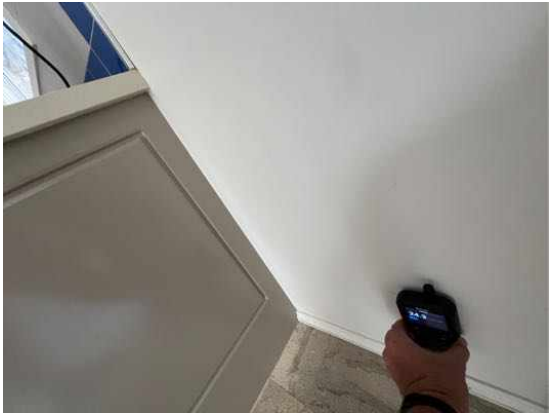
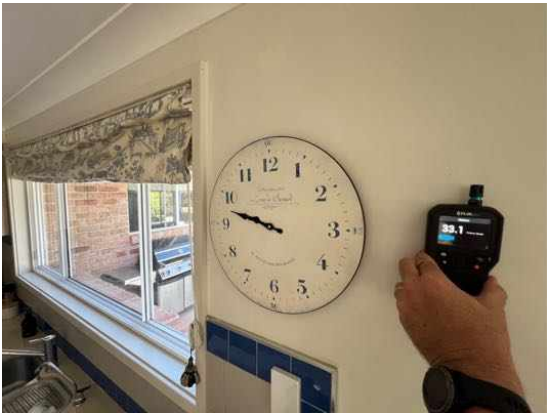
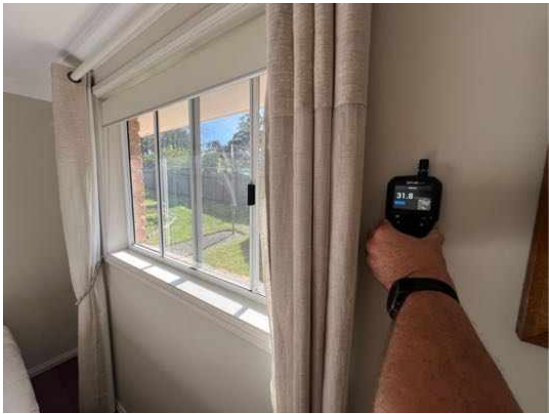
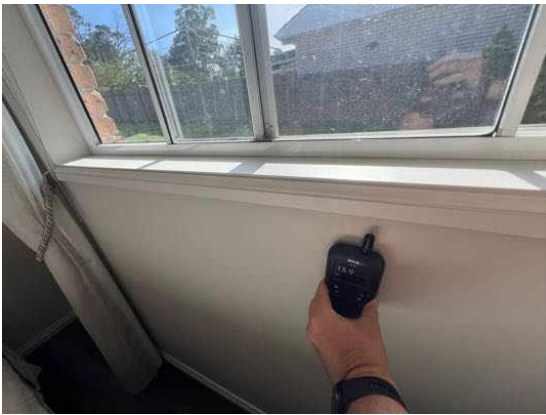
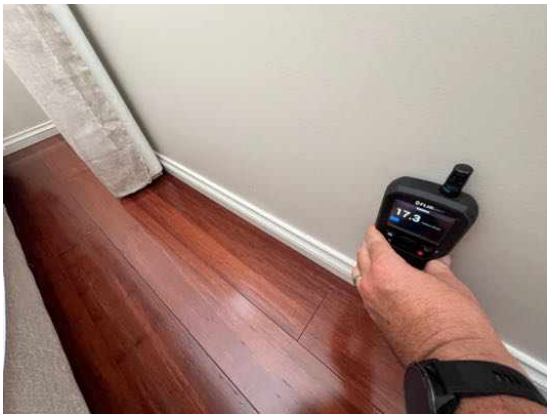
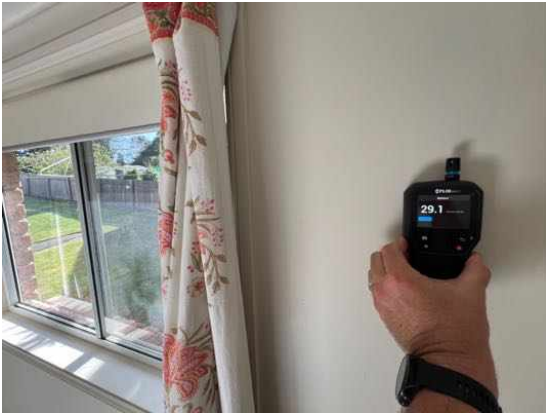
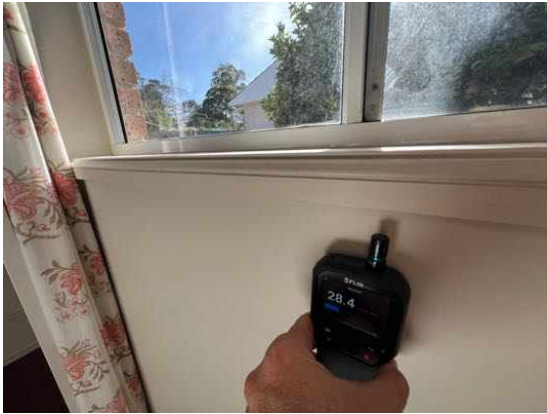
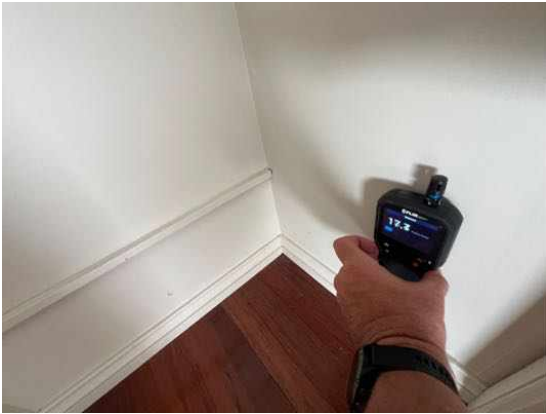
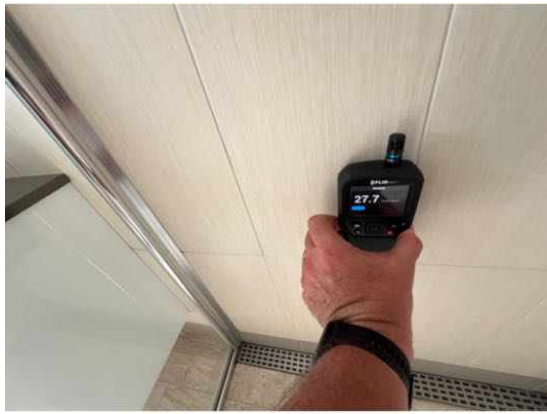
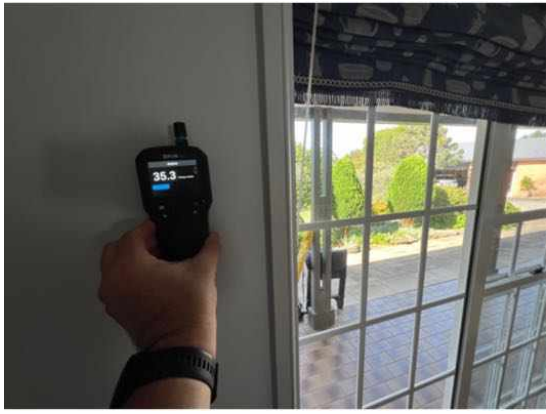
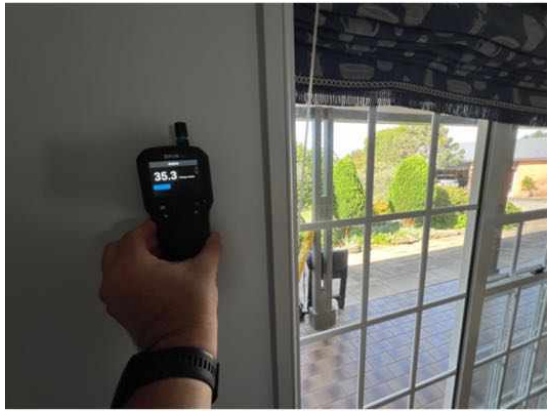
Building: Main Building
Location:
Finding: FYI - Additional Photos - Moisture readings with Flir MR277 Moisture meter
Information: Moisture readings were taken using a FLIR MR277 moisture meter, which provides relative numerical values rather than direct percentage readings. These figures indicate the presence and variation of moisture within building materials and are used as comparative indicators rather than as absolute measurements of moisture content. Each building material, such as plasterboard, timber, tile, or concrete, has its own natural baseline range of ambient moisture, and the meter's values reflect deviations from that baseline.

While percentage-based readings are more common, the numeric scale used by this instrument provides a more accurate, material-specific indication of moisture variation. Readings that exceed normal baseline levels by approximately 20 points or more are considered elevated and warrant further investigation, even where no visible damage is observed.

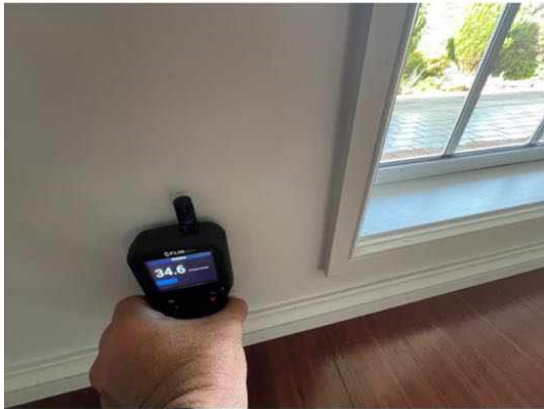
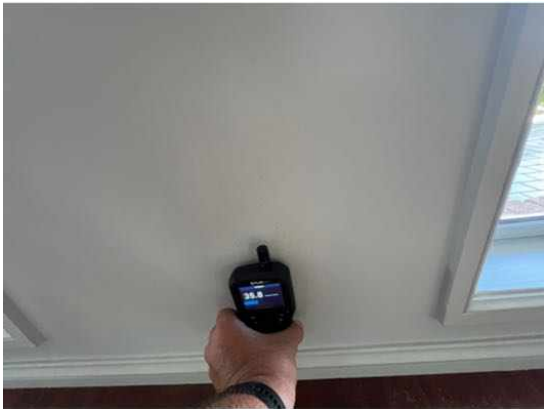
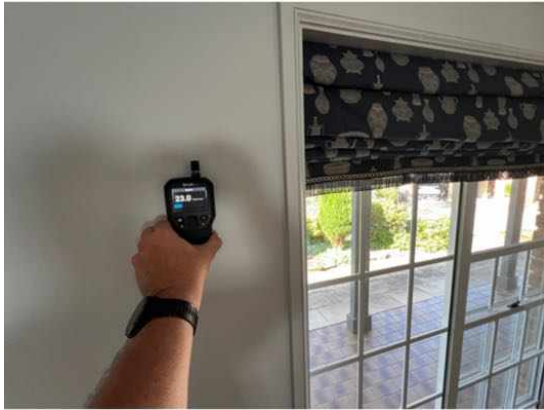
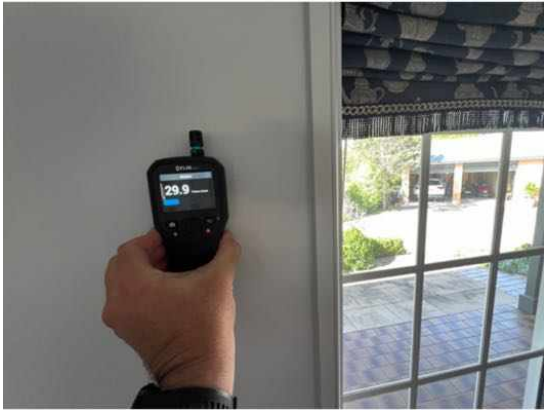
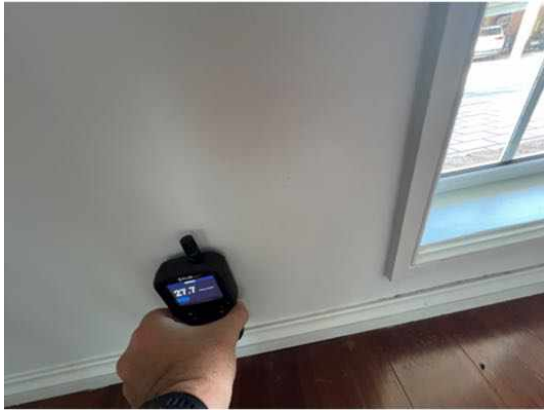
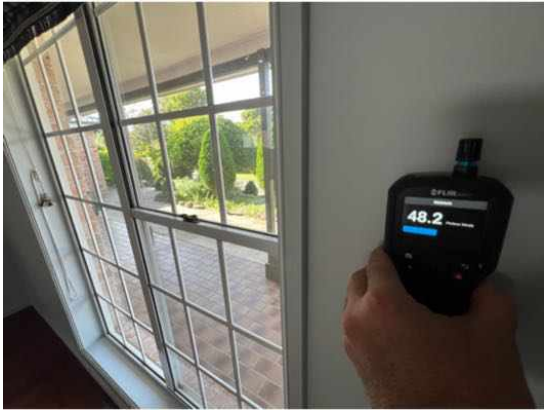
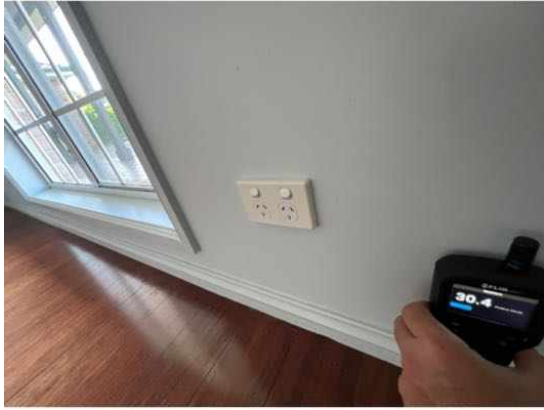
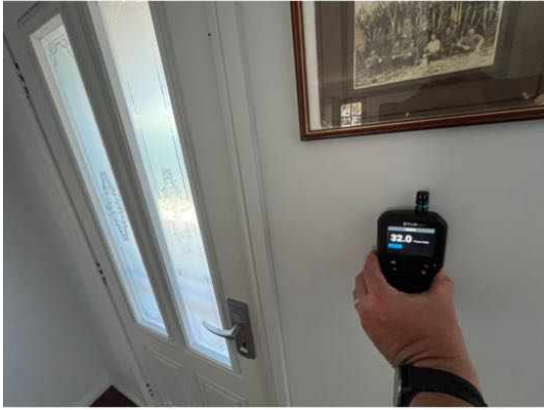
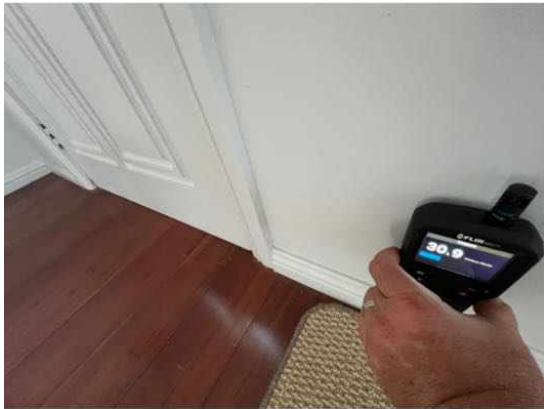
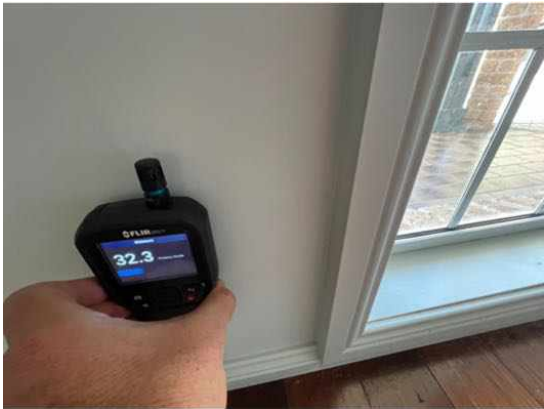
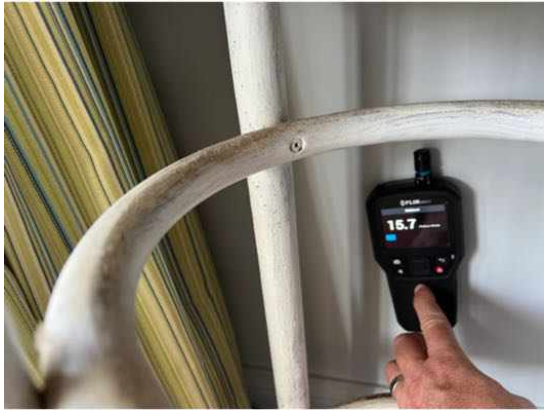
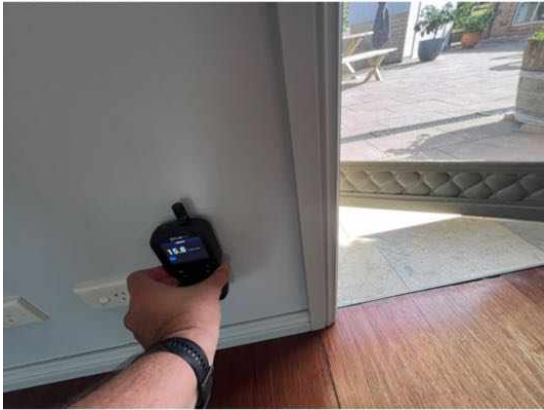
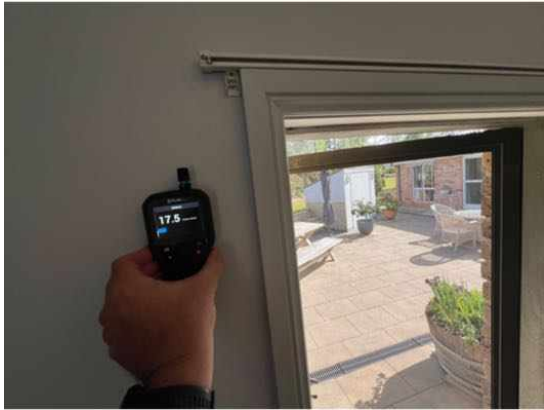
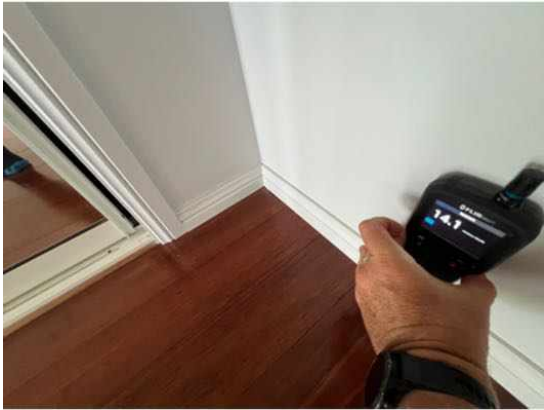
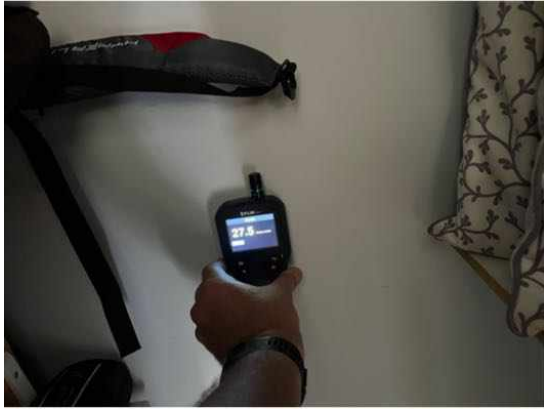
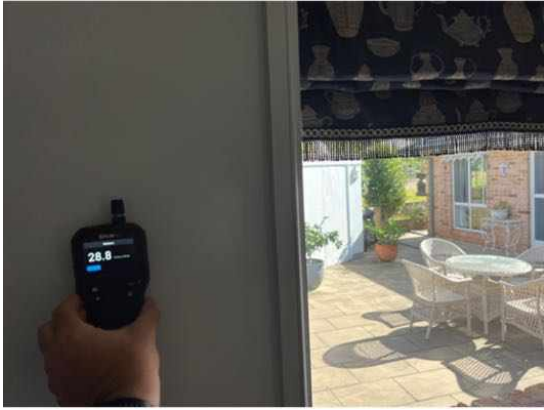
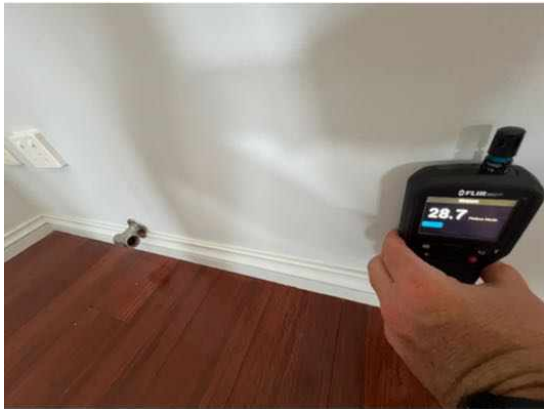
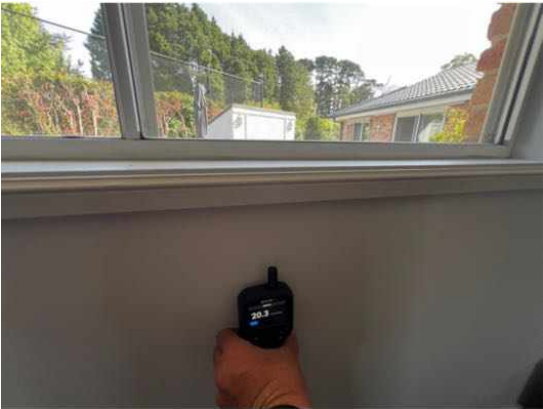
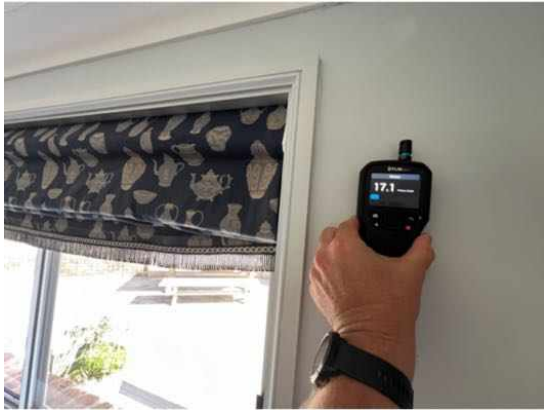
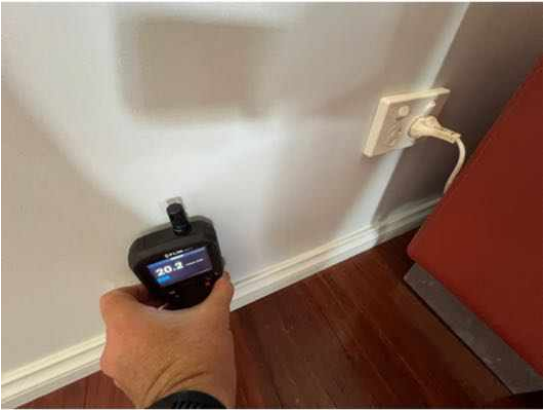
For example, plasterboard in dry internal areas generally records between 10 and 30 points, while ceramic tiles in bathrooms may register between 30 and 50 points due to their density and surface retention. Concrete wall surfaces, particularly those exposed to external conditions or located near wet areas, may range between 20 and 50 points depending on age, porosity, and exposure. These reference ranges allow for comparative assessment in key areas such as wall bases, around windows, and within wet zones to identify elevated moisture ingress.
