Building Inspection Report

Inspection Date: Mon, 2 Mar 2026

Property Address: 418/19 Epping Rd, Epping NSW 2121,
Australia

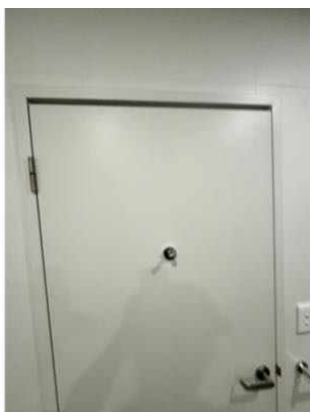
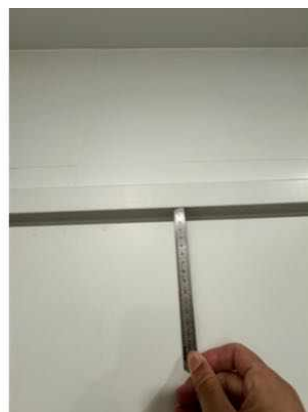
Defects 3.02

Building: Main Building
 Location: Ensuite - Master
 Finding: Door - Gap
 Information: A significant gap was identified between the door and door frame in this area. Where large gaps to the head or foot of door frames appear, it may indicative of a variety of defects, ranging from uneven framework, sagging hinges or uneven flooring.

A gap to the head of the door may also indicate movement of the foundation of the property, which is a common occurrence and does not indicate structural damage.

A qualified carpenter should be appointed to perform remedial works to restore the door to a fully operational level.

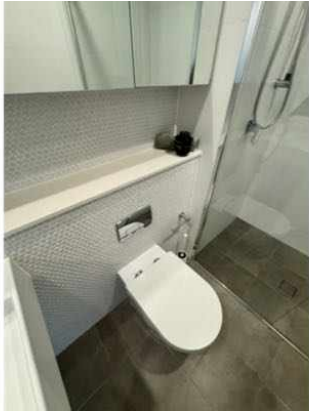
Defects 3.03

Building: Main Building
 Location: Bathroom
 Finding: Toilet pan - Loose
 Information: The toilet pan was found to be loose and relatively unstable at the time of inspection. It is suspected that this defect has developed due to general aging of the toilet pan and associated materials. However, the loose fixing may also be a result of impact damage.

If left unmanaged, the toilet pan could deteriorate further, leading to greater destabilisation and the potential for water leaks to surrounding building elements.

It is recommended that the pan be refixed to the floor with concrete or silicone by a licensed plumbing contractor.

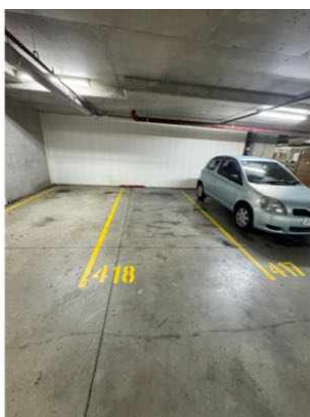
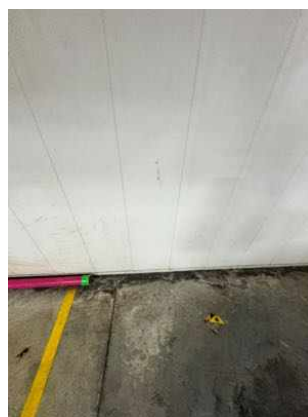
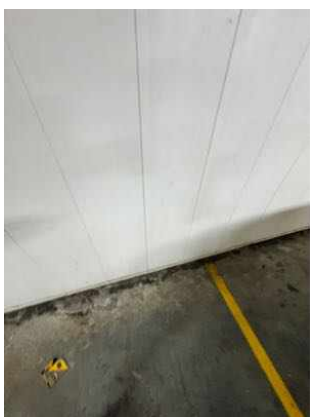
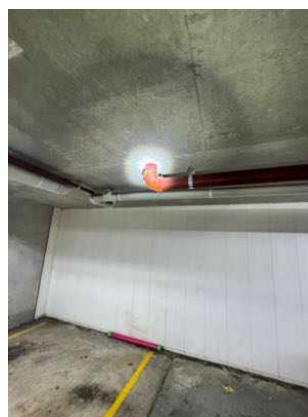
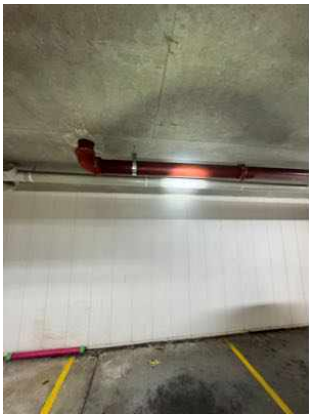
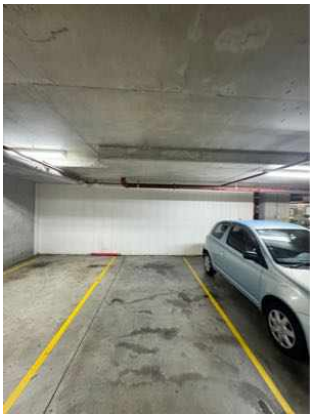
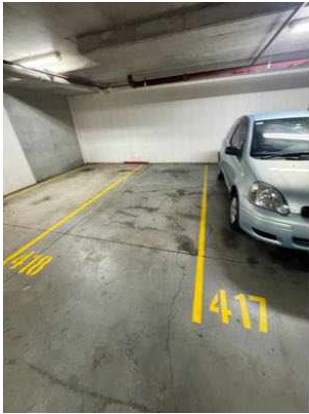
Building: Main Building
Location: Basement
Finding: Additional Photos - Obstructions and Limitations
Information: These photographs are an indication of the obstructions and limitations which impeded full inspection of the property at the time of inspection. These obstructions can hide an array of defects and should be removed to allow full inspection to be carried out. A re-inspection is recommended once the areas are made accessible.

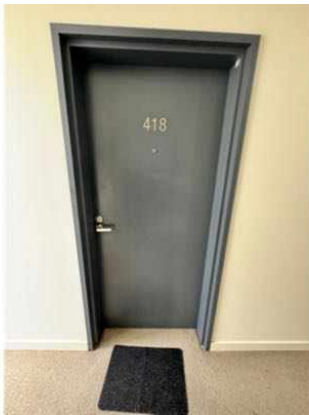
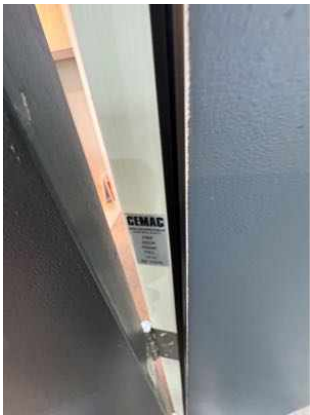
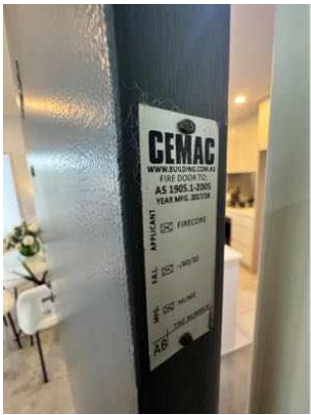
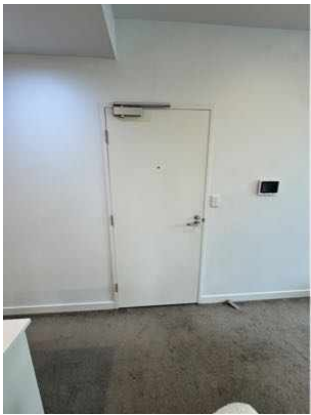
Building: Main Building
Location: Entry
Finding: Additional Photos - Obstructions and Limitations
Information: These photographs are an indication of the obstructions and limitations which impeded full inspection of the property at the time of inspection. These obstructions can hide an array of defects and should be removed to allow full inspection to be carried out. A re-inspection is recommended once the areas are made accessible.

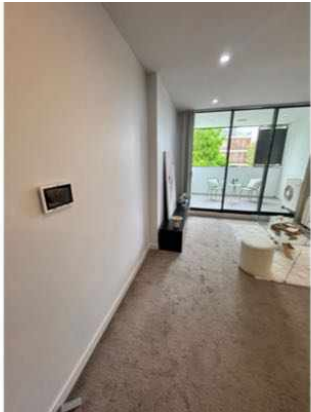
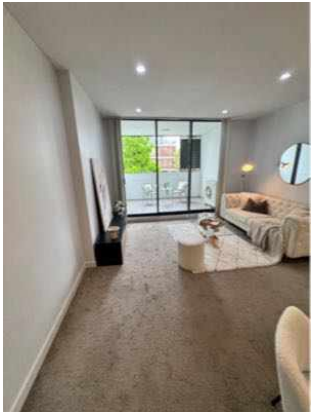
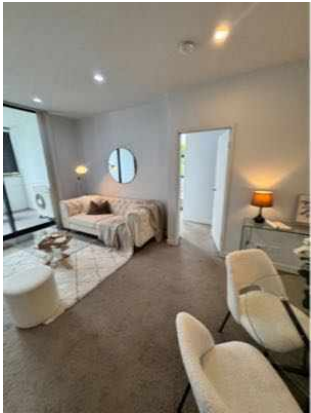
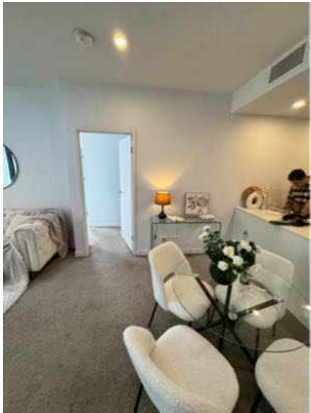
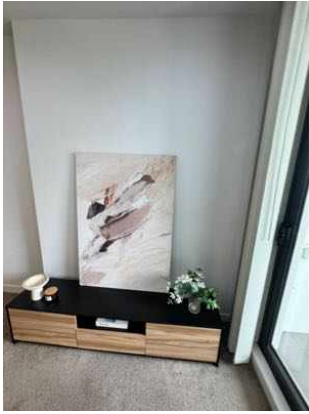
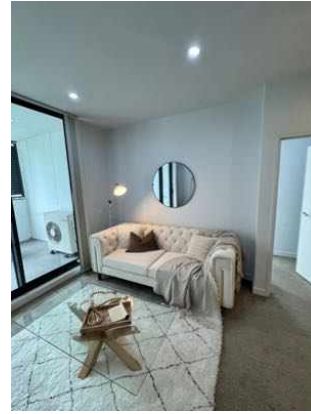
Building: Main Building
Location: Living Room
Finding: Additional Photos - Obstructions and Limitations
Information: These photographs are an indication of the obstructions and limitations which impeded full inspection of the property at the time of inspection. These obstructions can hide an array of defects and should be removed to allow full inspection to be carried out. A re-inspection is recommended once the areas are made accessible.

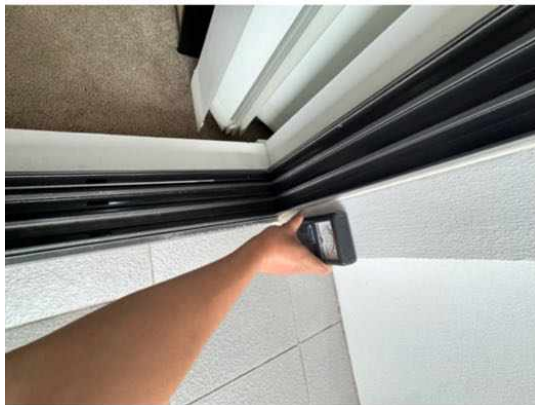
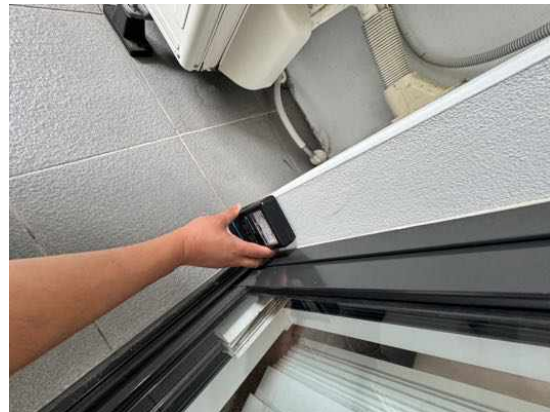
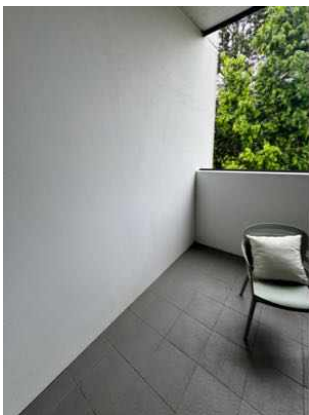
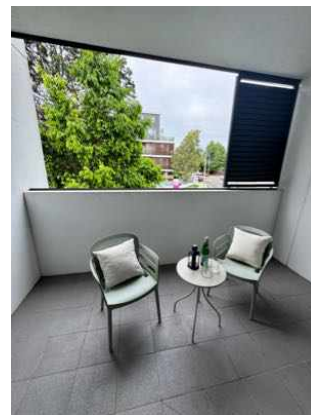
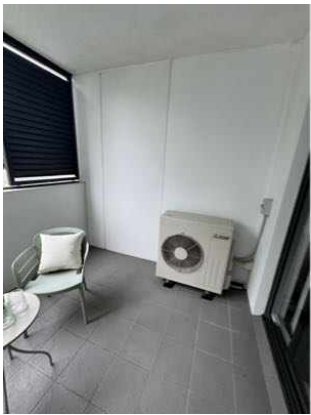
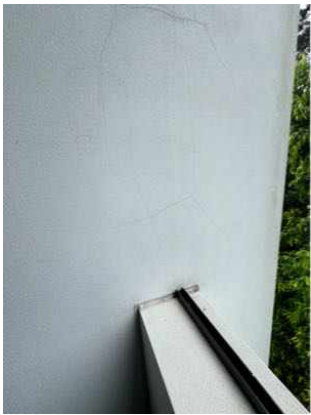
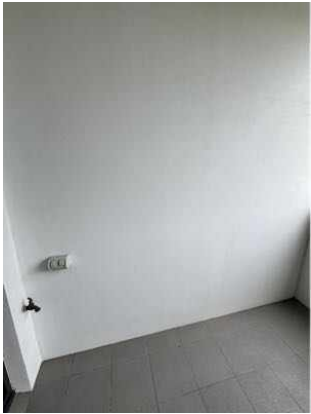
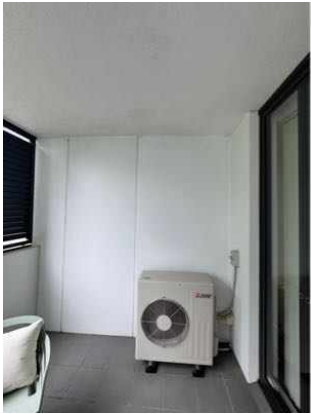
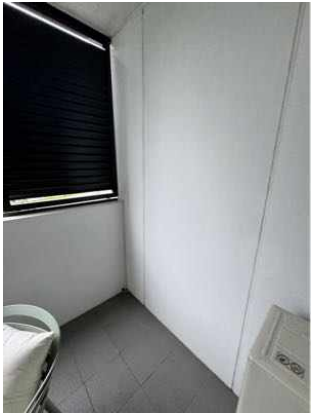
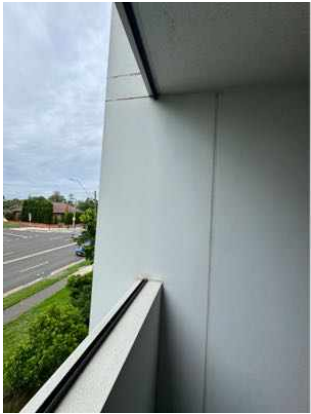
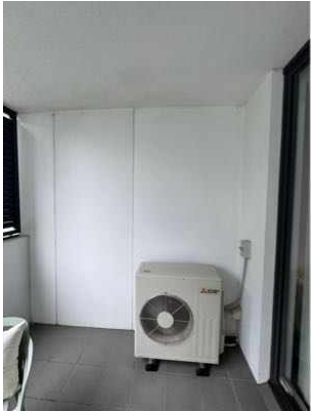
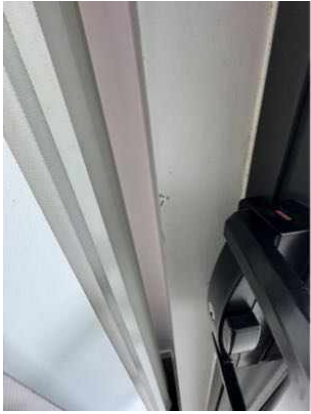
Information: These photographs are an indication of the obstructions and limitations which impeded full inspection of the property at the time of inspection. These obstructions can hide an array of defects and should be removed to allow full inspection to be carried out. A re-inspection is recommended once the areas are made accessible.

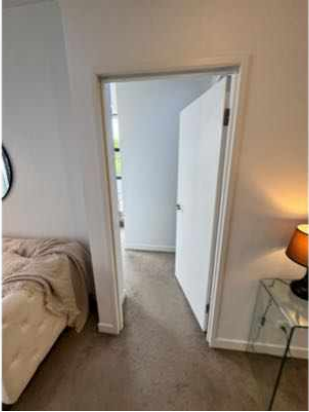
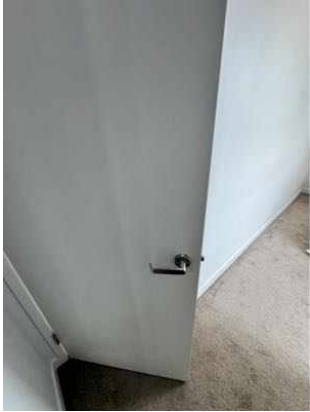
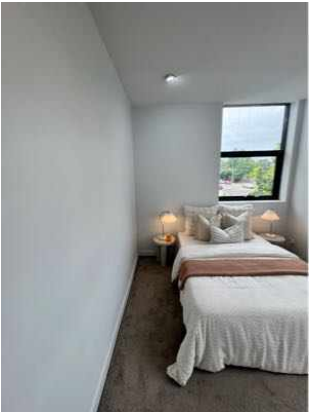
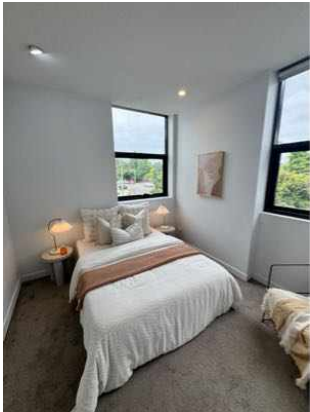
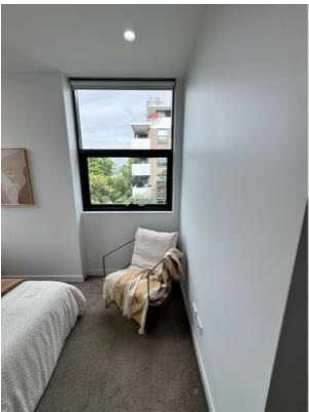
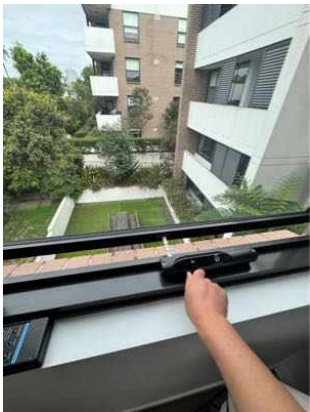
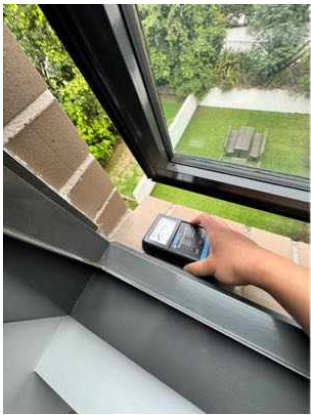
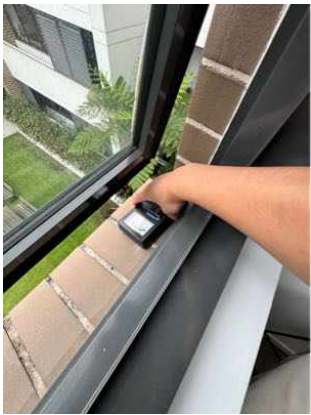
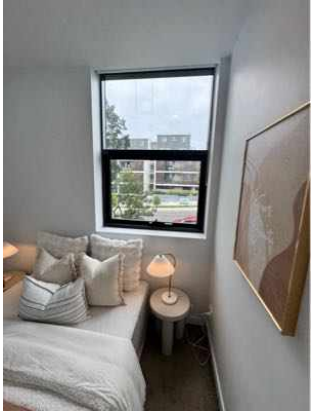
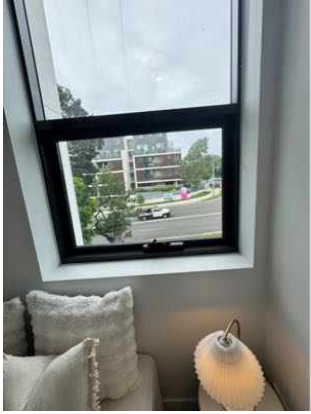
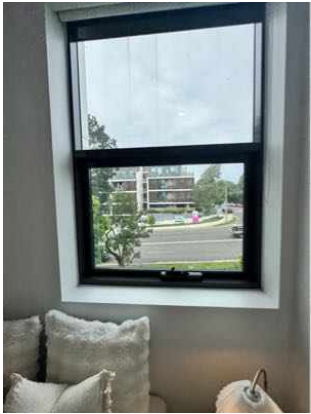
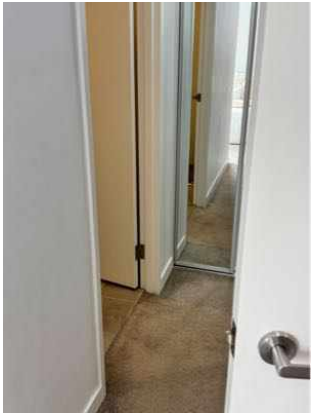
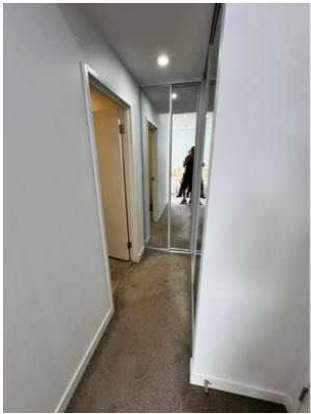
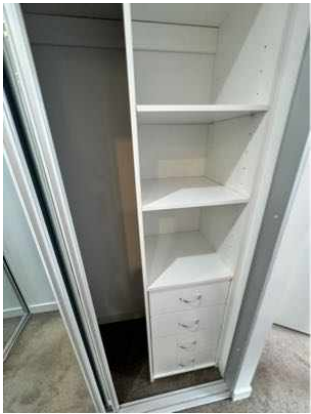
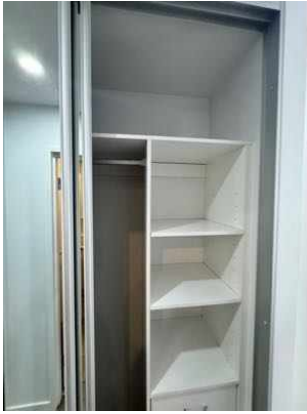
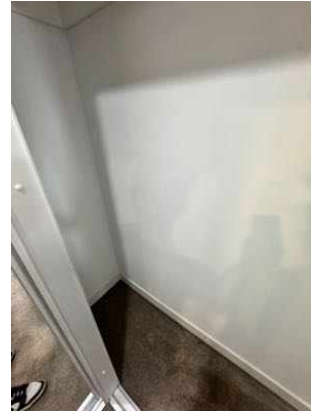
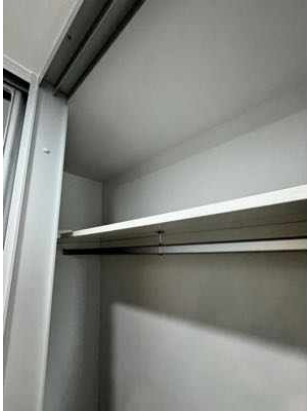
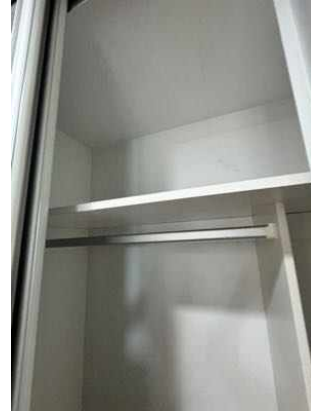
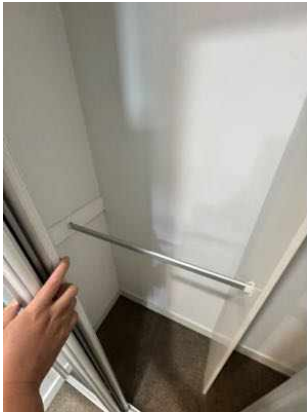
Building: Main Building
Location: Bedroom - Master
Finding: Additional Photos - Obstructions and Limitations
Information: These photographs are an indication of the obstructions and limitations which impeded full inspection of the property at the time of inspection. These obstructions can hide an array of defects and should be removed to allow full inspection to be carried out. A re-inspection is recommended once the areas are made accessible.

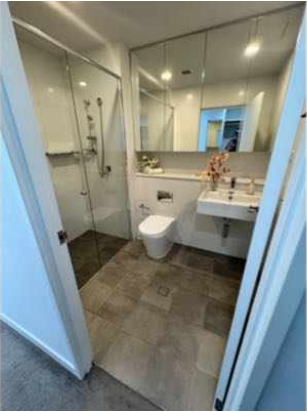
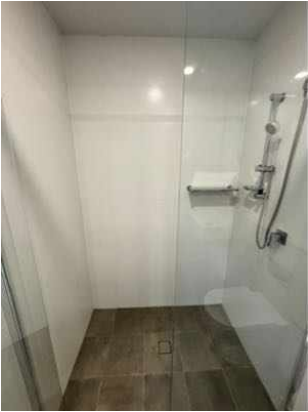
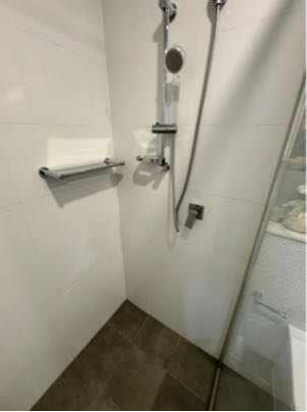
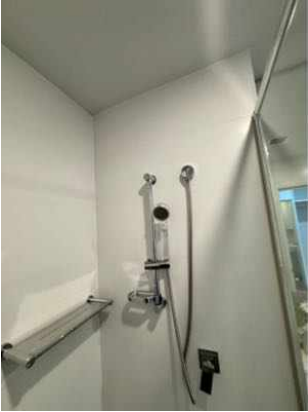
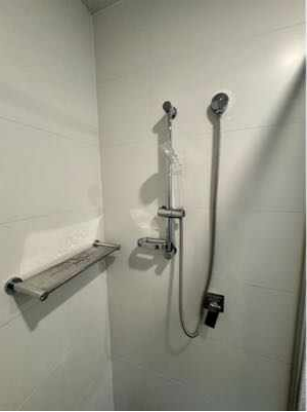
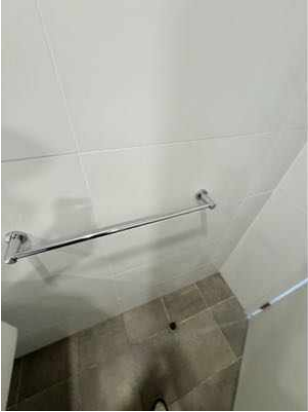
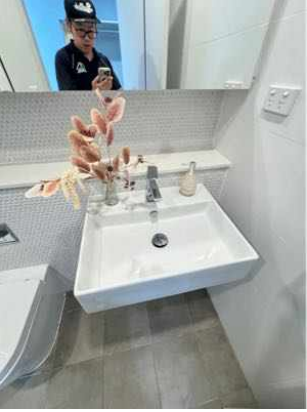
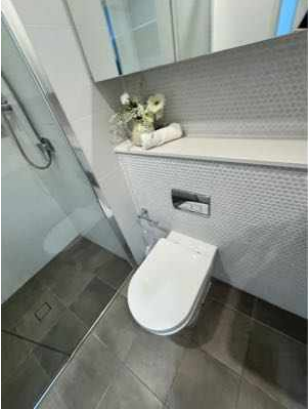
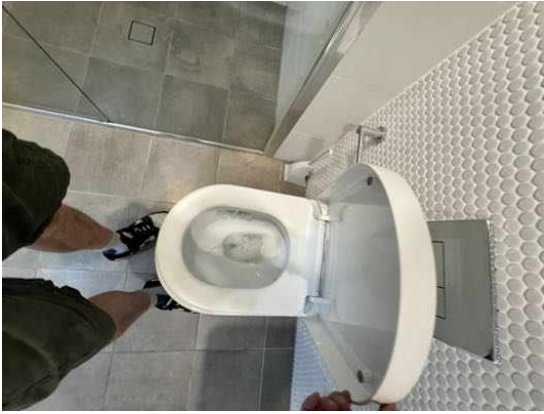
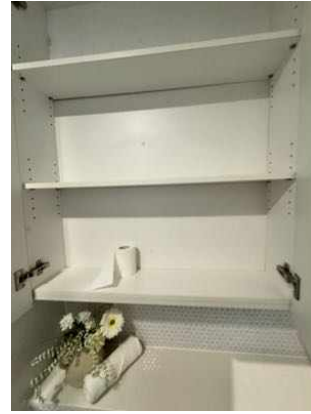
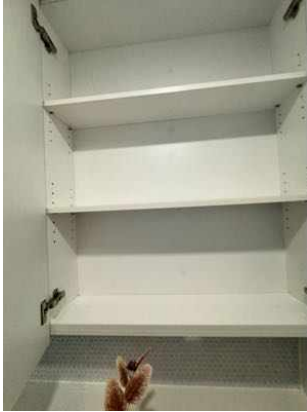
Building: Main Building
Location: Ensuite - Master
Finding: Additional Photos - Obstructions and Limitations
Information: These photographs are an indication of the obstructions and limitations which impeded full inspection of the property at the time of inspection. These obstructions can hide an array of defects and should be removed to allow full inspection to be carried out. A re-inspection is recommended once the areas are made accessible.

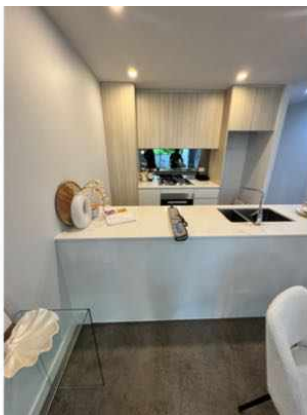
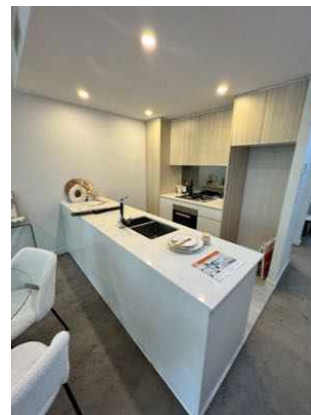
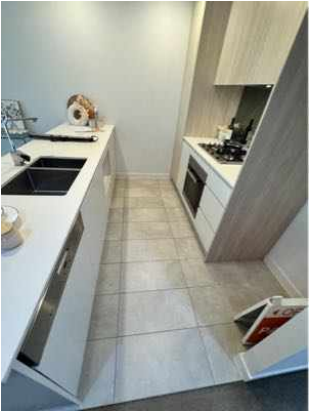
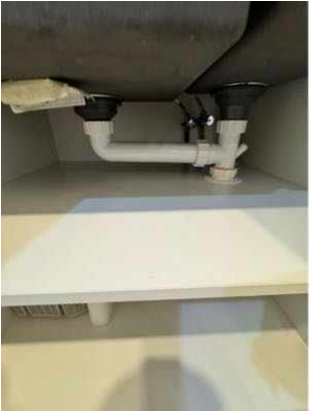
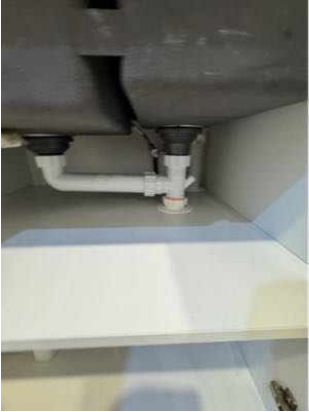
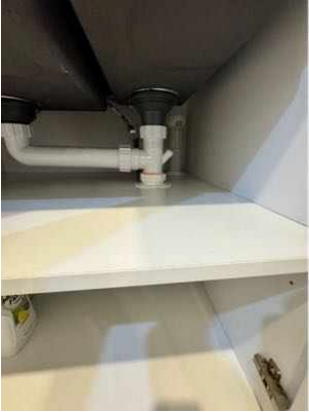
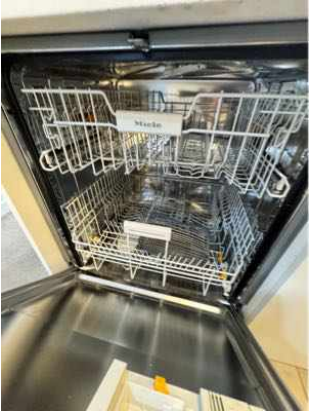
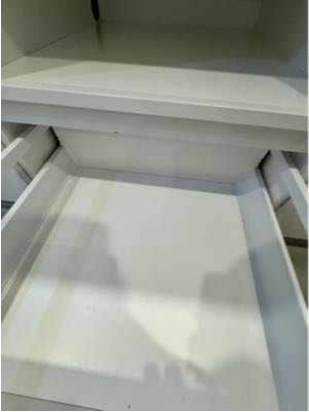
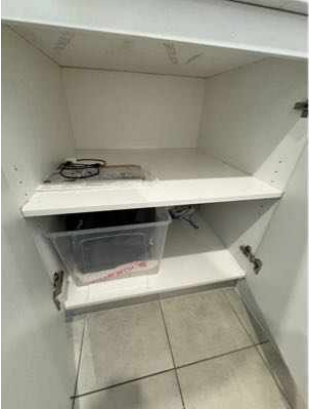
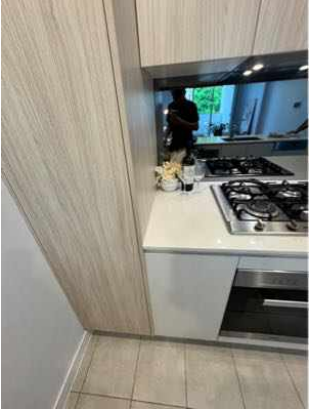
Building: Main Building
 Location: Kitchen
 Finding: Additional Photos - Obstructions and Limitations
 Information: These photographs are an indication of the obstructions and limitations which impeded full inspection of the property at the time of inspection. These obstructions can hide an array of defects and should be removed to allow full inspection to be carried out. A re-inspection is recommended once the areas are made accessible.

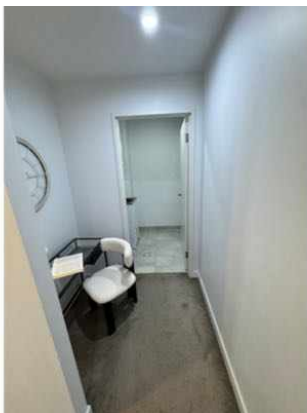
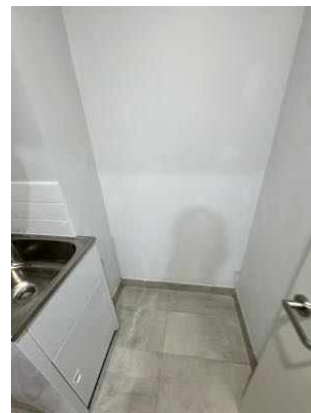
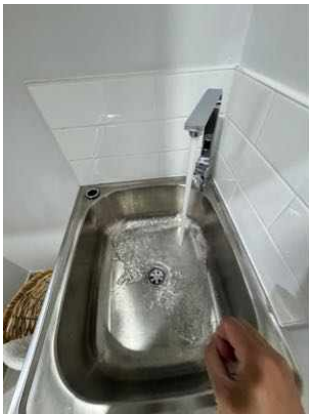
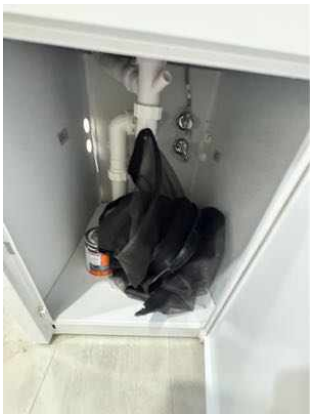
Finding: Additional Photos - Obstructions and Limitations

Information: These photographs are an indication of the obstructions and limitations which impeded full inspection of the property at the time of inspection. These obstructions can hide an array of defects and should be removed to allow full inspection to be carried out. A re-inspection is recommended once the areas are made accessible.

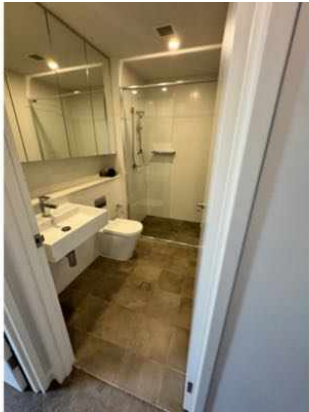
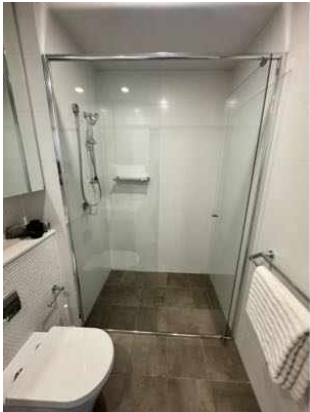
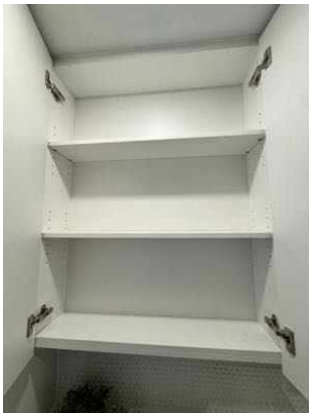
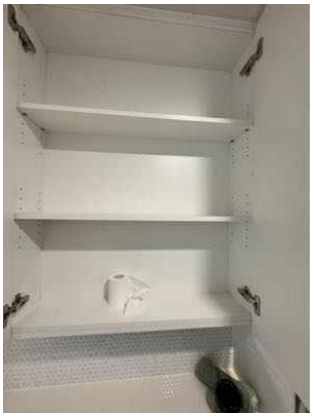
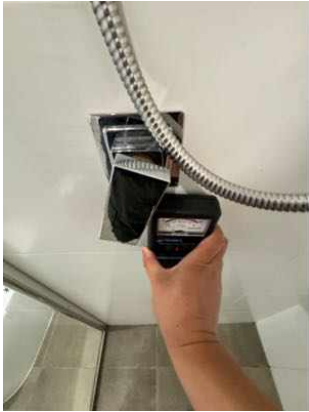
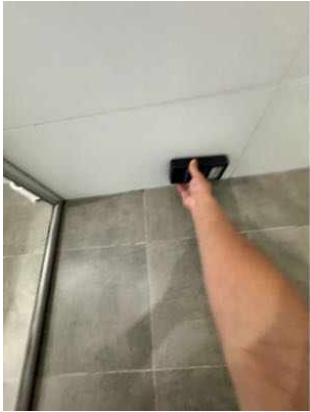
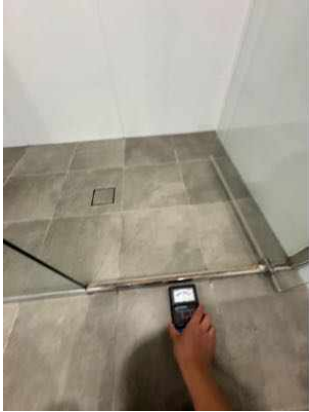
Building: Main Building
Location: Bathroom
Finding: Additional Photos - Obstructions and Limitations
Information: These photographs are an indication of the obstructions and limitations which impeded full inspection of the property at the time of inspection. These obstructions can hide an array of defects and should be removed to allow full inspection to be carried out. A re-inspection is recommended once the areas are made accessible.

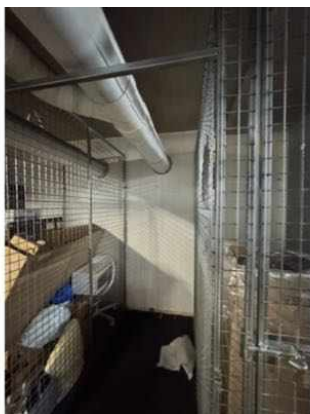
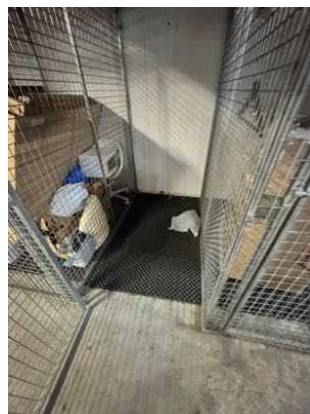
Building: Main Building
Location: Store Room
Finding: Additional Photos - Obstructions and Limitations
Information: These photographs are an indication of the obstructions and limitations which impeded full inspection of the property at the time of inspection. These obstructions can hide an array of defects and should be removed to allow full inspection to be carried out. A re-inspection is recommended once the areas are made accessible.
