Building and Timber Pest Inspection Report

Inspection Date: Fri, 27 Feb 2026

Property Address: 1108/13 Verona Dr, Wentworth Point NSW
2127, Australia

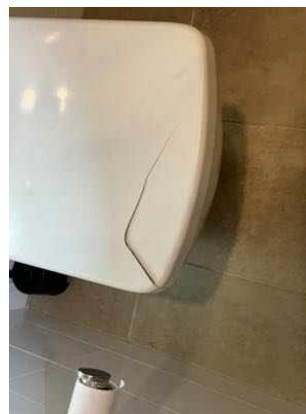
Finding 3.09

Building: Main Building
 Location: Bathroom
 Finding: Toilet seat cover - damaged
 Information: The toilet seat cover is damaged, exhibiting potential instability.

The damaged toilet seat cover poses a risk of injury, discomfort, and may lead to further breakage. Additionally, it can compromise hygiene standards and affect the overall functionality of the toilet.

A maintenance or facilities personnel should be notified to inspect and replace the damaged toilet seat cover promptly. Timely replacement is essential to ensure user comfort, safety, and maintain proper sanitation standards in the restroom.

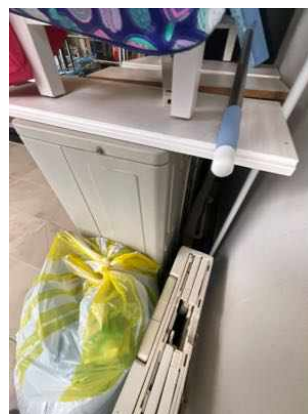
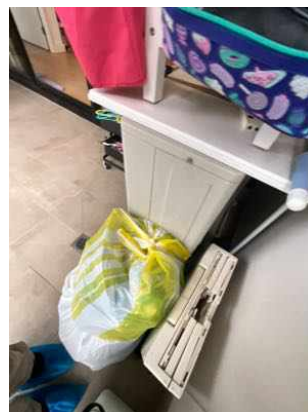
Where bridging has occurred full inspection is prevented and termites may enter a property in a concealed or undetected manner.

Recommended moving obstructions away from the external walls for further and future inspections.

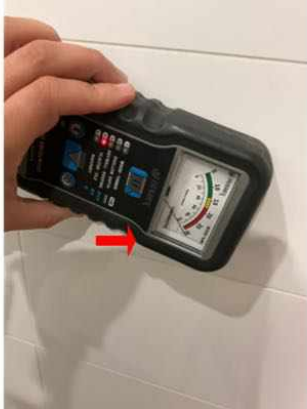
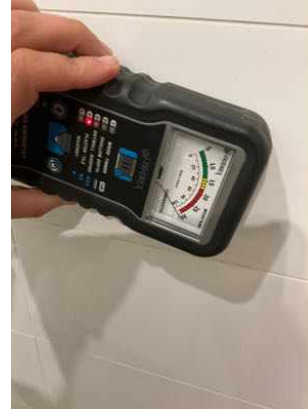
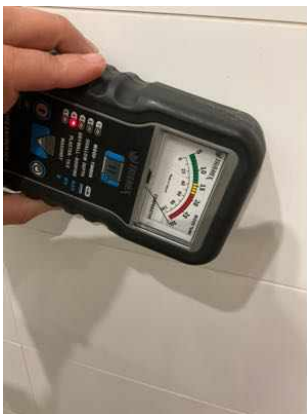
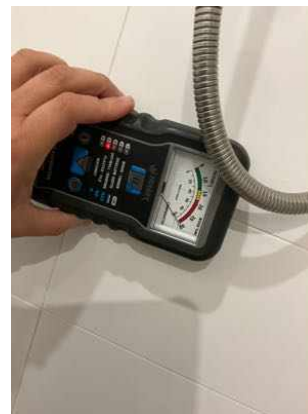
Finding 6.02

Building:	Main Building
Location:	Ensuite
Finding:	Excessive moisture - Conducive to Timber pest
Information:	Excessive moisture can attract termites and produce conditions that promote fungal growth and wood decay.

Prior to any remedial works being performed a qualified plumber should be appointed to further inspect the property and to identify the cause of the excessive moisture. Works to remove affected building elements may then be necessary and should be performed by an appropriate tradesperson.

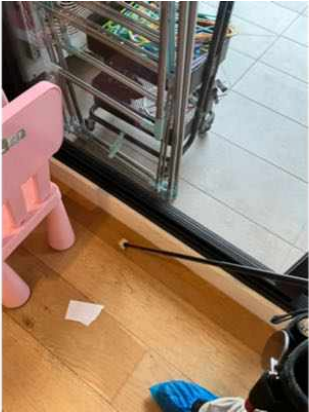
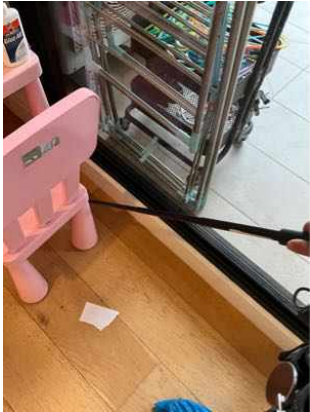
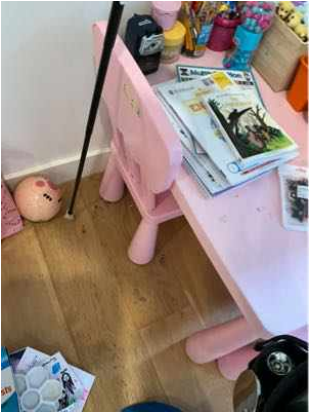
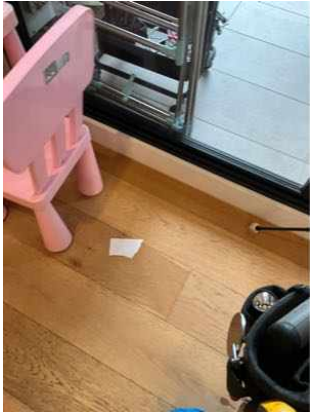
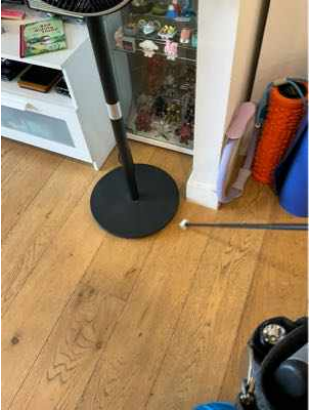
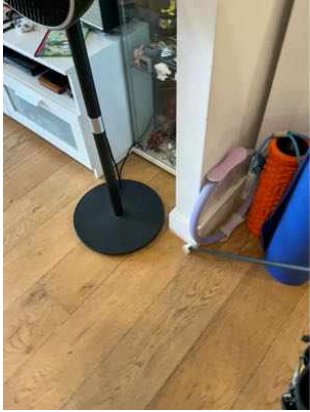
Noted Item

Building: Main Building
Location: All Areas
Finding: Additional Photos
Information: Additional photos are provided for your general reference

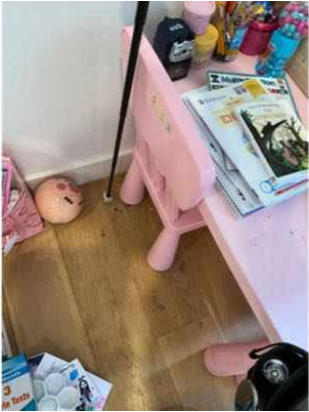
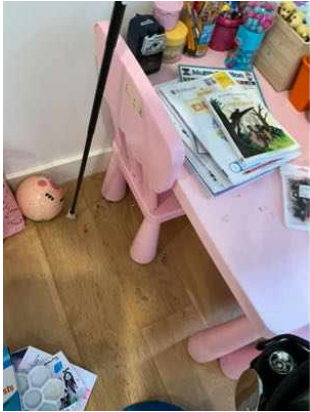
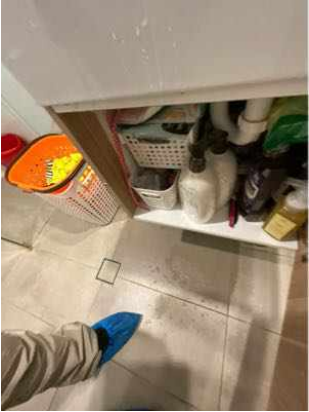
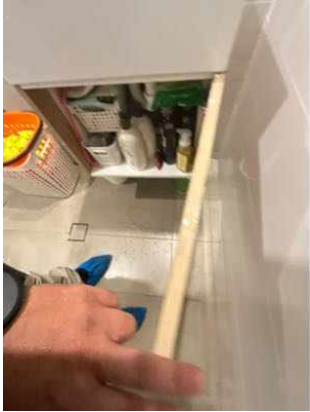
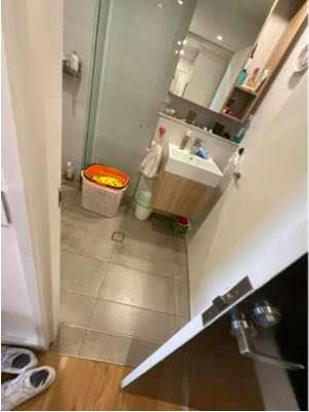
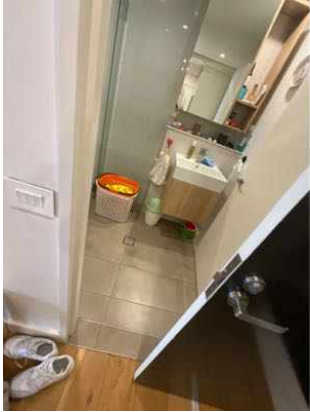
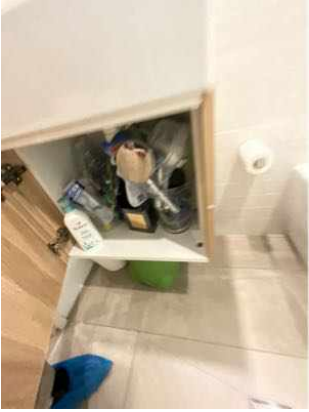
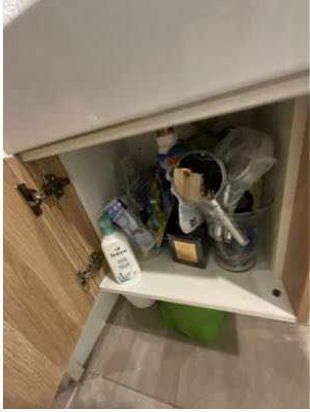
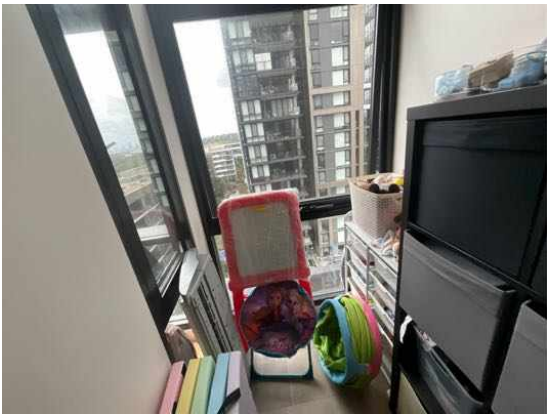
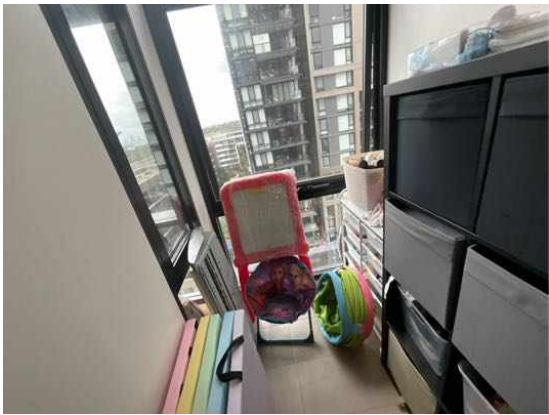
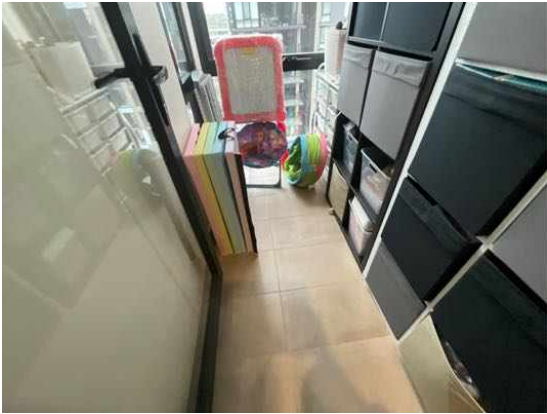
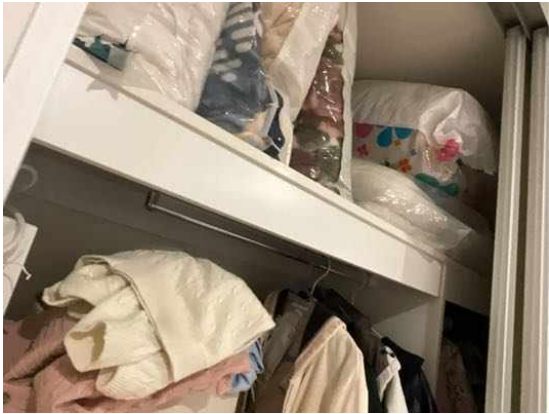
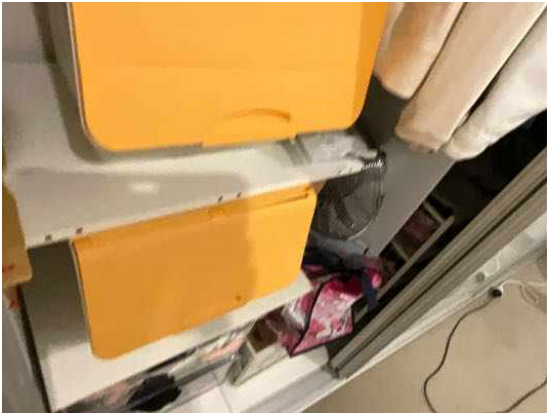
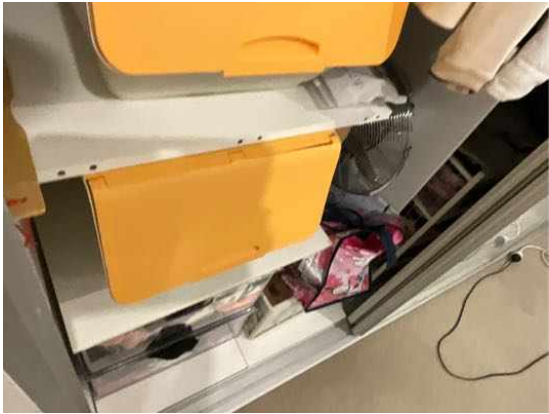
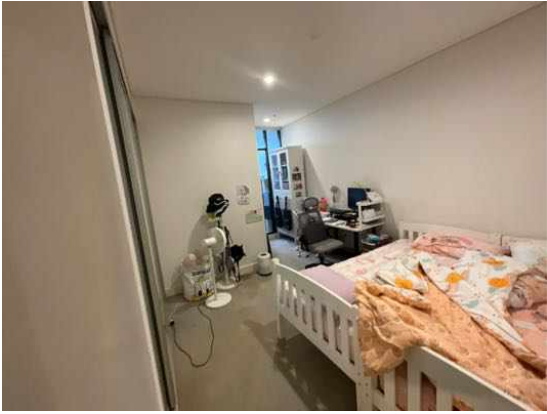
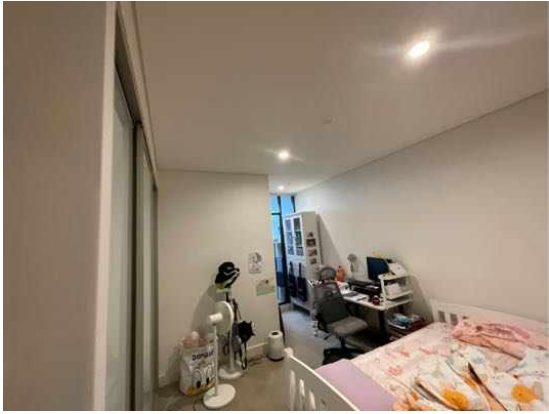
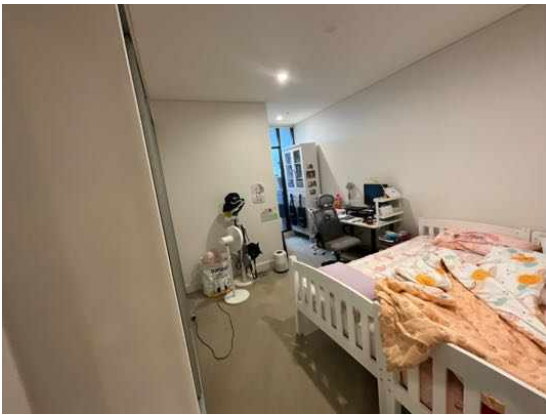
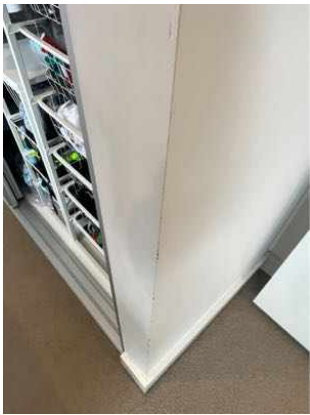
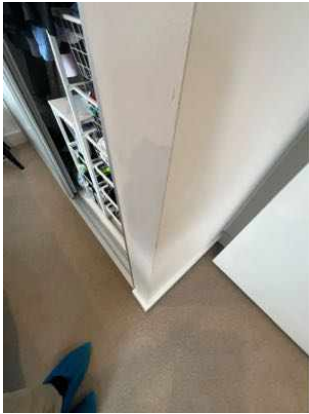
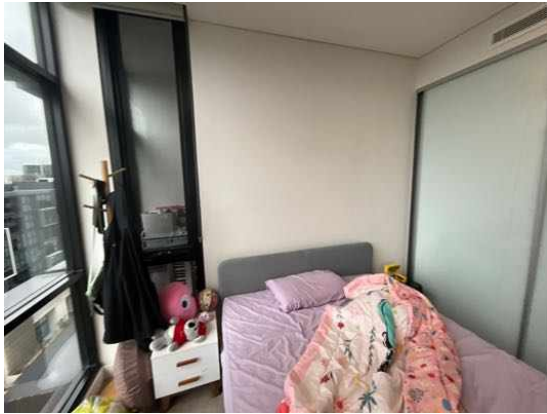
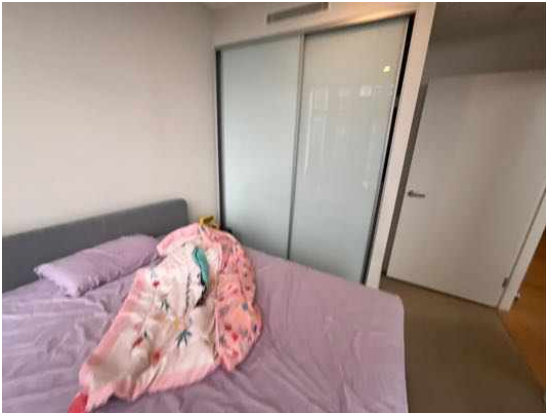
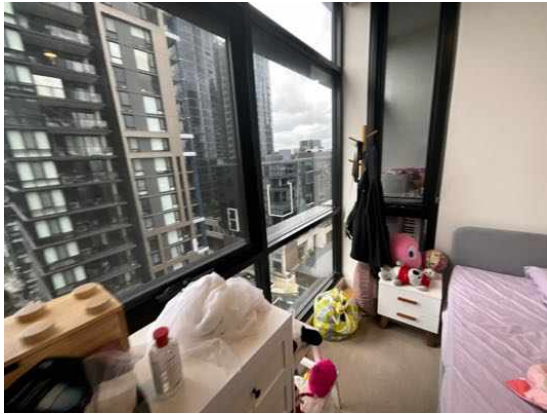
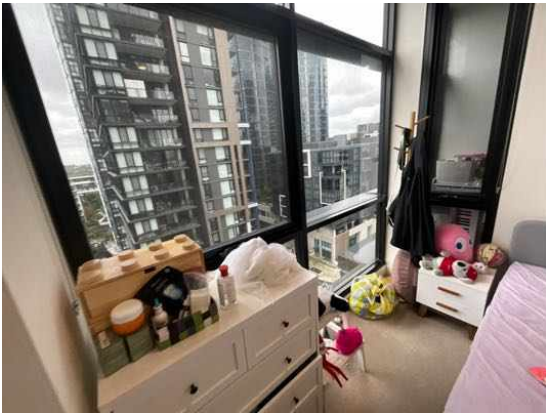
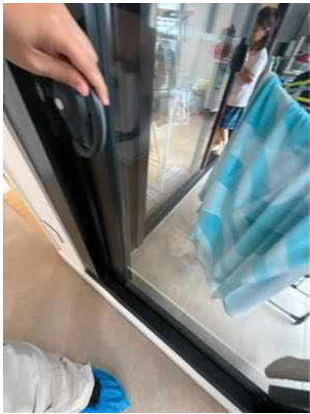
Building:	Main Building
Location:	All Areas
Finding:	Additional Photos - Obstructions and Limitations
Information:	These photographs are an indication of the obstructions and limitations which impeded full inspection of the property at the time of inspection. These obstructions can hide an array of defects and should be removed to allow full inspection to be carried out. A re-inspection is recommended once the areas are made accessible.
