Building Inspection Report

Inspection Date: Mon, 2 Feb 2026

Property Address: 6 Westward Ho Dr, Sunbury VIC 3429,
Australia

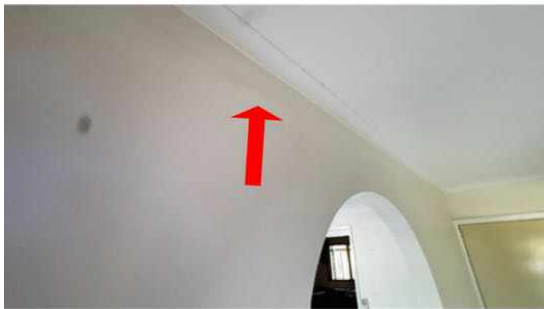
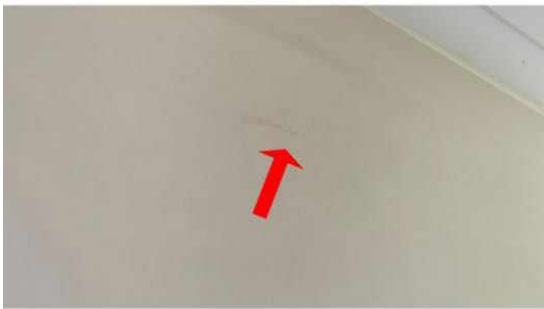
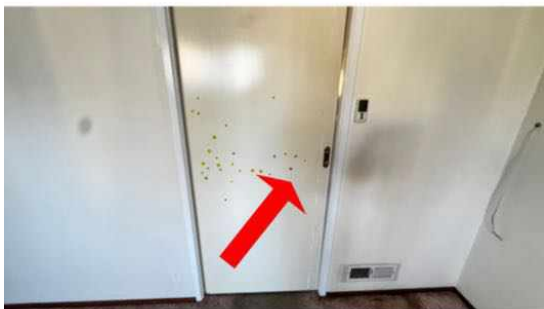
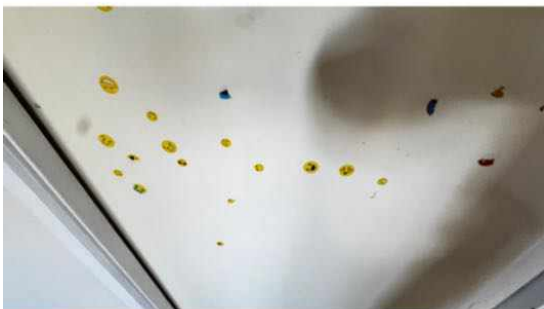
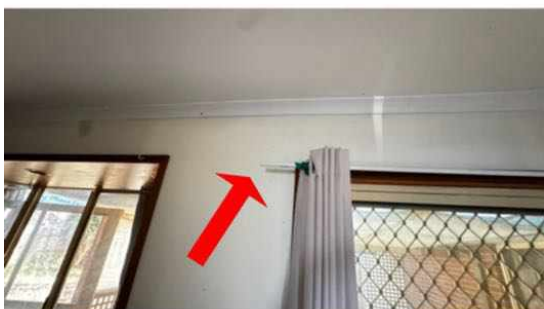
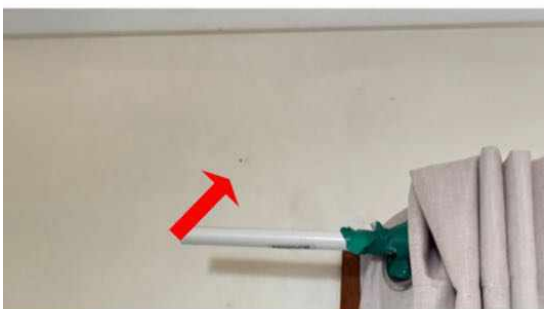
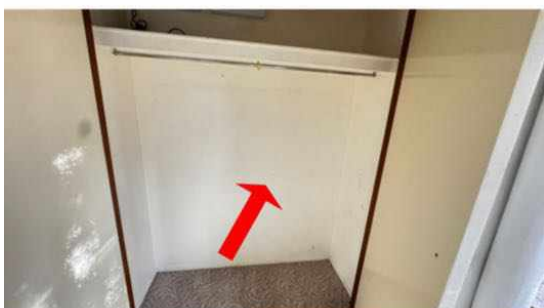
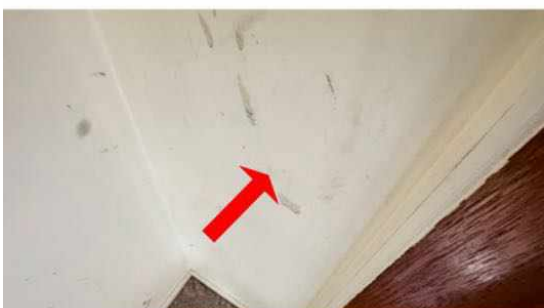
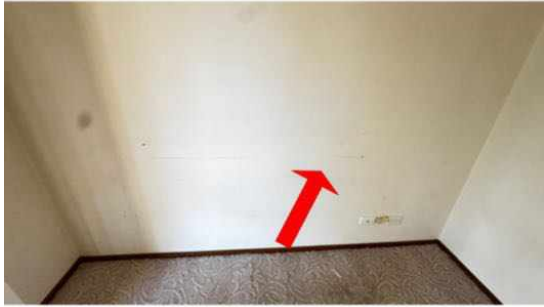
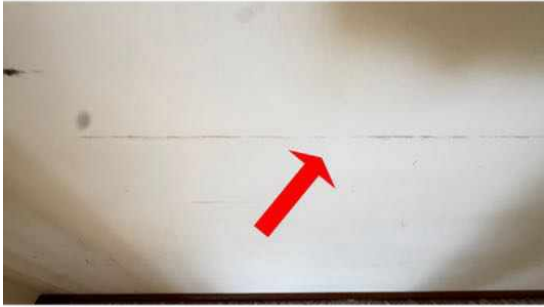
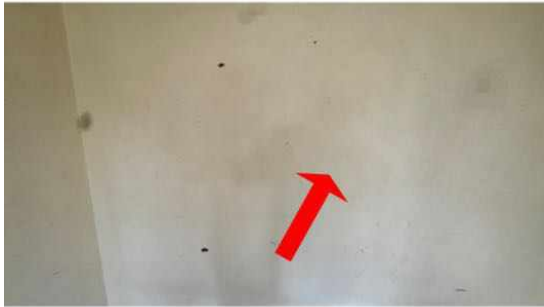
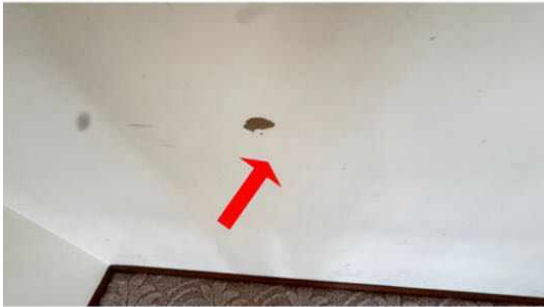
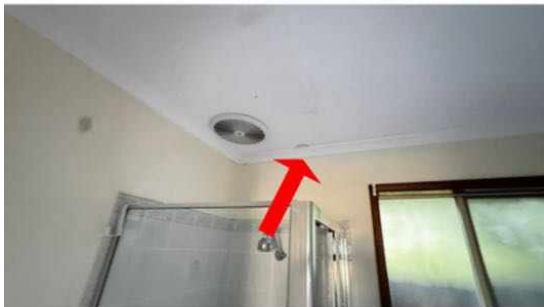
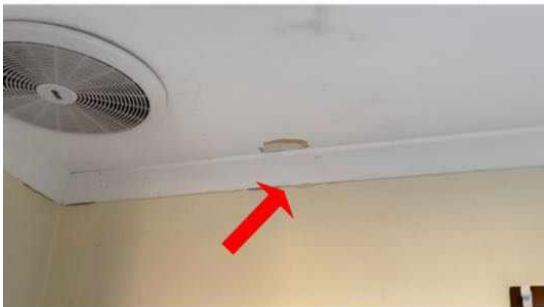
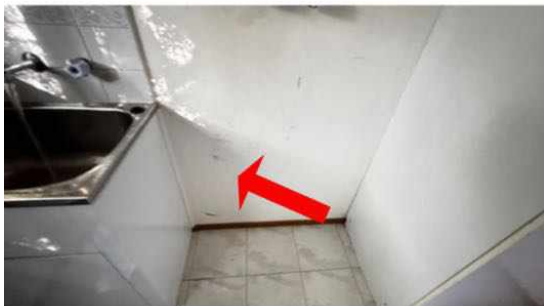
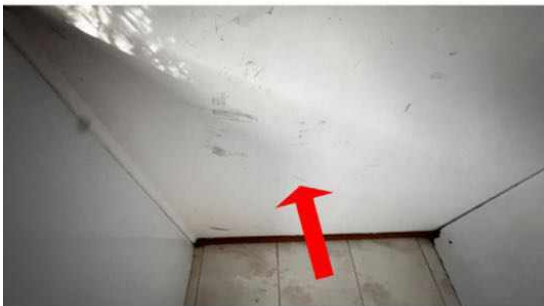
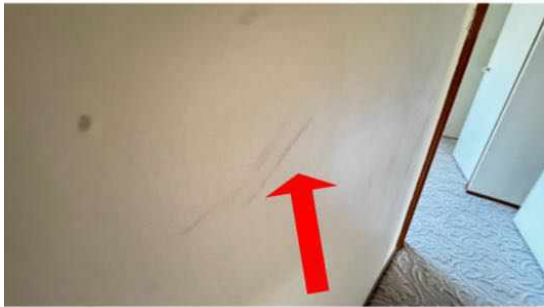
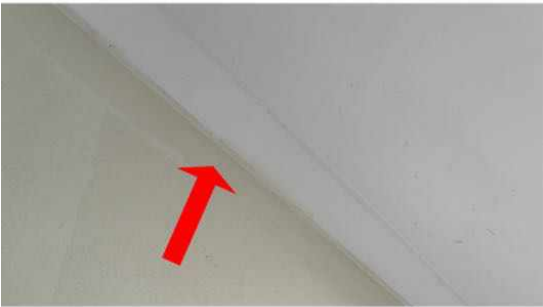
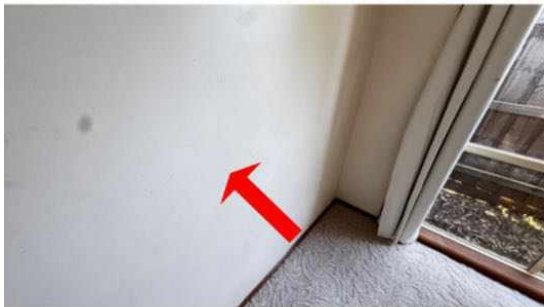
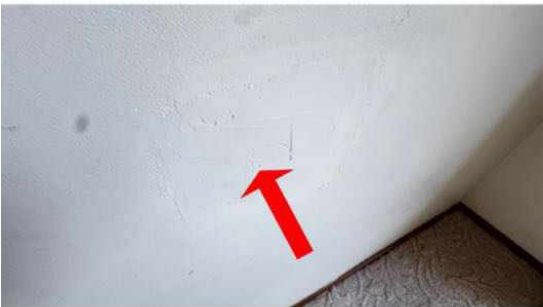
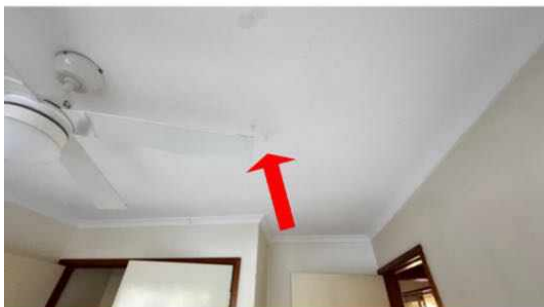
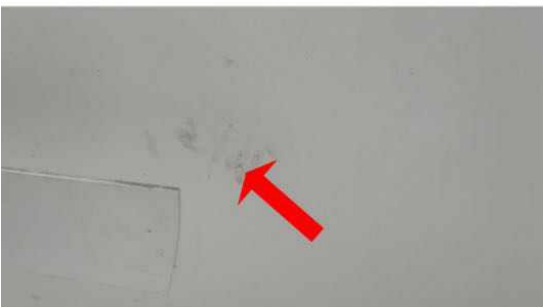
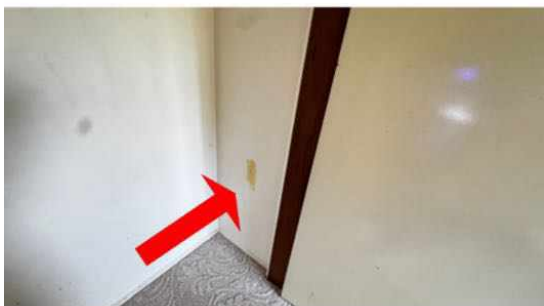
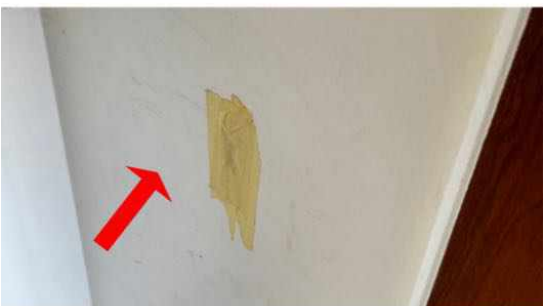
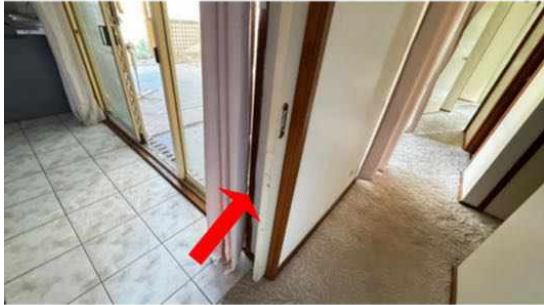
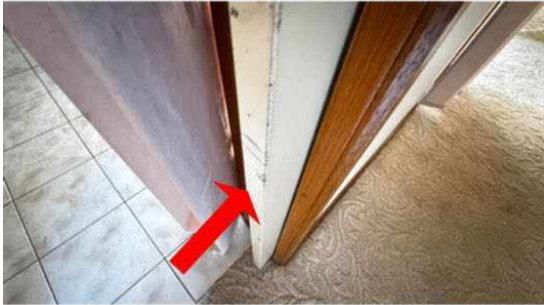
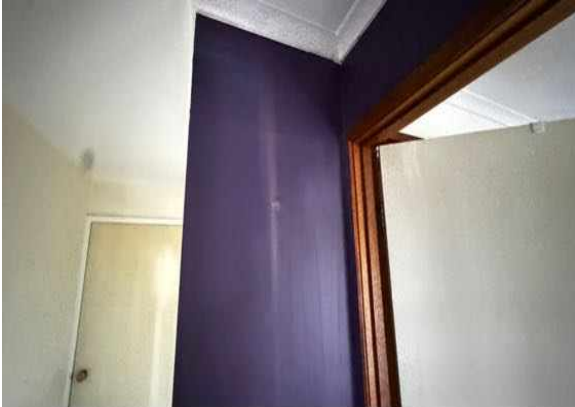
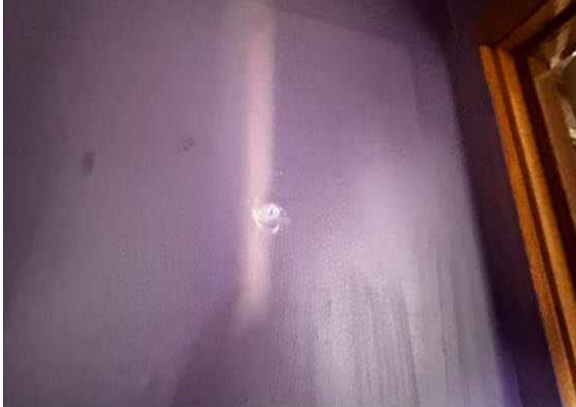
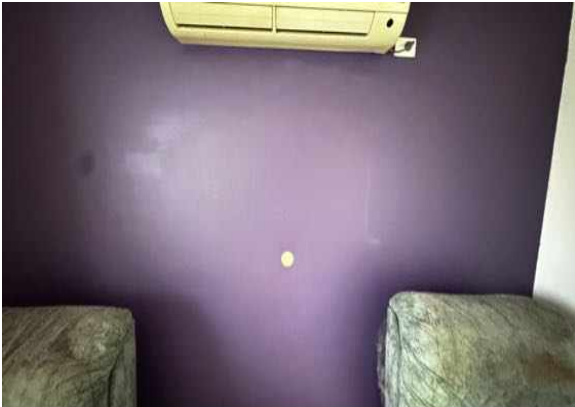
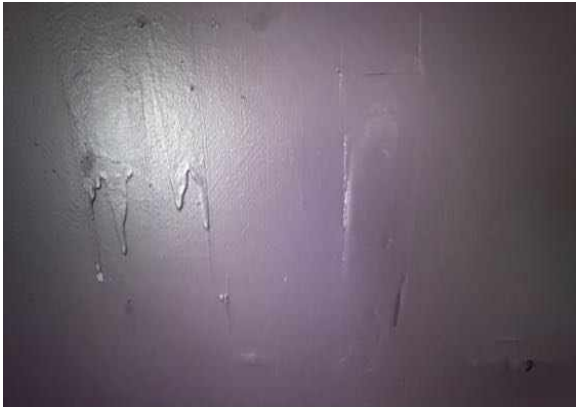
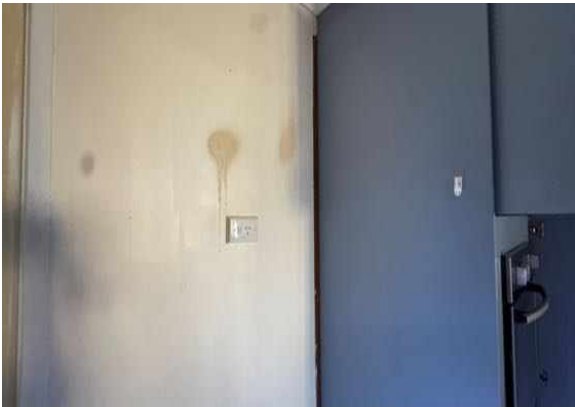
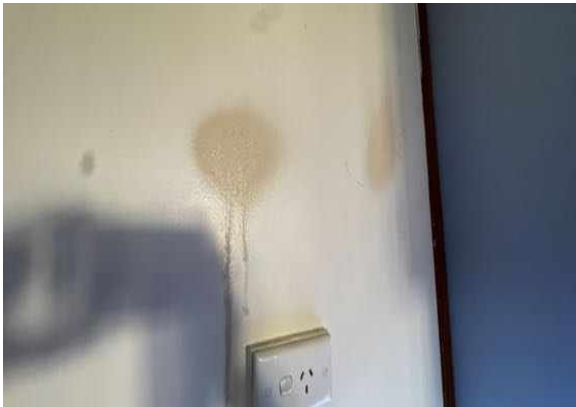
Defects 3.01

Building:	Main Building
Location:	All Areas
Finding:	Paint Finishes - Substandard
Information:	The paint finish in these areas was found to have been completed to a substandard level. Substandard painting is generally classified as an appearance defect. However, the substandard appearance may also be indicative of poor surface preparation and substandard workmanship.

Substandard paint finishes should be sanded back, filled, leveled and repainted, as applicable. Where inadequate paint protection has led to the deterioration of the associated building element, repair and/or replacement of this building element may be required.

A painting contractor should be appointed as soon as possible to perform necessary works to aid the appearance of the affected area and to ensure that the area is protected against further deterioration. Alternatively, the homeowner following manufacturer instructions may be able to provide this service.

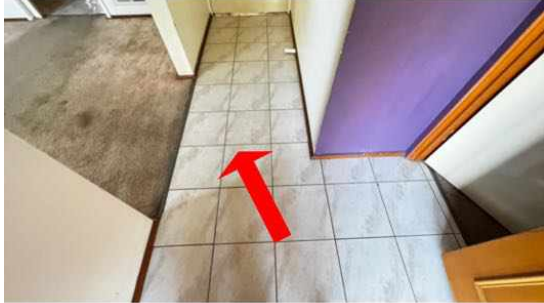
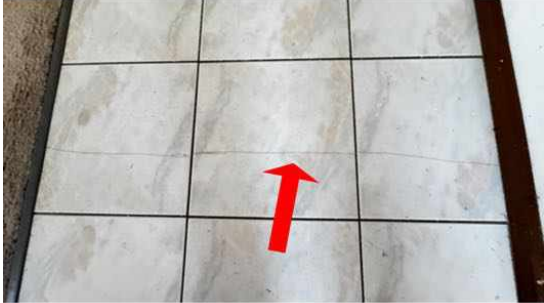
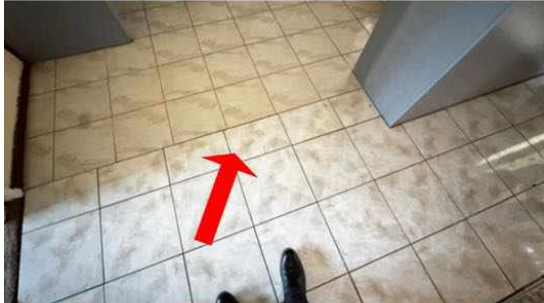
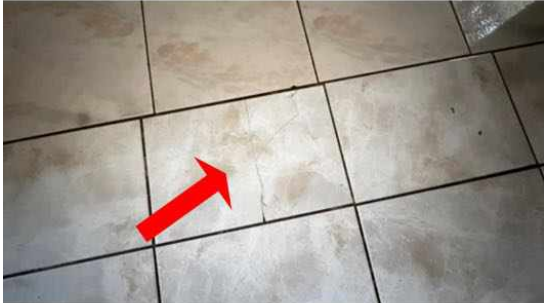
Defects 3.02

Building: Main Building
Location: All Areas >
Finding: Floor Tiles - Cracked
Information: Cracked floor tiles were observed in this area. Cracked tiles can affect the aesthetic appearance, create trip hazards, and allow moisture to penetrate underlying substrates, potentially leading to water damage or deterioration of adhesives and substrates.

Possible causes include impact damage, age-related wear, movement or settlement of the substrate, or poor installation practices.

When practical, a qualified tiler should be engaged to assess and replace all damaged tiles, repair or prepare the substrate if required, and restore the finished surface. Prompt attention will maintain durability, prevent water ingress, and improve appearance.

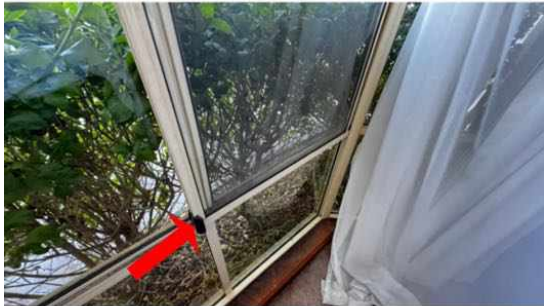
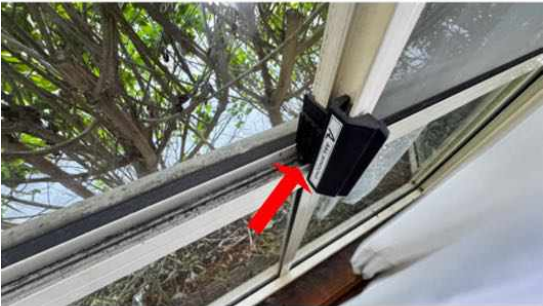
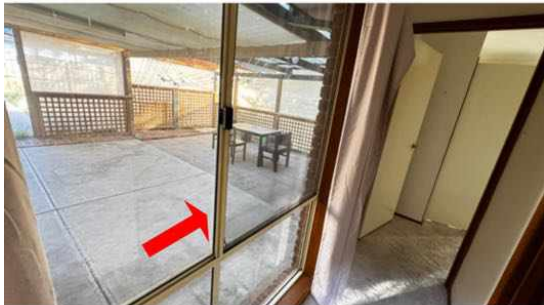
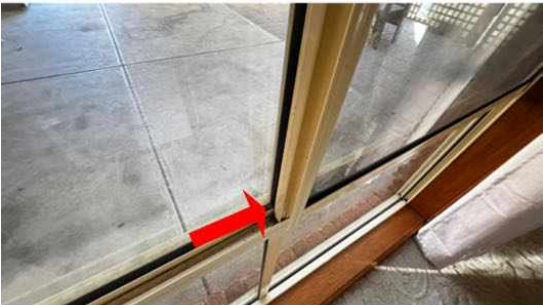
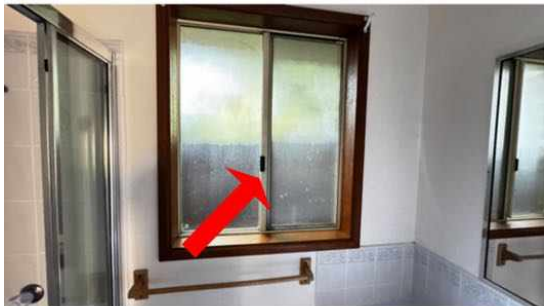
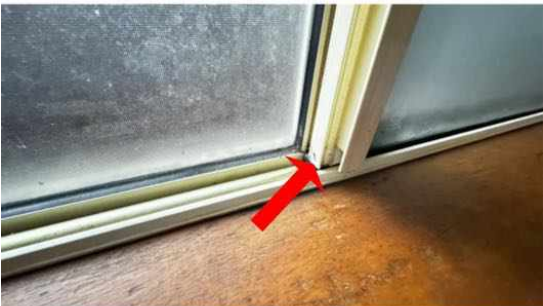
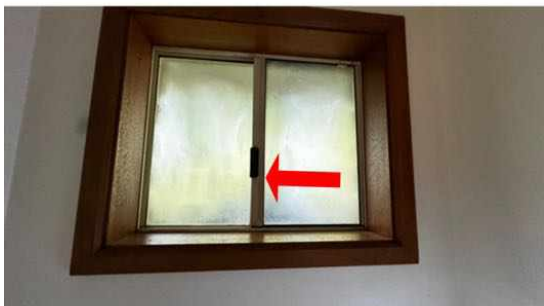
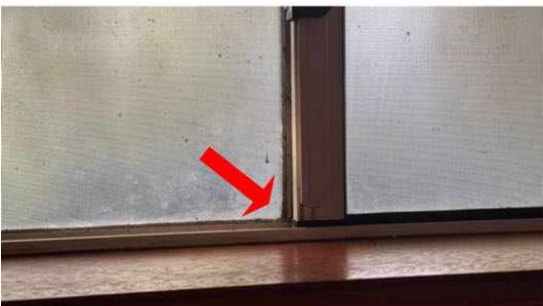
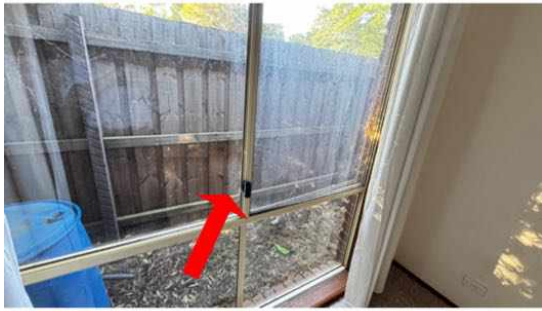
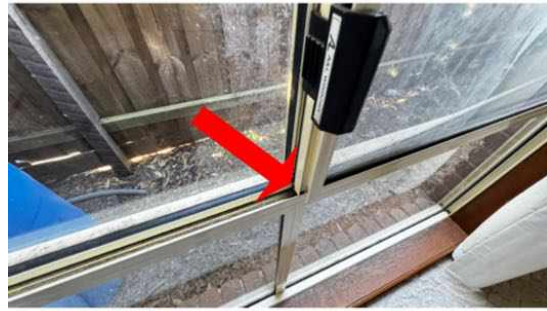
Defects 3.03

Building: Main Building
 Location: All Areas >
 Finding: Windows - Stiff To Open
 Information: Windows were observed to be stiff to open in this area. The stiffness can make the window difficult to operate, reduce usability, and may increase the risk of damage if force is applied.

Possible causes include misalignment, worn hardware, or buildup of debris.

It is recommended that the building owners engage a window specialist or registered builder immediately to assess the window and adjust, repair, or service it to restore

smooth operation.

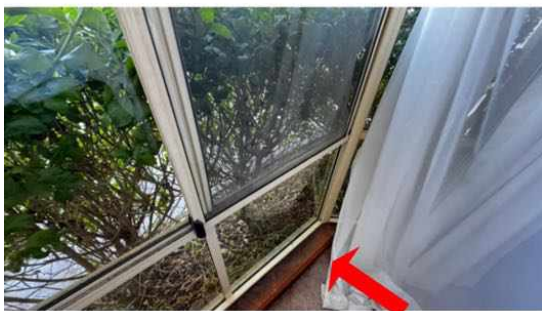
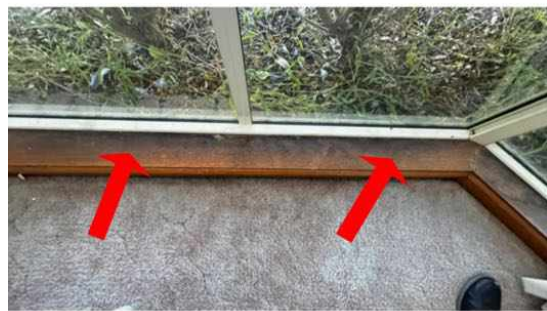
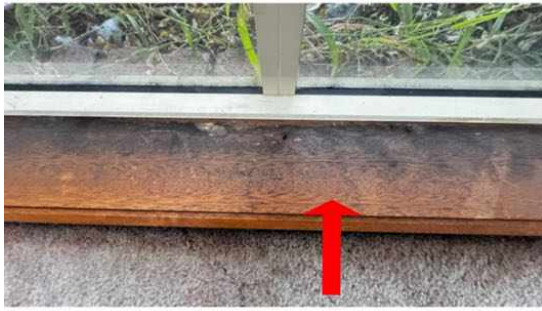
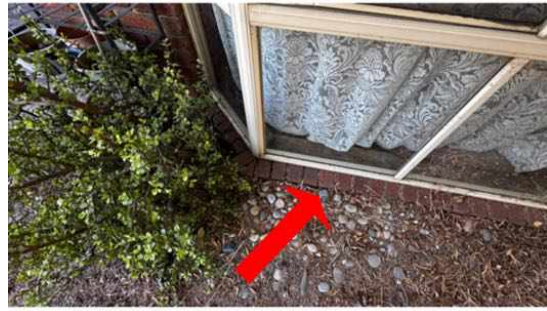
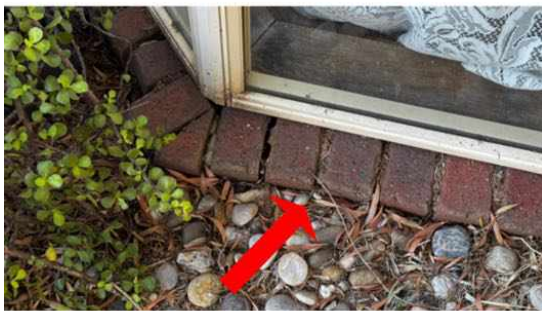
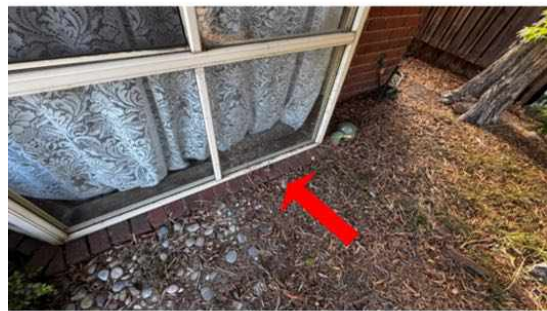
Defects 3.04

Building:	Main Building
Location:	Lounge Room & Bedroom 1 >
Finding:	Windows Frames - Water Staining Internal
Information:	Water staining was observed on the internal window frames in this area. The staining indicates past or ongoing moisture ingress, which can lead to timber or material deterioration, reduced weatherproofing, and the potential for mould growth if left unaddressed.

Possible causes include faulty seals, gaps around the window frames externally, or external water sources such as leaks or poor drainage.

It is recommended that the building owners engage a registered builder, window specialist, or carpenter immediately to inspect the affected areas, identify the source of the moisture, and undertake repairs to restore weatherproofing and prevent further damage.

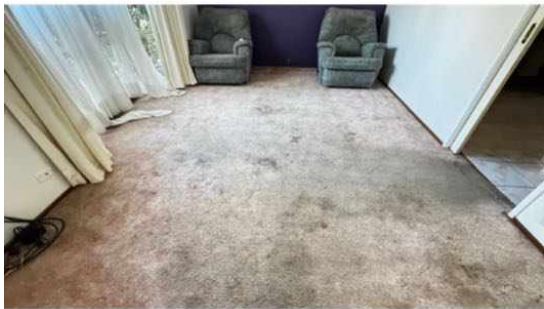
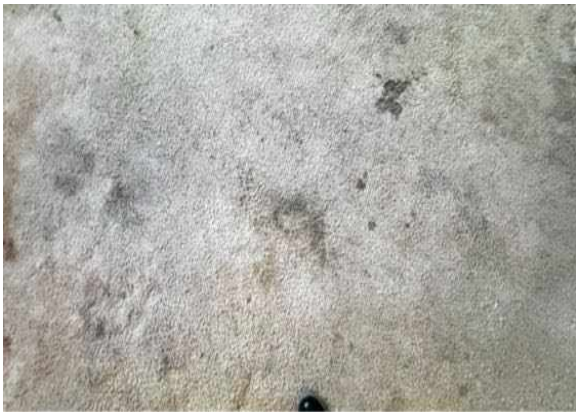
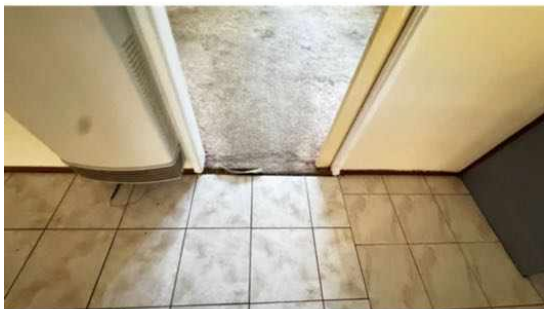
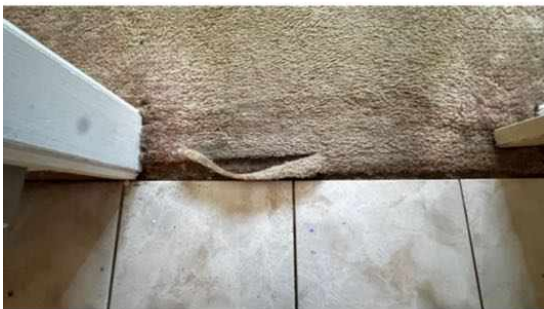
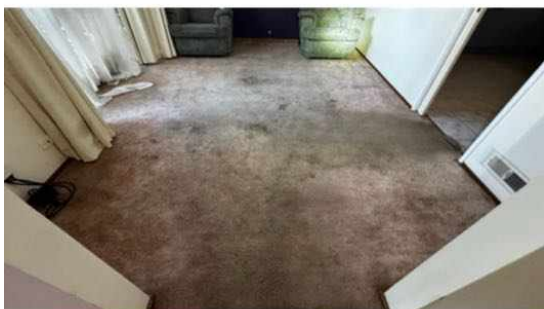
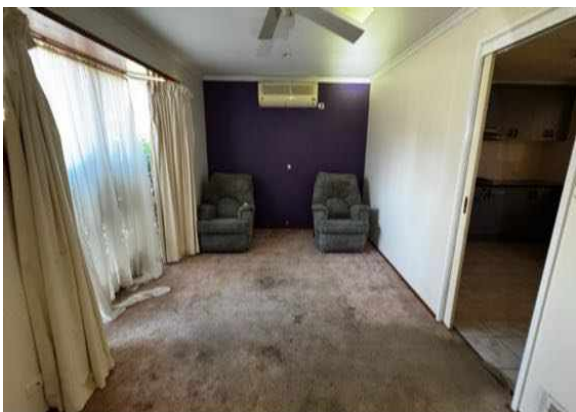
Defects 3.05

Finding: Floors - Carpet Damaged

Information: The carpet was inspected and found to be damaged in these areas, with signs of wear and staining. Damaged carpet can reduce comfort, detract from the appearance of the space, and, over time, expose the subfloor to additional wear or moisture.

This condition may result from everyday use, accidental impact, or age-related deterioration.

A qualified flooring installer should be engaged when practical to clean, repair and or replace the affected carpet. Timely attention will restore visual appeal, comfort, and the longevity of the flooring.

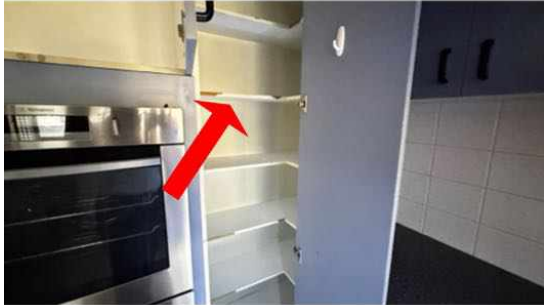
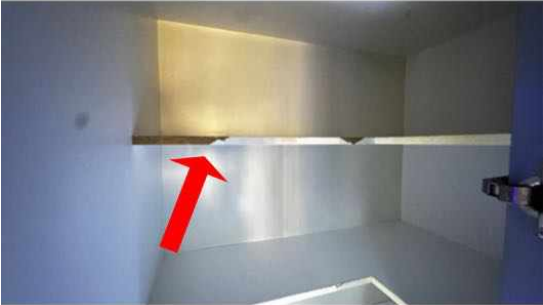
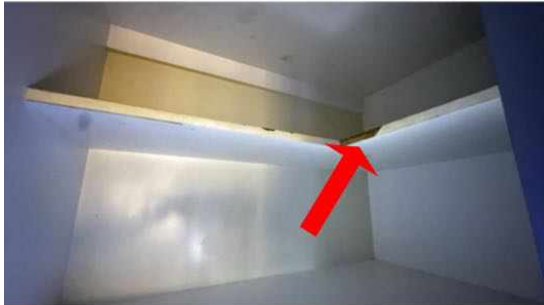
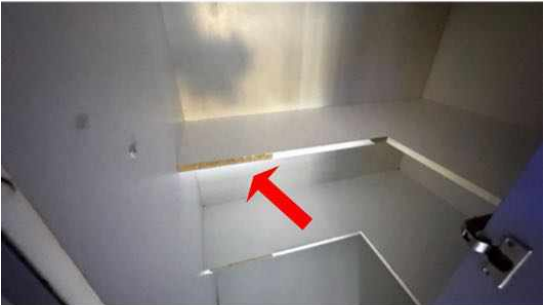
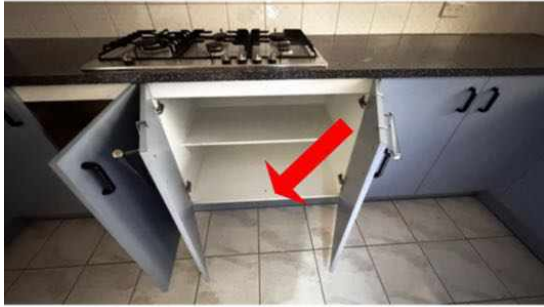
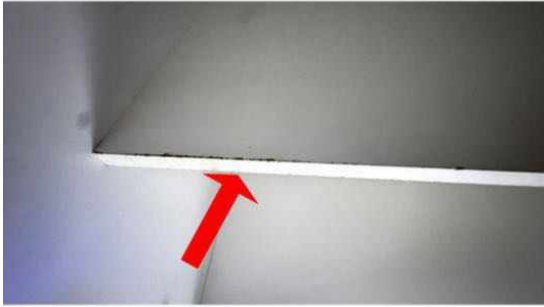
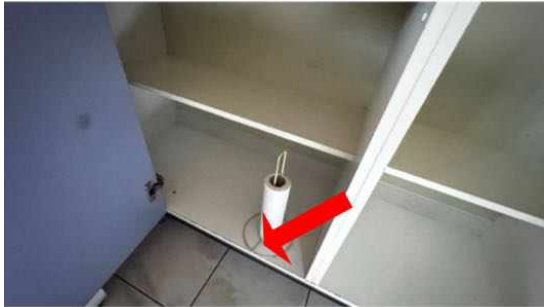
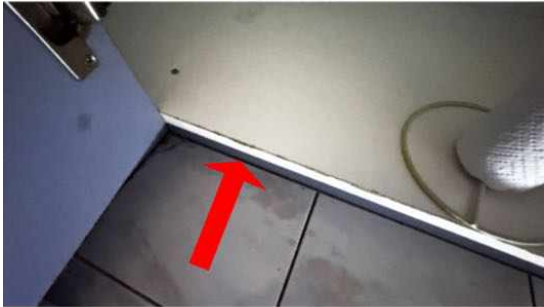
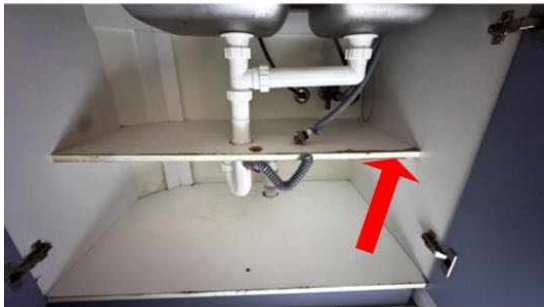
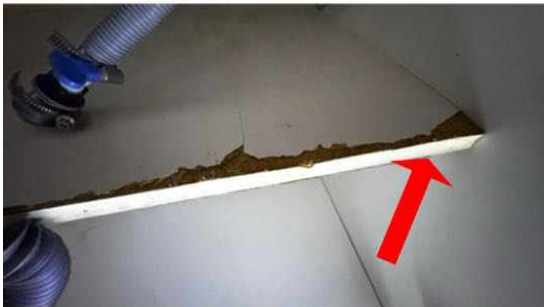
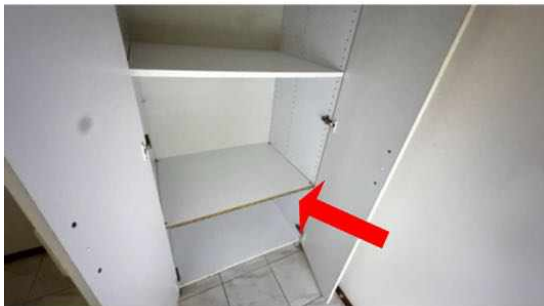
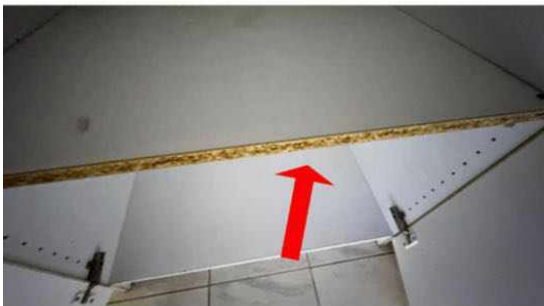
Defects 3.06

Building: Main Building
Location: Kitchen & Laundry
Finding: Cabinets - Damaged
Information:

The inspection identified cabinets with visible damage. Defective cabinets can compromise usability, hygiene, and, over time, may deteriorate further if exposed to moisture.

The issue may be caused by age-related material deterioration, poor installation practices or impact damage from daily use.

A licensed carpenter, joiner, or kitchen specialist should be engaged immediately to assess, repair, or replace the affected cabinets. Remedial works may include re-gluing, re-sealing, replacing damaged sections, or full replacement if structural integrity is compromised. Prompt rectification will restore functionality, prevent further deterioration, and maintain hygiene and appearance.

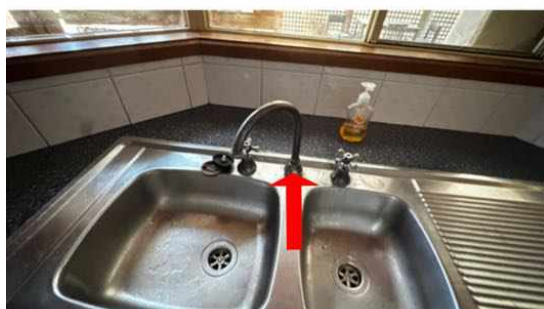
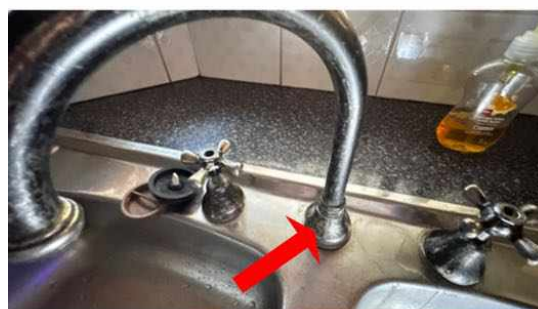
Defects 3.07

Building:	Main Building
Location:	Kitchen
Finding:	Kitchen - Taps Loose & Unstable
Information:	Taps were observed to be unstable in this area. Unstable taps can affect hygiene, cause water damage to surrounding surfaces, and may increase the risk of mould, damage to cabinetry, and structural deterioration.

This may be due to age-related wear, loose or improper installation, corrosion or failure of internal components, impact or mechanical stress, or other plumbing issues such as faulty connections.

A licensed plumber should be engaged immediately to inspect and repair or replace the unstable taps. This may include tightening or replacing fittings, securing the fixtures, and repairing any leaks. Prompt action will help prevent further water damage, maintain hygiene, and ensure safe operation.

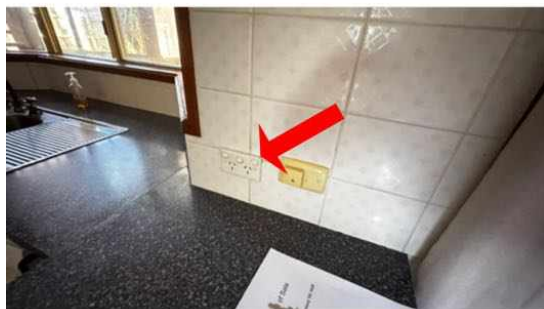
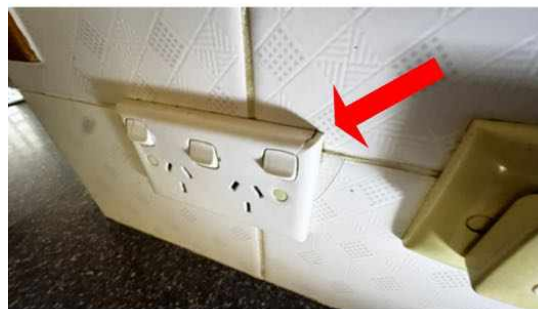
Defects 3.08

Building:	Main Building
Location:	Kitchen
Finding:	Electrical - Damaged GPO
Information:	A general power outlet (GPO) was observed to be damaged in this area. Damaged GPOs can result in poor electrical connections, increase the risk of electric shock, and may prevent safe use of electrical appliances.

The damage may have been caused by physical impact, age-related wear, loose connections, or exposure to environmental factors.

A licensed electrician should be engaged immediately to inspect and repair or replace the damaged GPO. Prompt rectification will ensure safe operation and reduce the risk of electrical hazards.

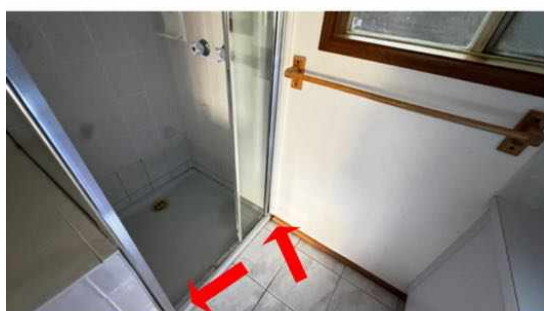
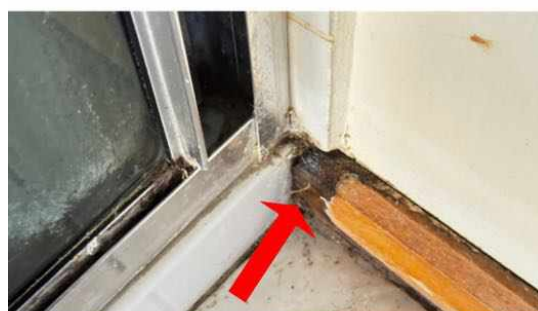
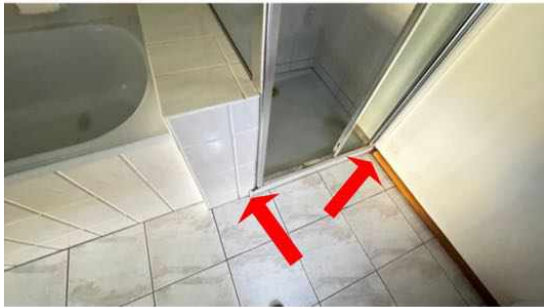
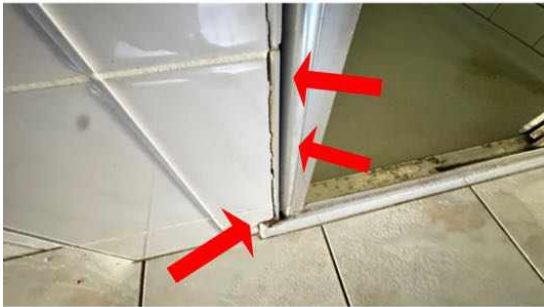
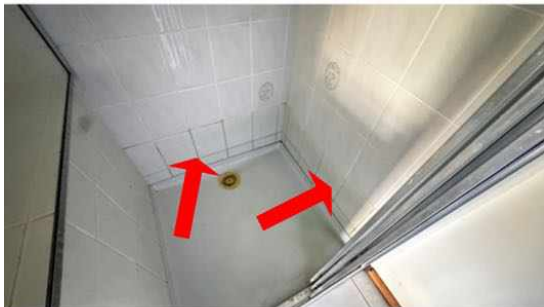
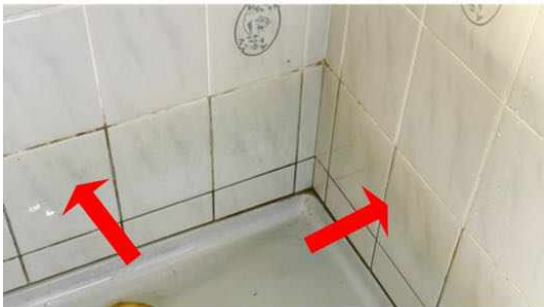
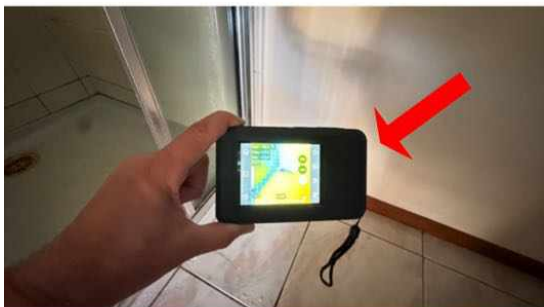
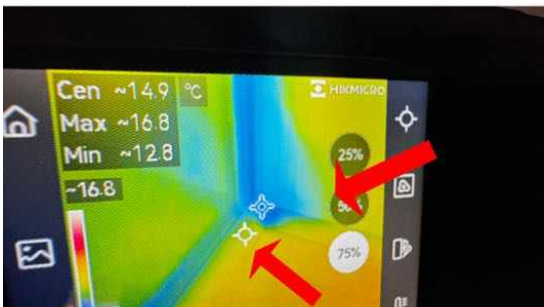
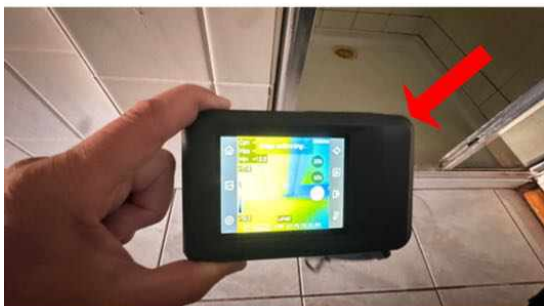
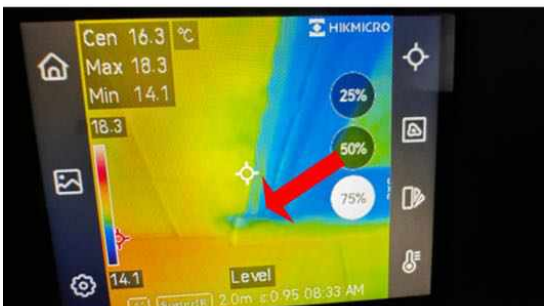
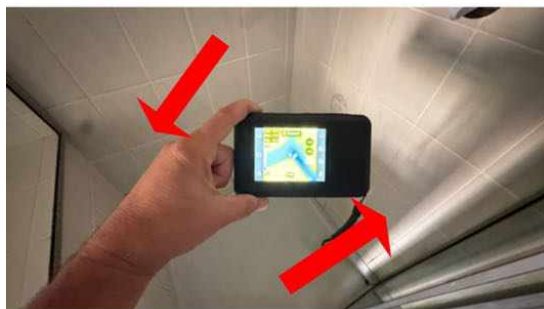
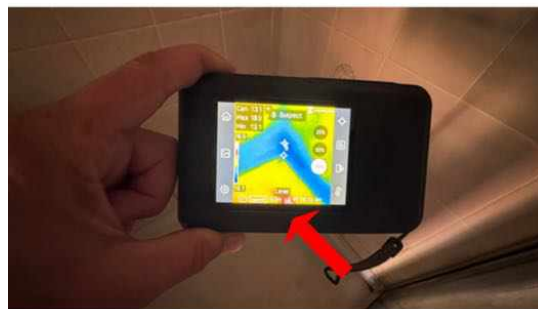
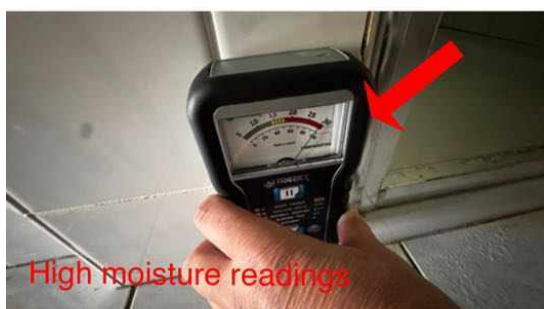
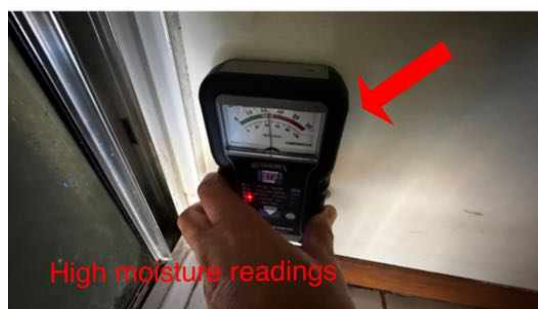
Defects 3.09

Building:	Main Building
Location:	Bathroom >
Finding:	Shower Damp - To Be Monitored & Epoxy Grout
Information:	Damp is evident to the lower wall to the shower alcove and acceptable level moisture readings were found to the reverse side of the shower. Moisture readings were not found to the wall adjacent to the shower.

Damp (or structural damp) refers to the presence of unwanted moisture in the structure of a building, either as the result of intrusion from outside, or condensation from within the structure. In the shower area, internal water leaks or other sources of excessive moisture are generally the cause of damp.

It is advised to engage an epoxy grout specialist to remove and replace the grout with epoxy grout and install epoxy to all floor wall corner joints.

Always ensure that sealant and grout is in good condition to prevent any moisture issues occurring in the future

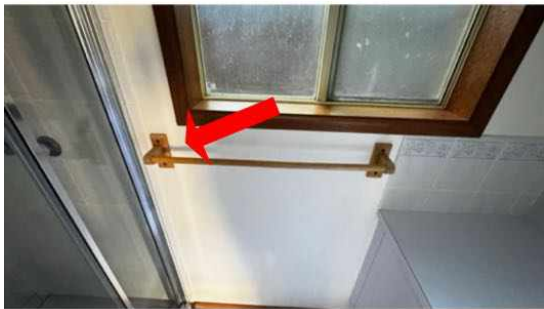
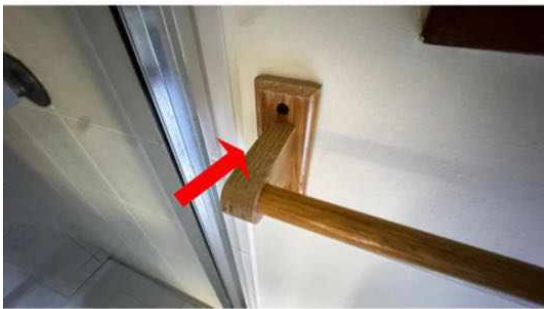
Defects 3.10

Building:	Main Building
Location:	Bathroom
Finding:	Bathroom Fittings - Loose
Information:	Bathroom fittings were observed to be loose and inadequately secured to walls in this area, moving when light pressure was applied. This reduces usability and may cause further damage if not addressed.

Common causes include incorrect or inadequate fixings, use of anchors unsuitable for the wall type, movement of the wall or timber substrate, wear from repeated use, or improper installation.

If left unresolved, loose fittings may detach, damage wall finishes, or cause progressive deterioration of both fittings and surrounding surfaces.

When practical, a qualified carpenter or experienced handyman should be engaged to securely refix or replace all loose fittings using appropriate fixings and methods for the wall type. The fittings should be monitored over time to ensure they remain secure.

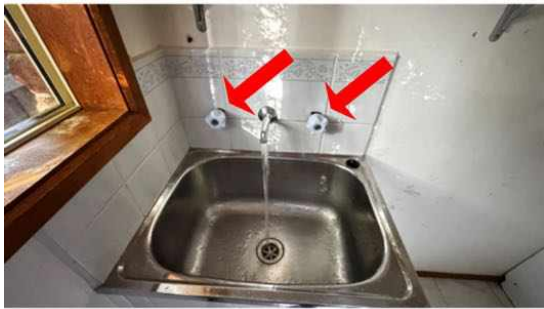
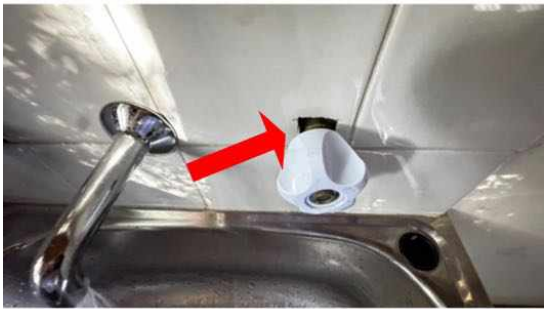
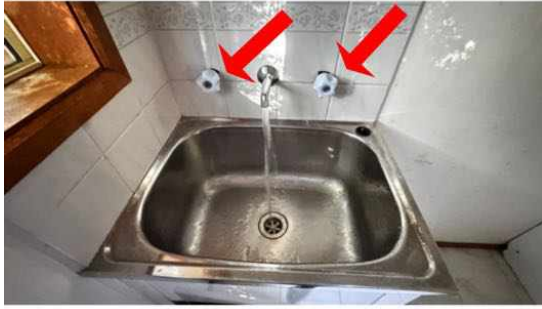
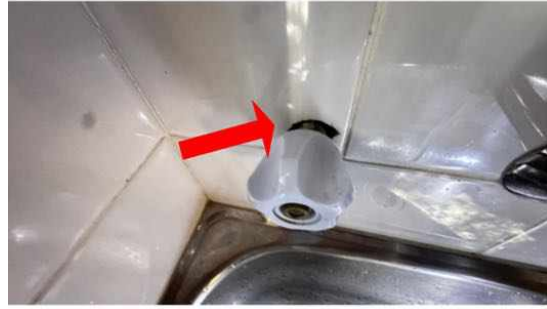
Defects 3.11

Building: Main Building
Location: All Areas >
Finding: Unsealed Pipe Penetrations - Internal
Information: Unsealed pipe penetrations were observed in this area, with gaps visible where pipes pass through cabinetry or wall linings. These openings can allow moisture and odours to enter and may cause deterioration of surrounding materials.

Common causes include missing and inadequate sealant during plumbing installation, incomplete sealing of service penetrations, or poor workmanship.

If left unaddressed, these gaps can lead to moisture damage, mould growth, material deterioration, and reduced hygiene in this area.

A licensed plumber or qualified handyman should be engaged immediately to seal all pipe penetrations with a suitable flexible sealant to prevent moisture ingress.

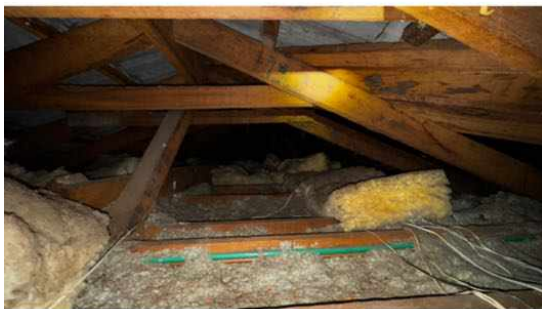
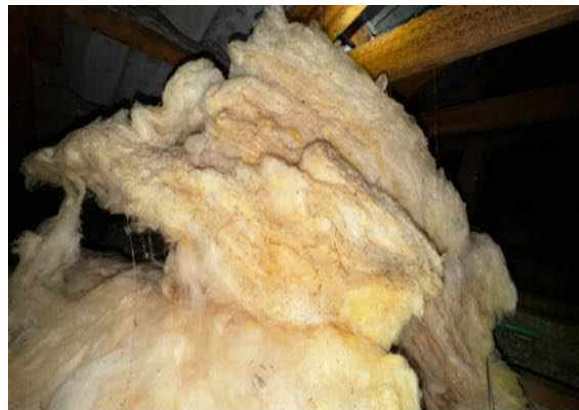
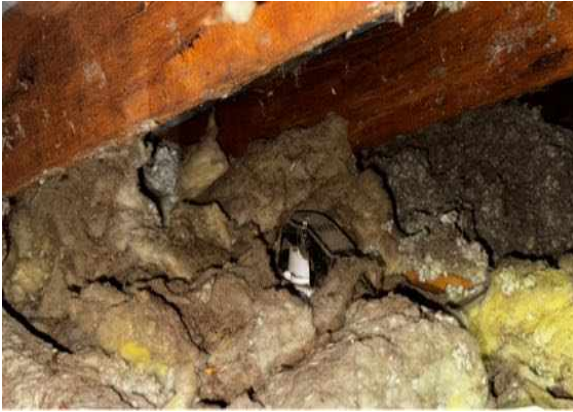
Defects 3.12

Building: Main Building
 Location: Roof Void
 Finding: Roof Void - Limited Access
 Information: Limited access to the roof void was present due to facts including but not limited to, limited access, insulation, Air condition Unit & ducting, obstructions or placement of insulation and or sarking, for this reason complete access to the roof void was not possible.

NOTE: Unless all insulation is removed from the roof space a full inspection is never possible, timber pest or termite activity and/or damage may not be visible.

A visual inspection was carried out from accessible areas only, recommend installing another access hatch in a more accessible area for a re-inspection.

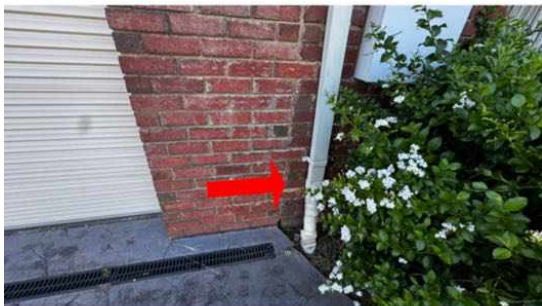
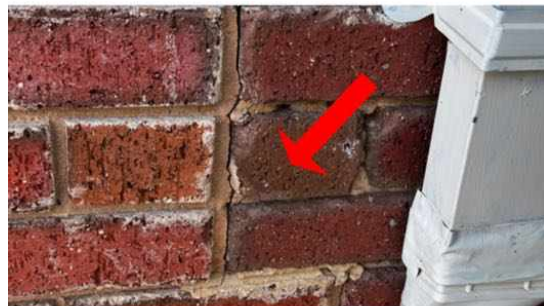
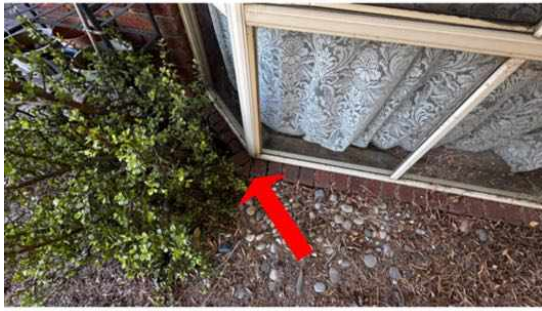
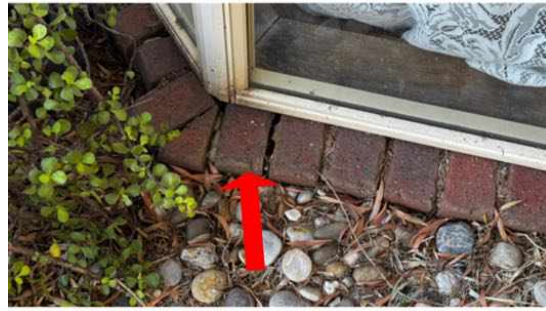
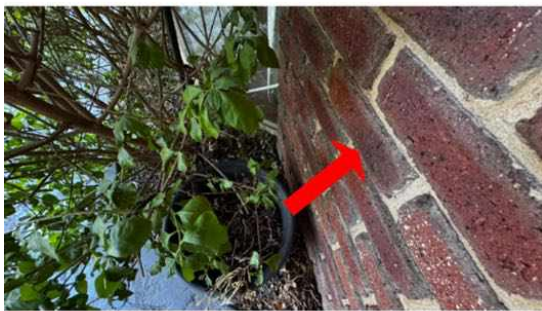
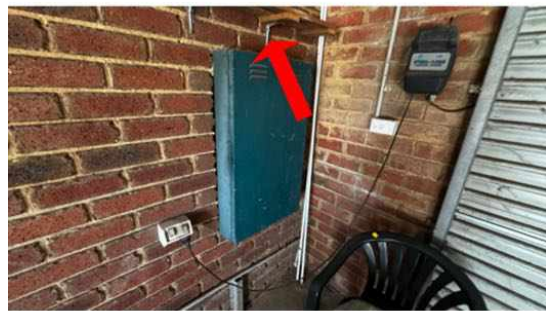
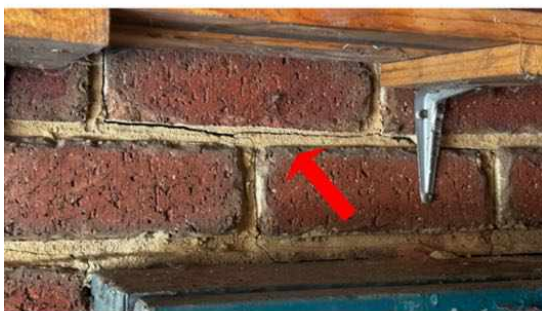
Defects 3.13

Building:	Main Building
Location:	All External Areas >
Finding:	Brickwork - Minor Cracking
Information:	Minor cracking was observed in the brickwork in this area. Hairline cracks are commonly cosmetic in nature; however, the presence of wider or stepped cracks, displaced bricks, or delaminated render may indicate structural movement or water ingress.

Possible contributing factors include normal thermal expansion and contraction, minor foundation settlement, structural movement, moisture penetration, impact damage, or workmanship-related issues.

*Note: No elevated moisture levels were detected at the time of inspection.

The brickwork in this area should be monitored, and if cracks widen or additional movement occurs, a structural engineer should be engaged immediately to assess the condition and advise on any required remedial works. Cosmetic hairline cracking can be repaired by a registered builder or qualified bricklayer to improve appearance and maintain weatherproofing.

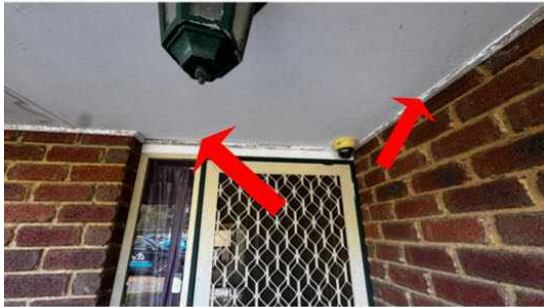
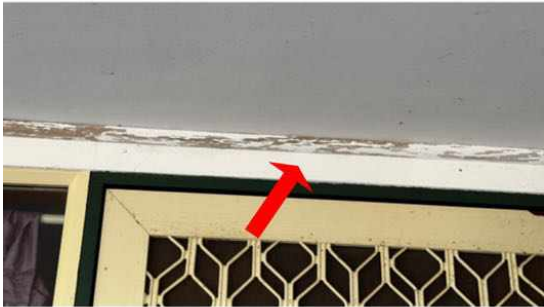
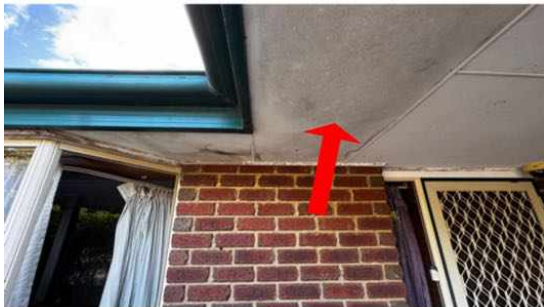
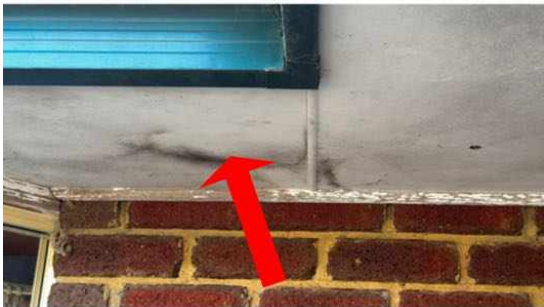
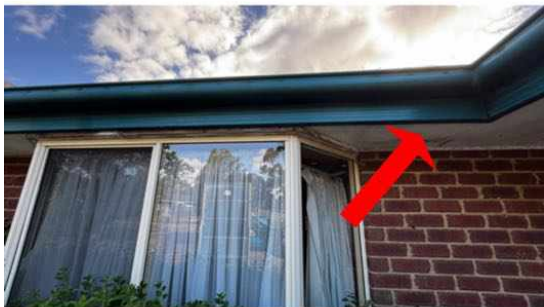
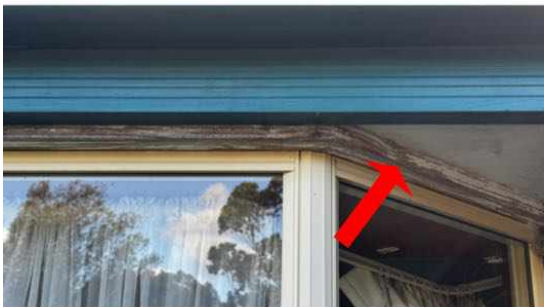
Defects 3.14

Building:	Main Building
Location:	All External Areas
Finding:	Eaves - Deteriorated
Information:	The eaves were inspected and paint deterioration, minor timber decay, and gaps at joints were observed in this area. Defective eaves can reduce weatherproofing, allow moisture ingress, and, in more severe cases, affect the structural integrity of roofing edges.

Possible causes include age-related timber decay from prolonged moisture exposure, UV and weathering damage, poor maintenance or lack of repainting, improper installation, and blocked or inadequate gutters causing water overflow onto timber

components.

When practical, a qualified carpenter or registered builder should be engaged to repair or replace affected timber, seal gaps, and repaint as required. Timely attention will protect the underlying structure, maintain weatherproofing, and prevent further decay.
