Building Inspection Report

Inspection Date: Mon, 2 Feb 2026

Property Address: 6 Westward Ho Dr, Sunbury VIC 3429,
Australia

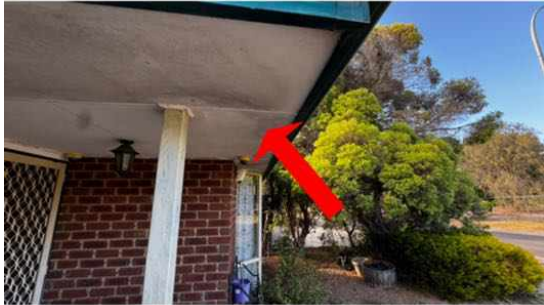
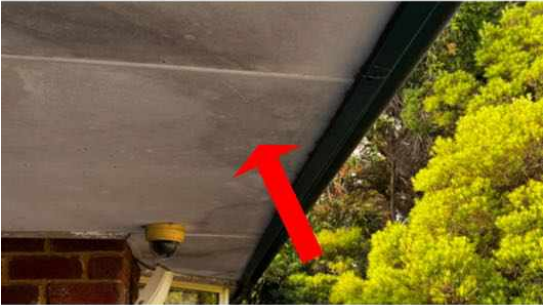
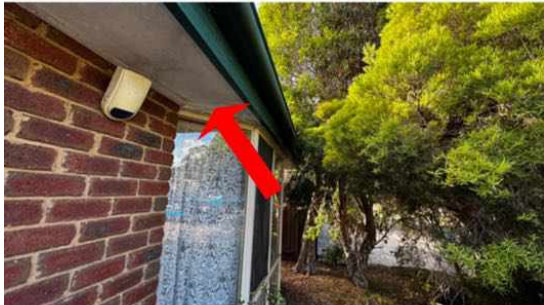
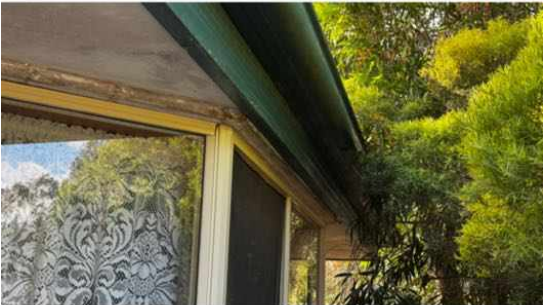
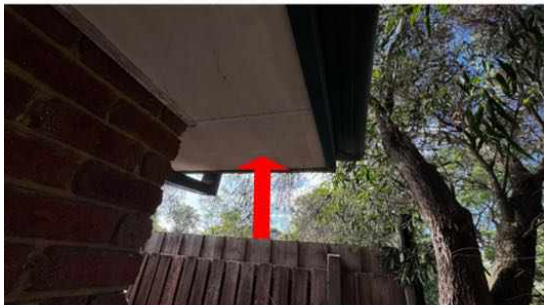
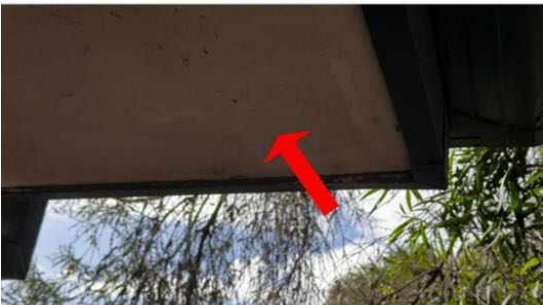
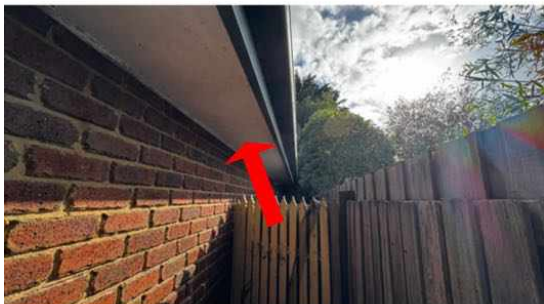
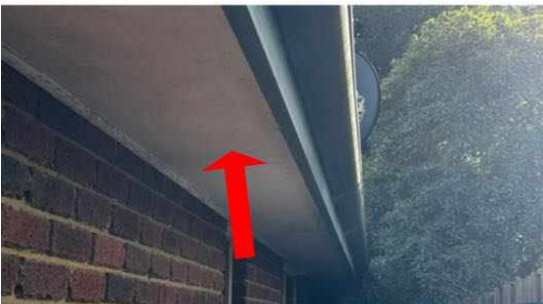
Defects 3.14

Building:	Main Building
Location:	All External Areas
Finding:	Eaves - Deteriorated
Information:	The eaves were inspected and paint deterioration, minor timber decay, and gaps at joints were observed in this area. Defective eaves can reduce weatherproofing, allow moisture ingress, and, in more severe cases, affect the structural integrity of roofing edges.

Possible causes include age-related timber decay from prolonged moisture exposure, UV and weathering damage, poor maintenance or lack of repainting, improper installation, and blocked or inadequate gutters causing water overflow onto timber

When practical, a qualified carpenter or registered builder should be engaged to repair or replace affected timber, seal gaps, and repaint as required. Timely attention will protect the underlying structure, maintain weatherproofing, and prevent further decay.

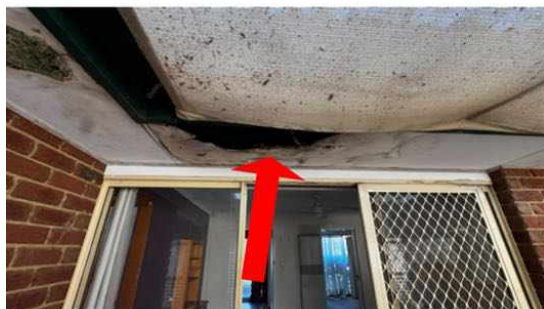
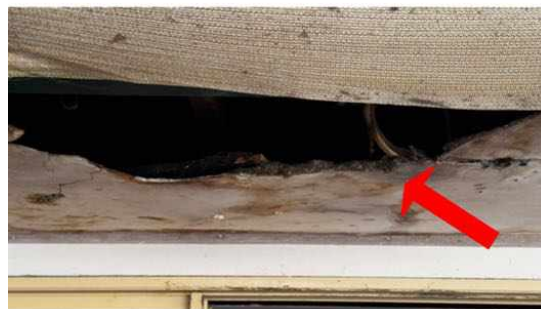
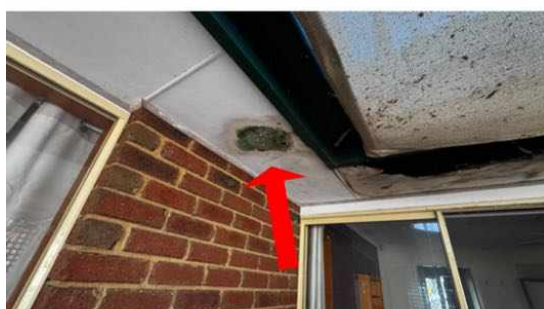
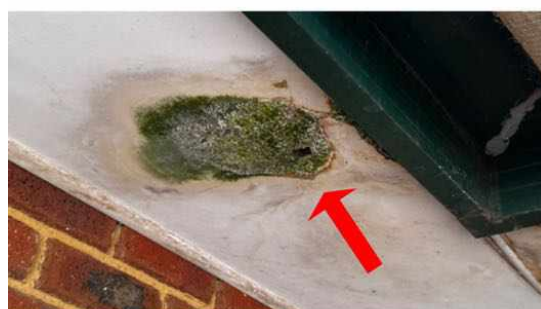
Defects 3.15

Building:	Main Building
Location:	All Roof Areas >
Finding:	Roof Plumbing - Rusted & Corroded
Information:	The roof plumbing has areas of rust and corrosion. It is suspected that this has been caused by blockages, resulting in pooling or standing water, that have prematurely rusted elements of the roof plumbing.

Rusted roof plumbing will generally develop holes and leaks that can affect other building elements with poor drainage of storm water. Poorly drained roof areas will also lead to damp conditions surrounding the base perimeter of the building which, if left unmanaged, can lead to a range of secondary building defects.

Repair and/or replacement of rusted roof plumbing is required in order to reinstate the roof drainage system to a fully operational level. To further maintain these areas, gutters should be cleaned frequently, allowing the avoidance of any partial blockages.

A licensed plumber or specialist roof restoration company should be appointed to undertake these works. It is advised that such works be completed as soon as possible to prevent any further damage and deterioration.

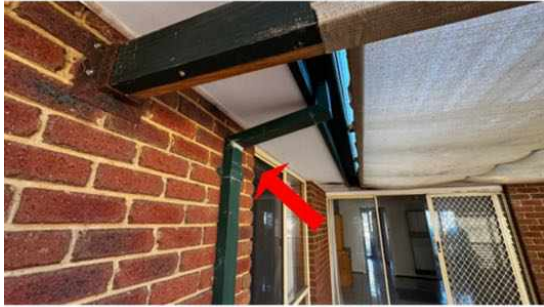
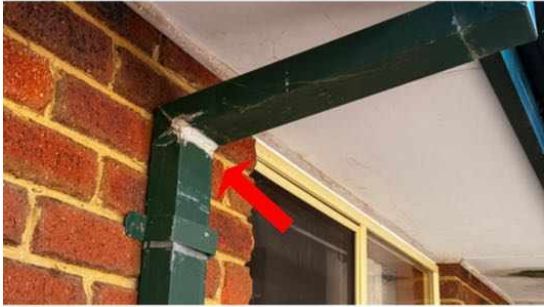
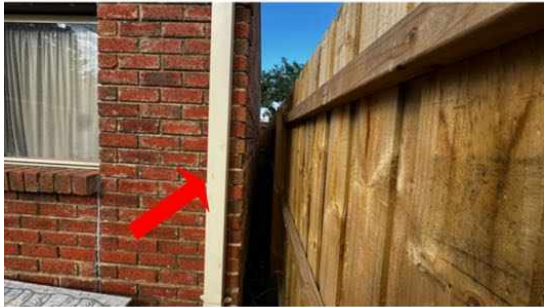
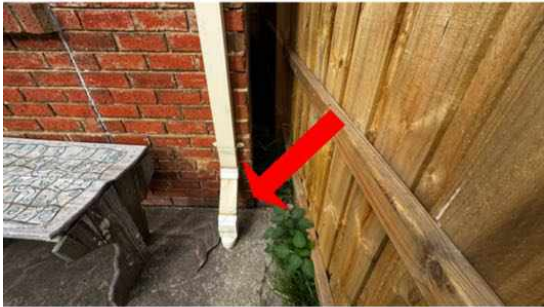
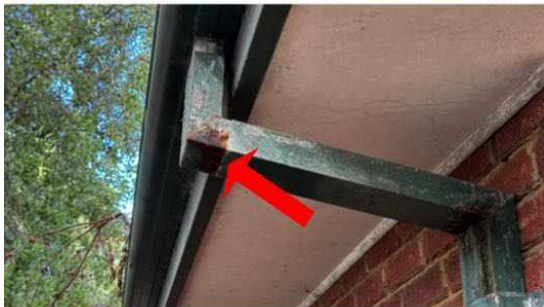
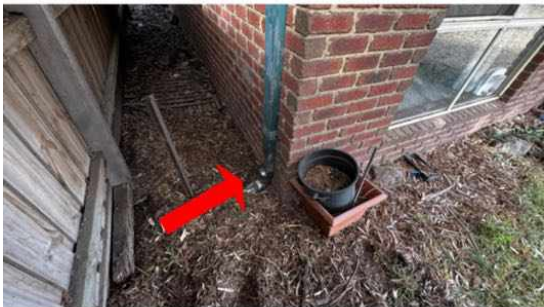
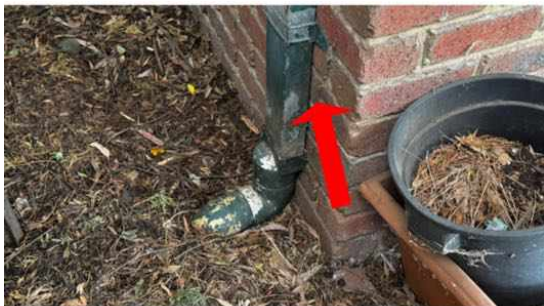
Defects 3.16

Building: Main Building
Location: All Roof Areas
Finding: Roof Plumbing - Gutters Blocked & Leaking
Information: Gutters in this area are blocked and leaking and not allowing water to flow freely. The issue is observed along the gutter runs where leaves, debris, or other obstructions have accumulated.

This has likely occurred due to lack of maintenance or build-up of debris over time. Blocked gutters may cause water to overflow, damage the roof, walls, or foundations, and increase the risk of erosion or water ingress.

A licensed roof plumber is required to inspect and clear the blocked gutters in this area immediately. This should be rectified immediately to ensure water drains correctly and to prevent potential damage to the building.

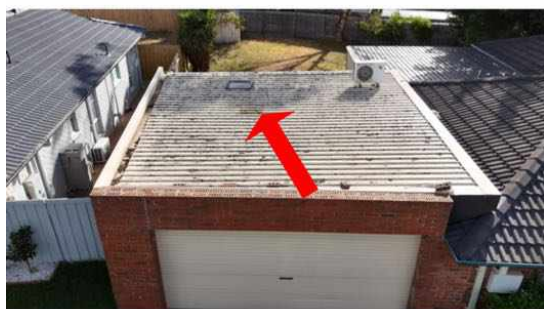
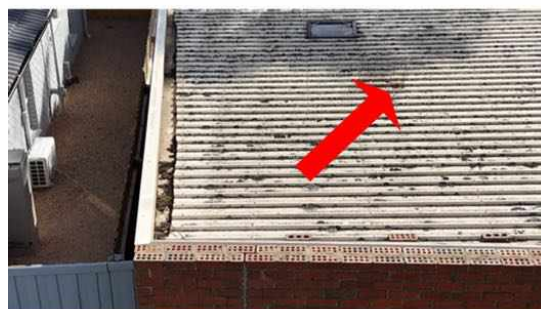
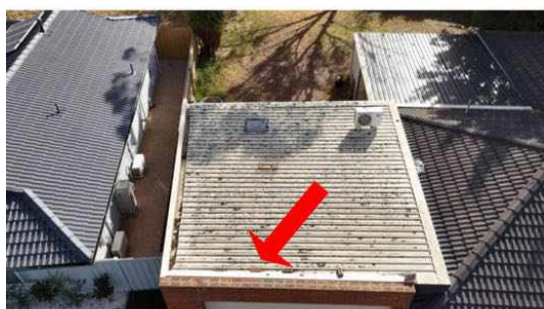
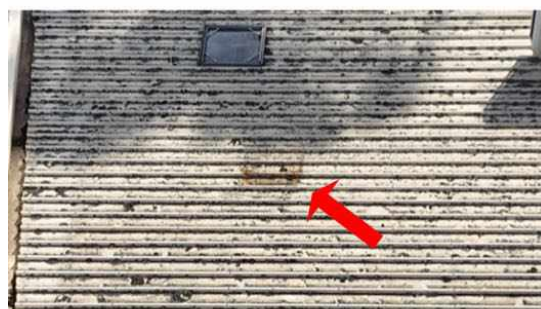
Defects 3.18

Building:	Main Building
Location:	Garage Roof >
Finding:	Roof Plumbing - Loose Flashings
Information:	The inspection identified loose flashings on the roof. Loose flashings can compromise the water-tightness of the roof, allowing water ingress, which may lead to leaks, corrosion, and damage to the underlying structure.

The issue may be caused by age-related wear, poor installation, wind damage, or building movement over time.

It is recommended that a licensed plumber or roofing specialist be engaged immediately to inspect and secure or replace the affected flashings. Prompt action will help maintain the integrity of the roof and prevent further water-related damage.

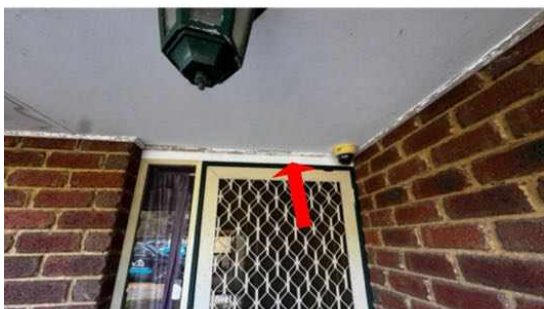
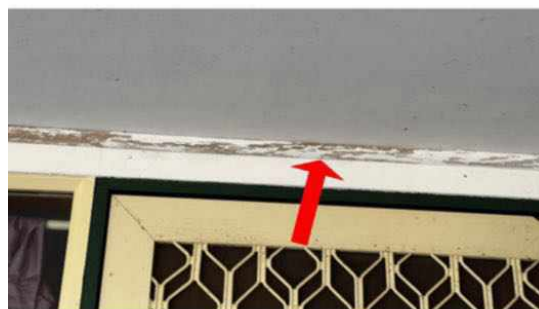
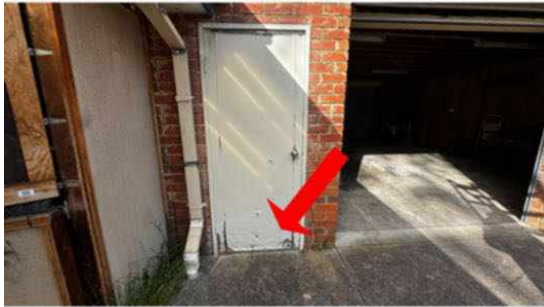
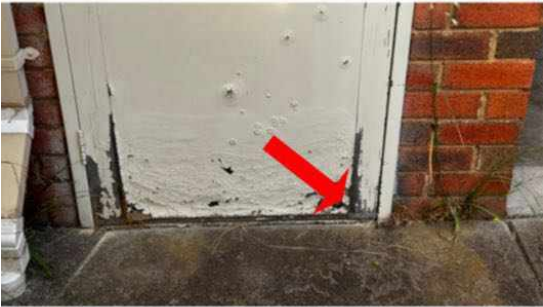
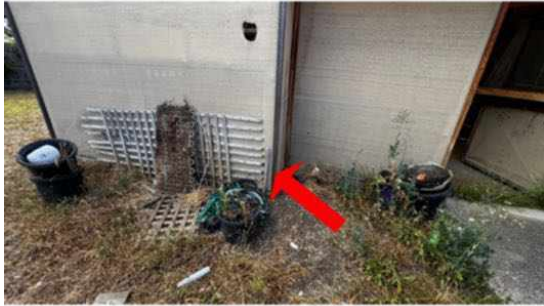
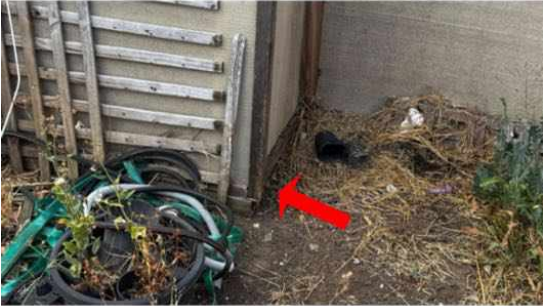
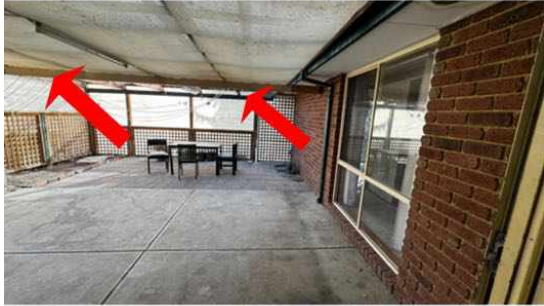
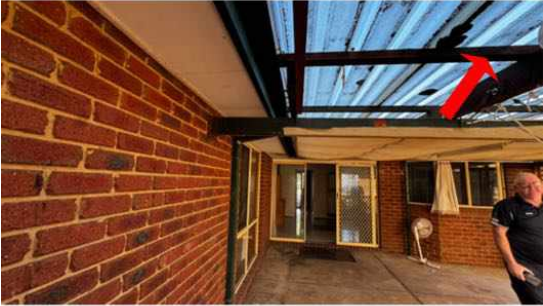
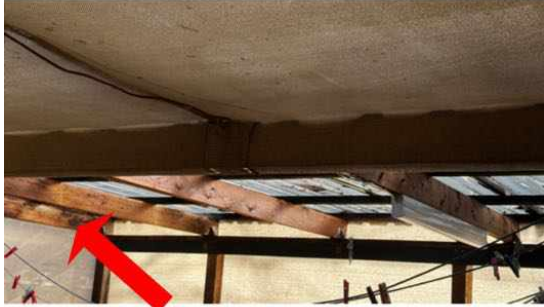
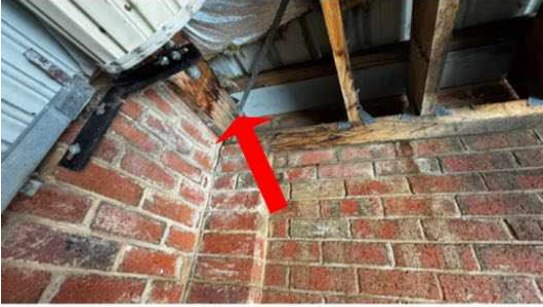
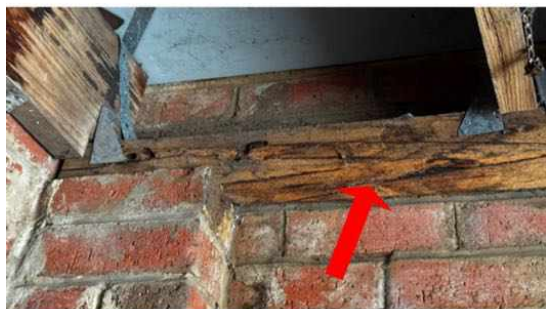
Defects 3.19

Building:	Main Building
Location:	All External Areas
Finding:	External Timber - Timber Rot
Information:	Timber elements including wall claddings, timber rails & posts, landscaping timbers, and other external timber surfaces were inspected and show signs of rot, decay and fungal attack in these areas. Softening, discoloration, splitting, and moisture penetration indicate ongoing timber degradation.

This is likely caused by prolonged moisture exposure, inadequate protective coatings or maintenance, direct contact with soil or water, or poor detailing that traps water or limits ventilation.

If left unaddressed, the affected timber may lose structural integrity, leading to progressive decay, potential collapse of walls, decks, or landscaping features, mould growth, and reduced durability and appearance of the building exterior.

A registered builder or timber specialist should inspect the affected areas immediately to determine the extent of damage. Damaged timbers should be repaired or replaced, protective treatments applied, and drainage or detailing corrected to prevent recurrence. Ongoing monitoring and urgent remedial action are required to prevent further deterioration.

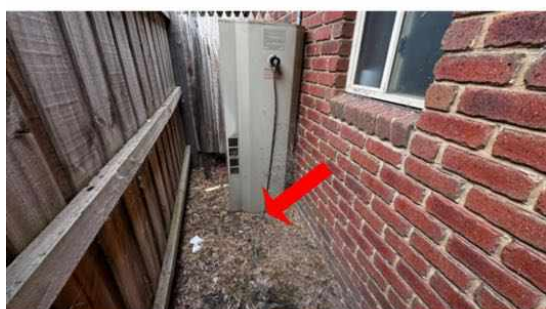
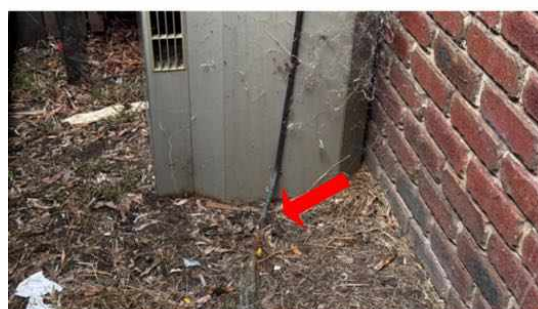
Defects 3.20

Building:	Main Building
Location:	All External Areas >
Finding:	HWS - (T&P) Valve Not Connected To Storm Water
Information:	The Hot Water System (HWS) Temperature & Pressure Relief (T&P) valve discharge pipe was observed to be disconnected from stormwater drainage.

When not properly connected, discharged water can create damp conditions around the HWS, potentially leading to secondary defects such as timber rot, corrosion of nearby metal components, mould growth, or slip hazards. Prolonged exposure to moisture in this area may also attract termite activity and contribute to long-term deterioration of surrounding building elements.

A licensed plumber should be engaged immediately to connect the T&P discharge pipe to a suitable stormwater outlet or floor waste. Prompt rectification will ensure safe operation of the HWS, protect surrounding structures, and reduce potential health and safety risks.

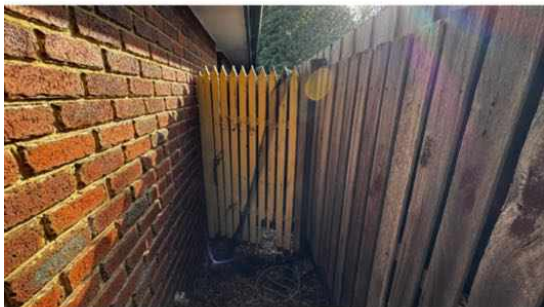
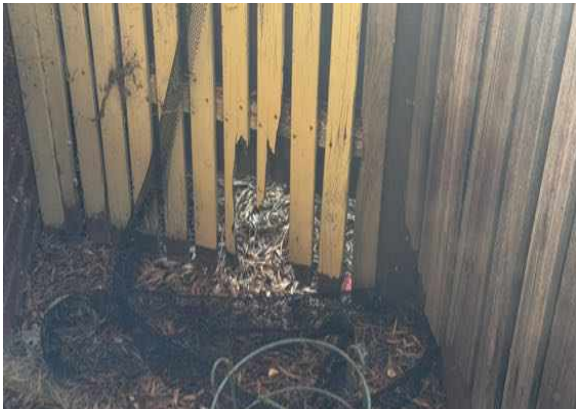
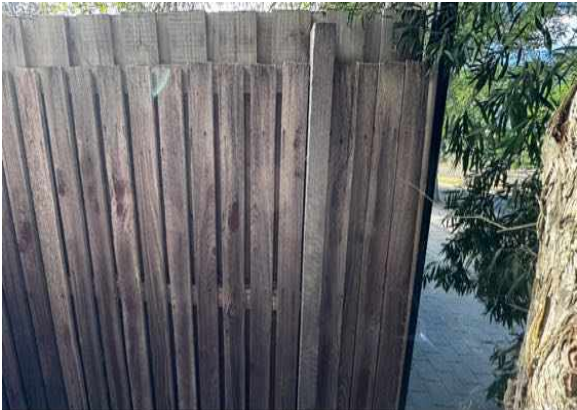
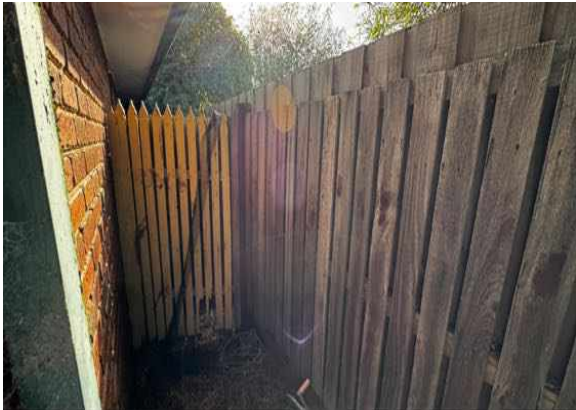
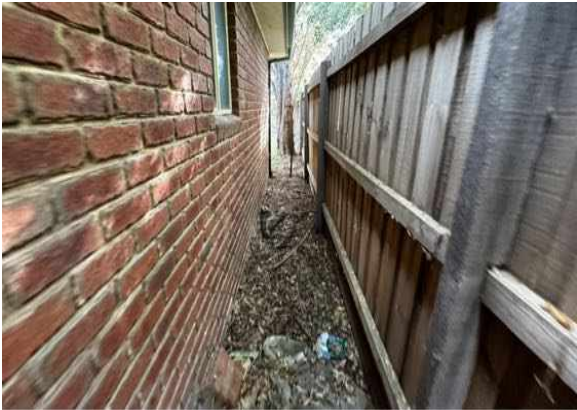
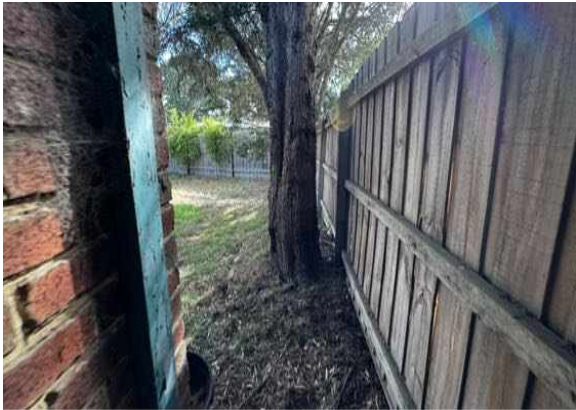
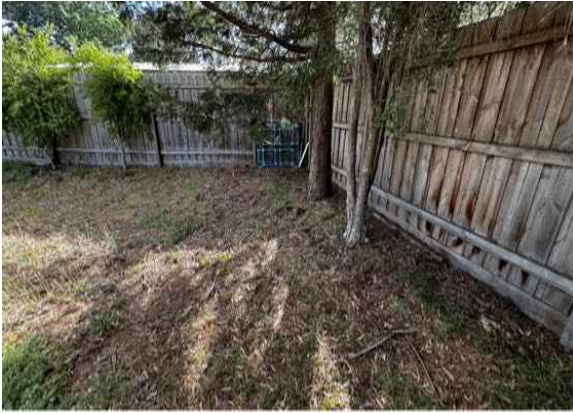
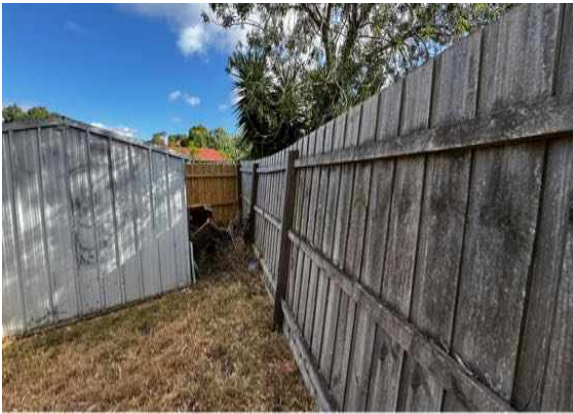
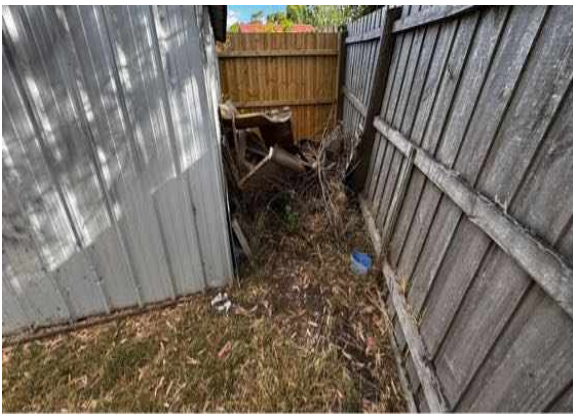
Defects 3.21

Building:	Main Building
Location:	Fencing All Areas

Information: Timber fencing was inspected and deterioration was observed in this area. Deteriorated fencing can compromise structural stability, reduce privacy, and may allow pest ingress or accelerated decay if left unaddressed.

Possible causes include age-related timber decay, prolonged exposure to moisture or sunlight, poor maintenance, or impact damage.

When practical, a qualified carpenter or fencing specialist should be engaged to repair or replace affected sections, and a qualified painter should be engaged to restore protective finishes. Prompt rectification will maintain structural performance, improve appearance, and extend the lifespan of the fencing.

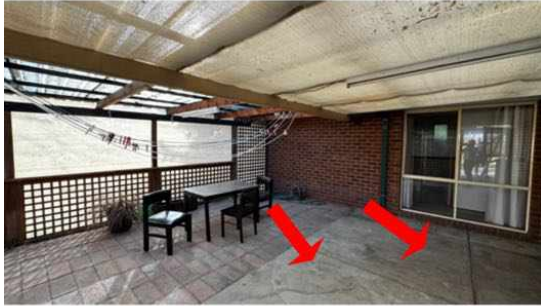
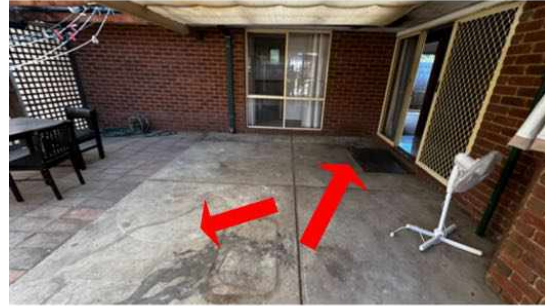
Defects 3.22

Building:	Main Building
Location:	All External Areas >
Finding:	Paving - Minor Cracking
Information:	<p>The external paved areas were visually inspected. Minor cracking, uneven surfaces, and general wear were observed in this area. These defects do not currently affect structural safety but may reduce durability, appearance, and safe pedestrian access.</p> <p>This may be caused by age-related deterioration of concrete, pavers, or other materials, soil movement or settlement beneath paved surfaces, tree root intrusion or erosion, or inadequate original installation or sub-base compaction.</p>

A qualified landscaper should be engaged as soon as possible to repair or resurface sections as required. Rectification will restore even surfaces, reduce trip hazards, and improve the serviceability and appearance of the paved areas.

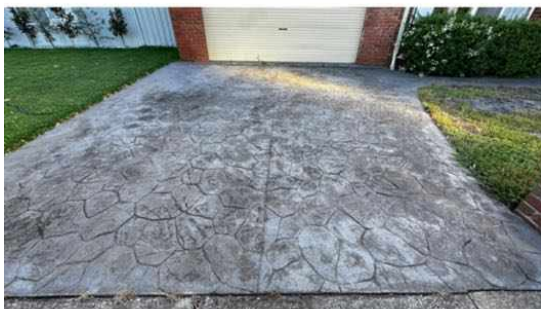
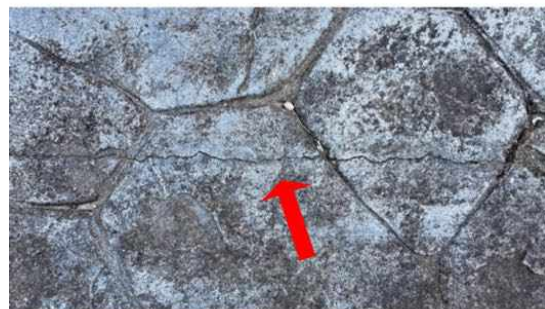
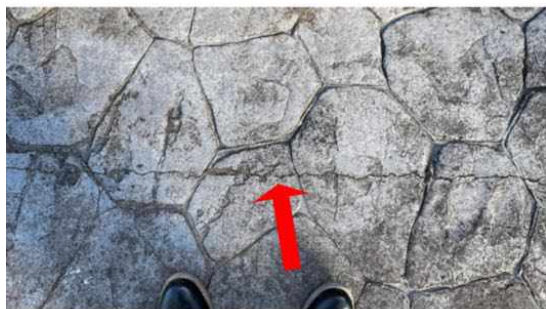
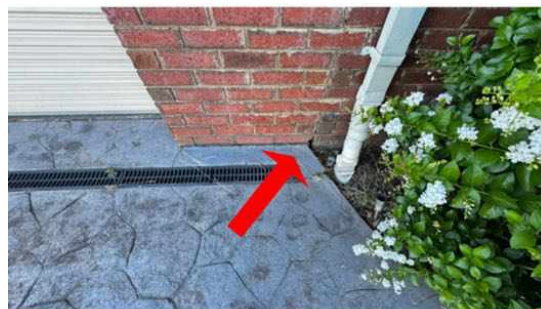
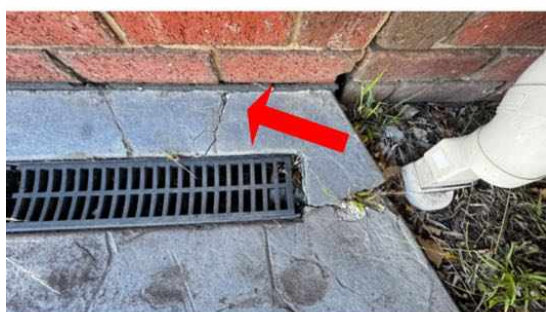
Defects 3.23

Building:	Main Building
Location:	Driveway
Finding:	Driveway - Minor Cracking & Surface Imperfections
Information:	The external driveway was visually inspected. Minor cracking, surface settlement, and minor unevenness was observed in this area. While these defects do not currently compromise structural safety, they may affect long-term durability, appearance, and vehicle access.

These issues may be caused by age-related wear, soil movement or settlement beneath the driveway, possible tree root intrusion, or inadequate original construction or reinforcement.

A qualified concreter should be engaged when practical to repair or resurface affected areas. Prompt rectification will restore a smooth surface, improve appearance, and prevent further deterioration.

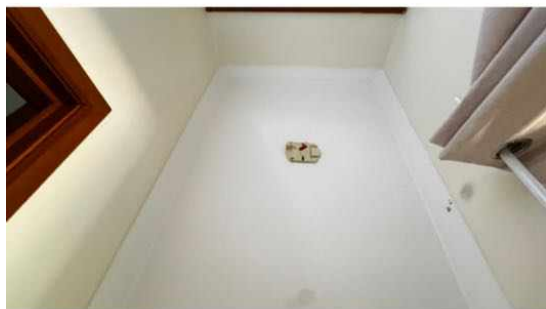
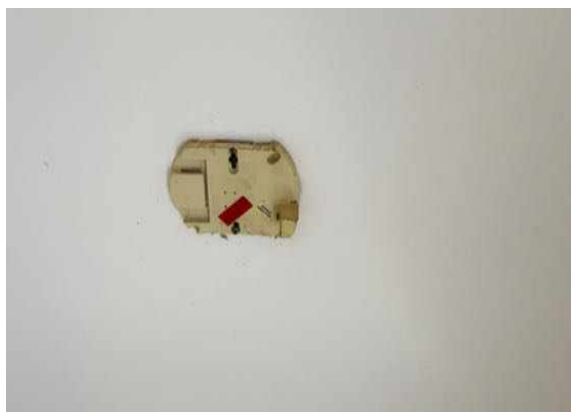
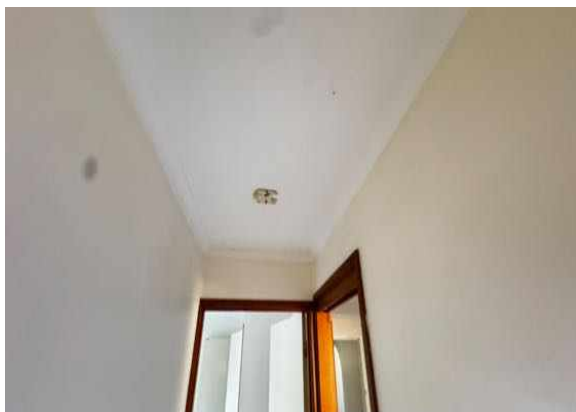
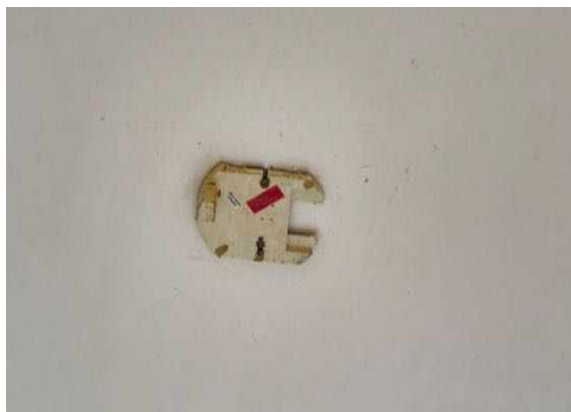
Defects 3.24

Building:	Main Building
Location:	All Internal Areas
Finding:	Smoke Detectors - Advisory
Information:	During the inspection, smoke detectors were noted for advisory purposes only. The operation, age, type, and compliance of smoke detectors could not be fully verified as part of this inspection.

Smoke detectors are critical life-safety devices, and non-compliant, outdated, or non-operational units may not provide adequate warning in the event of a fire.

It is recommended that a licensed electrician be engaged immediately to test, service, and upgrade smoke detectors as required to ensure correct operation and compliance with current safety requirements.

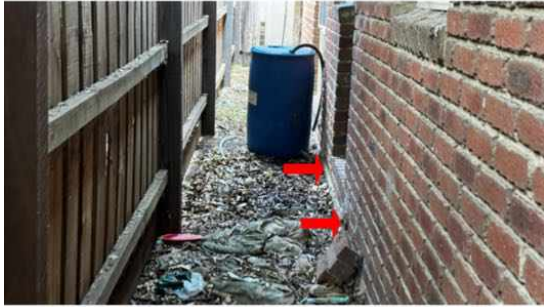
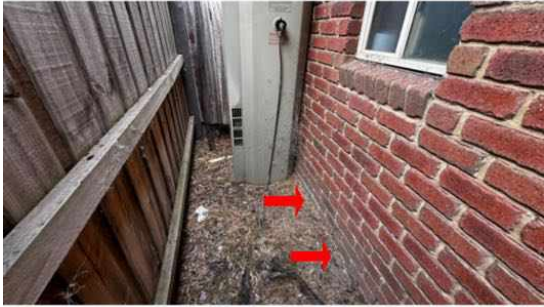
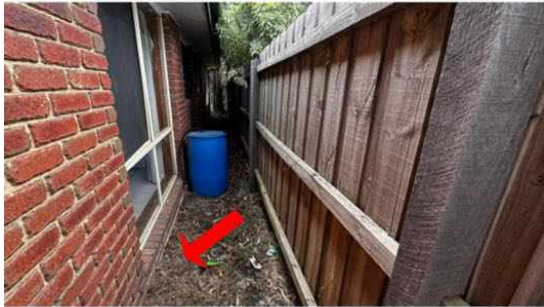
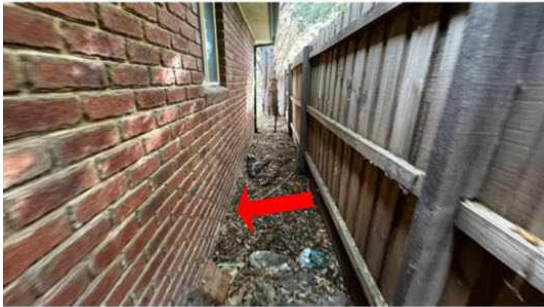
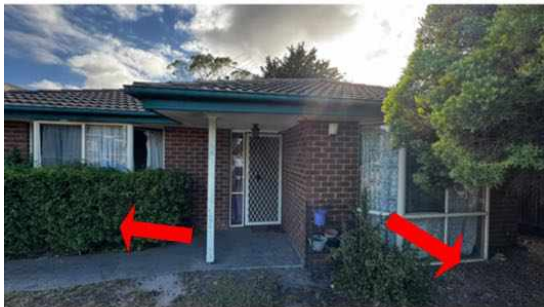
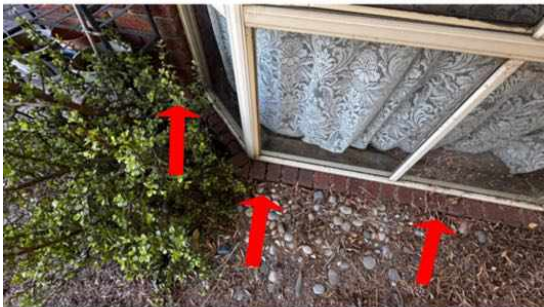
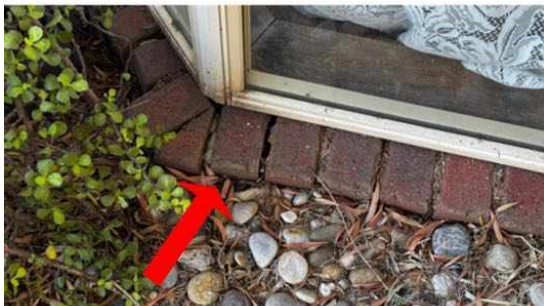
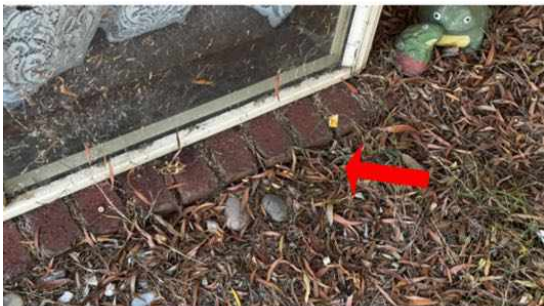
Defects 3.25

Finding: Site Drainage - Inadequate

Information: The overall site drainage was observed to be inadequate at the time of inspection. Poor drainage can cause water to pond near external walls, increasing the risk of rising damp, foundation movement, timber decay, and deterioration of associated building elements.

Ground levels should slope away from the dwelling to direct water from walls and footings. Downpipes must be properly connected to the stormwater system and should not discharge directly onto walls, paving, or plinths. Stormwater should be directed away from the property through adequately sized and maintained drains. Where ground levels are too high and cover the damp-proof course (DPC), lowering the levels may be necessary to expose the DPC and allow effective drainage.

A licensed plumber should be engaged promptly to investigate and recommend suitable remedial works, which may include the installation of an agricultural (aggie) drain or other site drainage improvements. Immediate action is strongly recommended, as inadequate drainage can lead to progressive water damage and secondary building defects over time.

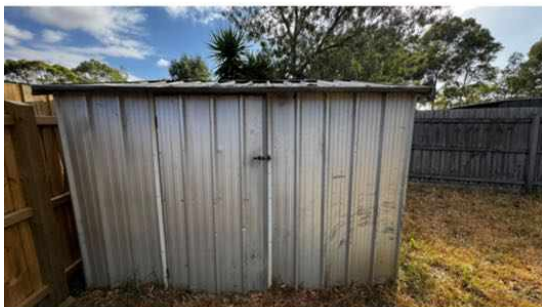
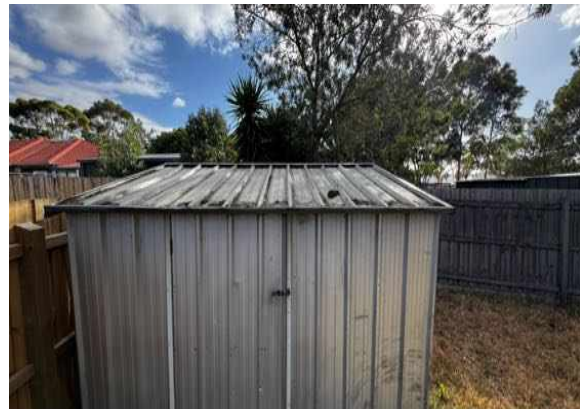
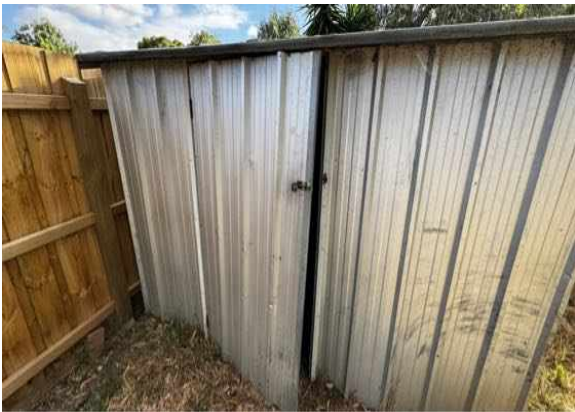
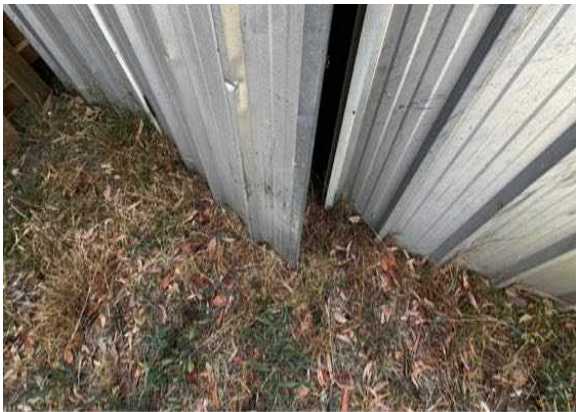
Building: Main Building
Location: All External Areas
Finding: Garden Shed - General Condition
Information: The garden shed was inspected visually. The shed structure shows signs of age-related deterioration, including corrosion of roofing and walls and weathered components.

The shed does not appear to compromise the primary dwelling structure but may reduce usability, weatherproofing, and amenity. This deterioration is likely due to age, exposure to weather, and a lack of regular maintenance.

When practical, a competent hand man should be engaged to repair or replace damaged, missing, or weathered components. Rectification will restore functionality, durability, and weatherproofing of the shed.

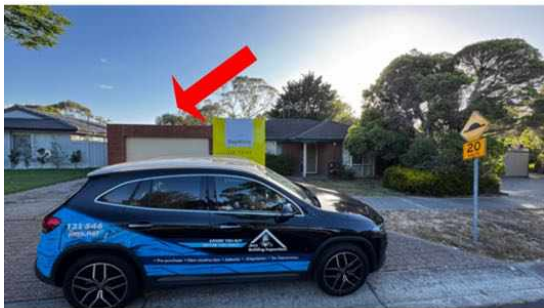
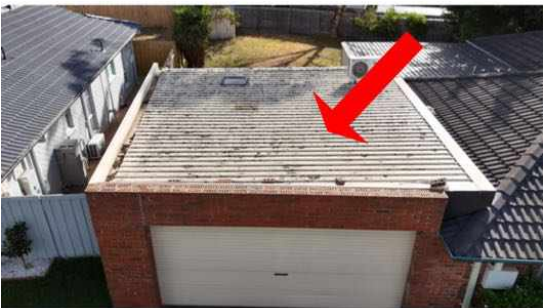
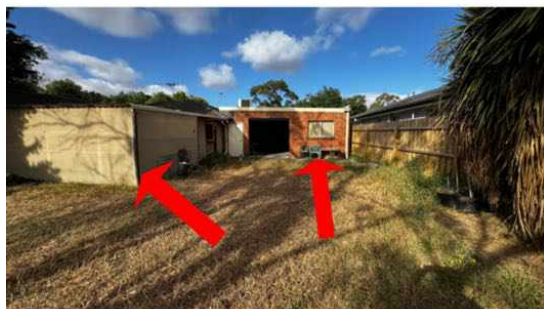
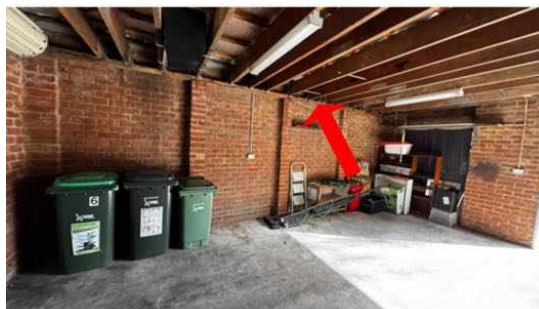
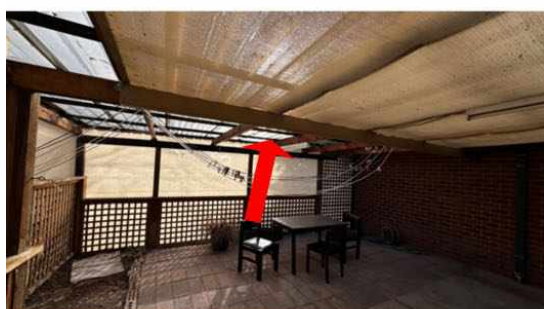
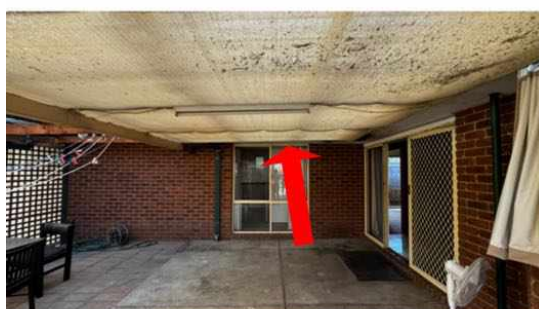
Building: Main Building
Location: All Areas
Finding: Building Approvals – Prior Renovations Advisory
Information: For your information, the dwelling has undergone several renovations over the past years. Evidence of multiple alterations and upgrades was observed at the time of inspection. The inspection did not include verification of council approvals, permits, or compliance documentation for these works.

Unapproved or undocumented renovations may present compliance, safety, insurance, or resale risks if not properly approved or certified.

It is strongly recommended to make enquiries with the relevant local council immediately and engage appropriately qualified professionals, where necessary, to confirm that all historic renovations were carried out with the required permits, approvals, and certifications.

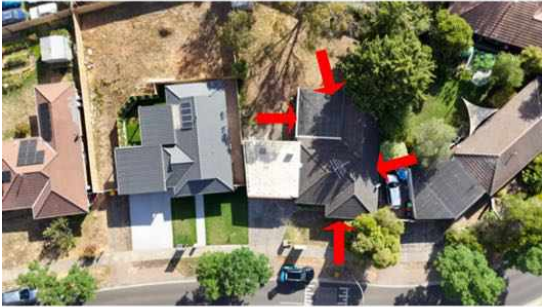
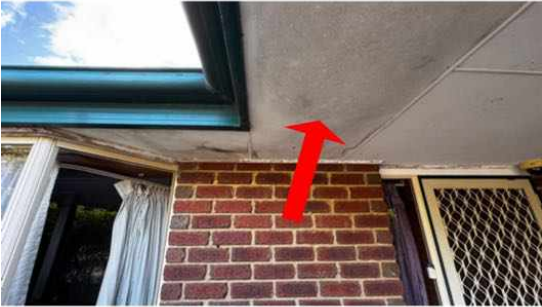
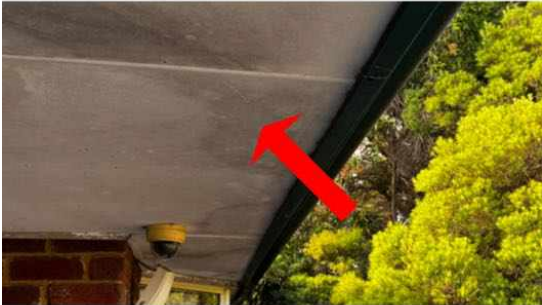
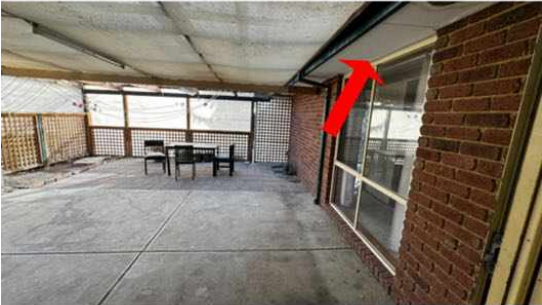
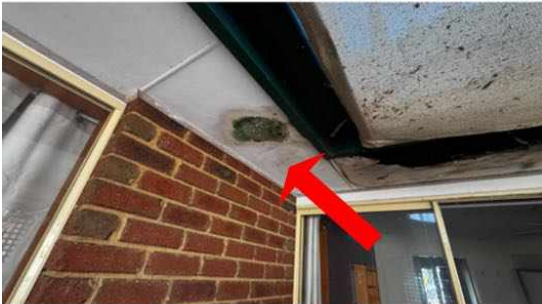
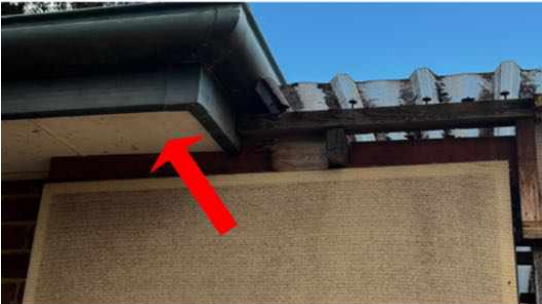
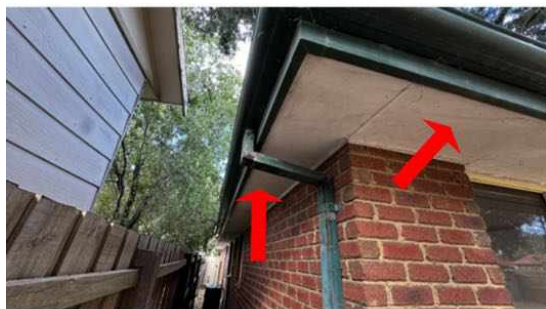
Building:	Main Building
Location:	All Areas
Finding:	Asbestos - Suspected Asbestos Containing Material - Ceilings & Eaves
Information:	The ceiling & eave linings in this area appear to be an asbestos containing material (ACM).

The observable areas of ceiling linings appears to have no obvious signs of damage or deterioration, indicating that the asbestos is currently encapsulated and contained. Damaged and deteriorated ACMs are more likely to release asbestos fibres, creating a significant health risk.

In the interim, as the ceiling material is suspected to be constructed using Asbestos, it is advisable that the condition of all ceiling linings and eaves also be considered. Any areas of damage and deterioration represent opportunities for the fibrous Asbestos

materials to be released into the air, creating a significant health and safety risk. Interaction with and access to the ceiling material should be prevented, particularly if there is any damage or deterioration.

Removal by a Licensed Asbestos Removal firm is highly advised.

Where the client elects to retain the ACM, the client should regularly monitor the affected area. Such monitoring should be conducted at least annually, but more frequently should damage or evidence of deterioration occur.

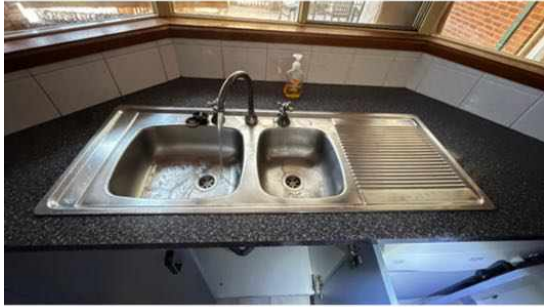
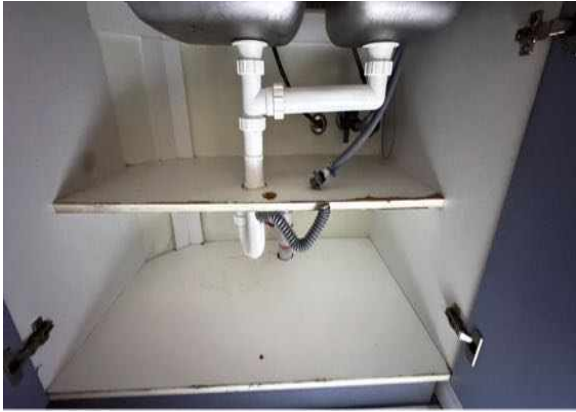
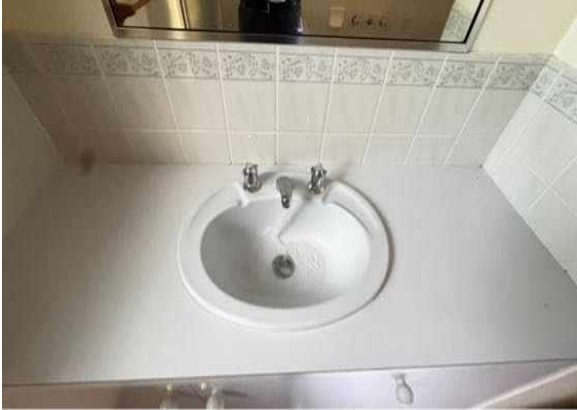
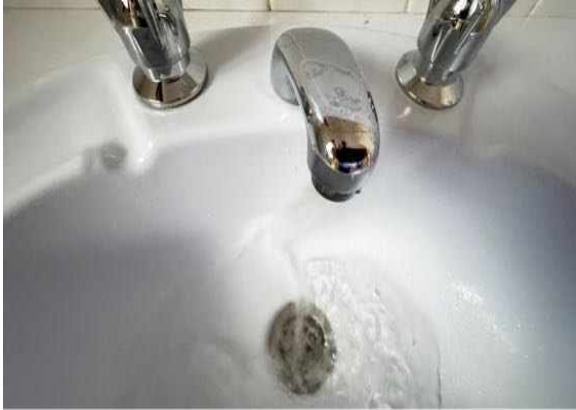
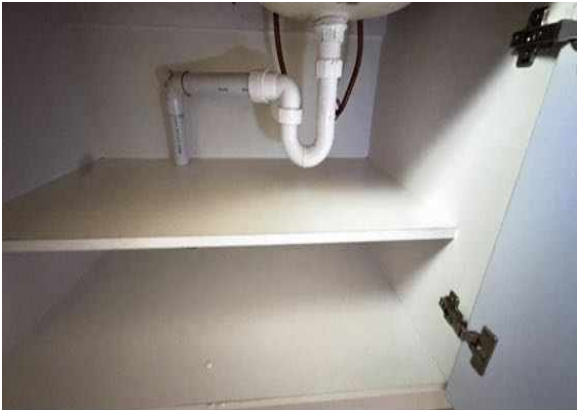
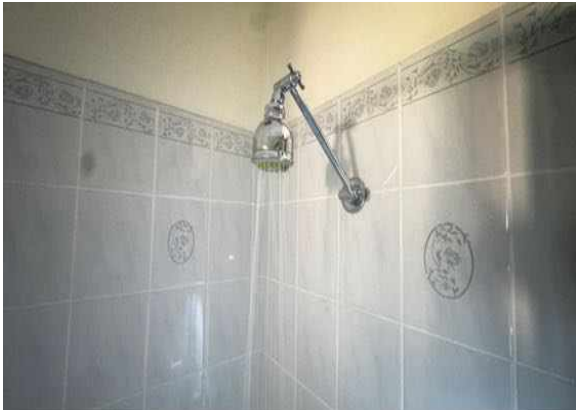
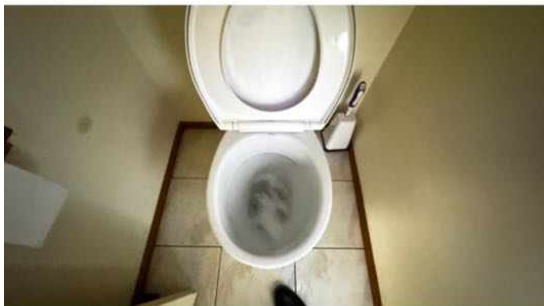
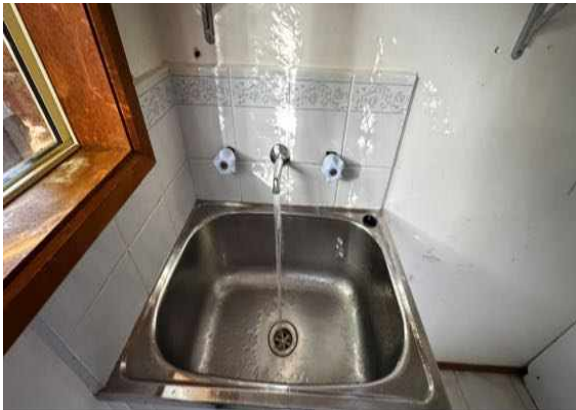
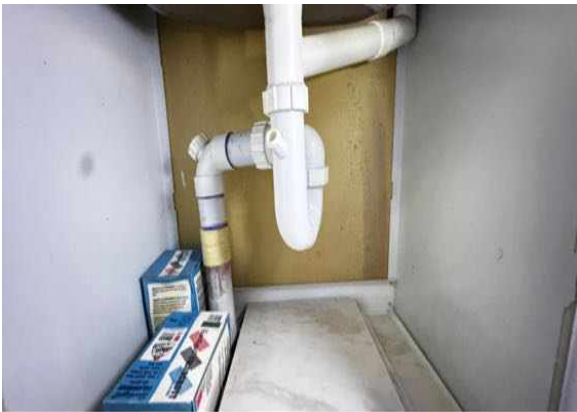
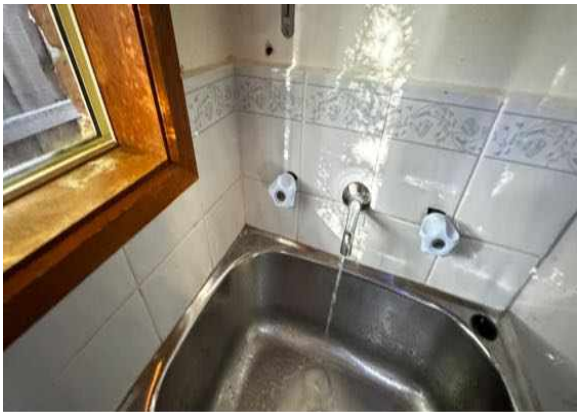
Building: Main Building
 Location: All Internal Areas
 Finding: Water Supply & Drainage - Shower, Basins, Toilets, & Plumbing Fixtures
 Information: The shower recess was tested, and no visible water penetration to surrounding areas was observed at the time of inspection, except where noted as a separate defect elsewhere in this report. Water appeared to flow freely toward the floor waste. Moisture detected to the shower walls is documented separately in the report. The shower floor waste appeared clear during inspection.

Flushing the toilet revealed no visible leaks, and the fixture appeared to operate normally unless otherwise noted as a separate defect. No water damage was observed to the vanity unit unless specifically stated elsewhere in the report. Basins, bathtubs, laundry tubs, vanities, and sinks were tested and inspected with no evidence of leaks, blockages, or drainage issues at the time of inspection unless otherwise noted. All internal taps and shower heads were tested with no leaks observed, unless documented as a separate defect.

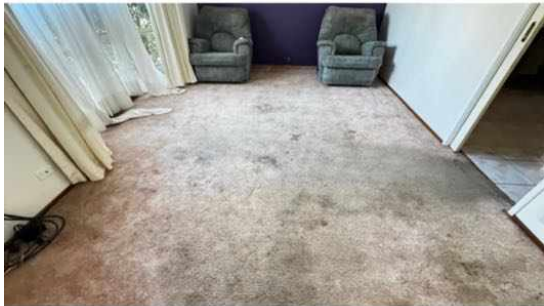
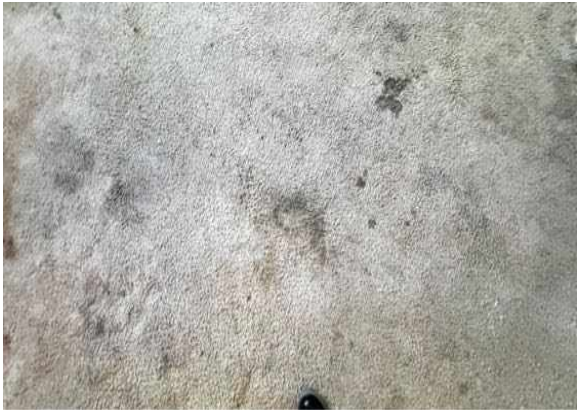
Building: Main Building
Location: All Areas
Finding: Cleanliness & Hygiene - Internal Property Requires Commercial Cleaning
Information: The internal areas of the property, including bedrooms, bathrooms, laundry, floors, carpets, tiles, kitchen surfaces, cupboards, walls, and windows, were observed to require a thorough commercial clean. Accumulated dust, dirt, and general soiling may affect hygiene, indoor air quality, and the overall presentation of the property.

This condition is likely due to routine use, insufficient maintenance, or delayed professional cleaning.

When practical, a professional commercial cleaning service should be engaged to clean all internal surfaces, including bedrooms, bathrooms, laundry, floors, carpets, tiles, kitchen surfaces, cupboards, walls, and windows. Regular cleaning is recommended to maintain hygiene, presentation, and overall amenity of the property.
