Building Inspection Report

Inspection Date: Mon, 2 Feb 2026

Property Address: 6 Westward Ho Dr, Sunbury VIC 3429,
Australia

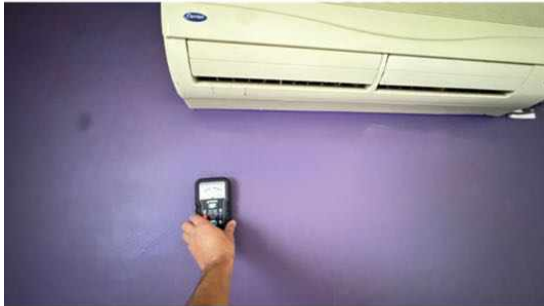
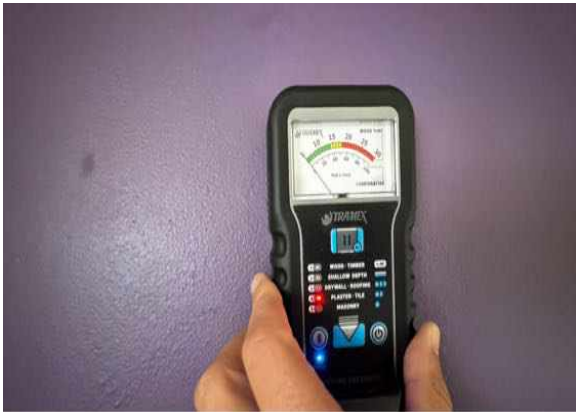
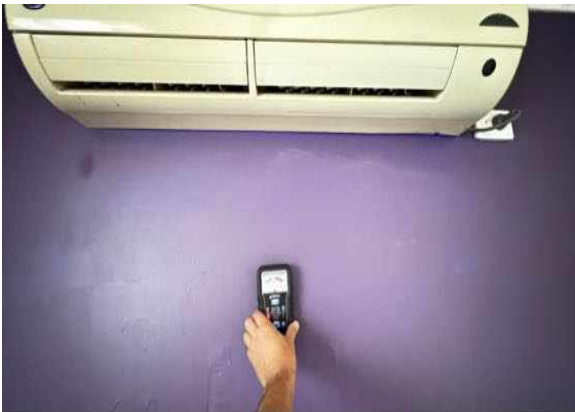
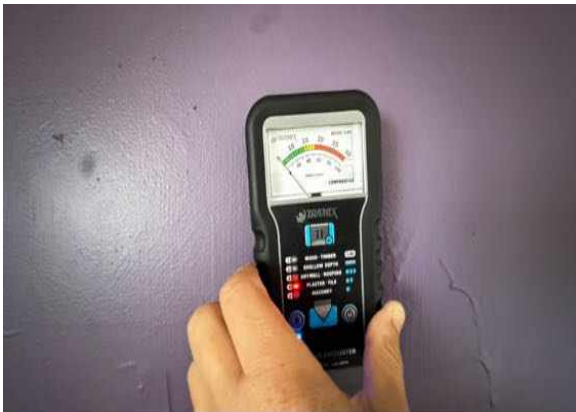
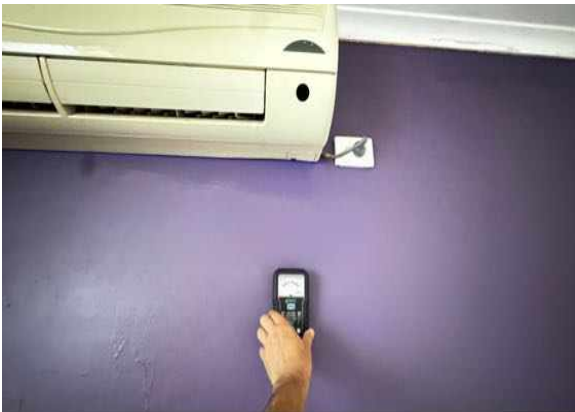
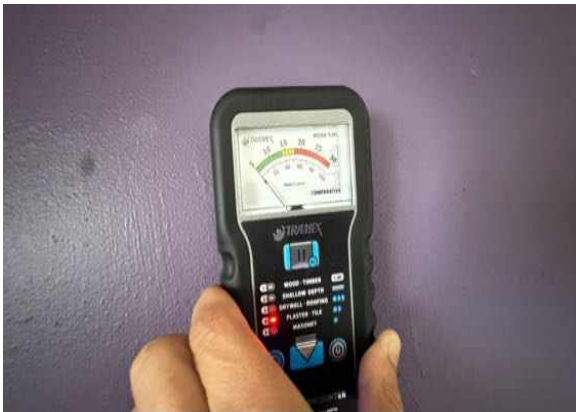
Building: Main Building
 Location: All Areas Interior & Exterior
 Finding: Moisture Levels - Advisory - No Elevated Moisture Levels Present
 Information: At the time of inspection, no elevated moisture levels were detected in these areas. Moisture readings were taken (using a Tramex Moisture Meter) and non-invasive testing methods and reflect conditions present at the time of inspection only. This item is noted for advisory purposes and should not be relied upon as a guarantee that moisture issues are not present elsewhere or may not occur in the future.

It is important to note that moisture levels can fluctuate due to weather conditions, plumbing usage, seasonal changes, or intermittent leaks. Concealed moisture within

wall cavities, subfloor areas, or other inaccessible locations may not be detected during a visual or limited moisture assessment.

Ongoing monitoring of the property is recommended, and further investigation by a qualified tradesperson should be considered if signs of water ingress, dampness, staining, mould growth, or material deterioration become apparent.

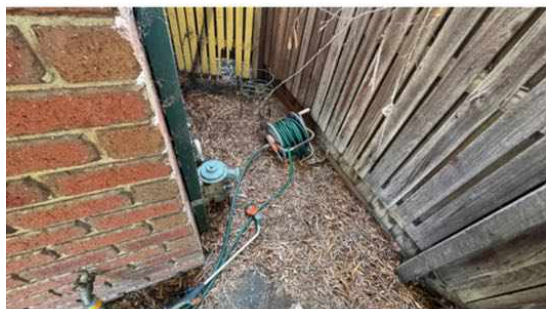
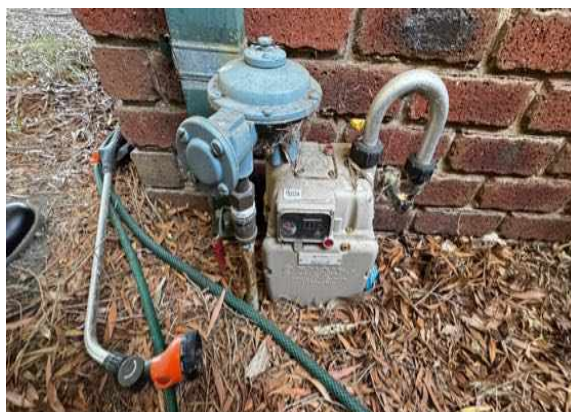
Building:	Main Building
Location:	All External Areas
Finding:	Gas Meter - Location For Your Information
Information:	The gas meter was inspected and photographed for reference and location purposes only.

Gas meters can be affected over time by age, environmental exposure, or accidental impact, which may lead to corrosion, physical damage, leakage, or non-compliance with current regulations. Regular checks are recommended to ensure ongoing safe operation.

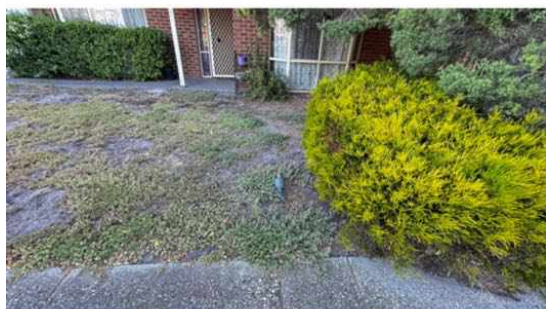
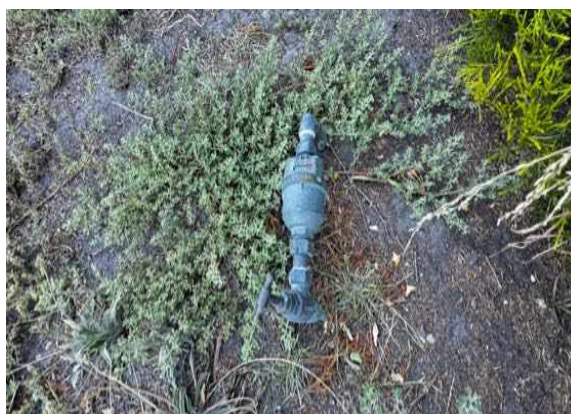
Building: Main Building
 Location: All External Areas
 Finding: Water Meter - Location For Your Information Only
 Information: The water meter was photographed at the time of the inspection. The meter is included for reference & location purposes only.

Water meters can be affected over time by age, environmental exposure, accidental impact, or poor maintenance. Potential issues could include leaks, corrosion, or malfunction that may impact water supply or cause water damage.

It is recommended that a licensed plumber carry out routine inspections and maintenance to ensure continued safe and compliant operation. Observations are for informational purposes only and do not form part of a full safety or compliance inspection.

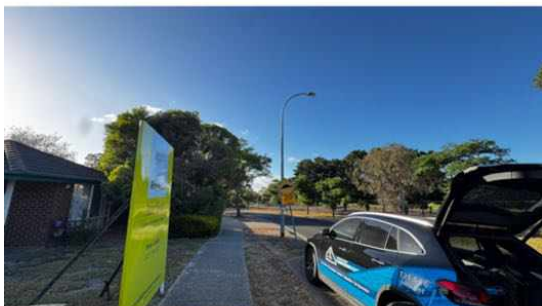
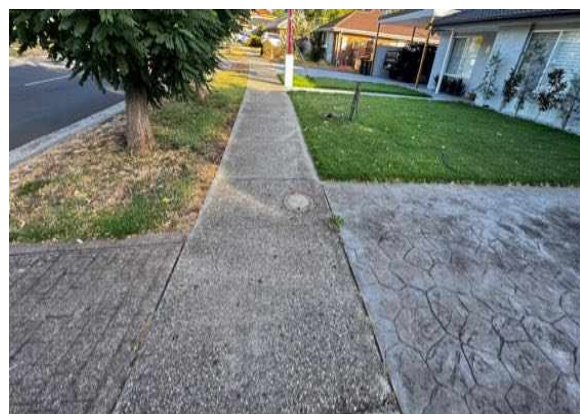
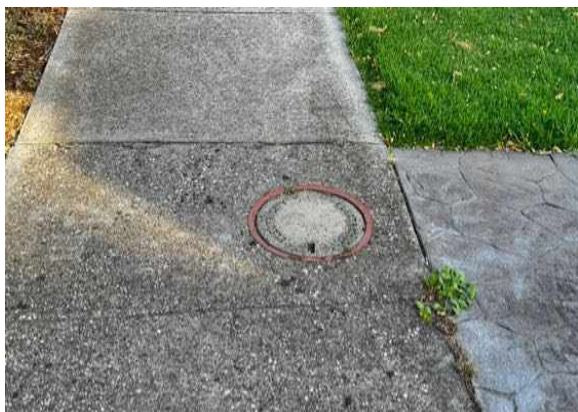
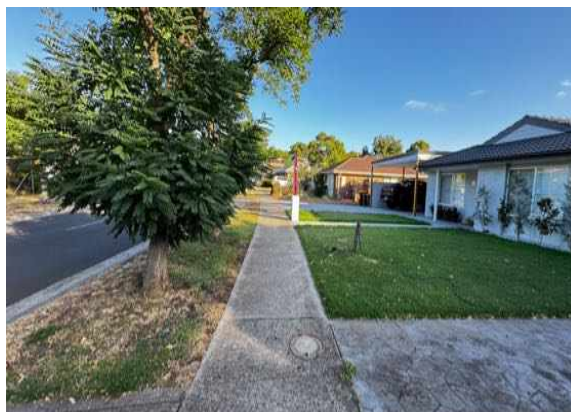
During the inspection, minor cracking, surface wear, or uneven sections were observed on footpaths or crossovers. Some accessible metal components, such as street signage or grates, showed signs of rust or deterioration. Debris accumulation and vegetation encroachment were also noted around council infrastructure. Access or visibility was limited to certain council-owned assets.

These areas should be monitored, and for detailed assessment, maintenance, or compliance verification, the relevant local council authority should be contacted immediately. Regular monitoring of adjacent council assets is recommended to ensure ongoing safety and proper maintenance.

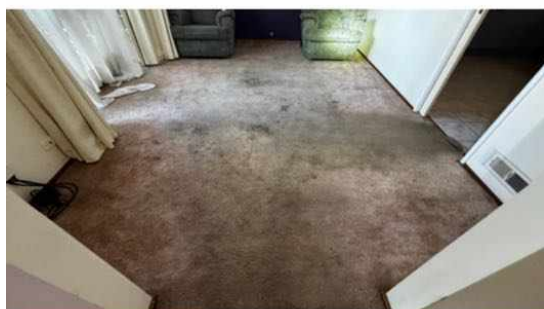
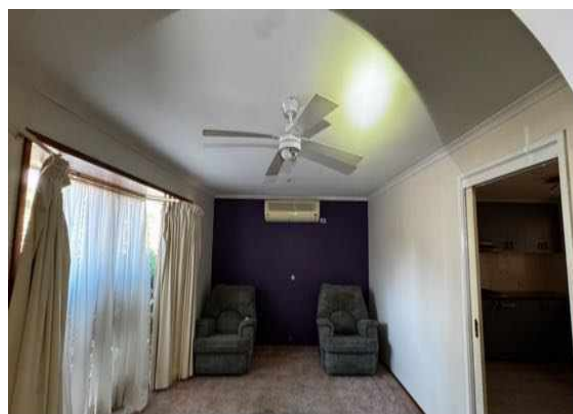
It is important to note that these restrictions can conceal a wide range of building defects, including but not limited to:

Because these areas could not be visually assessed, no comment can be made on their condition within this report.

It is strongly recommended that obstructions be removed and concealed areas made fully accessible immediately. A re-inspection should then be carried out to allow a complete assessment of the property's condition. This is particularly important prior to purchase, as defects in concealed areas can carry significant rectification costs.
