# Building and Timber Pest Inspection Report

Inspection Date: Tue, 20 Jan 2026

Property Address: 26 zeinert street wodonga

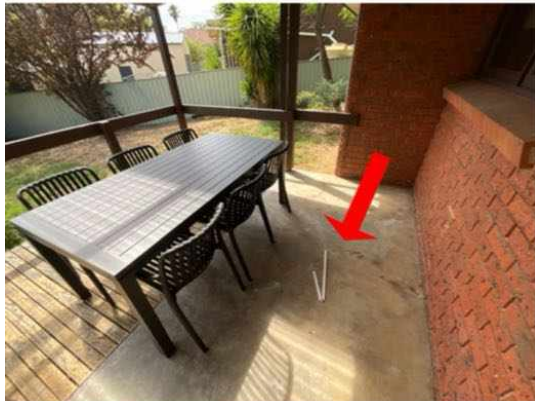
Fine cracks may also be due to poor original installation of the concrete. Factors such as poor compaction of the sub surface and/or inadequate reinforcing of the slab may create cracking and other secondary defects.

Monitoring of all cracking should be conducted frequently. Always contact a building inspector should cracks widen, lengthen, or become more numerous.

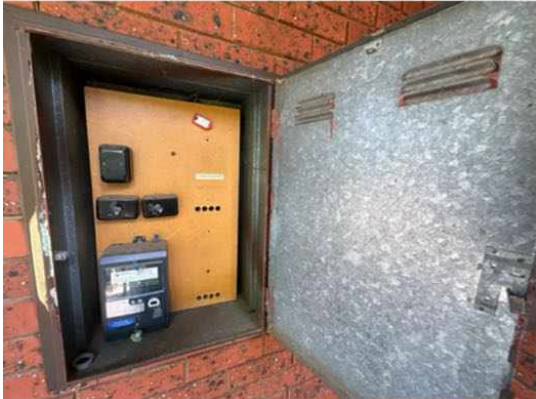
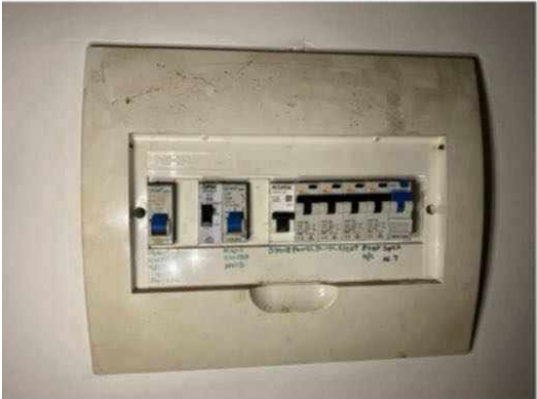
A durable notice should be placed in the switchboard unit to indicate current termite barriers. At the time of inspection, it appeared as though no termite management system has been installed, with no evidence to suggest preventative works taking place.

The client may consider gaining further advice from a pest controller as to the costs and procedures involved with this application. It is recommended that obtaining such advice be a short-term priority.
