# Building and Timber Pest Inspection Report

Inspection Date: Wed, 25 Feb 2026

Property Address: 136 High St, Violet Town VIC 3669,  
Australia

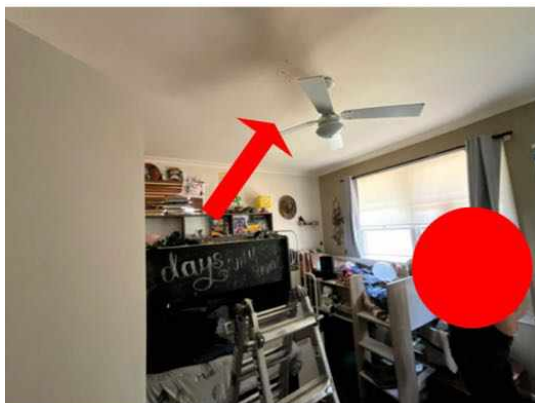
Building:	Building 1
Location:	Bedroom 2
Finding:	Painted surface - Flaking
Information:	Sections of paint in this area was found to have deteriorated. Paint flaking is generally

an indication of excessive moisture in the area, that is currently hidden by the painted surface.

The presence of excessive moisture can have major implications on associated building elements if left unattended. While only seemingly minor at this stage, the damage cannot be determined due to the paint obstructing any further inspection of the damage.

A qualified Painter should be contacted at the Owner's discretion to re-paint the ceiling.

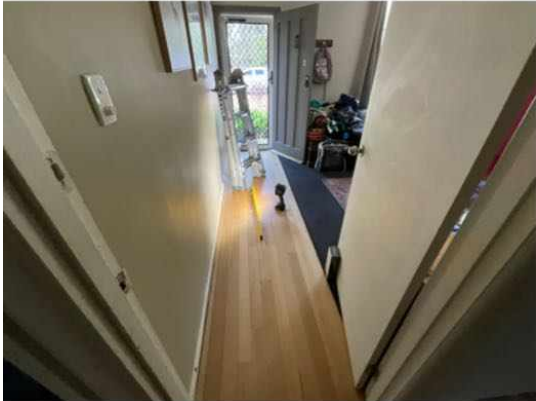
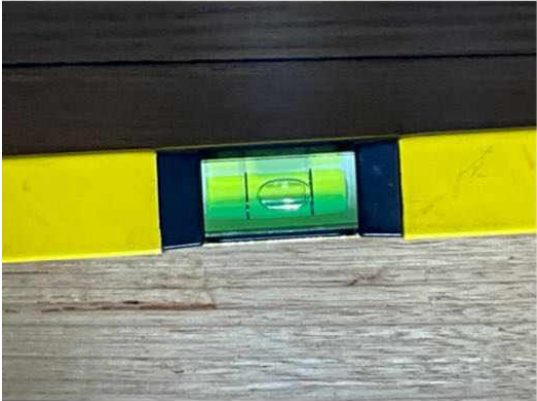
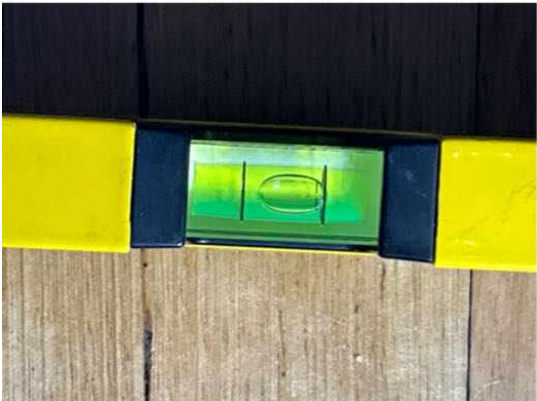
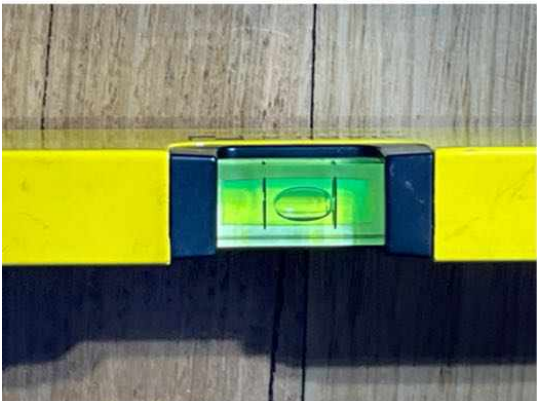
### Finding 3.02

Building:	Building 1
Location:	All Internal Areas
Finding:	Flooring - Uneven
Information:	The internal flooring in this area is out of level and uneven. Uneven flooring is likely to indicate minor defects such as expected movement of the foundations of the property, but may also indicate subsidence of the associated subfloor stumps.

It is advised that the flooring be closely monitored to identify any further movement. Where flooring remains relatively unchanged for an extended period of time (i.e. several months), it is likely that this defect has been caused by expected movement of the

foundations of the property.

However, where flooring is uneven further, potentially invasive inspection of the subfloor structures and stumps in this area is required. In this case, works to repair are likely to be required, and would be carried out by a registered builder specialising in re-stumping.
