Building and Timber Pest Inspection Report

Inspection Date: Fri, 13 Feb 2026

Property Address: 102 Minorca Cct, Spring Farm NSW 2570,
Australia

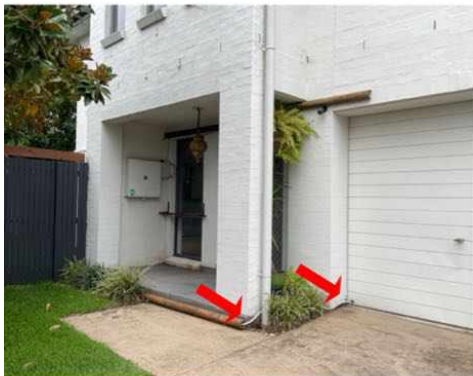
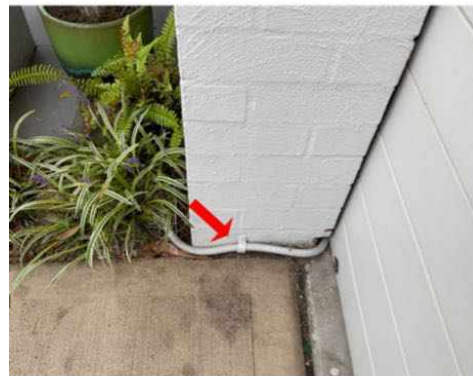
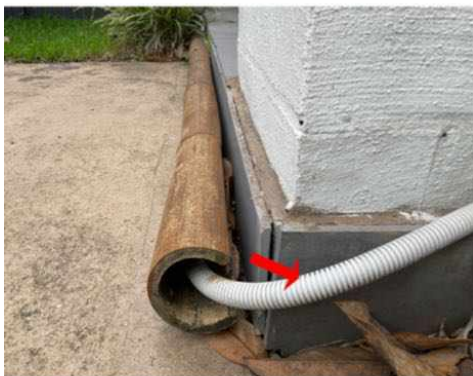
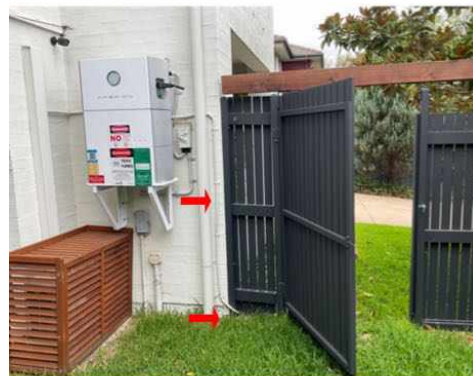
Building: Building 1
Location: Front walls
Finding: Electrical solar wiring exposed above ground
Information: Electrical cables have been installed above ground and are not buried or protected as required. This appears to be non-compliant with NSW safety regulations and poses a risk of electric shock or damage. These cables ducting has already been damaged by lawn mowing activities.

- Properly buried to the required depth, or
- Protected with suitable conduit or mechanical protection.

This needs urgent rectification.

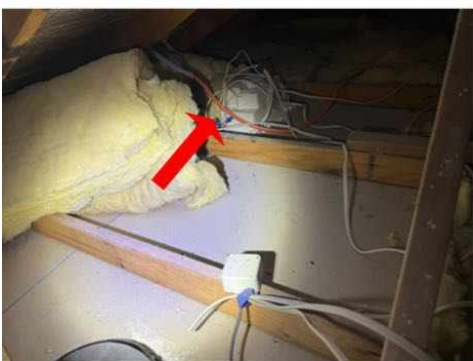
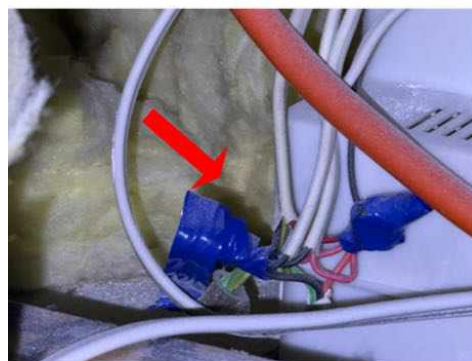
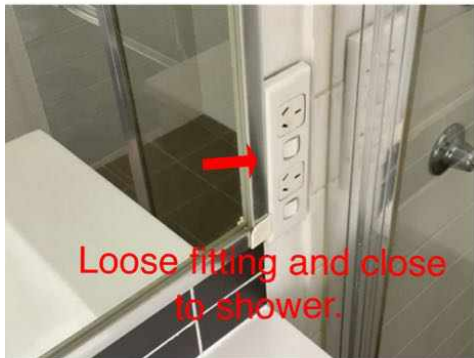
Finding 1.02

Building:	Building 1
Location:	Roof void and bathroom
Finding:	Electrical power point and cables loose
Information:	The electrical fitting in this bathroom wall area and cables in the roof void were found to be loose at the time of inspection.

These loose fittings/cables may expose electrical works, and may create a safety hazard if there is potential contact with persons in the area.

The proximity of this power point to the shower is also substandard and may pose a risk of electrocution if the shower sealant degrades.

A Licensed electrician should be appointed to rectify these areas immediately.

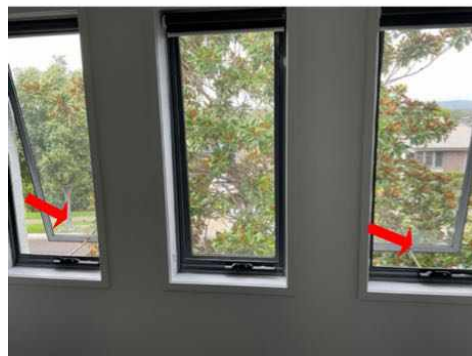
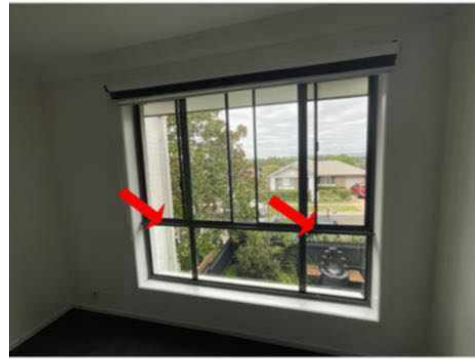
Finding 1.03

Building:	Building 1
Location:	Many upstairs windows
Finding:	Window opening restrictors missing.
Information:	The Building Code of Australia rules require all openable windows (where the internal floor is more than 2m above the ground outside) in residential rooms to be fitted with a suitable screen or restrictor. Windows located 1.7m above the floor level do not require protection.

Window restrictors are required where people who are vulnerable to the risk of falling have access to windows. This means all windows above ground level which do not have another fall prevention safety measure in place, such as a balcony or balustrade should have a restrictor.

These need to be added urgently for the safety of all persons.

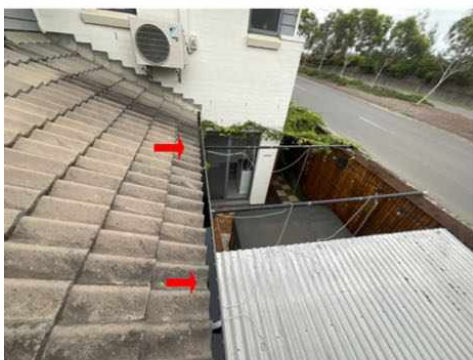
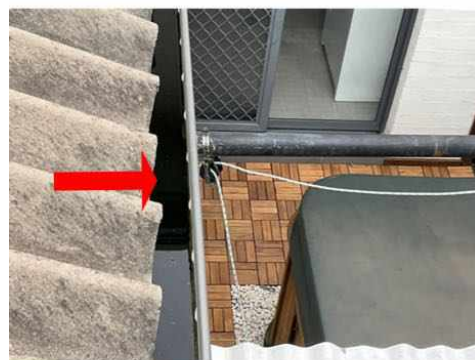
Building: Building 1
 Location: Roof Exterior
 Finding: Roof plumbing - Insufficient fall
 Information: There is an insufficient fall in the rear roof drainage, which means that the angle is inadequate to facilitate movement of rainwater. This is resulting in pooling of water in the area, creating the potential for water damage to associated building elements.

Without adequate roof drainage, premature rust and decay of the roof plumbing structures is imminent. The development of such deterioration is likely to lead to the formation of secondary defects to adjoining wall sections and roofing elements.

Adjustment by a roofing plumber is required as soon as possible to prevent any further damage to the area.

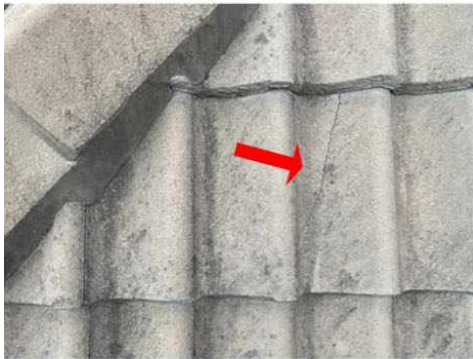
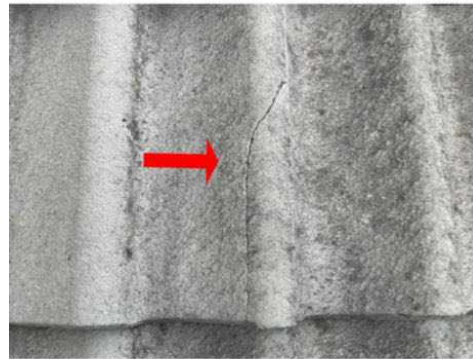
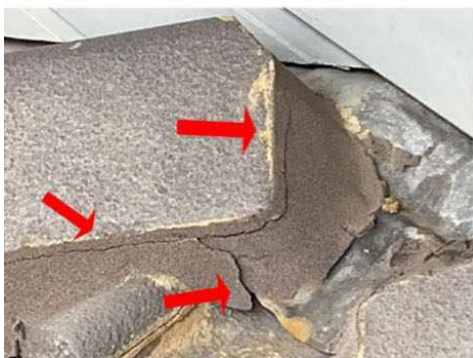
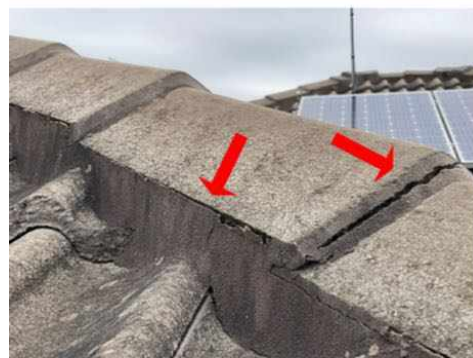
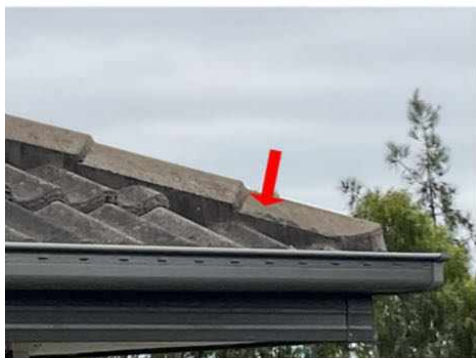
Finding 3.02

Building:	Building 1
Location:	Roof Exterior
Finding:	Roof tiles - Weathered
Information:	Upon inspection of the exterior roofing, the majority of roof tiles were considered to be in a good condition. While weathering of the tiles is consistent with the age of the property, maintenance works are required.

Isolated areas of mortar and minor mortar cracking and broken tiles are present. Re-pointing and re-sealing the may be considered as an interim solution by the client to help preserve and extend the life span of the tiles.

Where left unmanaged, deteriorating roof tiles are likely to lead to a number of secondary defects, including minor water leaks and weather exposure to internal roofing structures.

Consultation with a roofing contractor is highly advised to gain advice on cost of remedial works that may be required in the short to medium term. Remedial works are likely to increase the longevity of the exterior roofing structure.

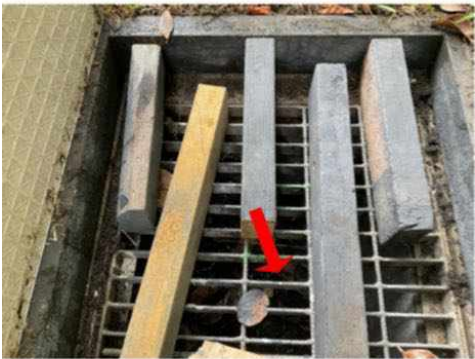
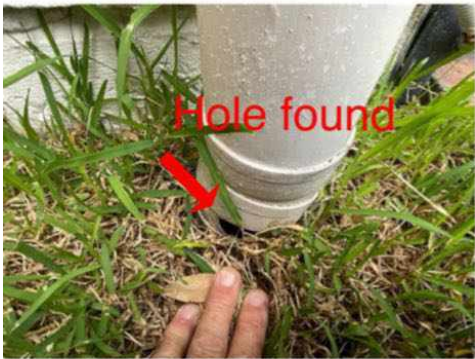
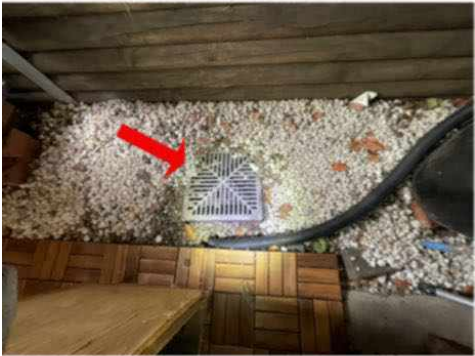
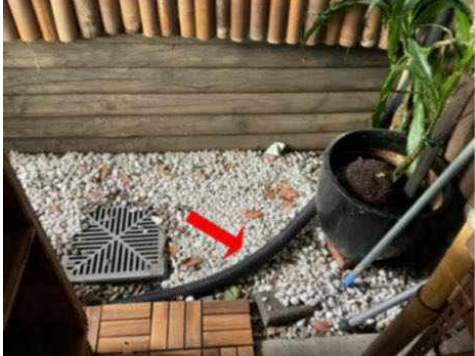
Finding 3.03

Building:	Building 1
Location:	West Wall - pergola and other areas
Finding:	Site drainage - Inadequate
Information:	The site drainage in these areas was found to be inadequate at the time of inspection, creating potential for subsequent water damage to associated building elements.

1. Water was found to pool on the pergola tiling and may run under or around the house slab.
2. The air conditioner and hot water system overflow run against the house walls.
3. The front downpipe is damaged.
4. The two rear drains are full of debris.
5. The spa pergola roof drainage is substandard and runs on top of the ground.
6. The rear shower had no drain.

It is important that water does not lie against the base of walls; surrounding paths and ground levels should be sloped to drain water away from walls. Downpipes should not discharge stormwater onto lower walls or plinths. Stormwater should be carried away by large, regularly cleaned drains. Ground levels may need to be lowered to expose a buried DPC.

Where site drainage is inadequate, installation of an Agricultural (Aggie) Drain may be required. A qualified plumber should be appointed to further inspect the property and perform any remedial works as necessary. Secondary defects are likely to occur if left unmanaged.

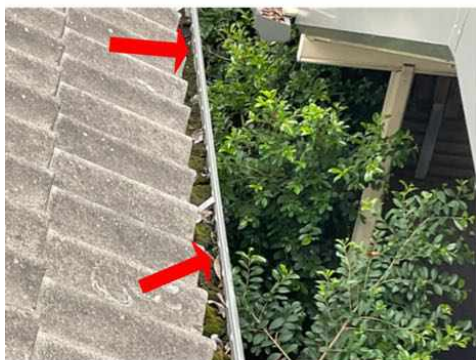
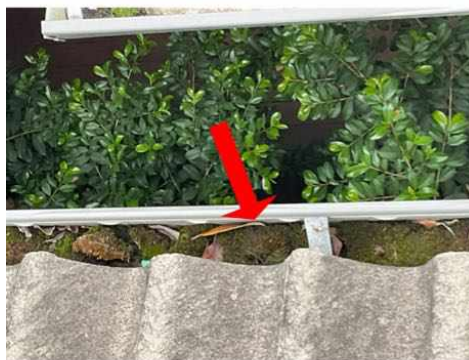
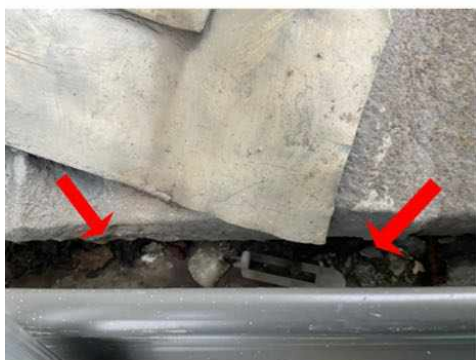
Finding 3.04

Building: Building 1
 Location: Roof exterior
 Finding: Gutters - Full and blocked
 Information: The guttering on around the roof was found to be blocked at the time of the inspection. Roof plumbing structures, such as guttering and downpipes, should be free of all debris to prevent blockages. Blockages of the guttering and downpipes will lead to pooling and accumulated water overflows, which is likely to subsequently flood eaves and exterior walls.

Blocked gutters are likely to lead to high levels of moisture in the affected areas which can cause rust and decay of the gutters and downpipes and wood rot to adjoining timber areas. Blockages in gutters should therefore be removed immediately to ensure dry conditions are maintained.

It is highly advised that gutters be cleaned by the homeowner or a general handyperson as a matter of urgency.

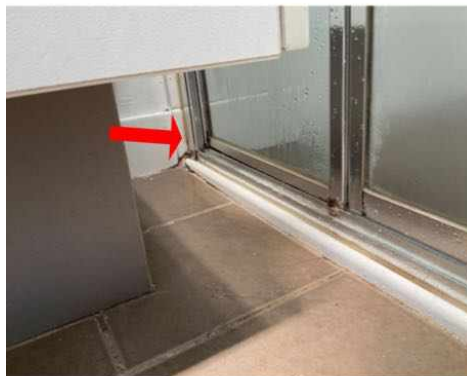
Finding 3.05

Building: Building 1
 Location: Ensuite
 Finding: Shower screen - Leaking
 Information: Leaking was evident to the shower screening at the time of inspection. It is suspected

that the leaking has occurred as a result missing sealant. Leaking from the shower , where left unattended, is likely to lead to water damage to adjoining flooring and walls. Such damage can lead to water damage and necessitate extensive remedial works being required. Active water leaks may also create an environment that is susceptible to the formation and development of mould.

Appointment of a sealant expert is required to repair or replace this missing sealant. Such works should be performed as soon as possible to ensure that no further damage occurs.

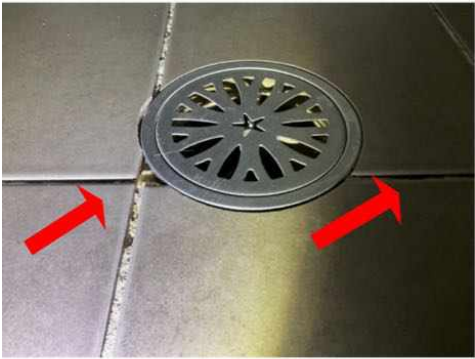
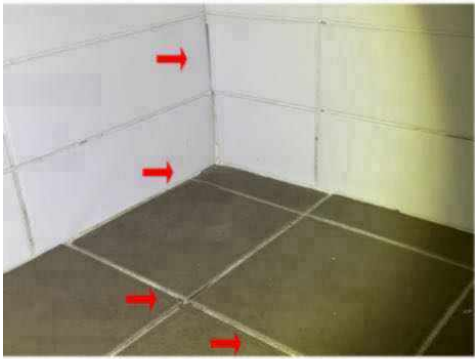
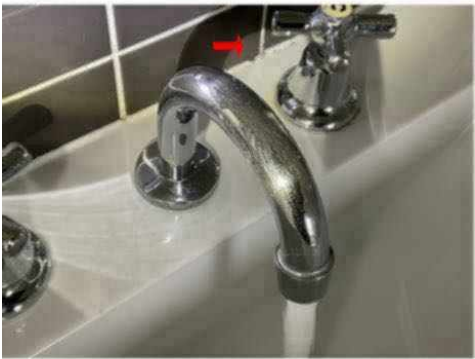
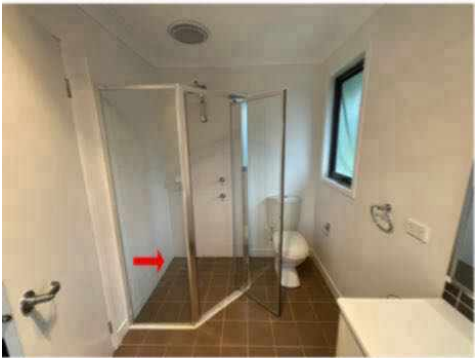
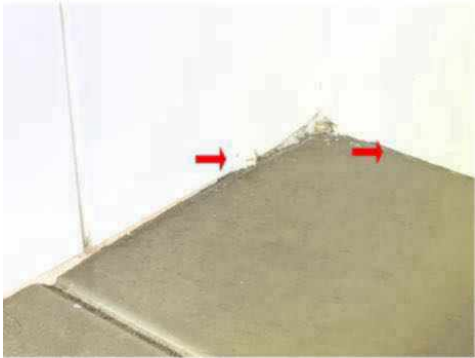
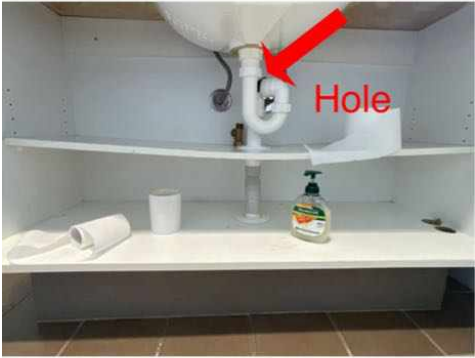
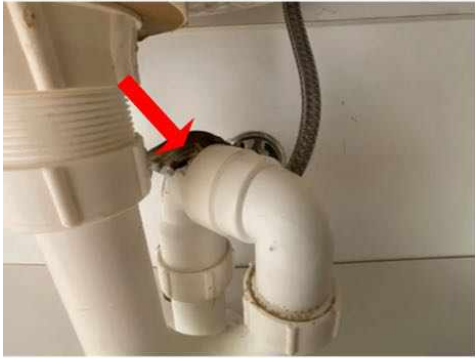
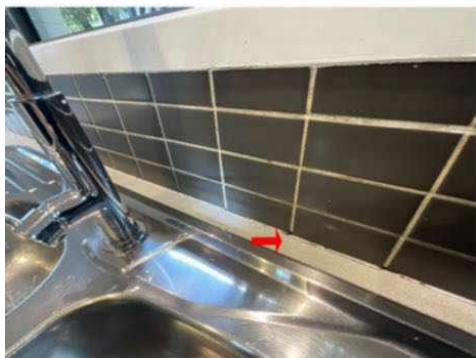
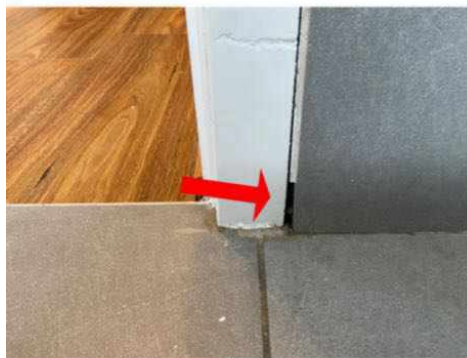
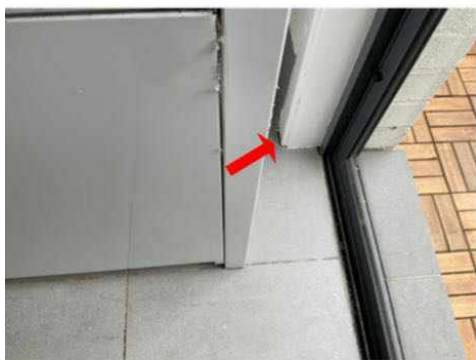
Finding 3.06

Building:	Building 1
Location:	Kitchen, laundry and bathroom
Finding:	Sealant and grouting - Missing or damaged and hole in plumbing
Information:	It was noted on inspection that sealant or grout is degraded to these pictured areas.

Different materials and floor areas move at different rates, generally causing cracking to grout or sealant at this point. A flexible sealant is required to allow for expected expansion and contraction, while keeping the joint water tight and protective of all associated building materials.

Flexible and mould resistant materials should be applied to affected areas to prevent any subsequent water damage that is likely to occur. Regular maintenance and replacement of damage or missing or damaged sealant and grout is highly recommended to the wet areas, as this is a regular wear and tear defect. Sealant and grouting in areas that come into regular contact with water should be maintained for the long term care of your property.

A sealant specialist or tiling contractor should be appointed to complete these works as soon as possible

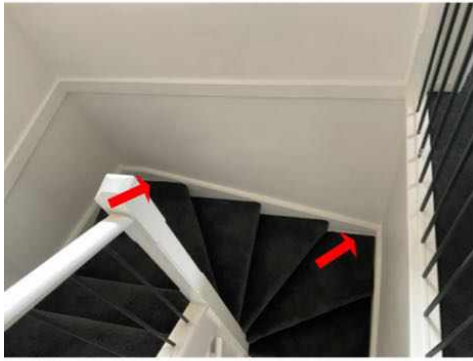
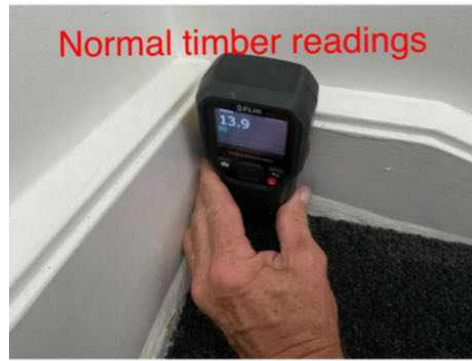
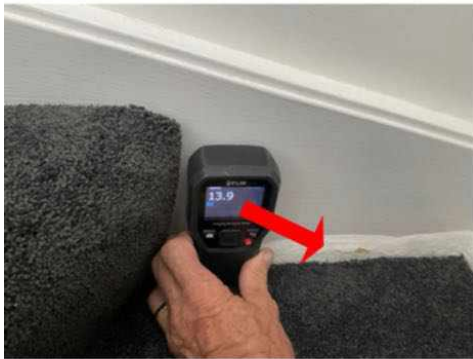
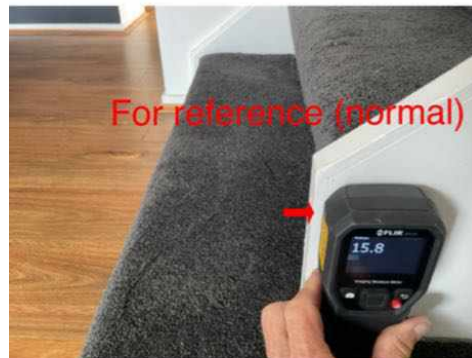
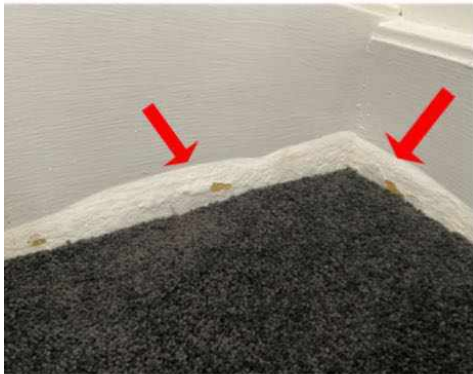
Building:	Building 1
Location:	Stairs - Internal
Finding:	Swollen building elements
Information:	Swollen building elements generally indicate that the building materials have been affected by excessive moisture over a prolonged period of time, and have swollen as a result. The structural integrity of swollen building elements cannot be guaranteed, and further damage is possible if these areas are left unmanaged.

No elevated moisture was found in these areas and it is suspected a lazy pet caused this damage.

Repair or replacement of swollen building elements should be conducted by a qualified carpenter.

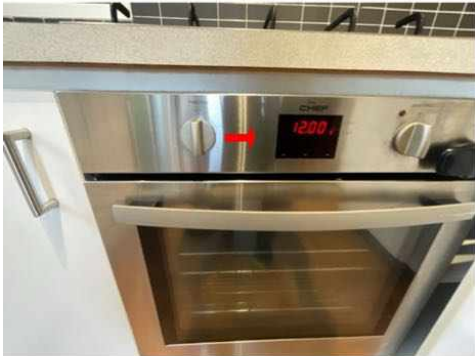
Finding 3.08

Building: Building 1
 Location: Pictured external areas
 Finding: Building elements - Damaged
 Information: Evidence of damaged areas were identified at the time of the inspection. These include

-
- 1. Some brickwork showed minor damage.
- 2. The oven had unusual noises emitting from it.
- 3. The laundry exhaust fan did not appear to work.

A carpenter would be the trade responsible for rectification of these areas when convenient.

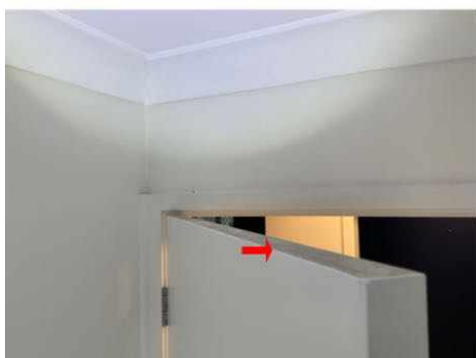
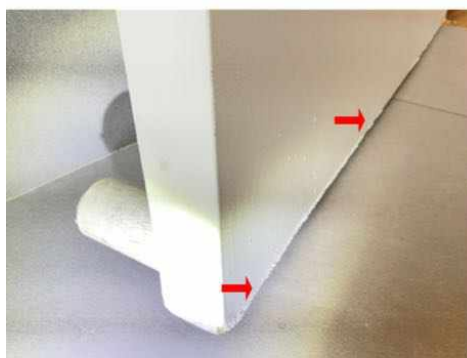
Finding 3.09

Building: Building 1
Location: Some doors
Finding: Paint finish on doors - Incomplete
Information: The paint finish to some doors was identified as being incomplete at the time of inspection leading to minor moisture damage.

Whilst incomplete or missing paint finish is generally an appearance defect, it can also lead to the development of secondary building defects over time. Incomplete areas of paint finish expose the area to moisture, potentially accelerating the deterioration of underlying building materials.

Incomplete paint finishes should be sanded back, filled, leveled and painted, as applicable. Where inadequate or missing paint protection has led to the deterioration of the associated building element, repair and/or replacement of this building element may be required.

A painting contractor should be appointed as soon as possible to perform necessary works to aid the appearance of the affected area and to ensure the area is protected against further deterioration. Alternatively, the homeowner following manufacturer instructions may perform these works.

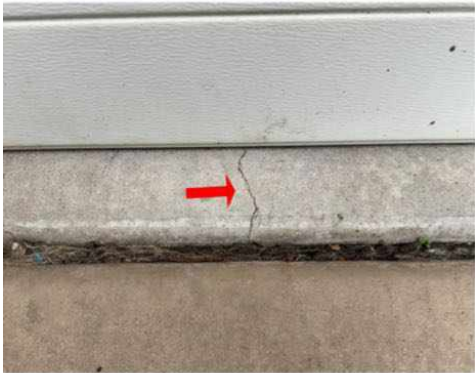
Finding 3.10

Building:	Building 1
Location:	Yard - front
Finding:	Crack in concrete slabs - Category 1
Information:	Cracks coded as Category 1 was identified in these pictured slabs. A Category 1 crack is described as a fine but noticeable crack, with the slab at an otherwise reasonable level. To be considered Category 1, the approximate width of the crack is less than 1.0mm, or a less than 10mm change in offset when a 3m straight edge is placed over the defect.

Category 1 cracks should be monitored for a period of 12 months. At the end of the monitoring period, identified cracks that are rated greater than Category 2 are considered defects, and require rectification.

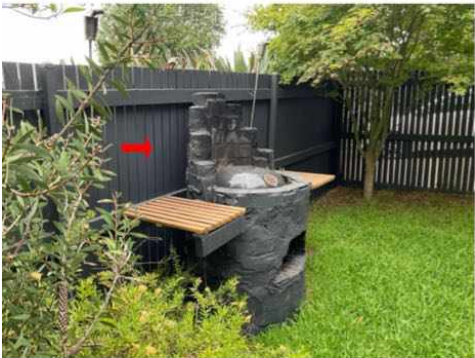
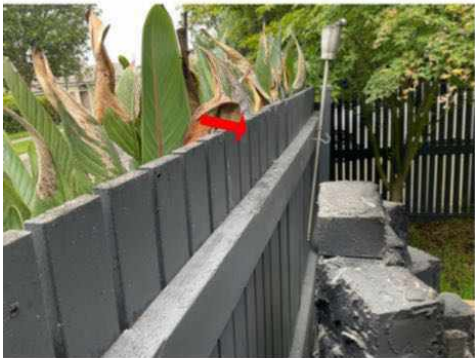
Finding 3.11

Building: Building 1
Location: Pictured front fence
Finding: Fences damaged - leaning
Information: Evidence of damage to the pictured fence was identified at the time of the inspection. The likely cause of this fence on a minor lean is not enough concrete used in the post footings. If left unmanaged this fence may deteriorate further.

It is suggest a fencing contractor be engaged for rectification when convenient.

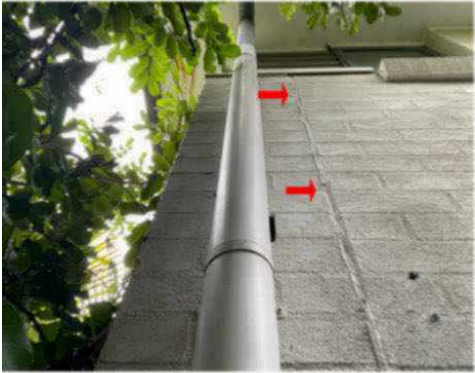
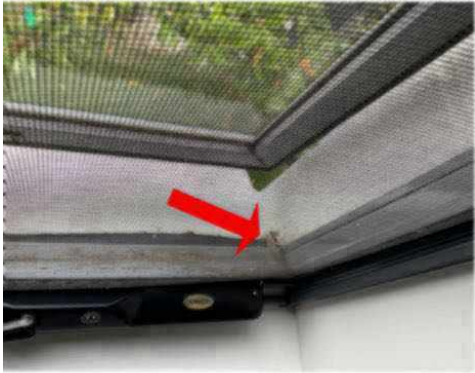
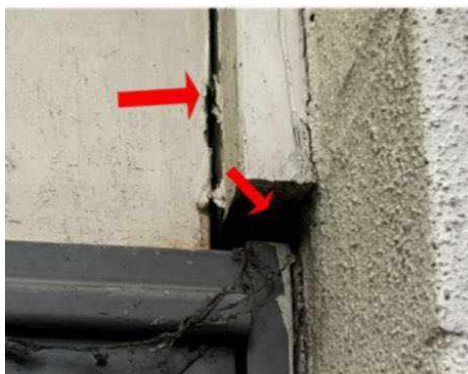
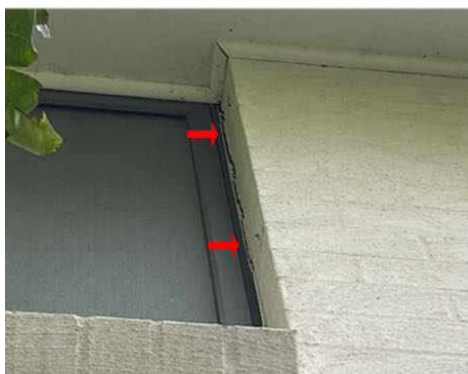
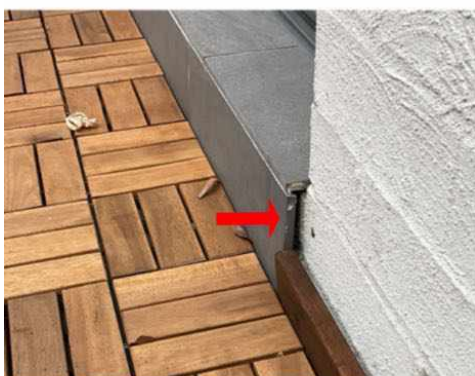
Finding 3.12

Building: Building 1
Location: Many exterior walls
Finding: Sealant (external) - missing
Information: It was noted on inspection that areas of external sealant was missing to small areas of the external walls.

A sealant specialist or skilled handy person should be appointed to complete these works as soon as possible

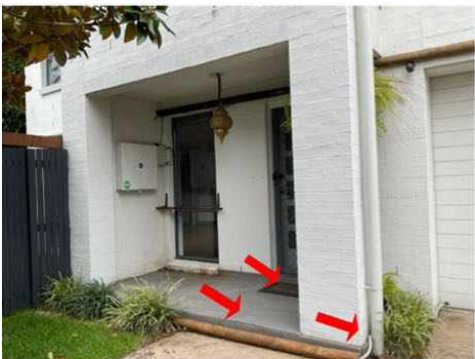
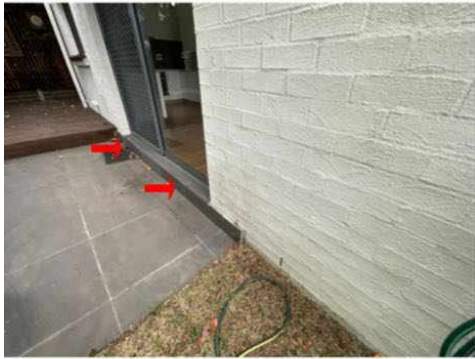
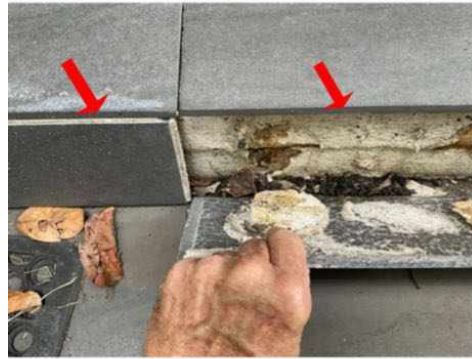
Finding 3.13

Building: Building 1
 Location: External areas and bathroom
 Finding: Tiles cracked and loose.
 Information:

Cracked tiles were evident in these pictured areas at the time of inspection. It is suspected that this cracking has occurred as a result of minor settlement or impact damage.

Cracked tiles throughout the household detract from the overall appearance of the affected areas. In wet areas of kitchens and bathrooms, it can lead to water damage of adjoining walls and floors.

Replacement of cracked tiles is recommended as soon as possible. A tiling contractor may be appointed to perform these works. Where cracks become more numerous, contact a licensed building inspector for further investigation.

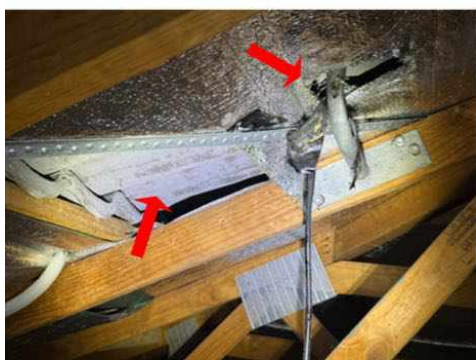
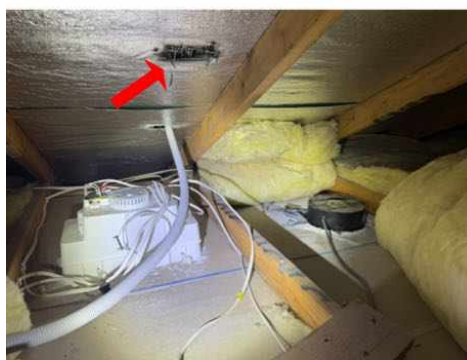
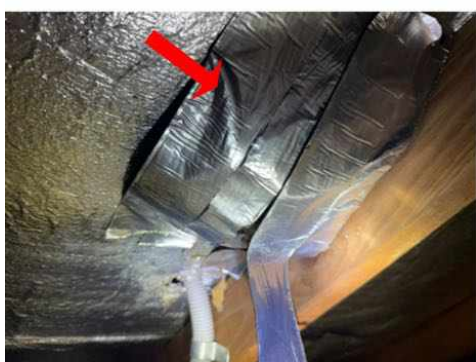
Building:	Building 1
Location:	Roof Cavity
Finding:	Sarking - Damaged
Information:	Sarking, a laminated aluminium foil applied to the interior of the roof covering, assists in insulating the property and acting as a vapour-barrier to the roof void and, subsequently, to the household.

Where sarking is damaged, both insulation and moisture protection of the property are inhibited. This creates a loss of energy and thus negatively impacts the energy efficiency of the property, allowing potential for moisture ingress from condensation or leaking roof tiles.

It is important to repair any holes or damaged sections of sarking to ensure that the building material is fully functional. A registered builder or qualified carpenter should be consulted to provide further advice on this defect and to perform rectification works at client discretion.

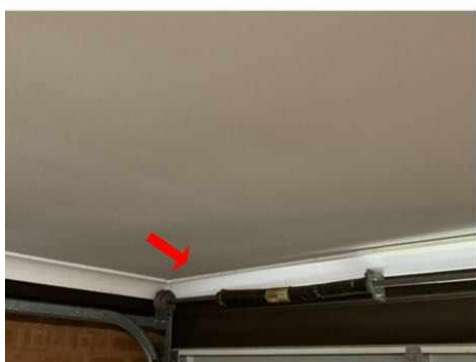
Finding 3.16

Building:	Building 1
Location:	Garage

Finding: Ceiling - Sagging (minor)
Information: Sections of the ceiling were found to be sagging at the time of inspection. Sagging to the fixed ceiling structure generally indicates that the building materials have swollen, due to contact with water, or that fixings (e.g. nails or glue) have become loose and require reattachment.

Where minor sagging is evident, comparatively minor works, such as re-gluing of ceiling sheets, may be required. Such works may be performed by relevant tradespeople, such as plasterers and painters. Where excessive moisture has caused the roofing structure to swell and sag, the source of the water leak should primarily be identified prior to any remedial works being performed.

The appropriate action should be taken by the client as soon as possible to ensure that any potential further damage is limited.

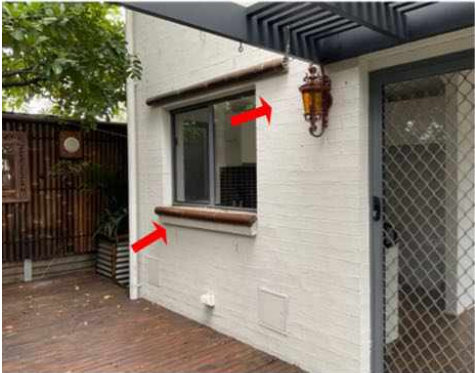
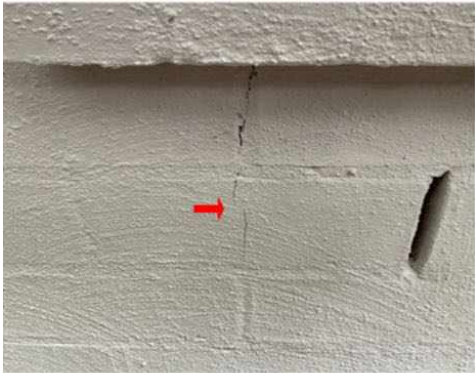
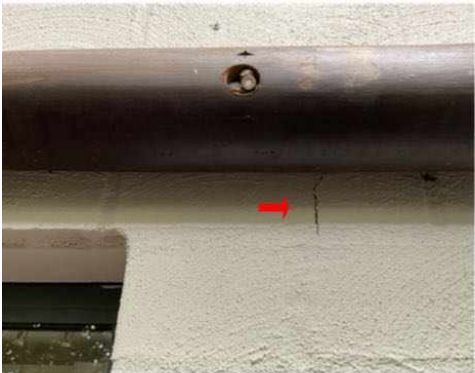
Finding 3.17

Building: Building 1
Location: Exterior walls
Finding: Render (external) cracking of 1mm.
Information: It has been observed that cracking to some external rendered surfaces. The degree of damage is described as “slight” noticeable cracks which are easily filled. Cracking of this size are generally less than 5mm in width. Removal of this render may show this is minor step cracking.

Always contact your building inspector should cracks widen, lengthen, or become more numerous.

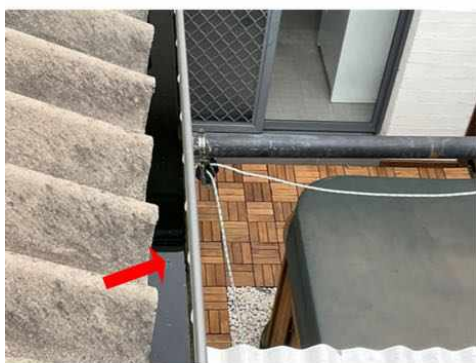
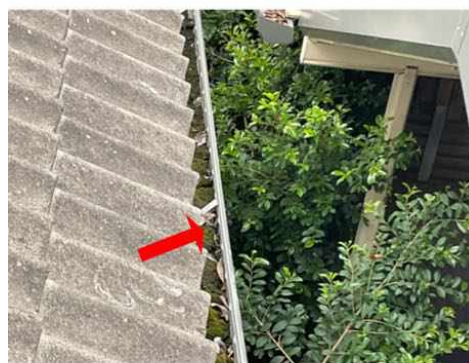
Building: Building 1
 Location: Roof exterior
 Finding: Gutters - Full and blocked
 Information: The guttering on around the roof was found to be blocked at the time of the inspection. Roof plumbing structures, such as guttering and downpipes, should be free of all debris to prevent blockages. Blockages of the guttering and downpipes will lead to pooling and accumulated water overflows, which is likely to subsequently flood eaves and exterior walls.

Blocked gutters are likely to lead to high levels of moisture in the affected areas. Such moisture will not only cause rust and decay of the associated building materials, but can also provide conditions that are conducive to termite and timber pest activity. Blockages in gutters should therefore be removed immediately to ensure dry conditions are maintained.

It is highly advised that gutters be cleaned by the homeowner or a general handyperson as a matter of urgency.

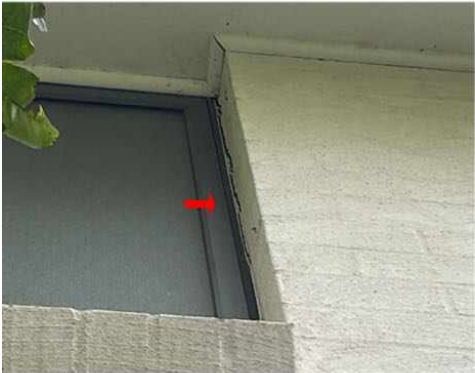
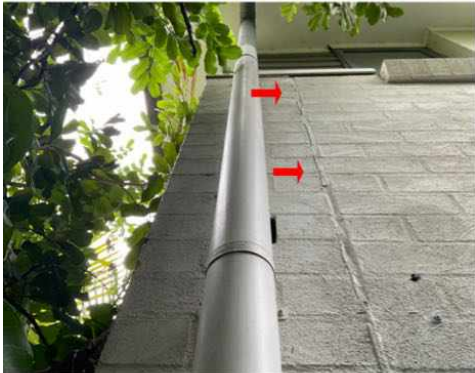
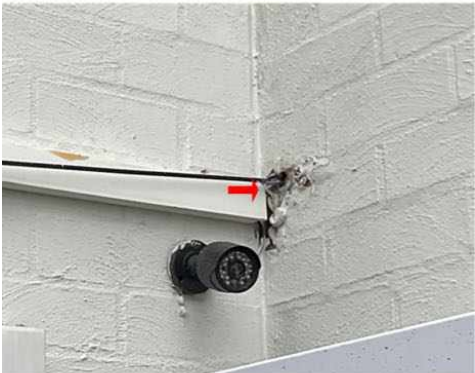
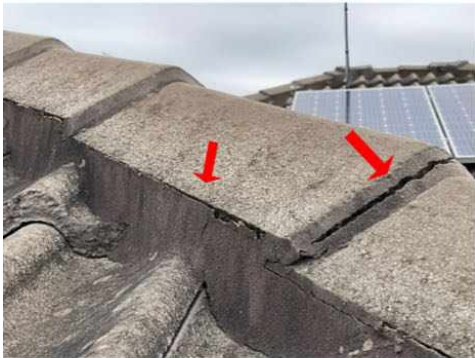
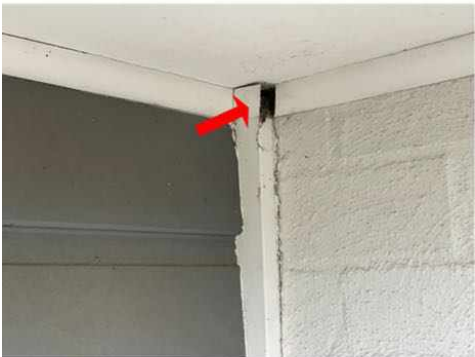
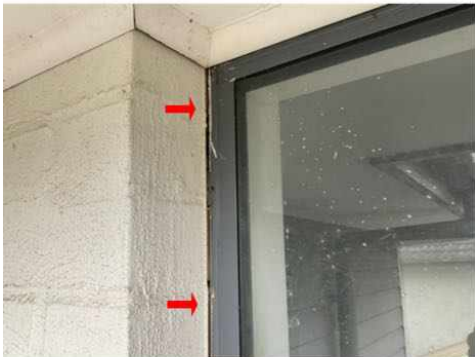
Finding 6.02

Building: Building 1
 Location: Many External Areas

Finding: Sealant (external) - missing and attractive to termites
Information: It was noted on inspection that areas of external sealant was missing to small areas of the external walls. A flexible sealant or flashing is required to protect the associated building materials from rainwater ingress. Any moisture ingress into the property is very attractive to termites. Flexible sealants or flashing should be applied to these affected areas to prevent termite activity.

A sealant specialist or skilled handy person should be appointed to complete these works as soon as possible

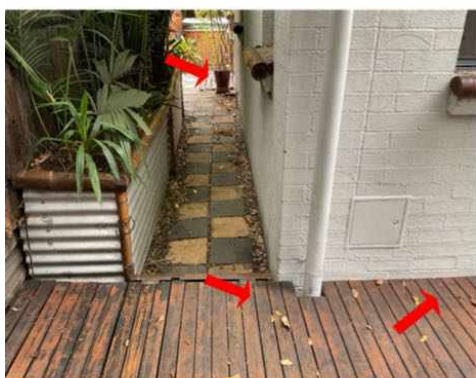
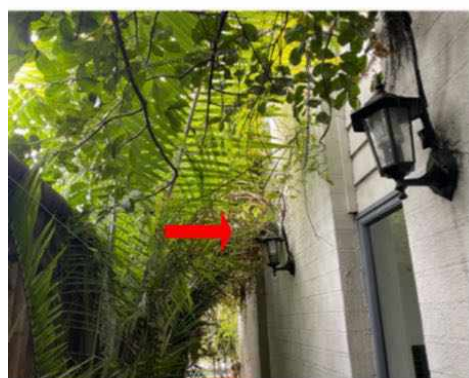
Finding 6.03

Building:	Building 1
Location:	Yard side and rear
Finding:	Bridging - Vegetation and decking
Information:	Where vegetation and decking obstructs inspection of building elements, also known as bridging as it provides a bridging point for the access of termites, full inspection can not be achieved. Consequently moisture or dampness may be present and the areas becomes conducive to termite activity. Plants and decks against or very close to buildings provide cover, shade and can provide an environment that is attractive to termite infestation.

The removal and replanting of plant species that do not provide "cover" or cutting back of existing vegetation and leaving a small gap between decking and the building walls will assist greatly in preventing Bridging from occurring.

The removal of any such stored building or plant materials that may be conducive to termite activity should be carried out as soon as possible and arrange re inspection to minimize the risk of termite attack.

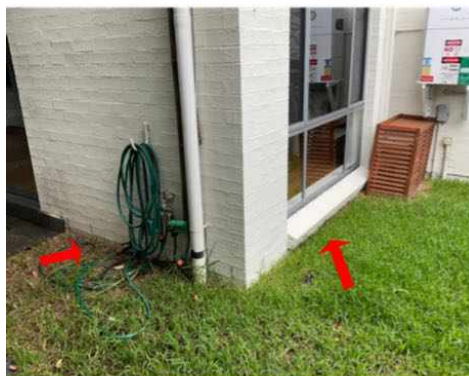
Finding 6.04

Building:	Building 1
Location:	Exterior walls
Finding:	Slab Edge - Exposure
Information:	An inspection zone of at least 75mm in relation to the exposed slab edge, between the bottom brick and the perimeter pavement, is required. This inspection zone should be maintained in order to force termites into the open where they can be detected more readily during regular inspections. The slab edge should not be concealed by anything that may prevent inspection of the area, including render, landscaping, soil, turf, paving, concrete cladding or other structures.

If the slab edge is not properly exposed there is a high risk of termite attack. Sometimes, in order to determine the type of slab, a suitably qualified person such as an architect or builder may be required to consult the construction plans.

Where the slab edge cannot be properly inspected, it is highly recommended that termite or timber pest inspections be carried out every 6-12 months to aid protection of the property against infestation.

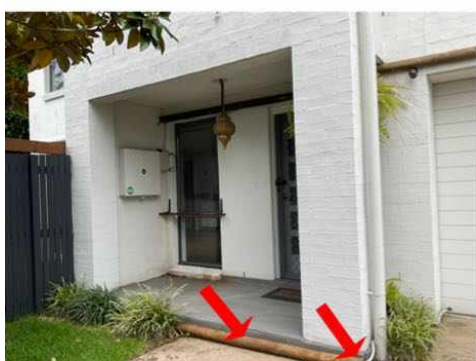
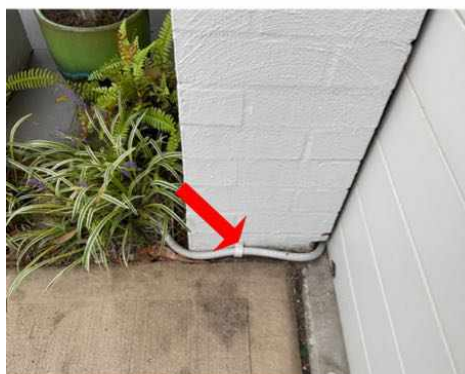
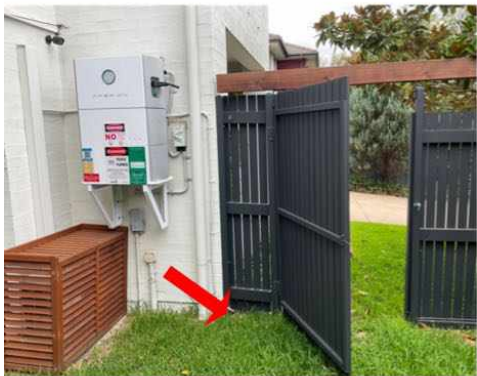
Building: Building 1
 Location: Pictured areas
 Finding: Safety Hazards and Major defects require immediate rectification
 Information: All safety hazards including the solar electrical conduit on the front paving should be rectified immediately as a matter of urgency as leaving these unattended may result in severe injury.

All major defects should be rectified immediately as a matter of urgency. Leaving these major defects unmanaged will lead to further deterioration of structural elements which may become safety hazards.

The rectification of all minor defects in this report should be conducted as soon as possible, as leaving these unmanaged may lead major defects and/or safety hazards in the future.

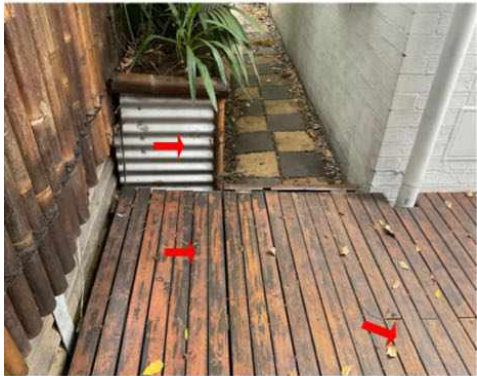
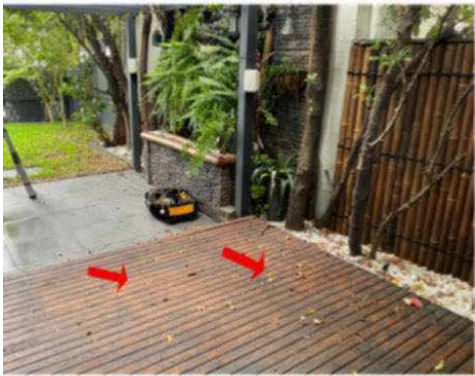
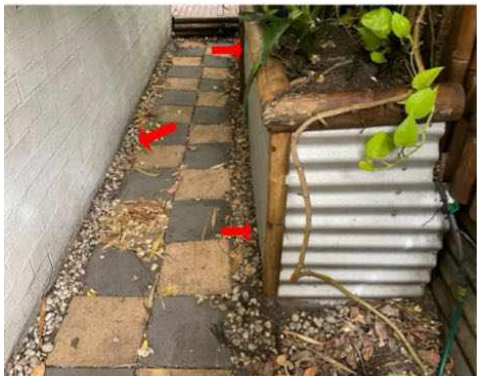
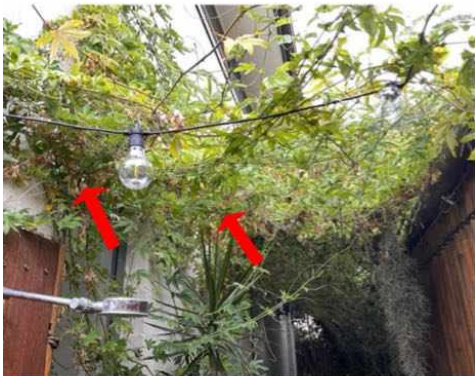
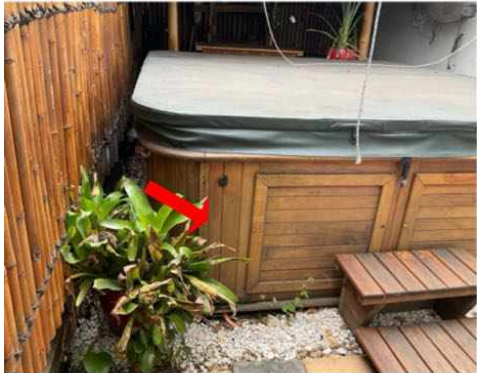
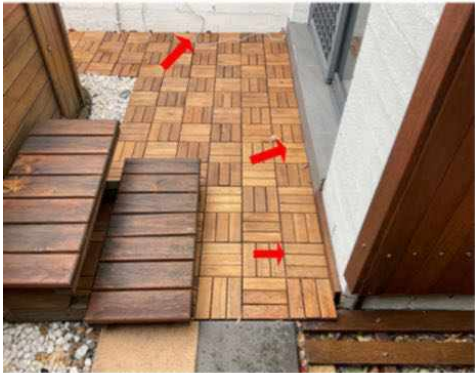
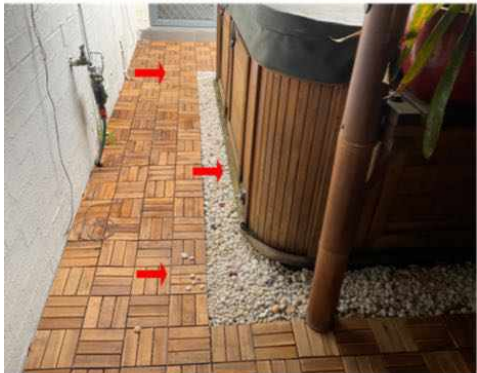
Building: Building 1
Location: All External Areas
Finding: Additional Photos - Obstructions and Limitations of EXTERNAL AREAS
Information: These photographs are an indication of the obstructions and limitations which impeded full inspection of external areas at the time of inspection. These obstructions can hide an array of defects and should be removed to allow full inspection to be carried out. A re-inspection is recommended once the areas are made accessible.

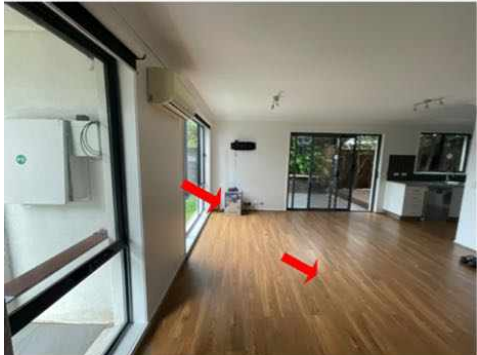
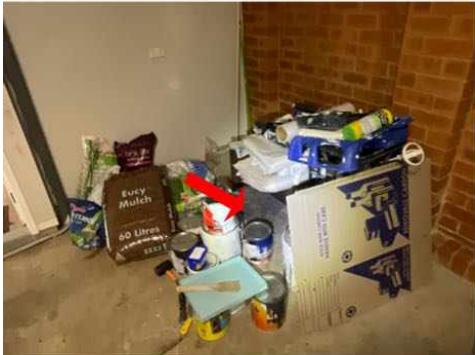
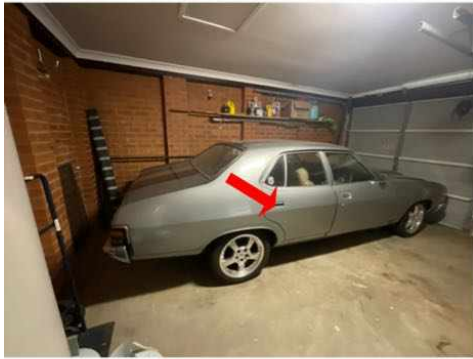
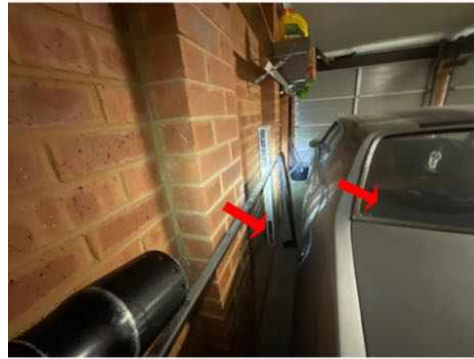
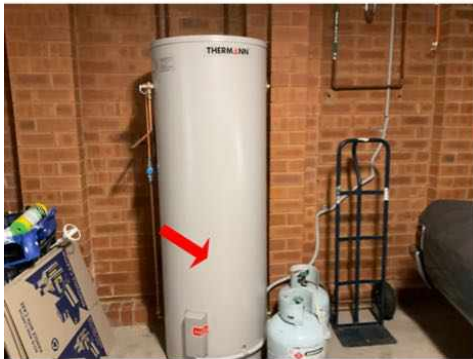
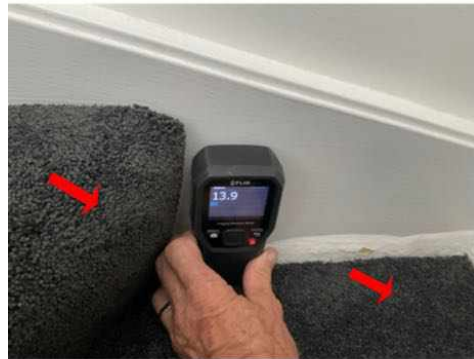
Building: Building 1
Location: All Internal Areas
Finding: Additional Photos - Obstructions and Limitations of INTERNAL AREAS
Information: These photographs are an indication of the obstructions and limitations which impeded full inspection of Internal areas at the time of inspection. These obstructions can hide an array of defects and should be removed to allow full inspection to be carried out. A re-inspection is recommended once the areas are made accessible.

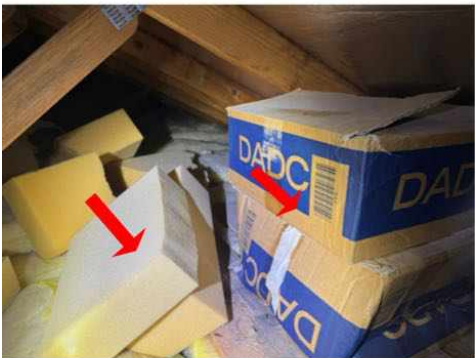
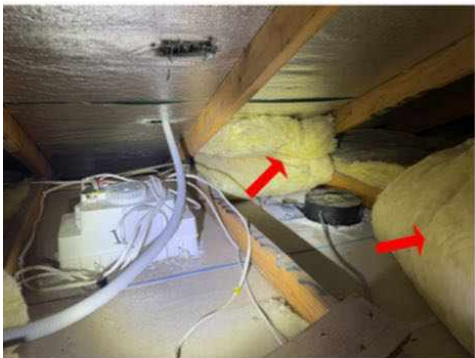
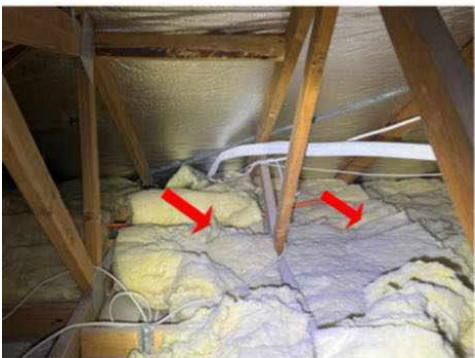
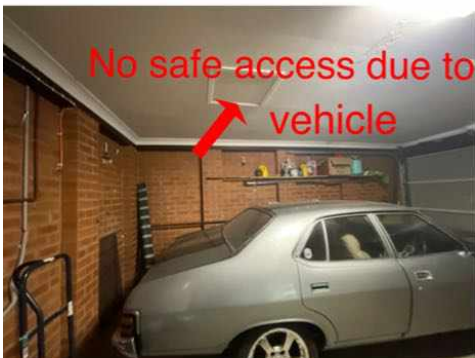
Building: Building 1
 Location: All Roof cavity areas
 Finding: Additional Photos - Obstructions and Limitations of the ROOF CAVITY
 Information: These photographs are an indication of the obstructions and limitations which impeded full inspection of roof cavity areas at the time of inspection. These obstructions can hide an array of defects and should be removed to allow full inspection to be carried out if applicable. A re-inspection is recommended once the areas are made accessible.

The inspection was also limited to areas with an allowable crawl space of 600mm x 600mm, in particular towards the external walls where the roof line diminishes, these areas were not accessible.

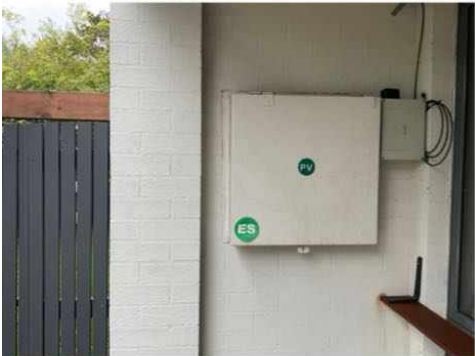
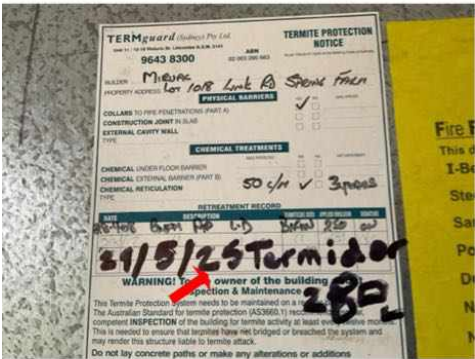
Building: Building 1
 Location: Meter Box
 Finding: Termite Management System - evidence of a chemical installation
 Information: The application of a post-construction chemical termite barrier is highly recommended for all properties. Such barriers are highly effective in preventing termite attack on any timber building elements throughout the property.

A durable notice should be placed in the switchboard unit to indicate current termite barriers. At the time of inspection, the durable notice was evident and it appeared as though a chemical termite management system has been installed, with evidence to suggest preventative works took place in May 2025.

The client may consider gaining further advice from a pest controller as to the costs and procedures involved with upkeep of this 'chemical' application. It is recommended that obtaining such advice be a short-term priority.
