# Building and Timber Pest Inspection Report

Inspection Date: Thu, 26 Feb 2026

Property Address: 14 Wavell Ave, Carlingford NSW 2118,  
Australia

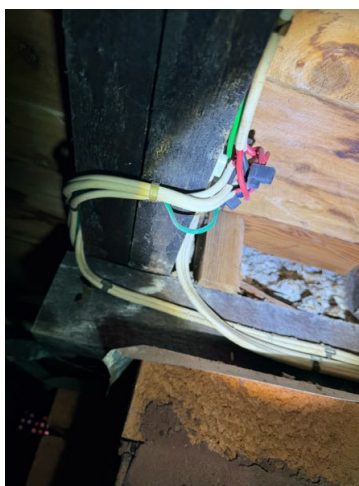
Finding: Electrical junction box - Missing

Information: Several wiring joins in this area are not adequately protected by a junction box. Junction boxes provide a second insulation barrier to adequately seal off and protect the wires, increasing the safety of the immediate environment and ensuring that the wiring is not damaged.

The absence of junction boxes in this area poses as an electrical safety hazard, providing risk of electrocution. It appears as though wiring in this area has been completed to a substandard level of workmanship, evidenced by the lack of adequate wiring protection.

Appointment of a licensed electrician is highly advised to provide additional information on the risks of unprotected wiring and to install junction boxes and any other elements as required. Such works should be carried out as a matter of urgency; until this time, any persons within this area should exercise a high level of caution.

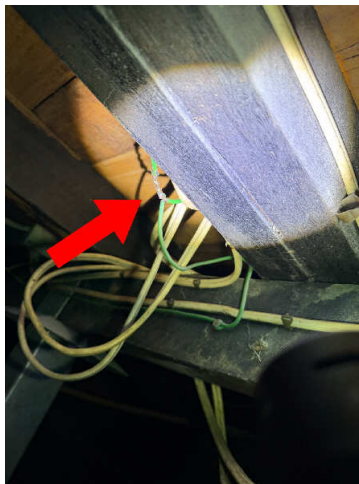
#### Finding 1.02

Finding: Electrical wires exposed

Information: Exposed electrical wiring was identified. Exposed electrical wiring represents a potential safety hazard including for fire and personal contact. Contact a licensed electrician urgently for further inspection investigation and rectification.

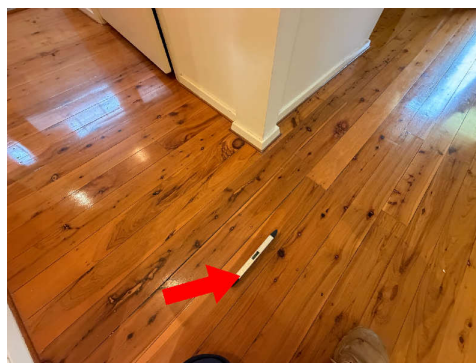
Information: The internal flooring in this area is out of level and uneven. Uneven flooring is likely to indicate minor defects such as expected movement of the foundations of the property, but may also indicate subsidence of the associated subfloor stumps.

It is advised that the flooring be closely monitored to identify any further movement. Where flooring remains relatively unchanged for an extended period of time (i.e. several months), it is likely that this defect has been caused by expected movement of the foundations of the property.

However, where flooring is uneven further, potentially invasive inspection of the subfloor structures and stumps in this area is required. In this case, works to repair are likely to be required, and would be carried out by a registered builder specialising in re-stumping.

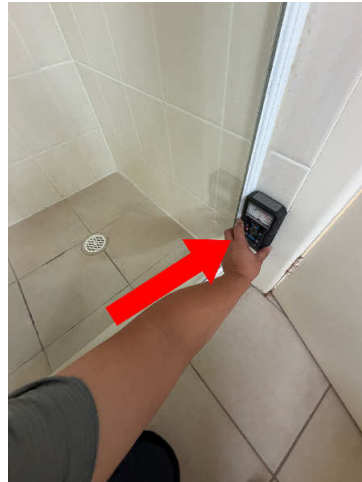
### Finding 3.02

Building:	Main Building
Location:	Bathroom 1 & Bathroom 3
Finding:	Shower damp - Monitor
Information:	Damp is evident to the wall outside of the shower area.

This defect is quite common, and is suspected to have been caused by moisture permeating or leaching through the grouting and perhaps gaps in the sealant prior to repair.

Monitoring the area is advised and if any visual signs of excessive moisture appear (peeling paint, mould) then consultation with a qualified plumber or bathroom specialist would be advised to identify the cause of damp and to perform remedial works as required.

Always ensure that sealant and grout is in good condition to prevent any moisture issues occurring in the future.

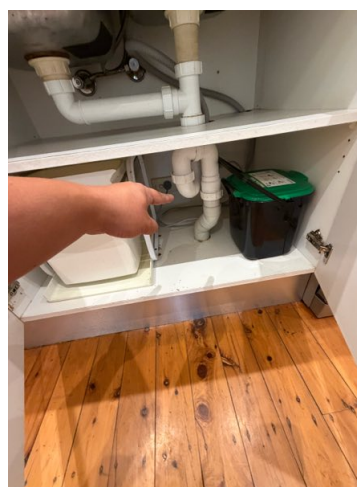
### Finding 3.03

Finding: Trap - Leaking

Information: The trap under sink in this area was found to be leaking at the time of inspection.

While this defect only seems minor, if left unmanaged, it is likely to result in the development of rust, water damage and/or extensive water usage.

It is advised that a handyman or licensed plumber be appointed to perform remedial works on the affected trap. Such works should be performed prior to the development of secondary defects to ensure adequate functionality of all associated building elements.

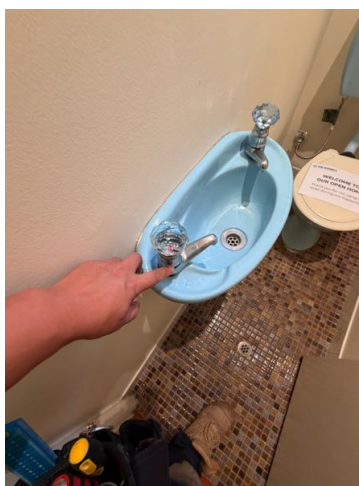
### Finding 3.04

Finding: Tap - Loose

Information: The tap in this area has not been installed correctly, or has deteriorated with age, and is consequently loose. This tap being loose creates potential for water leaks and subsequent water damage to the surrounding area.

Where taps or spouts are loose, a qualified plumber should be appointed to re-fix the plumbing fitting.

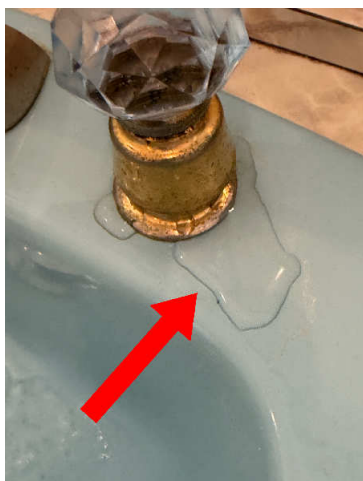
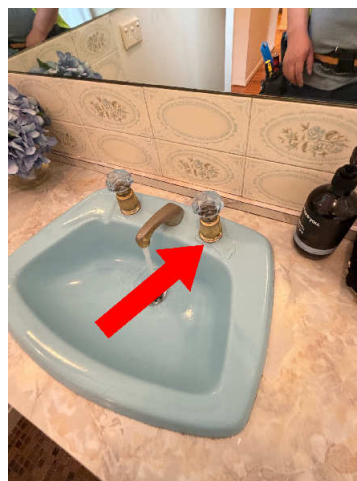
### Finding 3.05

Finding: Tap - Leaking

Information: The tap in this area was found to be leaking at the time of inspection. This is a common defect that is consistent with general ageing of the building element. However, it may be indicative of substandard plumbing workmanship if the tap is relatively new.

While this defect only seems minor, if left unmanaged, it is likely to result in the development of rust, water damage and/or extensive water usage.

It is advised that a handyman or licensed plumber be appointed to perform remedial works on the affected tap. Such works should be performed prior to the development of secondary defects to ensure adequate functionality of all associated building elements.

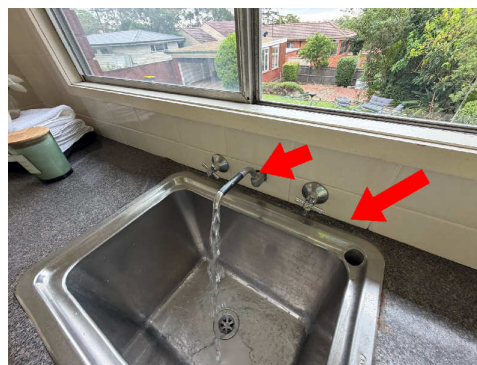
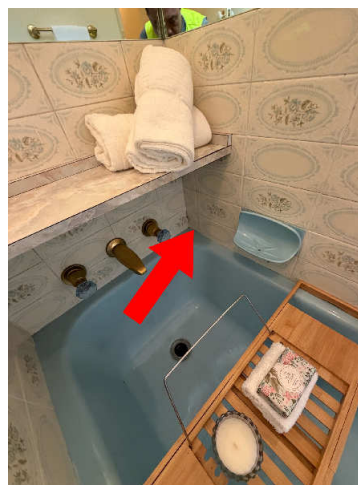
### Finding 3.06

Finding: Sealant and grouting - Missing or damaged

Information: It was noted on inspection that sealant or grout is degraded in multiple locations of the property.

Different materials and floor areas move at different rates, generally causing cracking to grout or sealant at this point. A flexible sealant is required to allow for expected expansion and contraction, while keeping the joint water tight and protective of all associated building materials.

Flexible and mould resistant materials should be applied to affected areas to prevent any subsequent water damage that is likely to occur. Regular maintenance and replacement of damage or missing or damaged sealant and grout is highly recommended to the wet areas, as this is a regular wear and tear defect. Sealant and grouting in areas that come into regular contact with water should be maintained for the long term care of your property.

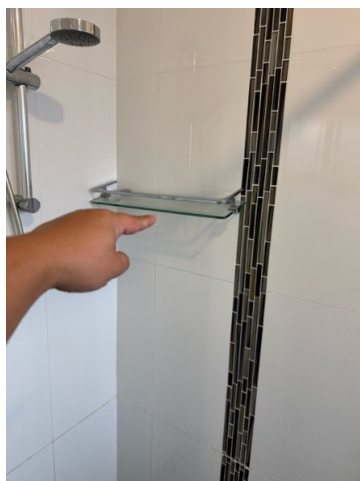
### Finding 3.07

Finding: Bathroom Fittings - Loose/Damaged

Information: The bathroom fitting was found to be loose/damaged at the time of inspection. While not a major operational defect, function can deteriorate if the problem is left unmanaged.

It is advised that the homeowner performs remedial works to re-attach the bathroom fittings to their original fixing. A general handyperson may be required to perform these works.

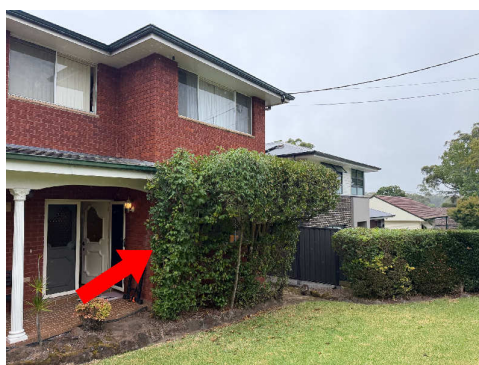
Finding: Garden Beds - Conditions Conducive to Termites

Information: Garden beds were found to be evident in close proximity to the building. Garden beds immediately adjacent to the perimeter of the building block the visual inspection of these areas providing a concealed termite entry point.

Garden beds can include untreated timber and a combination of moisture from watering produce conditions conducive to termite activity and ingress.

Further advice from a Timber Pest Technician is required to ensure appropriate Termite Management systems are implemented.

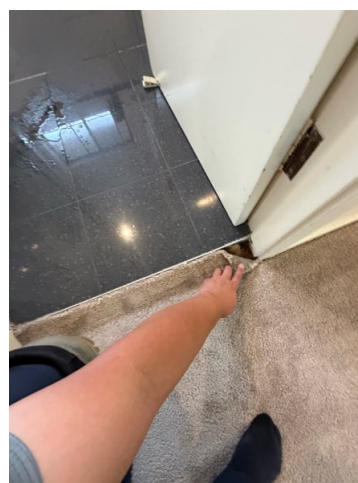
### Finding 7.01

Finding: Wood rot

Information: Localised wood rot was noted to the timber at the floor. The affected area shows signs of moisture-related deterioration.

Monitoring and timely repair or replace are recommended to prevent further deterioration.

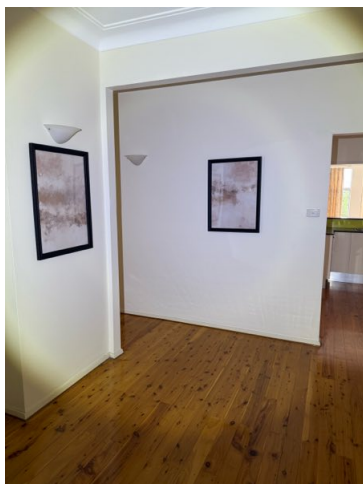
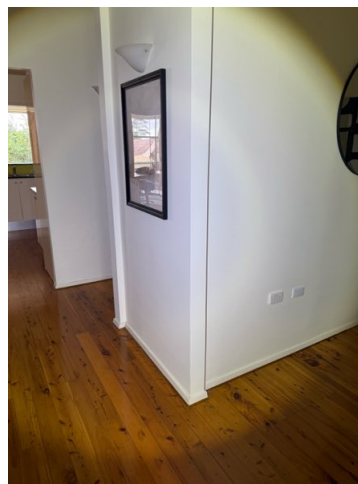
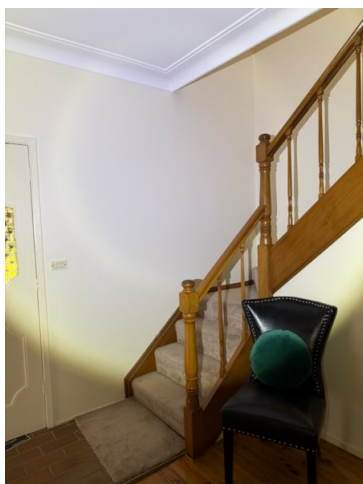
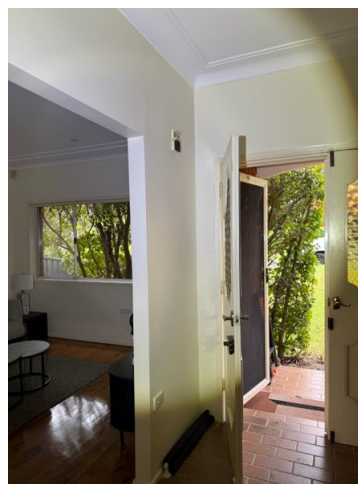
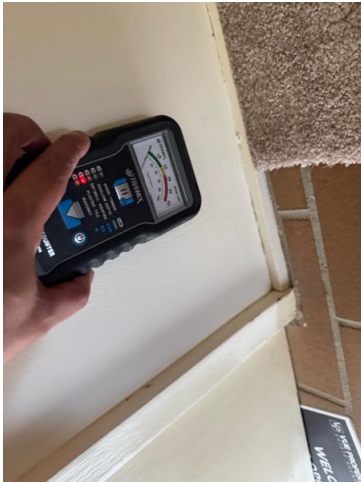
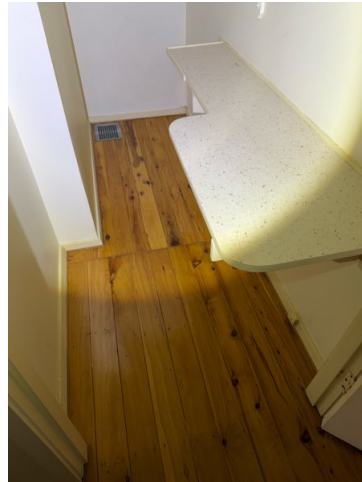
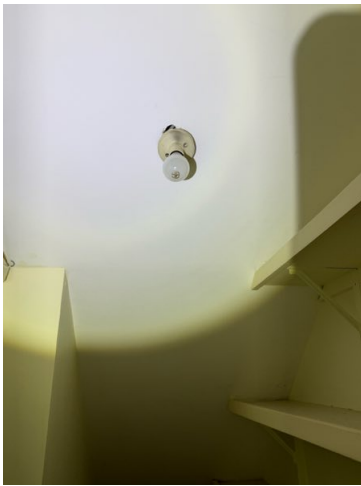
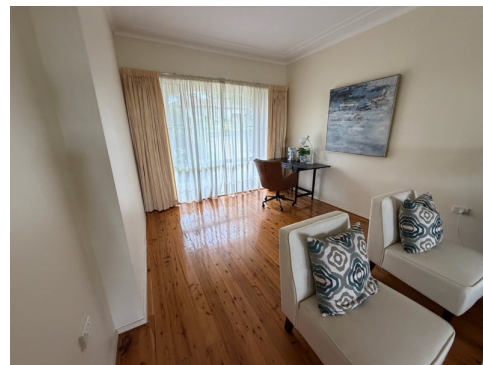
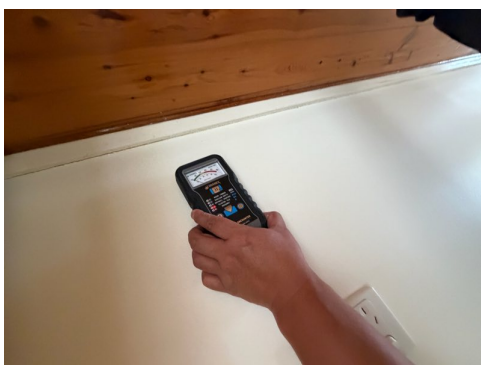
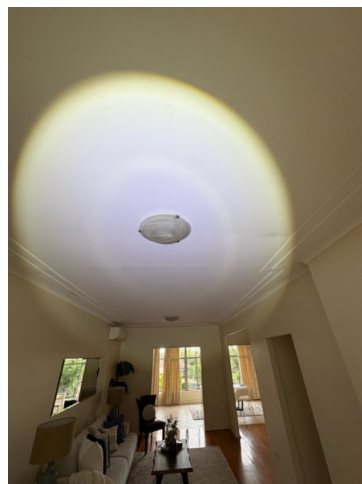
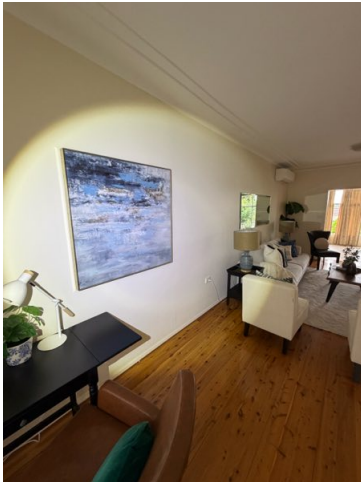
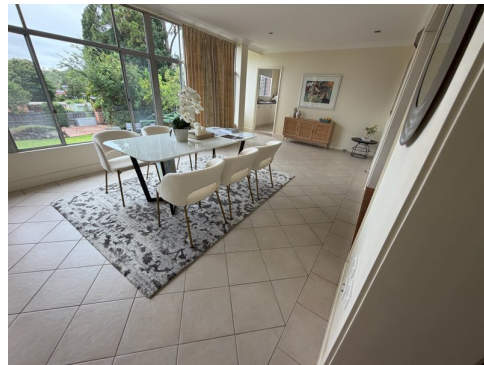
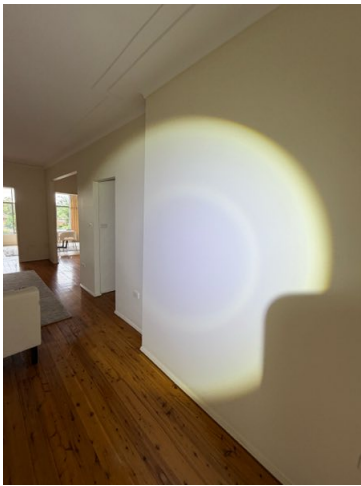
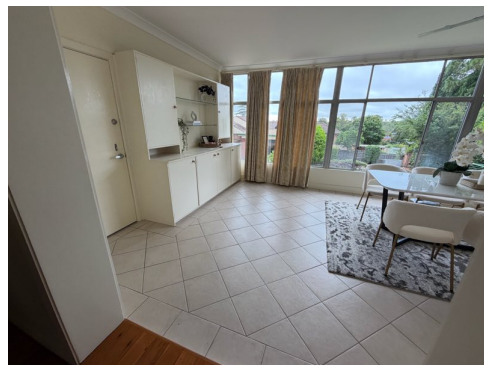
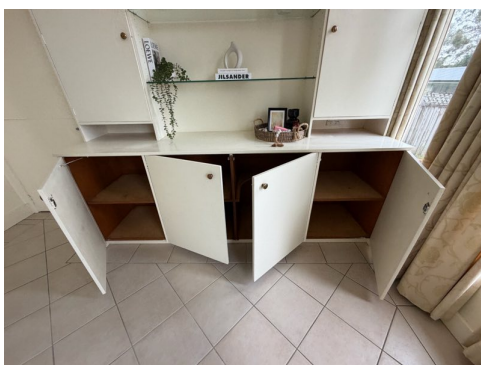
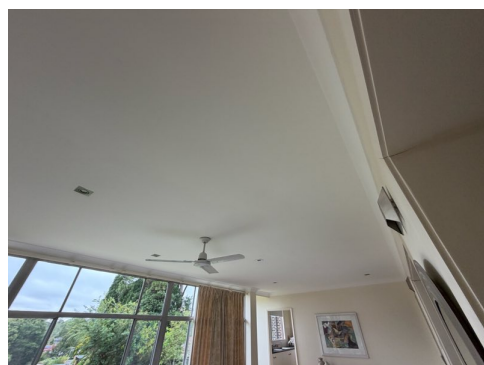
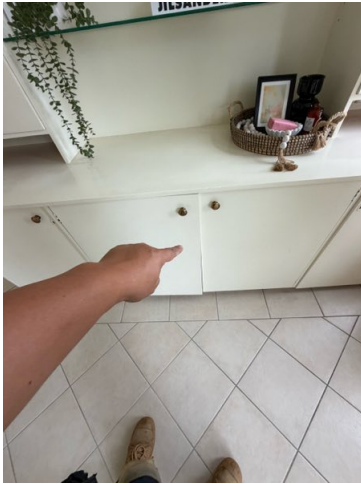
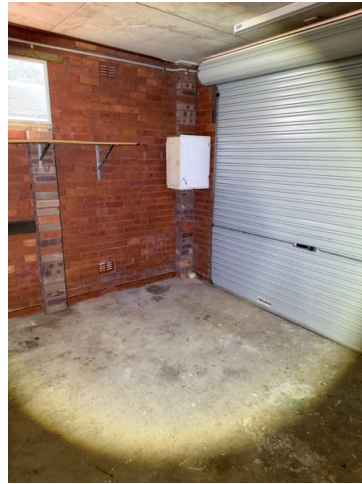
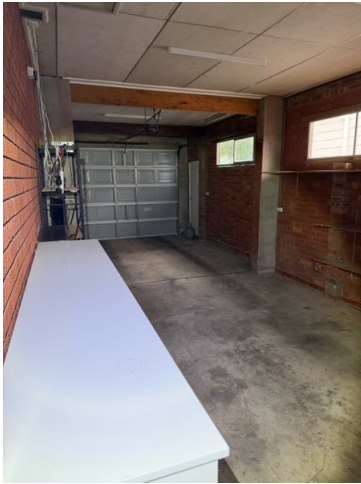
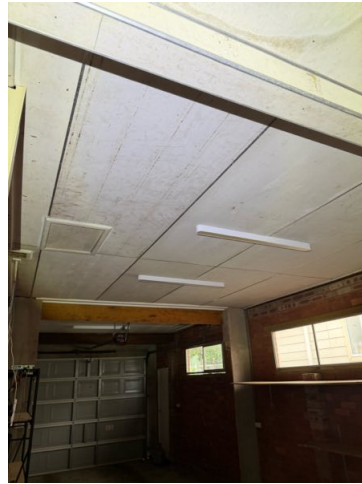
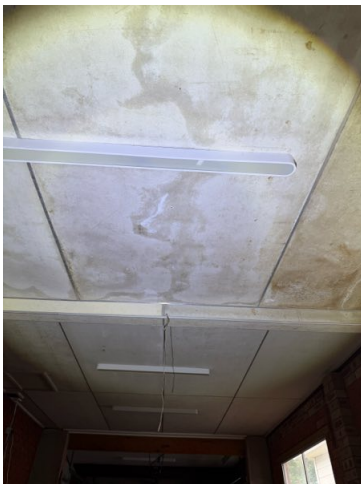
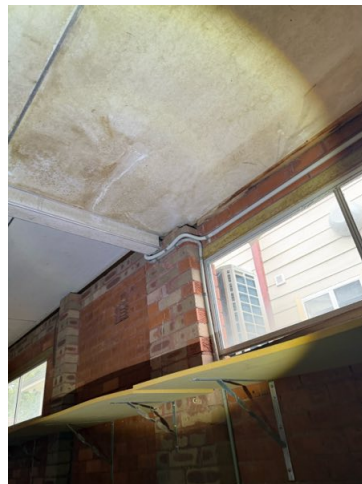
Finding: Additional Photos - Obstructions and Limitations— Interior Area

Information: These photographs are an indication of the obstructions and limitations which impeded full inspection of the interior area at the time of inspection. These obstructions can hide an array of defects and should be removed to allow full inspection to be carried out. A re-inspection is recommended once the areas are made accessible.

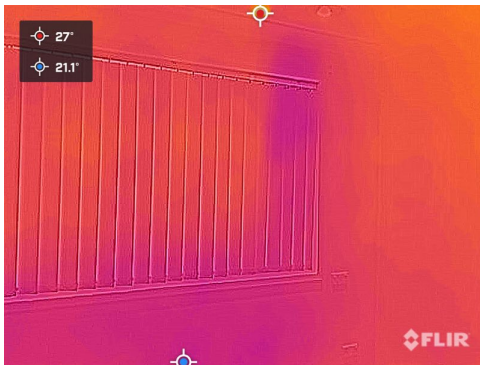
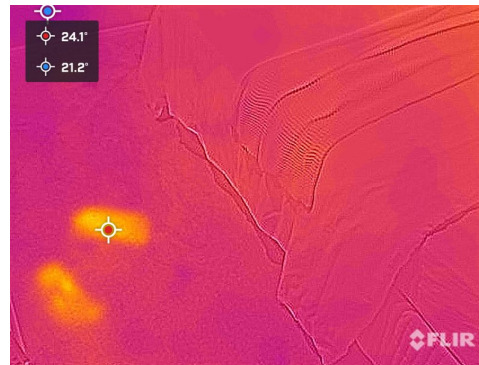
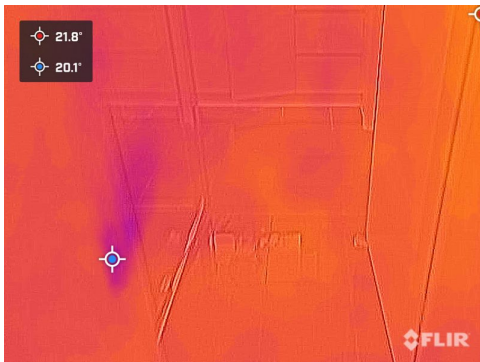
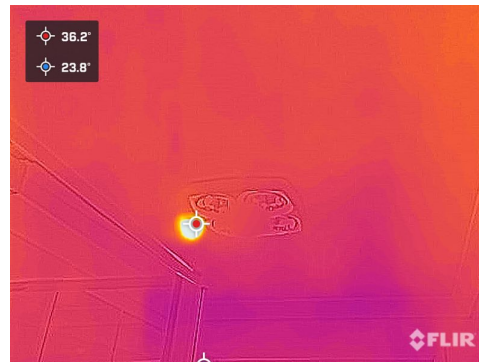
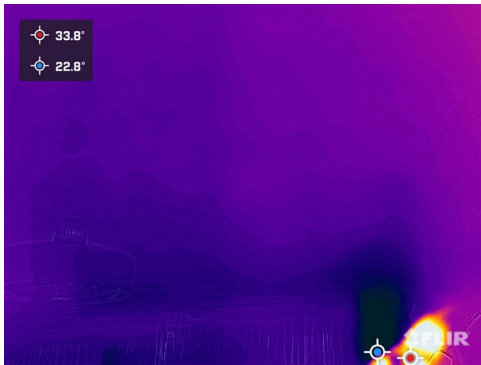
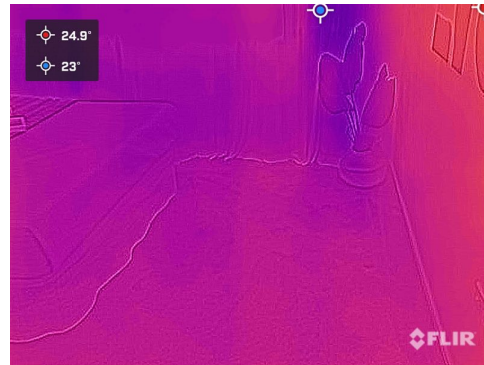
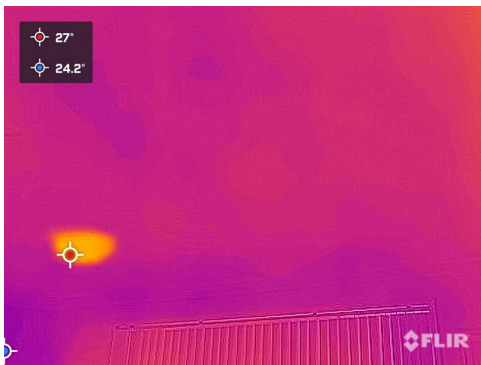
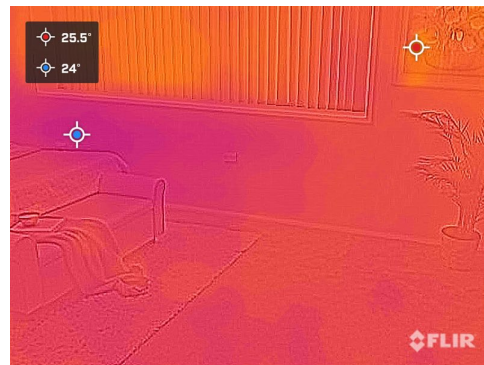
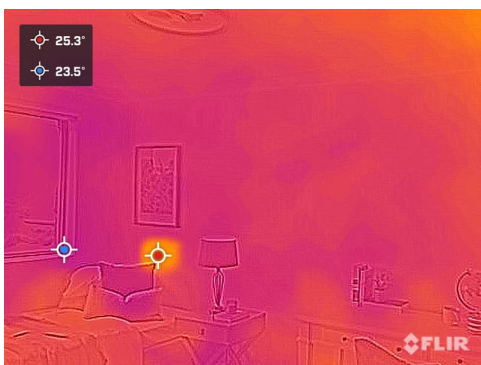
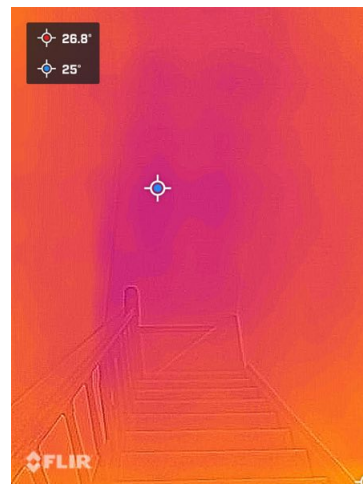
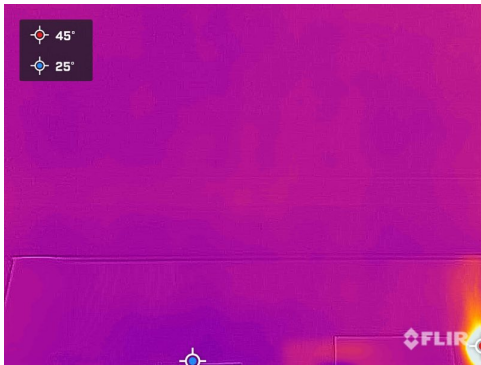
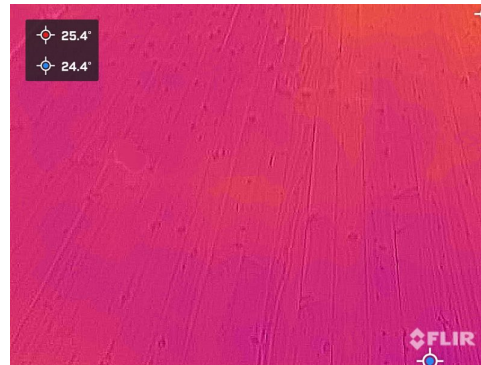
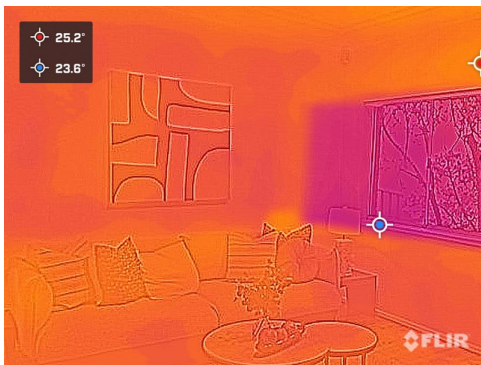
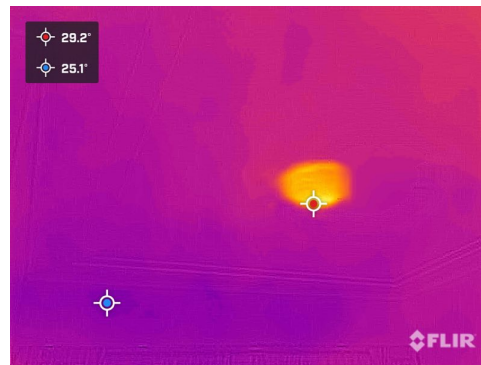
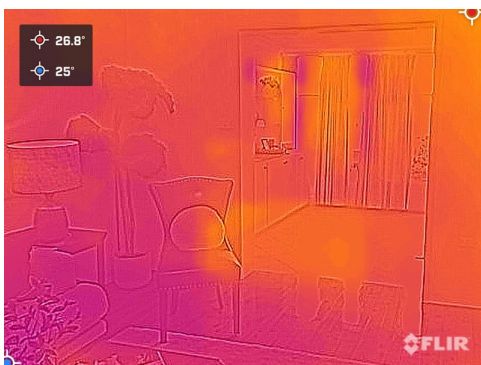
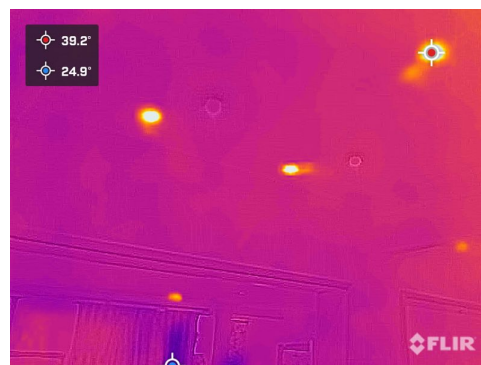
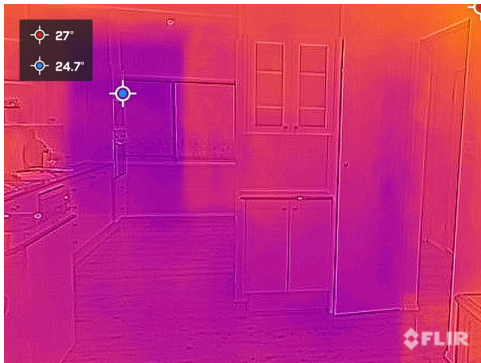
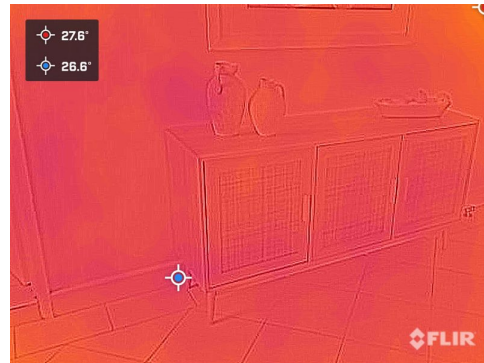
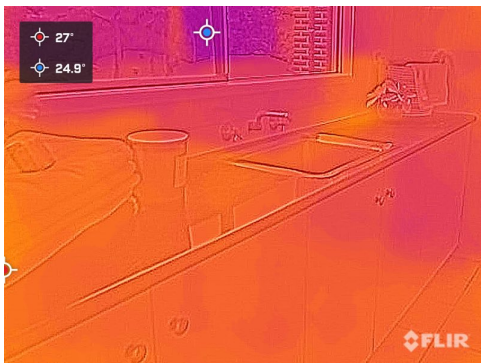
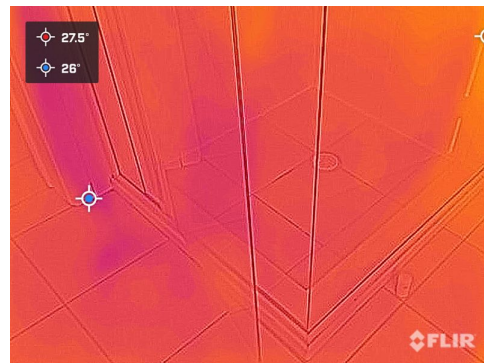
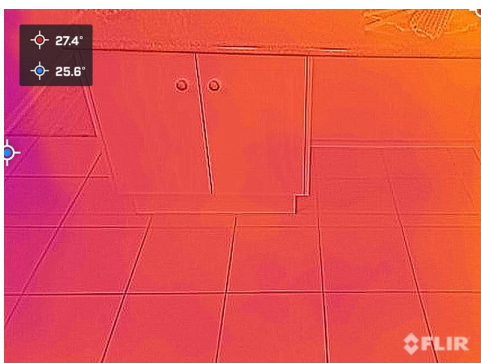
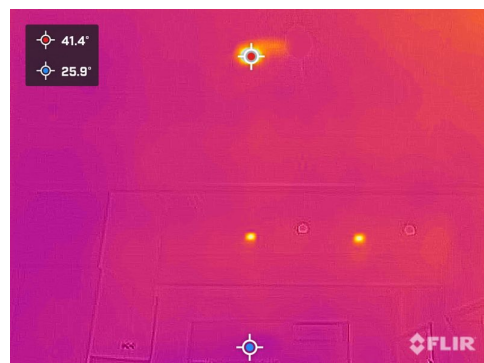
Finding: Additional Thermal Image Photos - Interior Area

Information: These Thermal Image photographs are an indication of the interior area at the time of inspection.

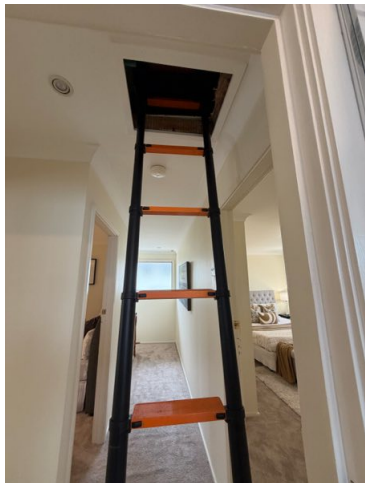
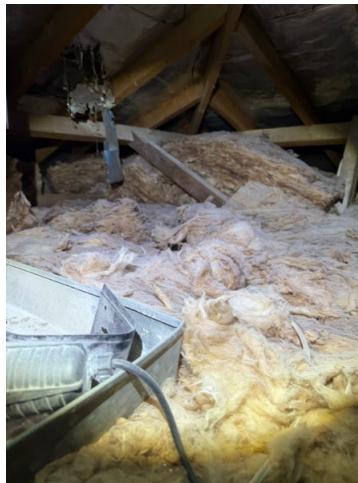
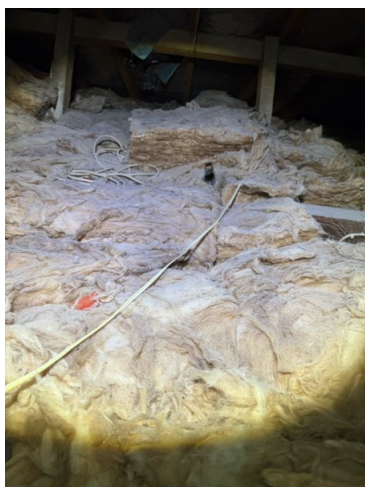
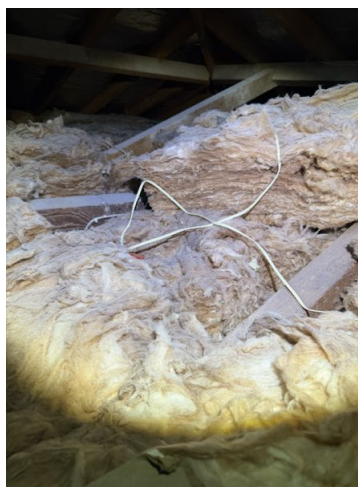
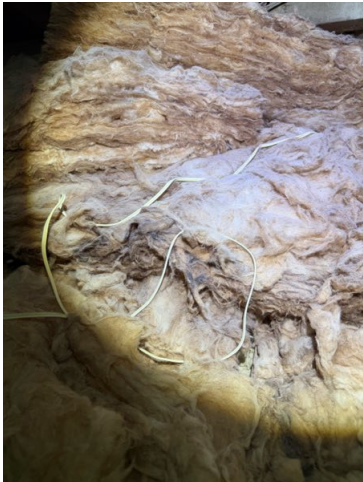
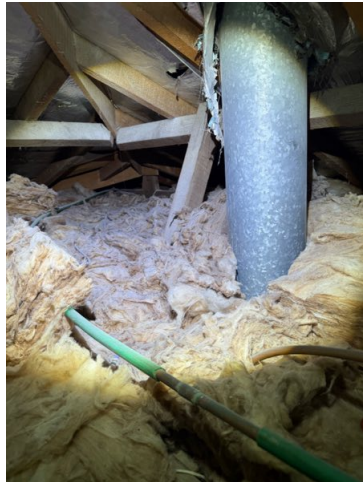
Finding: Additional Photos - Obstructions and Limitations—roof space area

Information: These photographs are an indication of the obstructions and limitations which impeded full inspection of the roof space area at the time of inspection. These obstructions can hide an array of defects and should be removed to allow full inspection to be carried out. A re-inspection is recommended once the areas are made accessible.

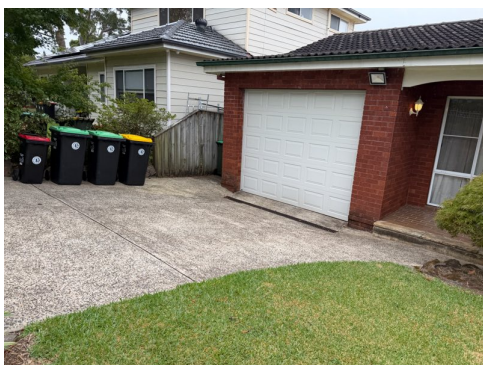
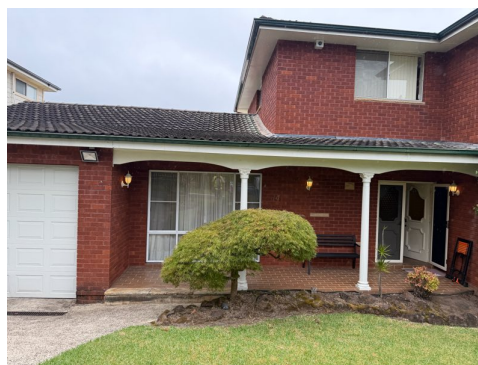
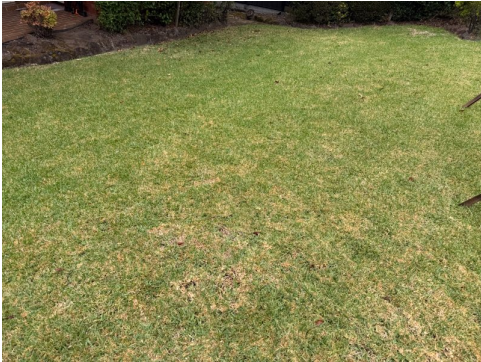
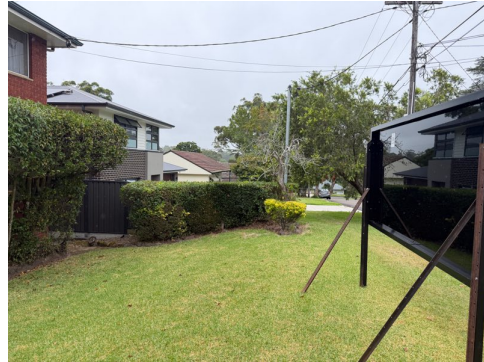
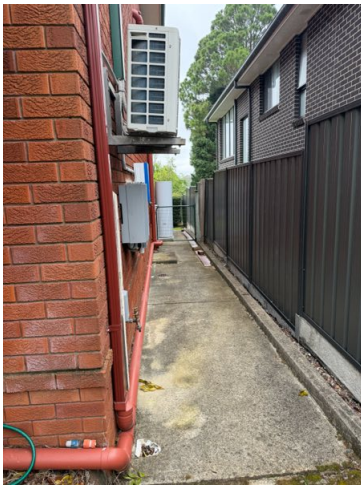
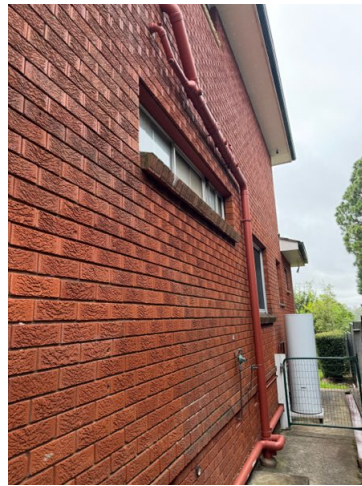
Finding: Additional Photos - Obstructions and Limitations—Exterior Area

Information: These photographs are an indication of the obstructions and limitations which impeded full inspection of the exterior area at the time of inspection. These obstructions can hide an array of defects and should be removed to allow full inspection to be carried out. A re-inspection is recommended once the areas are made accessible.

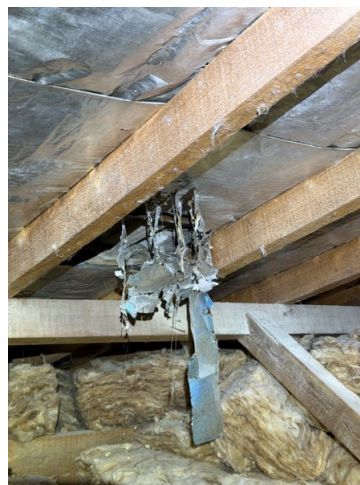
Finding: Sarking - Damaged

Where sarking is damaged, both insulation and moisture protection of the property are inhibited. This creates a loss of energy and thus negatively impacts the energy efficiency of the property, allowing potential for moisture ingress from condensation or leaking roof tiles.

It is important to repair any holes or damaged sections of sarking to ensure that the building material is fully functional. A register builder or qualified carpenter should be consulted to provide further advice on this defect and to perform rectification works at client discretion.

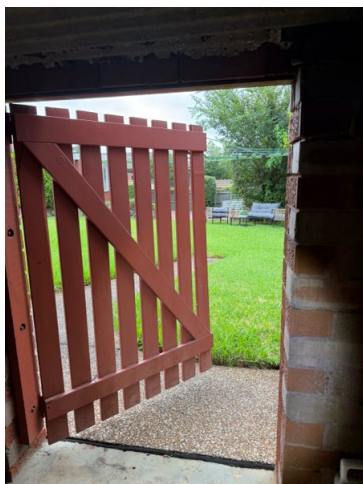
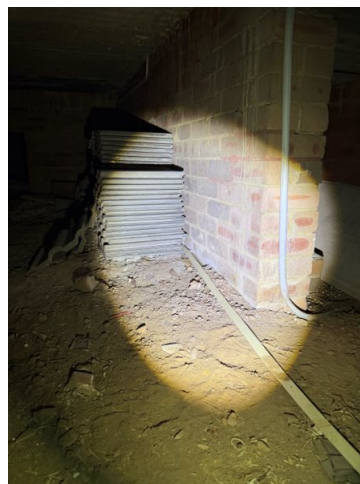
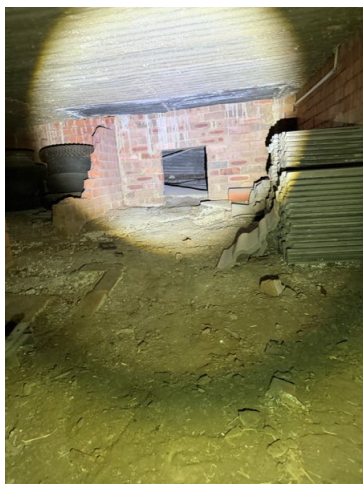
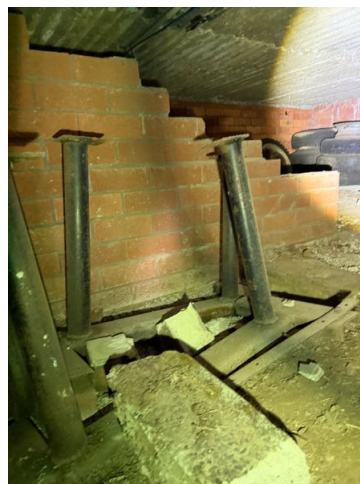
Finding: Additional Photos - Obstructions and Limitations—subfloor area

Information: These photographs are an indication of the obstructions and limitations which impeded full inspection of the subfloor area at the time of inspection. These obstructions can hide an array of defects and should be removed to allow full inspection to be carried out. A re-inspection is recommended once the areas are made accessible.
