# Building and Timber Pest Inspection Report

Inspection Date: Fri, 13 Mar 2026

Property Address: 9A Lewis St, South Wentworthville NSW  
2145, Australia

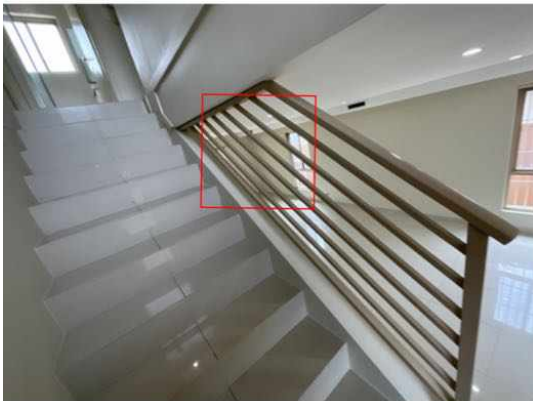
Building: Main Building  
 Location: Staircase  
 Finding: Loose handrail — Fall from heights  
 Information: The handrail was lacking appropriate support and fixing to the adjacent wall or floor at the time of inspection.

The handrail was further loose and moving upon minimal force applied with hand.

These handrails pose a risk and persons coming in contact may fall from heights if these handrails fail, thus causing sever injury.

A licensed builder must be appointed as soon as possible to rectify any non-compliance.

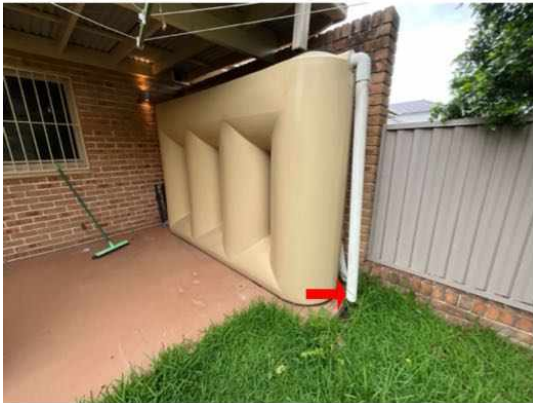
### Finding 3.03

Building:	Main Building
Location:	Alfresco
Finding:	Plumbing - Point of connection non-compliant
Information:	At the time of inspection it was noted that connections between above ground pipe work and below ground sewer/storm water systems were incomplete.

Additionally, where sewer pipes are concerned, gases can escape from unsealed connections which can pose a serious health risk.

Engagement of a certified plumber is strongly recommended to ensure all connection points are sealed in accordance with the plumbing construction guidelines.

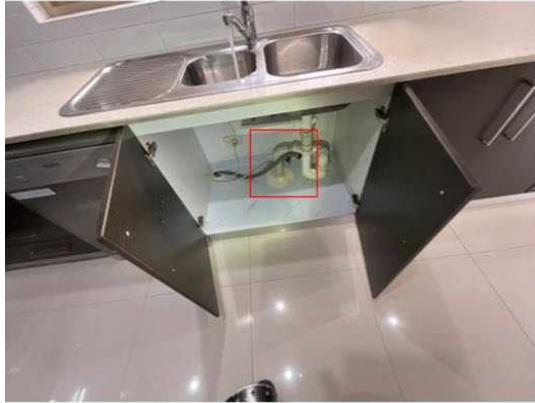
Finding: Water leak - Active

Information: Generally, water leaks occur when a particular area of the property is not weather or water tight. As the surrounding area was found to be damp at the time of inspection, the leak is considered ongoing and hence requires urgent action.

Regardless of the location, even minor leaks that are left unmanaged can lead to serious damage of associated building elements and result in the need for replacement of building materials. Mould and other hazards such as electrical hazards may also arise if the leak is left to develop.

It is highly advised that the cause of the leak be identified and resolved immediately by a licensed plumber to prevent any further damage. Depending on the extent of the damage previously sustained, repair and/or replacement of any affected building materials may be required.

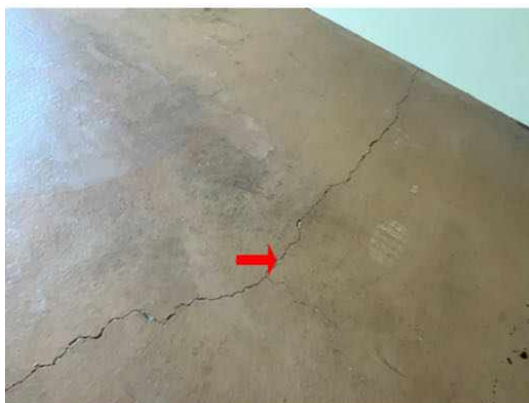
Finding: Crack in concrete slab - Category 2  
 Information: A crack coded as Category 2 was identified in the slab. A Category 2 crack is described as a distinct crack, with the slab being noticeably curved or changed in level.

To be considered Category 2, the approximate width of the crack is less than 2.0mm, or a change in offset of less than 15mm when a 3m straight edge is placed over the defect.

Category 2 cracks to slabs should be monitored for a period of 12 months. At the end of the monitoring period, cracks rated greater than Category 2 are considered defects that require rectification.

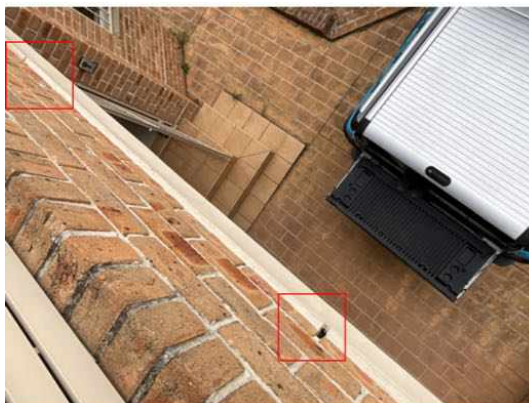
Where roof plumbing doesn't drain adequately, the area at the base perimeter can become excessively damp, potentially creating an environment that is susceptible to rust and corrosion of surrounding building elements, as well as attracting termites and other pests.

It is highly recommended that a plumber be appointed to further inspect the area and to install adequate drainage equipment where necessary.

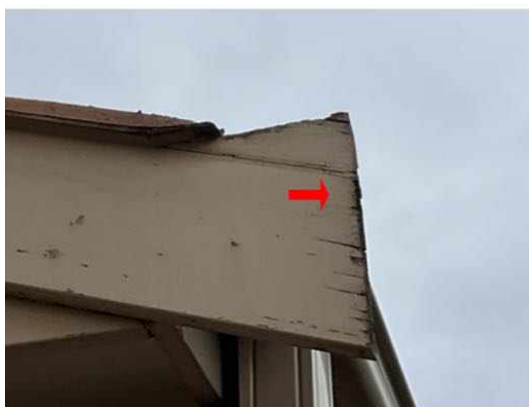
Early intervention and regular maintenance, particularly of exterior timbers, will prolong the useful life of these building elements. Prior to any works being performed, the cause of the moisture that has created the visible wood rot should be identified and addressed in a suitable manner. Replacement of affected timbers may then be a necessary step in protecting surrounding building elements from such deterioration.

A licensed plumber may be appointed to assess the cause of excessive moisture and to provide advice on any remedial works as required. A licensed carpenter may also be required to replace affected building materials.

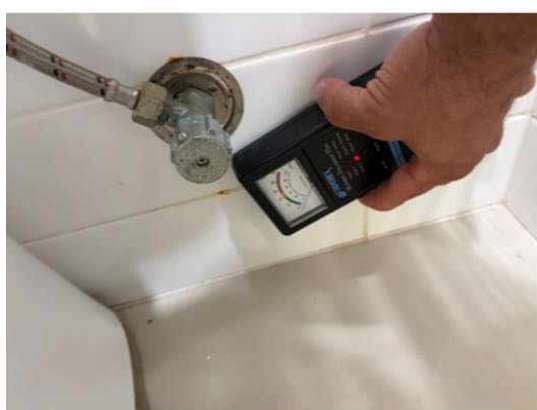
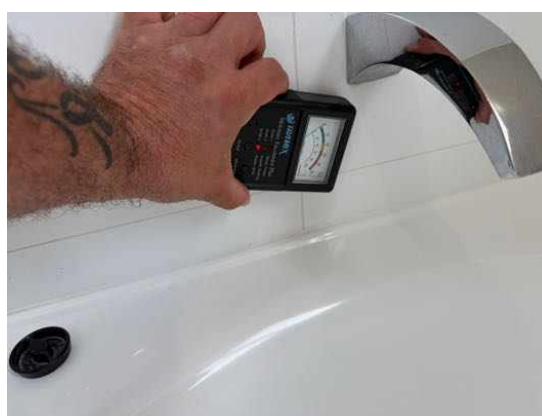
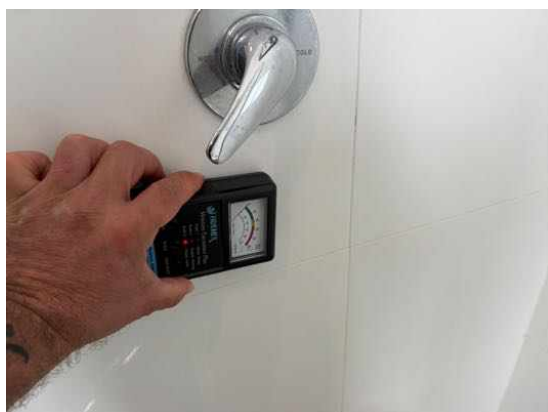
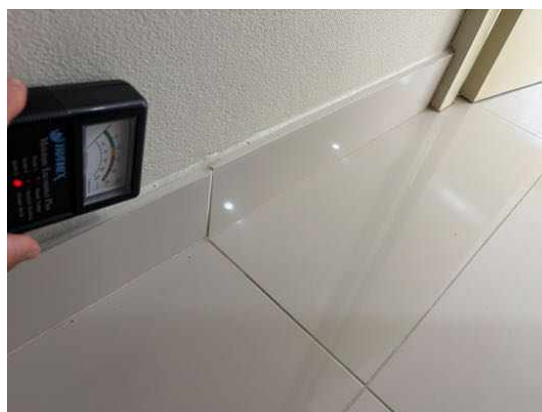
Building: Main Building  
 Location: All Areas  
 Finding: Moisture metre  
 Information: During the inspection the property was checked for moisture using a moisture metre.

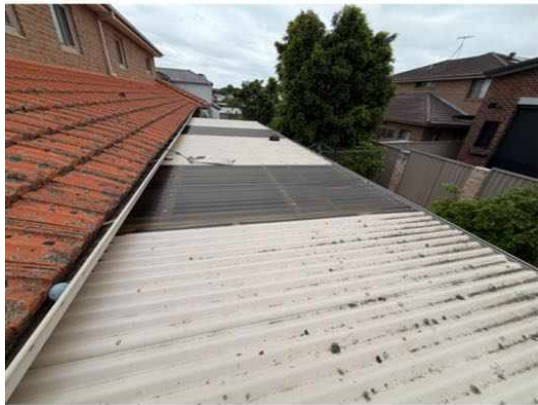
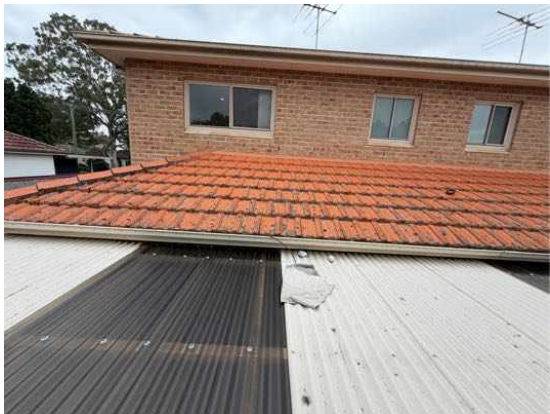
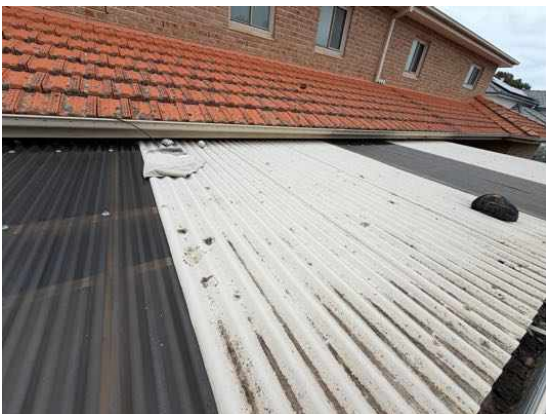
Building: Main Building  
Location: Roof Exterior  
Finding: Additional Photos  
Information:

Additional photos are provided for your general reference.

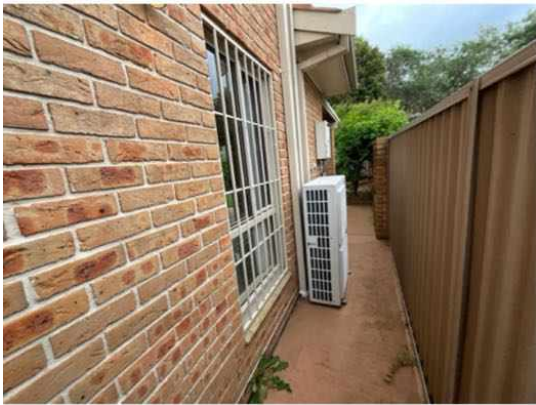
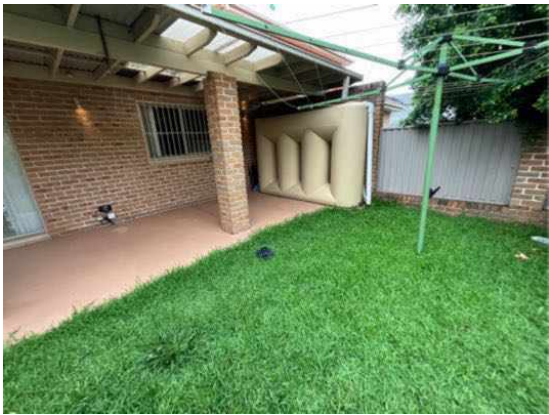
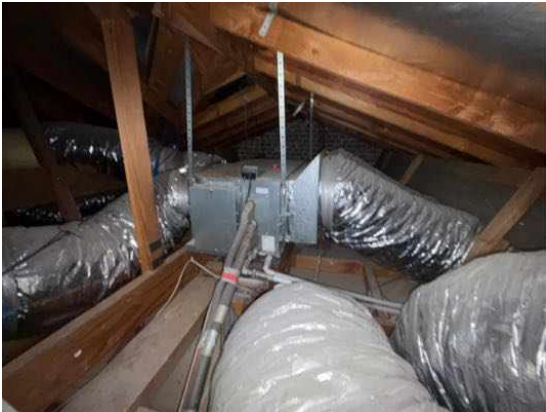
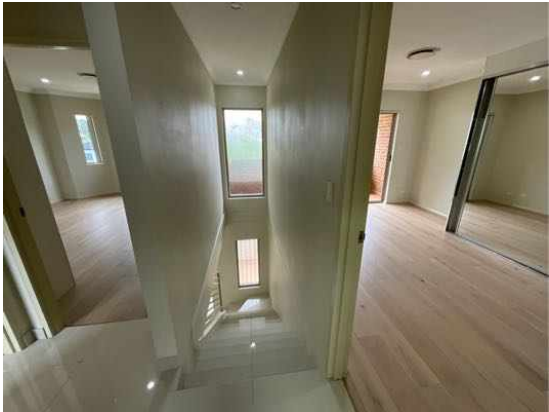
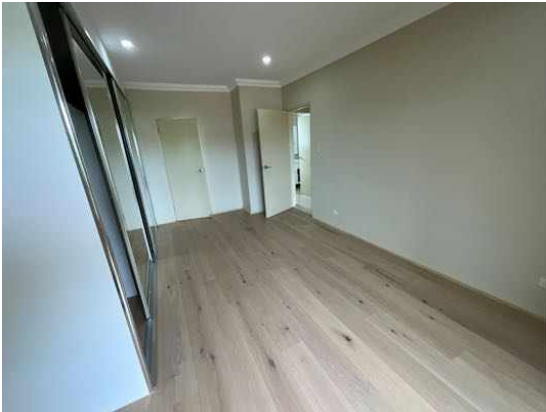
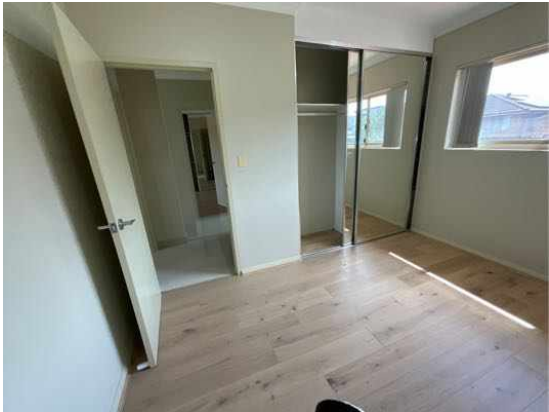
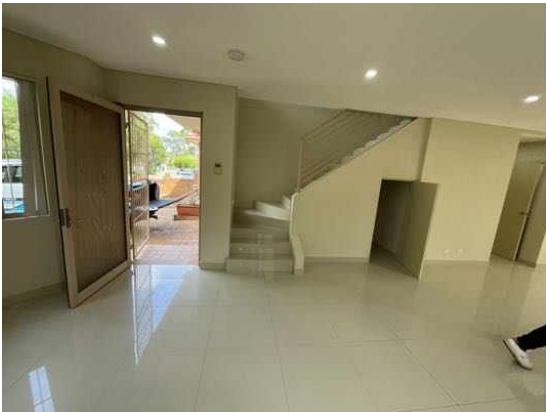
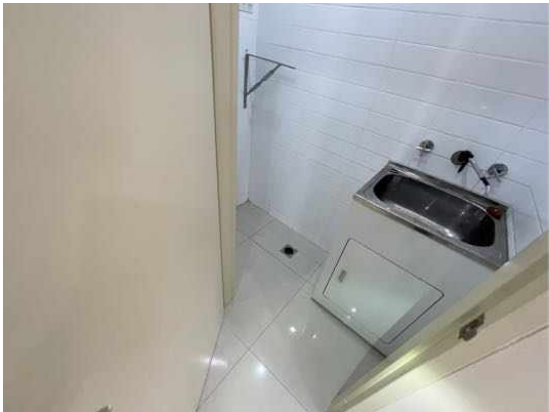
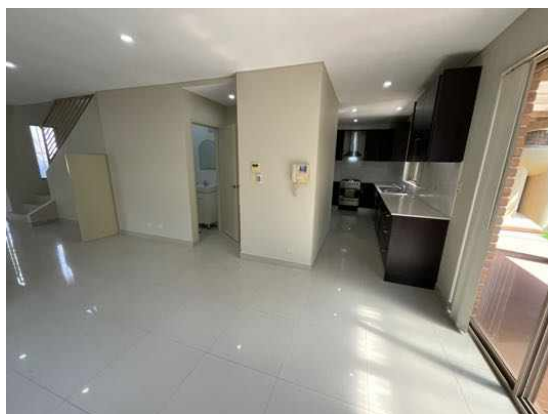
Building: Main Building  
 Location: All Areas  
 Finding: Additional Photos - Obstructions and Limitations  
 Information: These photographs are an indication of the obstructions and limitations which impeded full inspection of the property at the time of inspection. These obstructions can hide an array of defects and should be removed to allow full inspection to be carried out. A re-inspection is recommended once the areas are made accessible.

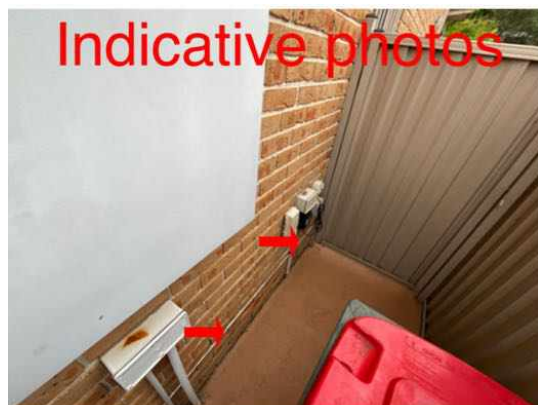
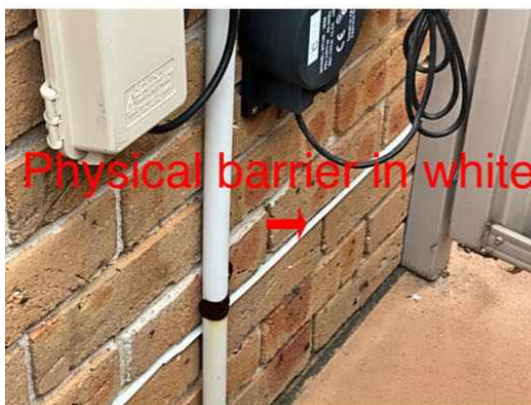
Where a Termite Management System has been identified you should refer to the type of barrier date of installation warranty conditions and any documentation provided by a builder or past owner. Consult the company who installed the barrier to confirm whether the system is still under warranty.

Most chemical termite management systems expire and require replenishment and all physical systems are primarily designed to prevent concealed entry.
