Building Inspection Report

Inspection Date: Fri, 27 Feb 2026

Property Address: 16 Avenue Rd, Prospect SA 5082, Australia

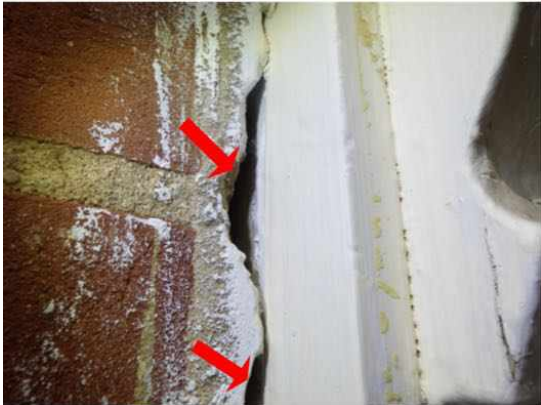
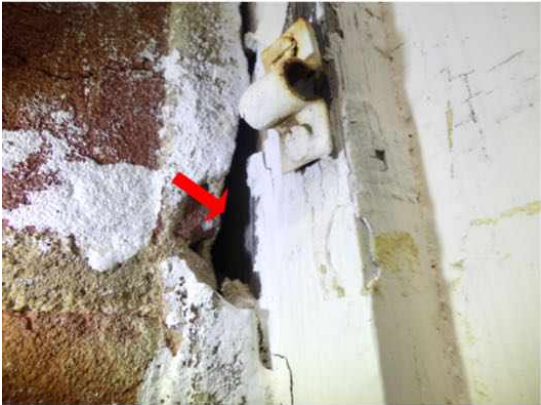
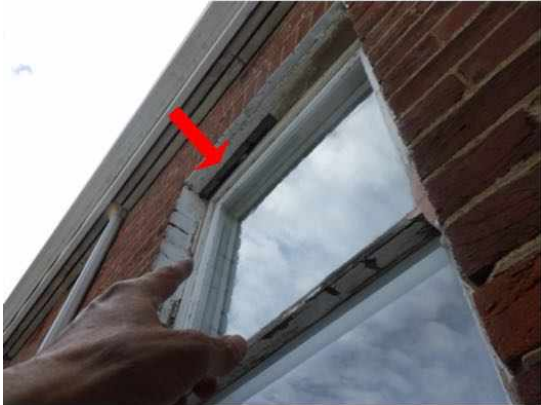
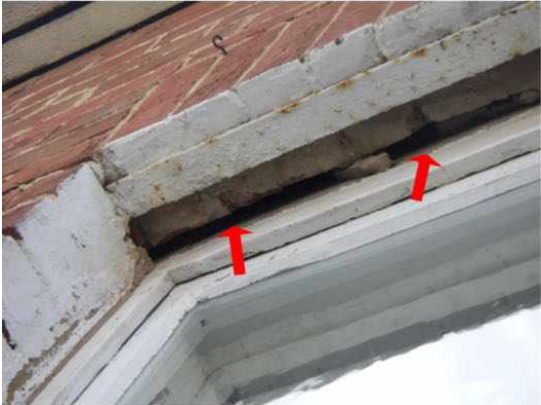
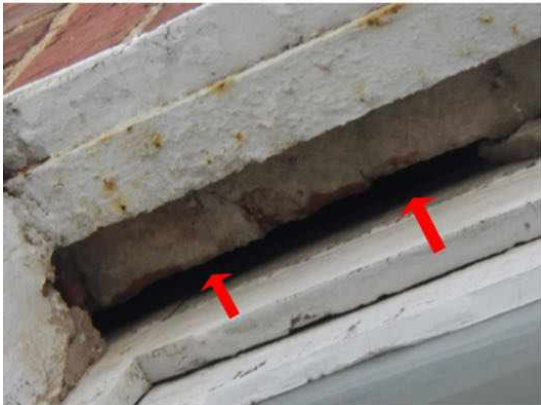
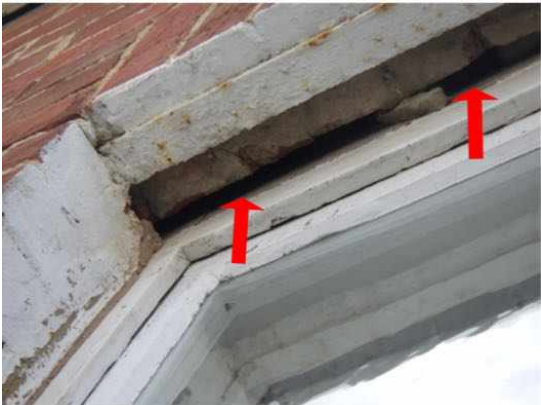
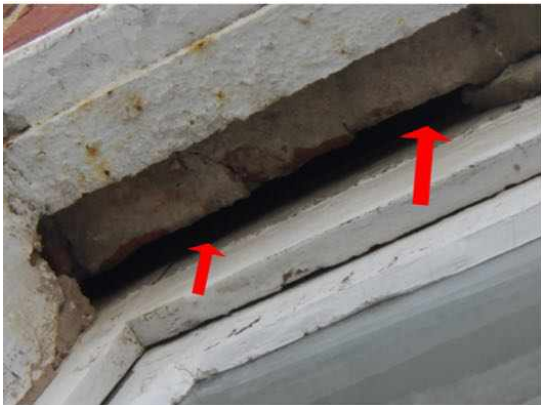
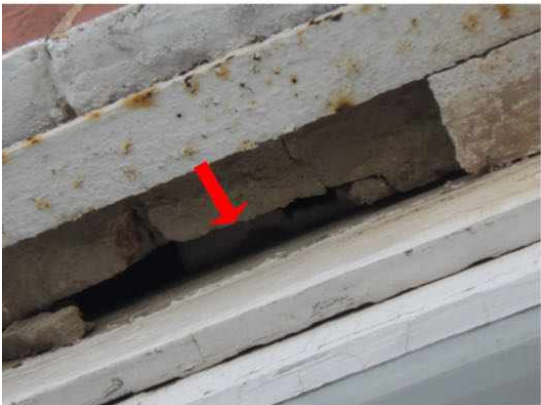
Finding: External Walls & Window Frame Assemblies - Significant Gaps Observed

Information: At the time of inspection, it was noted that significant gaps are present between the external wall cladding and several window frame assemblies at various locations around the property. These gaps indicate poor detailing, movement, deterioration of materials, or inadequate installation and sealing.

Such conditions may arise due to age-related degradation, environmental exposure, or physical damage. If left unrectified, these gaps may allow water and air ingress, potentially leading to secondary defects, including moisture damage, deterioration of adjacent building elements, and reduced thermal and weatherproof performance.

Repair and/or replacement of the affected components is recommended to reinstate the integrity and performance of the building envelope. All building elements play an essential role in the operation and overall performance of the structure, and defects of this nature may adversely impact durability and habitability.

It is advised that a suitably qualified and licensed tradesperson be engaged as soon as practicable to assess and rectify the affected areas to prevent further deterioration or consequential damage.

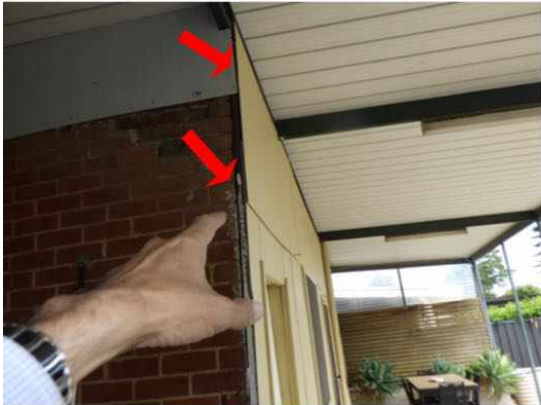
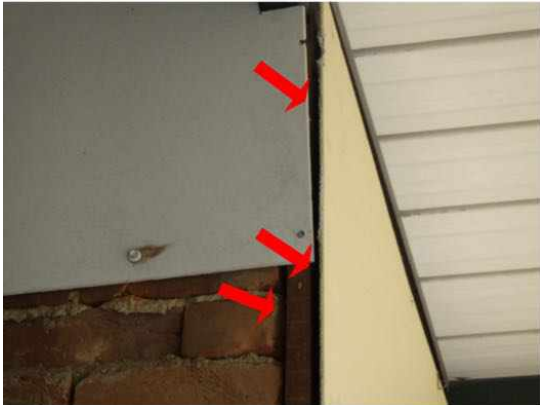
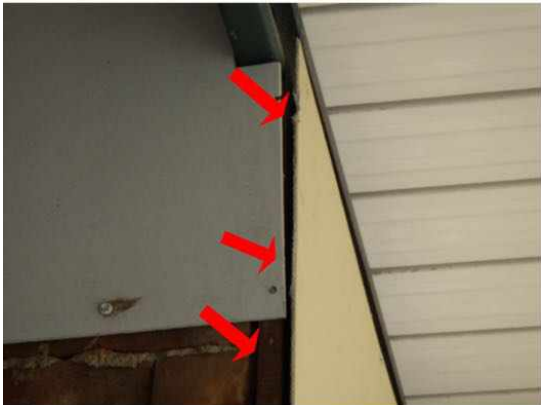
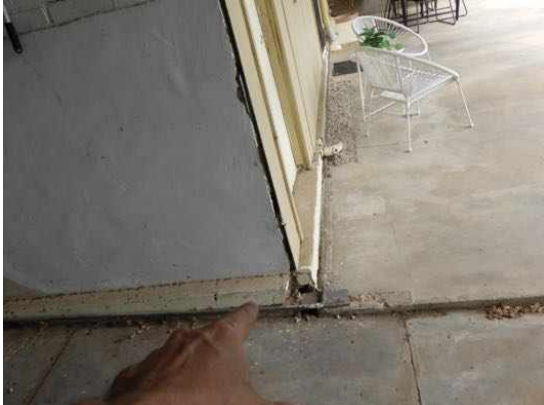
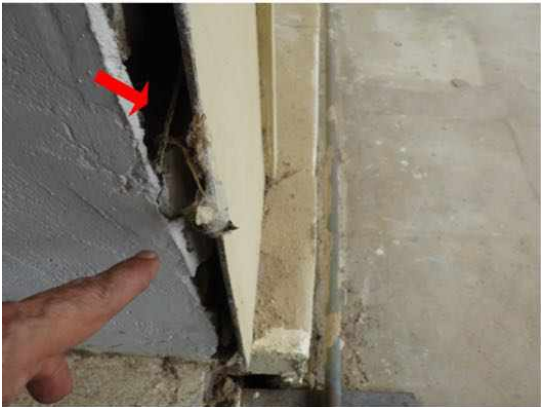
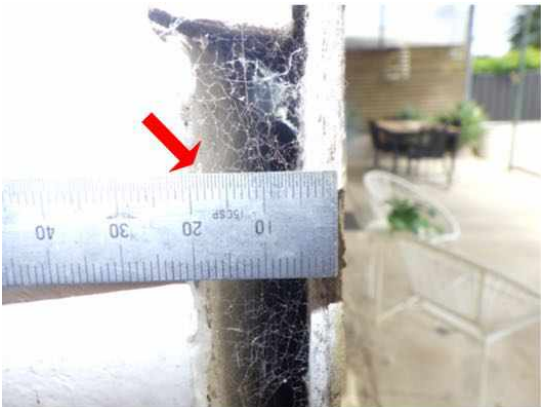
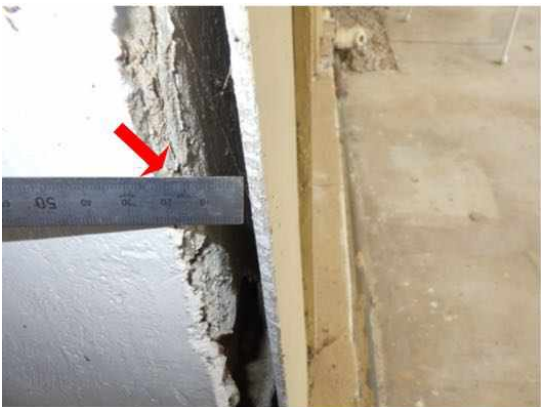
Defects 2.02

Building: Building 1
Location: All External Areas
Finding: External Walls – Rear - Significant Gaps at Joints / Loose from Original Fixing
Information: At the time of inspection, it was observed that the rear external wall cladding exhibits significant gaps at several joint locations, and sections appear loose from their original fixing. These conditions indicate inadequate installation, movement, deterioration of materials, or possible fixing failure.

Breakage and separation of building elements can occur due to age-related deterioration, environmental exposure, or physical damage. If left unaddressed, such defects may allow moisture ingress and contribute to secondary issues, including structural degradation and reduced performance of the building envelope.

Repair and/or replacement of the affected wall sections is recommended to restore the integrity and performance of the external wall system. All building elements form an integral part of the overall structure, and defects of this nature may adversely affect the building’s durability and weather resistance.

It is advised that a suitably qualified and licensed tradesperson be engaged as soon as practicable to assess, repair, or replace the affected areas to prevent further deterioration or consequential damage.

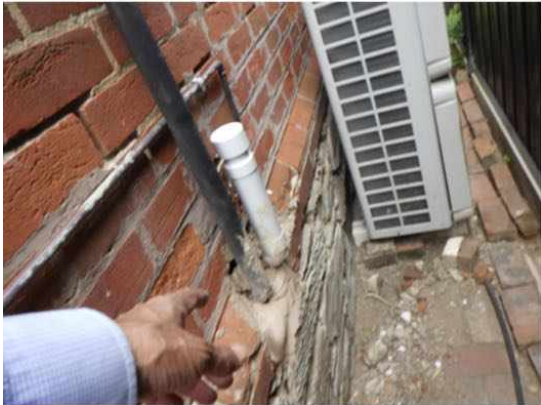
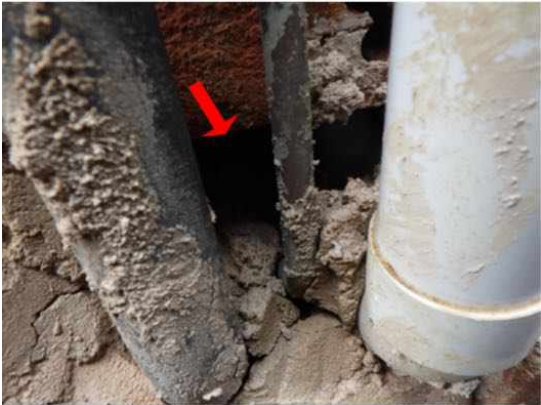
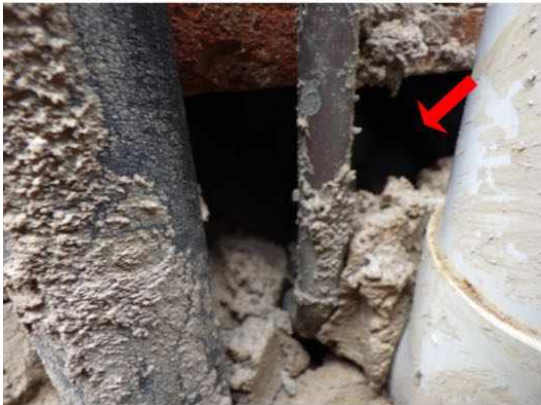
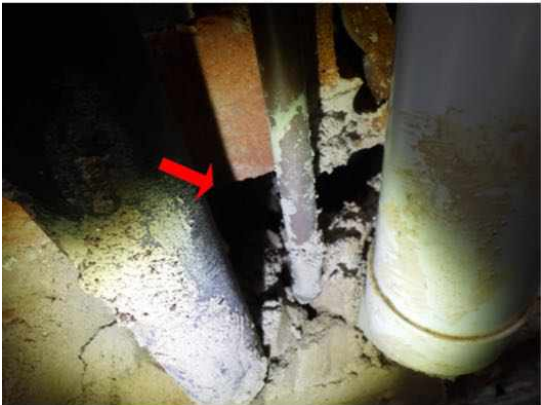
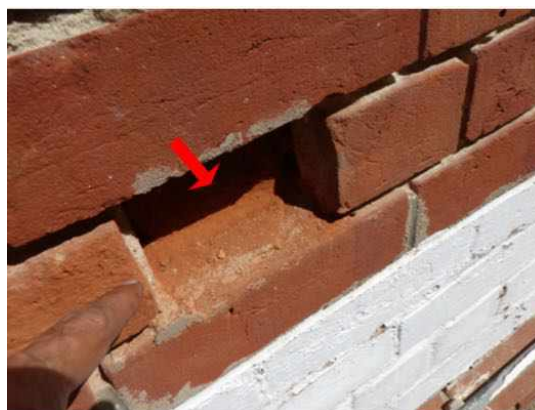
Defects 2.03

Building: Building 1
Location: All External Areas
Finding: External walls - Holes
Information: Significant holes were identified around pipe penetrations in this wall section. It is suspected that the installation of this pipework was completed to a substandard level of workmanship or is incomplete.

Gaps and holes around pipework makes the area susceptible to insect and vermin ingress, as well as allowing water penetration to the cavity wall. As such, associated building elements are likely to deteriorate at an accelerated rate, and major implications are expected if holes around the pipework are left unmanaged.

All excessive holes, gaps or cracks should be adequately filled by a suitable sealant or trimmings as soon as possible to prevent any further damage. Such works may be conducted by a general handyperson or licensed plumber.

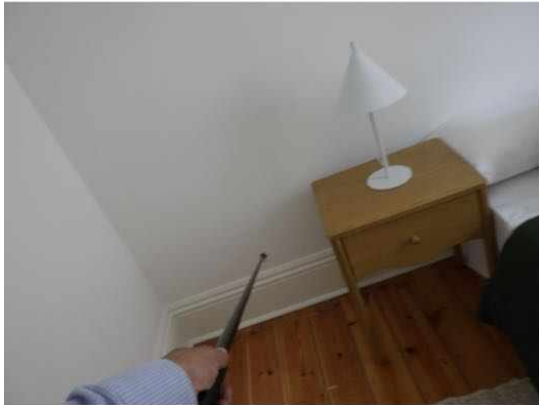
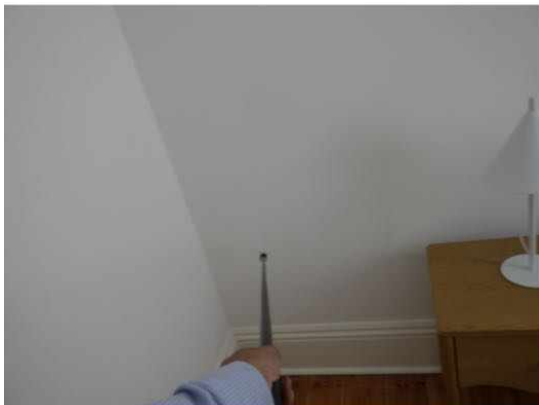
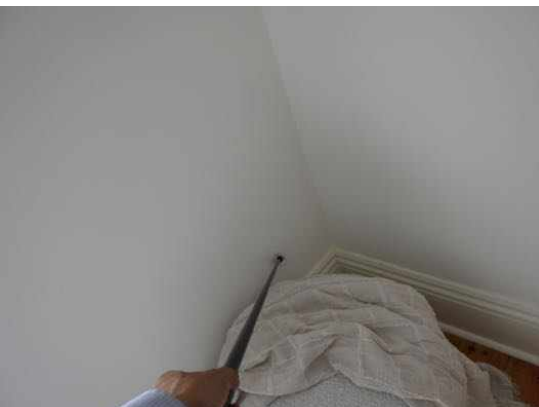
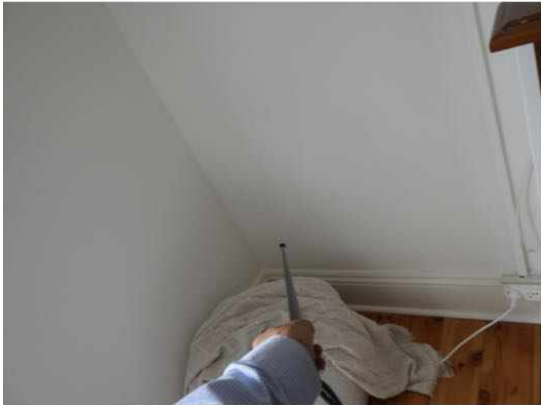
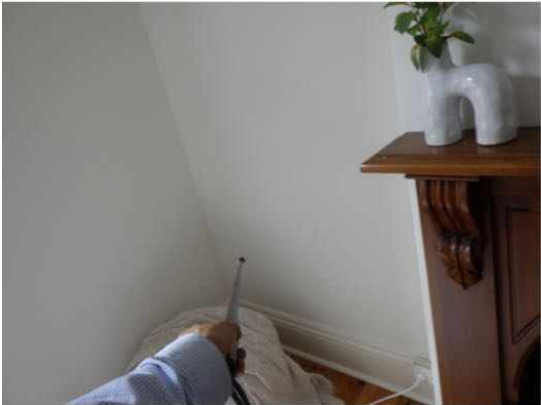
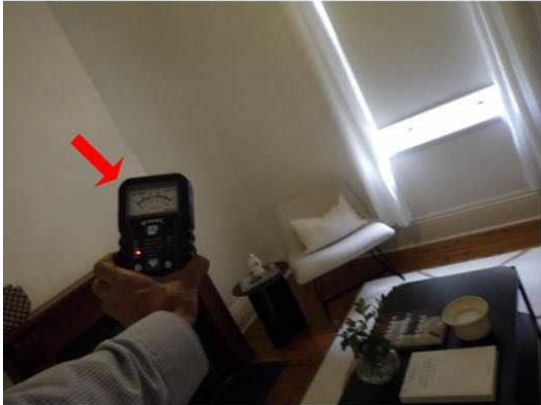
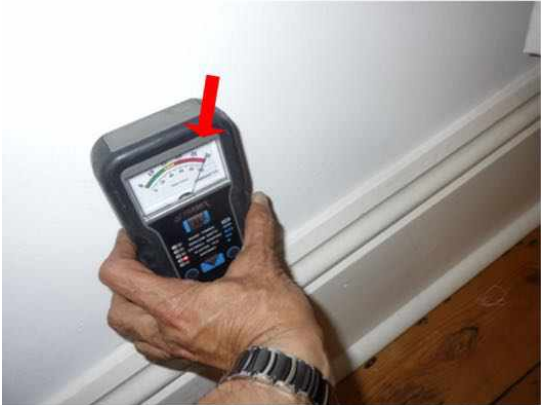
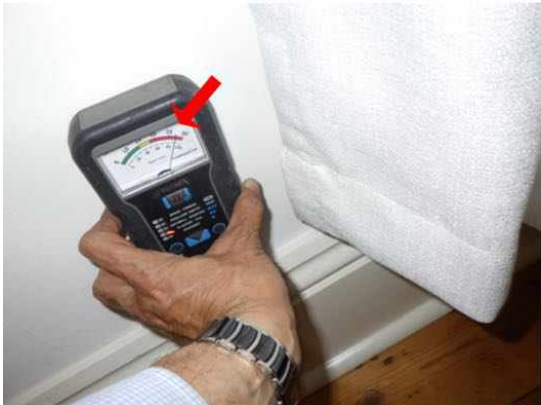
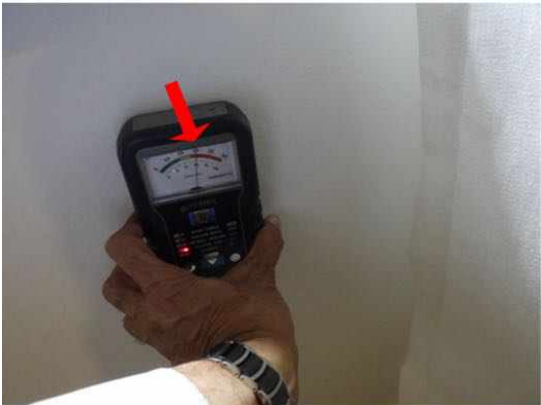
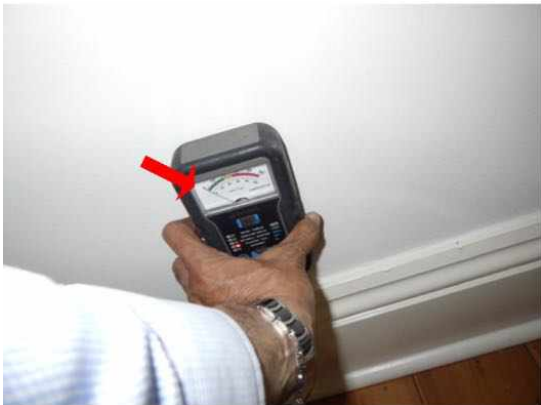
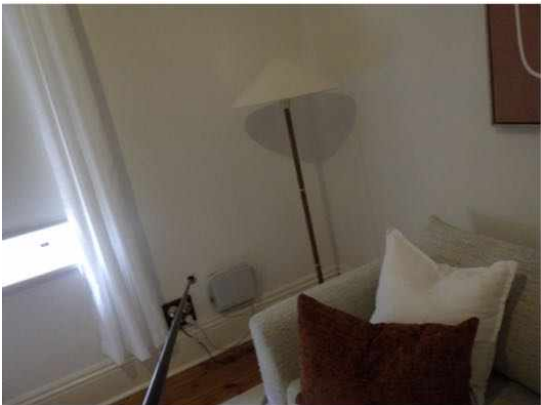
Defects 2.04

Building:	Building 1
Location:	All Areas
Finding:	Internal walls - Damp at lower base
Information:	At the time of inspection it was noticed that high moisture readings were noted in few sections of internal walls around the property at lower base.

Damp (or structural damp) refers to the presence of unwanted moisture in the structure of a building, either as the result of intrusion from outside, or condensation from within the structure. Generally, structural damp is caused by rain penetration, rising damp, and leaks from plumbing pipes.

Unmanaged damp facilitates the formation and development of mould, fungi growth and wood rot, decaying associated building materials and compromising their structural integrity. Damage to finishes is also likely to occur, including lifting, bubbling, peeling and staining of paint, plaster and wallpaper.

The first step in addressing damp is to diagnose the cause. The identified cause

should be addressed first prior to repairing the appearance and other defects which have resulted from the rising damp. If the original cause is not resolved, further cases of damp are likely to ensue, resulting in secondary defects.

Consultation with a qualified plumber is advised immediately to identify the cause of damp and perform remedial works as required. Where excessive mould growth is present, further inspection by a specialist environmental health inspector should also be considered.

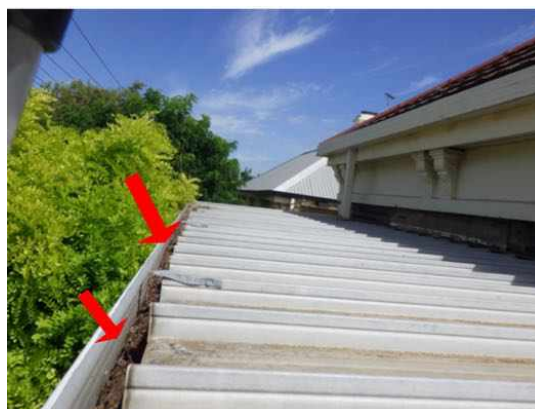
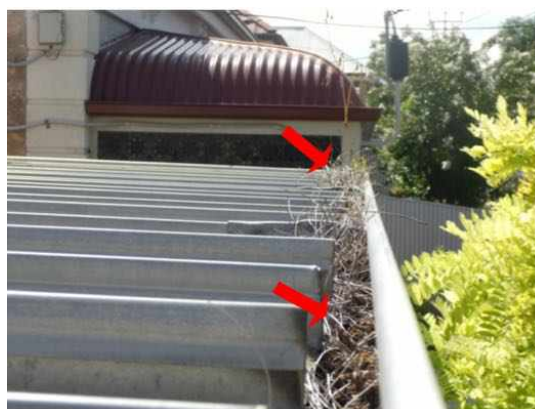
Defects 3.01

Blocked gutters are likely to lead to high levels of moisture in the affected areas. Such moisture will not only cause rust and decay of the associated building materials, but can also provide conditions that are conducive to termite and timber pest activity. Blockages in gutters should therefore be removed immediately to ensure dry conditions are maintained.

Consult a Licensed Plumber for further specific advice on remedial works that may be required. In the interim, it is highly advised that blocked gutters be removed by the homeowner or a general handyperson as a matter of urgency.

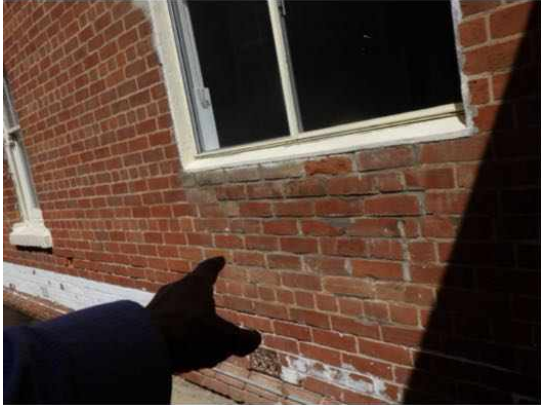
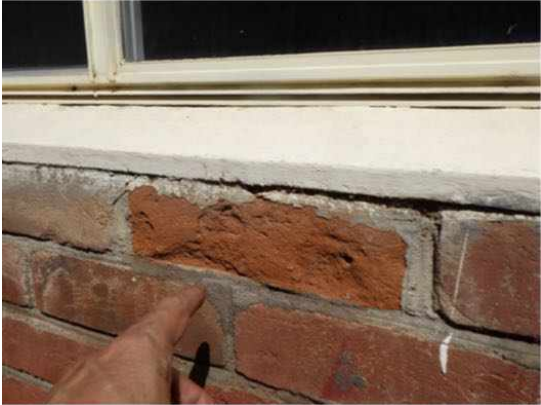
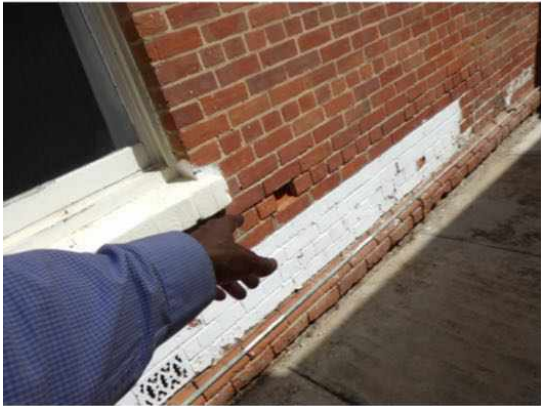
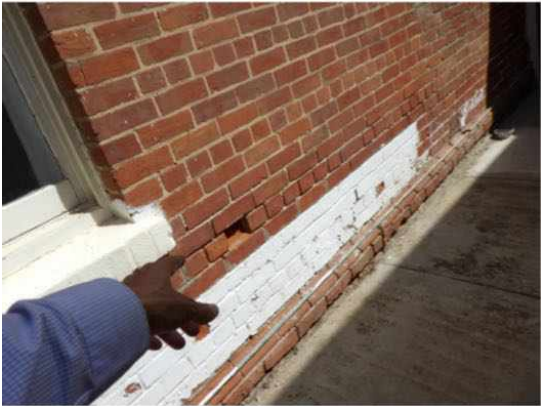
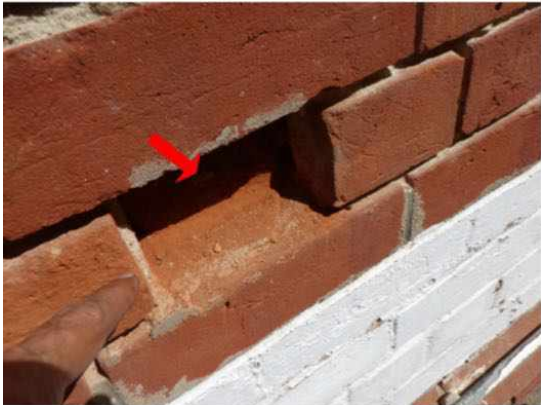
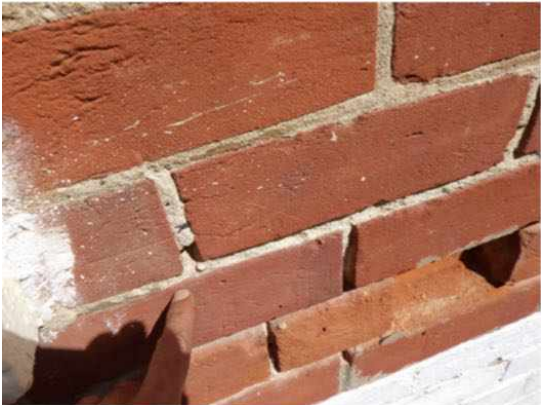
Defects 3.02

Building:	Building 1
Location:	All External Areas
Finding:	Brickwork - Deterioration
Information:	Deterioration was evident to sections of the brickwork in this area at the time of inspection. Commonly referred to as brick corrosion or erosion, the bricks are aged and likely to have been affected by a variety of factors, including weather exposure, damage, salt-based deterioration, and more.

Overtime, these factors can affect the bricks, causing them to become brittle and appear corroded or eroded. The mortar in the brickwork may also become powdery, further detracting from the structural integrity of the brickwork. If left unmanaged, potential implications include further deterioration of the building materials, the development of secondary defects, and potential development of structural instability of the wall.

Where this degree of damage has already occurred, you should consult a Building Surveyor or Engineer to seek advice regarding the structural stability and load bearing

capabilities of the wall. Such consultation is always required prior to performing any remedial works on the affected brickwork.

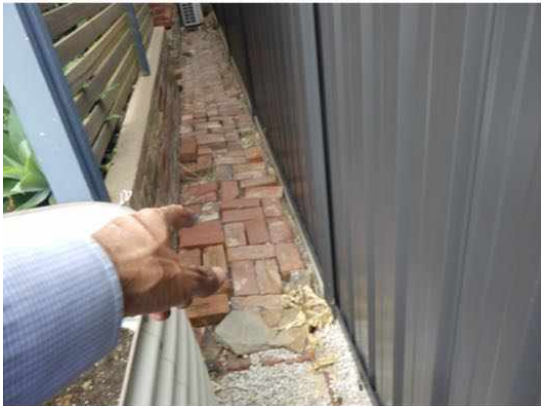
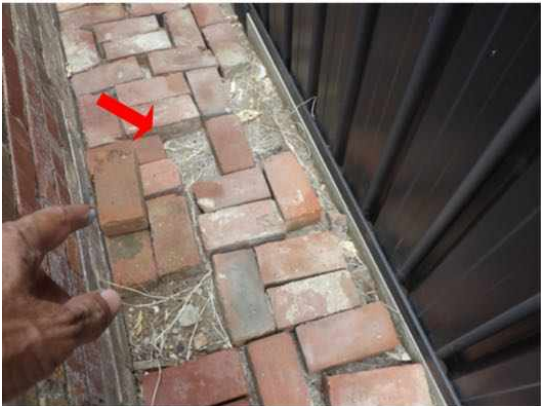
Defects 3.03

Information: Sections of the external paved area are uneven, creating a potential trip hazard. It appears as though the area has been subject to rough installation, or that paving sections have lifted due to movements in the foundation of the property.

Where paving creates a trip hazard, personal injury may ensue if due caution is not taken by all persons within this area.

Re-paving of the area is required as soon as possible to remedy this situation. Further consultation with a specialist concreter is advised.

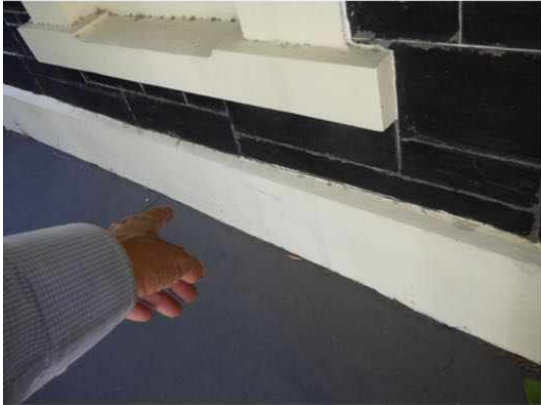
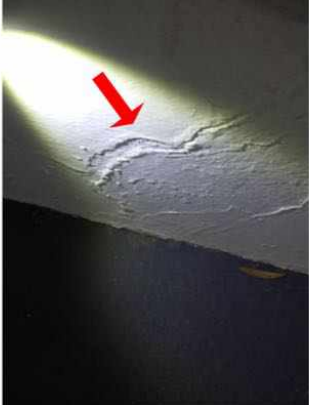
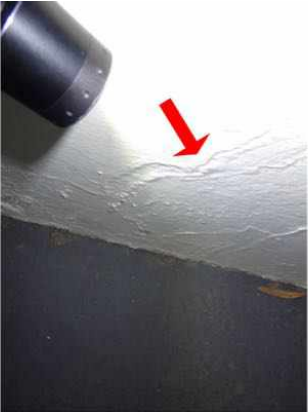
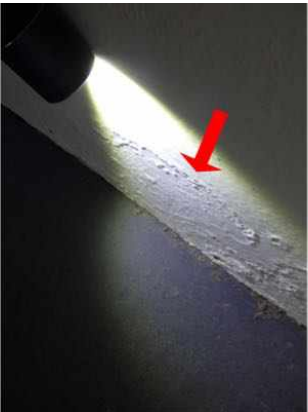
Defects 3.04

Building:	Building 1
Location:	All External Areas
Finding:	Plaster - Drummy
Information:	Sections of plaster sheeting in this area appear to be drummy. The term 'drummy' is used to describe plaster which, whilst solid, has become detached from its original fixing.

The most common causes of plaster failure are physical damage and moisture damage. Moisture causes plaster to swell and shrink as the humidity of the air changes, or as a consequence of leaks, which can be enough to create drumminess or cracking.

Drummy plaster generally needs chemical re-adhesion or to be screwed back to the substrate, with minor consequent patching and painting required.

Ensure that the general environment is free of moisture and humidity to aid in the prevention of drummy plaster and plaster damage. Appointment of a qualified plasterer is advised in order to complete remedial works as necessary.

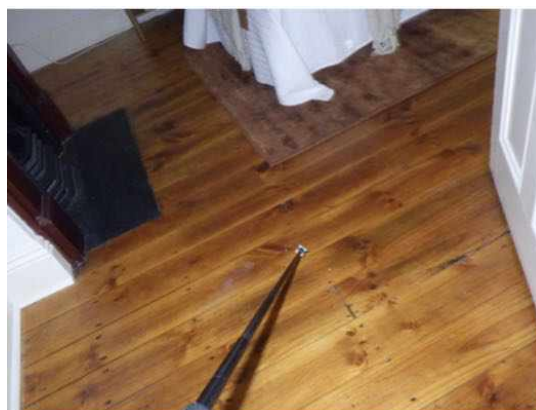
Defects 3.05

Bouncy floors generally indicate that the floorboards or the subfloor structures are coming loose from the joists that they are installed on. Bouncy flooring may also be the result of gaps between flooring and stumps or joist structures, which require packing.

The client is advised to seek quotations for required repairs from a Registered Builder specialising in re-stumping. The potential resolution may range from packing gaps in subfloor structures through to replacement of subfloors stumps and refixing of flooring.

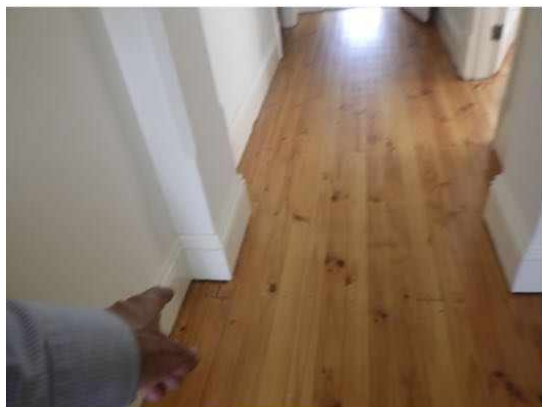
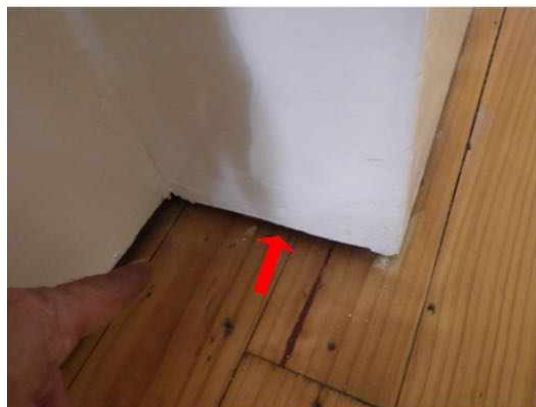
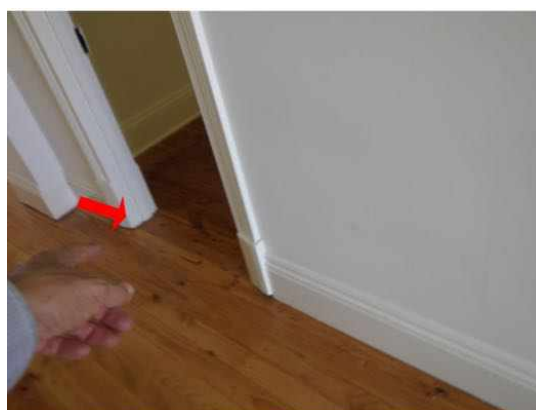
Defects 3.06

Building: Building 1
Location: All Internal Areas
Finding: Timber flooring - Gaps to edges
Information: Considerable gaps were noticeable around door jambs and edges of flooring. These gaps serve the purpose of allowing the flooring material to expand and contract, which is expected due to moisture levels and humidity.

While purposeful, these gaps make the adjoining building elements prone to water penetration, creating potential for the development of secondary damage.

While beading is used in most places to cover this gap around smaller corners, it is recommended that these gaps be filled with a coloured caulking compound. Such works should be performed by a qualified carpenter or general handyperson, and should be completed at the discretion of the client.

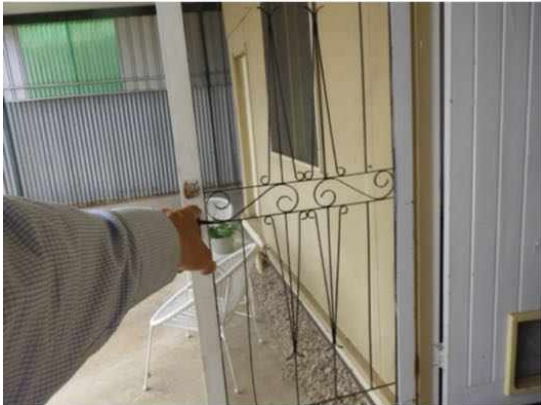
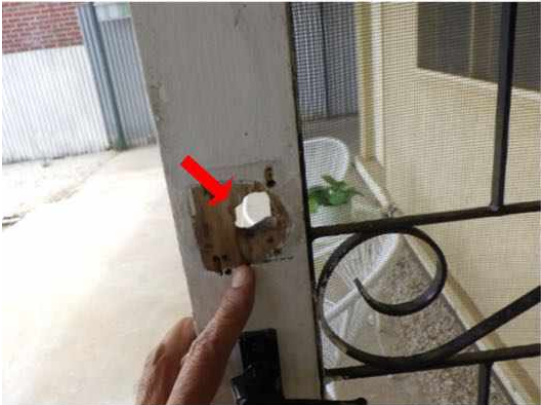
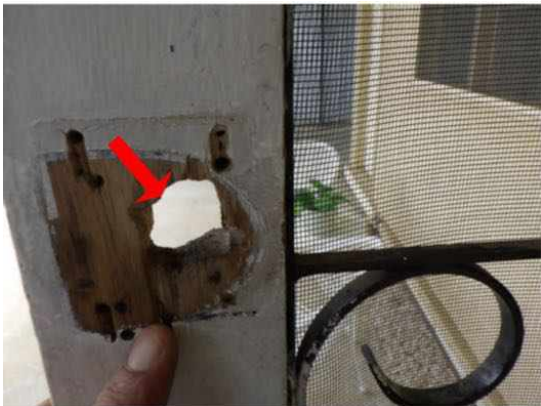
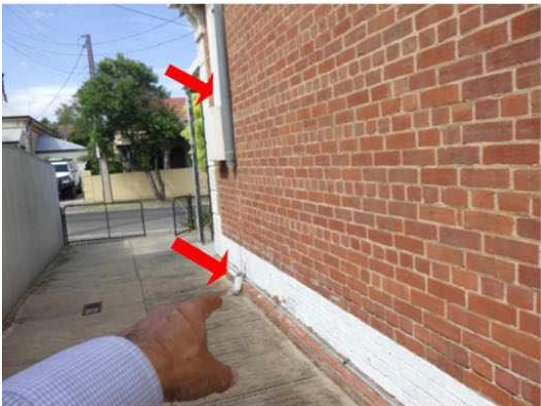
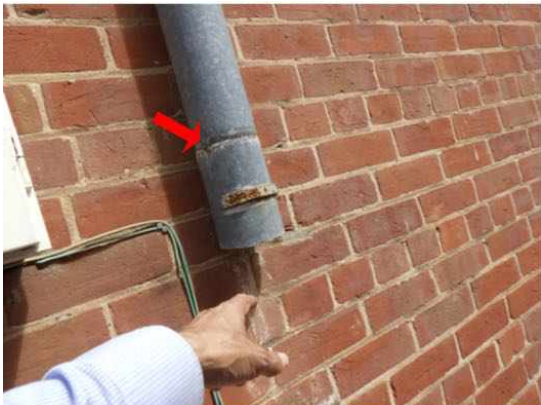
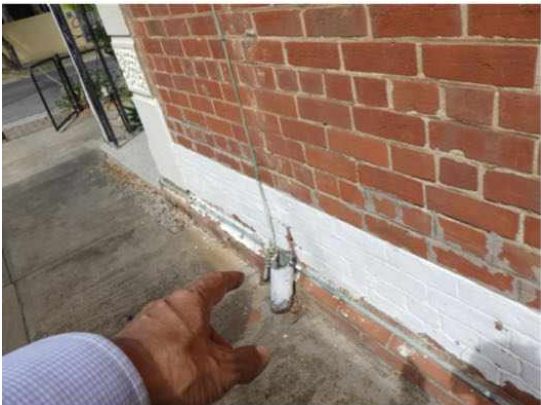
Defects 3.07

Building:	Building 1
Location:	All Areas
Finding:	Building element - Damaged
Information:	At the time of inspection it was noticed that rear flyseen door frame assembly and pipe were damaged

Breakage occurs generally when the building materials have either aged and decayed, or as a result of damage (accidental or deliberate).

Repair and/or replacement of broken elements is advised to ensure that additional secondary defects do not arise as a consequence. Such works are necessary, as all building elements play a key role in the operation and function of the overall structure and its performance.

A relevant tradesperson should be appointed to repair or replace the affected building element prior to any subsequent damage being caused.

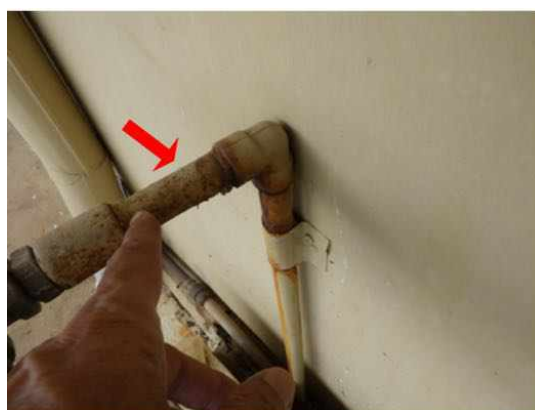
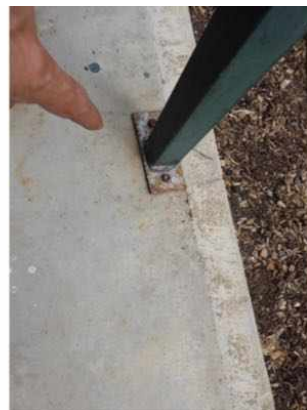
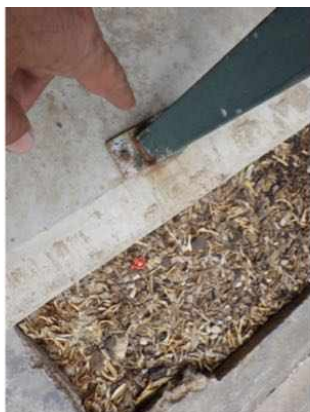
Defects 3.08

Building:	Building 1
Location:	All External Areas
Finding:	Building element - Rusted or corroded
Information:	This building element shows evidence of rusting and corrosion, which is likely to have developed as a result of excessive exposure to moisture and or inadequate coatings.

As surface rust provides no protection to the underlying iron, the deteriorating condition is likely to worsen if not addressed in the short-term future.

Where possible, the use of galvanized (treated) metals or aluminium coated metals aid in rust prevention, as does regular general maintenance. Rust formation can be controlled with coatings, such as paint, that isolate the iron from the environment.

Rusting and corrosion should be managed by ideally removing or limiting the affected surface from exposure to moisture. A registered builder may be appointed to replace any building elements that have been severely affected by rust or water damage.

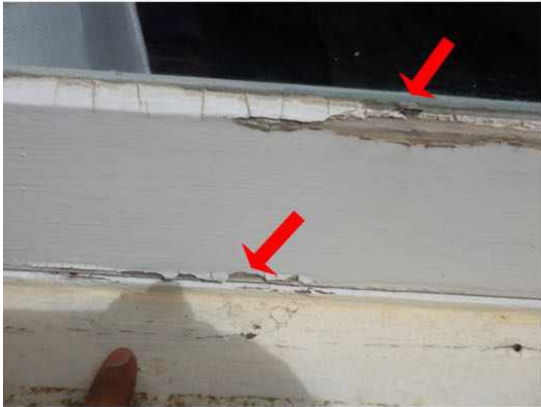
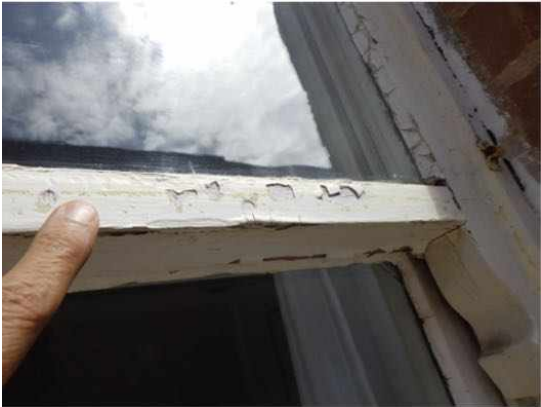
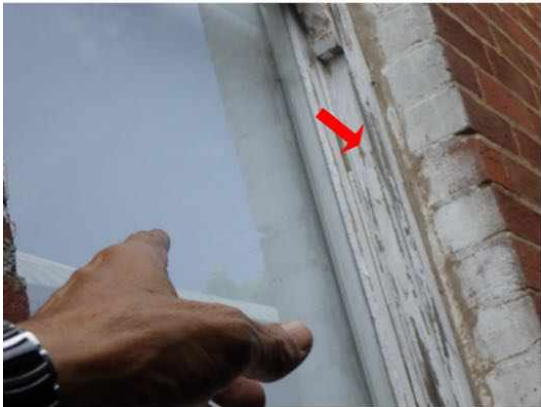
Defects 3.09

Building:	Building 1
Location:	All External Areas
Finding:	External painting deteriorated
Information:	Much of the external paintwork including but not limited to windows, fascias, guttering, veranda and other external fitments have been neglected and require attention to prepare and re-paint.

Whilst incomplete or missing paint finish is generally an appearance defect, it can also lead to the development of secondary building defects over time. Incomplete areas of paint finish expose the area to moisture, potentially accelerating the deterioration of underlying building materials.

Degraded paint finishes should be sanded back, filled, leveled and painted, as applicable. Where inadequate or missing paint protection has led to the deterioration of the associated building element, repair and/or replacement of this building element may be required.

A painting contractor should be appointed as soon as possible to perform necessary works to aid the appearance of the affected area and to ensure the area is protected against further deterioration. Alternatively, the homeowner following manufacturer instructions may perform these works.

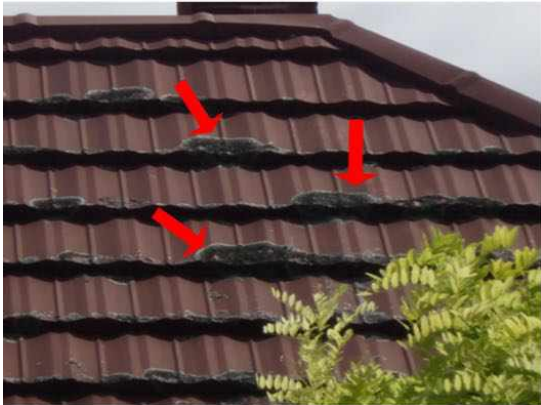
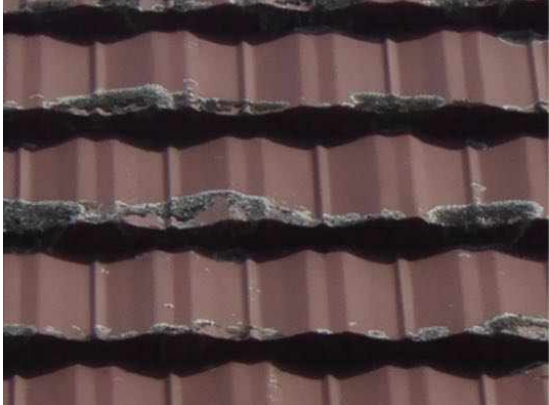
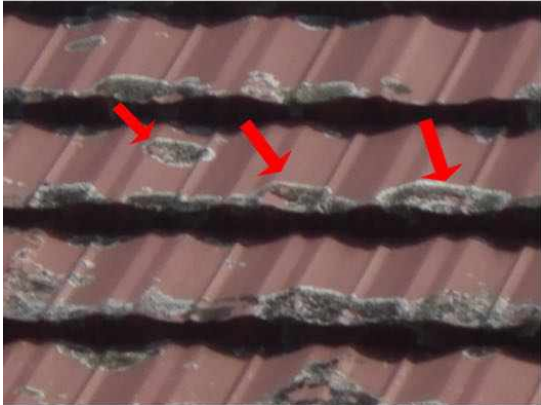
Defects 3.10

Building: Building 1
Location: All Internal Areas
Finding: Roof sheets - Weathered
Information: Upon inspection of the exterior roofing, the majority of roof sheets were assessed to be in fair condition. General weathering was noted, which appears consistent with the age of the property.

While no significant defects were observed at the time of inspection, ongoing maintenance works are required to maintain the serviceability and weatherproof performance of the roof covering and to reduce the risk of future deterioration.

Where left unmanaged, deteriorating roof sheets are likely to lead to a number of secondary defects, including minor water leaks and weather exposure to internal roofing structures.

Consultation with a roofing contractor is highly advised to gain advice on cost of remedial works that may be required in the short to medium term. Remedial works are likely to increase the longevity of the exterior roofing structure.

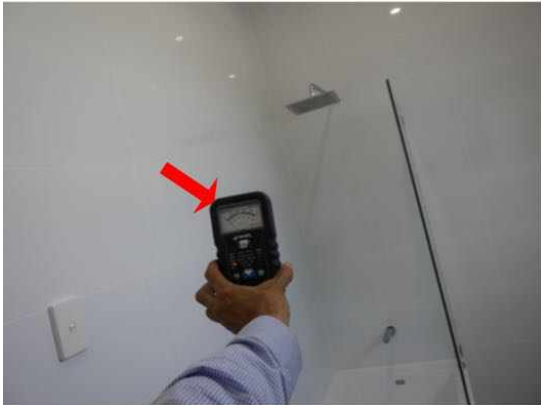
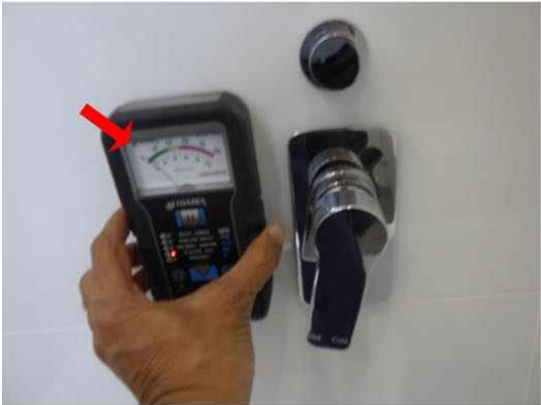
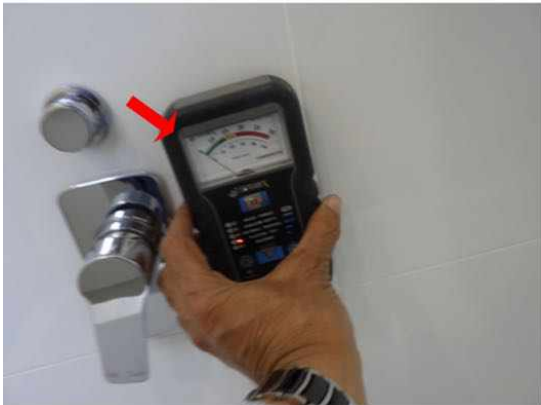
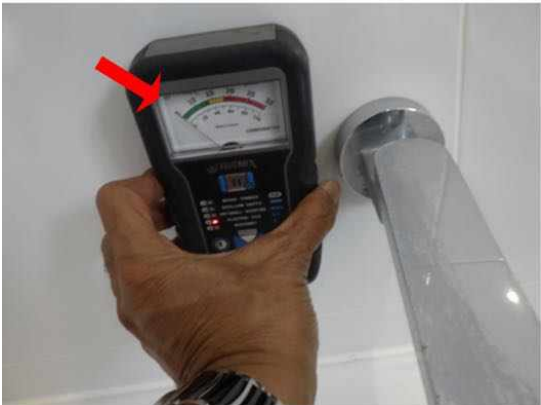
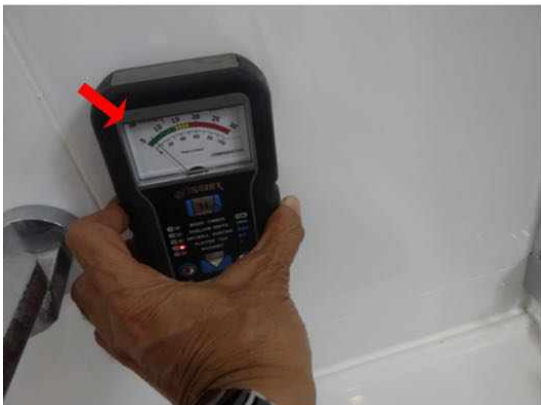
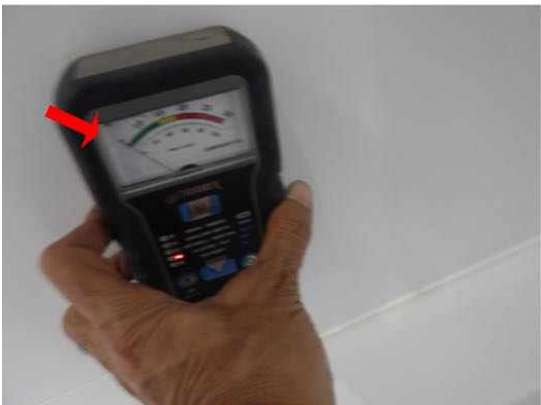
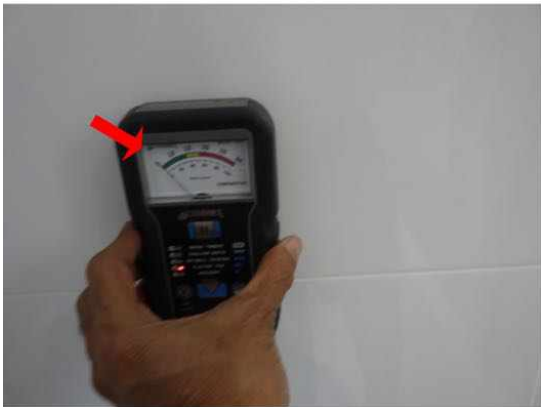
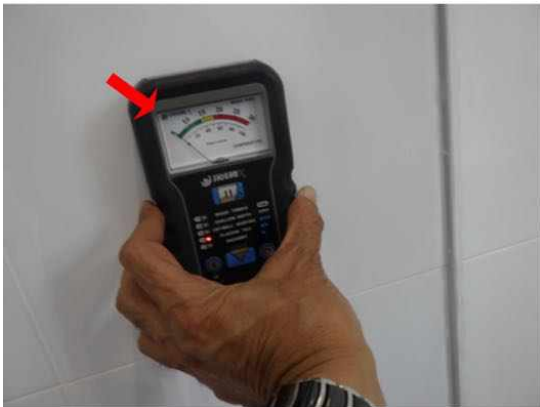
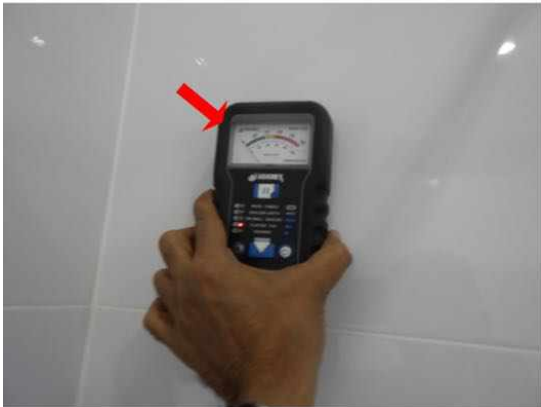
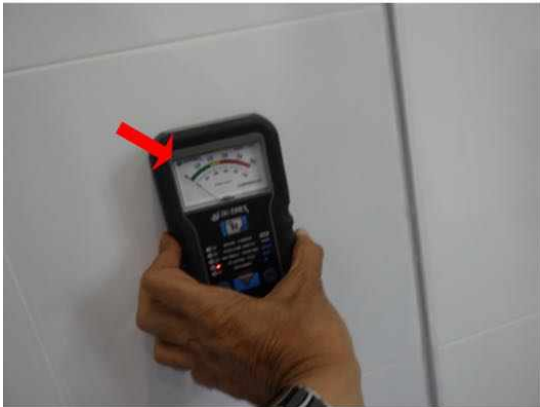
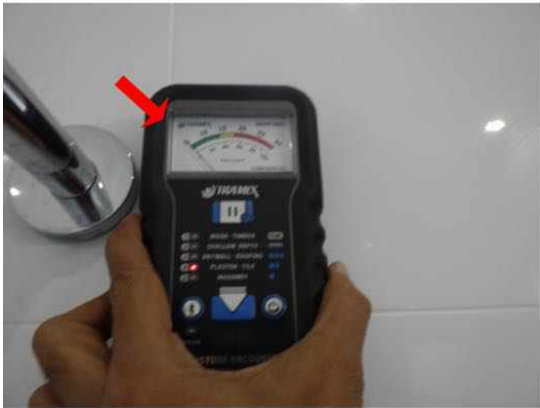
Precautionary Information:

Damp (or structural damp) refers to the presence of unwanted moisture in the structure of a building, either as the result of intrusion from outside, or condensation from within the structure. In the shower area, internal water leaks or other sources of excessive moisture are generally the cause of damp.

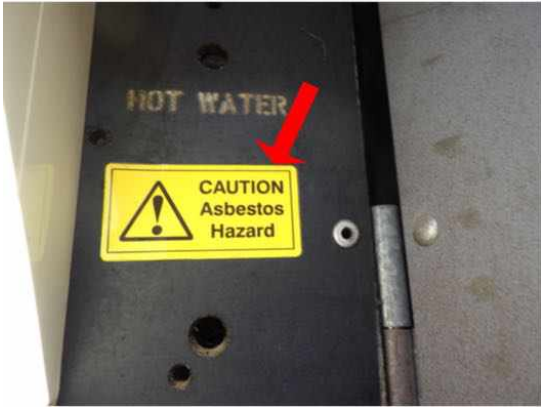
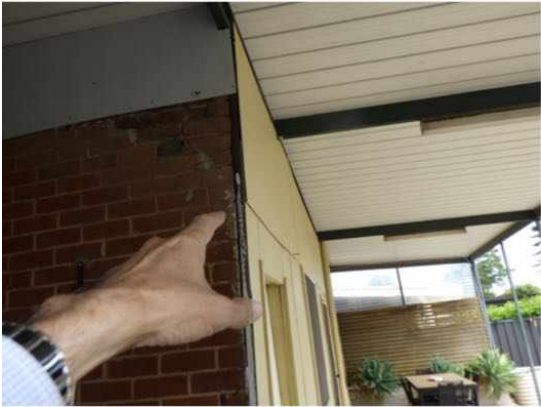
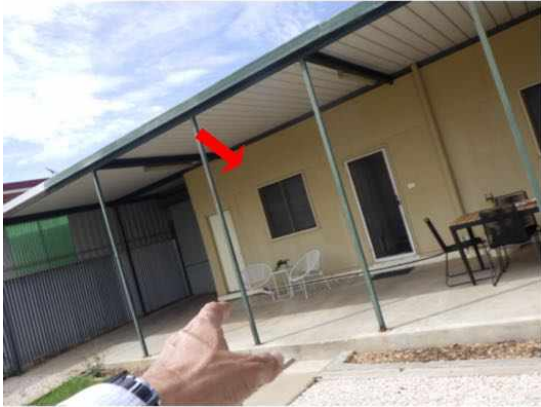
Noted Item

Building: Building 1
Location: All External Areas
Finding: Asbestos - Suspected ACM Identified on Site
Information: Reporting on Asbestos is outside the Scope of this Report. This suspected defect is highlighted as a caution only. We suspect, based on our experience in the building industry, that there is a higher risk of the identified building element containing asbestos.

As Asbestos Reporting is outside the scope of this report, we advise that you consider a separate Asbestos Inspection and Condition Audit, which can include the taking of samples for definitive confirmation of the presence of Asbestos.

In the interim, the client is advised to act with caution, especially when considering any damage to building materials general wear and tear renovations extensions demolition and general maintenance activities due to the suspected presence of Asbestos.
