Building Inspection Report

Inspection Date: Fri, 27 Feb 2026

Property Address: 16 Avenue Rd, Prospect SA 5082, Australia

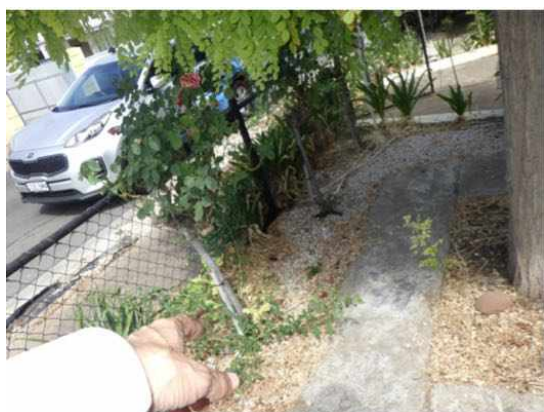
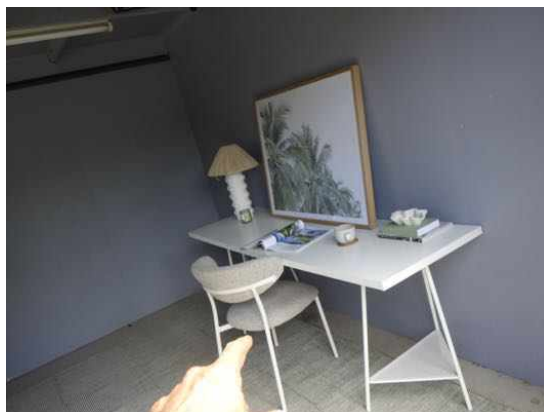
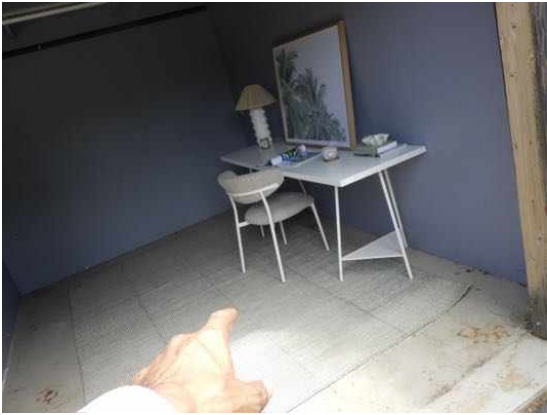
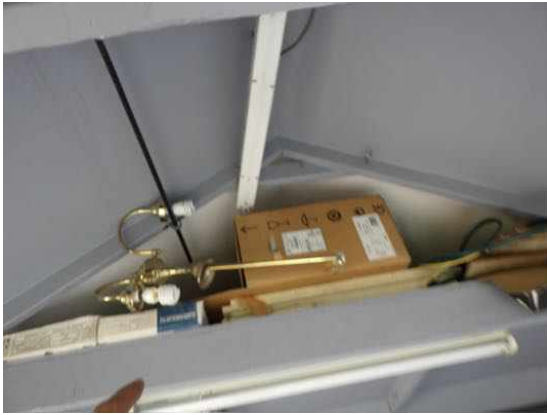
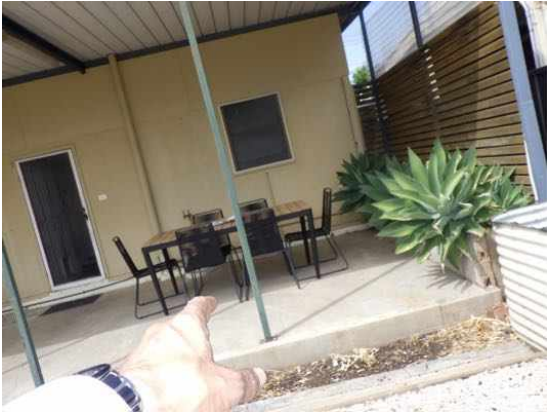
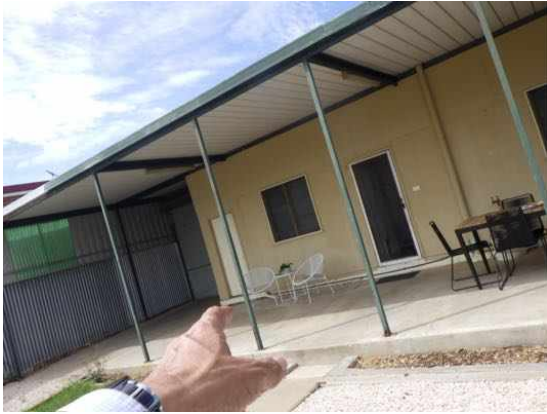
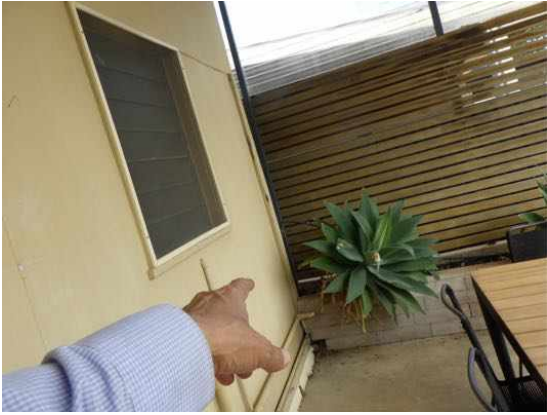
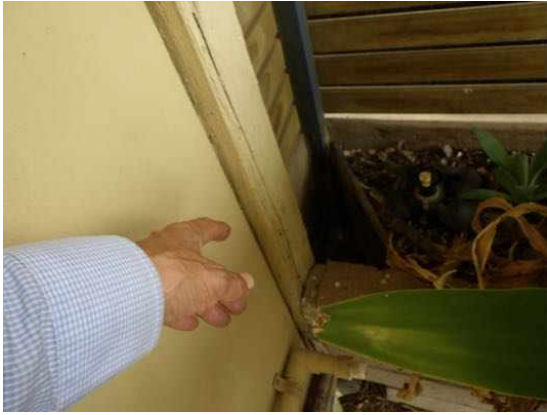
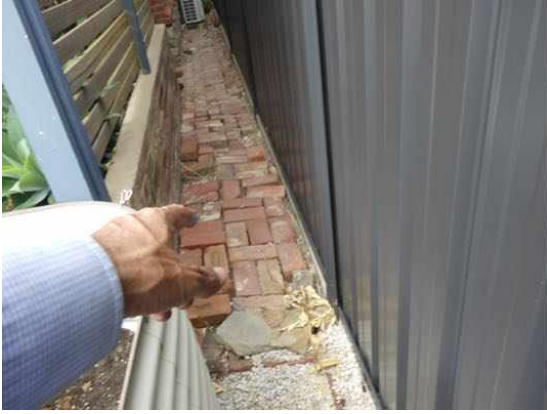
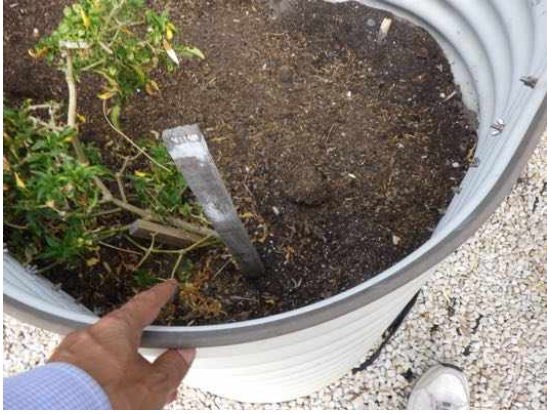
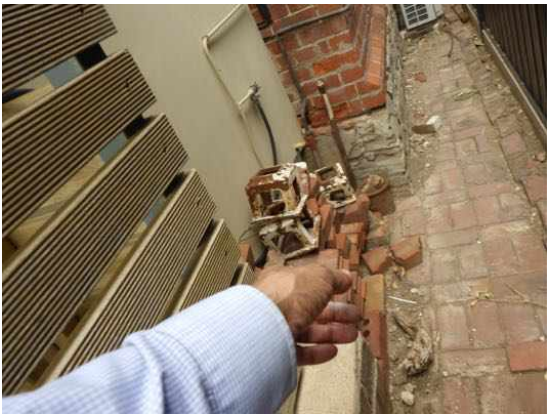
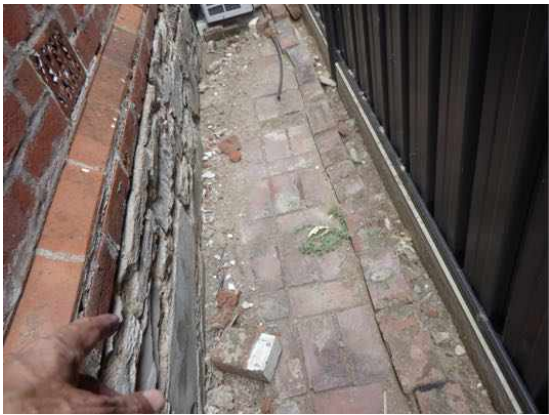
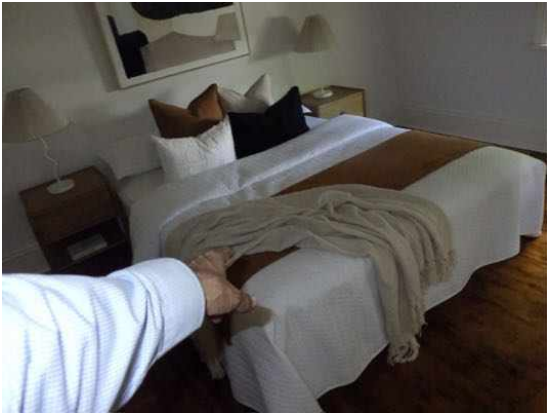
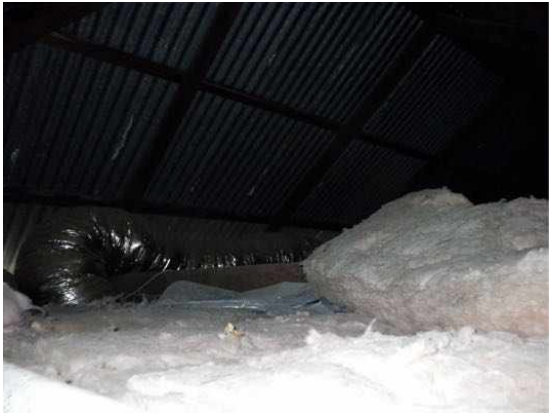
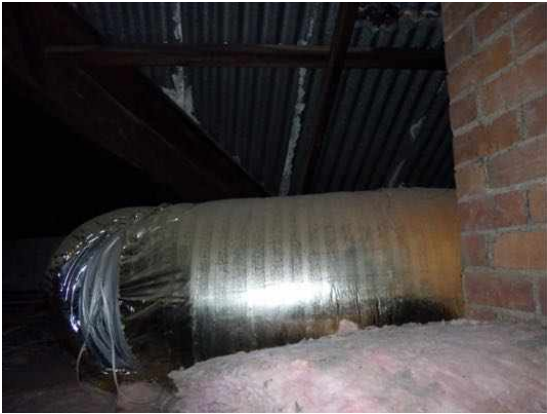
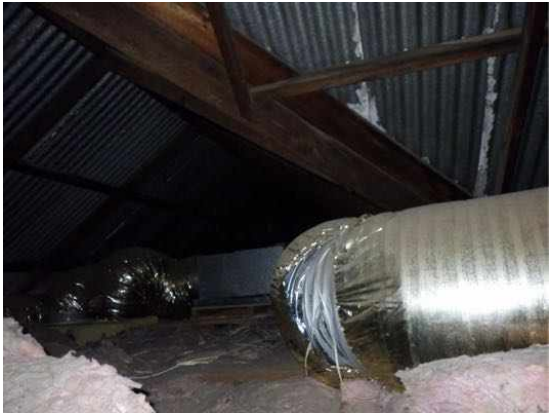
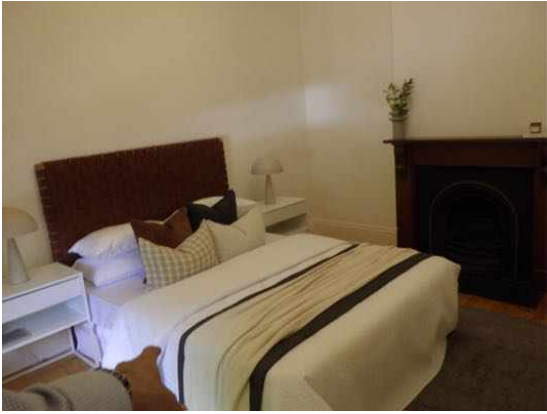
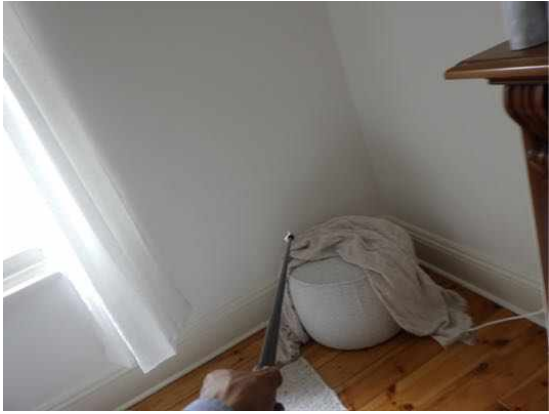
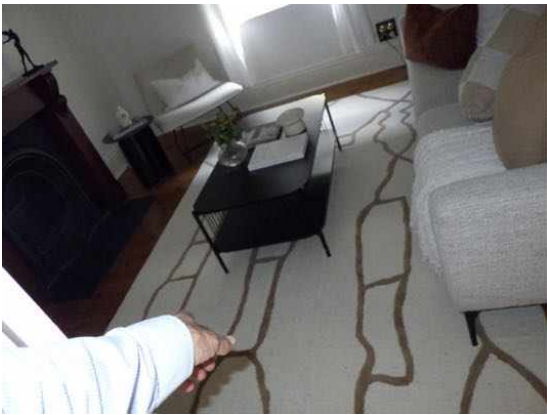
Noted Item

Building: Building 1
 Location: All Areas
 Finding: Additional Photos - Obstructions and Limitations
 Information: These photographs are an indication of the obstructions and limitations which impeded full inspection of the property at the time of inspection. These obstructions can hide an array of defects and should be removed to allow full inspection to be carried out. A re-inspection is recommended once the areas are made accessible.

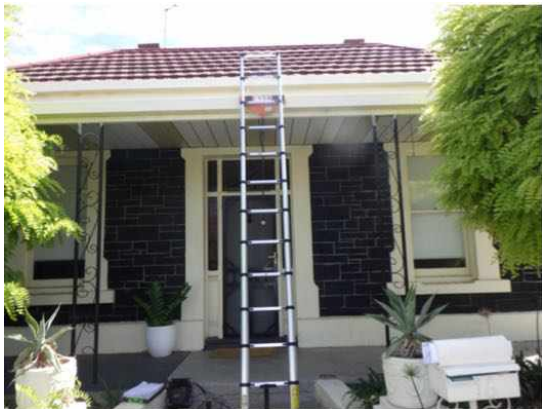
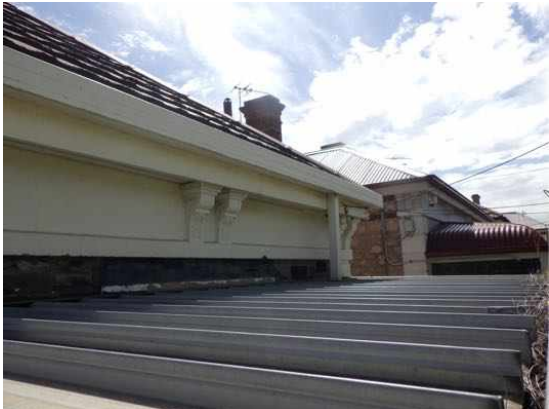
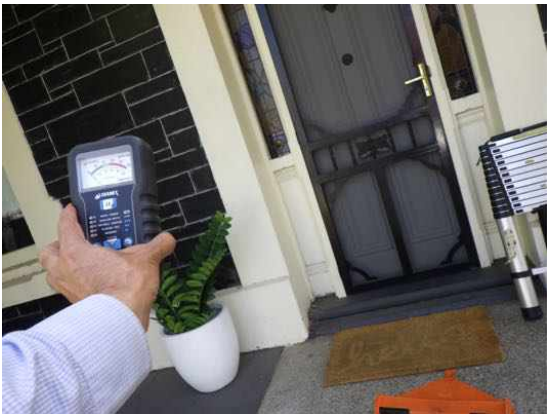
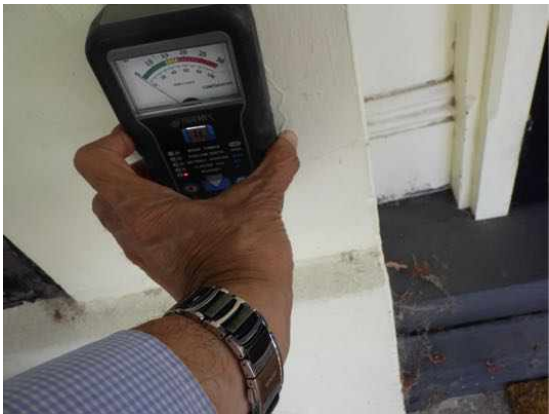
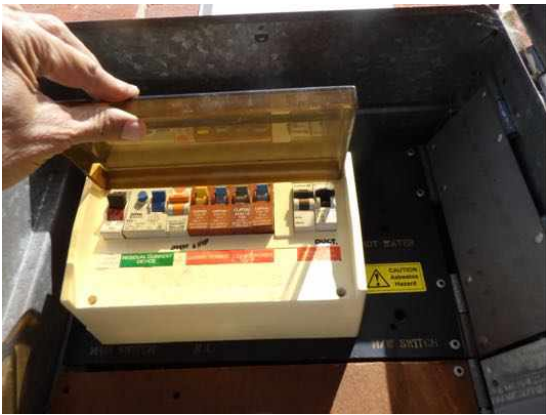
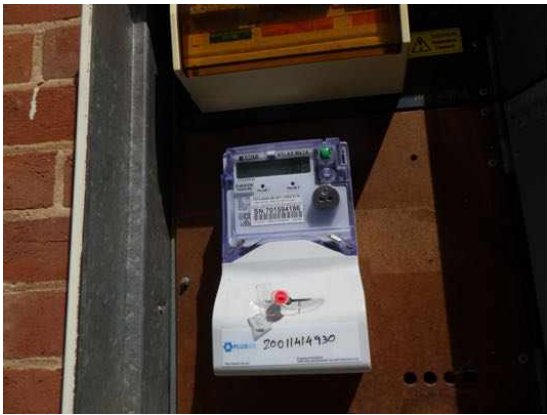
Building: Building 1
Location: All Areas
Finding: Additional Photos
Information: Additional photos are provided for your general reference
