Building and Timber Pest Inspection Report

Inspection Date: Tue, 3 Feb 2026

Property Address: 14 Gladstone Wy, Edgeworth NSW 2285,
Australia

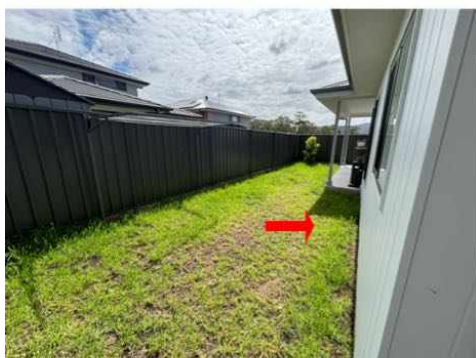
Finding 3.01

Building:	Main Building
Location:	Yard - Back
Finding:	Inadequate Site Drainage - Exterior Areas
Information:	At the time of inspection, minor site drainage issues were observed in the backyard, where ground levels appear to fall towards the dwelling, allowing surface water to drain toward the property. While no active water ingress was observed at the time of inspection, this condition has the potential to contribute to moisture-related issues over time. The client is advised to slightly raise and regrade the ground levels so that surface water is directed away from the property, in accordance with good drainage practice. It is recommended that a qualified landscaping contractor be engaged to assess and undertake the required regrading works to improve site drainage and reduce the risk of future moisture issues.

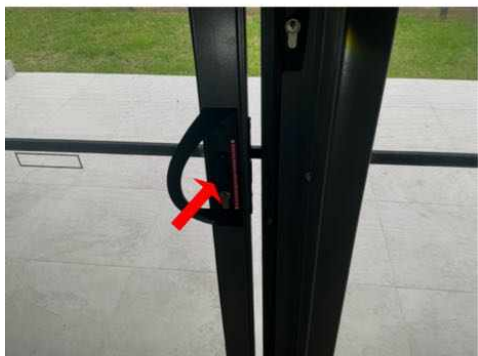
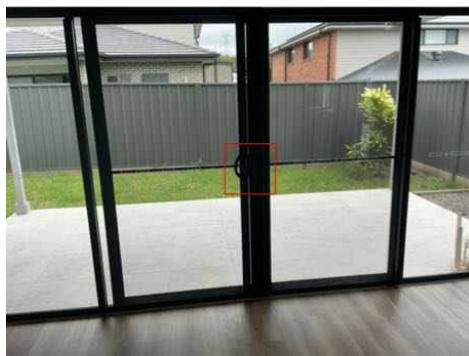
Finding 3.02

Building:	Main Building
Location:	Living Room
Finding:	Lock - Not working
Information:	The lock in this area was not operational at the time of inspection. Where locks have

deteriorated to a point where they are no longer usable, the security of the property is immediately compromised.

Repair or replacement of the lock is highly recommended. Consultation with a locksmith or general handyman is required to gain further advice on any added security that may be available for the area.

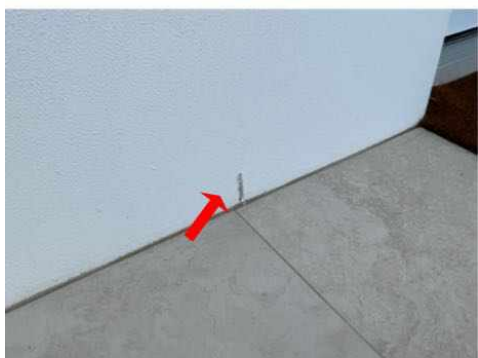
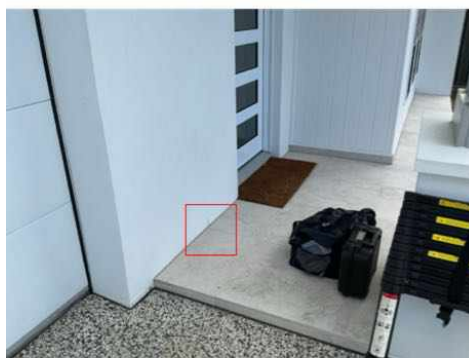
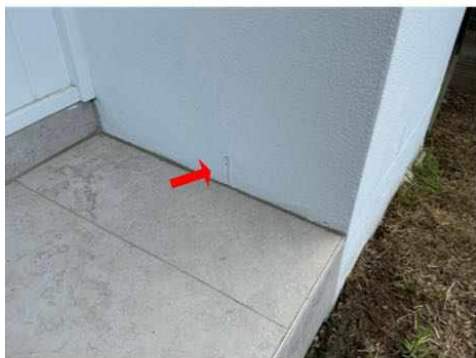
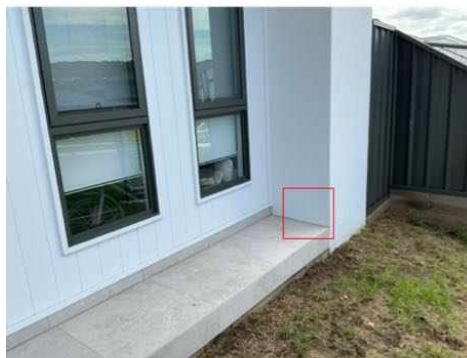
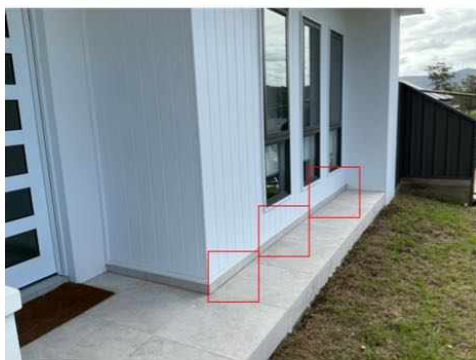
Finding 3.03

Building:	Main Building
Location:	Exterior walls - front
Finding:	Weep Holes - Blocked & At Ground Level
Information:	At the time of inspection, weep holes were observed to be blocked, and on ground level. This condition can trap moisture within the wall cavity and allow concealed termite entry by bridging the inspection zone. Clearing the weep holes and reducing ground levels below the weep holes is required to reduce moisture issues and termite risk. Consider engaging a licensed pest controller to carry out a termite treatment around the perimeter of the building.

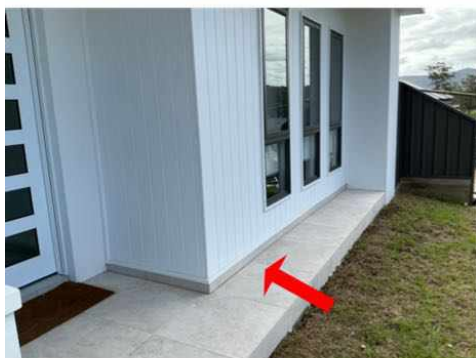
If the slab edge is not properly exposed there is a high risk of termite attack. Sometimes, in order to determine the type of slab, a suitably qualified person such as an architect or builder may be required to consult the construction plans.

Where the slab edge cannot be properly inspected, it is highly recommended that termite or timber pest inspections be carried out every 6-12 months to aid protection of the property against infestation.

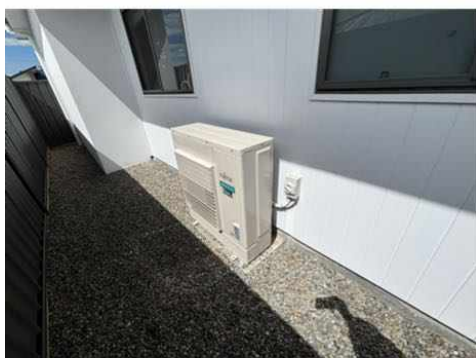
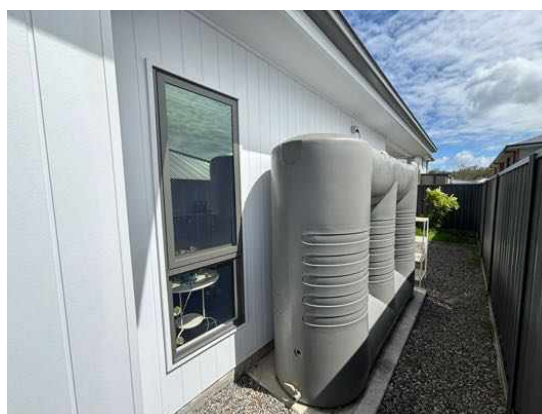
Finding 6.02

Building: Main Building
 Location: All Areas
 Finding: Bridging Appliances/Water Tanks - Attachment to Buildings
 Information: Bridging occurs when items against a building provide a concealed entry point for termites into the building or by passing around a termite management system.

Where any part of an attachment to a building is not isolated and is not provided with a clear gap of not less than 25mm from the building, bridging occurs. Attachments to buildings such as hot water services, downpipes, verandahs, decks, steps, fences, service conduits and the like provide the opportunity for concealed entry.

Building attachments of this nature need to be frequently inspected for termite activity by a qualified inspector.

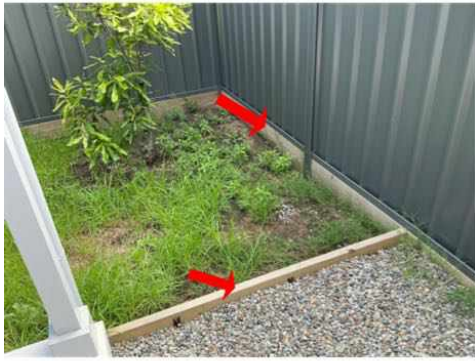
Finding 6.03

Building:	Yard
Location:	Yard - Back
Finding:	Building Materials in Direct Ground Contact - Conducive to Termites
Information:	Timber elements that are in direct contact with the ground and exposed to moisture or damp conditions are highly conducive to termite activity. This susceptibility arises because timber, when in contact with soil and dampness, creates an environment that is particularly attractive to termites, encouraging infestation and potential structural compromise. Whether the timber is used as a part of the building's construction or incorporated into fencing, its presence near or on the ground can become a pathway for termites to access and damage the property.

When exposed to excessive moisture, timber begins to deteriorate, developing conditions such as wood decay and rot. These compromised areas of timber are even more appealing to termites, as they are easier to infest and consume. This is especially true for untreated or non-durable timber, which lacks the protective treatments that can deter or withstand termite attacks. Termites can use these weakened, moisture-laden elements as a bridge into other parts of the structure, creating an entry point for potential infestations that can spread and cause extensive damage if left unchecked.

For any timber in direct contact with the external ground, special attention is required. The combination of moisture, untreated wood, and direct ground contact not only accelerates the decay process but also provides subterranean termites with a straightforward means of ingress into the structure. This entry can lead to termites moving undetected into other vulnerable areas, resulting in potentially significant structural issues and costly repairs.

To mitigate the risk of termite activity, it is imperative that any such materials or timber elements be appropriately treated or removed as soon as possible. Timbers that are necessary for use should be made durable through appropriate treatments and maintained to ensure they do not create conditions conducive to termites. Additionally, the client is advised to schedule regular termite treatments to maintain an effective barrier against infestations and ensure ongoing protection.

The client is strongly advised to assess the property for any timber elements that may be in direct contact with the ground and ensure prompt action is taken to remove or treat them effectively. Regular inspections, proactive maintenance, and consistent termite treatment are essential steps in minimising the risk of termite attack and protecting the structural integrity of the property. Taking these preventive measures is crucial for maintaining a termite-free environment and avoiding potentially costly damage and future repairs.

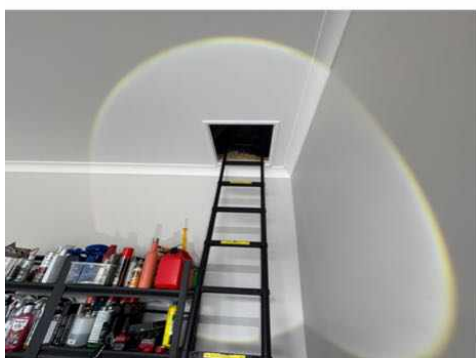
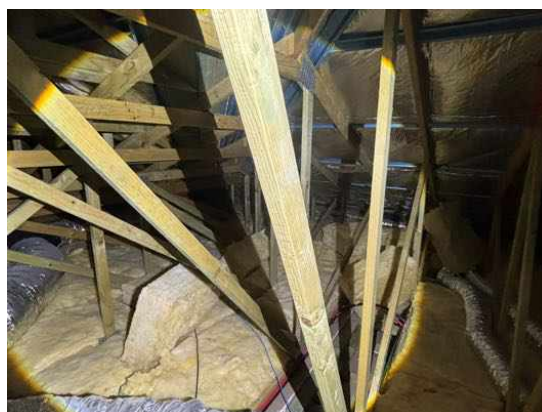
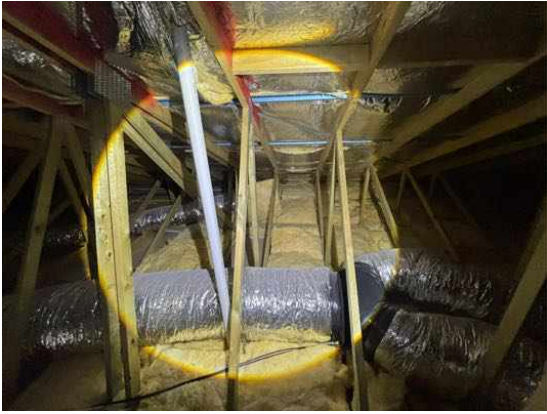
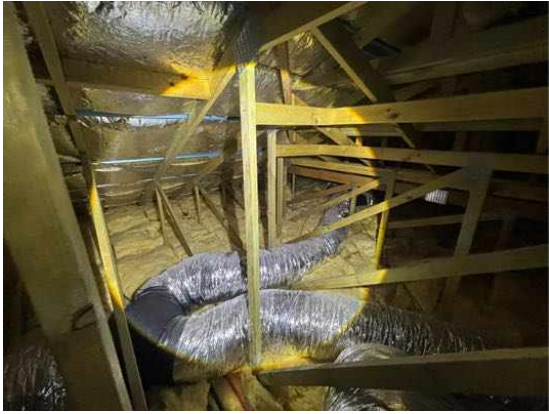
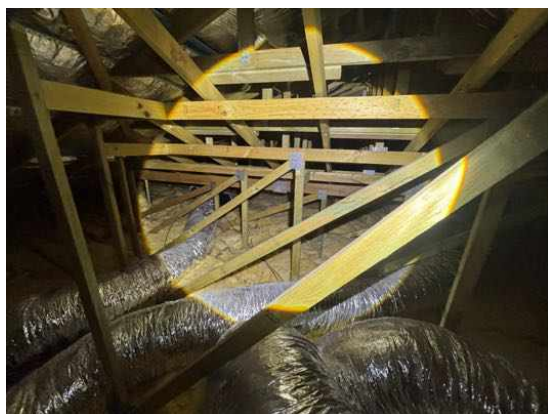
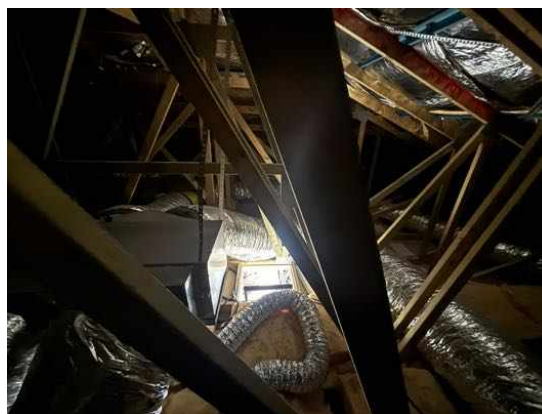
Noted Item

Building:	Main Building
Location:	Roof Void
Finding:	Obstructions, Limitations, and General Roof Space Condition
Information:	The photographs provided document both the general condition and the obstructions and limitations that were present in the roof cavity of the main building at the time of inspection. These obstructions—such as insulation materials, stored items, structural elements, or electrical wiring—restricted safe and adequate access to key areas within the roof space. As a result, a comprehensive inspection of all components could not be completed.

Obstructions of this nature may conceal a variety of potential defects, including damaged framing, compromised insulation, evidence of moisture ingress, pest activity, or electrical hazards. While no major issues were observed in the visible areas, the presence of these limitations means that some defects may remain undetected.

It is recommended that these barriers be removed or repositioned to facilitate full and safe access to the roof space. Once clear, a follow-up inspection should be conducted to allow for a thorough assessment of all concealed areas. This will help ensure that the condition of the roof cavity is accurately evaluated and any hidden issues are appropriately identified and addressed.

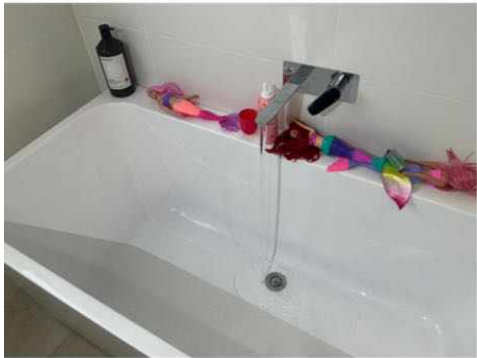
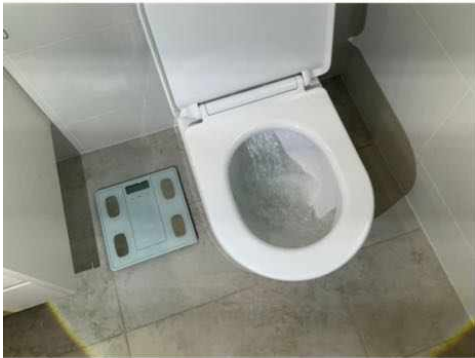
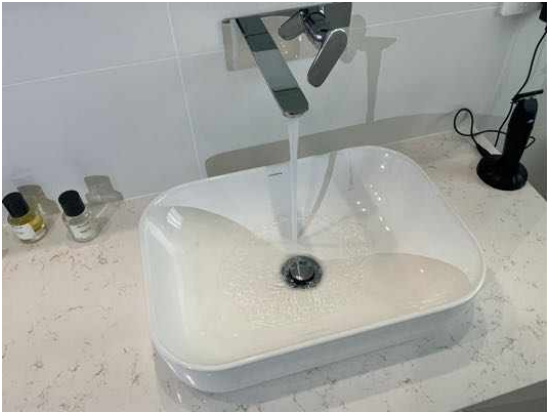
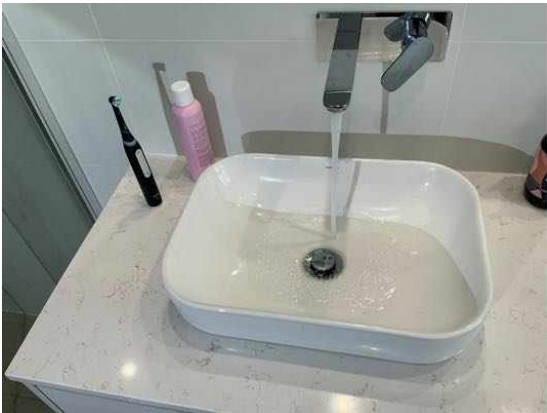
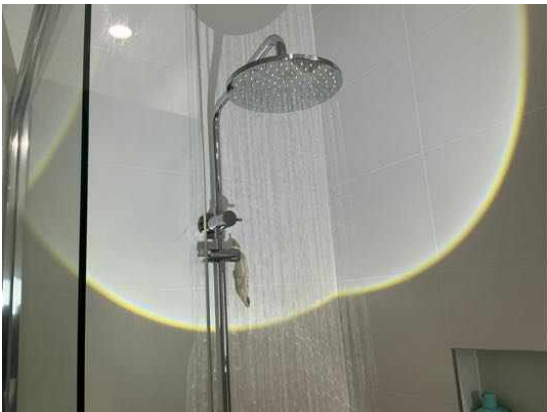
It is important to note that while a visual inspection of cupboards and cabinetry beneath sinks and vanities was undertaken, stored personal items and fixtures presented obstructions that limited full visibility of the internal areas. As per standard inspection practices, inspectors are not permitted to move or disturb personal belongings during the inspection process. Therefore, only visible and accessible sections were inspected, and concealed water damage or plumbing defects may not have been detected.

Given this, a re-inspection is recommended after all obstructions have been cleared to allow for a comprehensive assessment of these areas. Regular maintenance and monitoring of plumbing and drainage systems is also advised to ensure ongoing functionality and early detection of potential issues.

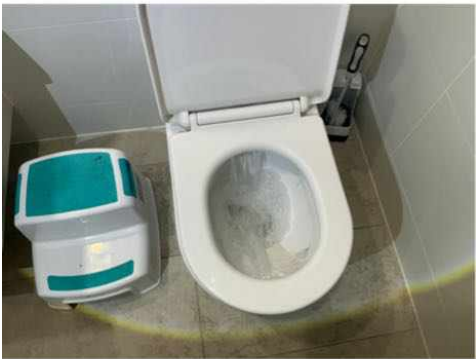
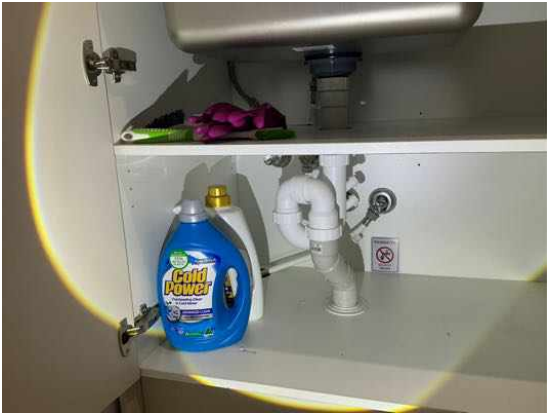
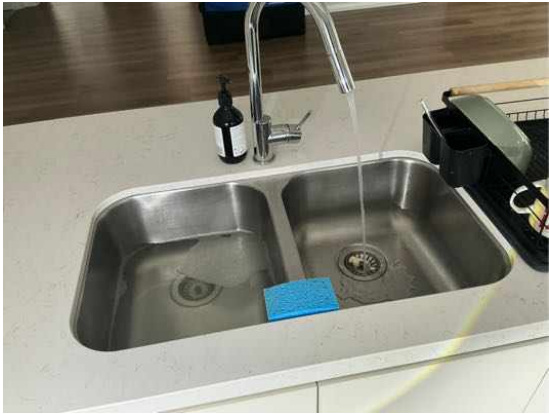
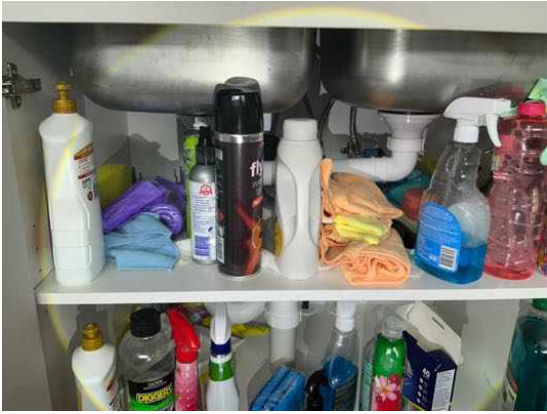
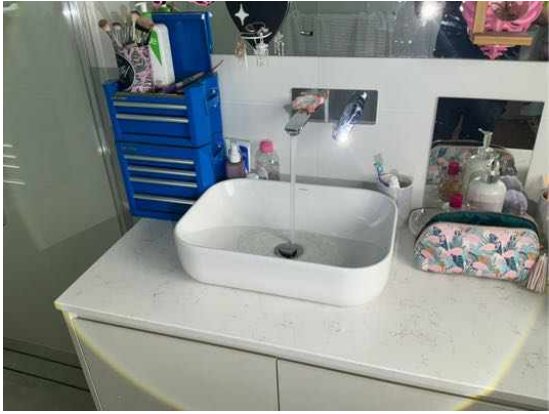
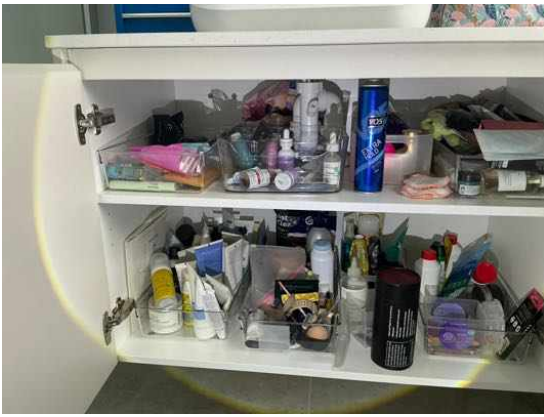
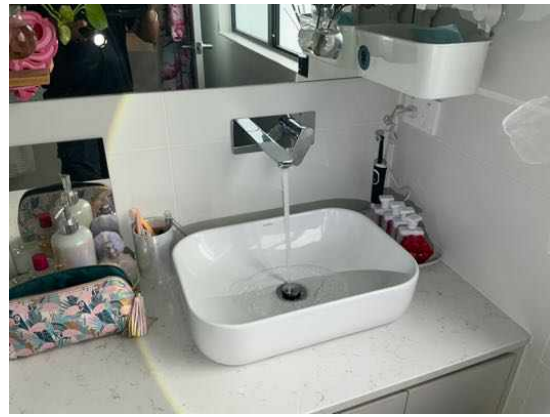
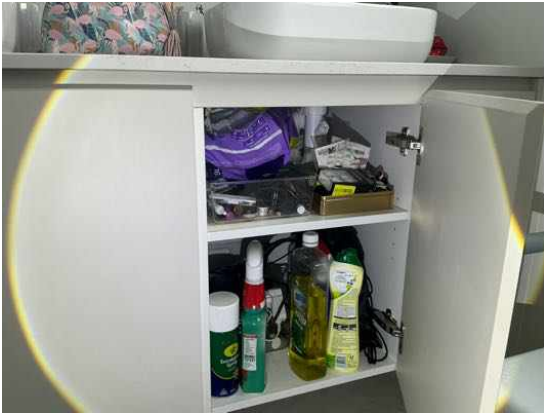
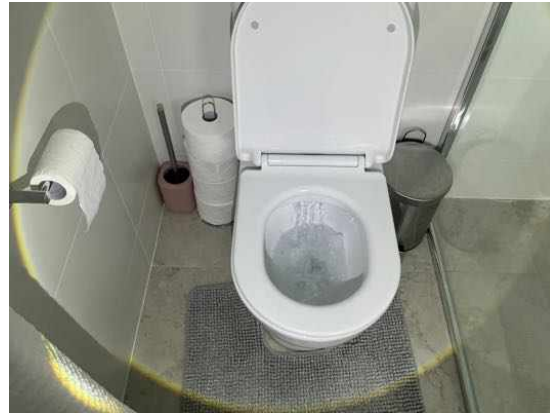
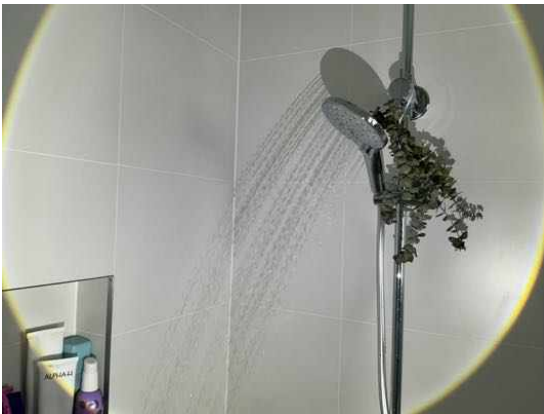
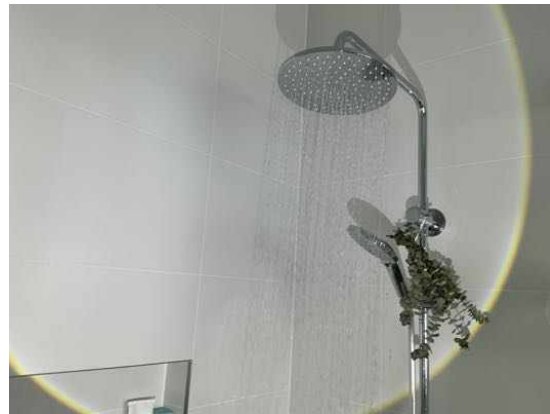
Building: Main Building
 Location: All Areas
 Finding: FYI - Taps, Drainage & Toilets Tested and Cabinetry Obstructions
 Information: During the inspection, all accessible taps, drainage systems, and toilets were tested for water flow and drainage efficiency, and checked for any visible signs of leakage. At the time of the inspection, no issues were noted in these areas. Unless highlighted in a separate defect statement, no immediate remedial work appears necessary. Supporting images may be found in the additional photos section for reference.

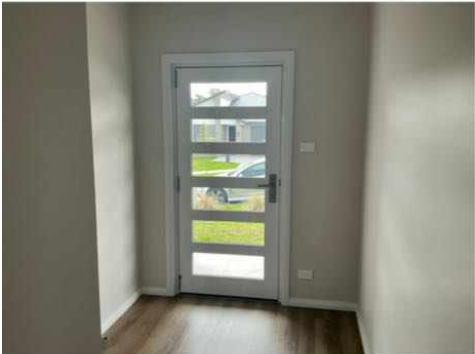
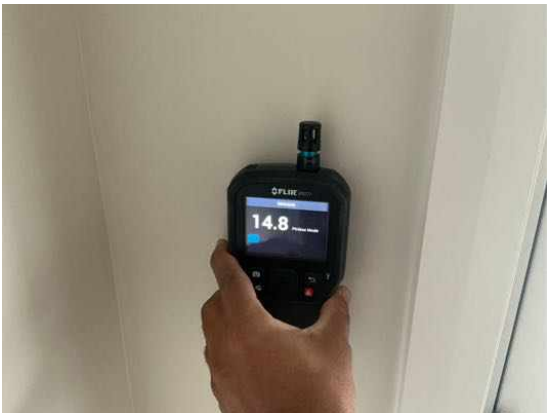
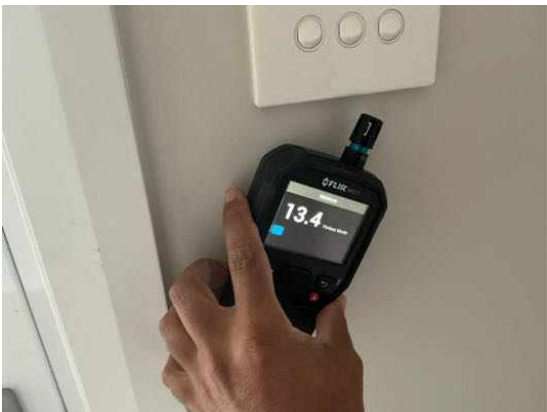
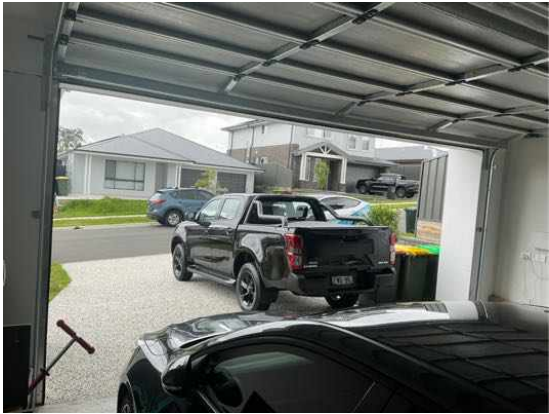
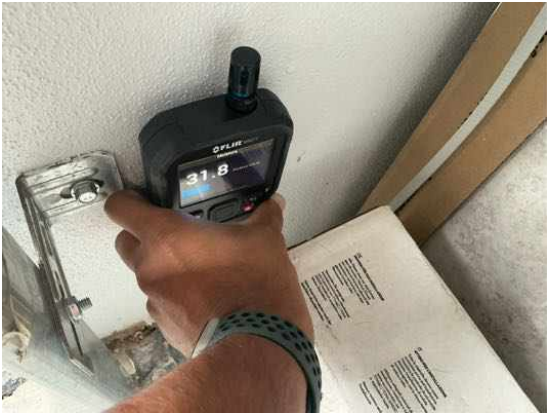
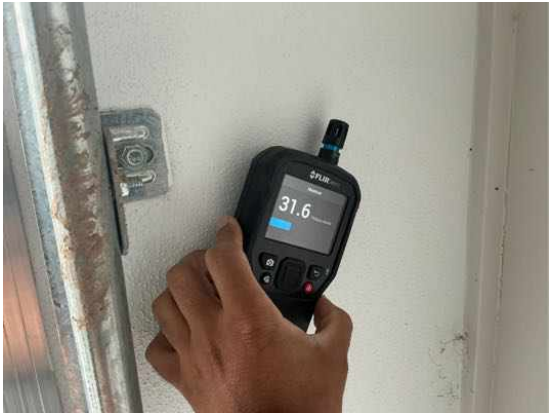
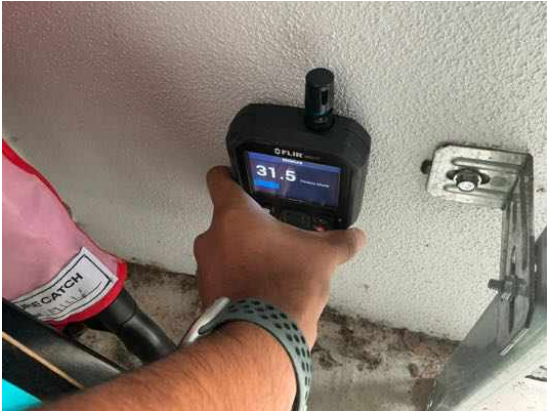
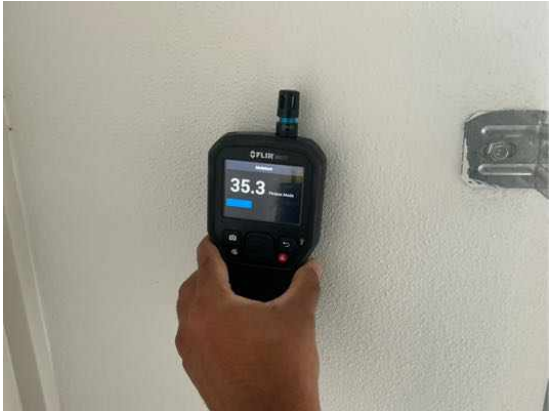
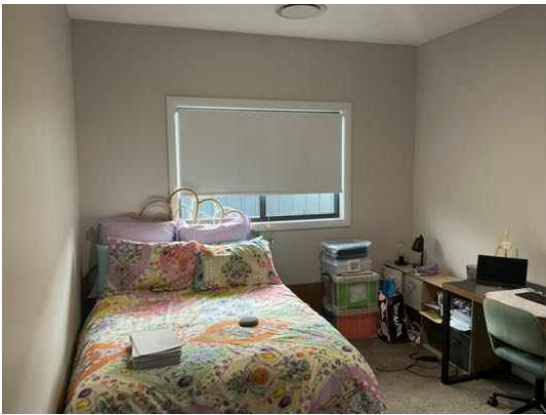
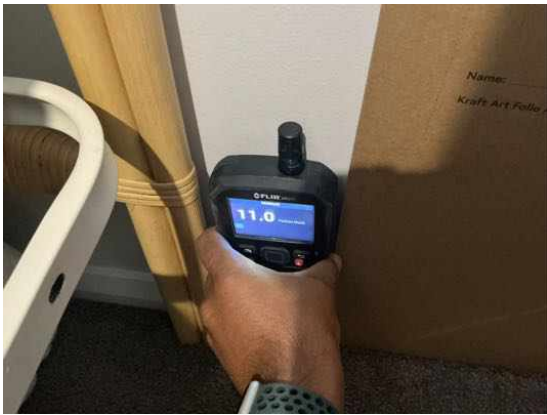
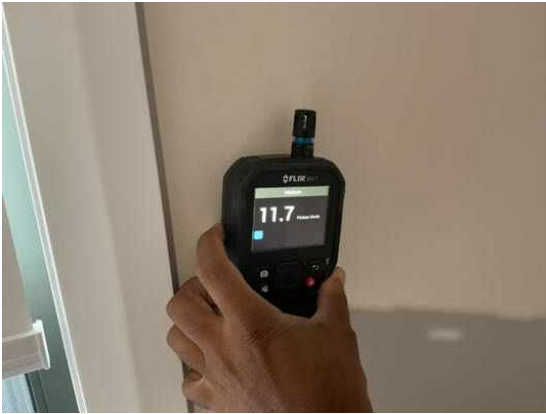
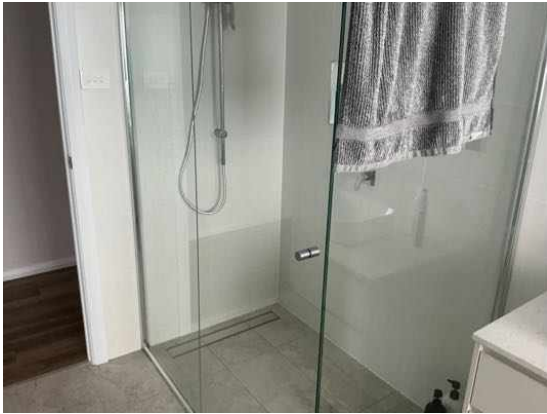
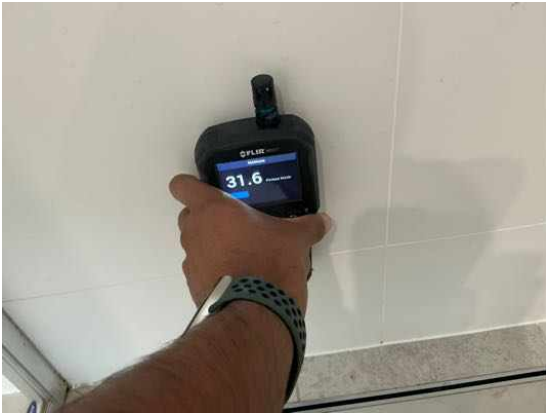
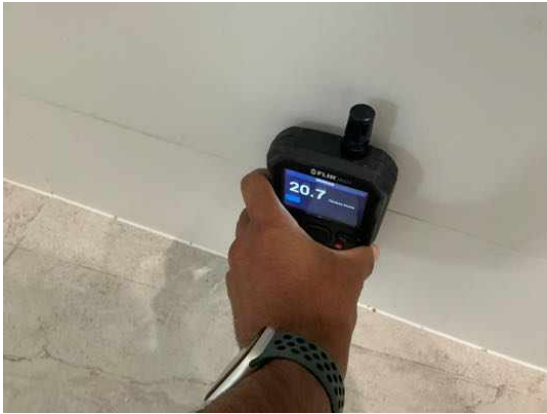
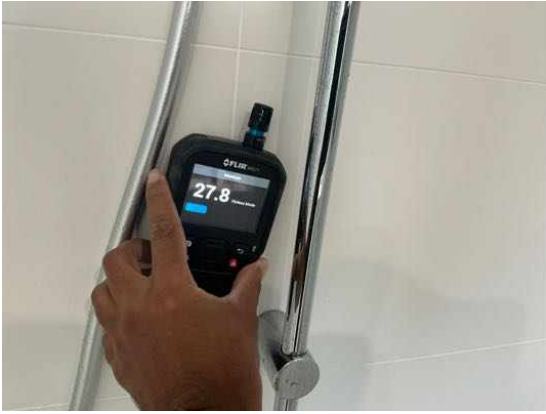
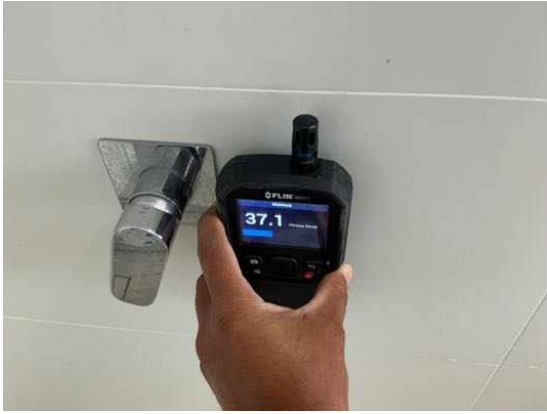
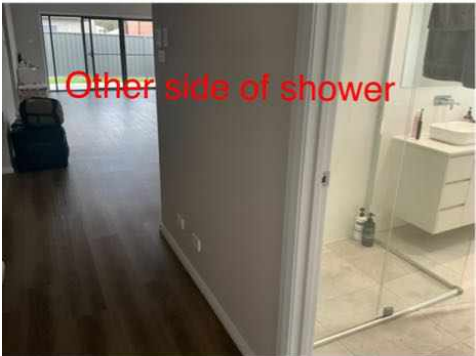
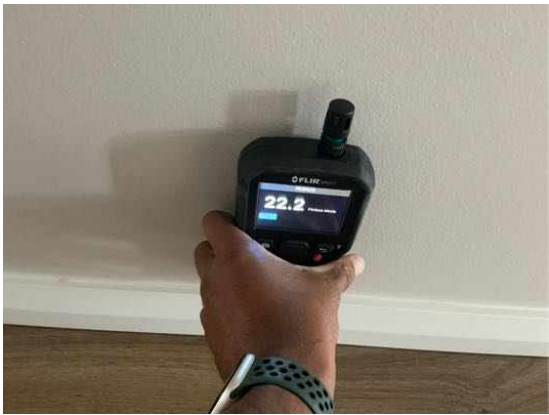
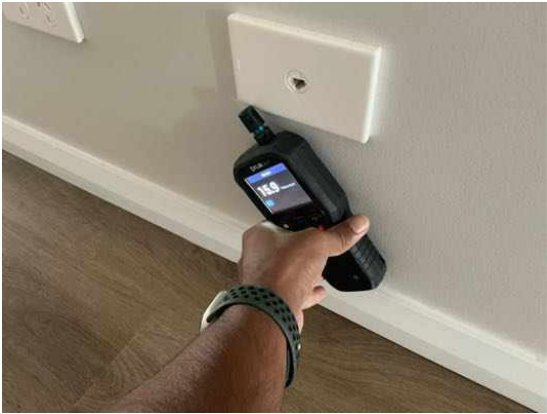
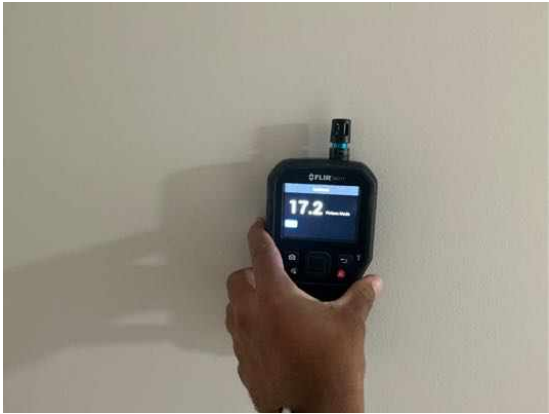
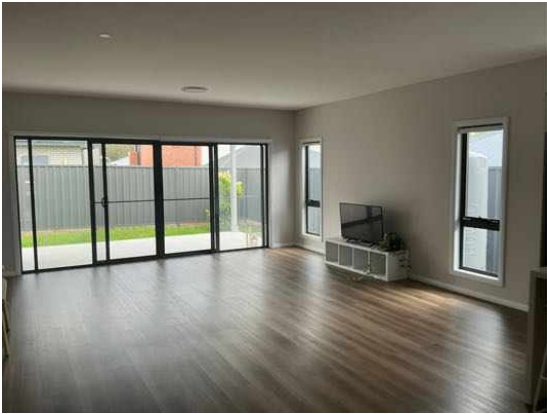
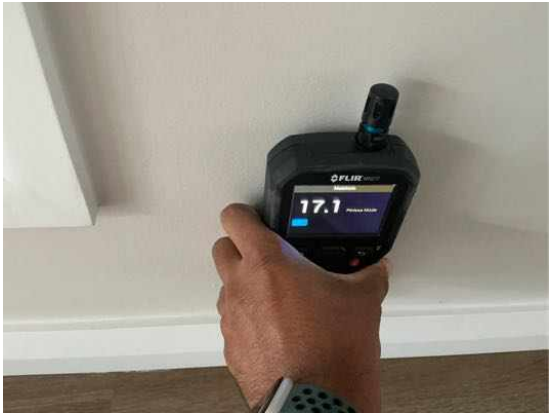
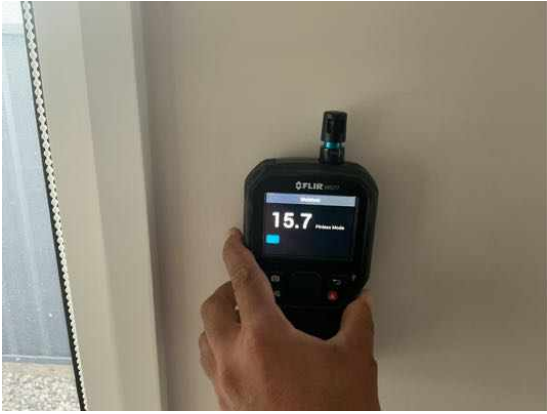
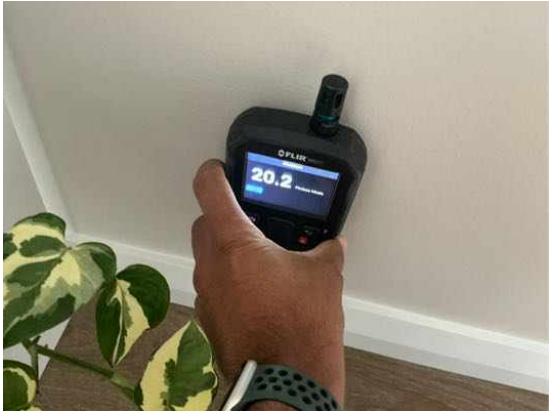
Finding: Additional Photos - Moisture Meter Readings

Information: Additional moisture meter reading photos have been provided for the property to offer further clarity on areas tested during the inspection. These photos are intended to give a visual reference for the specific locations where moisture levels were measured. These readings were taken at the time of the inspection to assess any potential moisture-related issues within the property. Any defects related to moisture that were identified during the inspection have been separately mentioned in the defect statements within the report.

For further clarification or additional information regarding the moisture readings, the client is encouraged to contact the building inspector directly. Regular monitoring of moisture-prone areas is recommended to ensure any emerging concerns are addressed promptly, particularly during wetter seasons or in high-humidity conditions.

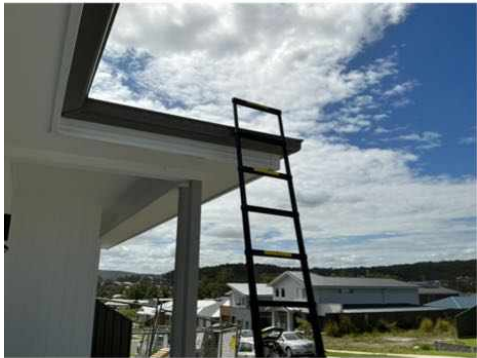
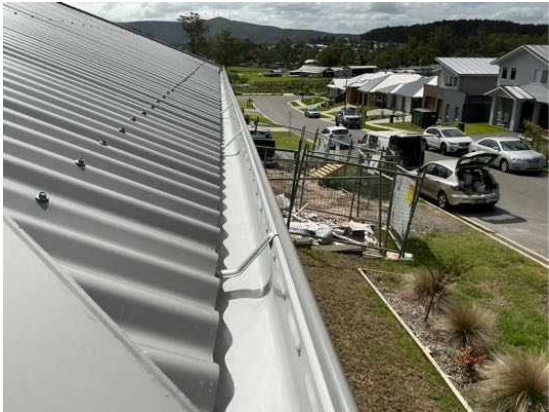
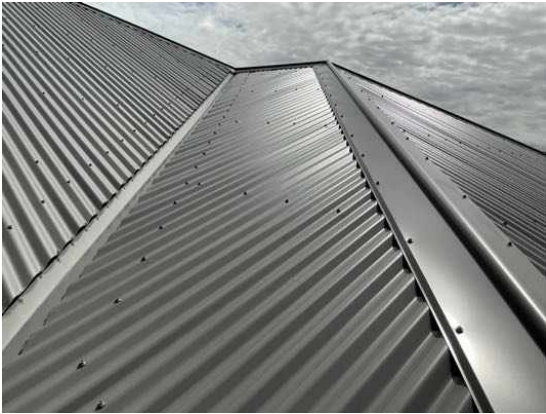
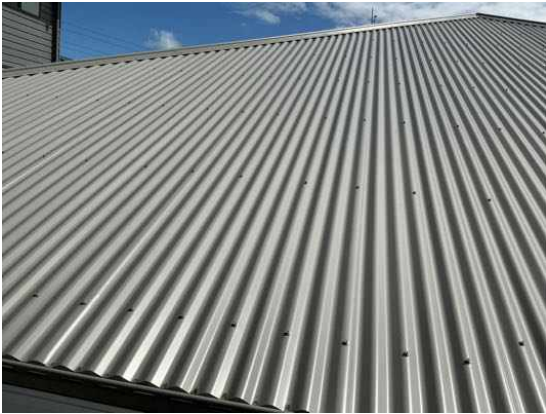
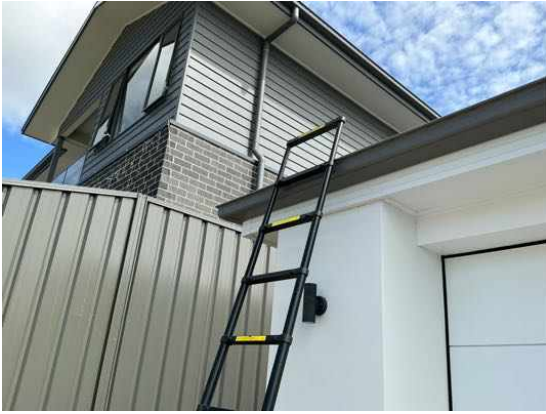
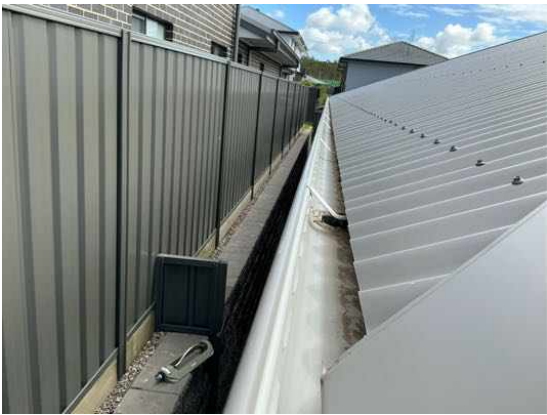
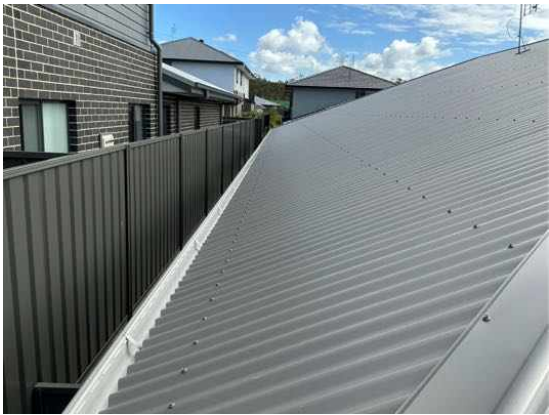
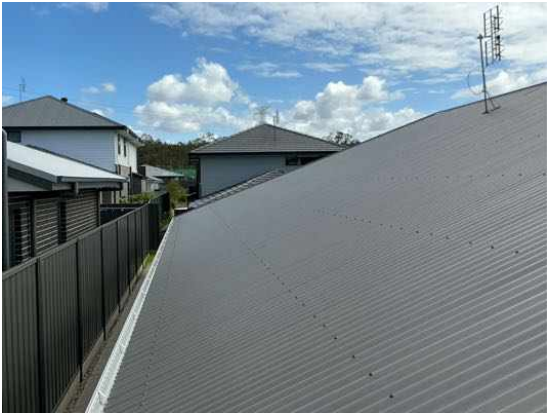
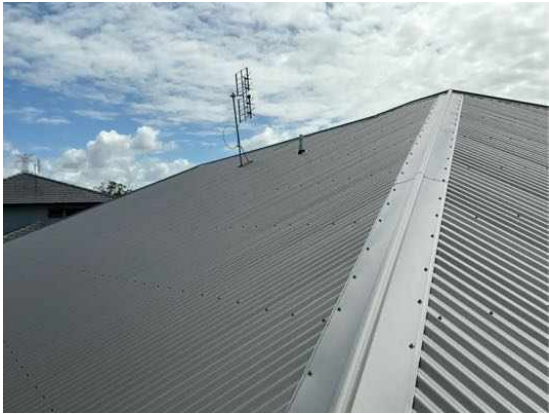
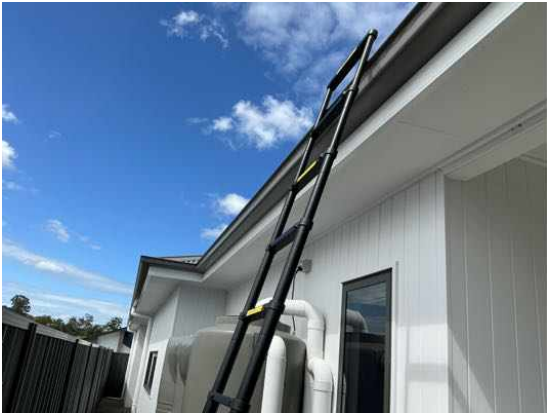
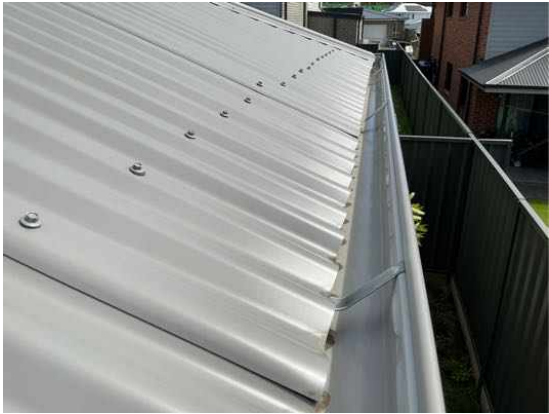
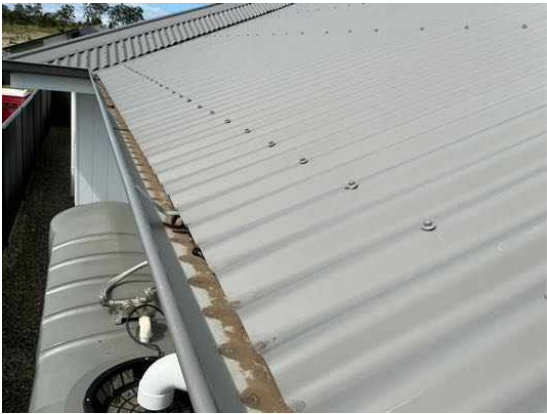
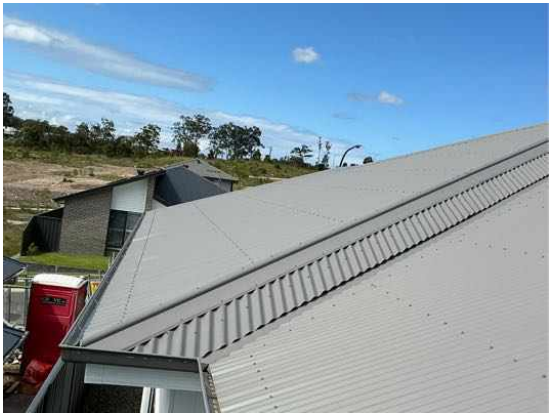
Building: Main Building
Location: Roof Exterior
Finding: Additional Roof Photos
Information:

As part of the information provided, please note that the attached roof photos represent the condition of the roof at the time of inspection. These photos are for visual reference only and do not constitute a detailed roofing assessment. Any defects or issues identified with the roof are mentioned separately in the defect statements. It is strongly recommended that the client engage a qualified roofer to conduct a thorough inspection of the roof, ensuring that any potential issues, such as leaks, structural integrity, or wear and tear, are properly identified and addressed.

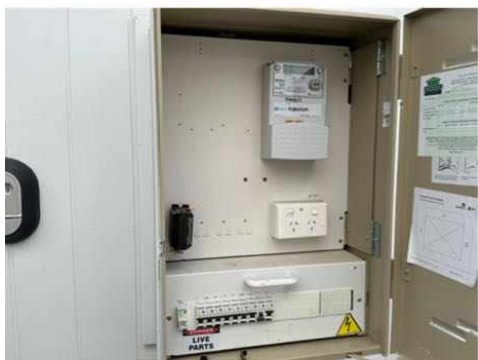
Building:	Main Building
Location:	Meter Box
Finding:	Termite Management Recommendation – No Evidence of Chemical Installation
Information:	At the time of inspection, there was no visible evidence of a chemical termite management system installed around the property. Chemical barriers are a key component of termite protection and are particularly important in preventing concealed termite entry into timber elements of the structure.

In accordance with standard requirements, a durable notice should be located within the electrical switchboard to detail any termite protection systems applied, including chemical treatments. No such notice was observed during the inspection.

It is recommended that the client engage a licensed pest controller to assess the suitability of installing a chemical barrier, and to provide advice on associated costs and procedures. This should be considered a short-term priority, particularly if the property has any history of termite activity or is located in a high-risk area.
