Building and Timber Pest Inspection Report

Inspection Date: Thu, 19 Feb 2026

Property Address: 13 Page St, Pagewood NSW 2035, Australia

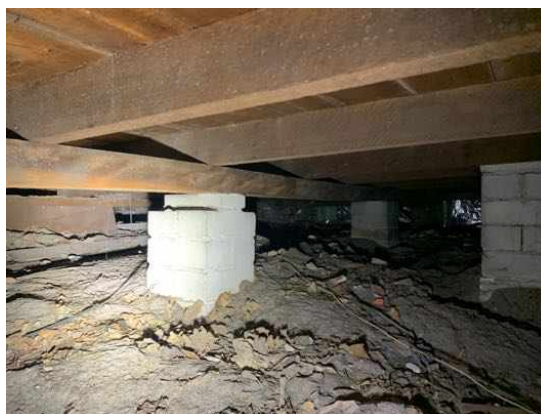
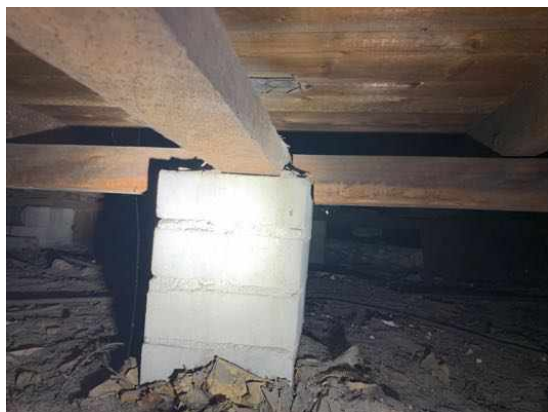
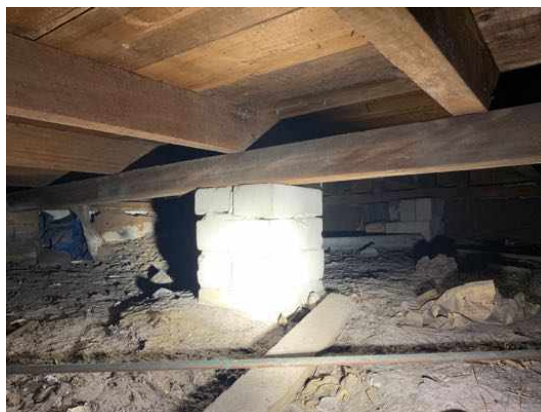
Finding 6.04

Installed during the construction process, ant caps are designed to easily identify termite or pest ingress from stumps to the adjoining bearers.

Where ant caps have not been installed, frequent monitoring of these areas should be carried out in order to identify any signs of termite or timber pest workings.

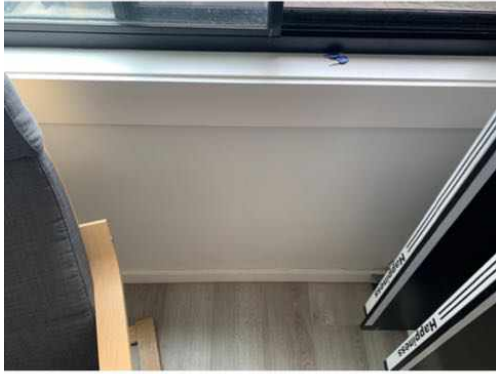
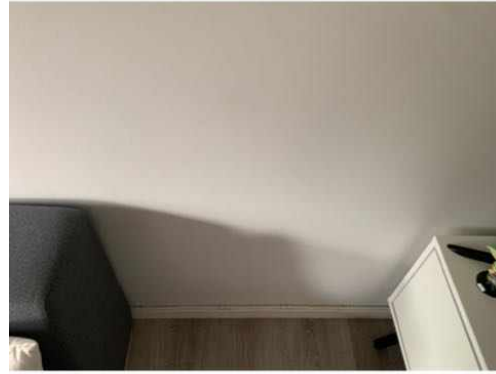
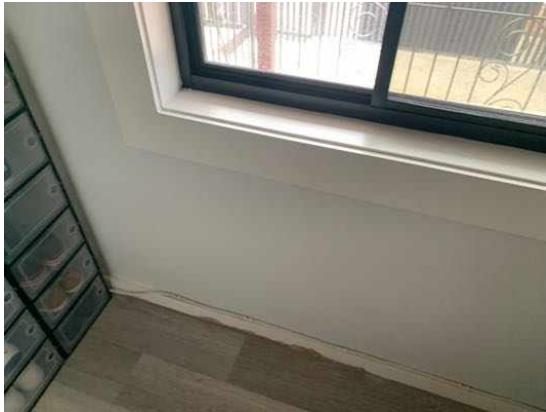
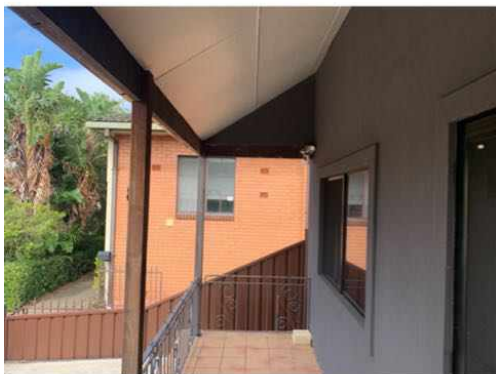
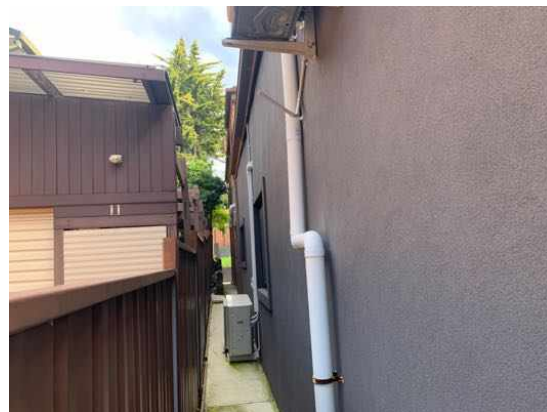
Noted Item

Building: Main Building
Location: All Areas
Finding: Additional Photos - Obstructions and Limitations / For Information
Information: These photographs are an indication of the obstructions and limitations which impeded full inspection of the property at the time of inspection. These obstructions can hide an array of defects and should be removed to allow full inspection to be carried out.

Also, an array of additional photographs have been provided for general information purposes.
