## Building Inspection Report

Inspection Date: Tue, 24 Mar 2026

Property Address: 2605/36 Walker St, Rhodes NSW 2138,  
Australia

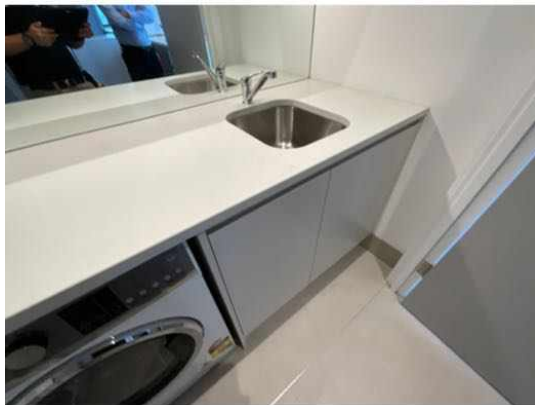
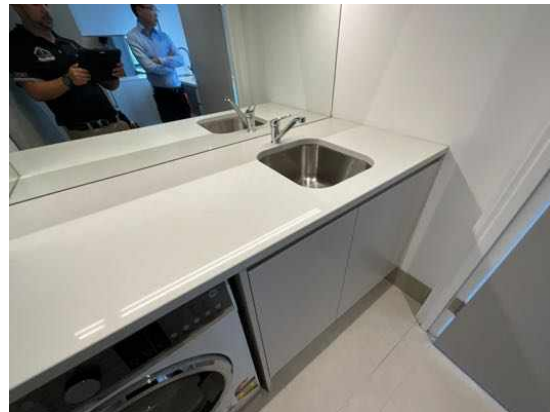
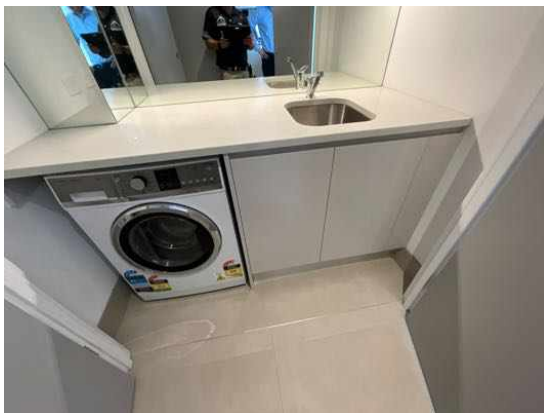
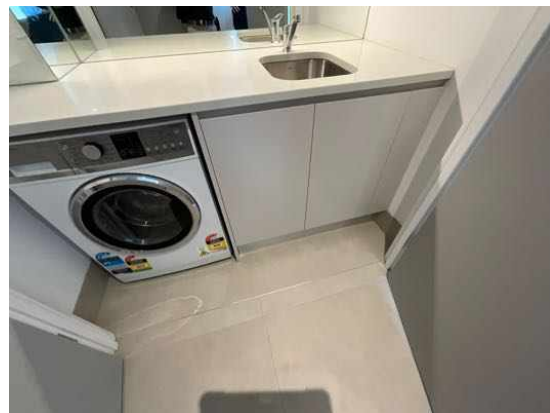
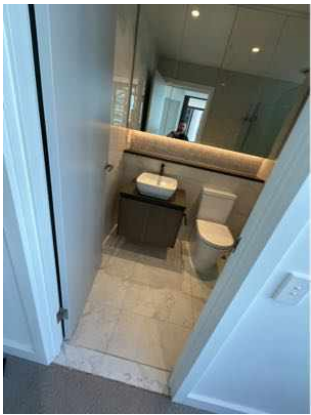
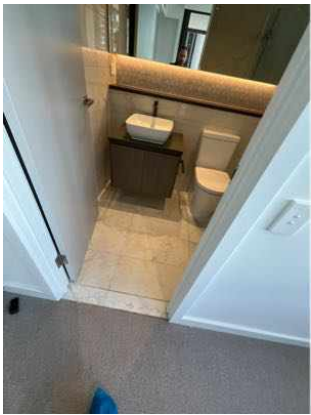
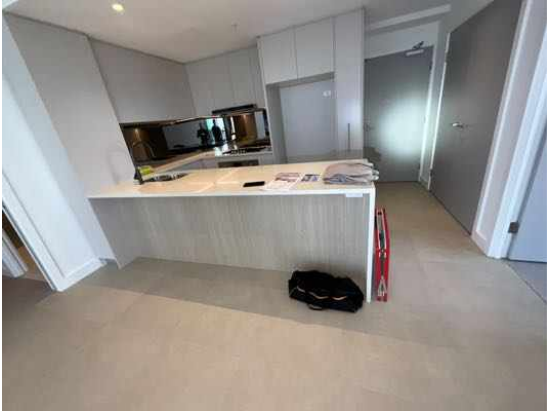
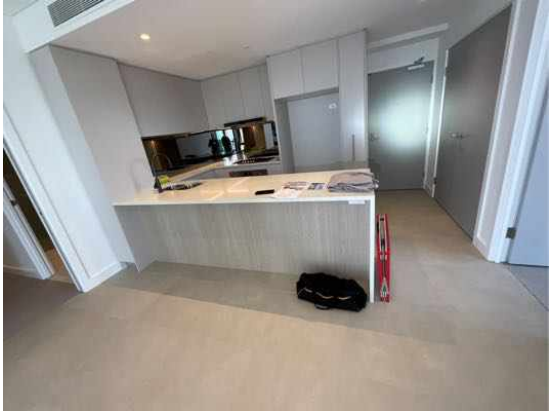
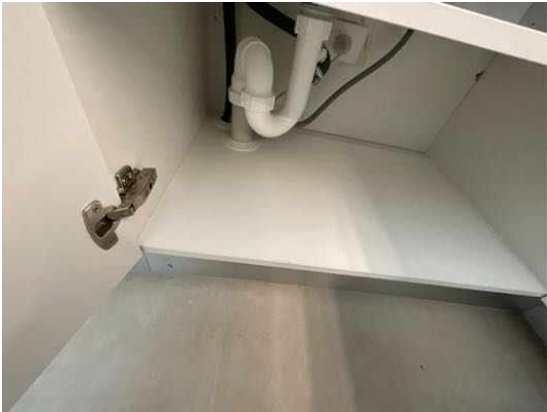
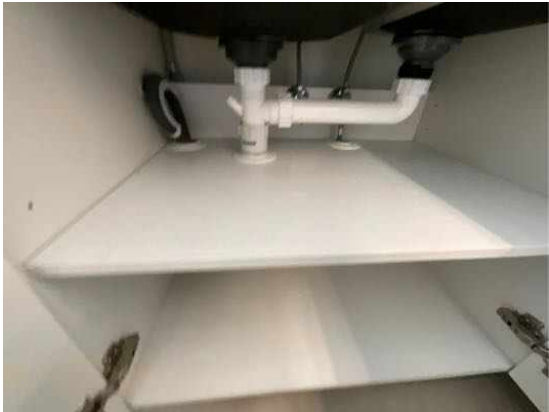
Finding: Additional Photos - Obstructions and Limitations

Information: These photographs are an indication of the obstructions and limitations which impeded full inspection of the property at the time of inspection. These obstructions can hide an array of defects and should be removed to allow full inspection to be carried out. A re-inspection is recommended once the areas are made accessible.
