Building and Timber Pest Inspection Report

Inspection Date: Tue, 17 Feb 2026

Property Address: 23 Ronald Ave, Greenwich NSW 2065,
Australia

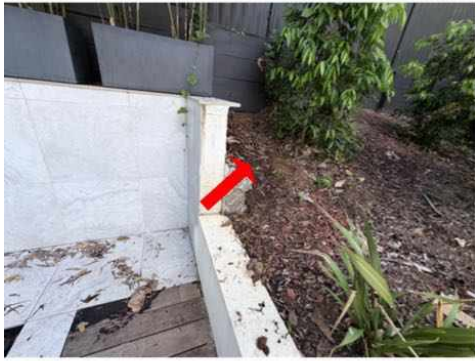
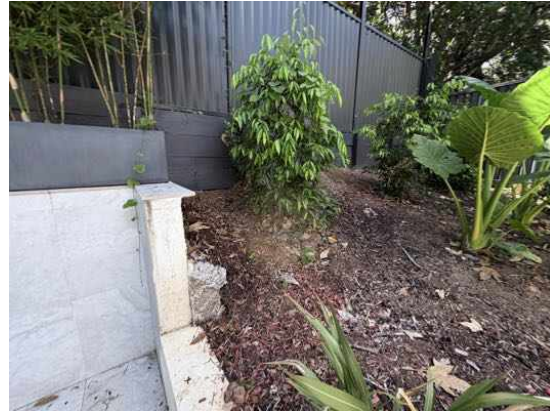
Building: Main Building
Location: Pool Area
Finding: Soil Erosion
Information: Soil erosion from inadequate retaining wall to the back fence and neighbouring property is found.

The soil appears to be washing away at the back of the retaining wall.

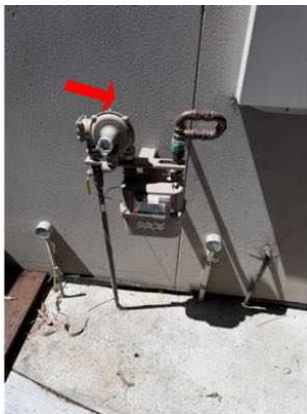
Finding 1.02

Building: Main Building
Location: Exterior walls - left side
Finding: Gas Meter Distance to Electrical Meter
Information: The gas meter and regulator is required a minimum 500mm away from the electrical meter.

Relocation of the gas meter is required.

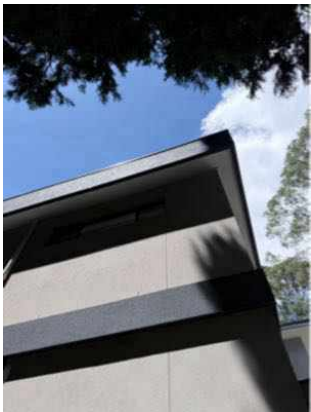
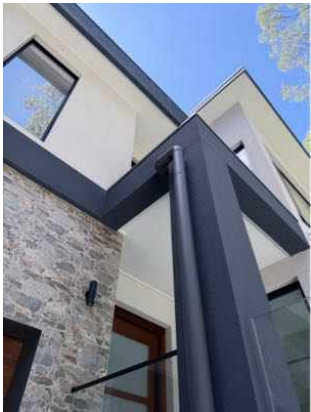
Finding 2.01

Building: Main Building
Location: Roof Exterior
Finding: Overflow of Roof Box Gutter Missing
Information: No overflow provision has been installed to the box gutter.

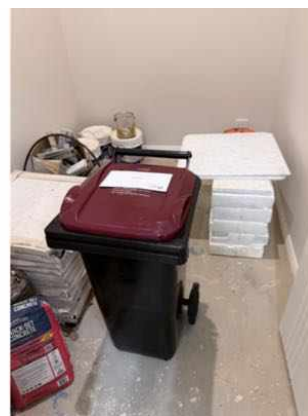
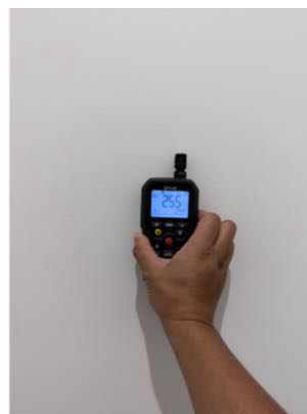
Finding 2.02

Building:	Main Building
Location:	Store Room
Finding:	Damp - Rising
Information:	Rising damp describes the upward movement of water in low sections of building elements (e.g. walls) by capillary action - the movement of water through porous materials such as bricks, sandstone or mortar.

Rising damp is generally managed by the installation of a damp proof course during construction. A Damp Proof Course (DPC) is an impermeable barrier at the base of the wall above ground level. However, many 19th Century buildings have no damp course installed, or the materials have failed. The DPC may have been omitted as a consequence of poor workmanship, or it may have been bridged where materials built up against the side of the house allow moisture ingress above the DPC level.

The first step in addressing rising damp is to diagnose the cause. The identified cause should be addressed first before addressing the appearance and other defects which have resulted from the rising damp. If the original cause is not resolved, further cases of damp are likely to ensue, resulting in secondary defects.

Consultation with a qualified plumber is advised immediately to identify the cause of the damp and perform remedial works as required.

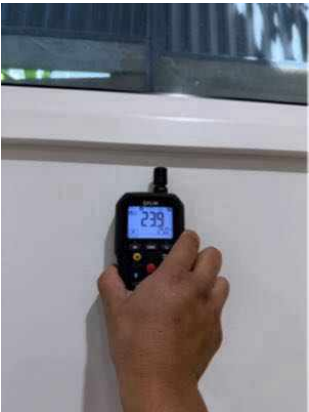
Finding 2.03

Building:	Main Building
Location:	Bedroom
Finding:	Exterior walls - Lateral damp
Information:	Lateral penetrating damp refers to the sideways movement of moisture, predominantly from the surrounding ground, which tends to affect basement walls and other earth-retaining walls. The implications of unmanaged damp range from mould fungi growth, wood rot and decaying building materials, to finishes including lifting, bubbling, peeling and staining of paint, plaster and wallpaper.

It is important to address damp conditions as the World Health Organisation notes that excess moisture leads - on almost all indoor materials - to the growth of microbes such as moulds, fungi and bacteria, which subsequently emit spores and other matter into the indoor air. Exposure to these contaminants is associated with a wide range of respiratory and other health-related problems. Additionally, the development of damp in timber building elements also provides an environment that is conducive to termite / timber pest attack.

Immediate consultation with a licensed plumber is advised to address the cause of the

damp and to perform remedial works as necessary.

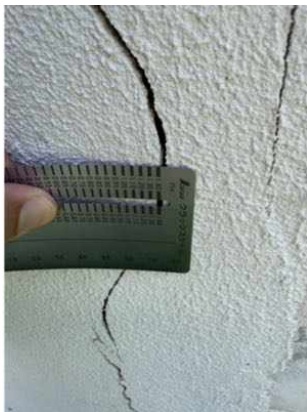
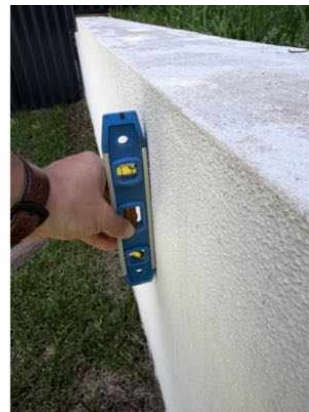
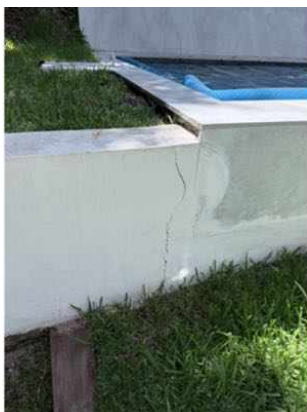
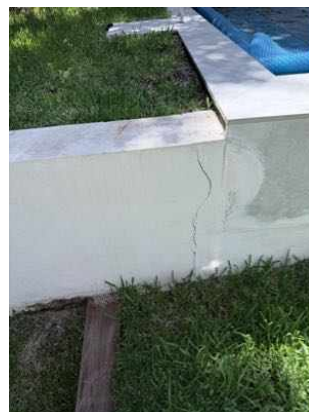
Finding 2.04

Building:	Main Building
Location:	Pool Area
Finding:	Retaining wall - Defective
Information:	Crack is observed to the retaining wall of greater than 2mm. The retaining wall is measured to be leaning outwards indicating a movement in the retaining wall.

The retaining wall in this area was found to be defective at the time of inspection. Generally, defective retaining walls are caused by poor original design or material use. However, deteriorated retaining walls may also be a result of substandard construction, poor site drainage or unmanaged stormwater flows.

If left unmanaged, the retaining wall may become a safety hazard if it continues to destabilise. Where retaining walls further rot and decay, an environment is created that is conducive to termite and pest infestation.

Significant repair and replacement should be expected. Where retaining walls are considered structural walls, a structural engineer / surveyor should be consulted regarding required remedial works. Otherwise, a landscaper or retaining wall installer may be appointed to repair or replace the wall, at the discretion of the client.

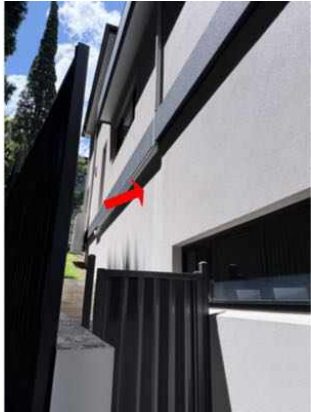
Finding 3.01

Building: Main Building
Location: Exterior walls - left side
Finding: Water Mark to Side Wall
Information: Water mark is observed to the left side wall, where a break in the external cladding is observed.

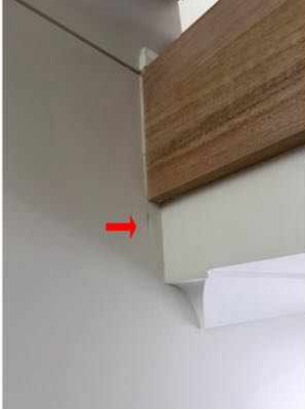
Finding 3.03

Building:	Main Building
Location:	Stair Landing
Finding:	Cracking - Damage Category 0 - Hairline (less than 1mm)
Information:	Hairline cracks are very minor in nature and generally are only ever an appearance defect. While such cracking may be noticeable in some cases, it is quite common and does not indicate any structural damage.

Cracking of this nature can generally be repaired with minor sanding, filling and/or

repainting. Such works should be performed by a qualified painter or a general handyman.

Monitoring of all cracking should be conducted frequently. Always contact a building inspector should cracks widen, lengthen, or become more numerous.

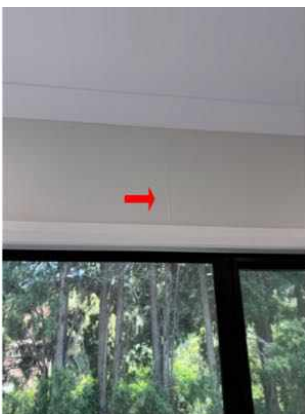
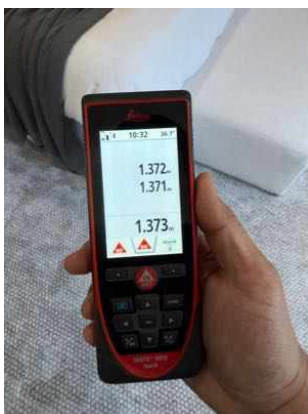
Finding 3.04

Building:	Main Building
Location:	Bedroom - Master
Finding:	Cracking - Damage Category 0 - Hairline (less than 1mm)
Information:	Hairline cracks are very minor in nature and generally are only ever an appearance defect. While such cracking may be noticeable in some cases, it is quite common and does not indicate any structural damage.

Cracking of this nature can generally be repaired with minor sanding, filling and/or repainting. Such works should be performed by a qualified painter or a general handyman.

Monitoring of all cracking should be conducted frequently. Always contact a building inspector should cracks widen, lengthen, or become more numerous.

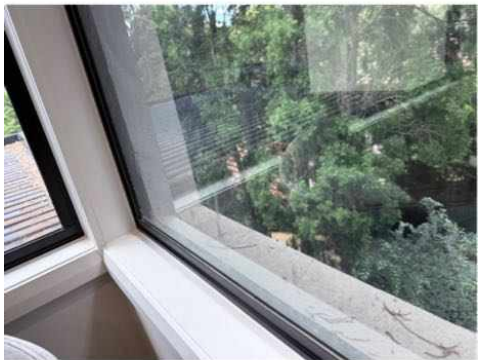
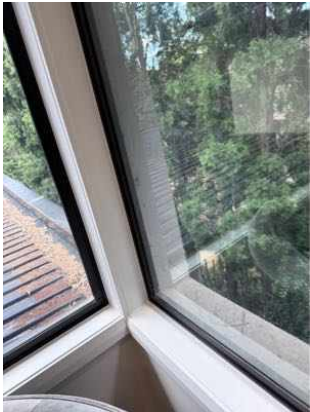
Finding 3.06

Building: Main Building
Location: Bedroom - Master
Finding: Window Not Cleaned
Information: Construction render and concrete splashes on the windows has not been cleaned.

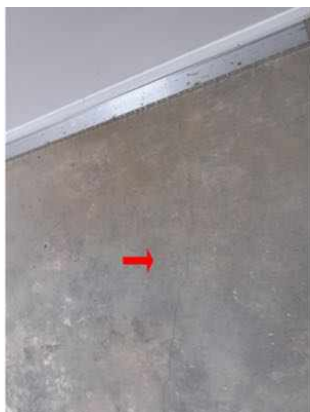
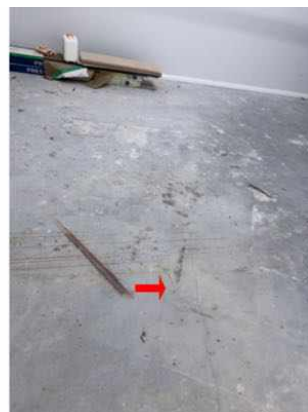
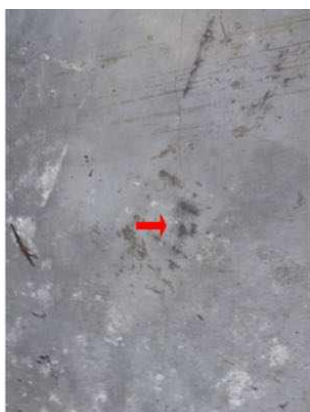
Building:	Main Building
Location:	Garage
Finding:	Crack in concrete slab - Category 1
Information:	A crack coded as Category 1 was identified in the slab. A Category 1 crack is described as a fine but noticeable crack, with the slab at an otherwise reasonable level.

To be considered Category 1, the approximate width of the crack is less than 1.0mm, or a less than 10mm change in offset when a 3m straight edge is placed over the defect.

Category 1 cracks should be monitored for a period of 12 months. At the end of the monitoring period, identified cracks that are rated greater than Category 2 are considered defects, and require rectification.

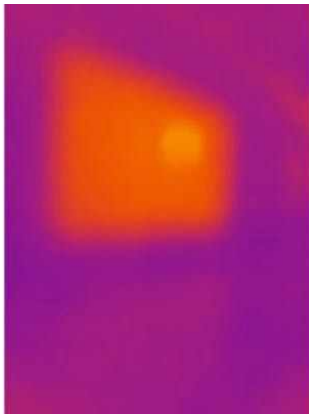
Finding 3.09

Building:	Main Building
Location:	Bedroom - Master
Finding:	Insulation - Missing
Information:	Upon inspection of the roof void it was noted that insulation is not present.

Insufficient insulation will result in a comparatively higher cost to heat and cool a property as there is a lack of Insulation (or uneven coverage of insulation) which works as a barrier to heat transfer. This helps to keep out unwanted heat in summer and preserves warmth inside your home in winter. It can also help soundproof your home from unwanted airborne noise transfer.

Where insulation is absent, the area does not meet current Australian Standards. Installation of adequate insulation is required and should be conducted as soon as possible.

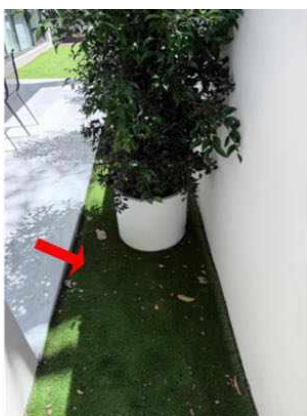
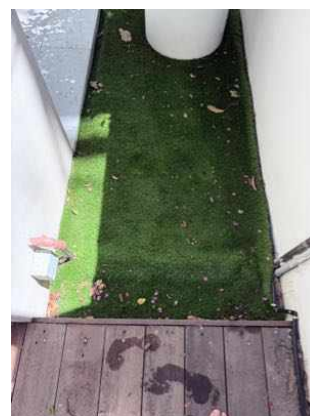
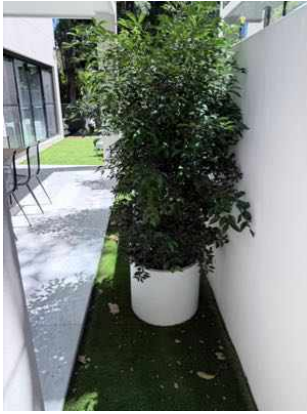
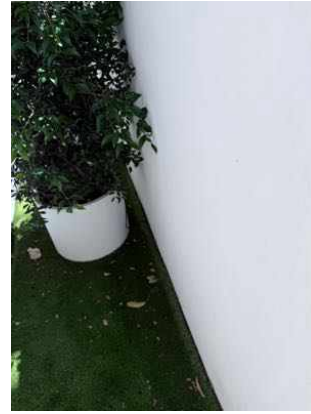
Finding 3.10

Building:	Main Building
Location:	Yard - Back
Finding:	Site drainage - Inadequate
Information:	The site drainage in this area was found to be inadequate at the time of inspection, creating potential for subsequent water damage to associated building elements.

It is important that water does not lie against the base of walls; surrounding paths and ground levels should be sloped to drain water away from walls. Downpipes should not discharge stormwater onto lower walls or plinths. Stormwater should be carried away by large, regularly cleaned drains. Ground levels may need to be lowered to expose a buried DPC.

Where site drainage is inadequate, installation of an Agricultural (Aggie) Drain may be required. A qualified plumber should be appointed to further inspect the property and perform any remedial works as necessary. Water damage and secondary defects are likely to occur if left unmanaged.

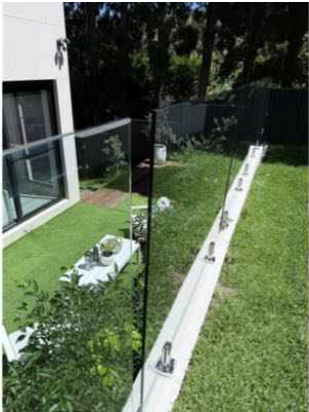
Finding 3.12

Building:	Main Building
Location:	Pool Area
Finding:	Glass Fence Misaligned
Information:	The glass fence is misaligned.

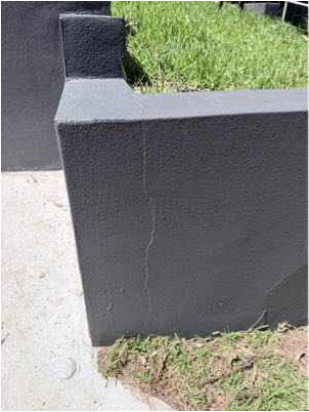
Finding 3.13

Building: Main Building
Location: Yard - Front
Finding: Cracking - Damage Category 1 - Fine (up to 1mm)
Information: Although fine cracks are quite noticeable, they are often only considered to be an appearance defect, and usually do not indicate any structural damage. Generally, the cause of a fine crack is indicative of a separation between building materials and finishes (e.g. paint, plaster, etc.) along joints.

Cracking of this nature can generally be repaired with minor sanding, filling and/or repainting. Such works should be performed by a qualified painter or a general handyman.

Monitoring of all cracking should be conducted frequently. Always contact a building inspector should cracks widen, lengthen, or become more numerous.

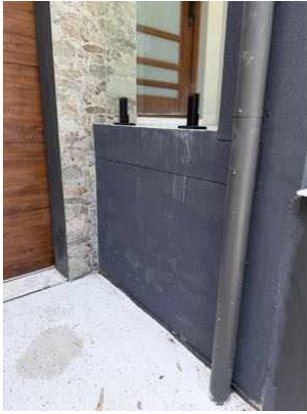
Finding 3.14

Building: Main Building
Location: Yard - Front
Finding: Water leak - External
Information: Water leaks were found to be present to exterior plumbing work. Leaks are generally caused by deterioration of the plumbing elements over time, due to exposure to weather conditions, but may have also been caused by minor impact damage.

Such leaking creates damp conditions in the affected area, causing potential for water pooling and subsequent water damage if left unattended. These conditions may also attract termite attack, particularly if the area is subject to minimal levels of sun throughout daylight hours.

It is highly advised that a licensed plumber be appointed to rectify any water leaks that may be present. Areas of repair and replacement of plumbing fittings and fixtures may be required and, as such, a quotation should be sought.

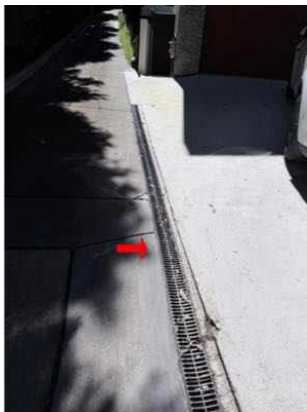
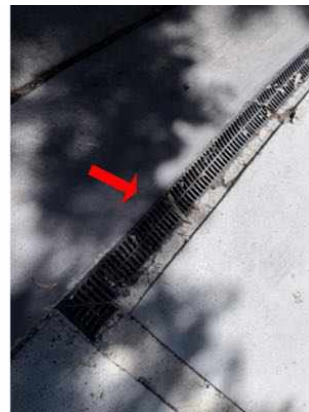
Finding 3.15

Building: Main Building
Location: Yard - Front
Finding: Drainage Channel - Not Vehicle Grade
Information: The drainage channel used at the front of the property is not vehicle grade.

Subsidence of the grate is observed.

Overtime the grate will require replacement.

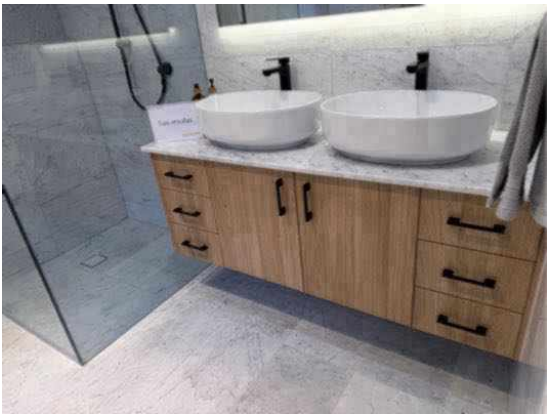
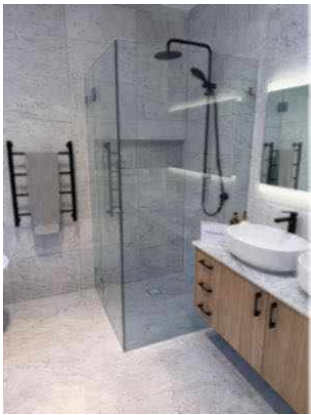
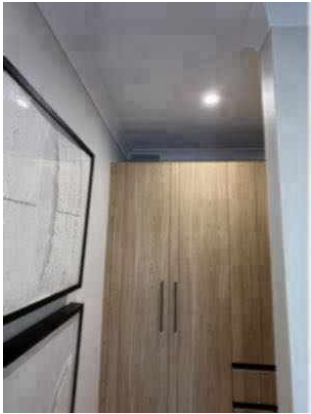
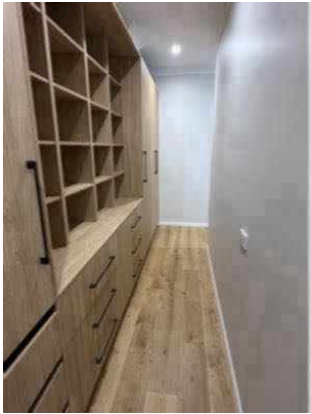
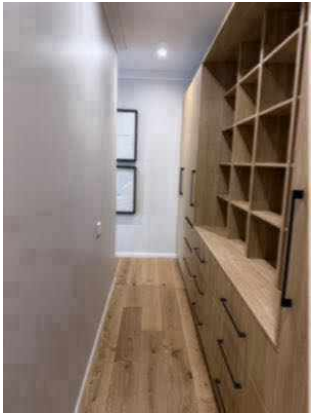
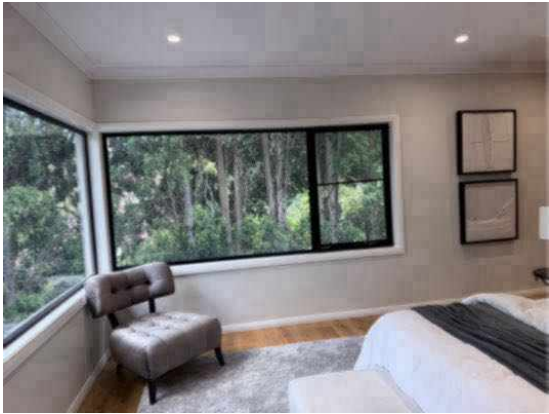
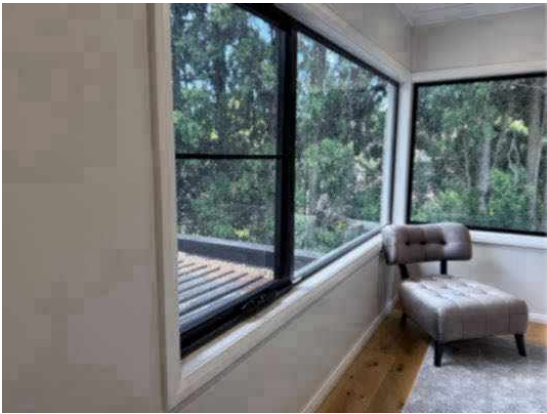
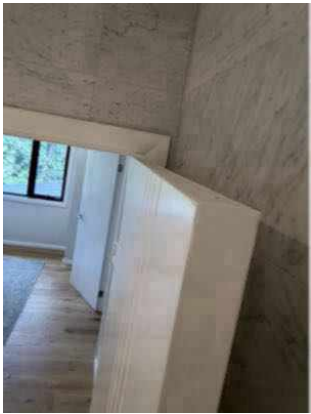
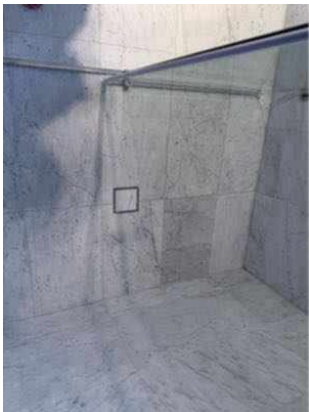
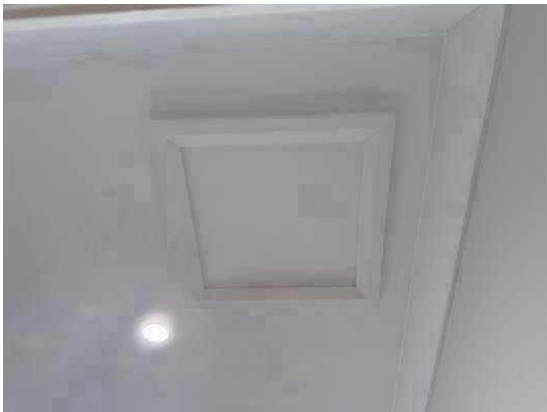
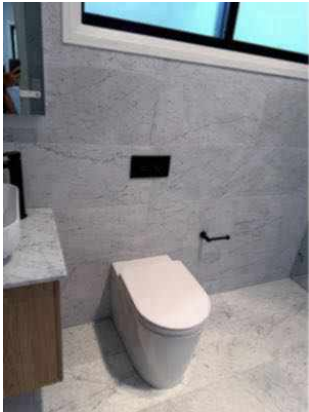
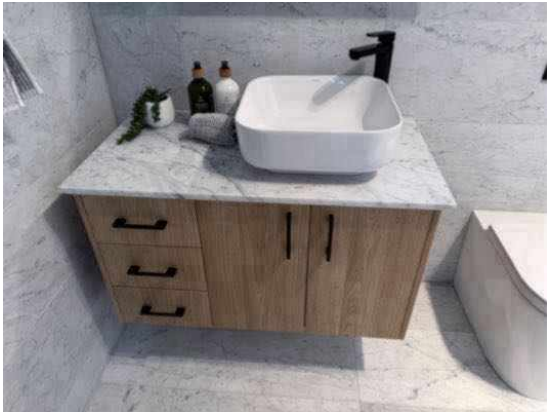
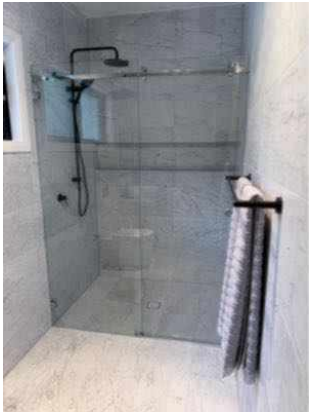
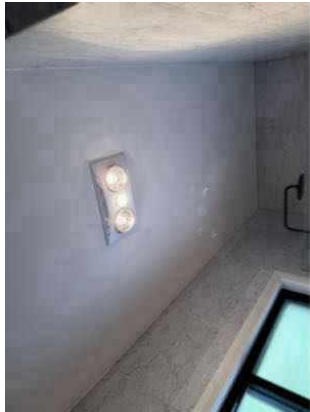
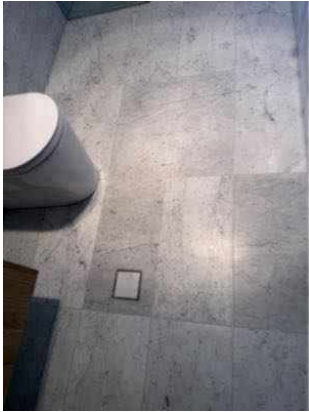
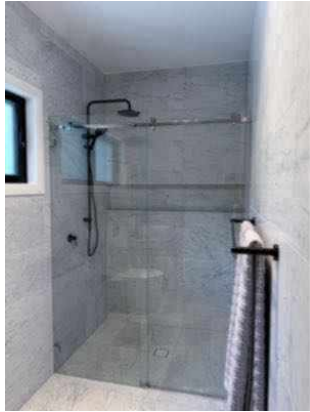
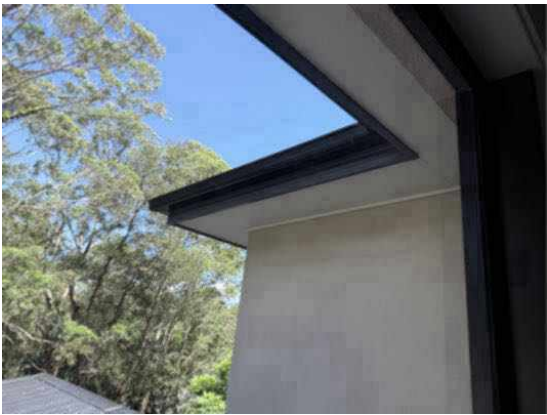
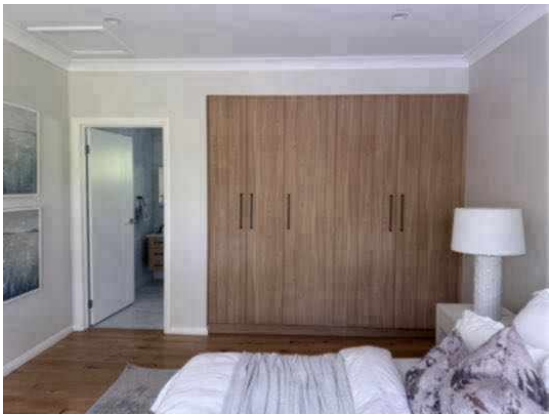
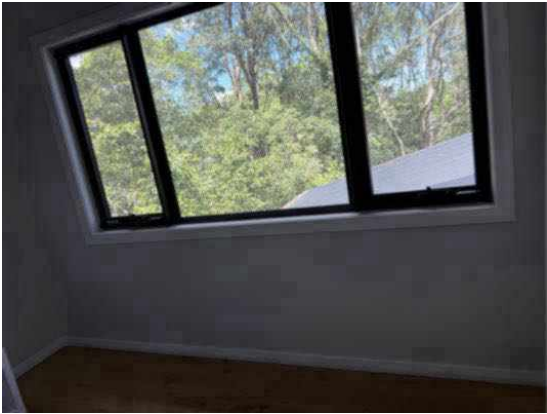
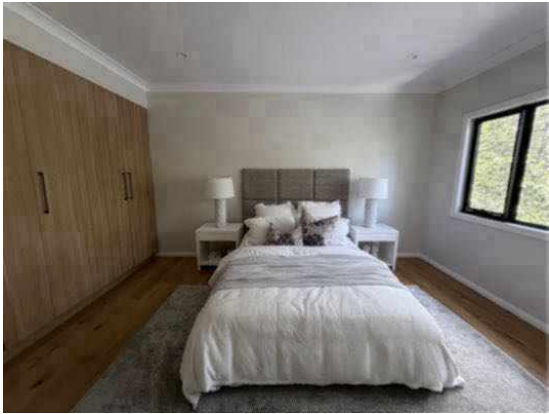
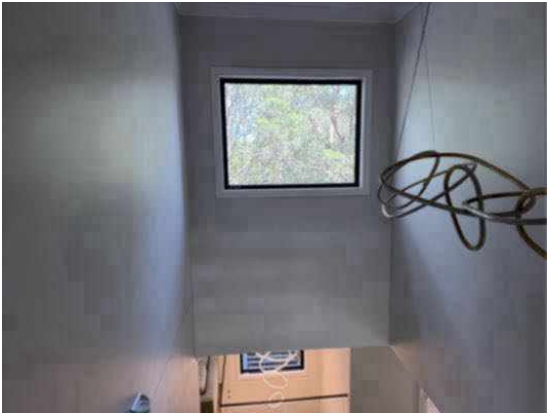
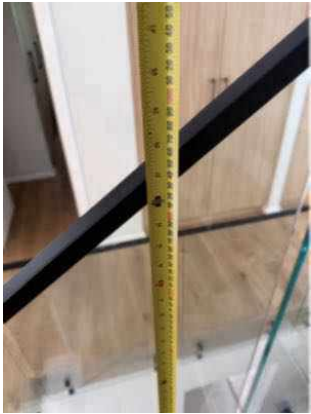
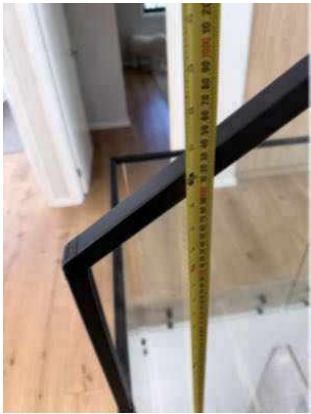
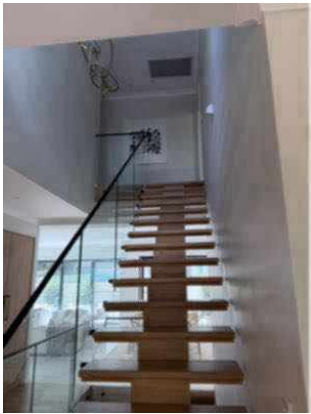
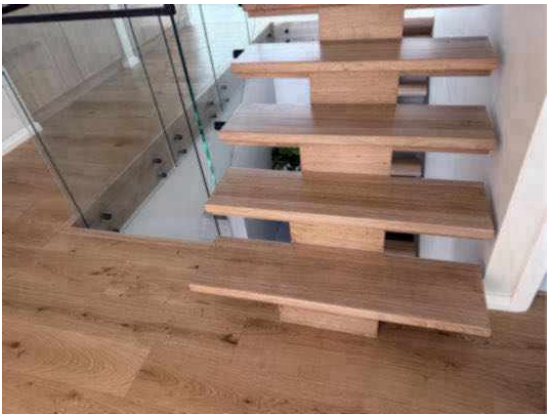
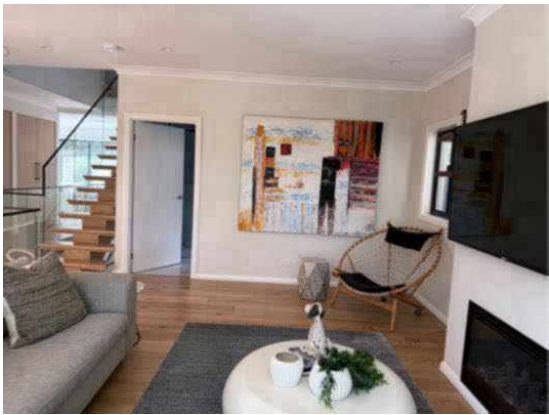
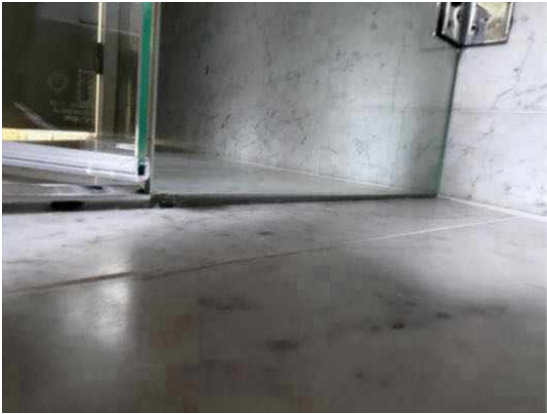
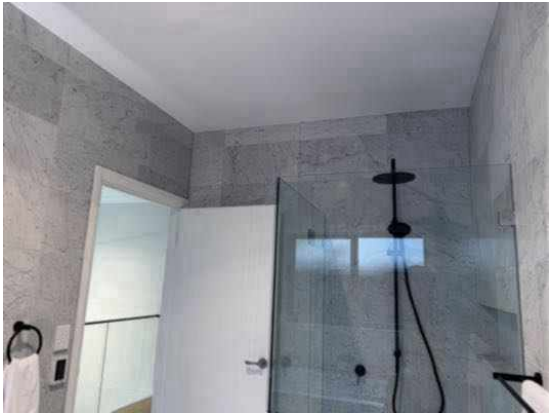
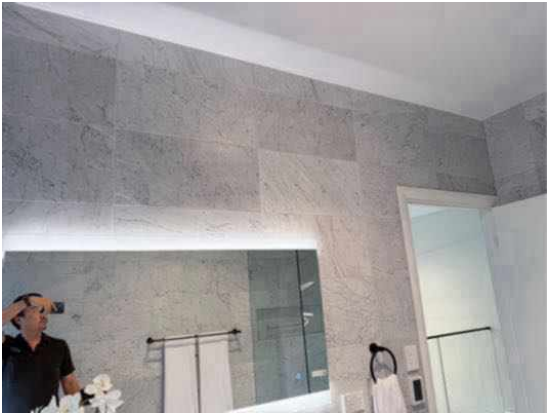
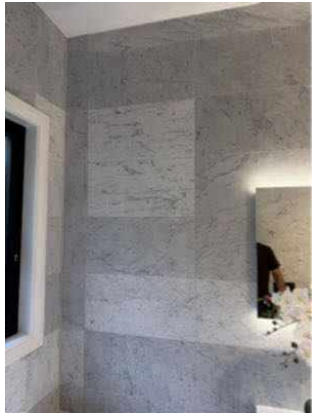
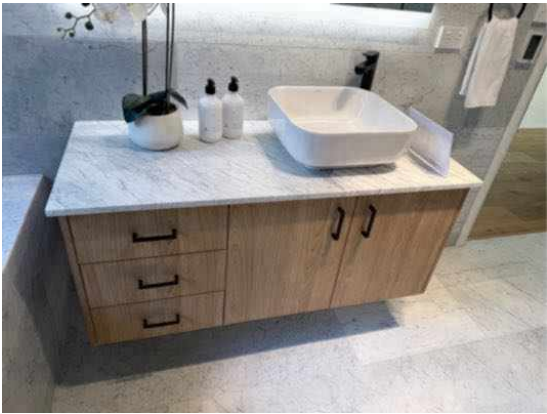
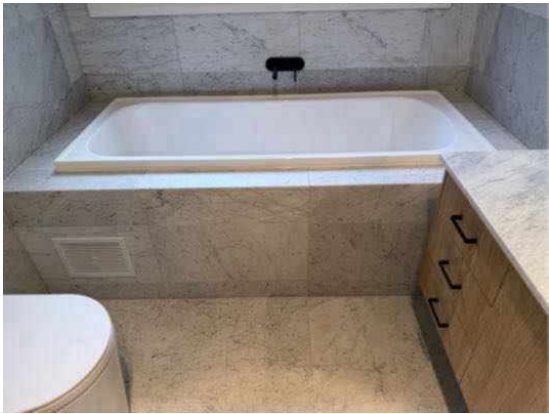
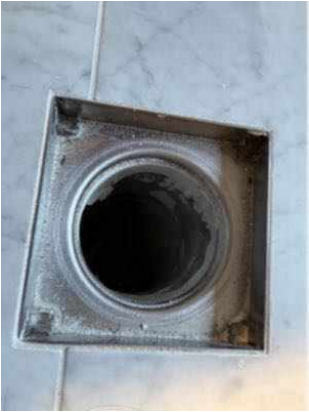
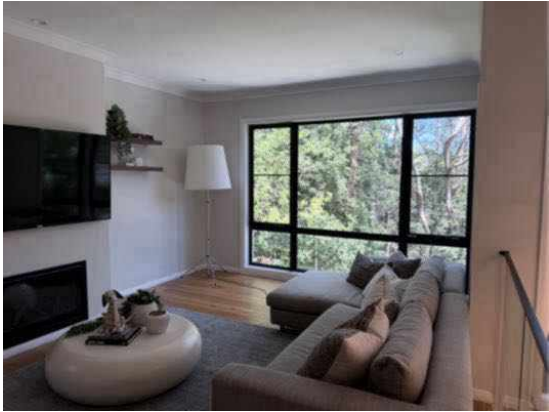
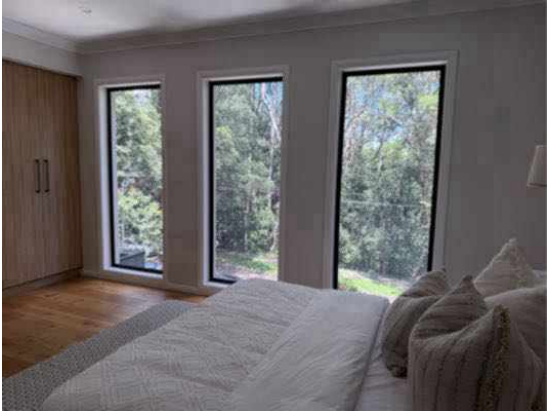
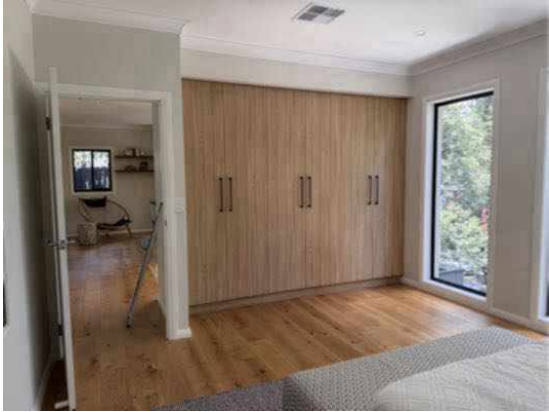
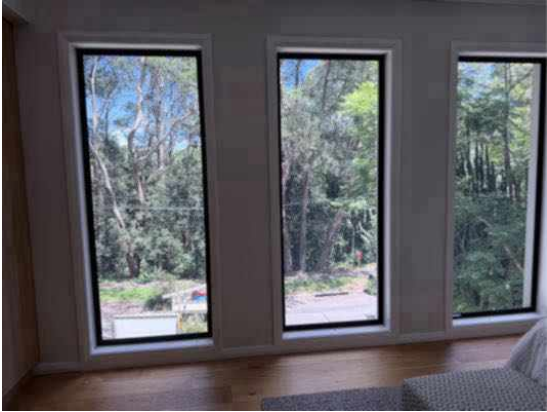
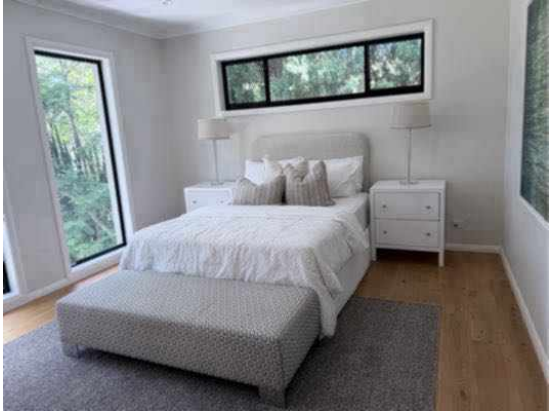
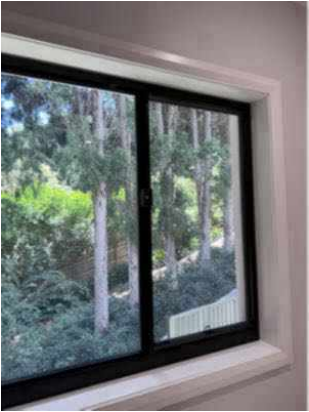
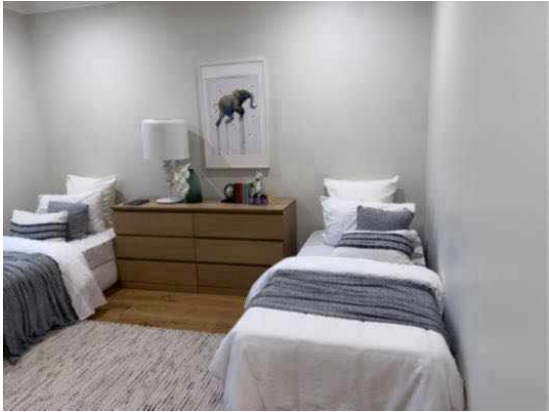
Building: Main Building
Location: All Internal Areas
Finding: Additional Photos
Information: Additional photos are provided for your general reference

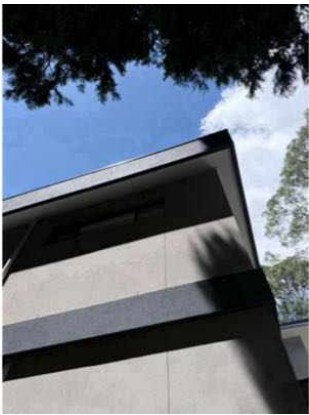
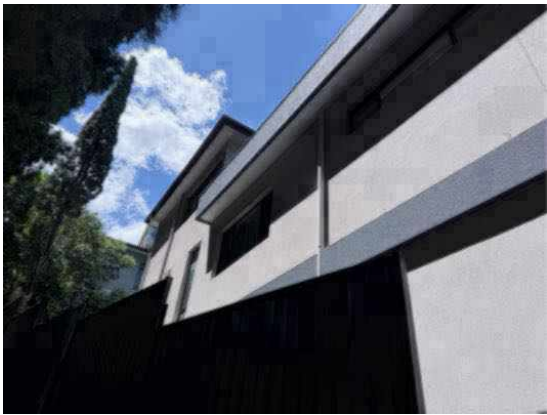
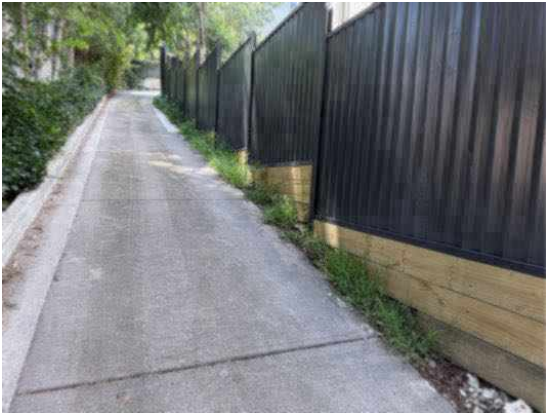
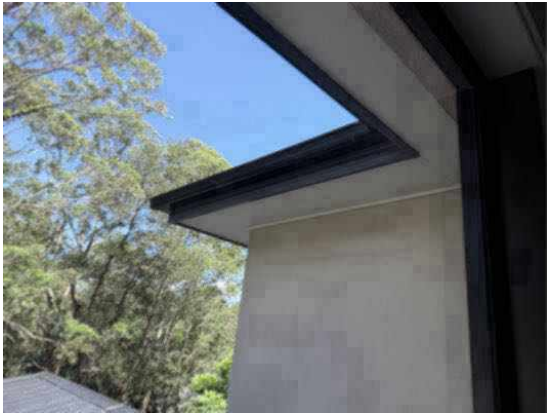
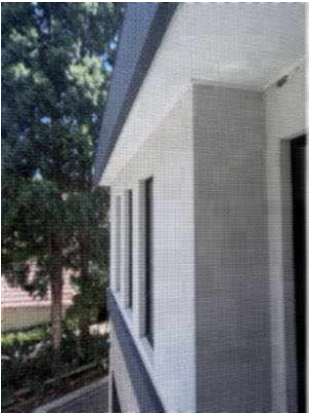
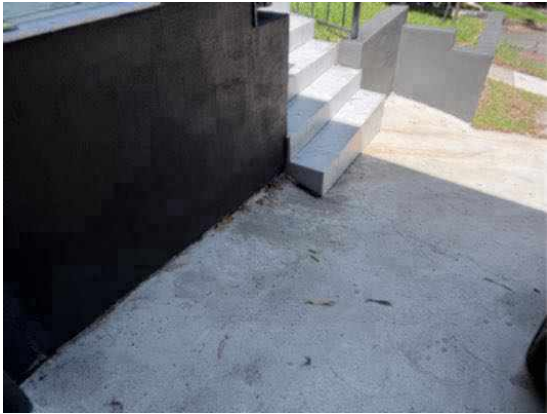
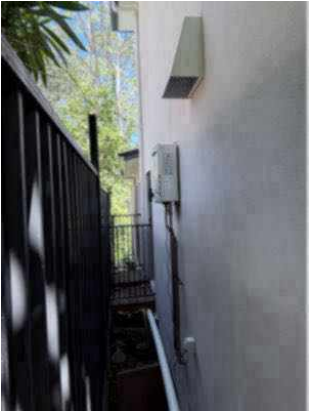
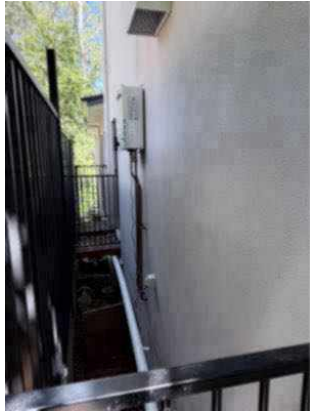
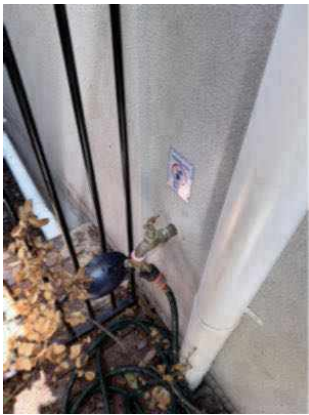
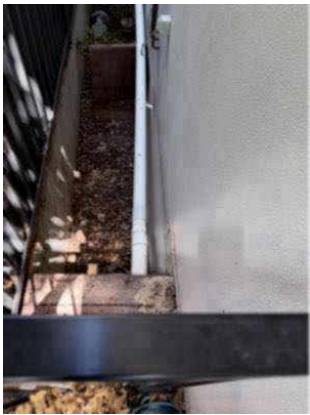
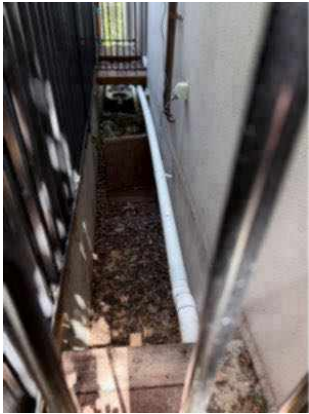
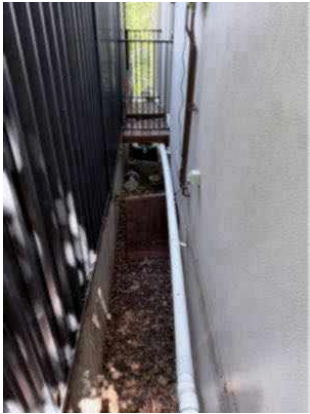
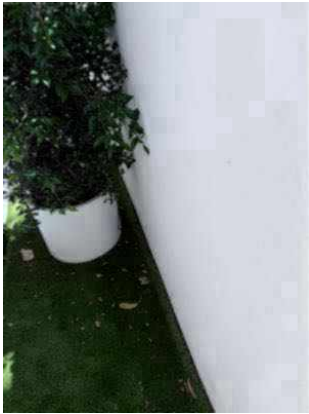
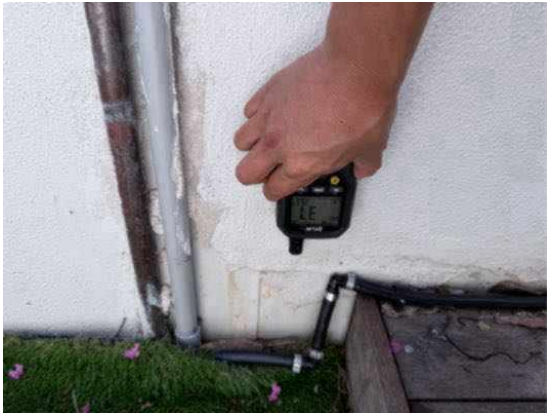
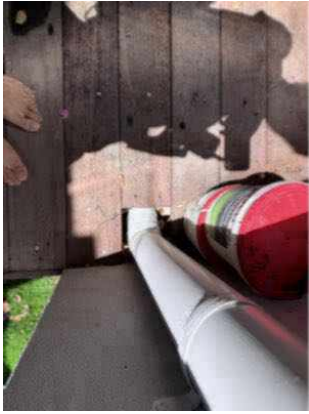
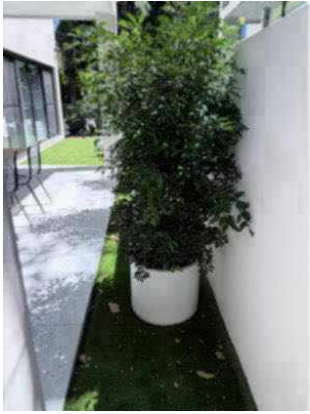
Building: Main Building
Location: All External Areas
Finding: Additional Photos
Information: Additional photos are provided for your general reference
