# Building and Timber Pest Inspection Report

Inspection Date: Thu, 29 Jan 2026

Property Address: lot 174/83-93 Dalmeny Ave, Rosebery NSW  
2018, Australia

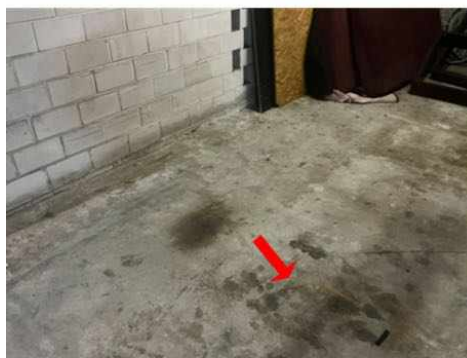
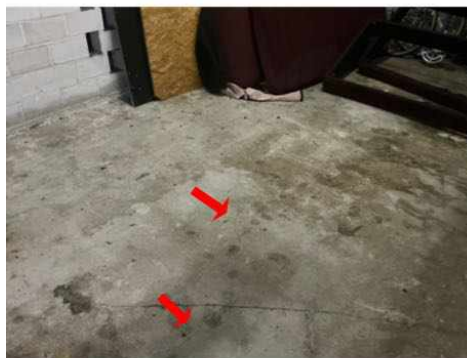
Building: Main Building  
Location: Garage floor  
Finding: Cracking - external concrete -Damage Category 2 - Noticeable (up to 5mm)  
Information: Noticeable cracks are a common occurrence as a result of many primary defects. Such causes may include age, general wear and tear, expected building movement, general expansion/contraction of building materials in different weather conditions, and/or minor failings in the installation or application of building materials.

Monitoring of all cracking should be conducted frequently. Always contact a building inspector should cracks widen, lengthen, or become more numerous. Additionally, your building inspector should also be contacted if associated building elements such as doors and windows become more difficult to operate over time.

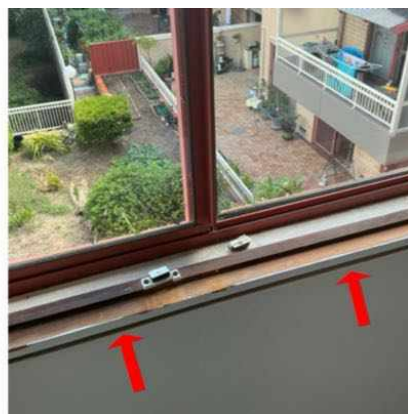
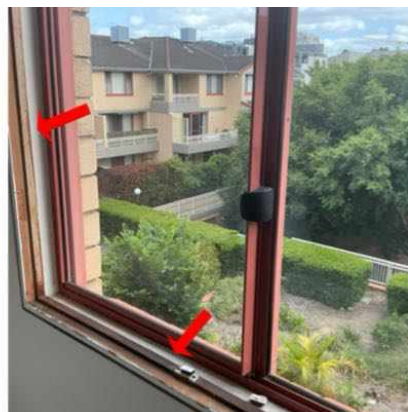
### Finding 3.02

Building:	Main Building
Location:	Window recesses in lounge room and upstairs bedrooms.
Finding:	Incomplete or substandard works- frameworks for former blinds in disrepair. Requires removal resealing, painting.
Information:	The works to this area appear to be incomplete or have been completed to a substandard level.

Works that have not been completed to a satisfactory level create potential for the development of building defects and may impede on the safety and integrity of the overall structure.

It is highly recommended that a handyman be appointed to complete these works and ensure the safety of the area and the longevity of all associated building elements.

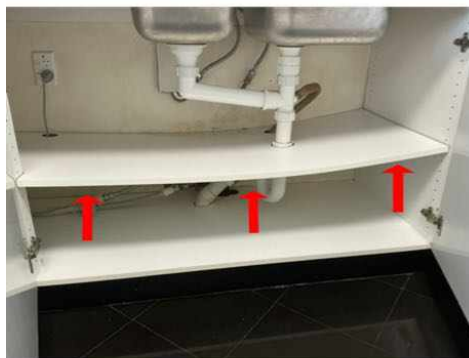
### Finding 3.03

Building:	Main Building
Location:	Vanity- Under kitchen sink
Finding:	Building element- broken/ damaged. - Shelving under kitchen sink
Information:	Breakage occurs generally when the building materials have either aged and decayed, or as a result of damage (accidental or deliberate).

Repair and/or replacement of broken elements is advised to ensure that additional secondary defects do not arise as a consequence. Such works are necessary, as all building elements play a key role in the operation and function of the overall structure and its performance.

A relevant tradesperson should be appointed to repair or replace the affected building element prior to any subsequent damage being caused.

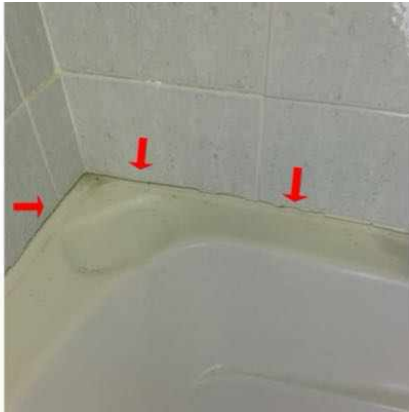
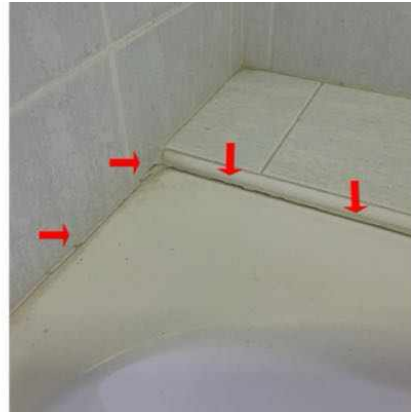
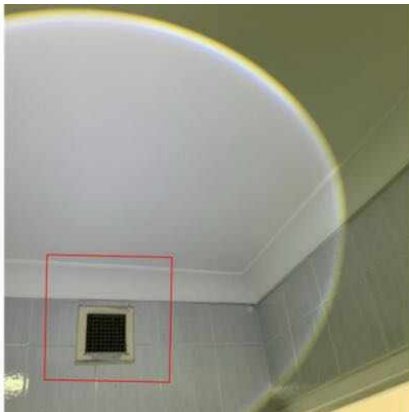
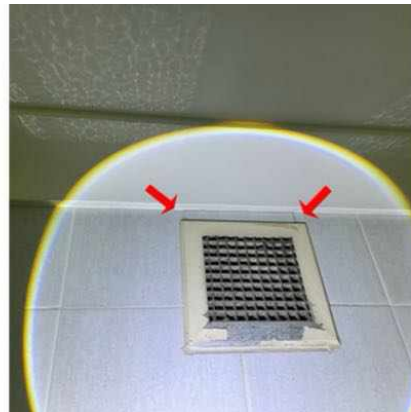
### Finding 3.04

Building:	Main Building
Location:	Bedroom ensuite
Finding:	Sealant and grouting - Missing or damaged
Information:	It was noted on inspection that sealant or grout is degraded to the tiled shower alcove and or other areas of the bathroom.

Different materials and floor areas move at different rates, generally causing cracking to grout or sealant at this point. A flexible sealant is required to allow for expected expansion and contraction, while keeping the joint water tight and protective of all associated building materials.

There appears to be excessive mould to the sealant and grout which will likely require scraping out and replacement.

Flexible and mould resistant materials should be applied to affected areas to prevent any subsequent water damage that is likely to occur. Regular maintenance and replacement of damage or missing or damaged sealant and grout is highly recommended to the wet areas, as this is a regular wear and tear defect. Sealant and grouting in areas that come into regular contact with water should be maintained for the long term care of your property.

A sealant specialist or tiling contractor should be appointed to complete these works as soon as possible

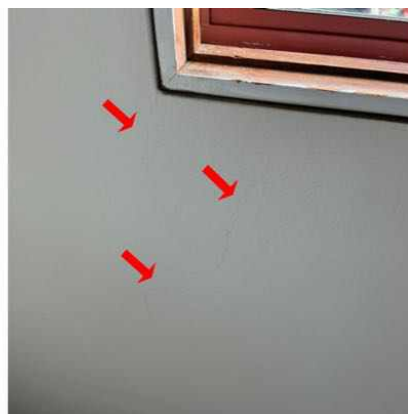
### Finding 3.05

Building: Main Building  
 Location: Smaller bedroom (western side)  
 Finding: Cracks to internal render - Category 1  
 Information: It has been observed that cracking to internal rendered surfaces has occurred. The degree of damage falls within Category 1, described as fine cracks that do not need repair and which are less than 1.0mm in width limit.

Damage of this category is not considered a defect for rectification. Always contact your building inspector should cracks widen, lengthen, or become more numerous.

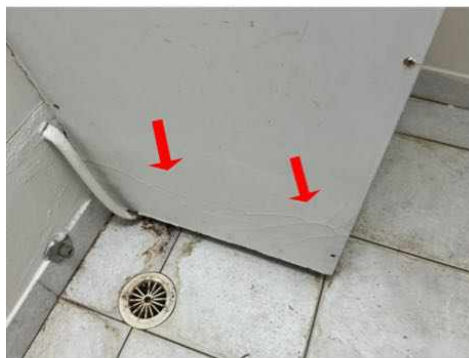
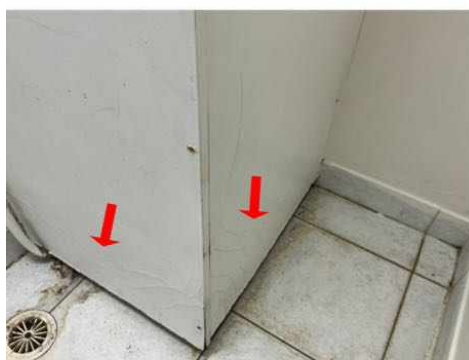
### Finding 3.06

Building:	Main Building
Location:	Laundry
Finding:	Building element - Broken or Damaged- Laundry cabinet
Information:	Breakage occurs generally when the building materials have either aged and decayed, or as a result of damage (accidental or deliberate).

Repair and/or replacement of broken elements is advised to ensure that additional secondary defects do not arise as a consequence. Such works are necessary, as all building elements play a key role in the operation and function of the overall structure and its performance.

A relevant tradesperson should be appointed to repair or replace the affected building element prior to any subsequent damage being caused.

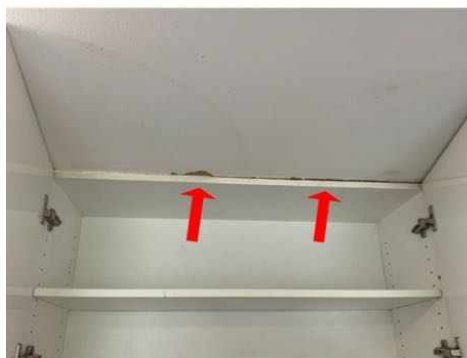
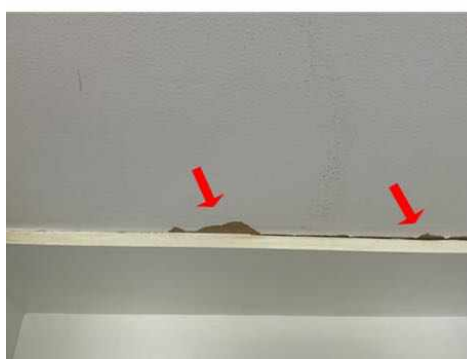
### Finding 3.07

Building:	Main Building
Location:	Kitchen cupboard, above fridge cavity
Finding:	Paint finish - Substandard
Information:	The paint finish in this area was found to have been completed to a substandard level. Substandard painting is generally classified as an appearance defect. However, the substandard appearance may also be indicative of poor surface preparation and substandard workmanship.

If this applies, further areas of poor and incomplete finishes could develop over time. Furthermore, substandard paint finishes in areas exposed to moisture, e.g. external areas or wet areas, could lead to deterioration of underlying building materials.

Substandard paint finishes should be sanded back, filled, leveled and repainted, as applicable. Where inadequate paint protection has led to the deterioration of the associated building element, repair and/or replacement of this building element may be required.

A painting contractor should be appointed as soon as possible to perform necessary works to aid the appearance of the affected area and to ensure that the area is protected against further deterioration. Alternatively, the homeowner following manufacturer instructions may be able to provide this service.

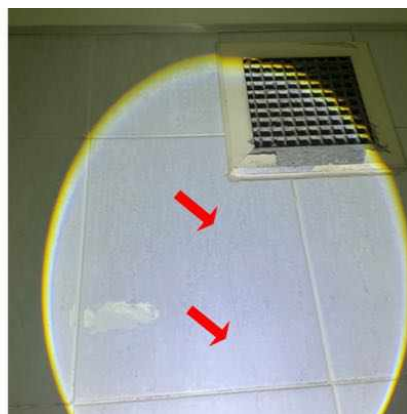
### Finding 3.08

Building:	Main Building
Location:	Bedroom ensuite
Finding:	Tile cracked or damaged- (wet areas)
Information:	Cracking was evident to the tiling in this area at the time of inspection. While the cracking appears to be minor, this area is frequently exposed to water, allowing potential for water penetration into adjoining sections of walls or flooring.

If left unmanaged, water penetration to these areas may lead to subsequent water damage, which is likely necessitate repair work to affected building elements.

A tiling contractor should be appointed to ensure that no further water damage occurs. The re-application of silicone and grouting throughout remaining tile work is also advised, to further protect the area against water penetration.

Where water penetration has led to water damage, appointment of a relevant tradesperson may be required to repair damaged building elements.

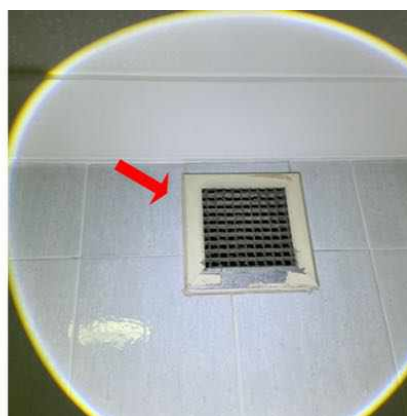
### Finding 3.09

Building:	Main Building
Location:	Bedroom ensuite
Finding:	Exhaust fan - Not functioning
Information:	An exhaust fan is not functioning properly in this area. Missing exhaust fans may lead to the development of more significant defects such as moisture damage to surrounding building materials from inadequate ventilation. Inadequate ventilation in internal areas creates an environment that is conducive to the formation and development of mould and other respiratory hazards. It is highly advised that a licensed electrician be appointed to retrospectively install an exhaust fan. Failure to perform works to aid the ventilation of the area may lead to the development of these secondary defects.

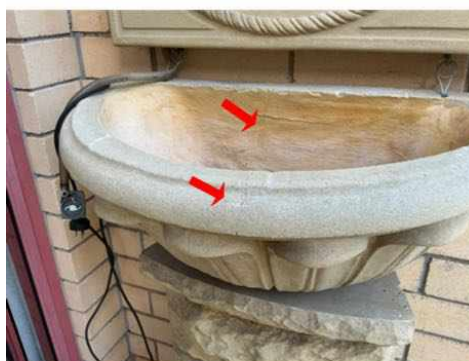
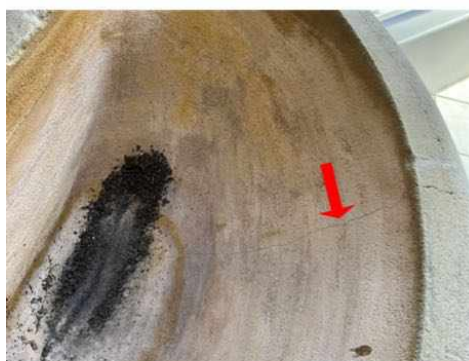
Finding: Basin - Cracked  
 Information: Cracking was evident to the basin at the time of inspection, which is suspected to have been by minor impact damage. While the cracking appears to be minor, any further impact damage sustained by the basin may lead to additional cracking.

As the cracking provides potential ingress for water, secondary water damage may occur to associated cabinetry, walls or flooring, if the cracking is left unmanaged.

Consultation with a plumber regarding basin repair or replacement is required. Remedial works may be required to protect against any further damage.

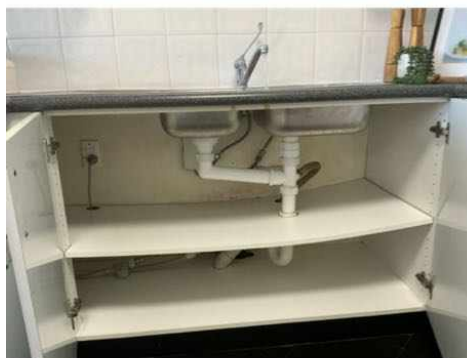
Building:	Main Building
Location:	Switch board or under kitchen sink
Finding:	Termite Management System - no evidence of a chemical installation
Information:	The application of a post-construction chemical termite barrier is highly recommended for all properties, particularly if live termite activity has been found on the site previously. Such barriers are highly effective in preventing termite attack on any timber building elements throughout the property.

A durable notice should be placed in the switchboard unit to indicate current termite barriers. At the time of inspection, it appeared as though no termite management system has been installed, with no evidence to suggest preventative works taking place.

The client may consider gaining further advice from a pest controller as to the costs and procedures involved with this application. It is recommended that obtaining such advice be a short-term priority.

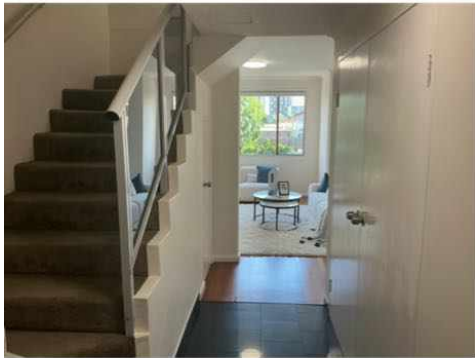
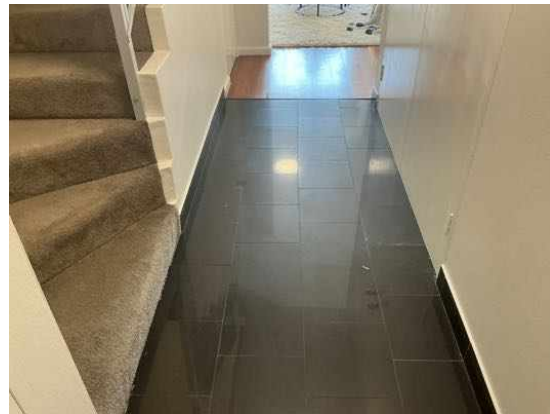
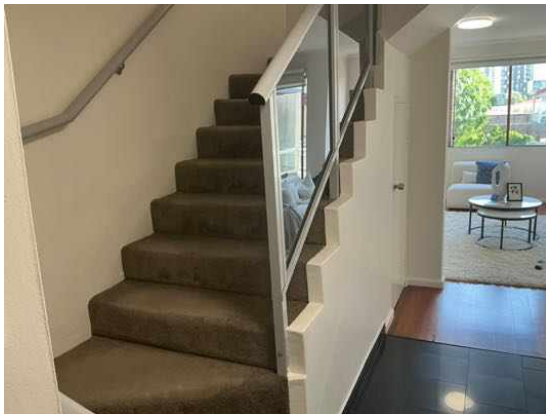
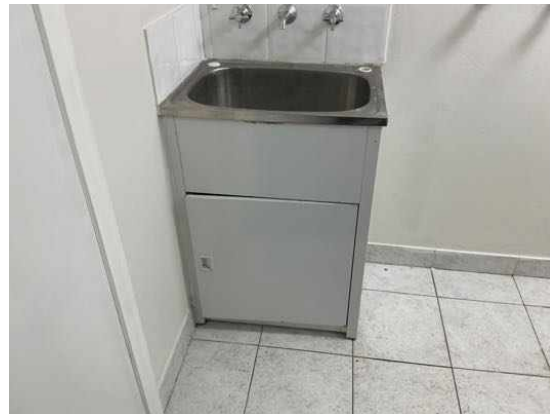
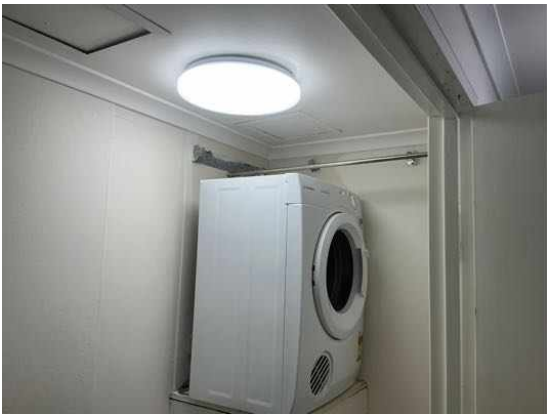
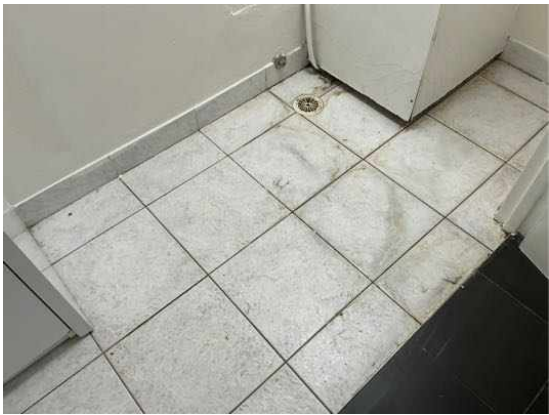
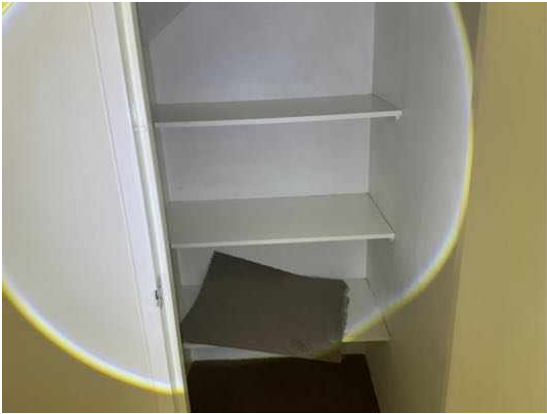
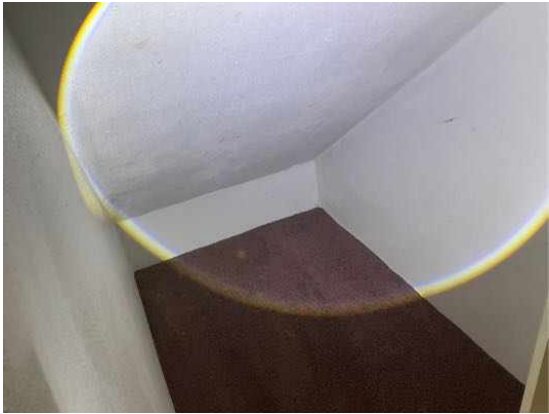
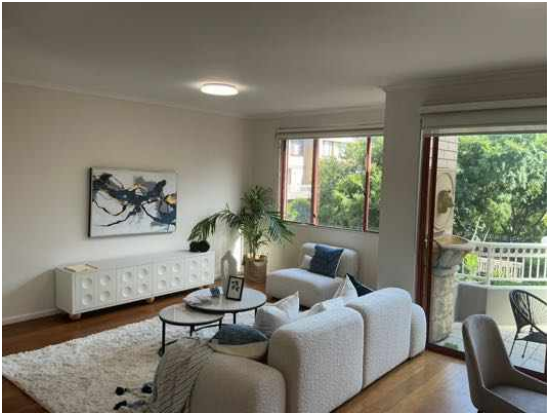
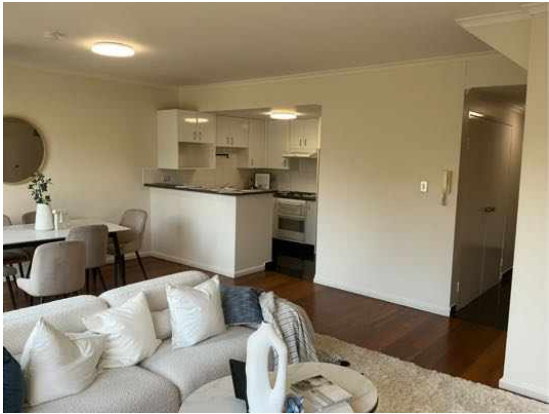
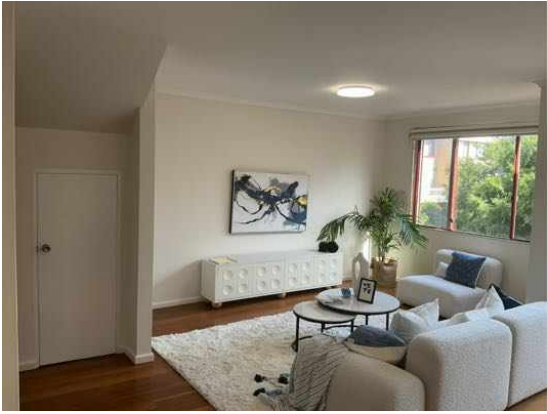
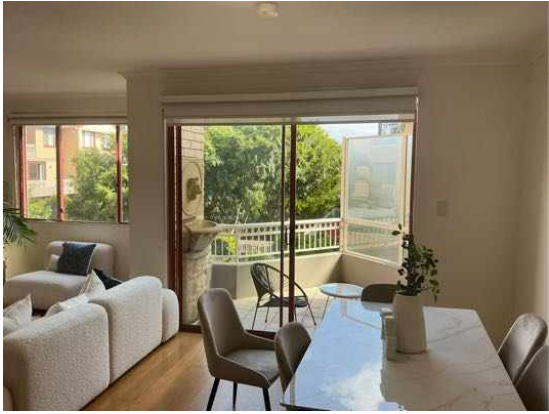
### Noted Item

Building: Main Building  
Location: All Areas  
Finding: Additional Photos - Obstructions and Limitations  
Information: These photographs are an indication of the obstructions and limitations which impeded full inspection of the property at the time of inspection. These obstructions can hide an array of defects and should be removed to allow full inspection to be carried out. A re-inspection is recommended once the areas are made accessible.

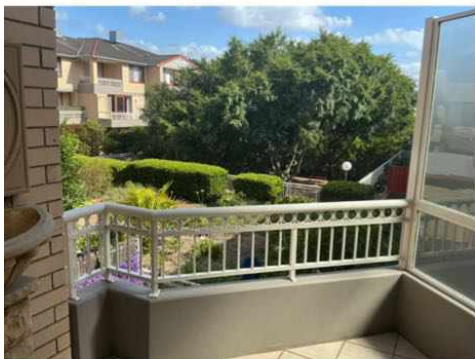
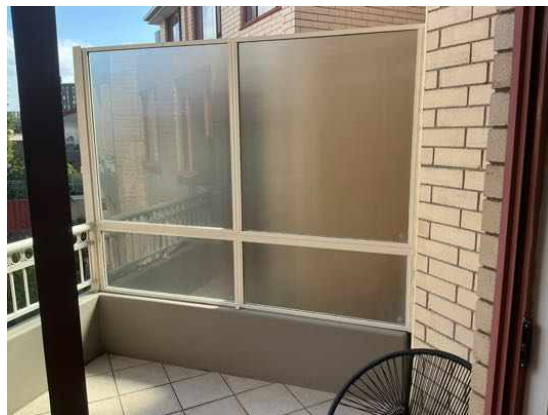
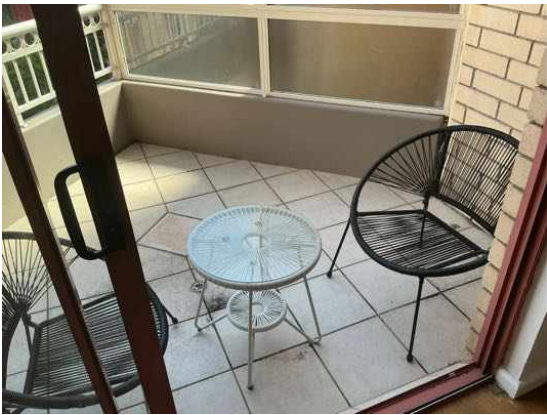
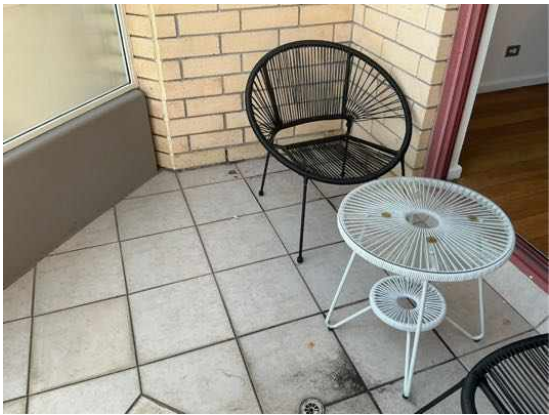
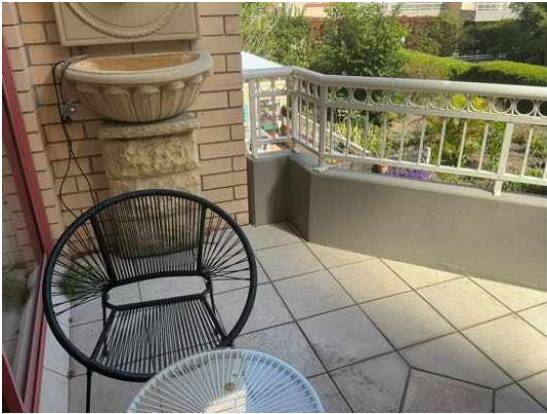
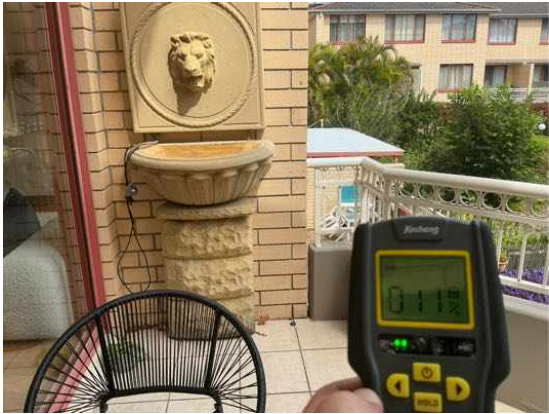
Building:	Main Building
Location:	All Areas
Finding:	Additional Photos - Obstructions and Limitations
Information:	These photographs are an indication of the obstructions and limitations which impeded full inspection of the property at the time of inspection. These obstructions can hide an array of defects and should be removed to allow full inspection to be carried out. A re-inspection is recommended once the areas are made accessible.
