# Building and Timber Pest Inspection Report

Inspection Date: Wed, 28 Jan 2026

Property Address: 45 Fitzwilliam Rd, Vaucluse NSW 2030,  
Australia

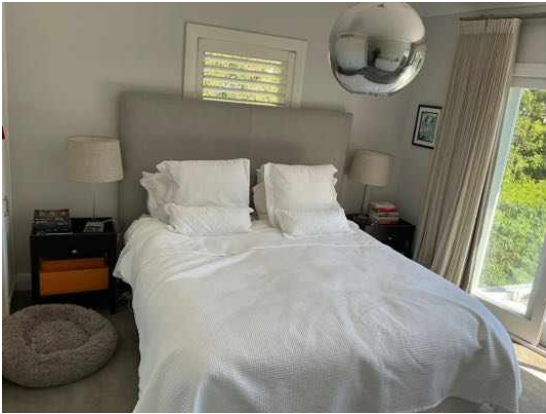
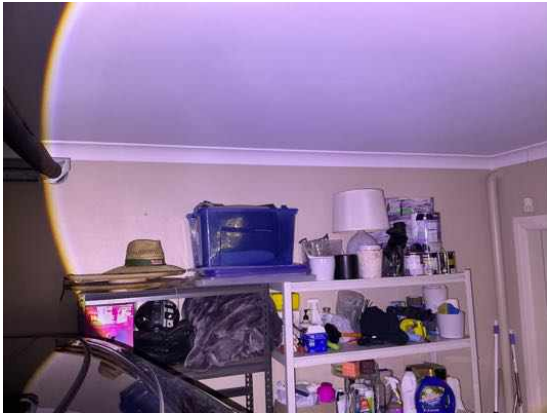
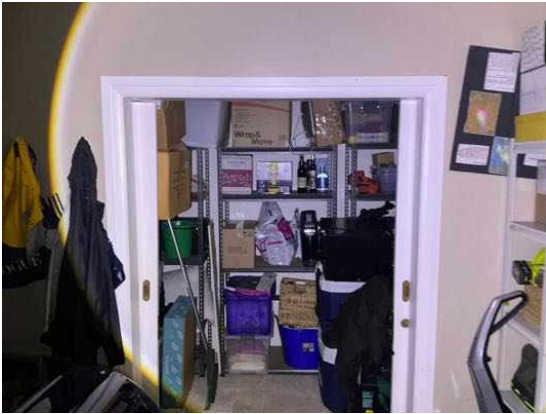
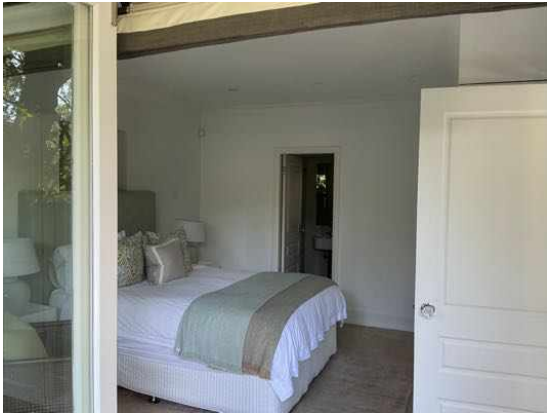
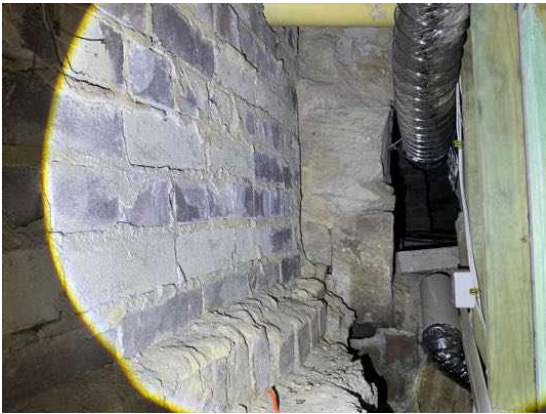
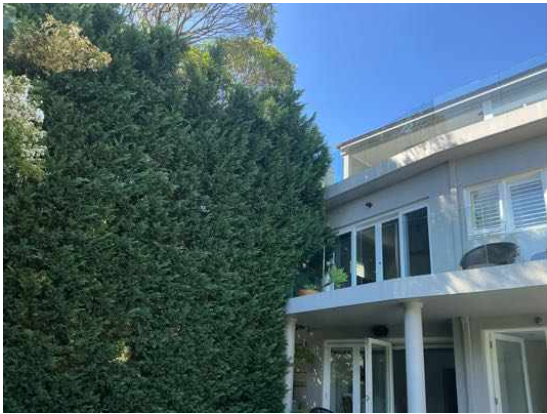
Building: Main Building  
Location: All Areas  
Finding: Additional Photos - Obstructions and Limitations  
Information: These photographs are an indication of the obstructions and limitations which impeded full inspection of the property at the time of inspection. These obstructions can hide an array of defects and should be removed to allow full inspection to be carried out. A re-inspection is recommended once the areas are made accessible.

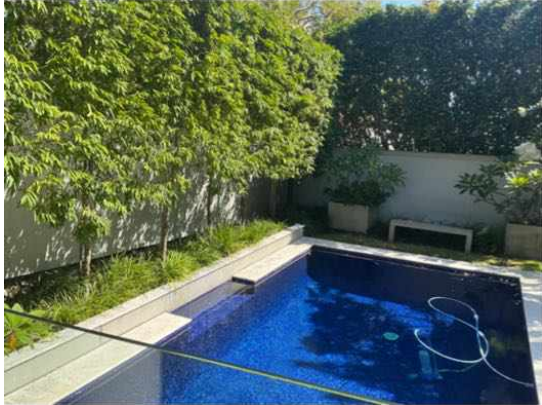
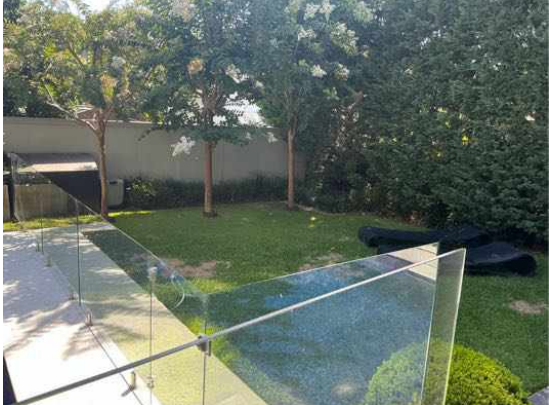
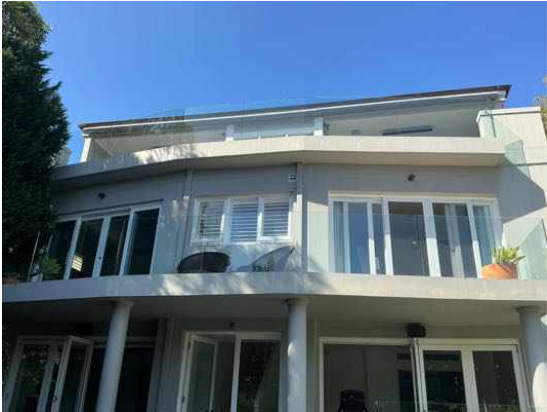
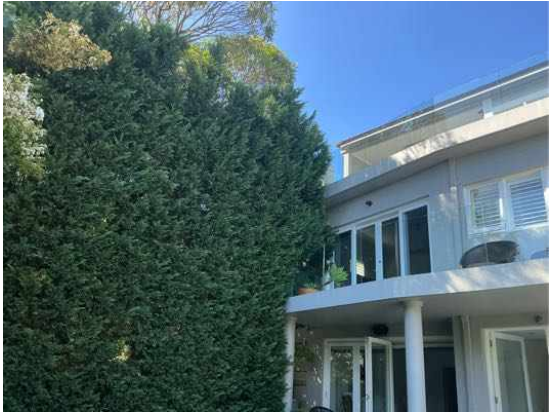
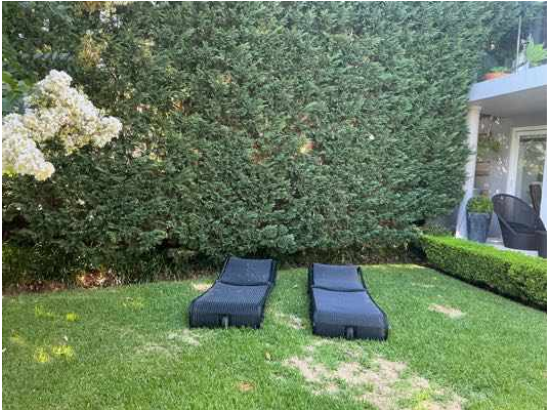
Building: Main Building  
Location: Yard - Back  
Finding: No Visible Building Defects Observed  
Information: During the inspection, no visible building defects were noted in this area at the time of assessment. Everything appeared to be in satisfactory condition based on a visual inspection.

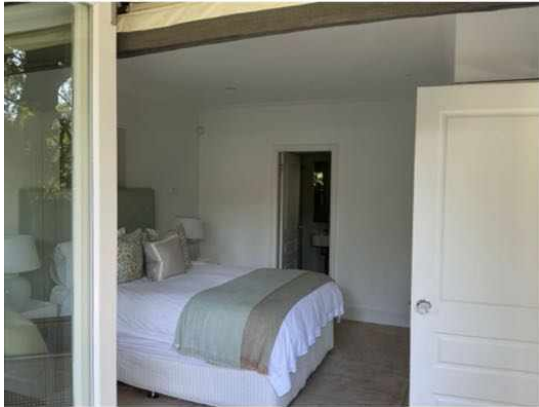
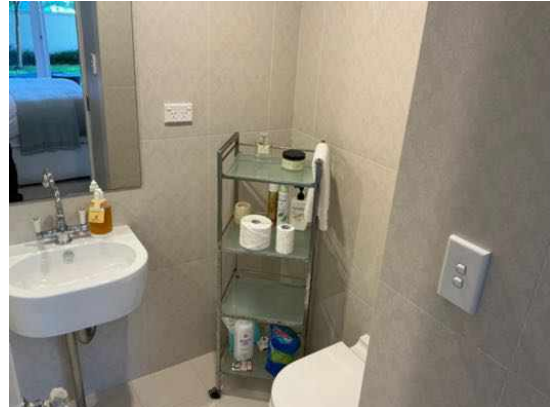
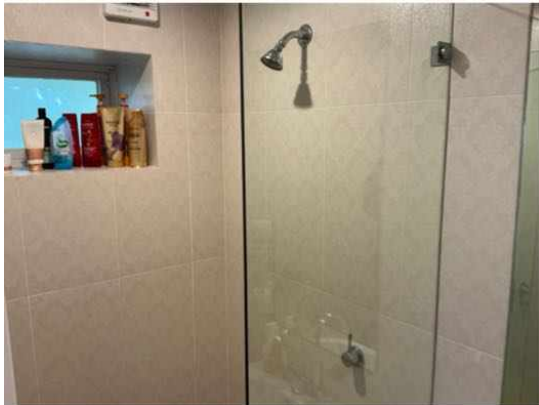
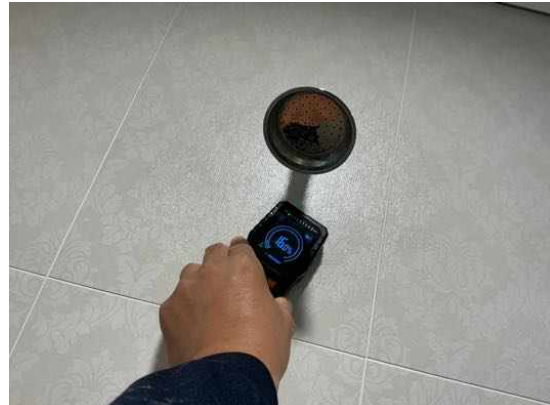
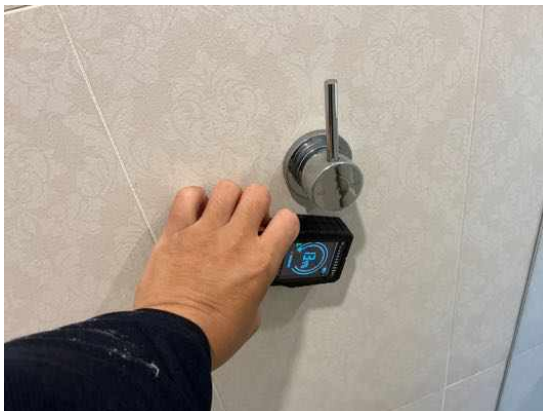
Building: Main Building  
Location: Lower Ground Bedroom  
Finding: No Visible Building Defects Observed

Information: During the inspection, no visible building defects were noted in this area at the time of assessment. Everything appeared to be in satisfactory condition based on a visual inspection.

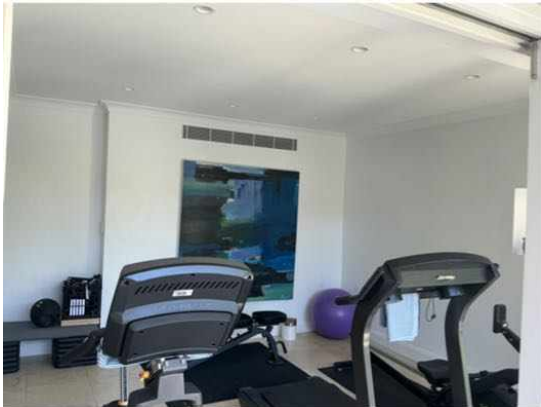
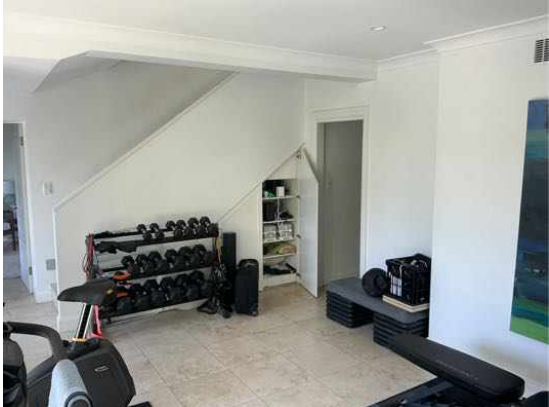
Building: Main Building  
 Location: Lower Ground  
 Finding: No Visible Building Defects Observed  
 Information: During the inspection, no visible building defects were noted in this area at the time of assessment. Everything appeared to be in satisfactory condition based on a visual inspection.

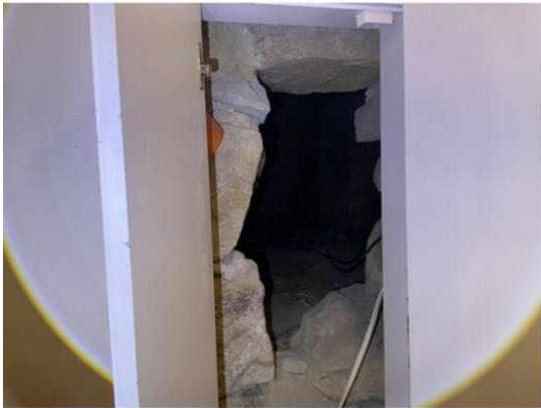
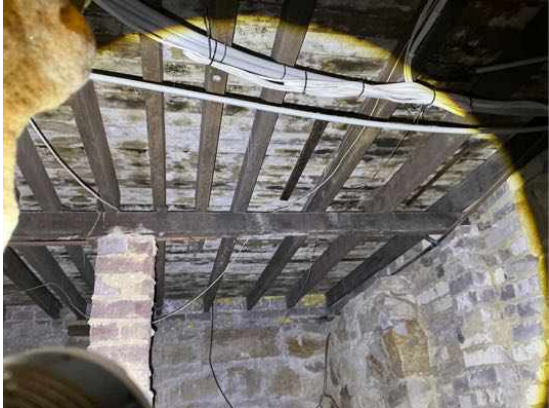
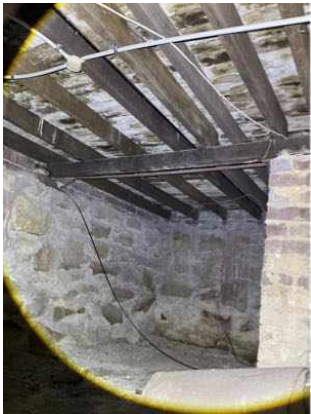
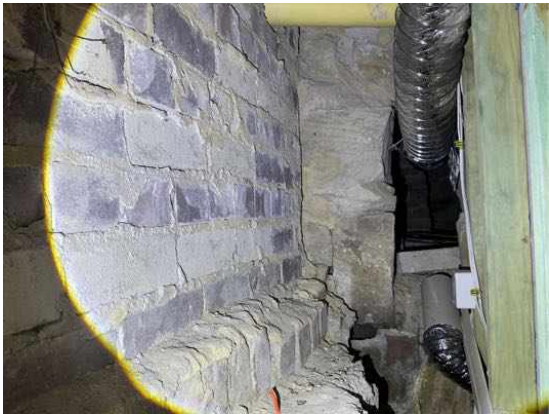
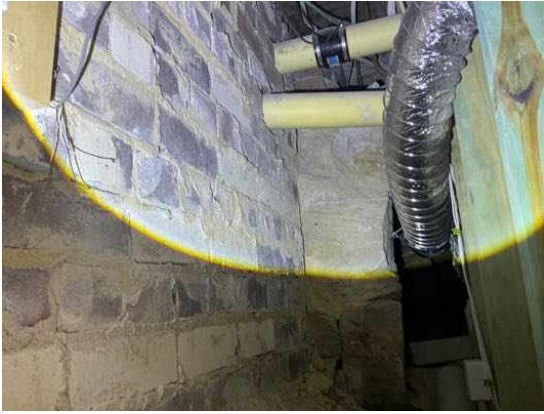
Building: Main Building  
Location: Subfloor  
Finding: Additional Photos  
Information: Additional photos are provided for your general reference

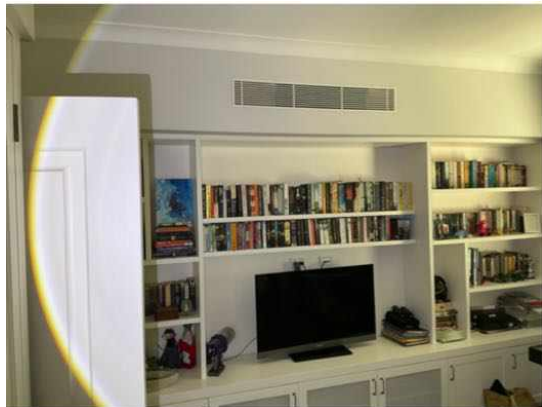
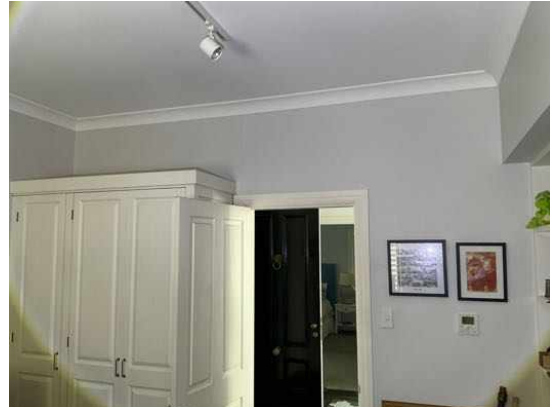
Building: Main Building  
 Location: Office  
 Finding: No Visible Building Defects Observed  
 Information: During the inspection, no visible building defects were noted in this area at the time of assessment. Everything appeared to be in satisfactory condition based on a visual inspection.

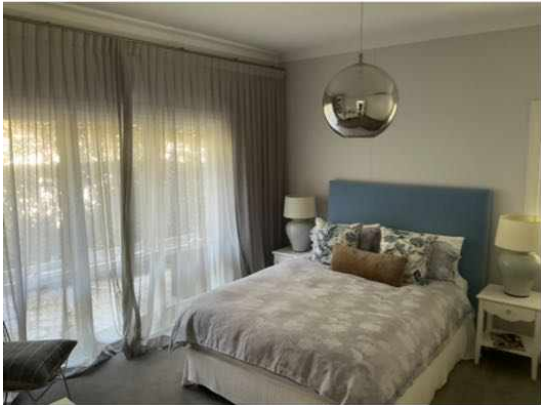
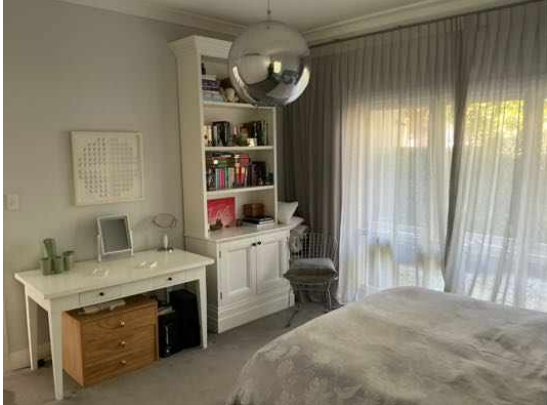
Building: Main Building  
 Location: Bedroom  
 Finding: No Visible Building Defects Observed  
 Information: During the inspection, no visible building defects were noted in this area at the time of assessment. Everything appeared to be in satisfactory condition based on a visual inspection.

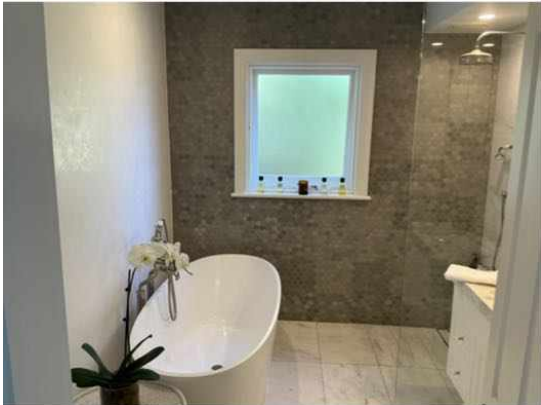
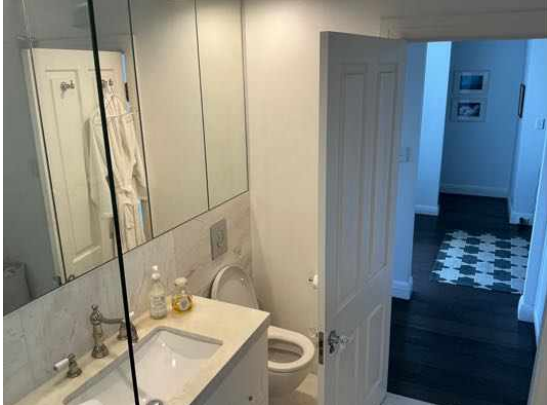
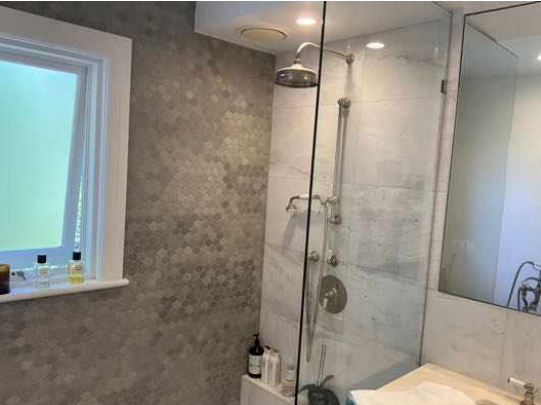
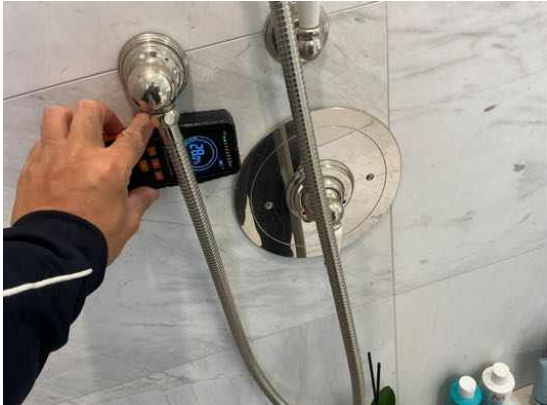
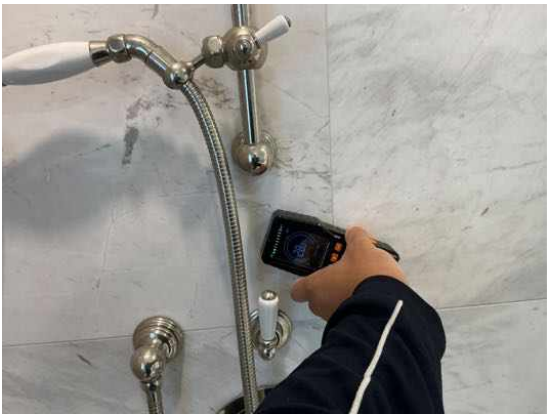
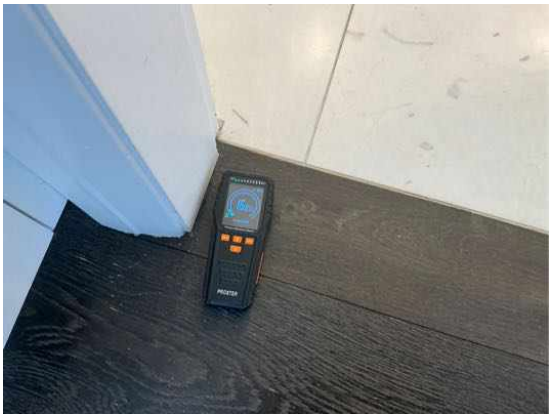
Building: Main Building  
Location: Bathroom  
Finding: No Visible Building Defects Observed  
Information: During the inspection, no visible building defects were noted in this area at the time of assessment. Everything appeared to be in satisfactory condition based on a visual inspection.

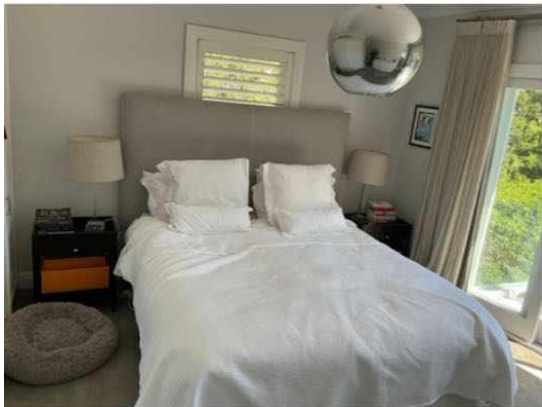
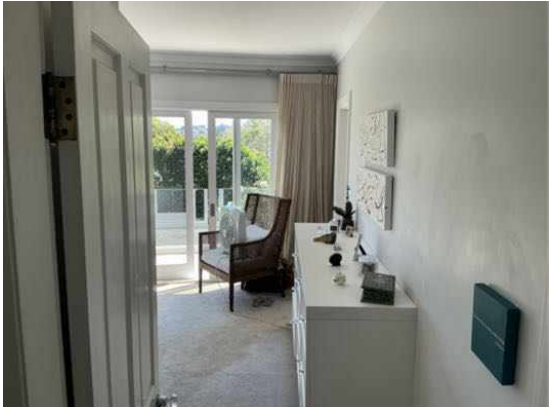
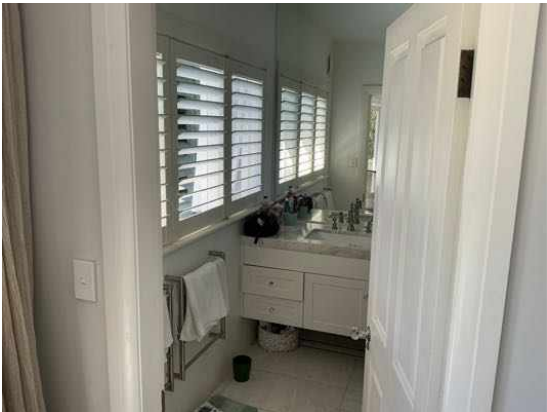
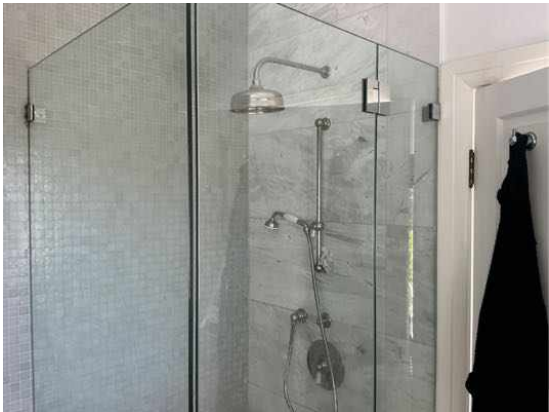
Building: Main Building  
Location: Bedroom - Master  
Finding: No Visible Building Defects Observed  
Information: During the inspection, no visible building defects were noted in this area at the time of assessment. Everything appeared to be in satisfactory condition based on a visual inspection.
