# Building and Timber Pest Inspection Report

Inspection Date: Fri, 6 Mar 2026

Property Address: 4 Strathmore St, Wodonga VIC 3690,  
Australia

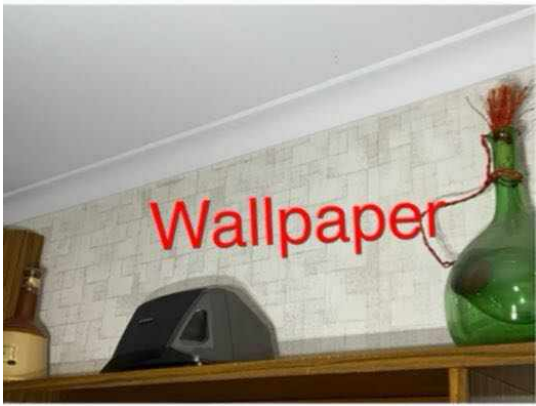
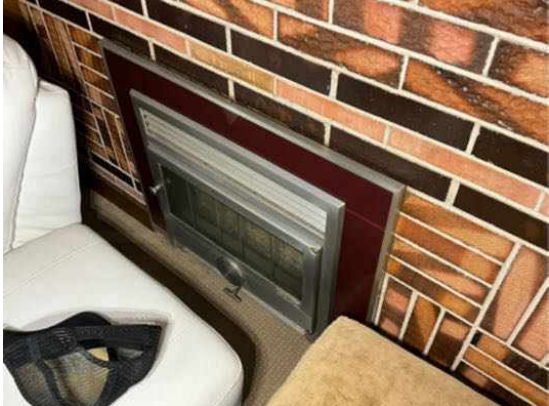
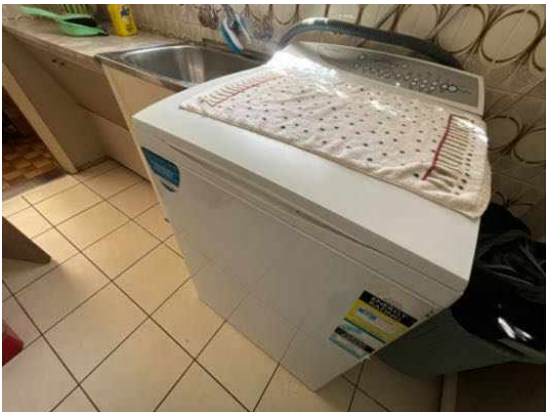
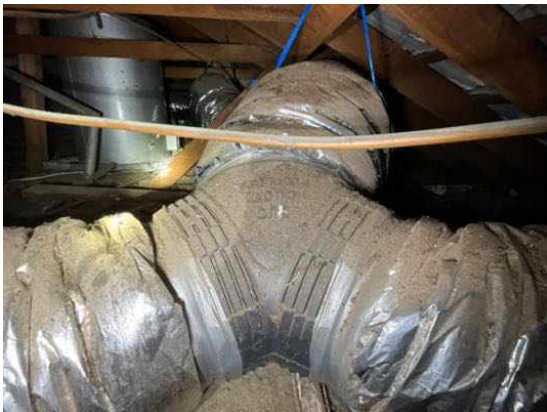
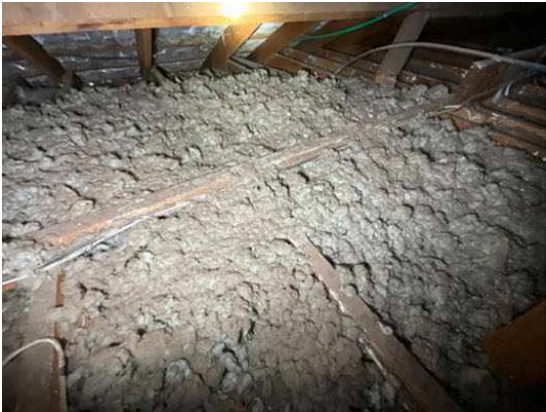
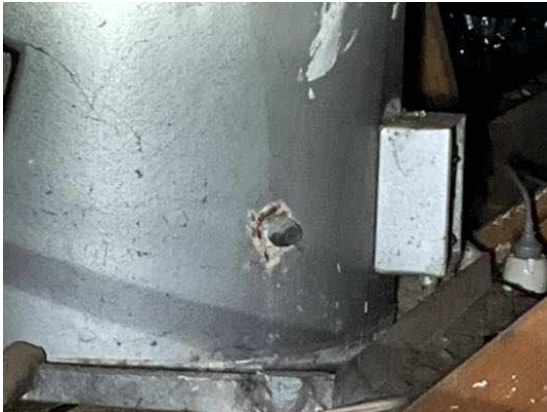
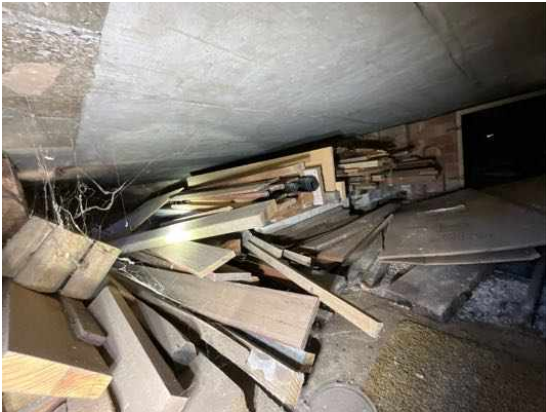
Building: Building 1  
 Location: All Areas  
 Finding: Additional Photos - Obstructions and Limitations  
 Information: These photographs are an indication of the obstructions and limitations which impeded full inspection of the property at the time of inspection. These obstructions can hide an array of defects and should be removed to allow full inspection to be carried out. A re-inspection is recommended once the areas are made accessible.
