Building Inspection Report

Inspection Date: Tue, 7 Apr 2026

Property Address: 3/59 Wills Rd, Woollooware NSW 2230,
Australia

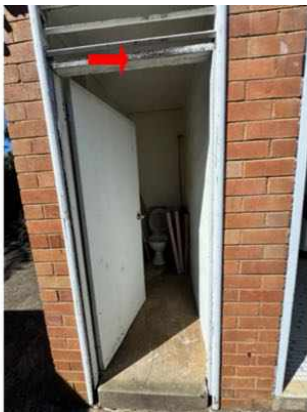
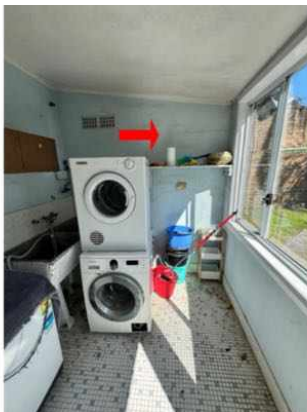
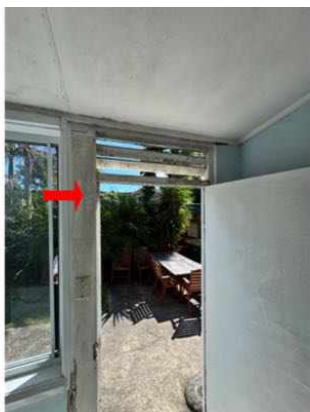
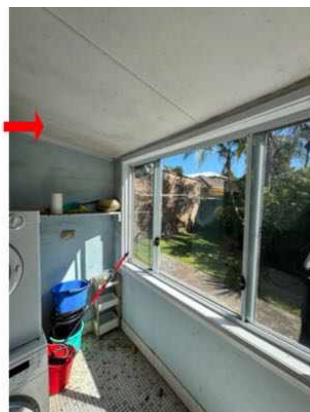
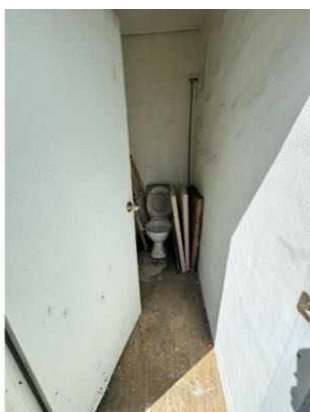
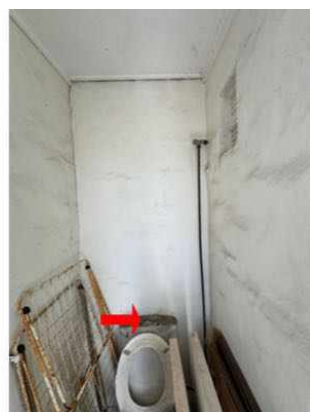
Defects 1.01

Information: Where evidence of mould growth was noted, there may be environmental, biological or health issues associated with the report. A specialist inspection by a suitably qualified environmental health inspector is warranted, where mould is extensive or where any queries regarding air quality spores or other related issues apply.

Generally, the client is advised to ensure that the general environment is free of moisture and humidity to aid in the prevention of mould formation and development. Any mould found during the inspection should be cleaned immediately by a cleaning contractor or the homeowner as applicable.

Please note that severely affected building elements may require replacement by a registered builder or qualified carpenter.

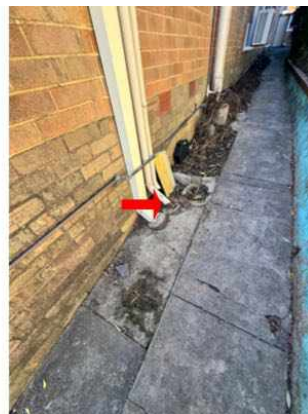
Defects 3.01

Building: Main Building
Location: Exterior walls - left side
Finding: Building element - Damaged

Information: Breakage occurs generally when the building materials have either aged and decayed, or as a result of damage (accidental or deliberate).

Repair and/or replacement of broken elements is advised to ensure that additional secondary defects do not arise as a consequence. Such works are necessary, as all building elements play a key role in the operation and function of the overall structure and its performance.

A relevant tradesperson should be appointed to repair or replace the affected building element prior to any subsequent damage being caused.

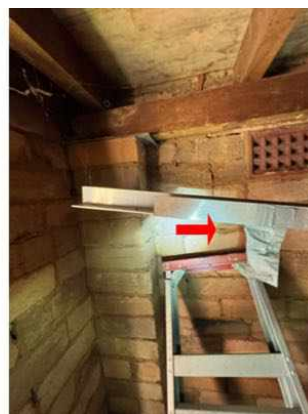
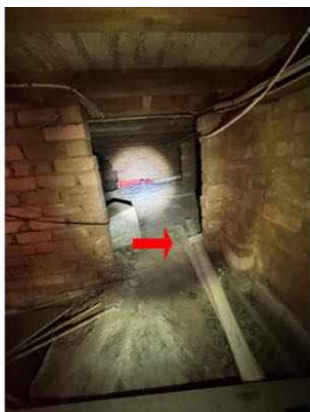
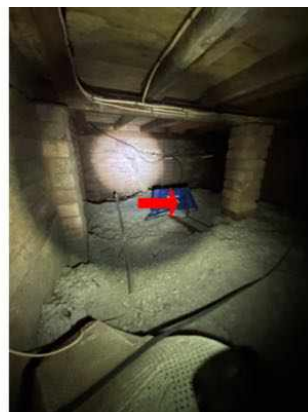
Defects 3.02

Information: An array of debris was found in the subfloor area at the time of inspection. Debris in this area restricts subfloor ventilation and creates potential for concealed pest entry. Stored timbers and other materials may also make the area susceptible to termite activity and wood rot.

A clear and empty subfloor will be better ventilated and easier to maintain in a dry condition. The removal of any timber debris is vital in minimising the risk of termite or wood borer activity.

Debris in the subfloor should be removed as soon as possible. Depending on the location and amount of debris and stored items, the homeowner may elect to undertake this task. Alternatively there are a large number of rubbish removal subcontractors that could undertake these works.

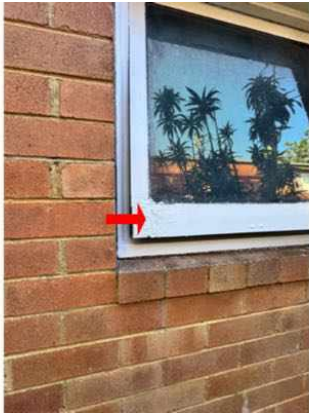
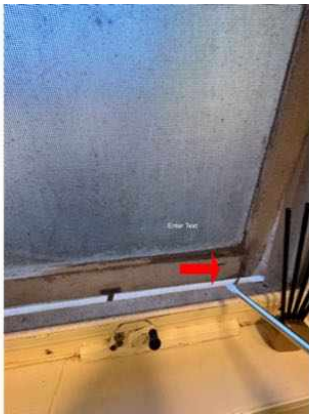
Defects 3.03

| Finding: | Windows - Wood rot |
| Information: | Wood rot was found to be affecting external windows. Wood rot, also known as Fungal Decay, occurs when timbers and other cellulose building materials are exposed to damp conditions on an ongoing basis. |

It is likely that this wood rot has developed as a result of frequent exposure to rain and other weather conditions. It is suspected that failure to maintain the window frames over a prolonged period has resulted in them deteriorating at an accelerated rate, increasing their susceptibility to the development of wood rot. Leaks in roof plumbing or associated pipework may have also contributed to the formation of the wood rot in this area.

Early intervention and regular maintenance will prolong the useful life of these building elements. Prior to any works being performed, any associated pipework or roof plumbing should be inspected by a licensed plumber for faults or leaks.

Repair and/or replacement of affected window frames may be a necessary step in protecting surrounding building elements from such deterioration. Remedial works should be performed by a qualified carpenter or registered builder as soon as possible to prevent any further damage.

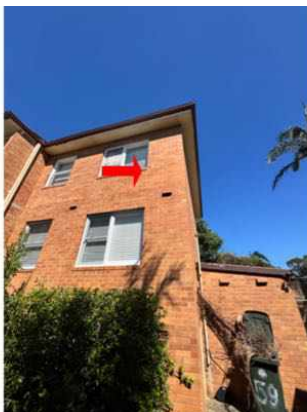
Defects 3.07

| Finding: | Brickwork - Step cracking |
| Information: | Step cracking was identified to the brickwork in this area at the time of inspection. Step cracking, which is similar to other forms of cracking, has a variety of possible causes. However, the most common is the subsidence of adjacent footings. |

Step cracking is a relatively common defect, and is most likely to occur adjacent to windows, doors and other openings. Mortar failure in the gaps between affected bricks indicates the stresses and tensions affecting the wall.

Where step cracking is extensive or severe, the client is advised to consult a structural engineer. Minor step cracking can be used as a warning sign to address factors causing stress to the wall, which can include the effect of surrounding trees, water leaks, soil erosion, or even the presence of reactive soils in the surrounding area.

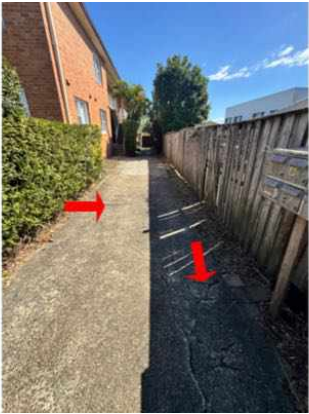
Defects 3.08

Location: Driveway
Finding: Crack in concrete slab - Category 2
Information: A crack coded as Category 2 was identified in the slab. A Category 2 crack is described as a distinct crack, with the slab being noticeably curved or changed in level.

To be considered Category 2, the approximate width of the crack is less than 2.0mm, or a change in offset of less than 15mm when a 3m straight edge is placed over the defect.

Category 2 cracks to slabs should be monitored for a period of 12 months. At the end of the monitoring period, cracks rated greater than Category 2 are considered defects that require rectification.

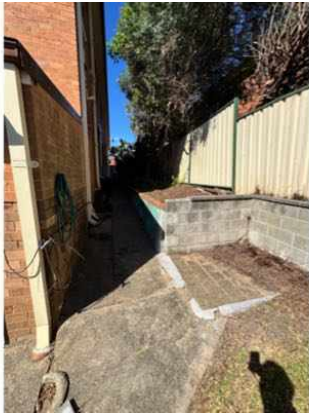
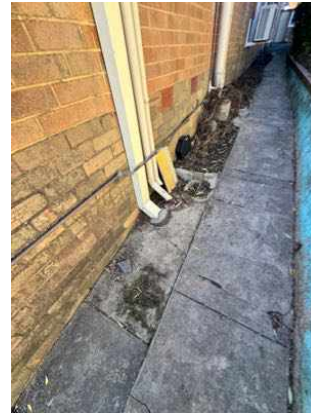
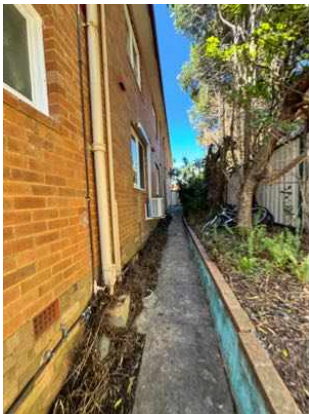
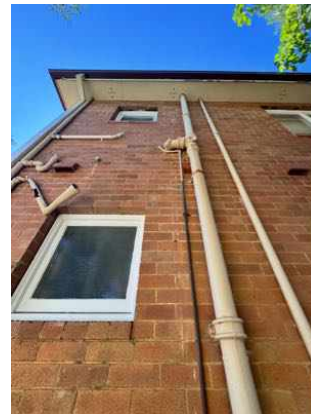
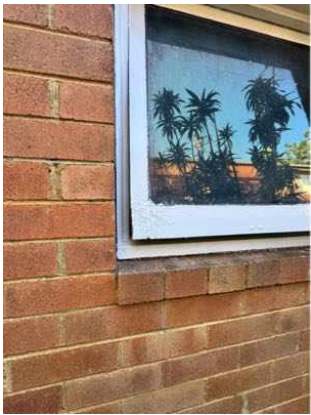
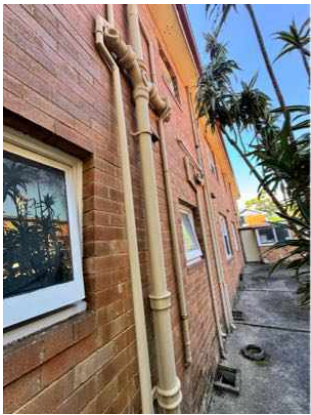
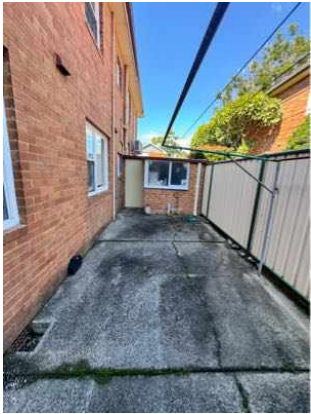
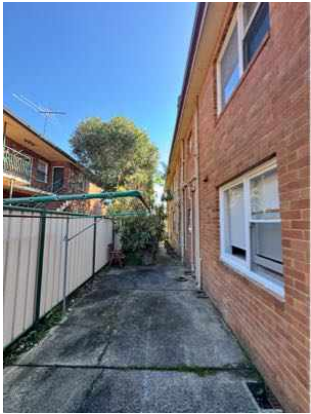
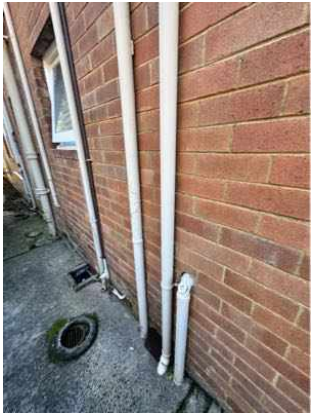
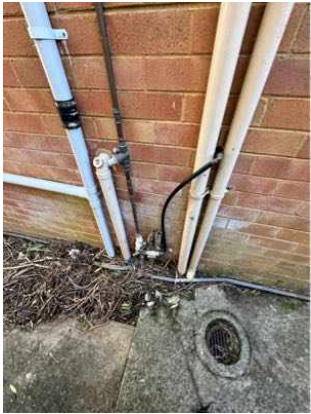
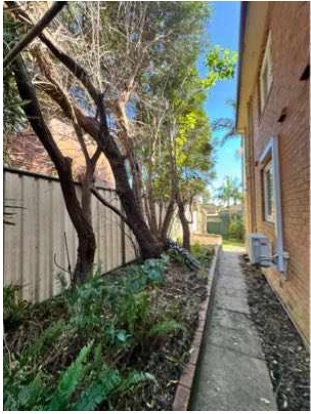
Building: Main Building
Location: Exterior walls - left side
Finding: Additional Photos - Obstructions and Limitations
Information: These photographs are an indication of the obstructions and limitations which impeded full inspection of the property at the time of inspection. These obstructions can hide an array of defects and should be removed to allow full inspection to be carried out. A re-inspection is recommended once the areas are made accessible.

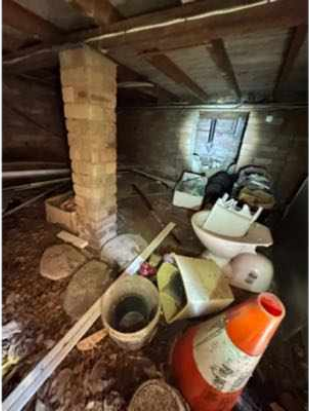
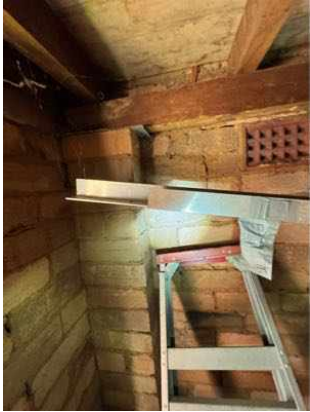
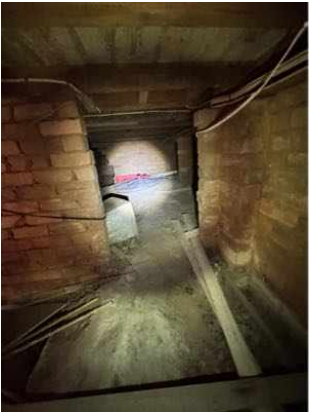
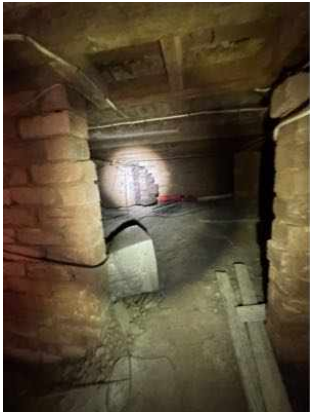
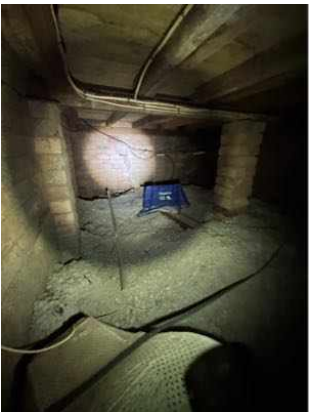
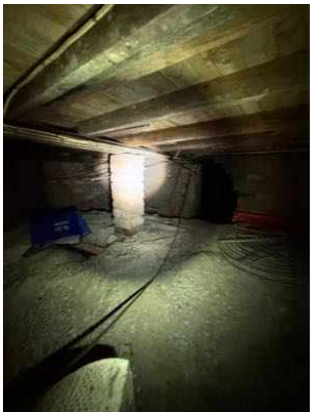
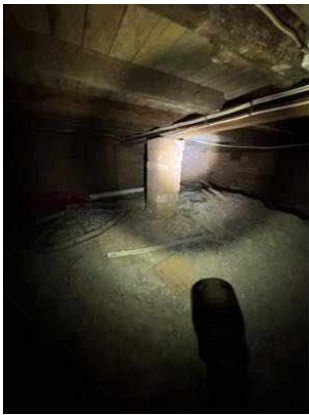
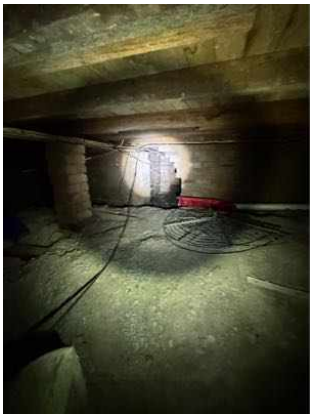
Building: Main Building
Location: Subfloor
Finding: Additional Photos - Obstructions and Limitations
Information:

These photographs are an indication of the obstructions and limitations which impeded full inspection of the property at the time of inspection. These obstructions can hide an array of defects and should be removed to allow full inspection to be carried out. A re-inspection is recommended once the areas are made accessible.

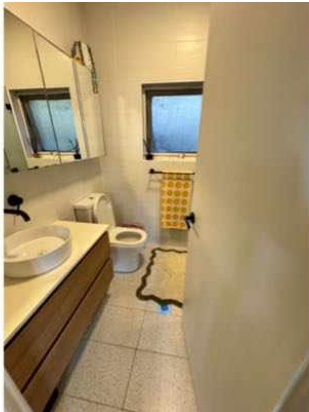
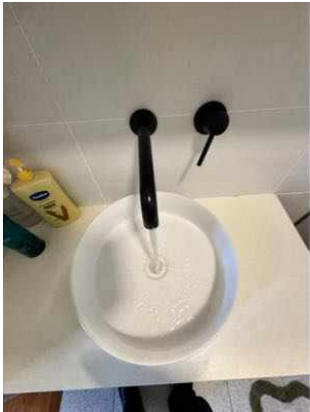
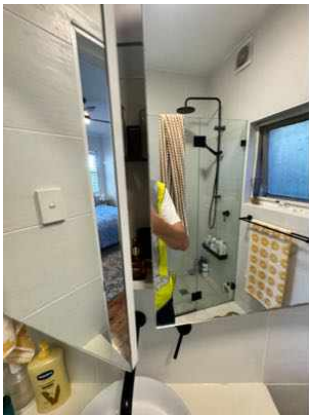
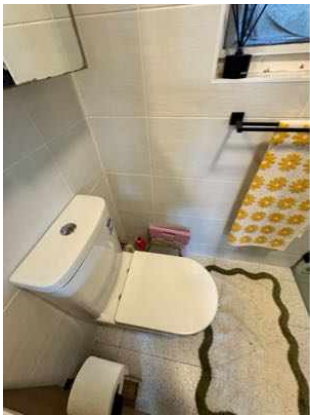
Building: Main Building
Location: Bathroom
Finding: Additional Photos - Obstructions and Limitations
Information: These photographs are an indication of the obstructions and limitations which impeded full inspection of the property at the time of inspection. These obstructions can hide an array of defects and should be removed to allow full inspection to be carried out. A re-inspection is recommended once the areas are made accessible.

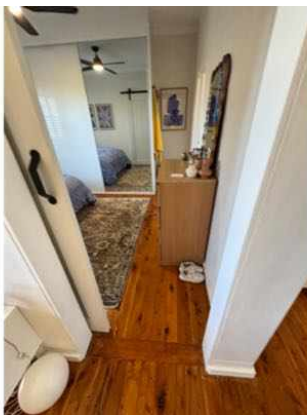
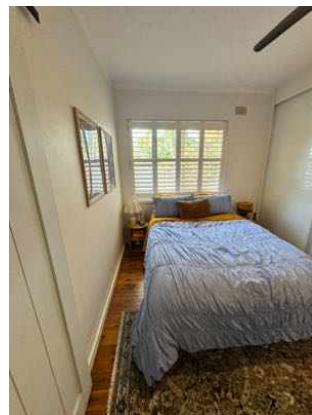
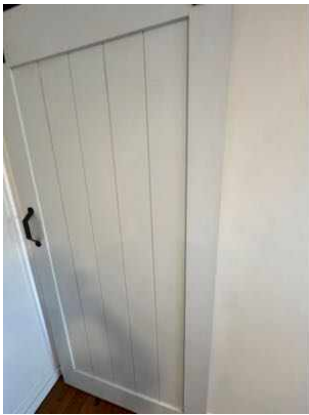
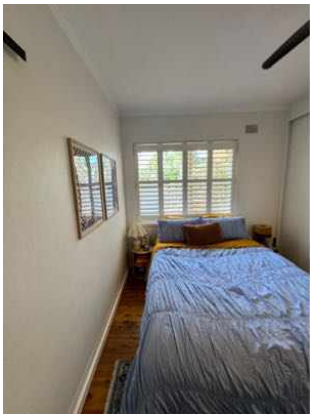
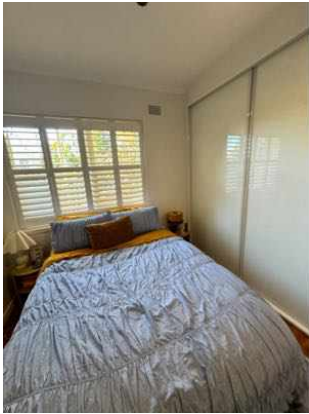
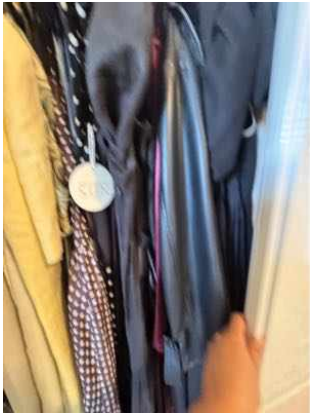
Finding: Additional Photos - Obstructions and Limitations

Information: These photographs are an indication of the obstructions and limitations which impeded full inspection of the property at the time of inspection. These obstructions can hide an array of defects and should be removed to allow full inspection to be carried out. A re-inspection is recommended once the areas are made accessible.

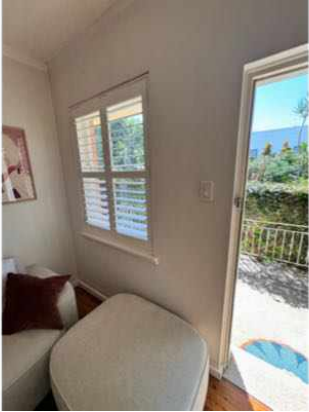
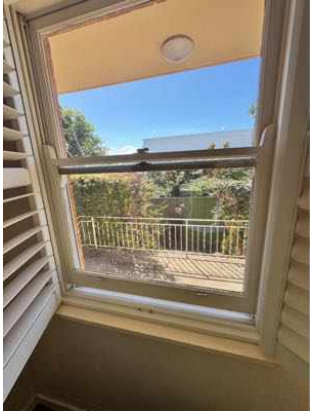
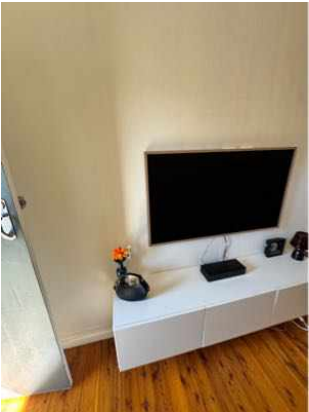
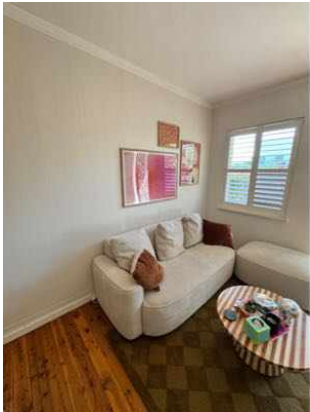
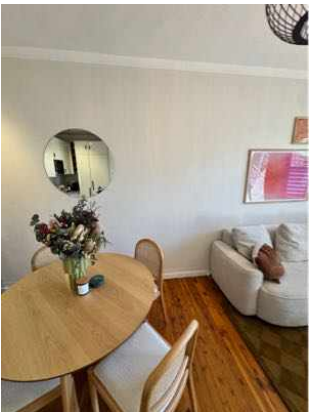
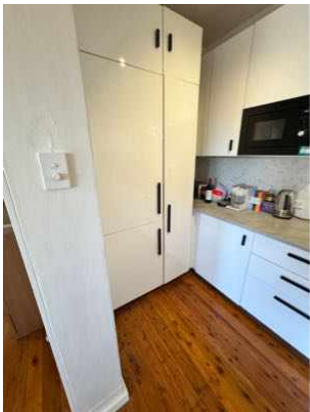
Building: Main Building
Location: All Internal Areas
Finding: Additional Photos - Obstructions and Limitations
Information: These photographs are an indication of the obstructions and limitations which impeded full inspection of the property at the time of inspection. These obstructions can hide an array of defects and should be removed to allow full inspection to be carried out. A re-inspection is recommended once the areas are made accessible.

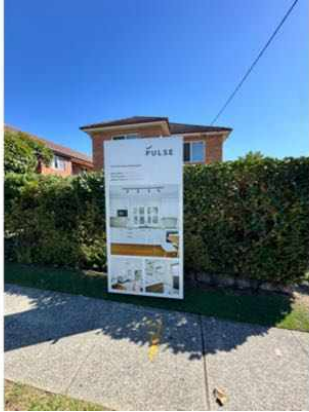
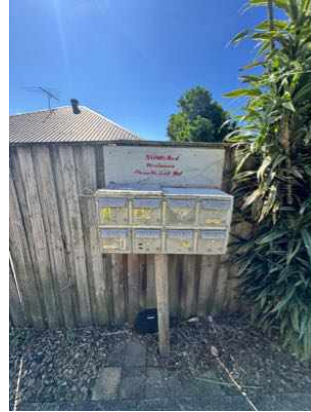
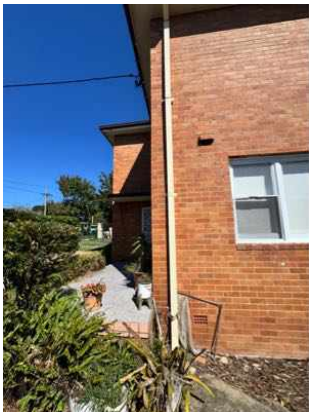
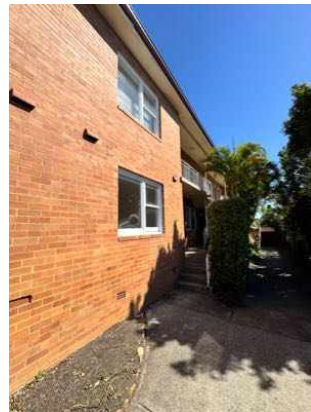
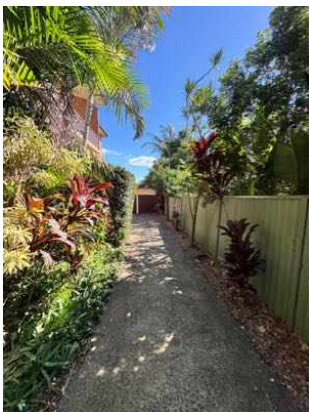
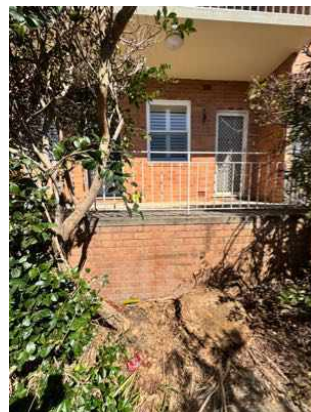
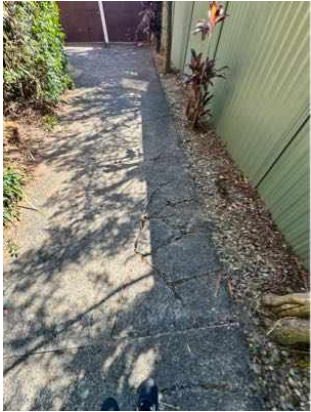
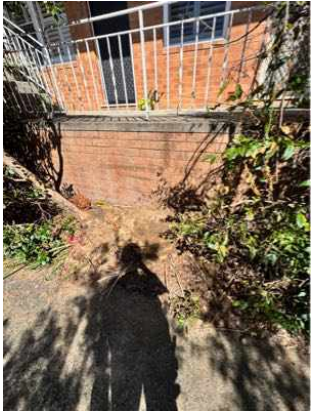
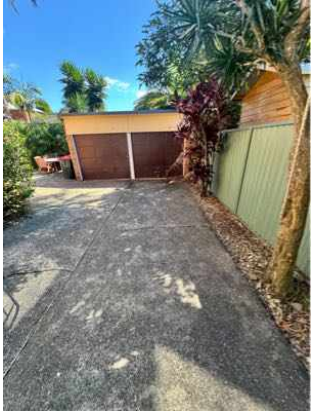
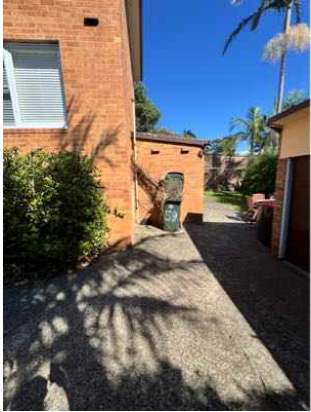
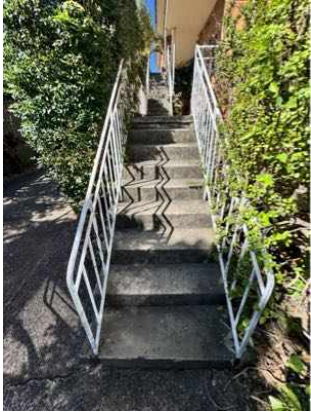
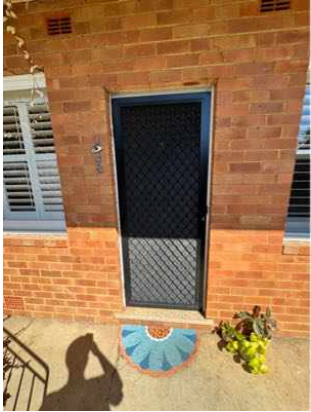
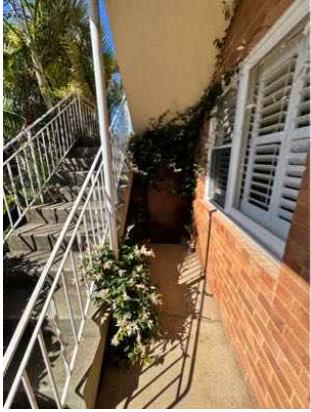
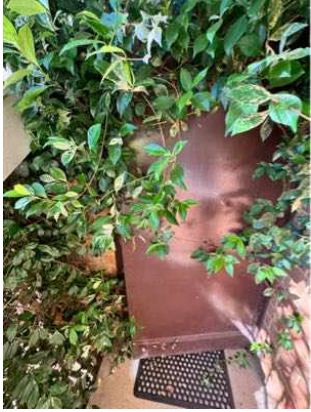
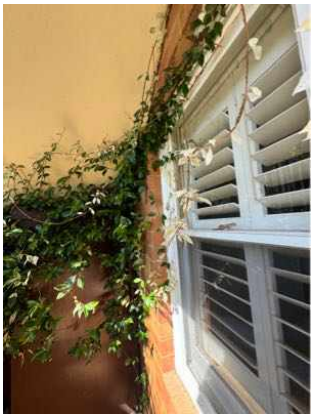
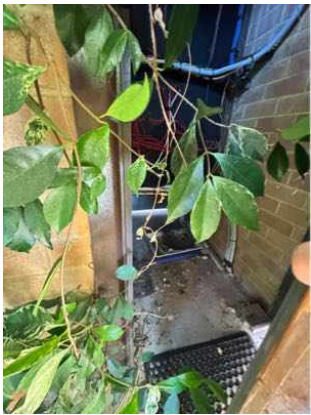
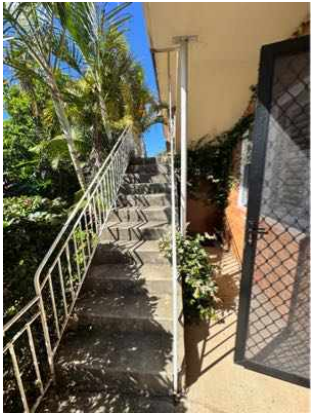
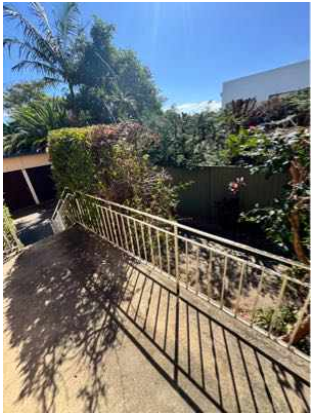
Finding: Additional Photos - Obstructions and Limitations

Information: These photographs are an indication of the obstructions and limitations which impeded full inspection of the property at the time of inspection. These obstructions can hide an array of defects and should be removed to allow full inspection to be carried out. A re-inspection is recommended once the areas are made accessible.
