## Building Inspection Report

Inspection Date: Fri, 27 Feb 2026

Property Address: 523/1-39 lord Sheffield circuit, Penrith,  
NSW 2750

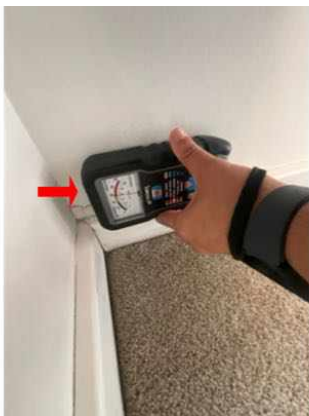
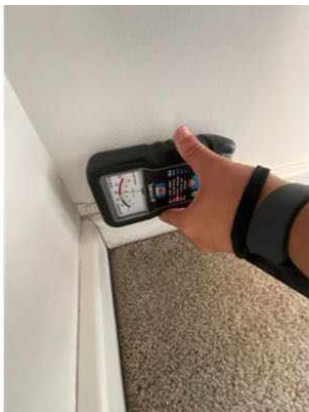
### Defects 2.01

Building:	Main Building
Location:	Bedroom 2
Finding:	Water damage
Information:	The area has sustained water damage resulting in potential structural issues. This damage compromises both the aesthetic and functional aspects.

1 **\*\*Plumber:\*\*** If the water damage is due to plumbing issues, a plumber can fix leaks and ensure there are no further water-related problems.

2 **\*\*General Contractor:\*\*** If the damage is extensive and affects the surrounding area, a general contractor can coordinate the repair work, including any related structural or cosmetic repairs.

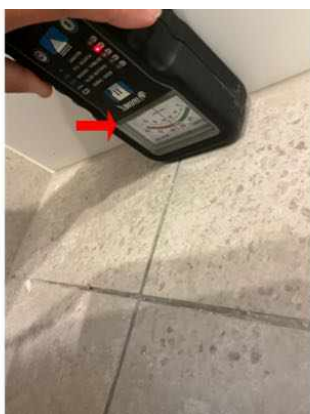
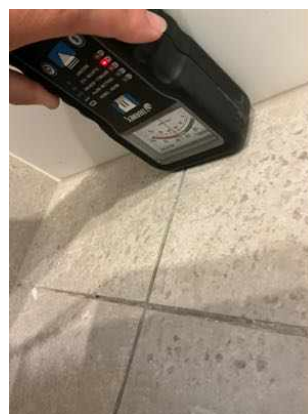
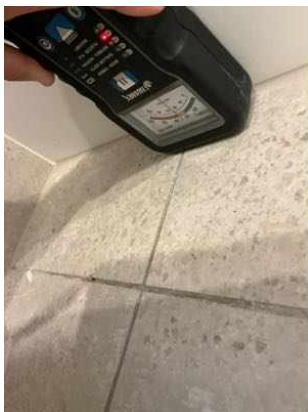
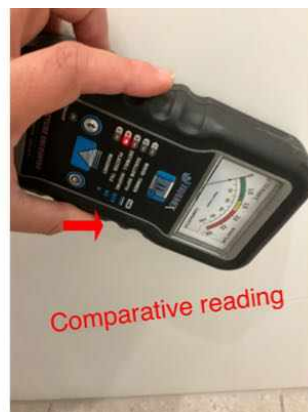
### Defects 3.01

Building: Main Building  
Location: Bathroom  
Finding: Shower - Damp  
Information: Damp is evident to the lower 300mm of wall to the shower alcove. This defect is quite common, and is suspected to have been caused by moisture permeating through the

grouting in this area, which shows evidence of deterioration. Leaking pipes within the adjoining wall is also a possible cause.

Unmanaged damp in the shower recess is likely to facilitate the formation and development of mould and fungi growth, decaying associated building materials and compromising their structural integrity. It is important to address damp conditions, as the World Health Organisation notes that excess moisture leads - on almost all indoor materials - to growth of microbes such as moulds, fungi and bacteria, which subsequently emit spores and other matter into the indoor air. Exposure to these contaminants is associated with a wide range of respiratory and other health-related problems.

Consultation with a qualified plumber or bathroom specialist is advised immediately to identify the cause of damp and to perform remedial works as required. Where excessive mould growth is present, further inspection by a specialist environmental health inspector should also be considered.

Always ensure that sealant and grout is in good condition to prevent any moisture issues occurring in the future.

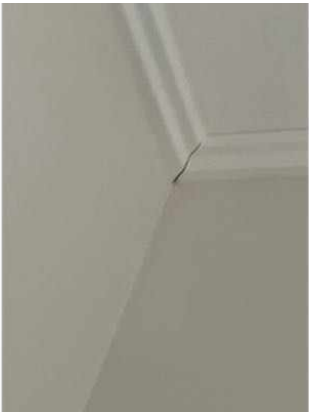
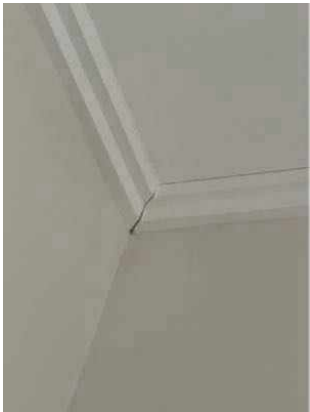
**Defects 3.03**

The fine cracks in the gyprock pose a risk of further widening, compromising the aesthetic appeal of the space, and potentially indicating underlying structural problems.

A skilled plasterer or a contractor specializing in drywall repairs should assess the extent of the cracks and address them promptly. Identifying and fixing the root cause of the issue, whether related to settling or structural concerns, is essential to prevent further damage and maintain the integrity of the ceiling.

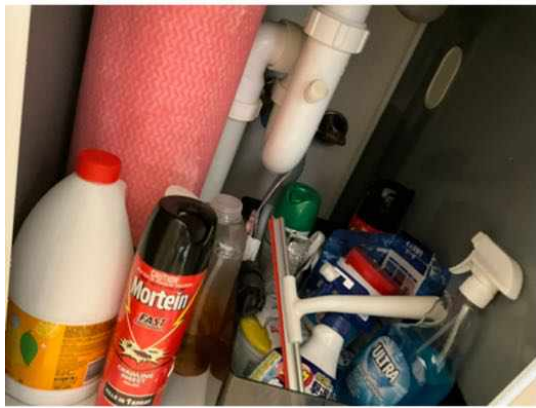
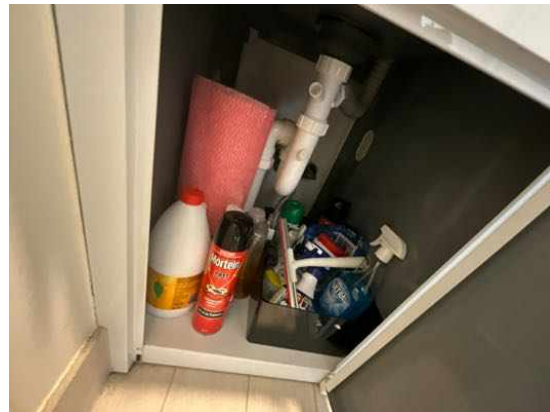
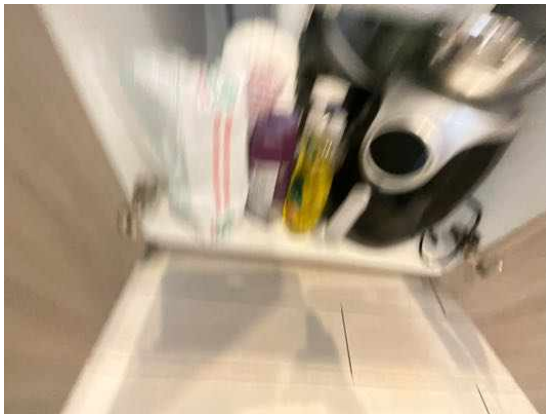
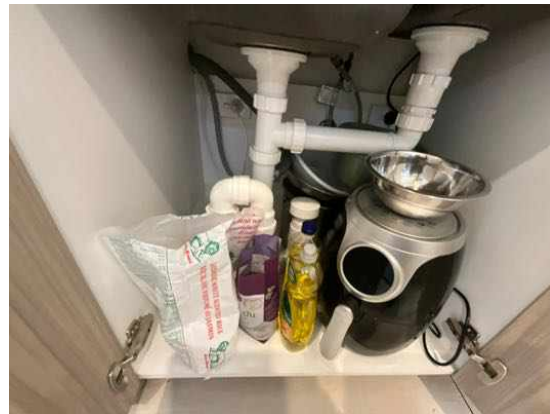
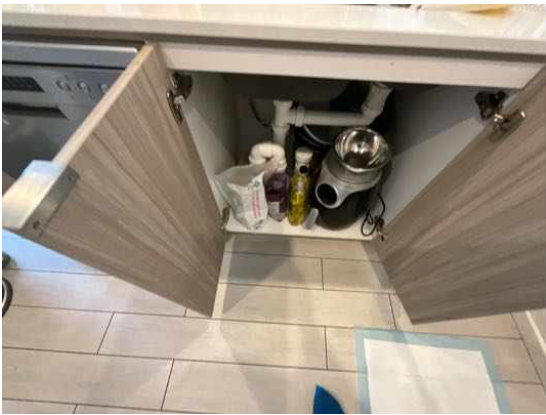
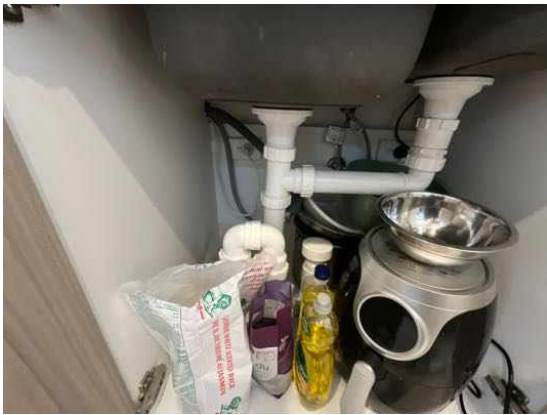
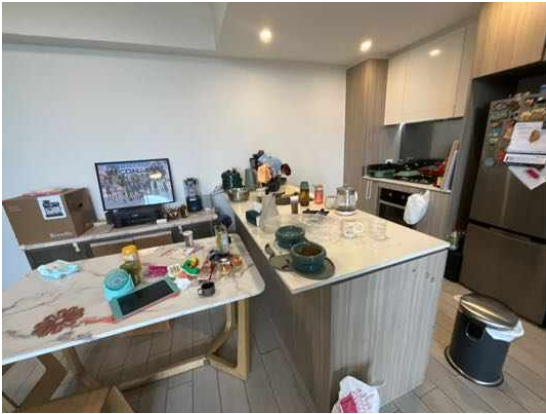
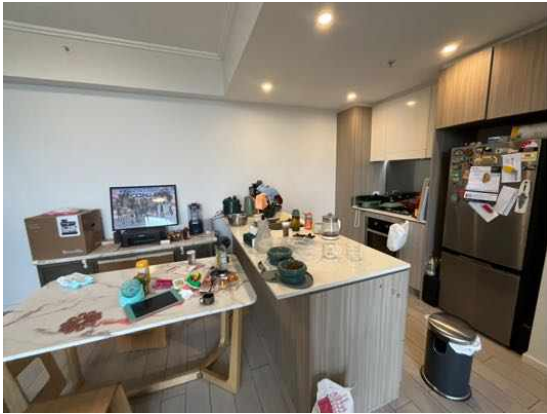
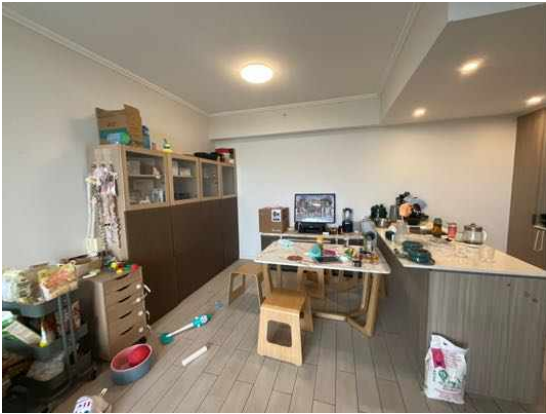
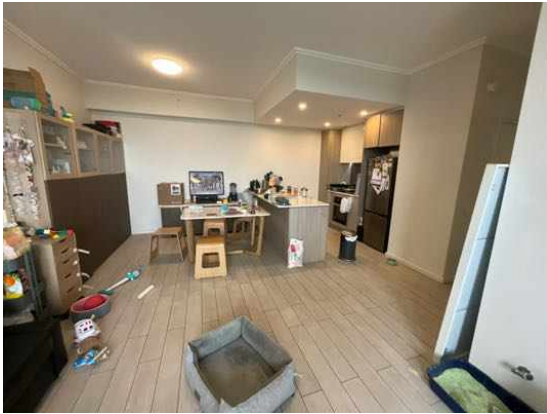
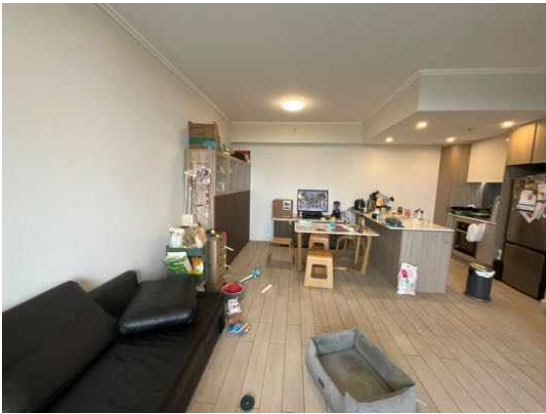
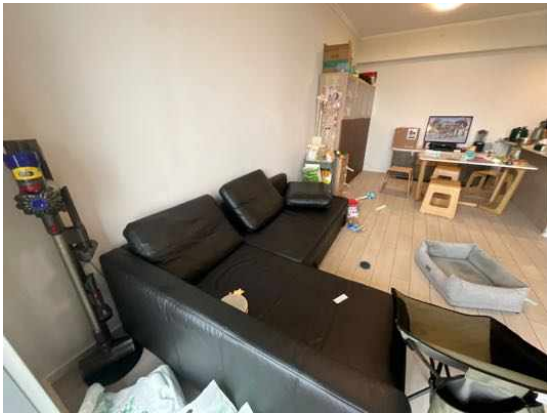
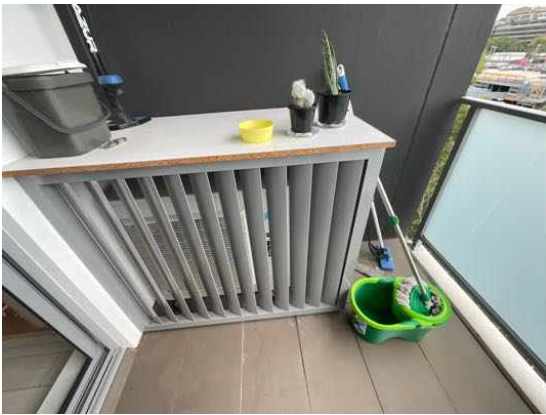
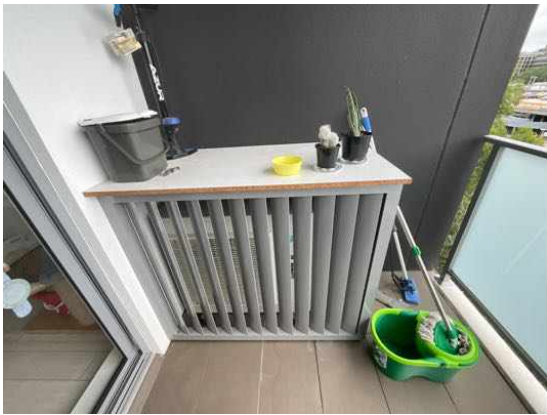
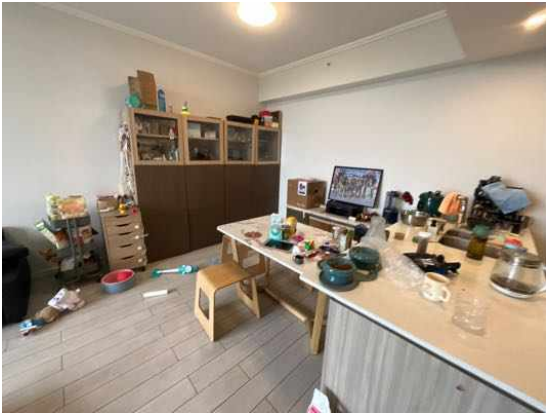
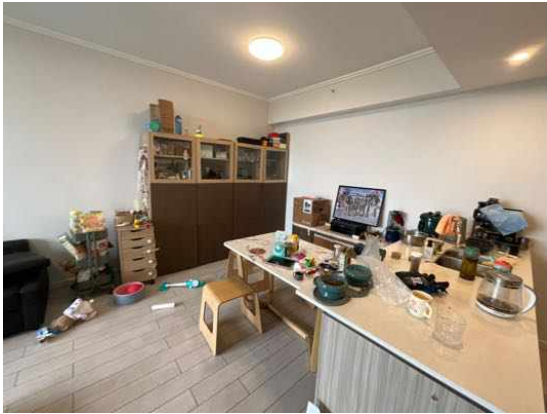
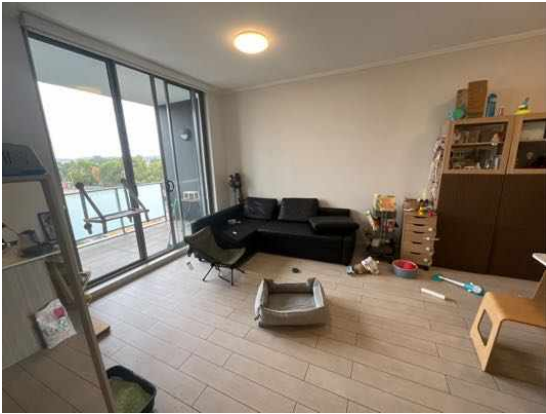
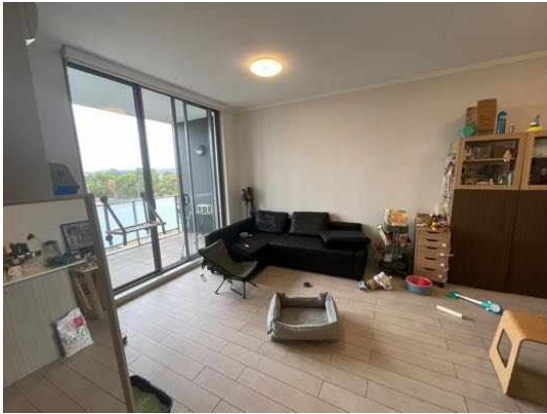
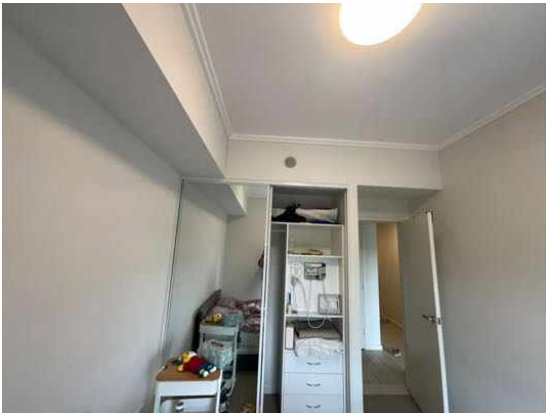
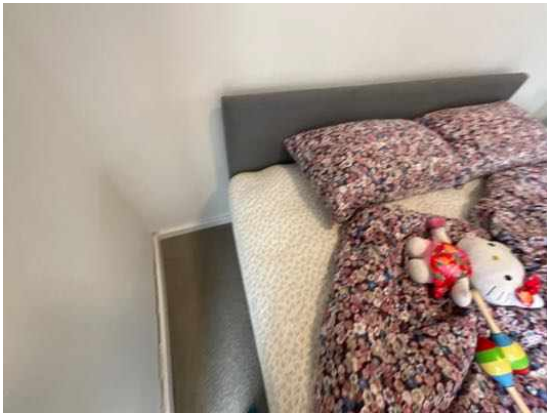
### Noted Item

Building: Main Building  
Location: All Areas  
Finding: Additional Photos - Obstructions and Limitations  
Information: These photographs are an indication of the obstructions and limitations which impeded full inspection of the property at the time of inspection. These obstructions can hide an array of defects and should be removed to allow full inspection to be carried out. A re-inspection is recommended once the areas are made accessible.
