## Building Inspection Report

Inspection Date: Wed, 21 Jan 2026

Property Address: 183/33 Lakefront Cres, Varsity Lakes QLD  
4227, Australia

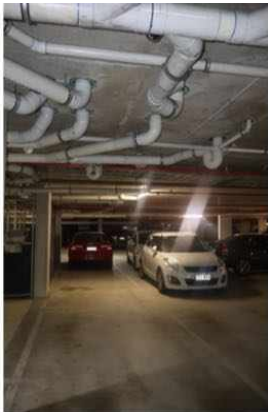
Building: Main Building  
Location: Car park > Existing  
Finding: Additional Photos  
Information: Additional photos are provided for your general reference
