# Building and Timber Pest Inspection Report

Inspection Date: Thu, 2 Apr 2026

Property Address: 16 The Dress Cir, Athelstone SA 5076,  
Australia

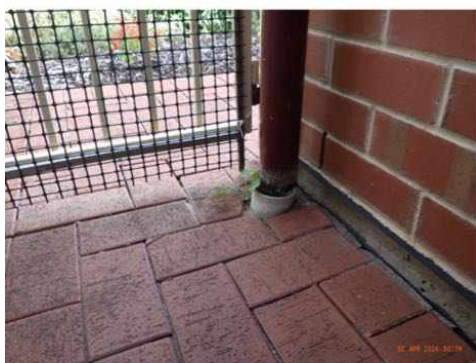
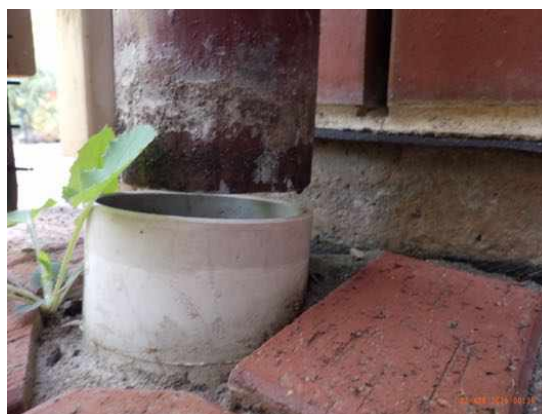
Where roof plumbing doesn't drain adequately, the area at the base perimeter can become excessively damp, potentially creating an environment that is susceptible to rust and corrosion of surrounding building elements, as well as attracting termites and other pests.

It is highly recommended that a plumber be appointed to further inspect the area and to install adequate drainage equipment where necessary.

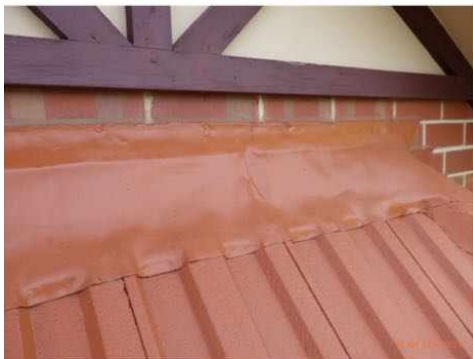
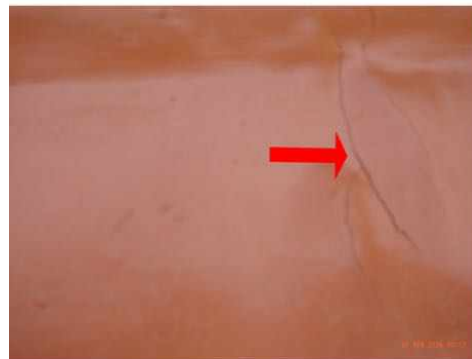
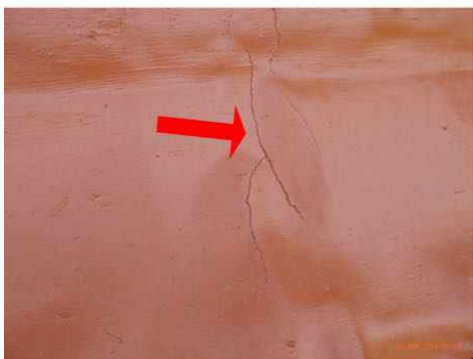
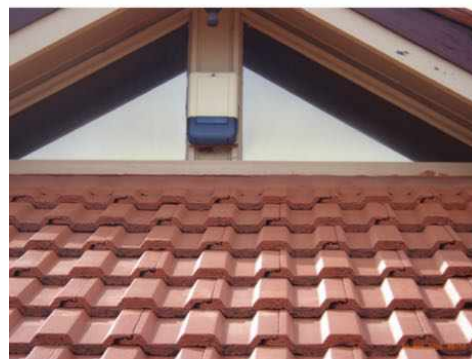
#### Finding 2.02

Building: Building 1  
 Location: Roof Exterior  
 Finding: Roof plumbing - Flashing cracked  
 Information: Water leaks generally occur when a particular area of the property is not weather or water tight. Cracks were evident to the lead roof flashings at the time of inspection.

Regardless of the location, if left unmanaged, even minor leaks can lead to serious damage of associated building elements, potentially resulting in the need for

replacement of building materials. Damage to ceilings, wood rot, mould and other hazards, such as electrical hazards, may also arise if left unmanaged.

The cause of the water leak should be identified and addressed immediately to prevent further damage. The water leak should be resolved prior to any repairs of the damaged area, which may require localised replacement of building materials and refinishing.

Further inspection by a qualified carpenter or licensed plumber is advised to adequately rectify the potential leak. Sealing the cracks should be adequate.

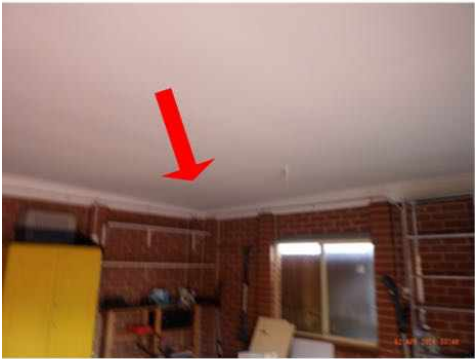
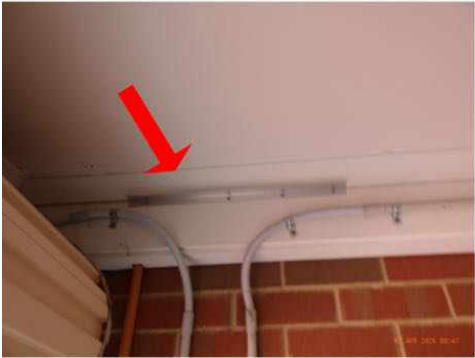
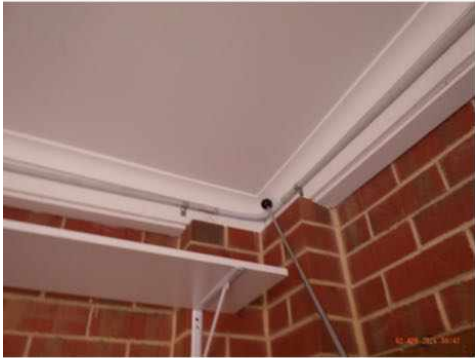
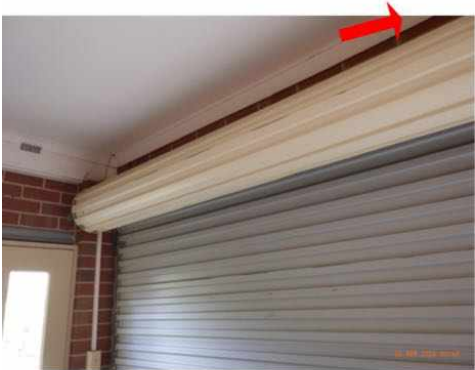
### Finding 2.03

Building:	Building 1
Location:	Garage
Finding:	Ceiling sagging - garage
Information:	Sections of the ceiling were found to have sagging evident to the garage ceiling at time of inspection.

Sagging to the fixed ceiling structure generally indicates that the building materials have swollen, due to contact with water, or that fixings (e.g. nails or glue) have become loose and require reattachment.

This is a very common defect in carports due to their lack of insulation and or their

susceptibility to moisture. Condensation builds up in the roof and rests on the plasterboard softening it somewhat which makes it more likely to sag and release from its fixing points.

Repairs to the ceiling will be required and should be carried out by licensed builders, plasterers and painters in the short term. Fixing battens to the ceiling can be a good short term repair especially adjacent to roller doors.

Insulating the area is also highly recommended.

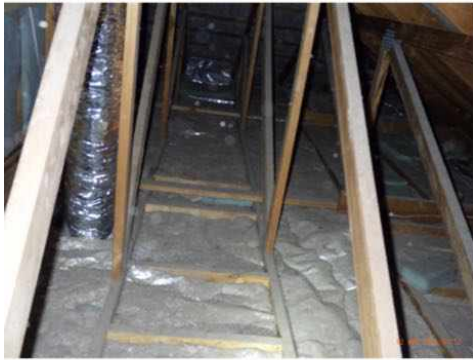
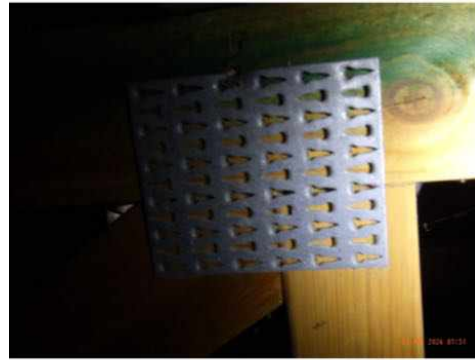
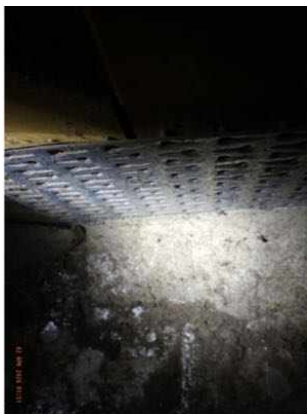
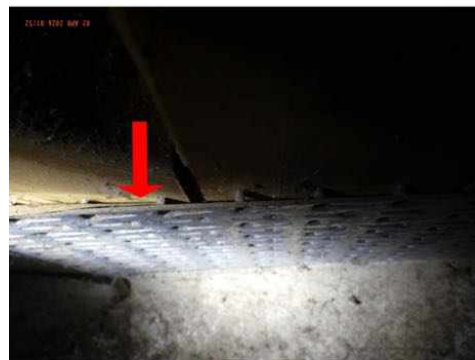
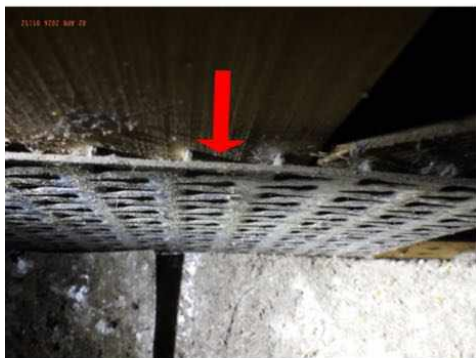
**Finding 2.04**

This could be due to one or more of several reasons including faulty nail plates, varying moisture levels, and slight movement of timber elements. Secondary defects can be created, ranging from damage to ceiling linings through to structural failure.

The issue appears to be effecting approximately 10 nail plates however more may become apparent with minimal back out evident usually less than 2mm and as such, repair is possible.

A structural engineer would be required to provide recommendations to be carried out by a licensed builder ASAP to prevent any further deterioration and to prevent a hazard being created.

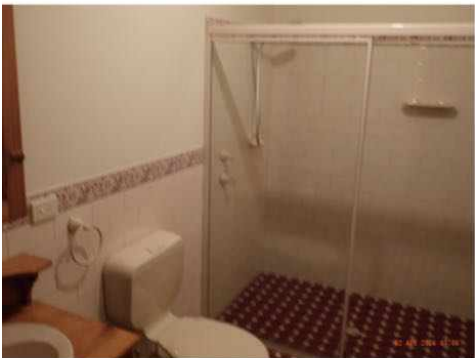
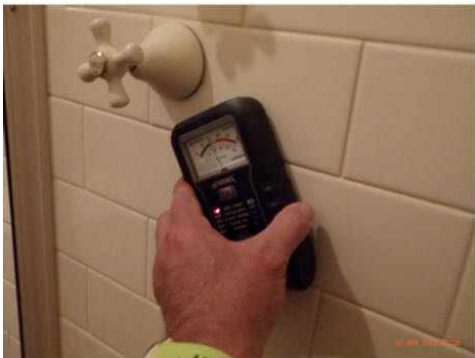
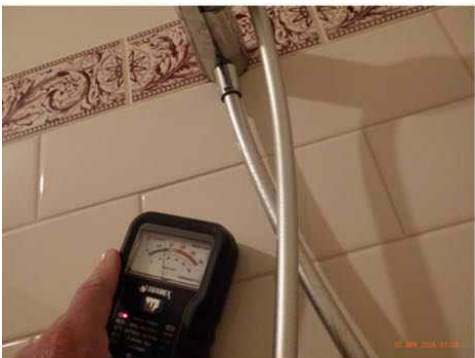
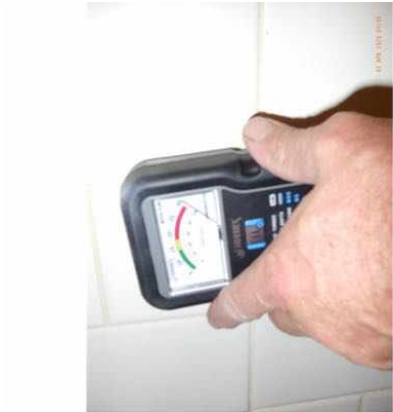
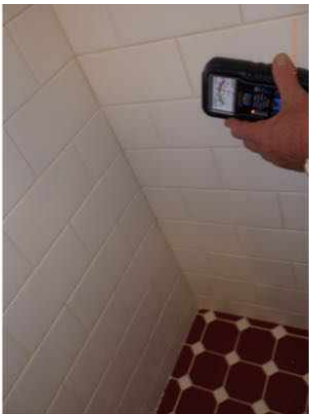
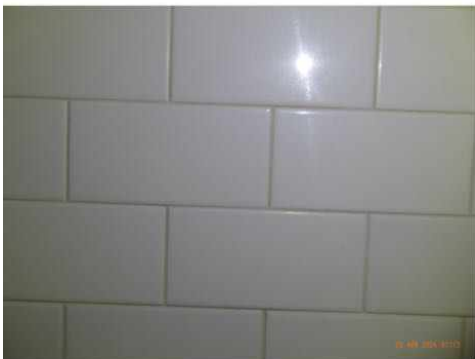
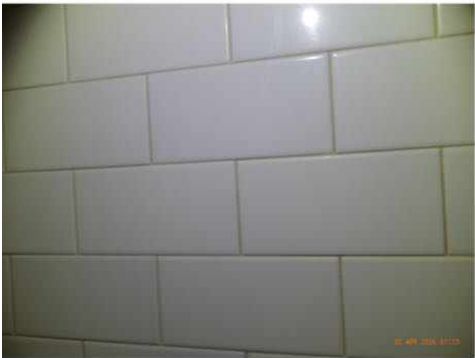
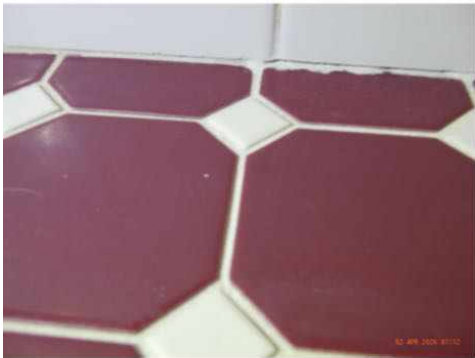
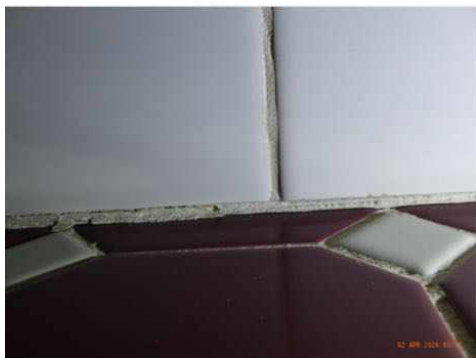
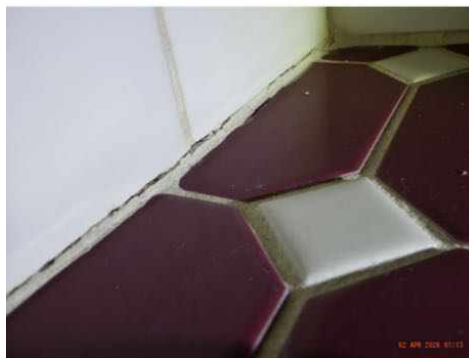
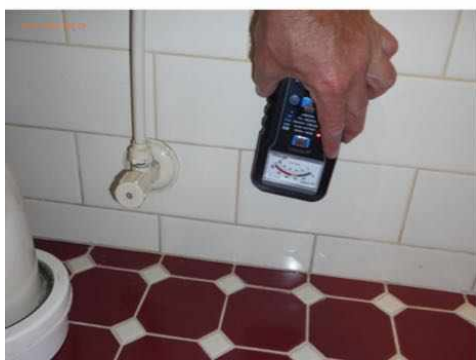
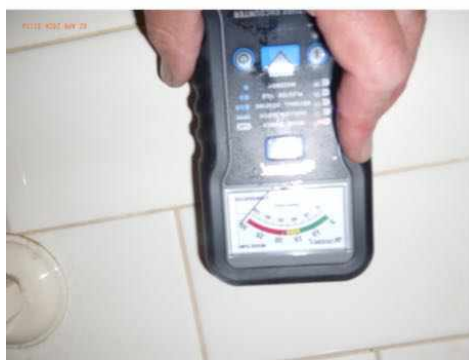
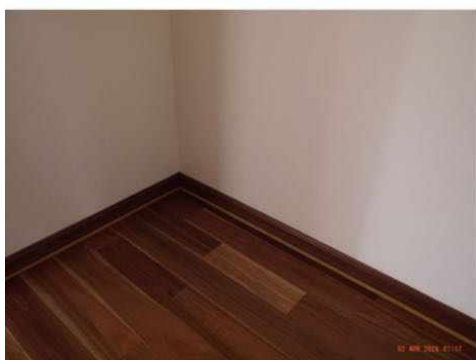
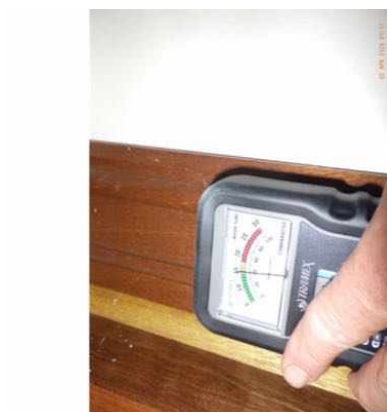
## Finding 2.05

Building:	Building 1
Location:	Ensuite - Master
Finding:	Shower - Damp
Information:	Damp is evident to the lower 700mm of wall to the shower alcove.

This defect is quite common, and is suspected to have been caused by moisture permeating through the tiling, grouting and or sealant in this area, which shows evidence of deterioration.

Leaking pipes within the adjoining wall is also a possible cause however it seems unlikely in this instance as there was no high readings around the taps.

Consultation with a qualified plumber or bathroom specialist is advised immediately to identify the cause of damp and to perform remedial works as required.

Always ensure that sealant and grout is in good condition to prevent any moisture issues occurring in the future.

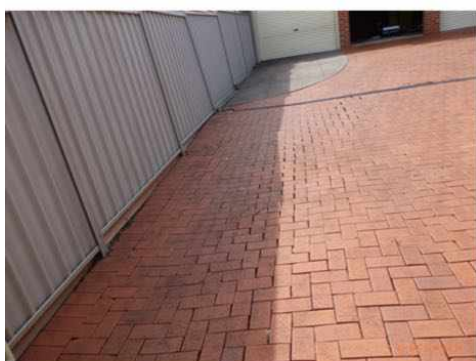
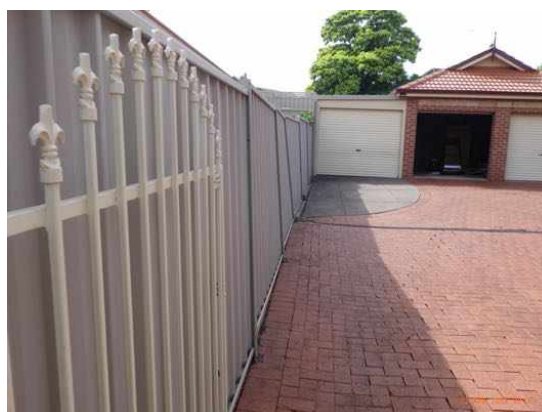
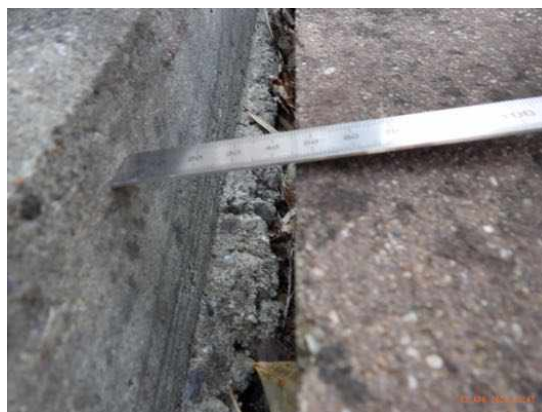
### Finding 3.01

Building:	Building 1
Location:	Yard - Side
Finding:	Retaining wall - Defective
Information:	The retaining wall in this area was found to be defective at the time of inspection. Generally, defective retaining walls are caused by poor original design or material use. However, deteriorated retaining walls may also be a result of substandard construction, poor site drainage or unmanaged stormwater flows.

If left unmanaged, the retaining wall may become a safety hazard if it continues to destabilise. Where retaining walls further rot and decay, an environment is created that is conducive to termite and pest infestation.

Significant repair and replacement should be expected. Where retaining walls are considered structural walls, a structural engineer / surveyor should be consulted regarding required remedial works. Otherwise, a landscaper or retaining wall installer may be appointed to repair or replace the wall, at the discretion of the client.

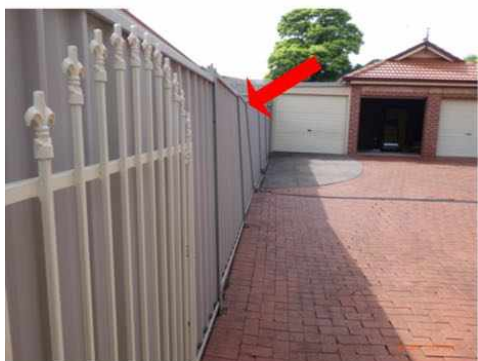
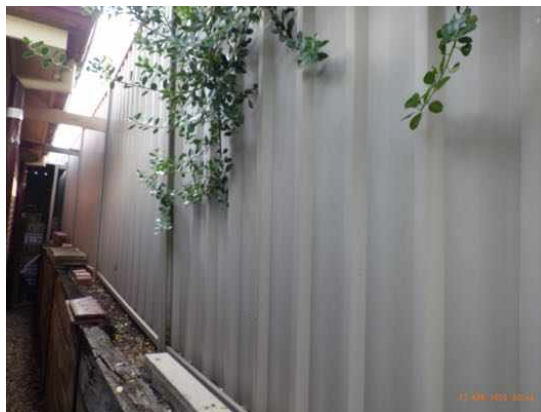
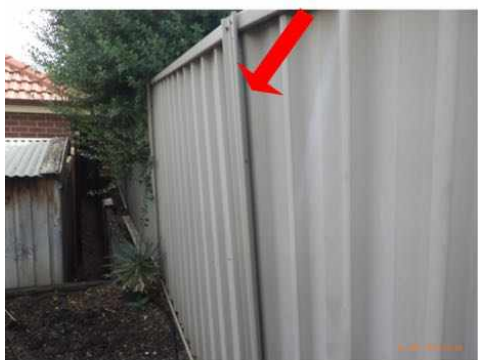
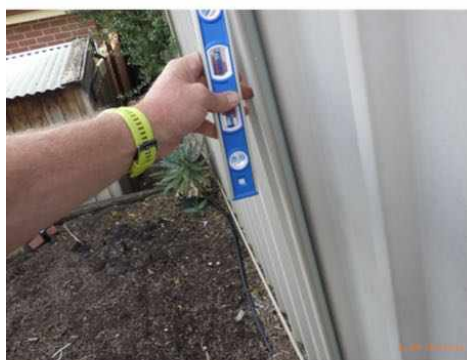
### Finding 3.02

Building:	Building 1
Location:	Yard - Back
Finding:	Fencing - Deteriorated
Information:	It was noted at the time of inspection that sections of the fencing throughout the property have deteriorated. Typically fencing deteriorates due to age and or wear, rot and or rust which is generally expected for a structure of this age, due to prolonged exposure to weather conditions. Sometimes inadequate installation or maintenance can be to blame.

If left unattended, it is likely that further damage will occur. It is suspected that repair of several elements of the fencing may be required however replacement may be a consideration of the client also.

A licensed fencing contractor should be appointed to provide further advice and perform rectification works as necessary.

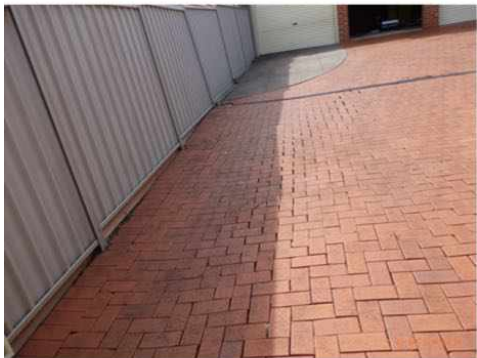
### Finding 3.03

Building:	Building 1
Location:	All External Areas
Finding:	Paving - Uneven
Information:	Sections of the external paved area surrounding the building are uneven, creating a potential trip hazard.

Where paving creates a trip hazard, personal injury may ensue if due caution is not taken by persons within this area.

Movement paving is likely due to heavy traffic from vehicles and potentially poor installation. The slope of the paved driveway is another likely contributing factor.

Re-paving of the area is required as soon as possible to remedy this situation. Further consultation with a specialist paving contractor is advised and works will likely be extensive.

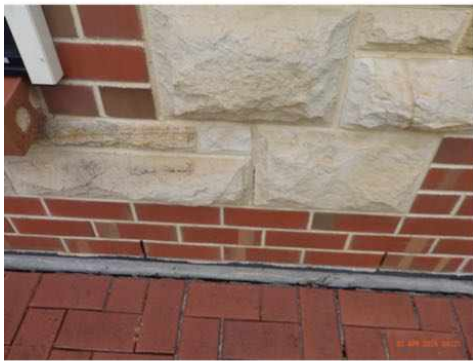
Finding 3.04

Building: Building 1  
Location: Exterior walls  
Finding: Brickwork - Cracking [Fine]  
Information: There were fine cracks evident to the external brickwork at the time of inspection. several cracks were identified between the stone facing and brickwork, and most of these measure less than 1 mm however there were several slightly larger cracks up to 3 mm wide.

Although fine cracks are quite noticeable, they are often only considered to be an appearance defect and usually do not indicate any structural damage. Generally, the cause of a fine crack is indicative of a separation between brickwork and mortar throughout the structure, but single bricks may also show cracks of this nature.

Cracking of this nature can generally be repaired with minor filling and should be conducted by a qualified bricklayer.

Always contact a building inspector should cracks widen lengthen or become more numerous.

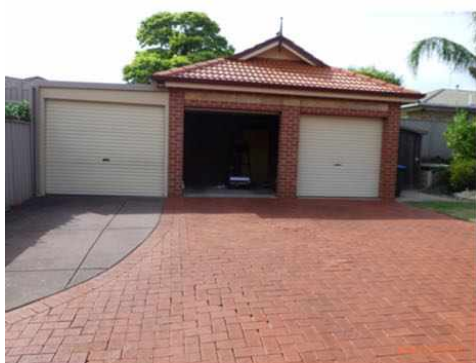
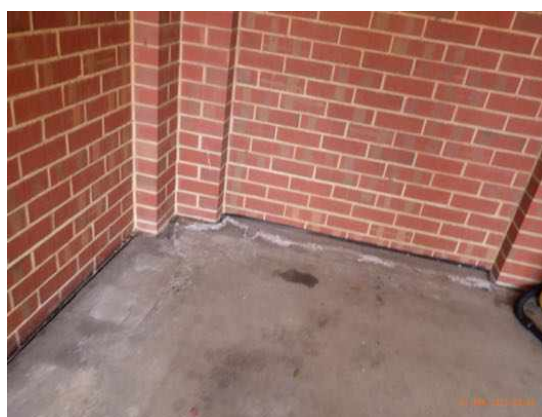
### Finding 3.05

Building:	Building 1
Location:	All External Areas
Finding:	Slab edge - Efflorescence
Information:	Efflorescence appears to be affecting the concrete around the side of the garage.

It is typically seen as white salt deposits on the surfaces of concrete pavement and spalling on the face of the concrete.

Generally, soluble salt deposits can be removed by dry brushing with a stiff-bristled brush. Repeated dry brushing is an ideal treatment for eliminating this forming of efflorescence. A cleaning contractor or general handyperson may be appointed to perform these works at the discretion of the client.

Always contact a building inspector should efflorescence get significantly worse.

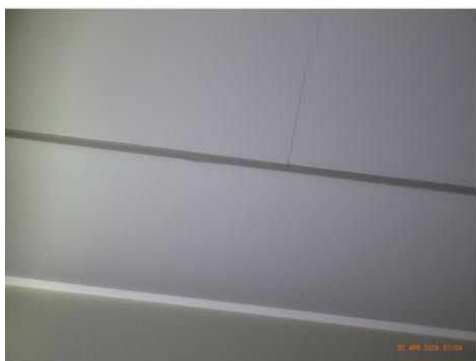
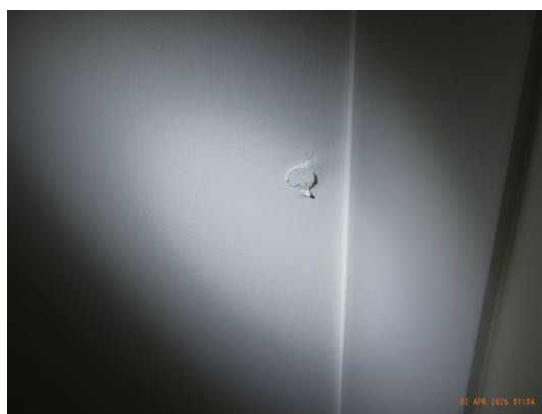
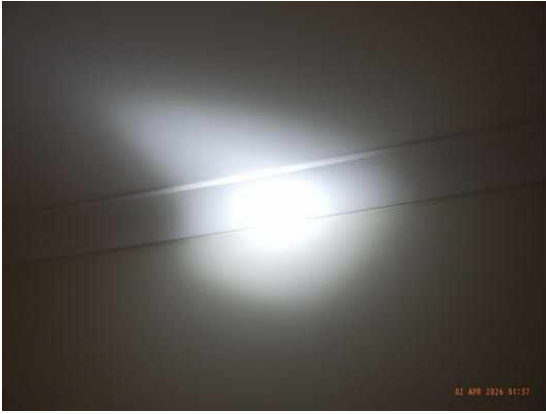
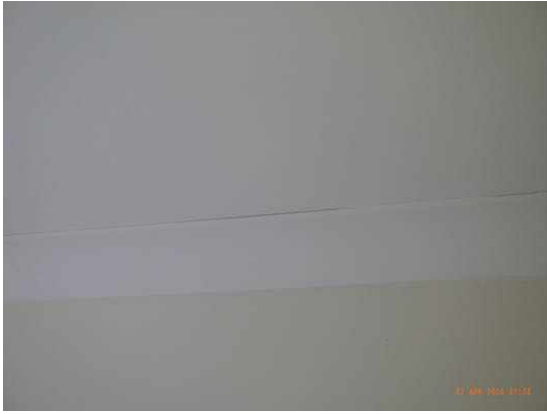
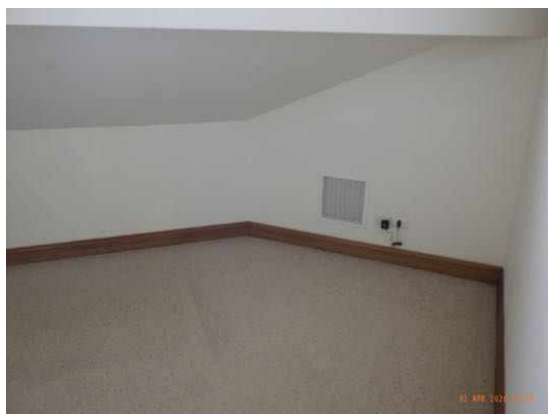
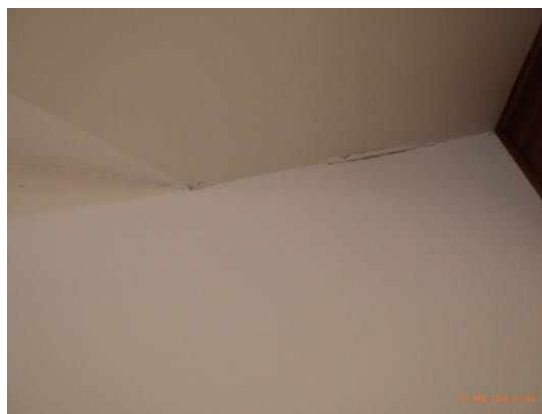
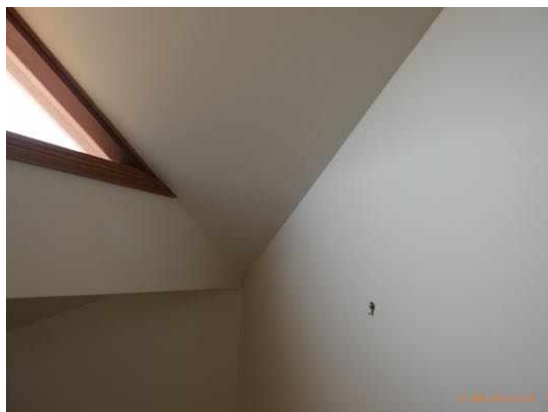
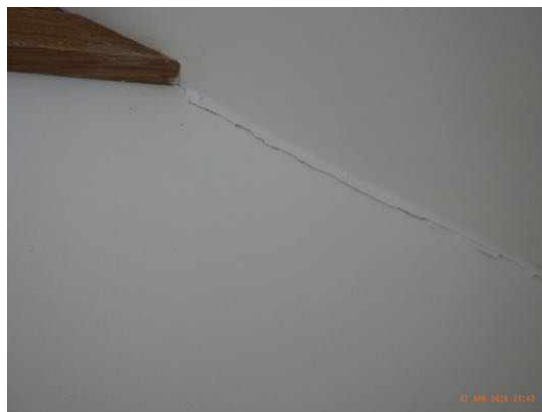
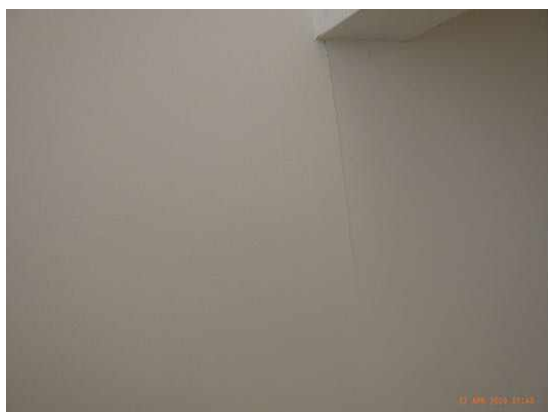
### Finding 3.06

Building:	Building 1
Location:	All Internal Areas
Finding:	Cracking - Damage Category 1 - Fine (up to 1mm)
Information:	There were fine cracks evident to the walls and ceilings throughout the dwelling at the time of inspection.

Although fine cracks are quite noticeable, they are often only considered to be an appearance defect, and usually do not indicate any structural damage. Generally, the cause of a fine crack is indicative of a separation between building materials and finishes (e.g. paint, plaster, etc.) along joins.

Cracking of this nature can generally be repaired with minor sanding, filling and/or repainting. Such works should be performed by a qualified painter or a general handyman.

Monitoring of all cracking should be conducted frequently. Always contact a building inspector should cracks widen, lengthen, or become more numerous.

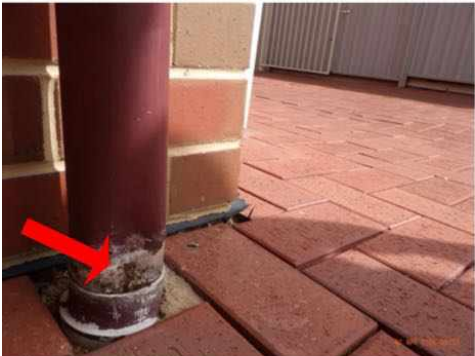
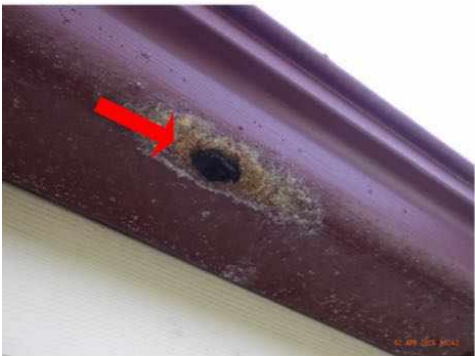
### Finding 3.07

Building:	Building 1
Location:	All External Areas
Finding:	Roof plumbing - Rusted or corroded
Information:	The guttering to the garage has rust evident along with some rusting evident to the rear veranda and downpipes of the house.

Likely contributing factors for premature rusting of gutters include but not limited to buildup of leaf debris or lack of maintenance.

Poorly drained roof areas will also lead to damp conditions surrounding the base perimeter of the building which, if left unmanaged, can lead to a range of secondary

building defects.

Repair and/or replacement of rusted roof plumbing is highly required in order to reinstate the roof drainage system to a fully operational level. To further maintain these areas, gutters should be cleaned frequently, allowing the avoidance of any partial blockages.

A licensed roof plumber or specialist roof restoration company should be appointed to undertake repair works prior to leaks becoming evident.

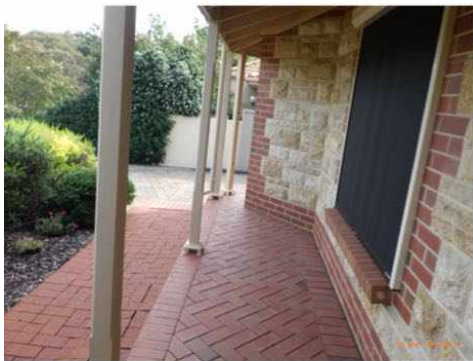
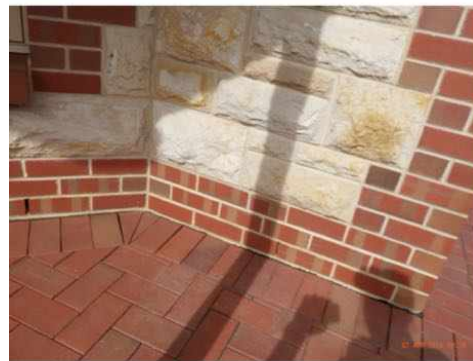
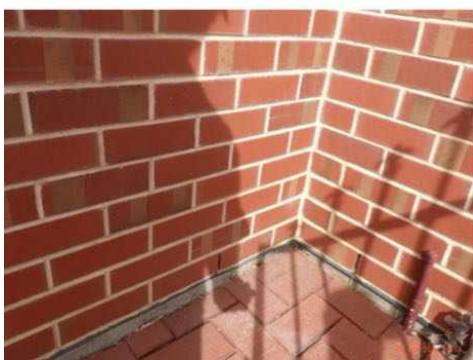
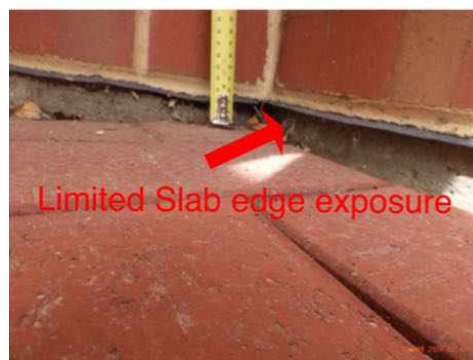
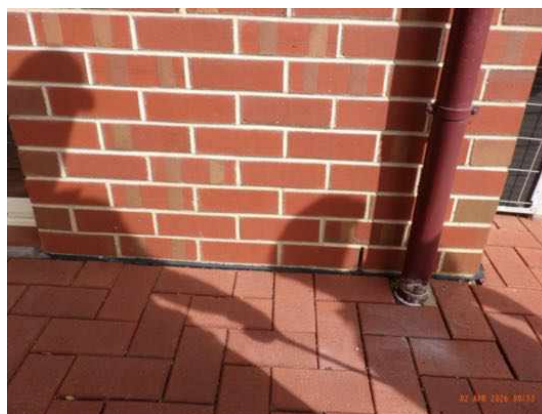
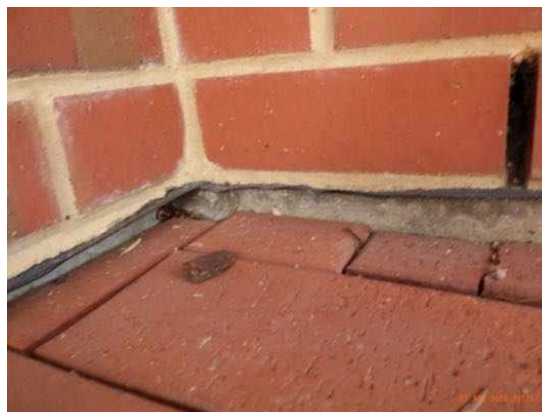
If the slab edge is not properly exposed there is a high risk of concealed termite attack which your inspector will likely not be able to see. Sometimes, in order to determine the type of slab, a suitably qualified person such as an architect or builder may be required to consult construction plans.

Where the slab edge cannot be properly inspected, it is highly recommended that termite or timber pest inspections be carried out every 6-12 months to aid protection of the property against infestation and termite treatment advice is followed closely.

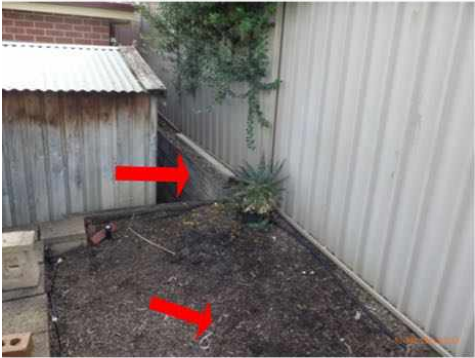
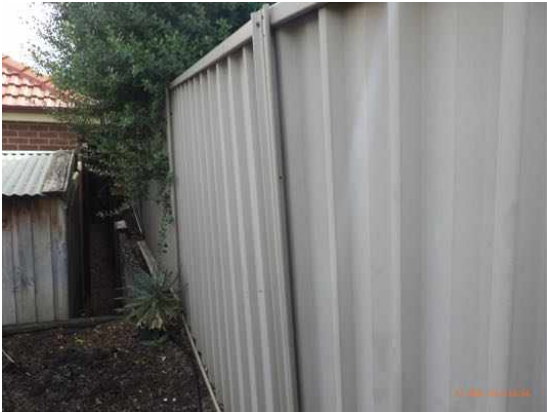
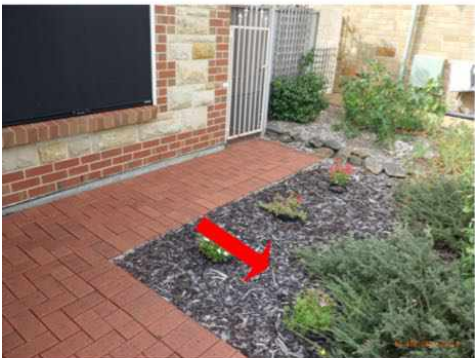
## Finding 6.02

Building:	Building 1
Location:	All External Areas
Finding:	Untreated or non-durable timbers in a hazardous environment
Information:	To reduce the risk of timber pest attack it is essential that timber used in a hazardous environment (e.g. in direct contact with the ground or frequently exposed to damp conditions) is of sufficient durability and/or is adequately preservative treated. Additionally any timber lying around or timber stumps should be removed.

Untreated timbers in direct contact with the ground are likely to develop severe wood rot and/or fungal decay if left unattended creating attraction for subterranean termites to infest the timbers from surrounding areas.

If untreated or non-durable timbers are found to be in a hazardous environment it is highly advised that replacement of these building elements be performed as soon as possible to aid the protection of the property against termite / timber pest attack. Failing this close monitoring is recommended in an attempt to identify termite infestation at an early stage.

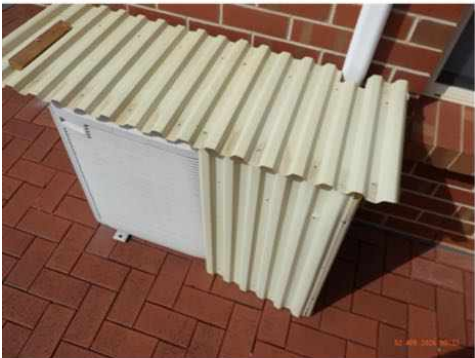
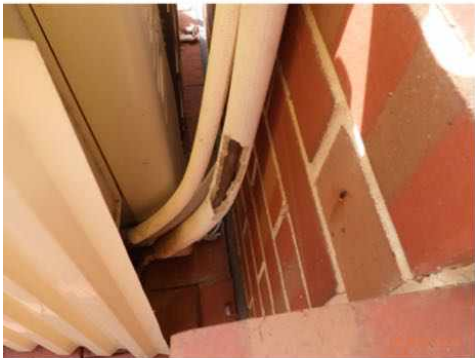
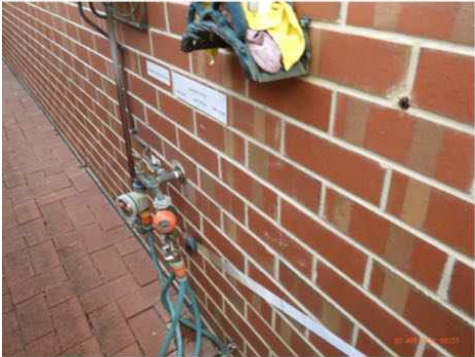
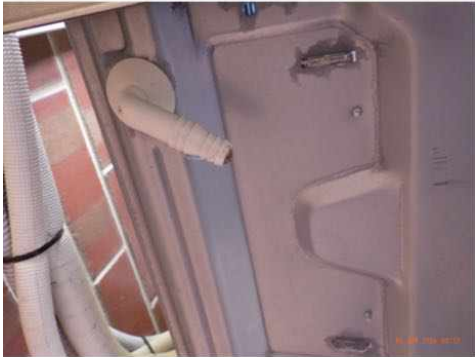
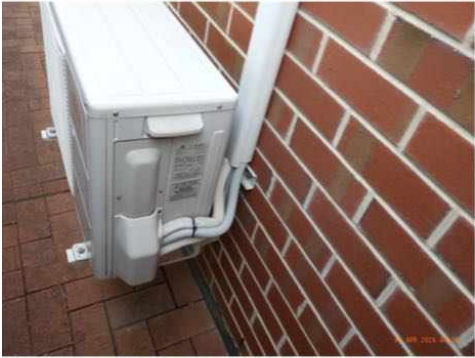
Building: Building 1  
Location: All External Areas  
Finding: Air conditioner and or external tap - No drainage

There appears to be no drainage points set up to the air conditioning unit, and or the external tap. While this is not a legal requirement it is recommended to reduce the risk of moisture related issues and the creation of an environment conducive to termite activity.

It is recommended that a licensed plumber be appointed to set up drainage in order to prevent such an environment from being created.

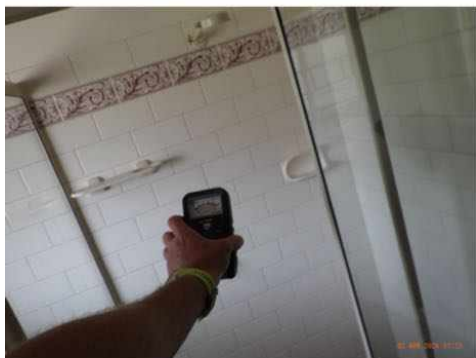
## Finding 6.04

Building:	Building 1
Location:	Bathroom
Finding:	Sealant and grouting - Regular maintenance
Information:	It was noted on inspection that sealant and grout has small areas of deterioration evident to the shower alcove at the time of inspection.

Silicone and grout generally need repair at least every 5 years and as such close monitoring should be carried out in the future after repairs are carried out.

Different materials and floor areas move at different rates, generally causing cracking to grout or sealant at this point. A flexible sealant is required to allow for expected expansion and contraction, while keeping the joint water tight and protective of all associated building materials.

Flexible and mould resistant materials should be applied to affected areas to prevent any subsequent water damage that is likely to occur. Regular maintenance and replacement of damage or missing or damaged sealant and grout is highly recommended to the wet areas, as this is a regular wear and tear defect. Sealant and grouting in areas that come into regular contact with water should be maintained for the long term care of your property.

A sealant specialist or tiling contractor should be appointed to complete these works as soon as possible

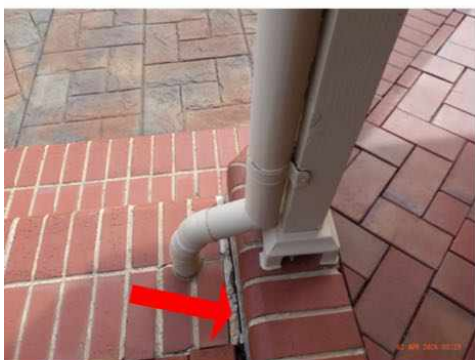
### Finding 6.05

Building:	Building 1
Location:	Front Elevation
Finding:	Gaps in footpath
Information:	Gaps in the external paving at several locations around the dwelling were identified at the time of inspection.

With reactive clay soils, it is extremely important to ensure that all stormwater flows including roof and ground flows are contained and continually maintained.

A licensed paving contractor may be required to Fill the gap between the pavement and the buildings which is recommended in the short term to prevent unwanted moisture accessing the foundation.

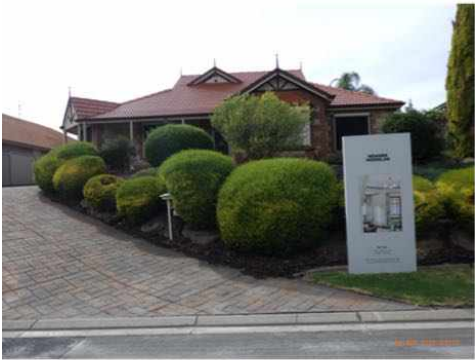
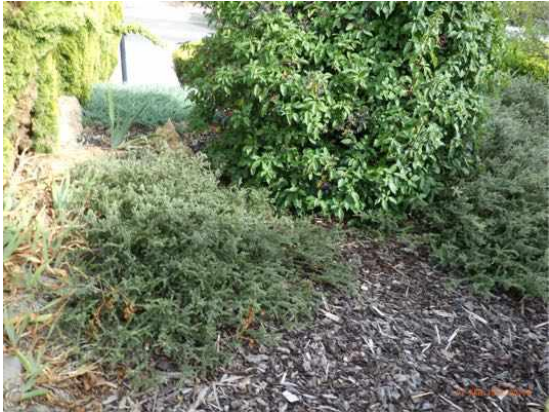
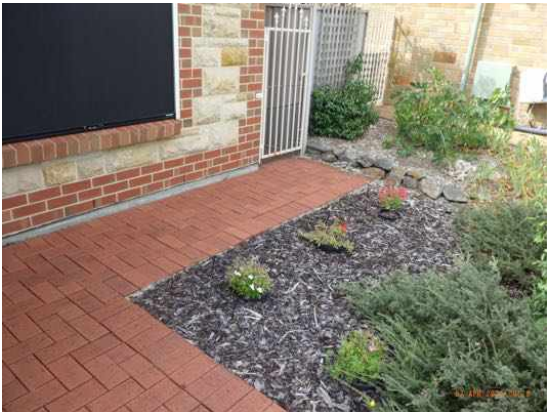
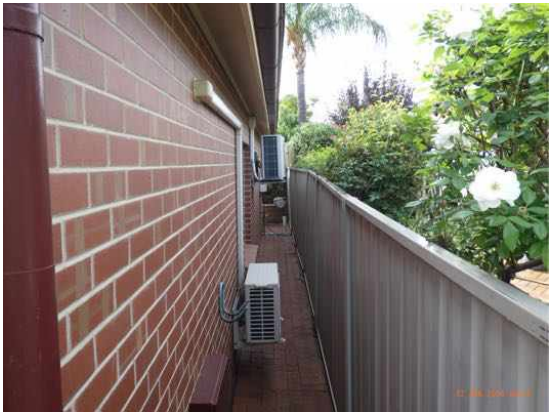
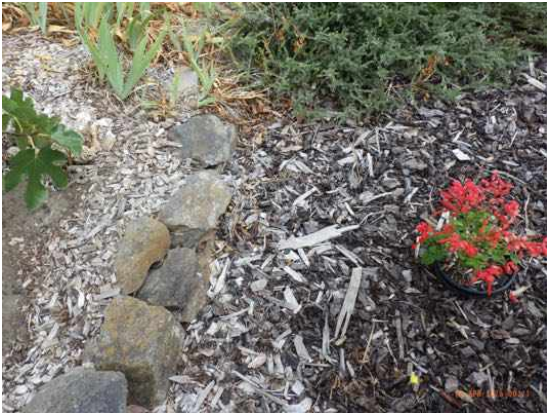
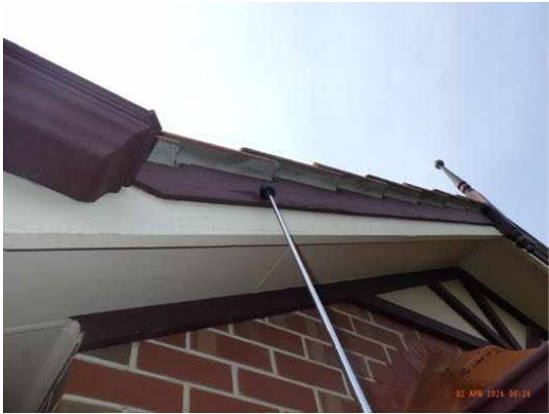
Building: Building 1  
Location: All Areas  
Finding: Additional Photos - Obstructions and Limitations  
Information: These photographs are an indication of the obstructions and limitations which impeded full inspection of the property at the time of inspection. These obstructions can hide an array of defects and should be removed to allow full inspection to be carried out.

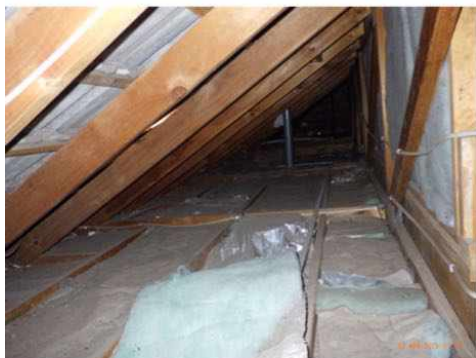
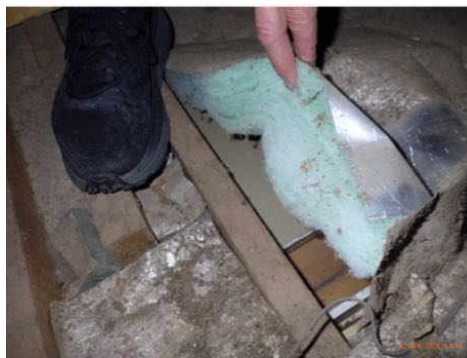
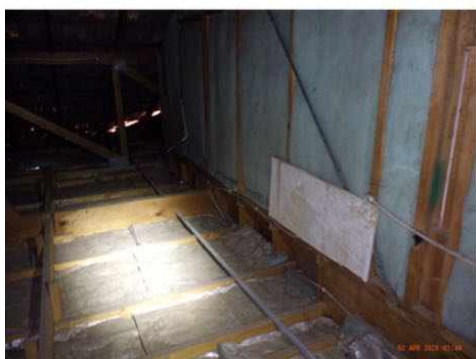
Building: Building 1  
 Location: Roof Void  
 Finding: Insulation - Reduced in volume  
 Information: Insulation in many older homes Deteriorate or sink over time reducing their effectiveness. Modern insulations provide a much better insulation than older forms. Well technically not a defect. This is noted for your information.

This will ensure that the property is adequately insulated and will promote an increase

in energy efficiency within the property. An insulation contractor should be appointed to provide further advice on replacement options and to perform works as necessary.
