Building and Timber Pest Inspection Report

Inspection Date: Mon, 2 Feb 2026

Property Address: 29 Chapel St, Maldon VIC 3463, Australia

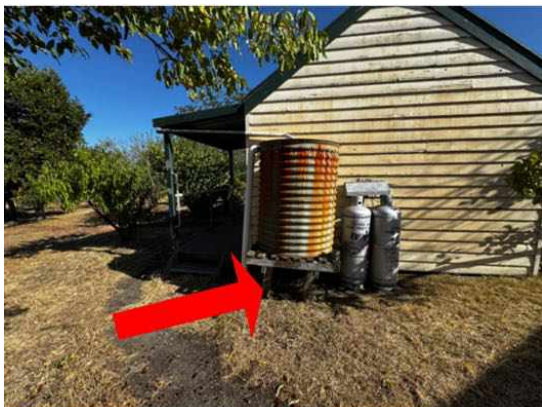
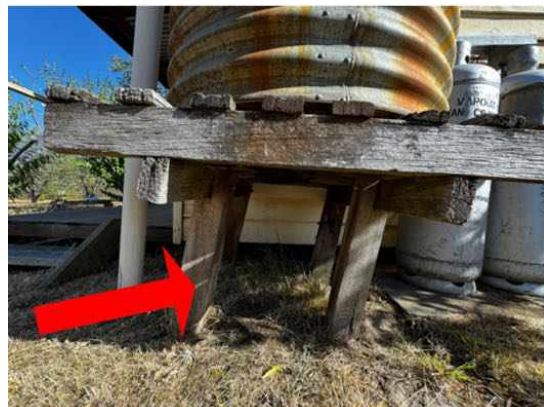
Building:	Main Building
Location:	Water tank > Rear Left
Finding:	Unstable and deteriorated water tank support structure
Information:	The elevated timber structure supporting the water tank was observed to be heavily weathered, aged, and in a deteriorating condition. The timber support legs are visibly leaning to one side, indicating loss of structural stability. Given the weight imposed by a full water tank, the current condition of the structure presents a high risk of structural failure or collapse. Timber deterioration and weather exposure appear to have reduced the load-bearing capacity of the structure. In accordance with AS 4349.1 – Inspection of Buildings, this condition is considered a Safety Hazard, as sudden collapse could cause injury, damage to nearby structures, and failure of the water storage system.

Engage a qualified carpenter to urgently assess the support structure. The water tank should be temporarily drained or isolated until the structure is made safe. Rectification is likely to require replacement of the timber support structure with a suitably designed and durable support system (e.g. treated timber or engineered steel frame) constructed on a stable footing in accordance with good building practice.

Immediate. Rectification should be carried out without delay to prevent potential collapse and associated safety risks.

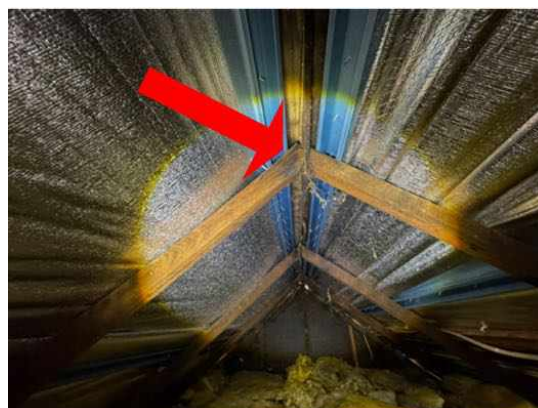
Finding: Damaged roof rafters at ridge beam junction

Information: Several timber rafters within the roof space above the front bedroom and living area were observed to be severely split at the junction where they connect to the ridge beam. The splitting appears significant and is suspected to have occurred during a previous roof replacement, possibly due to incorrect fixing methods, over-driving of fasteners, or inadequate detailing at the ridge connection. The extent of splitting observed is considered to compromise the structural integrity of the affected roof framing members, reducing their capacity to safely transfer roof loads. In accordance with AS 4349.1, damage to primary structural roof members that affects load-bearing performance is classified as a Major Defect and represents a risk of further structural deterioration if left unrectified.

It is recommended that a suitably qualified structural carpenter or structural engineer be engaged to assess the affected rafters. Damaged rafters should be replaced or structurally repaired in accordance with current accepted building practice and engineering requirements. Any rectification works should ensure proper connection detailing to the ridge beam to restore full structural performance.

Short term – rectification should be undertaken as a priority to reduce the risk of further roof movement or structural failure.

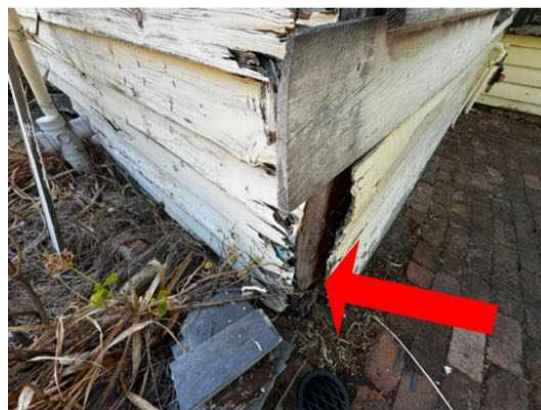
Finding 2.03

Building:	Main Building
Location:	Timber stumps > Rear Right, Front Right, Centre Right
Finding:	Suspected deterioration of timber stumps to northern elevation
Information:	Timber stumps supporting the perimeter of the building along the northern elevation were observed to show considerable signs of deterioration and suspected structural compromise. The affected stumps exhibited visible degradation consistent with age-related decay and prolonged exposure to ground moisture. Due to restricted access conditions, the majority of the subfloor area and remaining timber stumps were inaccessible, and while the accessible stumps away from this elevation appeared to be in comparatively better condition, their overall condition could not be fully verified. In accordance with AS 4349.1, deterioration or damage to load-bearing subfloor supports is classified as a Major Defect, as it may adversely affect the structural stability and serviceability of the building.

It is recommended that a licensed builder or structural engineer be engaged to undertake a full subfloor assessment, including provision of improved access where required. All timber stumps to the northern elevation that are deteriorated or suspected to be compromised should be replaced with compliant supports to restore adequate structural support and maintain the long-term integrity of the building.

Short term – rectification should be undertaken promptly to minimise the risk of further structural movement or settlement.

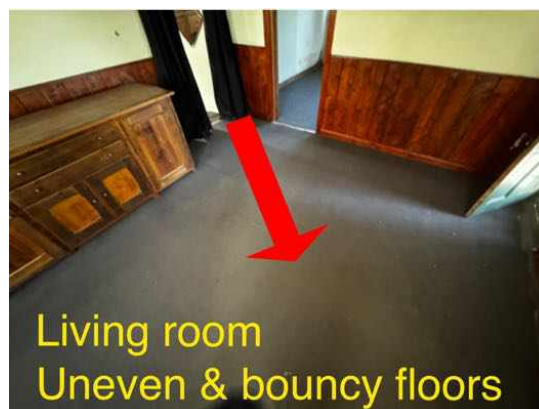
Finding 2.04

Building:	Main Building
Location:	Living room, bedroom 1 > Front Right, Front Left
Finding:	Suspected uneven and bouncy timber flooring to front living and bedroom areas
Information:	<p>Uneven and bouncy floor conditions were detected to the front living area and adjacent bedroom during inspection, with the movement clearly noticeable under foot. The observed floor behaviour is suspected to be the result of settlement or deterioration of timber stumps and/or bearers beneath the floor, particularly toward the southern subfloor area. It is also suspected that the span of the supporting floor structure may be inadequate or no longer performing as intended, contributing to excessive deflection and floor bounce. In accordance with AS 4349.1 – Inspection of Buildings, noticeable floor movement, deflection, or instability is indicative of a Major Defect, as it may adversely affect the structural performance and serviceability of the building.</p>

It is recommended that a licensed builder or structural engineer be engaged to undertake a detailed subfloor assessment, including inspection of timber stumps, bearers, joists, and span configurations. Any timber stumps that have settled, deteriorated, or are inadequately supporting the structure should be re-levelled or replaced, and additional supports installed if required to reduce floor deflection and restore structural performance.

Short term – further investigation and rectification should be undertaken promptly to reduce the risk of ongoing movement and progressive structural damage.

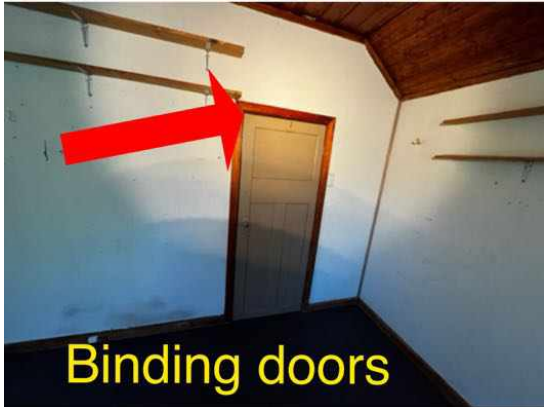
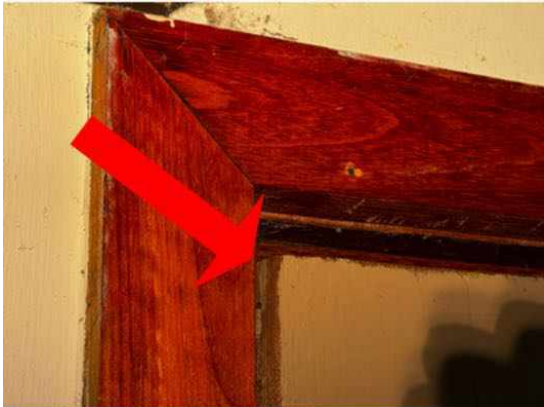
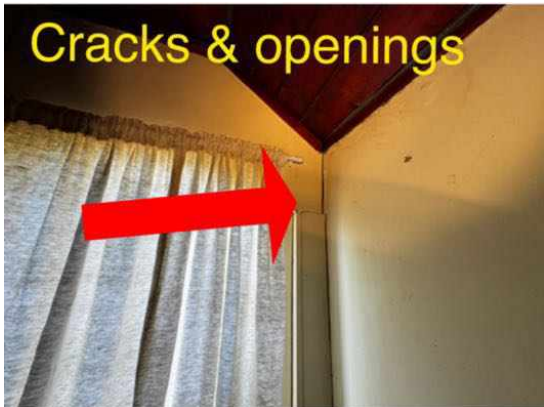
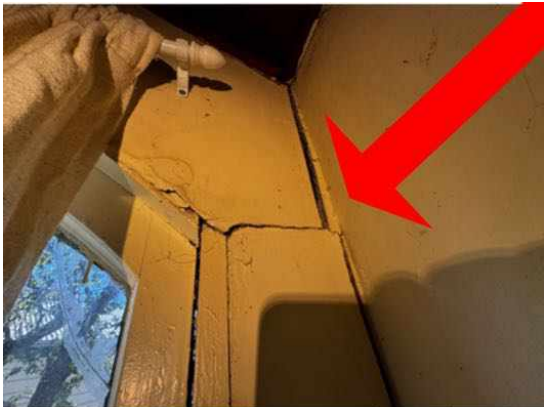
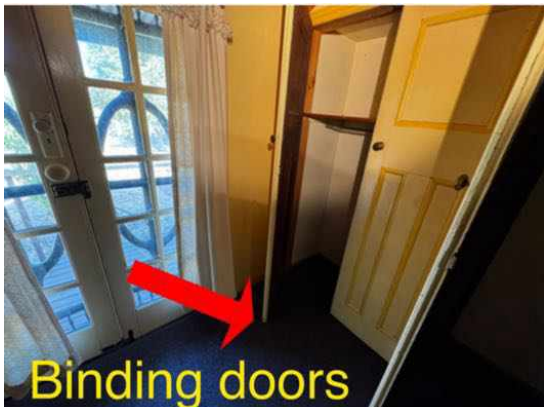
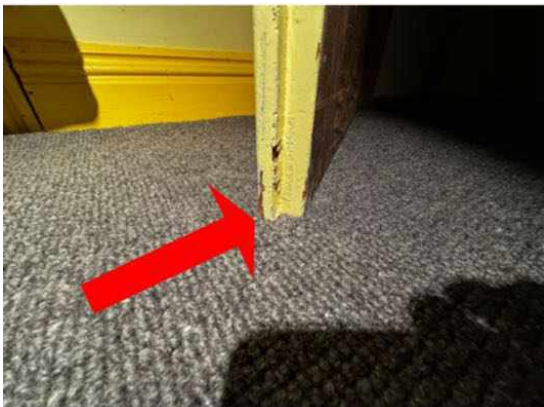
Finding 2.05

Building:	Main Building
Location:	All Areas > All Areas
Finding:	Suspected building movement affecting internal doors and wall/ceiling finishes
Information:	Several internal doors throughout the building were observed to be binding during operation, indicating misalignment of door frames. In addition, cracks were observed to walls and ceiling areas in multiple locations across the building. These conditions are suspected to be associated with building movement, particularly movement within the footings, foundations, and/or subfloor structure. The nature and spread of the defects are consistent with other movement-related defects identified during the inspection, including uneven and bouncy floors. In accordance with AS 4349.1 – Inspection of Buildings, door binding and cracking to wall and ceiling finishes that are indicative of structural movement are considered to be a Major Defect, as they suggest potential structural distress rather than isolated cosmetic issues.

Short term – further investigation should be undertaken as soon as practicable to determine the extent of movement and to minimise the risk of progressive structural deterioration.

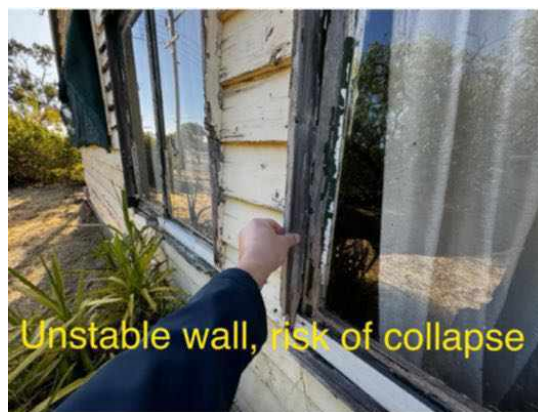
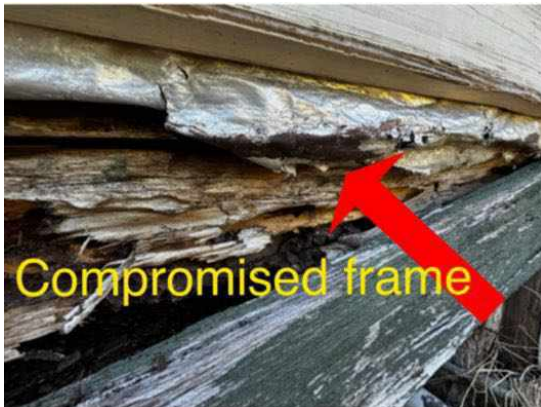
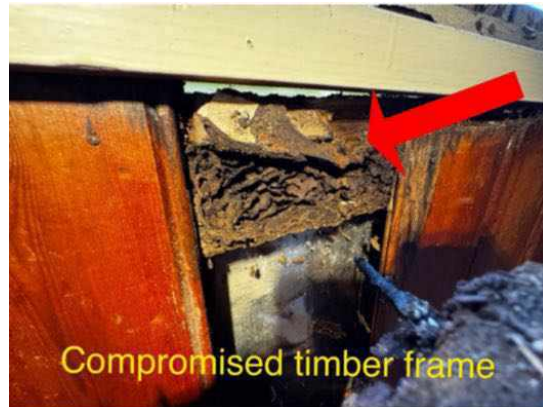
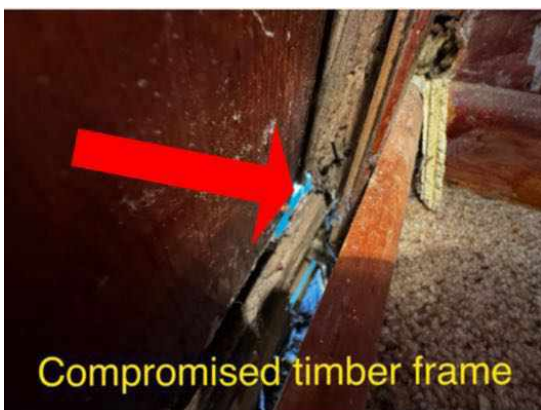
Finding 2.06

Building: Main Building
Location: Bedroom 2 > Centre Right
Finding: Major structural failure due to termite damage and timber decay – bedroom two external wall
Information: A suspected major structural defect was observed to the external wall of bedroom two, located on the right-hand side (north aspect) of the building. The external wall cladding and the underlying structural timber wall framing were severely affected by suspected termite damage and advanced timber rot. The timber framing was observed to be significantly deteriorated and disintegrating when lightly probed, indicating a substantial loss of structural capacity. The affected wall section could be moved by applying manual force, demonstrating that the wall is no longer providing adequate structural support and is at risk of partial or full collapse. In accordance with AS 4349.1 – Inspection of Buildings, damage that compromises the load-bearing capacity or stability of structural elements is classified as a Major Defect. Due to the extent of deterioration and instability, this condition also constitutes a serious safety hazard, and the affected area is not considered suitable for habitation in its current condition.

Immediate – this issue requires urgent attention due to the high risk of structural failure and potential harm to occupants.

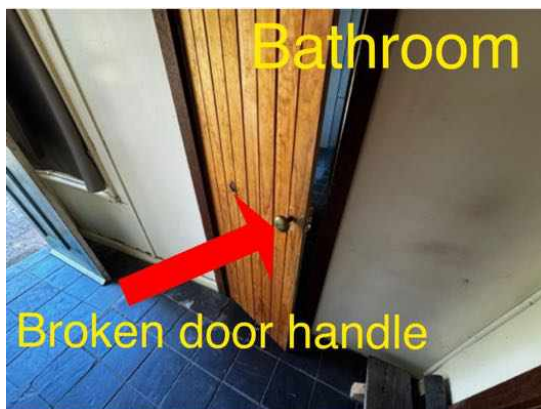
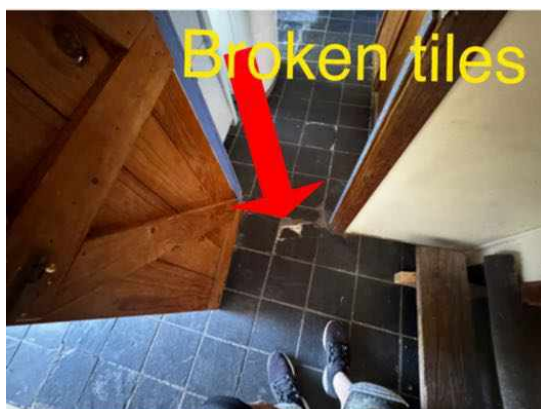
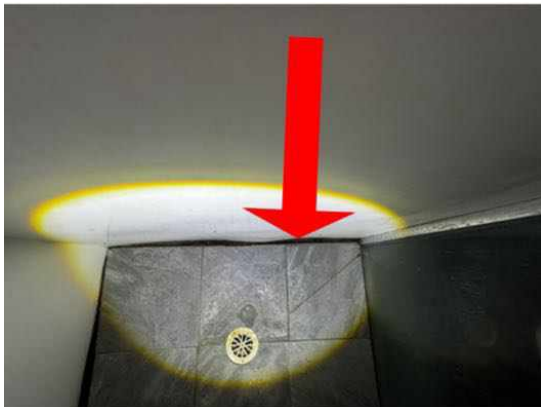
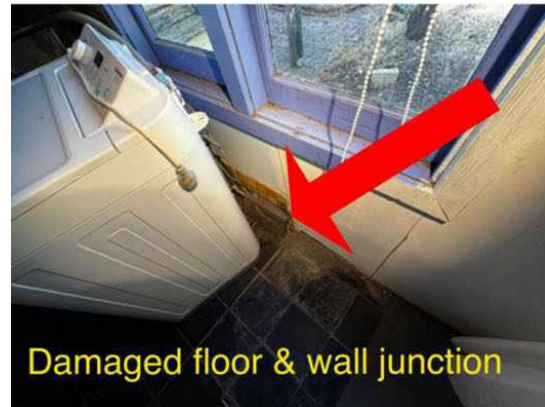
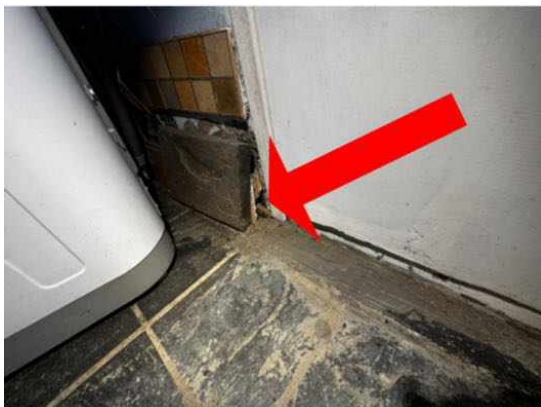
Finding 2.07

Building:	Main Building
Location:	Bathroom > Rear Right
Finding:	Bathroom defects & suspected non-compliant and failed bathroom shower enclosure
Information:	Multiple defects were observed within the bathroom, including a broken door handle, broken floor tiles, and damage to the wall and floor junction behind the washing machine. The shower enclosure was found to be defective, with the shower walls observed to be out of alignment and battening, consistent with building movement. Gaps have formed at the wall and floor junctions inside the shower enclosure, exposing underlying timber elements. During shower operation, water is able to freely discharge into the subfloor, indicating a failure of waterproofing and enclosure

Immediate. The shower should be taken out of service until rectification works are completed to prevent further structural deterioration and moisture damage.

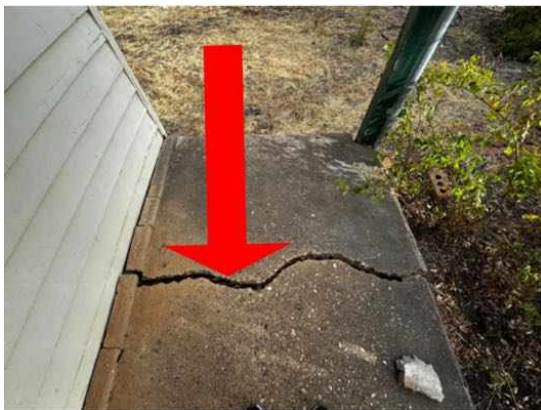
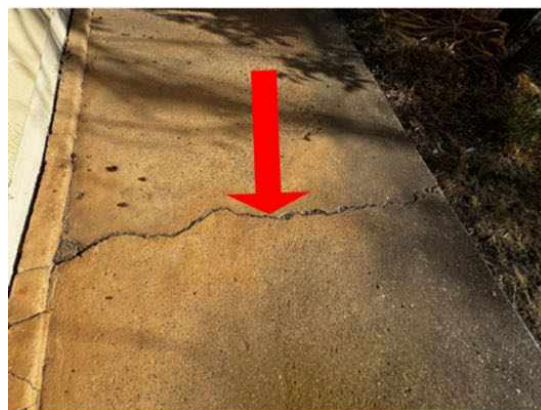
Finding 2.08

Building:	Main Building
Location:	Porch > Front
Finding:	Major cracking to concrete front porch
Information:	Significant cracking was observed to the concrete paving at the front porch in multiple locations, with several cracks measured to be greater than 10 mm in width, exceeding acceptable tolerances and indicating structural movement rather than minor shrinkage. In addition, the side section of the elevated concrete porch was observed to be collapsing, indicating a loss of support to the slab edge. The pattern and severity of cracking, combined with the partial collapse, is consistent with foundation and footing movement. The likely contributing cause is excessive moisture in the ground,

Immediate. Investigation and rectification should be undertaken as soon as practicable to reduce the risk of further collapse, ongoing movement, and associated safety hazards.

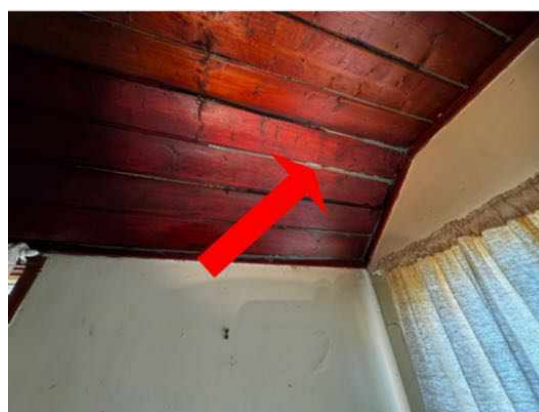
Finding 3.02

Building:	Main Building
Location:	Living Room > Front Left
Finding:	Suspected ceiling panel separation due to building movement – living area
Information:	Several timber ceiling panels within the living area were observed to have visible gaps and cracking between panel joints. These defects have been filled with silicone sealant, resulting in a substandard and visually poor finish. The sealant application appears to be a makeshift remedial measure rather than a permanent repair. Based on the widespread evidence of building movement observed elsewhere within the property, including uneven floors, binding doors, and wall cracking, it is suspected that the ceiling gaps and cracking are primarily the result of building movement rather than poor installation. The sealant is suspected to have been applied in an attempt to

Within the short to medium term, or sooner if cracking widens, ceiling panels continue to separate, or additional signs of movement become evident.

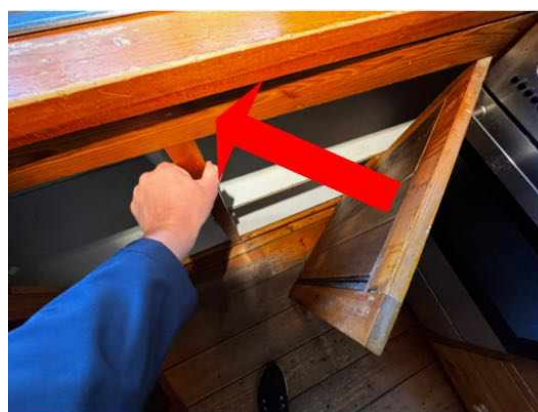
Finding 3.03

Building: Main Building
 Location: Kitchen > Rear Left
 Finding: Loose and inadequately fixed kitchen base cabinet – under sink

Within the short term, as part of routine maintenance, to prevent further deterioration or damage to the cabinetry and associated fittings.

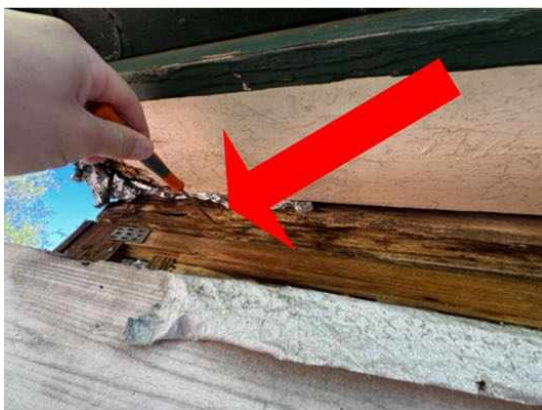
Building: Main Building
Location: All Areas > All Areas
Finding: Severe termite damage and timber rot to external wall – unsafe condition
Information: Severe and extensive suspected termite damage in conjunction with advanced timber

rot was observed to the external wall on the northern side of the building, most notably to the wall servicing the middle bedroom. The external weatherboard cladding in this area and other areas of the building was found to be severely deteriorated, with the damage extending into the internal wall cavity on the northern side of the building. The timber framing elements within the wall cavity were observed to be extensively damaged and structurally compromised to the point where the wall exhibited noticeable movement when moderate manual force was applied. This condition indicates a complete loss of structural capacity to this wall section and presents a serious risk of partial or full wall collapse. The affected area is therefore considered unsafe for habitation. Additional suspected termite damage was observed to other external wall areas, however these were not as advanced as the primary location described above. This condition is consistent with a Major Defect as defined under AS 4349.

Recommendation:

Urgent action is required. The affected area should be immediately isolated and access restricted. A licensed builder and suitably qualified structural engineer should be engaged to assess the extent of structural damage and determine appropriate demolition, structural repair or rebuilding requirements. A licensed termite management professional should also be engaged to undertake a full termite inspection, identify active or dormant termite activity, and implement an appropriate termite treatment and management system in accordance with AS 3660. Any structural repairs should not proceed until termite risks have been adequately addressed.

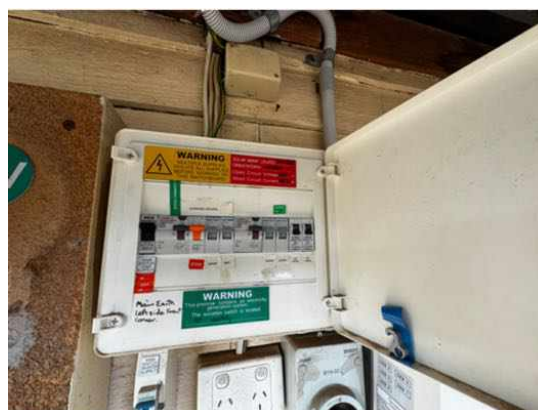
Finding 6.01

Building:	Main Building
Location:	Meter Box > Front
Finding:	Termite management system - no evidence of chemical installation (TP)
Information:	At the time of inspection, there was no visible evidence to suggest that a chemical termite management system has been installed or remains effective. In addition, no durable notice was observed within the electrical switchboard to identify the presence, type, or date of any termite protection measures.

For this reason, the installation of a chemical termite management system is highly recommended to reduce the risk of termite activity. A durable notice should also be installed within the electrical switchboard to clearly identify the treatment provided and support ongoing inspection and maintenance.

Engagement of a licensed termite management or pest control contractor is recommended as a matter of priority to assess the site conditions, consider local termite risk, and determine the most appropriate treatment method and procedures for this property.

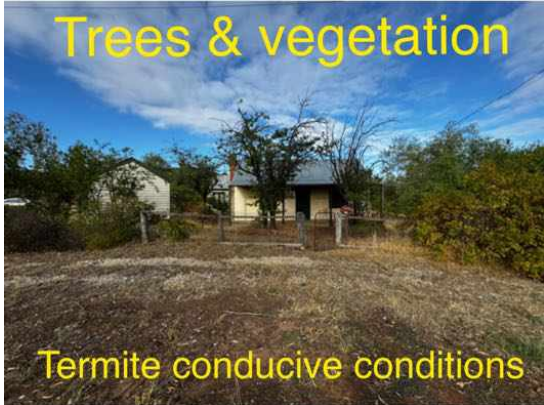
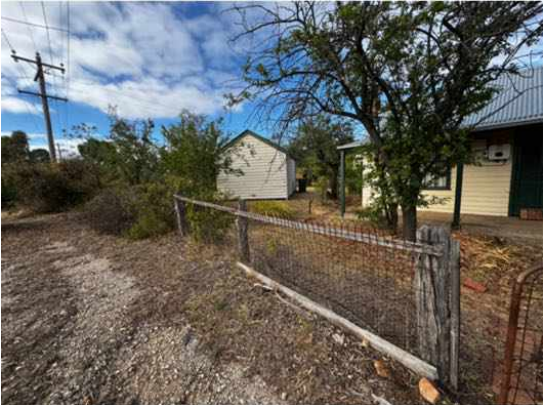
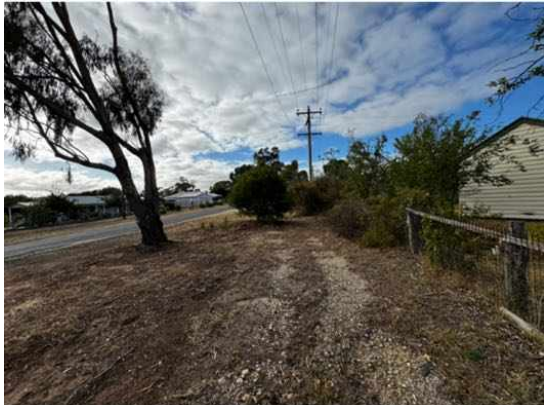
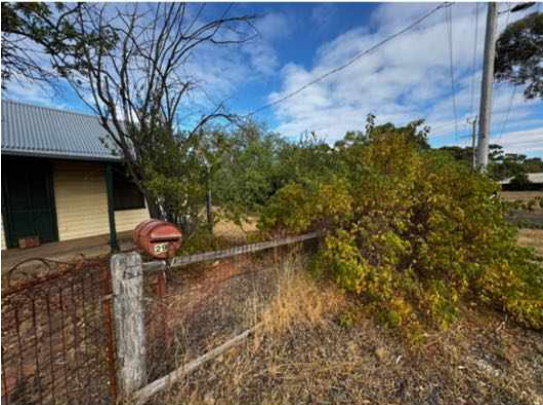
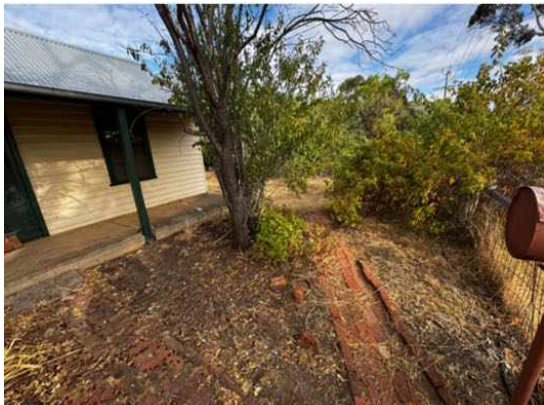
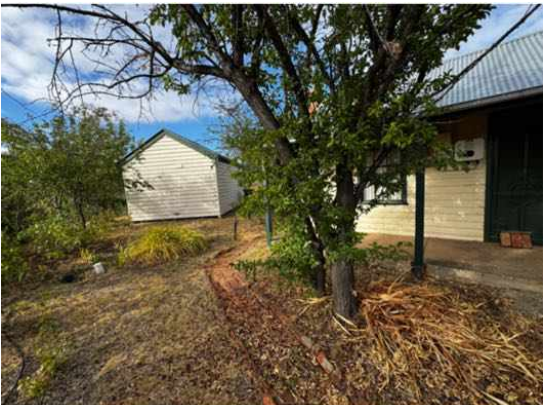
Finding 6.02

Building:	Main Building
Location:	Yard - Front, sides, back > All Areas
Finding:	Landscaping & vegetation - conducive conditions (TP)
Information:	At the time of inspection, landscaping elements were observed to the front, side and rear yards, including garden beds, trees, shrubs and vegetation such as small to medium trees located in proximity to the building. These conditions create an environment that may be conducive to termite activity by retaining moisture and providing potential food sources and concealed access pathways.

In accordance with AS 3660.2, termite risk management for existing buildings includes consideration of environmental and site conditions surrounding the structure, as factors such as excessive moisture, mulch, garden beds, and vegetation close to the building can increase the likelihood of termite presence and concealed entry. Mulch and irrigated areas can maintain damp conditions against or near the building perimeter, while established trees and vegetation may harbour termite colonies or foraging activity that can extend toward the structure.

As a result, the existing landscaping configuration is considered to increase the overall risk of termite activity to the property. It is recommended that a licensed termite management or pest control contractor be engaged to assess the site conditions and provide advice on appropriate risk reduction measures, which may include modifying landscaping practices, managing moisture sources, and implementing or supplementing termite management measures suitable for the existing building.

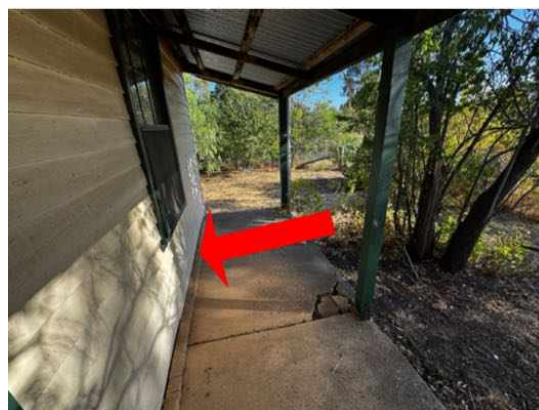
Finding 6.03

Building:	Main Building
Location:	Porch > Front
Finding:	Concrete paved porch are hard up against building (TP)
Information:	At the time of inspection, the concrete paved area to the front porch was observed to be constructed hard up against the building, concealing the edge of the building and footing. This condition restricts visual access to the building perimeter and limits the ability to inspect critical areas intended for early detection of termite activity.

early warning, increasing the likelihood of undetected termite activity.

As a result, the paved area to the front porch is considered to increase the risk of concealed termite entry. It is recommended that a licensed termite management or pest control contractor be engaged to assess this area and provide advice on suitable rectification options, which may include modifying the paving to reinstate inspection access or implementing supplementary termite management measures appropriate to the existing conditions.

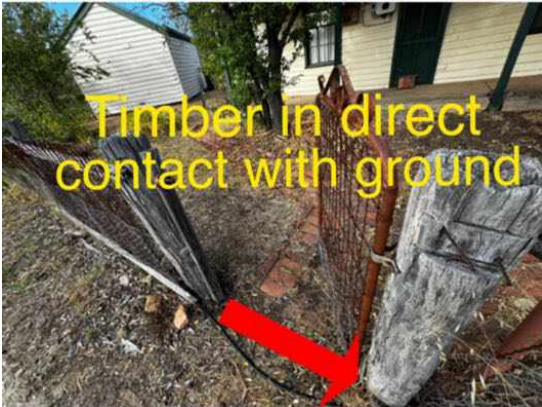
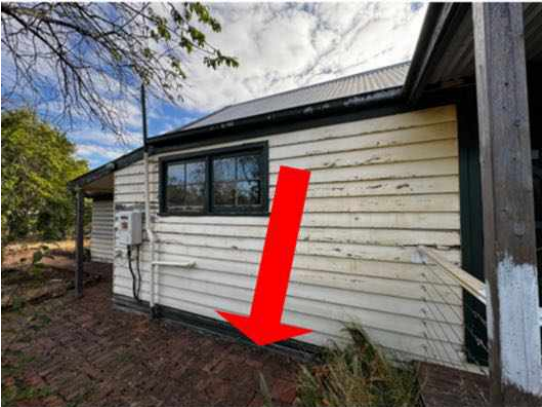
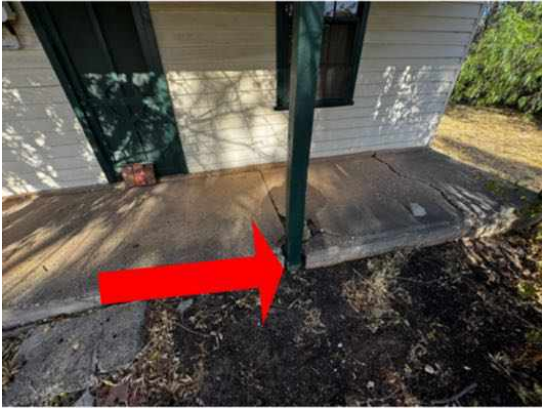
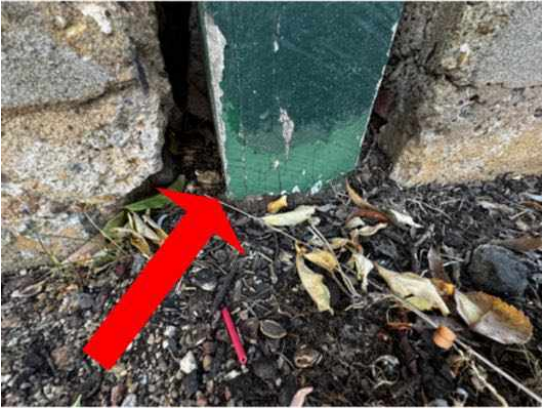
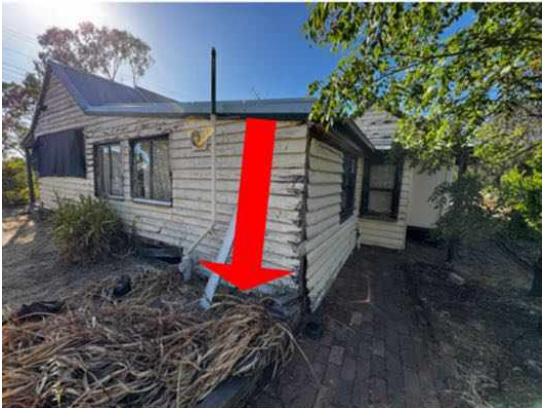
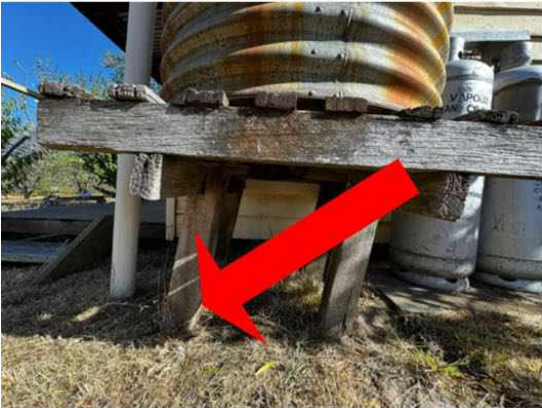
Finding 6.04

Building:	Main Building
Location:	All Areas > All Areas
Finding:	Timber in or on direct ground (TP)
Information:	At the time of inspection, multiple conducive termite conditions were observed around the external areas of the building, including timber vegetable garden structures, timber planter boxes, timber retaining walls to garden beds, firewood storage located to the rear and side yards, stored timber planks to the rear and side of the property, and a dead, decaying tree trunk positioned near the front boundary. Evidence of decaying timber was also noted within the firewood stacks and in other timber materials stored around the site.

Conditions that provide timber food sources, retain moisture, or allow concealed termite activity are recognised as significantly increasing termite risk to existing buildings. Decaying and stored timber materials in contact with or close to the ground can attract subterranean termites, support ongoing foraging activity, and allow colonies to establish concealed pathways toward nearby structures without early detection.

As a result, the number and distribution of these conducive conditions are considered to substantially increase the risk of termite activity affecting the property. It is recommended that a licensed termite management or pest control contractor be engaged to assess and manage these risks, which may include removal of decaying timber, relocation or replacement of timber elements with non-susceptible materials,

improved storage practices for firewood and timber, and implementation or review of appropriate termite management measures suited to the existing building and site conditions.

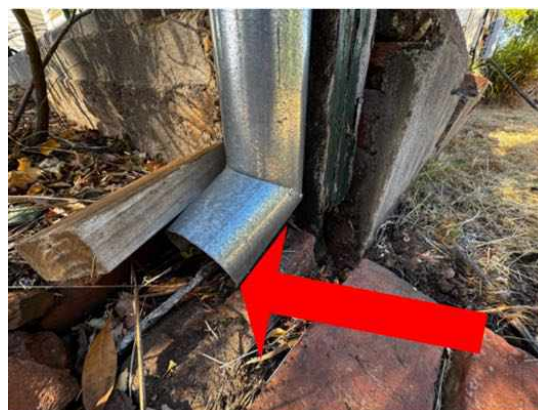
Finding 6.05

Building: Main Building
 Location: Porch > Front Right
 Finding: Disconnected downpipe to front elevation (TP)
 Information: At the time of inspection, a downpipe servicing the front porch was observed to be not connected to a drainage system and discharging directly onto the ground. This condition promotes poor site drainage and allows ongoing water accumulation around the base of the building.

Conditions that result in persistent dampness or poor drainage around a building are recognised as conducive to termite activity, as elevated moisture levels can attract subterranean termites and support concealed foraging activity toward the structure.

Uncontrolled discharge of roof water can therefore increase both moisture-related deterioration and termite risk.

As a result, the disconnected downpipe is considered to contribute to conditions conducive to termite activity. It is recommended that an appropriately qualified roof plumber be engaged to inspect all roof plumbing and ensure that downpipes are correctly connected to the stormwater drainage system, with no roof water discharged directly onto the ground.

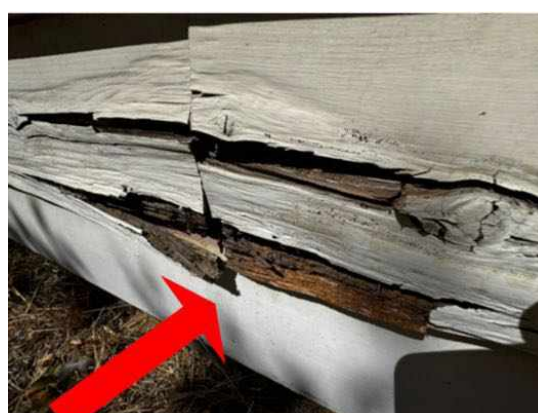
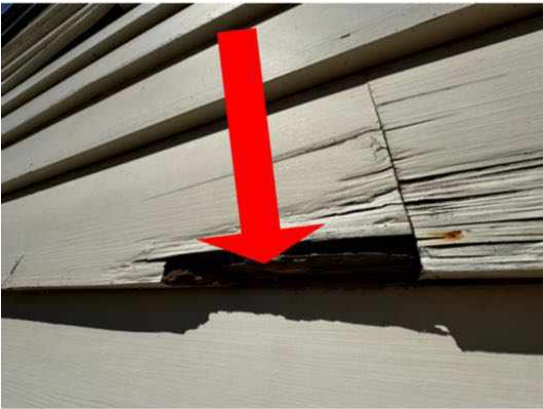
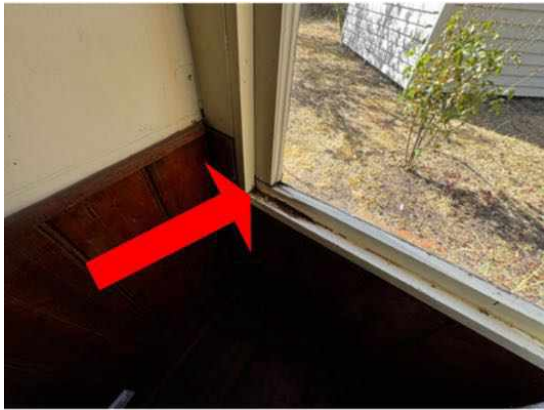
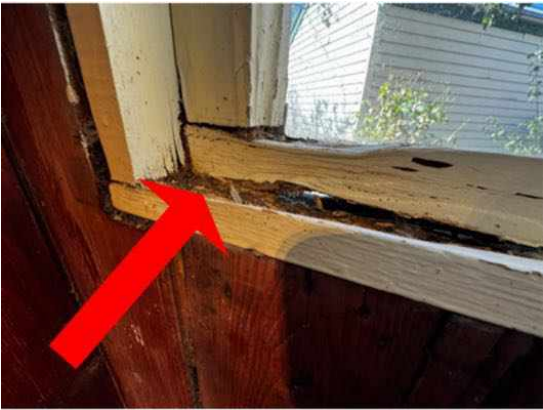
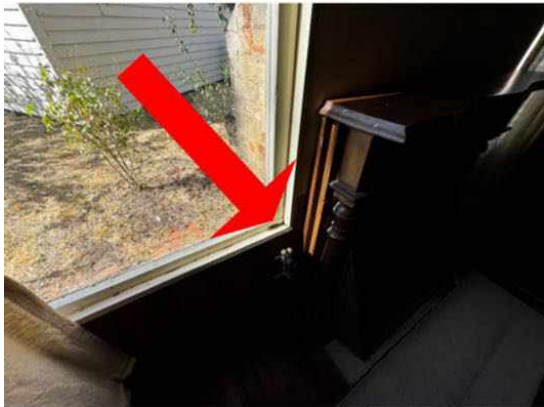
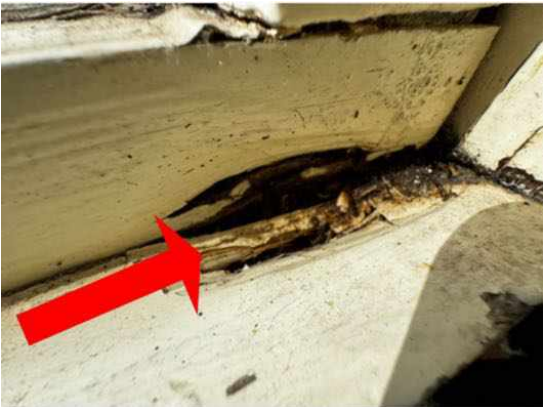
Building:	Main Building
Location:	All Areas > All Areas
Finding:	Timber decay & rot - Conducive conditions (TP)
Information:	At the time of inspection, severe timber decay was observed throughout the entire building. The affected areas include the weatherboard cladding, window and door frames, timber posts, and structural timber.

This condition is suspected to have developed over time due to prolonged moisture exposure and a lack of appropriate timber maintenance, allowing moisture ingress and decay to progress within the timber elements. In accordance with AS 3660.2, deteriorated and moisture-affected timber is recognised as increasing the risk of termite activity, as decayed timber can attract termites and may provide concealed access or harbourage.

As a result, these conditions are considered to present an elevated risk of ongoing deterioration and termite susceptibility. It is recommended that an appropriately qualified builder or carpenter be engaged to further assess the extent of timber decay, remove any concealed deteriorated material, and undertake suitable repairs or replacement, with consideration also given to advice from a licensed termite management or pest control contractor where termite risk is identified.

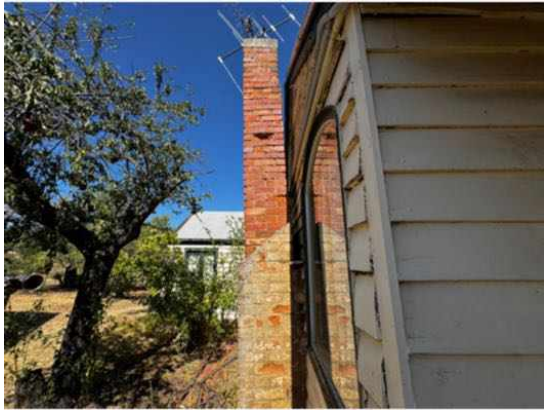
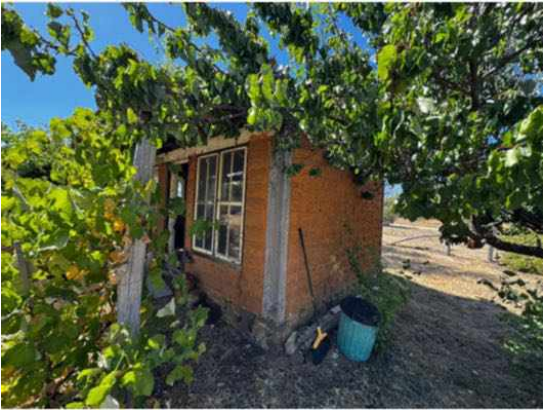
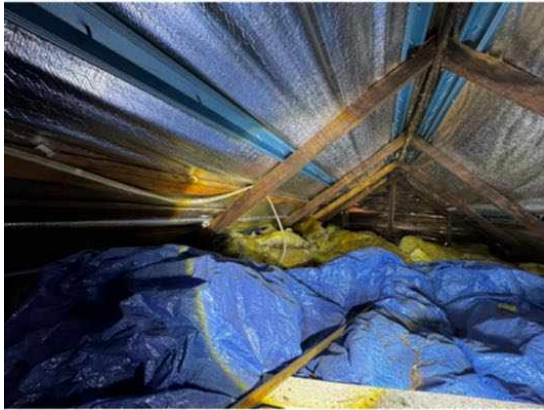
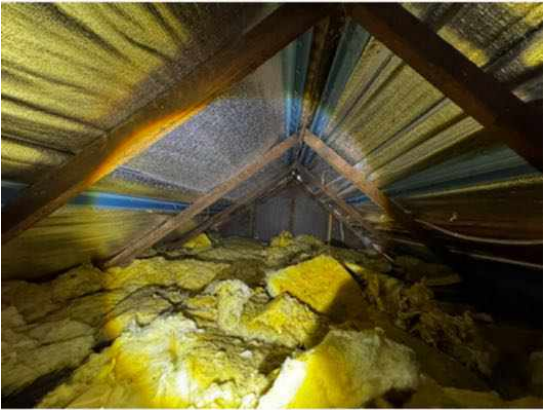
Building: Main Building
Location: All Areas > All Areas
Finding: Additional Photos - Obstructions and Limitations
Information: These photographs are an indication of the obstructions and limitations which impeded full inspection of the property at the time of inspection. These obstructions can hide an array of defects and should be removed to allow full inspection to be carried out. A re-inspection is recommended once the areas are made accessible.

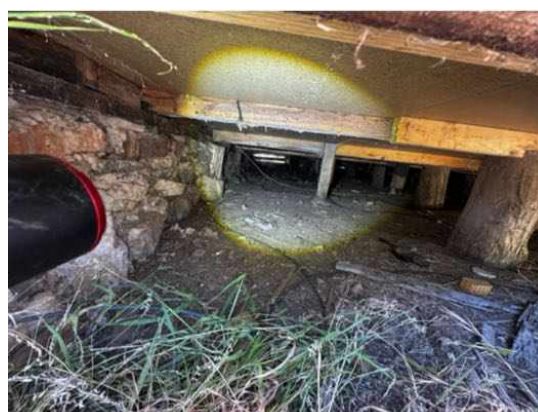
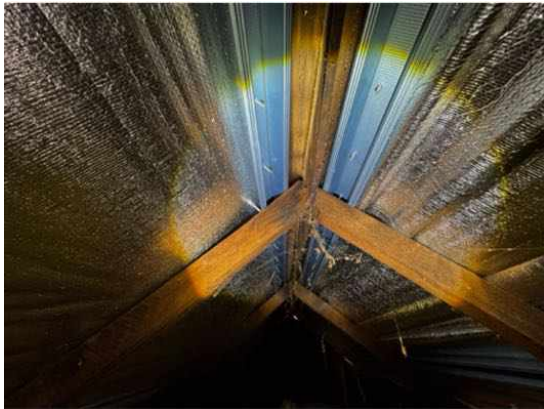
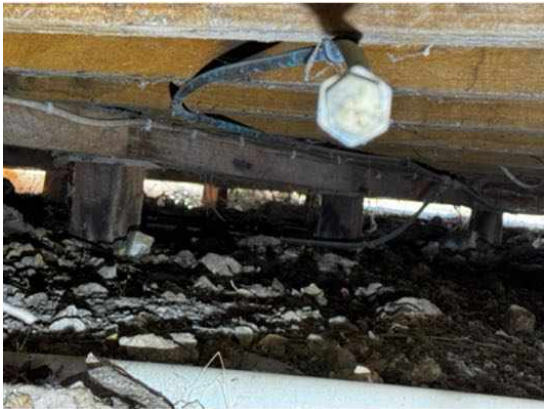
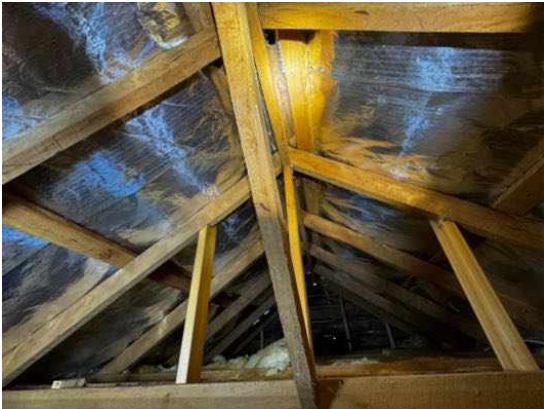
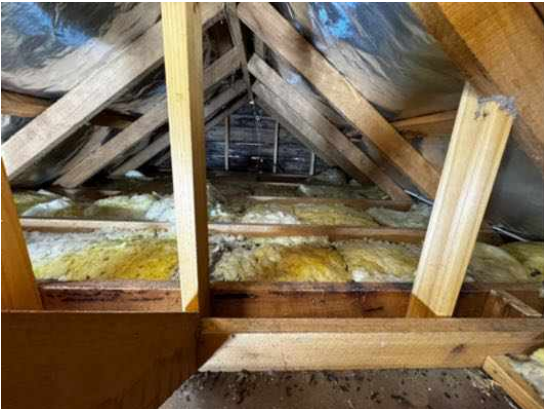
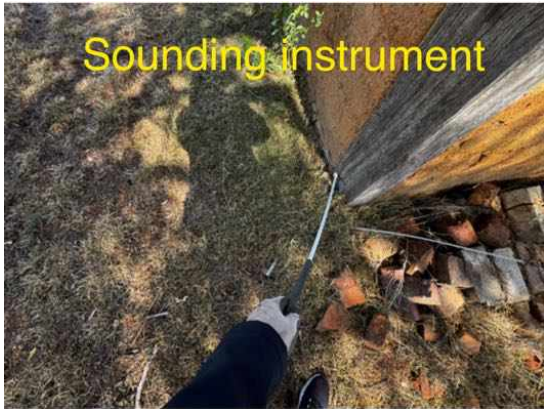
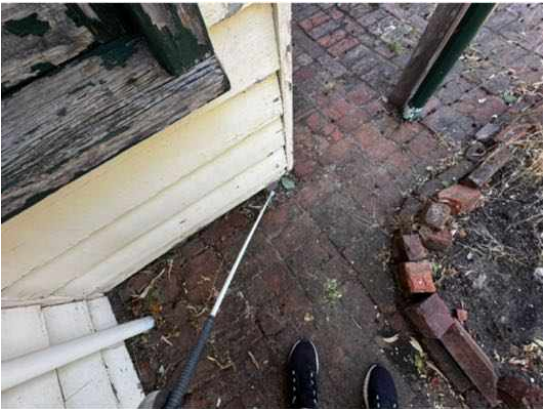
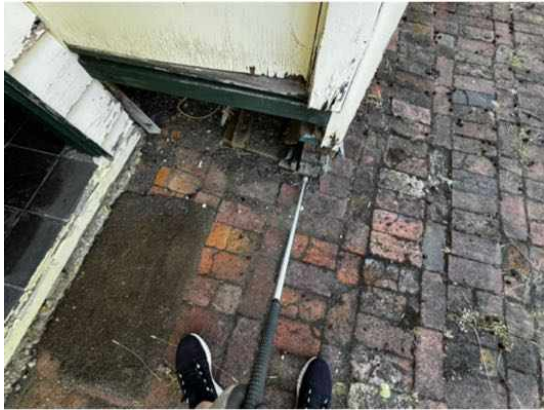
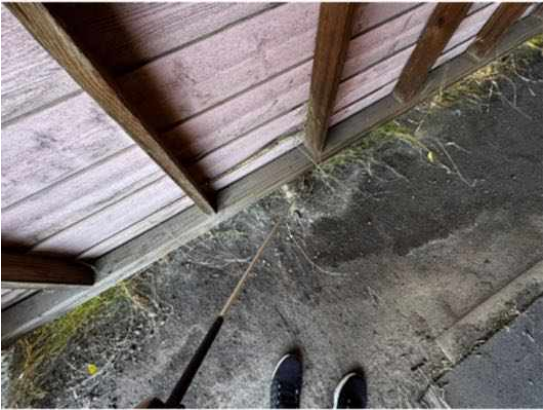
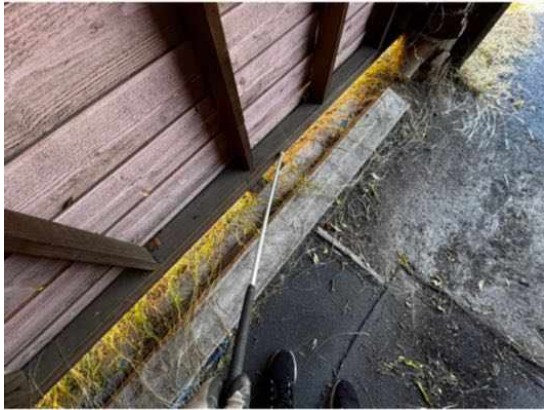
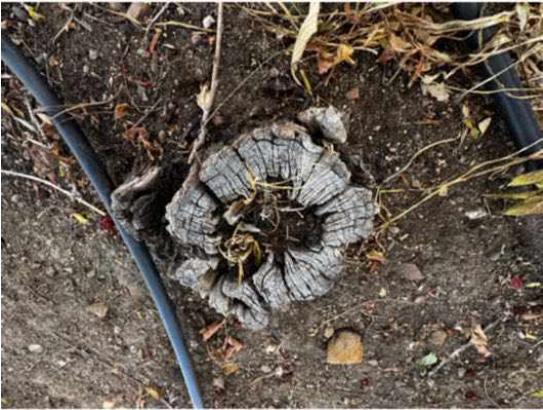
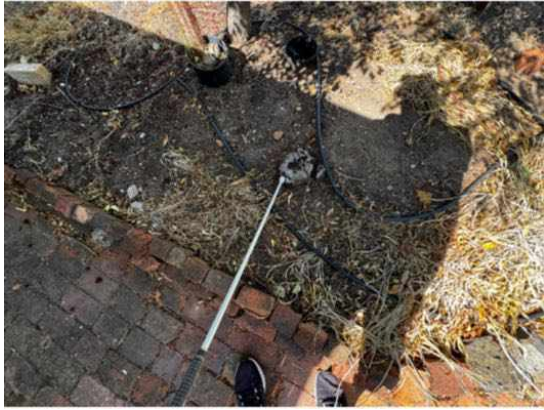
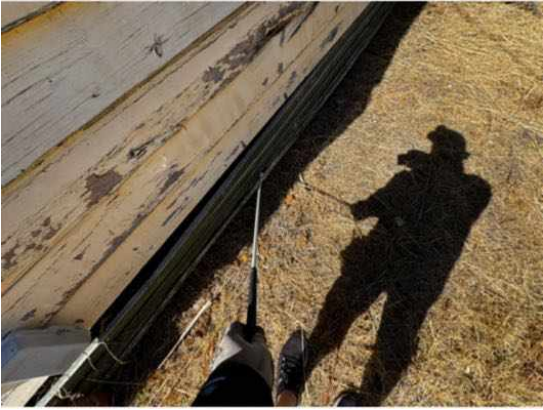
Building: Main Building
Location: All Areas > All Areas
Finding: Termite investigation techniques (TP)
Information: All accessible areas of the dwelling were inspected, with particular attention paid to wet areas, which were closely assessed for elevated moisture levels and temperature anomalies that may indicate conditions conducive to termite activity. No evidence of termite activity was identified within the interior of the dwelling at the time of inspection. However, evidence of termite damage was found to the exterior and wall cavities of the building.

In an attempt to identify concealed or hidden timber pest activity, a range of inspection techniques were adopted. These included the use of a moisture meter to assess susceptible areas, sounding of timber elements using a handheld probing device, and visual assessment of materials for signs commonly associated with termite activity. These signs include moisture-related deterioration, deformation of timber, termite mud leads or bridging, and irregular or regular shaped holes within timber elements that may indicate pest-related damage.

It is noted that termite activity can generate increased moisture and localized temperature variations, and where such irregularities are detected, further investigation may be warranted. However, it is also acknowledged that certain obstructions, including floor coverings, wall linings, wall tiles, and fixed cabinetry such as bathroom fit-offs, can conceal termite activity and limit the effectiveness of visual inspection. As a result, the absence of visible evidence at the time of inspection does not eliminate the possibility of concealed termite activity within inaccessible or obstructed areas of the building.
