Building and Timber Pest Inspection Report

Inspection Date: Wed, 21 Jan 2026

Property Address: 1 Harcourt Ave, Frankston South VIC 3199,
Australia

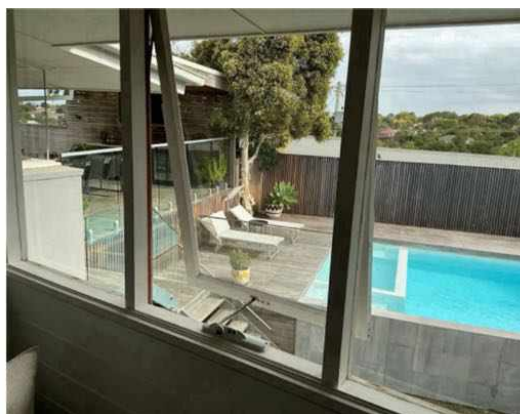
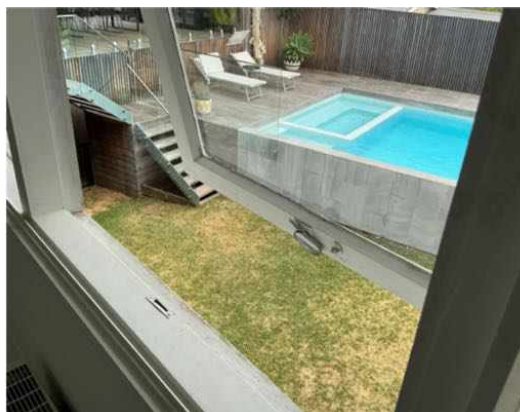
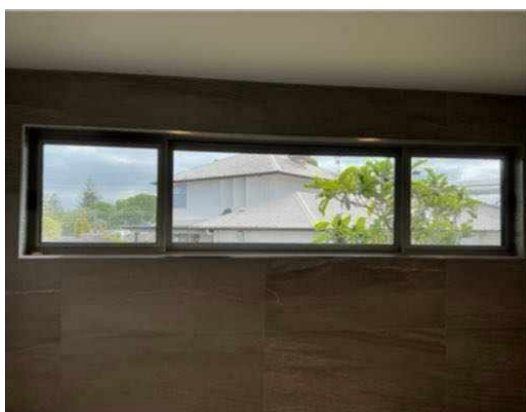
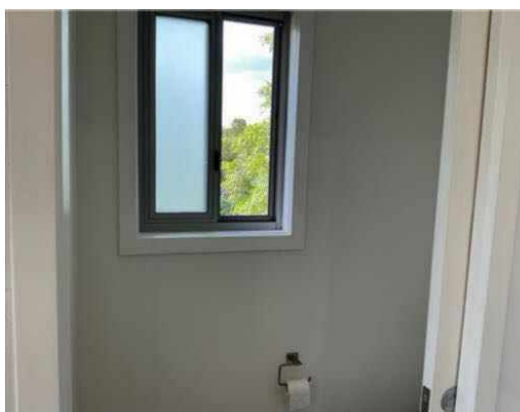
Finding 1.02

Building: Main Building
 Location: Balcony
 Finding: Balustrade - Suspected Non-Compliance
 Information: Part of the balustrade to the patio facilitates climbing with a horizontal ledge and garden beds, creating a potential fall hazard particularly for children.

This defect creates a potential safety hazard and should be rectified as soon as possible to ensure the safety of the area and to meet present building standards and regulations.

A registered builder should be contacted to discuss possible rectification solutions.

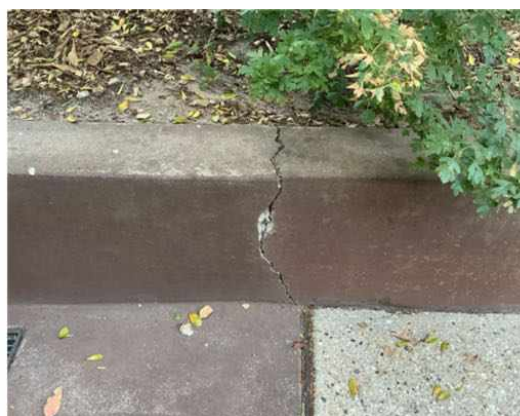
Finding 3.03

Building: Main Building
 Location: Driveway and pathways
 Finding: Driveway Cracking - External Concrete Paving Damage Category 1 - Fine (less than 2mm)

Information: Fine cracks were identified in the driveway and pathways external concrete paving. Although fine cracks are quite noticeable, they are often only considered to be an appearance defect, and usually do not indicate any structural damage. To be considered a Category 1 or fine crack, the crack is found to be less than 2mm in width.

Generally the cause of a hairline crack in existing concrete paving such as driveways and pathways is indicative of the expansion and contraction of the concrete. Such causes are generally due to environmental factors, such as moisture levels, weather conditions, root systems of nearby trees or the soil types on which they are laid.

Fine cracks may also be due to poor original installation of the concrete. Factors such as poor compaction of the sub surface and/or inadequate reinforcing of the slab may create cracking and other secondary defects.

Monitoring of all cracking should be conducted frequently. Always contact a building inspector should cracks widen, lengthen, or become more numerous.

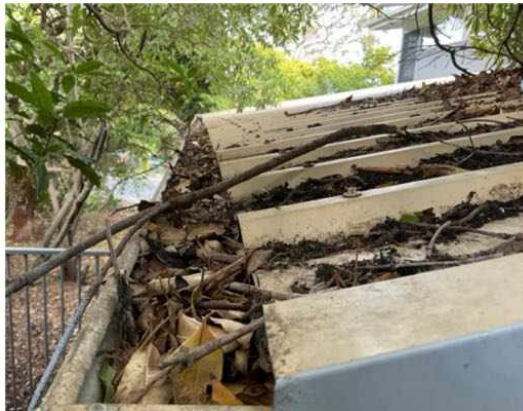
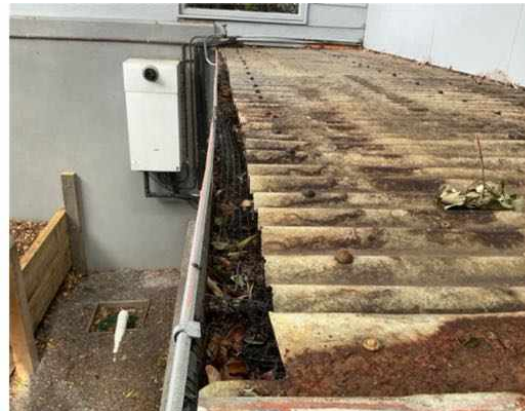
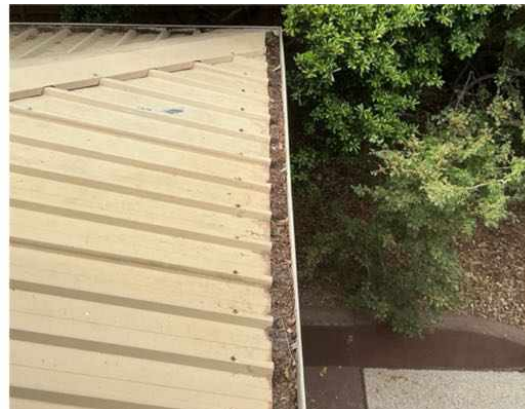
Finding 3.07

Building: Main Building
Location: Roof Exterior
Finding: Gutters -Partially Blocked with debris
Information: It was noticed on inspection that some of the gutters were partially blocked with debris. Roof plumbing structures, such as guttering and downpipes, should be free of all debris to prevent blockages. Blockages of the guttering and downpipes will lead to pooling and accumulated water overflows, which is likely to subsequently flood eaves and exterior walls.

Blocked gutters are likely to lead to high levels of moisture in the affected areas. Such moisture will not only cause rust and decay of the associated building materials, but can also provide conditions that are conducive to termite and timber pest activity. Blockages in gutters should therefore be removed immediately to ensure dry conditions are maintained.

Consult a Licensed Plumber for further specific advice on remedial works that may be required. In the interim, it is highly advised that blocked gutters be removed by the homeowner or a general handyperson as a matter of urgency.

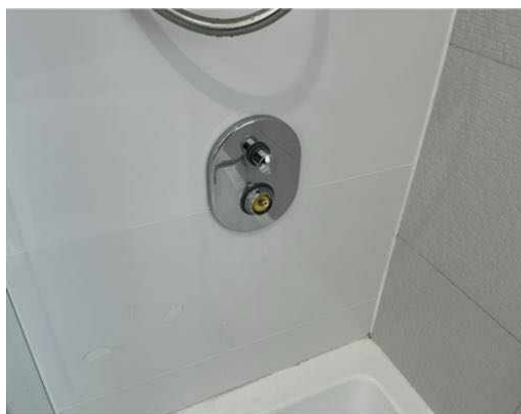
Finding 3.15

| Finding: | Bathroom Sealant grouting - Missing or damaged degraded |
| Information: | It was noted on inspection that sealant or grout is degraded/missing or damaged to the tiled shower alcoves and or other areas of the bathrooms. |

Flexible and mould resistant materials should be applied to affected areas to prevent any subsequent water damage that is likely to occur. Regular maintenance and replacement of damage or missing or damaged sealant and grout is highly recommended to the wet areas, as this is a regular wear and tear defect. Sealant and grouting in areas that come into regular contact with water should be maintained for the long term care of your property.

A sealant specialist or tiling contractor should be appointed to complete these works as soon as possible

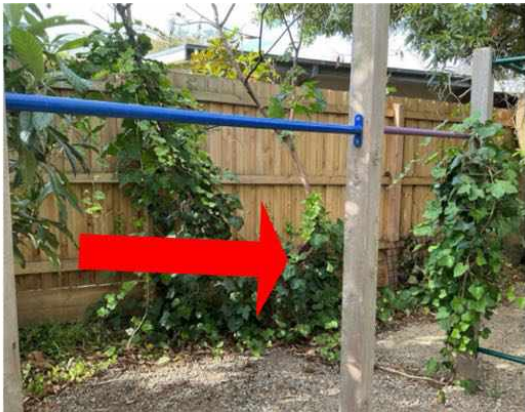
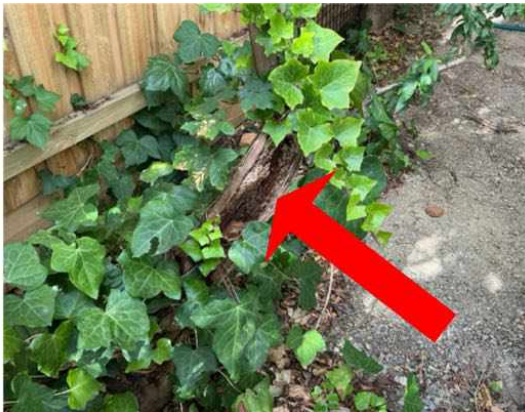
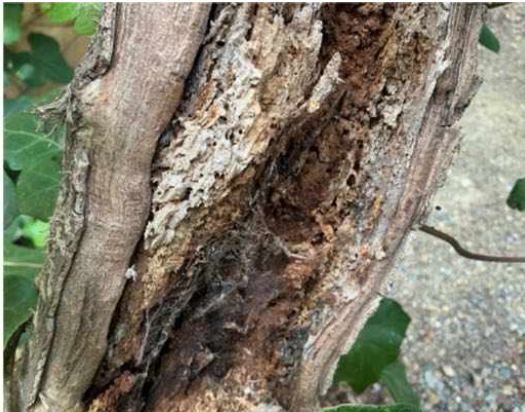
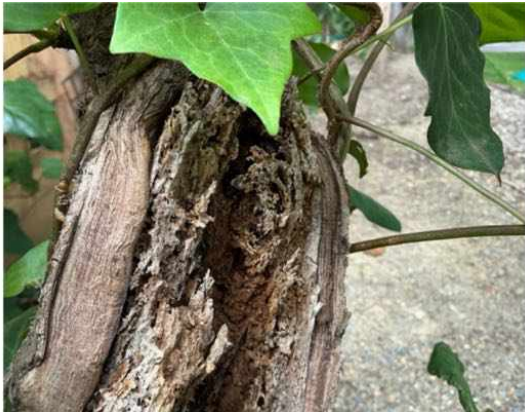
Building: Main Building
Location: Yard - Back
Finding: Trees termite damage
Information: Despite no live termite or timber pest activity being indicated, previous termite damage was found to have affected these trees in the rear yard. This damage is considered to be inactive and is minor in nature. Recommend engaging a pest controller for an invasive investigation on the trees and to install a termite barrier immediately.

It is advised that the area be visually inspected frequently to ensure that the condition of affected building materials does not worsen. At the time of inspection, damage is only considered to be superficial.

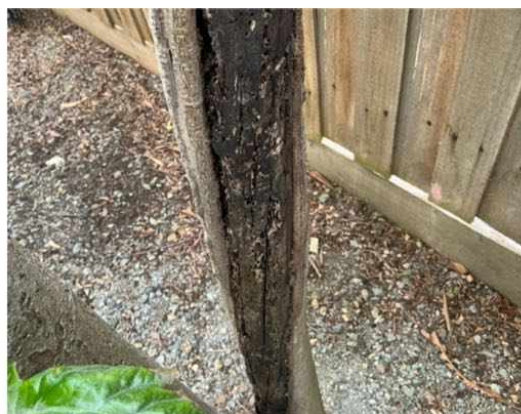
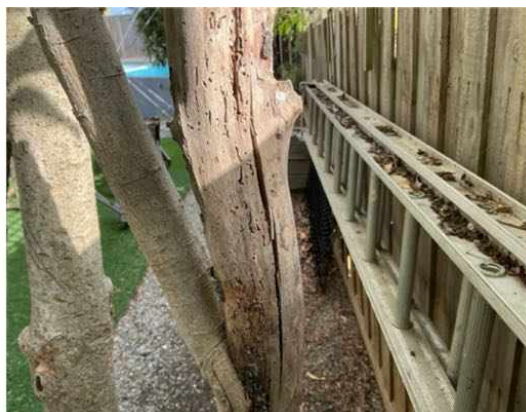
| Information: | The application of a post-construction chemical termite barrier is highly recommended for all properties, particularly if live termite activity has been found on the site previously. Such barriers are highly effective in preventing termite attack on any timber building elements throughout the property. |

A durable notice should be placed in the switchboard unit to indicate current termite barriers. At the time of inspection, it appeared as though no termite management system has been installed, with no evidence to suggest preventative works taking place.

The client may consider gaining further advice from a pest controller as to the costs and procedures involved with this application. It is recommended that obtaining such advice be a short-term priority.

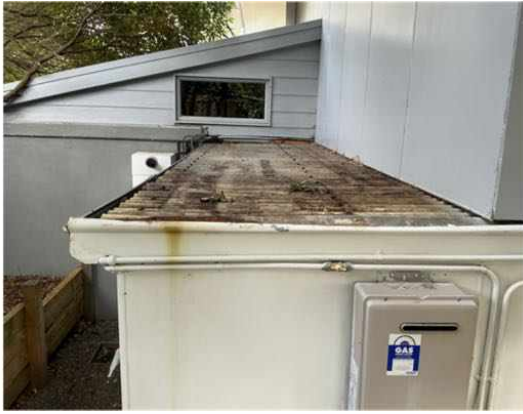
Finding 6.02

| Information: | It was identified that the shed roofing structure has an insufficient fall or angle, which prevents effective water drainage and parts are starting to rust. This defect increases the risk of water pooling on the roof surface and may lead to various secondary building defects including. |

Material deterioration, prolonged water exposure can accelerate the breakdown of roofing materials and attract termites and other pests.

Leaks, water accumulation may penetrate joints or seams leading to leaks that could damage internal structures.

Corrosion, metal components of the roofing structure and associated building materials may corrode overtime due to prolonged exposure to moisture.

The angle of the roof is currently inadequate to facilitate the efficient flow of rainwater into the roof plumbing system. If left on addressed these issues will likely worsen overtime leading to more extensive structural damage and costly repairs.

Engage a registered building contractor to assess the roofing structure (potentially including structural changes to the roof)and provide a quotation for rectification works. Modify the roof angle to meet the required minimum fall for proper drainage insuring compliance with relevant building standards and codes. Inspect roof plumbing systems to confirm they are correctly installed and functioning efficiently in conjunction with the roof modifications.

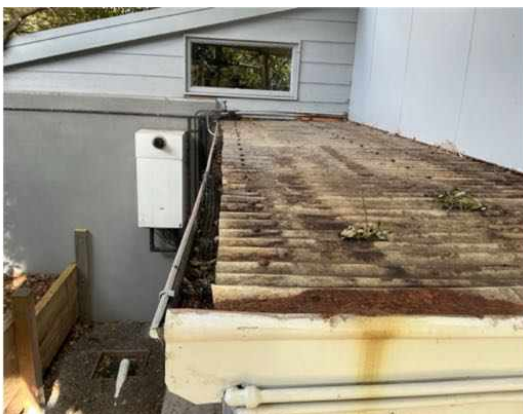
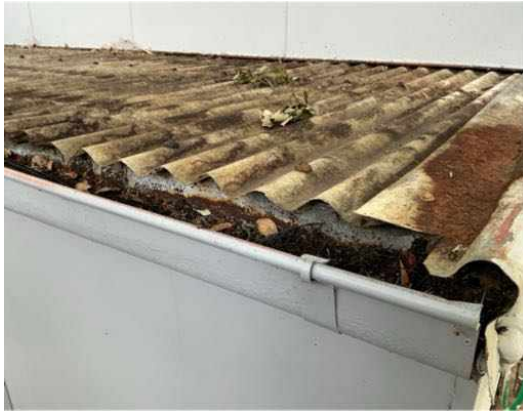
Finding 6.03

Finding: Gutters - Rusted or corroded

Information: The gutters to the shed roof shows evidence of rusting and corrosion, which is likely to have developed as a result of excessive exposure to moisture and or inadequate coatings. This will cause excessive moisture and could attract termites.

As surface rust provides no protection to the underlying iron, the deteriorating condition is likely to worsen if not addressed in the short-term future.

Where possible, the use of galvanized (treated) metals or aluminium coated metals aid in rust prevention, as does regular general maintenance. Rust formation can be controlled with coatings, such as paint, that isolate the iron from the environment.

Rusting and corrosion should be managed by ideally removing or limiting the affected surface from exposure to moisture. A registered builder may be appointed to replace any building elements that have been severely affected by rust or water damage.

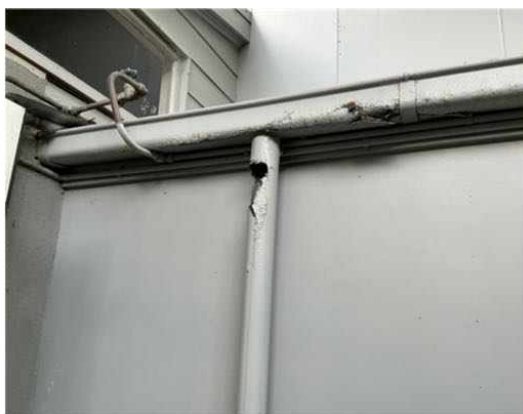
Finding 6.04

| Finding: | Downpipe - Rusted or corroded |
| Information: | The shed down pipe shows evidence of rusting and corrosion, which is likely to have developed as a result of excessive exposure to moisture and or inadequate coatings. |

As surface rust provides no protection to the underlying iron, the deteriorating condition is likely to worsen if not addressed in the short-term future.

Where possible, the use of galvanized (treated) metals or aluminium coated metals aid in rust prevention, as does regular general maintenance. Rust formation can be controlled with coatings, such as paint, that isolate the iron from the environment.

Rusting and corrosion should be managed by ideally removing or limiting the affected surface from exposure to moisture. A registered builder may be appointed to replace any building elements that have been severely affected by rust or water damage.

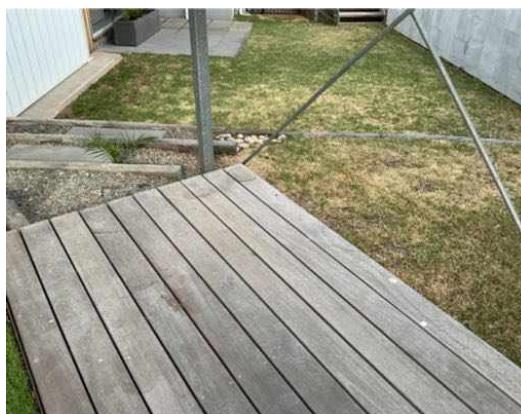
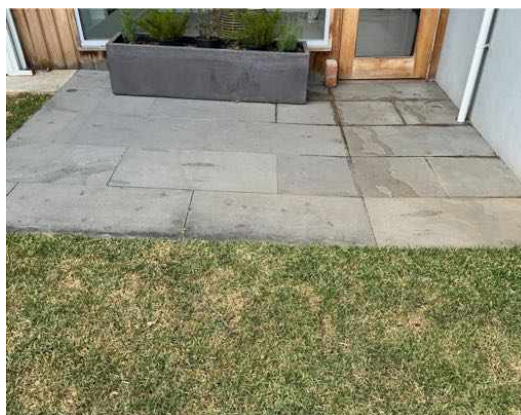
Finding 6.05

| Finding: | Site drainage - poor/inadequate |

Information: The site drainage to parts of the yards was found to be inadequate at the time of inspection, creating potential for subsequent water damage to associated building elements. Excessive moisture will attract termites.

It is important that water does not lie against the base of walls; surrounding paths and ground levels should be sloped to drain water away from walls. Downpipes should not discharge stormwater onto lower walls or plinths. Stormwater should be carried away by large, regularly cleaned drains. Ground levels may need to be lowered to expose a buried DPC.

Where site drainage is inadequate, installation of an Agricultural (Aggie) Drain may be required. A qualified plumber should be appointed to further inspect the property and perform any remedial works as necessary. Water damage and secondary defects are likely to occur if left unmanaged.

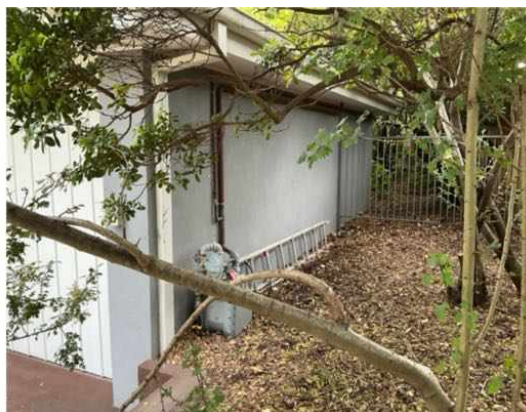
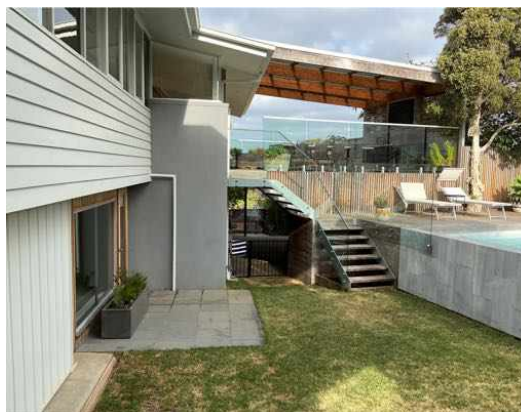
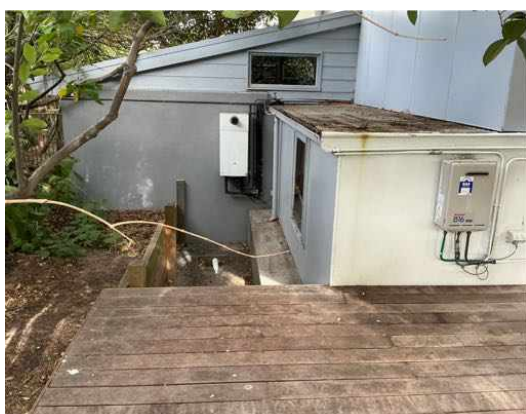
Finding 6.06

Building: Main Building
Location: All External Areas
Finding: Bridging attachments to buildings
Information: Bridging occurs when items against a building provide a concealed entry point for termites into the building or by passing around a termite management system.

Where any part of an attachment to a building is not isolated and is not provided with a clear gap of not less than 25mm from building, bridging occurs. Attachments to buildings such as hot water services, downpipes, verandahs, decks, steps, fences, service conduits and the like provide the opportunity for concealed entry.

Building attachments of this nature need to be frequently inspected for termite activity by a qualified inspector.

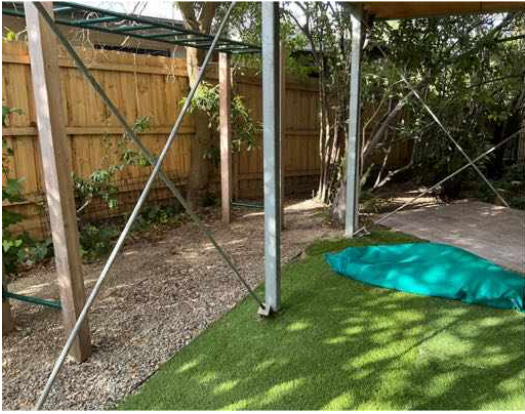
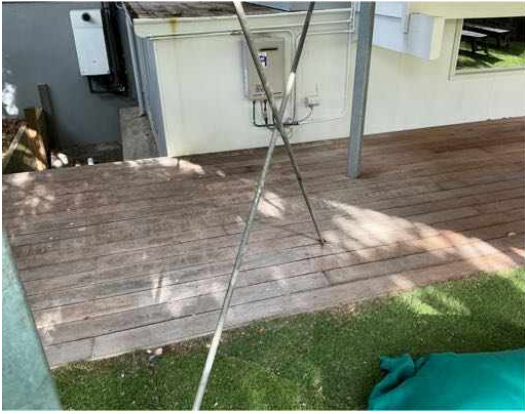
Finding 6.07

| Information: | Any timbers in direct ground contact provide opportunity for concealed termite entry and are likely to be subject to premature rot and decay as the soil retains moisture or damp conditions against the timbers. |

Remove untreated timber that is in direct contact with external grounds. Consider replacement with more durable materials i.e. treated timber or non timber elements. Frequent pest inspections are advised to readily identify any termite activity in these areas.

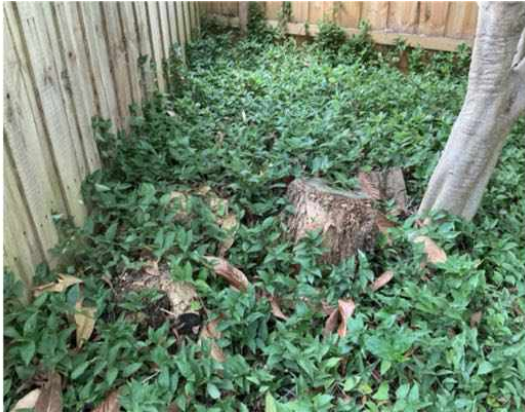
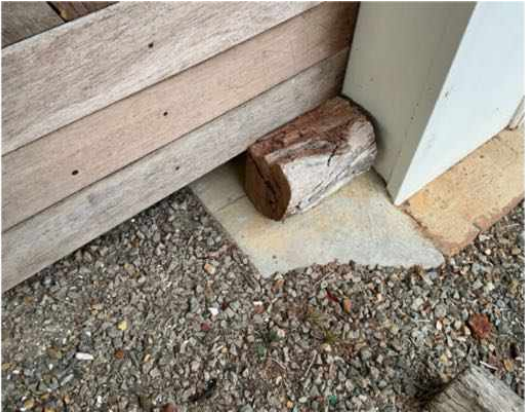
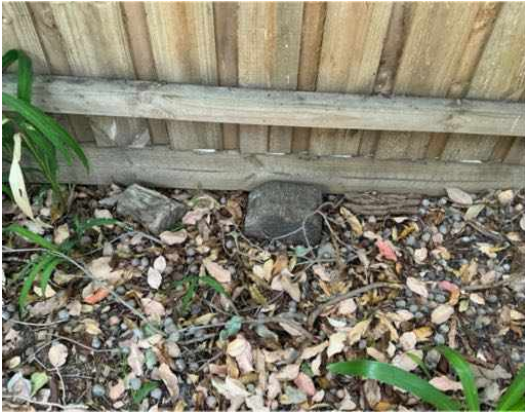
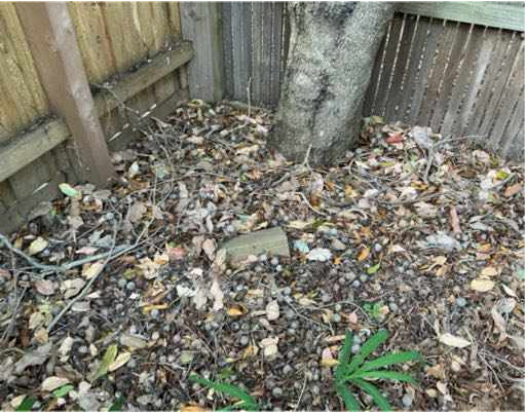
Finding 6.08

Building: Main Building
Location: Yards
Finding: Tree roots/stumps and timbers - external area
Information: Tree roots/stumps and timbers to the external property increases the risk of termite activity being present. As they are likely to come into contact with weather conditions or excessive moisture wood rot is likely to develop on timbers that are not treated.

It is highly recommended that any stored timbers or stumps be immediately removed from areas in which they may attract any termite / timber pest attack. Minimisation of risk / prevention of termite attack is far more adequate than dealing with the presence of termite activity.

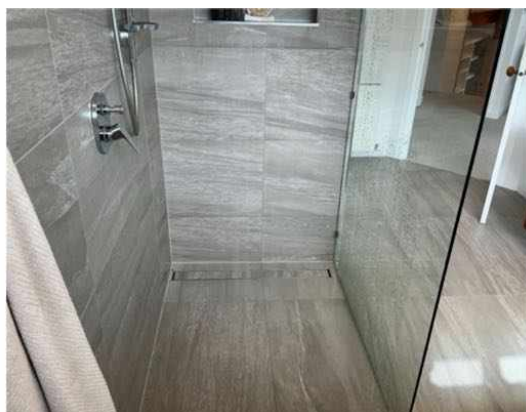
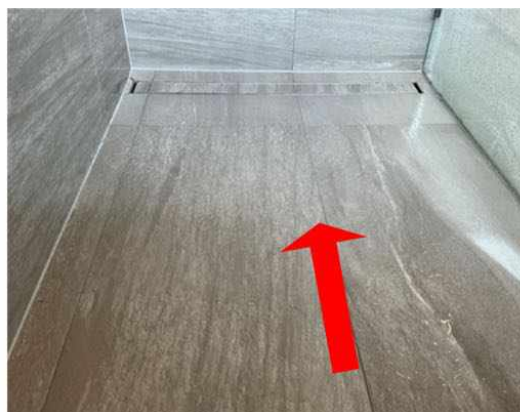
Finding 6.09

| Information: | Evidence of water pooling around the floor waste in the ensuite bathroom shower recess was noticed at the time of inspection. It is suspected that this excessive moisture is attributed to insufficient fall in the shower floor tiles. |

This pooling is minor overall but is still considered unsatisfactory, as standard practices would not permit this situation to occur. Pooling water around floor wastes can create a slip hazard in extreme cases and create conditions that are conducive to termites and mould growth over time. Where left unmanaged, the degradation of sealant and grouting is also likely to occur, possibly necessitating further repair works. Recommend engaging a tiler to rectify to reduce the risk of further deterioration as soon as possible.

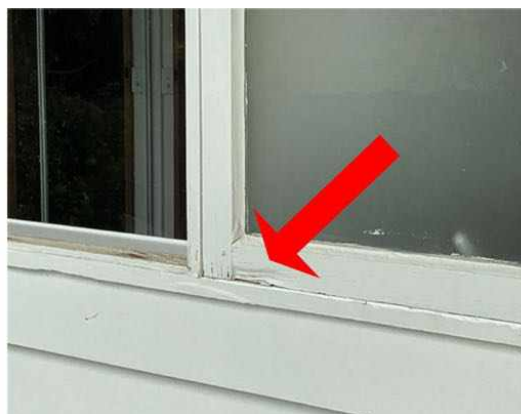
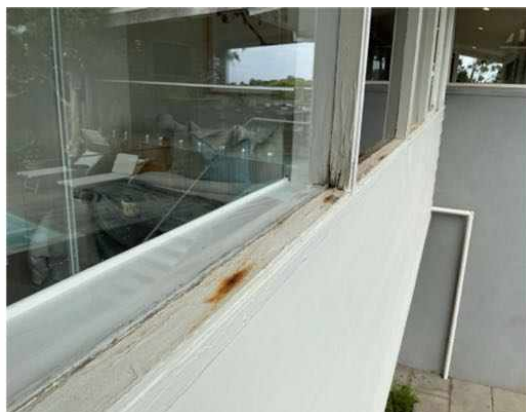
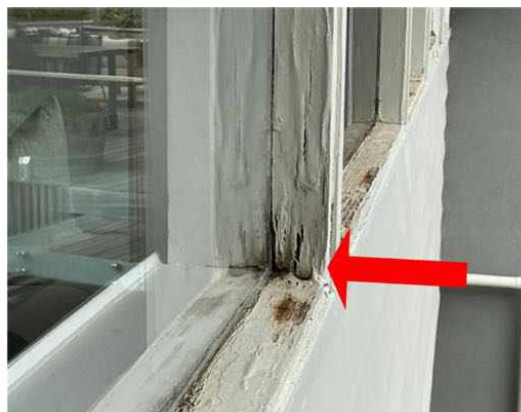
| Finding: | Windows - Wood rot |
| Information: | Wood rot was found to be affecting parts of the external windows. Wood rot, also known as Fungal Decay, occurs when timbers and other cellulose building materials are exposed to damp conditions on an ongoing basis. |

It is likely that this wood rot has developed as a result of frequent exposure to rain and other weather conditions. It is suspected that failure to maintain the window frames over a prolonged period has resulted in them deteriorating at an accelerated rate, increasing their susceptibility to the development of wood rot. Leaks in roof plumbing or associated pipework may have also contributed to the formation of the wood rot in this area.

Early intervention and regular maintenance will prolong the useful life of these building elements. Prior to any works being performed, any associated pipework or roof plumbing should be inspected by a licensed plumber for faults or leaks.

Repair and/or replacement of affected window frames may be a necessary step in protecting surrounding building elements from such deterioration. Remedial works should be performed by a qualified carpenter or registered builder as soon as possible to prevent any further damage.

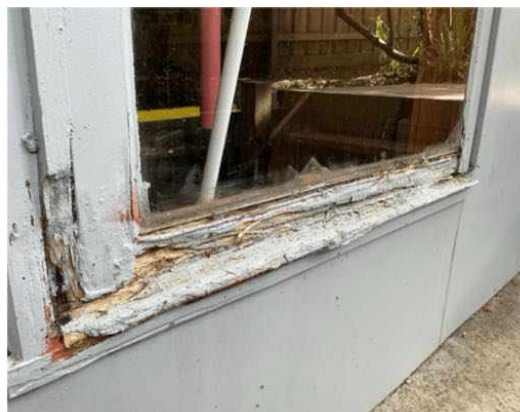
Finding 7.02

| Finding: | Window - Wood rot |
| Information: | Wood rot was found to be affecting parts of the shed window. Wood rot, also known as Fungal Decay, occurs when timbers and other cellulose building materials are exposed to damp conditions on an ongoing basis. |

It is likely that this wood rot has developed as a result of frequent exposure to rain and other weather conditions. It is suspected that failure to maintain the window frames over a prolonged period has resulted in them deteriorating at an accelerated rate, increasing their susceptibility to the development of wood rot. Leaks in roof plumbing or associated pipework may have also contributed to the formation of the wood rot in this area.

Early intervention and regular maintenance will prolong the useful life of these building elements. Prior to any works being performed, any associated pipework or roof plumbing should be inspected by a licensed plumber for faults or leaks.

Repair and/or replacement of affected window frames may be a necessary step in protecting surrounding building elements from such deterioration. Remedial works should be performed by a qualified carpenter or registered builder as soon as possible to prevent any further damage.

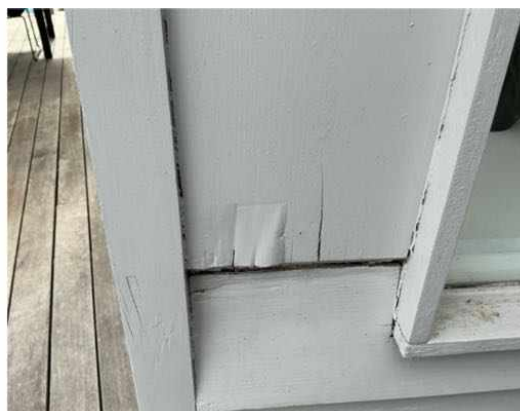
Finding 7.03

Finding: Wood rot cladding

Information: Parts of the cladding to the left hand side of the building shows evidence of deterioration and wood rot. Wood rot, also known as Fungal Decay, occurs when timbers and other cellulose building materials are exposed to damp conditions on an ongoing basis. This could be the result of exposure to weathering over a prolonged period of time, or the attraction of excessive moisture from other abutting building materials. Contributing factors also include poor air ventilation in the area.

Wood rot is often associated with general damp problems and is evidenced by a 'musty' smell or mould and mildew occurring on surfaces. If left unmanaged, damp conditions can lead to further health problems and the decay of timbers will continue.

Early intervention and regular maintenance, particularly of exterior timbers, will prolong the useful life of these building elements. Prior to any works being performed, the cause of the moisture that has created the visible wood rot should be identified and addressed in a suitable manner. Replacement of affected timbers may then be a necessary step in protecting surrounding building elements from such deterioration.

A qualified plumber may be appointed to assess the cause of excessive moisture and to provide advice on any remedial works as required. A qualified carpenter or registered builder may also be required to replace affected building materials.

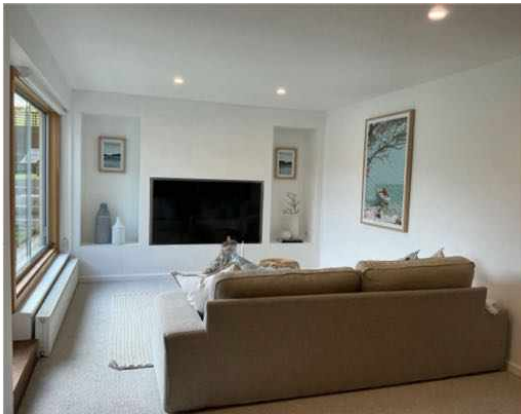
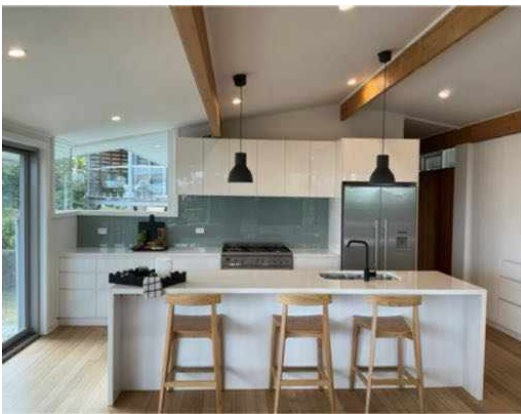
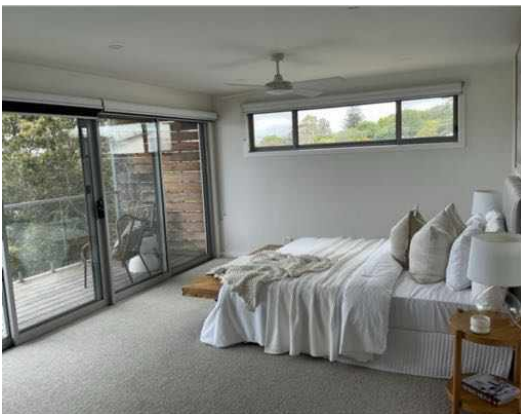
Building: Main Building
 Location: All Internal Areas
 Finding: Additional Photos - Obstructions and Limitations
 Information: These photographs are an indication of the obstructions and limitations which impeded full inspection of the property at the time of inspection. These obstructions can hide an array of defects and should be removed to allow full inspection to be

carried out. A re-inspection is recommended once the areas are made accessible.

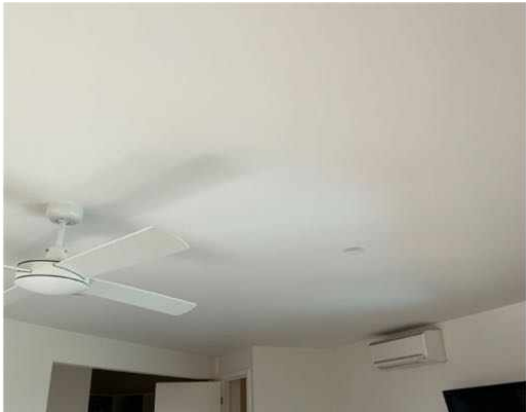
| Finding: | Obstructions and Limitations -no access roof cavity |
| Information: | The roof cavity was inaccessible at the time of inspection due to no access hole which impeded the inspection of the roof cavity of the main building. This obstructions can hide an array of defects and it is highly recommended that an access hatch be constructed to allow full inspection to be carried out. A re inspection is recommended once the area is made accessible. |

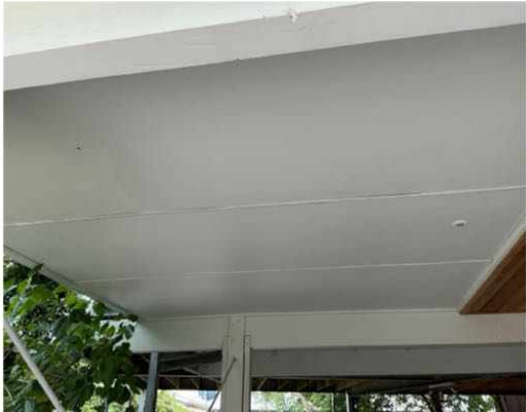
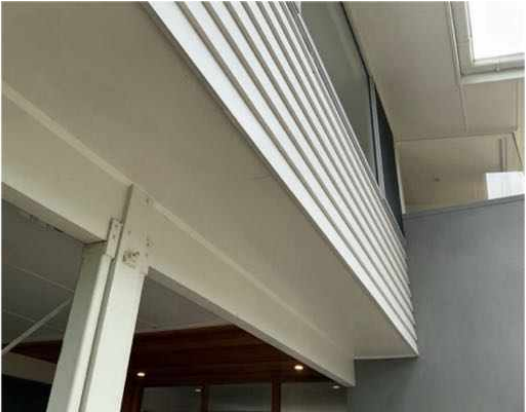
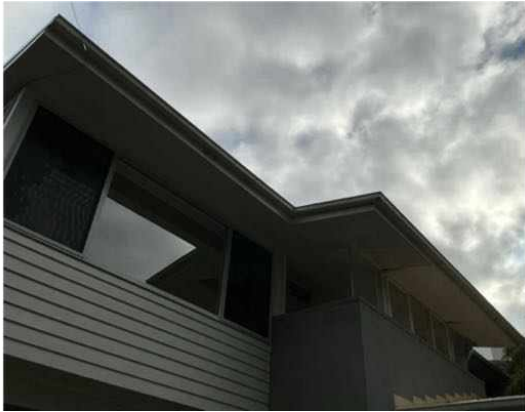
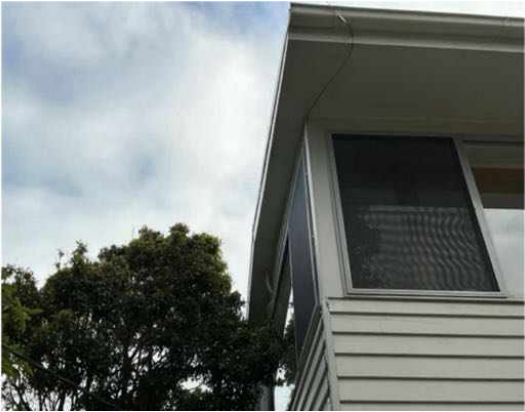
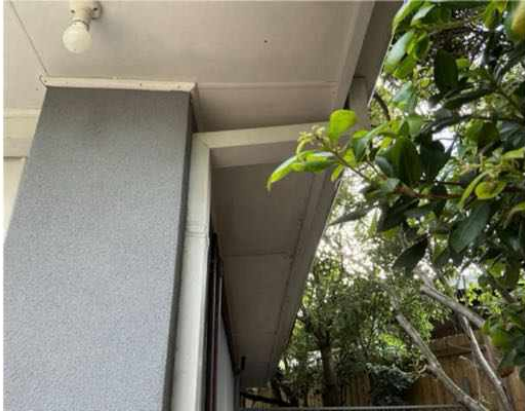
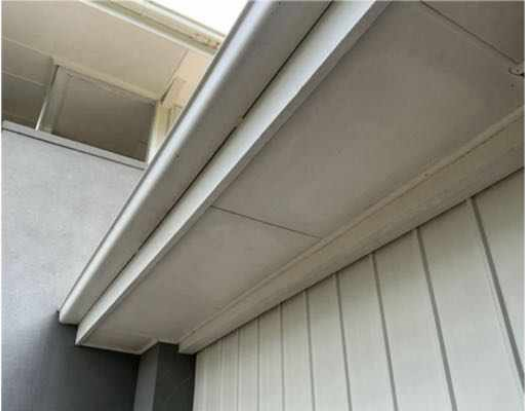
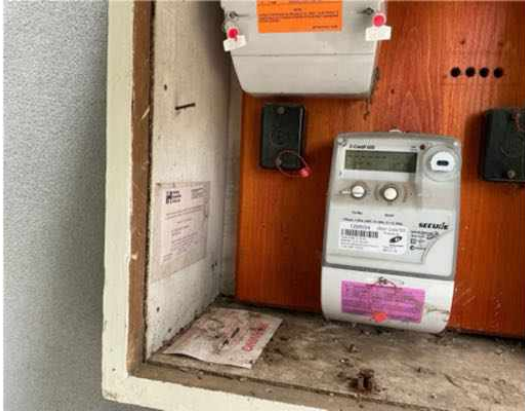
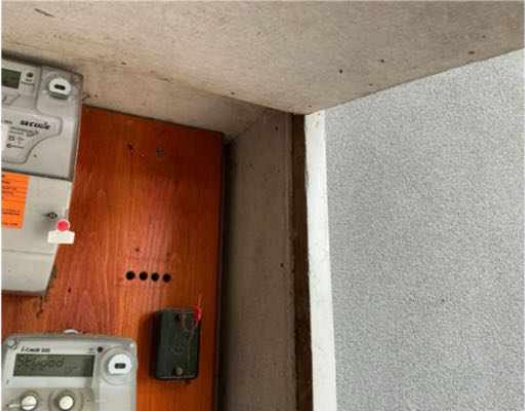
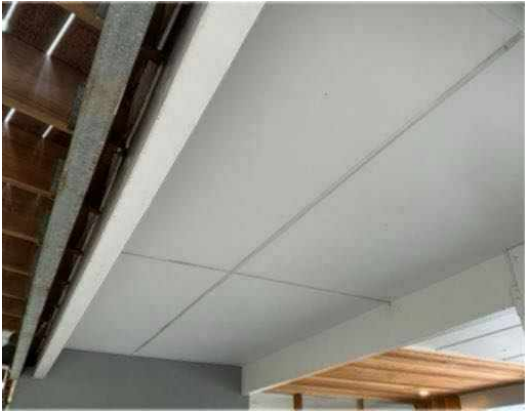
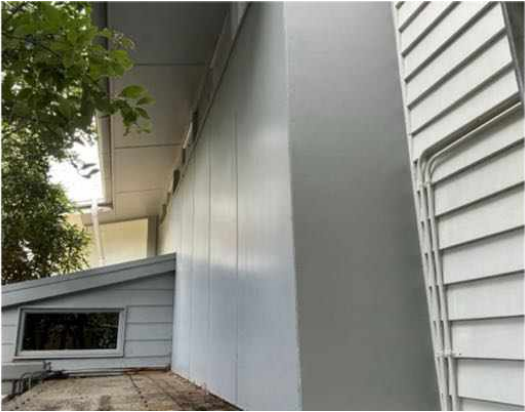
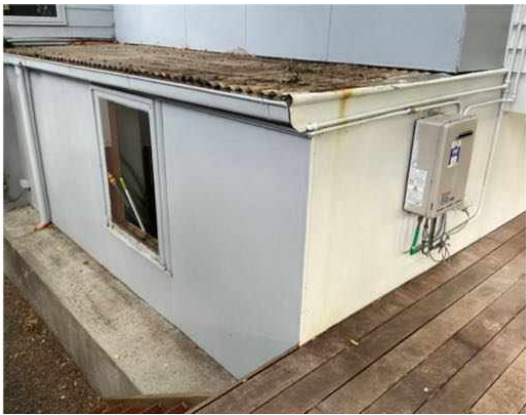
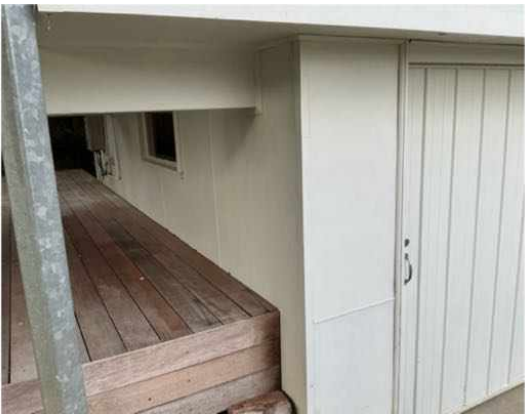
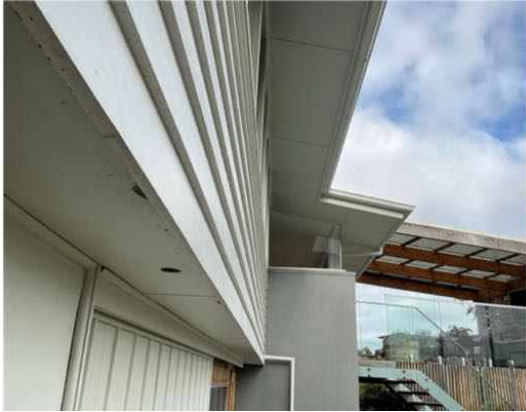
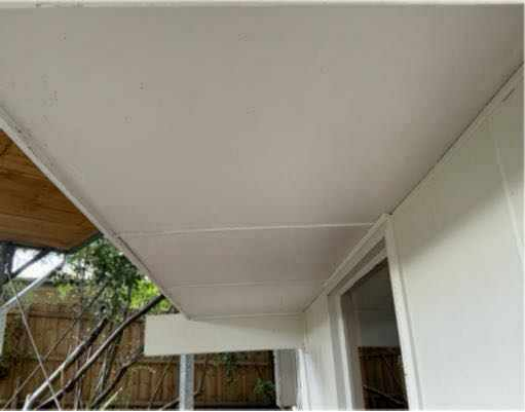
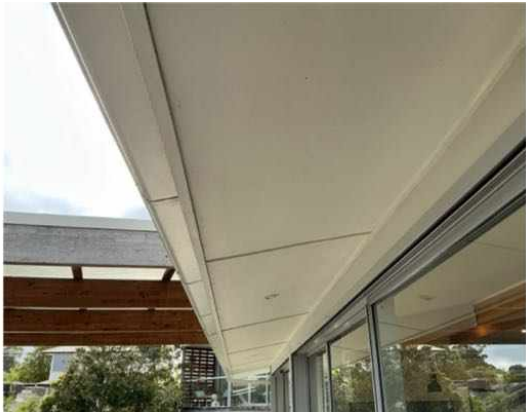
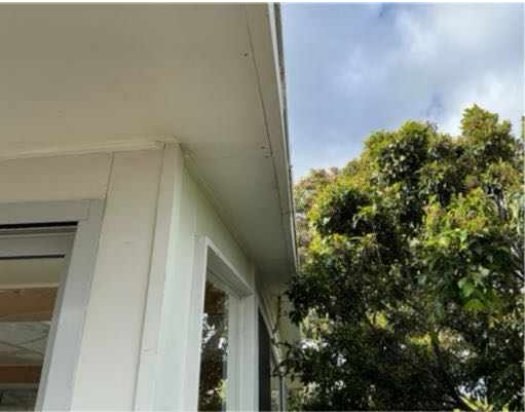
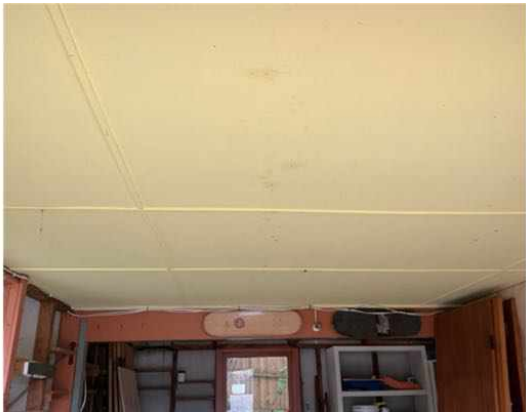
Building: Main Building
Location: Eaves and meter box
Finding: Asbestos - Suspected ACM Identified on Site
Information: Reporting on Asbestos is outside the Scope of this Report. This suspected defect is highlighted as a caution only. We suspect, based on our experience in the building industry, that there is a higher risk of the identified building element containing asbestos.

As Asbestos Reporting is outside the scope of this report, we advise that you consider a separate Asbestos Inspection and Condition Audit, which can include the taking of samples for definitive confirmation of the presence of Asbestos.

In the interim, the client is advised to act with caution, especially when considering any damage to building materials, general wear and tear, renovations, extensions, demolition and general maintenance activities due to the suspected presence of Asbestos.

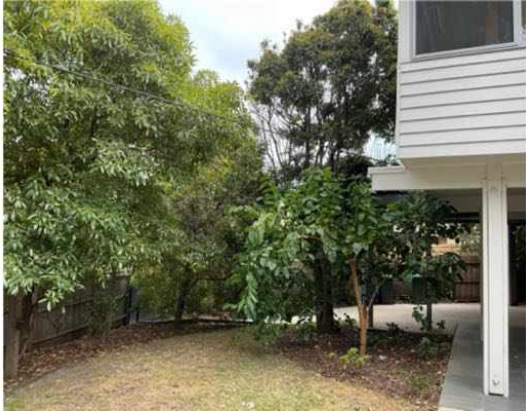
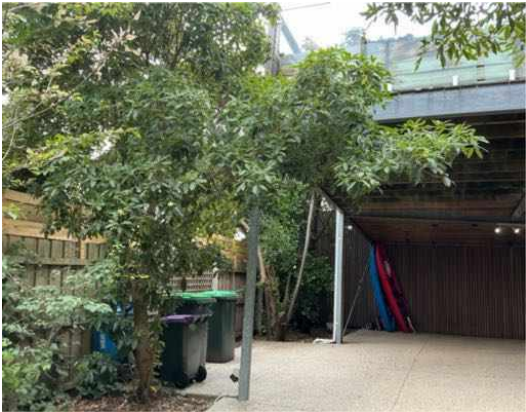
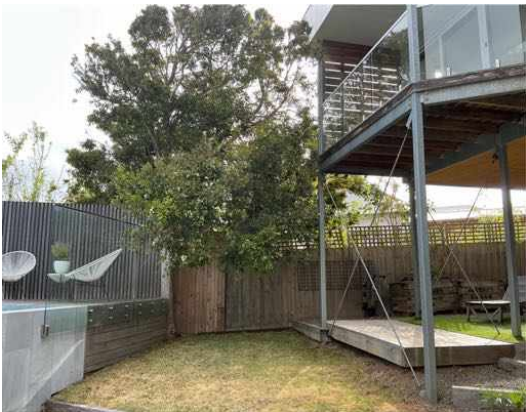
Building: Main Building
Location: Yards
Finding: large trees near property
Information: Some large trees are growing near the structure. Tree roots can cause major foundation and plumbing related issues. Recomend engaging an arborist to further investigate and advise on the severity of the root systems and any rectification works that may be required to reduce the risk of property damage and deterioration.
