Building and Timber Pest Inspection Report

Inspection Date: Mon, 16 Feb 2026

Property Address: 1/75 Hudson St, Hurstville NSW 2220,
Australia

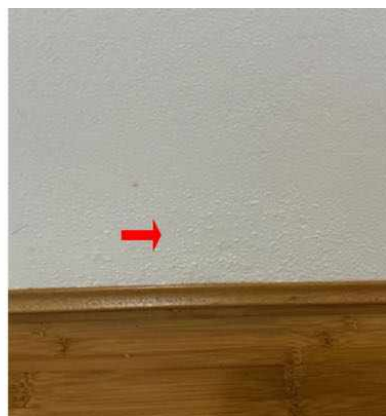
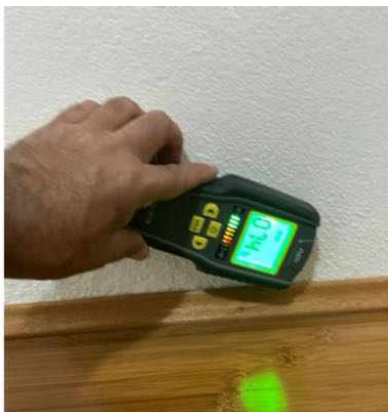
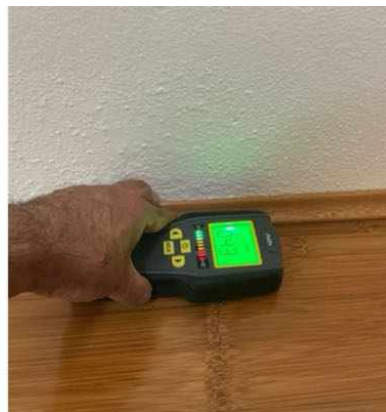
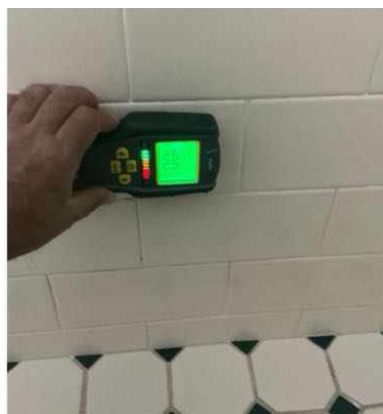
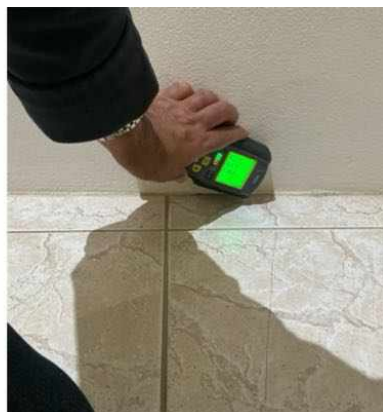
Finding 2.01

Building: Main Building
Location: Bathroom
Finding: Elevated Moisture Bathroom & Back of shower
Information: Elevated moisture levels were detected to tiled surfaces in bathroom/shower areas. The back of shower area also showed elevated moisture with visible minor deterioration evident at the time of inspection. This may be due to porous or missing grout, cracked tiles or recent use, however the possibility of waterproofing membrane failure or plumbing leaks cannot be excluded. Persistent moisture ingress can lead to concealed damage, including timber rot and mould growth. Further investigation by a licensed plumber and/or waterproofing contractor is recommended as soon as possible.

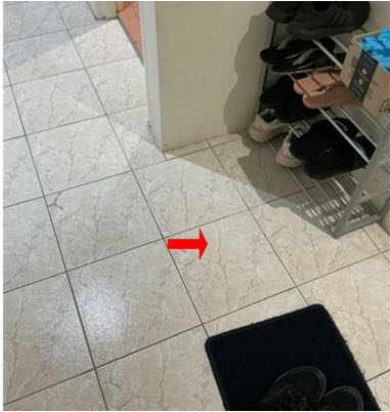
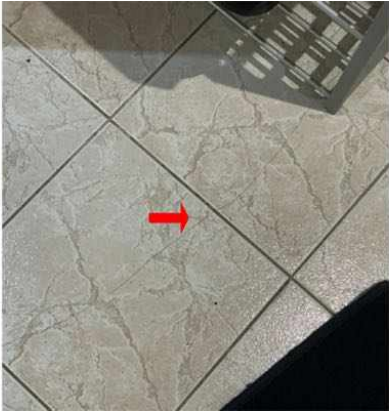
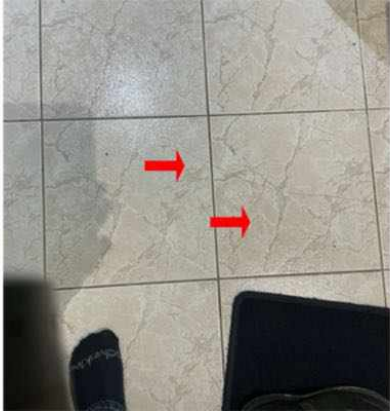
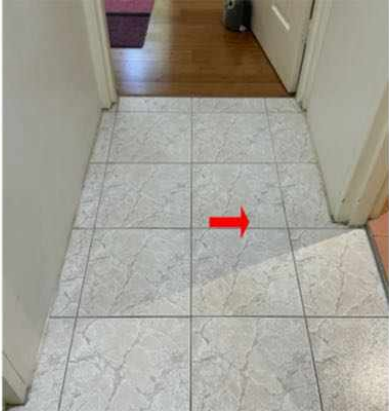
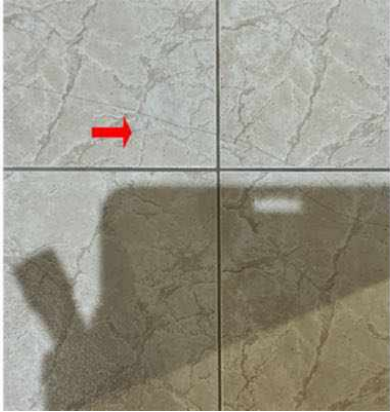
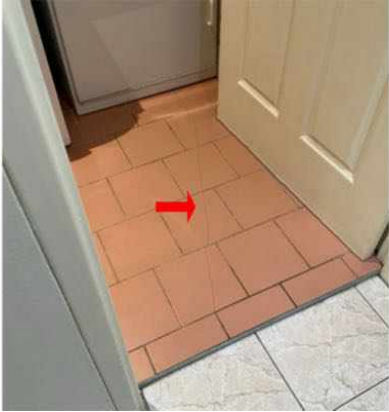
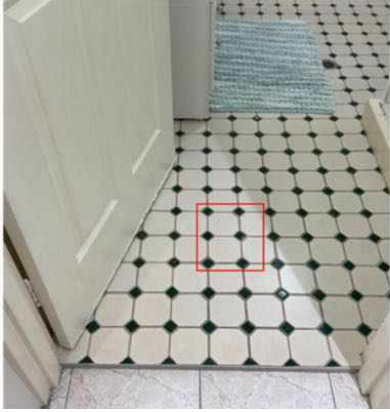
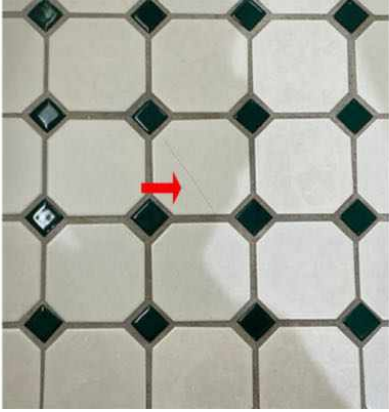
Finding 3.01

Building:	Main Building
Location:	All Internal Areas
Finding:	Tiles - Cracked or damaged
Information:	Cracking was evident to the tiling in this area at the time of inspection. While the cracking appears to be minor, this area is frequently exposed to water, allowing potential for water penetration into adjoining sections of walls or flooring.

If left unmanaged, water penetration to these areas may lead to subsequent water damage, which is likely necessitate repair work to affected building elements.

A tiling contractor should be appointed to ensure that no further water damage occurs. The re-application of silicone and grouting throughout remaining tile work is also advised, to further protect the area against water penetration.

Where water penetration has led to water damage, appointment of a relevant tradesperson may be required to repair damaged building elements.

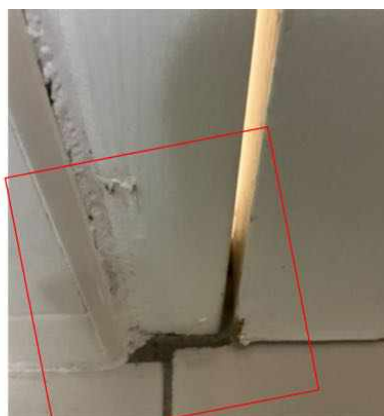
Building: Main Building
 Location: All Internal Areas
 Finding: Wet-Area Door Jambs – Moisture Staining / Decay
 Information: moisture staining and deterioration were observed at the base of the wet-area door jamb and architraves. This is commonly due to water splashing or moisture tracking from the bathroom floor into adjacent joinery or inadequate waterproof transition at the bathroom threshold.

Further inspection by a licensed waterproofing contractor is recommended to verify exact cause and remedial measures

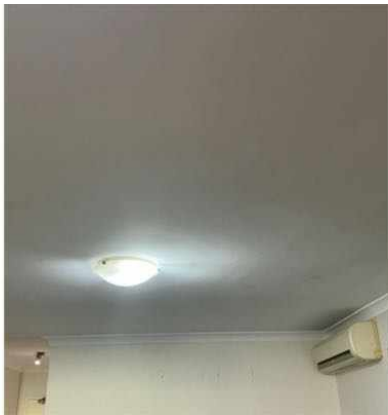
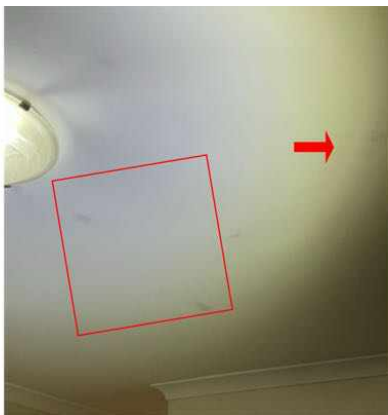
Building:	Main Building
Location:	All Internal Areas
Finding:	Paint finish and hairline cracking
Information:	The paint finish in this area was identified as being incomplete at the time of inspection including some hairline minor cracking.

Whilst incomplete or missing paint finish is generally an appearance defect, it can also lead to the development of secondary building defects over time. Incomplete areas of paint finish expose the area to moisture, potentially accelerating the deterioration of underlying building materials.

Incomplete paint finishes should be sanded back, filled, leveled and painted, as applicable. Where inadequate or missing paint protection has led to the deterioration of the associated building element, repair and/or replacement of this building element may be required.

A painting contractor should be appointed as soon as possible to perform necessary works to aid the appearance of the affected area and to ensure the area is protected against further deterioration. Alternatively, the homeowner following manufacturer instructions may perform these works.

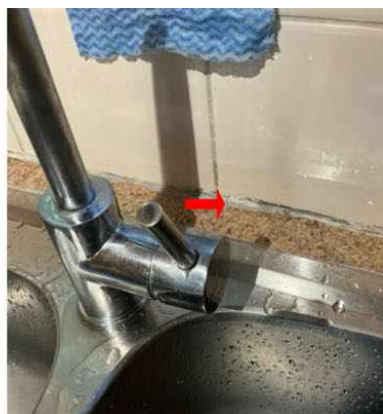
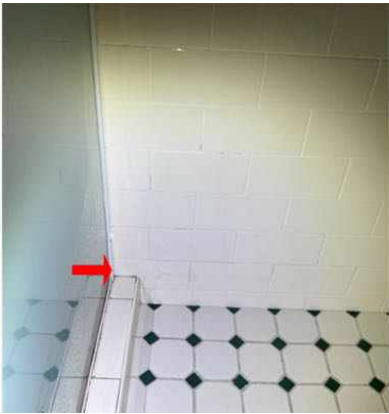
Finding 3.07

Building:	Main Building
Location:	All Internal Areas
Finding:	Sealant and grouting - Missing or degraded
Information:	It was noted on inspection that sealant or grout is degraded. There is also evidence of poor workmanship and excessive use of sealant. Silicone should never be used as a first line of defence against waterproofing. Further inspection by a licensed waterproofing contractor is highly recommended.

Different materials and floor areas move at different rates, generally causing cracking to grout or sealant at this point. A flexible sealant is required to allow for expected expansion and contraction, while keeping the joint water tight and protective of all associated building materials.

Flexible and mould resistant materials should be applied to affected areas to prevent any subsequent water damage that is likely to occur. Regular maintenance and replacement of damage or missing or damaged sealant and grout is highly recommended to the wet areas, as this is a regular wear and tear defect. Sealant and grouting in areas that come into regular contact with water should be maintained for the long term care of your property.

A sealant specialist or tiling contractor should be appointed to complete these works as soon as possible.

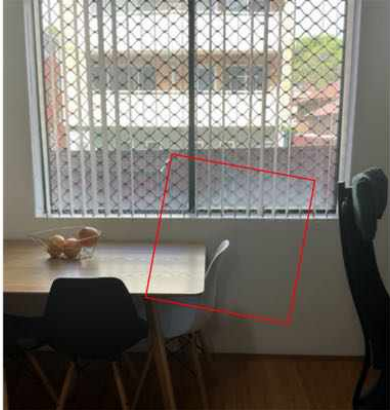
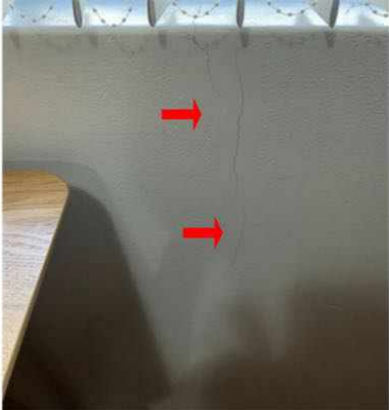
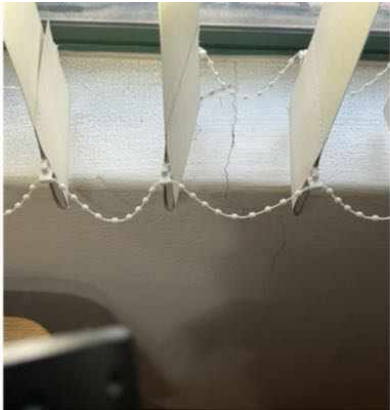
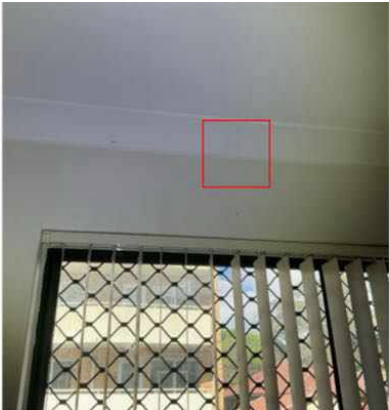
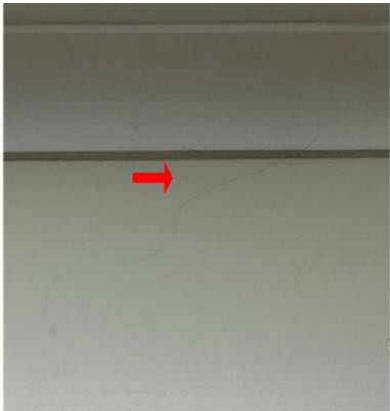
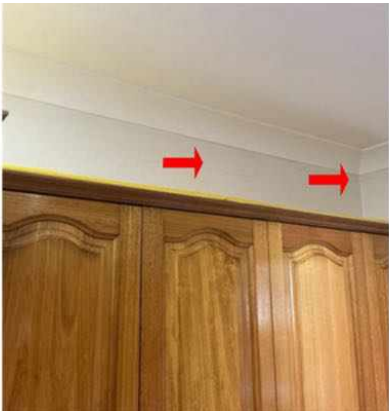
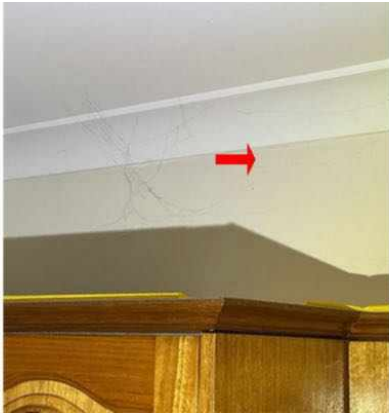
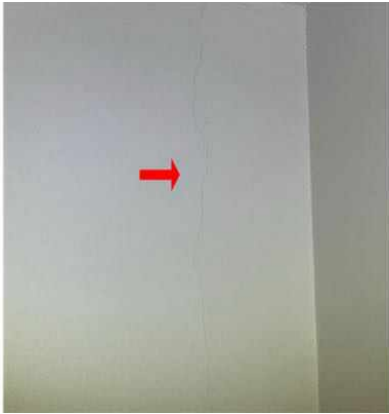
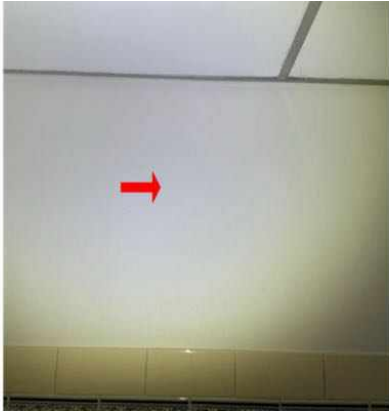
Finding 3.08

Building: Main Building
Location: All Internal Areas - Kitchen , Lounge, bedroom, bathroom
Finding: Cracks to internal render - Category 1
Information: It has been observed that cracking to internal rendered surfaces has occurred. The degree of damage falls within Category 1, described as fine cracks that do not need repair and which are less than 1.0mm in width limit.

Damage of this category is not considered a defect for rectification. Always contact your building inspector should cracks widen, lengthen, or become more numerous.

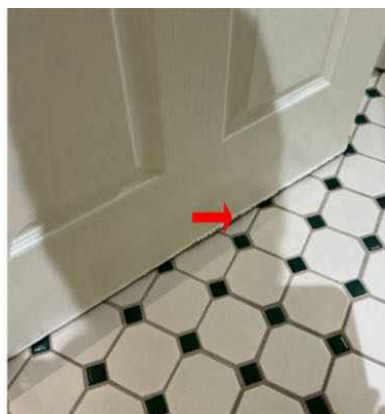
Finding 3.10

Building:	Main Building
Location:	Bathroom, Laundry
Finding:	Delamination of timbers
Information:	Delamination is one means by which composite materials (e.g. layered timber composites) may fail over time. In laminated materials, repeated cyclic stresses may

Delamination of timbers may be repaired where the area affected is minor and/or easily accessible, by gluing and screwing layers back together. However, this is an interim repair, and where delamination has occurred, the client should plan for the replacement of affected timbers sooner than would otherwise be expected.

All timber structures affected by delamination should be replaced as soon as possible to avoid any further damage. Repair and replacement estimates should be sought from a registered builder or qualified carpenter.

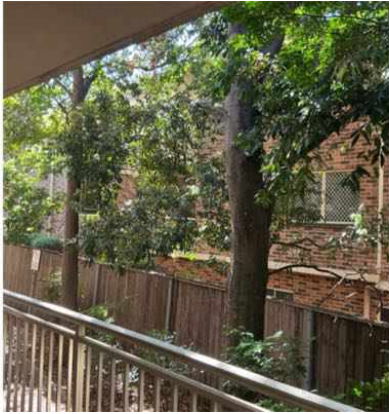
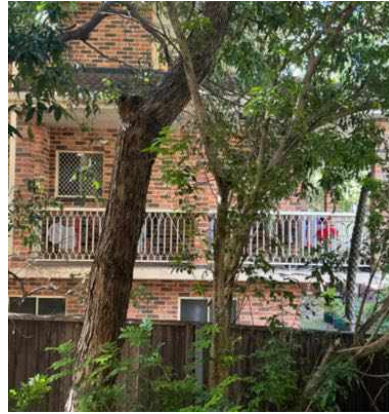
Building:	Main Building
Location:	All External Areas
Finding:	Trees within 50m
Information:	Trees within 50m of the property can be conducive to termite activity. It is recommended an invasive inspection of all trees with 50m to the property be carried

out by a qualified pest control expert.

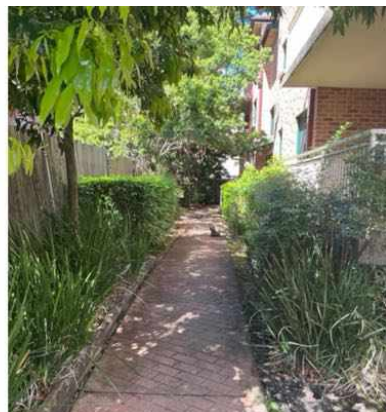
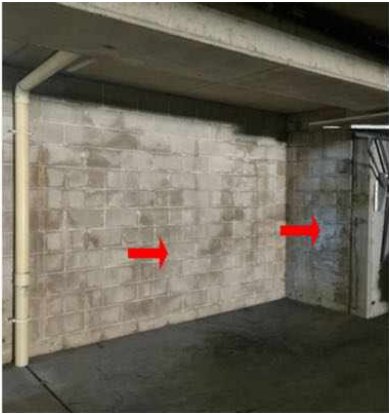
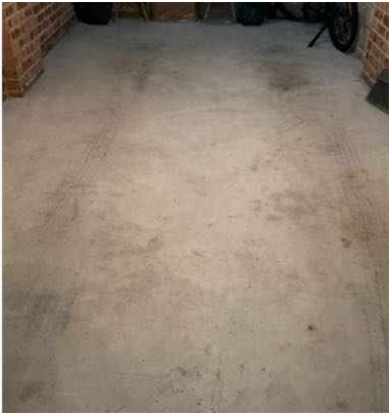
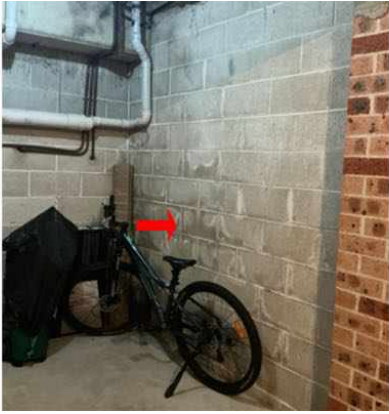
Building: Main Building
Location: All External Areas
Finding: Additional Photos - Obstructions and Limitations
Information: These photographs are an indication of the obstructions and limitations which impeded full inspection of the property at the time of inspection. These obstructions can hide an array of defects and should be removed to allow full inspection to be carried out. A re-inspection is recommended once the areas are made accessible.

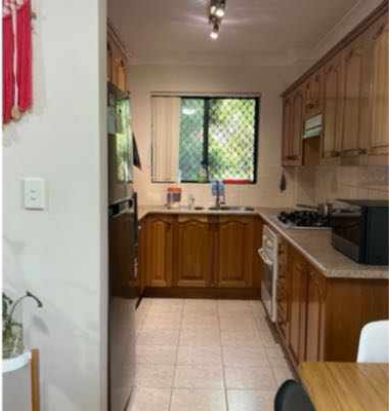
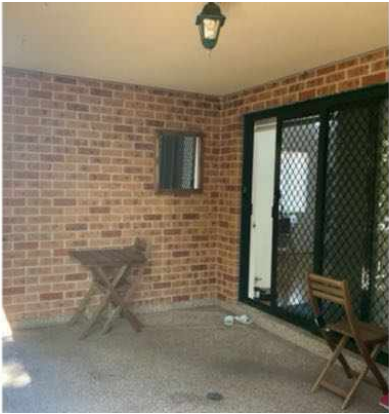
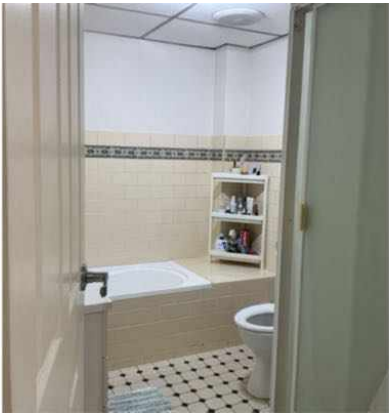
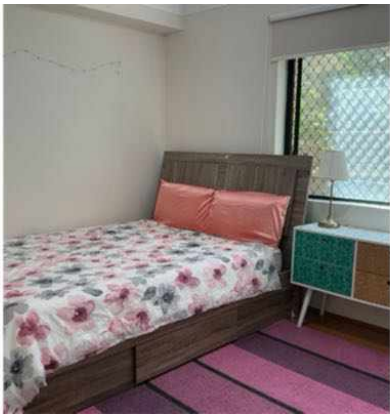
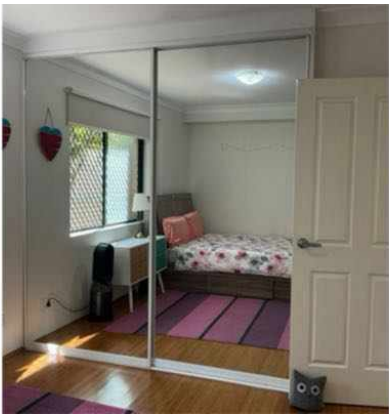
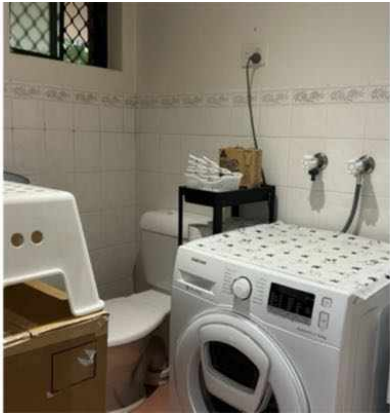
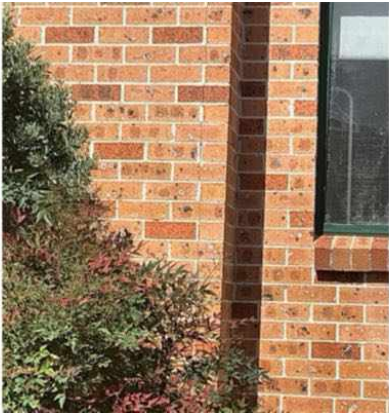
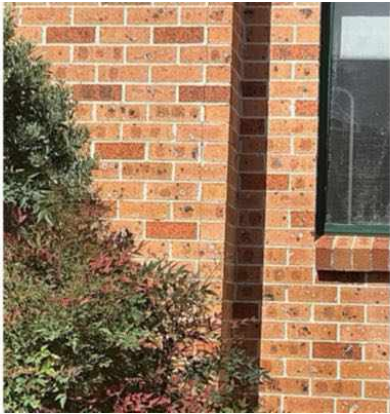
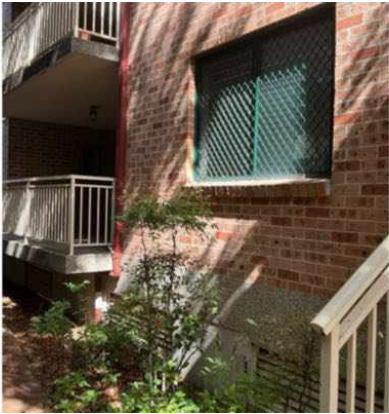
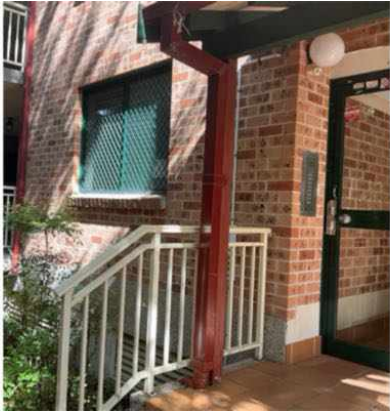
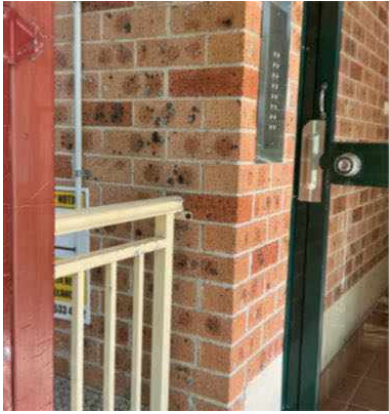
Building: Main Building
Location: All Internal Areas
Finding: Additional Photos - Obstructions and Limitations
Information: These photographs are an indication of the obstructions and limitations which impeded full inspection of the property at the time of inspection. These obstructions can hide an array of defects and should be removed to allow full inspection to be carried out. A re-inspection is recommended once the areas are made accessible.
