# Building and Timber Pest Inspection Report

Inspection Date: Wed, 18 Feb 2026

Property Address: 204 Mildura Dr, Helensvale QLD 4212,  
Australia

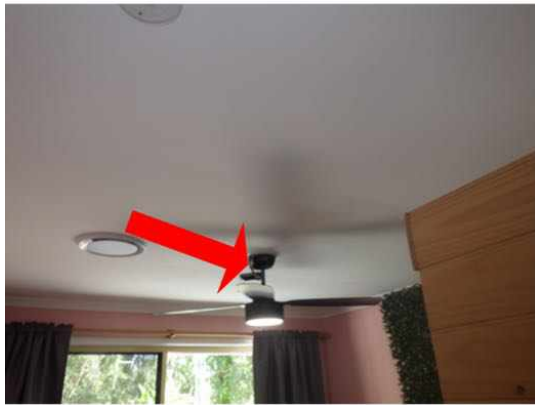
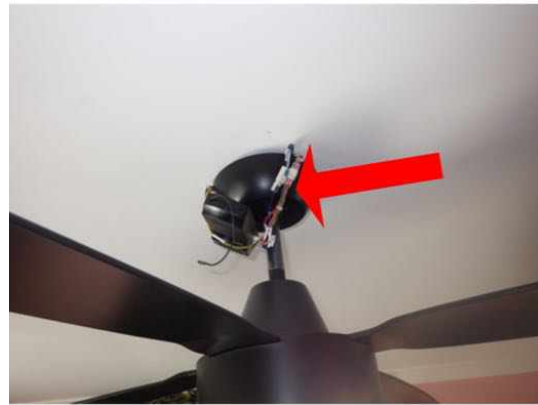
Building:	Main Building
Location:	Bedroom 2 > Centre
Finding:	Electrical cables exposed
Information:	Exposed electrical cabling was identified in the bedroom 2 ceiling fan area. Exposed electrical cabling represents a potential safety hazard including accidental personal contact.

A licensed electrician should be engaged to check the operational condition of the ceiling fan and secure the electrical cables.

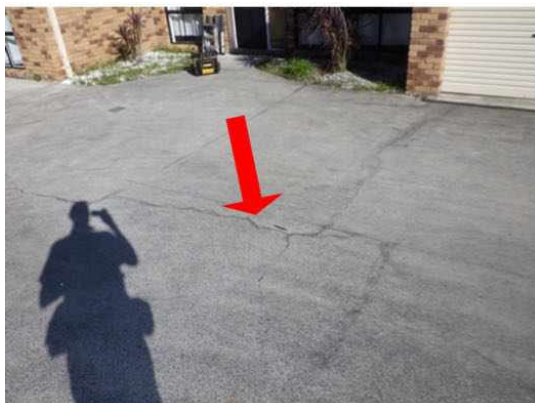
Building: Main Building  
 Location: Driveway > Ground Level  
 Finding: Cracking in concrete slab - Category 1-2  
 Information: Cracking coded as Category 1 - 2 was identified in the driveway and footpaths concrete slabs (as per example photos). A Category 1 crack is described as a fine but noticeable crack, with the slab at an otherwise reasonable level.

To be considered Category 1, the approximate width of the crack is less than 1.0mm, or a less than 10mm change in offset when a 3m straight edge is placed over the defect.

Category 1 cracks should be monitored for a period of 12 months. At the end of the monitoring period, identified cracks that are rated greater than Category 2 are considered defects, and require rectification.

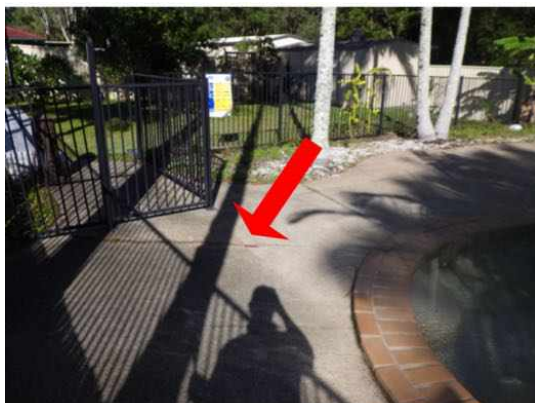
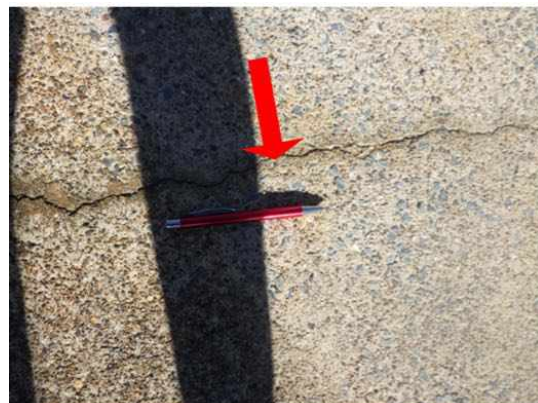
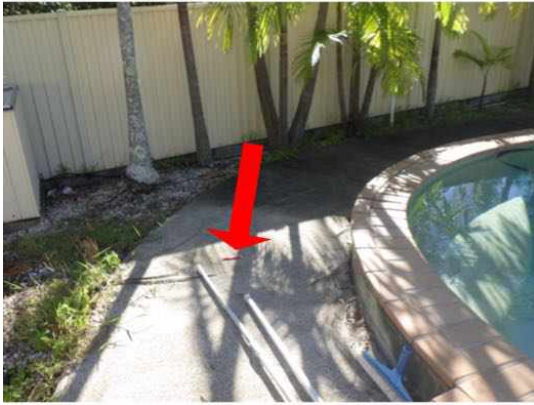
Building: Main Building  
 Location: Pool Area > Ground Level  
 Finding: Cracking in concrete slab - Category 1  
 Information: Cracking coded as Category 1 was identified in the pool surround concrete slab (as per example photos). A Category 1 crack is described as a fine but noticeable crack, with the slab at an otherwise reasonable level.

To be considered Category 1, the approximate width of the crack is less than 1.0mm, or a less than 10mm change in offset when a 3m straight edge is placed over the defect.

Category 1 cracks should be monitored for a period of 12 months. At the end of the monitoring period, identified cracks that are rated greater than Category 2 are considered defects, and require rectification.

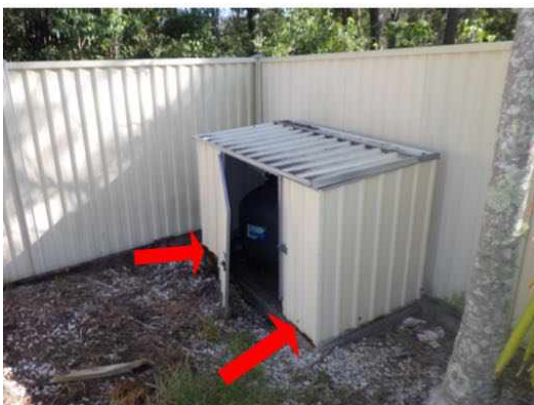
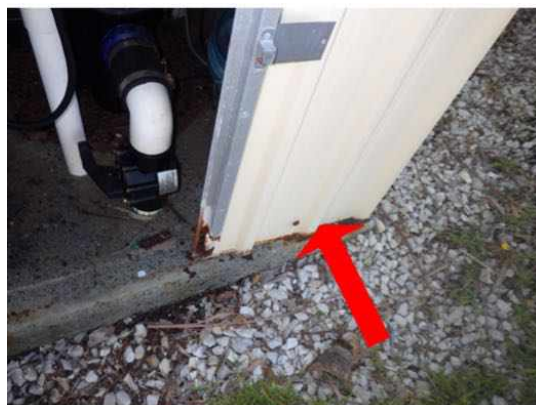
### Finding 3.06

Building:	Main Building
Location:	Pool Area > Rear Right
Finding:	Pool Shed - Rusted or corroded
Information:	The pool pump shed at the rear of the property shows evidence of significant rusting and corrosion, which is likely to have developed as a result of excessive exposure to moisture and or inadequate coatings.

As surface rust provides no protection to the underlying iron, the deteriorating condition is likely to worsen if not addressed in the short-term future.

Where possible, the use of galvanized (treated) metals or aluminium coated metals aid in rust prevention, as does regular general maintenance. Rust formation can be controlled with coatings, such as paint, that isolate the iron from the environment.

A general handyman may be appointed to replace any building elements that have been severely affected by rust or water damage.

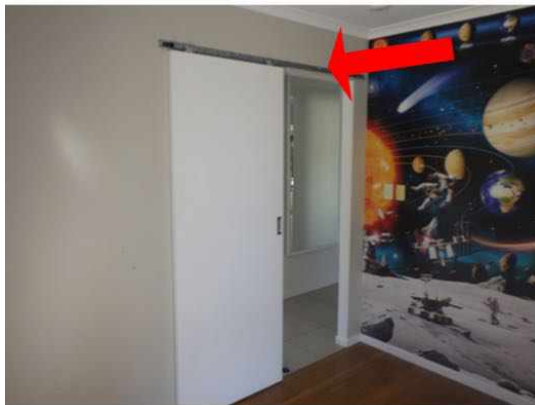
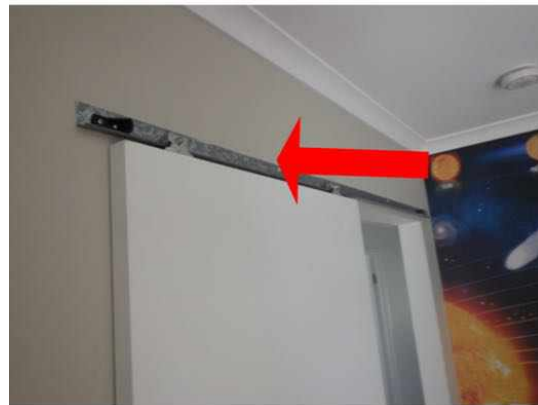
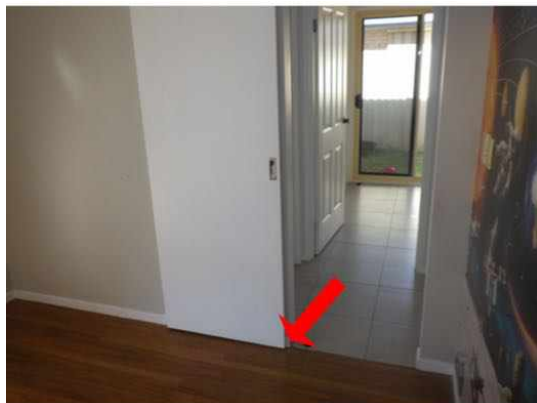
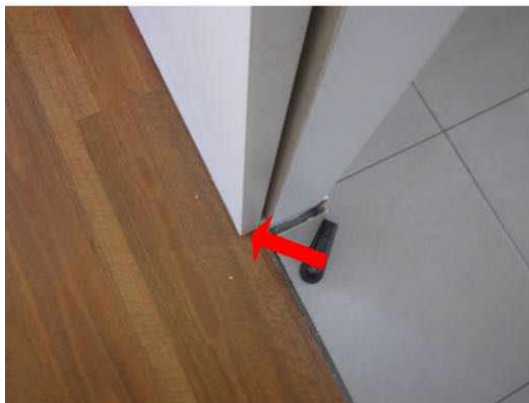
Building: Main Building  
 Location: Bedroom 4 > Front  
 Finding: Door Guide  
 Information: It was noted that the door track pelmet and door guide to the bedroom 4 area sliding door were missing at the time of inspection.

This is noted as a minor defect that you need to be aware of.

A licensed carpenter or general handyman could be engaged to replace the pelmet and door guide at the clients discretion.

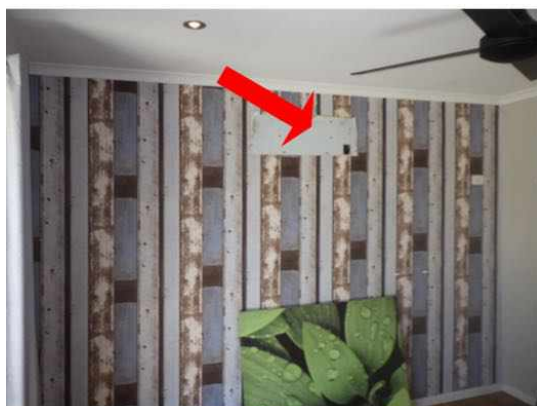
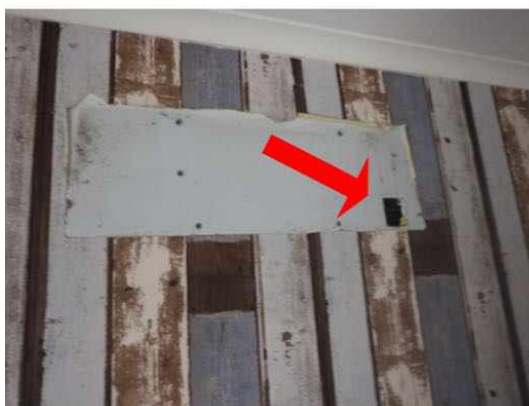
### Finding 3.12

Building:	Main Building
Location:	Bedroom - Master > Centre Right
Finding:	Internal Wall - Holes
Information:	Holes were identified in the main bedroom right side wall section. It is suspected that the holes are from a previously removed fixture or fitting.

All excessive holes, gaps or cracks should be adequately filled by a suitable sealant or filler to prevent any possible pest or vermin activity or nesting. Such works may be conducted by a general handyperson or licensed painter.

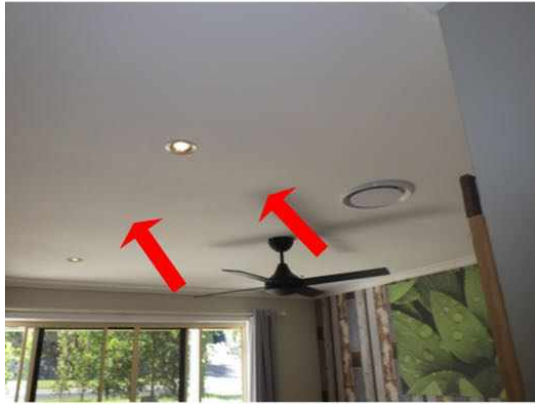
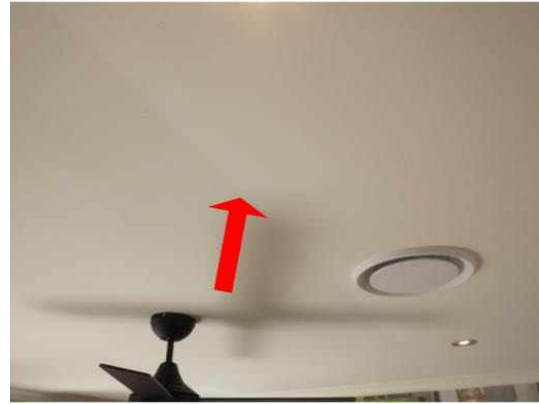
### Finding 3.13

Building:	Main Building
Location:	Bedroom - Master > Existing
Finding:	Ceiling - Sagging
Information:	The ceiling linings in the main bedroom showed signs of minor sagging at the time of inspection. Sagging to the fixed ceiling structure generally indicates that the building materials have swollen, due to exposure to moisture, or that fixings (e.g. nails or glue) have become loose and require reattachment.

screwing of ceiling sheets, may be required.

Such works may be performed by relevant tradespeople, such as plasterers and painters.

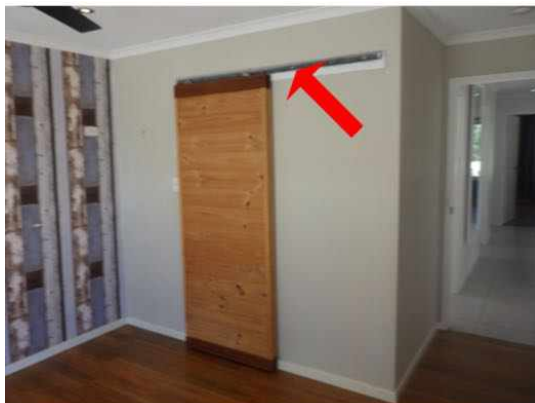
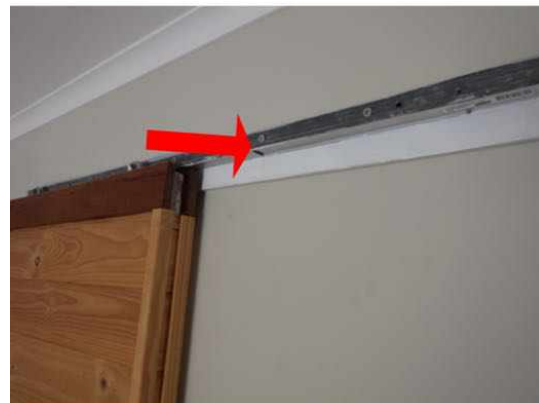
### Finding 3.14

Information: It was noted that the door track pelmet and door guide to the main bedroom/ ensuite area sliding door were missing at the time of inspection.

This is noted as a minor defect that you need to be aware of.

A licensed carpenter or general handyman could be engaged to adjust or replace the pelmet and the door guide at the clients discretion.

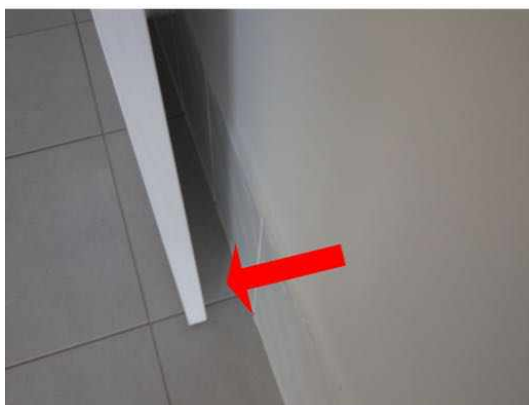
### Finding 3.17

Building: Main Building  
 Location: Laundry > Front  
 Finding: Door stop - Missing  
 Information: The laundry door stop is missing or is inadequate to stop the door handle from impacting the wall.

Re-installation or replacement of the door stop is advised to prevent any subsequent damage to the wall linings or associated structures.

A general handyman may be appointed to perform these works at client discretion.

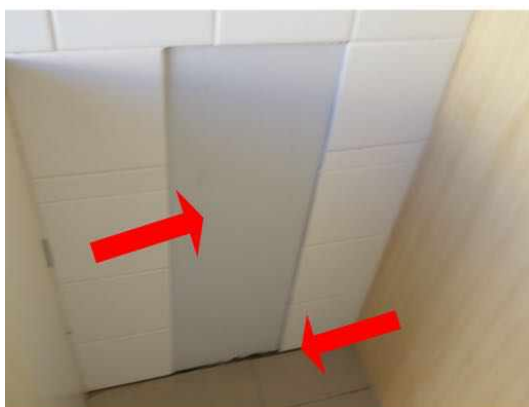
### Finding 3.18

Building:	Main Building
Location:	Laundry > Centre Right
Finding:	Tiles - Missing
Information:	It was noted on inspection that wall tiles and flexible sealant are missing from the laundry area right side wall. It is important this area is tiled and sealed to prevent moisture or liquids penetrating the wall linings or framing. Tiles and sealant also prevents vermin from accessing and or nesting in these areas.

A tiling contractor should be appointed to complete these works as soon as possible.

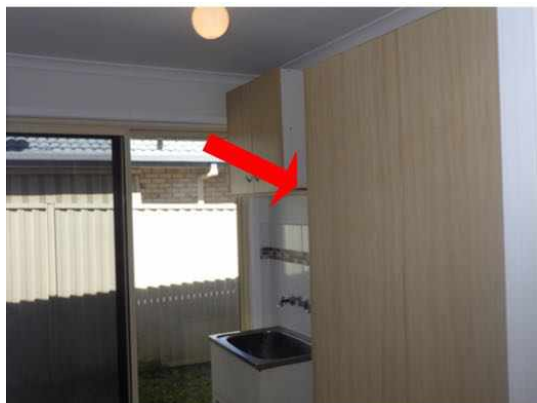
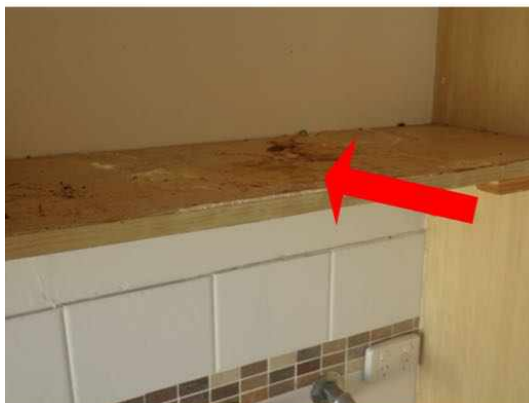
### Finding 3.19

Building:	Main Building
Location:	Laundry > Centre Right
Finding:	Cabinetry - Deterioration
Information:	At the time of inspection the laundry cabinetry/shelving showed signs of deterioration. The level of damage appears consistent with exposure to moisture or general wear and tear.

A qualified cabinet maker or general handyman could be engaged to undertake repair works at the clients discretion.

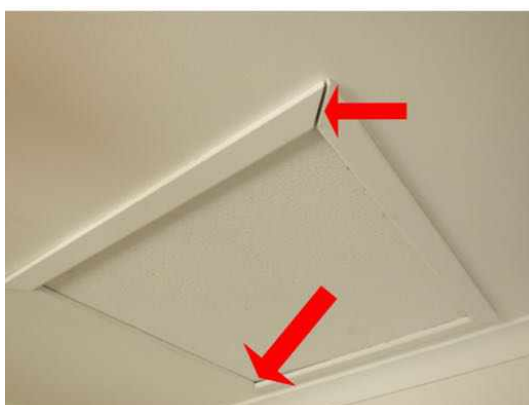
### Finding 3.20

Building: Main Building  
 Location: Laundry > Centre  
 Finding: Architrave - Movement  
 Information: It was noted that the timber architrave is separating from the manhole frame/ceiling linings and cracking in the laundry area.

This is a common defect which may have been caused from persons accessing the manhole.

A painter or general handyman might be engaged to undertake minor repair works.

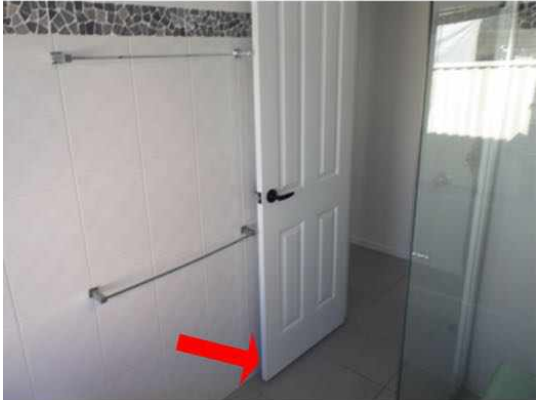
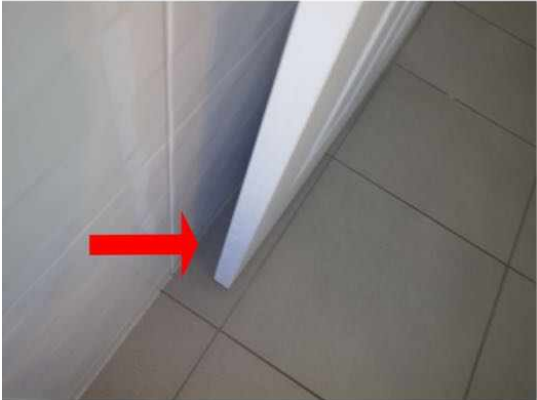
### Finding 3.21

Building: Main Building  
 Location: Bathroom > Front  
 Finding: Door stop - Missing  
 Information: The bathroom door stop is missing or is inadequate to stop the door handle from impacting the wall.

Re-installation or replacement of the door stop is advised to prevent any subsequent

damage to the wall linings or associated structures.

A general handyman may be appointed to perform these works at client discretion.

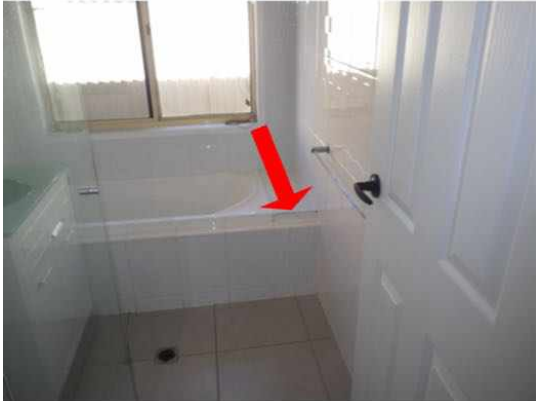
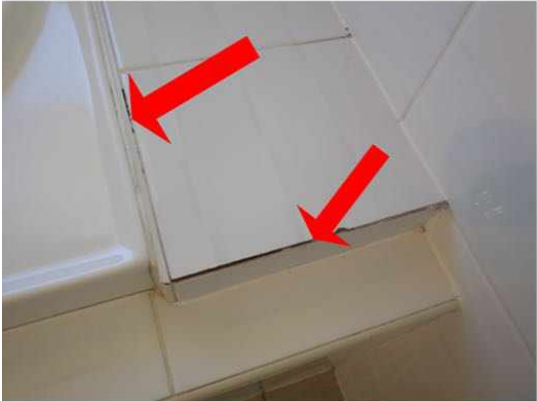
**Finding 3.22**

Building: Main Building  
Location: Bathroom > Centre Right  
Finding: Sealant and grouting - Missing  
Information: It was noted on inspection that sealant and/or grout is missing from the bath hob tiles area of the bathroom. Grout is used to protect gaps and crevices in building materials to ensure that they are water-tight and prevent water penetration to the associated structure

A sealant specialist or tiling contractor should be appointed to complete repair work.

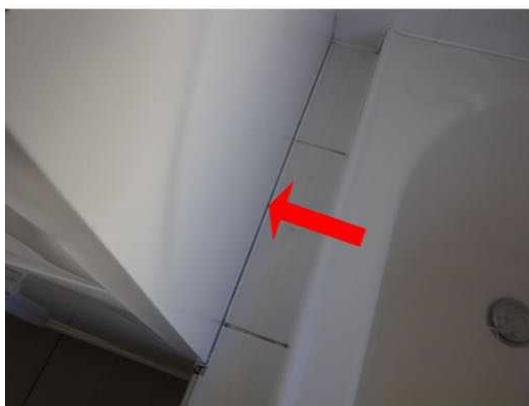
### Finding 3.23

Building:	Main Building
Location:	Bathroom > Centre Left
Finding:	Tiles - Missing
Information:	It was noted on inspection that floor tiles are missing from under the bathroom vanity unit. It is important this area is tiled and sealed to prevent moisture or liquids penetrating under the surrounding tiles and/or the wall linings. Tiles and sealant also prevents vermin from accessing and or nesting in these areas.

A tiling contractor should be appointed to complete these works as soon as possible.

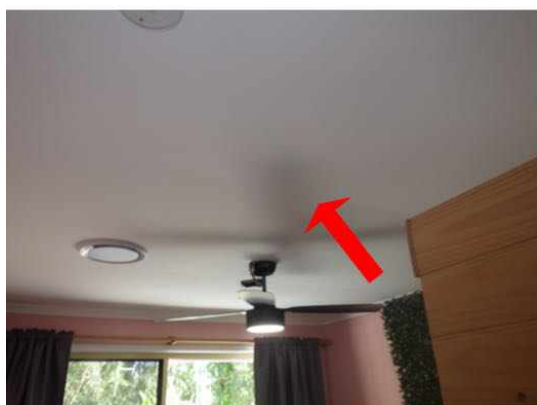
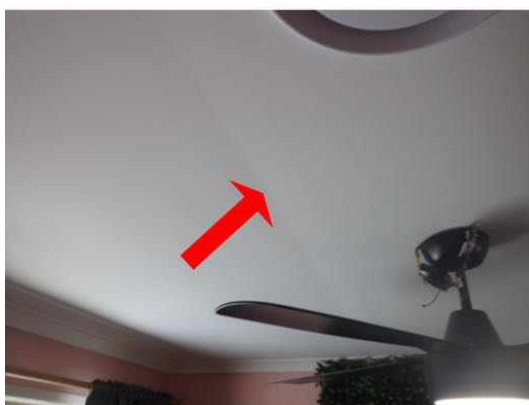
### Finding 3.33

Building:	Main Building
Location:	Bedroom 2 > Existing
Finding:	Ceiling - Sagging
Information:	The ceiling linings in bedroom 2 showed signs of minor sagging at the time of inspection. Sagging to the fixed ceiling structure generally indicates that the building materials have swollen, due to exposure to moisture, or that fixings (e.g. nails or glue) have become loose and require reattachment.

Where minor sagging is evident, comparatively minor works, such as re-gluing and re-screwing of ceiling sheets, may be required.

Such works may be performed by relevant tradespeople, such as plasterers and painters.

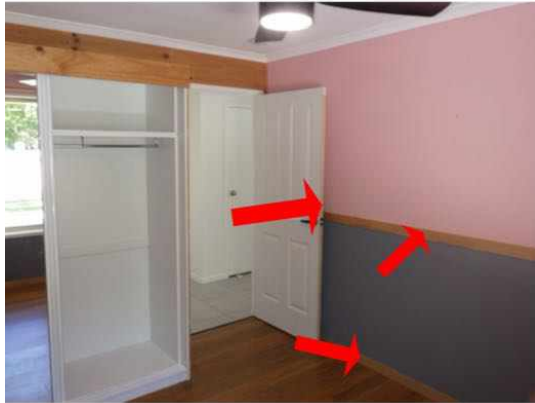
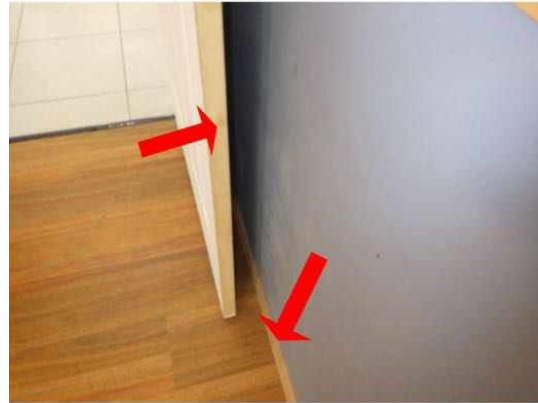
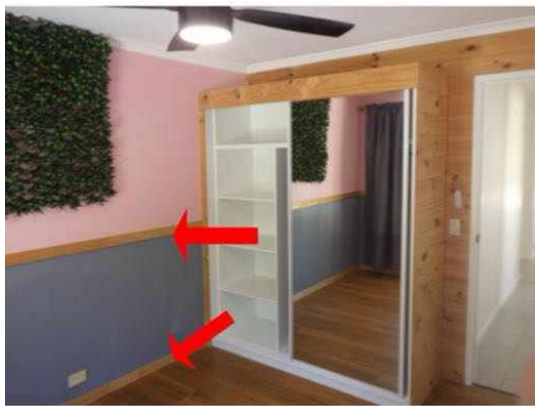
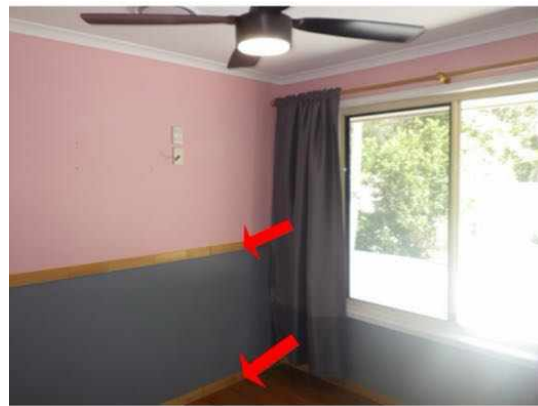
### Finding 3.34

Building:	Main Building
Location:	Bedroom 2 > Existing
Finding:	Incomplete works.
Information:	At the time of inspection it appeared there were areas of incomplete painting to timber trims and doors in bedroom 2.

A qualified painter or general handyman could be engaged to complete the work, at the clients discretion.

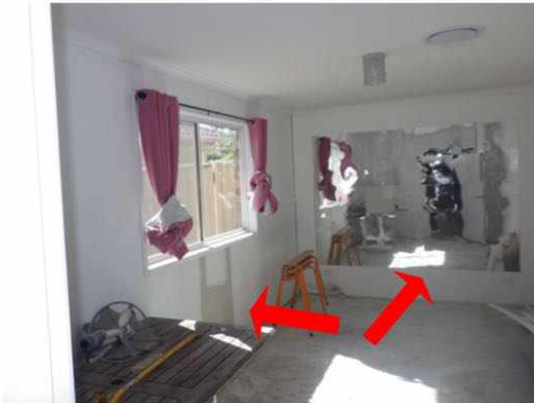
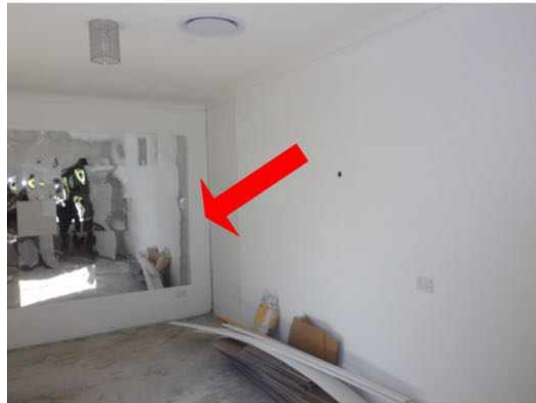
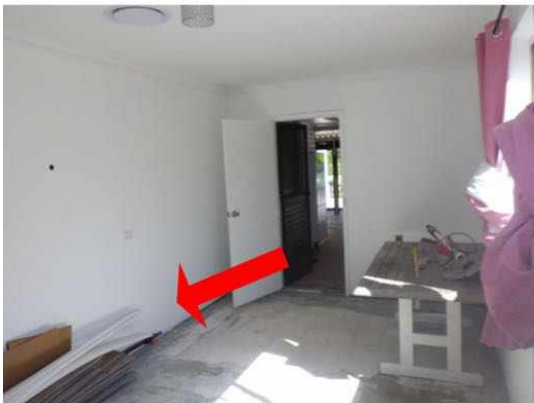
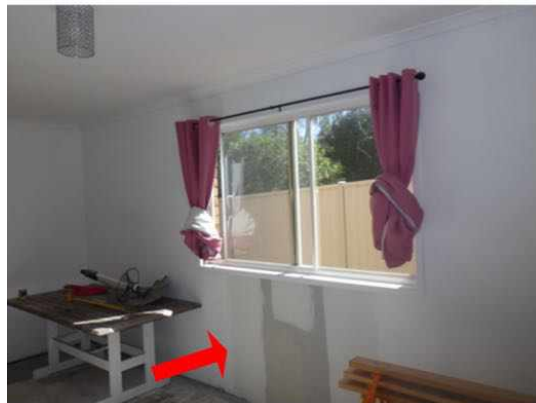
### Finding 3.35

Building:	Main Building
Location:	Garage > Existing
Finding:	Incomplete works.
Information:	At the time of inspection it appeared there were alterations and areas of incomplete renovation work to the wall and floor areas in the garage.

A qualified carpenter or general handyman could be engaged to complete the work, at the clients discretion.

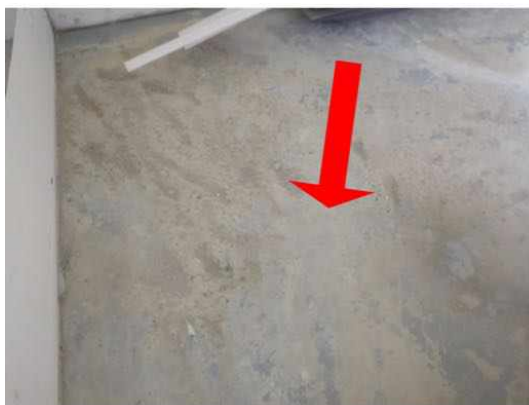
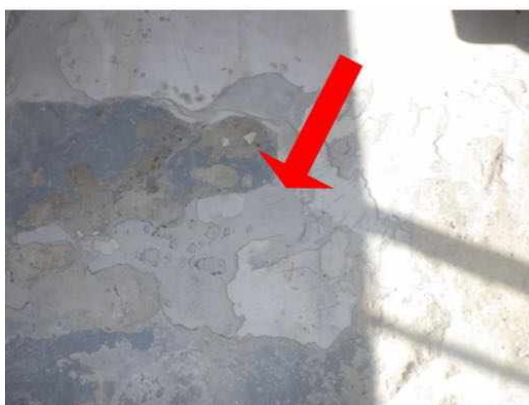
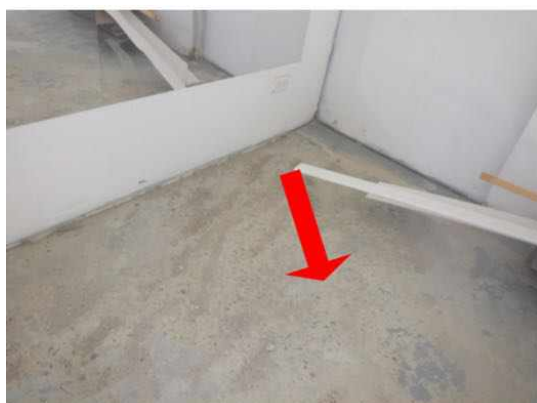
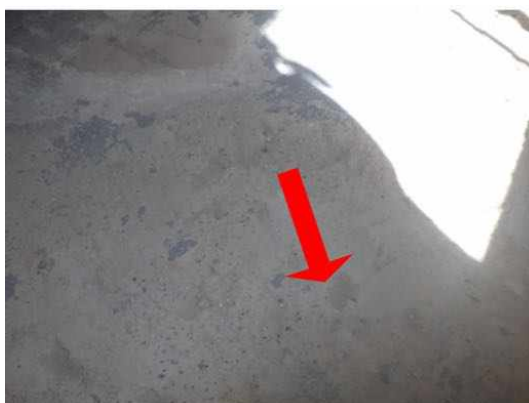
### Finding 3.36

Building: Main Building  
 Location: Garage > Ground Level  
 Finding: Concrete floors - damaged  
 Information: Areas where the concrete floor in the garage area have been damaged were identified at the time of inspection. The damage consists of deep gouges chips and scrape and associated marks. The damage appears consistent with incomplete alteration and/or renovation work.

A licensed carpenter could be engaged to undertake repair work at the clients discretion.

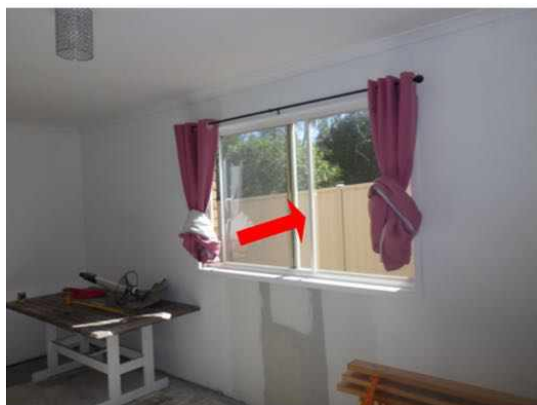
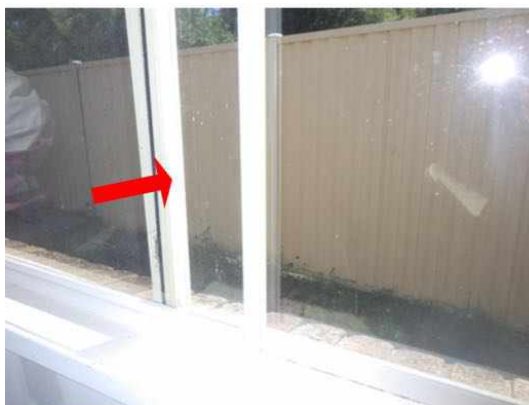
### Finding 3.37

Building: Main Building  
 Location: Garage > Centre Left  
 Finding: Window - missing latch  
 Information: The window latch to the garage area aluminium sliding window was found to be missing at the time of inspection. Breakage occurs generally when the building materials have aged and decayed.

Replacement of the missing window catch is advised to improve the operational state of the associated window.

An aluminium window service agent or general handyman should be appointed to replace the window latch at the client's discretion.

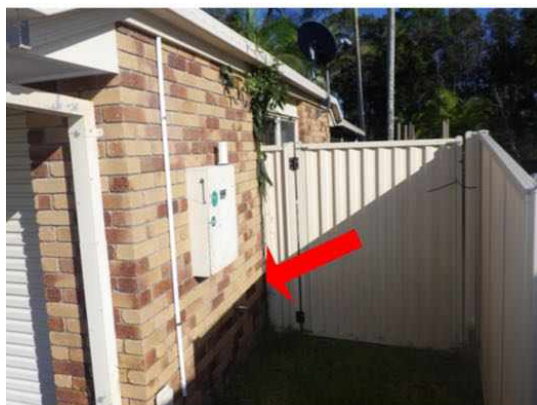
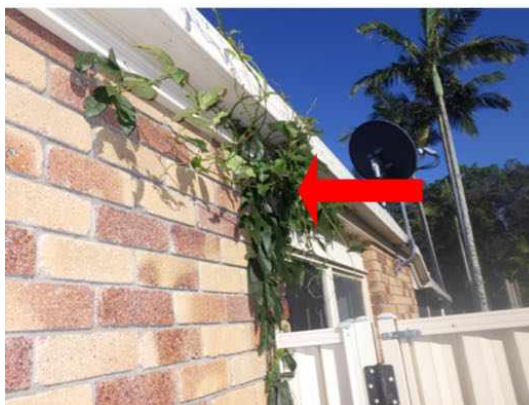
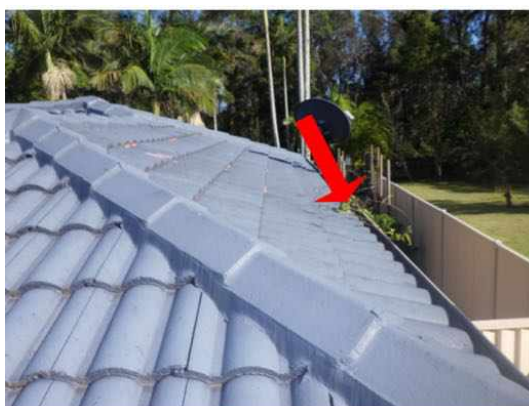
## Finding 6.02

Building:	Main Building
Location:	Exterior walls - right side > Front Right
Finding:	Vegetation
Information:	At the time of inspection there was vegetation growing over external wall and roof areas on the right side of the property.

The vegetation over growing wall areas should be trimmed back clear of the external surfaces. The grass and other vegetation heights should be maintained around the perimeter of the building to allow for an inspection zone around the building exterior.

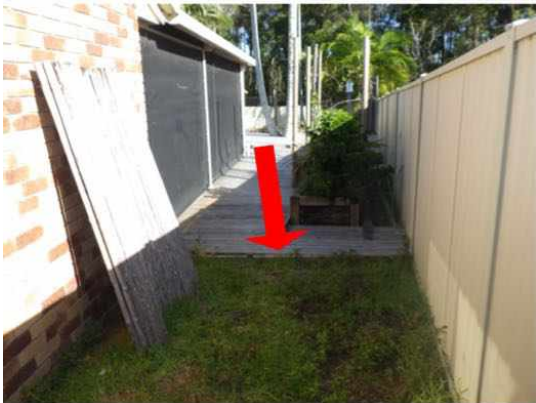
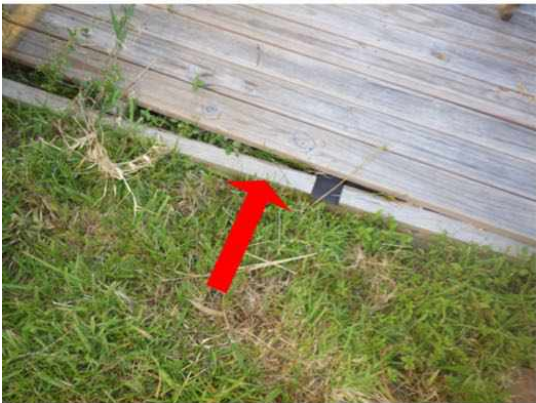
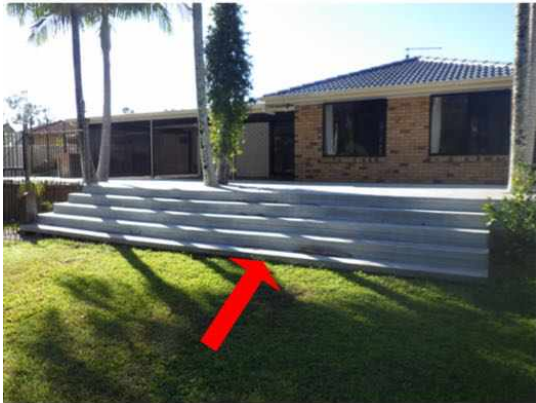
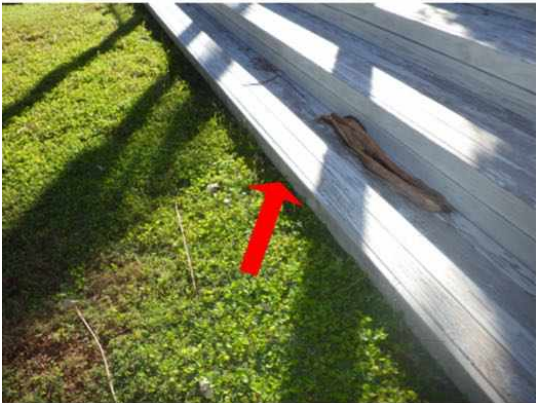
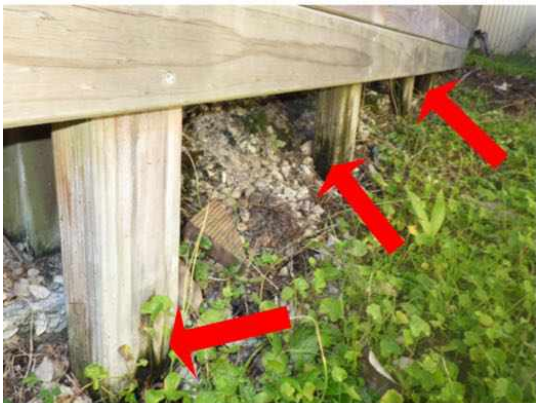
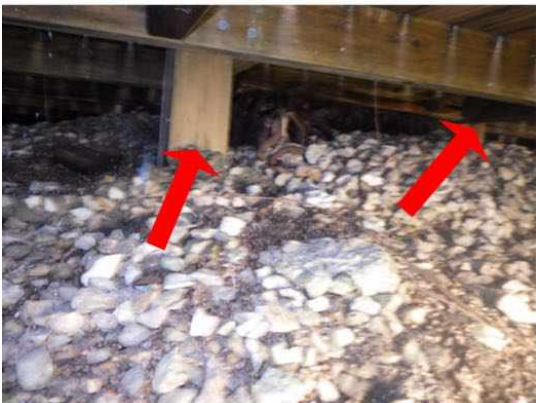
Building:	Main Building
Location:	Deck > Existing
Finding:	Deck - In ground contact
Information:	At the time of inspection it was noted the timber deck area to the rear of the property is in direct contact with the finished ground level.

Any timbers in direct ground contact provide opportunity for concealed termite entry and are likely to be subject to premature rot and decay as the soil retains moisture or damp conditions against the timbers.

Timber termite pest inspections every 1 - 3 months are highly advised to readily identify any termite activity in these areas.

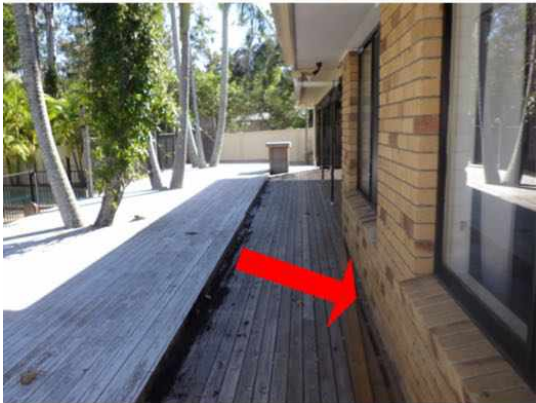
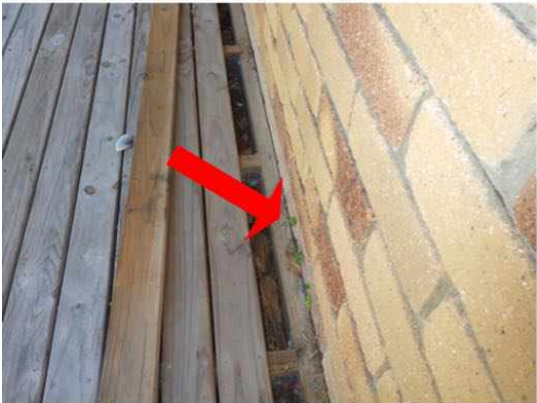
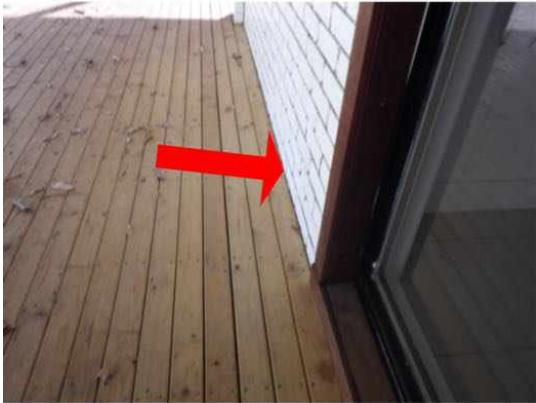
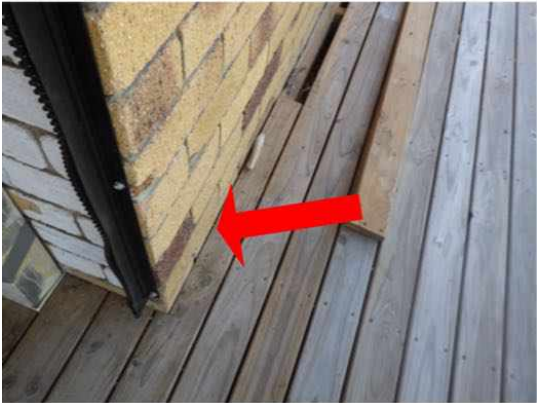
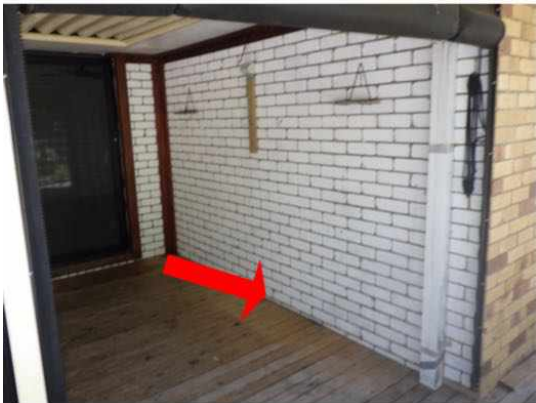
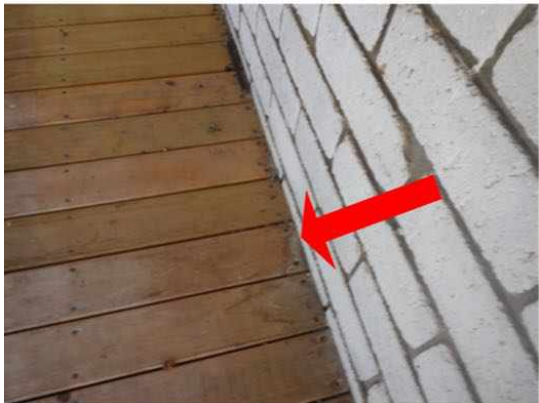
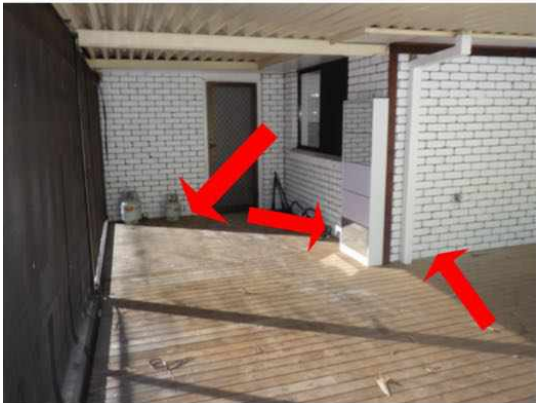
As noted in the report the timber deck area to the rear of the property has been installed tight against the exterior wall brick work and is in direct contact with ground surfaces, significantly restricting visual inspection of the area. These conditions are considered high risk for timber termite activity.

An inspection zone of 20mm between the timber decking to the slab edge or wall exterior is required. This inspection zone should be maintained in order to force termites into the open where they can be detected more readily during regular inspections. The slab edge or wall exterior inspection zone should not be concealed by anything that may prevent inspection of the area, including render, landscaping,soil, turf,paving, concrete, cladding,timber decking or other structures. If the slab edge or wall exterior inspection zone is not properly exposed, it is considered a high risk area of termite attack.

It is highly recommended that timber termite pest inspections be carried out every 1 - 3 months to aid protection of the property against infestation.

A timber termite chemical treatment along with annual inspections of the property is highly recommended.

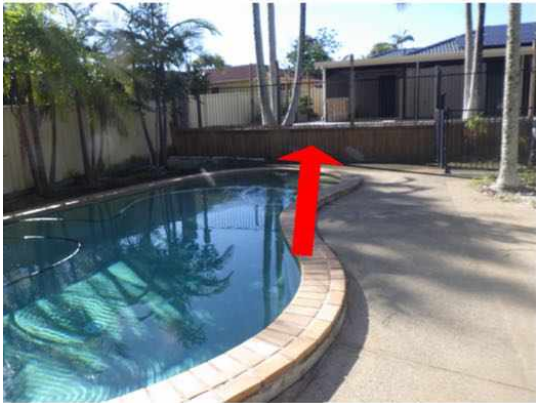
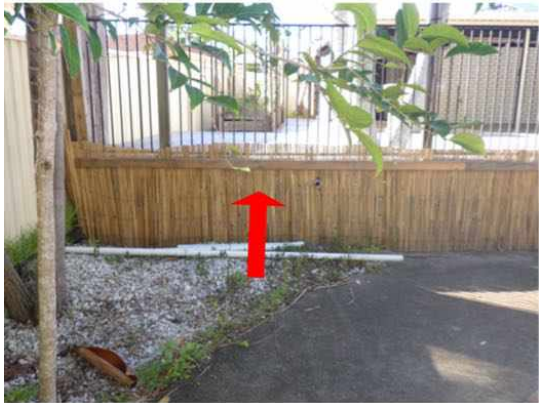
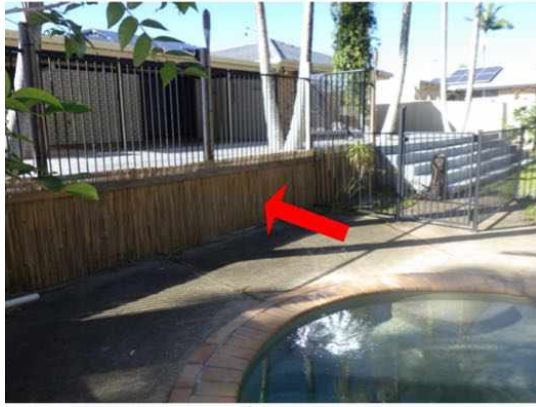
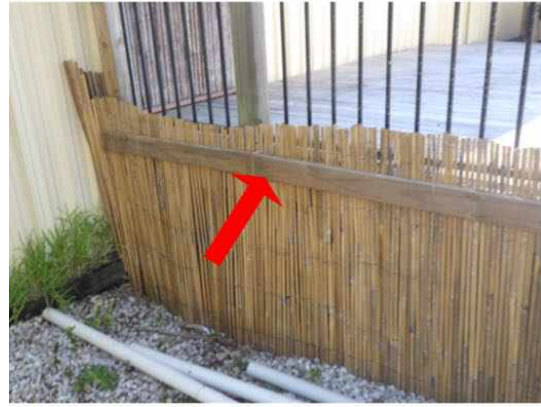
**Finding 6.06**

Building: Main Building  
 Location: Deck > Existing  
 Finding: No Access  
 Information: At the time of inspection there was no access to the sub floor area of the timber deck to the rear of the property.

Areas with limited or no access point severely restrict the full inspection of the area.

The client should engage a licensed carpenter or general handyman regarding provision of a hatch or access door to the timber deck sub floor area.

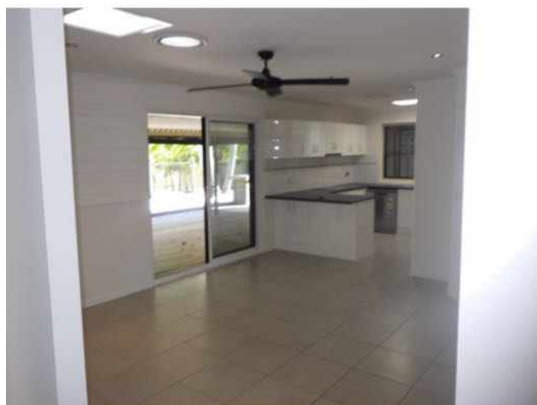
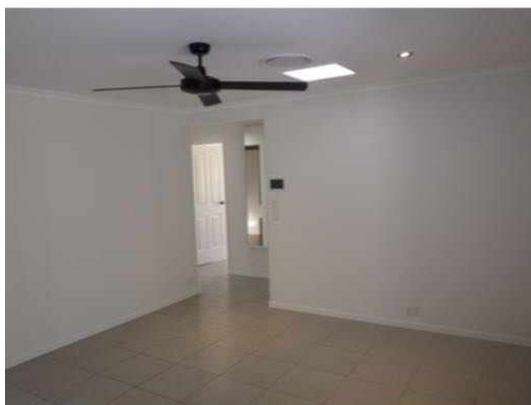
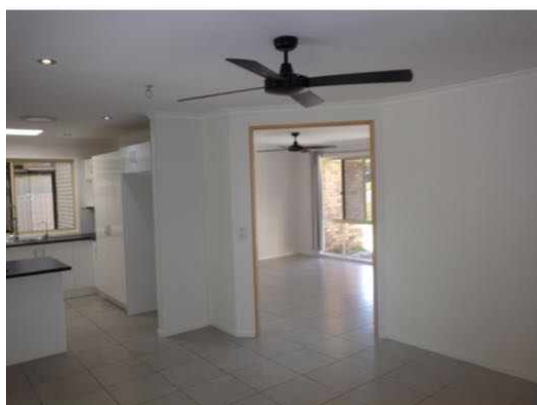
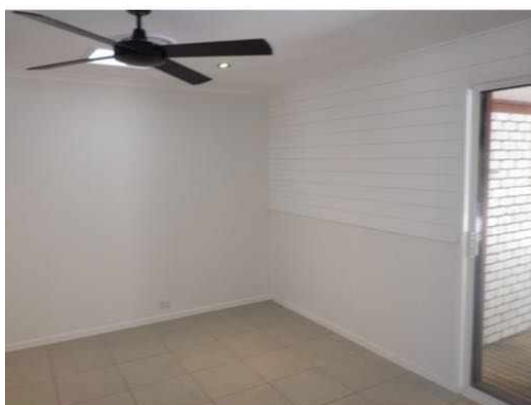
Building: Main Building  
Location: Dining Room > Existing  
Finding: No obvious defect  
Information: No obvious defects found at the time of inspection.

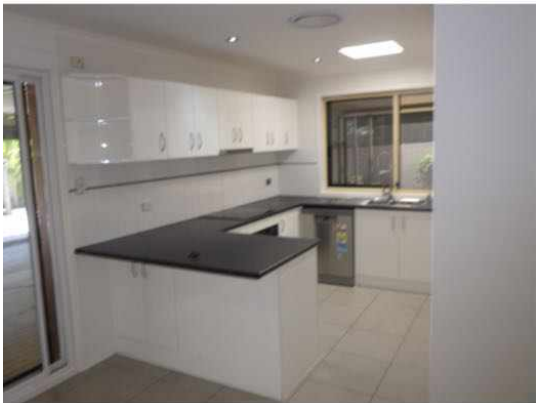
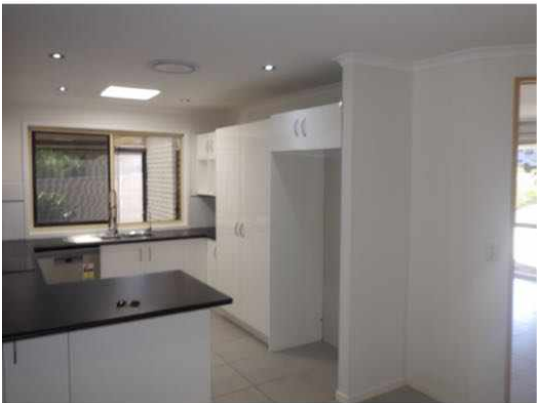
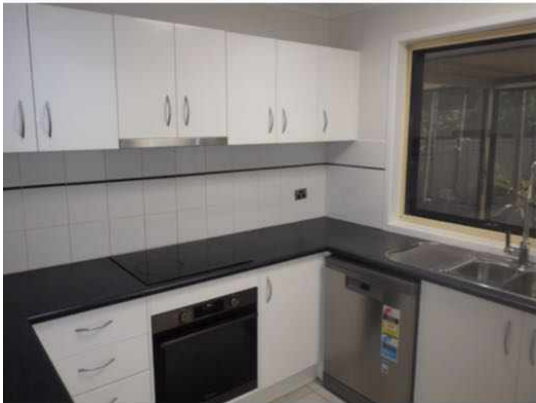
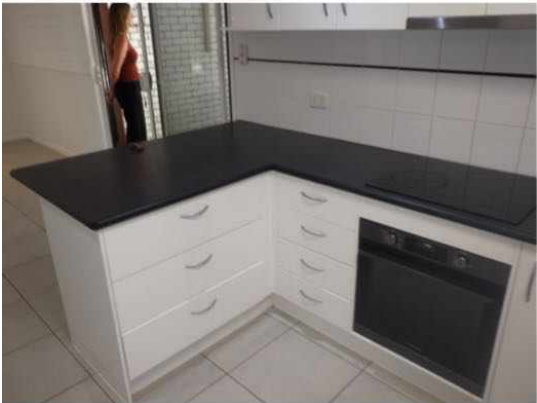
Building: Main Building  
Location: Kitchen > Existing  
Finding: No obvious defect  
Information: No obvious defects found at the time of inspection.

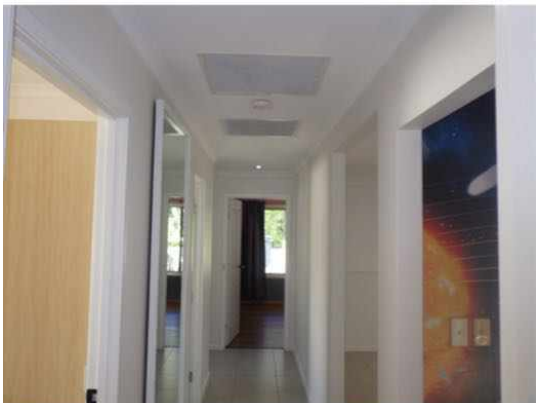
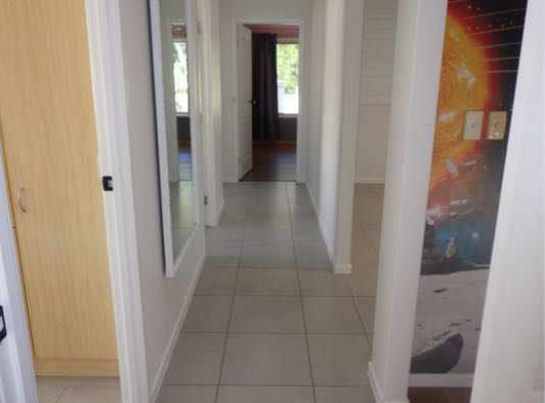
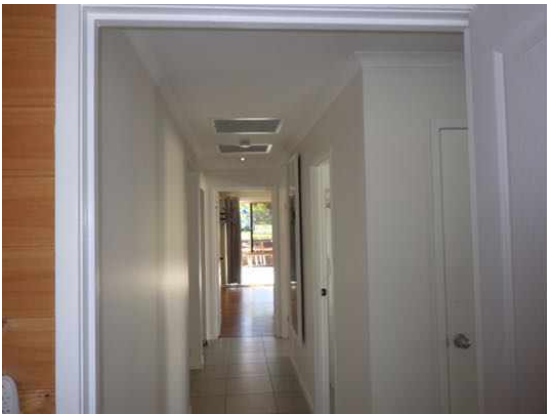
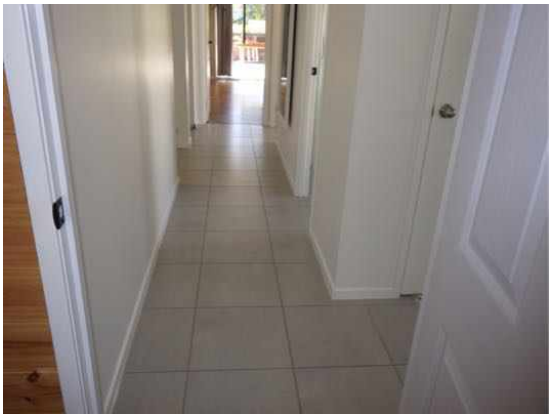
Building: Main Building  
Location: Hallway > Existing  
Finding: No obvious defect  
Information: No obvious defects found at the time of inspection.

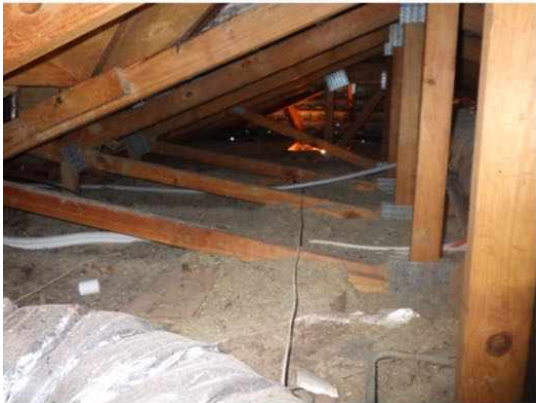
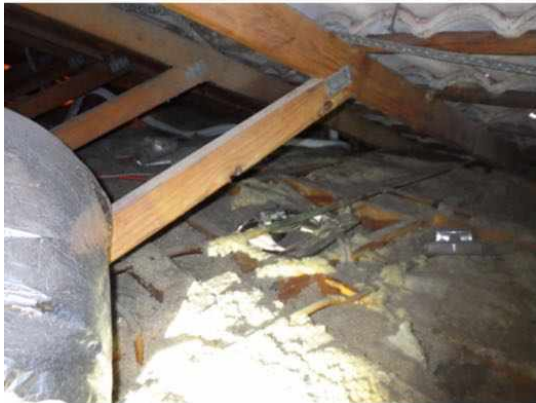
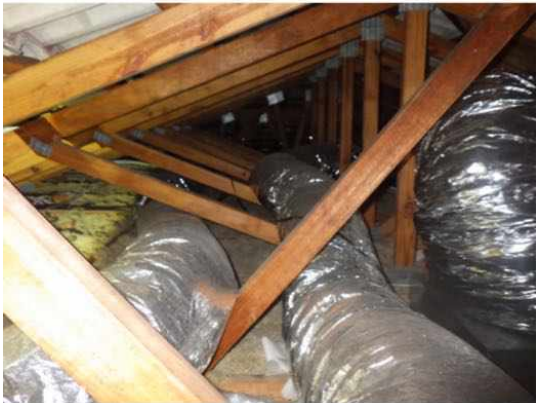
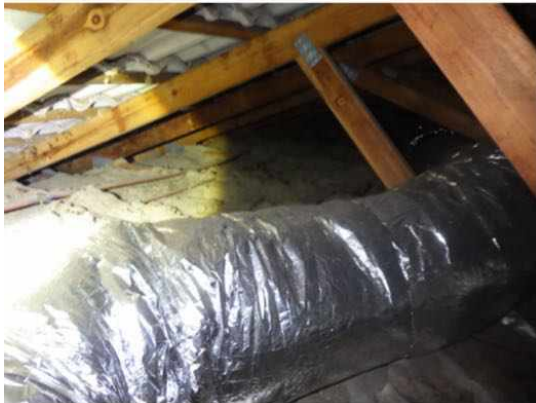
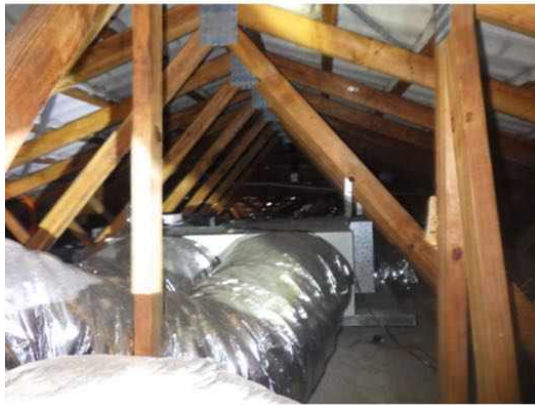
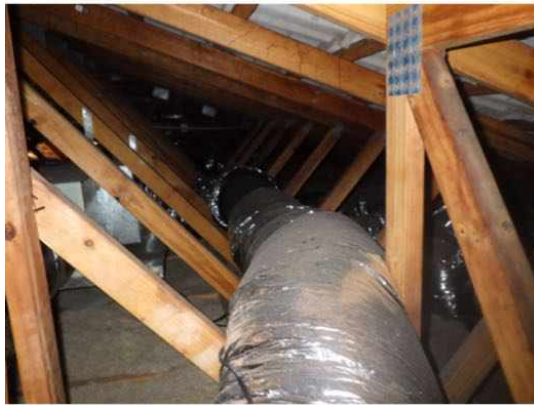
Building: Main Building  
Location: Attic > Existing  
Finding: Additional Photos  
Information: Additional photos are provided for your general reference

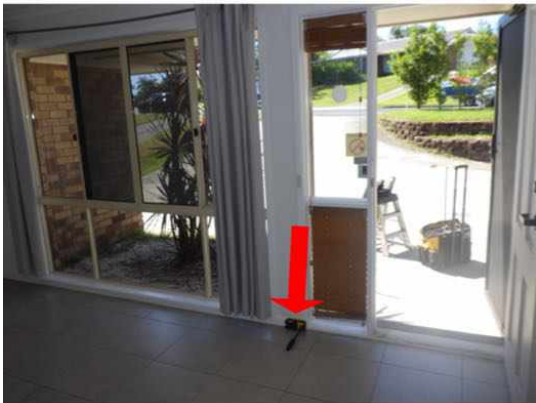
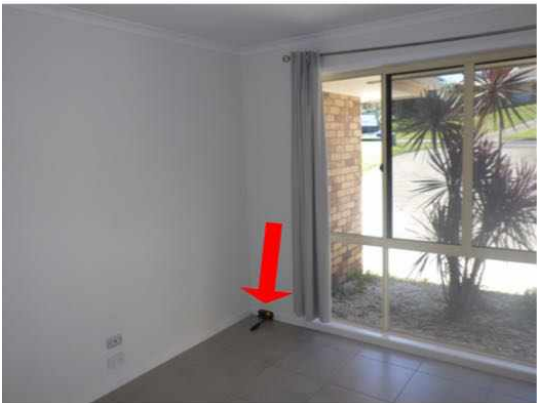
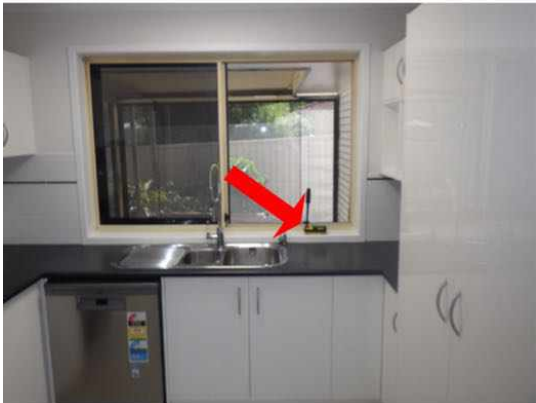
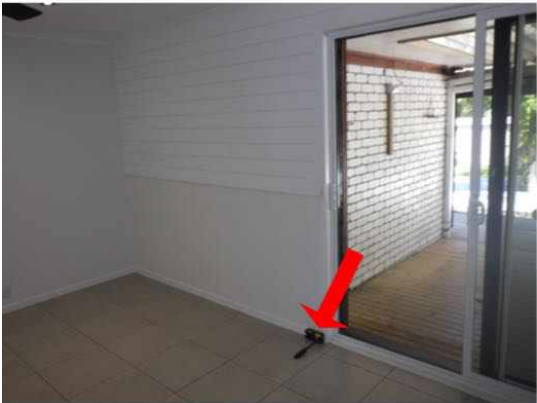
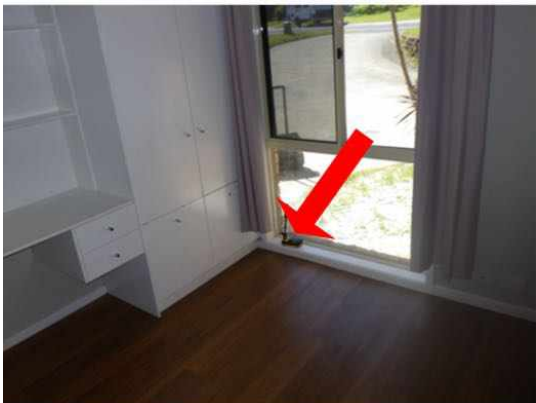
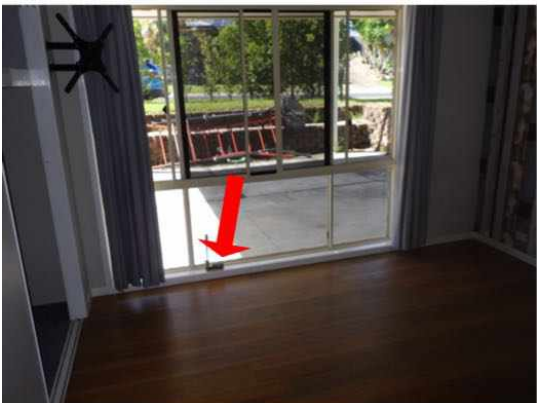
Building: Main Building  
Location: Internal Areas > Existing  
Finding: Termitracker  
Information: The termitracker itracker was positioned randomly to internal wall, timber skirting and window frame areas checking for signs of termite activity.

No activity was recorded at the time of inspection.
