# Building and Timber Pest Inspection Report

Inspection Date: Wed, 18 Feb 2026

Property Address: 204 Mildura Dr, Helensvale QLD 4212,  
Australia

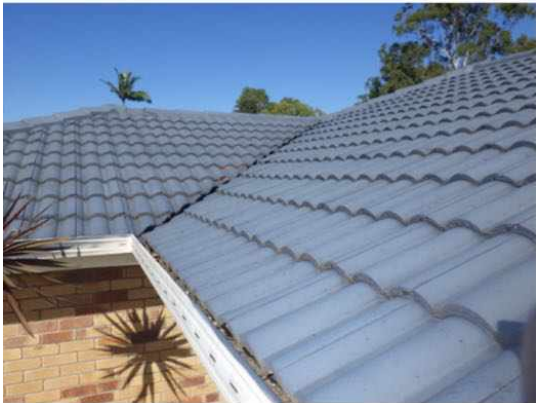
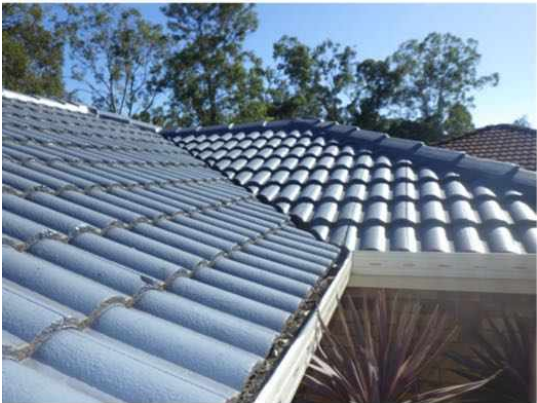
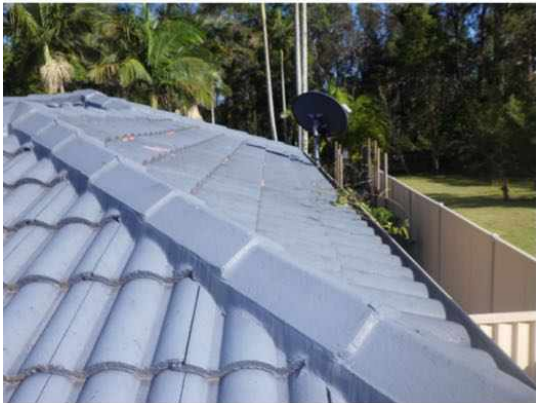
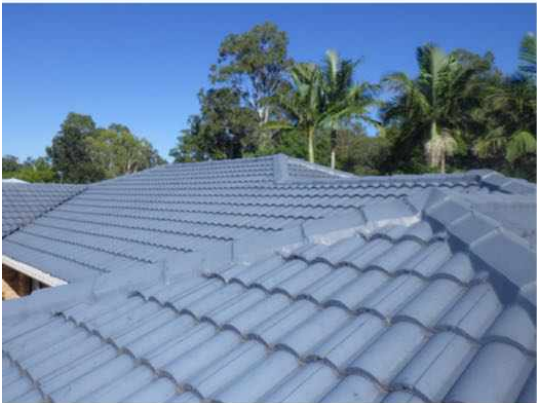
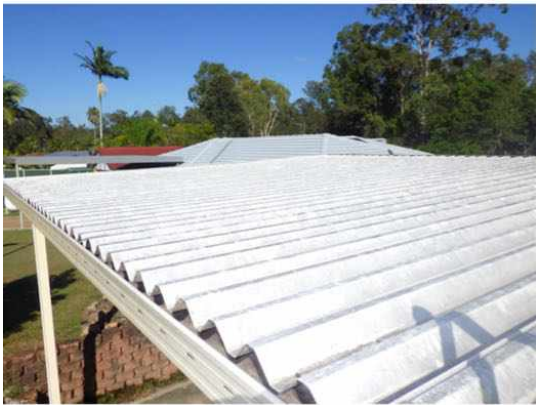
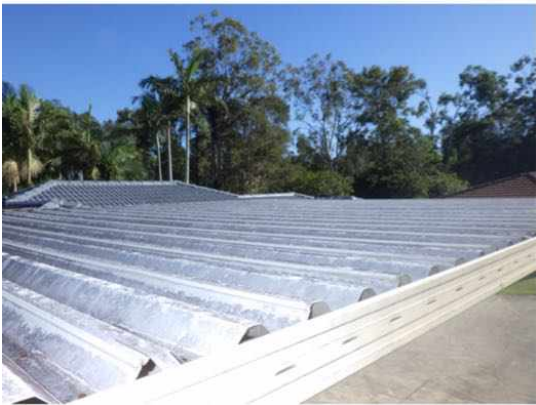
Building: Main Building  
Location: Roof Exterior > Existing  
Finding: Additional Photos  
Information: Additional photos are provided for your general reference

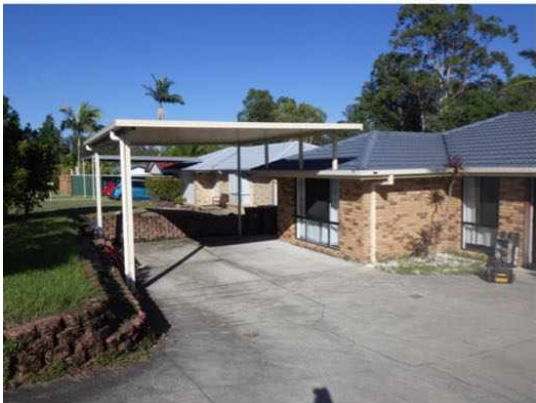
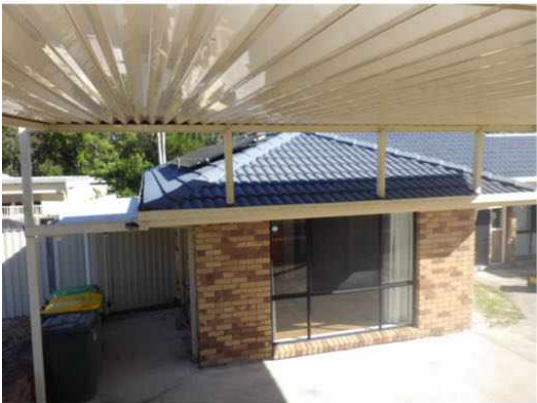
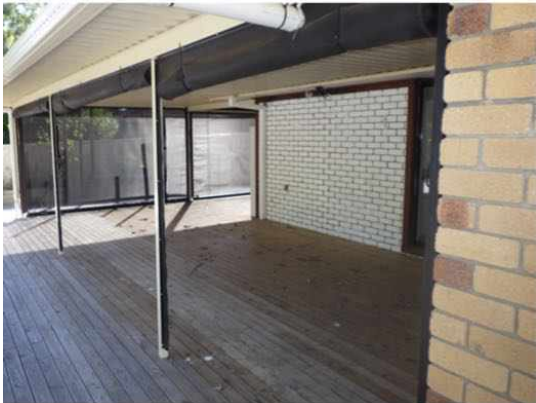
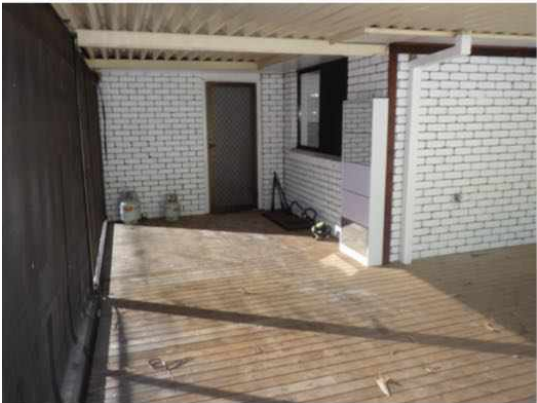
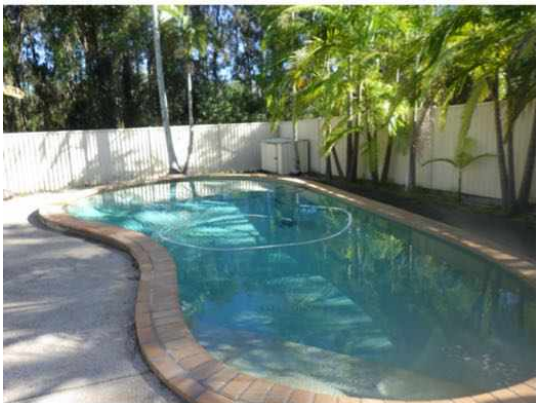
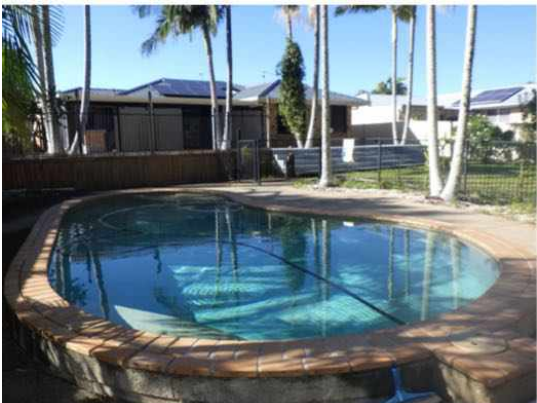
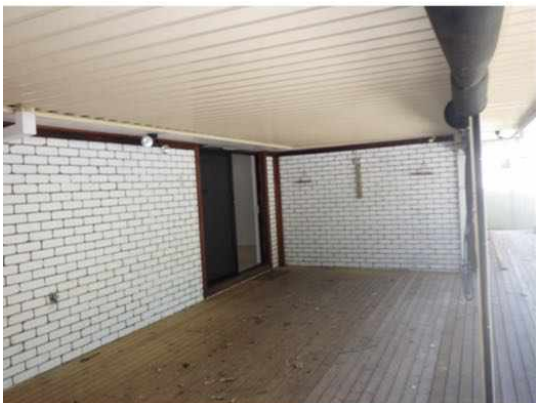
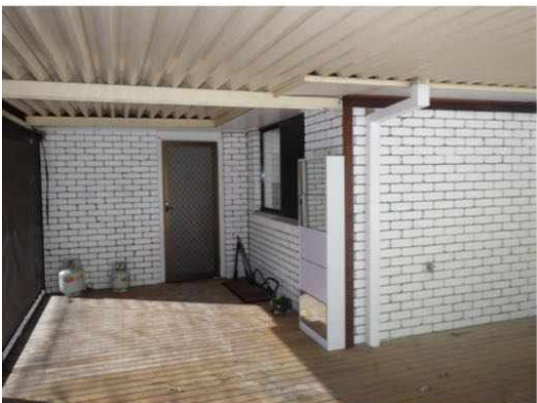
Building: Main Building  
Location: External Areas > Existing  
Finding: Additional Photos  
Information: Additional photos are provided for your general reference

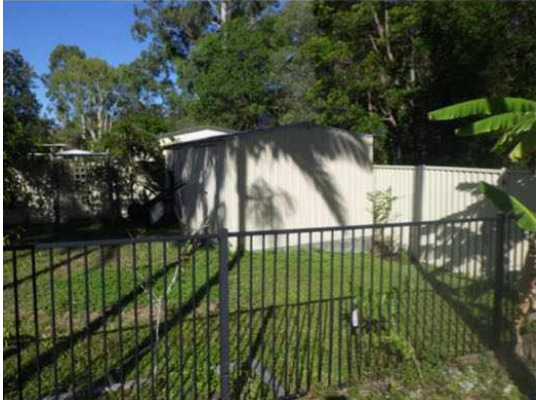
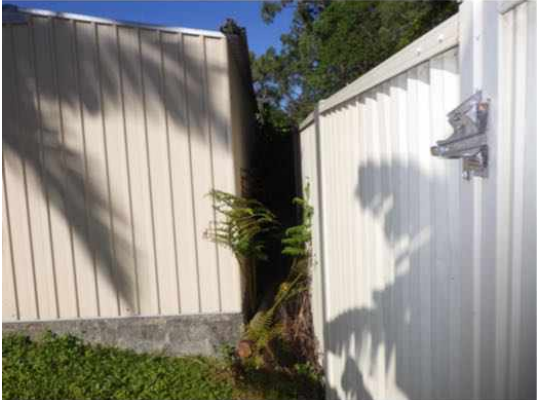
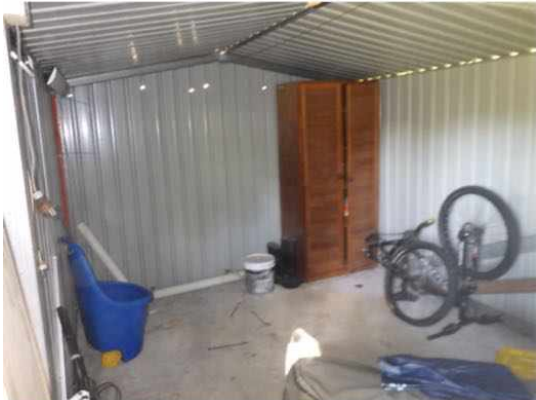
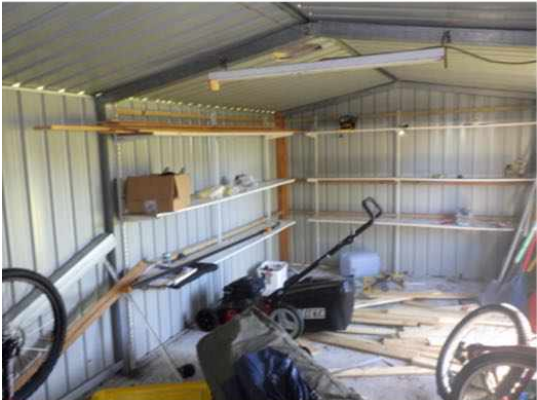
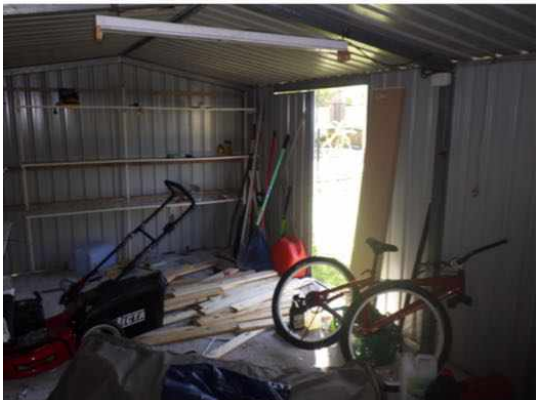
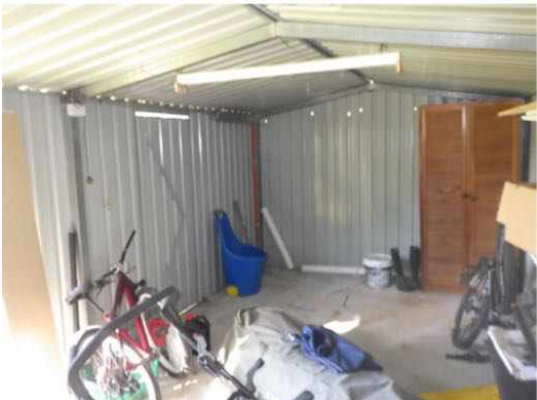
Building: Shed  
Location: External Areas > Existing  
Finding: Additional Photos  
Information: Additional photos are provided for your general reference
