Building Inspection Report

Inspection Date: Mon, 23 Feb 2026

Property Address: 25 Dennis St, Highett VIC 3190, Australia

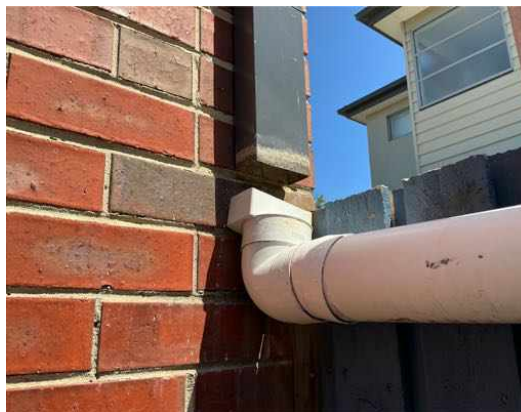
Defects 3.03

Where roof plumbing doesn't drain adequately, the area at the base perimeter can become excessively damp, potentially creating an environment that is susceptible to rust and corrosion of surrounding building elements, as well as attracting termites and other pests.

It is highly recommended that a plumber be appointed to further inspect the area and to install adequate drainage equipment where necessary.

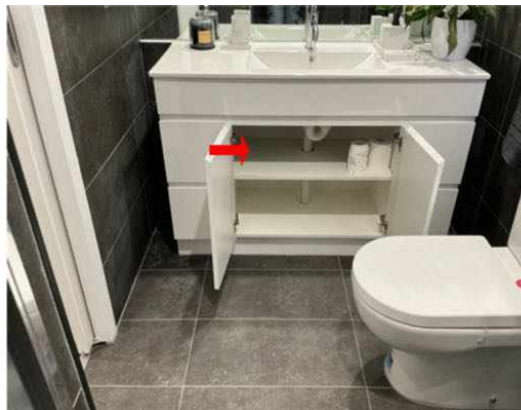
Defects 3.06

Building:	Main Building
Location:	Ensuite - Master
Finding:	Tap - Leaking
Information:	The tap in this area was found to be leaking at the time of inspection. This is a common defect that is consistent with general ageing of the building element. However, it may be indicative of substandard plumbing workmanship if the tap is relatively new.

While this defect only seems minor, if left unmanaged, it is likely to result in the development of rust, water damage and/or extensive water usage.

It is advised that a handyman or licensed plumber be appointed to perform remedial works on the affected tap. Such works should be performed prior to the development of secondary defects to ensure adequate functionality of all associated building elements.

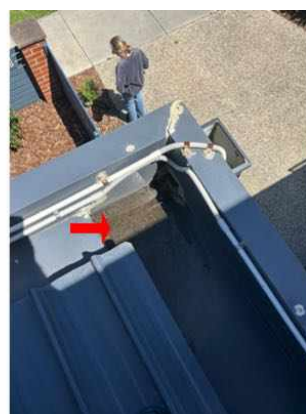
Defects 3.08

Building:	Main Building
Location:	Roof Exterior
Finding:	Gutters - Water pooling
Information:	Water was found to be pooling in sections of the roof guttering. This is generally a secondary defect caused by blocked or partially blocked gutters. Such blockages and subsequent water pooling are likely to lead to rust and water damage to associated structures if left unattended.

Any areas of guttering that shows evidence of water pooling should be checked for partial or full blockages and any secondary damage that may have occurred as a result. Depending on the extent of the damage, building elements may require repair and/or replacement to ensure adequate roof drainage and function of exterior plumbing system.

A roofing plumber should be appointed as soon as possible to rectify this issue. It is highly advised that all gutters be maintained on a frequent basis to ensure the condition of roof plumbing.

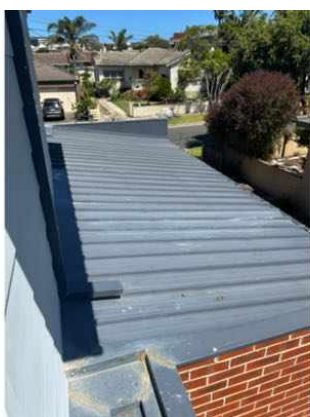
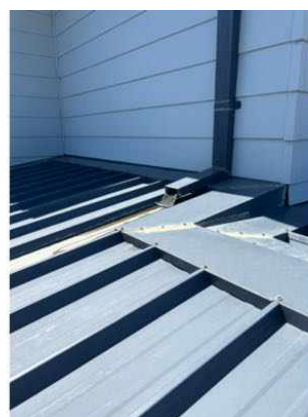
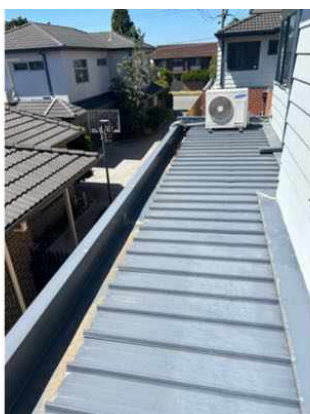
In that they are discharging water onto flashings, are too close to the wall and the PVC is not protected by painting.

We recommend that a Roof Plumber be contacted as soon as possible to rework or replace to achieve Compliance.

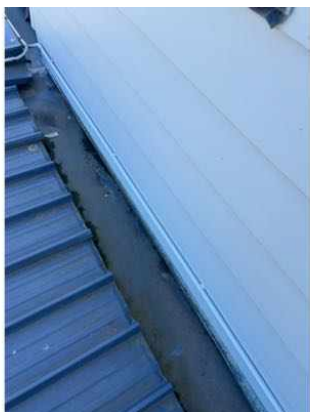
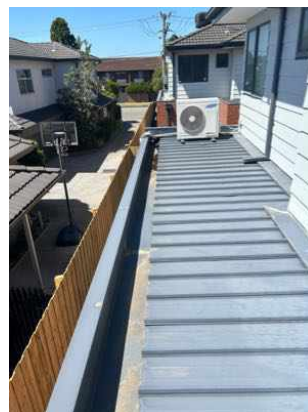
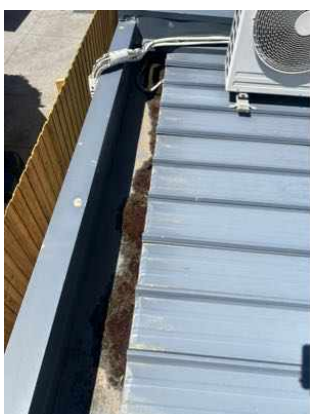
Defects 3.12

can also provide conditions that are conducive to termite and timber pest activity. Blockages in gutters should therefore be removed immediately to ensure dry conditions are maintained.

Consult a Licensed Plumber for further specific advice on remedial works that may be required. In the interim, it is highly advised that blocked gutters be removed by the homeowner or a general handyman as a matter of urgency.

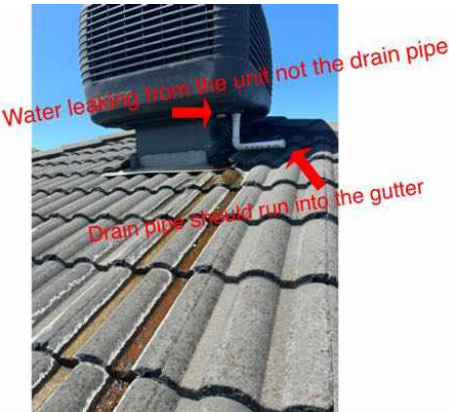
Defects 3.13

Building:	Main Building
Location:	Roof Exterior
Finding:	Air-conditioning unit - Leak
Information:	Leaking from an external air-conditioning unit may be a result of several causes, including poor installation, blockages in internal drains, or a blockage to the drain hole.

A refrigeration mechanic or licensed plumber should be appointed to assess the condition of the unit and to perform any remedial works as necessary. While discharge

from an air-conditioning unit can generally be managed through basic plumbing work, such appointments are deemed necessary to identify any major issues.

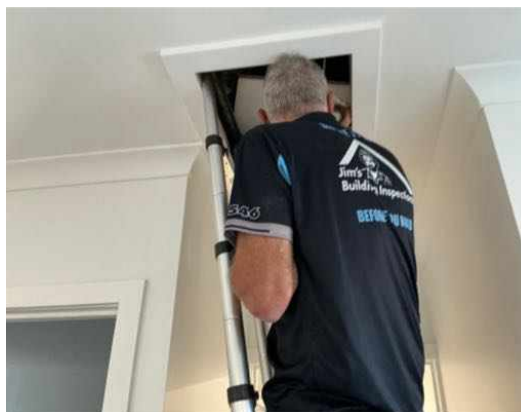
Noted Item

Building:	Main Building
Location:	Roof Void
Finding:	Roof void access limitations
Information:	Limited access to the roof void was present due to facts including but not limited to access hatch size or placement, for this reason access to the roof void was minimal.

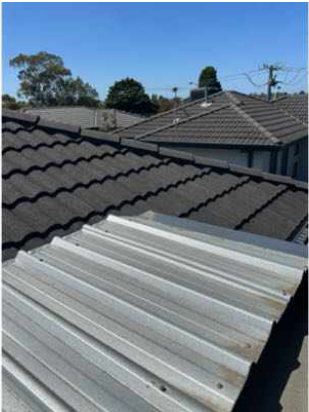
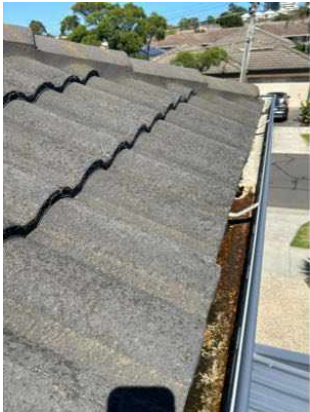
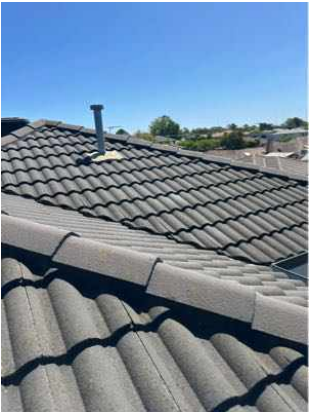
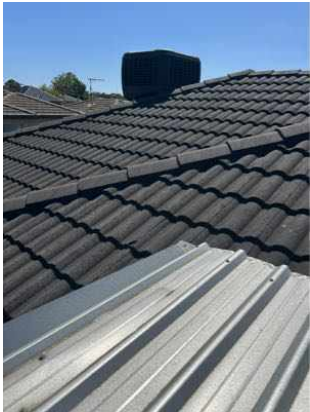
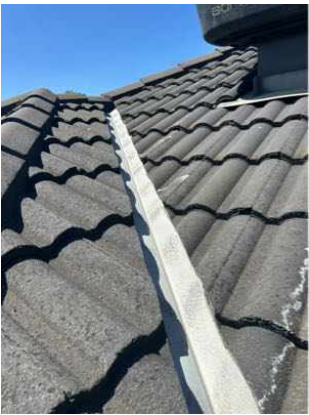
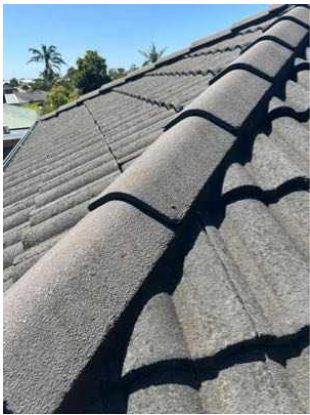
Building: Main Building
Location: Roof Exterior
Finding: Additional Photos
Information: Additional photos are provided for your general reference
