# Building and Timber Pest Inspection Report

Inspection Date: Tue, 24 Mar 2026

Property Address: 7 Bridge Rd, WESTMEAD, NSW, 2145,  
Australia

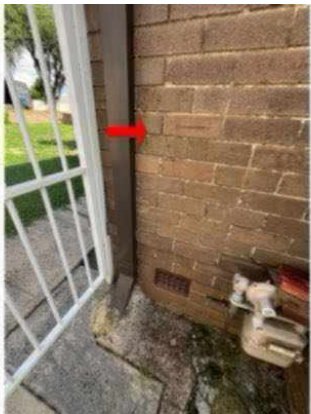
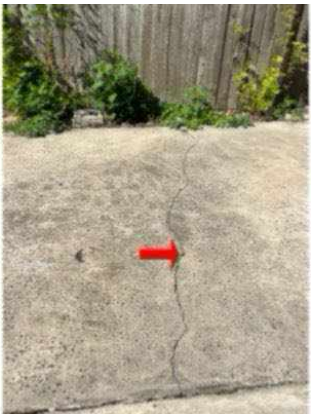
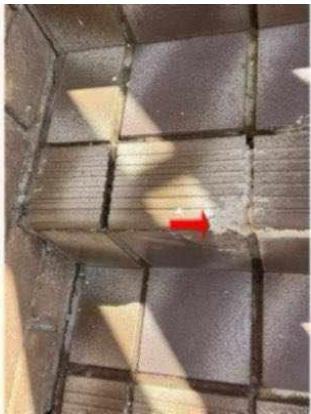
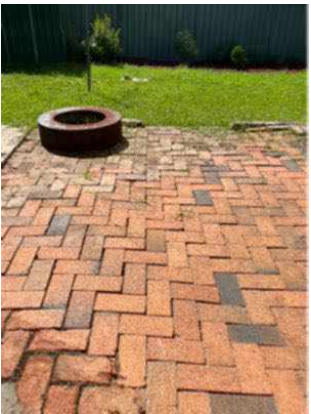
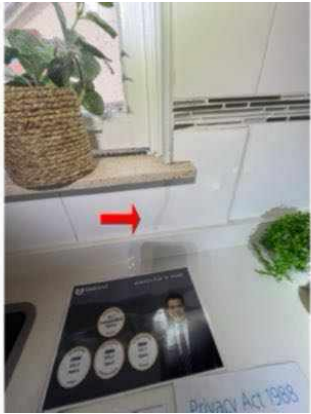
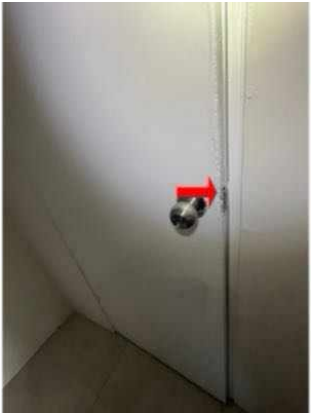
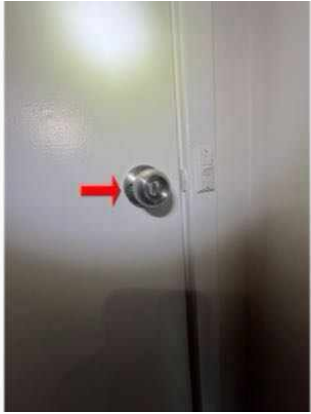
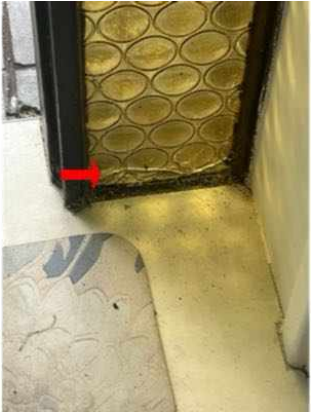
In accordance with the pre-inspection agreement, these minor and cosmetic conditions are generally excluded from reporting unless they constitute a major defect, safety issue, or significant structural concern. As such, the absence of specific reference to these items in the report should not be construed as an indication that they do not exist, but rather that they fall within the scope of accepted fair wear and tear and normal ageing for a property of this type and age.

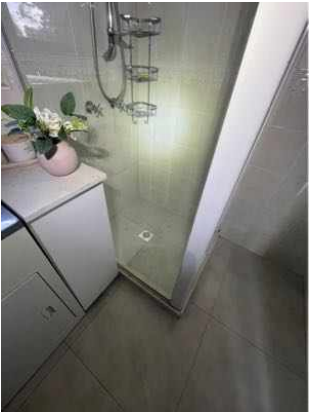
It is also important to note that this inspection was conducted using standard visual and non-invasive methods, which have inherent limitations. Such methods cannot reliably detect all types of concealed leaks or membrane failures, particularly those occurring behind wall linings or beneath floor tiles. For a more precise and conclusive assessment, a special-purpose or invasive inspection by a suitably qualified professional is recommended. Until such further investigation is undertaken, the possibility of a leak cannot be entirely ruled out.

Furthermore, although no visual evidence of water-related damage was identified, this does not guarantee that moisture ingress has never occurred. Concealed areas may still have been affected in the past, including the potential for timber deterioration or termite-related damage that may no longer be active or visible. Only an invasive inspection would allow the condition of concealed building elements to be fully determined.

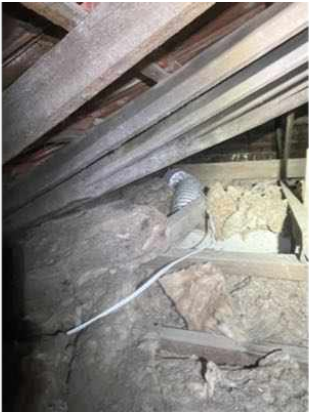
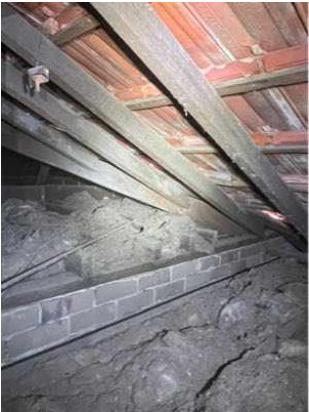
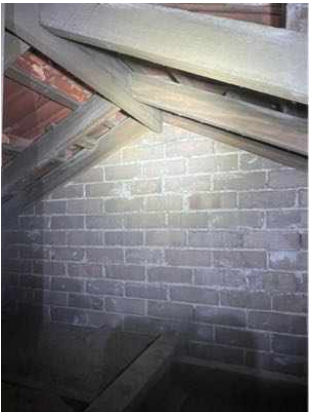
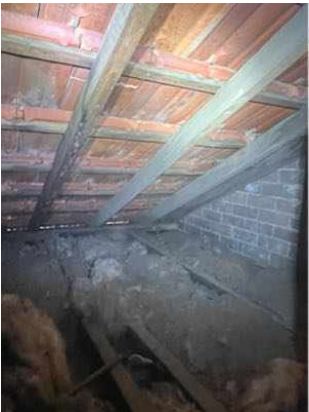
durability. Electrical cabling was noted running across the ceiling joists in a loose manner, which is typical of older installations, although care should be taken to ensure it remains protected and not subject to damage.

Overall, the roof void condition is consistent with an older structure, showing general age-related wear rather than any immediate structural concern. Ongoing maintenance of roof coverings, improvement of insulation distribution, and minor rectification of service installations would be beneficial to maintain performance and reduce the risk of future issues.

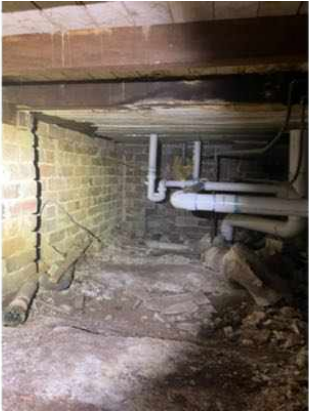
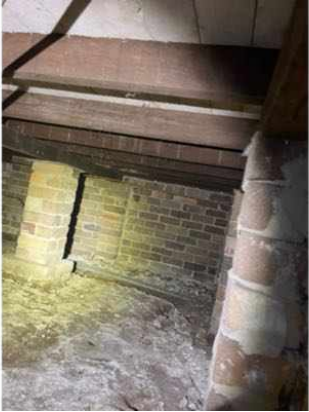
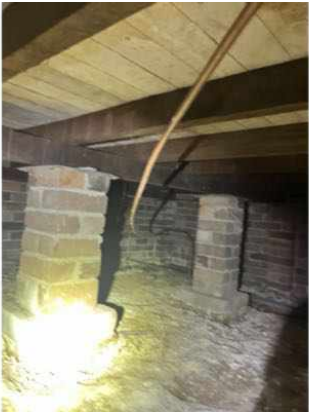
Overall, the subfloor condition reflects an ageing structure with a combination of moisture-related deterioration, maintenance issues and some structural concerns associated with the masonry supports. Further assessment by a suitably qualified contractor or structural specialist is recommended to address the cracking and displacement in the masonry, improve ventilation and drainage to the subfloor, and tidy and secure services to reduce the risk of damage or future defects.

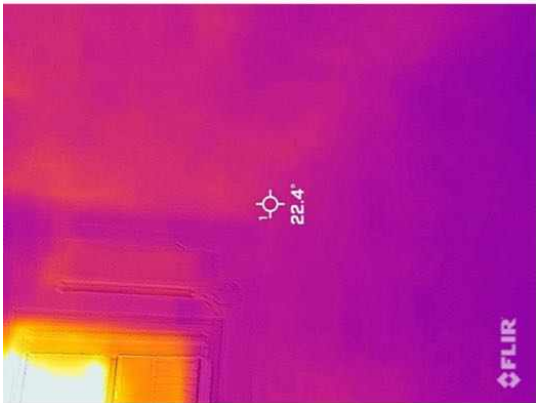
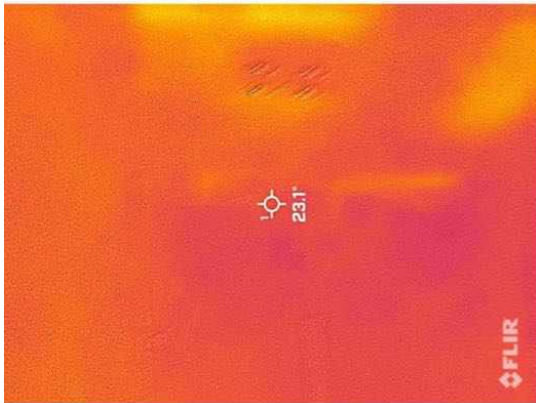
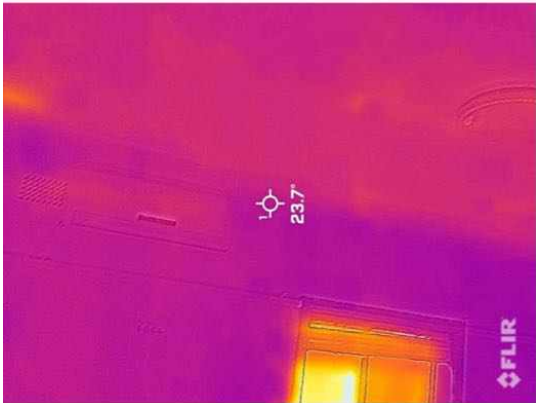
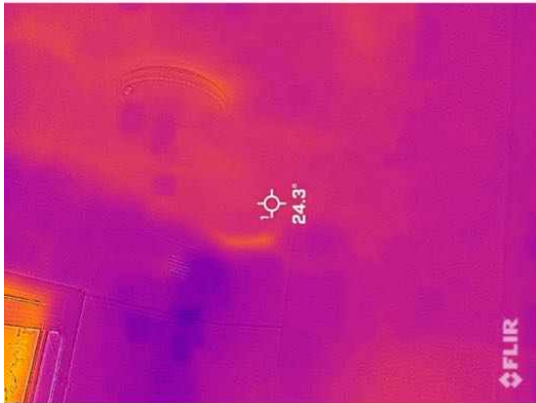
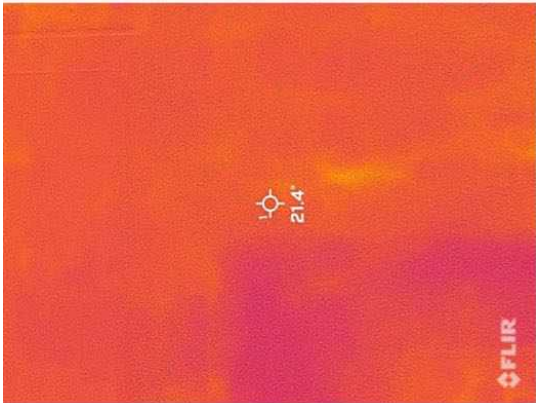
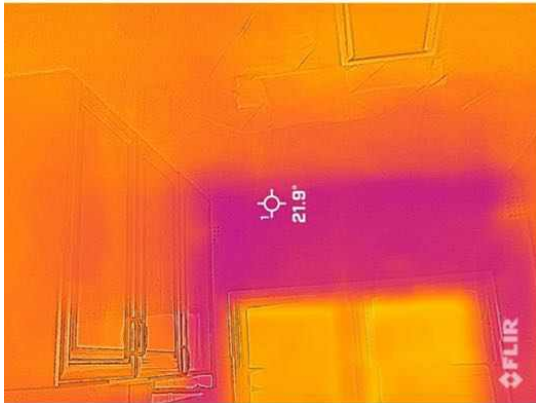
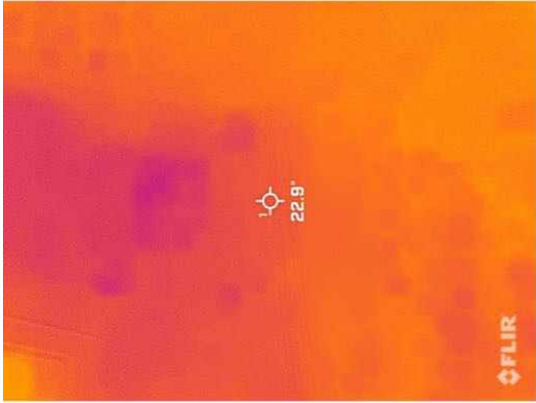
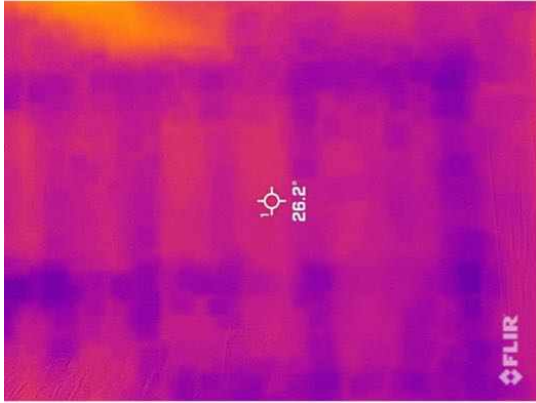
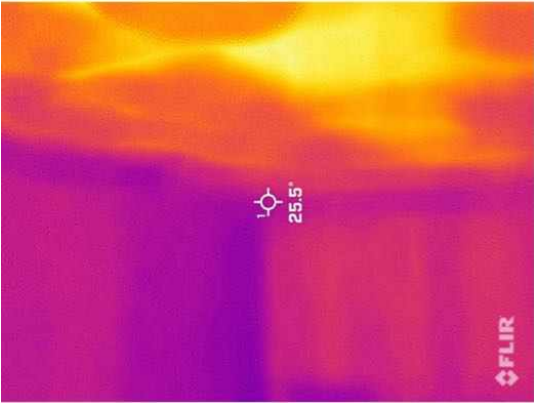
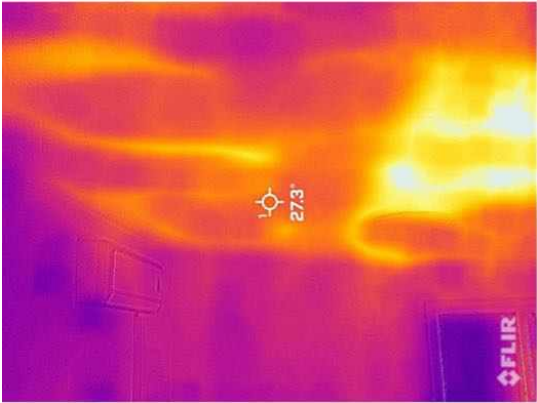
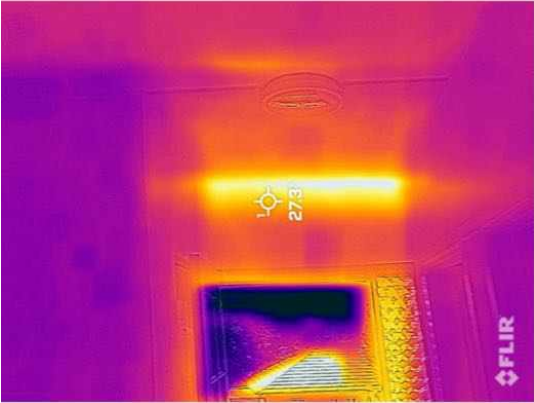
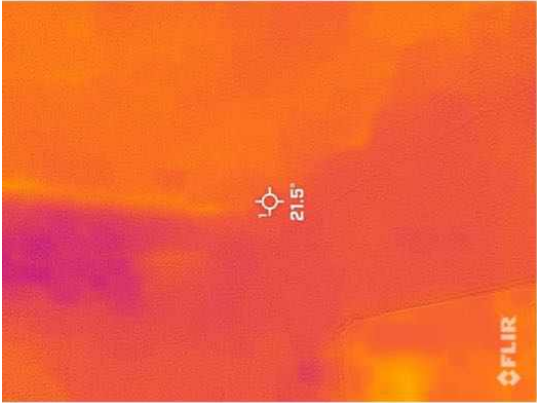
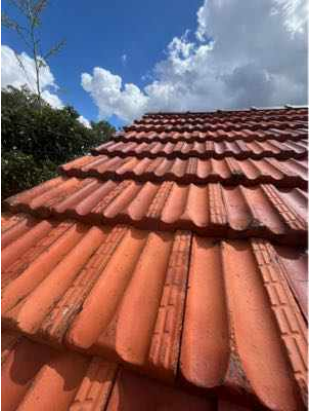
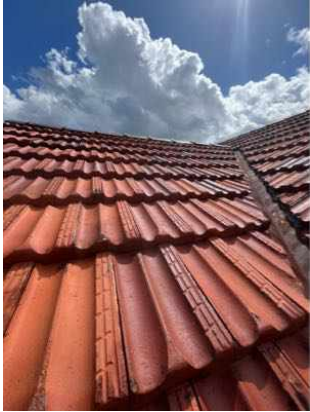
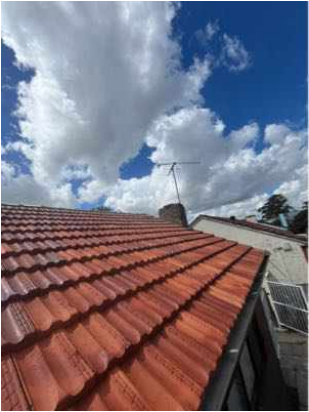
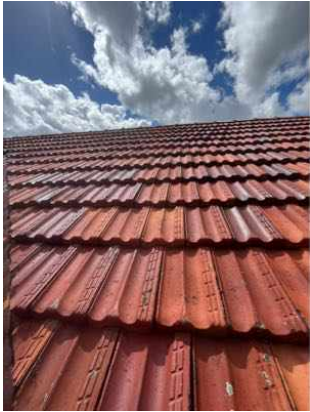
Building: Main Building  
Location: All Areas  
Finding: Additional Photos  
Information: Thermal imaging camera was used to detect any active water leaks or/ and termite activities in the property. No water leaks or termite activities were found from inspection by thermal imaging camera. Additional photos are attached for general reference.
