## Building Inspection Report

Inspection Date: Wed, 1 Apr 2026

Property Address: 104/17-19 Rookwood Rd, Yagoona NSW  
2190, Australia

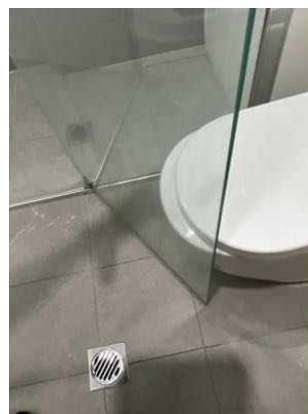
#### Defects 1.02

Building:	Main Building
Location:	Ensuite
Finding:	Shower screen - Hitting toilet
Information:	A safety hazard was identified in the bathroom of the property. The issue pertains to the shower screen, which, when fully opened, makes contact with the adjacent toilet.

Collision between the shower screen and the toilet can cause injury to individuals using the bathroom, particularly if the shower screen shatters upon impact. The repeated contact between the shower screen and the toilet can also result in damage to both fixtures, leading to costly repairs or replacements.

This is to be addressed prior to handover.

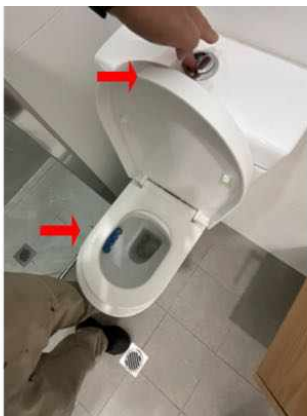
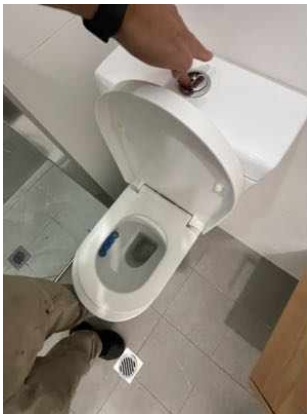
### Defects 3.03

Building: Main Building  
 Location: Ensuite  
 Finding: Flush Tank Not Operational  
 Information: The flush tank is currently not operational, rendering the toilet unusable. This could be due to various issues such as a malfunctioning flush mechanism, water supply issues, or internal component failure.

- **\*\*Sanitation Concerns:\*\*** An inoperative flush tank can lead to unsanitary conditions, unpleasant odors, and potential health hazards due to the inability to properly dispose

- **\*\*Inconvenience:\*\*** The lack of a functioning toilet can cause significant inconvenience to occupants, especially in households with limited bathroom facilities.

- **\*\*Water Damage:\*\*** Continuous attempts to flush an inoperative tank could lead to leaks or overflows, potentially causing water damage to the surrounding areas.

- **\*\*Plumber:\*\*** A qualified plumber should be contacted to diagnose and repair the issue. The plumber will inspect the flush tank, identify the root cause of the problem, and replace or repair any faulty components to restore proper functionality.

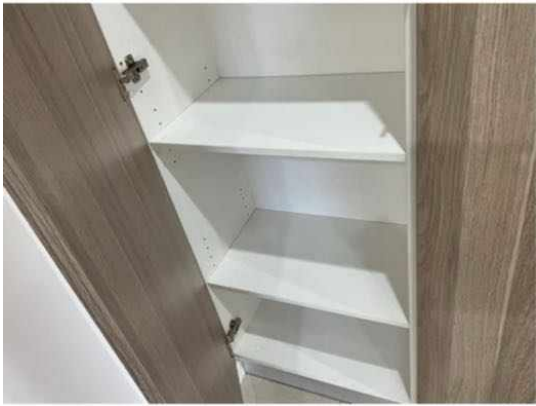
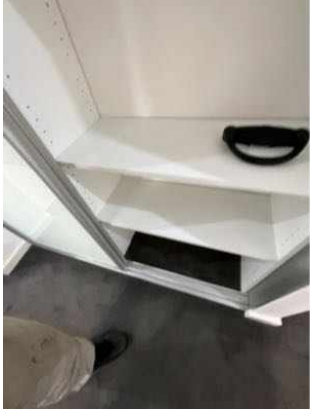
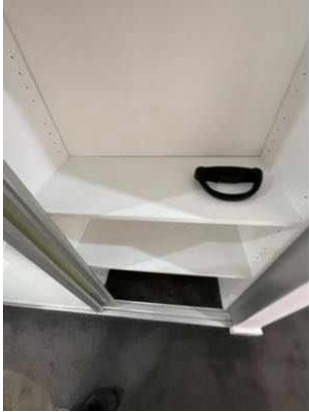
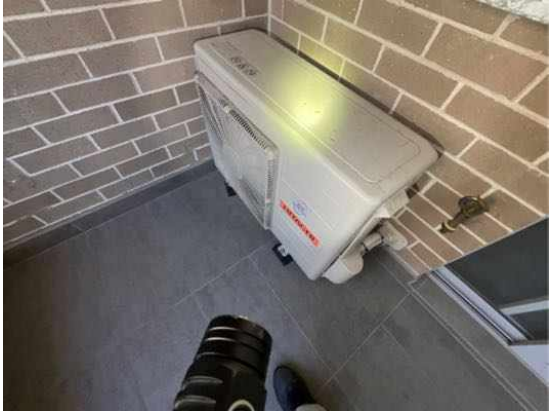
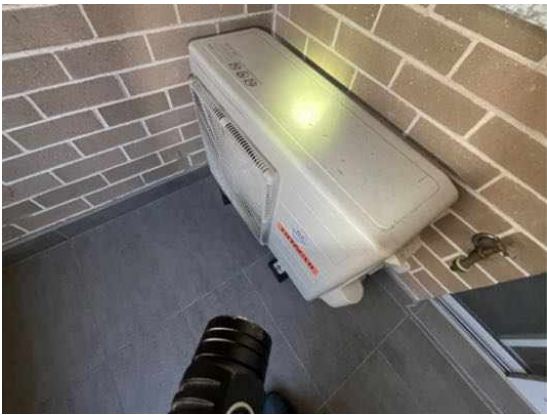
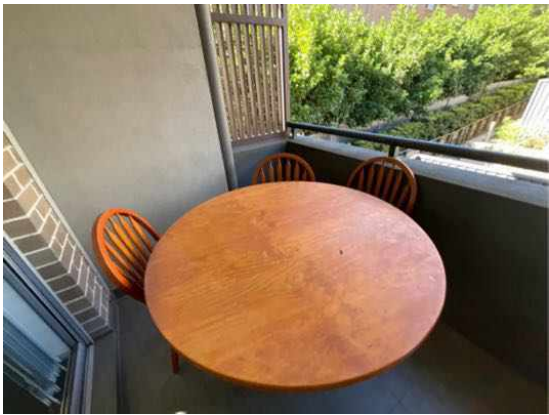
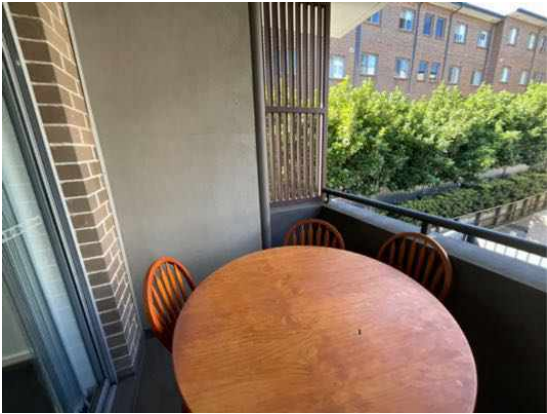
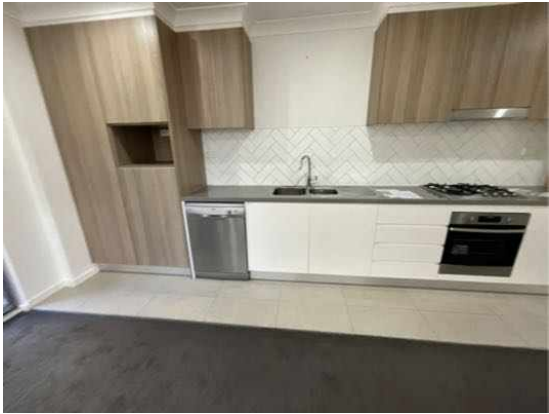
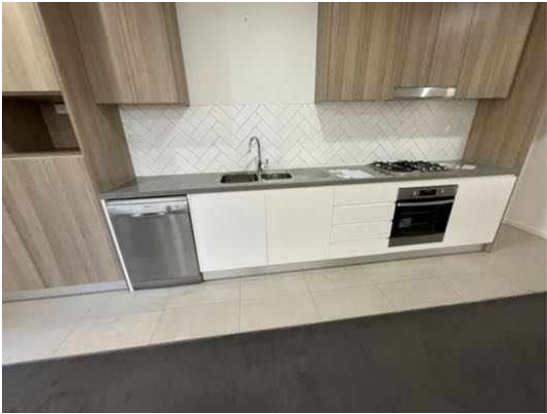
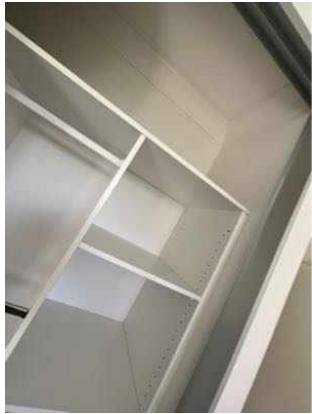
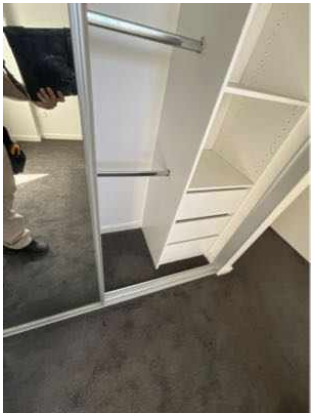
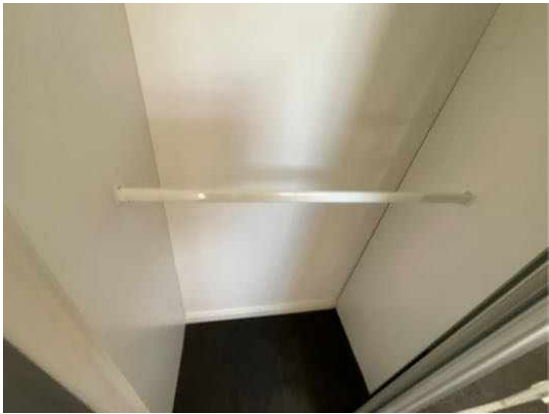
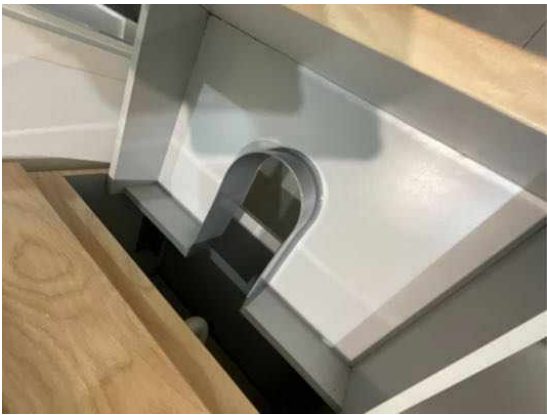
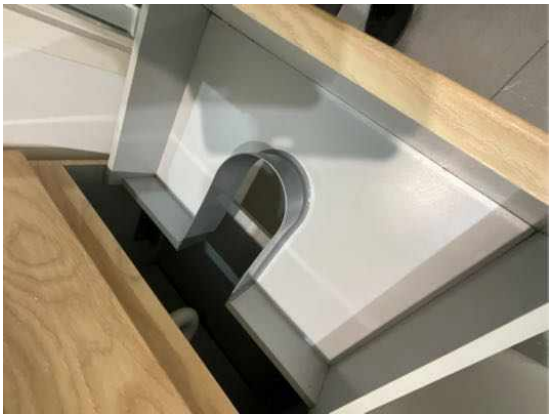
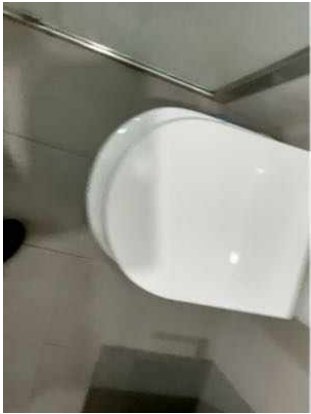
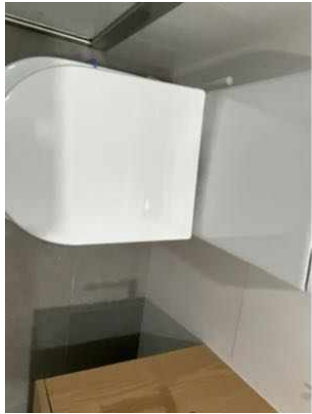
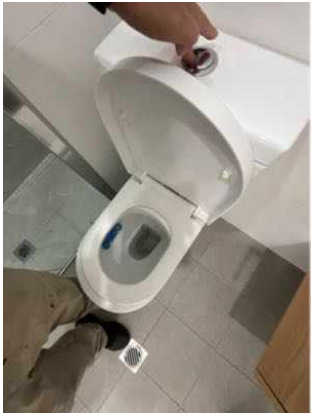
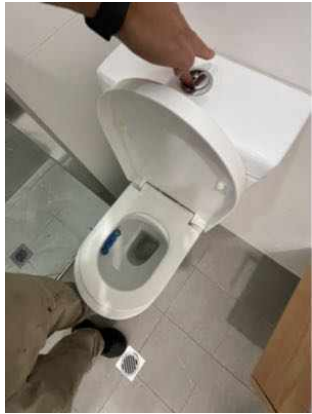
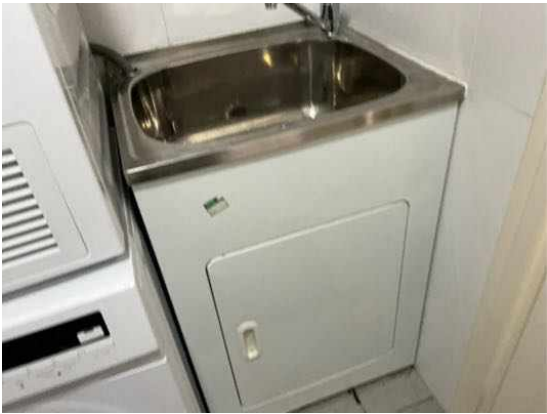
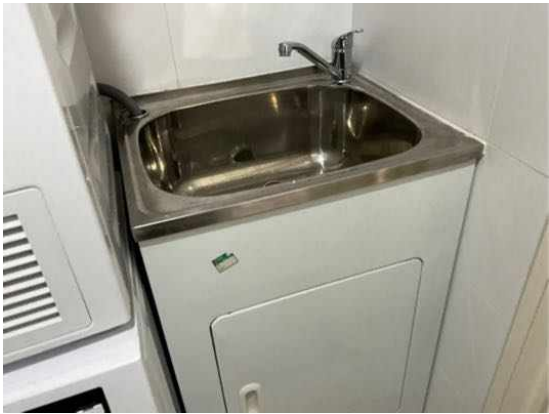
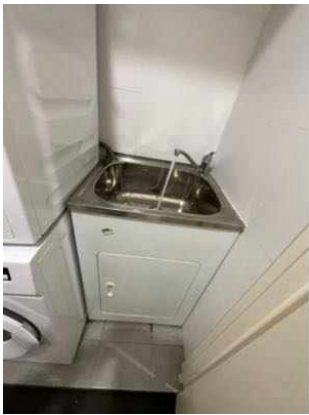
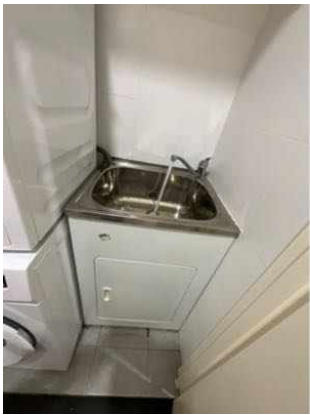
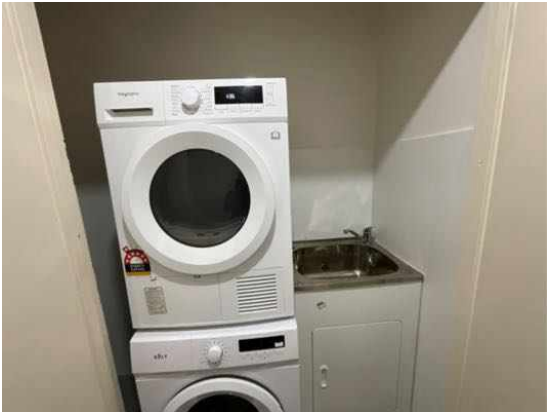
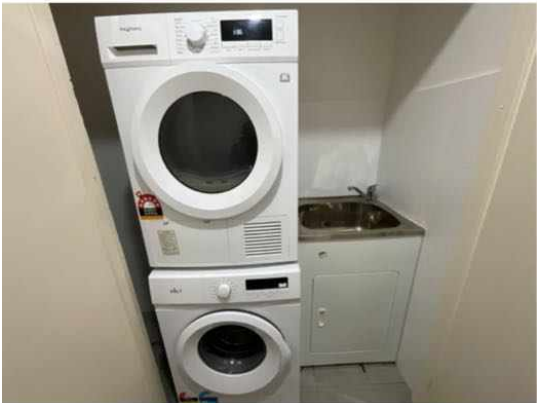
#### Noted Item

Building: Main Building  
Location: All Areas  
Finding: Additional Photos - Obstructions and Limitations  
Information: These photographs are an indication of the obstructions and limitations which impeded full inspection of the property at the time of inspection. These obstructions can hide an array of defects and should be removed to allow full inspection to be carried out. A re-inspection is recommended once the areas are made accessible.

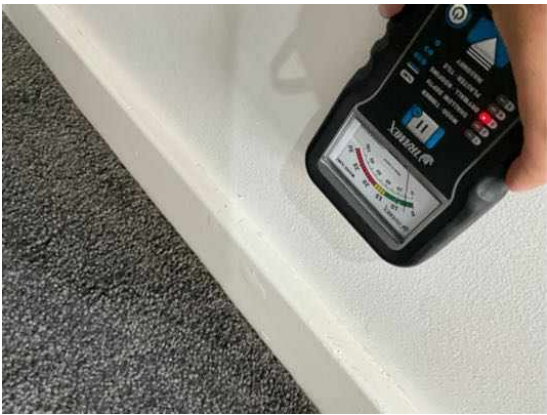
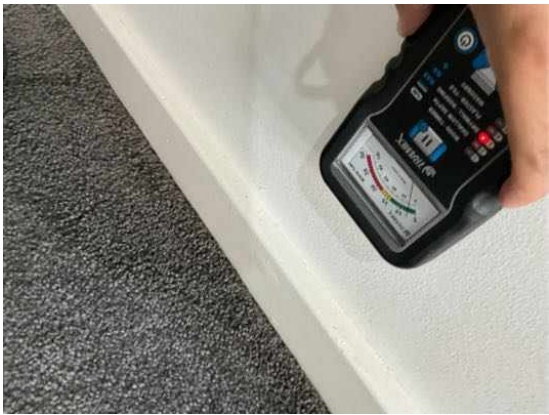
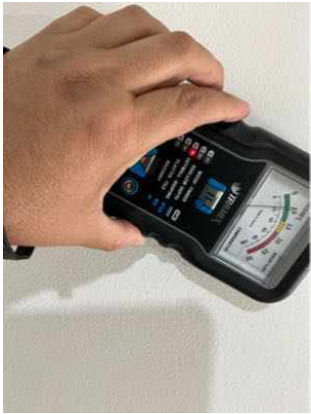
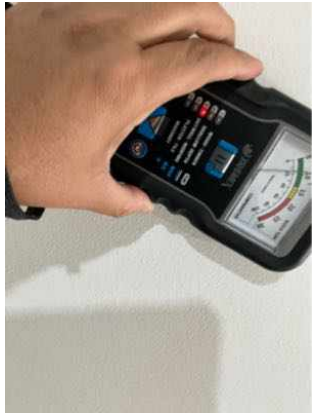
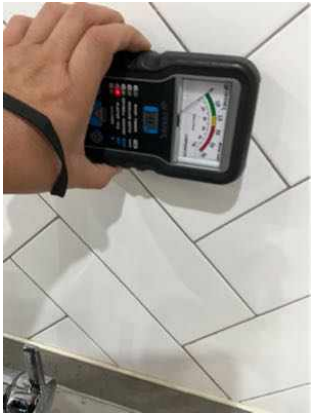
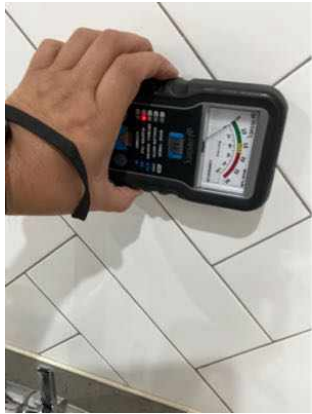
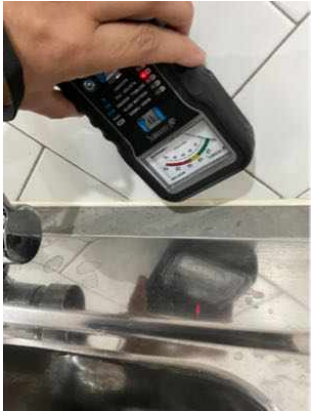
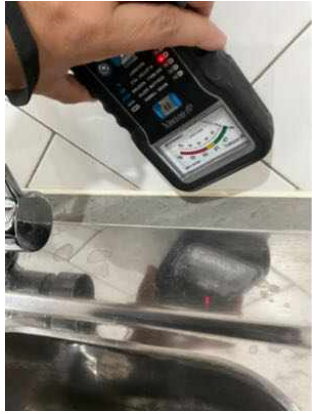
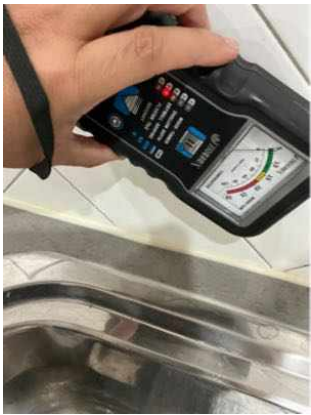
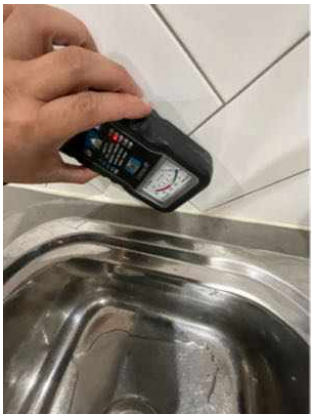
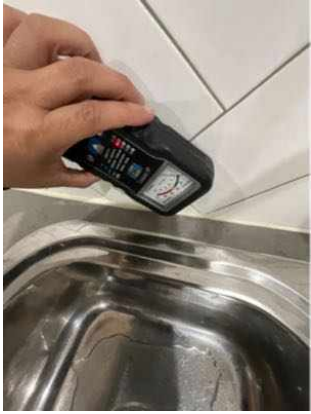
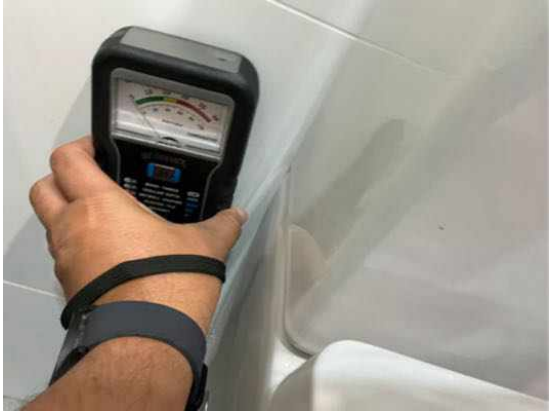
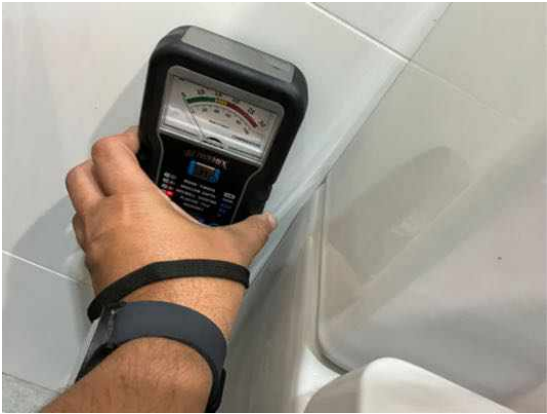
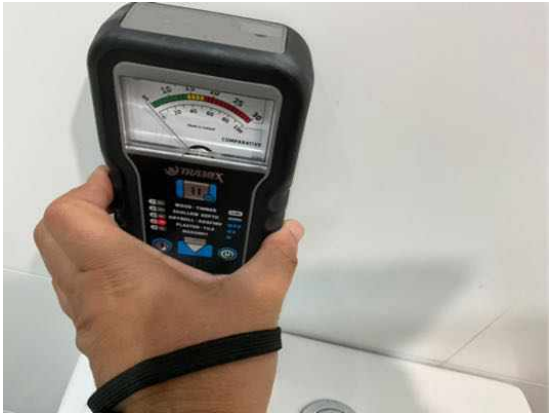
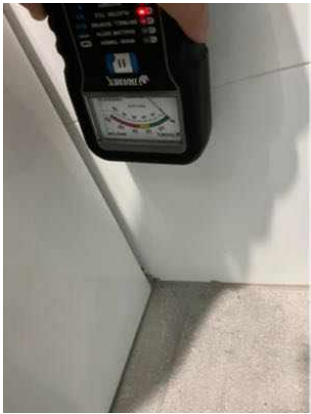
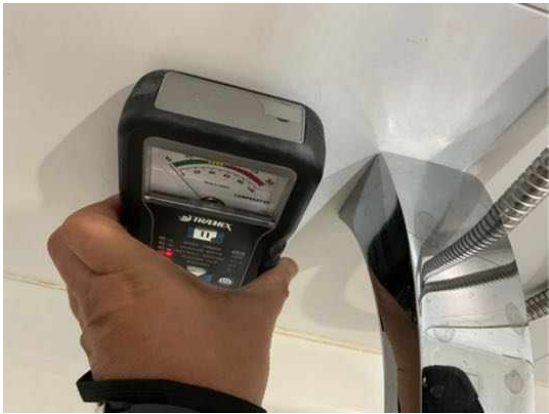
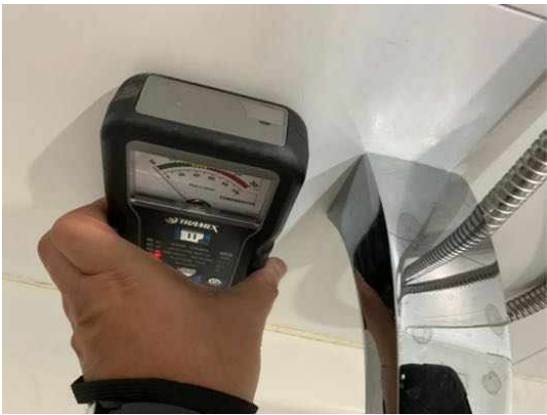
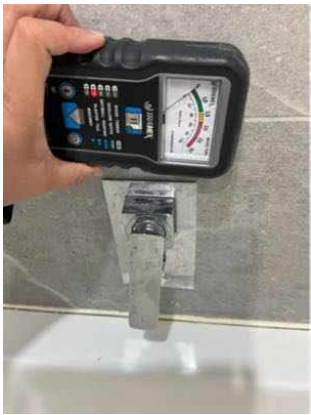
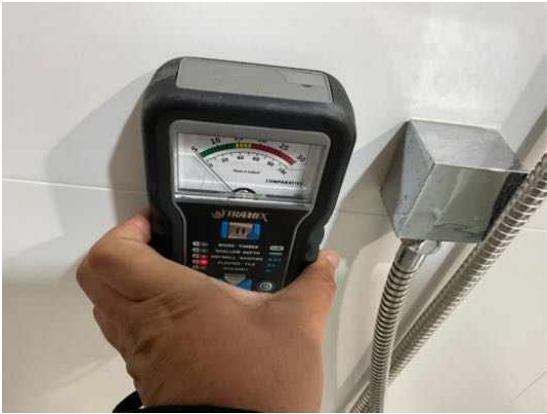
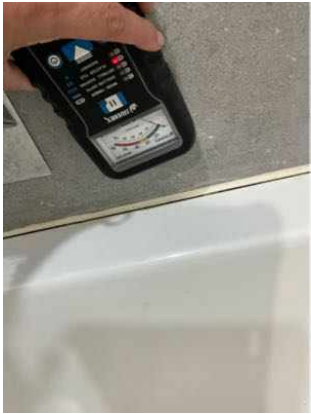
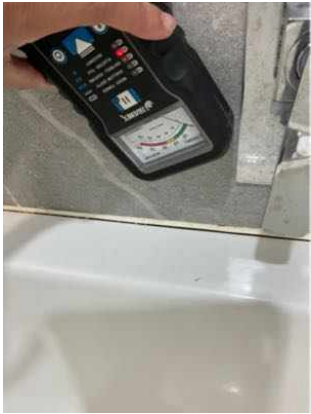
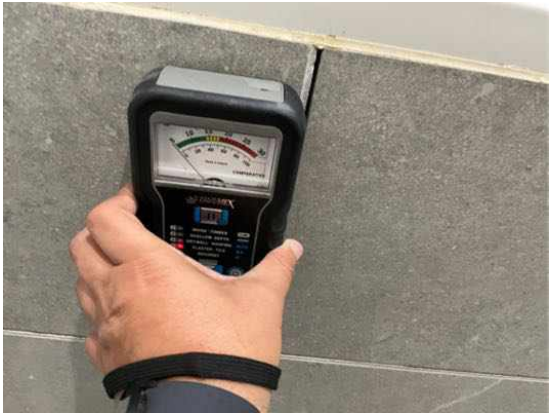
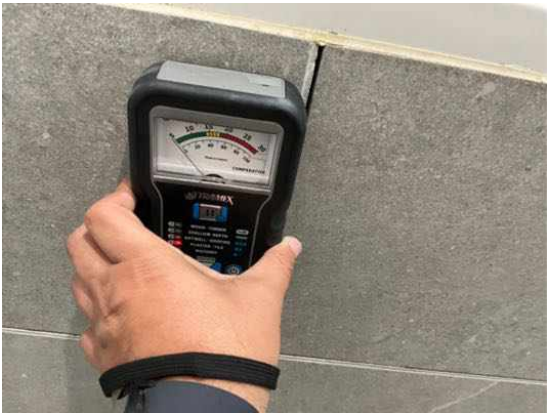
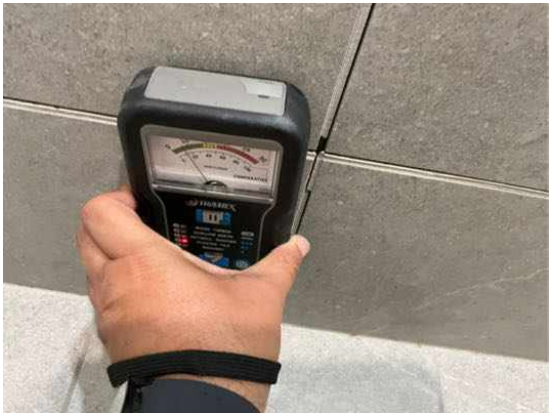
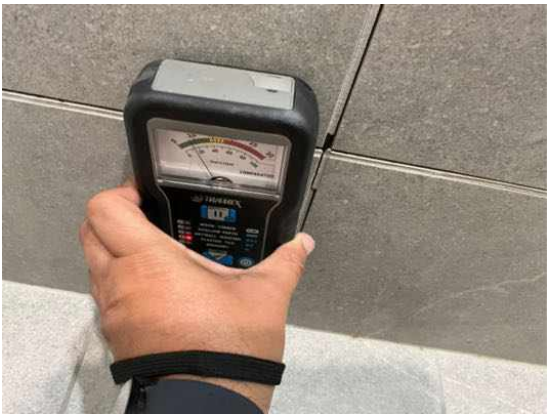
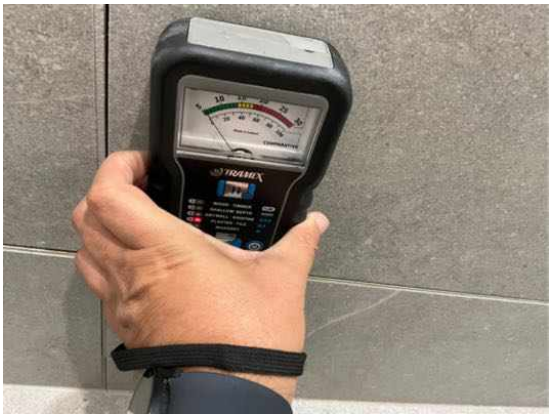
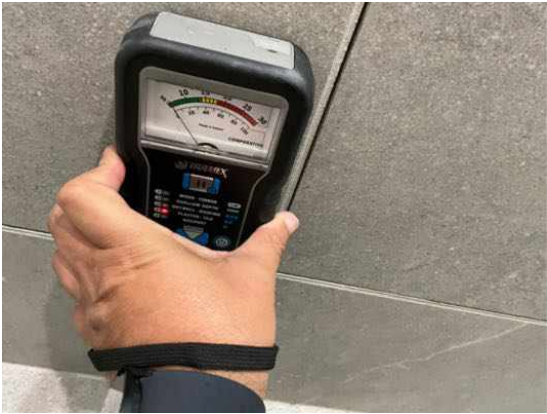
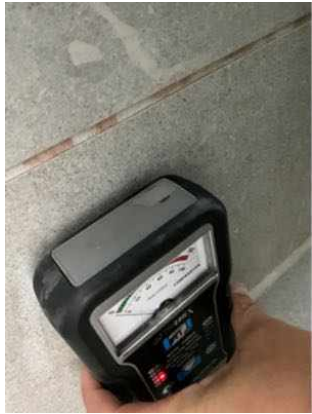
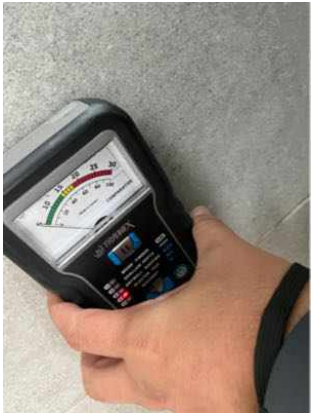
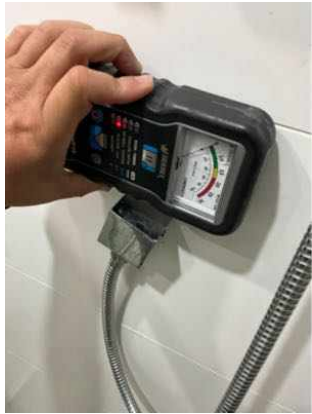
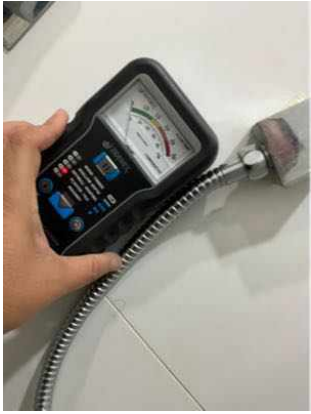
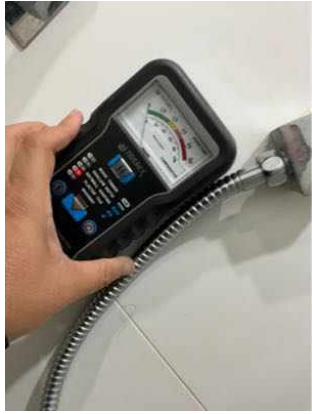
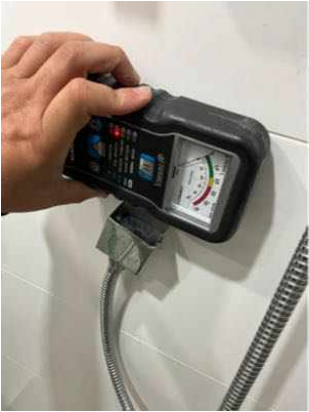
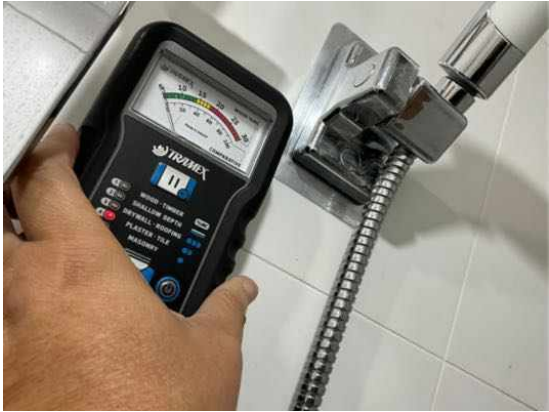
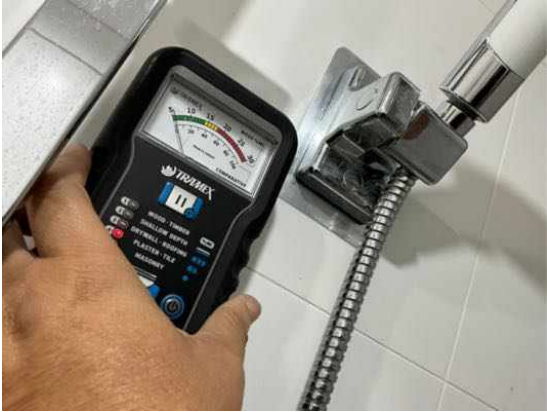
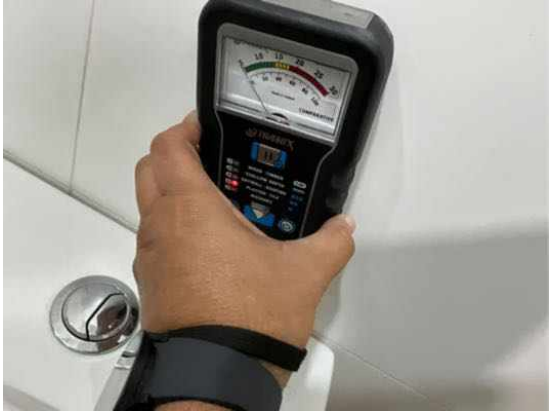
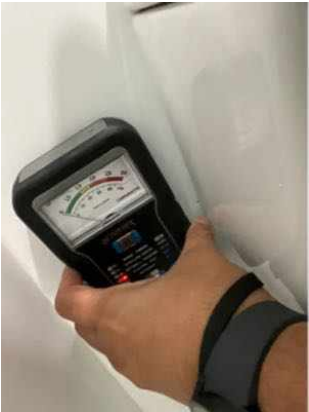
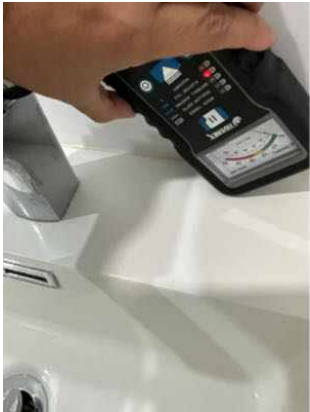
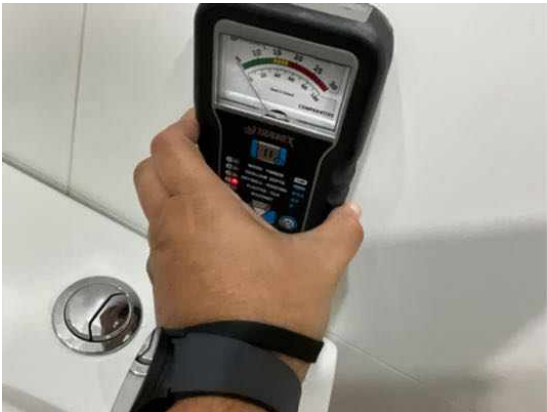
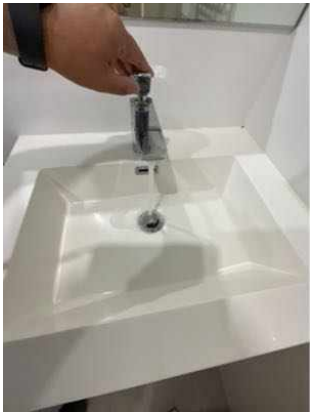
Building: Main Building  
Location: All Areas  
Finding: Additional Photos  
Information: Additional photos are provided for your general reference
